THE CATHERINE CREEK REACH ASSESSMENT GRANDE RONDE RIVER BASIN Tributary Habitat Program, Oregon

U.S. Department of the Interior
Bureau of Reclamation
Pacific Northwest Region
Boise, Idaho

December 2012

Tributary Habitat Program for the Federal Columbia River Power
System Biological Opinion, Grande Ronde River, OR
Pacific Northwest Region
Revision 1, SRH Report 2013-03

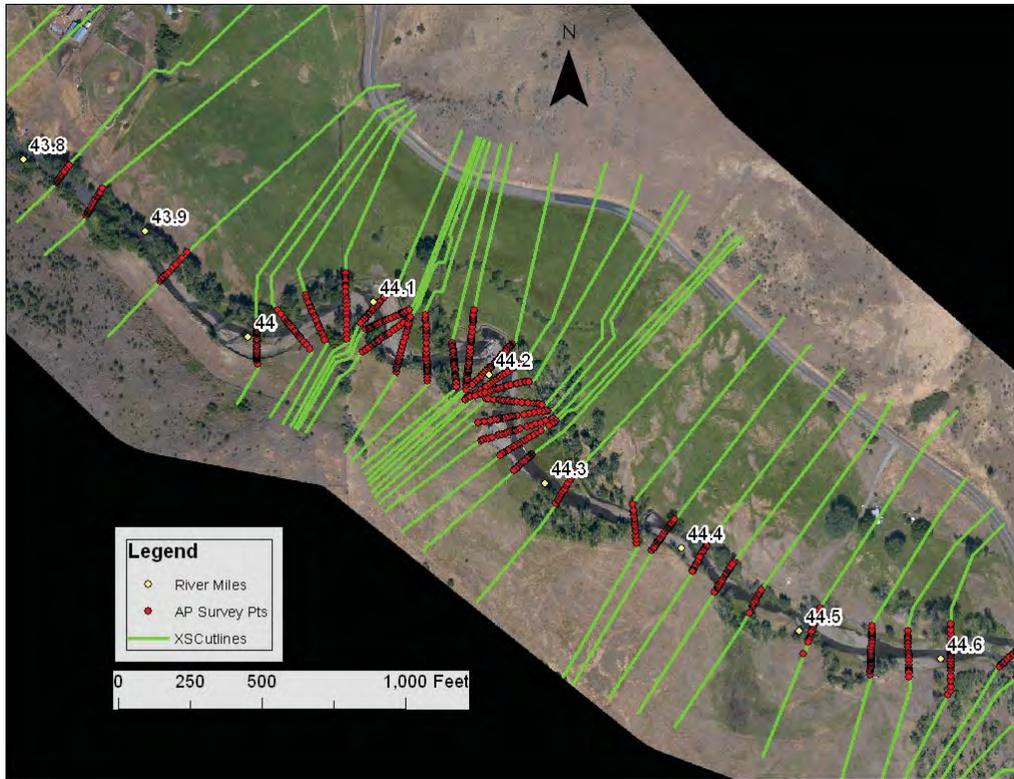
Figure 2. Example Portion of Catherine Creek with Delineated Cross Sections. The LiDAR data extents match those of the aerial photo which was taken during the same flight (Watershed Sciences, 2009).

HEC-GeoRAS is an interface between HEC-RAS and Geographic Information System (GIS) that provides tools to process geospatial data for use with HEC-RAS. The HEC-GeoRAS program (Version 10 for ArcGIS 10) was utilized to delineate cross sections, banklines, flowpaths, and a centerline along the modeled reaches. A total of 207 cross-section lines, spaced from 37 feet to 2,141 feet apart, with an average of 265 feet apart were applied to cover the 10.3 river miles modeled along Catherine Creek. Figure 2 shows a portion of the cross sections delineated upstream of Union, OR near RM 44.

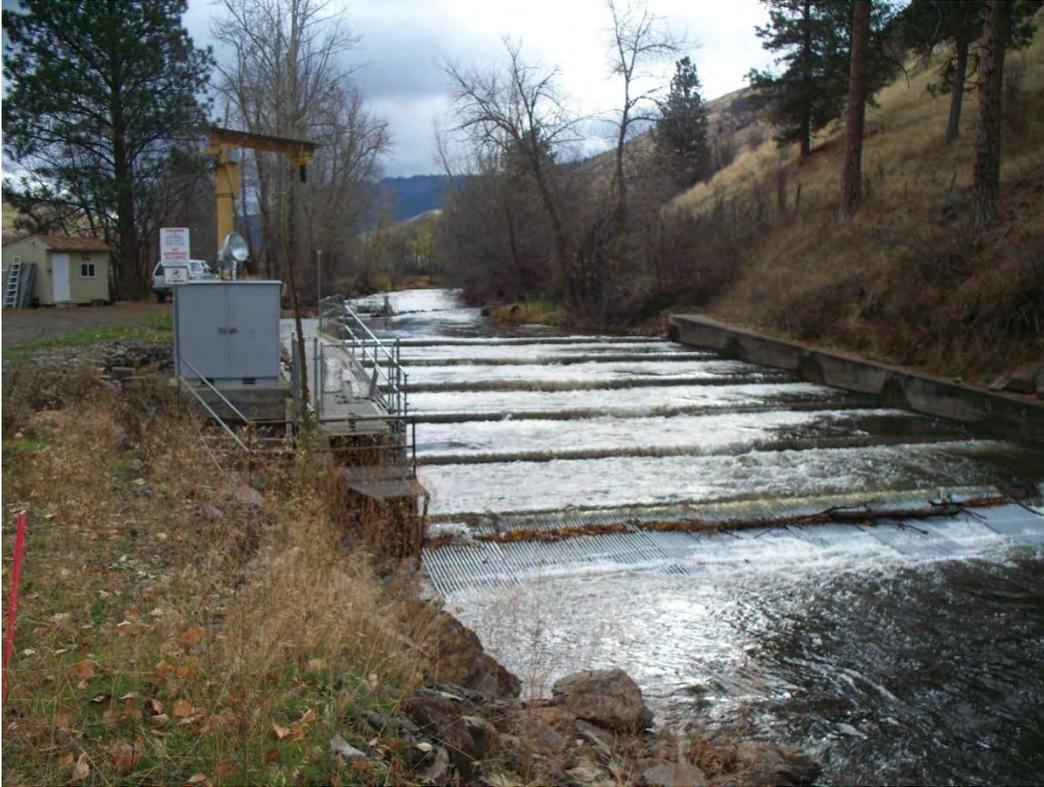
Figure 3. Catherine Creek Adult Collection facility (CCACF) looking upstream. Photo courtesy of AP, taken on November 16, 2010.

Six diversion dams were included in the updated HEC-RAS model. Only the grade control portion of the diversion dams were included. For example, the Catherine Creek Adult Collection Facility (CCACF) is a series of notched weirs (shown in Figure 3). To include this structure in HEC-RAS, the four adjacent surveyed cross sections were added to the HEC-RAS model. The surveyed cross sections were also supplemented with LiDAR topography data on the adjacent floodplains. Then, the highest weir elevations (typically the most upstream), width, and dimensions were input as an inline weir structure in HEC-RAS. The highest weir acts as a water surface control upstream of the diversion and the other weirs have only a small local effect on the hydraulics.

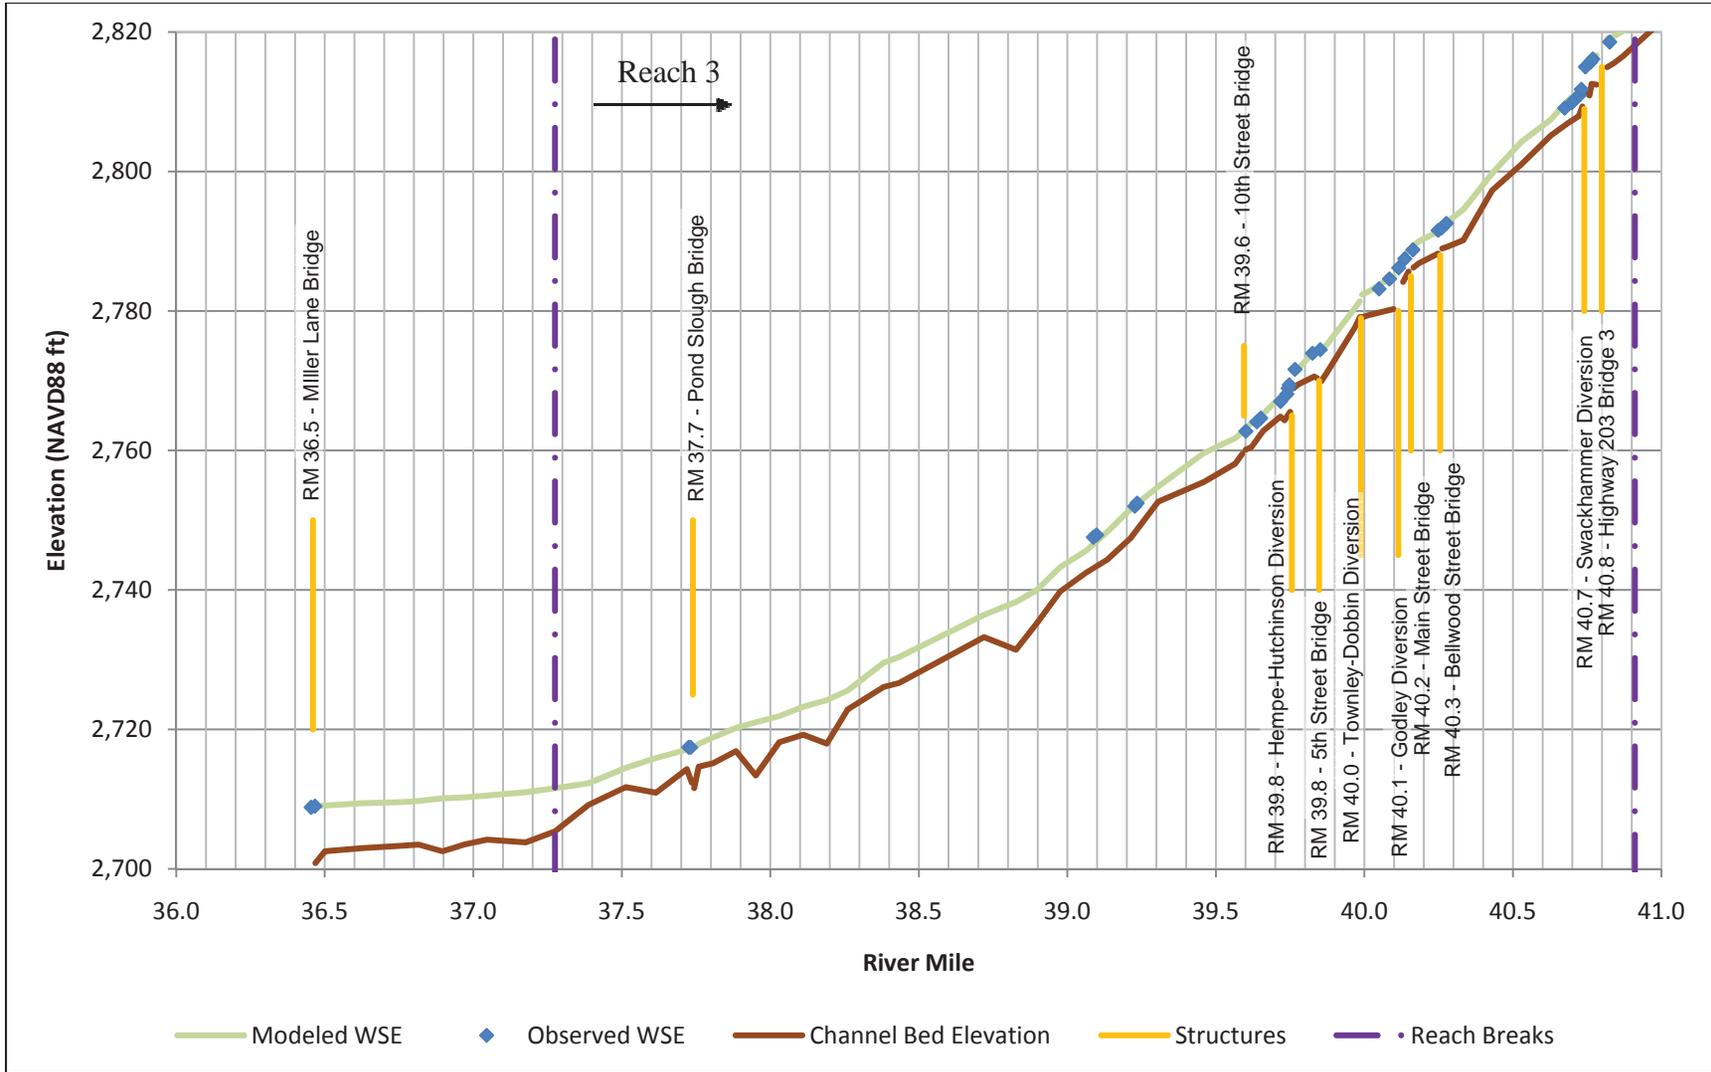
Figure 4. Modeled and observed water surface elevations along Catherine Creek Reach 3 (RM 36.5 to 41).

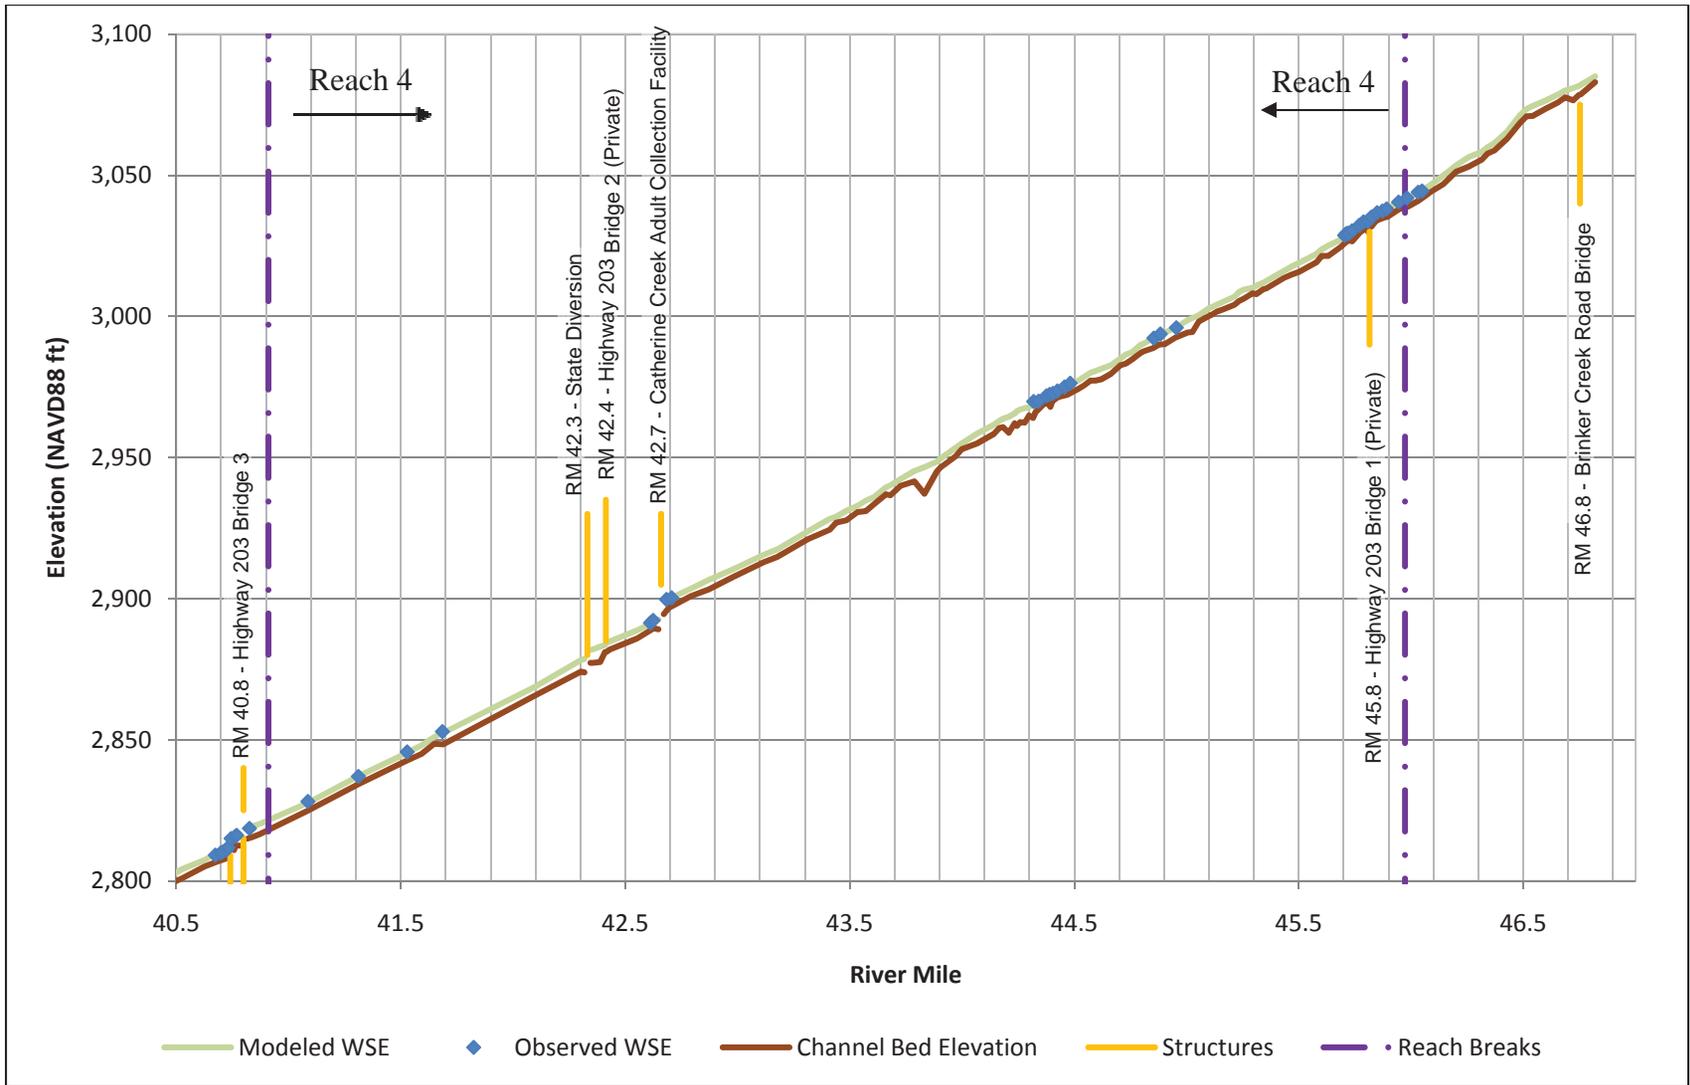
Figure 5. Modeled and observed water surface elevations along Catherine Creek Reach 4 (RM 41 to 46.8).

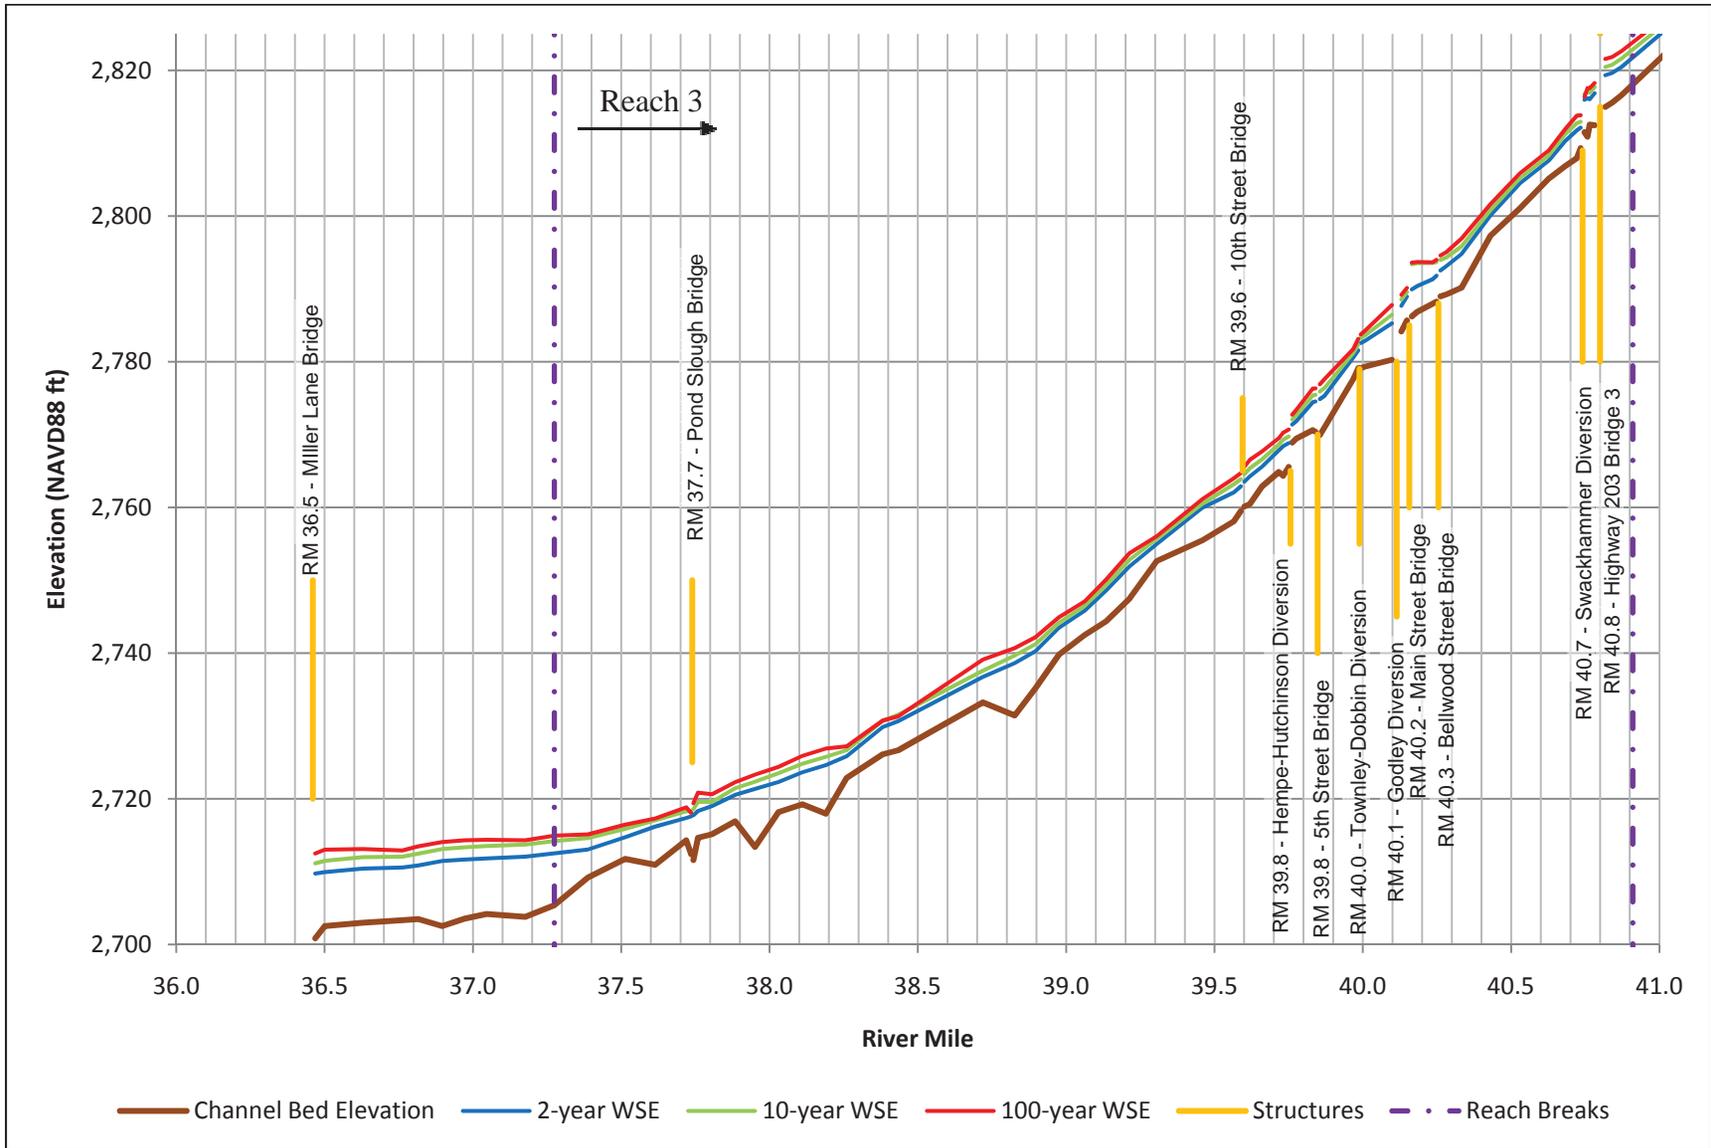
Figure 6. Computed Water Surface Profiles for Reach 3 (RM 36.5 to 41)

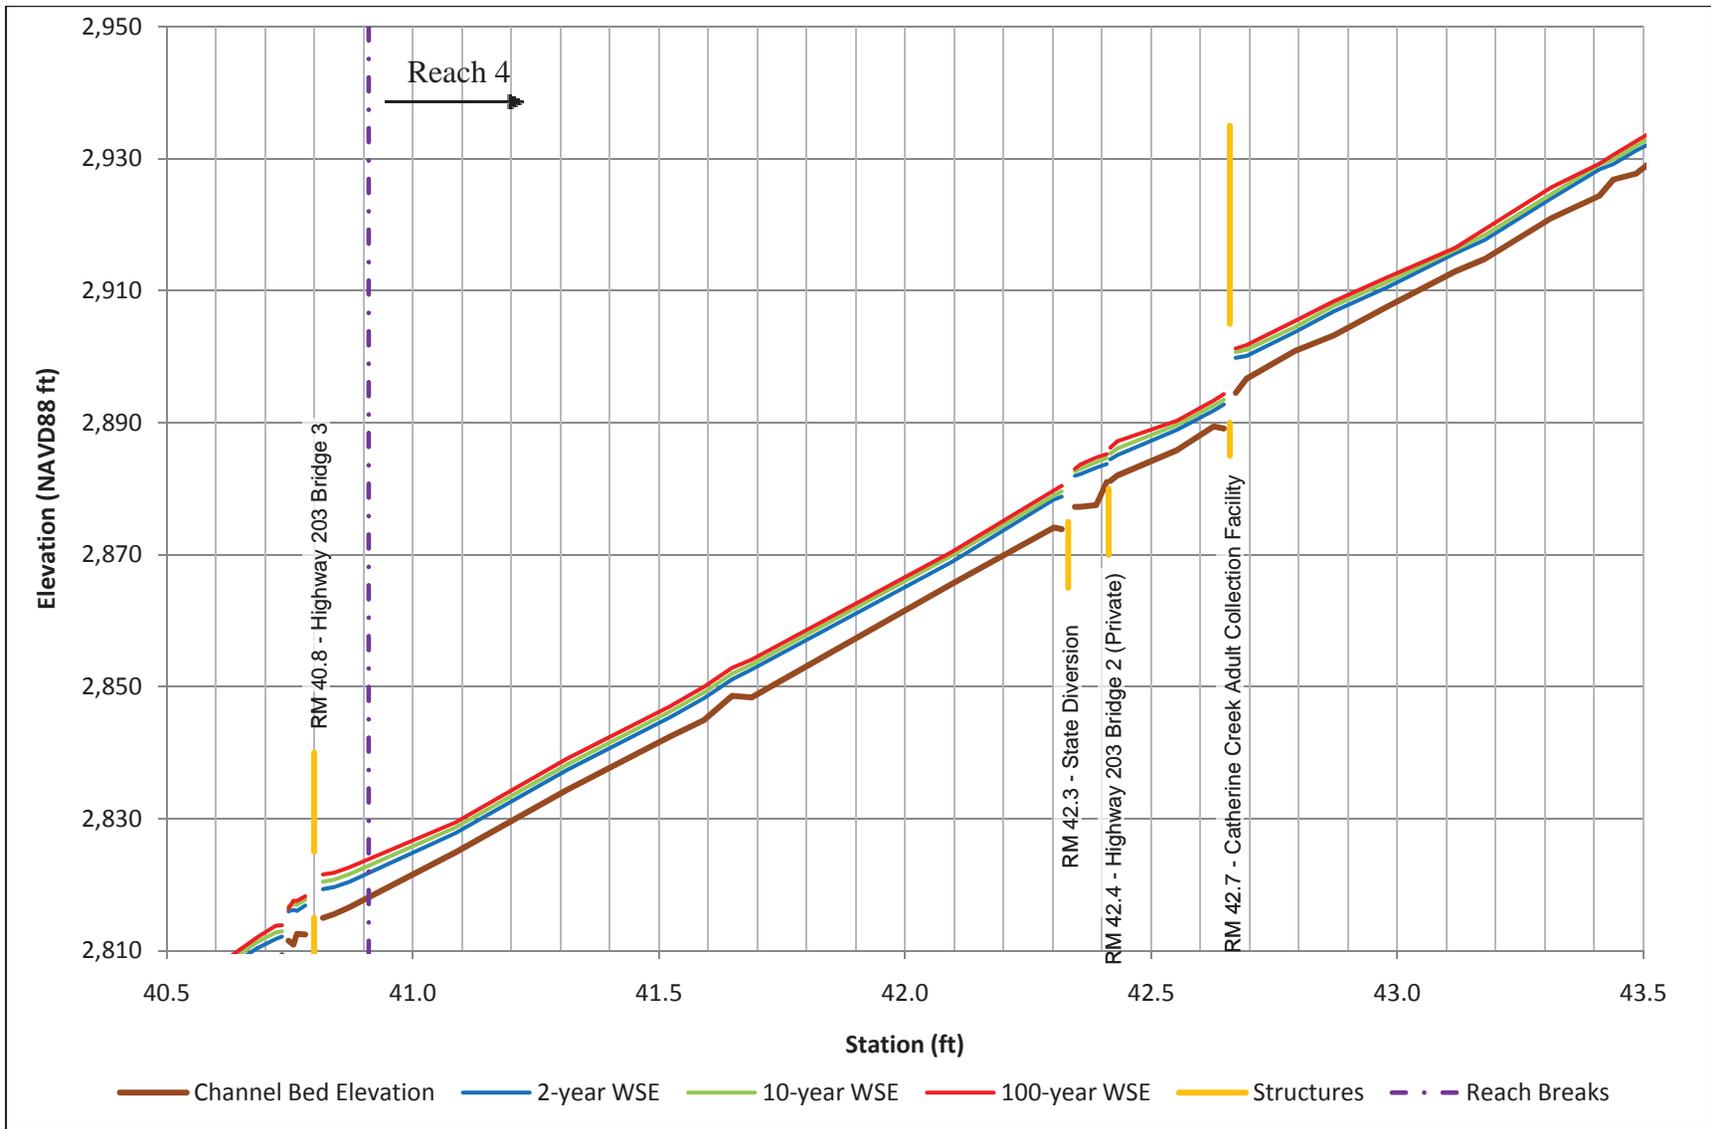
Figure 7. Computed Water Surface Profiles for the lower end of Reach 4 (RM 41 to RM 43.5).

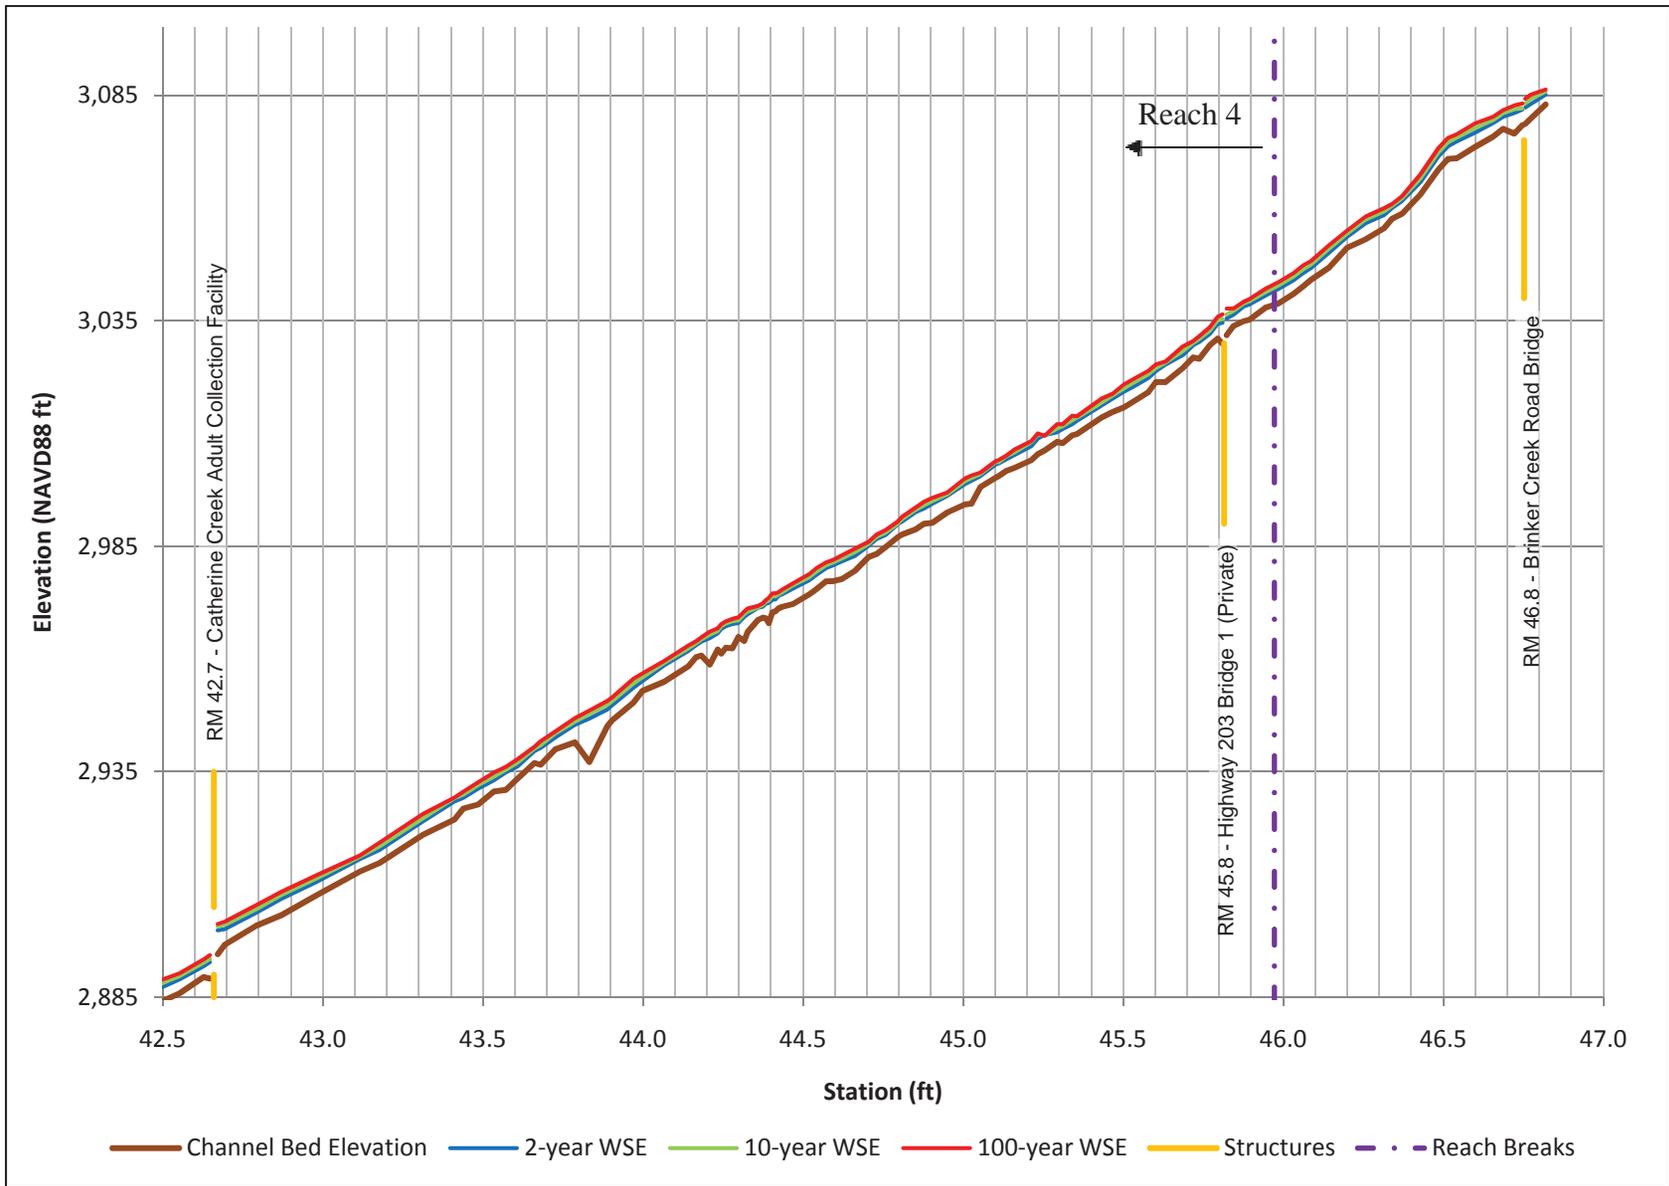
Figure 8. Computed Water Surface Profiles for upper end of Reach 4 (RM 42.5 to RM 47).

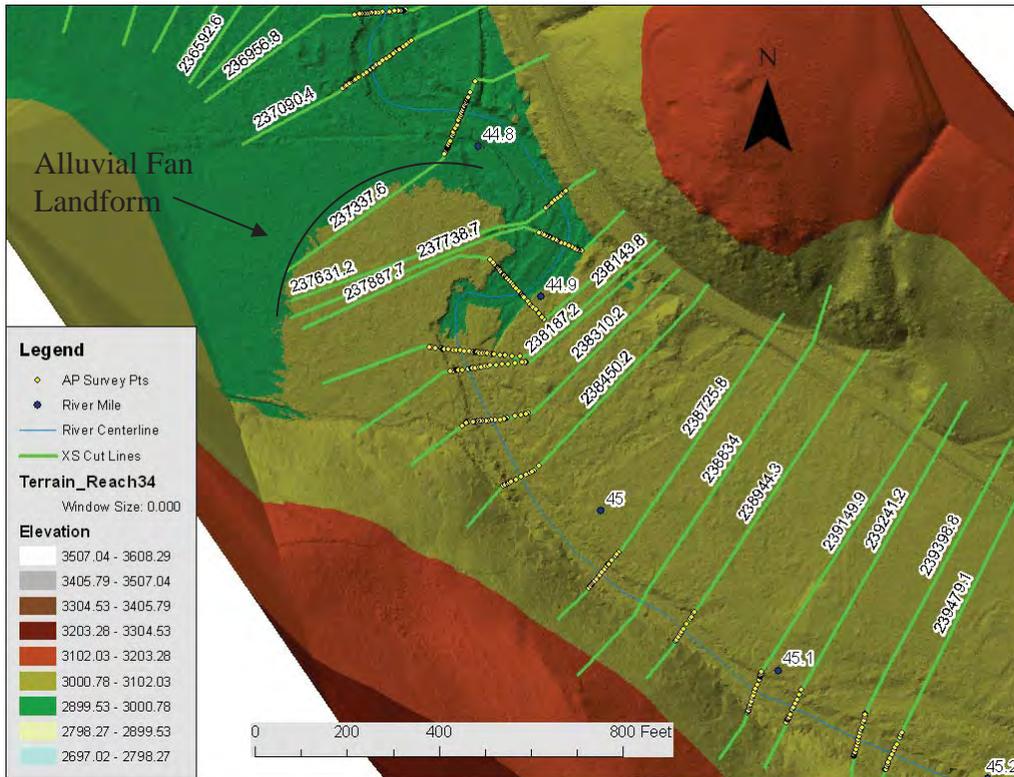
Figure 9. Alluvial Fan Landform Observed in LiDAR Data near RM 44.9.

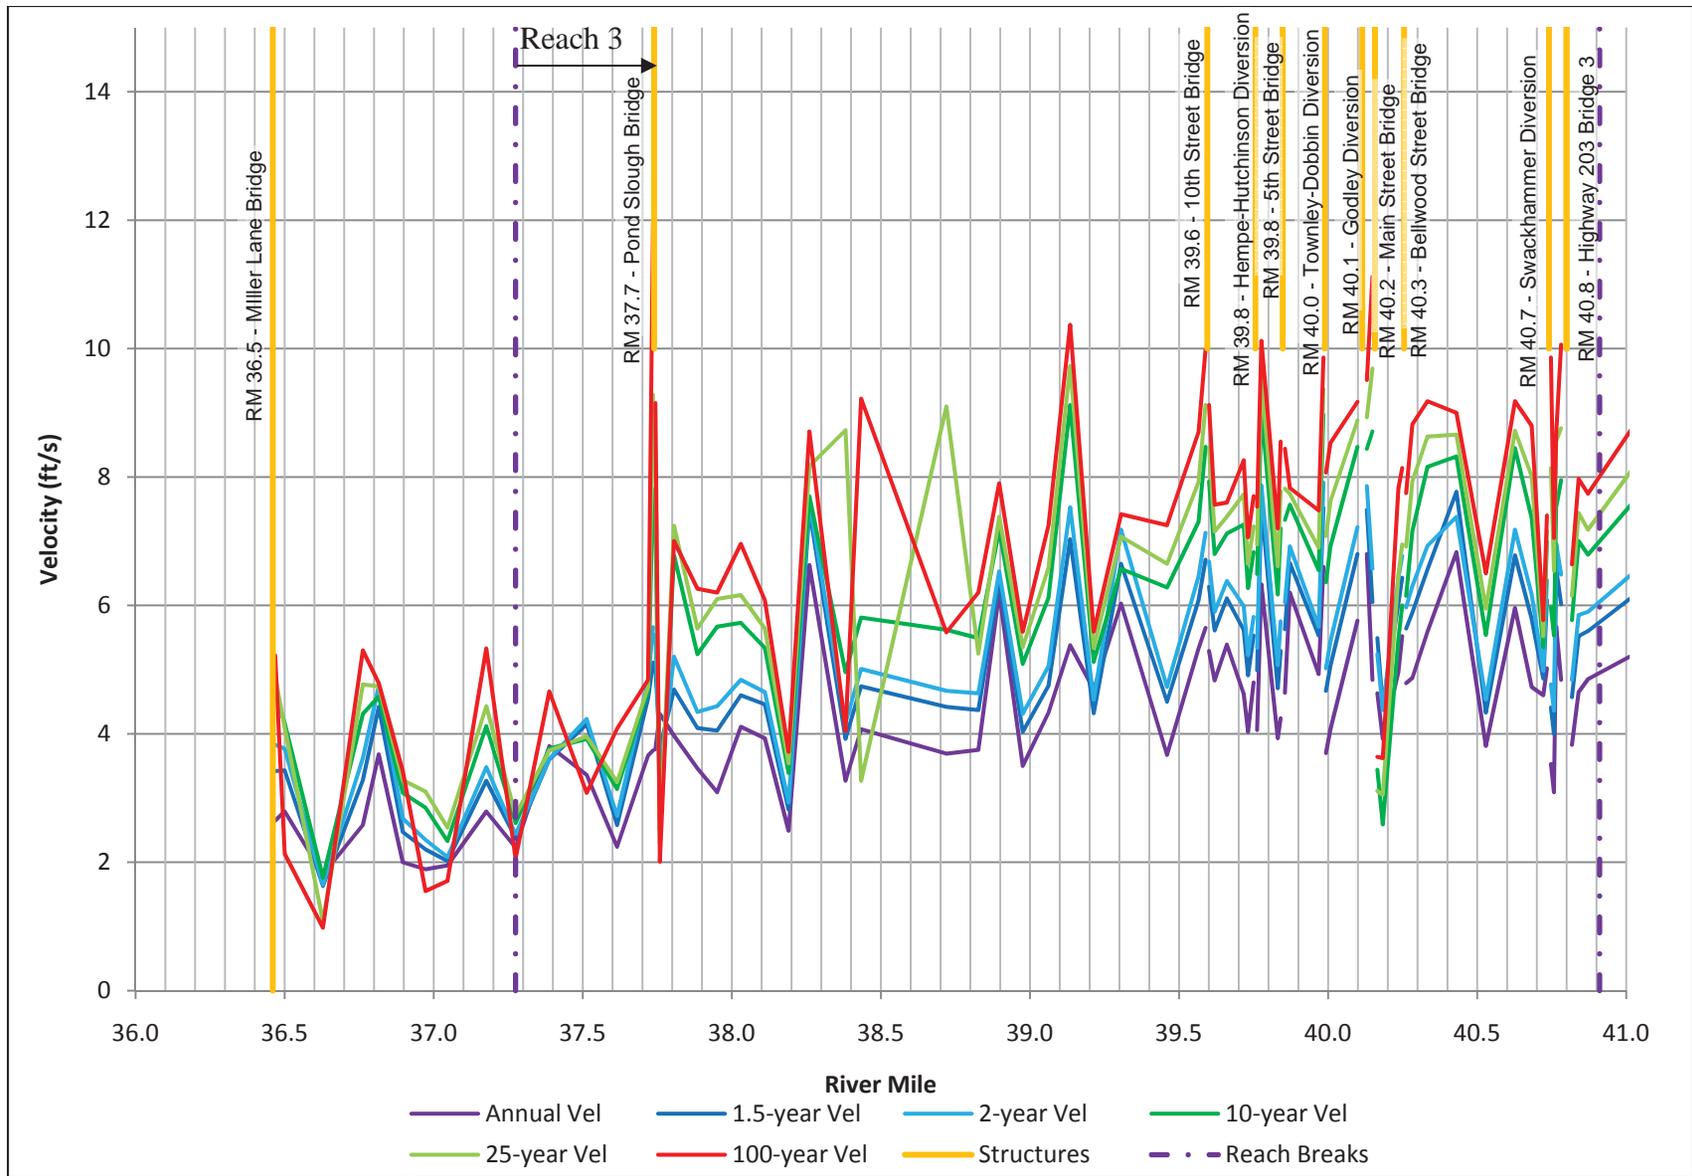
Figure 10. Computed Average Channel Velocities for Reach 3.

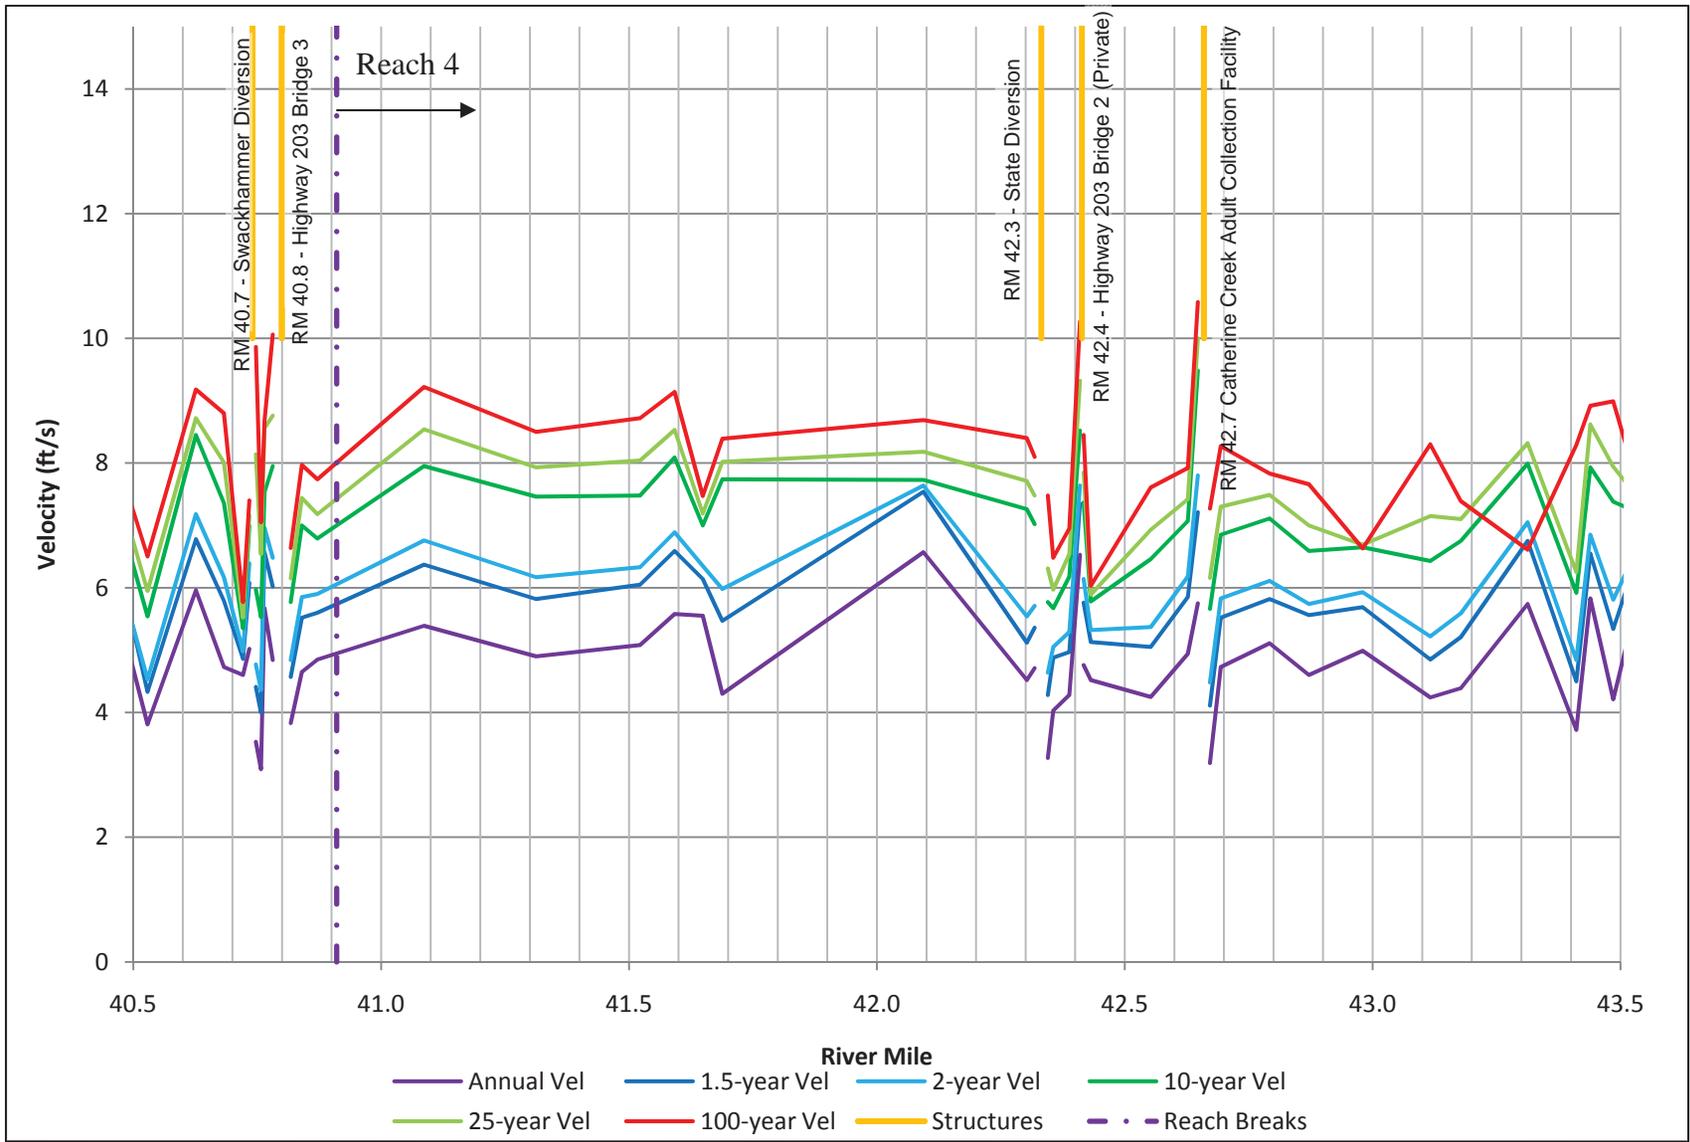
Figure 11. Computed Average Channel Velocities for lower Reach 4 (RM 41 to 43.5).

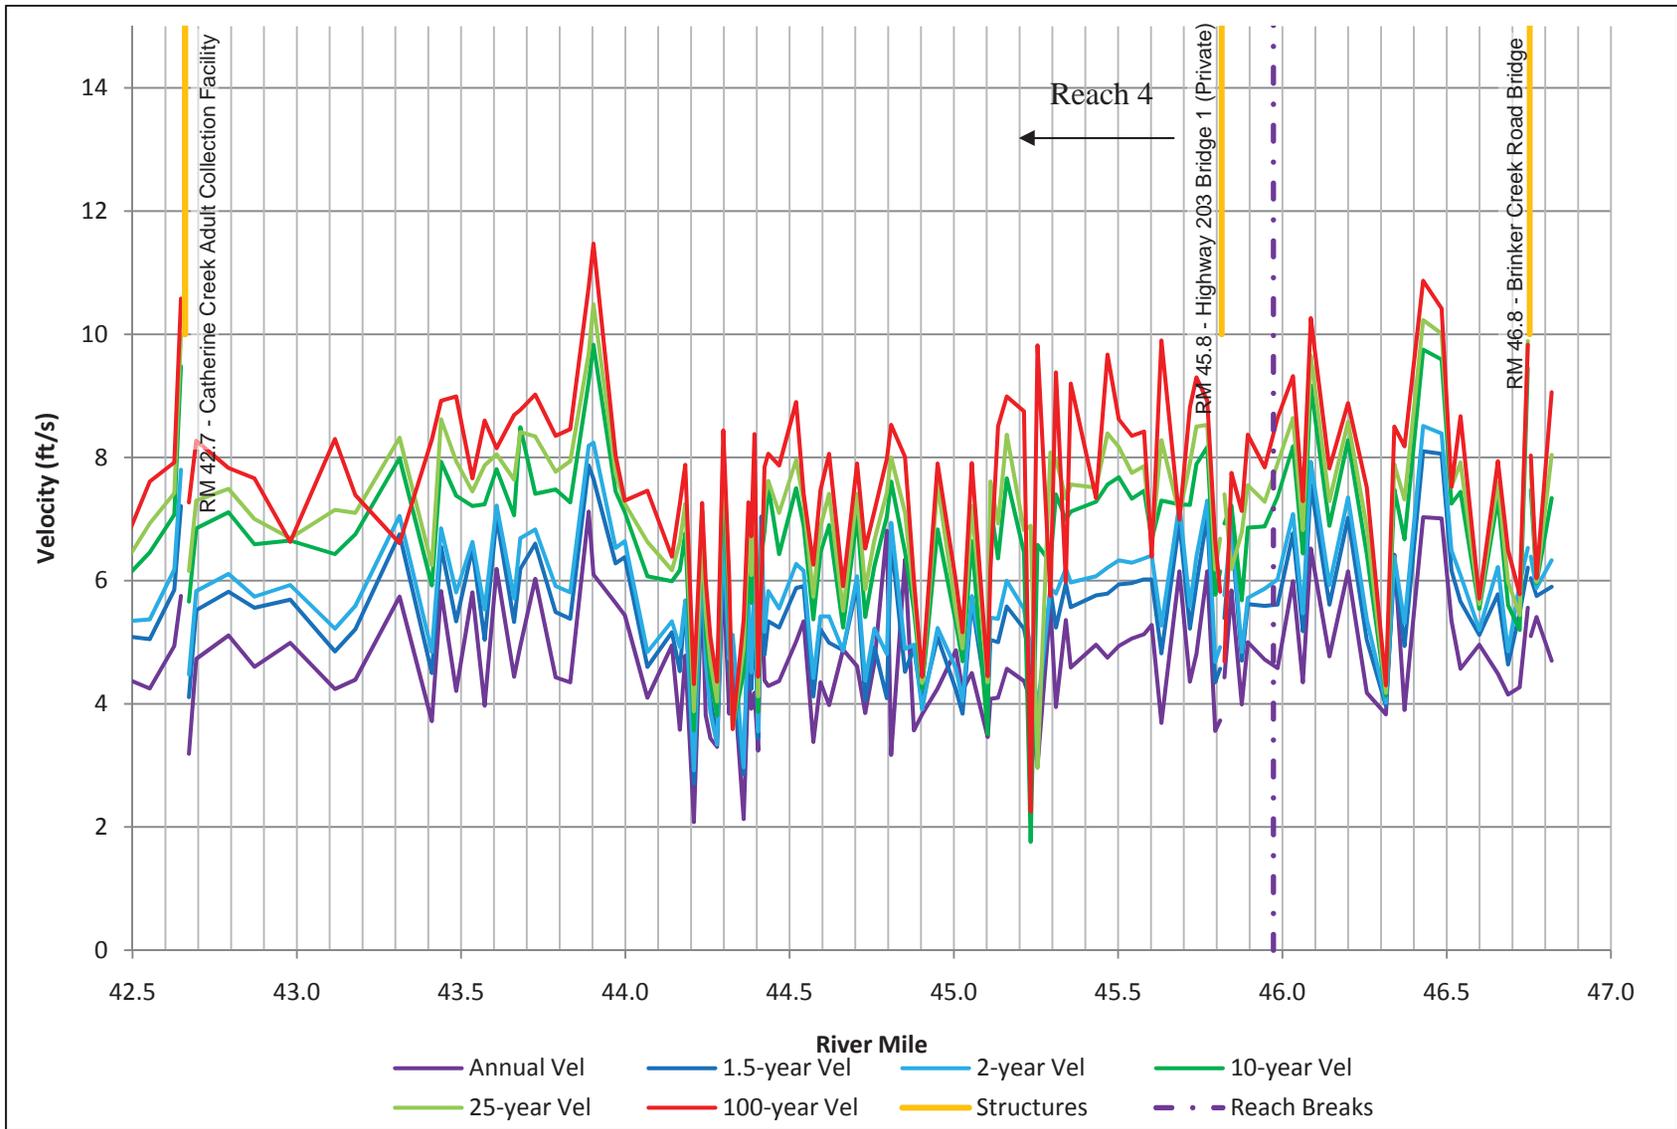
Figure 12. Computed Average Channel Velocities for upper Reach 4 (RM 42.5 to 47).

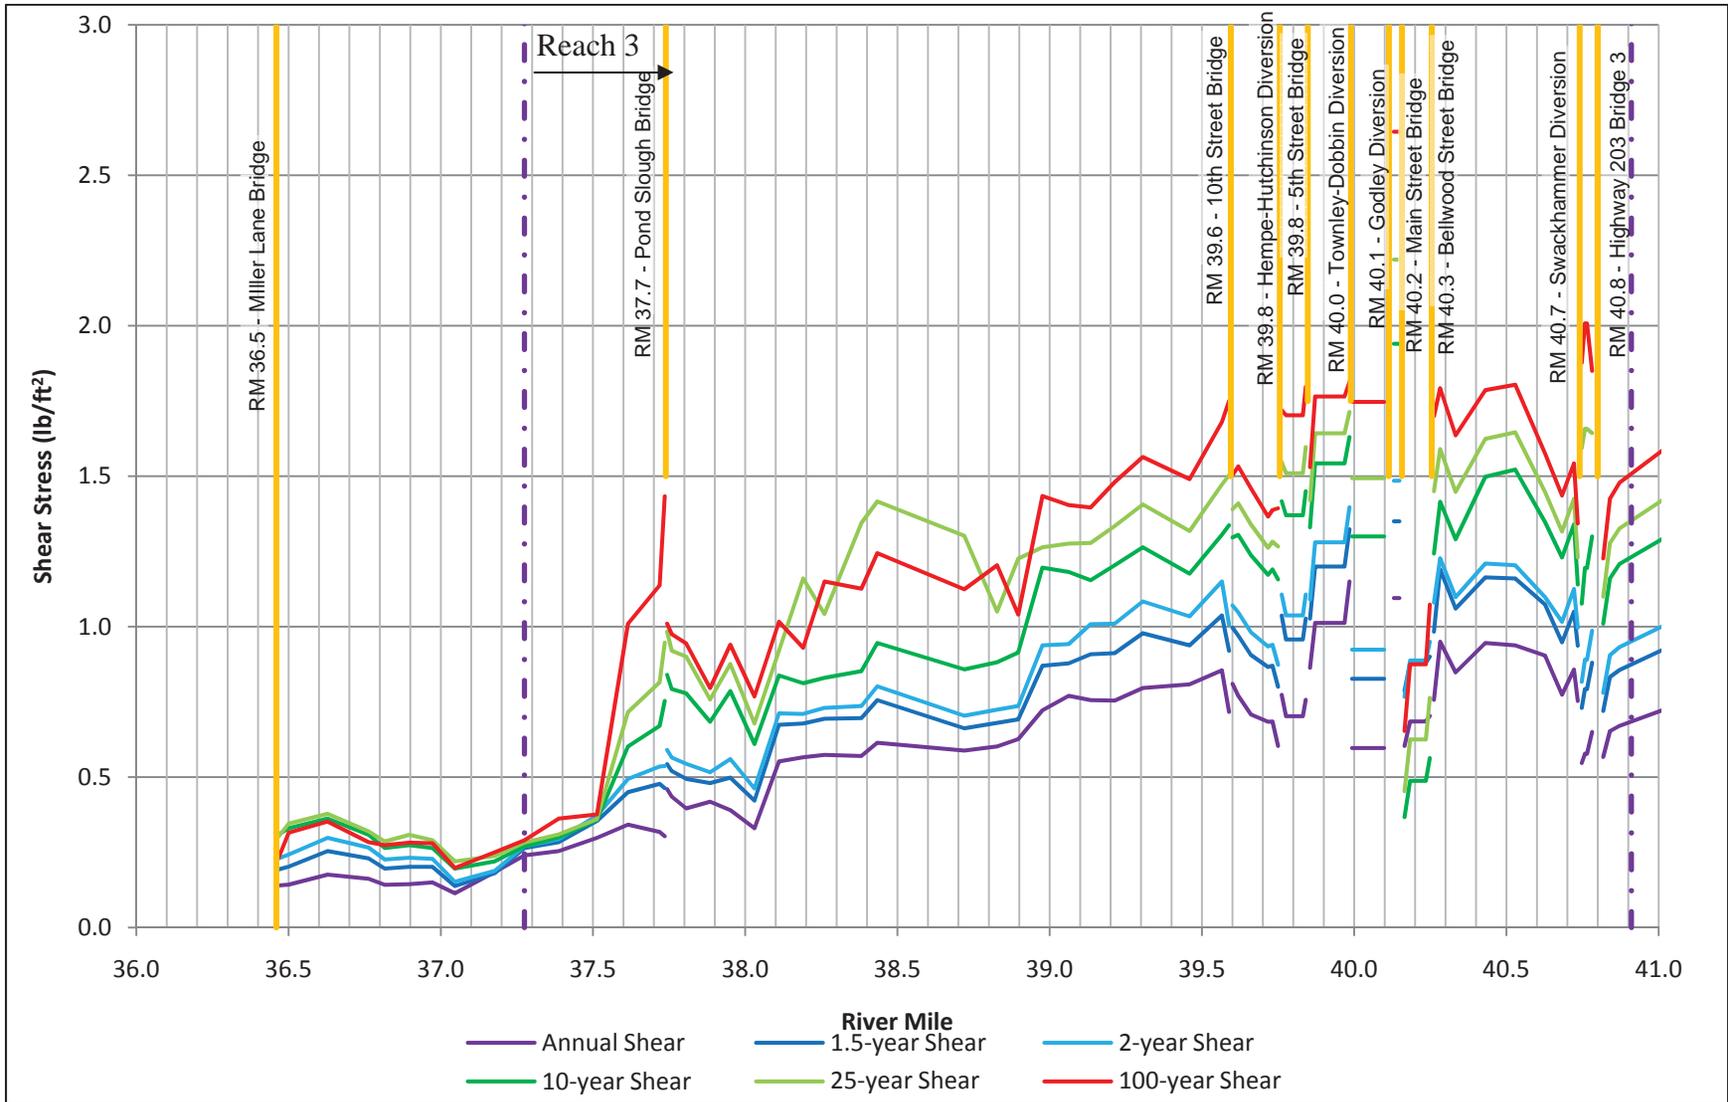
Figure 13. Computed Average Channel Shear Stress for Reach 3.

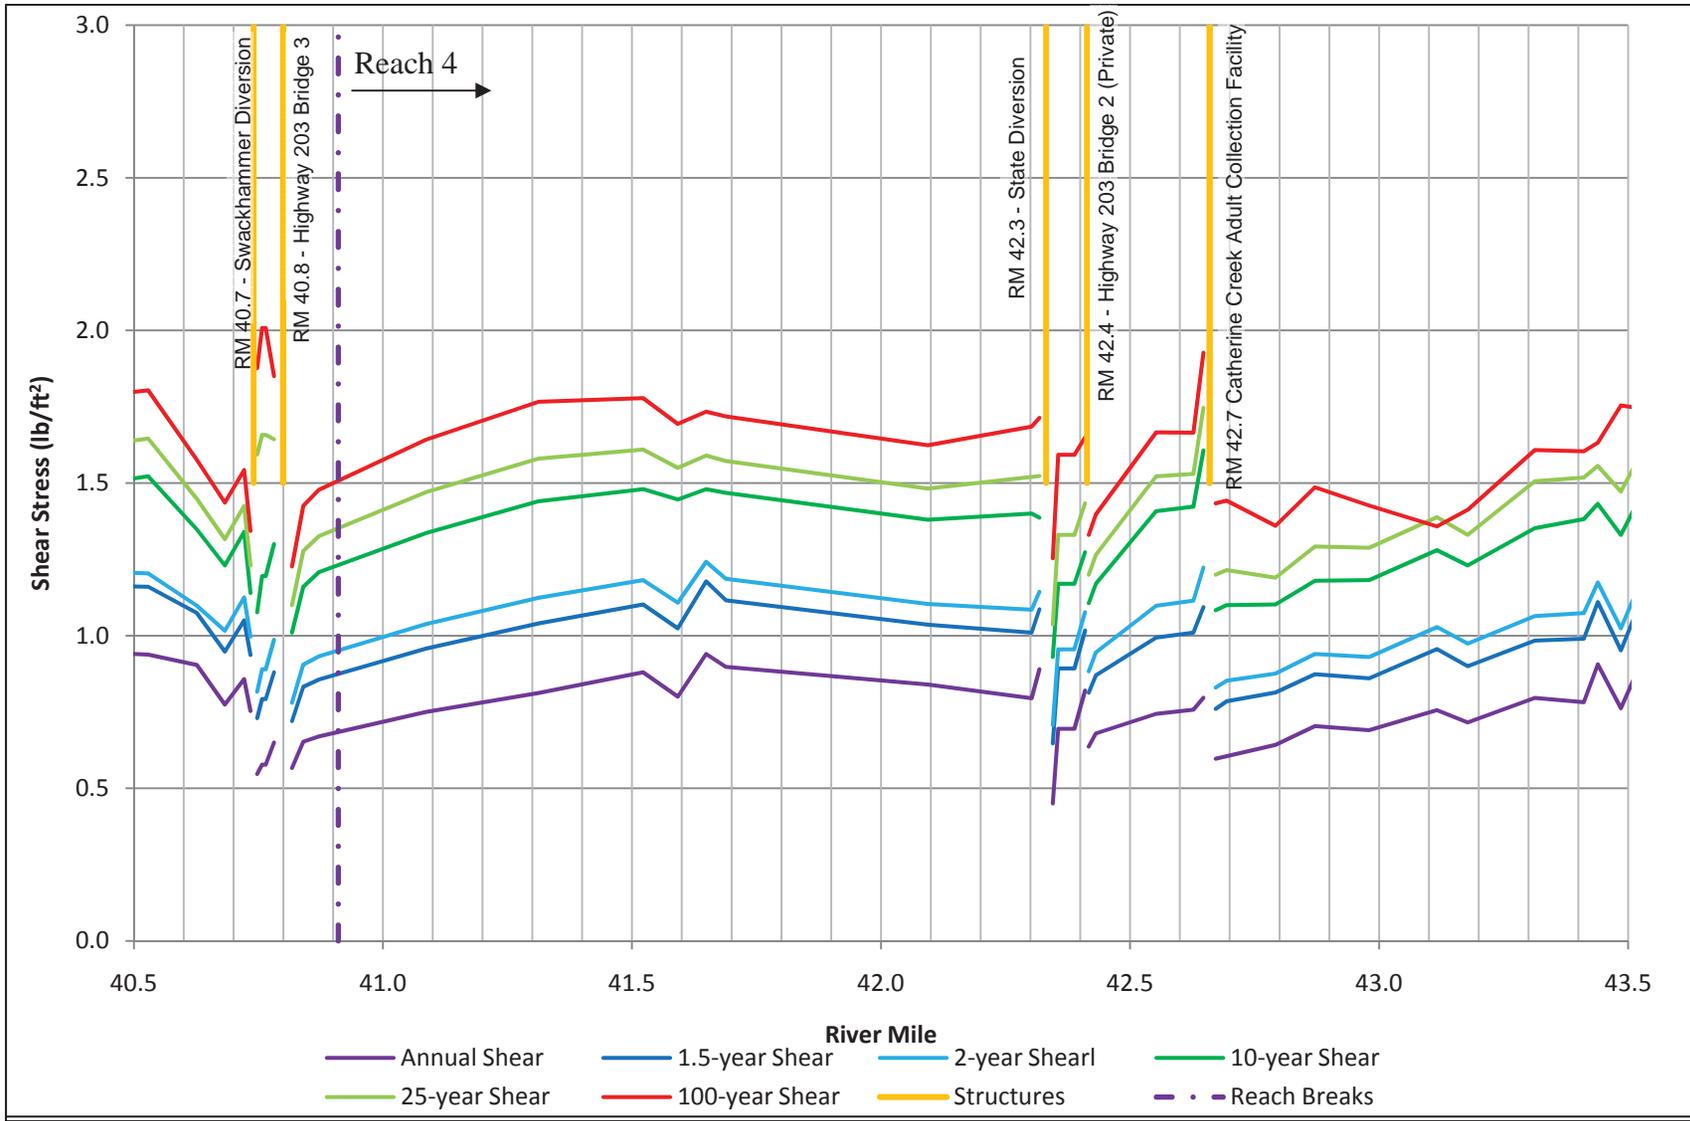
Figure 14. Computed Average Channel Shear Stress for lower Reach 4 (RM 41 to 43.5).
