THE CATHERINE CREEK REACH ASSESSMENT GRANDE RONDE RIVER BASIN Tributary Habitat Program, Oregon

U.S. Department of the Interior
Bureau of Reclamation
Pacific Northwest Region
Boise, Idaho

December 2012

Tributary Habitat Program for the Federal Columbia River Power
System Biological Opinion, Grande Ronde River, OR
Pacific Northwest Region
Revision 1, SRH Report 2013-03

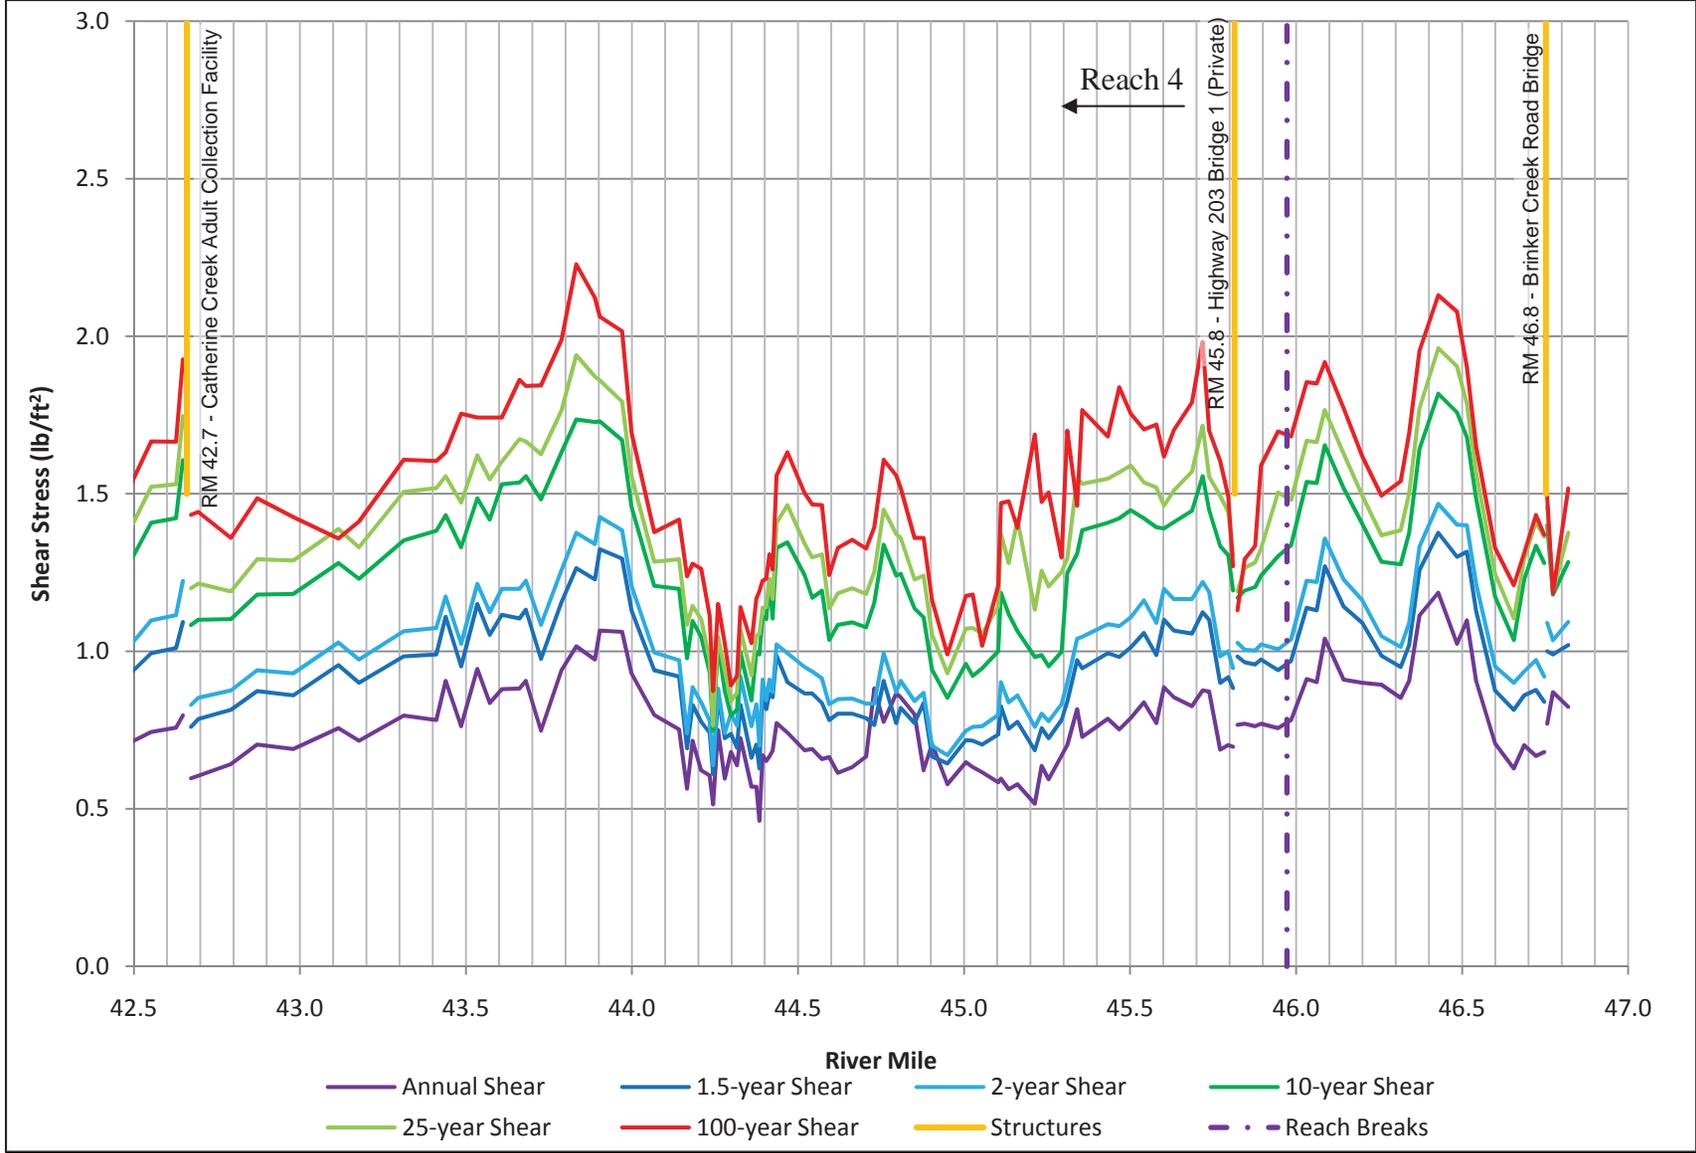
Figure 15. Computed Average Channel Shear Stress for upper Reach 4 (RM 42.5 to 47).

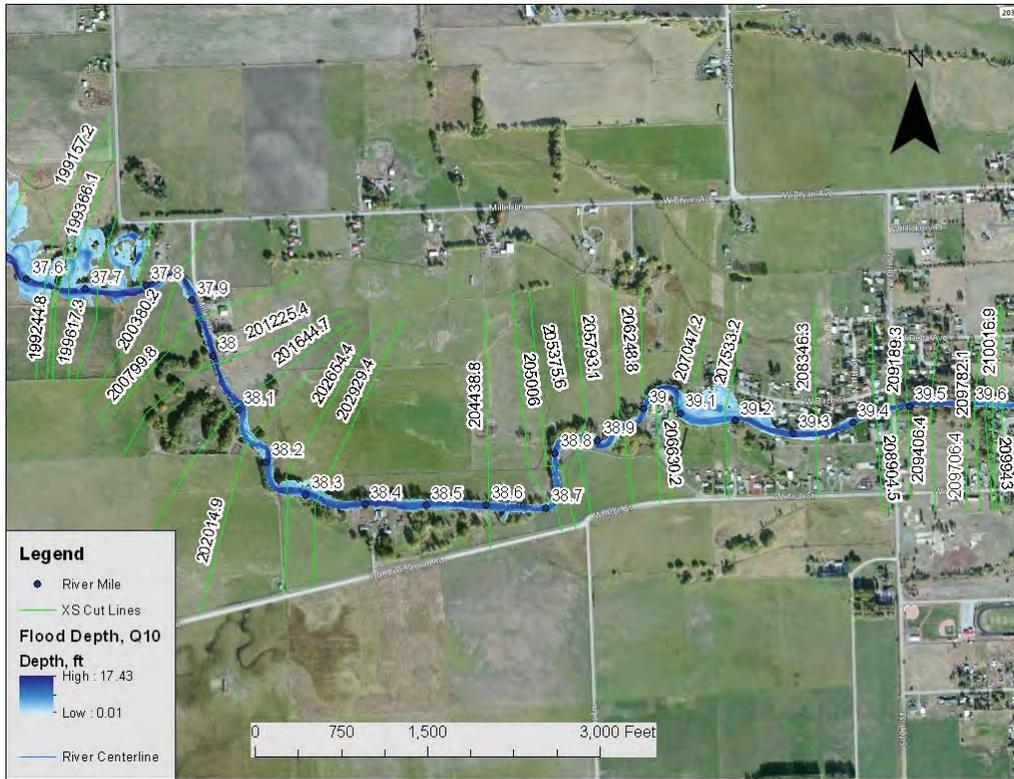
Figure 16. Example Map of Flood Depths in Reach 3 of Catherine Creek

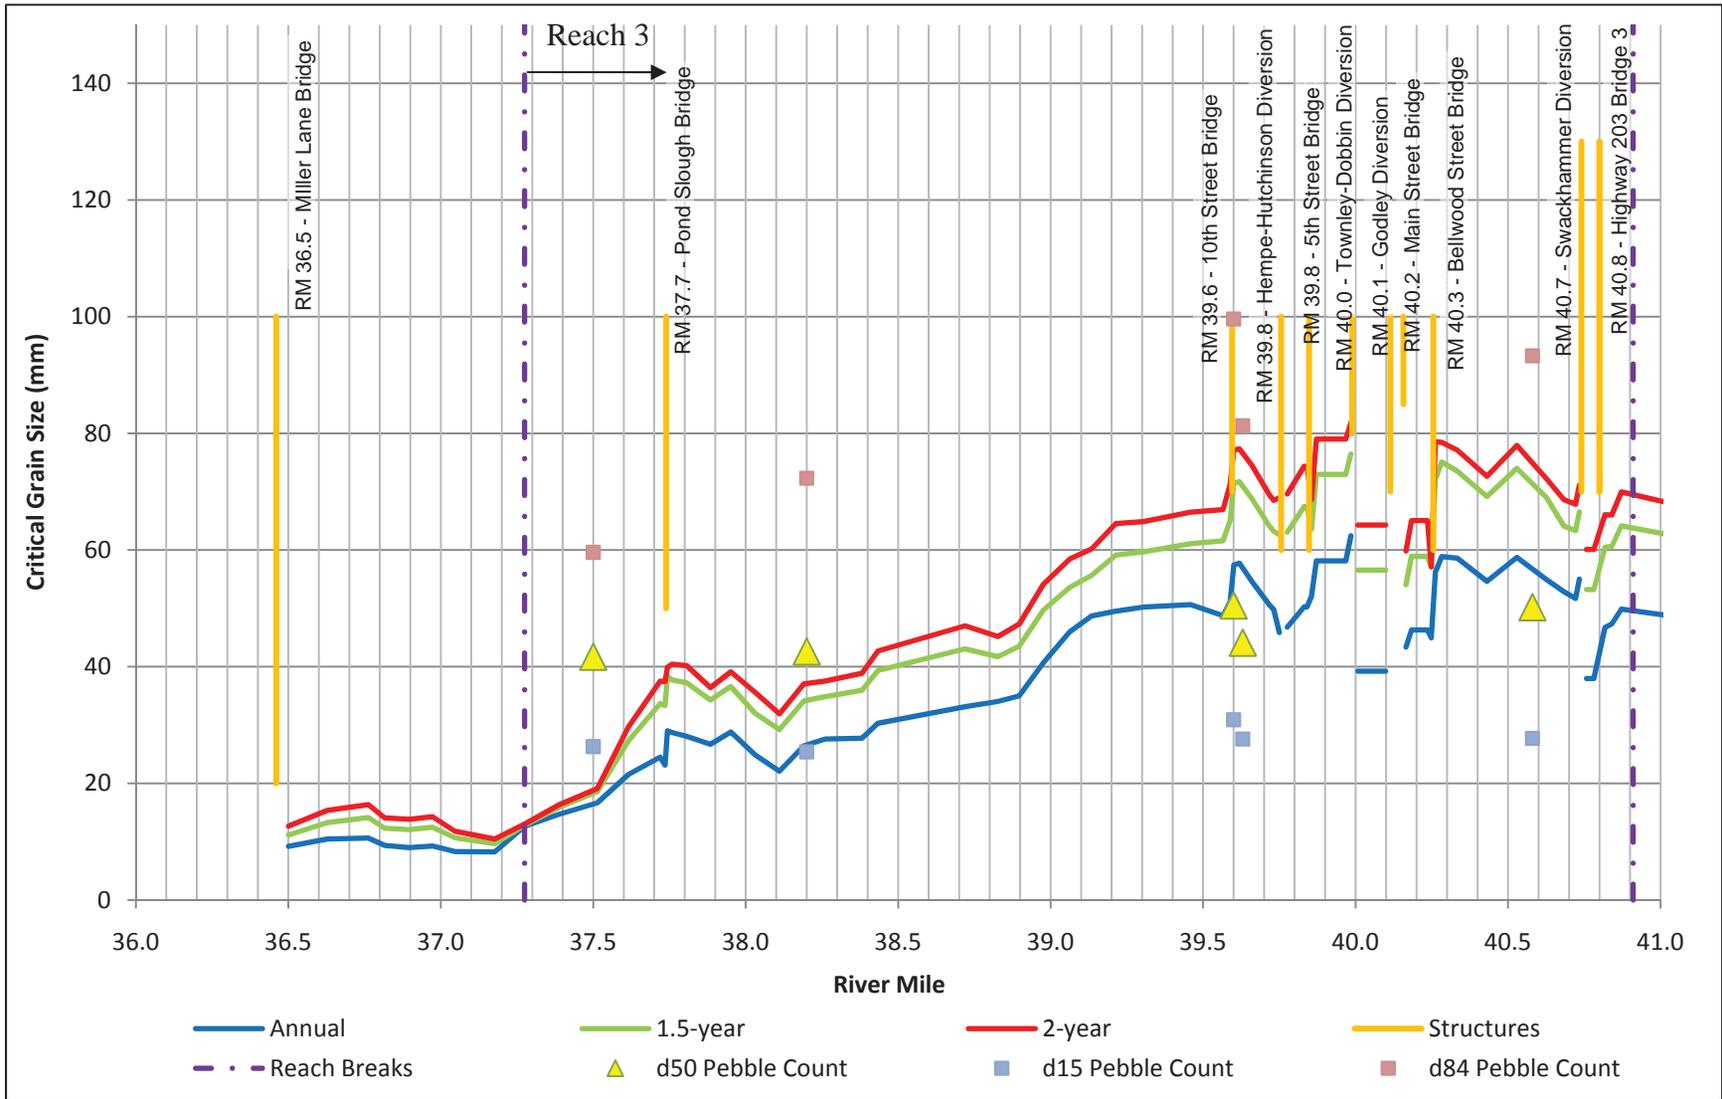
Figure 17. 5-Cross-Section Moving-Average Predicted Critical Sediment Size at Incipient Motion in Reach 3.

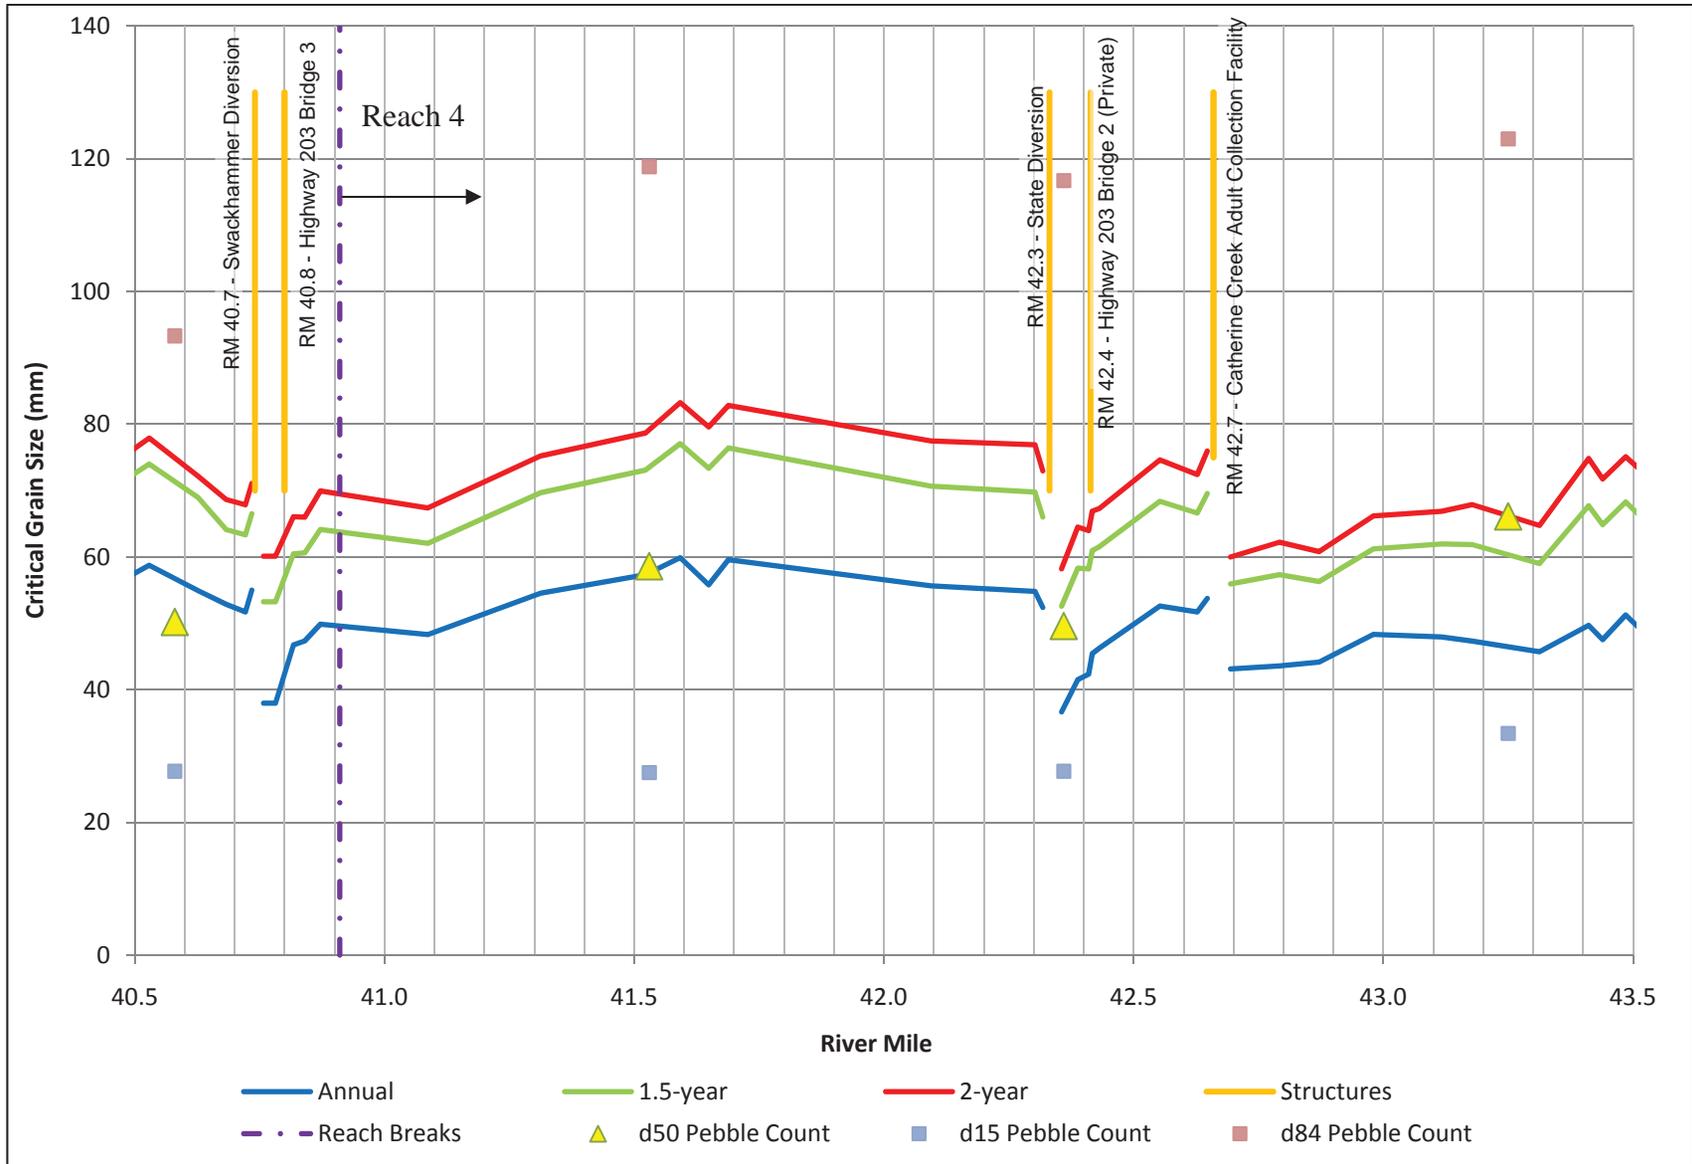
Figure 18. 5-Cross-Section Moving-Average Predicted Sediment Size at Incipient Motion in lower Reach 4 (RM 41 to 43.5).

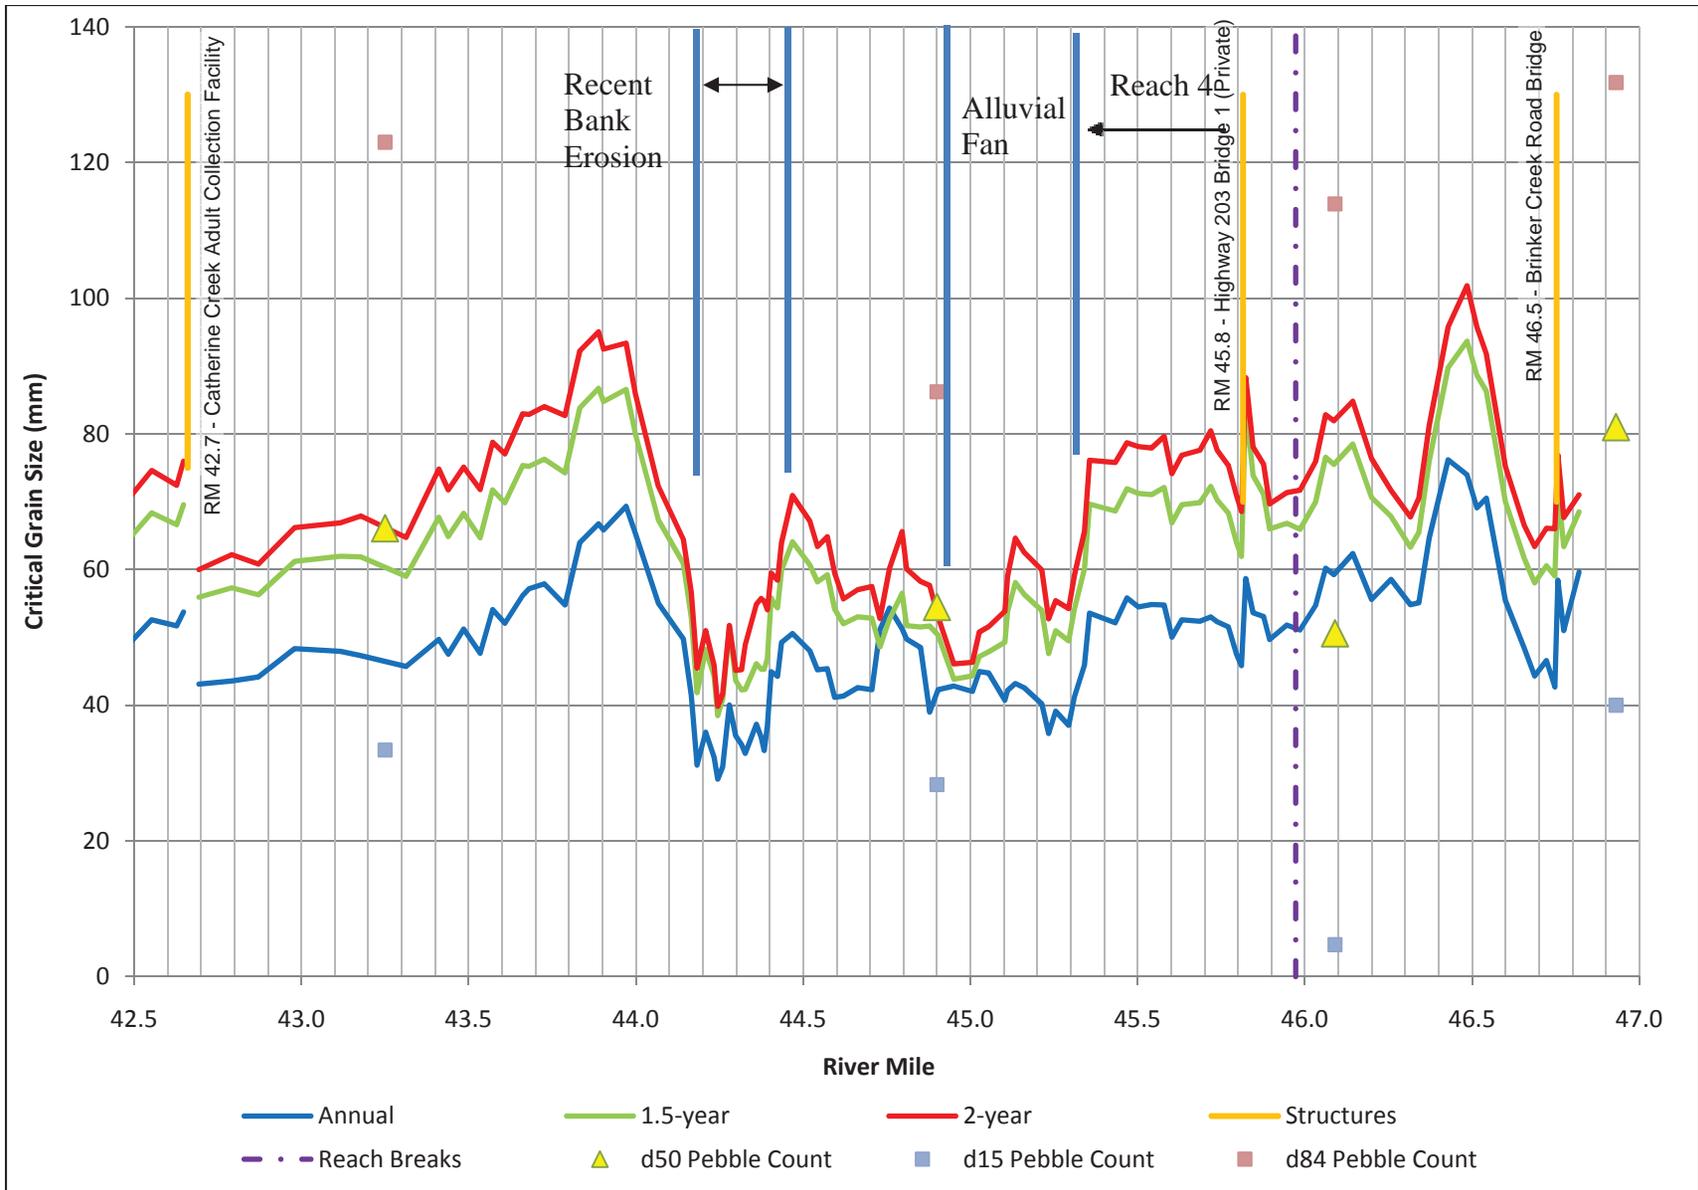
Figure 19. 5-Cross-Section Moving-Average Predicted Sediment Size at Incipient Motion in upper Reach 4 (RM 42.5 to 47)

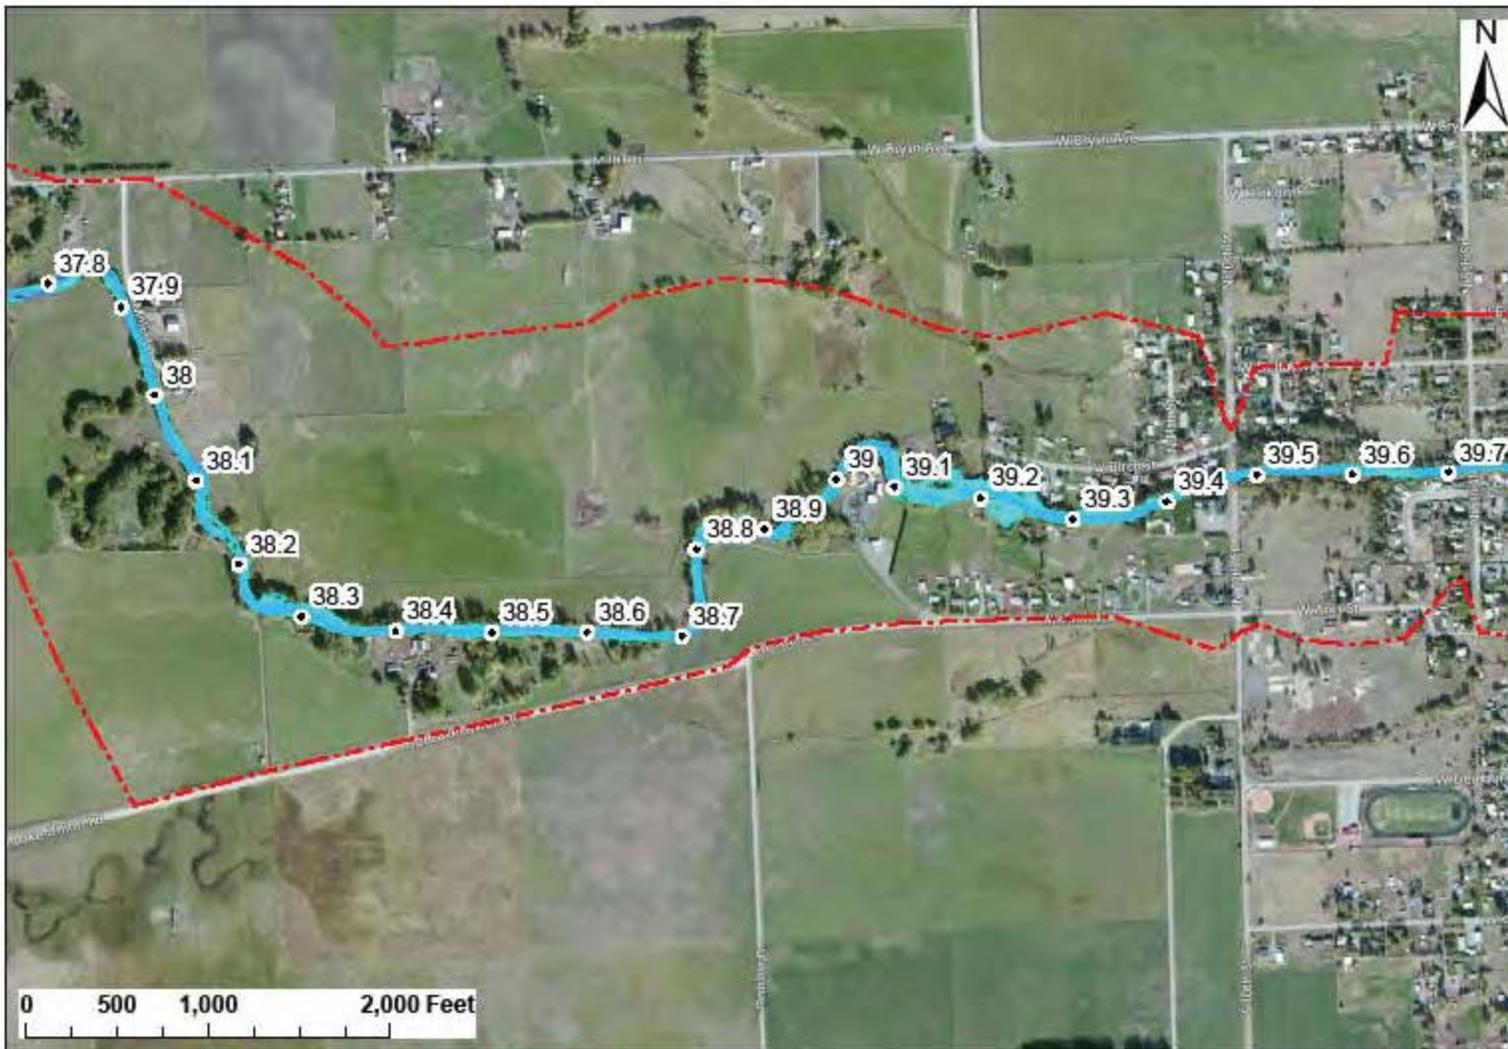
Depth, Feet 4.1 - 6 10.1 - 12 16.1 - 18 • River Miles **Catherine Creek Reach 3 & 4 Hydraulics**
 0 - 2 6.1 - 8 12.1 - 14 **Flow Depths, 2-year Discharge**
 2.1 - 4 8.1 - 10 14.1 - 16 **Map 5 of 6**

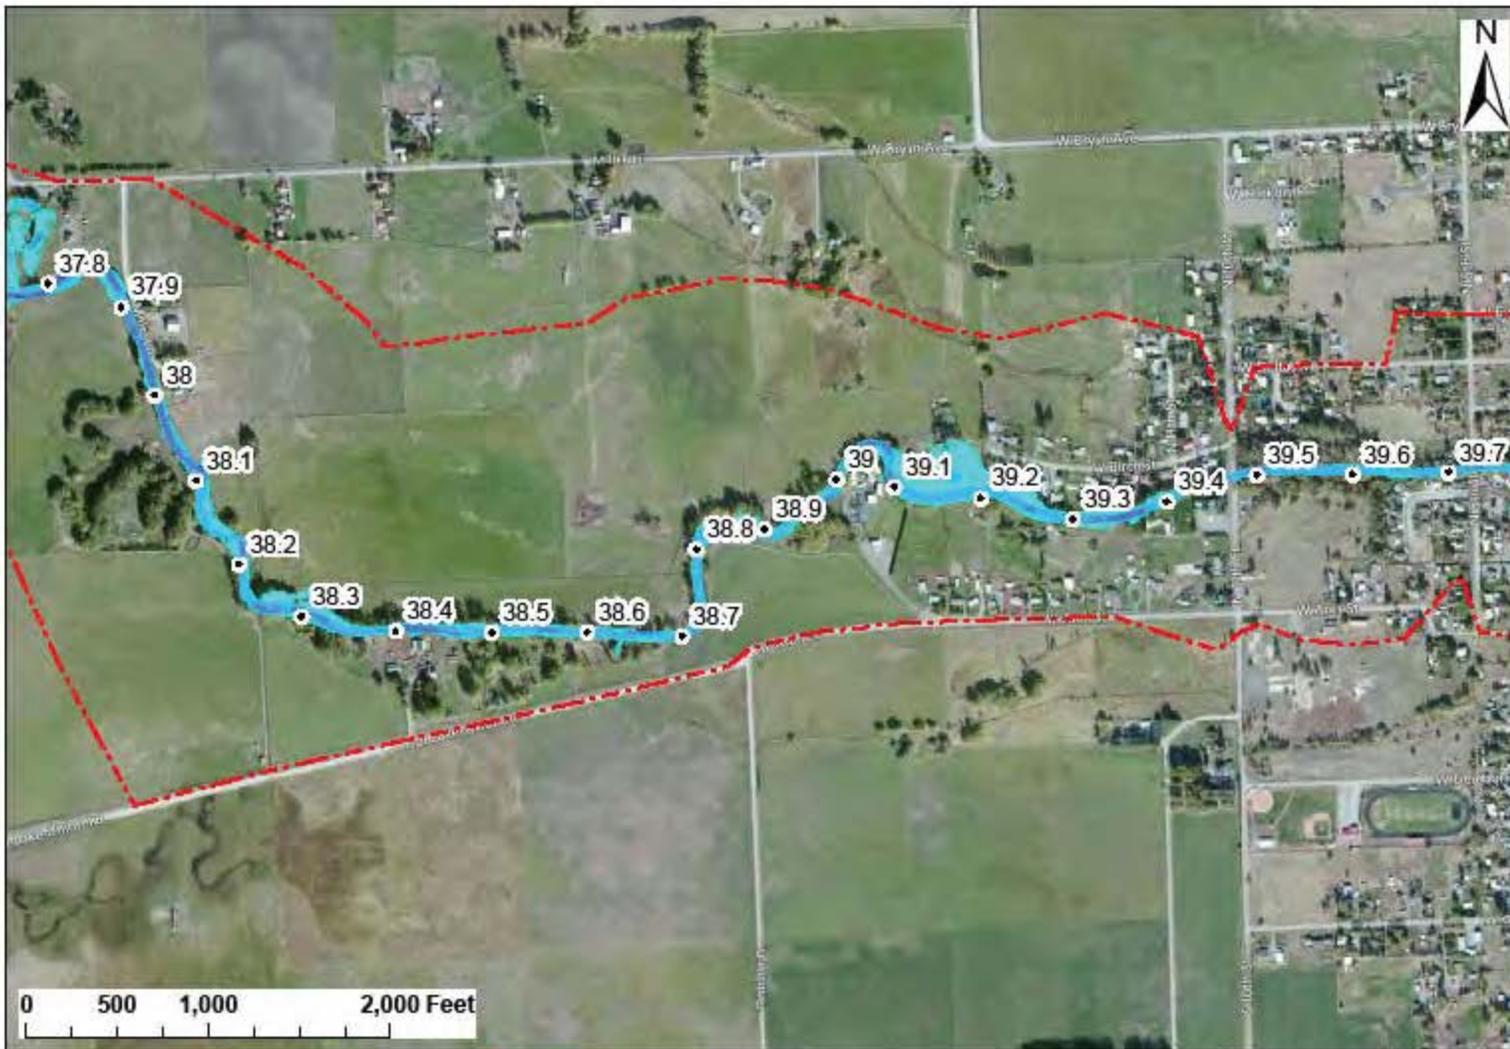
Depth, feet	0.1 - 2	2.1 - 4	4.1 - 6	6.1 - 8	8.1 - 10	10.1 - 12	12.1 - 14	14.1 - 16	16.1 - 18	• River Miles	Catherine Creek Reach 3 & 4 Hydraulics Flow Depths, 10-year Discharge Map 5 of 6
										Cross-Section Boundary

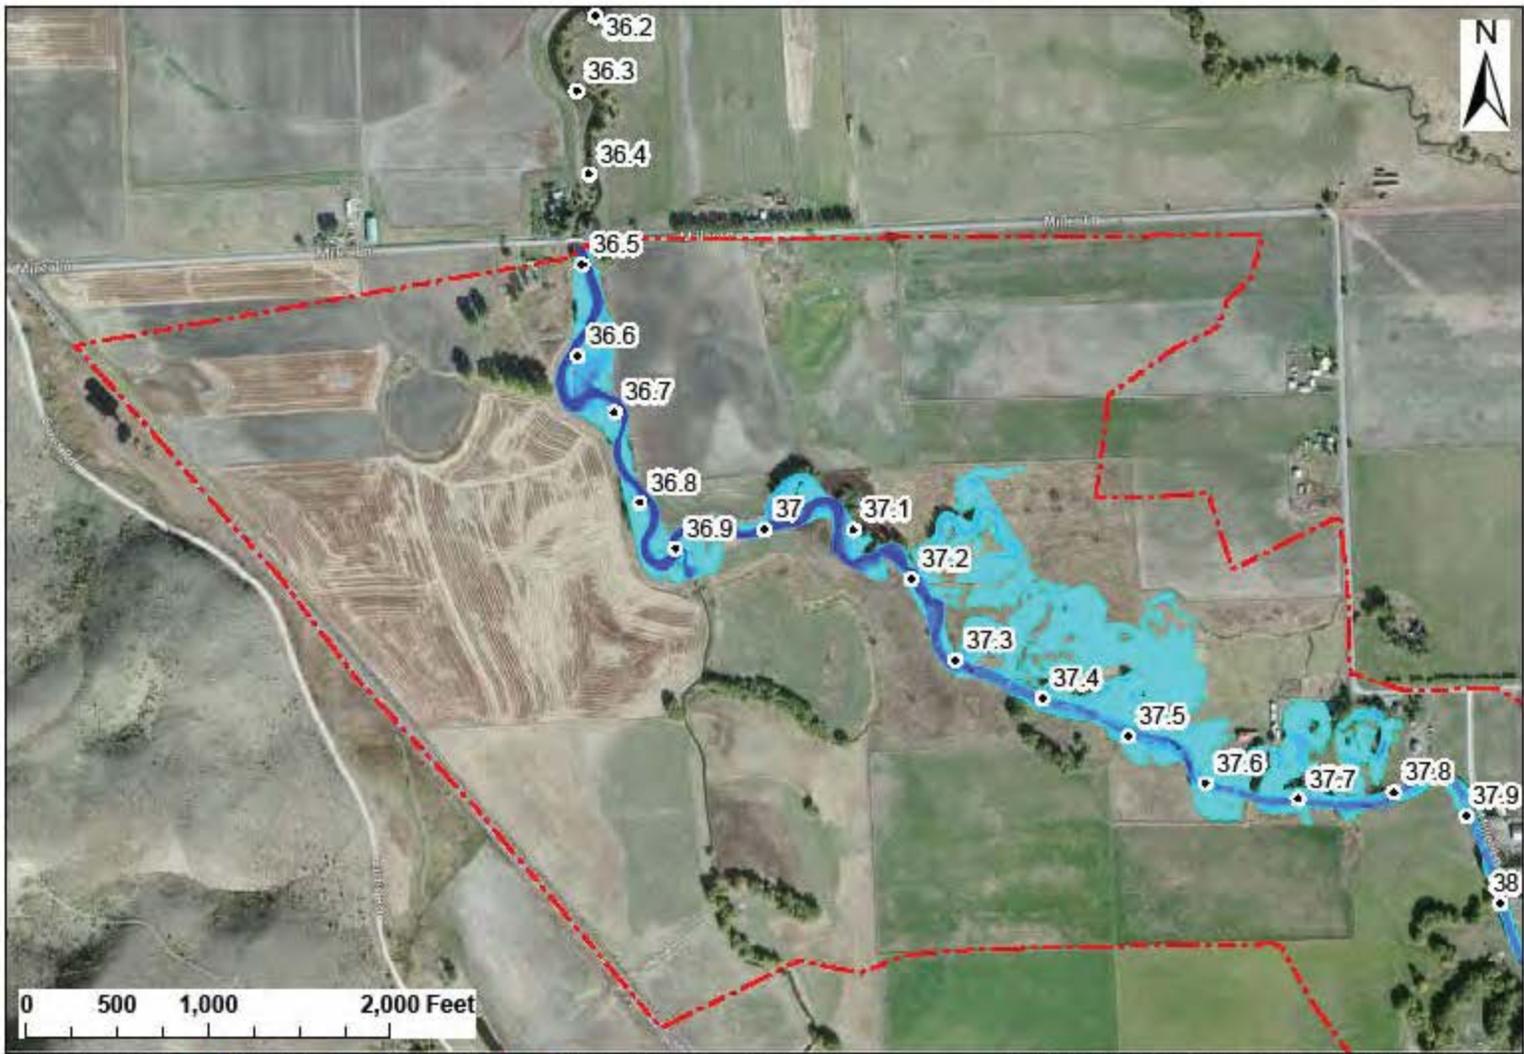
Depth, feet	0.1 - 2	2.1 - 4	4.1 - 6	6.1 - 8	8.1 - 10	10.1 - 12	12.1 - 14	14.1 - 16	16.1 - 18	• River Miles	Catherine Creek Reach 3 & 4 Hydraulics Flow Depths, 10-year Discharge Map 6 of 6
									Cross-Section Boundary

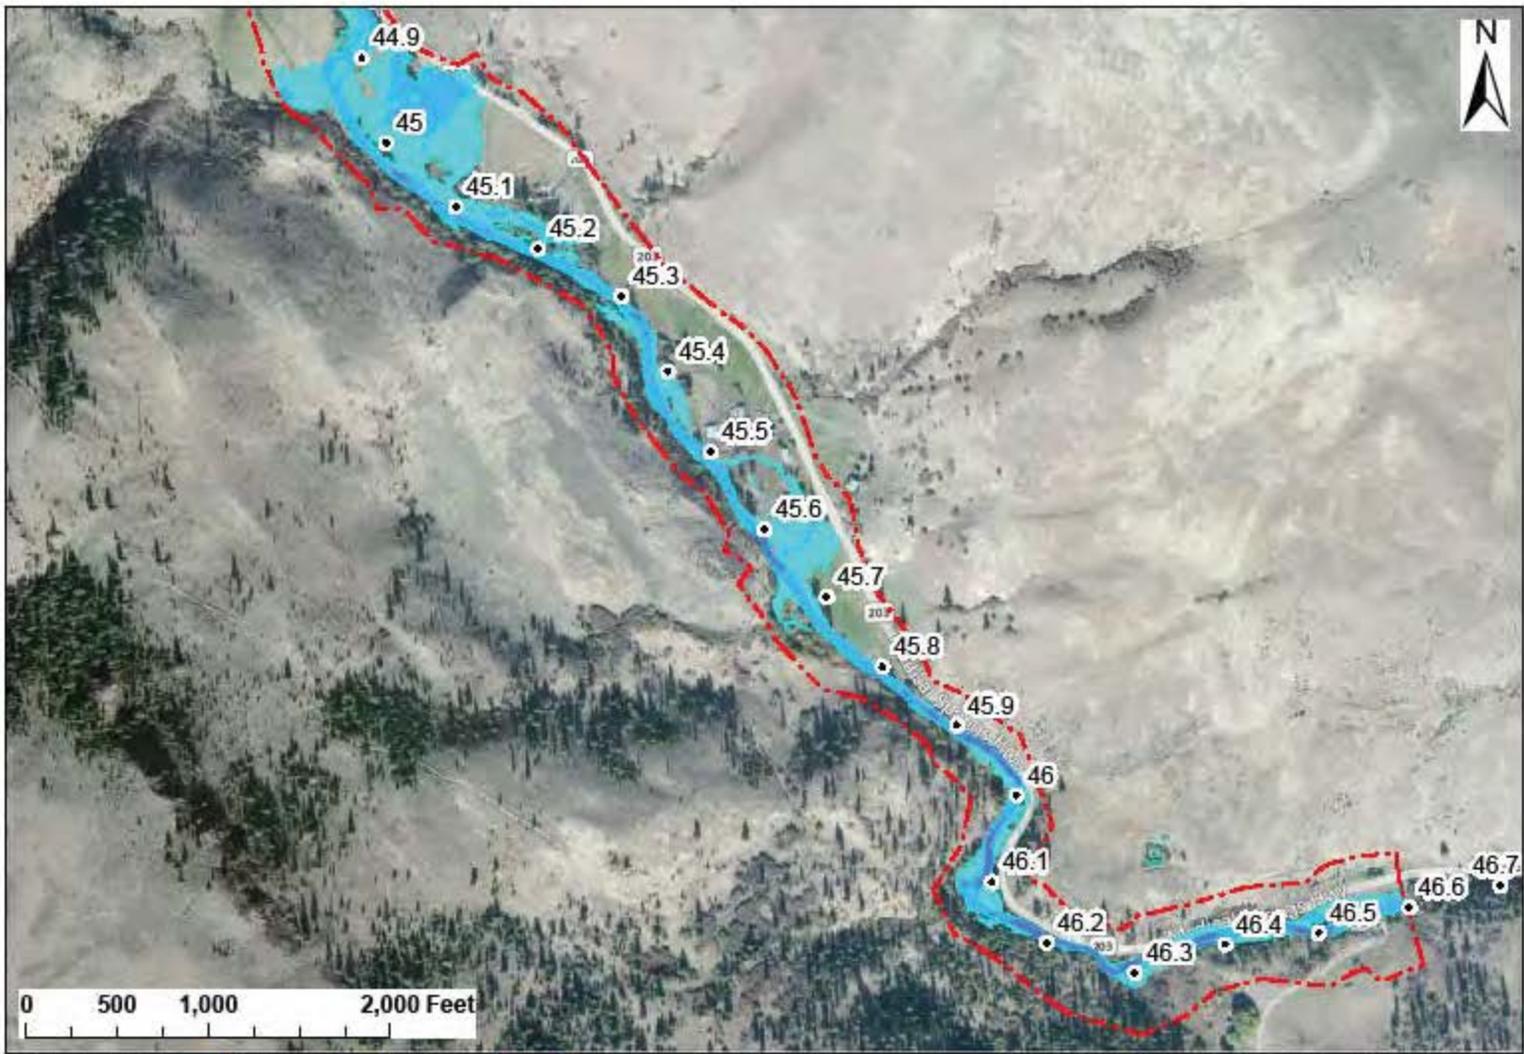
Depth, feet 4.1 - 6 10.1 - 12 16.1 - 18 • River Miles **Catherine Creek Reach 3 & 4 Hydraulics**
 0.1 - 2 6.1 - 8 12.1 - 14 Cross-Section Boundary **Flow Depths, 100-year Discharge**
 2.1 - 4 8.1 - 10 14.1 - 16 **Map 1 of 6**

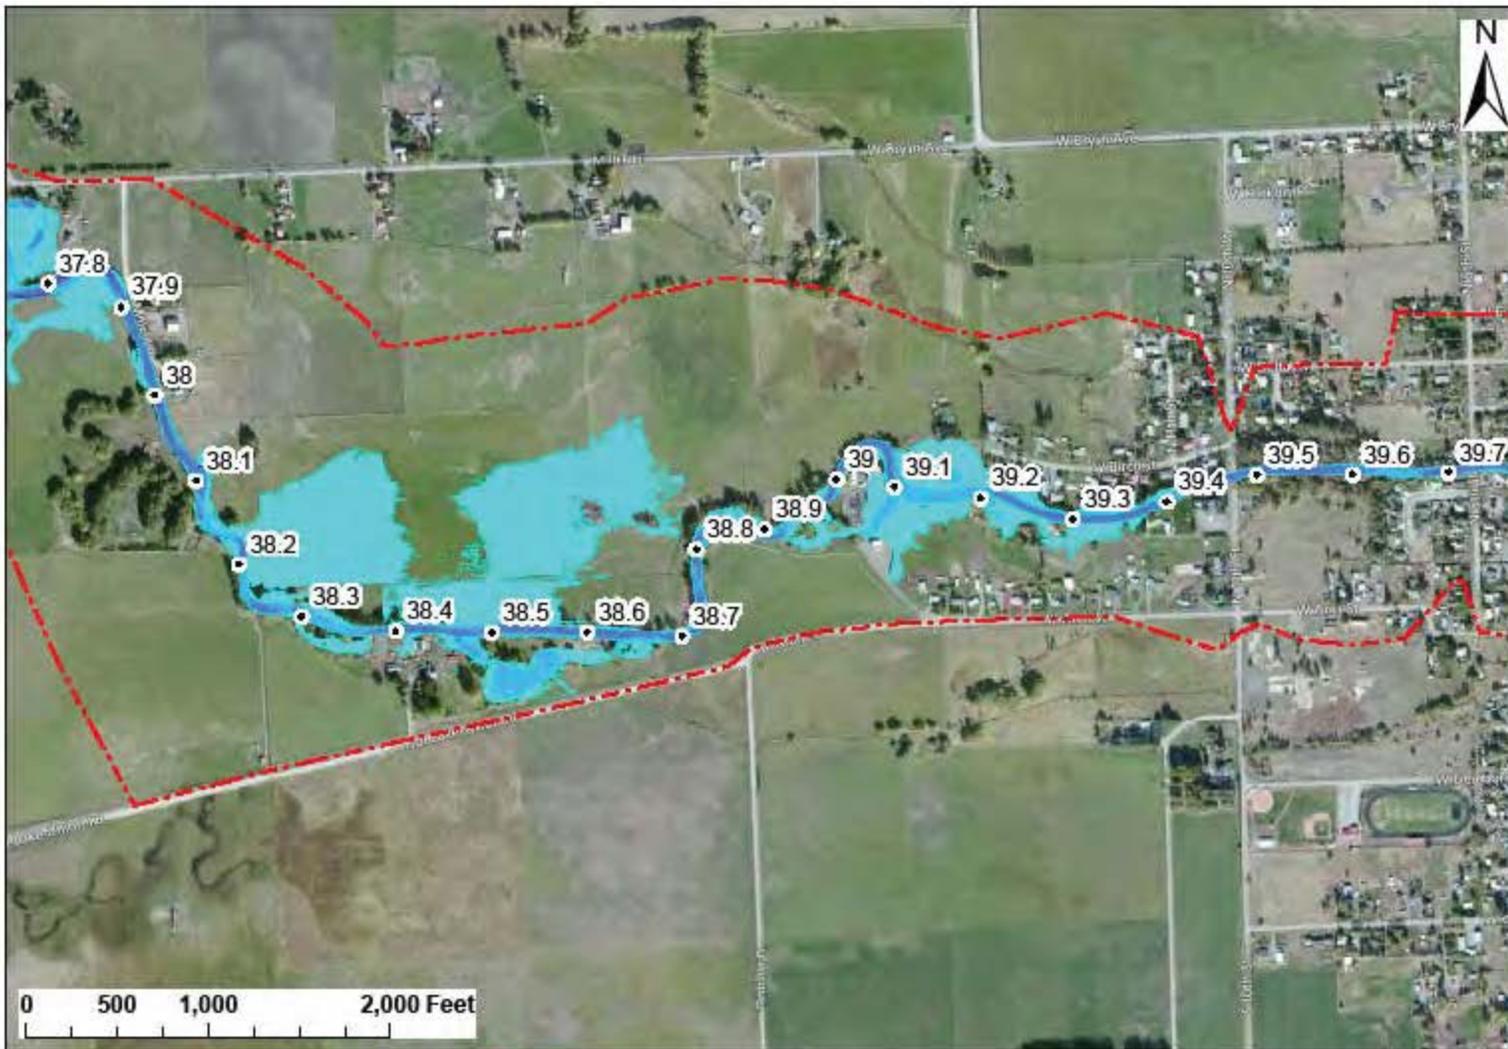
Depth, feet	0.1 - 2	2.1 - 4	4.1 - 6	6.1 - 8	8.1 - 10	10.1 - 12	12.1 - 14	14.1 - 16	16.1 - 18	• River Miles	Catherine Creek Reach 3 & 4 Hydraulics Flow Depths, 100-year Discharge Map 5 of 6
		Cross-Section Boundary

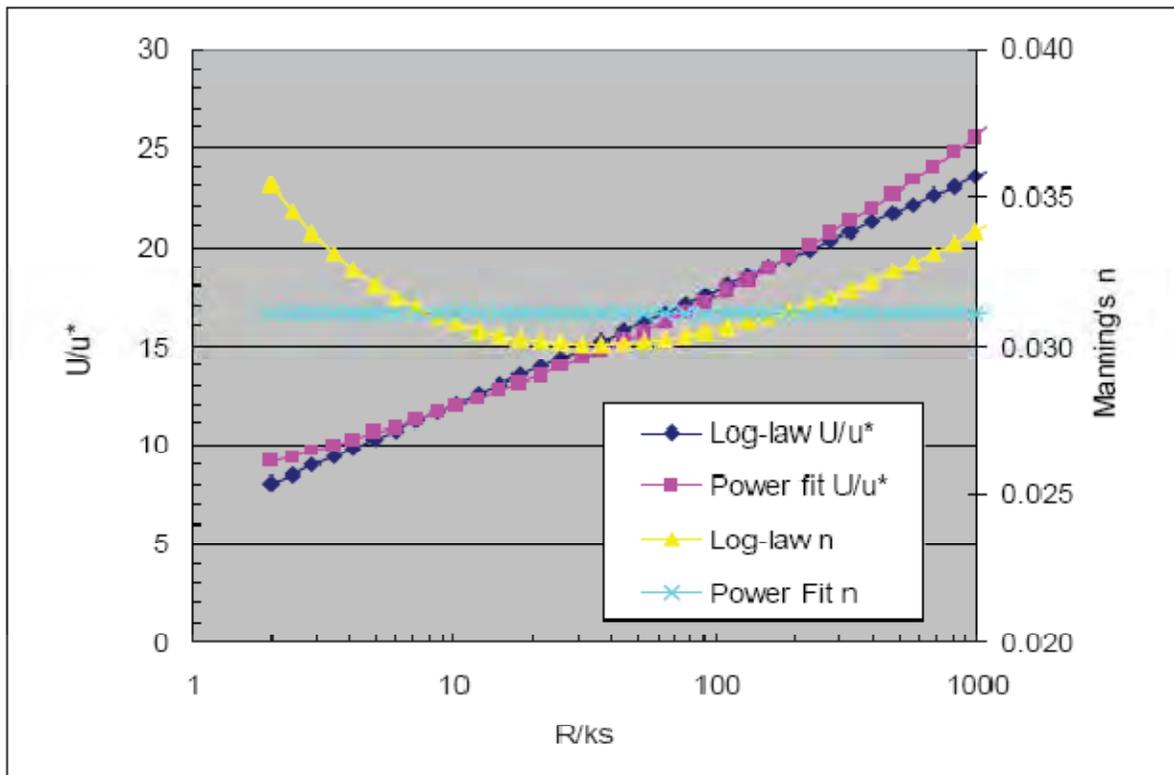
Figure 21. Comparison between log-law and power law approximations. Also shown on the figure is the comparison between assuming $k_s = 240$ mm.
