SRH-2013-27

Geomorphology and Hydraulic Modeling of the Forrest Conservation Area

Middle Fork John Day River, Grant County, Oregon

**U.S. Department of the Interior
Bureau of Reclamation
Technical Service Center
Denver, Colorado**

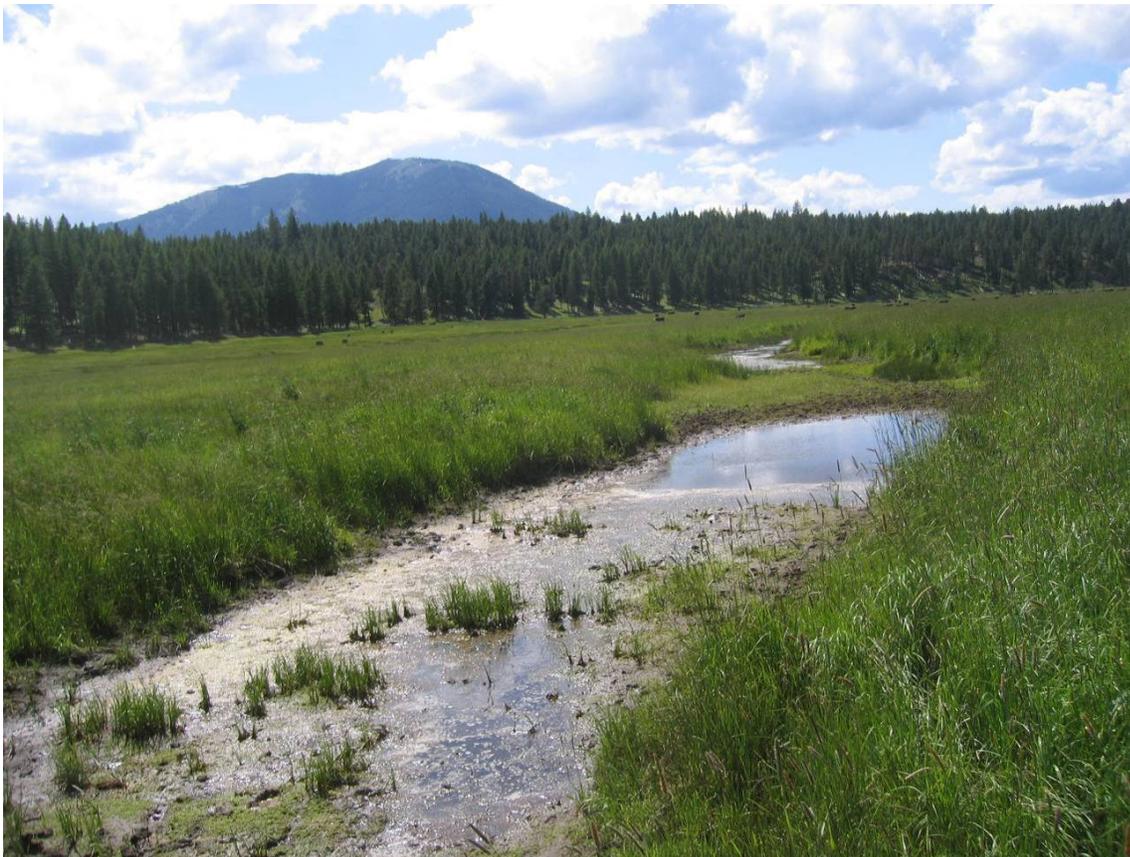
Figure 4. A disconnected historical channel on the floodplain near Vinegar Creek. Water-level in this channel and others on the floodplain in this reach that are separated from the river by the old railroad grade appears to be maintained by groundwater (photo taken on June 17, 2009).

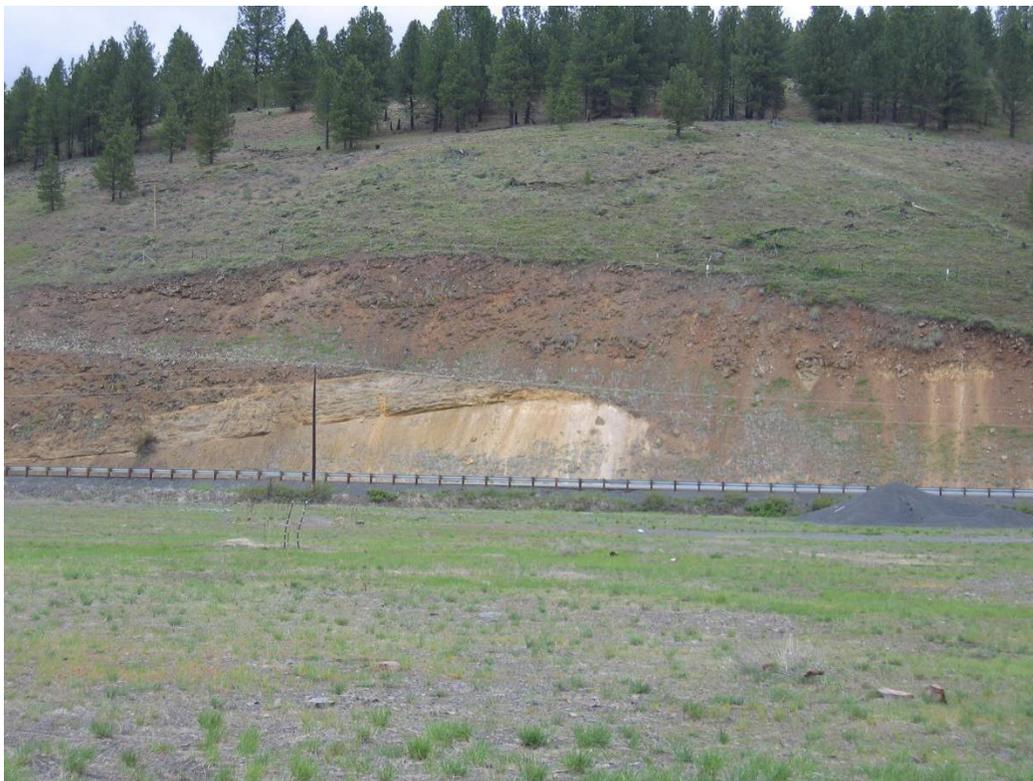
Figure 5. Exposure of the Strawberry Volcanics in a roadcut near the confluence of Bridge Creek just upstream of the Forrest Conservation Area.

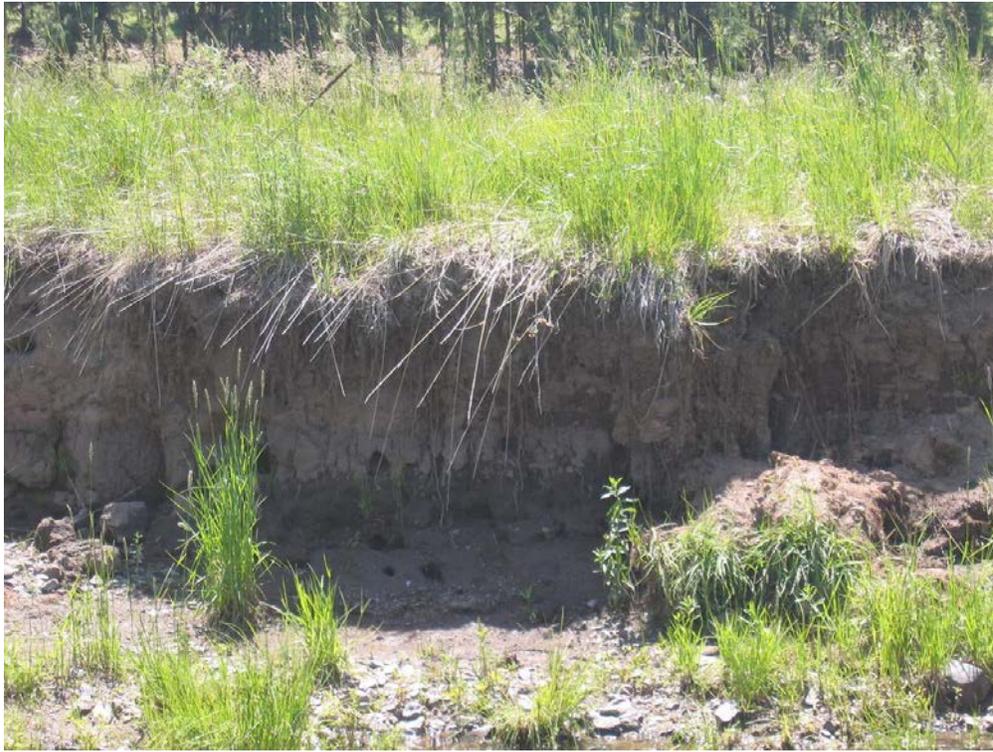
Figure 6. Sandy alluvial fan deposit of the Davis Creek alluvial fan (near RM 66.5).

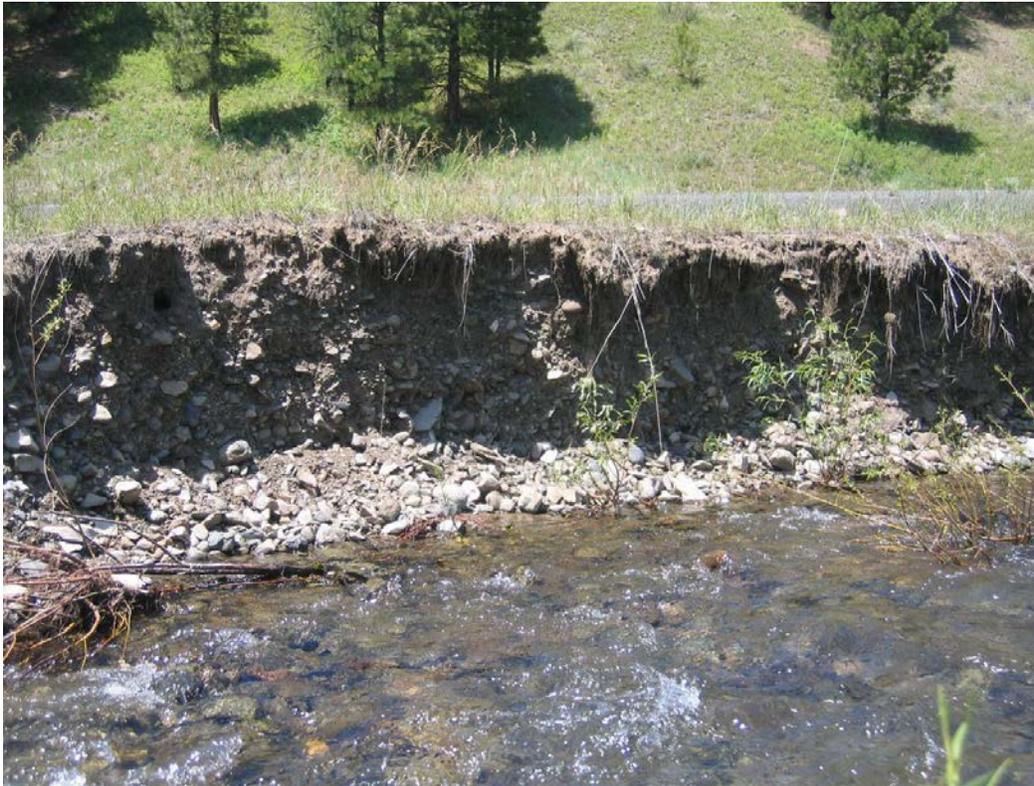
Figure 7. Gravelly alluvial fan deposit at the mouth of Vinegar Creek with its confluence with the MFJDR (near RM 66.3).

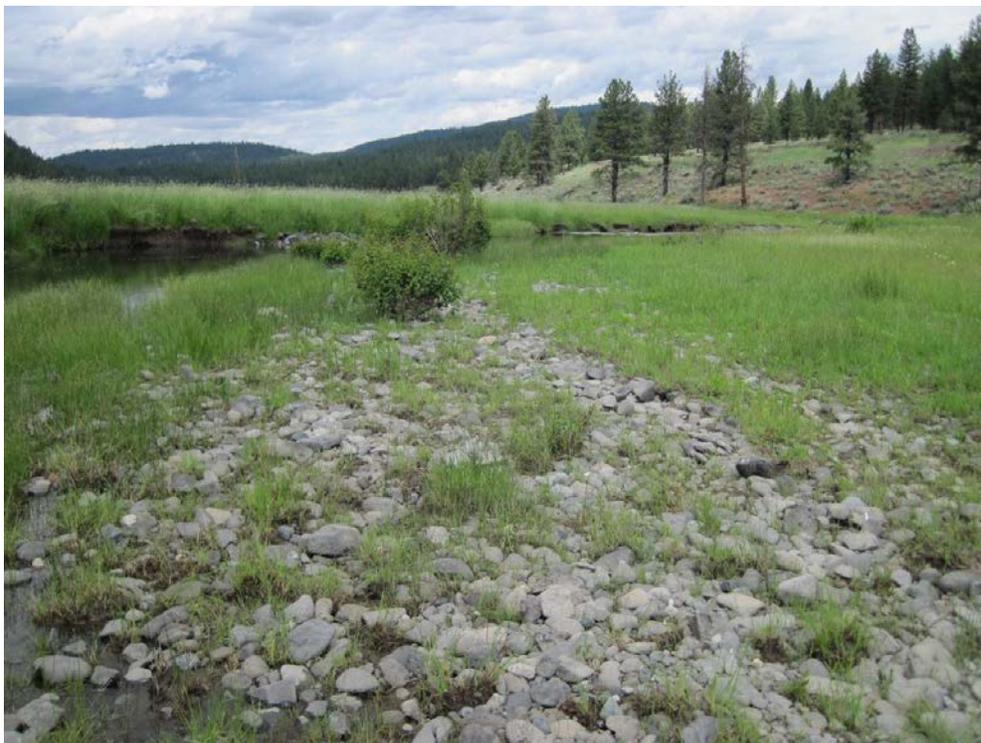
Figure 8. The Qa4 alluvium is composed primarily of sandy gravelly alluvium that forms the active channel and associated bars. Finer-grained sand facies of the Qa4 alluvium is found in pools and side channels.

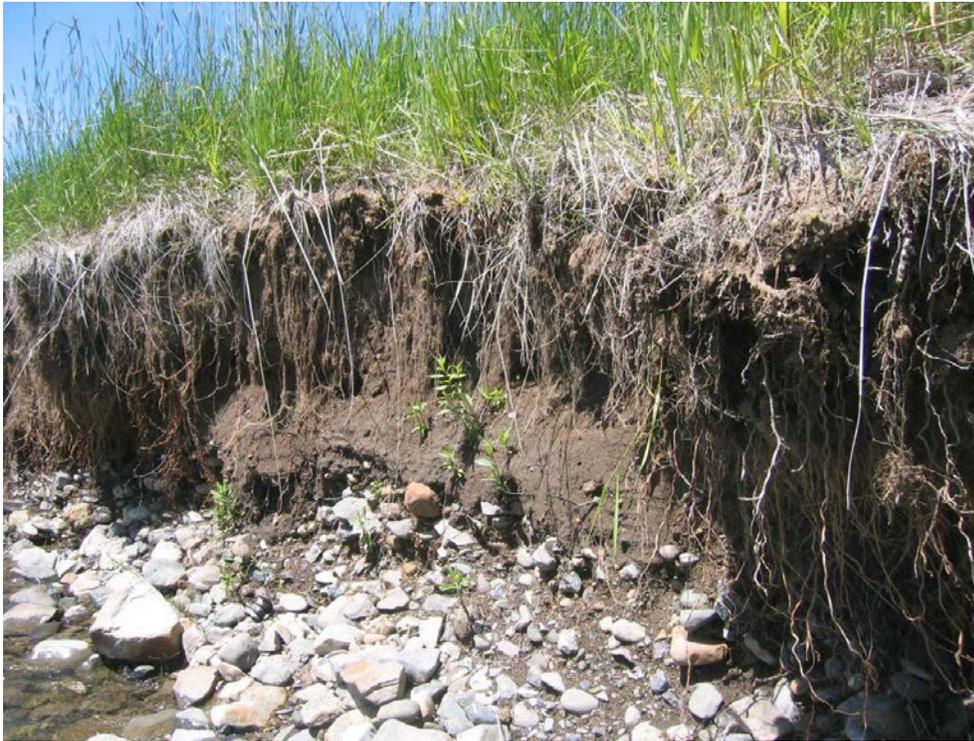
Figure 9. Bank exposure of Qa3 alluvium. Note the thick bed of fine-grained sediment (overbank deposits) overlying the sandy gravel alluvium (bedload).

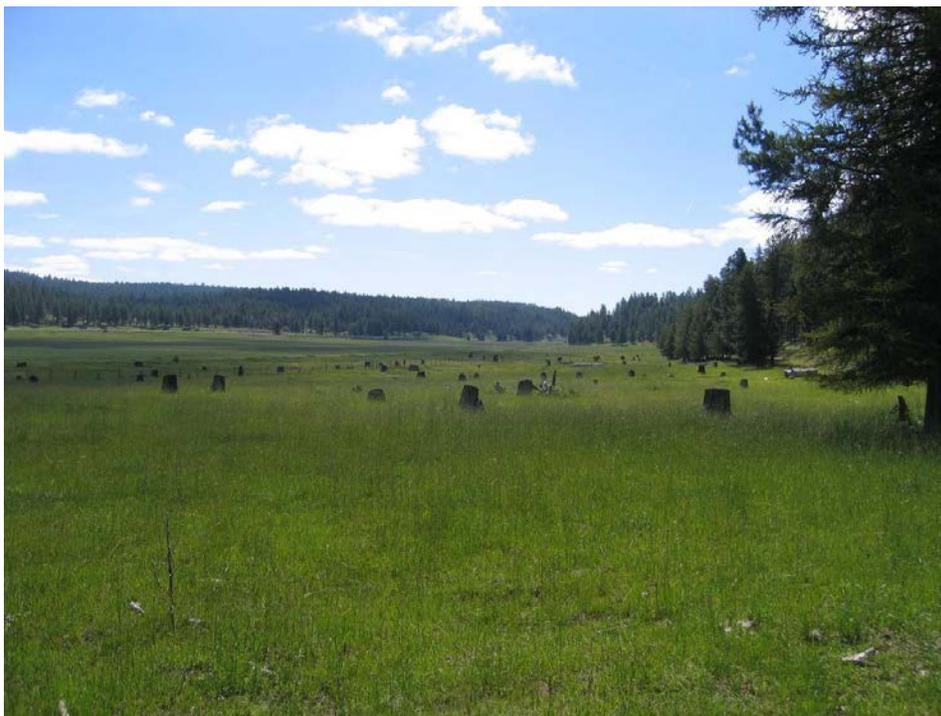
Figure 10. A Qa2 terrace located just upstream of Caribou Creek (near RM 64.5). Note the stumps of trees in growth position. The trees were about 400 years old when they were cut down in the late 1800s.

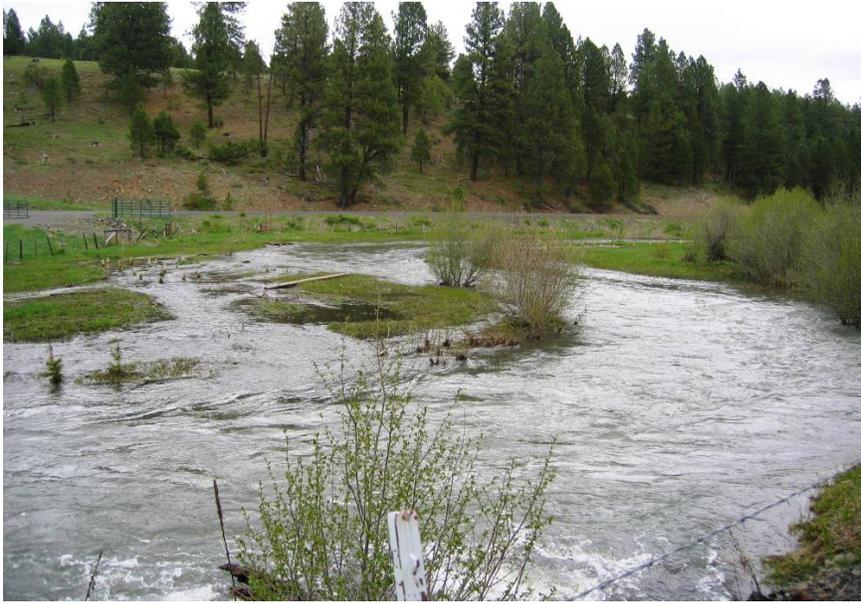
Figure 21. Photograph taken from location A as shown in Figure 20.

Ground photos of the flood event on May 20, 2008 are compared with model results in Figure 20 through Figure 29. Modeled discharge in these figures is 769 cfs. Comparisons of the photographs suggest that either flows on May 20 were less than the modeled 769 cfs or that the model slightly overpredicts water depths in some areas (typically by less than 0.5 feet). Without a measured discharge, determining which of these factors is responsible for the discrepancies is difficult. However, ground photographs in the same locations during a measured discharge of less than 500 cfs on May 7, 2009 show similar and sometimes more inundation than that observed on May 20, 2008. This would support a flow of less than 769 cfs on the Forrest Conservation Property on May 20, 2008.

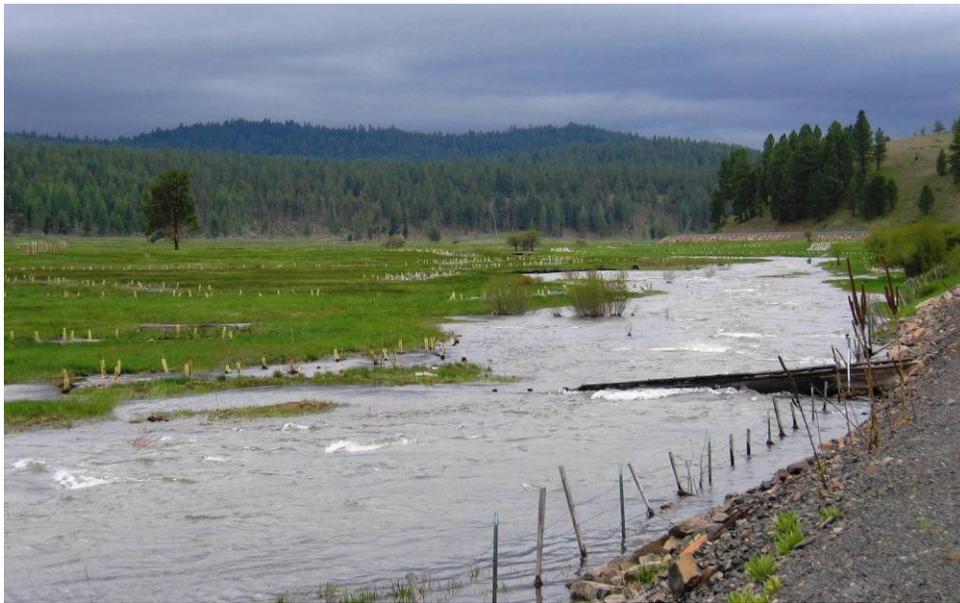
Figure 23. Photograph taken from location B as shown in Figure 22.

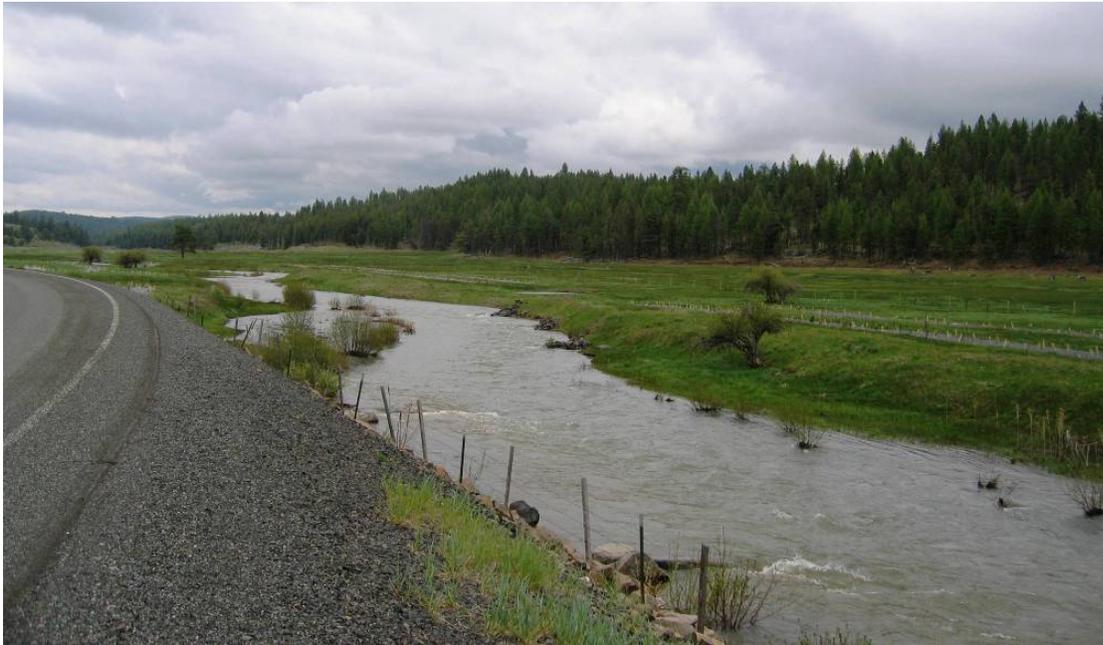
Figure 25. Photograph taken from location C as shown in Figure 24.

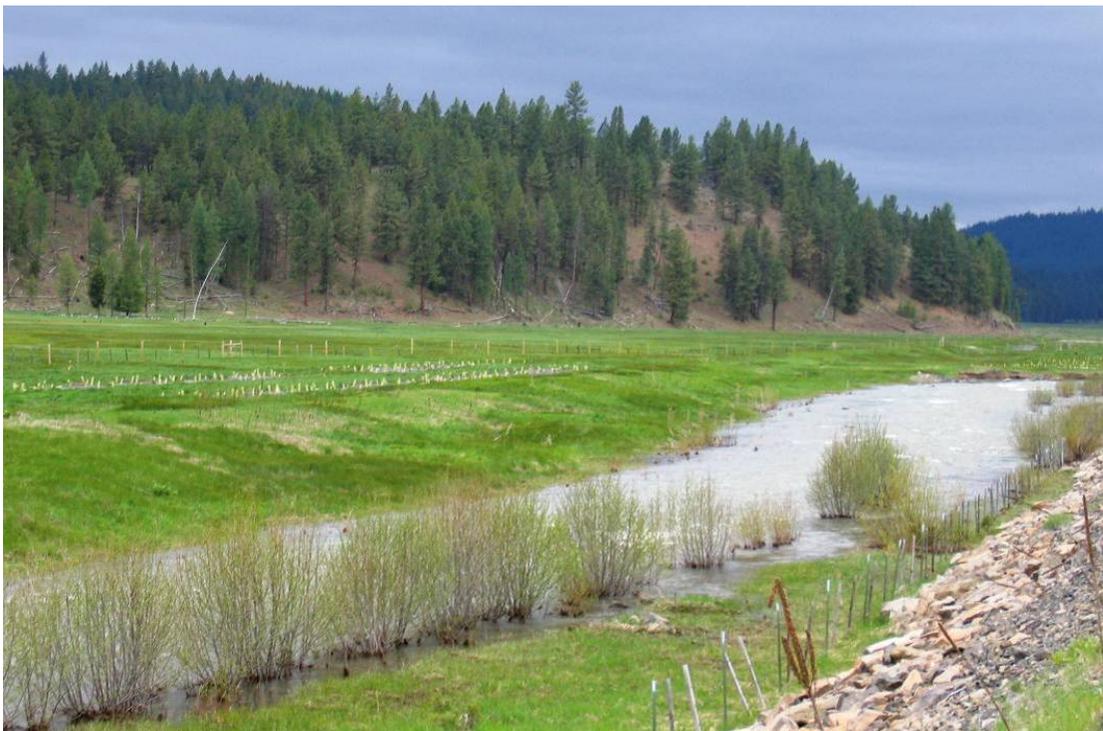
Figure 26. Photograph taken from location D as shown in Figure 24.

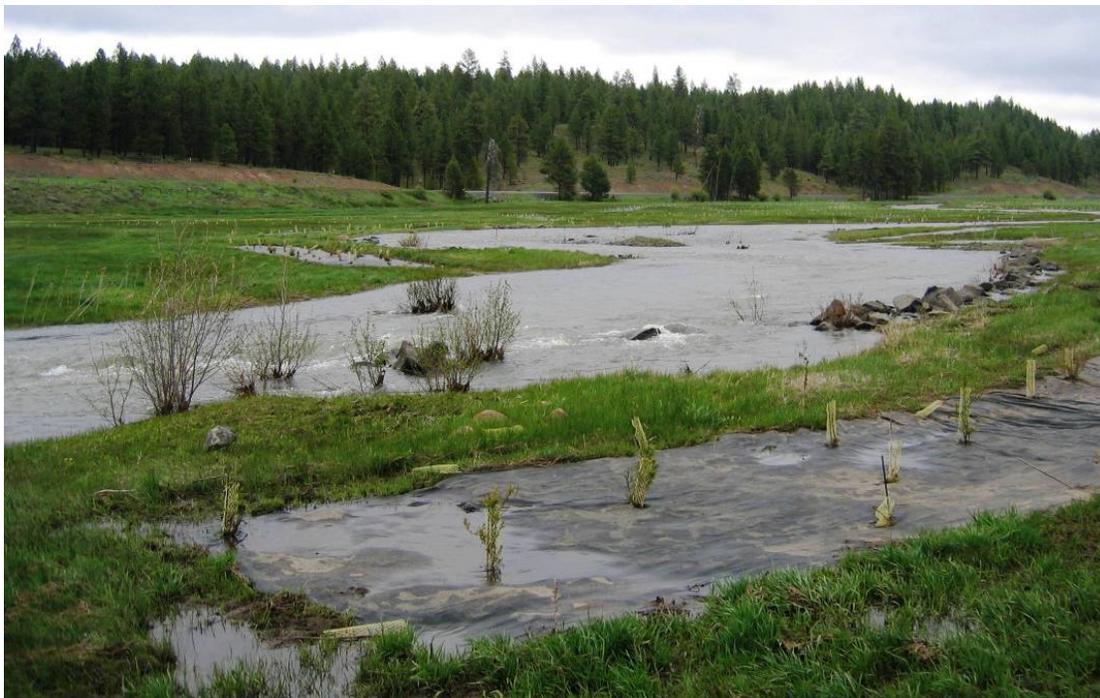
Figure 28. Photograph taken from location E as shown in Figure 27.

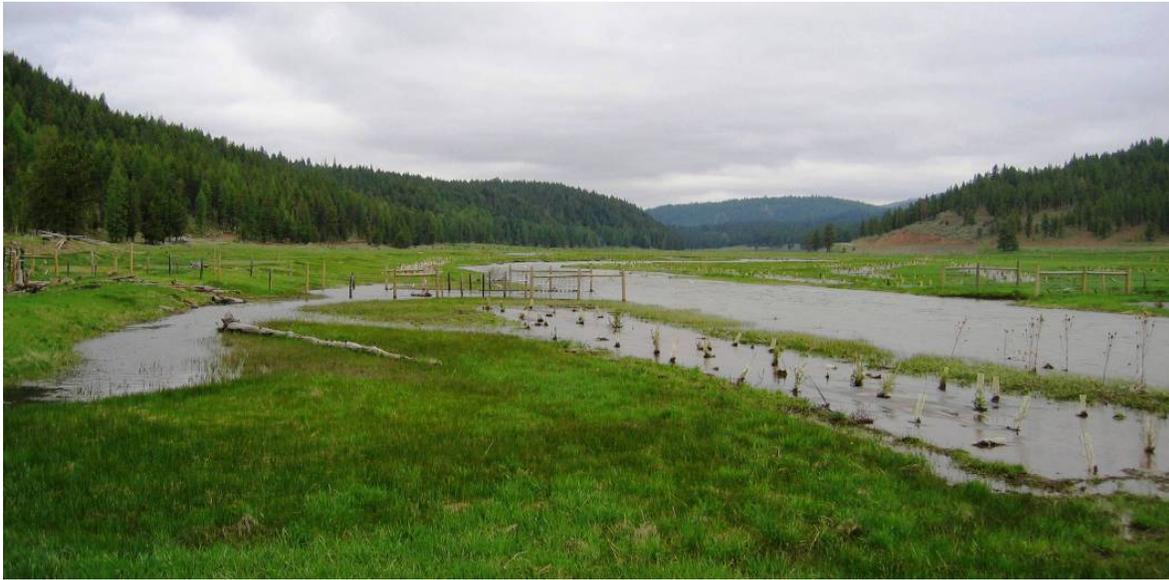
Figure 29. Photograph taken from location F as shown in Figure 27.

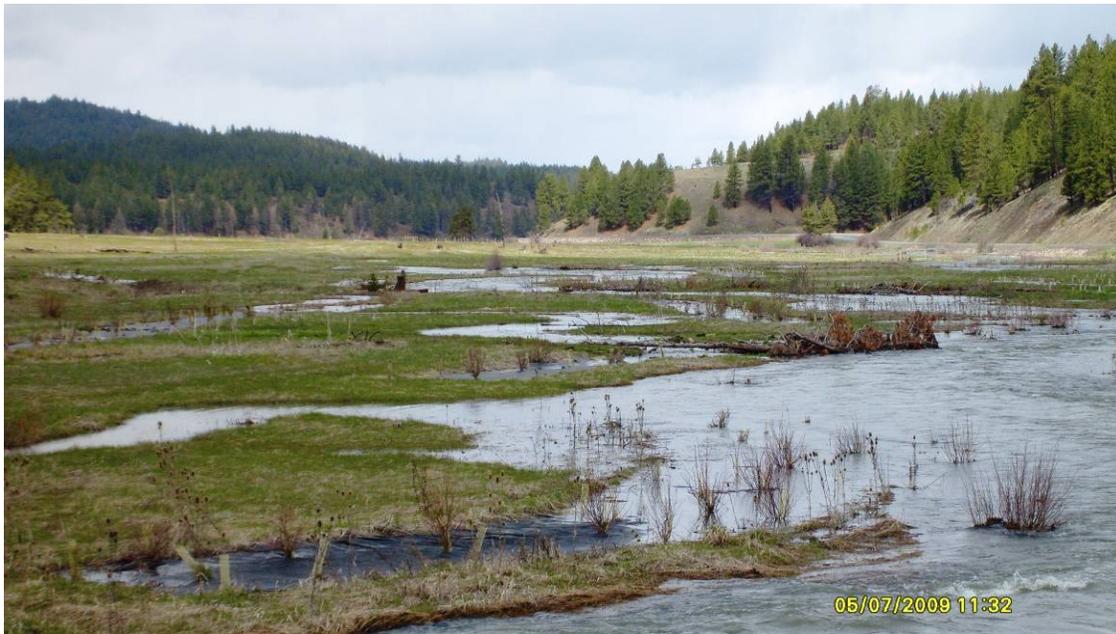
Figure 33. Photograph taken from location A as shown in Figure 32.

A qualitative evaluation of the model's ability to match ground photos from May 7th, 2009 was completed. The model was simulated with a flow of 331 cfs at the inlet and 496 cfs at the outlet, and discharges from the tributaries were scaled to most closely match the measured discharges of 391 cfs just downstream from Placer Gulch and 496 cfs just downstream from Vincent Creek. Ground photos of the observed discharge are compared with model results in Figure 20 through Figure 29. Vegetation mats elevations appear lower than the true ground surface, which may be due to the LiDAR returns. Therefore, vegetation mats are frequently wetted in model when not actually wetted during the observed flows. Side channel inundation appears to be accurately represented by the model. Overall, the model results compare well with the observed ground photographs. This information was the most useful in determining the final roughness values used for the high flow model.

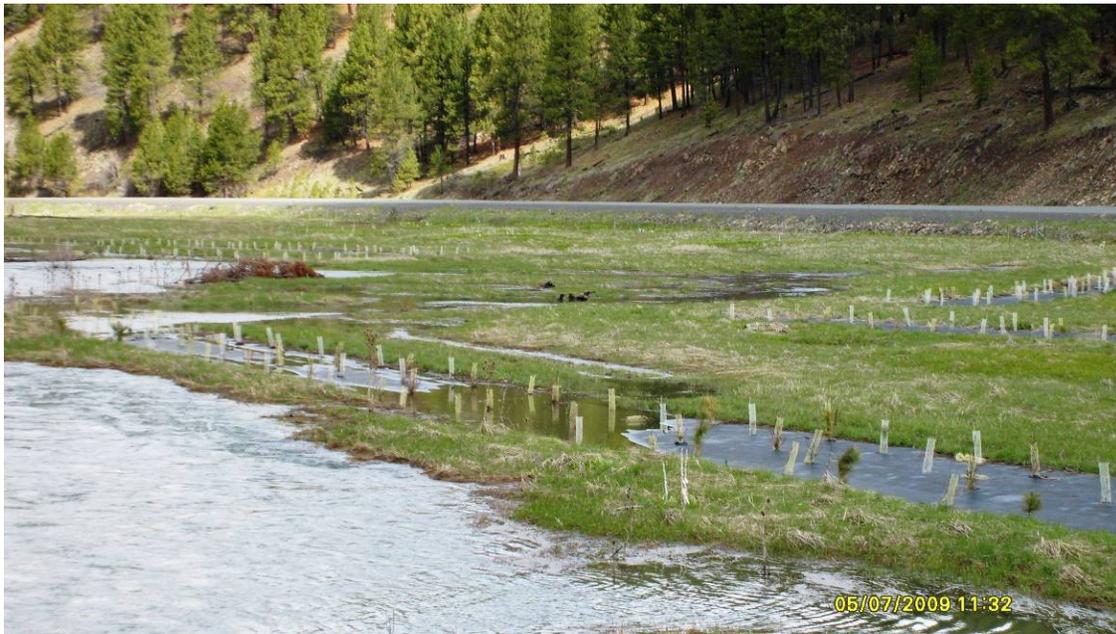
Figure 34. Photograph taken from location B as shown in Figure 32.

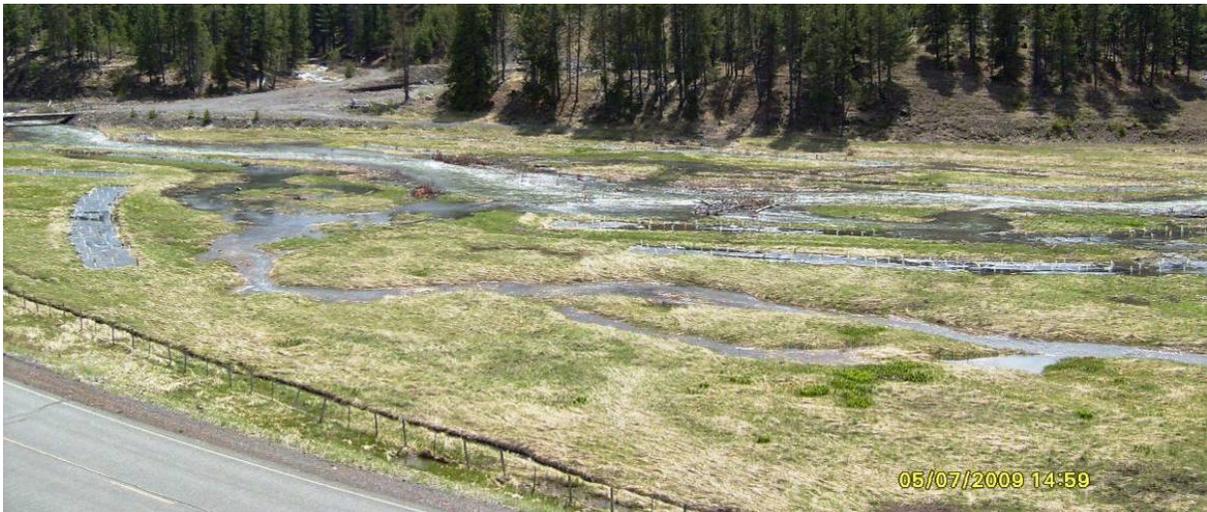
Figure 35. Photograph taken from location C as shown in Figure 32.

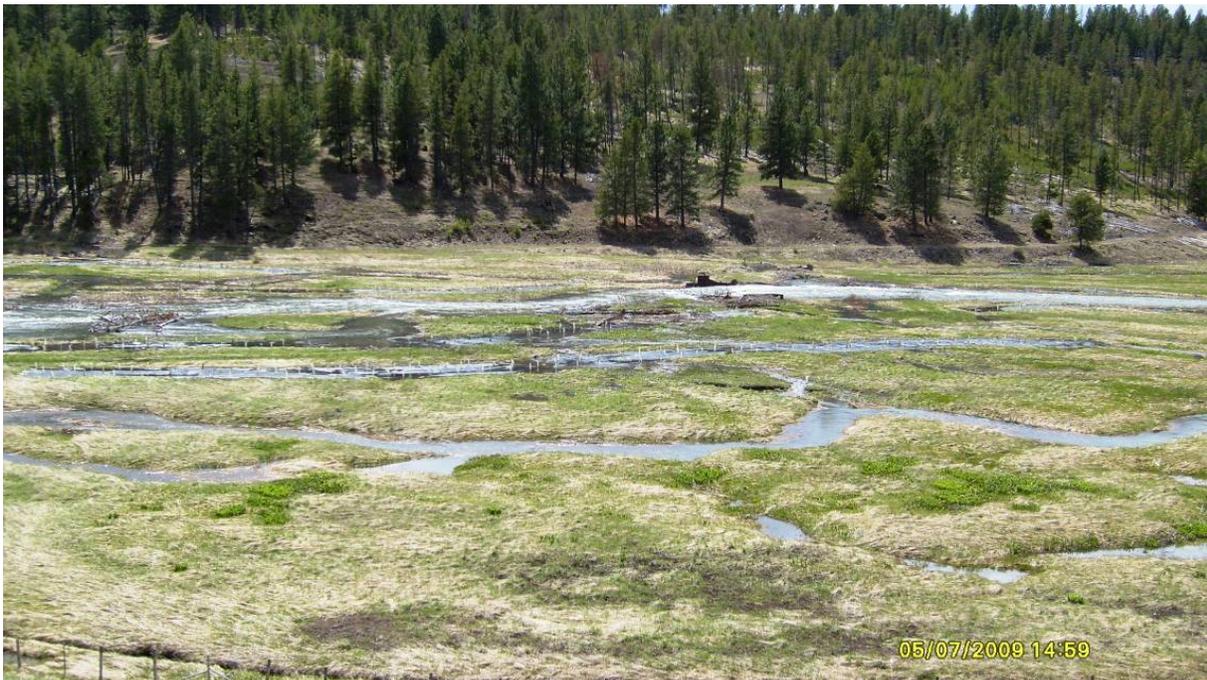
Figure 36. Photograph taken from location D as shown in Figure 32.

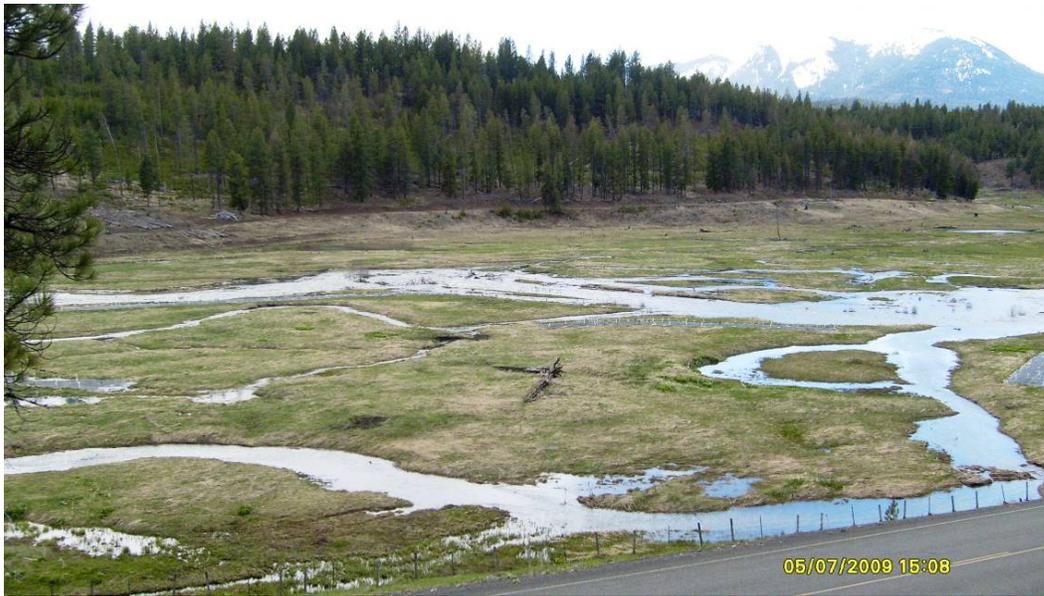
Figure 37. Photograph taken from location E as shown in Figure 32.

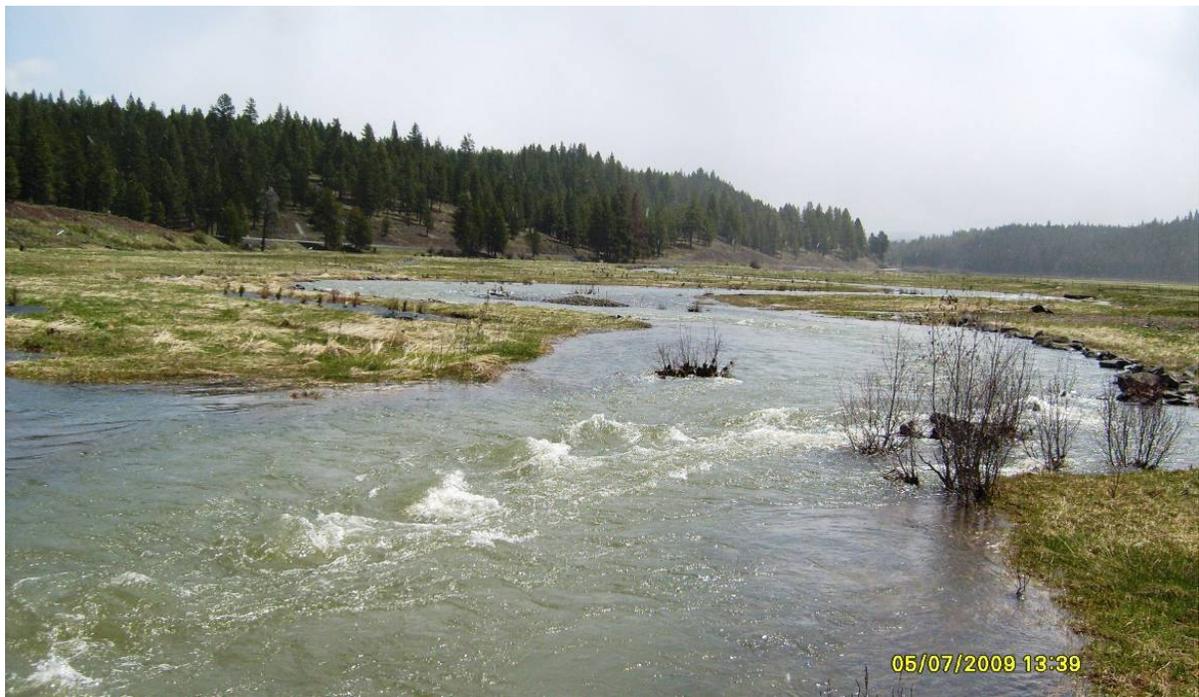
Figure 39. Photograph taken from location F as shown in Figure 38.

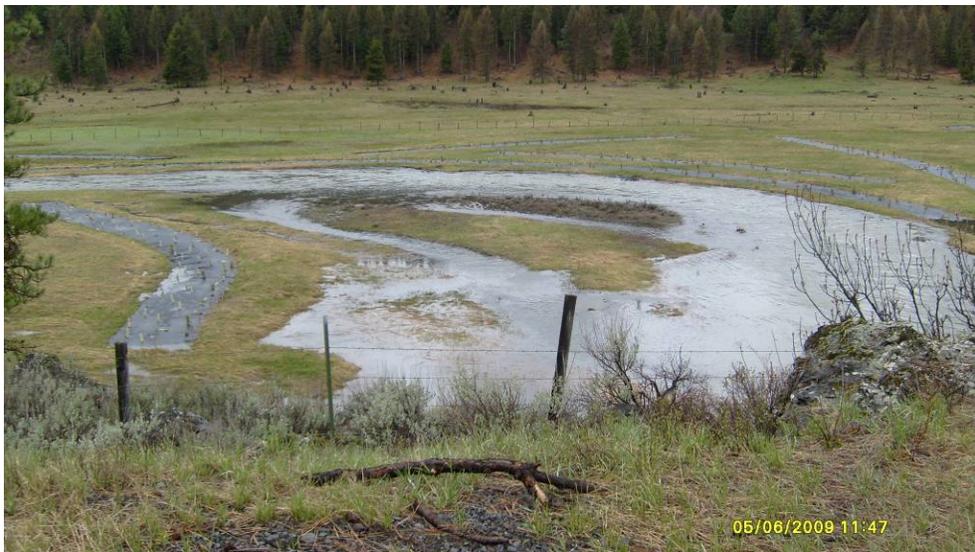
Figure 42. Photograph taken from location H as shown in Figure 41. Photograph taken one day prior to measured inlet flow of 391 cfs.

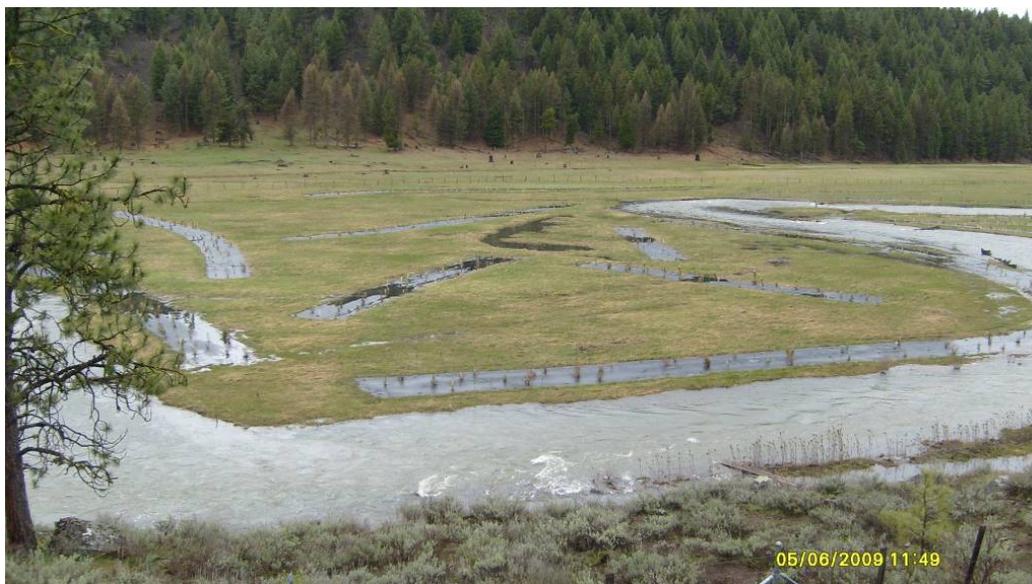
Figure 44. Photograph taken from location I as shown in Figure 43. Photograph taken one day prior to measured inlet flow of 391 cfs.
