RECLAMATION

MIDDLE FORK AND UPPER JOHN DAY RIVER TRIBUTARY ASSESSMENTS GRANT COUNTY, OREGON

BUREAU OF RECLAMATION
TECHNICAL SERVICE CENTER, DENVER, CO
AND
PACIFIC NORTHWEST REGIONAL OFFICE, BOISE, ID

MAY 2008

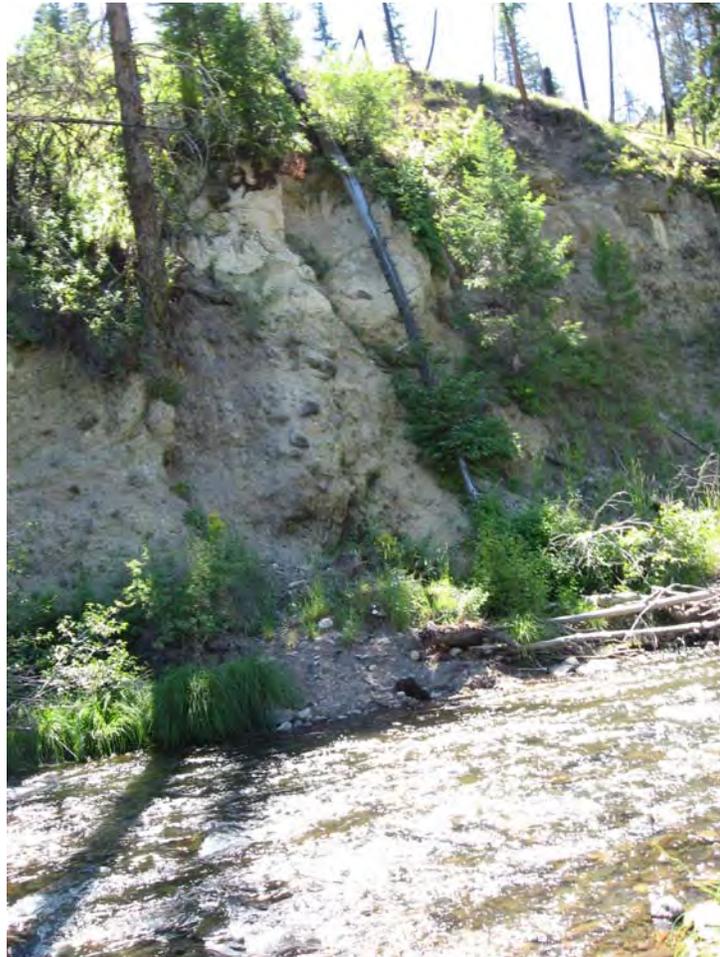
Figure 2 – Alluvial Bank Showing Bedrock Exposure. This material acts as a lateral control on the channel position in the Middle Fork, above Big Boulder Creek

Lateral boundaries of each reach are defined by the extent of the floodplain, referred to as the “low surface” in this report. The low surface is composed of the active channel (unvegetated main channel and sediment bars), side channels, vegetated islands, and the adjacent floodplain. The floodplain boundary consists of bedrock outcrops and alluvial fans that are difficult to erode on a decadal time scale and limit or at least slow lateral expansion (Figure 2).

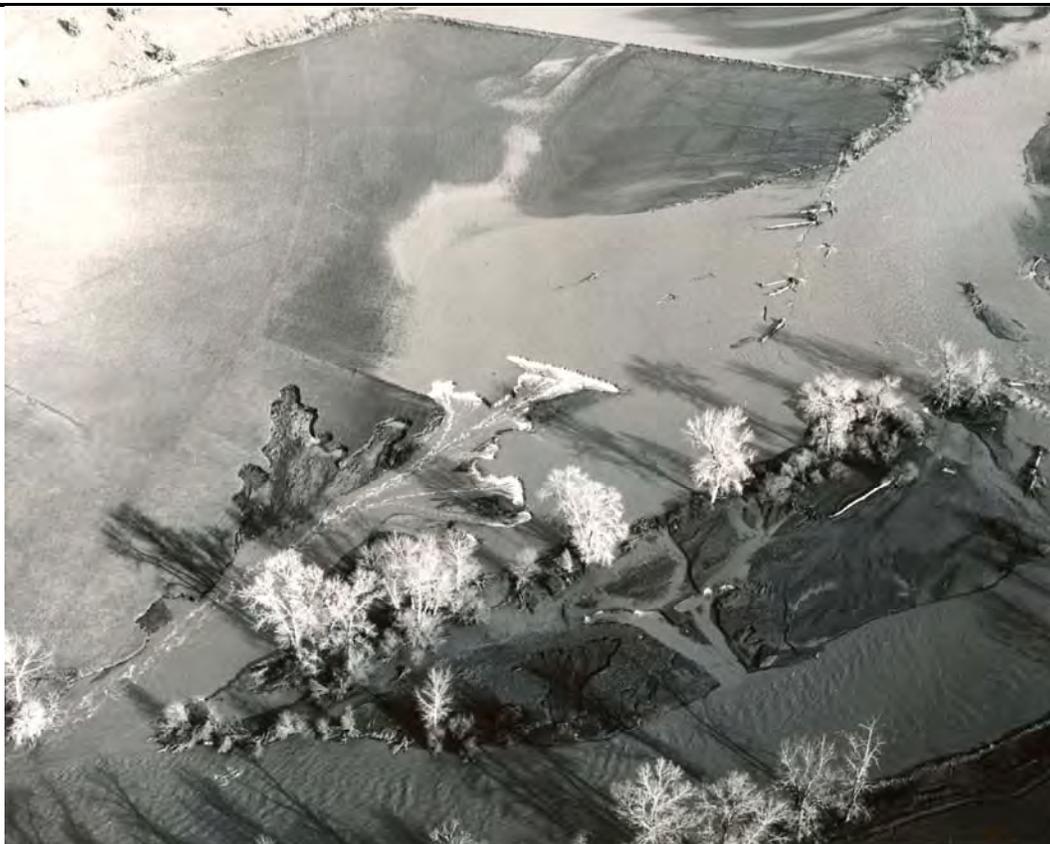
Figure 9 – John Day River near Dayville during 1964 Flood Event. This photo exemplifies typical channel avulsion occurring on a rancher’s property. The river eventually formed a new channel and straightened out the river bend. Photo compliments of Grant County.

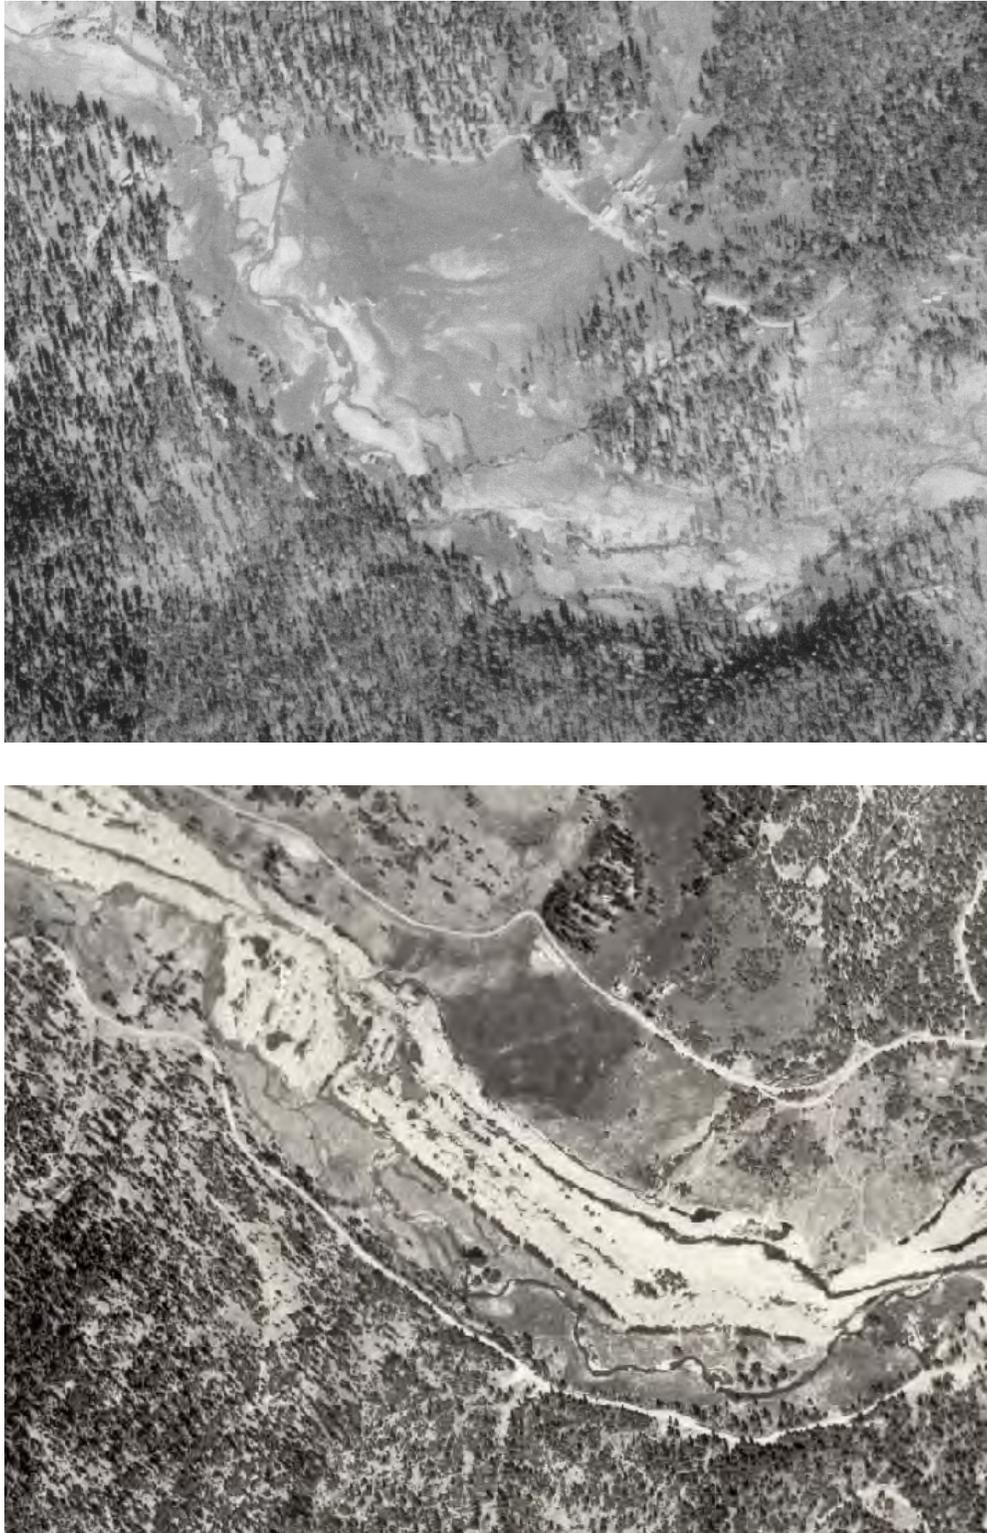
Figure 10 – Example of Dredge Mining Impacts on the John Day River and Adjacent Floodplain in Reach MF8. The top photograph shows the river conditions in 1939, just prior to the start of dredging operations in this reach. The bottom photograph was taken in 1956, almost 15 years following the end of dredge mining in the basin.

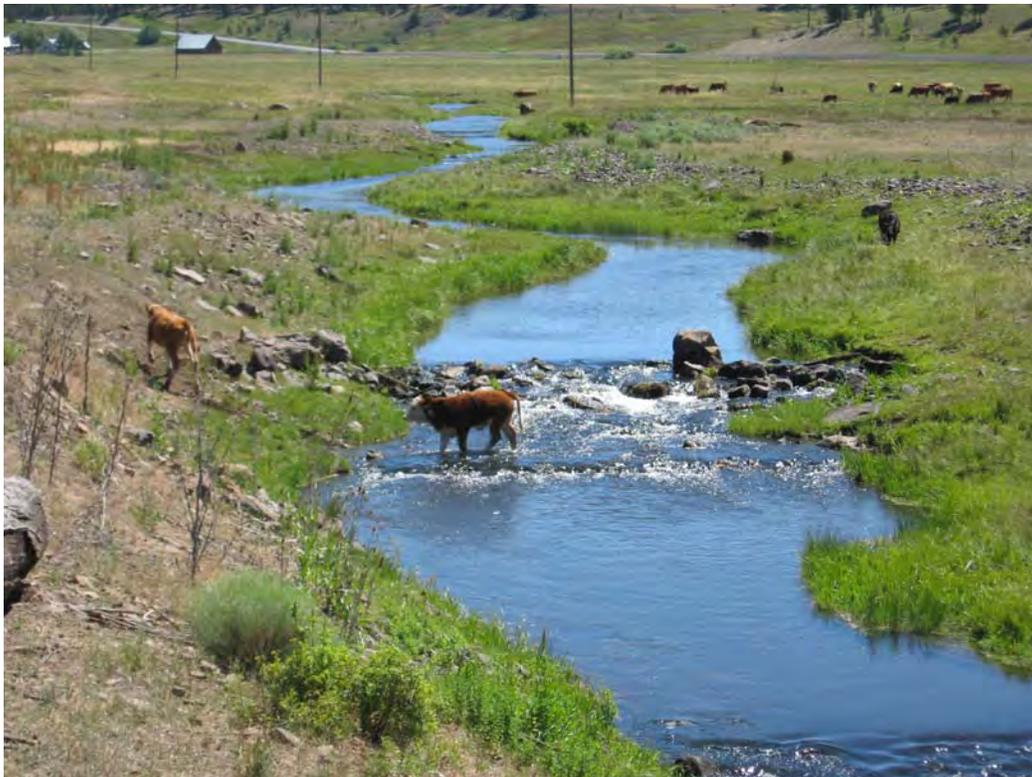
Figure 12 – Rock Structure in MF15. It may provide a vertical control on the extent of erosion.

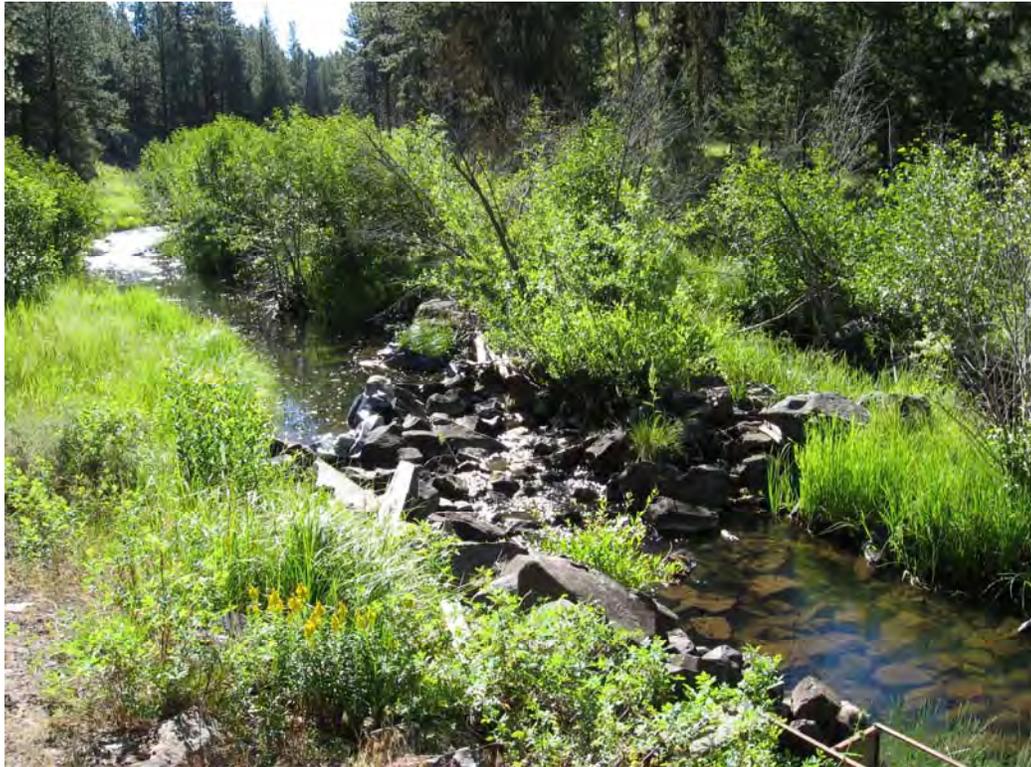
Figure 13 – Rock Diversion. It exerts some vertical control on the channel position in reach MF20.

In general, vertical controls have not changed substantially in the last 100 years, with the exception of some additional constructed controls. The exact number and locations of man-made vertical controls have not been mapped, but known locations include most diversion structures and culverts (see Figure 30), log and rock structures on Forest Service properties, and a rock grade control structures in MF16 (Figure 12 and Figure 13). These structures are discussed further in sections of Chapter 4.3. Like vertical geologic controls, constructed features can cause upstream aggradation, or if they are removed, can instigate headcuts.

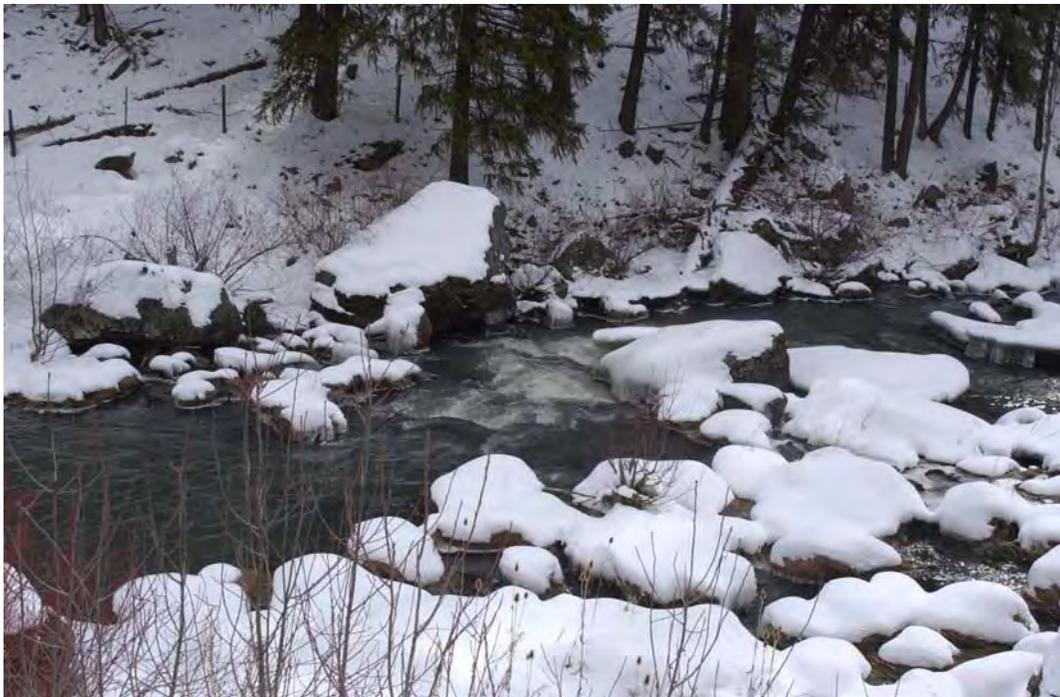
Figure 16 – Major Slope Break Near RM 62. The large boulders act as a vertical geologic control to channel the adjustment.

The range in slopes is much more variable for the Middle Fork Assessment Area than for the Upper Mainstem. The channel profile was used to identify significant geologic and anthropogenic vertical channel controls. In general, the channel slope of the Middle Fork coincides with the relative degree of floodplain confinement (Figure 15). Confined reaches tend to illustrate relatively high slopes when compared with moderately confined and unconfined reaches and generally have a greater capacity to transport sediment and LWD due to their high slopes. For example, reach MF11 is heavily confined and contains a sharp drop in grade as the channel travels over large boulder and bedrock controls (Figure 16). Unconfined reaches of the Middle Fork tend to have the lowest slopes.

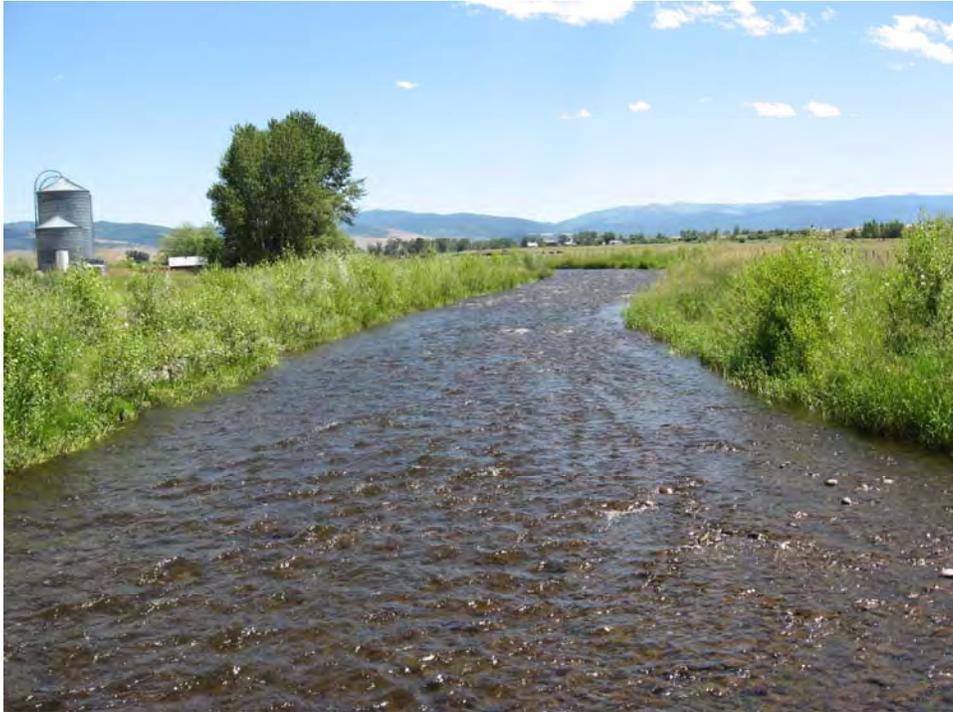
Figure 18 - Wide, Shallow River Devoid of Woody Vegetation in Reach UJD2.

While the mechanism is not entirely clear, a substantial portion of riparian vegetation was removed within the floodplain due to anthropogenic activities. Comparison of historic aerial photographs indicate that 37 percent of woody vegetation in reach UJD1, 66 percent of woody vegetation in reach UJD2, and 50 percent of woody vegetation in reach UJD3 was converted to low vegetation or open areas since 1939. However, a substantial amount of woody vegetation was probably removed prior to the earliest 1939 photographs.

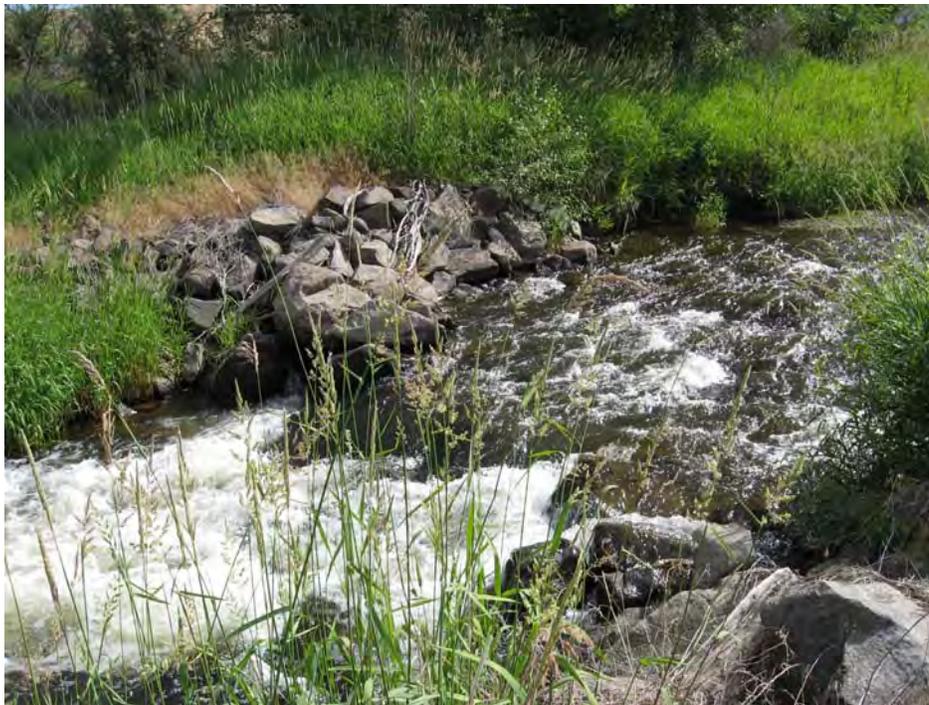
Figure 21 – Photograph of Grade Control Structure along Reach UJD3. A series of structures is present in the reach to support the required head for an upstream diversion.

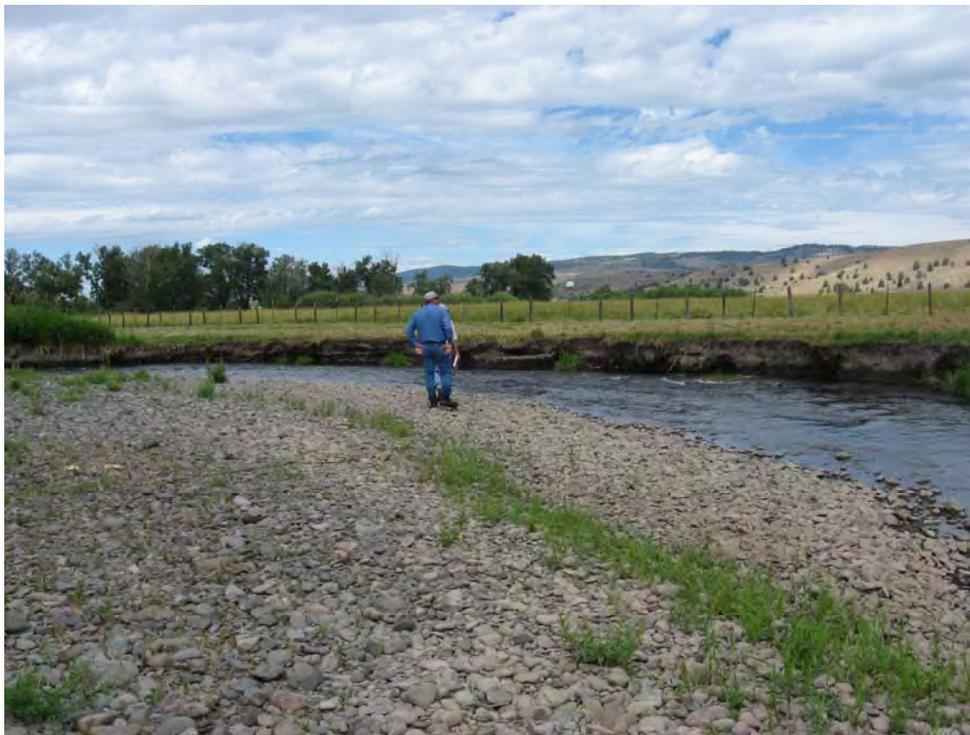
Figure 22 – Example Location of Lateral Channel Migration Processes. Note the lack of woody vegetation that could slow bank erosion rates.

Due to historic alterations to the sediment regime, the river may be continuing a trend of adjustment through attempts at lateral channel migration where possible (Figure 22). Reach UJD2 has an increased erosive capacity compared to both upstream and downstream reaches under flood flow events. These results suggest that there is a trend toward lateral and/or vertical channel degradation in this reach, but no vertical degradation was noted during field visits. Opposing alluvial fans at the transition of reach UJD2 and UJD3 may impart some control on vertical channel adjustment. Considerable bank erosion was noted in localized areas during field visits. Some bank erosion and lateral channel shifts should be associated with the natural process of bend migration; however, it is not known whether the erosion noted was part of natural bend migration processes, or a response to historic channel straightening. Flood flows have caused alterations in channel position during the limited time period of this study. Overall, the channel may be eroding banks and making lateral adjustments, but is not degrading the bed.

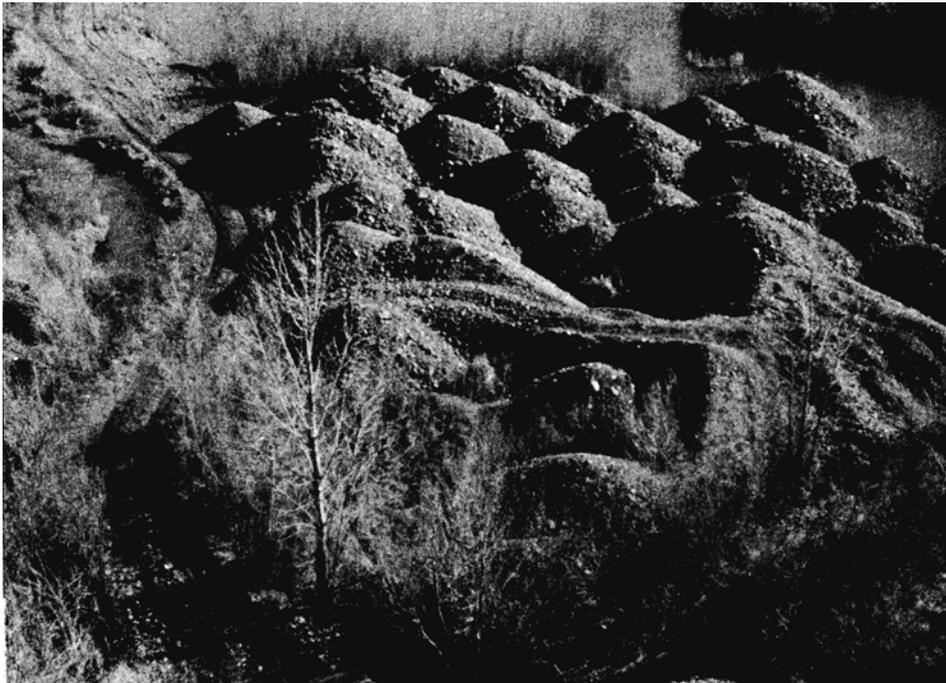
Figure 16 – Photograph of the Floodplain Deposits Following Dredge Mining Activities (Oliver 1962).

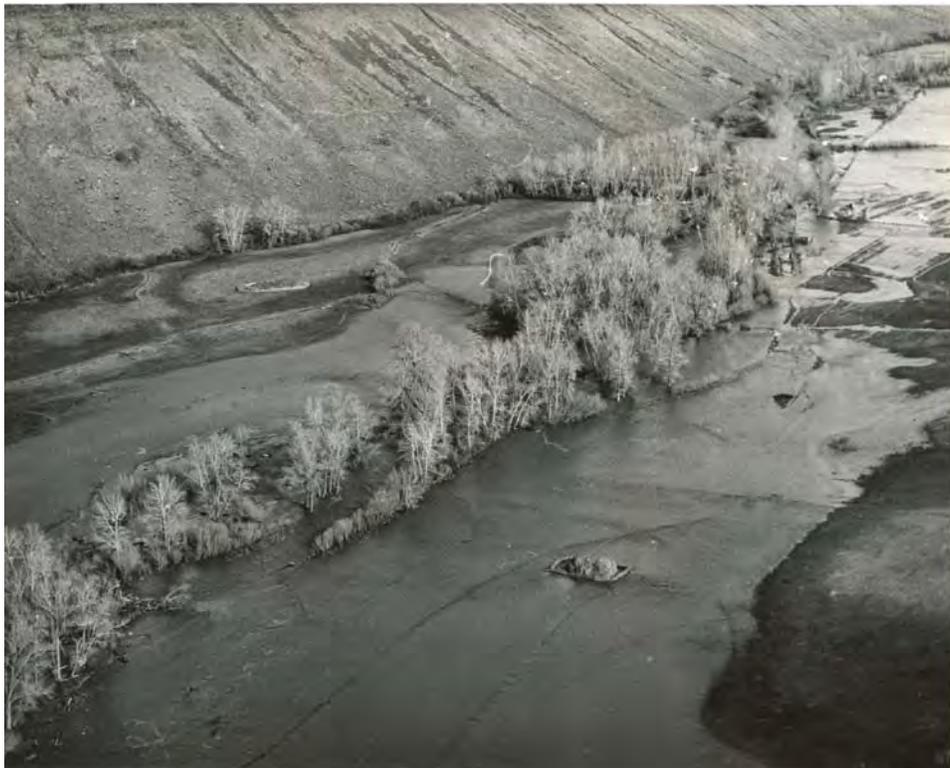
Figure 19 – John Day River Following the 1964 Flood Event. Channel blockage caused high water to overflow the banks and spill onto the floodplain. (Photo compliments of Grant County)

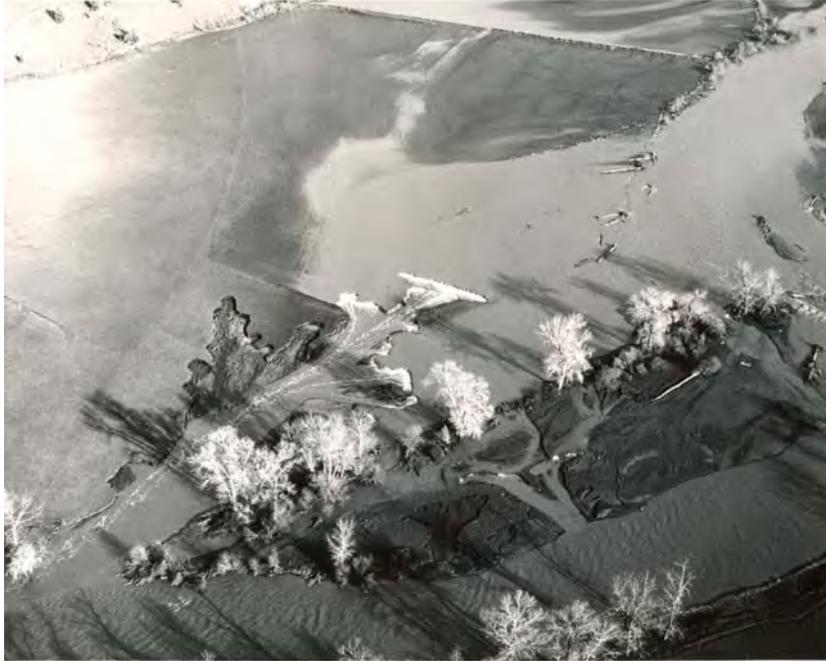
Figure 20 – John Day River near Dayville During 1964 Flood Event. This photograph exemplifies typical channel avulsion occurring on a rancher's property. The river eventually formed a new channel and straightened out the river bend. Photo compliments of Grant County.

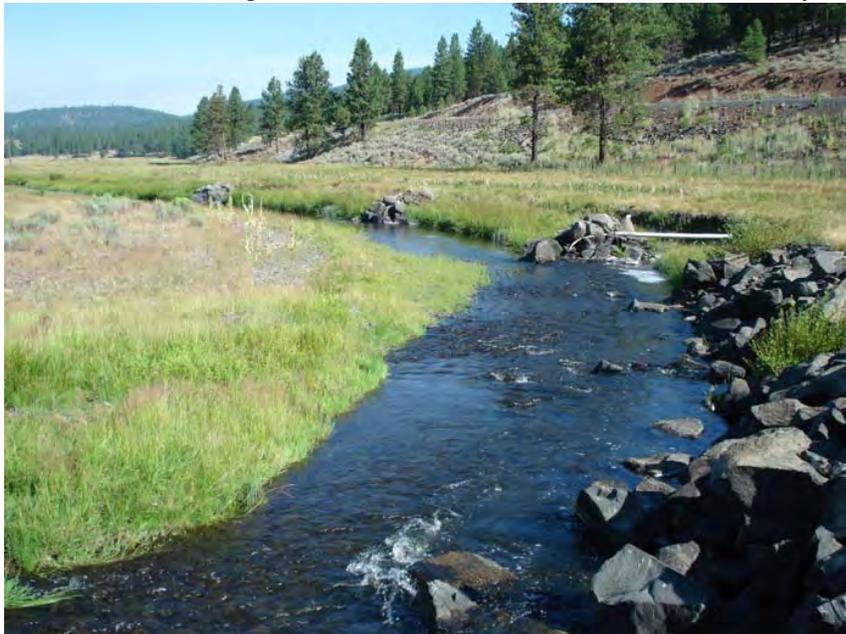
Figure 21 – Photograph of Rock Spurs on the Middle Fork Forrest Conservation Area. (Photograph by R. McAfee, July 20, 2007)

Emergency services provided by the Army Corps of Engineers consisted of channel straightening, riprap bank installations, and clearing of channel blockages, including the removal of LWD and other gravel and debris plugs. Several years after the 1964/1965 floods, the Soil Conservation Service further quelled ranchers' fears of property loss through the installation of bank protection measures, such as riprap and rock spurs (Figure 21; Grant 1997). The goal of their efforts was to deflect flow away from eroding

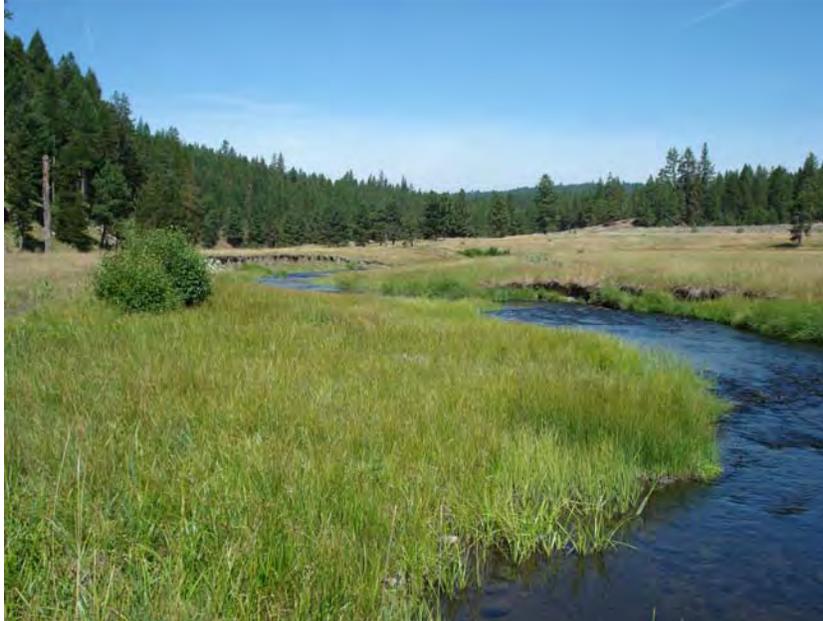
Figure 1 – Present-Day Example of a Wide, Unconfined Floodplain Topographic Features, Reach 13. Historic floodplains of this type were likely much more complex.

Highly complex floodplains could be present in wide, unconfined valleys of the Middle Fork (Figure 1). Compared with more confined floodplain types, this type generally consists of flatter slopes and larger supplies of sediment and LWD in storage in the floodplain and river channel. A highly sinuous main channel could frequently interact with the floodplain through a complex network of multiple side and overbank channels (Figure 2). This high degree of floodplain interaction would allow lateral channel migration and support the dynamic cycle of conversion from river to floodplain and vice

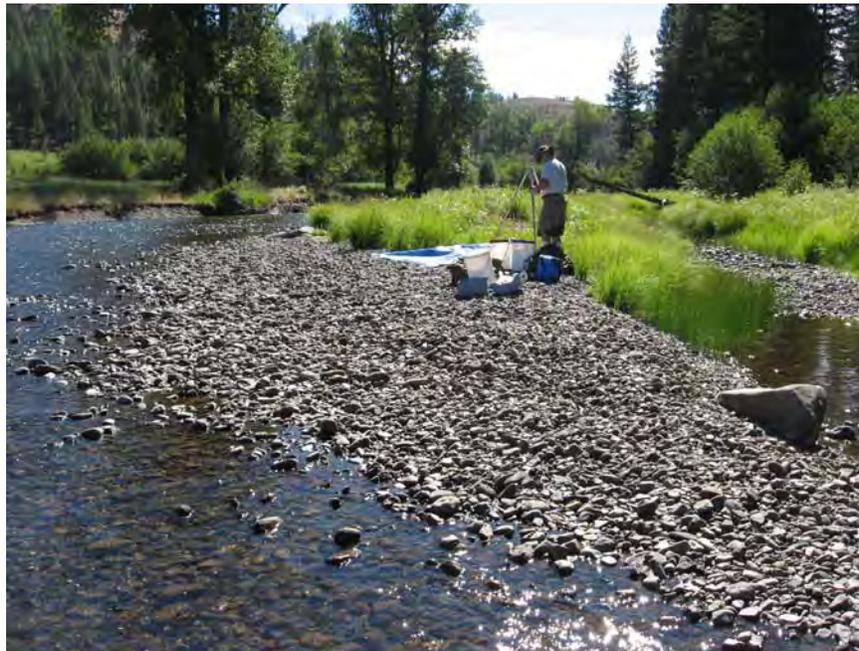
Figure 3 – Example of a Moderately Confined Floodplain in Reach MF5.

Moderately confined floodplains generally consist of a more defined main channel and fewer well-defined side channels compared with the high complexity floodplains (Figure 3 and Figure 4). Although the majority of water and coarse sediment can be conveyed through the main channel, some side channels may have potential to support habitat, particularly in locations where groundwater supplements the supply during low-flow conditions. Older surfaces present within the floodplain are higher and more stable than the surfaces of the unconfined floodplain areas. These surfaces may become inundated under large magnitude floods but can not be reworked as rigorously as lower, more frequently activated floodplain surfaces. Only fine sediments, carried in suspension, can be deposited on and removed from these surfaces.

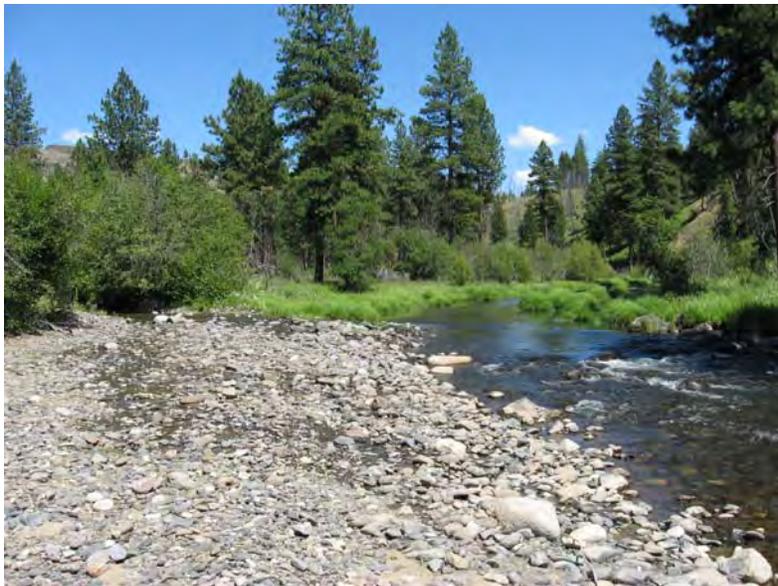
Figure 5 – Example of a Confined Floodplain, Reach MF4, at Big Boulder Creek Confluence.

The third typical floodplain type consists of confined, straight channel reaches with little to no off-channel habitat (Figure 5 and Figure 6). In most confined reaches, adjacent hillslopes dramatically increase above the floodplain surface. These surfaces are likely inundated only during paleoflood events. In a few of the confined reaches, alluvial fans and terraces may not have quite as dramatic hillslopes and may be inundated during 50- to 100-year flood events. Bedrock provides vertical and lateral geologic controls on channel position. Channel slopes within confined floodplains are typically substantially greater than slopes in moderately confined and unconfined floodplains.

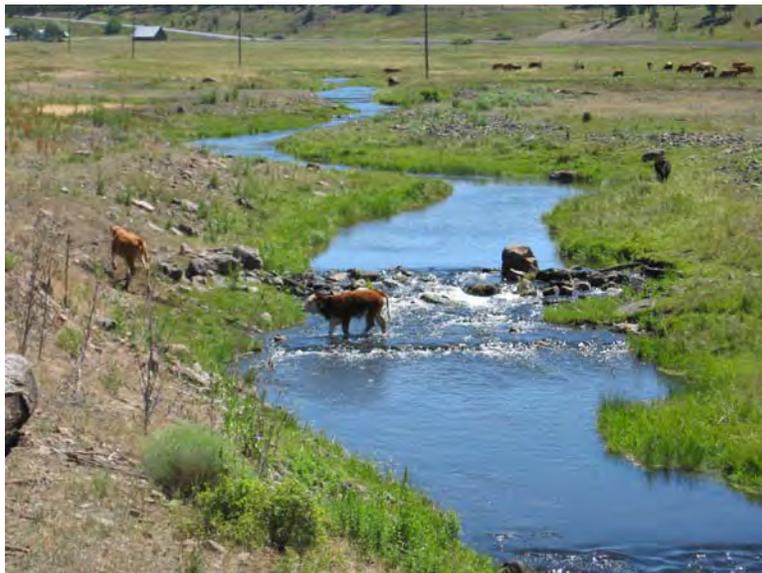
Figure 13 – Cattle Grazing in Reaches MF15 and MF 16.

Today, cattle grazing is moderated in many reaches of the Middle Fork. On the Oxbow and Forrest Conservation Areas, exclosure fencing prevents cattle from entering the channel and grazing within the riparian corridor. Within a few reaches of the assessment area, uncontained cattle grazing continues (Figure 13).

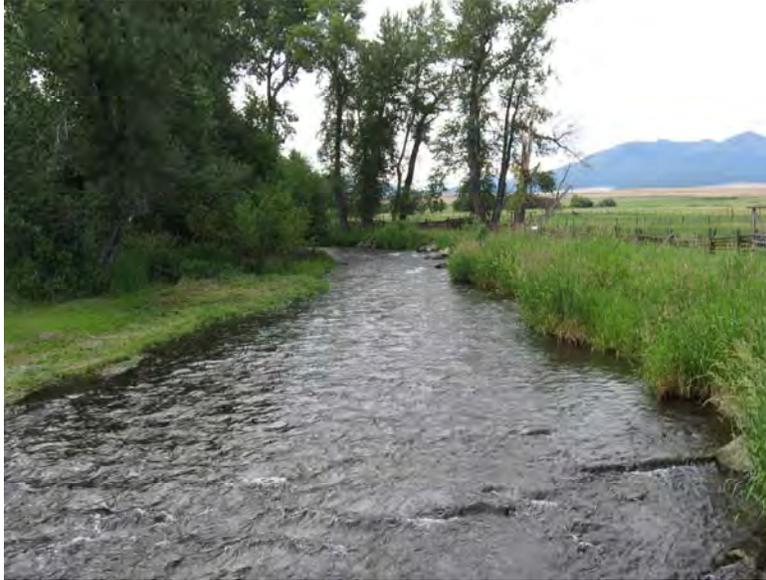
Figure 1 – Present Day Photograph near Upstream End of Unconfined Reach UJD3.

As described in the geologic characterization of the Upper Mainstem (Section 4.0 of this appendix), the topography over the low surface was defined by glacial movement and development of alluvial fans, which ultimately led to the formation of a “bowl-shaped” valley in the assessment area. Unconfined floodplain areas in this assessment have wide floodplains relative to moderately confined and narrow floodplains (Figure 1). Compared with more confined floodplain types, this type generally consists of flatter slopes and larger supplies of sediment and LWD in storage in the floodplain and river channel (Figure 2). A sinuous main channel could frequently interact with the floodplain through side and overbank channels. This high degree of floodplain interaction provides potential for lateral channel migration and could support the dynamic cycle of conversion from river to floodplain and vice versa. This dynamic process is what could maintain a healthy

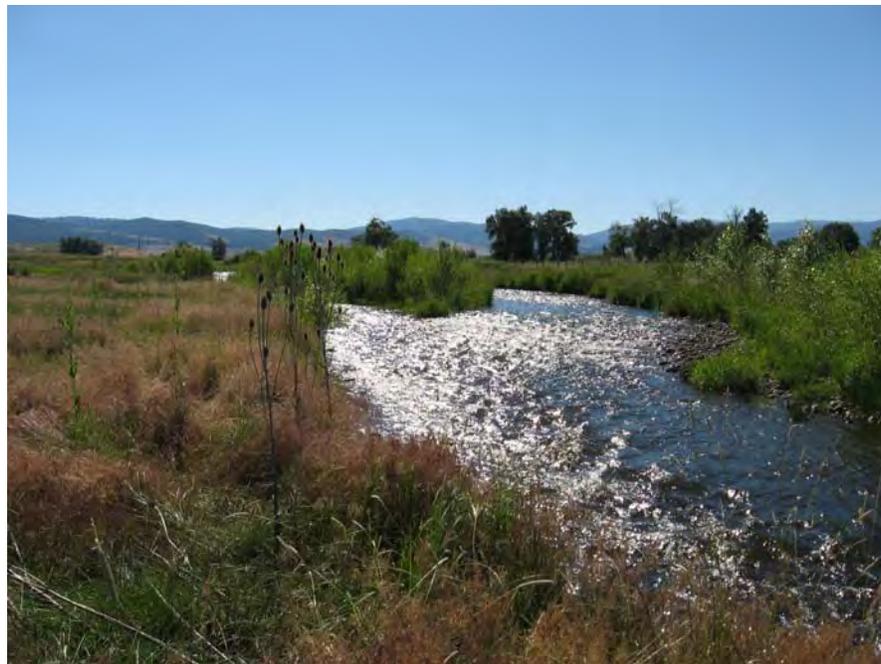
Figure 3 – Present Day Photograph of Moderately Confined Reach UJD2. Note proximity of terrace on the left side of the photograph.

Moderately confined floodplains generally consist of a single main channel and fewer well-defined side channels as compared with the unconfined floodplains (Figure 3). Although the majority of water and coarse sediment can be conveyed through the main channel, some side channels can have enough incoming flow to support habitat. Older surfaces present within the floodplain are slightly higher than the surfaces of the unconfined floodplain (Figure 4). These surfaces may be inundated at a similar frequency as unconfined floodplains due to backwater impacts from downstream geological constrictions, but the floodplain deposits do not have as much potential for reworking as lower, more frequently activated floodplain deposits. Fine sediments, carried in suspension, can be deposited on and transported from floodplain surfaces during different stages of a flood event.

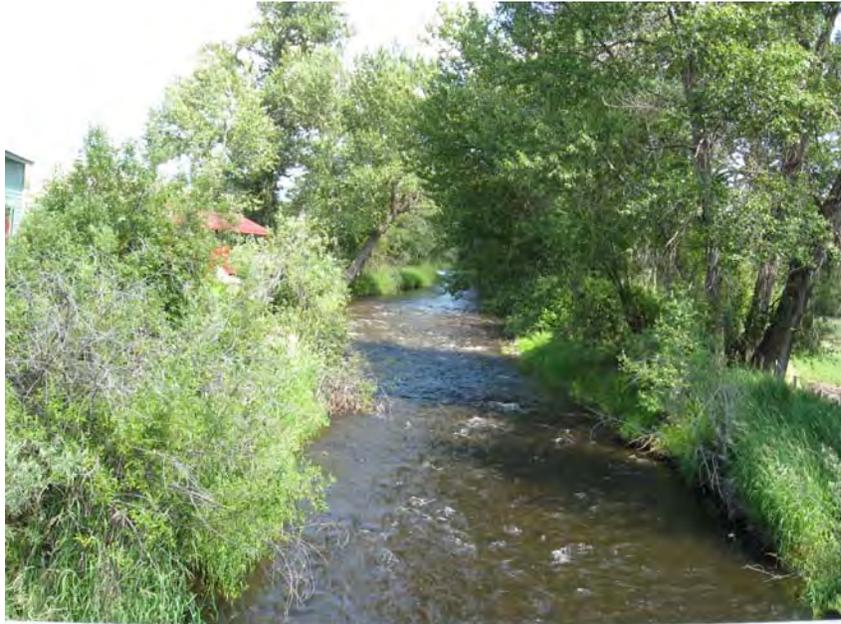
Figure 5 – Picture of Confined Reach UJD1. Note the houses adjacent to the river surface lie at a higher elevation.

The third historic floodplain type consists of confined, straight channel reaches with little to no off-channel habitat (Figure 5). In most confined reaches, adjacent terraces are more pronounced above the floodplain surface than in less confined reaches (Figure 6). These surfaces are likely inundated only during floods that pool in the valley due to backwater impacts from geologic channel constrictions. Channel slopes within confined floodplains are typically higher than slopes in moderately confined and unconfined floodplains, partially due to the inability of the channel to develop meanders through higher, more resistant surfaces.

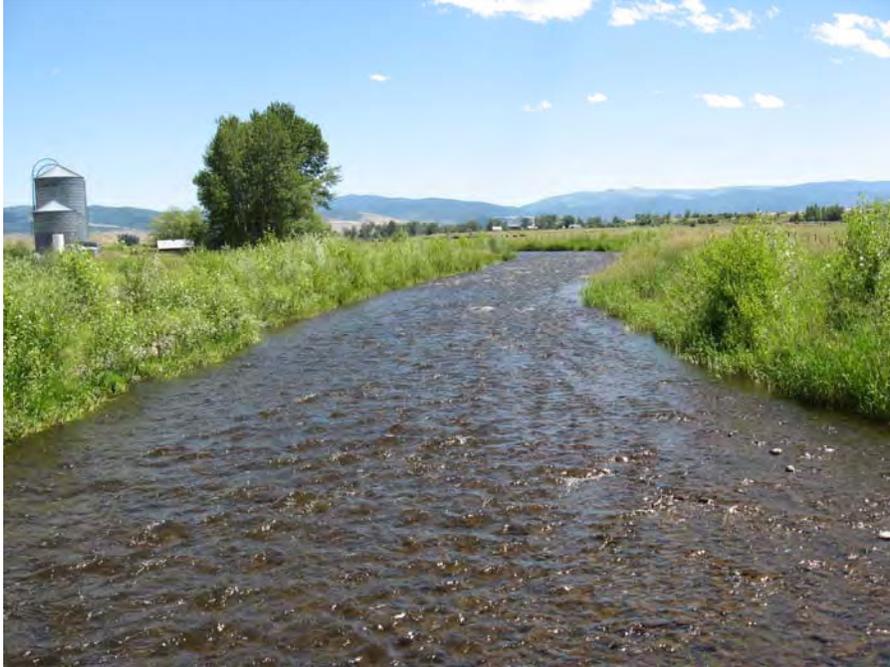
Figure 13 – Wide, Shallow River Devoid of Woody Vegetation in Reach UJD2. This condition may result from historic grazing impacts.

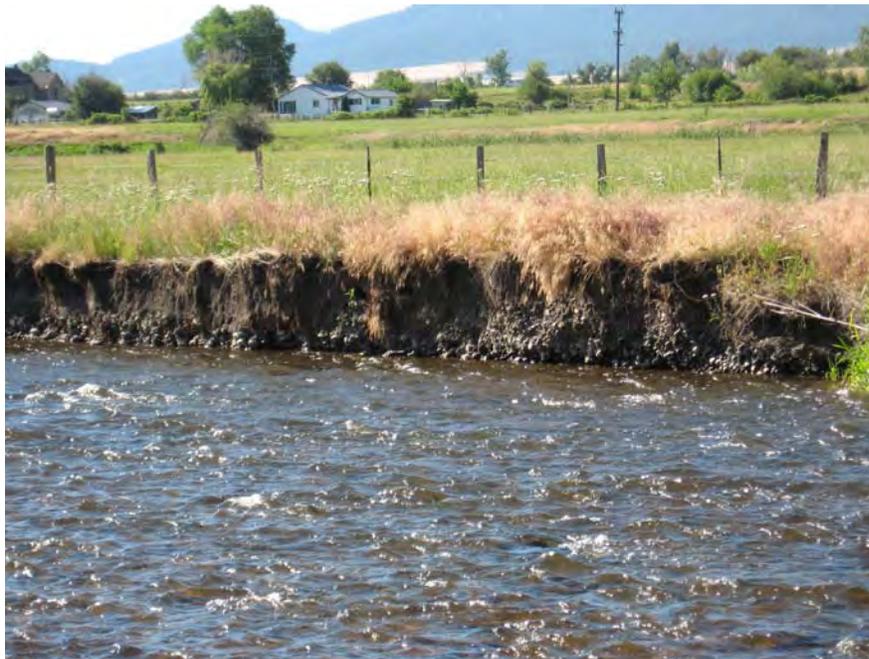
Figure 14 – Example Showing How Unvegetated Banks are More Susceptible to Erosion.
