FINAL GRAY REACH ASSESSMENT ENTIAT RIVER, CHELAN COUNTY, Washington

U.S. Department of the Interior
Bureau of Reclamation
Pacific Northwest Region
Boise, Idaho

May 2013

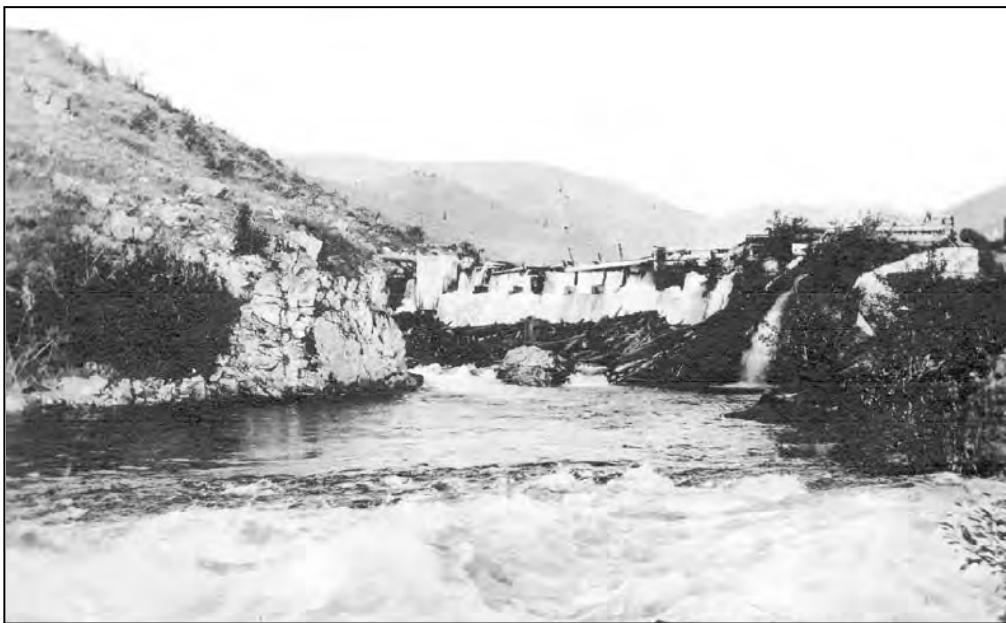
Figure 5. Formerly the T.J. Cannon, Cannon & Harris, and later the H.H. Gray & Son Mill Dam circa 1916 near RM 0.6 completely blocked upstream fish passage for decades (Reclamation 2009a).

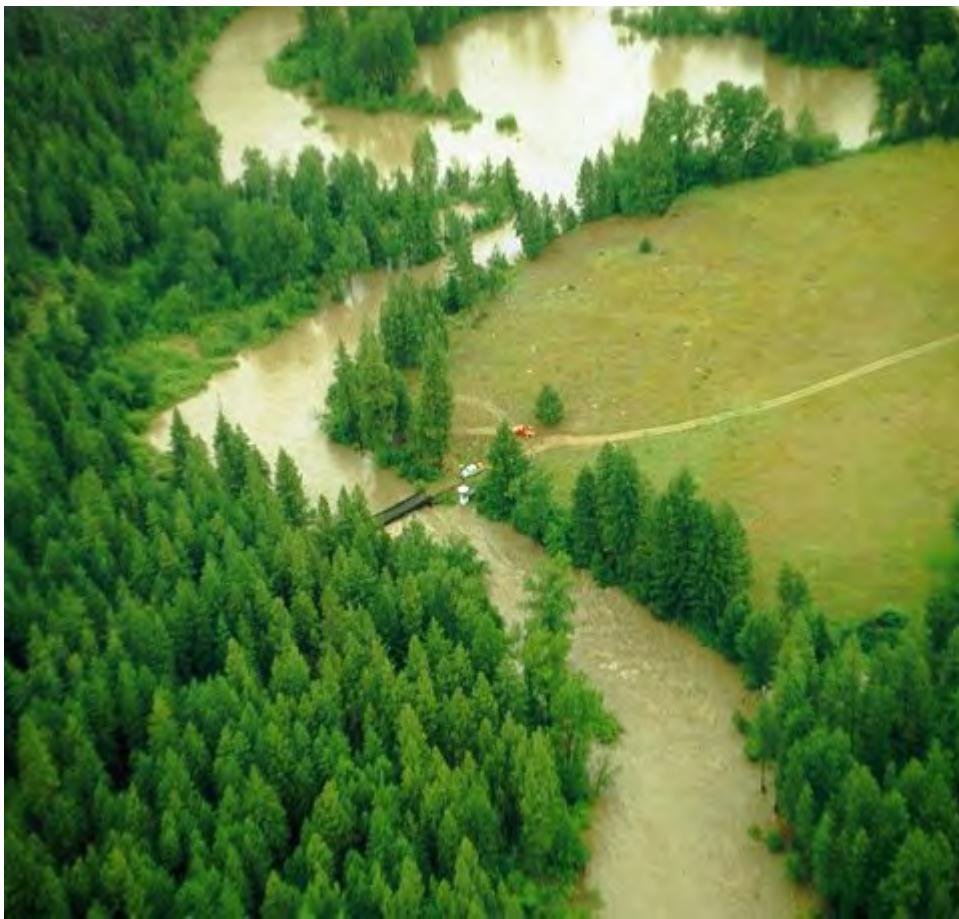
Figure 6. A 1972 oblique aerial photo of the bridge near RM 18, immediately upstream of the Gray Reach of the Entiat River during the 1972 Flood. Courtesy of Phil Archibald (Retired USFS) via Robes Parrish (USFWS).

Year or Period	Significant Historical Event
1887	First Euro-American settlers arrive in lower Entiat valley
1888 to 1917	Lumber mill holding dam formerly operated by T.J. Cannon, Cannon & Harris, and later H.H. Gray & Son at RM 0.6 blocked fish (Figure 5).
1913 to 1932	Kellogg Mill Dam at RM 3.6; 8-foot-high dam blocked fish.
1948	Flood of record is roughly 10,800 cfs as measured in lower Entiat River
1956	Rocky Reach Dam construction commenced on Columbia River
1961	Rocky Reach Reservoir filled (Lake Entiat)
1971	Last documented major removal of logjams from the river
1972	Flood measuring roughly 6,430 cfs at Ardenvoir (Figure 6).
1990s	Major fish habitat rehabilitation efforts begin

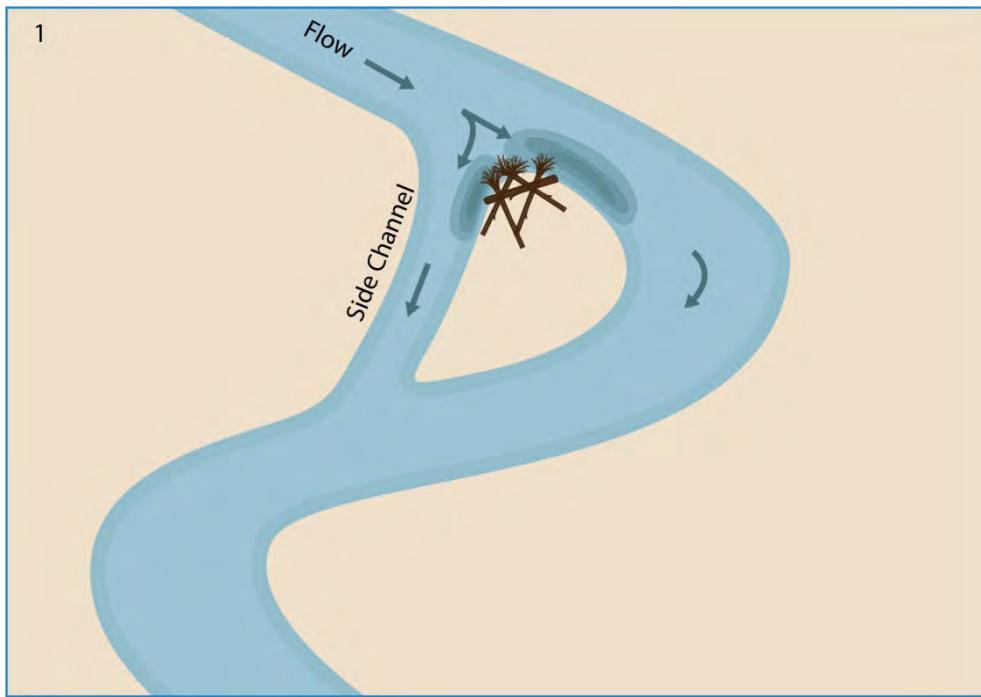
Figure 17. Diagram illustrating how a logjam on a point bar can potentially split high flow, resulting in the formation and relatively long-term maintenance of a side channel across the point bar.

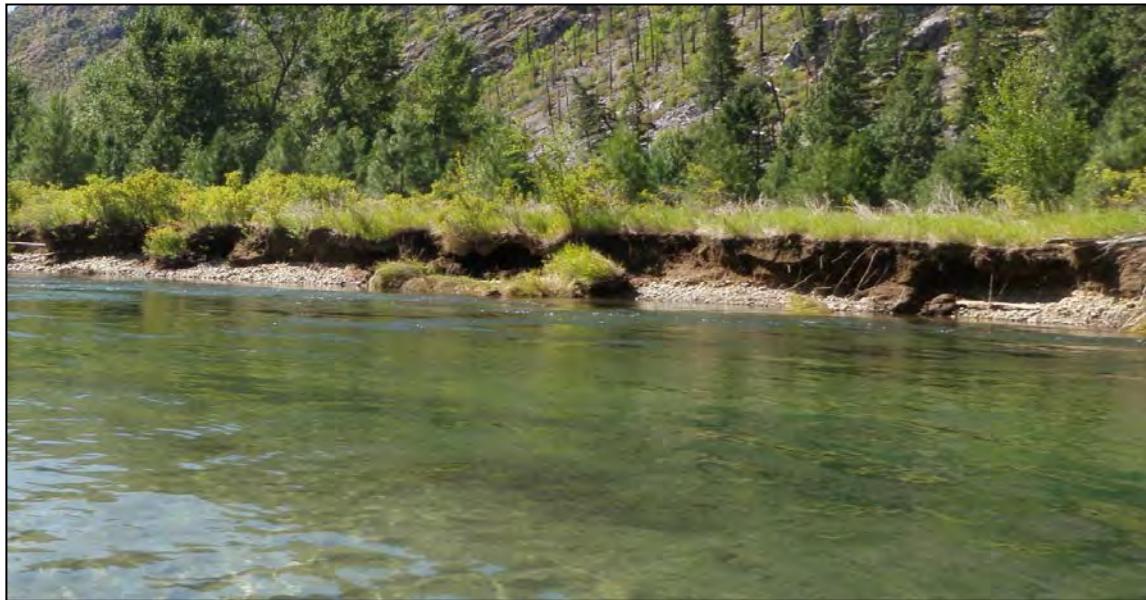
Figure 22. Bank erosion near RM 17.45 illustrating roughly 3 feet of floodplain silt/sand overlying gravel and cobble.

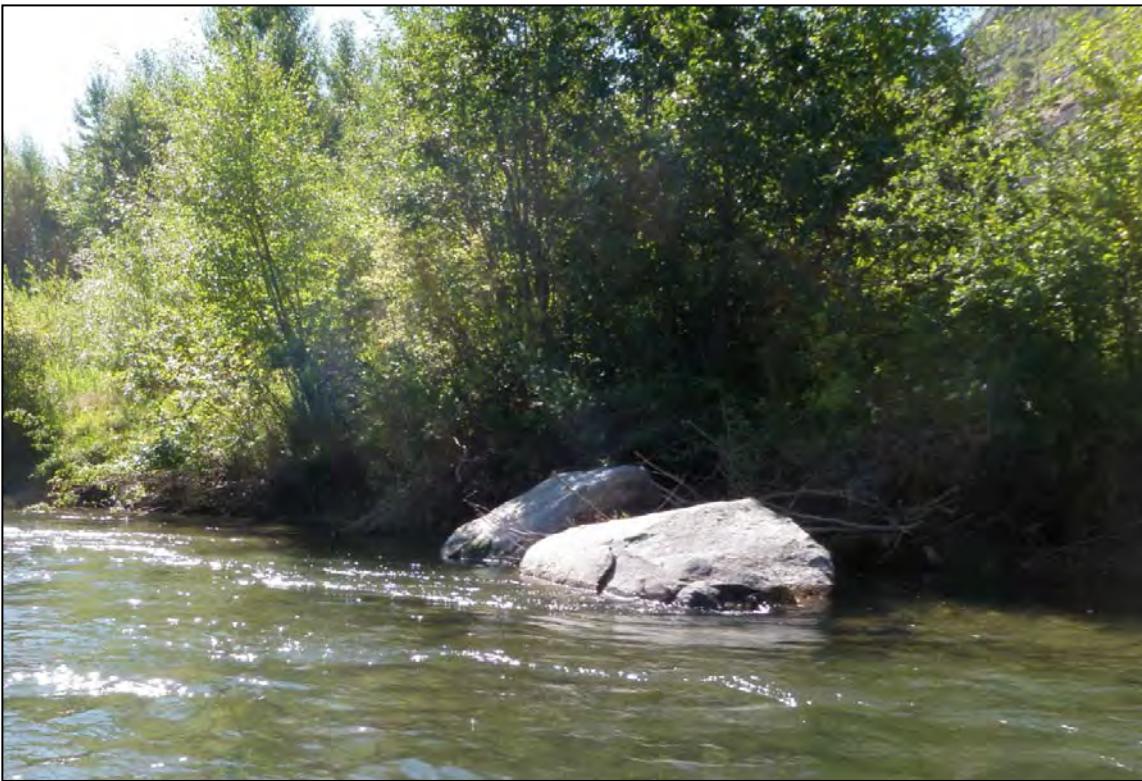
Figure 24. Large angular boulders comprise the majority of colluvium deposited along the valley wall. This photo was taken near RM 17.6 where the channel flows adjacent the valley wall for several hundred feet.

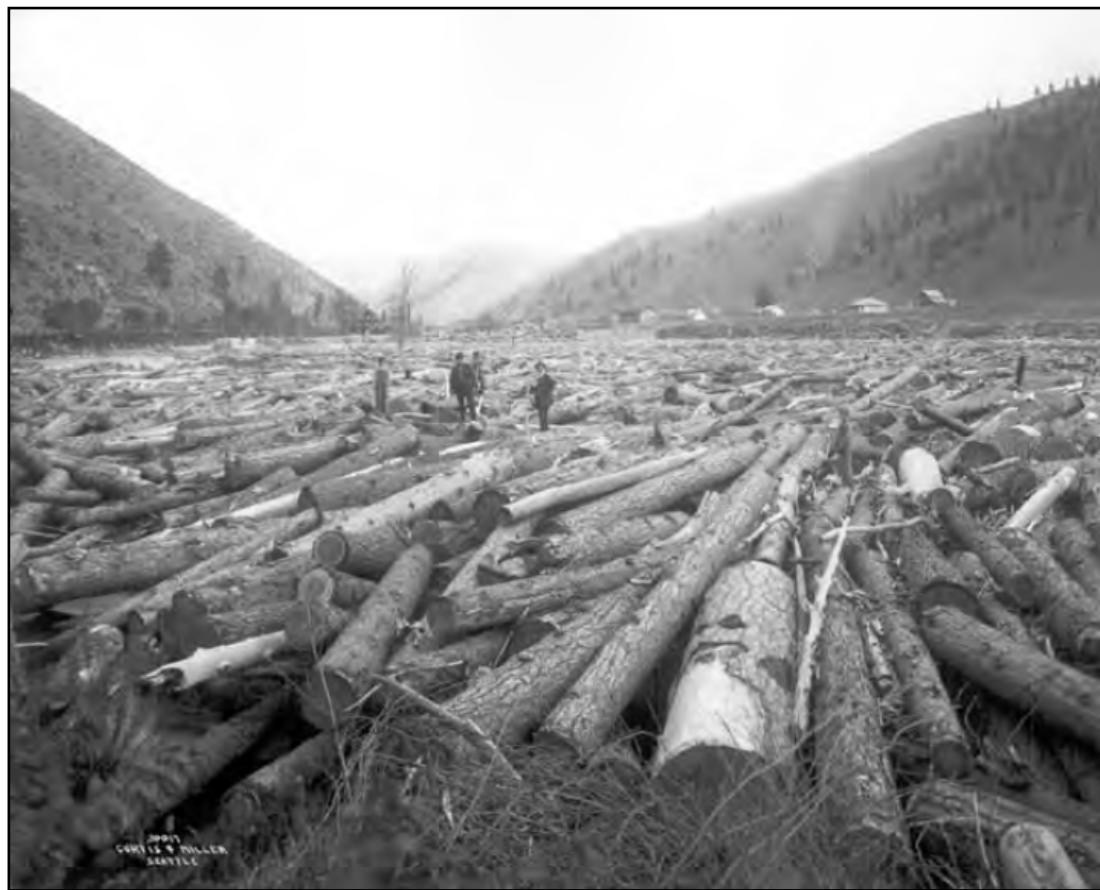
Figure 32. Photo of timber stockpiled at the Kellogg Mill near RM 3.4 in 1914. Note the large size of the timber and the general lack of standing trees both in the valley bottom and on the hillslopes (published in Erickson 2004).

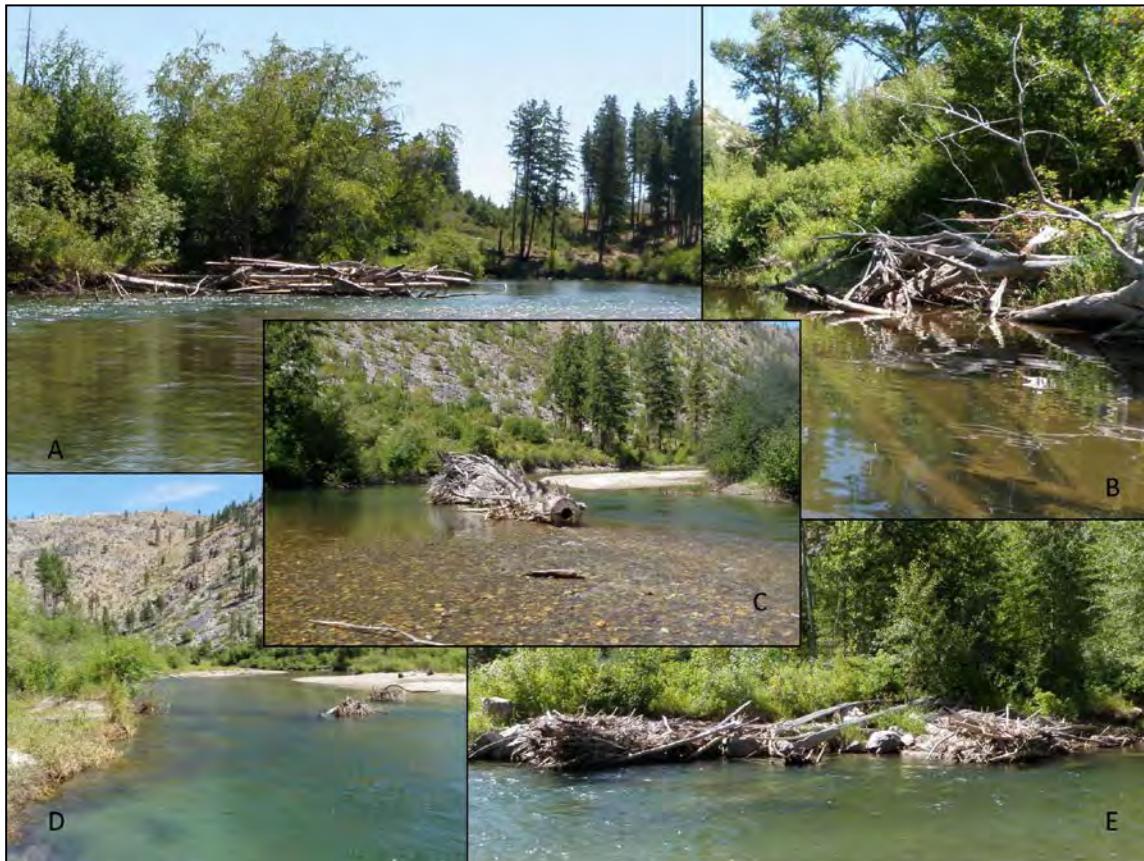
Figure 33. Photos of existing LWM in the Gray Reach.

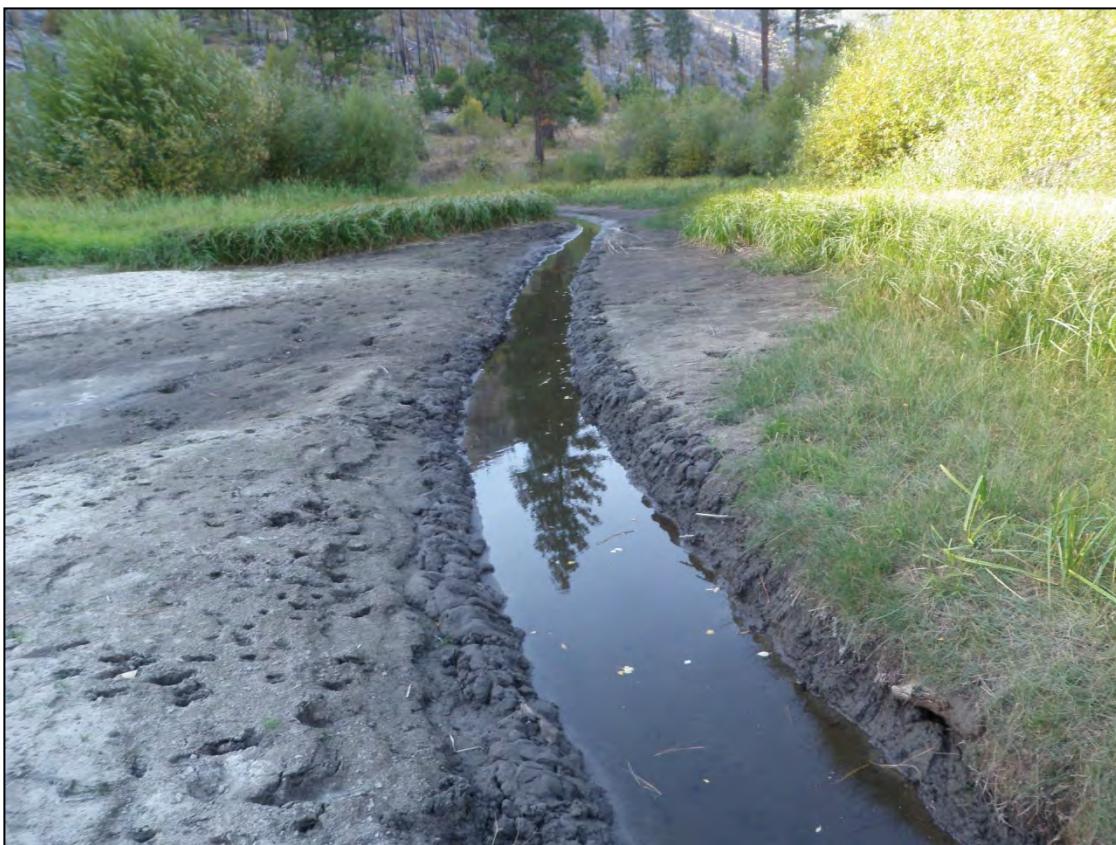
Figure 34. Low flow connection excavated in silt and sand by beavers between the mainstem channel and a beaver pond located in an alcove near RM 17.0.

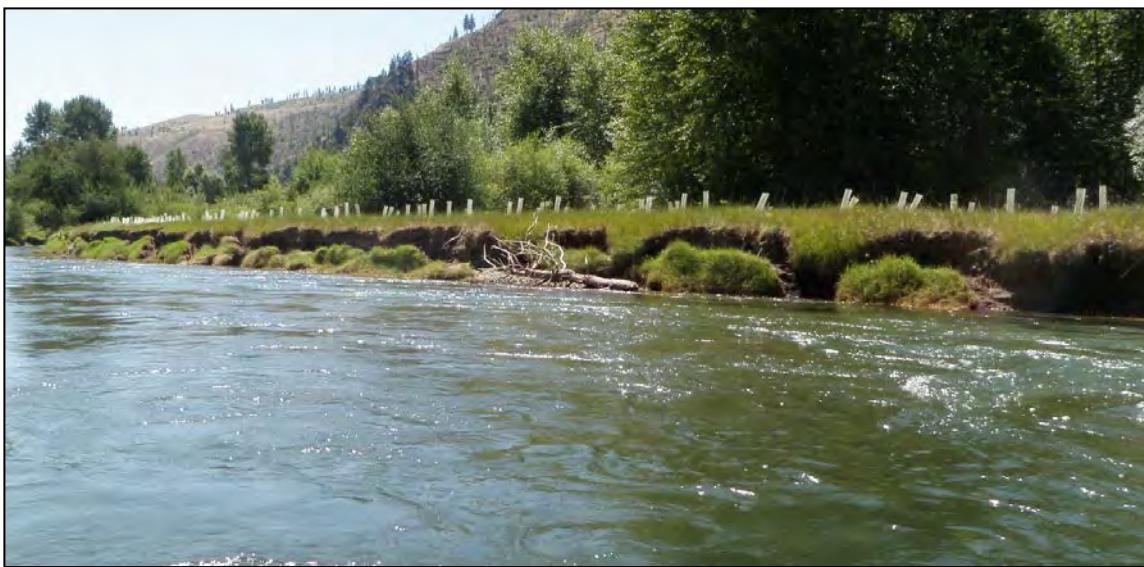
Figure 35. Bank erosion observed on the right bank near RM 16.5. The bank is composed of 3 to 4 feet of silt and sand over gravel and cobble. Recent riparian plantings can be observed on the floodplain surface, but the plantings are threatened by the erosion without any substantial structure to stabilize the bank.
