Methow Subbasin Geomorphic Assessment Okanogan County, Washington

METHOW SUBBASIN GEOMORPHIC ASSESSMENT, OKANOGAN COUNTY, WASHINGTON

BUREAU OF RECLAMATION
TECHNICAL SERVICE CENTER, DENVER, CO,
PACIFIC NORTHWEST REGIONAL OFFICE, BOISE, ID.
AND
METHOW FIELD STATION, WINTHROP, WA.

FEBRUARY 2008

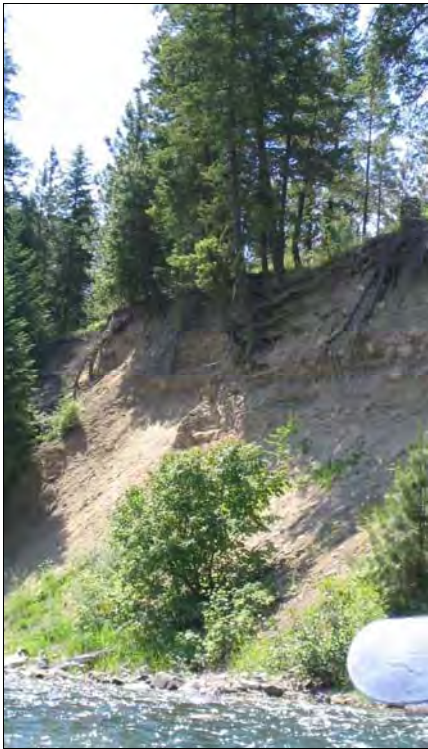
Figure 3. View of glacial bank along Methow River upstream of Winthrop.

bars), secondary or side channels, vegetated islands, and the adjacent floodplain, which may include overflow channels and surfaces less frequently inundated (Appendix G). The boundary of the floodplain consists of bedrock, alluvial fans, and glacial deposits that are difficult to erode on a decadal time scale and limit (or at least slow) lateral expansion (Figure 3 and Figure 4; also see Appendices E and G). Glacial deposits are the most common geologic unit along the boundary of the low surface in all four river valley segments (Appendix E). The second-most common geologic unit (by percentage) is alluvial fans in the Methow and Twisp, and bedrock in the Chewuch. Landslides compose less than 5% of the total boundary length on either side of the river for all four river valley segments.

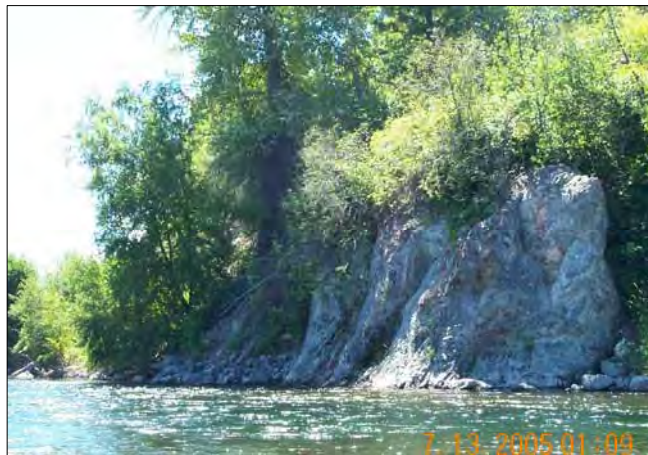
Figure 4. View of the Methow River between Carlton and Twisp River confluence, where bedrock composes the boundary of the low surface.

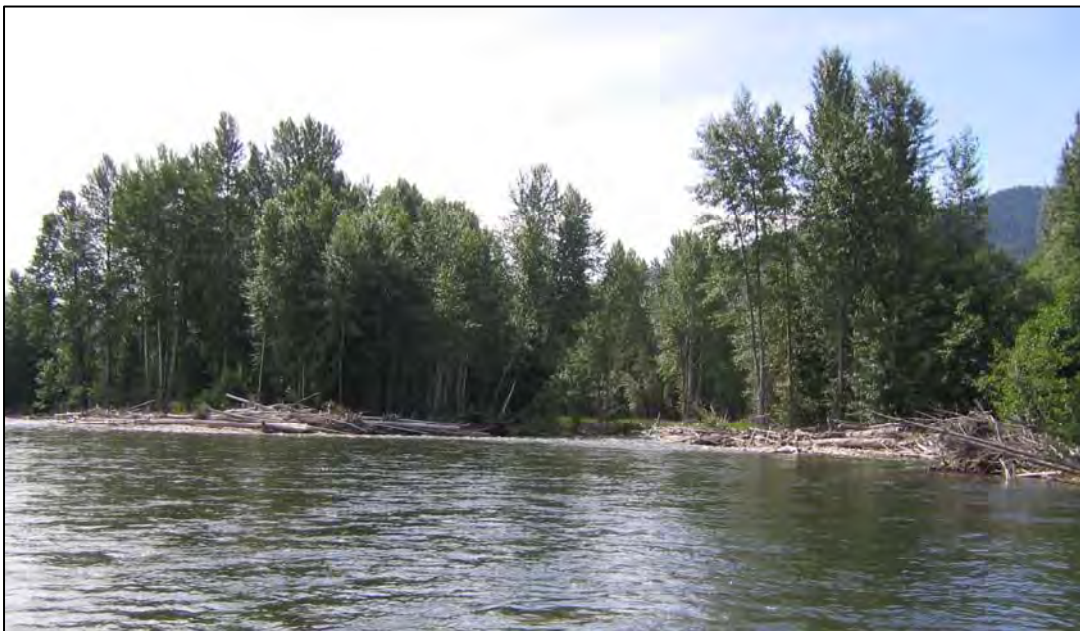
Figure 8. Log jam formed at head of vegetated island at location of flow split in Methow River upstream of confluence with Chewuch River.

The unconfined floodplain reaches typically have a high degree of channel and floodplain interaction from year to year with a dynamic cycle of conversion from river to floodplain and vice versa (Figure 7 and Figure 8). In a natural system, this dynamic process is what helps these reaches maintain a healthy riparian forest that provides ample shade and complexity while still being dynamic enough to build new habitat areas as others are eroded. Erosion and deposition are common as the channel migrates across the floodplain. During a single flood, one channel may fill with sediment. As this occurs, the channel can be abandoned and another channel enlarged (eroded) to become the new main channel. However the average channel bed elevations within the reach may not change over time, so that there is no temporal trend change in the total volume of sediment stored in the reach beyond a natural range of fluctuation.

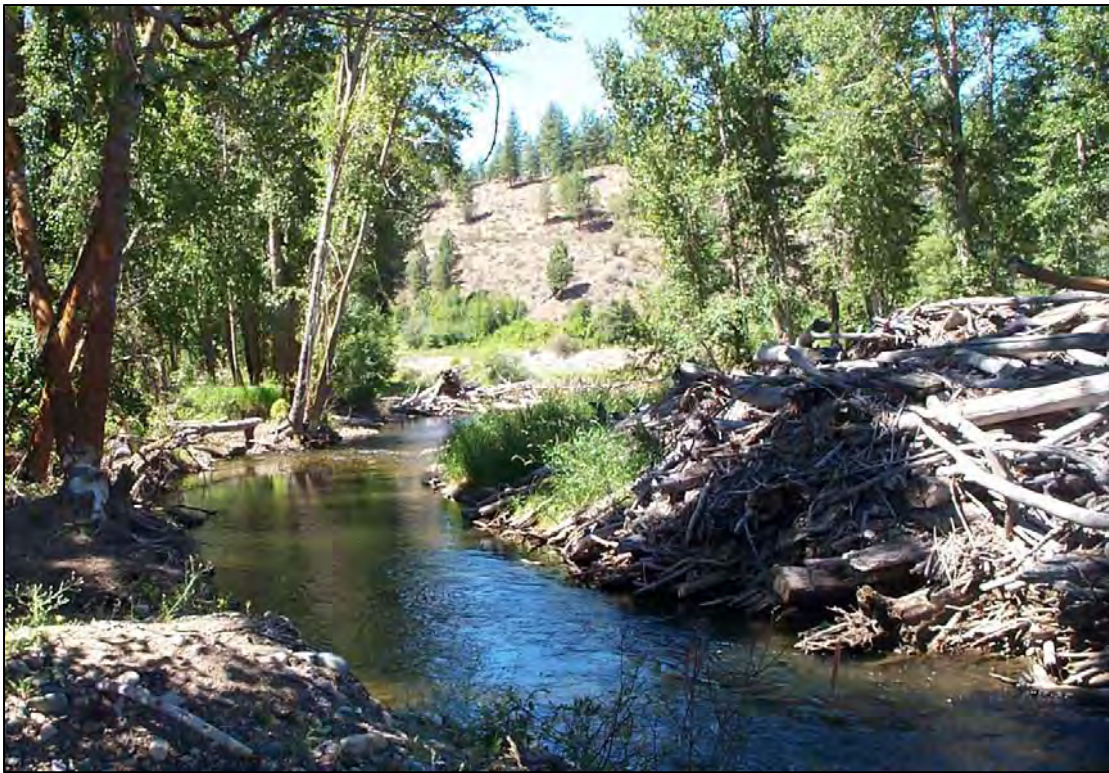
Figure 10. Looking downstream at beaver lodge on side channel of Methow River downstream of confluence with Chewuch River.

This moderately confined floodplain type contains a more defined main channel than the high-complexity reaches, and has only one or two well defined off-channel areas (Figure 9). Side channels offer valuable habitat, particularly when groundwater helps supply water to the channel during low-flow conditions (Figure 10). Older surfaces are often present within the floodplain, and these higher surfaces are more stable than the surfaces in the unconfined floodplain areas. The higher elevation surfaces are inundated during floods, but typically only suspended sediments are deposited on these surfaces. This results in less frequent lateral reworking of the floodplain. Changes in channel position typically occur within a few defined channels that transport the majority of coarse sediment rather than across the entire floodplain. The main channel remains in one place for several years to decades. A dense riparian buffer zone slows near-bank velocities, provides wood recruitment to the channel, and reduces the rate of bank erosion. LWD is most common in the slower velocity off-channel areas. Log jams often occur at the head of vegetated islands as in the unconfined floodplain types. Wetlands are occasionally present in the off-channel areas of these reaches, and beaver activity can be common.

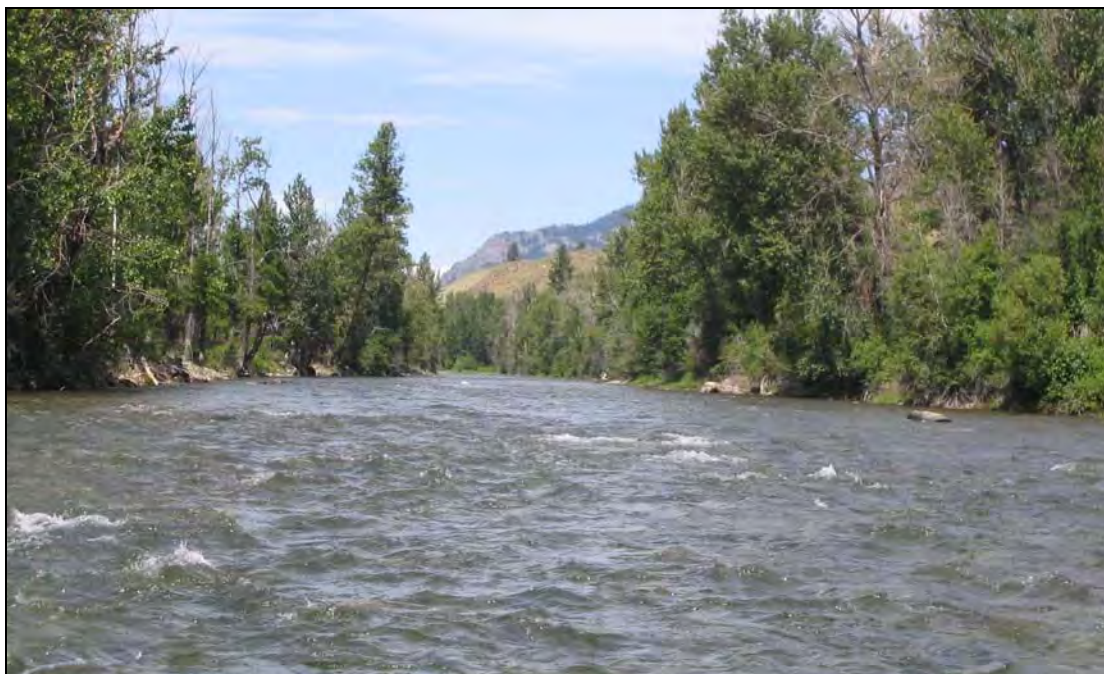
Figure 12. Example of confined floodplain section on Methow River between Winthrop (RM 51) and Wolf Creek (RM 55).

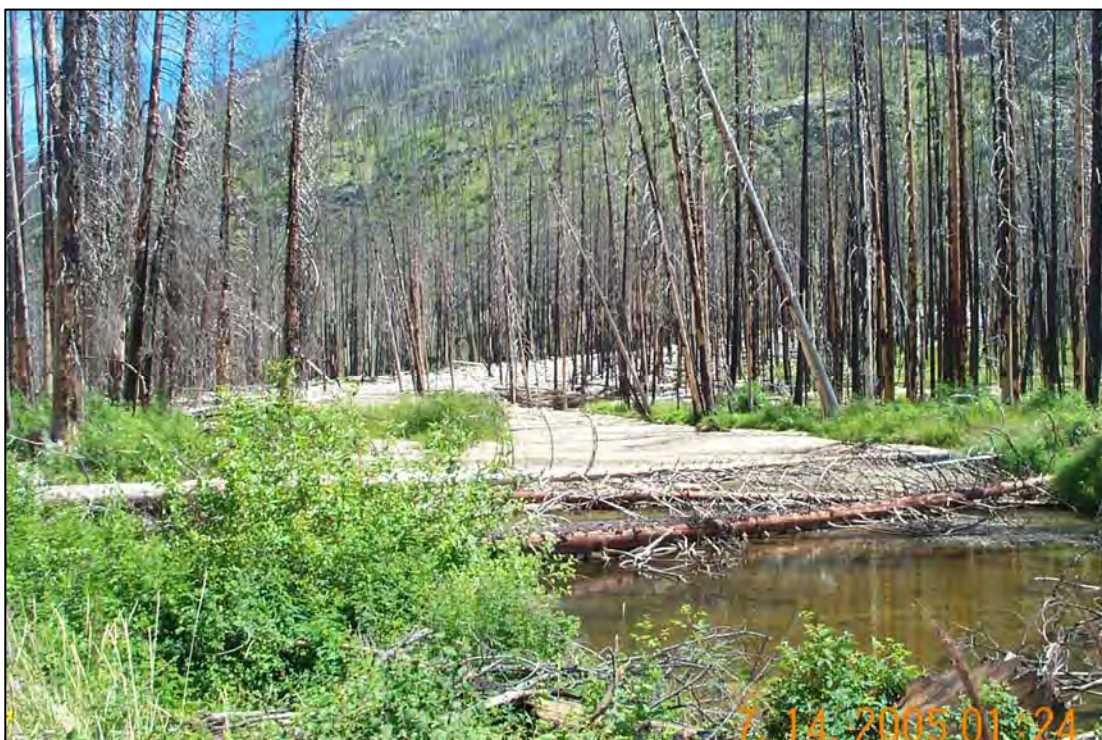
Figure 21. Photograph of Chewuch River in the area of the 2001 Thirtymile Fire area showing a large debris flow from hillslope where fine sediment was stored on the alluvial fan as well as being delivered to the river. (July 2005)

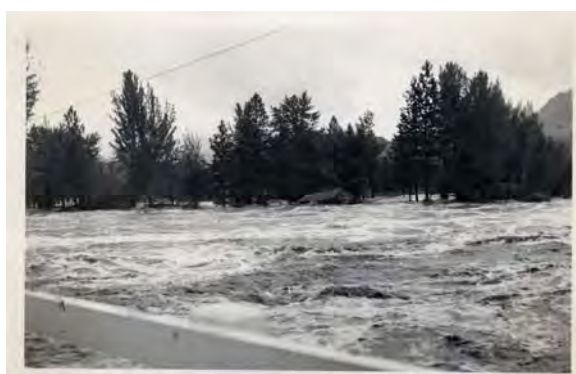
Figure 22. Photograph during the 1948 flood

Channel changes were also observed by comparing historical maps and aerial photography before and after large floods. The largest known floods were in 1894, 1948, and 1972 and channel changes would be expected as a result of these flows (Appendix J). The 1948 and 1894 floods are believed to be similar in magnitude, but the 1948 flood may have been slightly larger. The 1948 flood exceeded the 100-year flood frequency estimate and, based on historical photographs, this flood inundated the entire floodplain (low surface) (Figure 22). This flood is noted by locals to have "reset" the river,

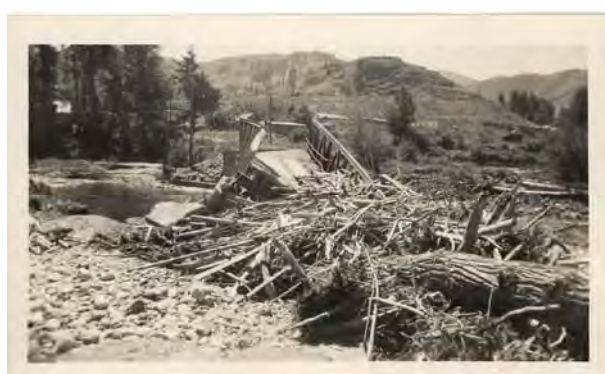
Figure 23. Photograph of “large woody debris” pile on the north side of the bridge across the Twisp River following the 1948 flood. The bridge shown is thought to have been located just upstream from a highway bridge.

mobilizing large portions of LWD and changing channel position and geometry in many cases (Figure 23). When a flood of this magnitude occurs, the channel geometry often changes but still may be within the bounds of natural variation expected in the system. Aerial photographs of the Methow River before, during, and after the 1948 flood validate that no change to the over-arching channel planform was observed for the mainstem Methow River. Aerial photographs before and after the 1972 flood were examined to validate this hypothesis on the Chewuch and Twisp Rivers, because the 1948 photographs were sporadically available from during the flood, but not before and after.

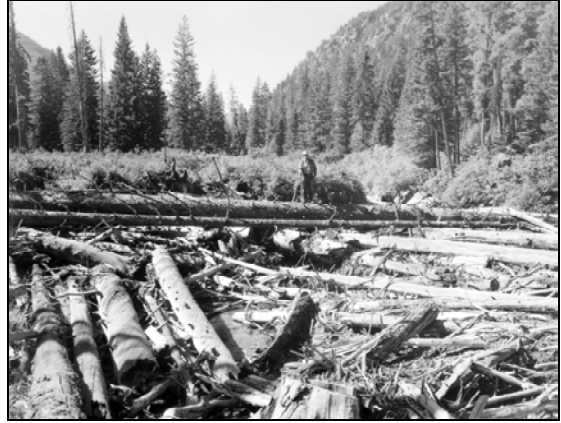
Figure 25. Log jam in the Sheep Creek/Thirtymile Creek area in the upper Chewuch drainage basin in 1962 that was subsequently removed (by man) the same year.

The largest departure from the natural channel processes results from roads, bridges, levees and push-up dikes that disrupt the lateral connectivity between the active floodplain areas and the main channel, and historic removal of large woody debris (Figure 24 and Figure 25). Many of these features and large woody debris removal activities occurred following the large floods in 1948 and 1972 to limit bank erosion and property damage from future floods. In most cases, the majority of floodplain levees, push-up dikes, and roads and bridges cut off the floodplain at unique locations, but do not confine the river for a very great longitudinal distance as in some systems. This allows the river to still have some connectivity during flood flows when river water gets high enough to overtop banks laterally (downstream of the human feature) and result in inundation. More detectable impacts would be expected in the side and overflow channels downstream of where the levees or dikes are located. These channels are not flushed with water and replenished with new sediment and LWD as frequently as would occur in the natural setting where there is a connection with the river at the upstream entrance.

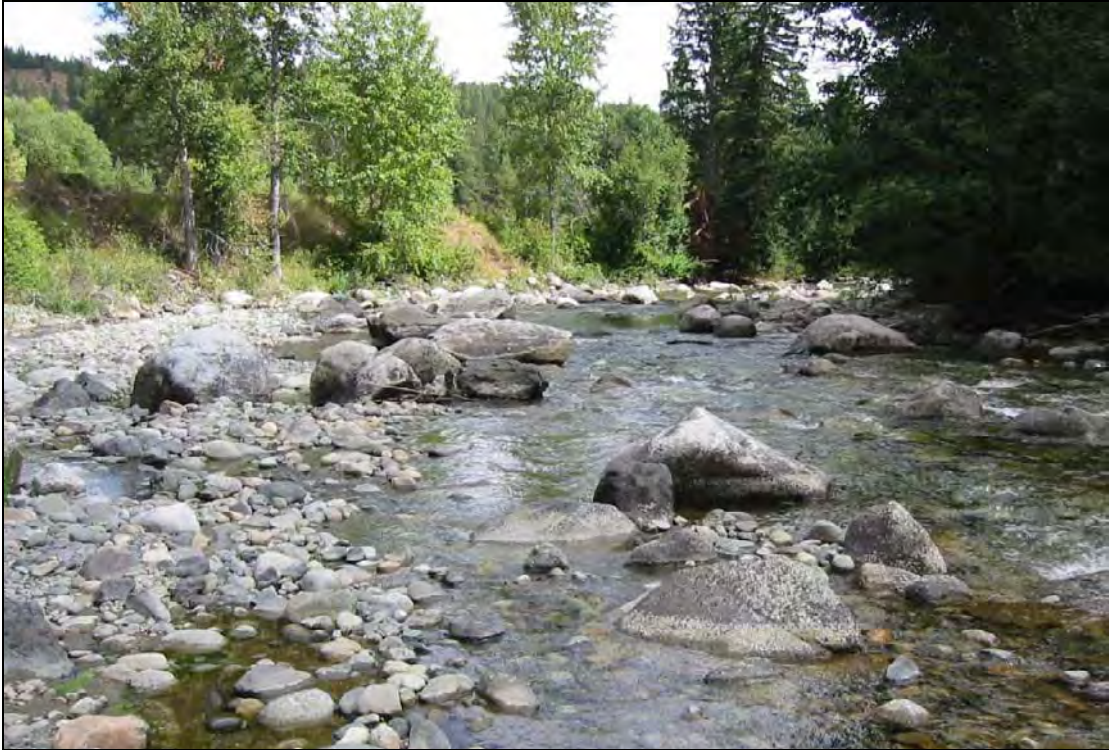
Figure 33. View of Twisp River just upstream of Little Bridge Creek near RM 10 (August 17, 2005).

The longitudinal profile on the Twisp River shows a sharp break at RM 10 near the Little Bridge Creek confluence (Figure 32 and Figure 33). Although minor variations in bedrock are present, the rock types are primarily the same longitudinally. The maximum extent of the alpine (valley) glacier that came down the Twisp River valley coincides with the approximate location of the slope change. Glacial erosion occurred upstream of this point resulting in deepening and widening of the valley and a flatter valley slope (trough). Fluvial erosion occurred downstream of the retreating glacier and the sediment-rich discharges incised through the glacial deposits and bedrock leaving a narrower and steeper valley slope. Exposed bedrock was noted in the channel bed at RM 5.1 to 5.3, 9.9, 11.1, 13.2, and at 16.2.

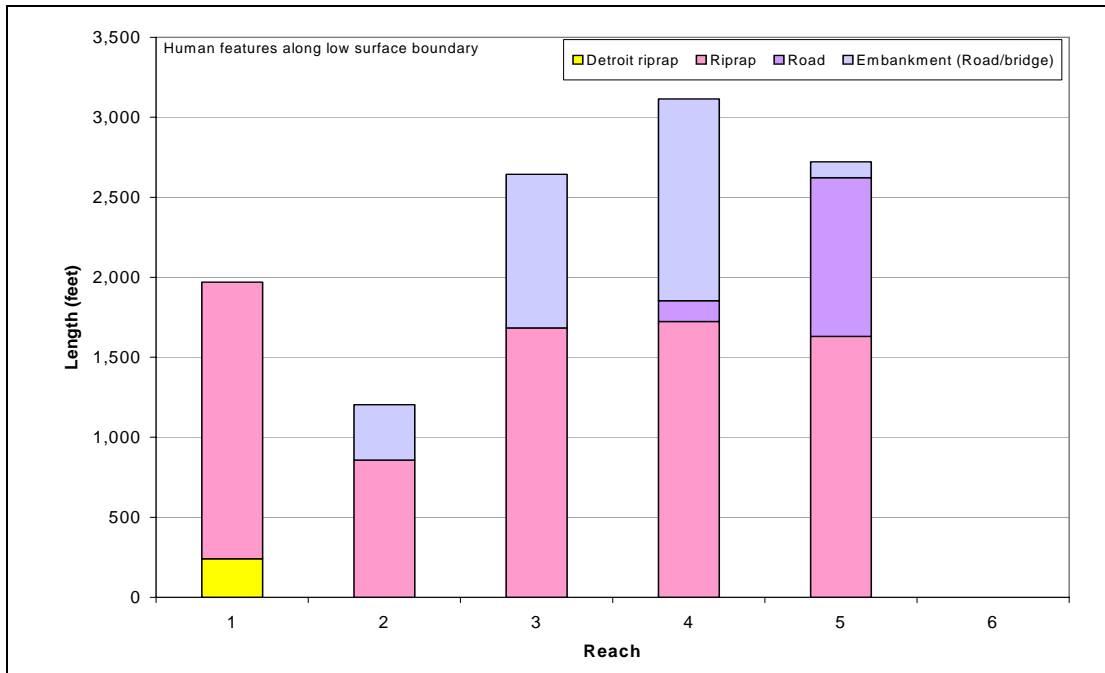
Figure 36. Twisp River – Types of human features along the boundary of the floodplain (low surface) by reach. The floodplain is bound by a combination of terrace deposits, alluvial fans, be bedrock, and glacial outwash (see Appendix G). See Table 3 for river mile boundaries of each reach.

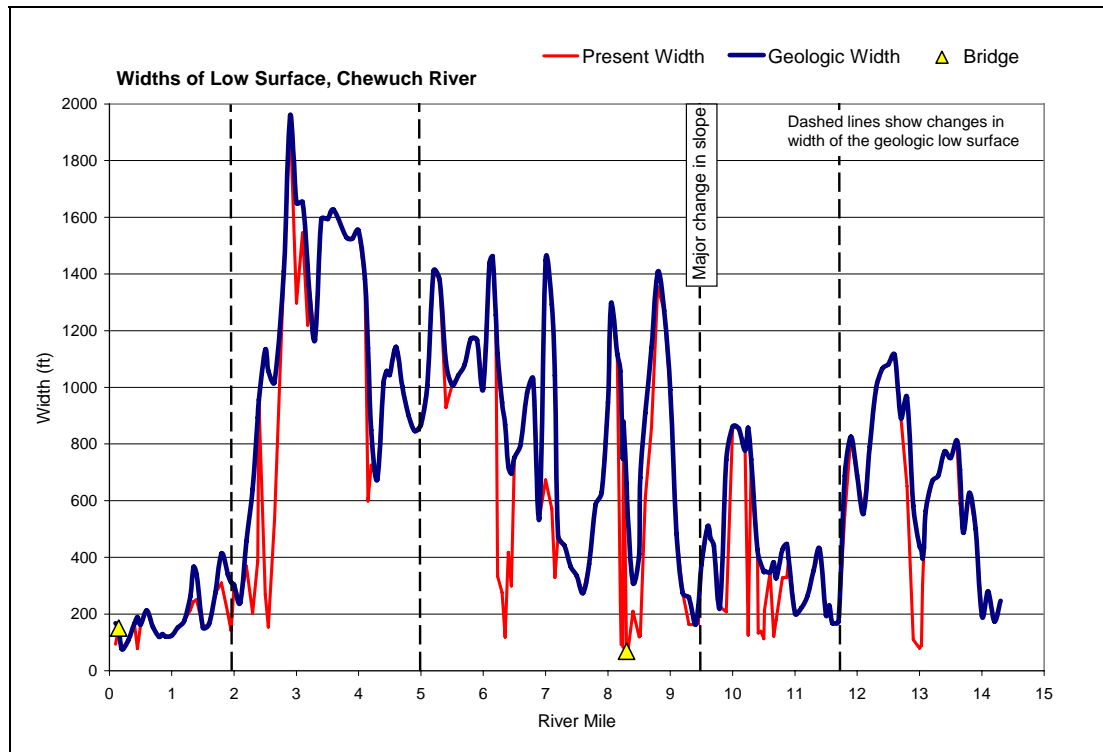
Figure 38. Chewuch River – Reduction in floodplain widths due to human features.

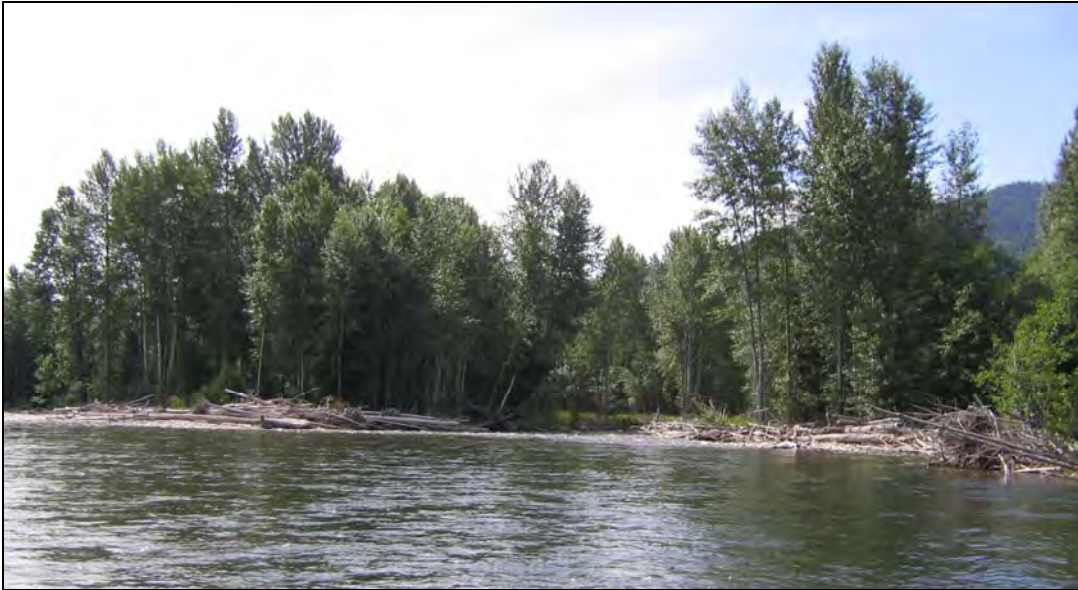
Figure C-2. Log jam formed at head of vegetated island at location of flow split in Methow River upstream of confluence with Chewuch River.

In these reaches, erosion of functioning habitat areas is as important as creation of new habitat areas. Riparian vegetation and LWD help the rate of floodplain reworking occur at a reasonable level, such that not all floodplain areas are eroded at once. LWD forms log jams in the channel areas and at the heads of bars (Figure C-2), which helps promote deposition downstream on the bar, which accumulates fine sediment, organic debris, seeds and pieces of living vegetation that provided a growing medium for future riparian forests. As sediment accumulates, riparian vegetation establishes. The LWD helps create stable hard points that allow vegetated islands to persist and slow the rate of channel migration across the floodplain. These stable hard points are important because they allow riparian vegetation to persist, so that the vegetation becomes large enough to slow channel migration and to contribute LWD to the river once it is eroded. The LWD provides complexity within the floodplain reach (Figure C-3), and also supplies LWD to downstream reaches.

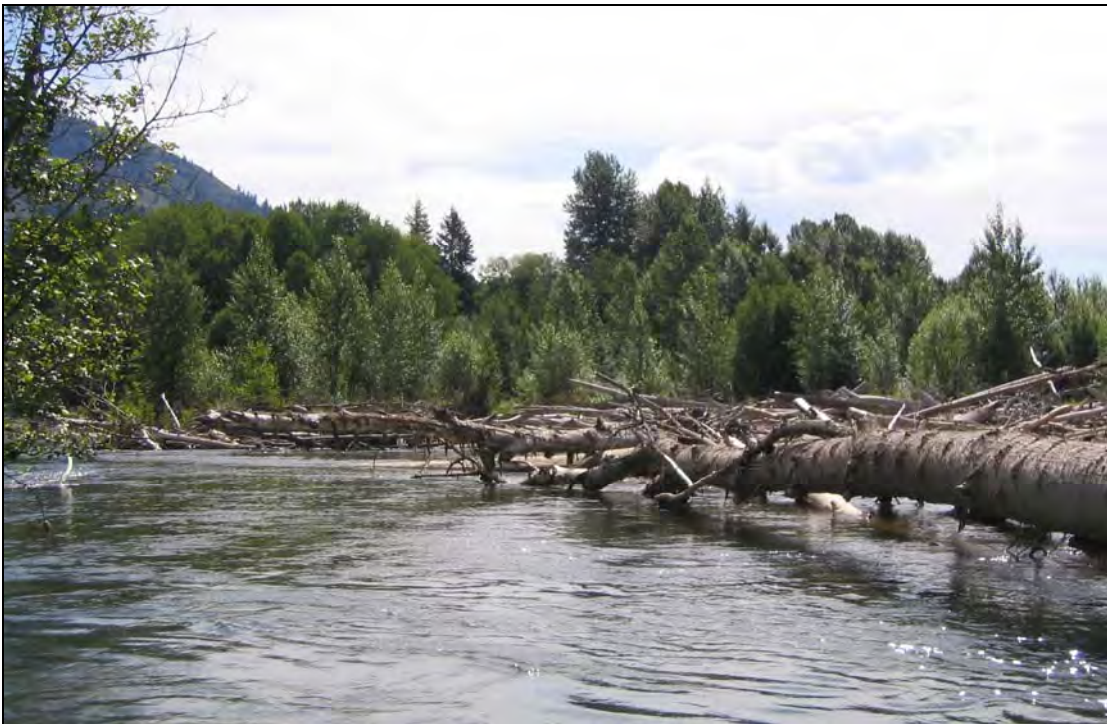
Figure C-3. Methow River upstream of confluence with Chewuch River, where there is a diverse forest of riparian vegetation and frequent interaction of LWD with the river.

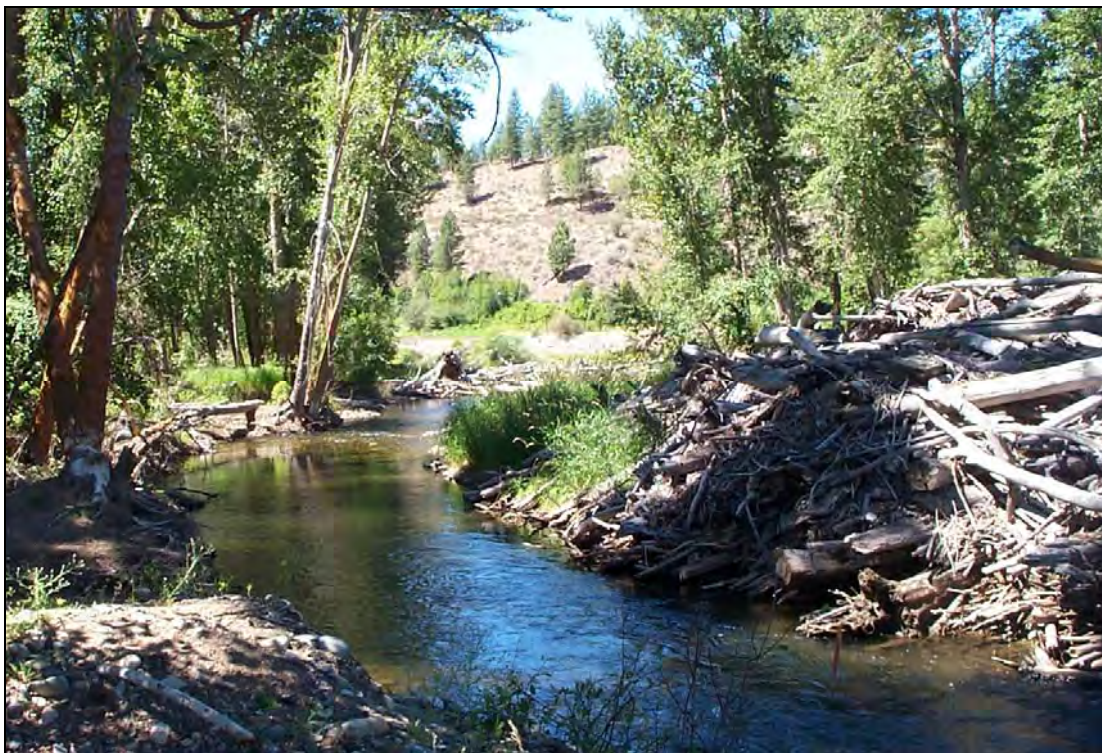
Figure C-5. Looking downstream at beaver lodge on side channel of Methow River downstream of confluence with Chewuch River.

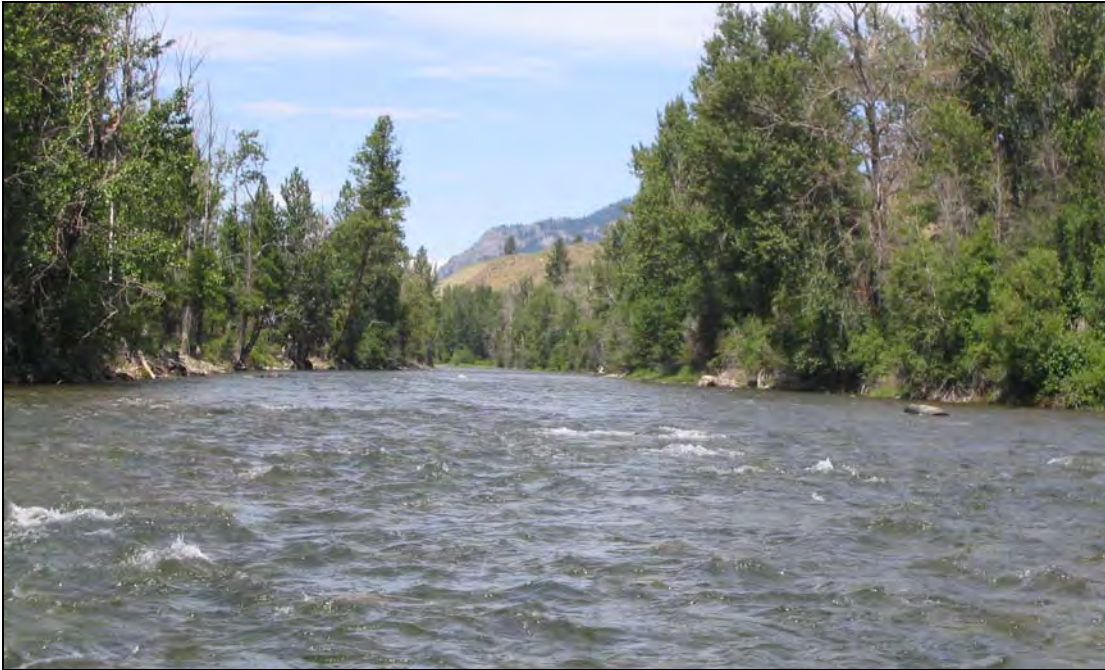
Figure C-7. Photo example of a confined floodplain section; Methow River between Winthrop (RM 51) and Wolf Creek (RM 55).

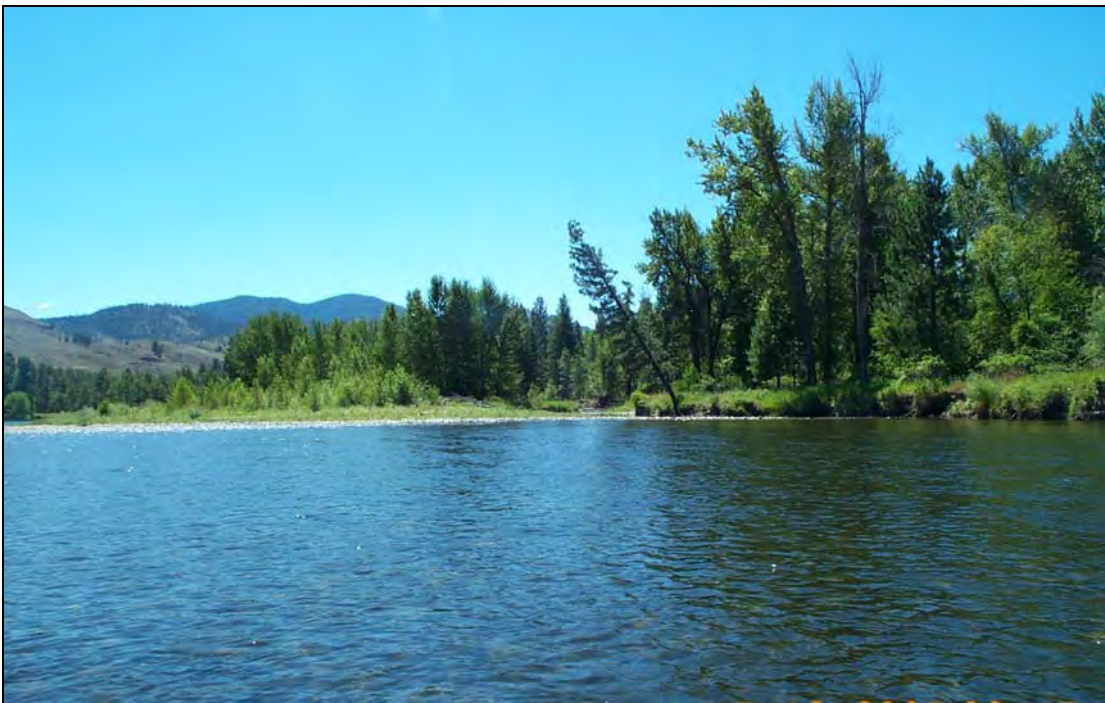
Figure C-8. Photo example of range in age and species of riparian vegetation on Middle Methow between Carlton and confluence with Twisp River.

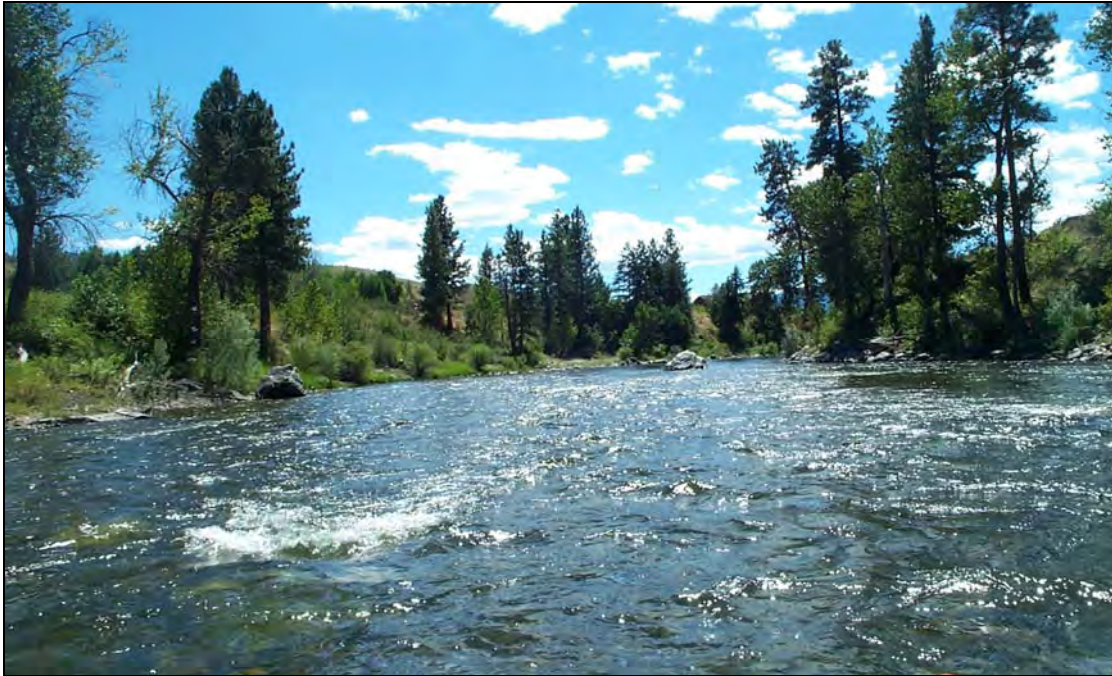
Figure C-9. Photo example of boulders that occasionally are present in the river bed and provide localized pockets of deeper, slower velocity water for fish in confined river sections.

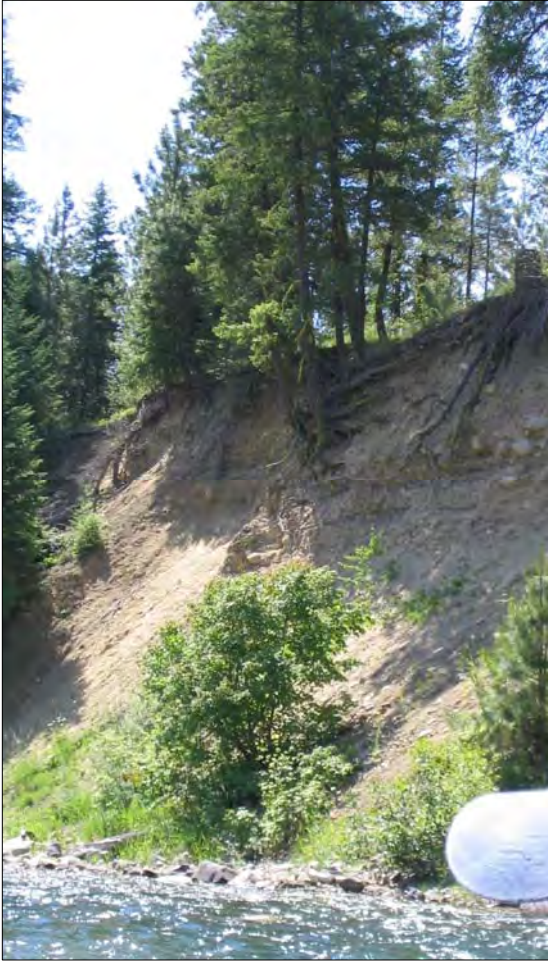
Figure E-1. Glacial terrace – view of bank along Methow River upstream of Winthrop.

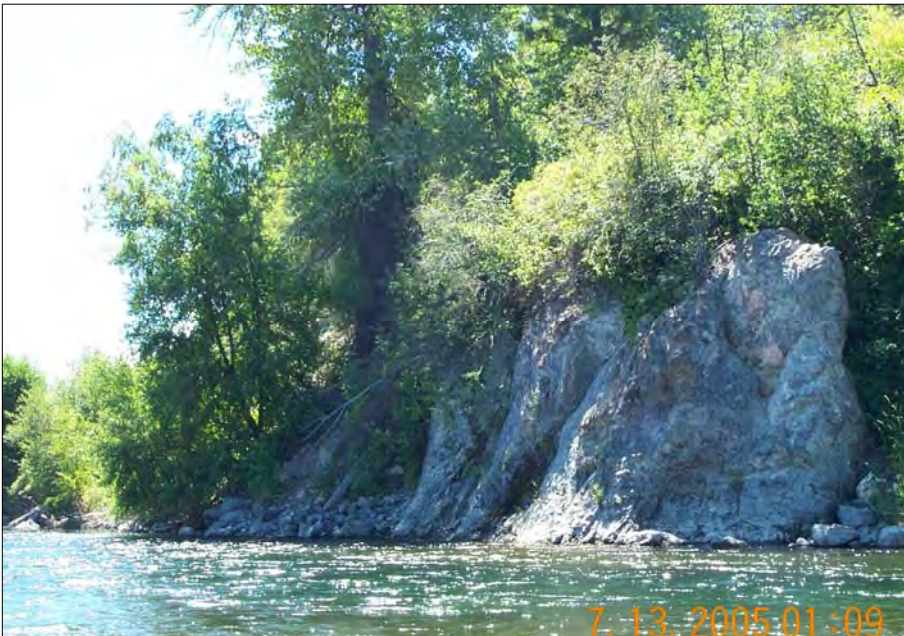
Figure E-2. Bedrock – view of Middle Methow between Carlton and Twisp River confluence, where bedrock composes the boundary of the low surface.

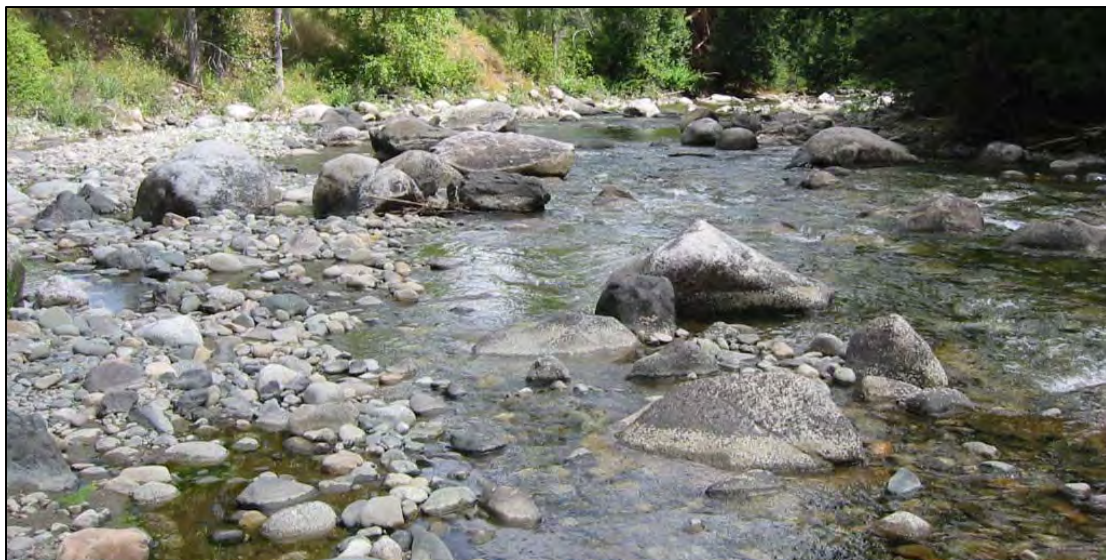
Figure E-8. View of Twisp River just upstream of Little Bridge Creek near RM 10 (August 17, 2005).

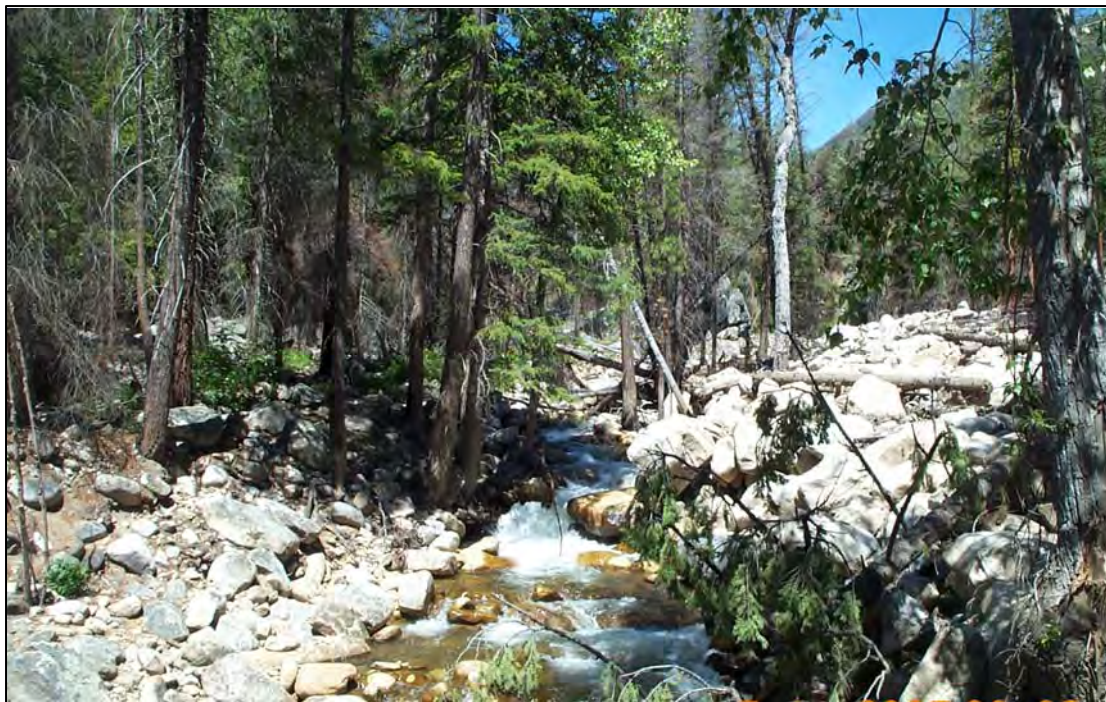
Figure E-10. Looking upstream at Andrews Creek, which has experienced periodic debris flows that deliver coarse sediment to the Chewuch River (*July 14, 2005*).

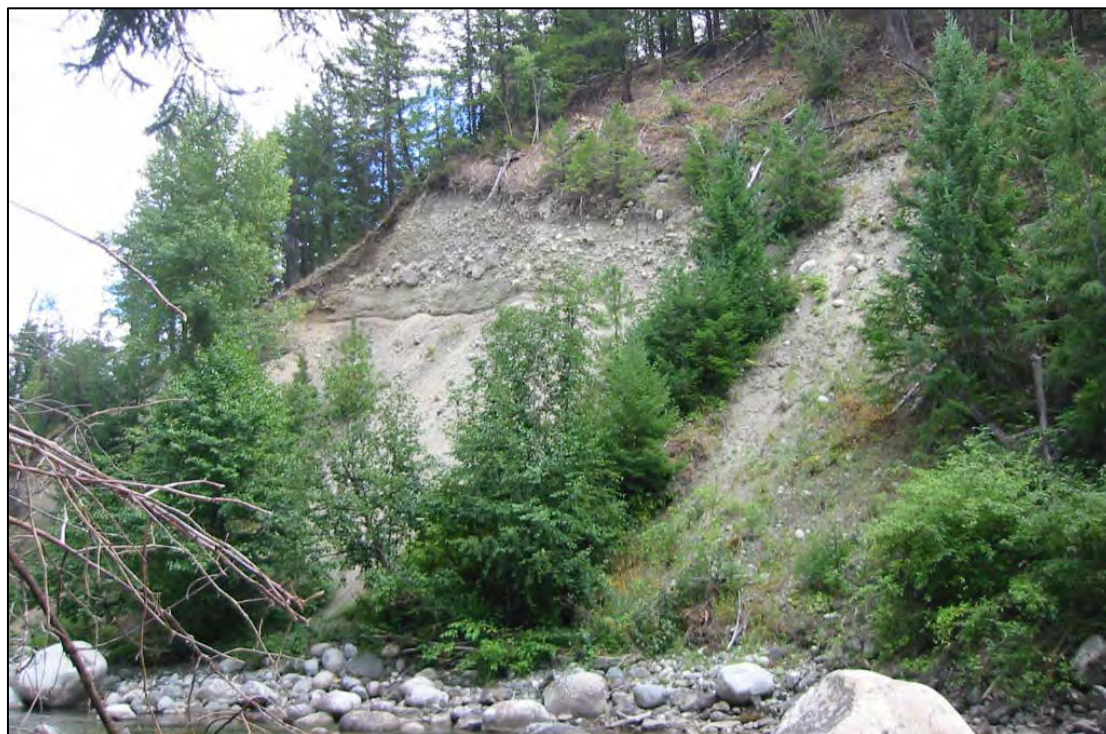
Figure E-11. View of landslide along river right on Twisp River just upstream of Little Bridge Creek confluence (RM 10). (*August 17, 2005*)

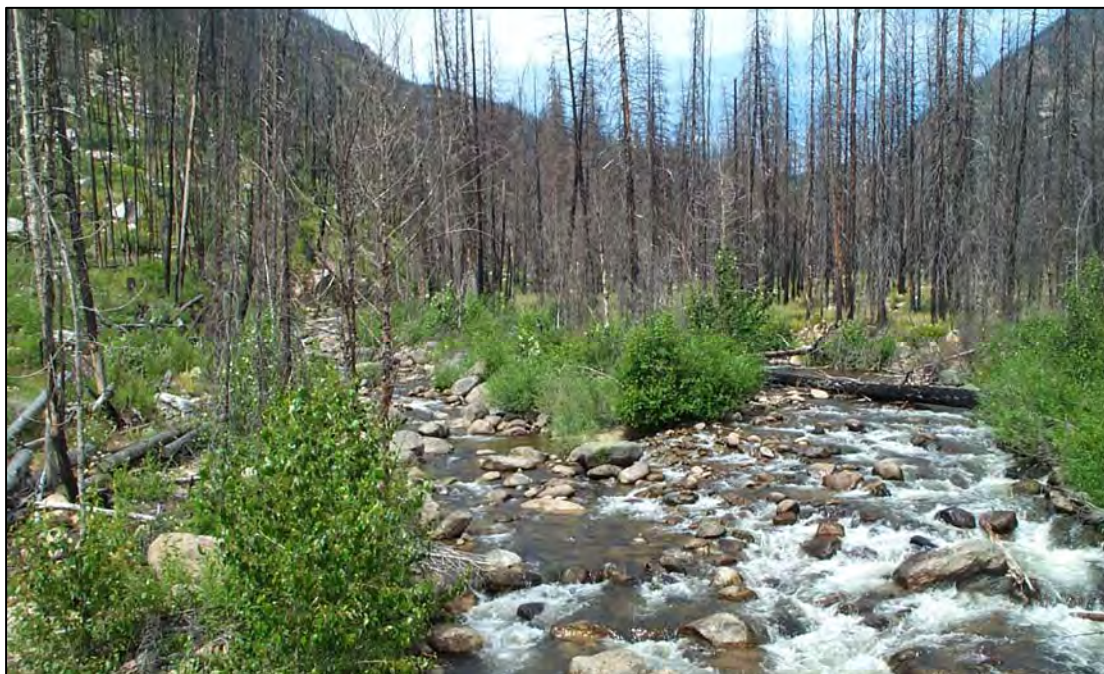
Figure E-12. View of Chewuch River in Thirtymile Fire area four years after the fire, in July 2005.

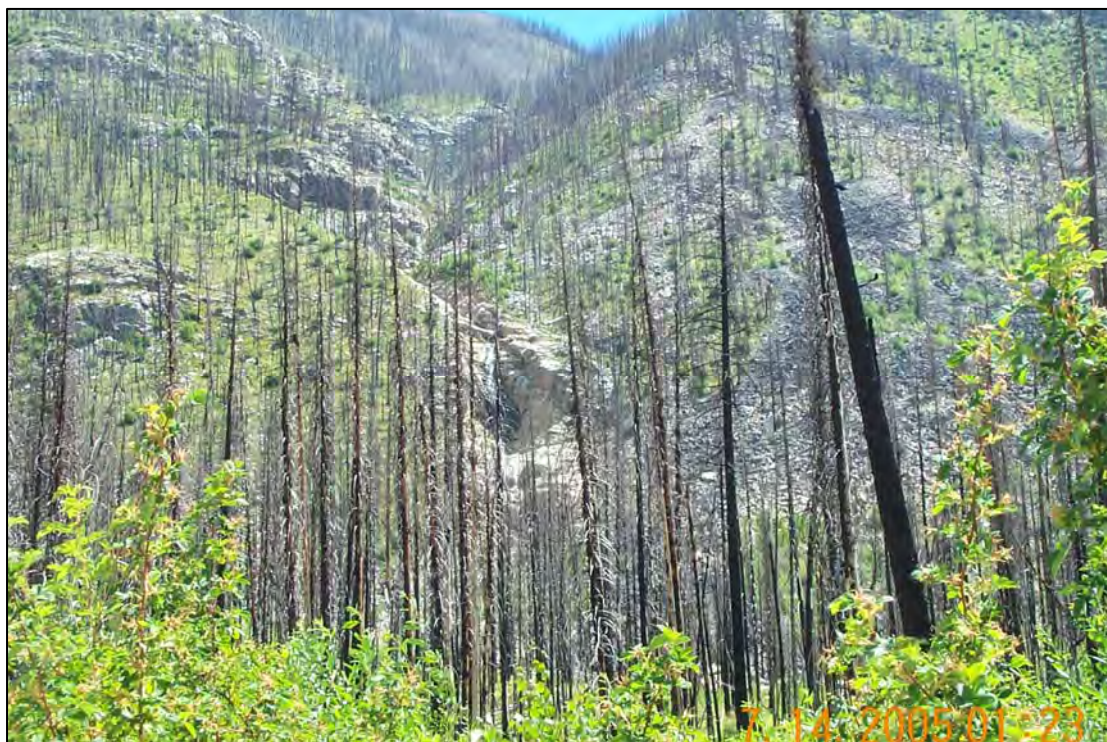
Figure E-13. View of debris flow entering Chewuch River in Thirtymile Fire area four years after the fire, in July 2005.

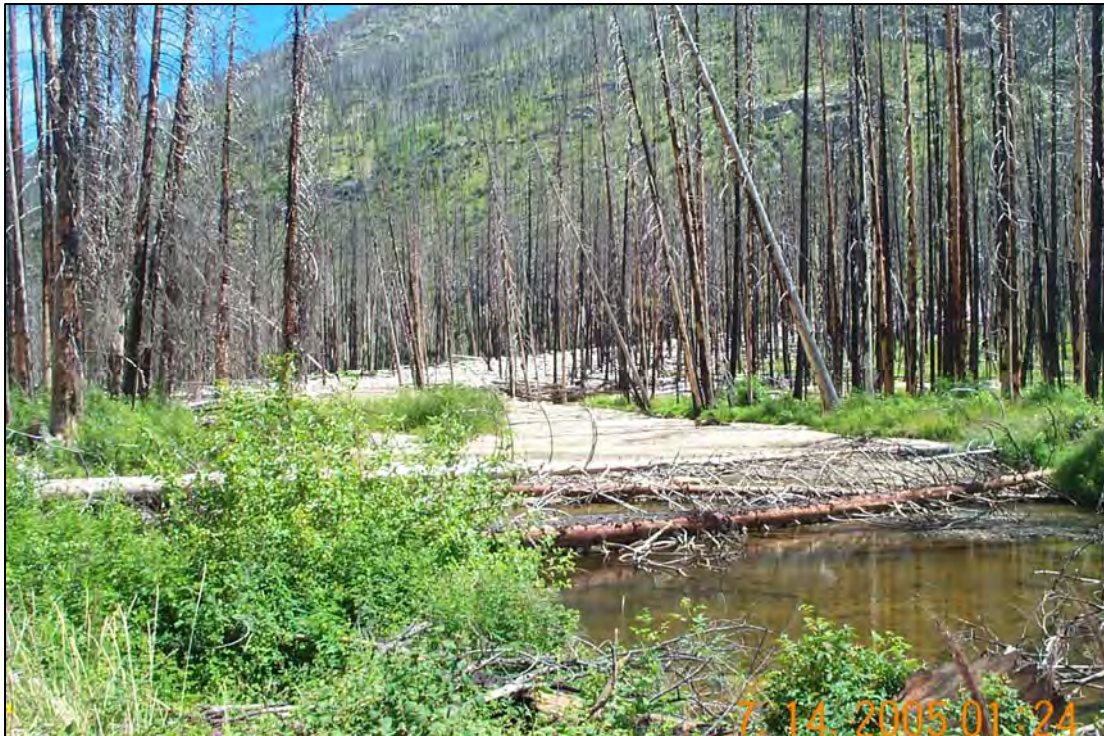
Figure E-14. View of Chewuch River in Thirtymile Fire area where a large debris flow from a hill slope where fine sediment was stored created an alluvial fan as well as being and delivered sediment to the river four years after the fire, in July 2005.

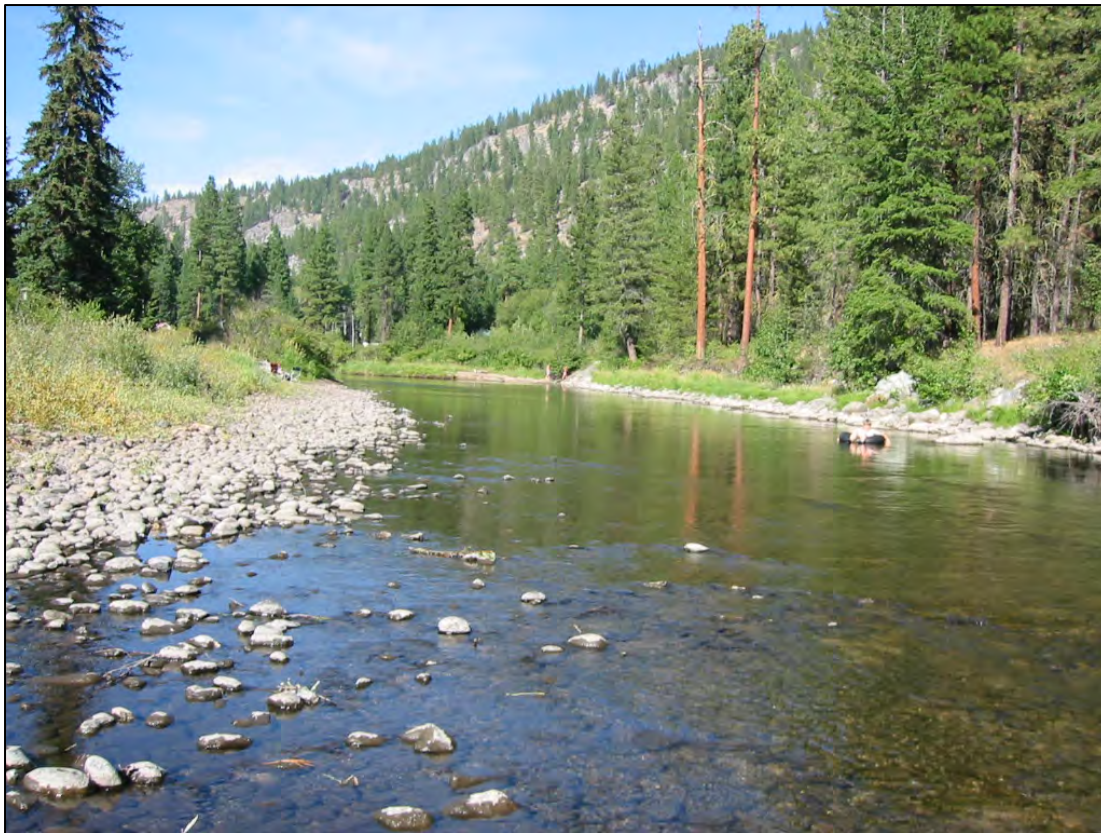
Figure E-16. View from right bank looking upstream at self-armoring banks on Chewuch River (GPS location is N48° 35' 08.8: W120 ° 09' 58.1). (August 26, 2005).

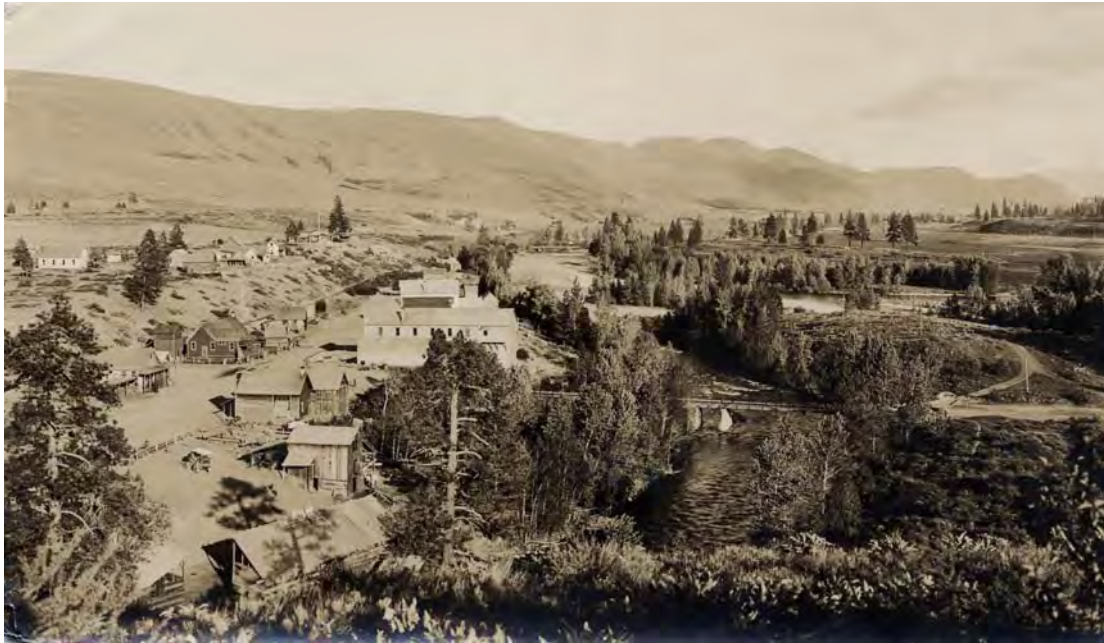
Figure E-41. Photograph looking south (downstream) at the confluence of the Methow and Chewuch Rivers near Winthrop, WA in 1908. Photograph courtesy of Shafer Museum, Winthrop, WA.

Historically, many of the terraces bounding the river were cleared of native vegetation through burning or logging activities. This process would have occurred gradually over the late 1800s and early 1900s. Within the low surface, the riparian vegetation may have largely been intact in several locations for many decades past the start of settlement (Figure E-41). However, certain areas were more subject to disturbance, particularly the upper Methow watershed where there were log drives and in areas where roads and bridges were placed. The aerial photographs show that over time there was additional clearing of vegetation on lower surfaces within the low surface. The large floods in 1894, 1948 and 1972 would have reworked or provided fresh soil on the majority of the active floodplain. These floods are noted by locals to have liberated large amounts of LWD, but channel-clearing activities likely removed a lot of the wood. The floods would have created ideal conditions for cottonwoods to re-establish.
