Methow Subbasin Geomorphic Assessment Okanogan County, Washington

METHOW SUBBASIN GEOMORPHIC ASSESSMENT, OKANOGAN COUNTY, WASHINGTON

BUREAU OF RECLAMATION
TECHNICAL SERVICE CENTER, DENVER, CO,
PACIFIC NORTHWEST REGIONAL OFFICE, BOISE, ID.
AND
METHOW FIELD STATION, WINTHROP, WA.

FEBRUARY 2008

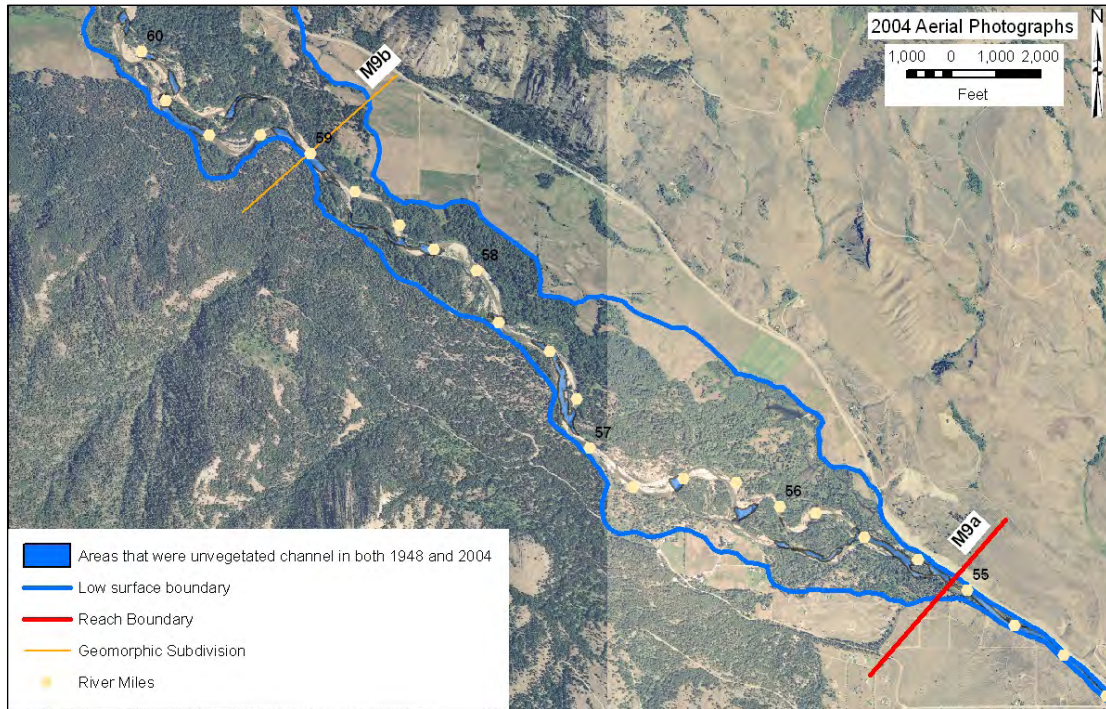
Figure G-34. Methow River – The areas that were unvegetated channel in both 1948 and 2004 for geomorphic subdivision M9a.

- Areas that were unvegetated channel in both years (Figure G–34).
- Areas that were unvegetated channel in 1948 but were no longer unvegetated channel in 2004 (Figure G–35). These areas had been abandoned by the unvegetated channel by 2004, and were secondary or overflow channels in 2004 or had been revegetated and appear to be no longer active by 2004.
- Areas that were unvegetated channel in 2004 but had not been unvegetated channel in 1948 (Figure G–35). These are areas that were vegetated in 1948, but were unvegetated and part of the channel by 2004.

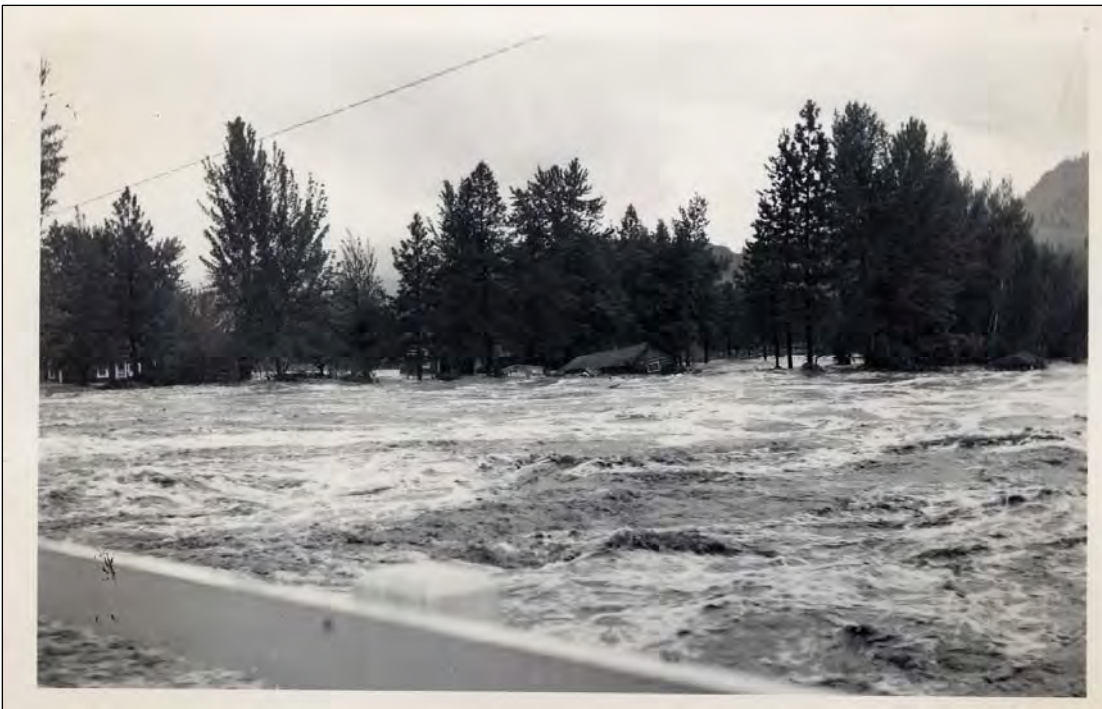
Figure O-5. Photograph of river taken during the 1948 Flood.

The 1948 Flood coincided with severe flooding throughout the Columbia Basin. The snowpack that accumulated during the winter was 19 percent above normal on the first of April. The snowpack was augmented by unusually heavy precipitation and cool temperatures until mid-May, when the temperatures rose to unseasonably high readings (Beck, 1973). A rain-on-snow event occurred when above average rainfall began in mid-May, which accelerated the rate of snowmelt resulting in a rapid rise in the river discharge. Near the mouth of Beaver Creek, the 1948 Flood left a high-water mark 4 feet above that of the 1894 Flood; 200-year-old trees that grew along the Methow River before the 1948 Flood were uprooted and washed away (Portman, 2002). Bank erosion occurred during the flood of both low river banks and higher banks (Portman, 2002). A local observer described the flood” “Big trees, debris and parts of buildings rode swiftly down the river” (Portman, 2002) (Figure O-5).

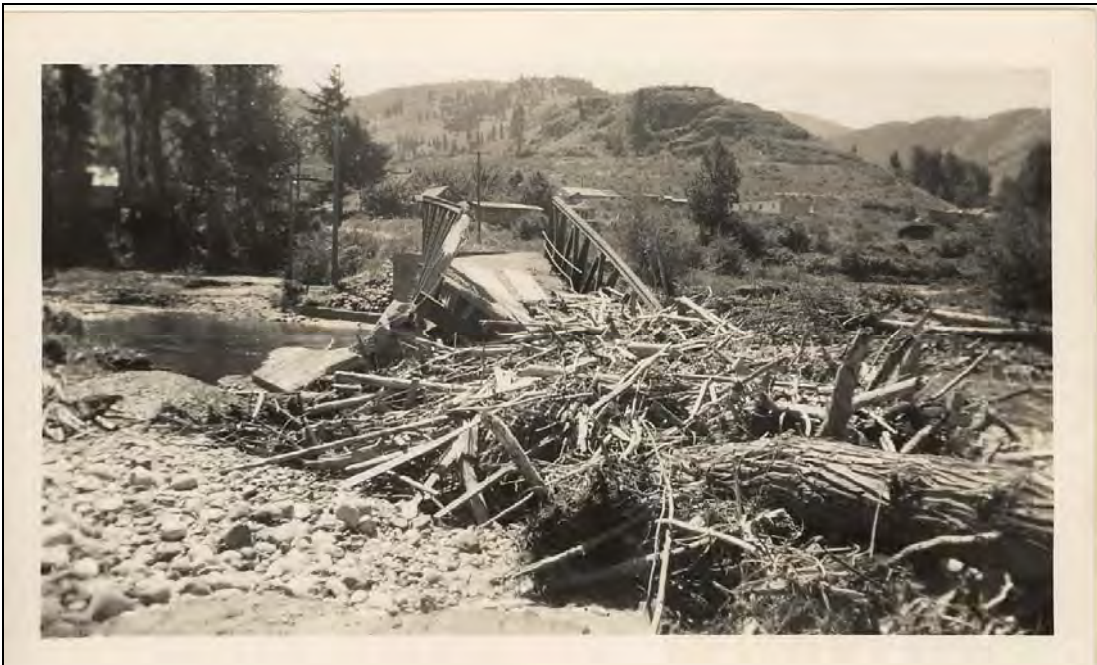
Figure O–6. Photograph of “large woody debris” pile on the north side of the bridge across the Twisp River following the 1948 Flood. The bridge is thought to have been located just upstream from the highway bridge.

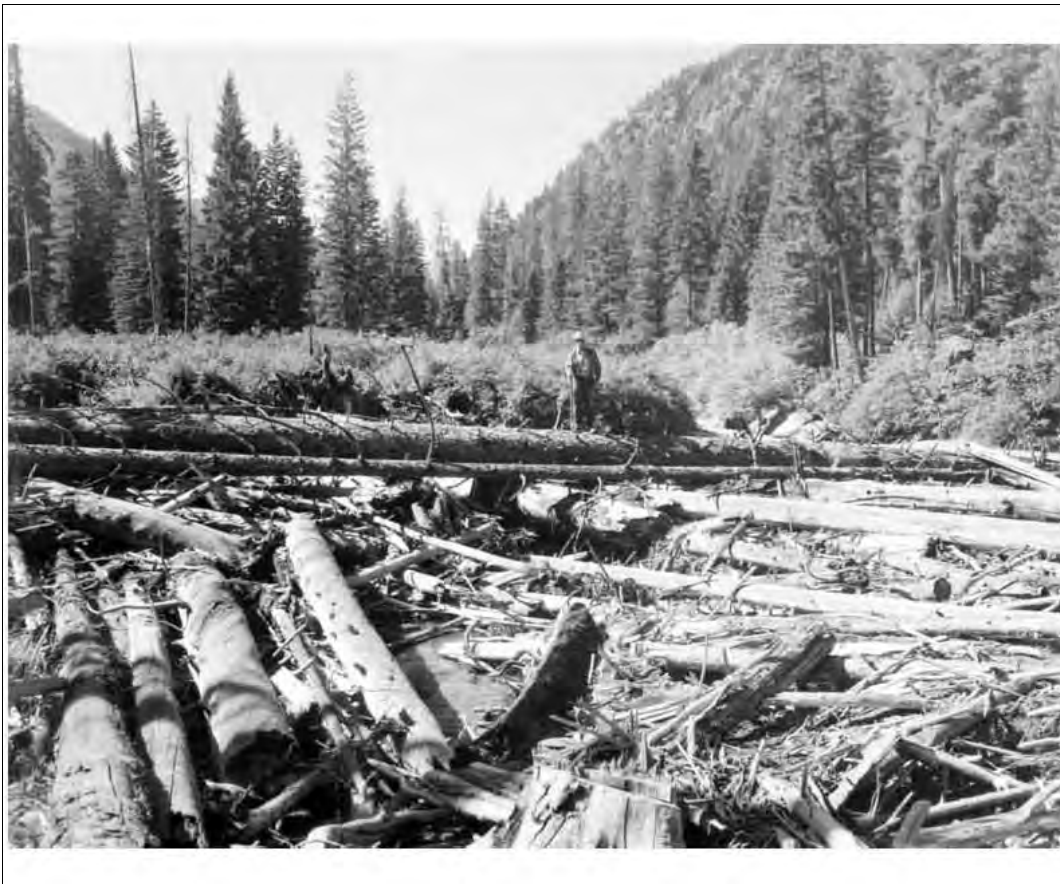
Figure O–9. Log jam in the Sheep Creek/Thirtymile Creek area in the upper Chewuch drainage basin in 1962.

In 1961, the USFS funded the removal of debris and logjams in portions of both the Chewuch River and Boulder Creek (Andonaegui, 2000). The Chewuch Watershed Analysis reports that large-scale, channel-clean-out efforts removed LWD and logjams following the 1948 and 1972 floods (Smith et al, 2000). In 1962, log jams in the Sheep Creek and Thirtymile Creek area were removed (Figure O–9 and Figure O–10). Surveyors collecting data for a recent stream survey on the Chewuch River saw evidence of ongoing wood removal near the Boulder Creek Campground, where wood was cut up for firewood (Smith et al., 2000). After the 1972 Flood, the ACOE and the National Guard assisted with channel clearing and levee building (Andonaegui, 2000). Ongoing restoration efforts have occurred in some areas of the Chewuch watershed to restore LWD (Andonaegui, 2000; PWI, 2004b). During the 1960s and the 1970s, LWD was removed from the channel of the Twisp River from the mouth to the end of the Twisp River Road (RM 27.0) (Andonaegui, 2000).

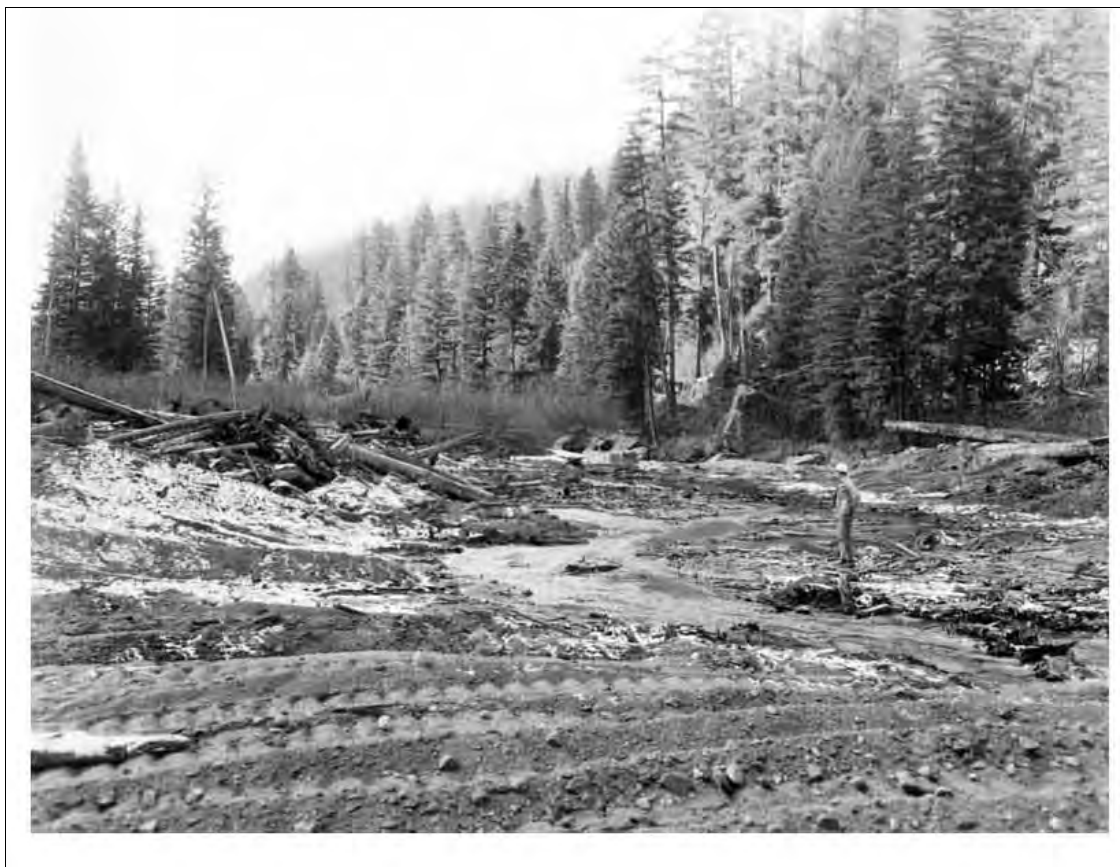
Figure O–10. The same area as shown in Figure O-9 after the log jam in the Sheep Creek/Thirtymile Creek area has been cleared in 1962.
