Technical Report No. SRH-2009-42

Geomorphology and Hydraulic Modeling for the Middle Methow River from Winthrop to Twisp

U.S. Department of the Interior
Bureau of Reclamation
Technical Service Center
Denver, Colorado

January 2010

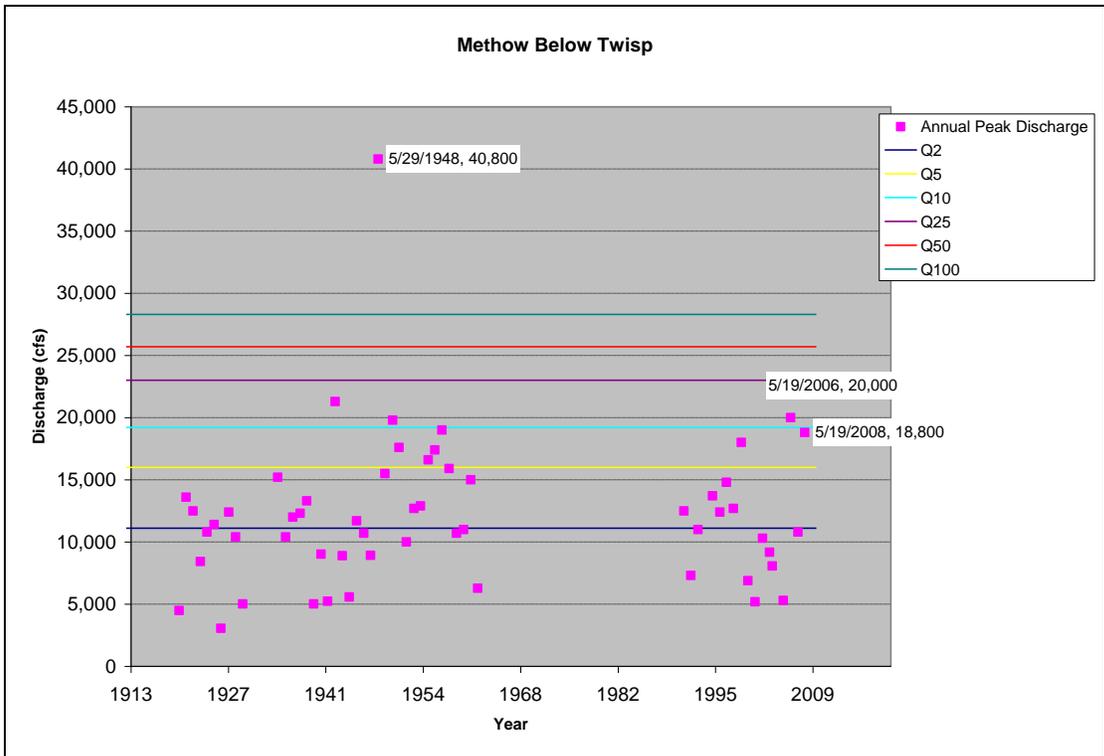
Figure 5. Flood frequency values plotted against annual peak discharges for the USGS gage below Twisp.

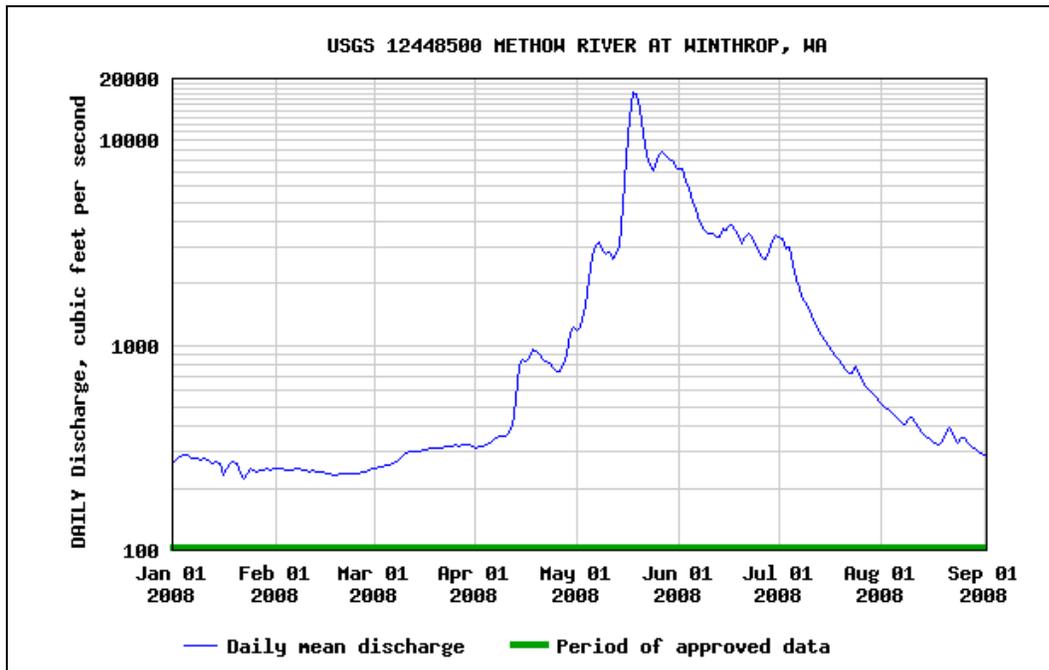
Figure 6. Example hydrograph of mean daily flows from USGS web site for the Methow gage below Winthrop (USGS gage 12448500). The peak discharge of 18,800 cfs occurred on May 19, 2008.

A published report on the local weather was not found for the 2006 or 2008 floods. As an example of the flood duration, a hydrograph of 2008 mean daily flows from the USGS gage below Winthrop is shown in Figure 6.

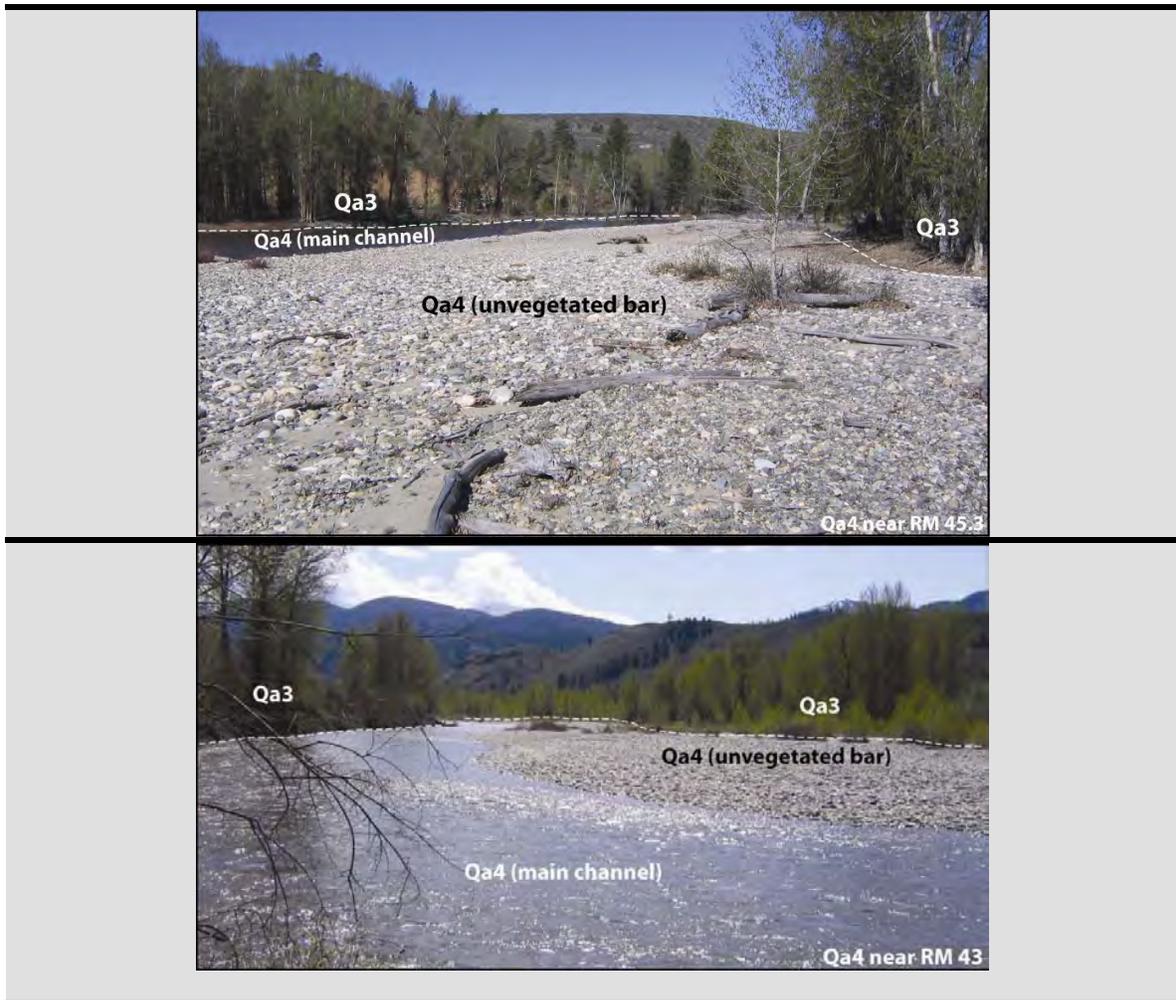
Figure 7. Main channel and unvegetated bars that compose map unit Qa4.

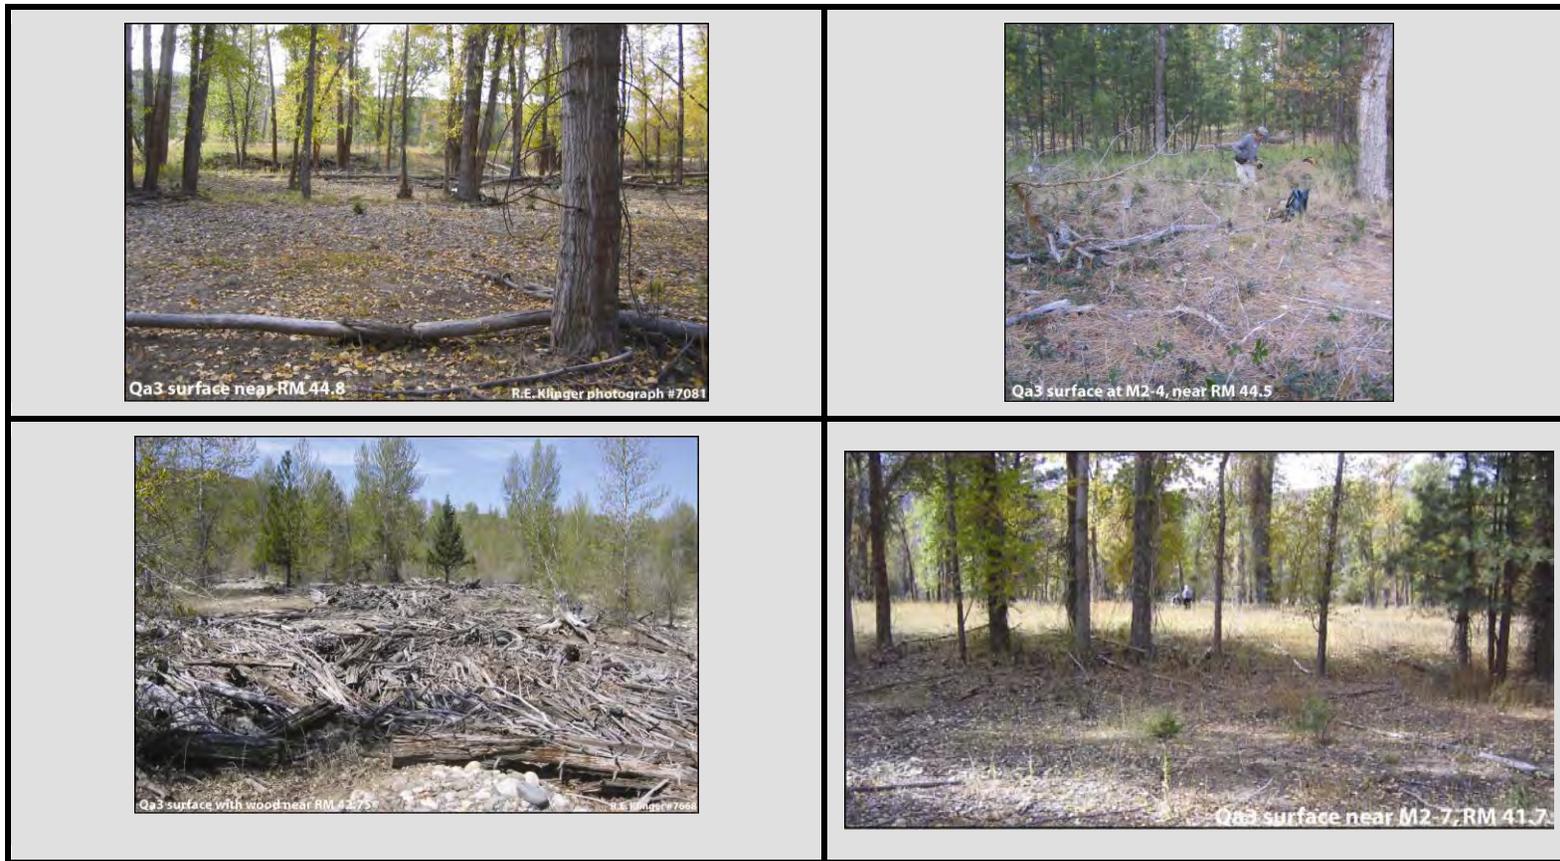
Figure 8. Examples of the morphology, vegetation, and wood on map unit Qa3.

Upper left photograph shows subtle channels with recently deposited sand and wood through cottonwood trees (R.E. Klinger photograph #7081). Upper right photograph shows recently deposited wood in foreground and conifers on a slightly higher surface within Qa3 in background. Lower left photograph shows wood that has been deposited during a recent flood that overtopped the Qa3 surface just upstream of the sugar dike (R.E. Klinger photograph #7668). Lower right photograph shows the open tree cover on Qa3 surface in background and the extent of sand and wood indicating recent flow in foreground.

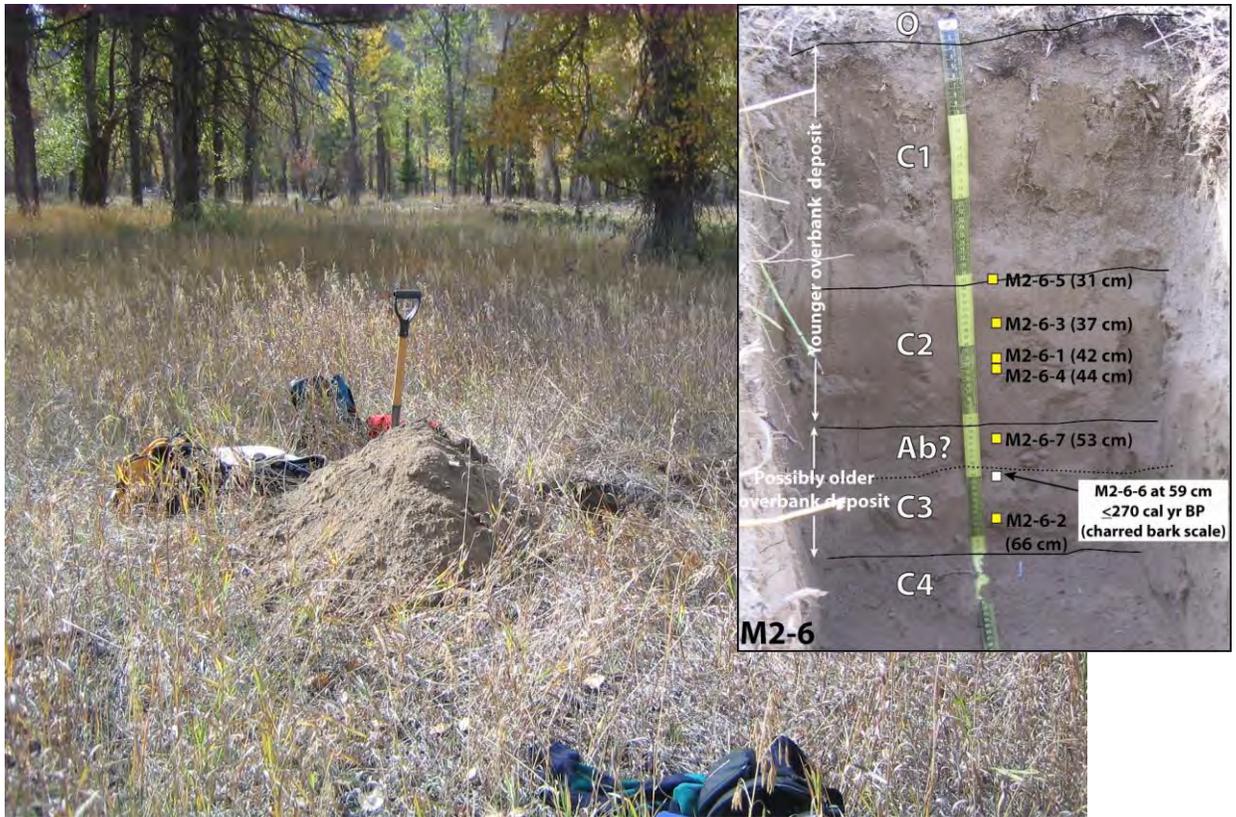
Figure 9. Soil profile M2-6 on Qa3 surface on river right near RM 41.7.

Four soil profiles were described on Qa3 surfaces: M2-4 near RM 44.5, M2-6 near RM 41.7, M2-7 near RM 42.25, and M2-9 near RM 43 (Appendix C). Soils on the Qa3 surfaces consist of a sequence of sandy overbank deposits with no or minimal soil development. Profile M2-4 and probably M2-6 (Figure 9) include buried A horizons that indicate a brief period of stability between flood events that deposited sand at these sites. These sites record evidence for recurrent overtopping by flood flows at intervals short enough to limit soil development. The youngest deposits at these sites may have been left by the 1948 flood. Gravelly channel deposits are present at depths of >0.5 meter at two sites. At M2-7, the gravelly channel deposits are overlain by silty and clayey sediment that was deposited in a backwater area (e.g., a cutoff oxbow).

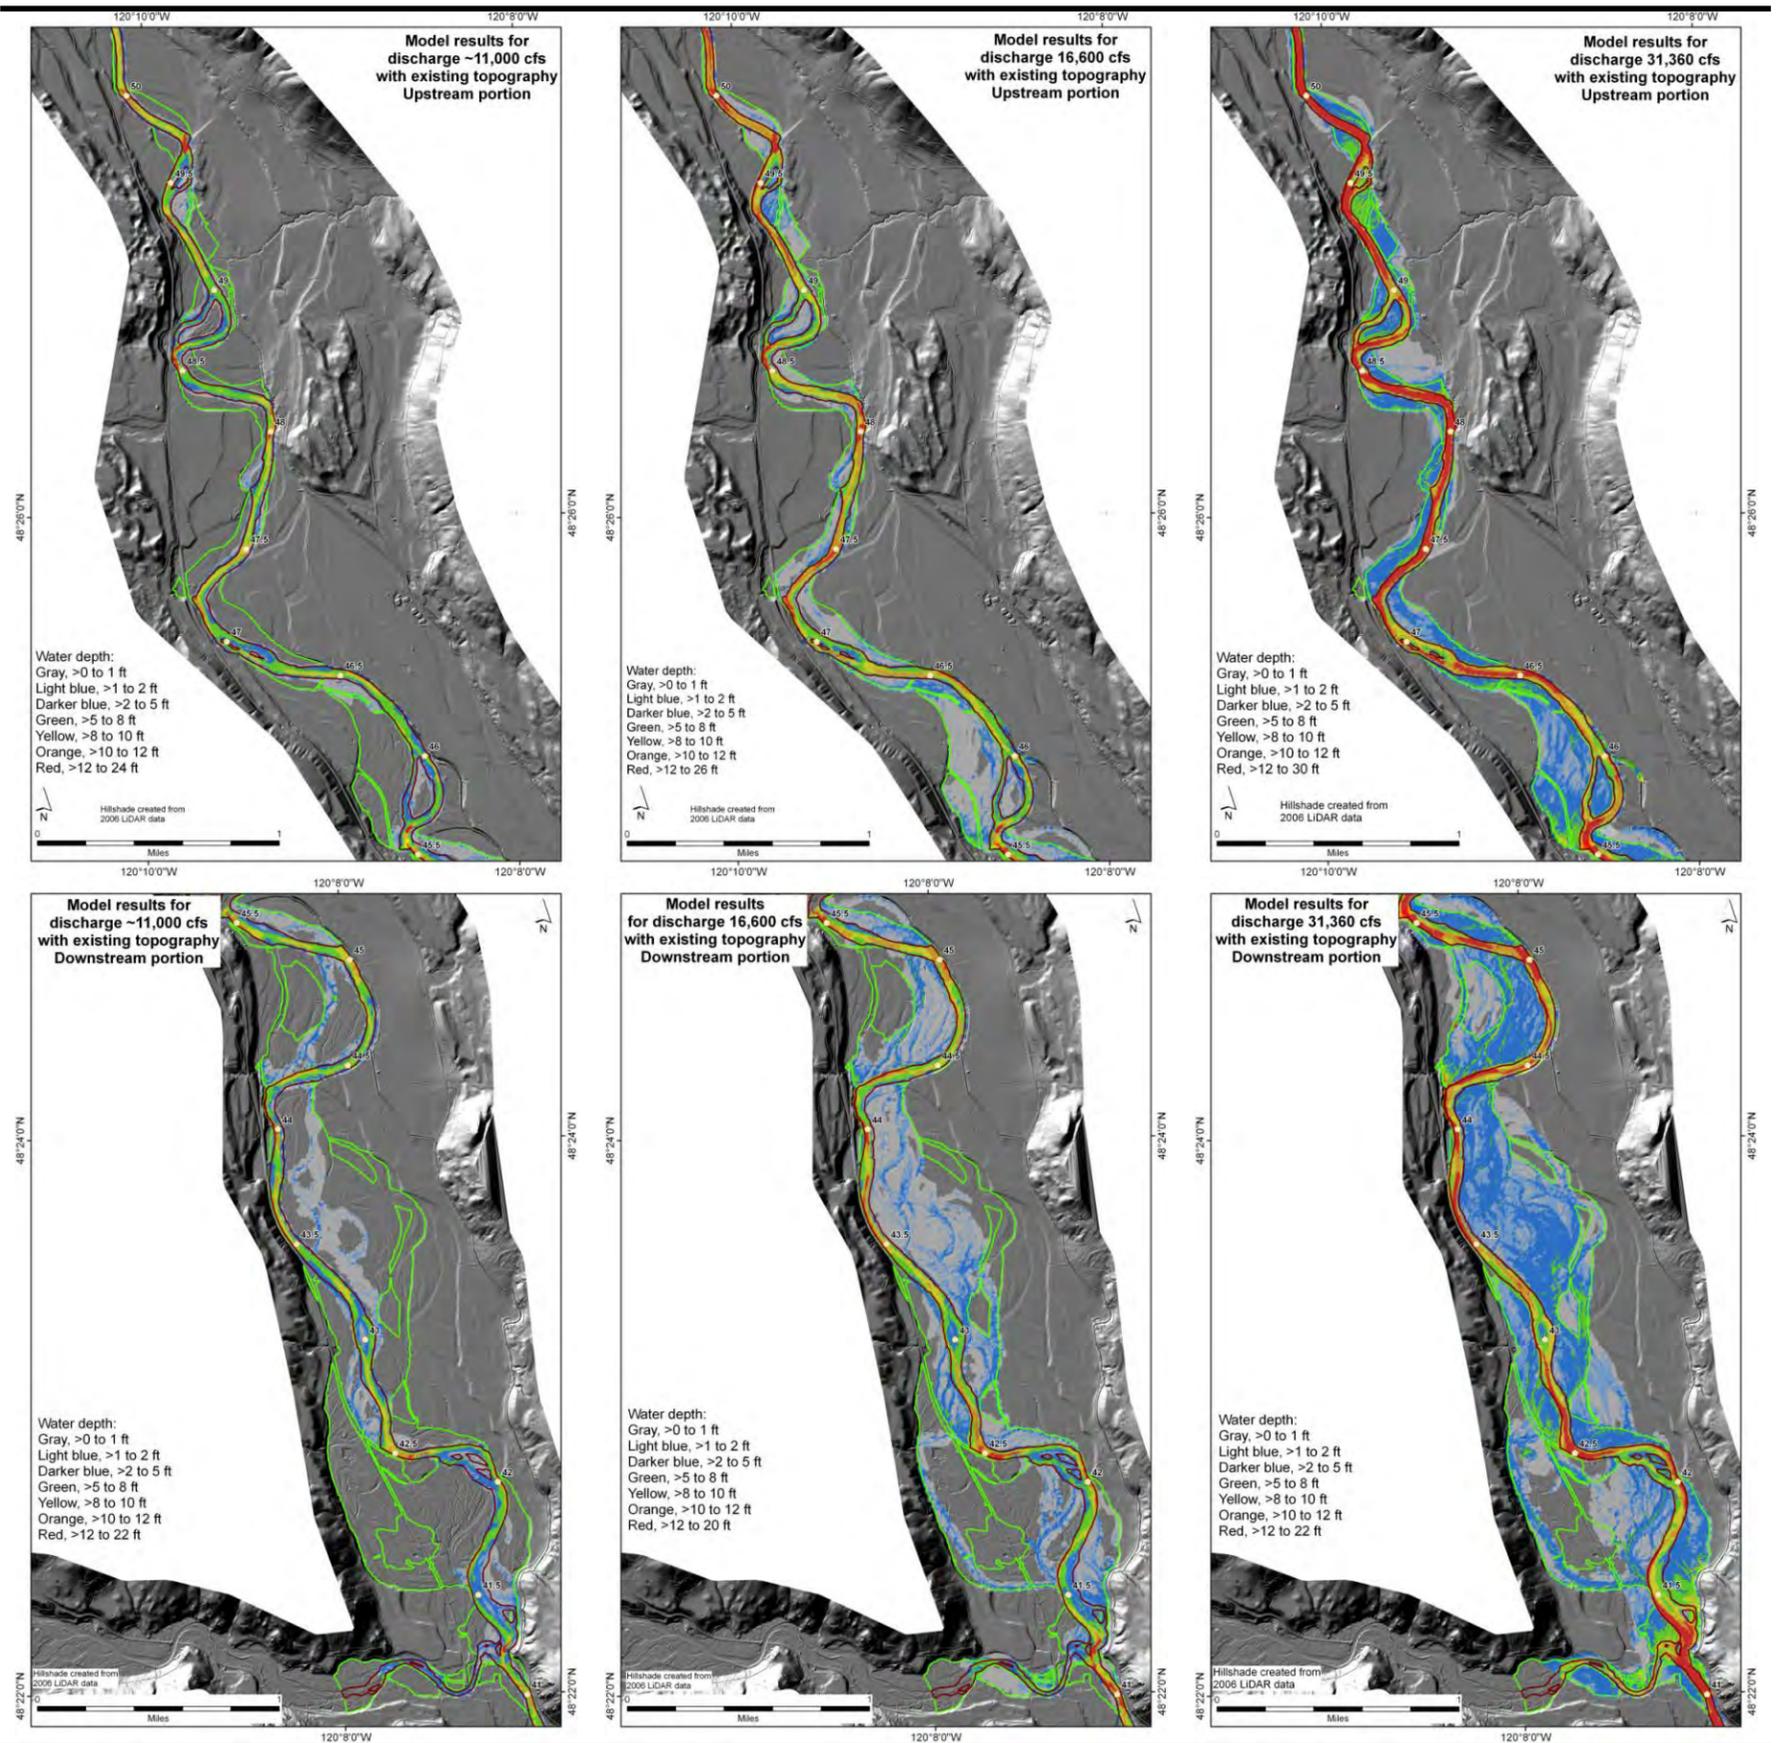
Figure 10. Hydraulic modeling results showing inundation of Qa4 and Qa3 surfaces at discharges of, from left to right, (1) about 11,000 cfs (about a 2-yr flood), (2) 16,600 cfs (a 10-year flood), and (3) 31,360 cfs (the 1948 flood peak).

Model results show that some channels within Qa3 are inundated at a discharge of about 11,000 cfs (a 2-year flood) (Figure 10). At a discharge of 16,600 cfs (a 10-year flood), the majority of the Qa3 surface becomes inundated by at least shallow flow except in the widest areas of Qa3 or where human features or fill has been placed and block or limit access by the river. A discharge of 31,360 cfs (1948 flood peak) is contained within Qa3, which is nearly entirely inundated by water deeper than about 2 ft. Most of the Qa3 surfaces were inundated during the 1948 flood. Some areas that were not inundated or only minimally inundated during the 1948 flood were included in the Qa3 map unit on the basis of their height above the present channel and their surface morphology. An example is the Lehman area, on river left between RM 42.75 and RM 44.25. Most of this area is the same elevation as areas inundated during the 1948 flood, but flooding of the entire Qa3 area is difficult to determine on the 1948 aerial photographs. Because of the elevation of this area, it is included in the Qa3 map unit, although major inundation during the 1948 flood likely occurred only in the section within about 1,500 feet of the present main channel.

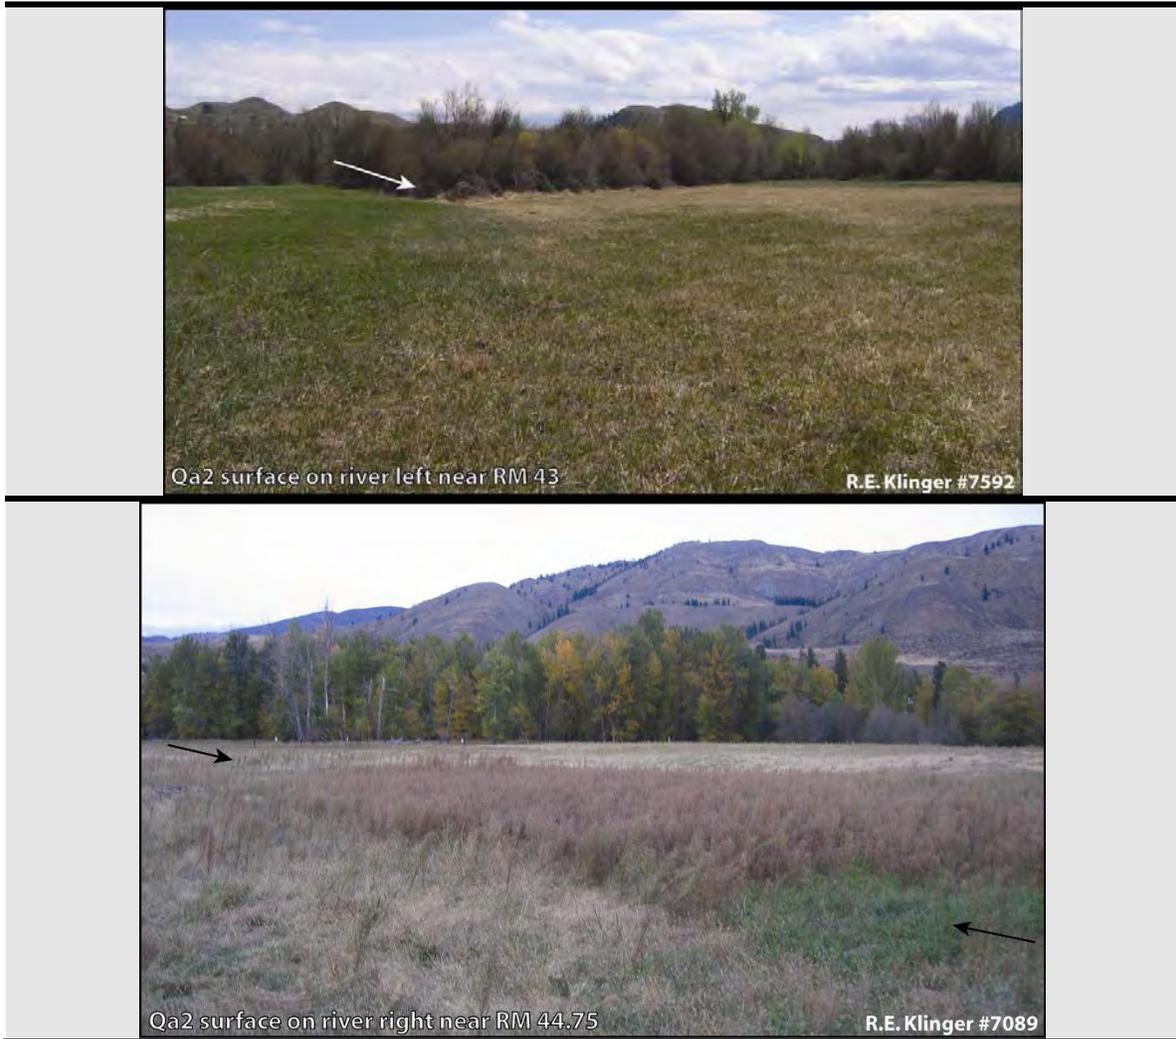
Figure 11. Morphology and vegetation on Qa2 surfaces.
Note the subdued form of overflow channels on these surfaces (indicated by arrows).

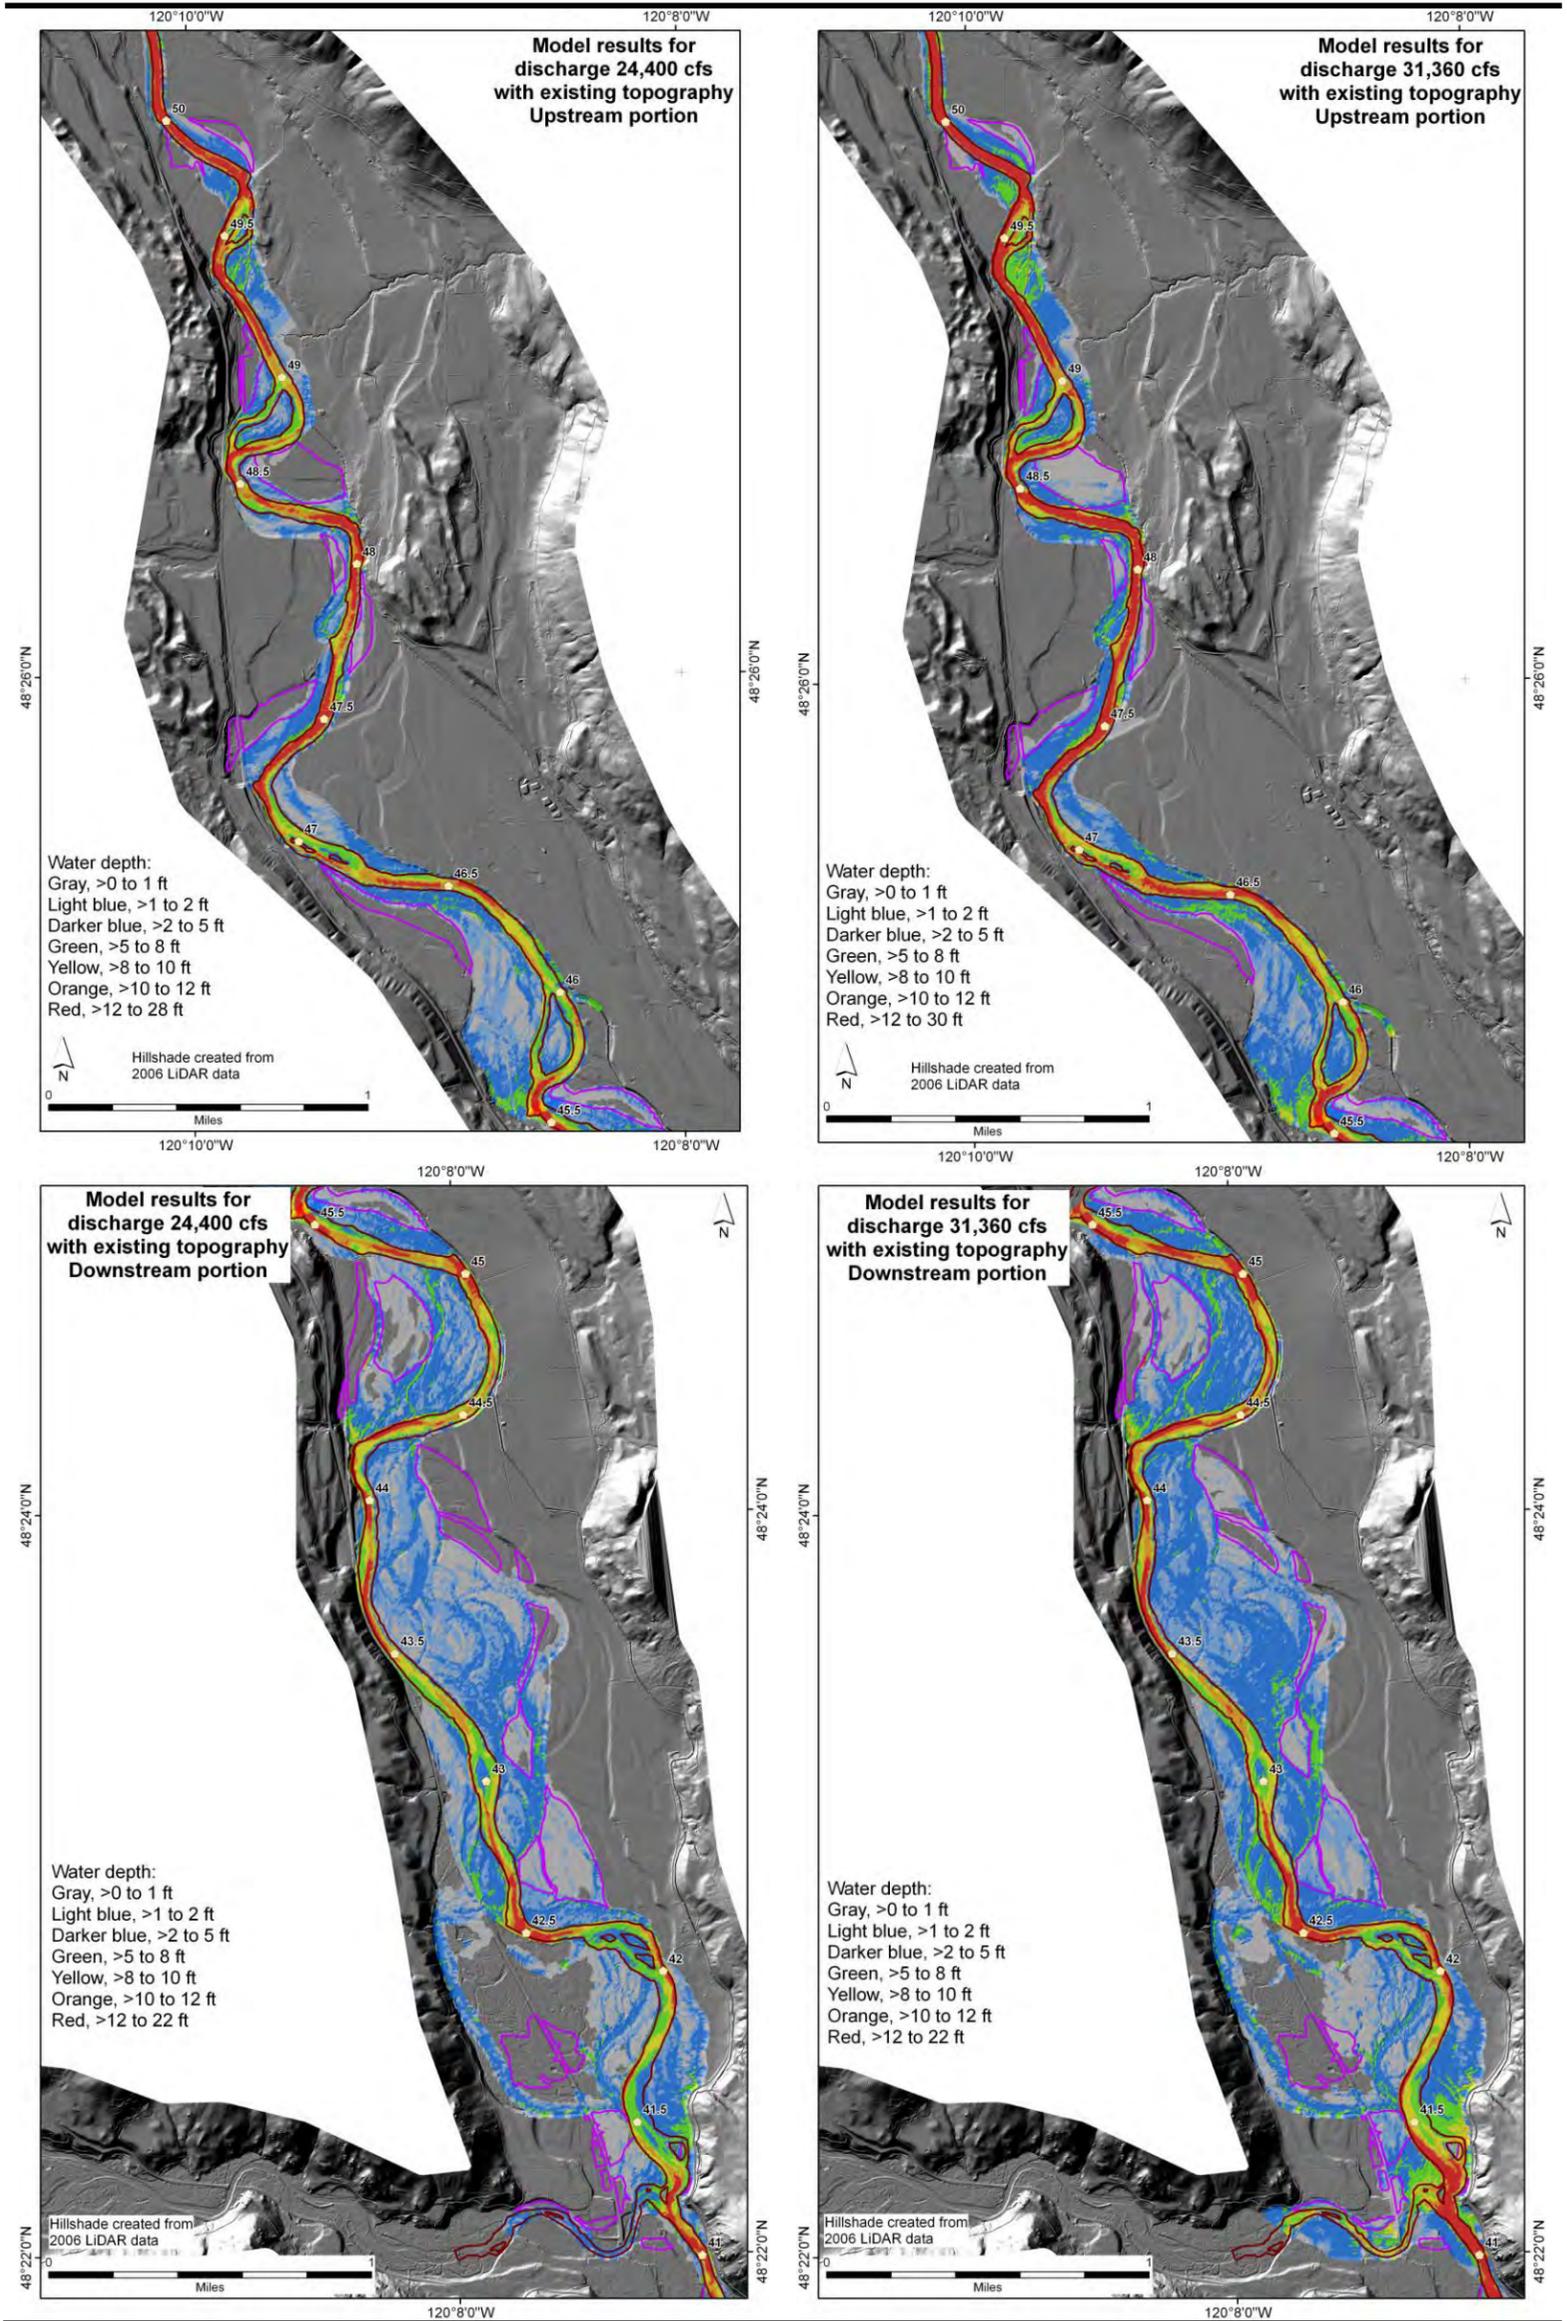
Figure 13. Hydraulic modeling results and inundation of Qa2 surfaces at discharges of, from left to right, (1) 24,400 cfs (a modeled 25-year flood), and (2) 31,360 cfs (a modeled 1948 flood). Qa2 surfaces are outlined in purple. Colors indicate potential water depths as shown on the maps. Area within brown outline is Qa4. Areas not outlined are other map units. Upper figures are for the upstream section of the M2 reach. Lower figures are for the downstream section.

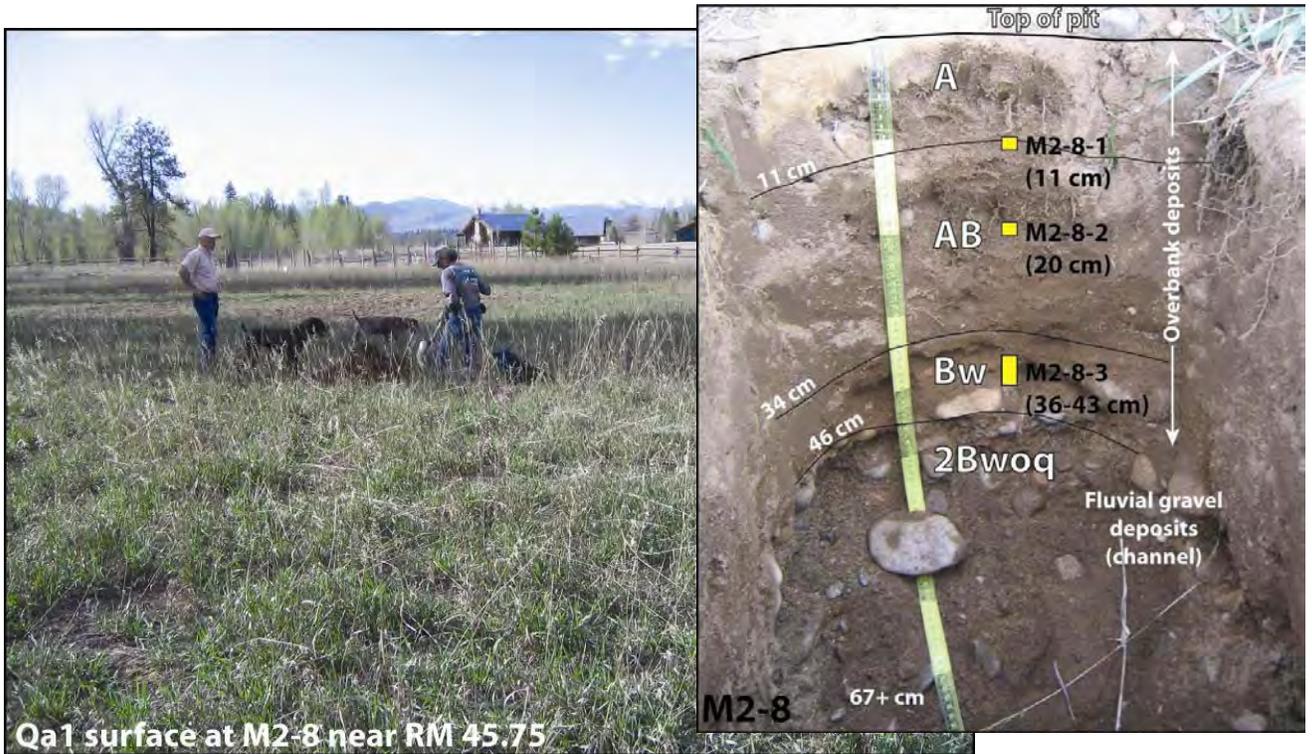
Figure 14. Morphology of Qa1 surface at soil description site M2-8 near RM 45.75.
Left: Photograph from the ground looking northwest at soil profile description site M2-8. Right: M2-8 soil profile.

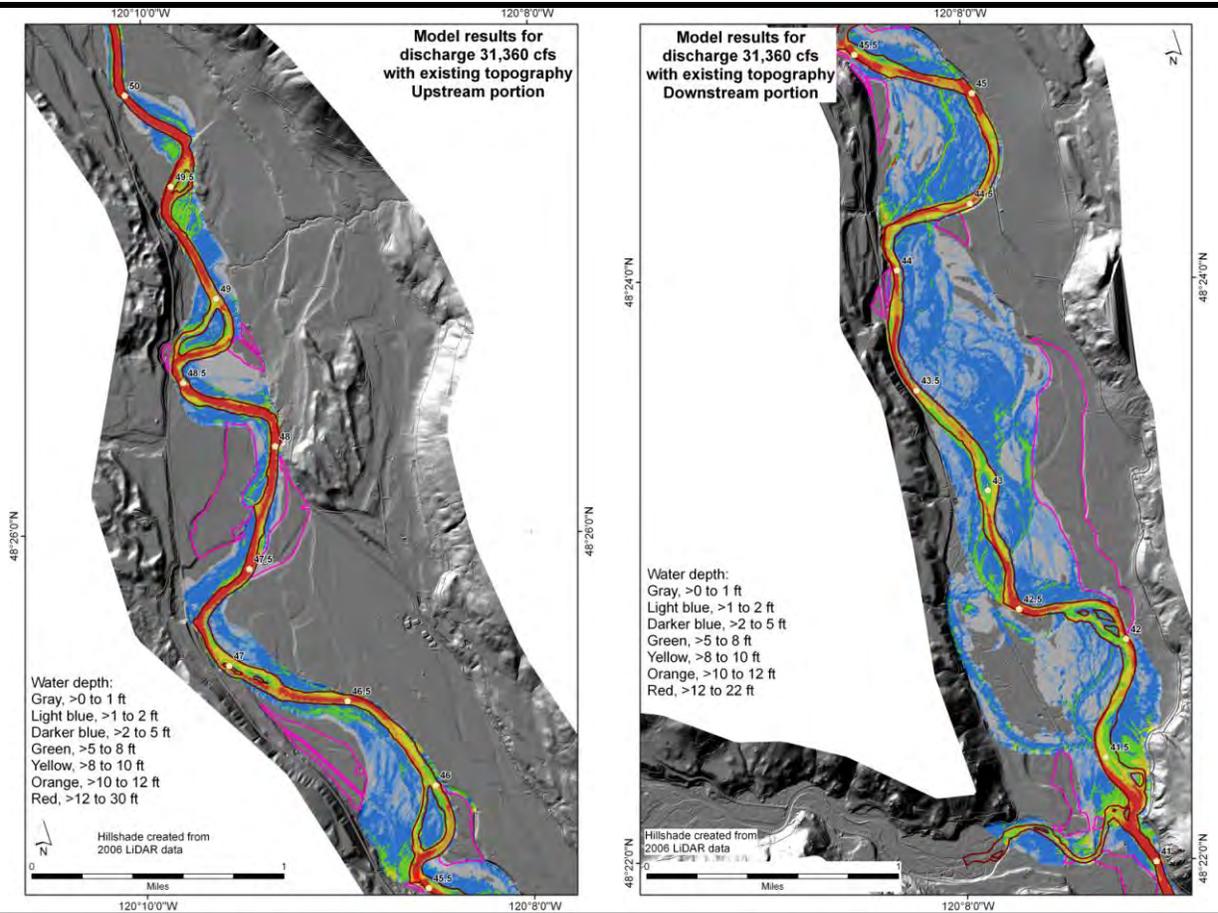
Figure 15. Qa1 surfaces are not inundated by a discharge of 31,360 cfs (the modeled 1948 flood) as shown for the upstream section (left) and the downstream section (right) of the M2 reach. Colors indicate potential water depths as shown on the maps. Area within brown outline is Qa4. Areas outlined in pink are Qa1. Areas not outlined are other map units.

Terrace Qa1 includes those areas that did not receive flow during the 1948 flood (31,360 cfs) and are in a position that they have received little, if any, flood flow historically. The Qa1 surfaces are present as discontinuous remnants along both sides of the valley. Most of the Qa1 surface remnants are along the higher floodplain (Qa2) or active floodplain (Qa3) and are found rarely along the main channel (Qa4).

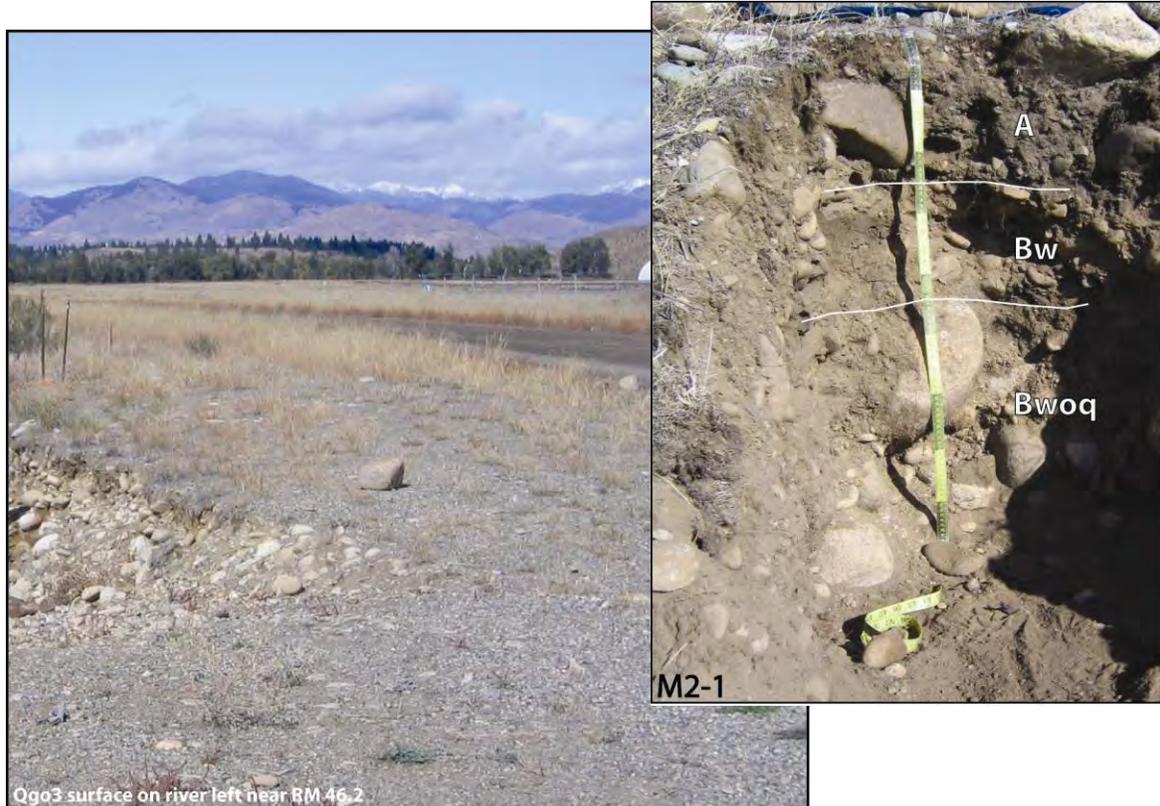
Figure 16. Qgo3 surface and soil profile M2-1 between RM 45.75 and 46.25.

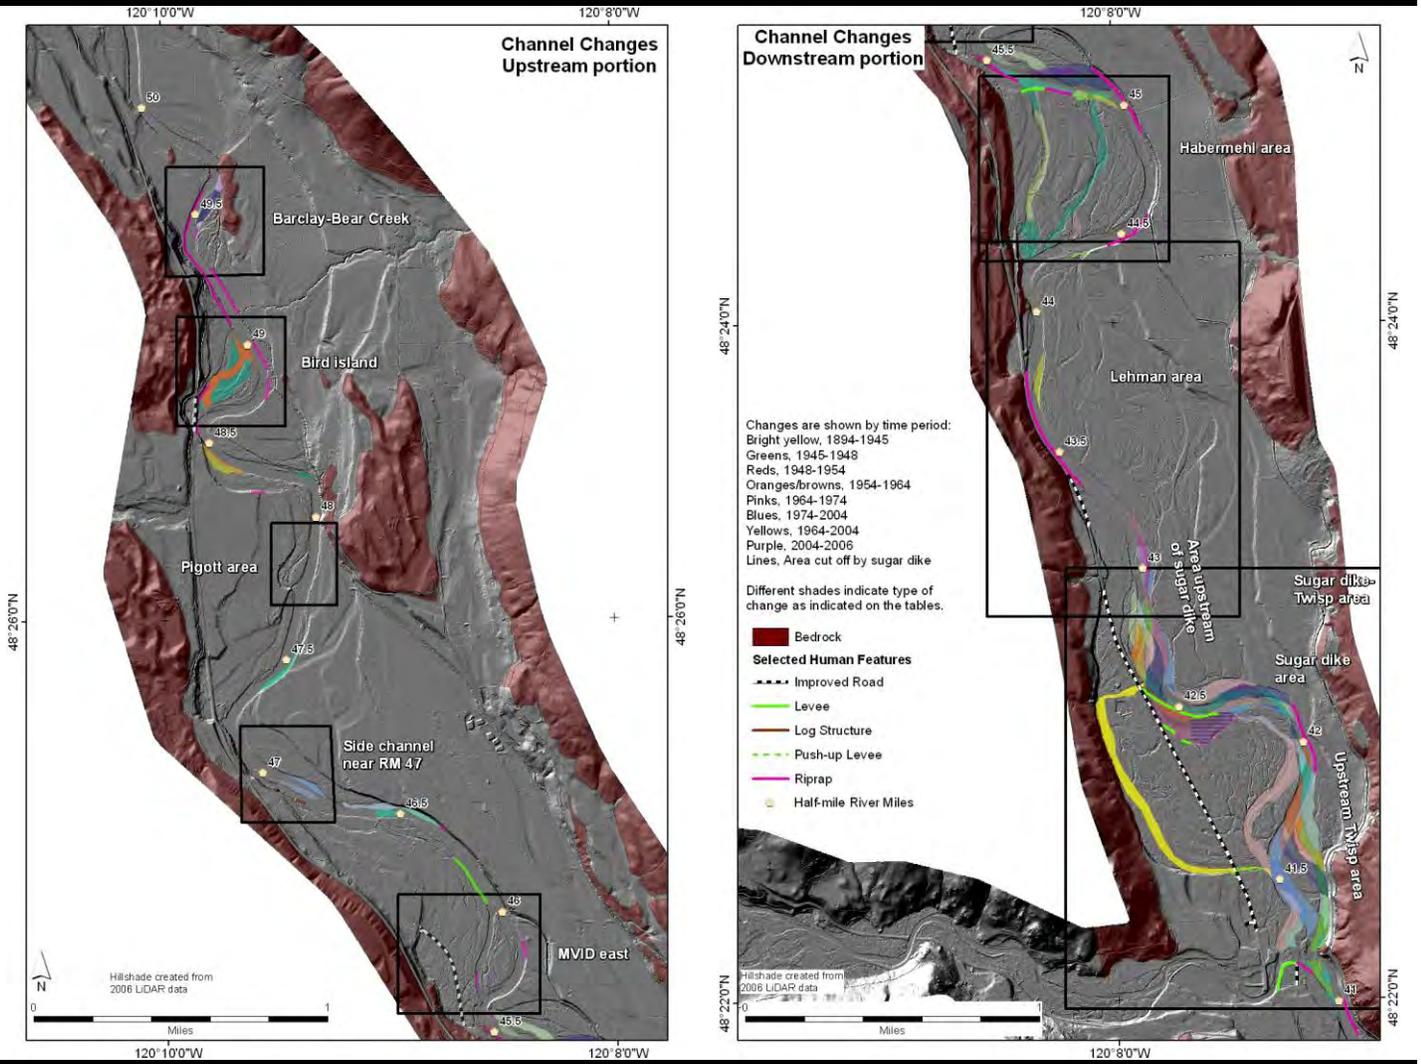
Figure 19. Changes in main and side channels between 1894 and 2006 for the M2 reach.

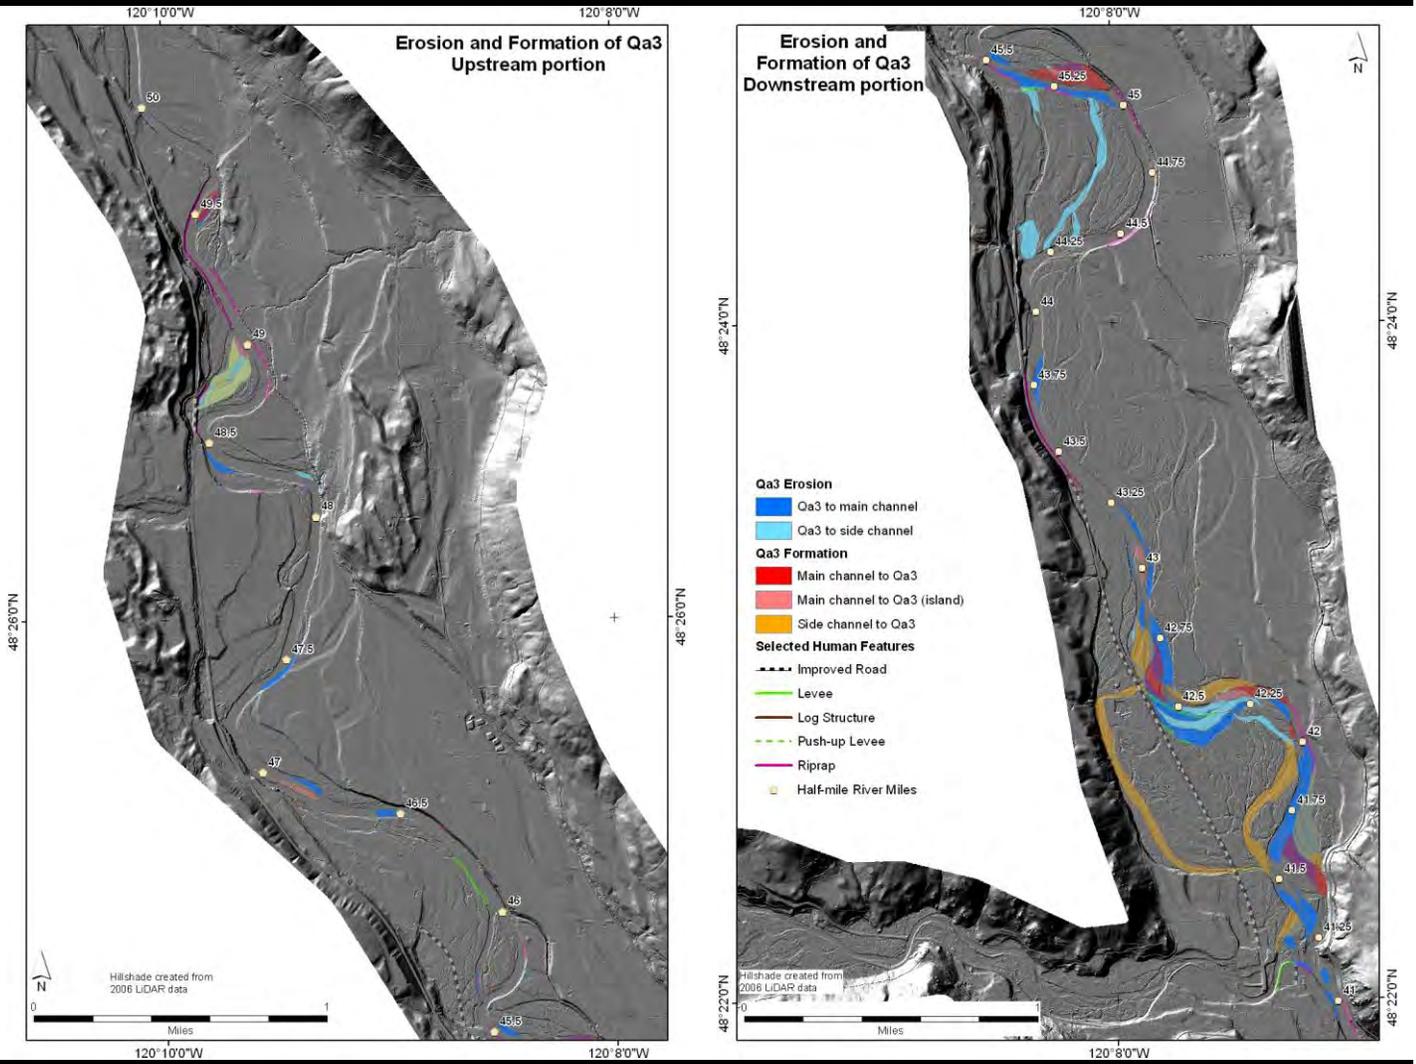
Figure 20. Erosion and formation of Qa3 between 1945 and 2006 for the M2 reach.

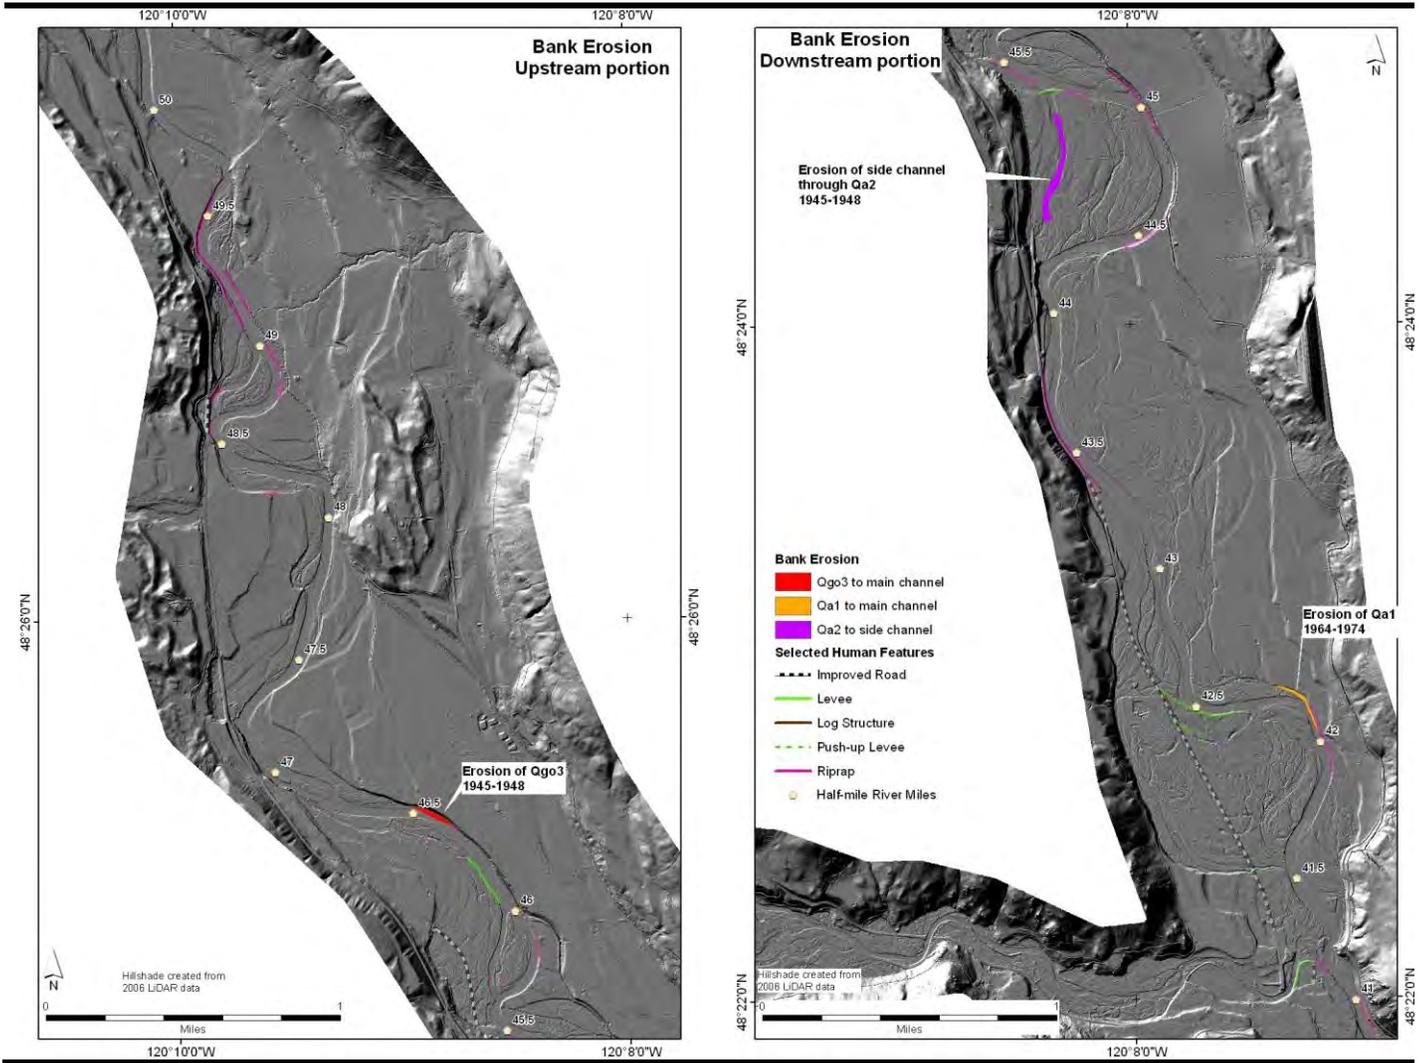
Figure 23. Erosion of units older than Qa3 between 1945 and 2006 for the M2 reach
