Technical Report No. SRH-2009-42

Geomorphology and Hydraulic Modeling for the Middle Methow River from Winthrop to Twisp

U.S. Department of the Interior
Bureau of Reclamation
Technical Service Center
Denver, Colorado

January 2010

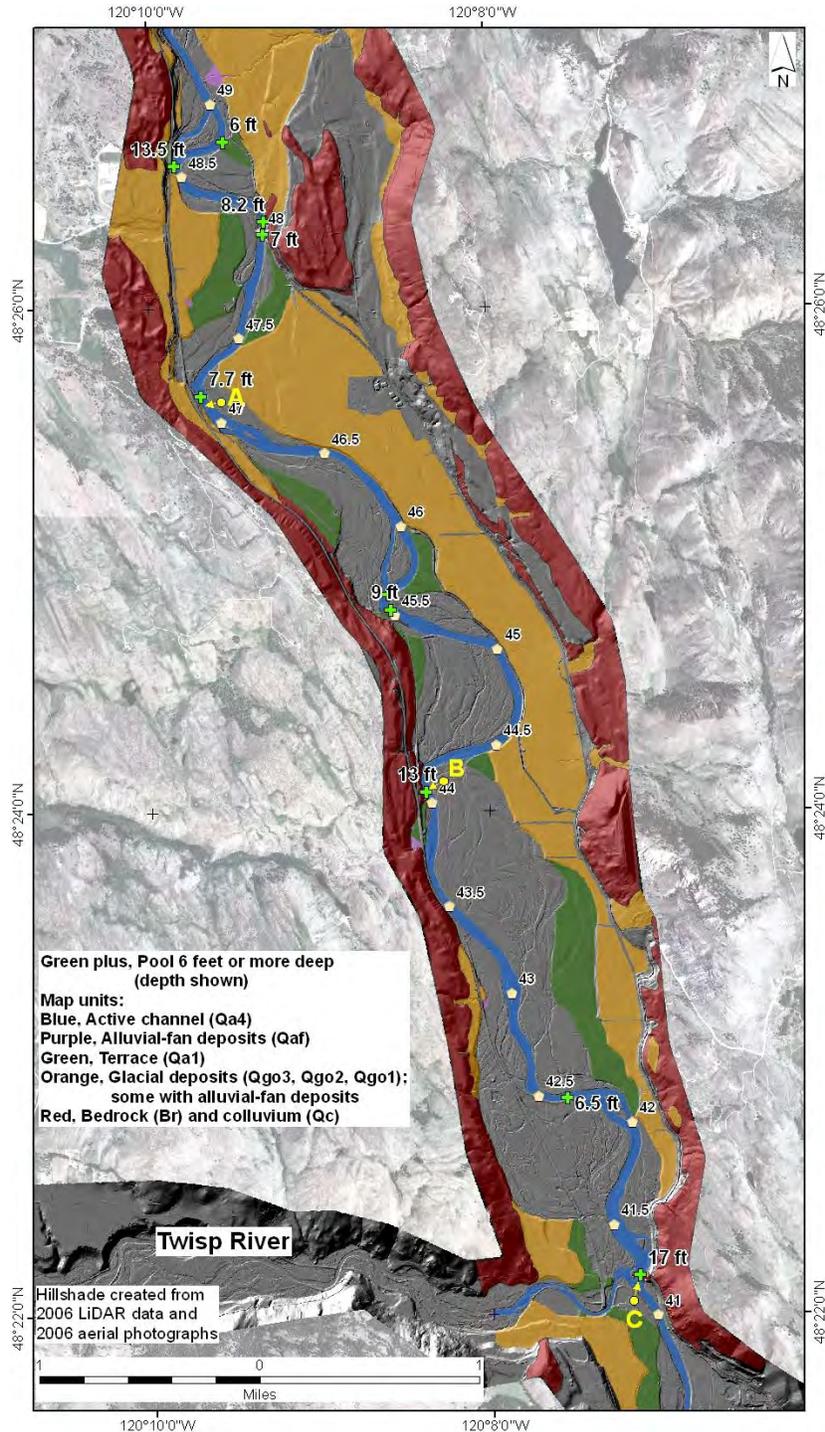
Figure 24. Bedrock (red) and glacial deposits (orange) provide lateral control on the main channel and floodplain. Pools about 6 feet or deeper (green pluses) are present in areas where bedrock is along the main channel. Yellow dots indicate the locations of ground photographs (Figure 25). Yellow arrows show direction of the view in the photographs.

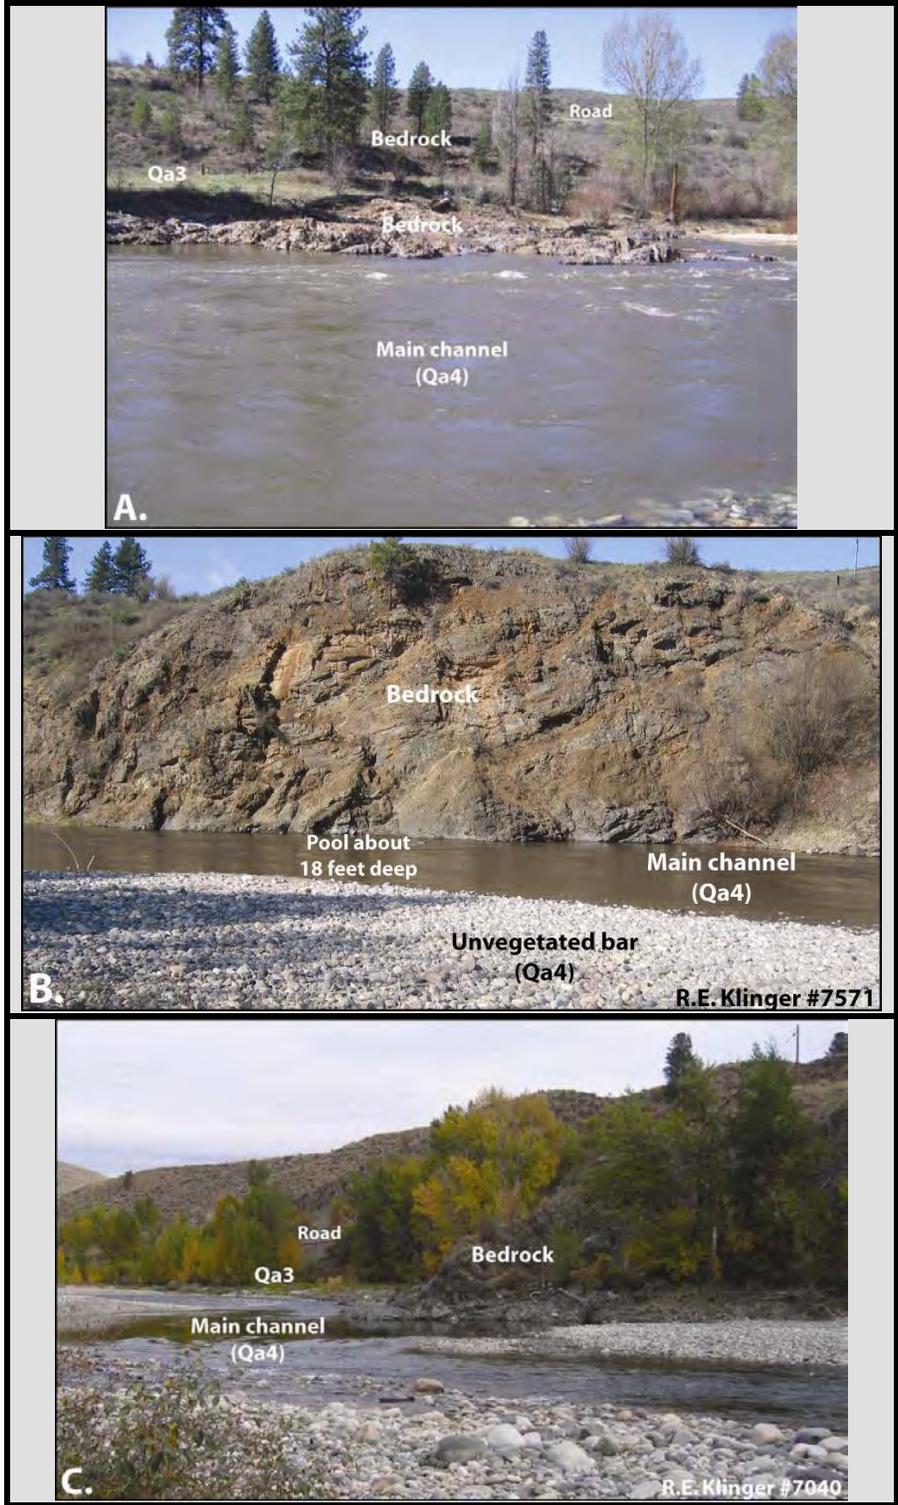
Figure 25. Examples of bedrock along the main channel. Photographs show bedrock along the main channel near RM 45.4 (upper photograph), near RM 44 (middle photograph), and near RM 41.2 (lower photograph).

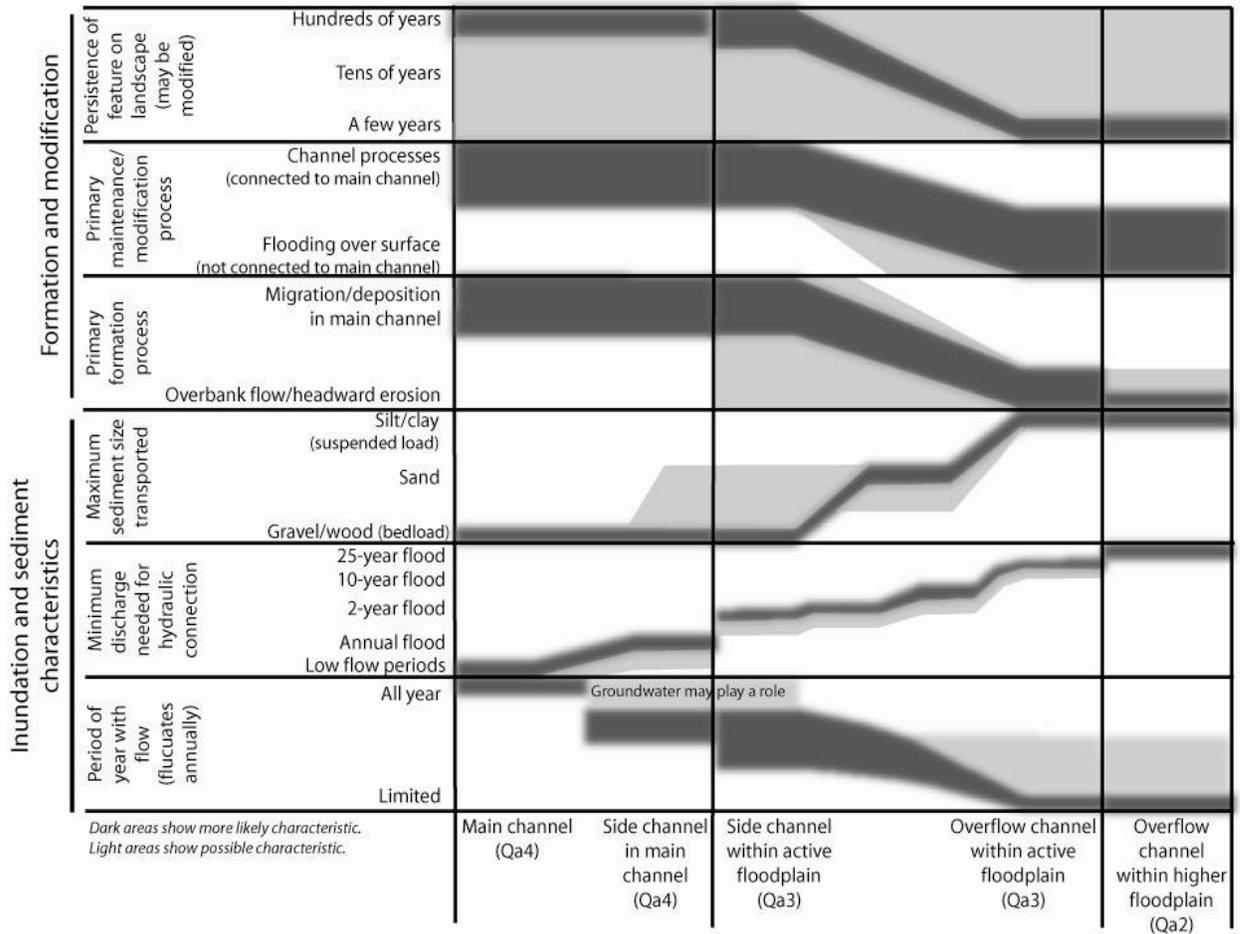
Figure 28. Conceptual illustration of characteristics of side channels in the M2 reach.

The location and physical characteristics of side channels observed in the M2 reach are shown in Figure 28. In general, the side channels are differentiated by the way they form, how they can be modified over time, their persistence on the landscape, sediment characteristics, and the frequency and magnitude of their surface connection with the main channel. For each characteristic, the most frequently observed value is shown with the dark gray shading, while the light grey shaded areas represent the total range of values observed. The figure is intended to represent a fluid process by which channels in the M2 reach may shift across categories over time as they are modified by the river. Different types of side and overflow channels exist together along the river and create the variety that is needed for a properly functioning river system (Figure 29).

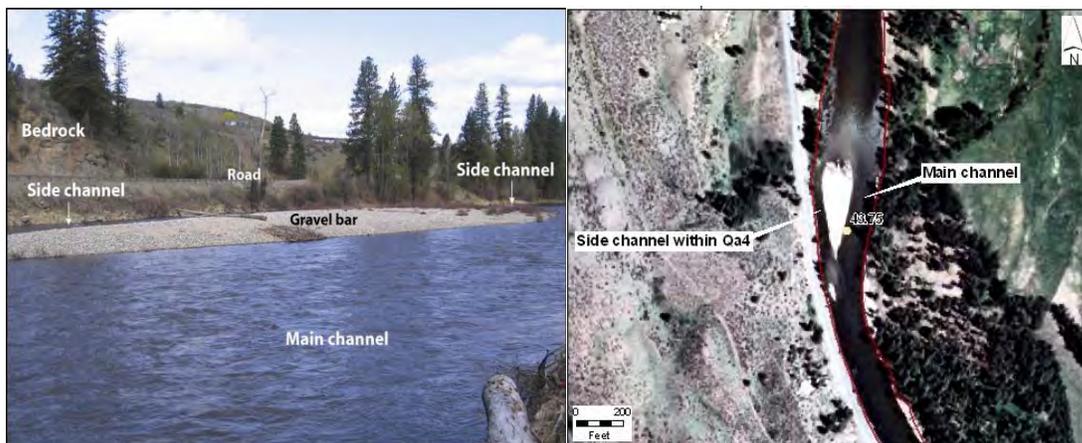
Figure 30. Example of a side channel within Qa4 near RM 43.75.

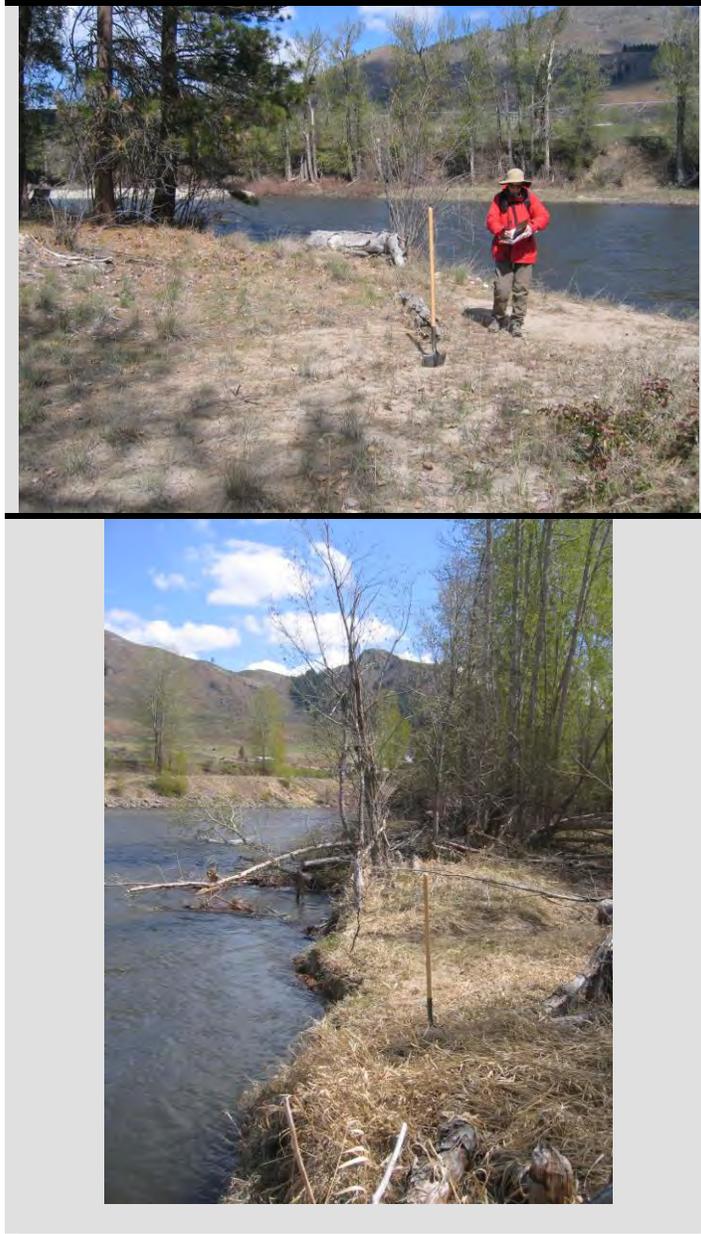
Figure 33. Examples of areas of overbank flow at the heads of overflow channels within Qa3.
Note that channel form is poor, but evidence for sheet flow is present. This evidence includes fresh sand (upper photograph) and wood (lower photograph).

As described above, overflow channels formed within the floodplain are only inundated by larger floods (greater than 5-to-10-year floods). Because of this characteristic, these channels may not represent reliable habitat as they are only directly connected to the main channel by surface flow on time frames greater than the lifespan of the salmonid species that might utilize them. Overflow channels within Qa3 and Qa2 typically convey flood flows when overtopping and inundation of the floodplain occurs (Figure 31). The form of these overflow channels may be quite variable (Figure 32) from shallow channels that may convey essentially sheet flow at their upstream ends (Figure 33) to well-defined, deeper channels that convey flow that has coalesced at their downstream ends (Figure 34). Because the overflow channels are inundated primarily by overbank flow, suspended sediment (fine sand, silt and clay) is transported and deposited in these channels. Gravel that is visible in the bed of these channels is usually found in the downstream portions of the channels and appears to be a lag deposit derived from older underlying deposits that have been exhumed through surface erosion. As these channels deepen at the downstream end, they may become inundated by backwater flow from the main channel before they develop an upstream surface water connection.

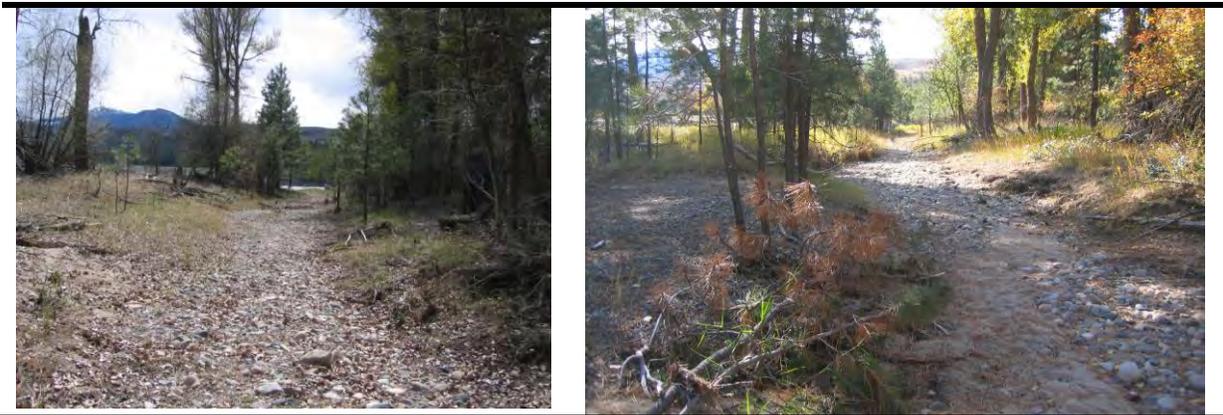
Figure 34. Side channels within Qa3 that require overbank flow for inundation can have well-defined channel form at their downstream ends.

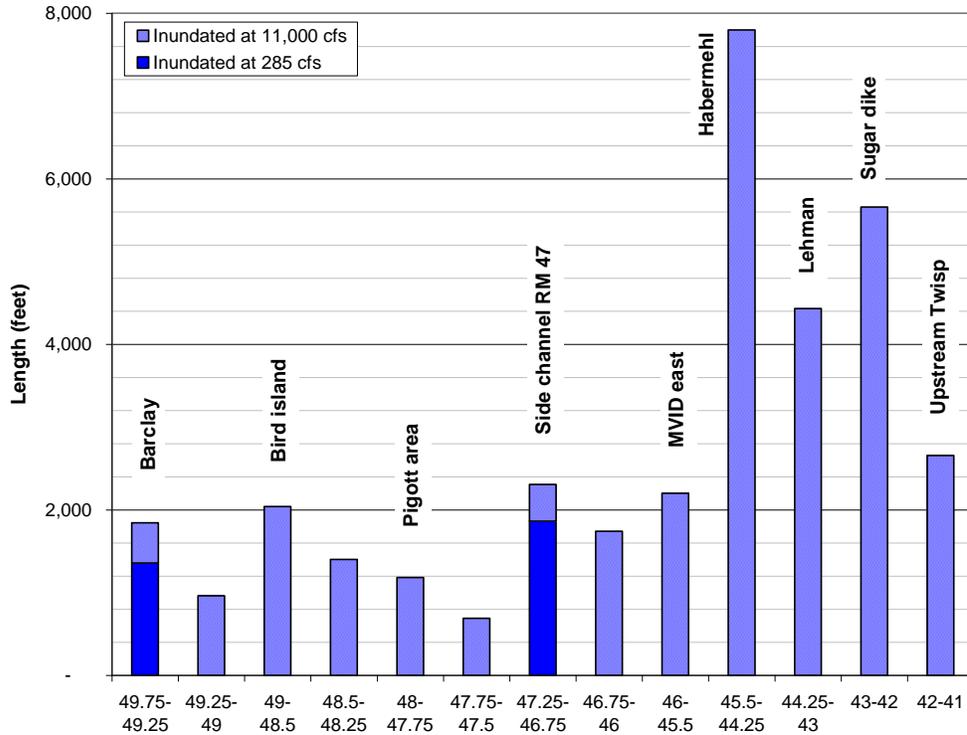
Figure 35. Cumulative length of side channels inundated for 285 cfs vs. 11,000 cfs for river segments along M2.

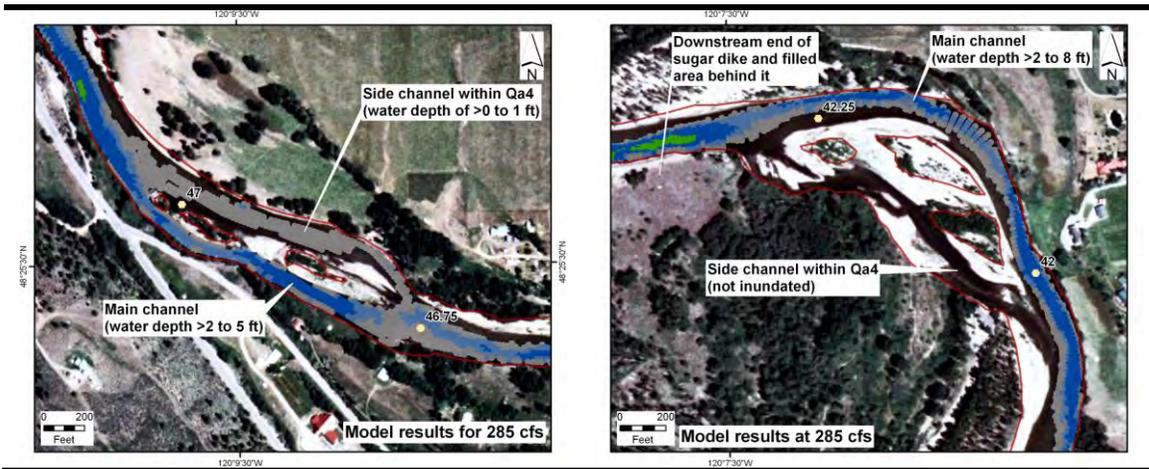
Figure 36. Examples of two side channels within Qa4 showing their inundation during low-flow conditions (285 cfs) relative to the 2006 NAIP aerial photograph presumably taken at a higher discharge.

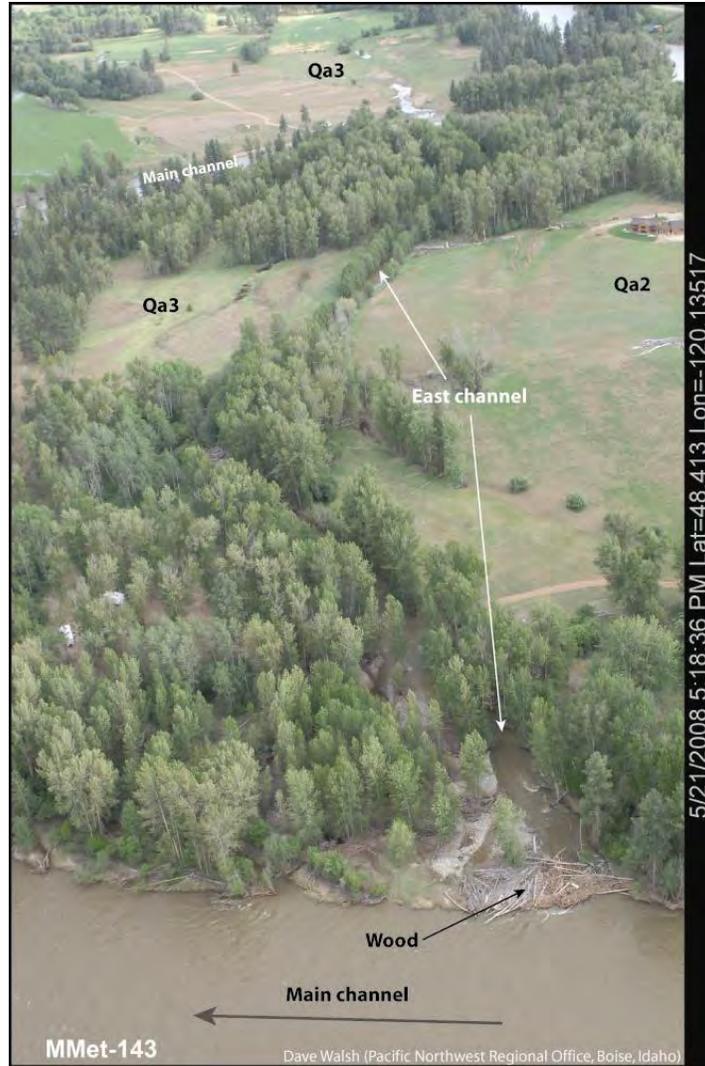
Figure 37. Head of east channel at Habermehl near RM 45.1 with wood and sediment 2 days after the peak of the May 2008 flood.

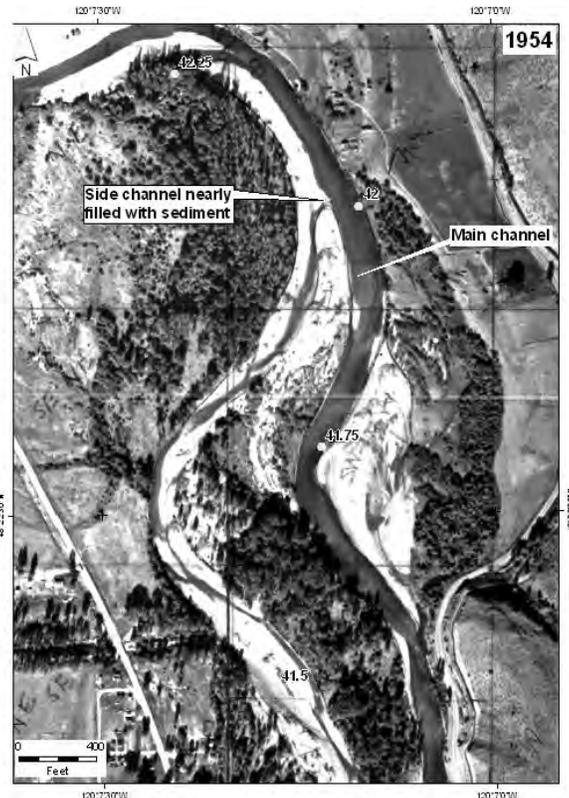
Figure 38. Example of how the discharge needed to inundate side channels can change over time
The side channel was formed when the main channel avulsed to river left (looking downstream) near RM 42 during the 1948 flood. Following the avulsion, a sediment bar formed on the inside of the meander bend limiting the flow directed into the side channel. As a result, the side channel was observed on subsequent aerial photography to be filling with sediment and vegetation. In 2006, the deposition of sediment had resulted in raising the elevation of the side channel to the point that large floods are needed for inundation of the side channel.

An example of this progressive modification can be seen in a side channel near RM 41.75 (Figure 38). In 1945, this side channel was the main channel, so it was initially large and well defined. When the river abandoned this channel, the upstream entrance to the channel became filled with sediment as can be observed in the 1954 aerial photography. Once flow into the channel was reduced, fine sediment carried into the channel by low velocity overbank flow began filling the channel while vegetation encroached from both banks. This same process is currently taking place at the Doran side channel that heads near RM 42.6. GLO maps indicate that this channel was one of two main channel paths in 1894. The overall width and depth of this channel is being reduced by the encroachment of vegetation and more infrequent inundation by flooding. At the present time, the upstream entrance to the channel is almost completely blocked by sediment. A large gravel bar has formed just upstream of the entrance and is building downstream and into the channel.

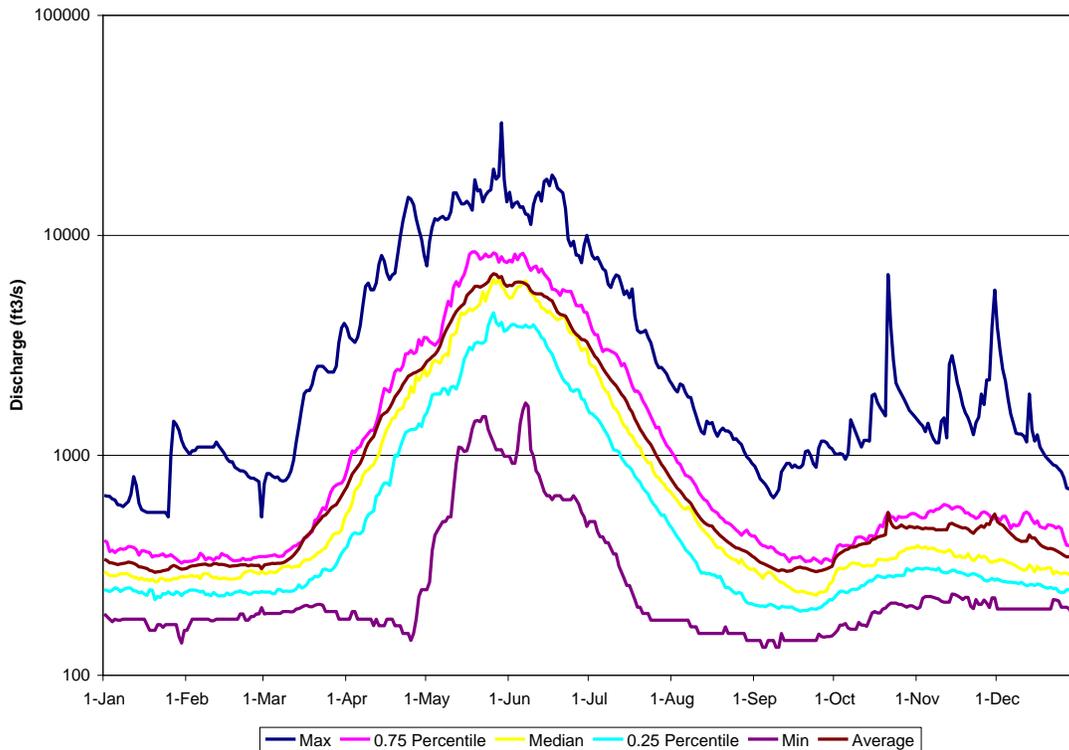
Figure 39. Summary hydrograph showing probability distribution of mean daily discharge based on 56 years of record at the gaging station on the Methow River at Twisp (USGS station #13449500).

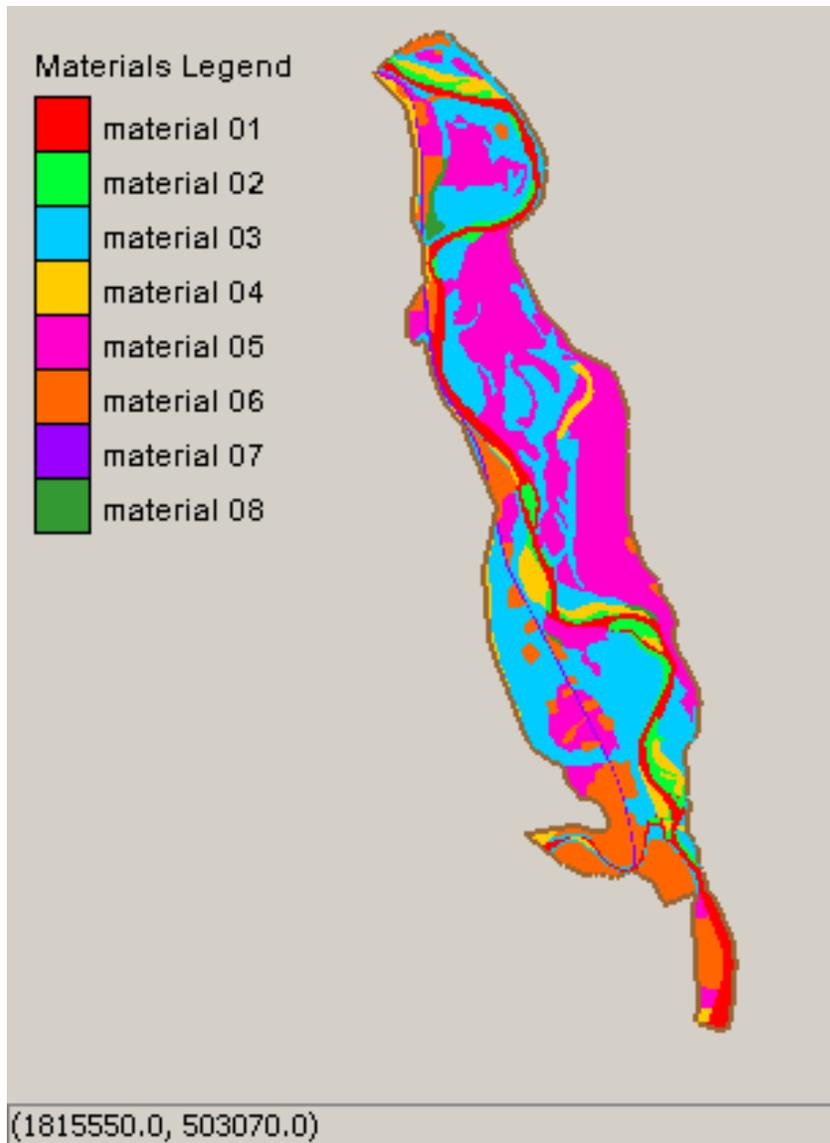
Figure 4. Roughness delineation.

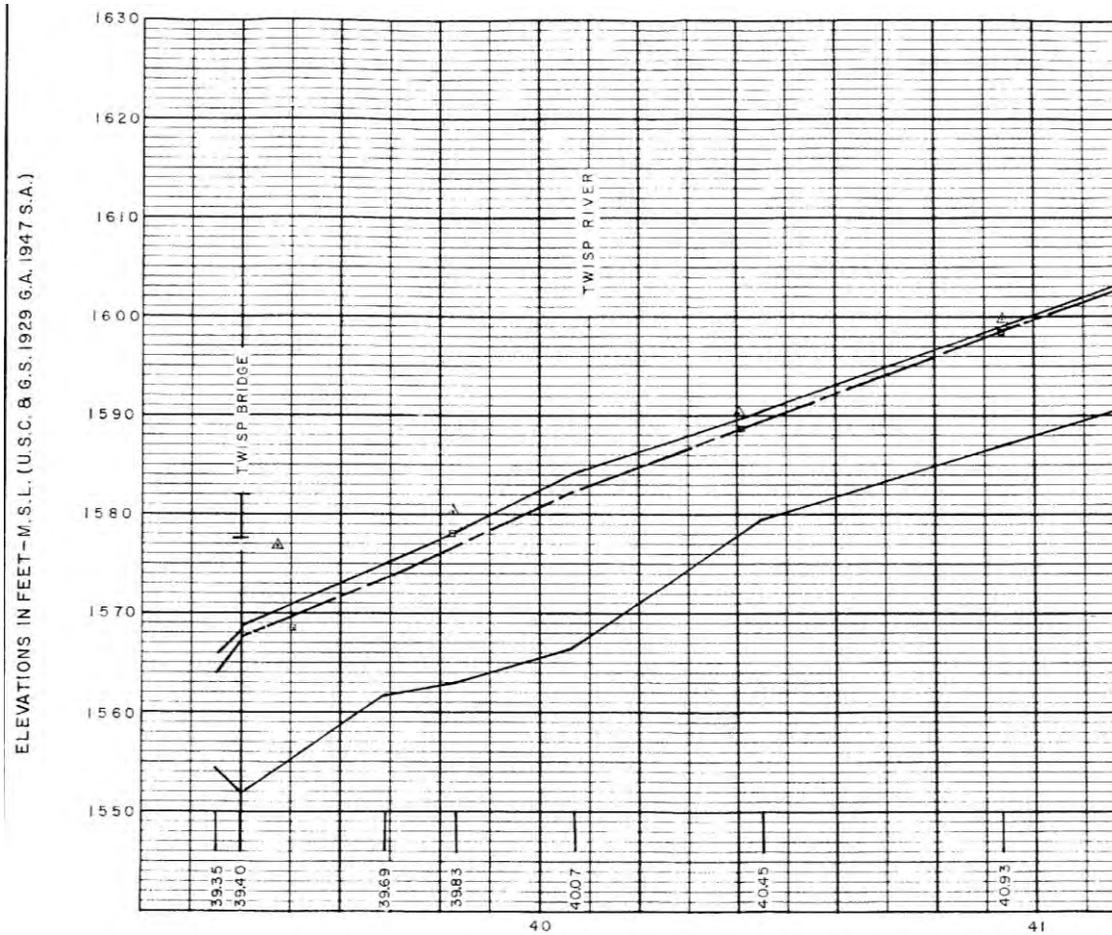
Figure 9. Example longitudinal profile of model results and observed high water marks from 1973 flood study (R.W. Beck and Associates, 1973).

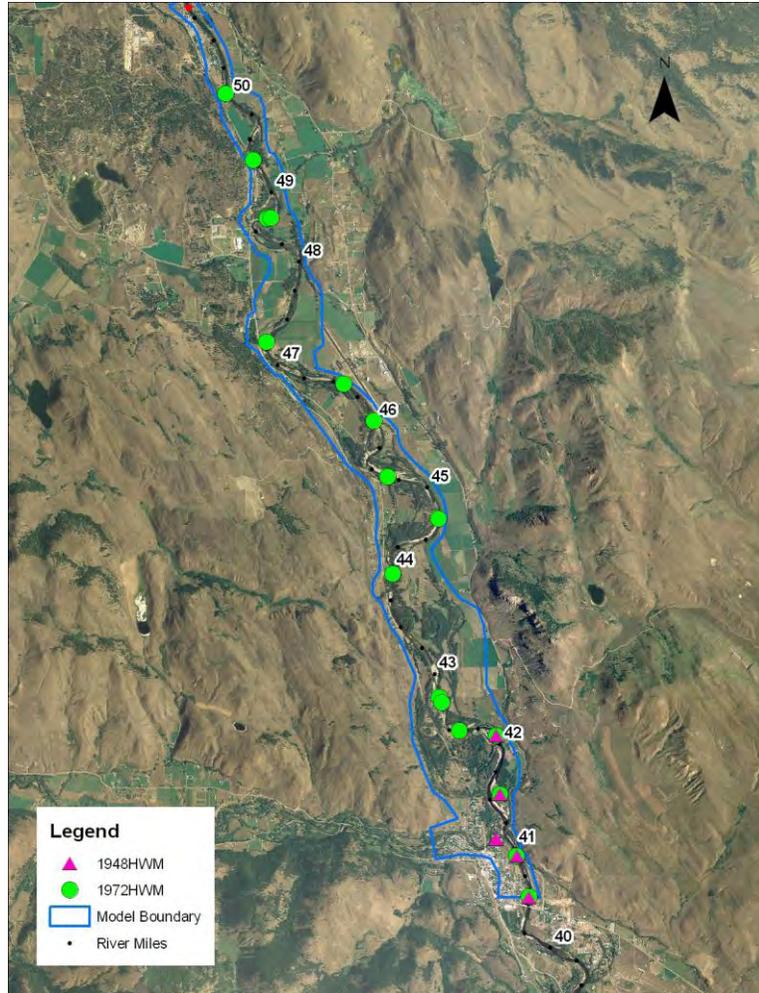
Figure 10. Approximate locations of 1948 and 1972 high water marks utilized for model comparison (R.W. Beck and Associates, 1973).

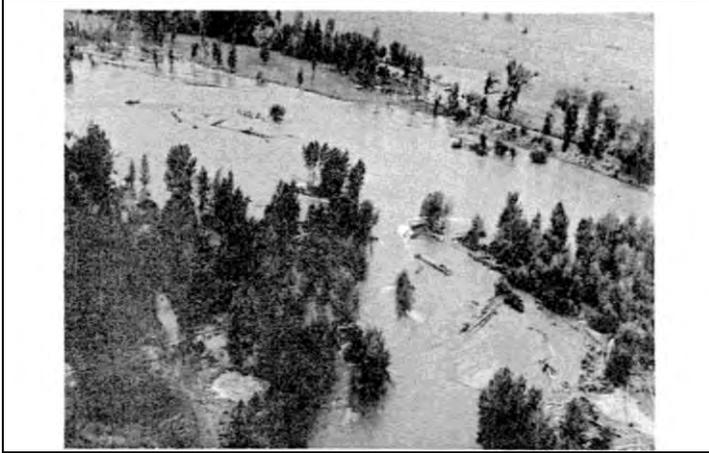
Figure 11. View looking upstream four and one-half miles north of Twisp during May 1972 flood (R.W. Beck and Associates, 1973). Report notes that photograph is courtesy of Soil Conservation Service, Okanogan, Washington - Mr. A. E. Blomdahl.

A few ground photographs of the 1972 and 1948 floods were also available (Figure 11, Figure 12, and Figure 13). Due to the limited amount of 1948 high water marks, aerial photography taken during the 1948 flood and flood maps from the 1973 study were also used to visually compare 2D model results. An example is provided in Figure 14.

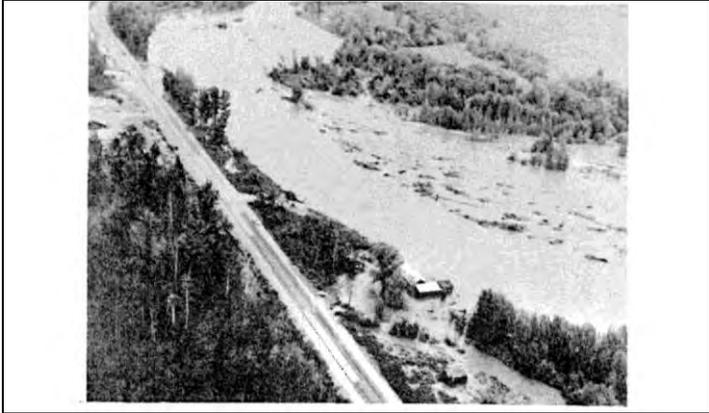
Figure 12. View looking upstream two miles north of Twisp during May 1972 flood (R.W. Beck and Associates, 1973). Report notes that photograph is courtesy of Soil Conservation Service, Okanogan, Washington - Mr. A. E. Blomdahl.

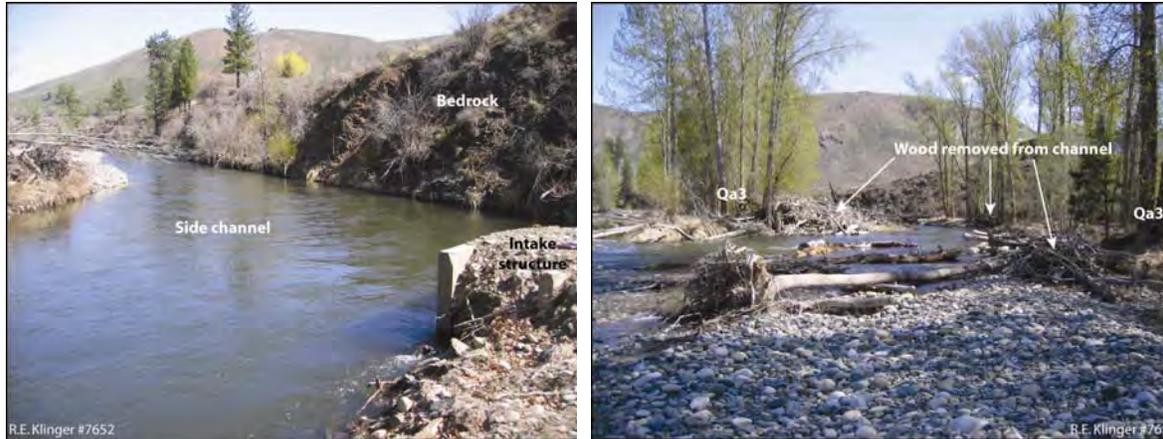
Figure 3. Ground photographs showing geomorphic and human features in the Barclay-Bear Creek area. Photograph A (left) shows the side channel and bedrock along river left looking upstream from the diversion structure. Photograph B (right) shows the downstream end of side channel and the wood that is removed and piled along the edges of Qa3 surfaces. See Figure 2 for location.

Figure 2. Barclay and Bear Creek area with the main features indicated. Locations at which photographs A and B (Figure 3) were taken are indicated by the yellow dots. Yellow arrows show the direction of view for each photograph.

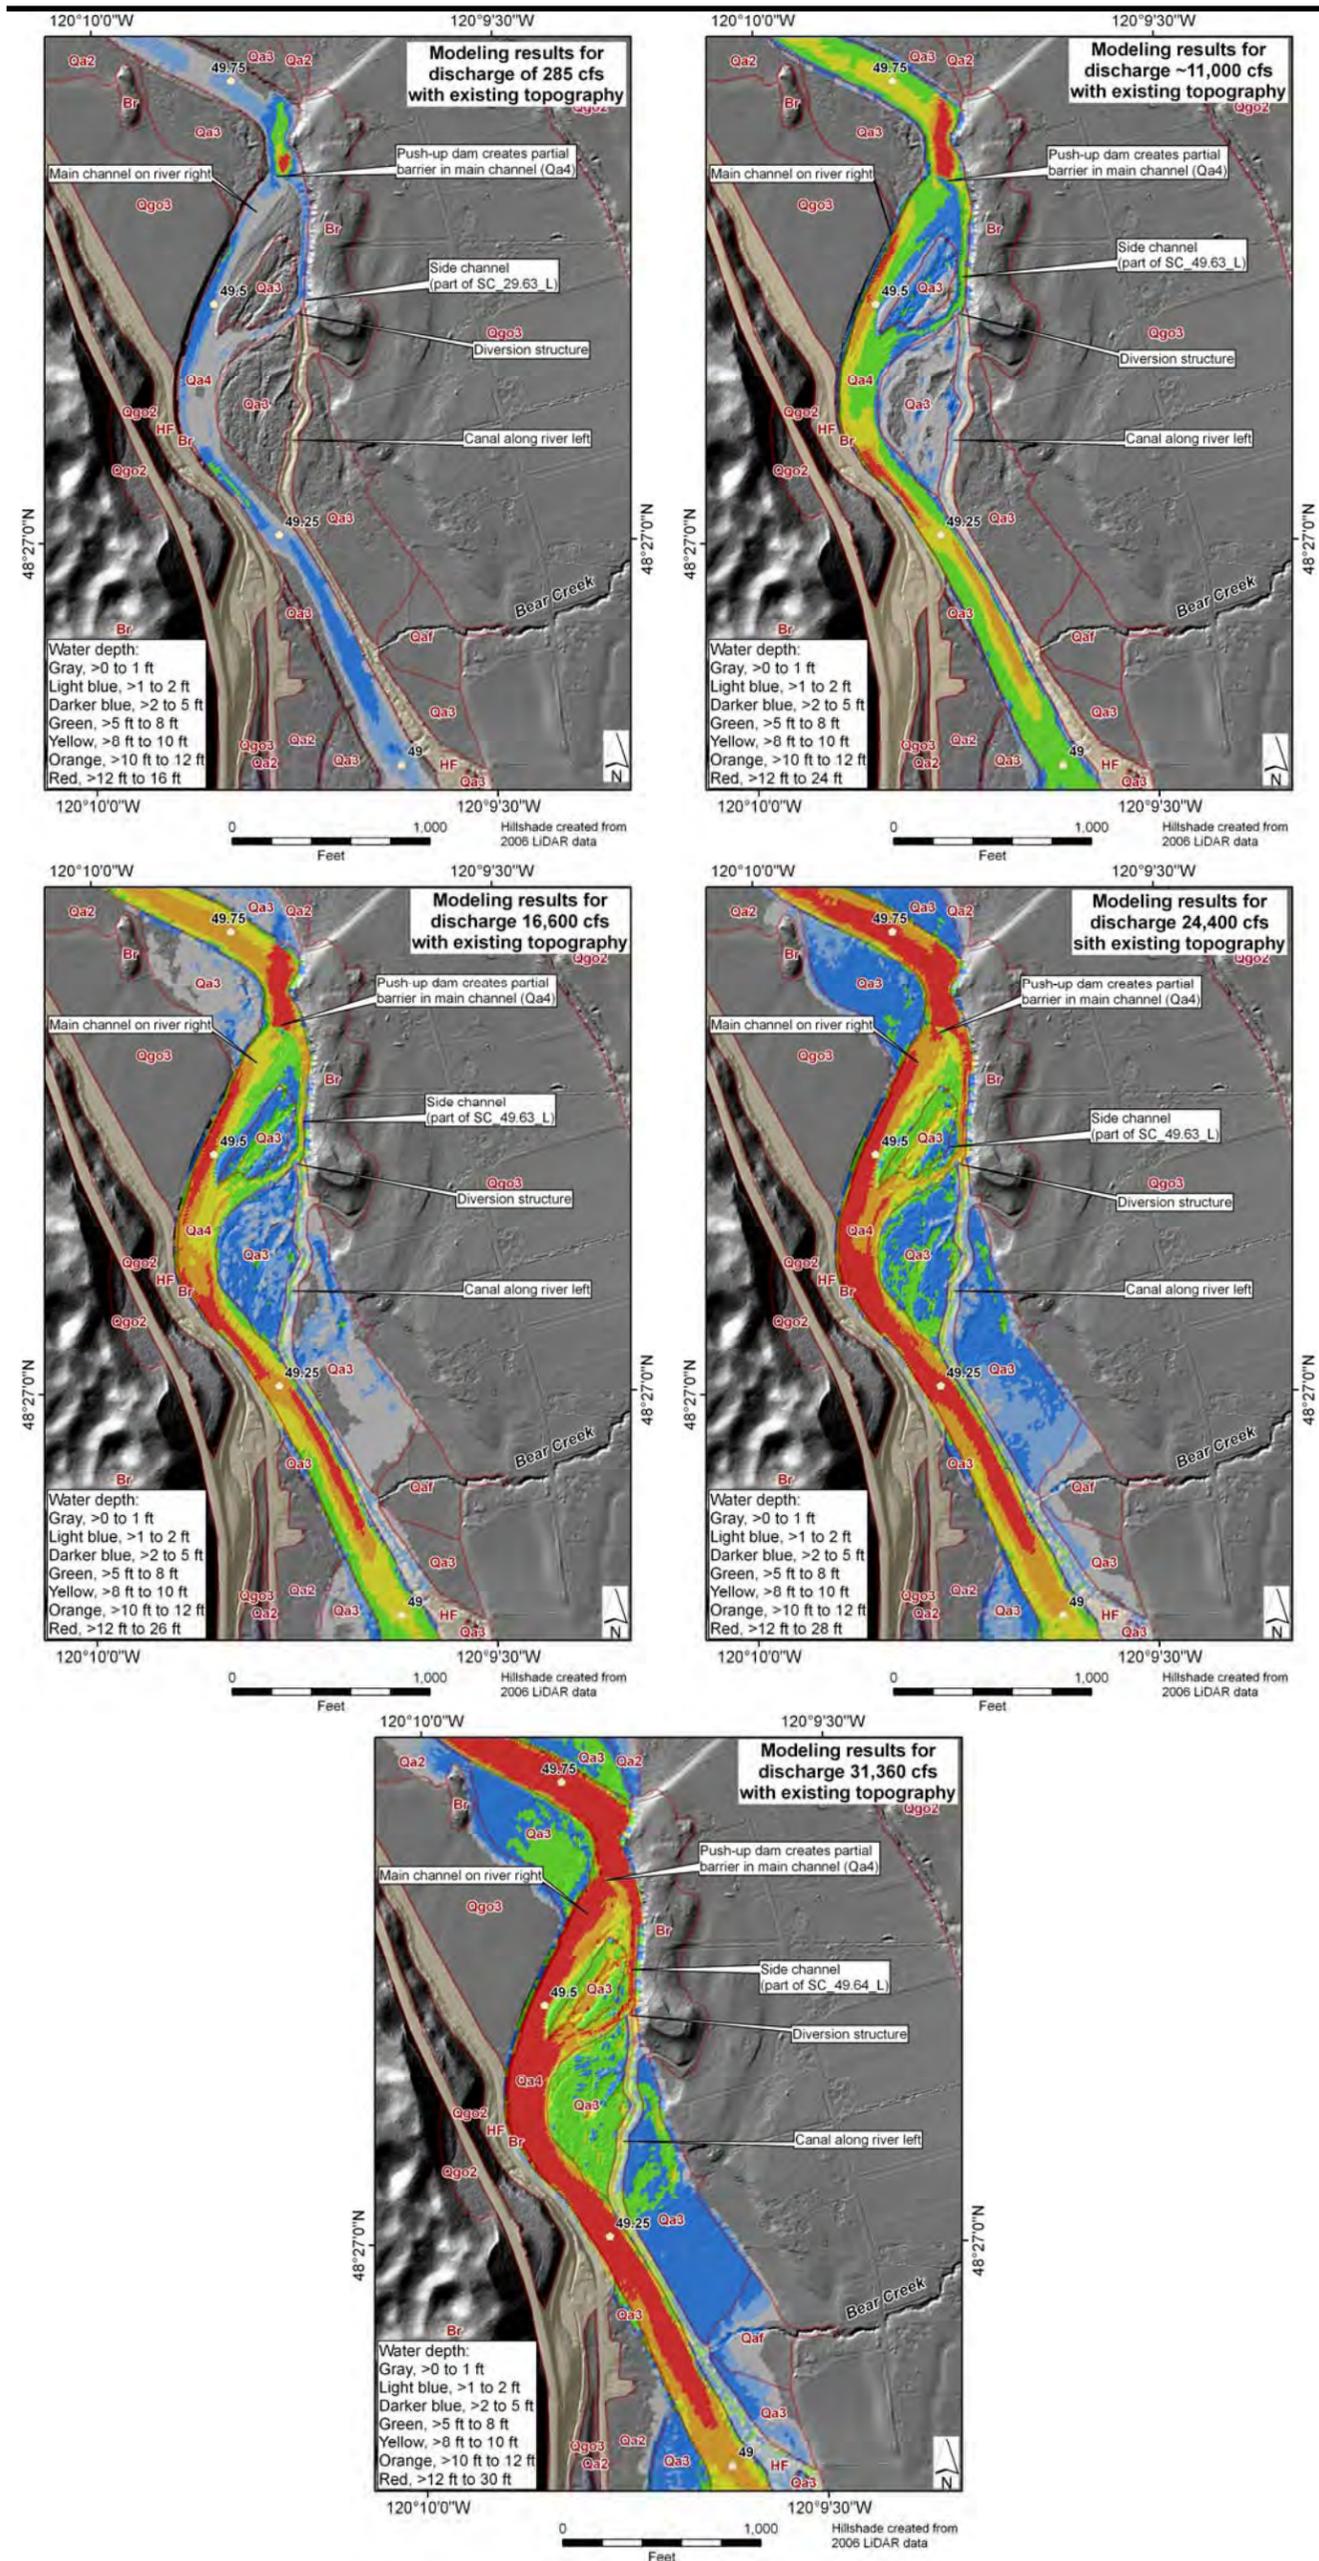
Figure 5. Five modeled flows in the Barclay-Bear Creek area.

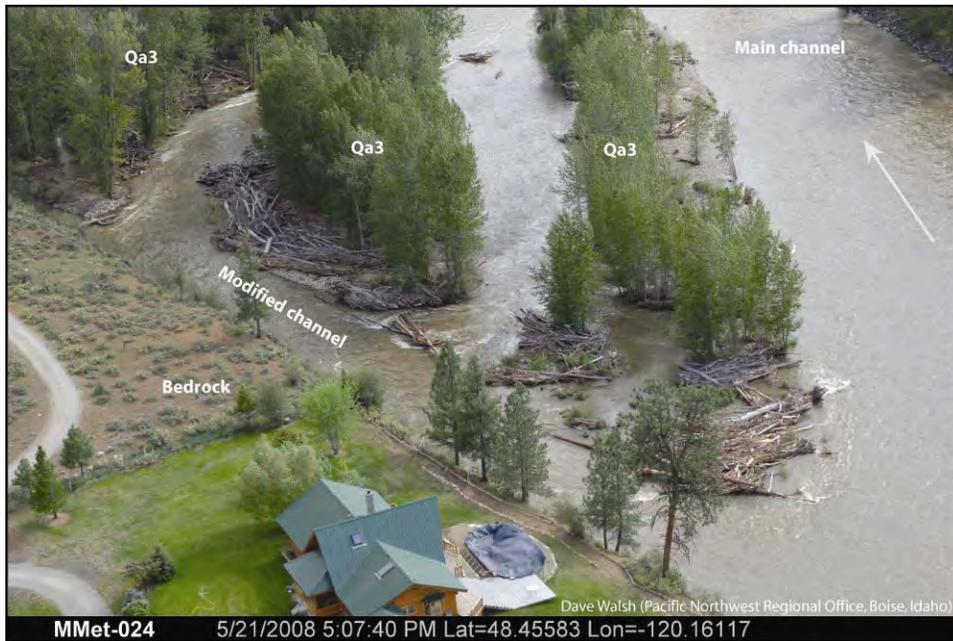
Figure 6. Upstream end of the Barclay-Bear Creek area looking downstream 2 days after the peak of the May 2008 flood.

Discharge at the time the photograph was taken was about 11,000 cfs. The photograph shows the activation of the left side channel (at left side of photograph) and the side channel through the Qa3 island (in center of photograph). Main channel is on the right.

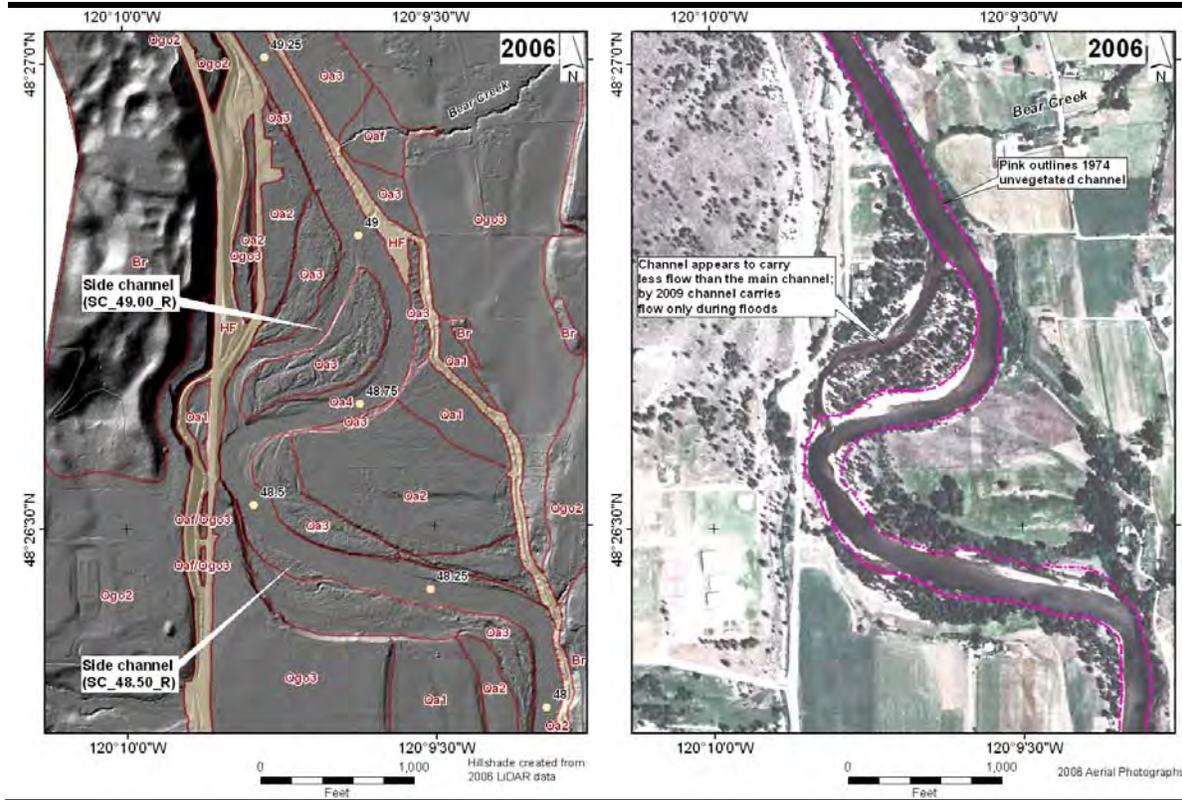
Figure 7. Geomorphic units, human features, and side channel in the Bird island area.
On the left is a hillshade created from 2006 LiDAR data. On the right is an aerial photograph taken in 2006.
