Technical Report No. SRH-2009-42

Geomorphology and Hydraulic Modeling for the Middle Methow River from Winthrop to Twisp

U.S. Department of the Interior
Bureau of Reclamation
Technical Service Center
Denver, Colorado

January 2010

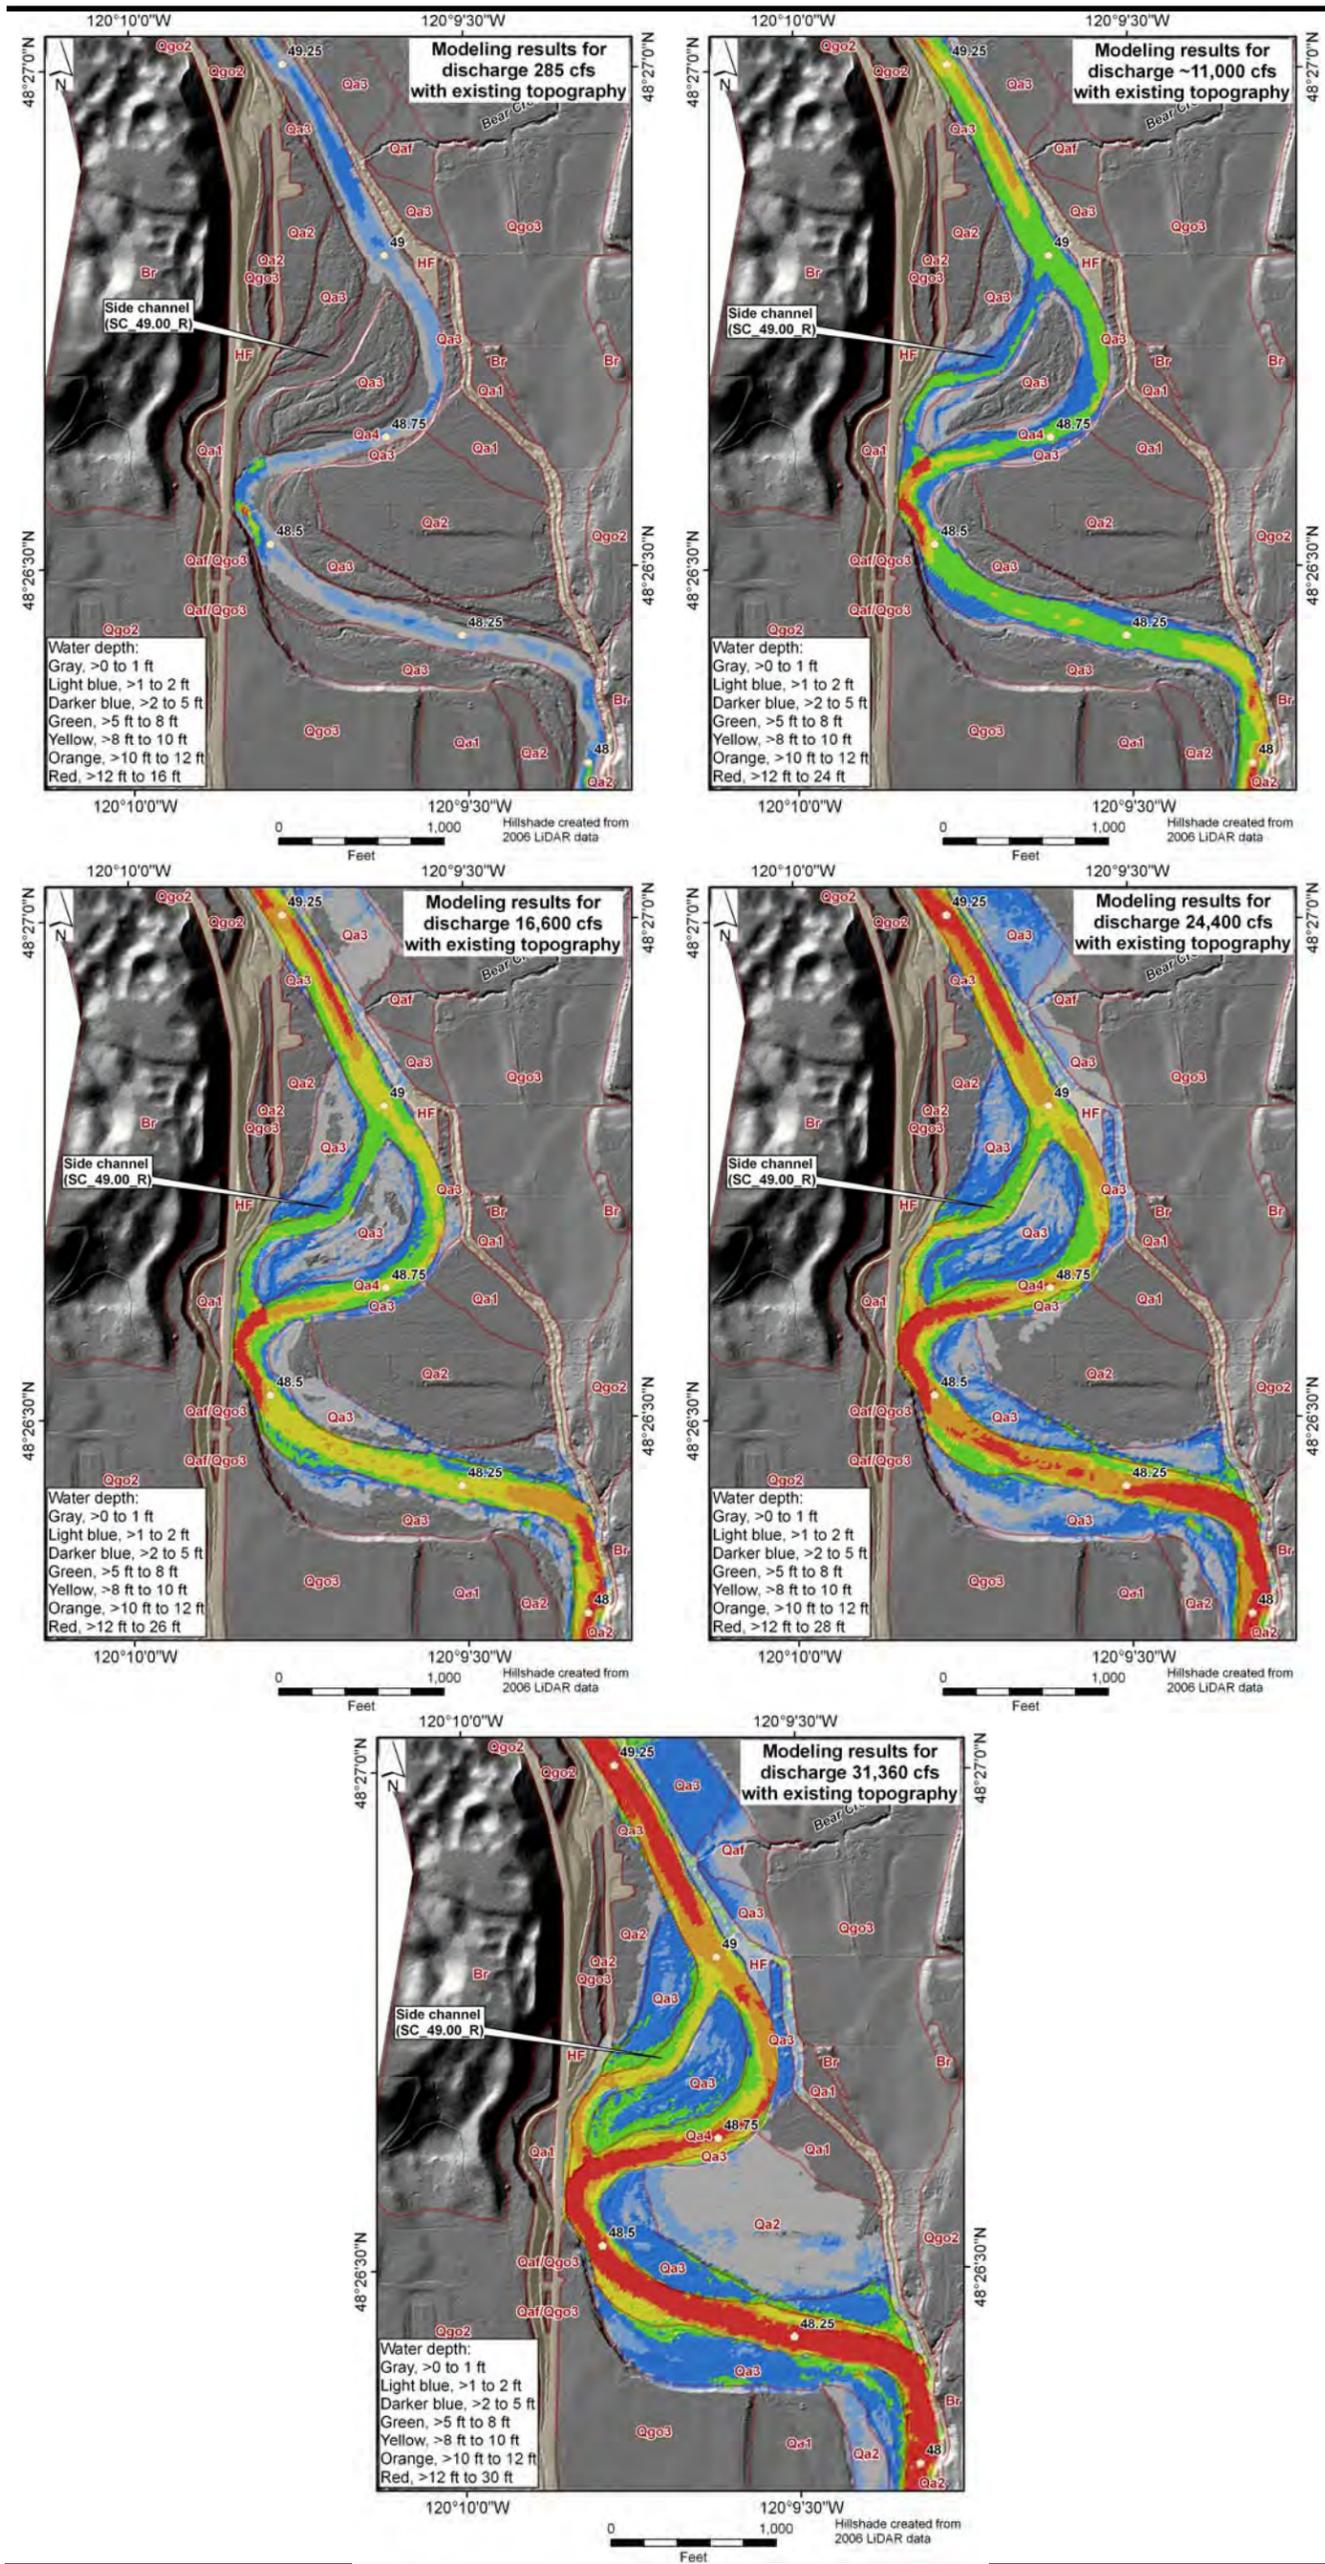
Figure 9. Five modeled flows for the Bird island area
 All model runs were done with existing topography. The active floodplain areas (Qa3) have increasingly deeper water, and the higher floodplain (Qa2) has shallow flow in a flood the size of the 1948 flood.

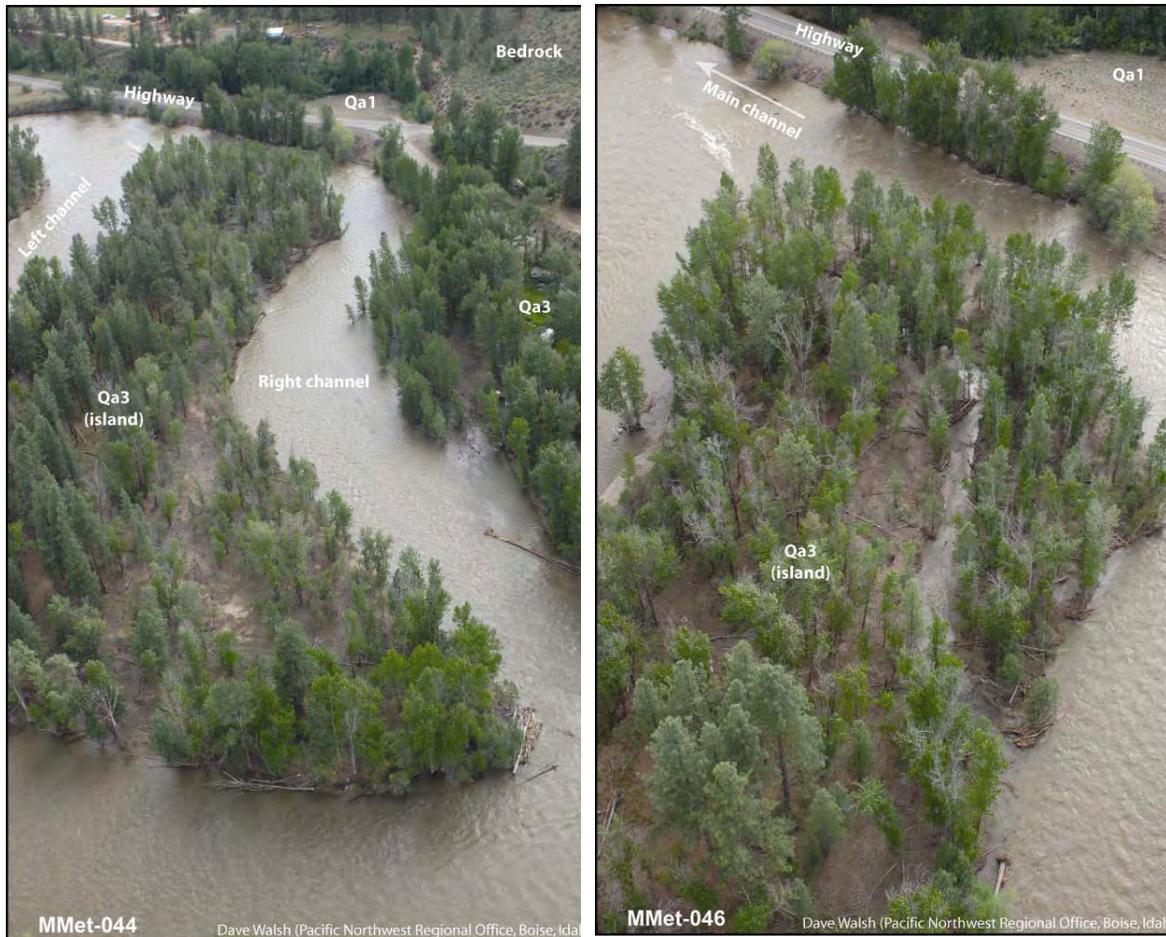
Figure 10. Bird island two days after the peak of the May 2008 flood looking downstream.
Discharge at the time of these photographs was approximately 11,000 cfs.

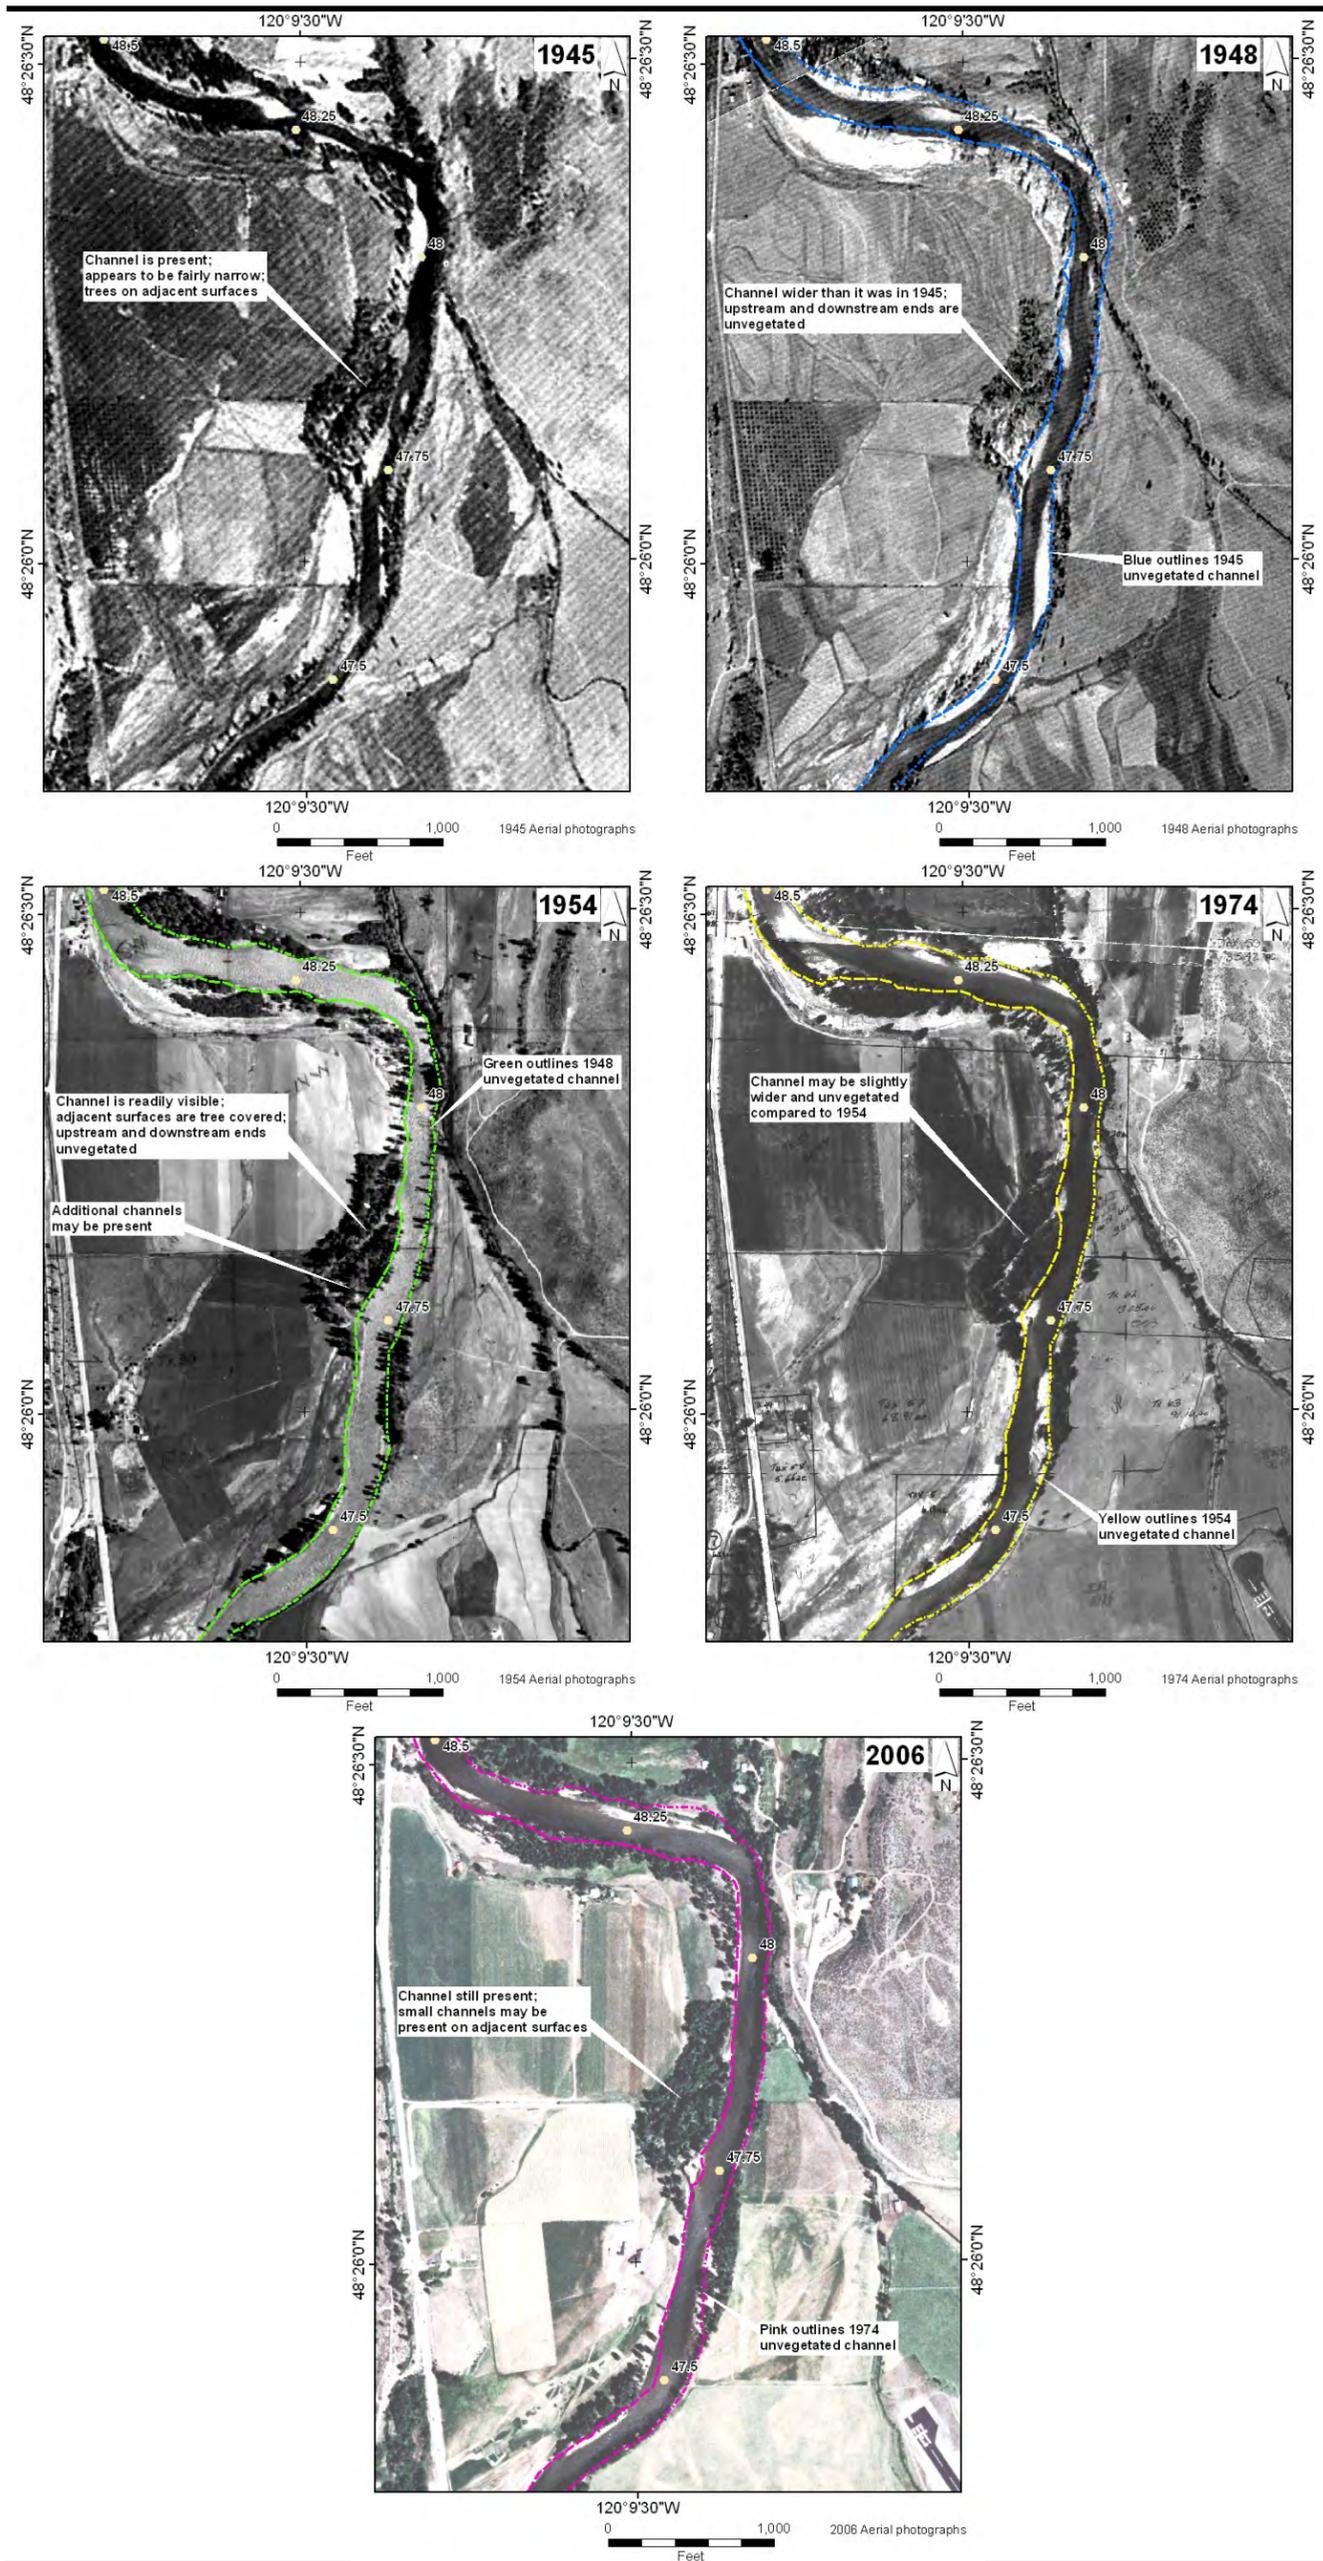
Figure 12. Sequence of historical aerial photographs for the Pigott area between 1945 and 2006. The channel was present in 1945 and bounded by tree-covered active floodplain surfaces (Qa3)

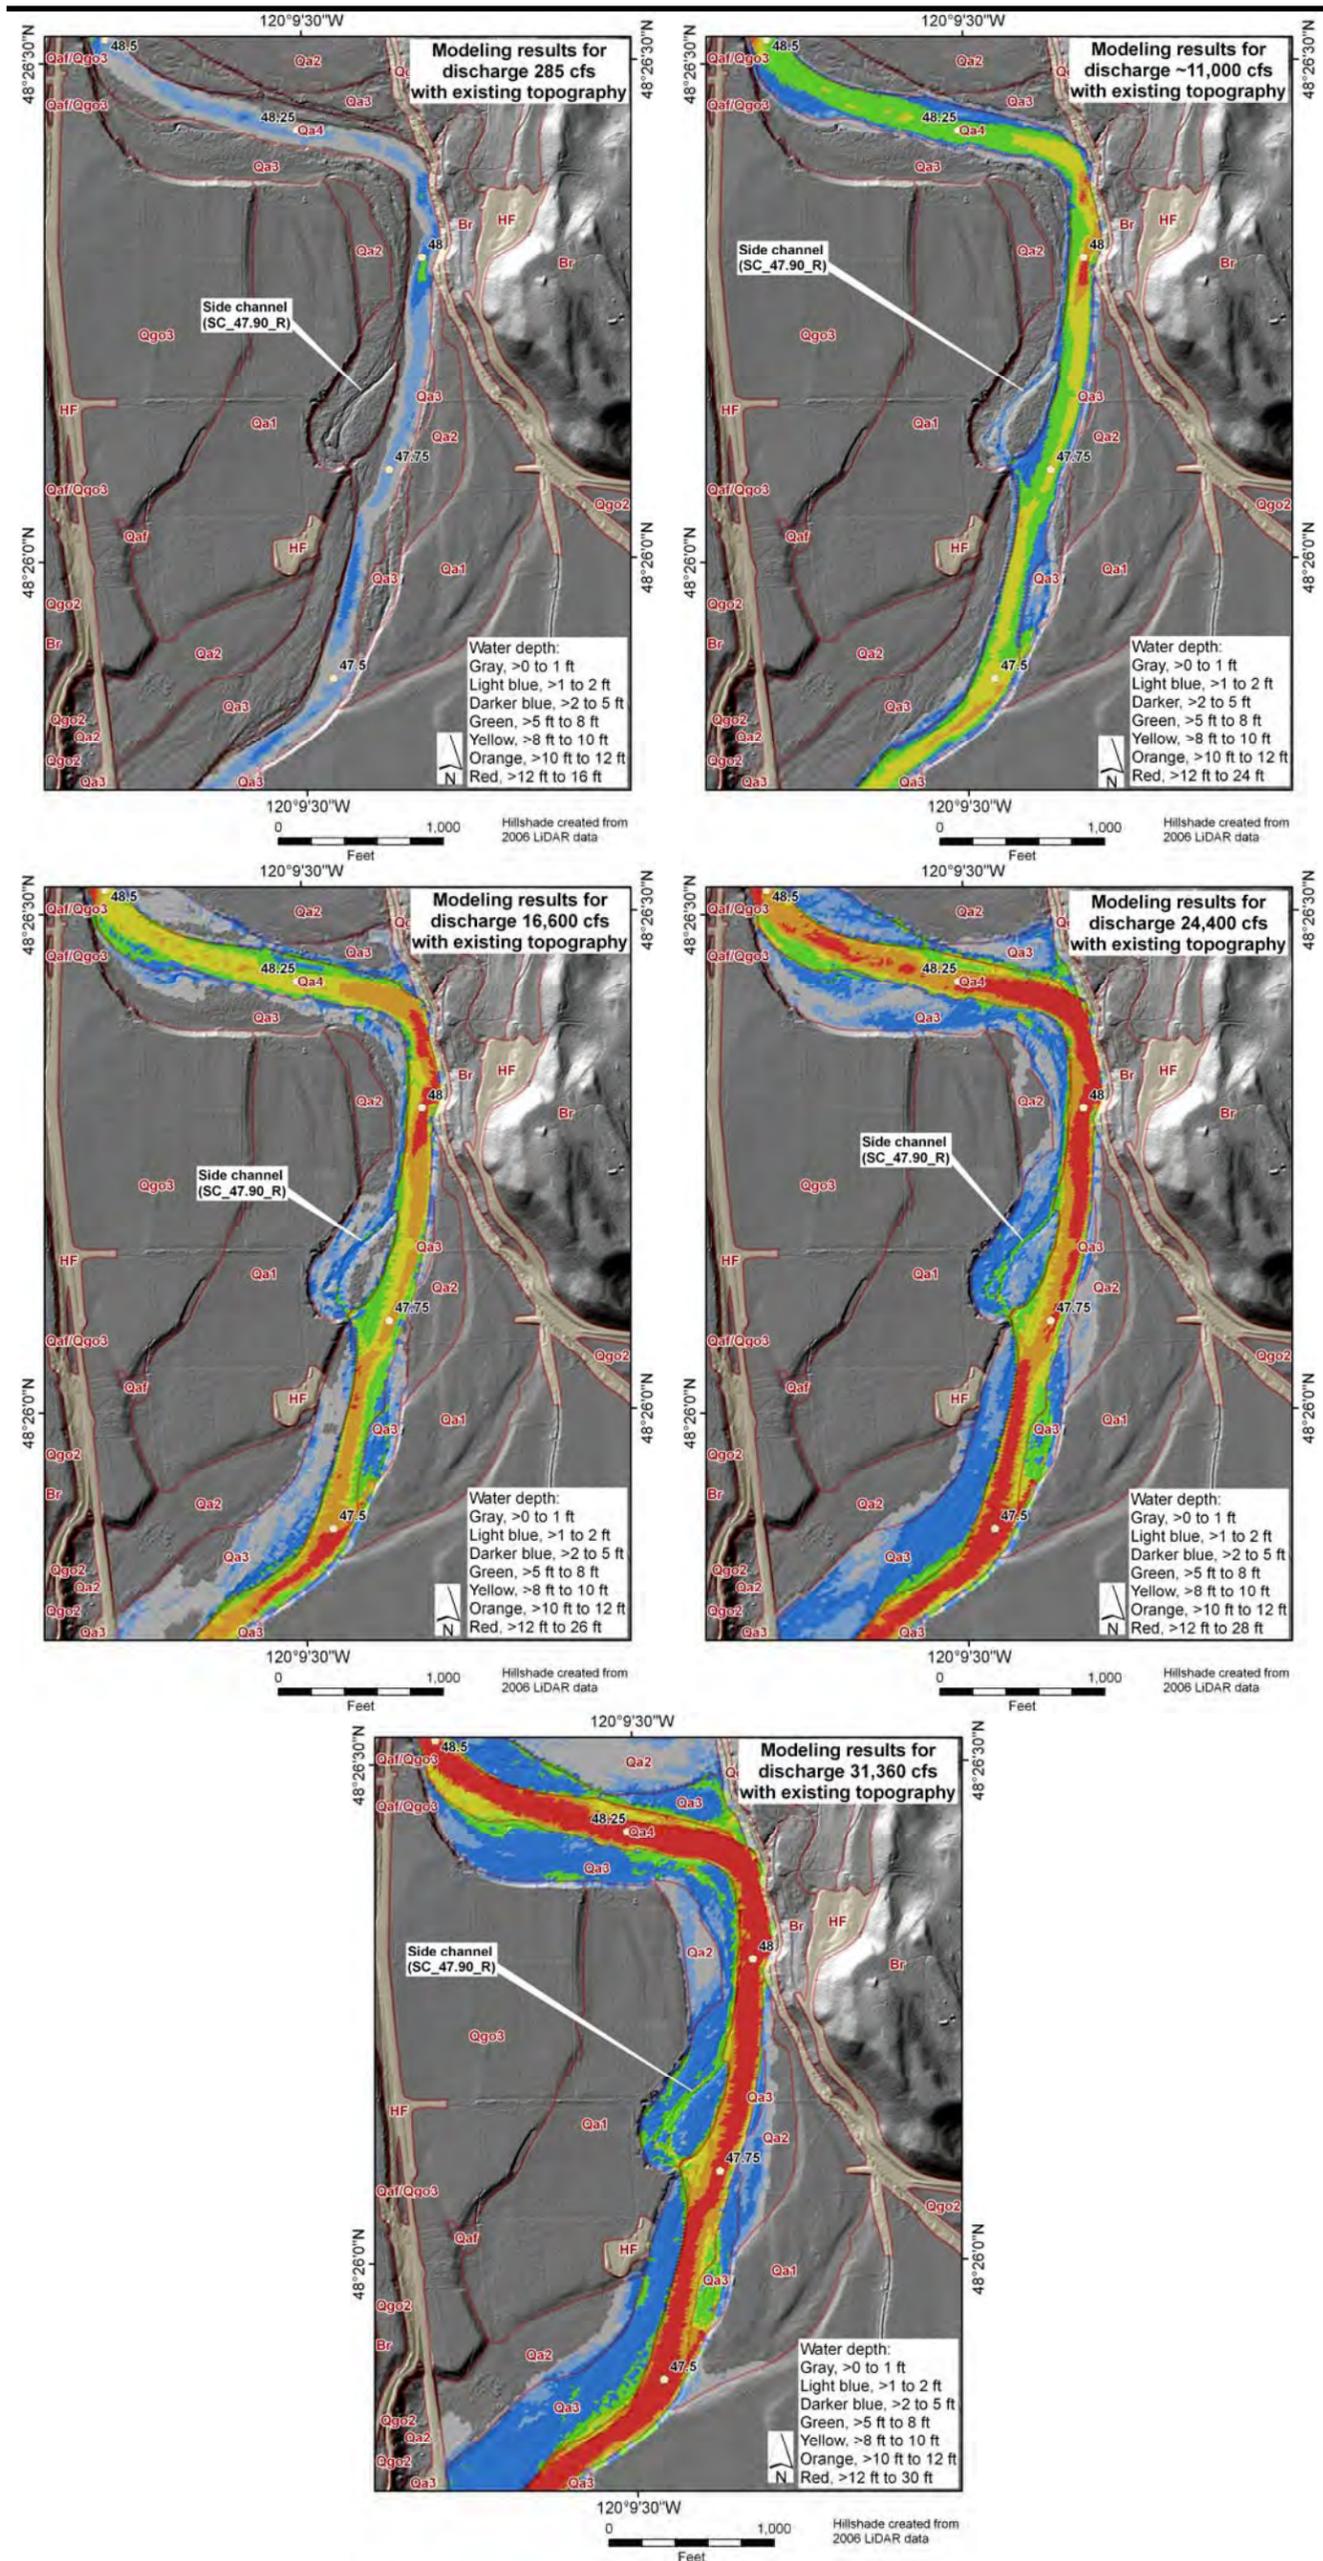
Figure 13. Five modeled flows for the Pigott area.

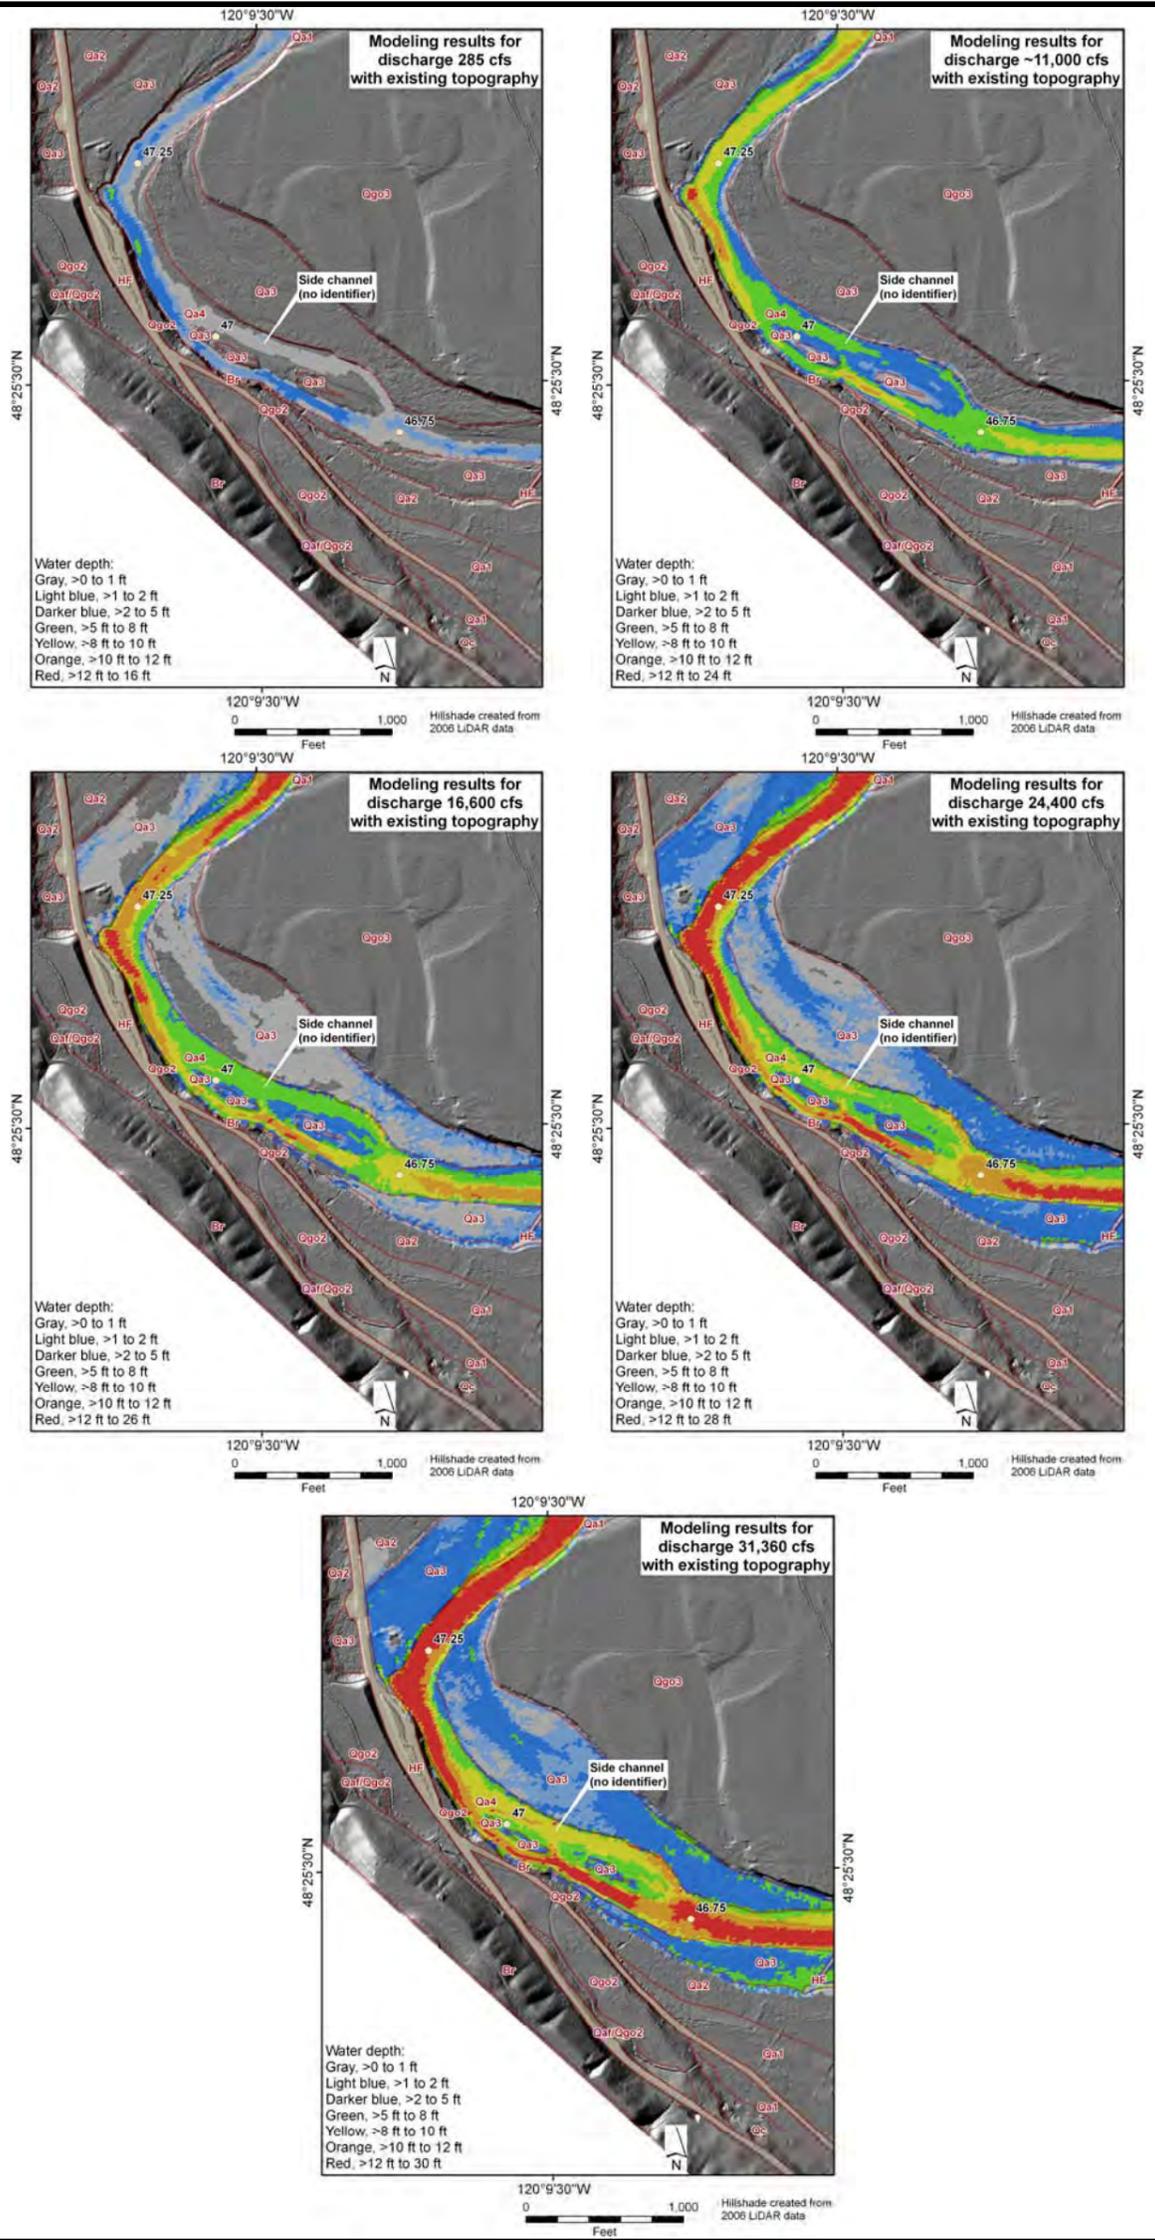
Figure 16. Five modeled flows for the side channel near RM 47.

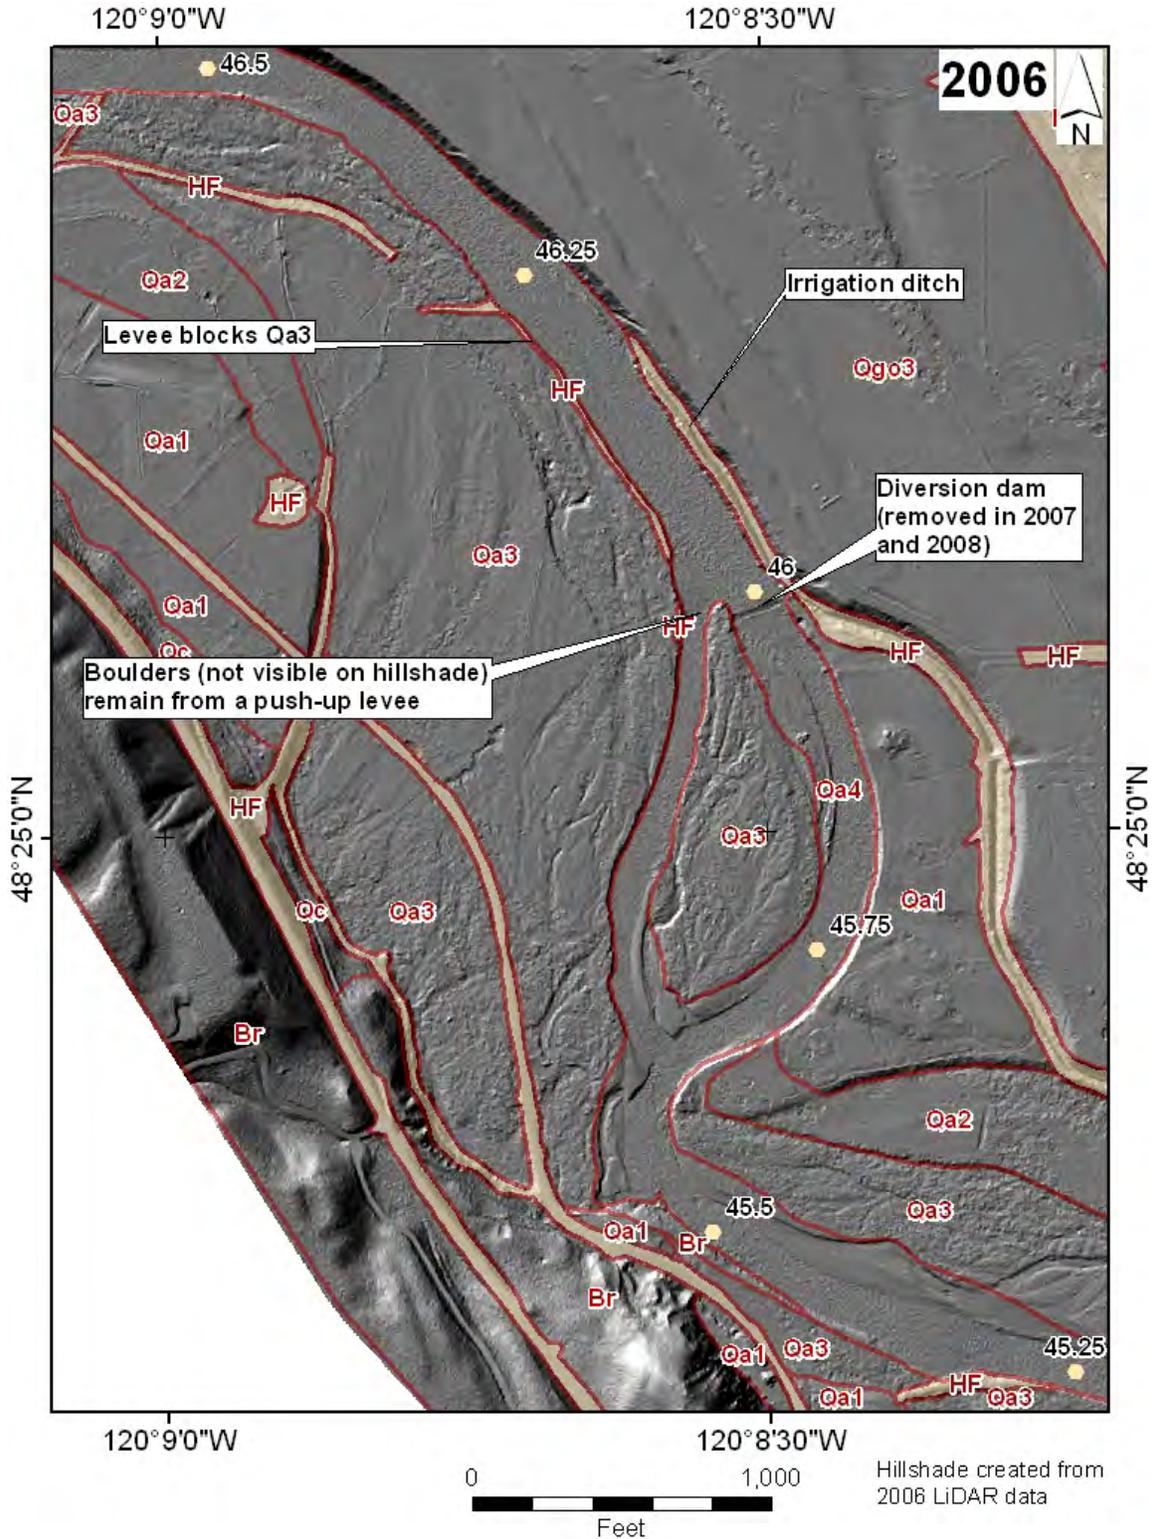
Figure 17. Geomorphologic units, human features, and side channel in the MVID East area shown on 2006 LiDAR hillshade.

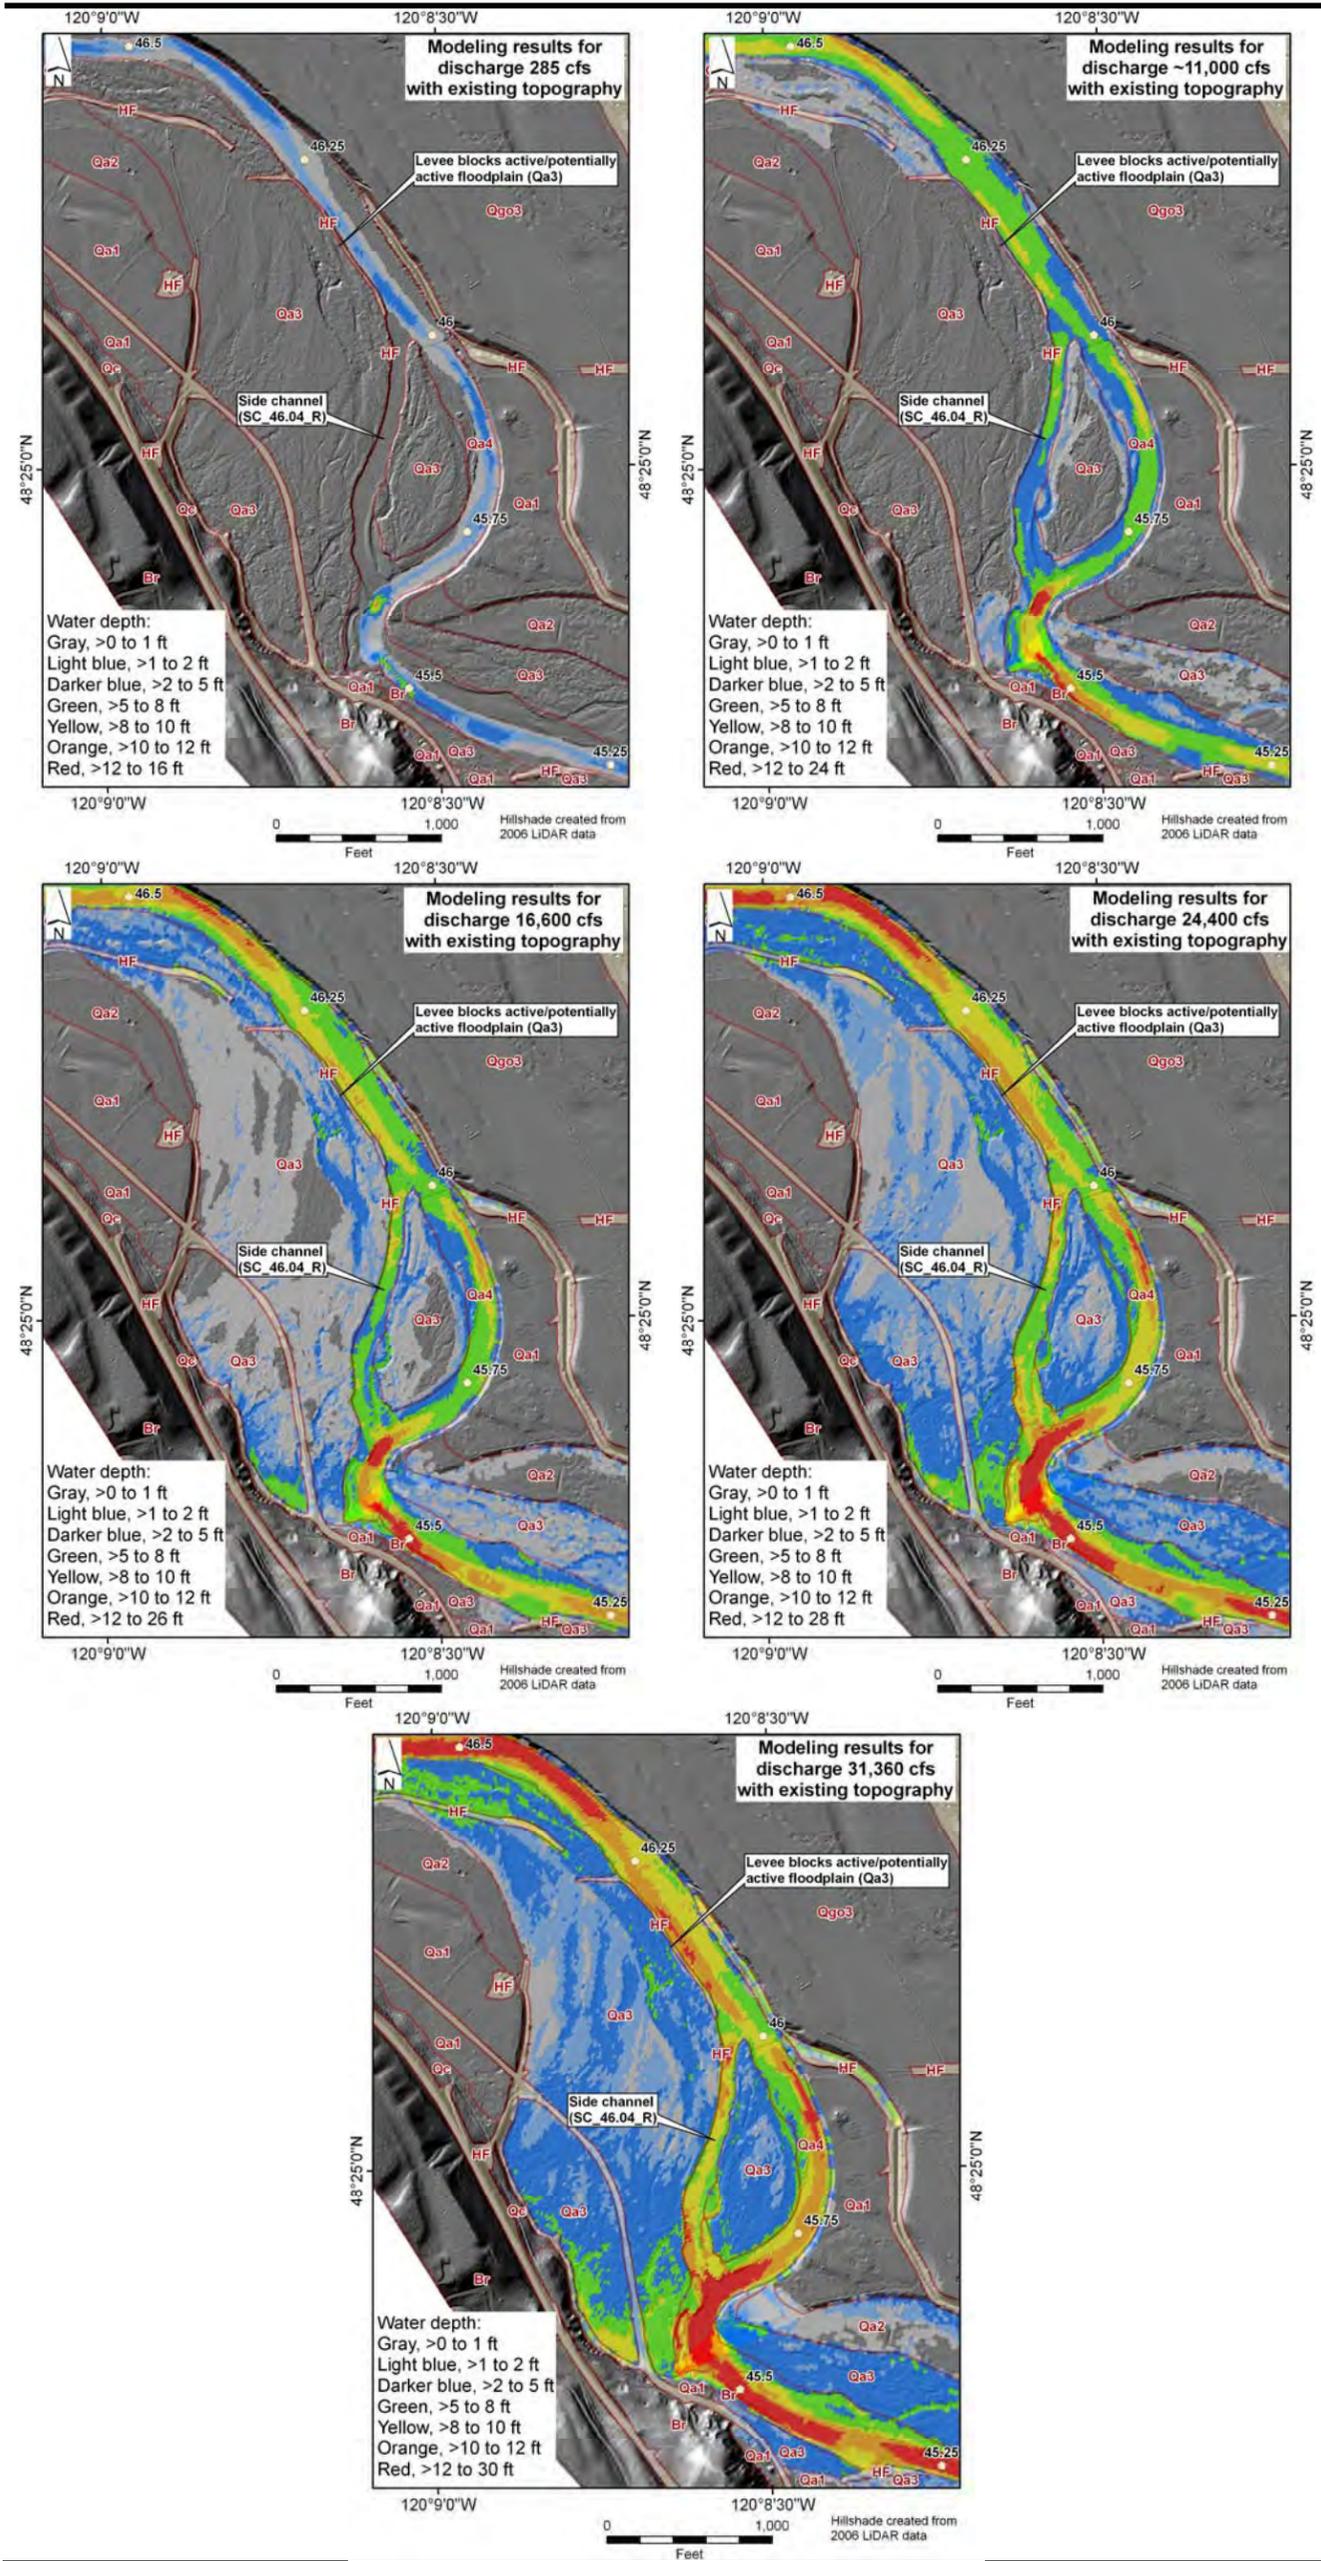
Figure 19. Five modeled flows for MVID east area.

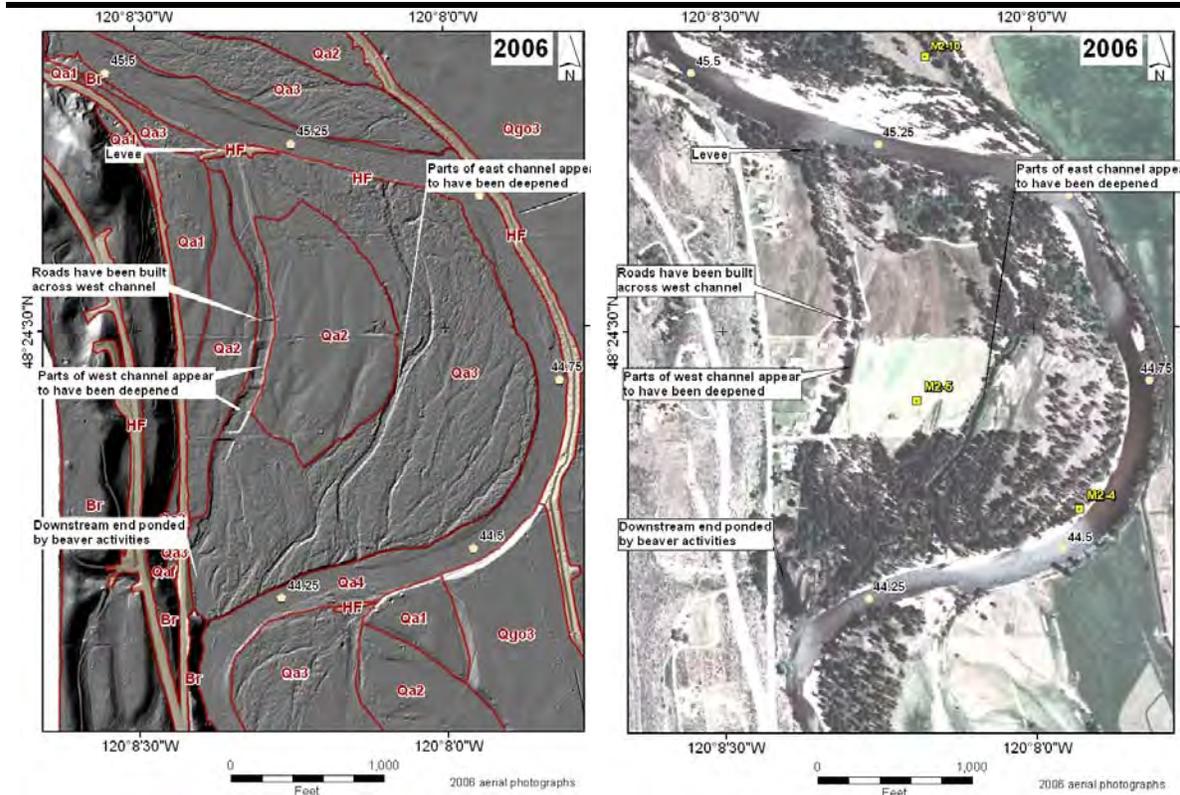
Figure 20. Geomorphic units, human features, and side channels in the Habermehl area shown on 2006 LiDAR data (left) and 2006 aerial photographs (right).
