Technical Report No. SRH-2009-42

Geomorphology and Hydraulic Modeling for the Middle Methow River from Winthrop to Twisp

U.S. Department of the Interior
Bureau of Reclamation
Technical Service Center
Denver, Colorado

January 2010

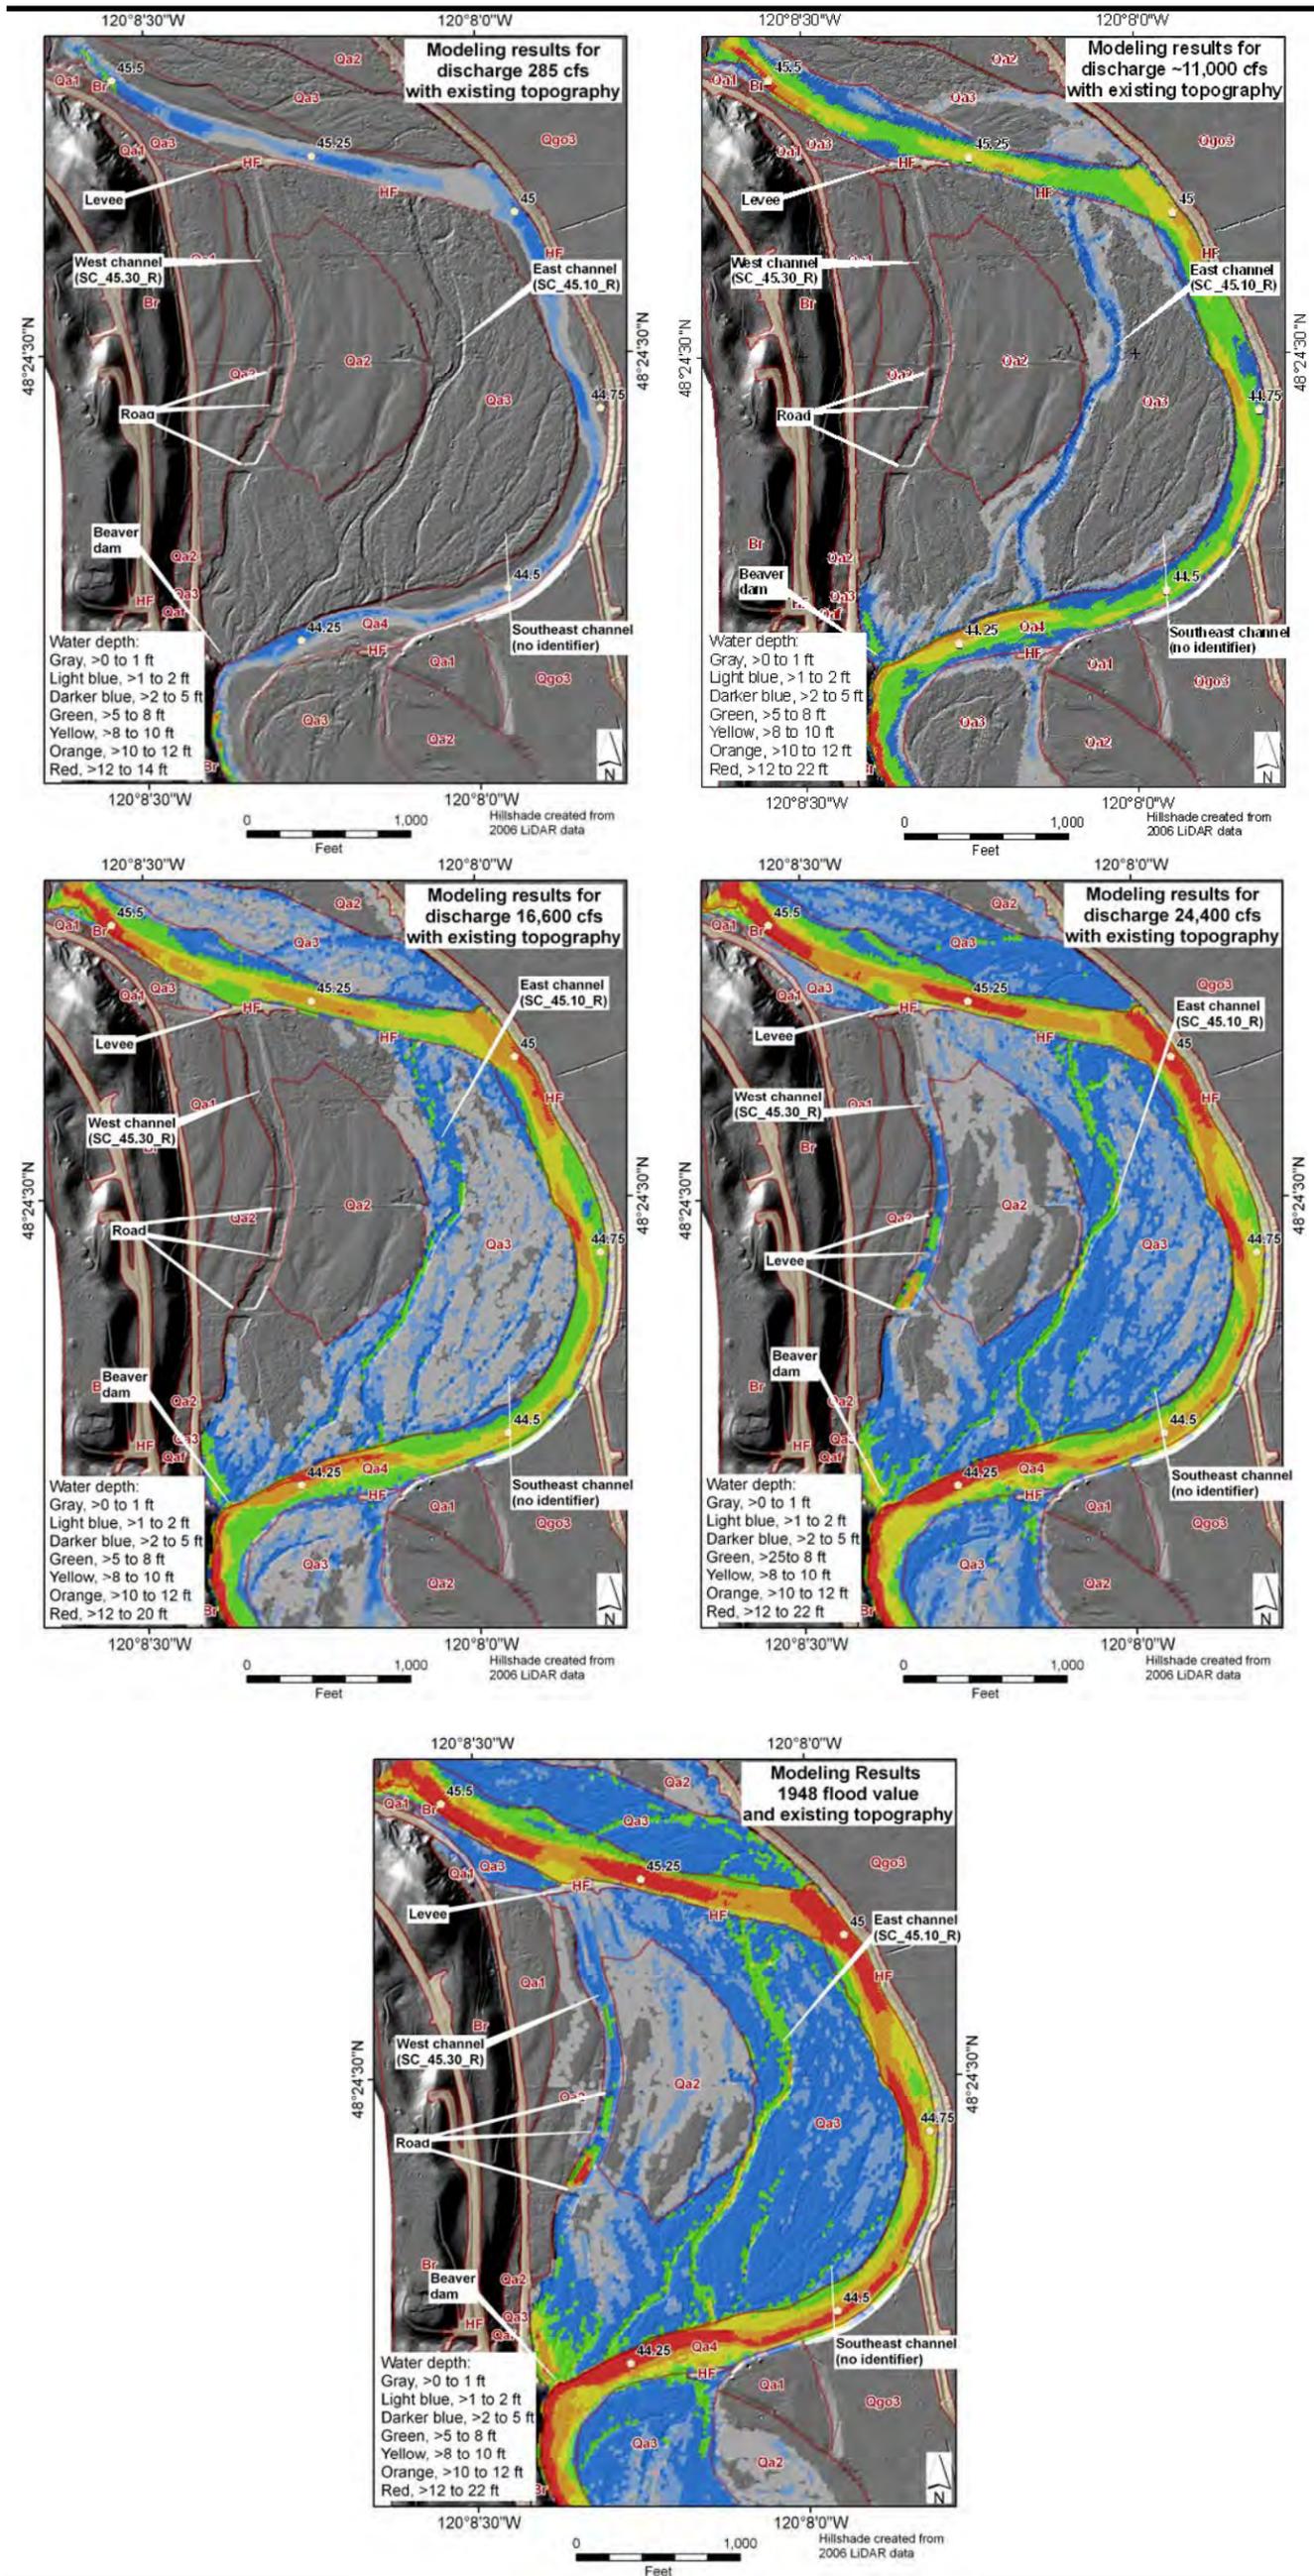
Figure 22. Five modeled flows for the Habermehl area.

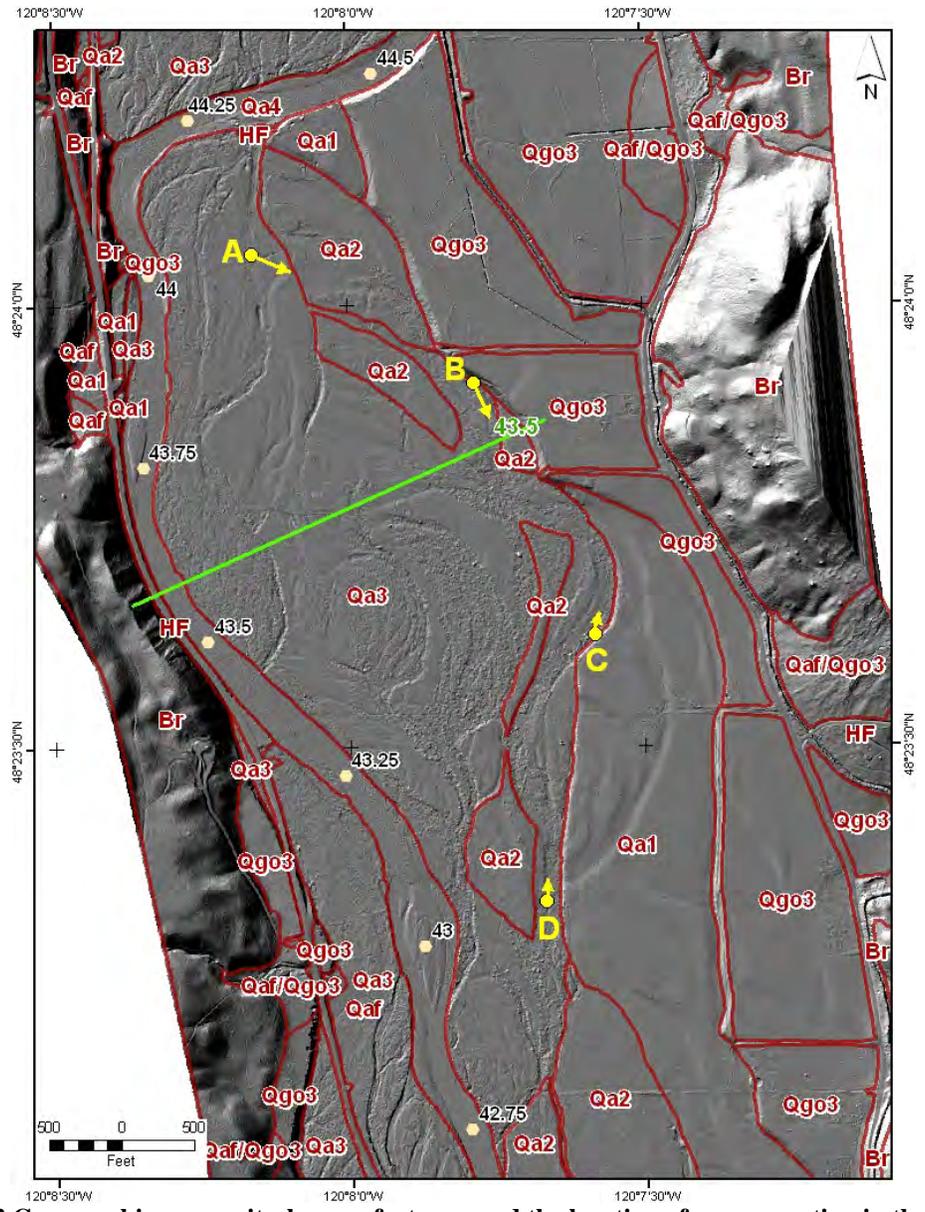
Figure 23 Geomorphic map units, human features, and the location of a cross section in the Lehman area.

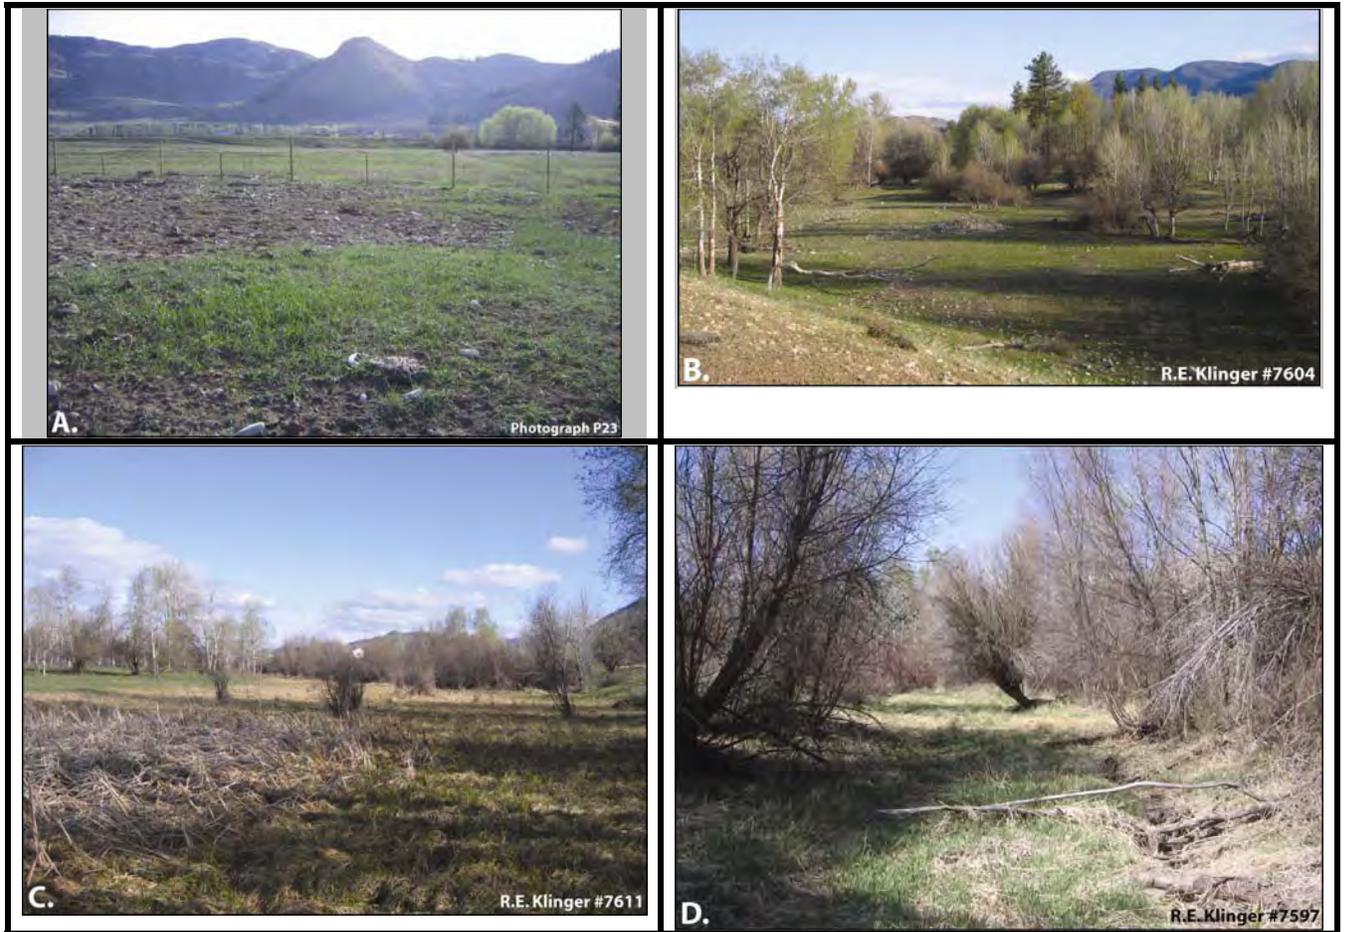
Figure 24. Examples of Qa3 and relict channel in the Lehman area.

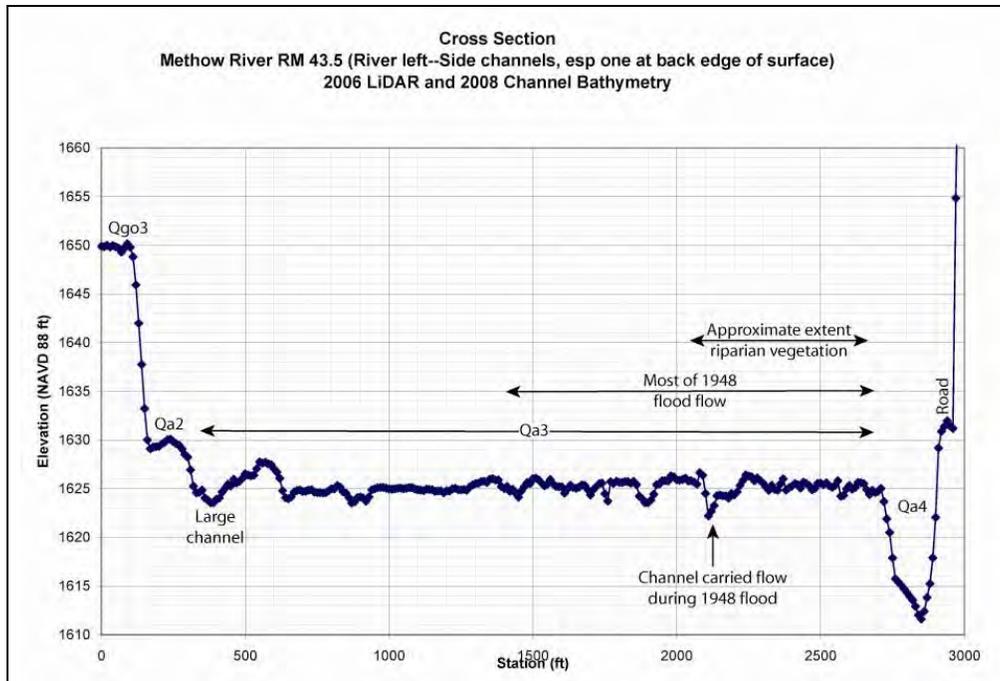
Figure 26. Topographic cross section across the Lehman area near RM 43.5 looking downstream.

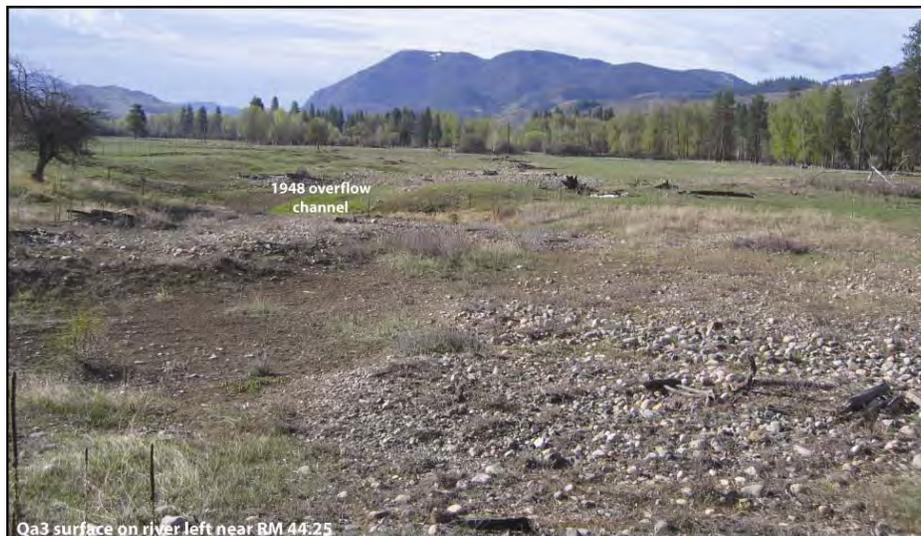
Figure 27. Qa3 surface looking downstream from the upstream end of the Lehman area near RM 44.25.

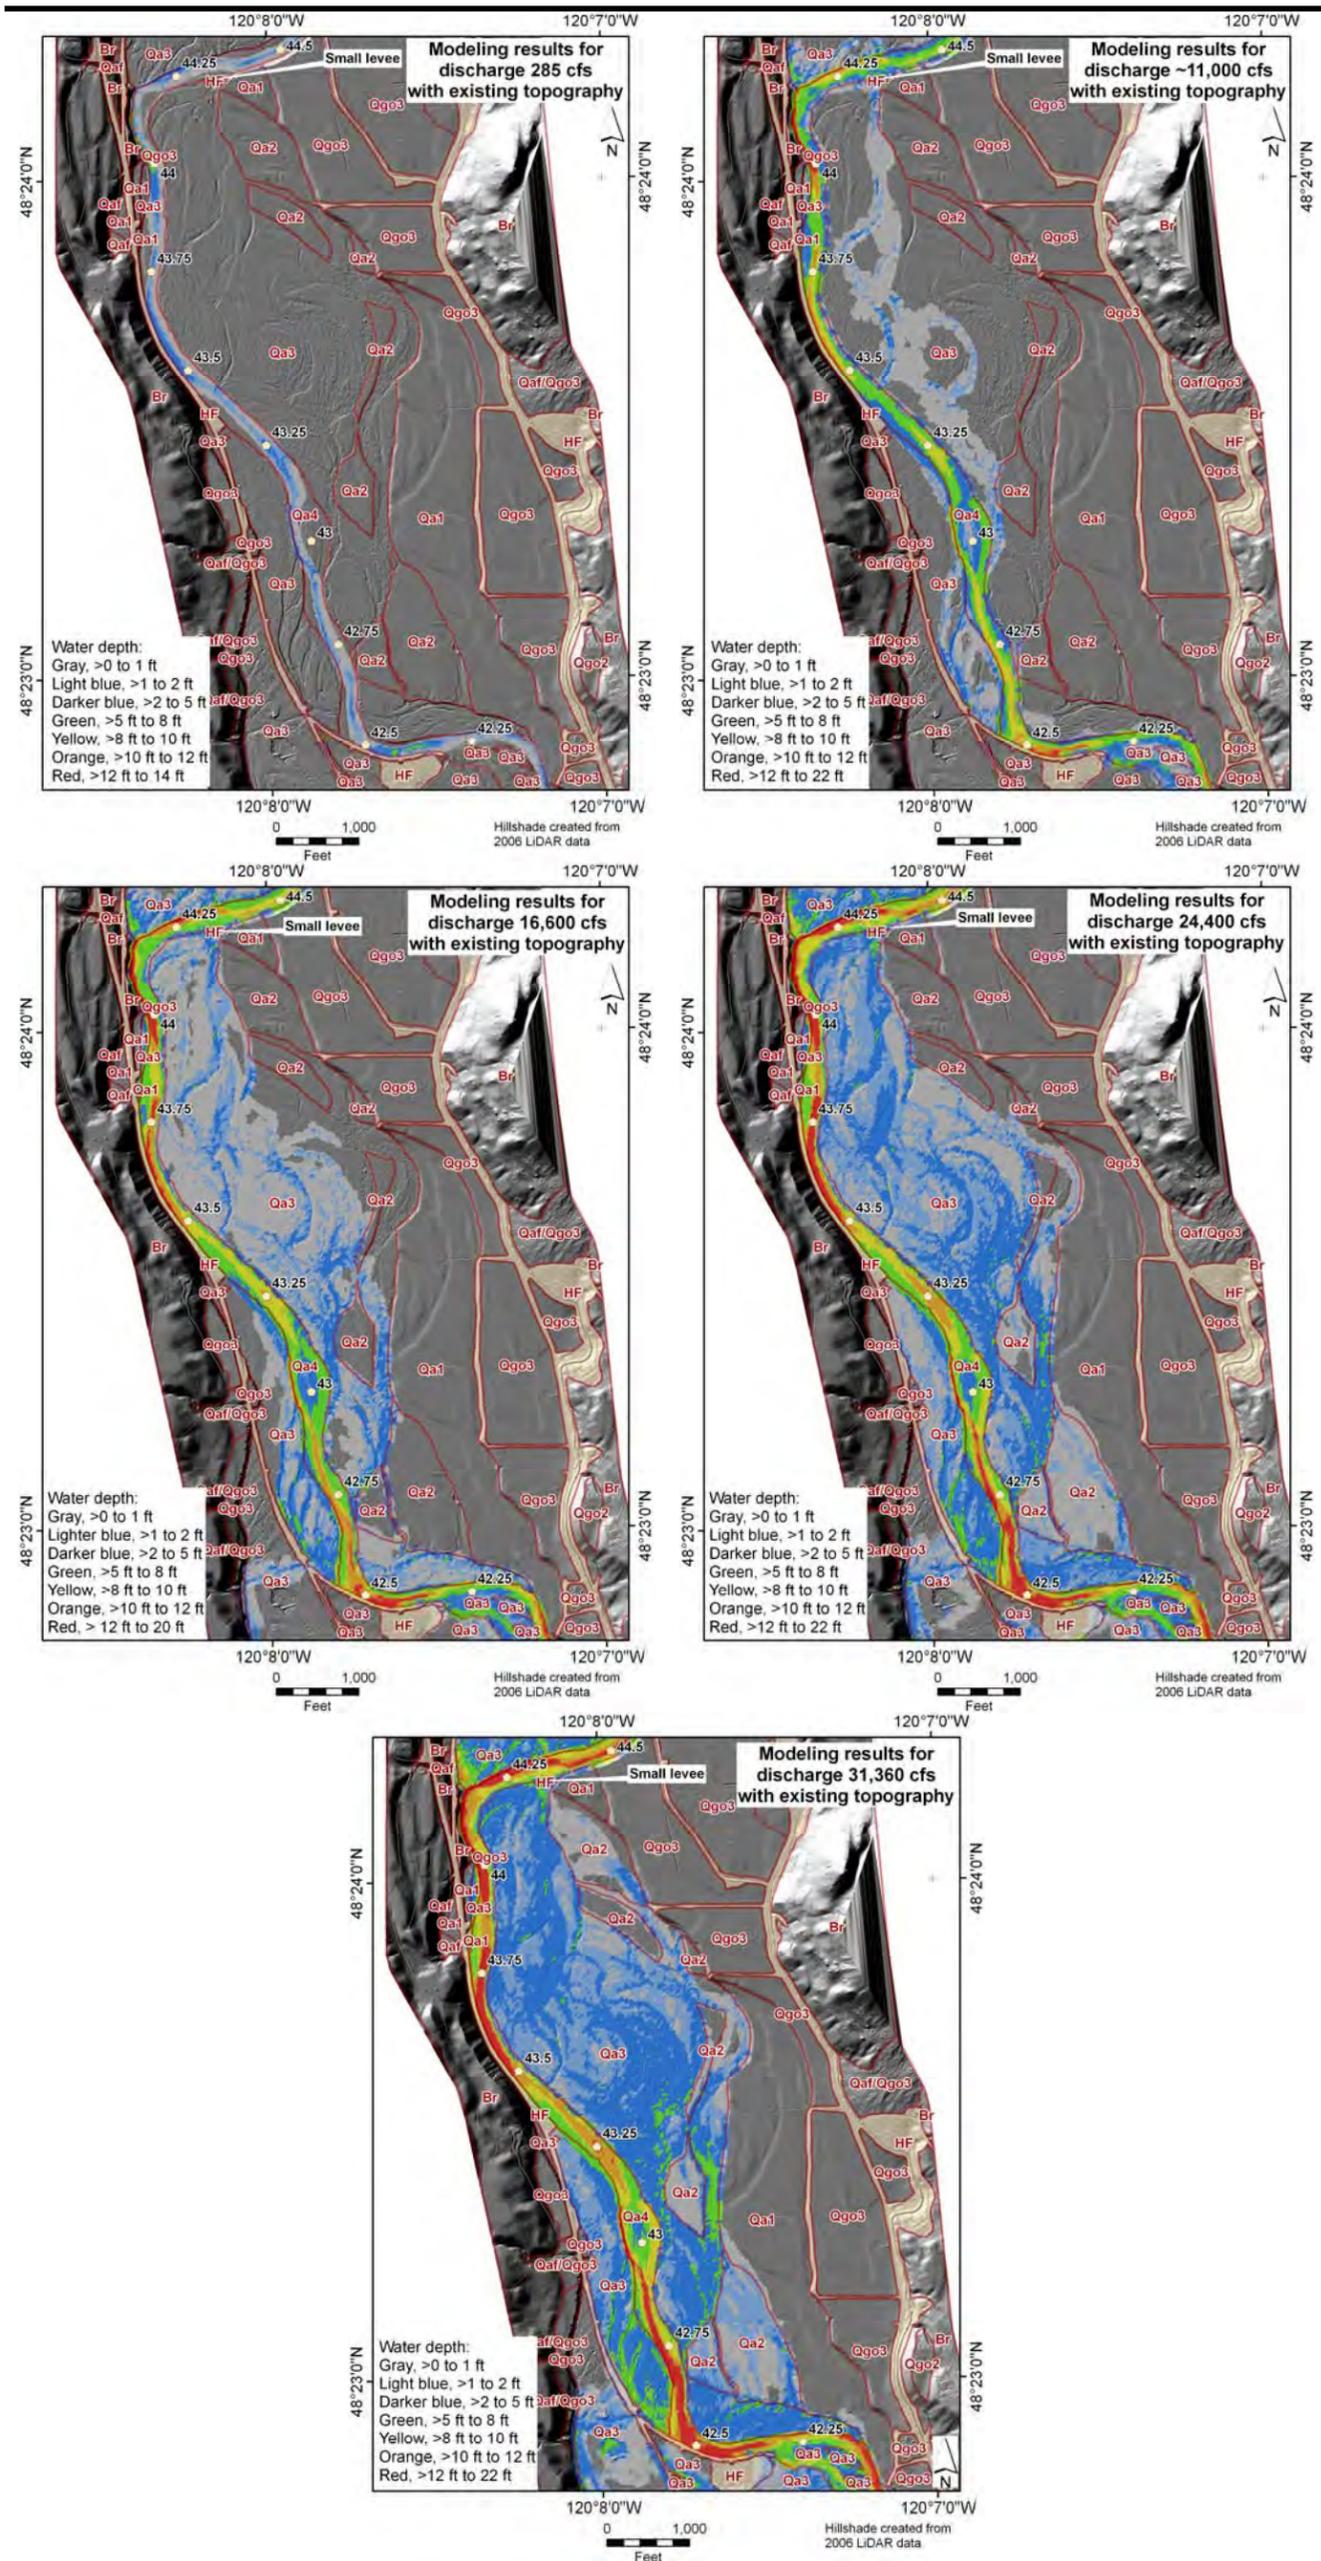
Figure 28. Five modeled flows for the Lehman area.

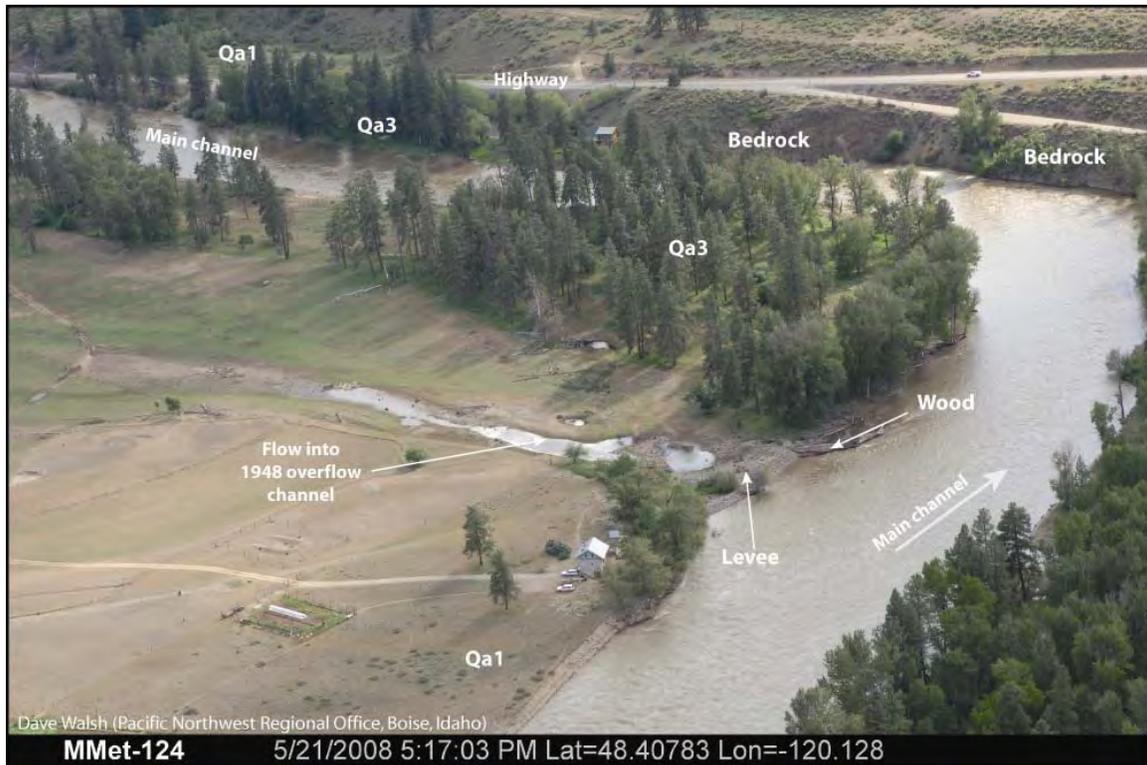
Figure 29. Upstream end of Lehman area two days after the May 2008 flood. Discharge at the time this photograph was taken is about 11,000 cfs (2-year flood). View is looking downstream. Levee was overtopped in this flood, and flow went into a channel that was active during the 1948 flood.

Side channels on Qa3 within about 1,500 feet of the main channel were inundated during the 1948 flood. Model results indicate that a levee now at the upstream end of this area impedes surface-water connection in the side channels and a portion of the Qa3 floodplain up through at least a discharge of 24,400 cfs (Figure 28). Model results show high velocity and shear stress values for flood flows along the downstream end of the levee. Field observations indicate the presence of wood near the downstream end of the levee and several recent localized levee failures where riprap has been placed. These results and observations suggest that there is potential for continued failure of the levee

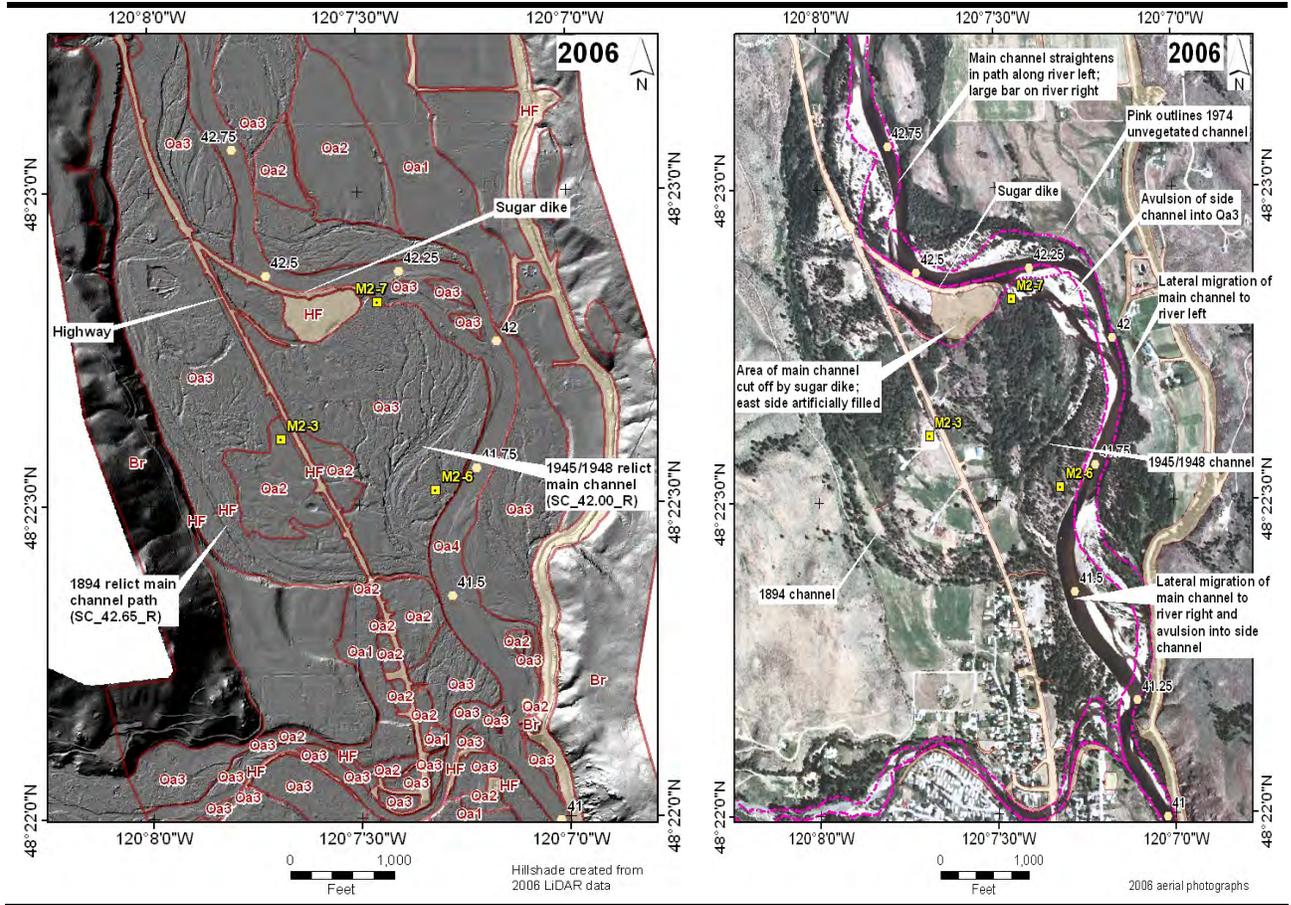
Figure 30. Geomorphic units, human features, and side channels in the sugar dike-Twisp area

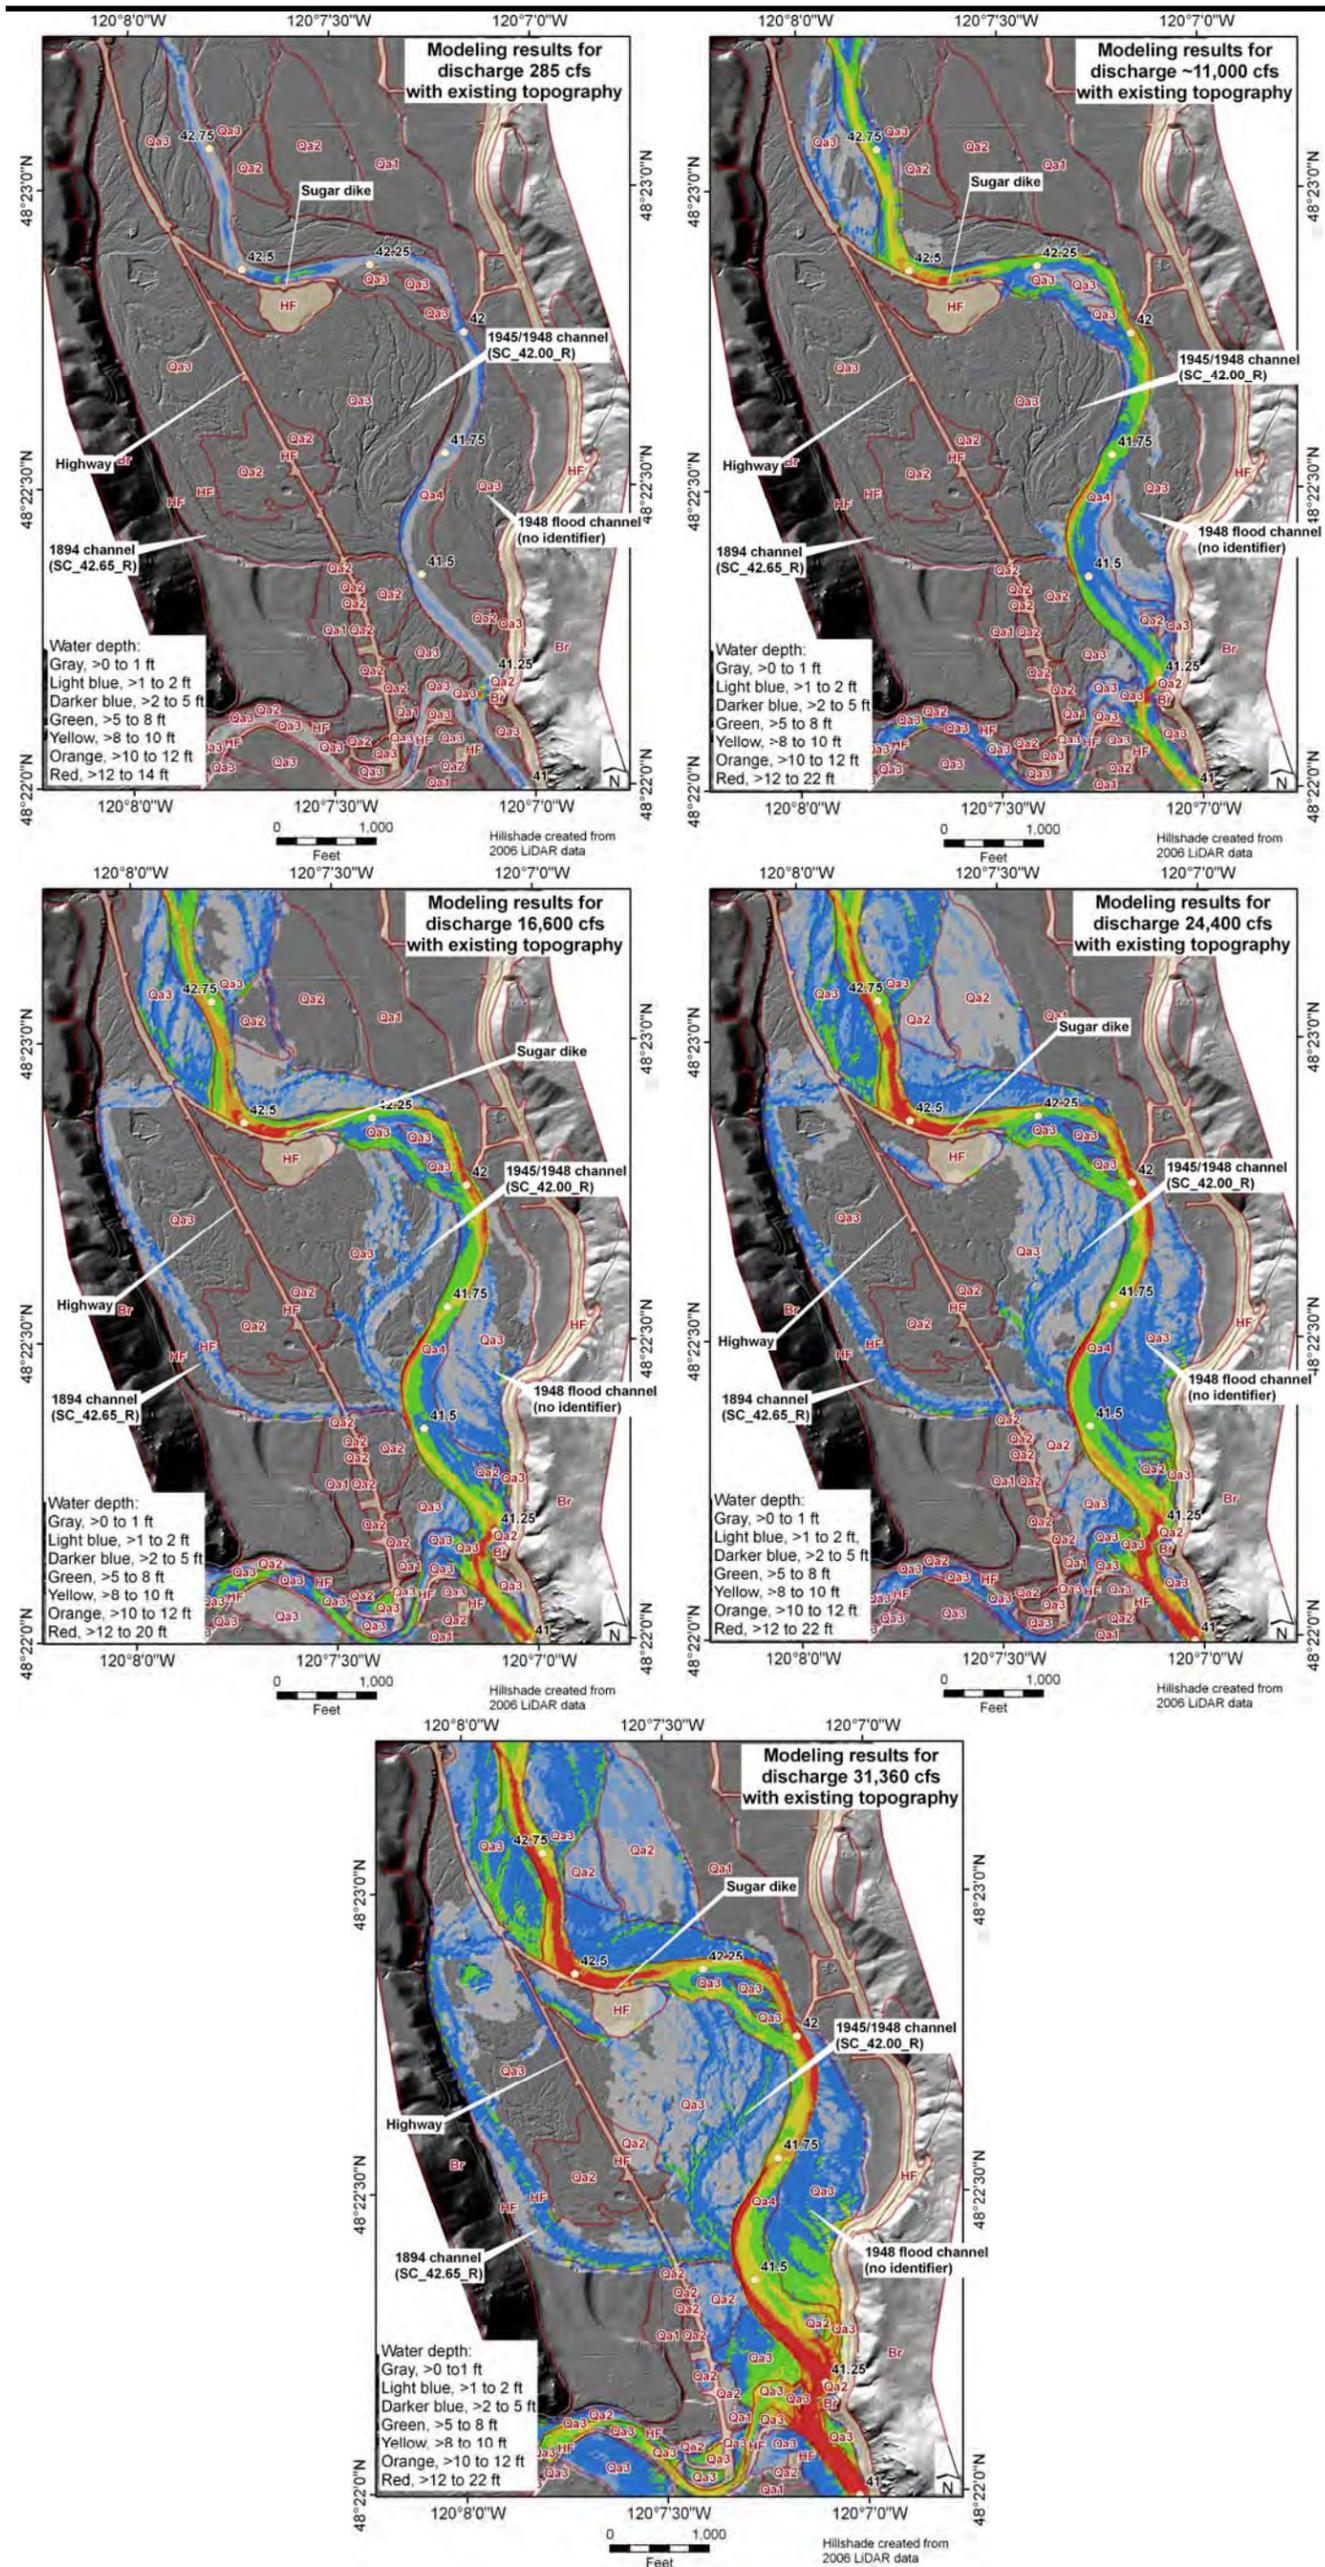
Figure 32. Five model results for the sugar dike-Twisp area.
