APPENDICES

Reach-based Ecosystem Indicators (REI) Version 1.1

MIDDLE METHOW RIVER (M2 Reach) HABITAT ASSESSMENT OVERVIEW
River Mile 40.3 to River Mile 52.4

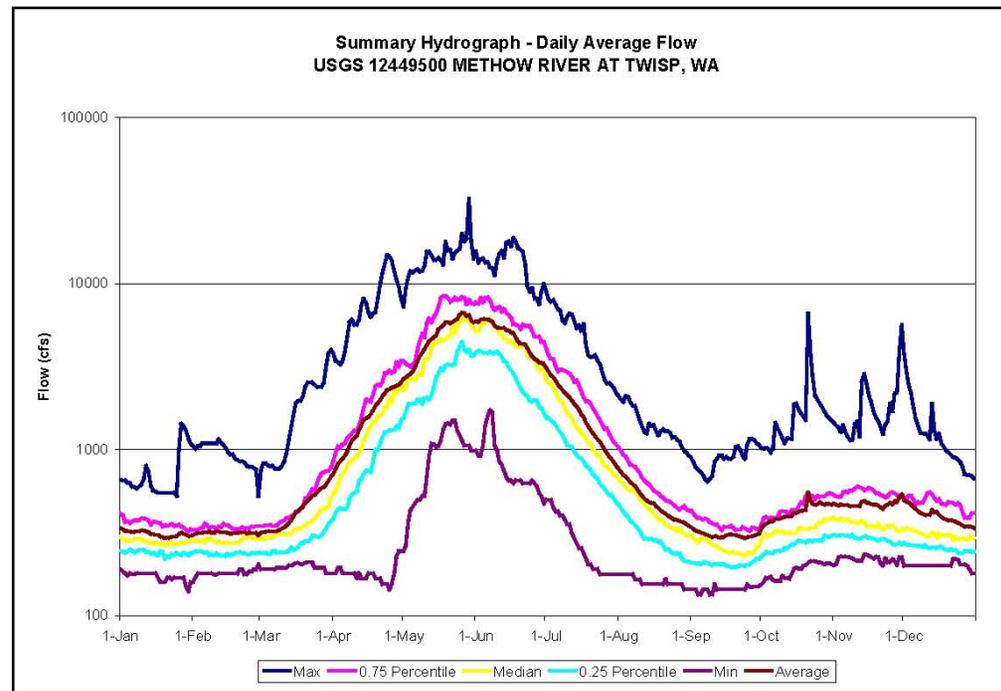
Figure 1. Mean daily flow statistics for Methow River at Twisp, WA. (Reclamation 2007).

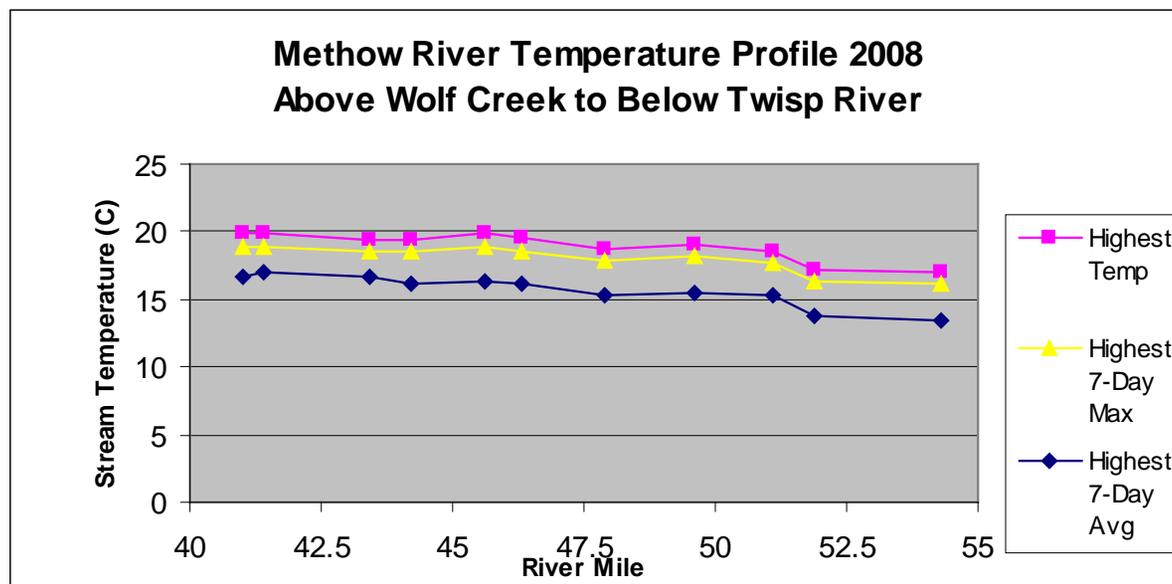
Figure 2. Summary chart of Methow River water temperature profile for 2008.

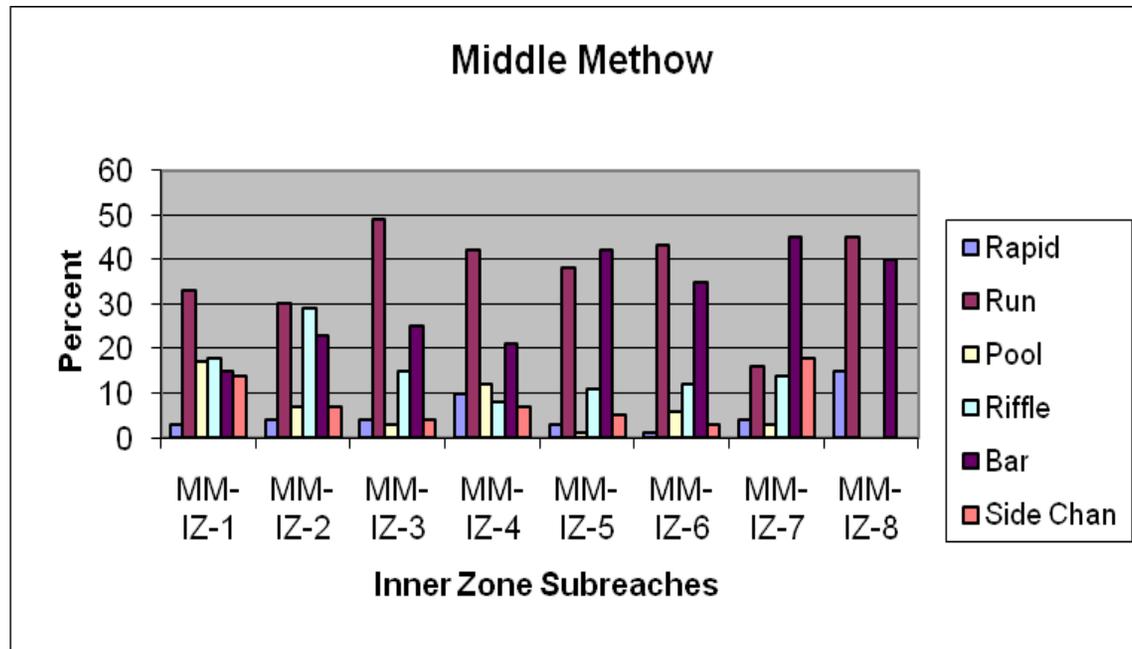
Figure 3. Bar graph of the percent based on acreage of channel units and exposed gravel bars within each subreach as mapped during the initial site assessment (Appendix C).

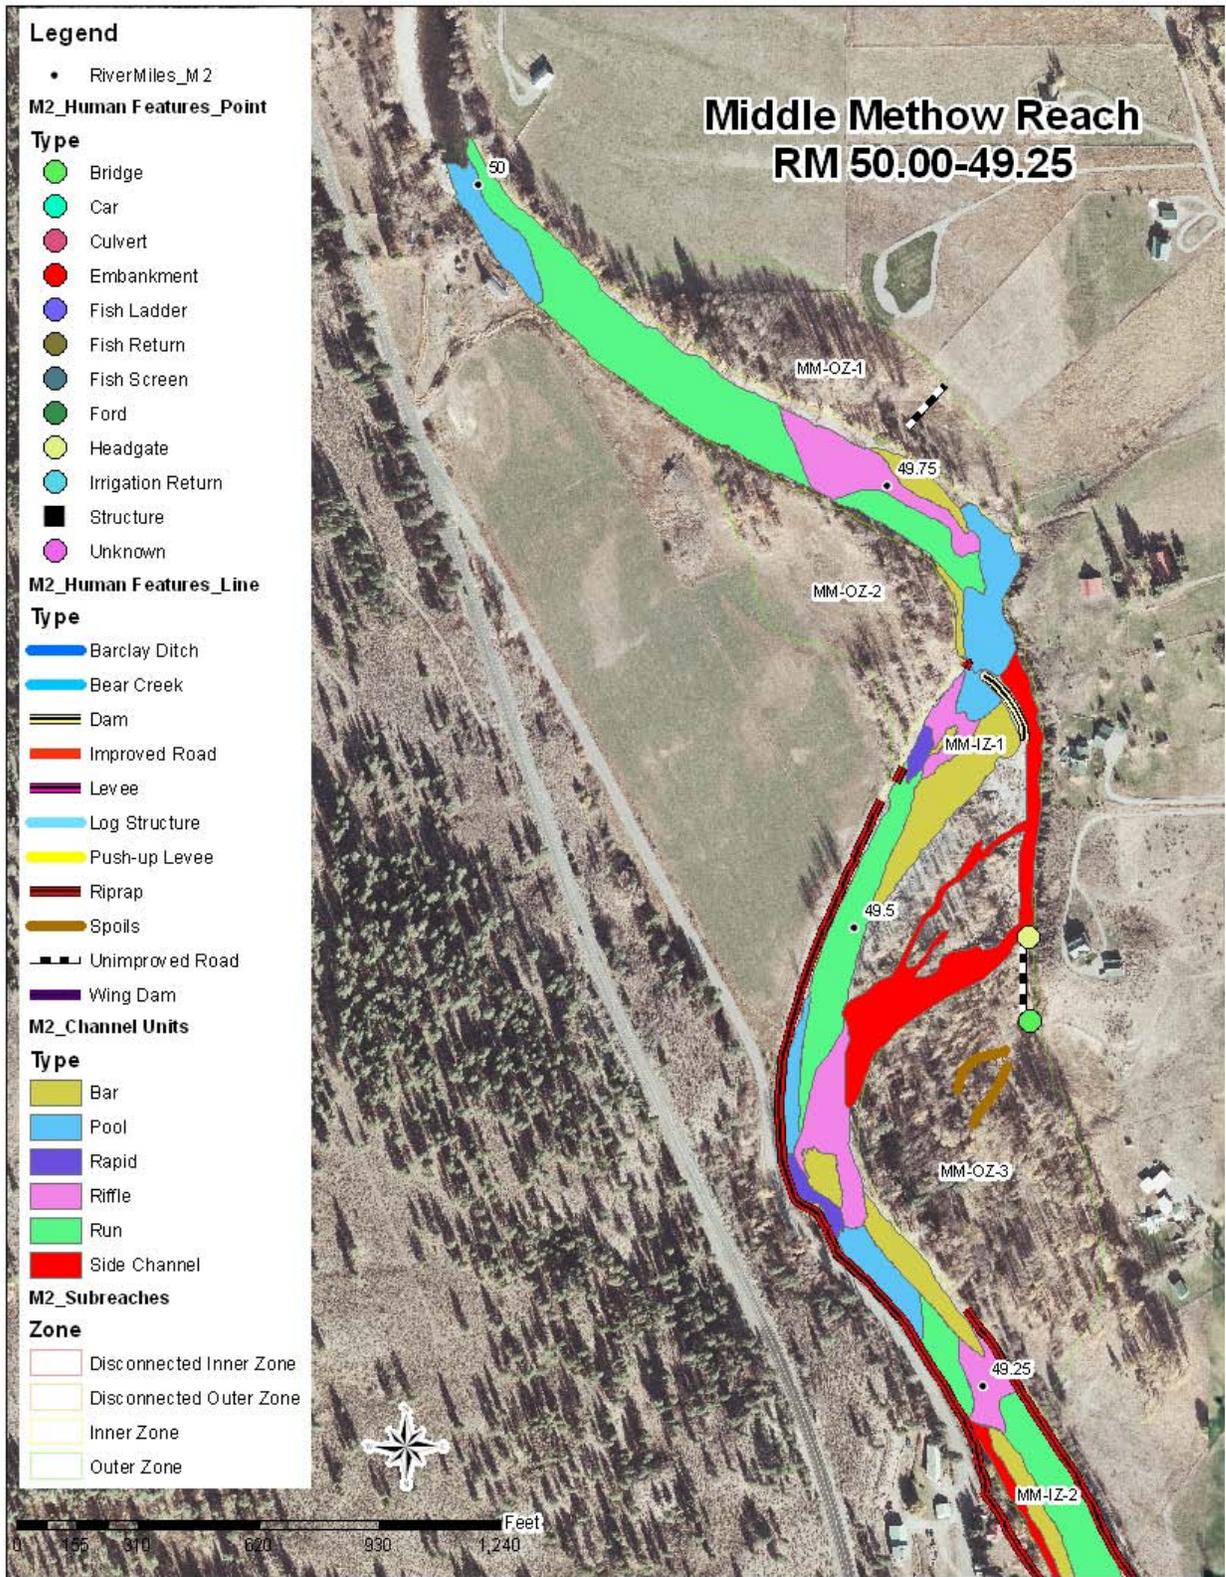
Figure 2. Channel unit mapping from RM 50.00 to RM 49.25.

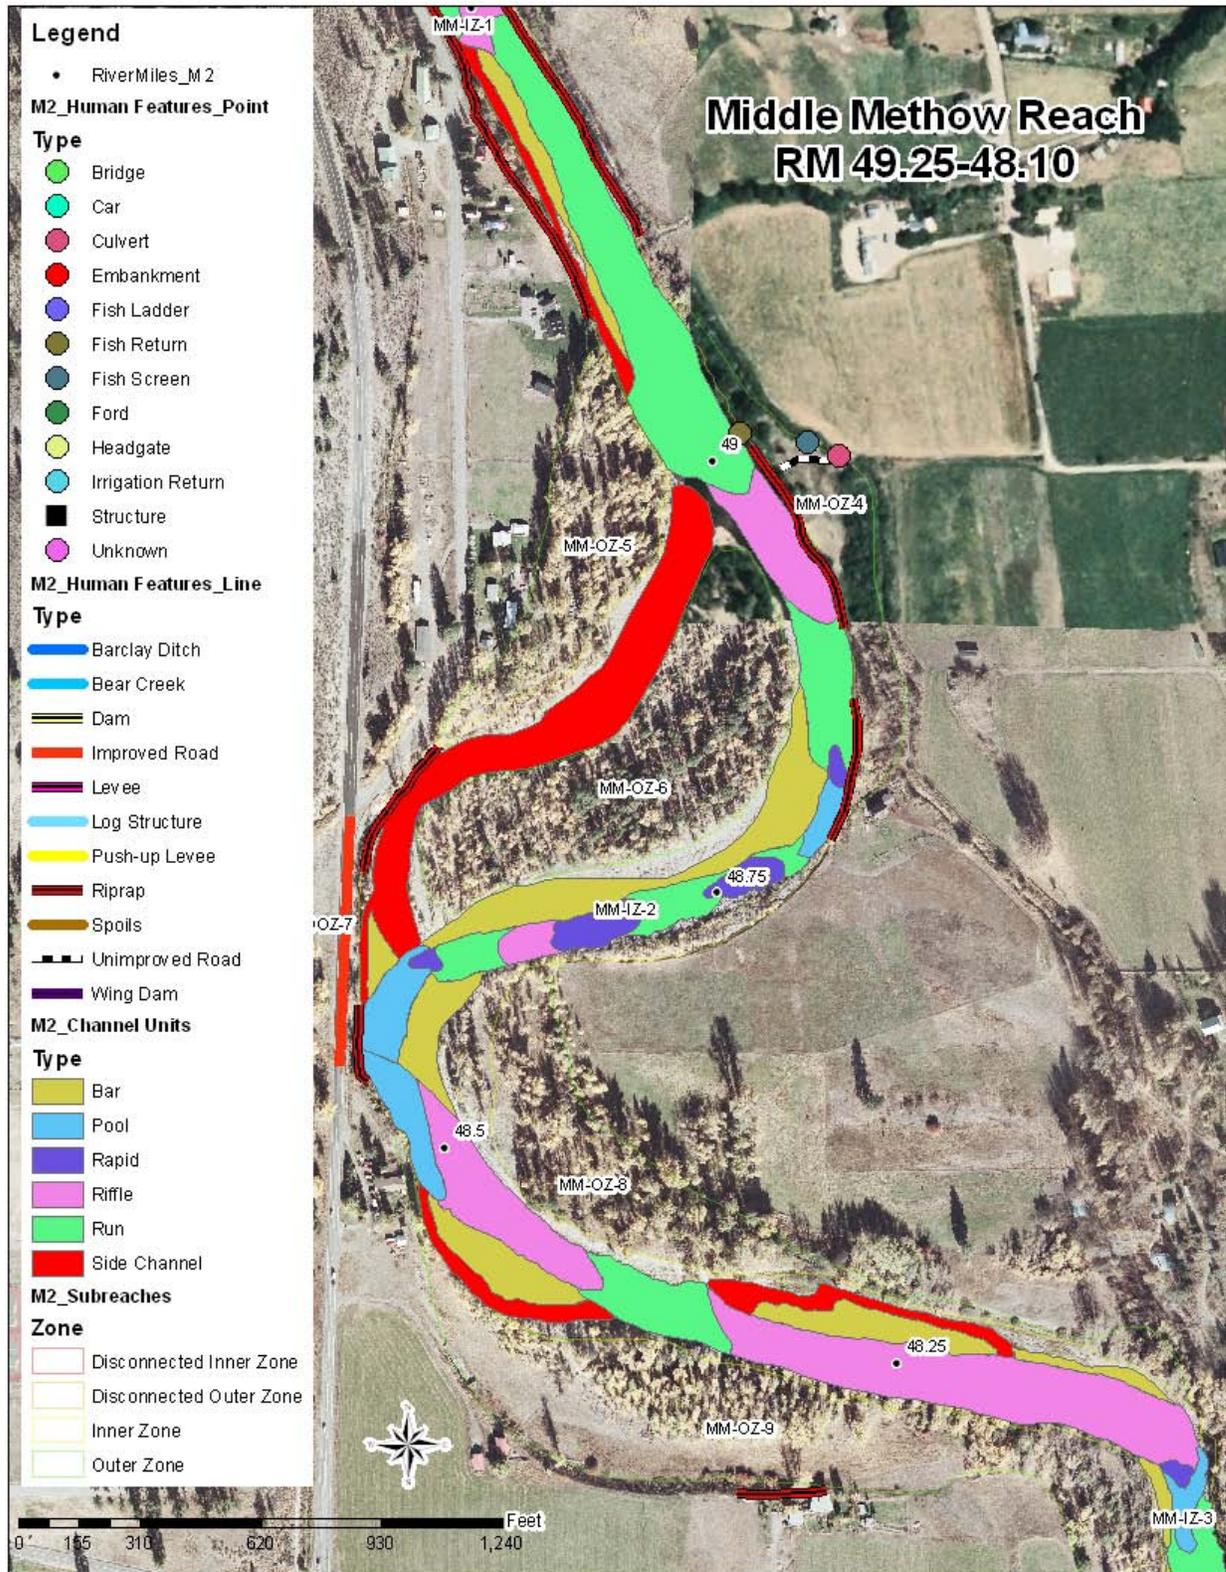
Figure 3. Channel unit mapping from RM 49.25 to RM 48.10.

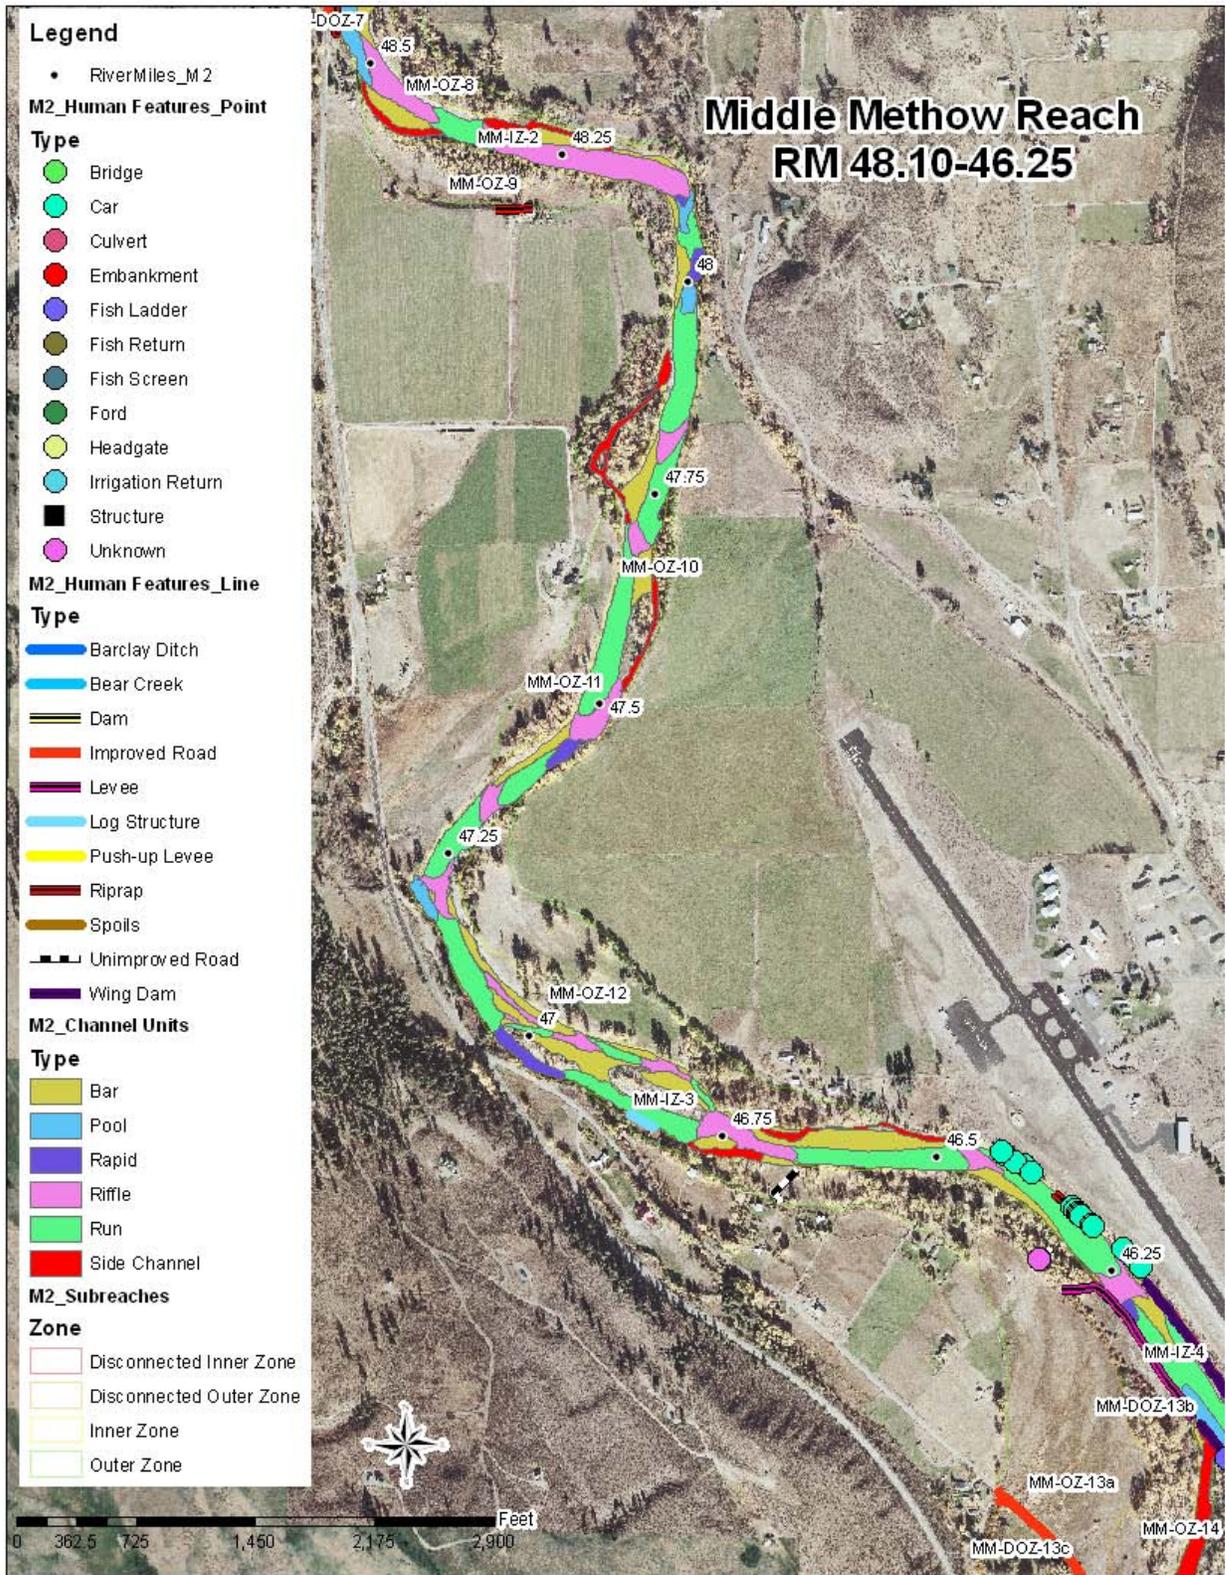
Figure 4. Channel unit mapping from RM 48.10 to RM 46.25.

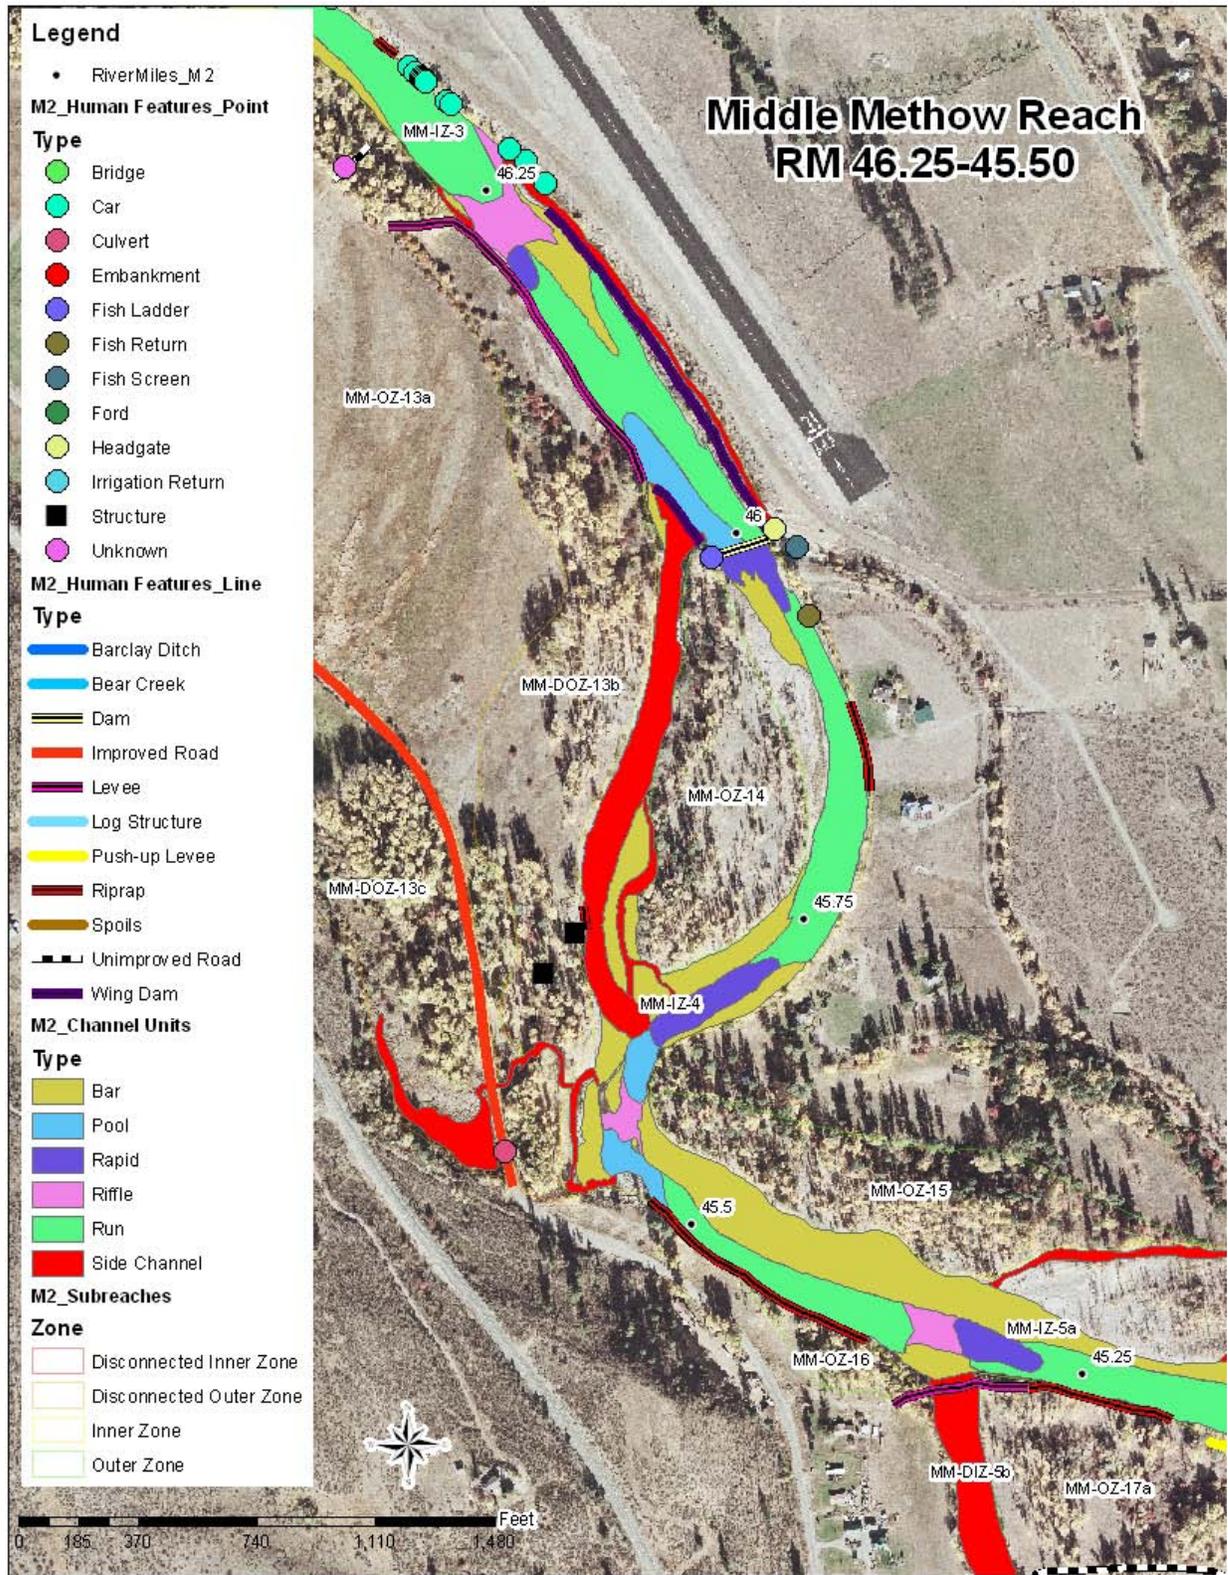
Figure 5. Channel unit mapping from RM 46.25 to RM 45.50.

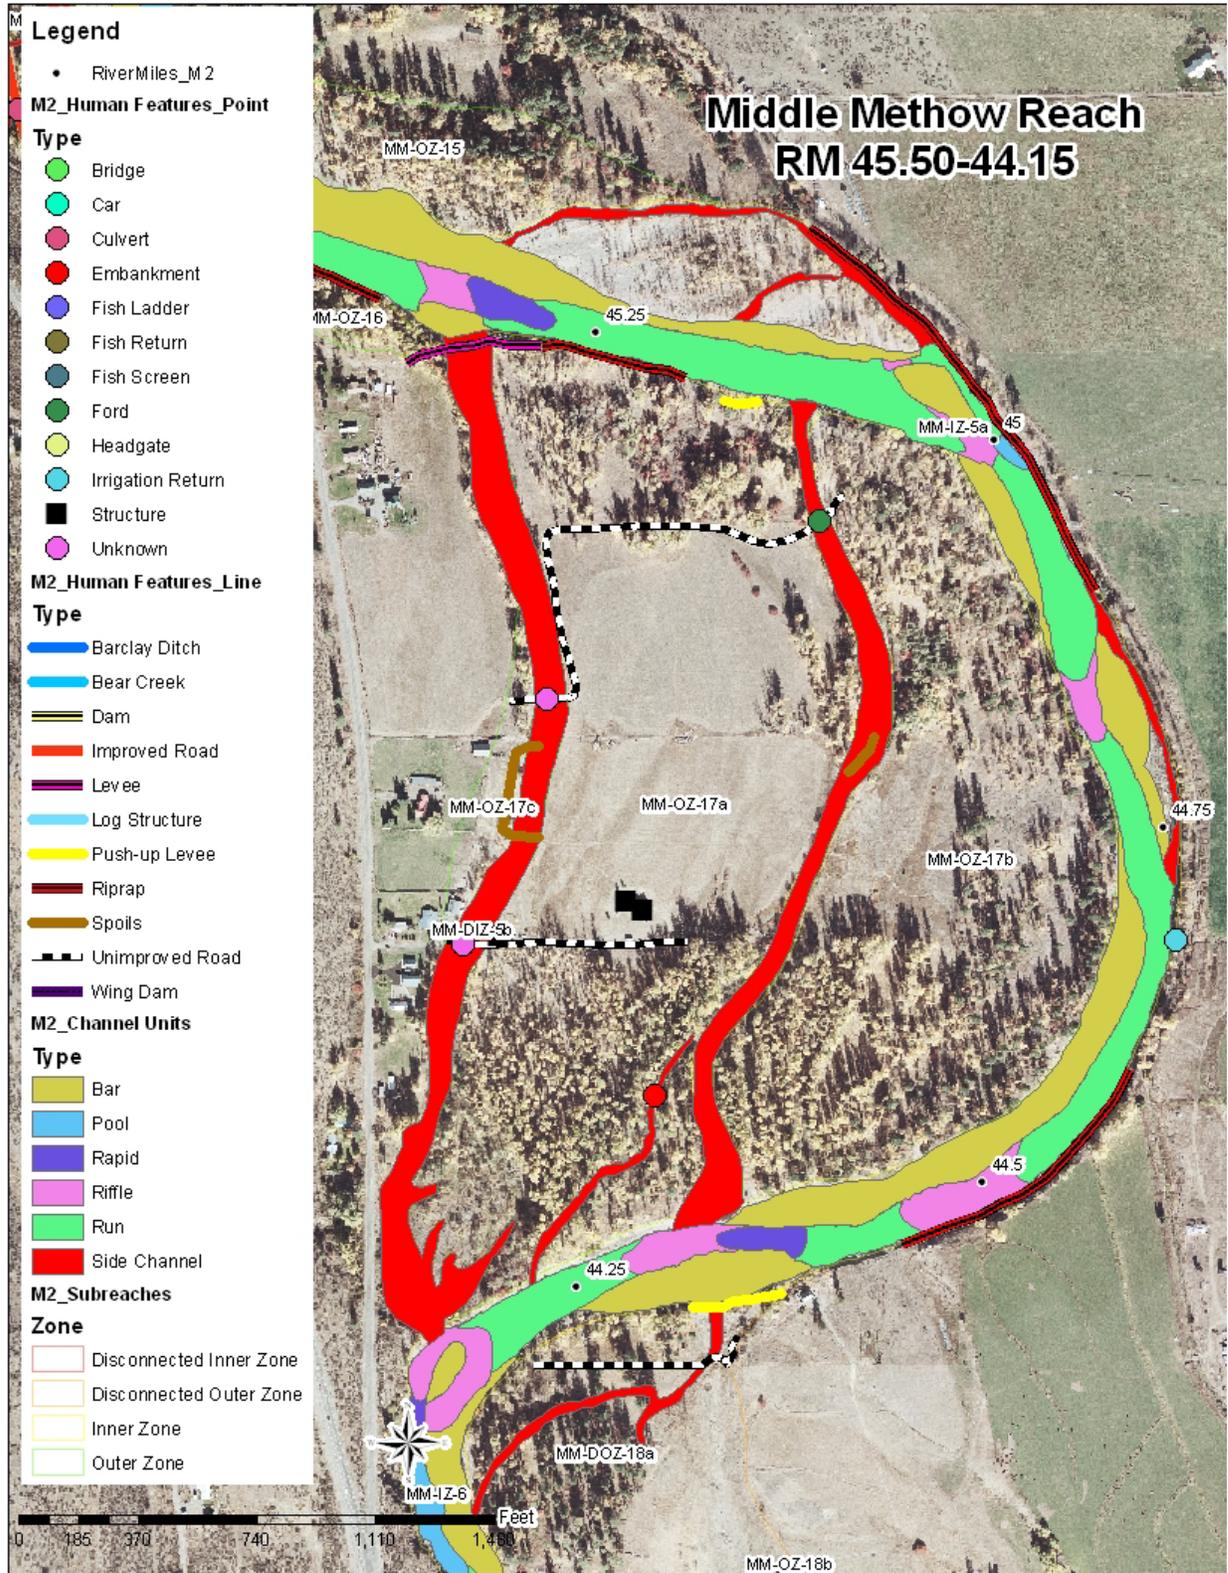
Figure 6. Channel unit mapping from RM 45.50 to RM 44.15.

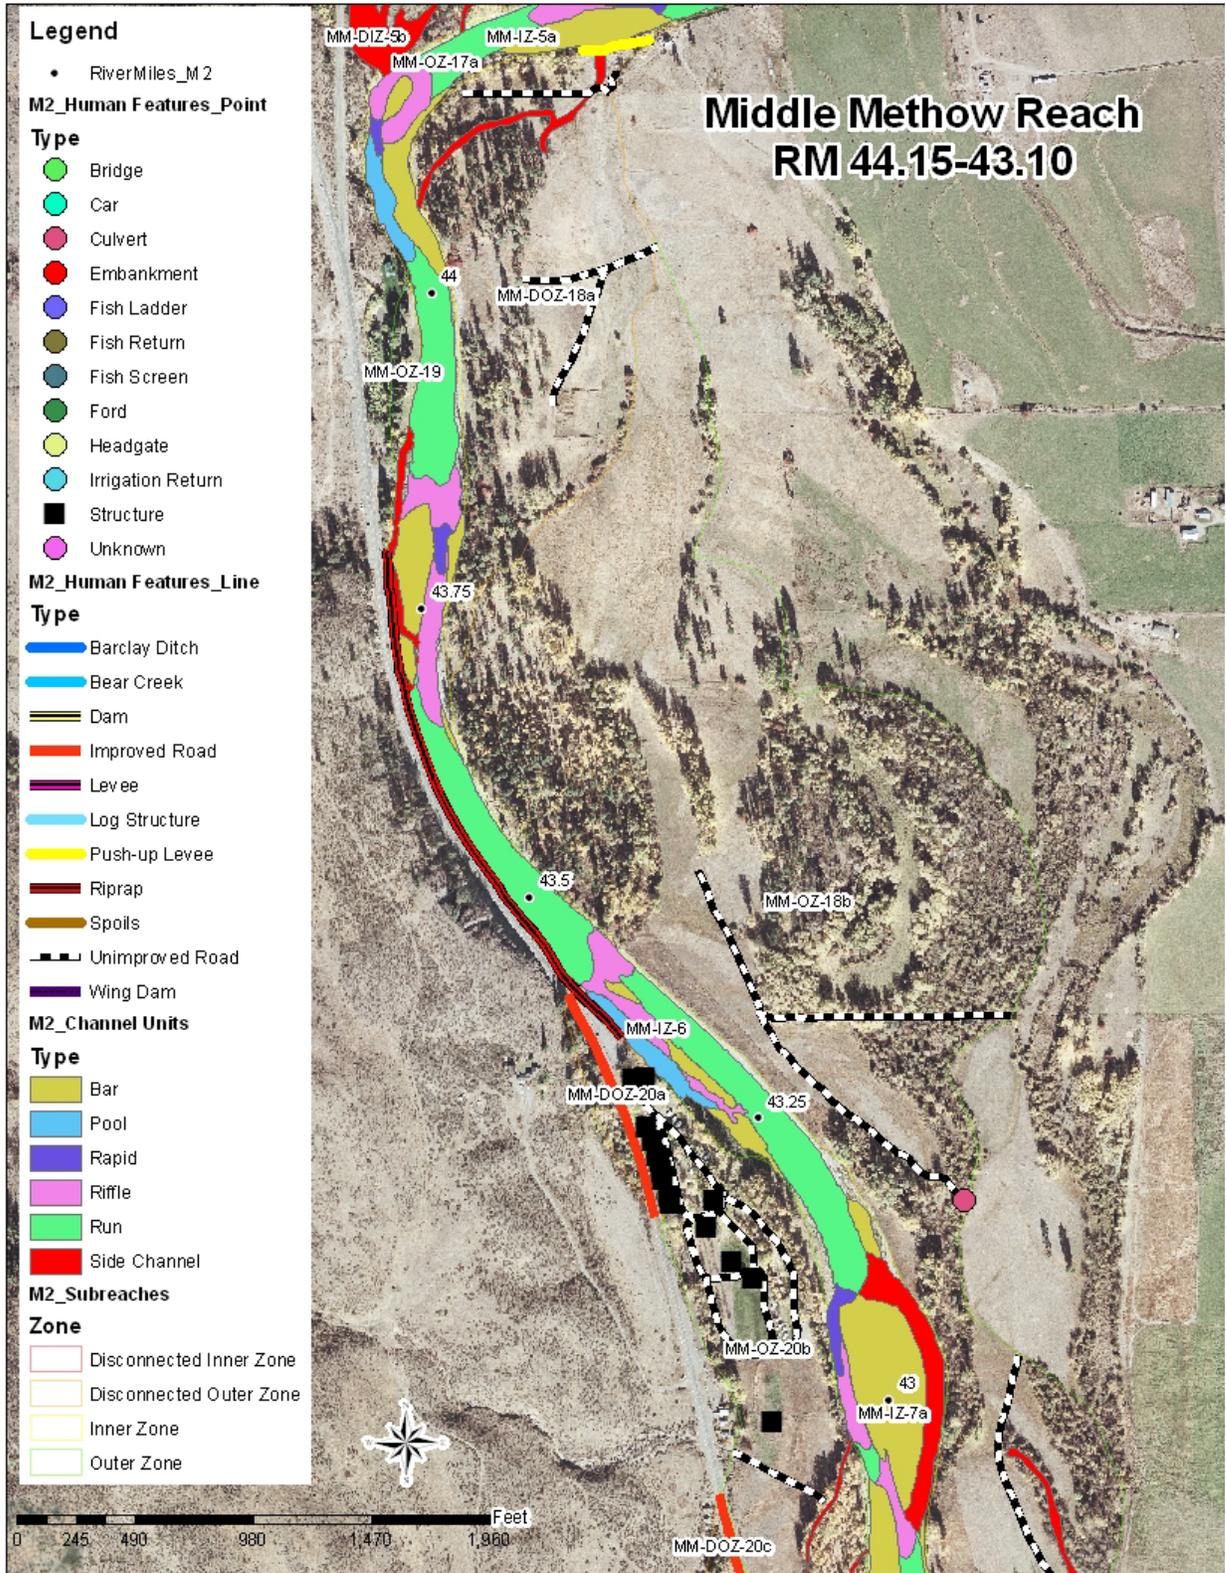
Figure 7. Channel unit mapping from RM 44.15 to RM 43.10.

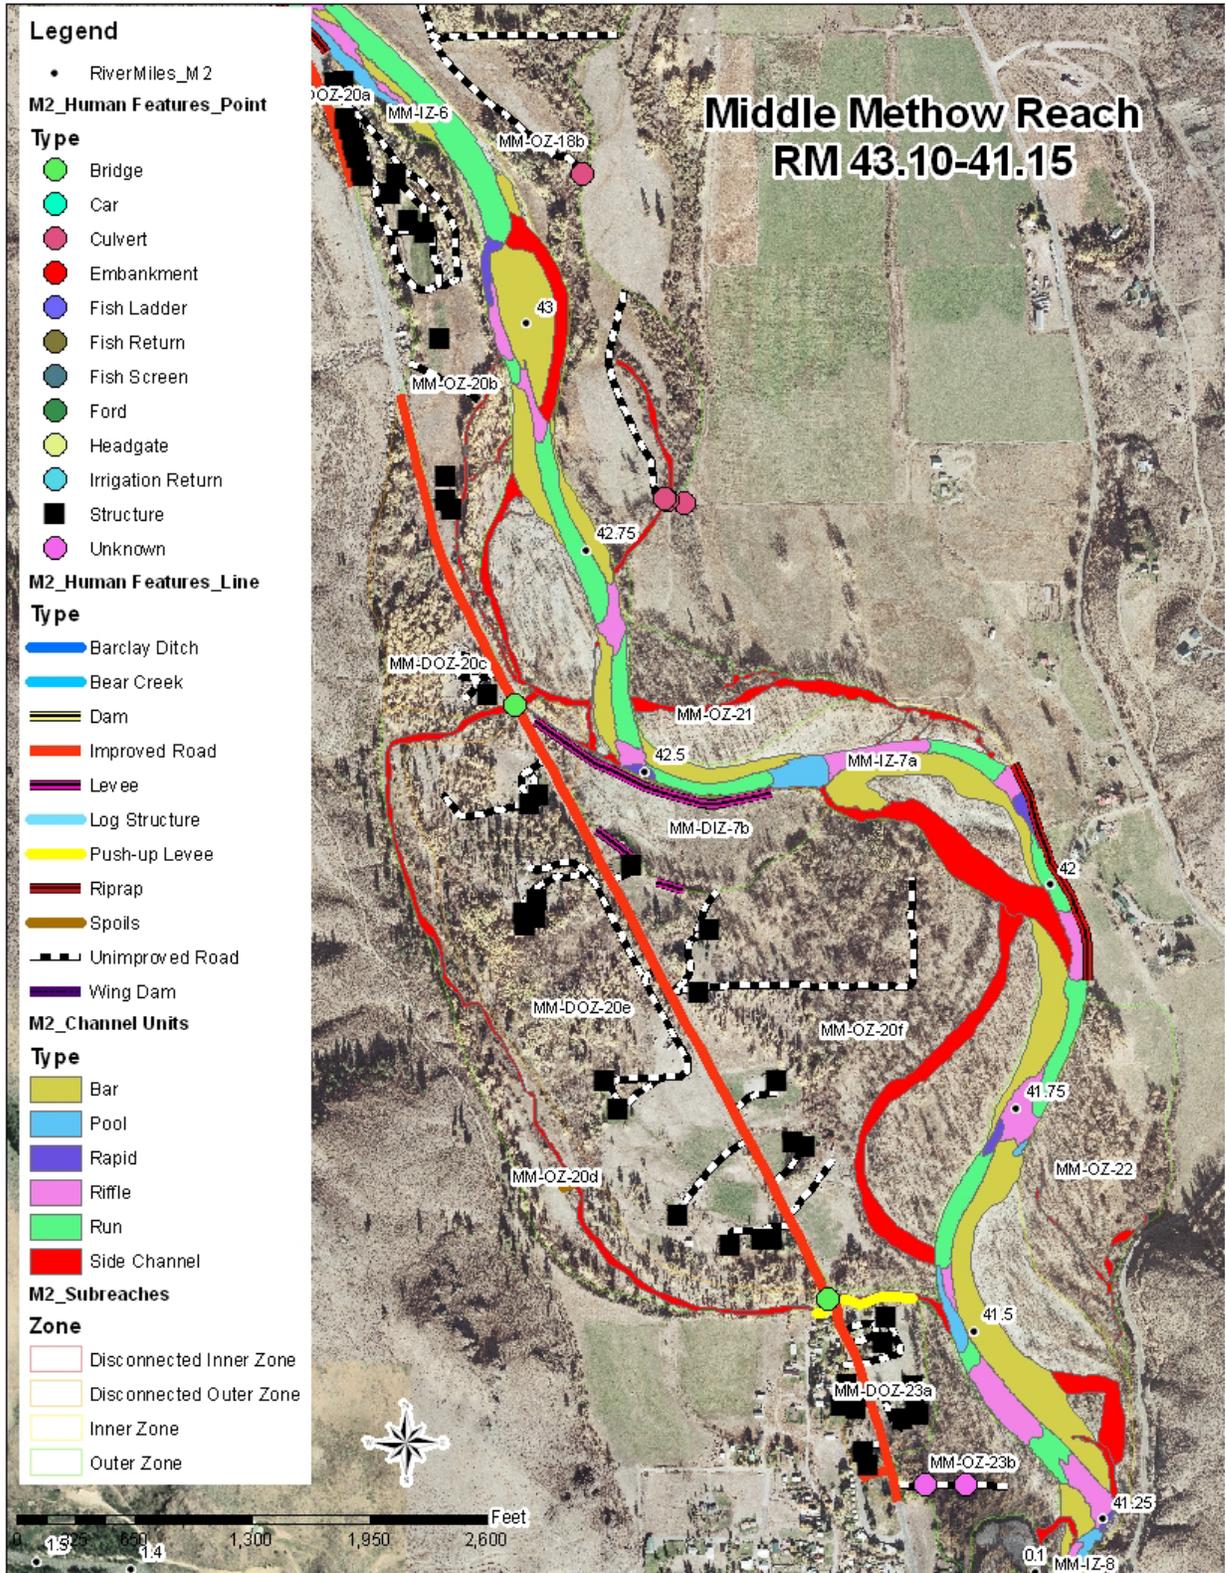
Figure 8. Channel unit mapping from RM 43.10 to RM 41.15.

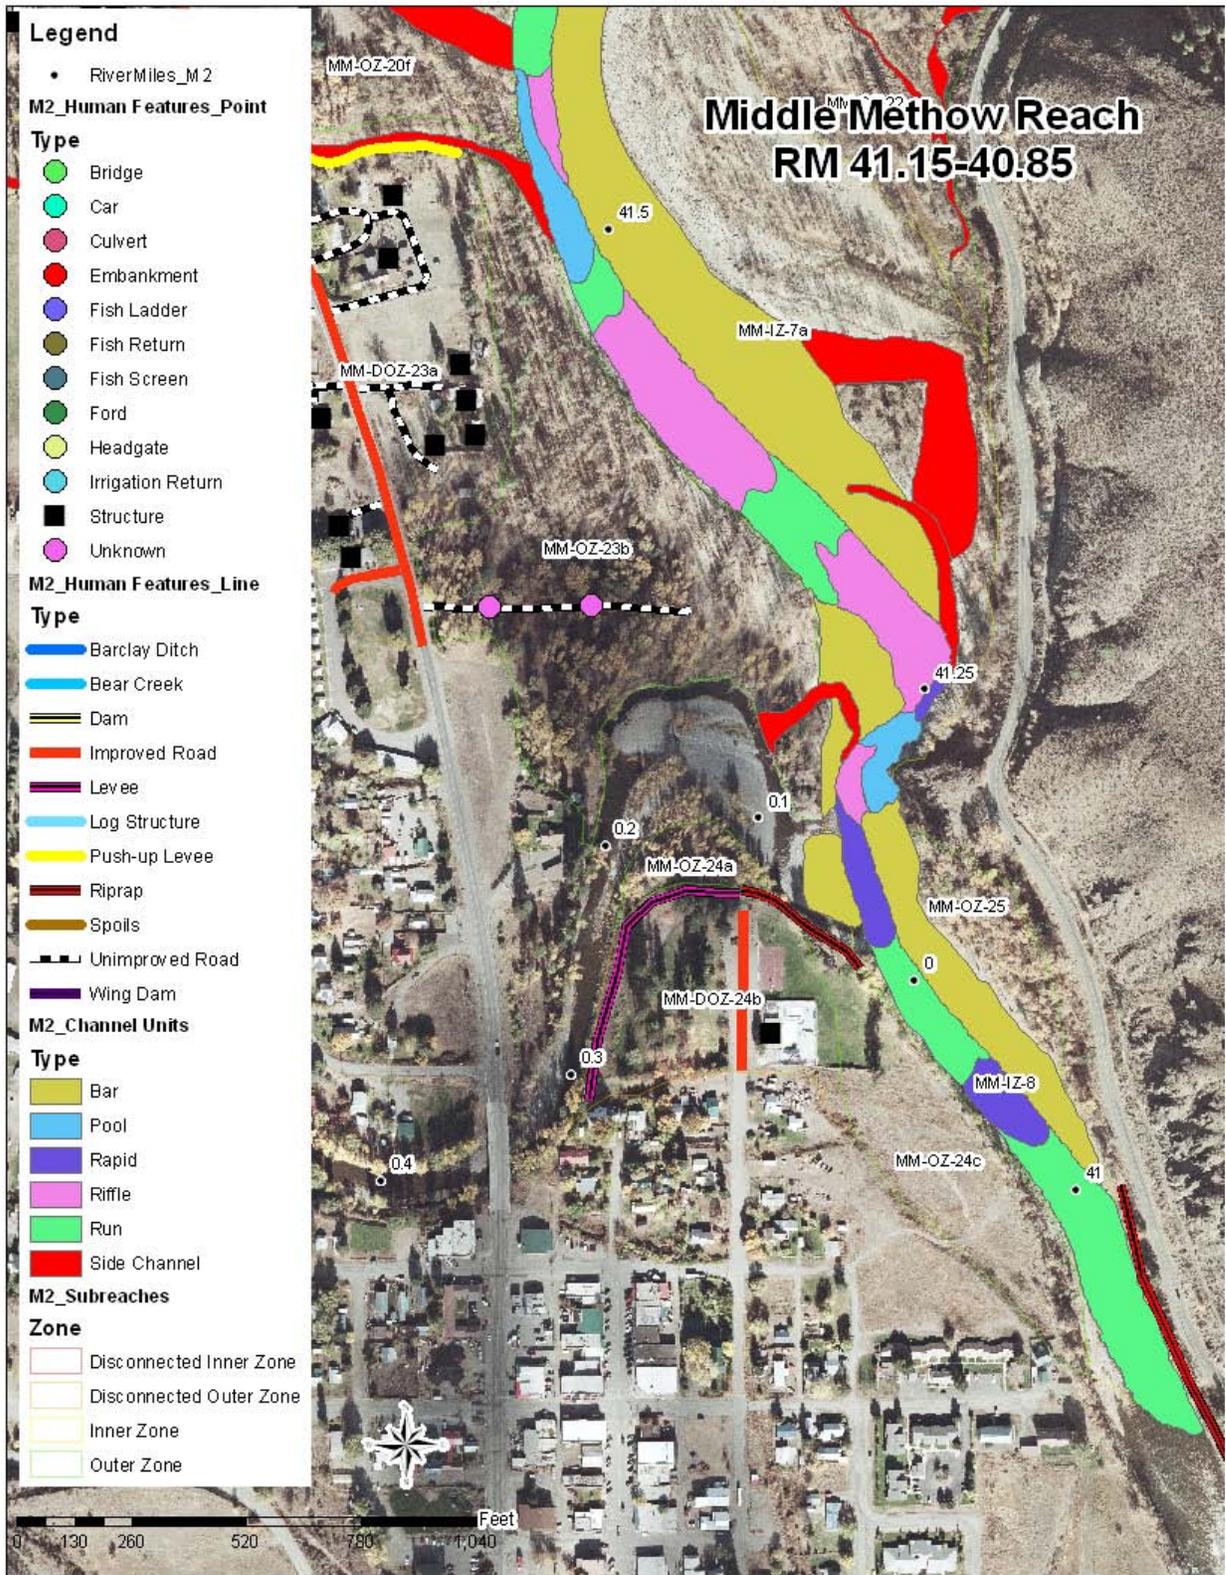
Figure 9. Channel unit mapping from RM 41.15 to RM 40.85.

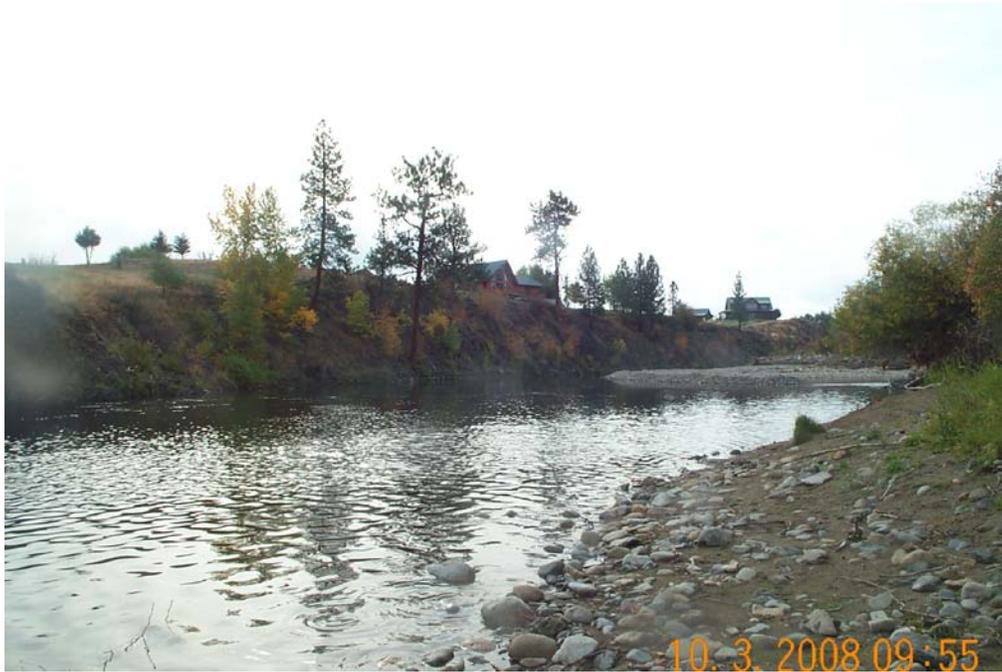
Photograph No. 1. View is to the southeast looking downstream at a large pool ponded by the Barclay Diversion Dam near RM 49.5. Middle Methow Reach Assessment – Methow Subbasin, Washington – Bureau of Reclamation Photograph by E. Lyon, October 3, 2008.

There are two irrigation diversion structures within the Middle Methow reach. The Barkley diversion dam near RM 49 is a push-up dam that during low summer flows is created to maintain irrigation flows. In addition, the Barkley diversion dam is modified annually which causes major disturbances in the stream channel that negatively impact the channel processes and creates an entrainment hazard for juvenile salmonids and Pacific lamprey. The Methow Valley Irrigation District's (MVID) east irrigation diversion dam near RM 46 has been mostly removed and is no longer a fish passage barrier or impingement hazard.

The main channel physical barriers general indicator is interpreted to be in an At Risk Condition because during very low flows (drought years) the Barkley diversion dam may be pushed-up almost completely across the river which causes an entrainment hazard and possibly a velocity barrier for smaller fish.

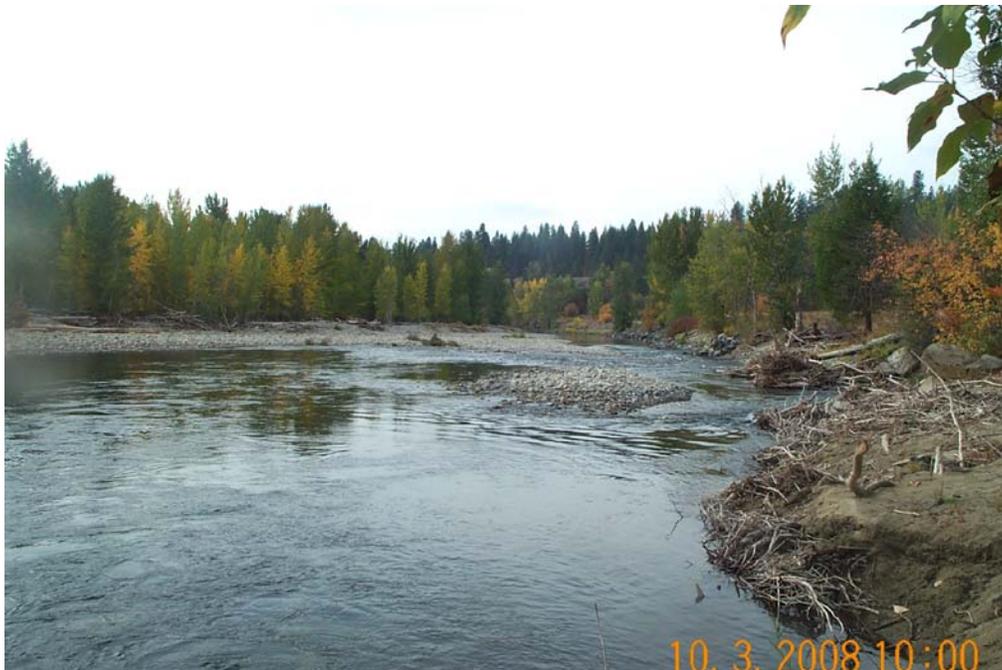
Photograph No. 2. View is to the south looking downstream at a pool-riffle-rapid-run channel unit sequence downstream of the Barkley Diversion Dam near RM 49.5. Middle Methow Reach Assessment – Methow Subbasin, Washington – Bureau of Reclamation Photograph by E. Lyon, October 3, 2008.

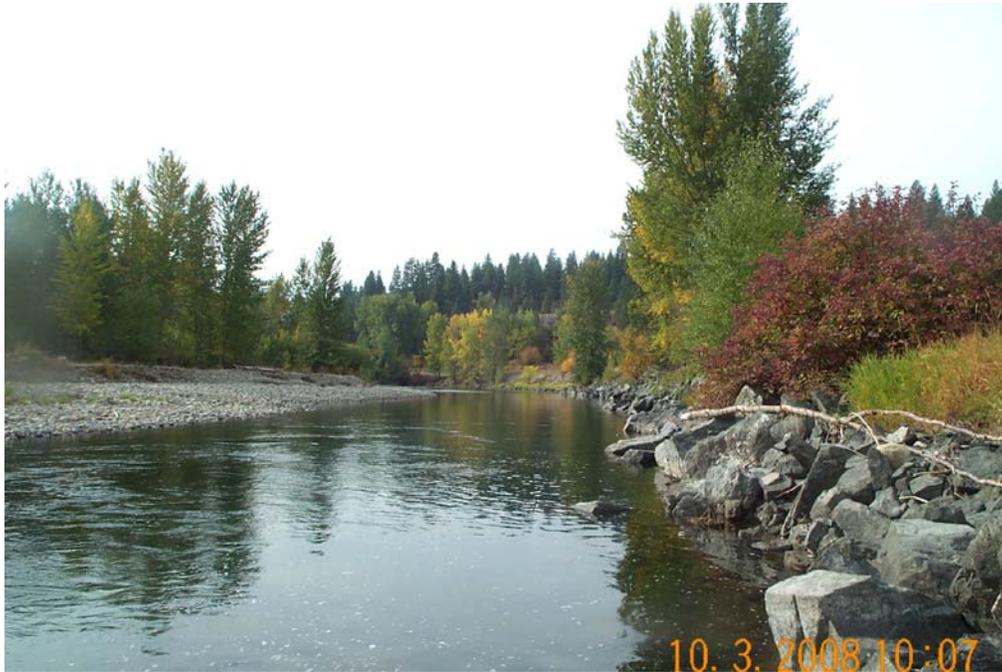
Photograph No. 3. View is to the southwest looking downstream at a deep run developed by scour along riprap placed along river right near RM 49.4. Middle Methow Reach Assessment – Methow Subbasin, Washington – Bureau of Reclamation Photograph by E. Lyon, October 3, 2008.

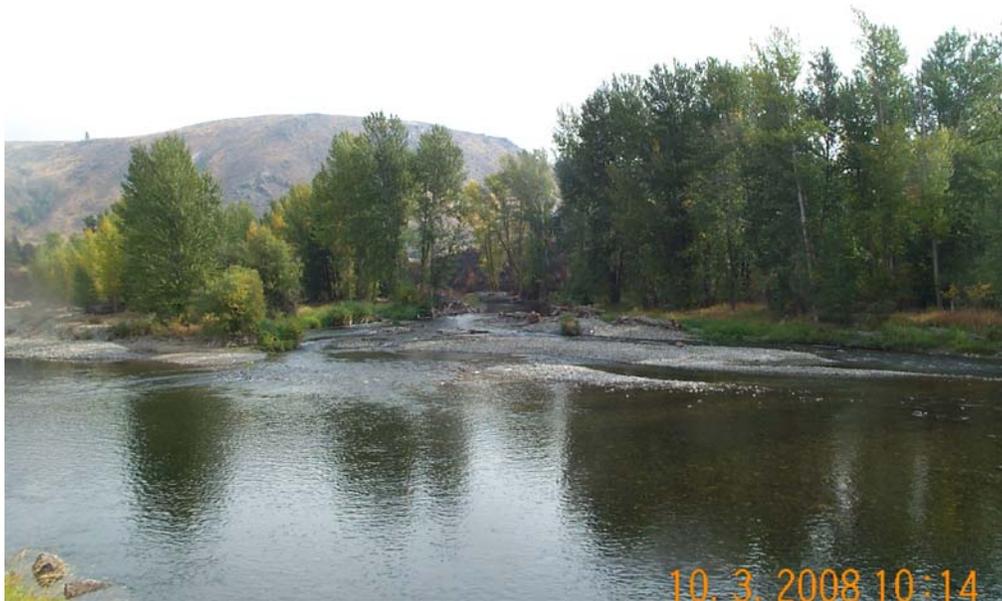
Photograph No. 4. View is to the northeast looking across the Methow River and upstream at the side channel from the Barkley diversion near RM 49.3. Middle Methow Reach Assessment – Methow Subbasin, Washington – Bureau of Reclamation Photograph by E. Lyon, October 3, 2008.

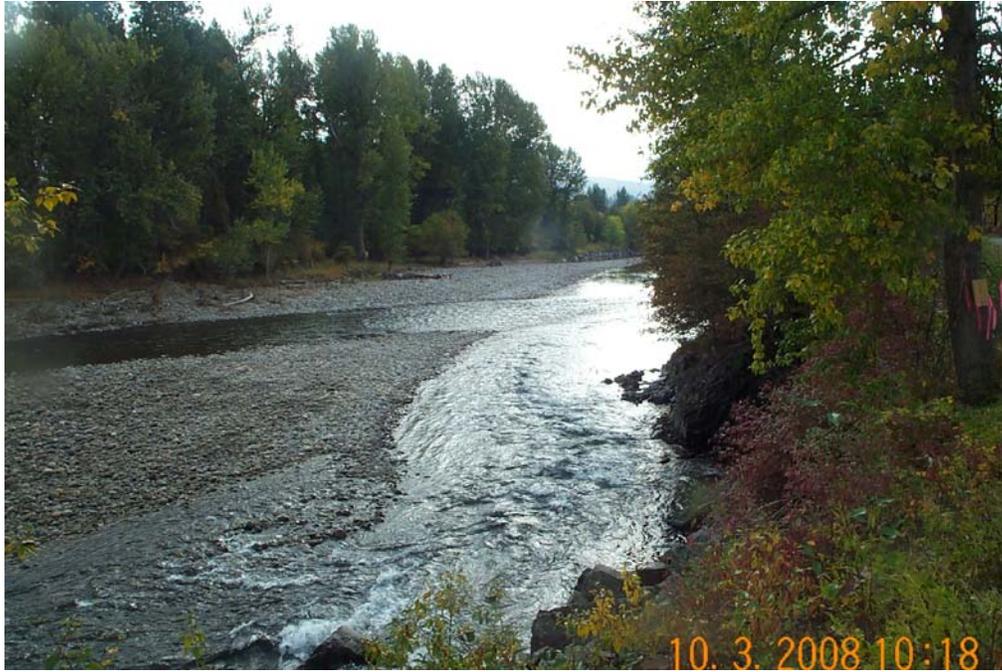
Photograph No. 5. View is to the southeast looking downstream at a rapid running along a bedrock outcrop along river right near RM 49.3. Middle Methow Reach Assessment – Methow Subbasin, Washington – Bureau of Reclamation Photograph by E. Lyon, October 3, 2008.

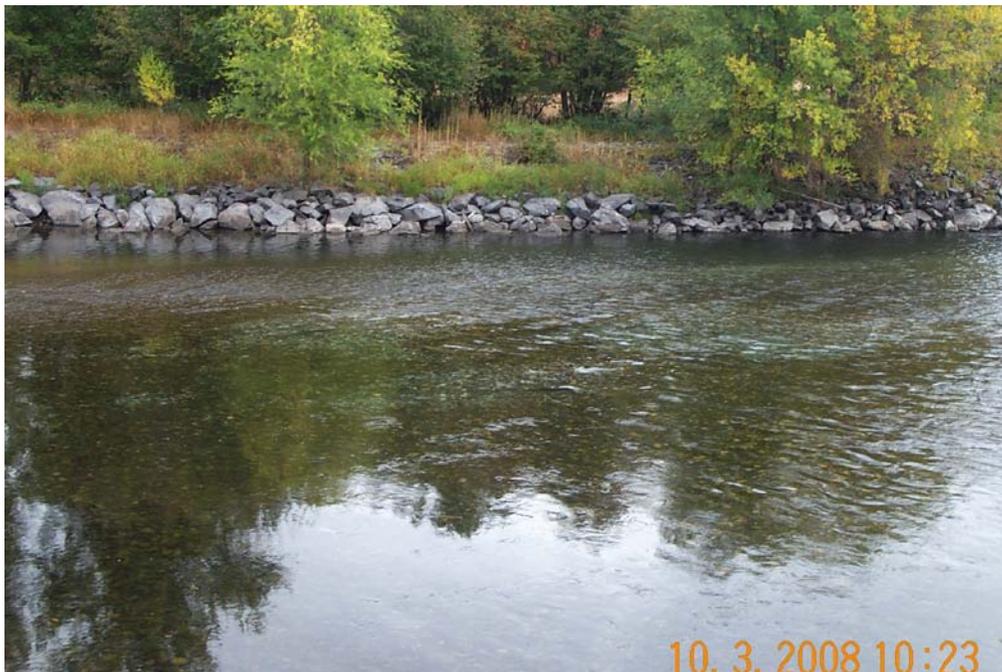
Photograph No. 6. View is to the southeast looking at spawning summer Chinook salmon and redds on a riffle comprised of predominantly of gravel near RM 49.2. Also note the riprap placed along river left to protect the Barkley irrigation ditch. Middle Methow Reach Assessment – Methow Subbasin, Washington – Bureau of Reclamation Photograph by E. Lyon, October 3, 2008.

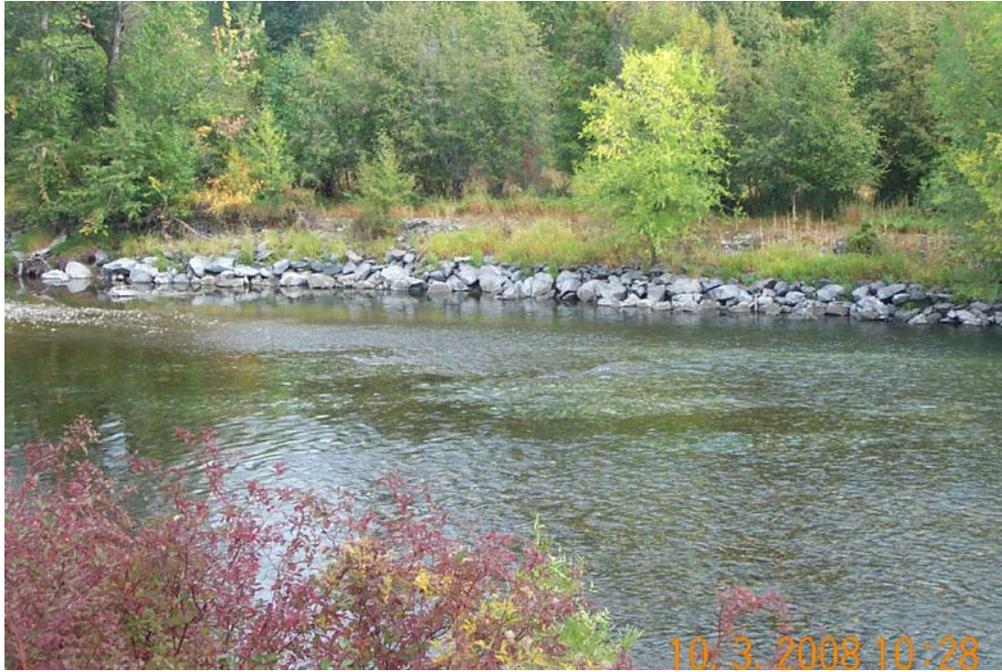
Photograph No. 7. View is to the northeast looking at the same spawning summer Chinook salmon and redds as in Photograph No. 6 near RM 49.2. Middle Methow Reach Assessment – Methow Subbasin, Washington – Bureau of Reclamation Photograph by E. Lyon, October 3, 2008.
