APPENDICES

Reach-based Ecosystem Indicators (REI) Version 1.1

MIDDLE METHOW RIVER (M2 Reach) HABITAT ASSESSMENT OVERVIEW
River Mile 40.3 to River Mile 52.4

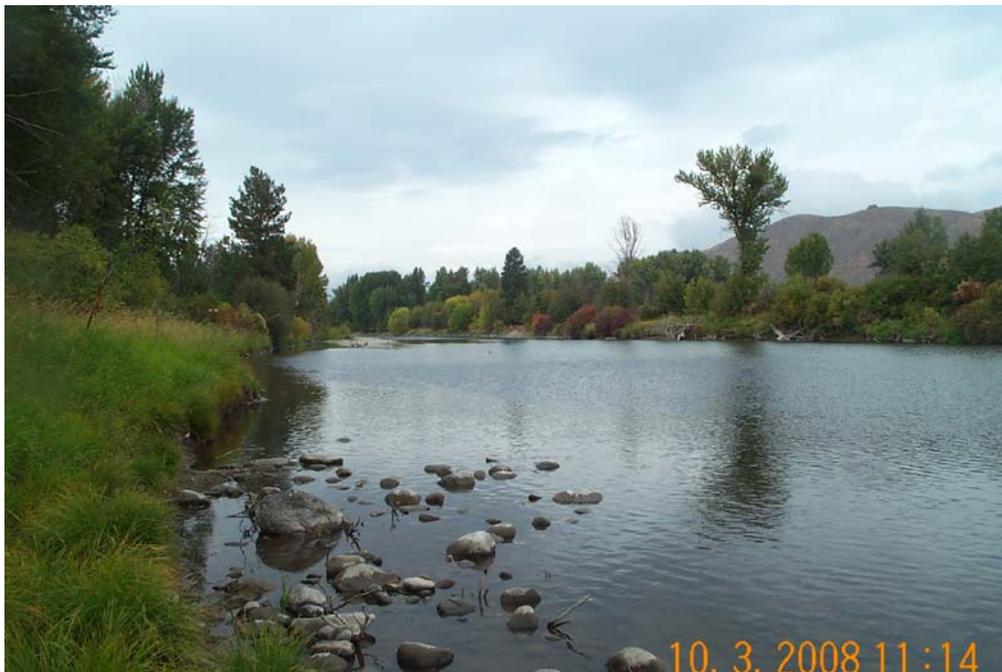
Photograph No. 8. View is to the northwest looking upstream along river right at a run that is over 0.1 mile long near RM 49.0. Middle Methow Reach Assessment – Methow Subbasin, Washington – Bureau of Reclamation Photograph by E. Lyon, October 3, 2008.

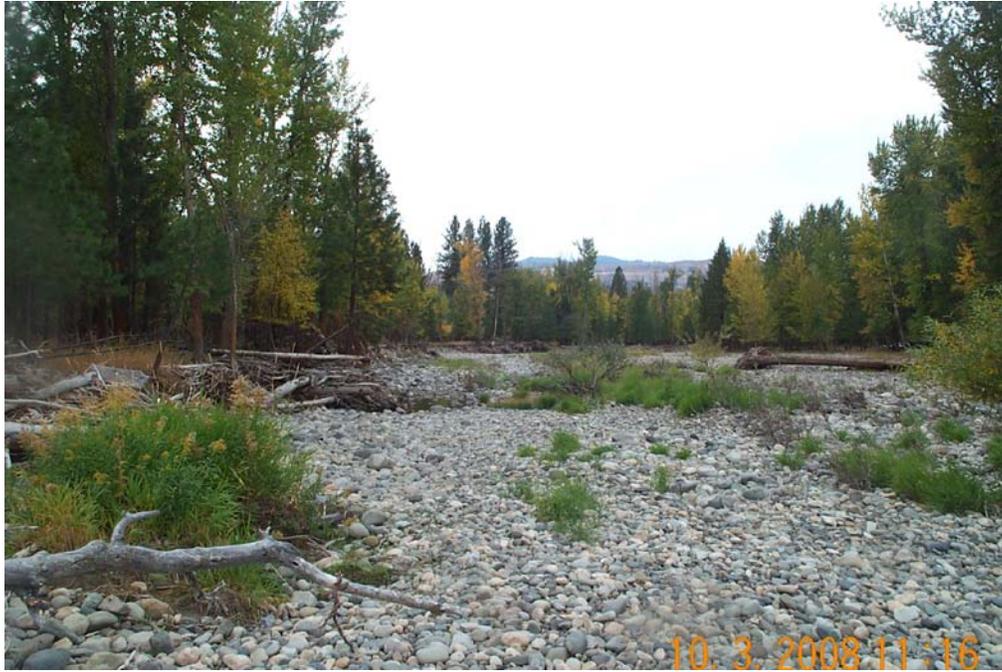
Photograph No. 9. View is to the southwest looking downstream from the head of Bird side channel along river right near RM 49.0. Middle Methow Reach Assessment – Methow Subbasin, Washington – Bureau of Reclamation Photograph by E. Lyon, October 3, 2008.

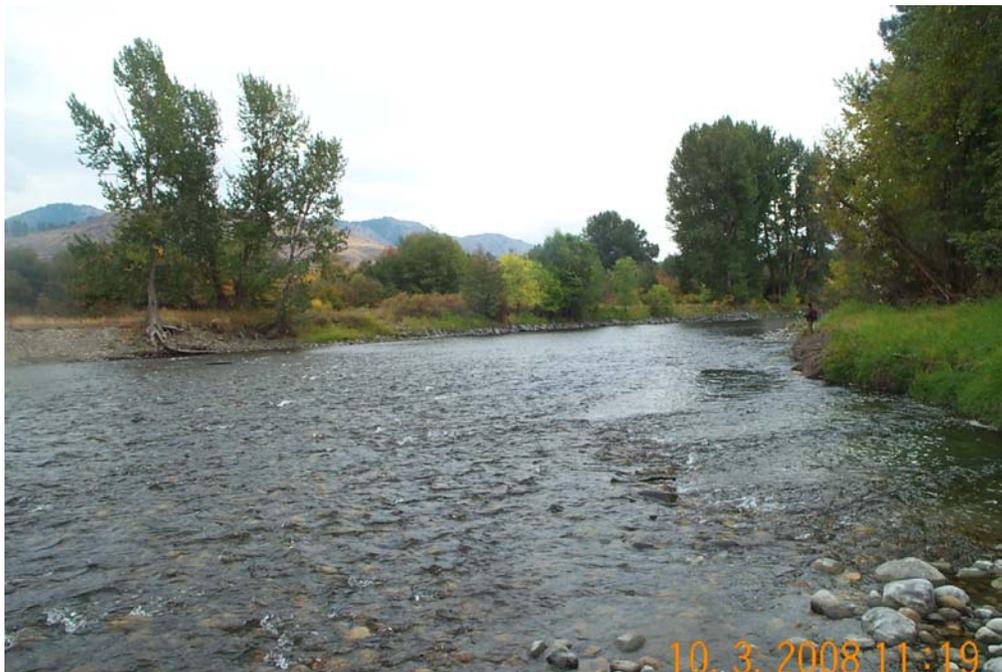
Photograph No. 10. View is to the southwest looking downstream at a riffle comprised predominantly of large gravel to small cobbles. Spawning summer Chinook salmon and redds were observed in the tail-out section of the riffle near RM 48.9. Middle Methow Reach Assessment – Methow Subbasin, Washington – Bureau of Reclamation Photograph by E. Lyon, October 3, 2008.

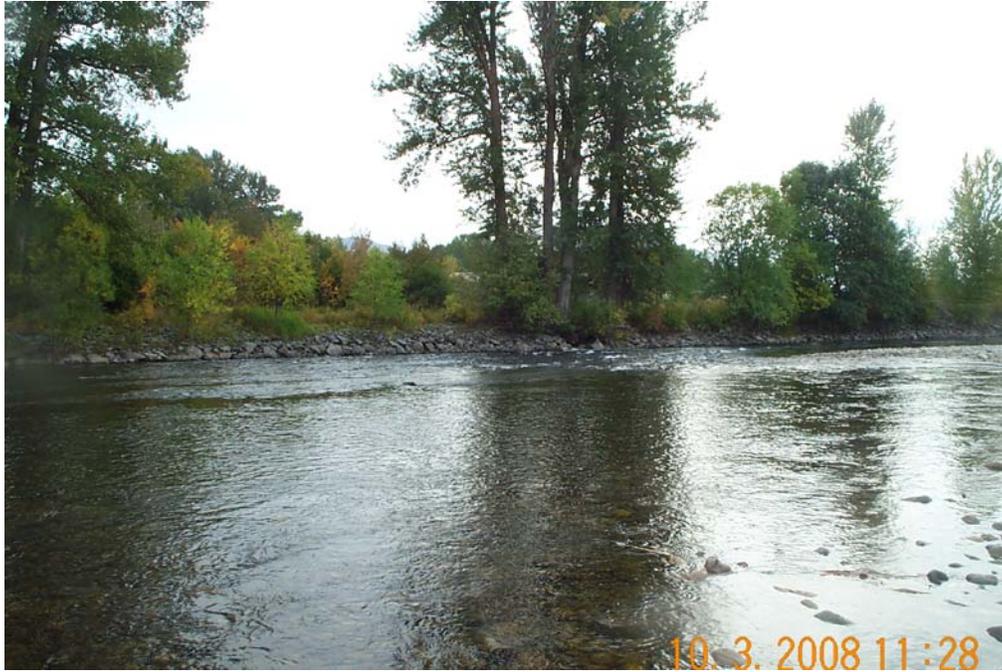
Photograph No. 11. View is to the southeast looking downstream at a run-rapid sequence and riprap placed along river left near RM 48.9. Middle Methow Reach Assessment – Methow Subbasin, Washington – Bureau of Reclamation Photograph by E. Lyon, October 3, 2008.

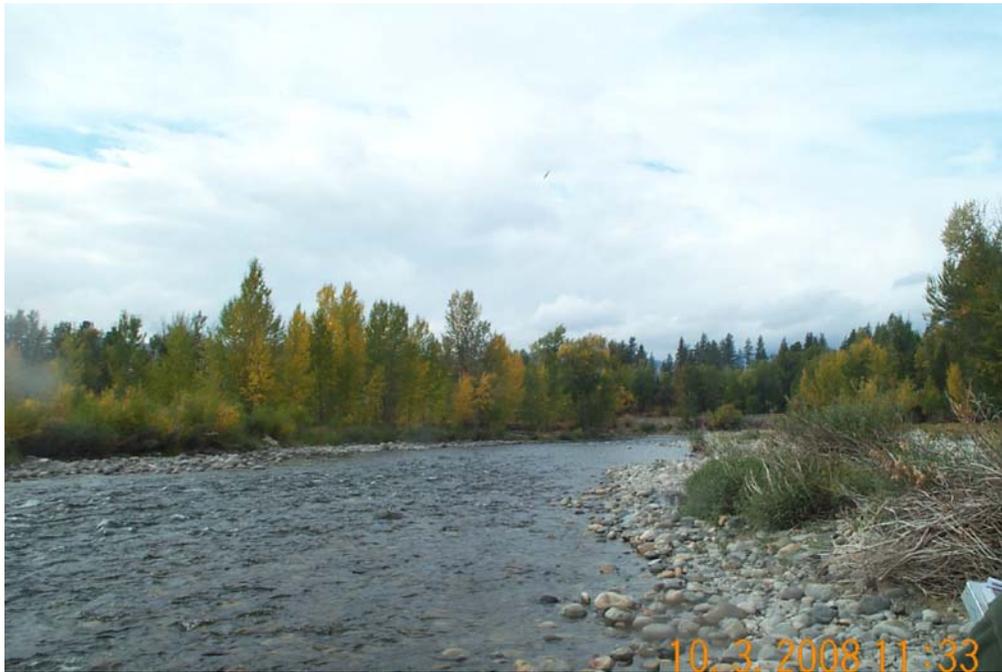
Photograph No. 12. View is to the southwest looking downstream at a rapid-run-rapid sequence near RM 48.8. Middle Methow Reach Assessment – Methow Subbasin, Washington – Bureau of Reclamation Photograph by E. Lyon, October 3, 2008.

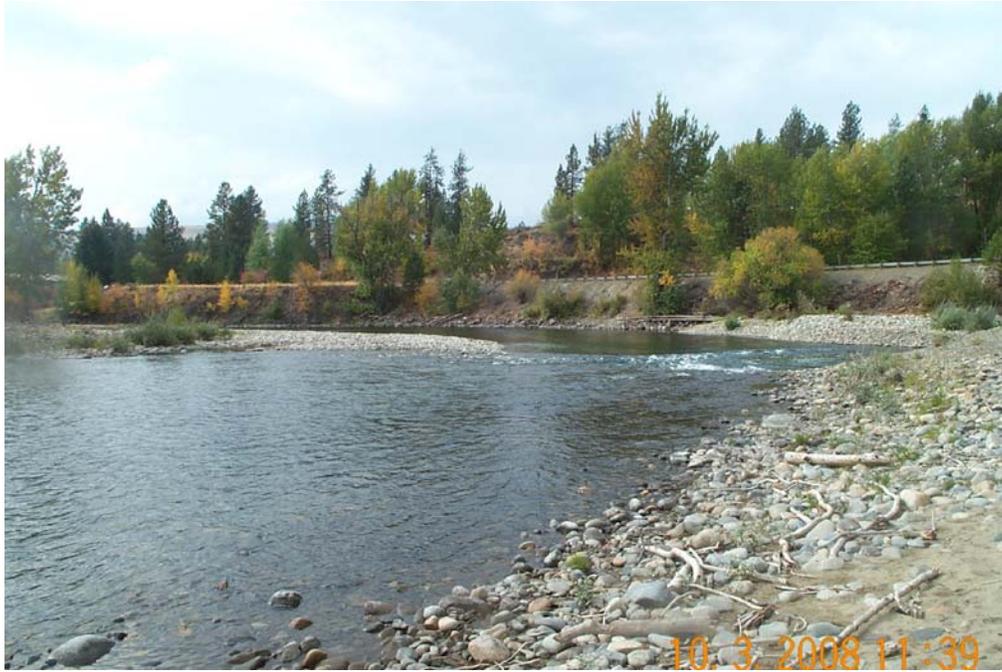
Photograph No. 13. View is to the southwest looking downstream at a rapid-pool sequence at the mouth of Birds side channel near RM 48.7. Middle Methow Reach Assessment – Methow Subbasin, Washington – Bureau of Reclamation Photograph by E. Lyon, October 3, 2008.

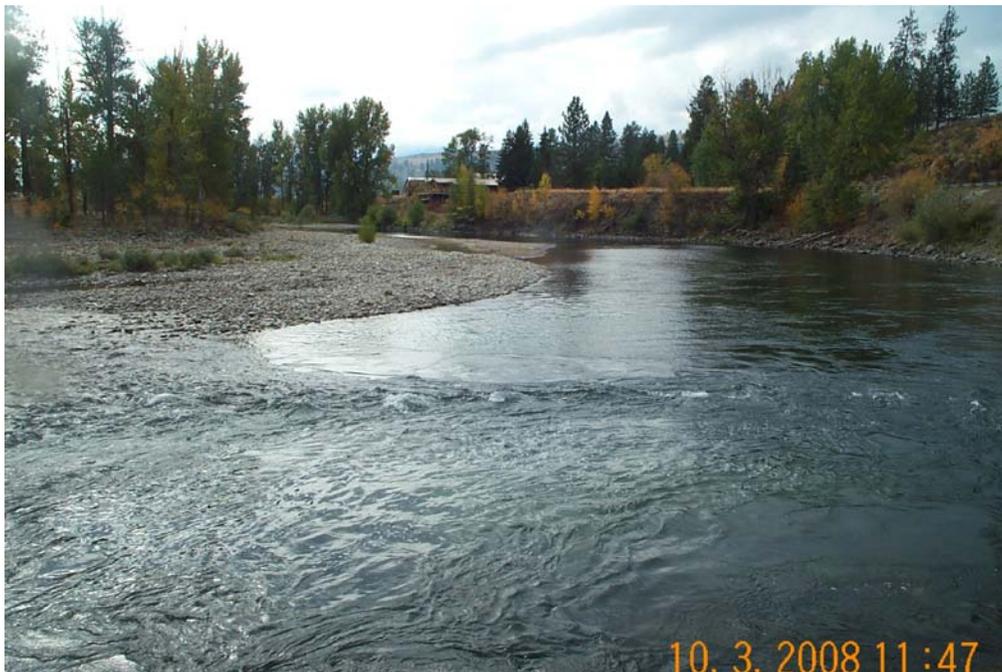
Photograph No. 14. View is to the southwest looking downstream at a lateral scour pool formed by riprap and bedrock along river right from the mouth of Bird side channel near RM 48.7. Middle Methow Reach Assessment – Methow Subbasin, Washington – Bureau of Reclamation Photograph by E. Lyon, October 3, 2008.

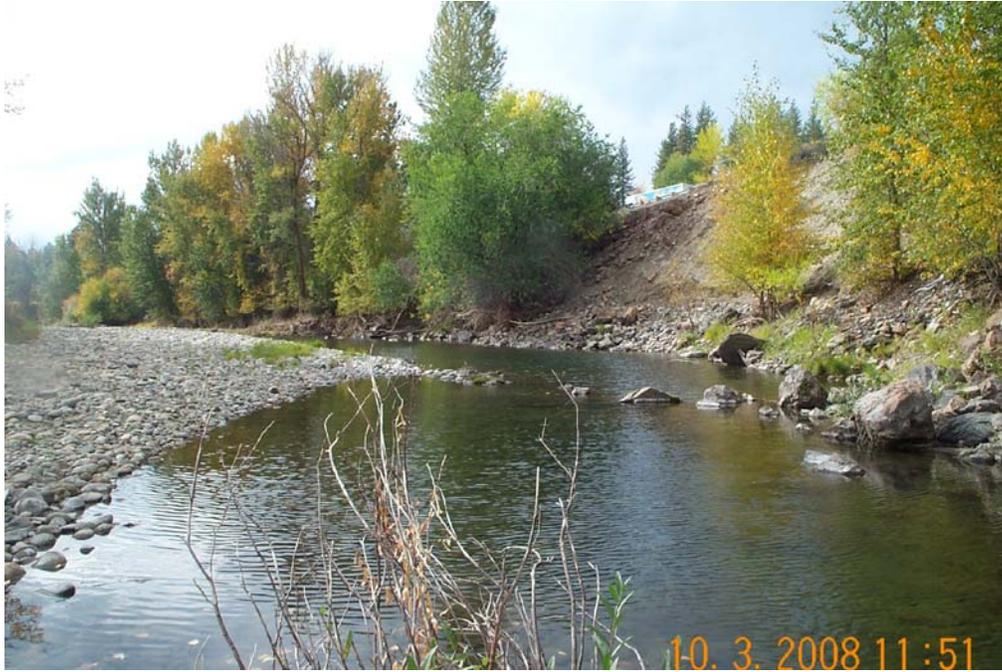
Photograph No. 15. View is to the southwest looking downstream at a lateral scour pool formed by riprap along the Bird side channel near RM 48.7. Middle Methow Reach Assessment – Methow Subbasin, Washington – Bureau of Reclamation Photograph by E. Lyon, October 3, 2008.

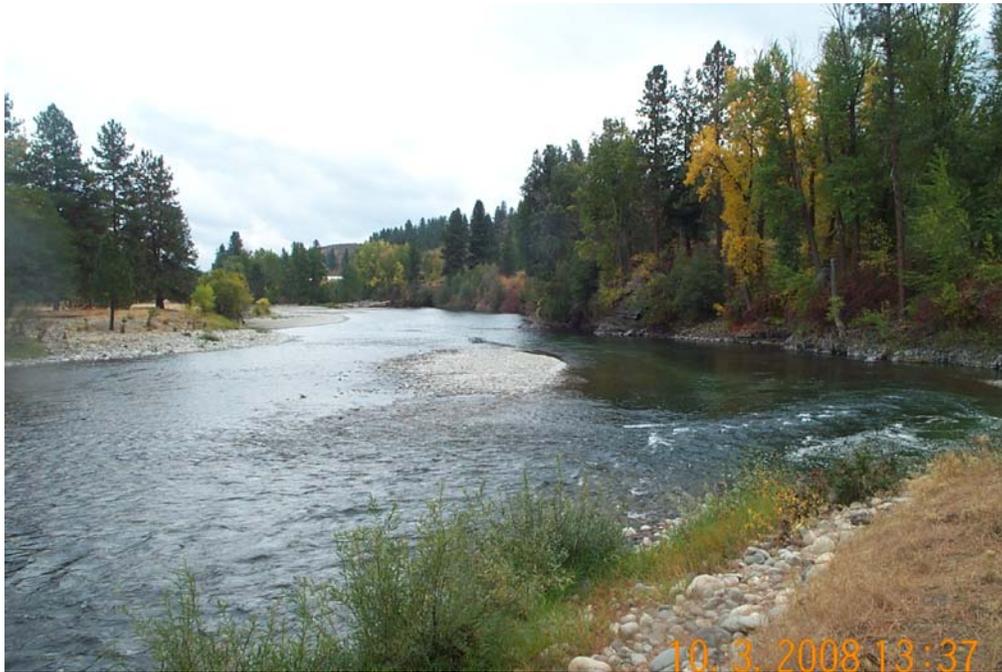
Photograph No. 16. View is to the southwest looking downstream at a rapid and lateral scour pool formed by bedrock along river right near RM 47.2. Middle Methow Reach Assessment – Methow Subbasin, Washington – Bureau of Reclamation Photograph by E. Lyon, October 3, 2008.

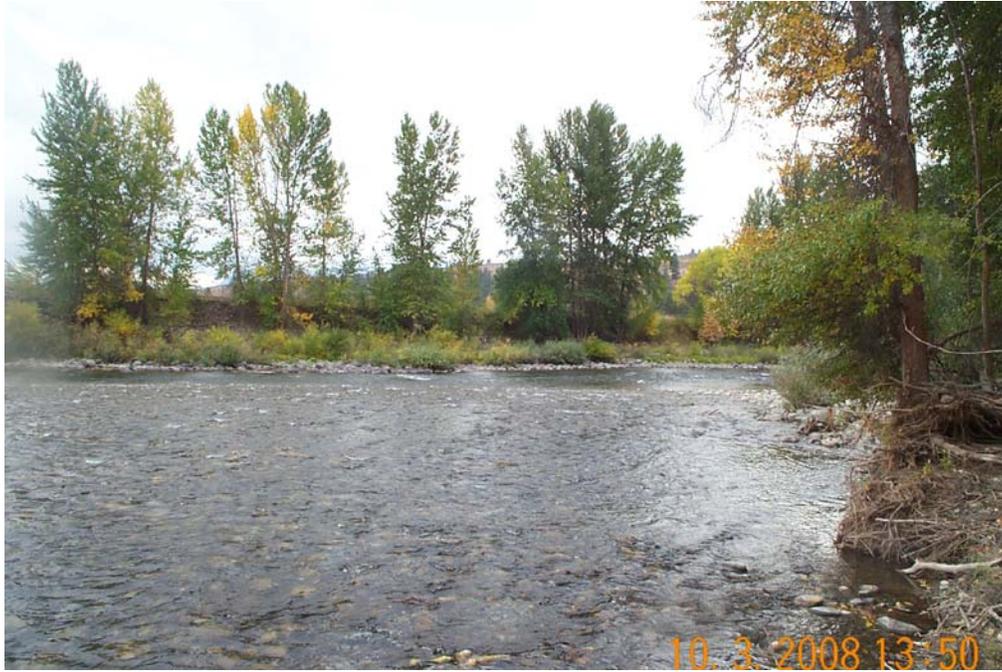
Photograph No. 17. View is to the south looking downstream at a riffle-rapid-run sequence near RM 47.4. Middle Methow Reach Assessment – Methow Subbasin, Washington – Bureau of Reclamation Photograph by E. Lyon, October 3, 2008.

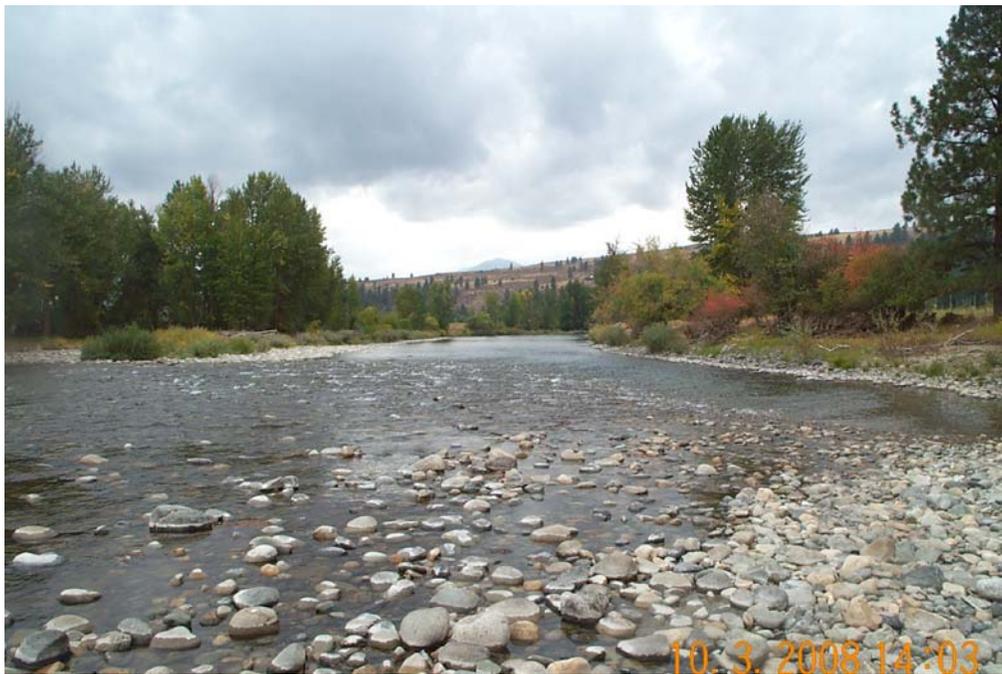
Photograph No. 18. View is to the south looking downstream at a riffle-run sequence where redds were observed in the tail-out section of the riffle near RM 47.6. Middle Methow Reach Assessment – Methow Subbasin, Washington – Bureau of Reclamation Photograph by E. Lyon, October 3, 2008.

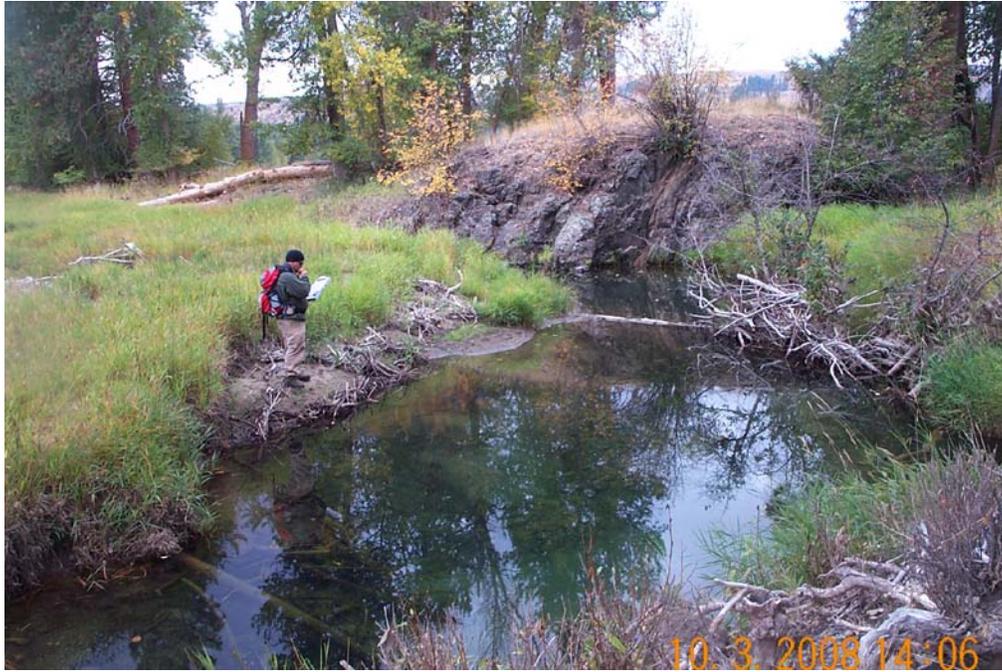
Photograph No. 19. View is to the south looking downstream at a lateral scour pool formed by bedrock along Pigott side channel along river right near RM 47.6. Middle Methow Reach Assessment – Methow Subbasin, Washington – Bureau of Reclamation Photograph by E. Lyon, October 3, 2008.

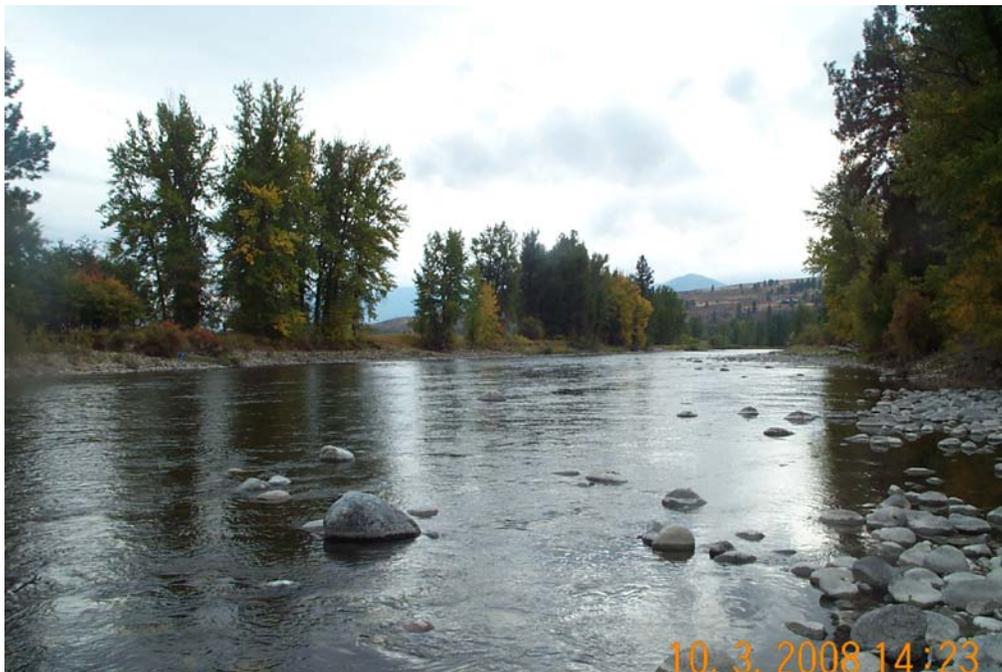
Photograph No. 20. View is to the south looking downstream at a run with the dominant substrate being cobbles and boulders near RM 47.9. Middle Methow Reach Assessment – Methow Subbasin, Washington – Bureau of Reclamation Photograph by E. Lyon, October 3, 2008.

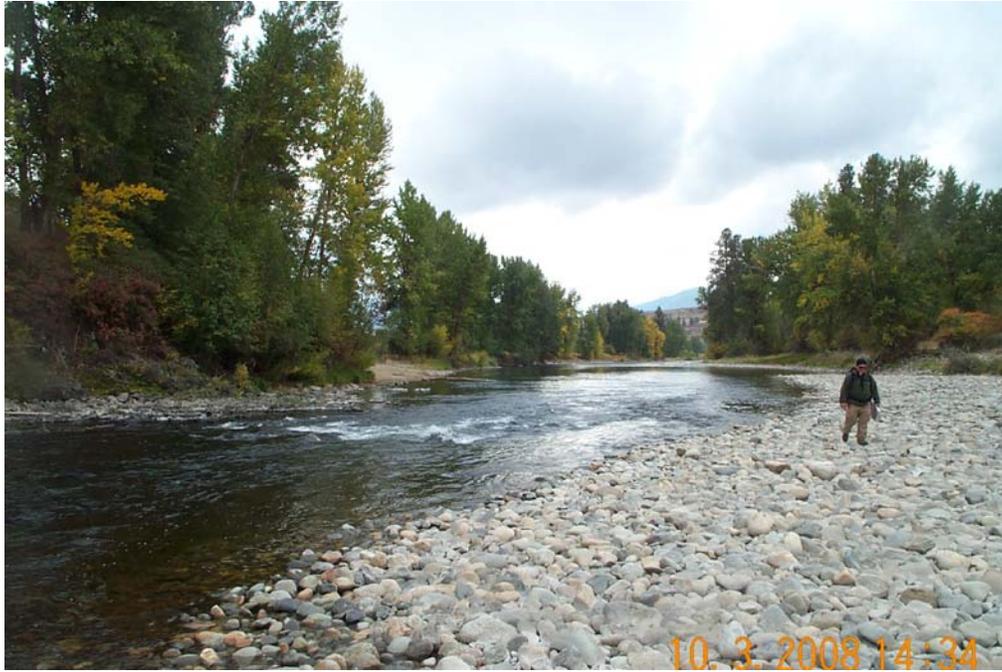
Photograph No. 21. View is to the south looking downstream at a run-rapid-pool sequence where bedrock crops out in the channel near RM 48.0. Middle Methow Reach Assessment – Methow Subbasin, Washington – Bureau of Reclamation Photograph by E. Lyon, October 3, 2008.

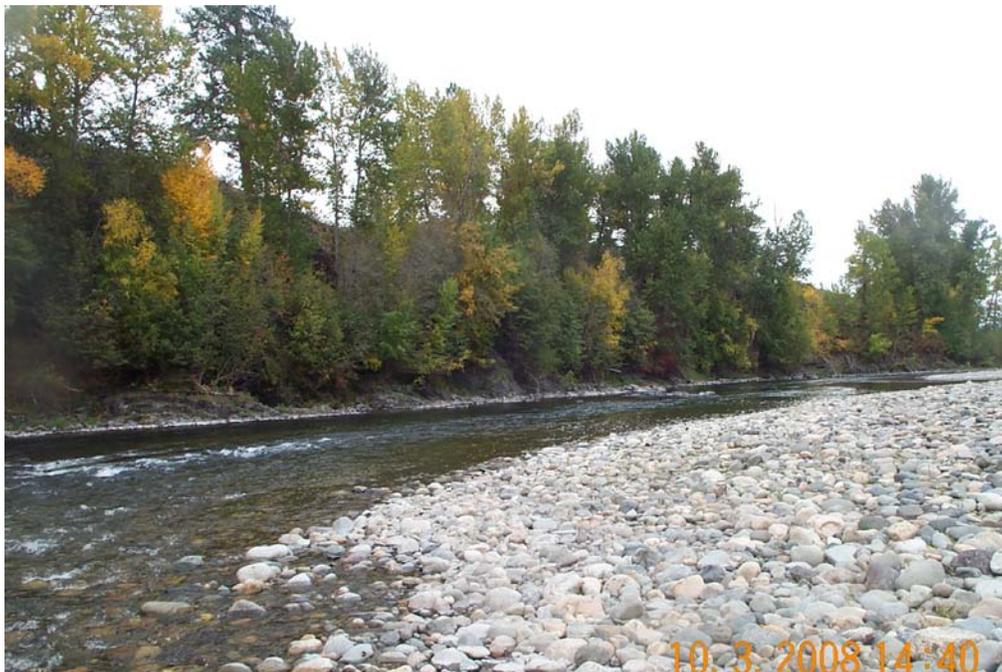
Photograph No. 22. View is to the southeast looking downstream at a rapid-pool sequence where bedrock crops out in the channel near RM 48.0. Middle Methow Reach Assessment – Methow Subbasin, Washington – Bureau of Reclamation Photograph by E. Lyon, October 3, 2008.

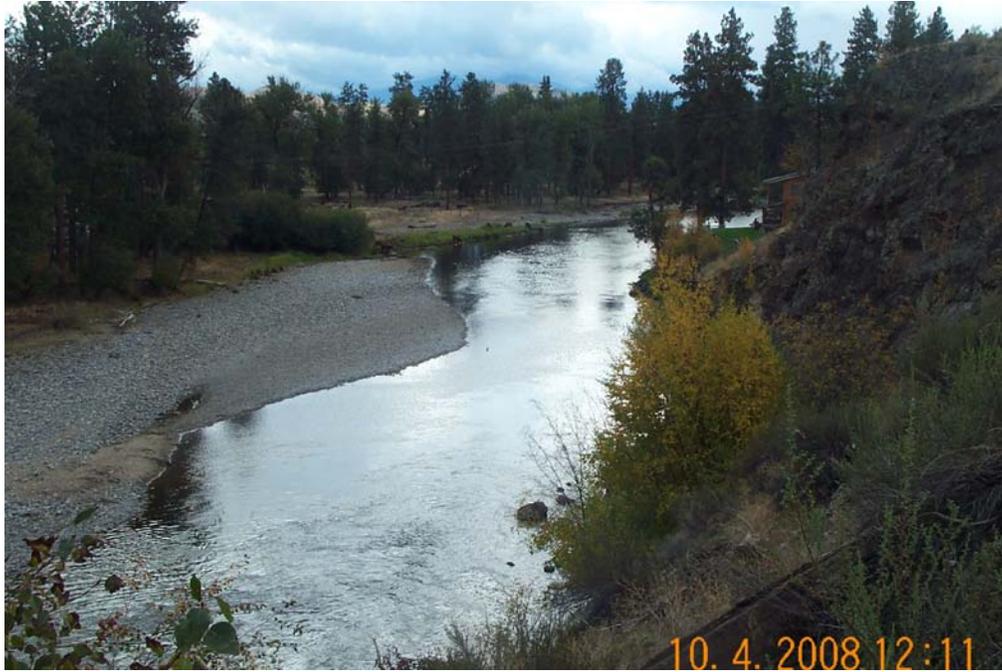
Photograph No. 23. View is to the southeast looking downstream at a large lateral scour pool formed by bedrock near RM 44.1. Note cattle accessing the river along river left. Middle Methow Reach Assessment – Methow Subbasin, Washington – Bureau of Reclamation Photograph by E. Lyon, October 4, 2008.

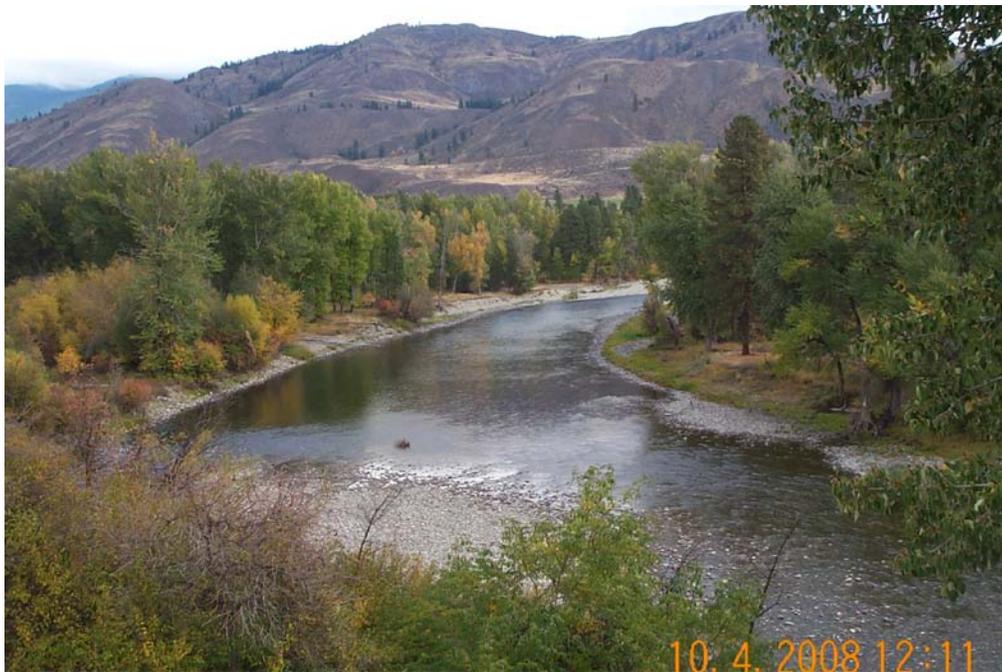
Photograph No. 24. View is to the northwest looking upstream at a run-riffle sequence near RM 44.1. Middle Methow Reach Assessment – Methow Subbasin, Washington – Bureau of Reclamation Photograph by E. Lyon, October 4, 2008.

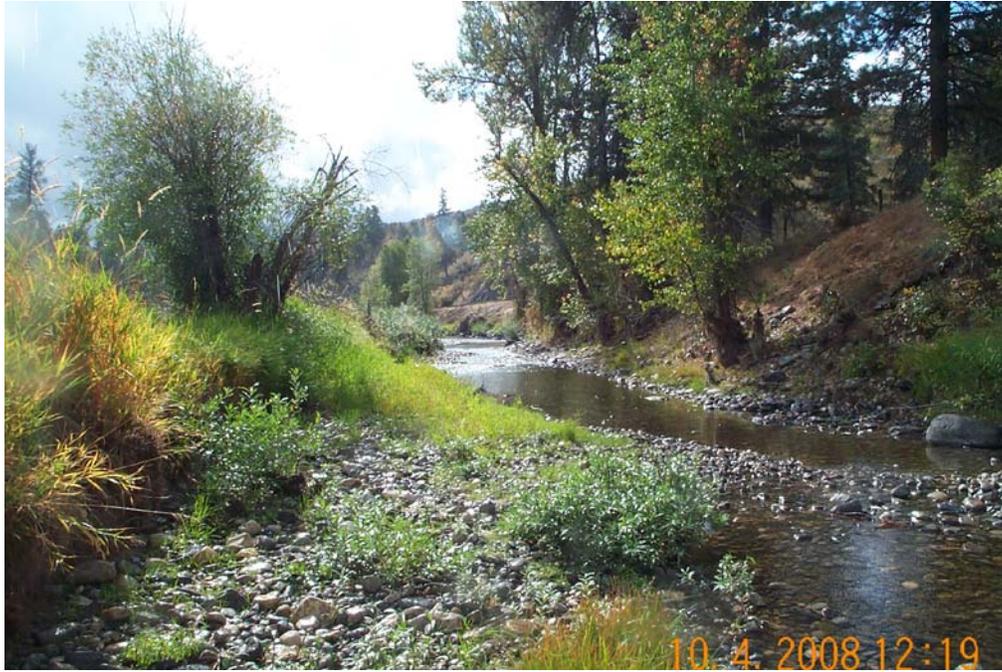
Photograph No. 25. View is to the south looking downstream along a perennial side channel along river right near RM 43.6. Middle Methow Reach Assessment – Methow Subbasin, Washington – Bureau of Reclamation Photograph by E. Lyon, October 4, 2008.

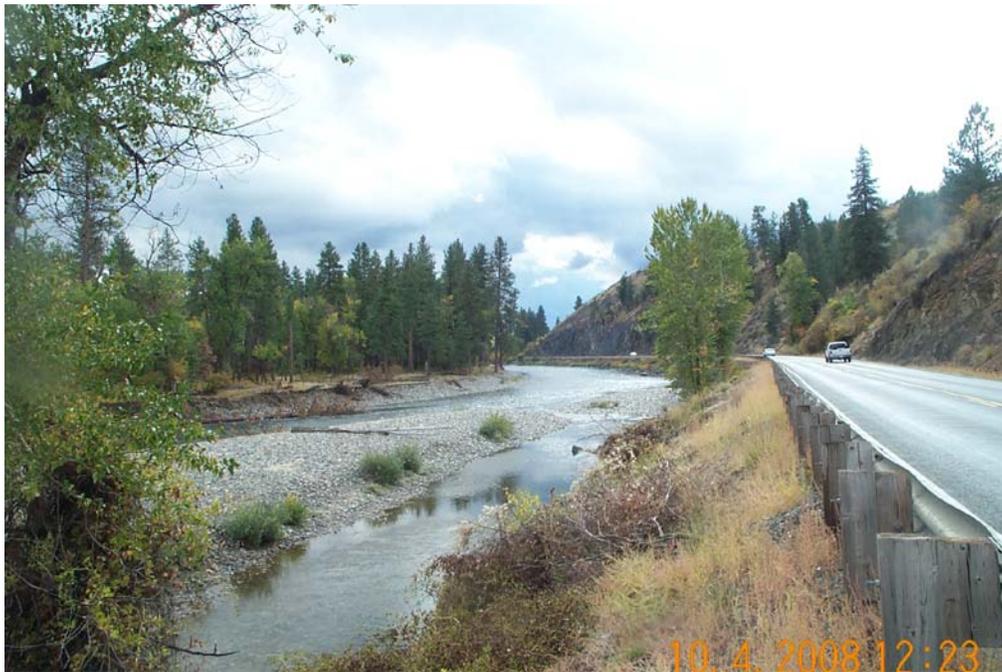
Photograph No. 26. View is to the south looking downstream at the outlet of the perennial side channel in Photograph No. 25 near RM 43.6. Middle Methow Reach Assessment – Methow Subbasin, Washington – Bureau of Reclamation Photograph by E. Lyon, October 4, 2008.

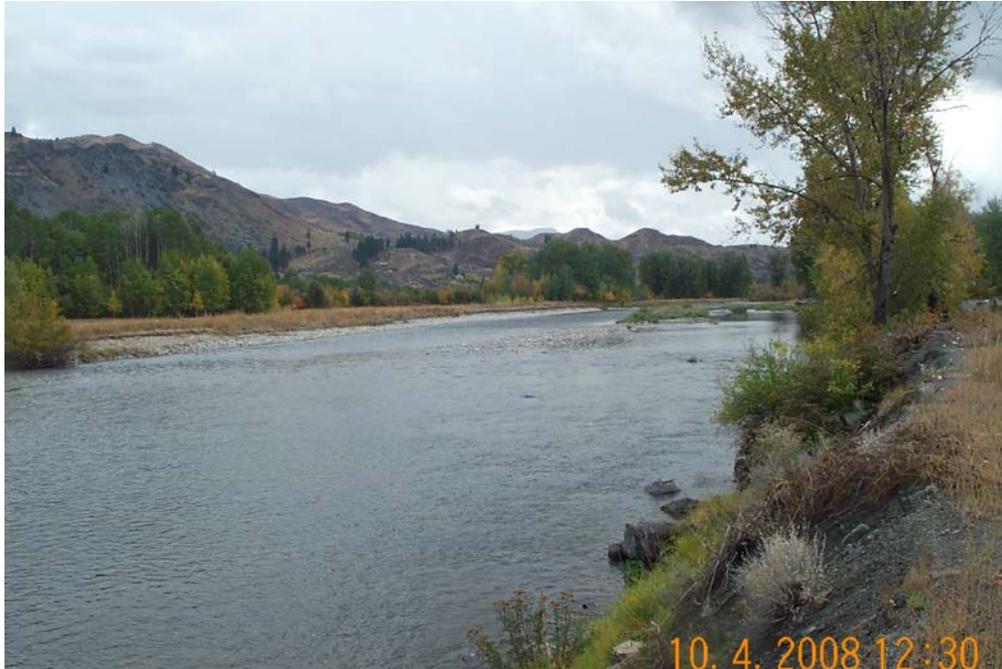
Photograph No. 27. View is to the southeast looking downstream at a split flow near RM 43.4. Note the bank erosion occurring along river left where the vegetation has been disturbed. Middle Methow Reach Assessment – Methow Subbasin, Washington – Bureau of Reclamation Photograph by E. Lyon, October 4, 2008.

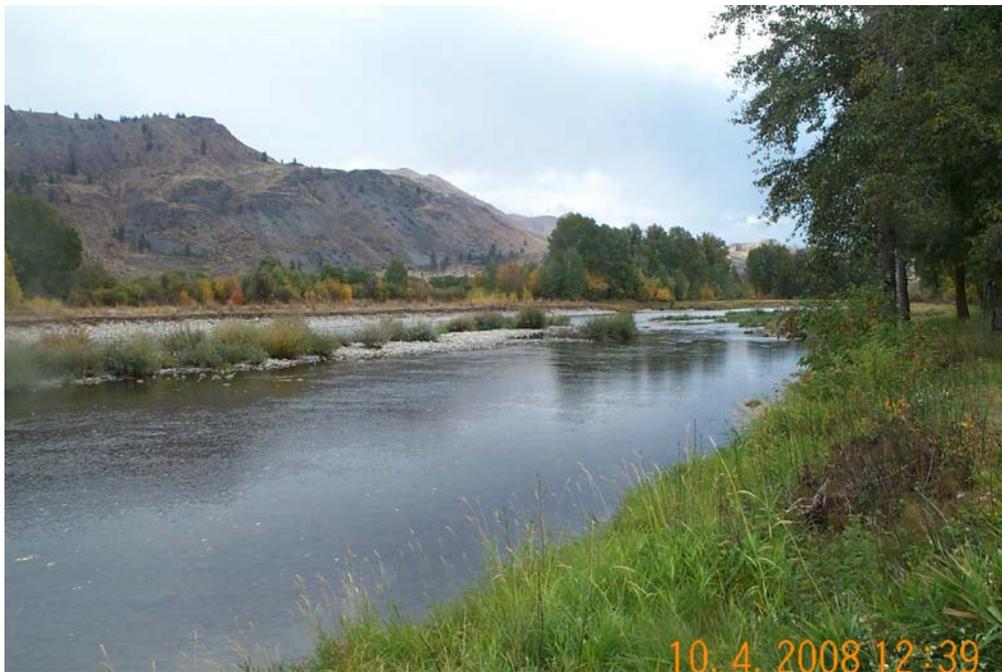
Photograph No. 28. View is to the southeast looking downstream along the right split-flow channel near RM 43.3. Middle Methow Reach Assessment – Methow Subbasin, Washington – Bureau of Reclamation Photograph by E. Lyon, October 4, 2008.

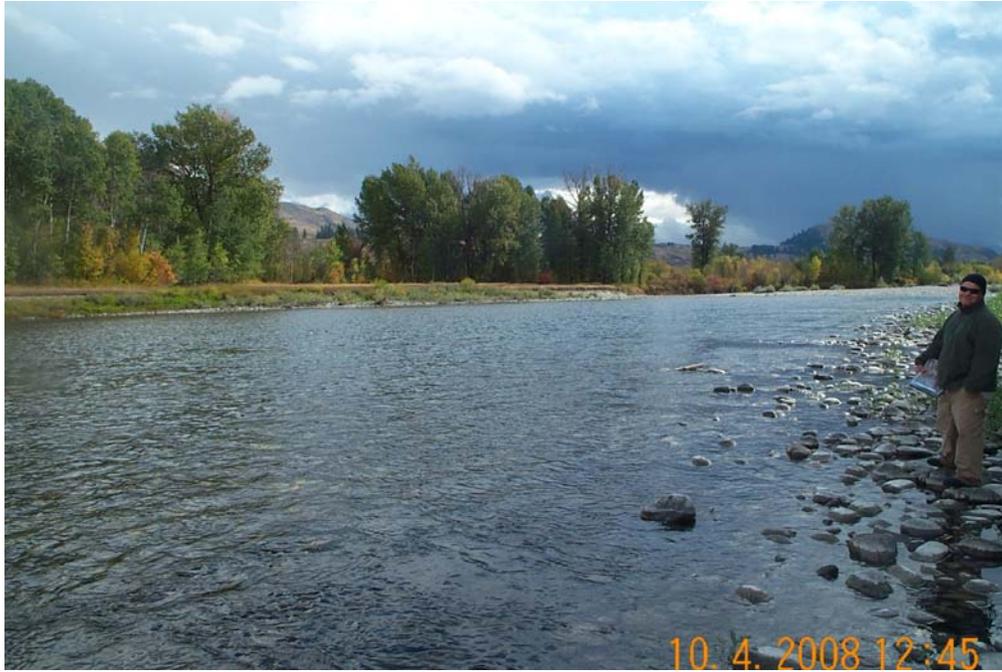
Photograph No. 29. View is to the southeast looking downstream at a run-riffle sequence where summer Chinook salmon were observed spawning near RM 43.1. Middle Methow Reach Assessment – Methow Subbasin, Washington – Bureau of Reclamation Photograph by E. Lyon, October 4, 2008.

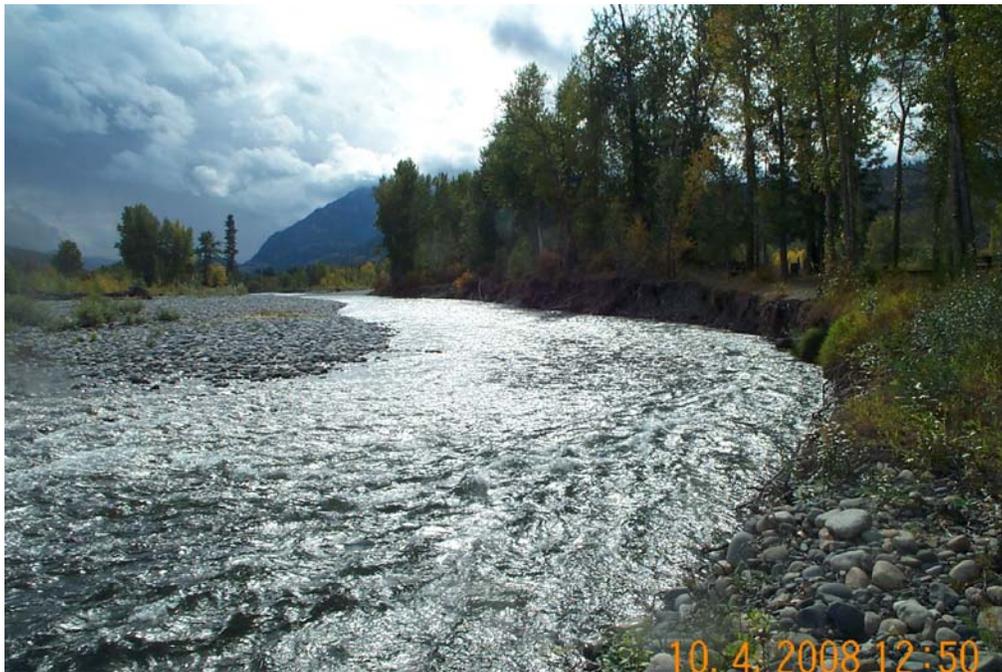
Photograph No. 30. View is to the south looking downstream at a rapid where the stream gradient has increased and the river is trying to migrate laterally along river right near RM 43.0. Middle Methow Reach Assessment – Methow Subbasin, Washington – Bureau of Reclamation Photograph by E. Lyon, October 4, 2008.

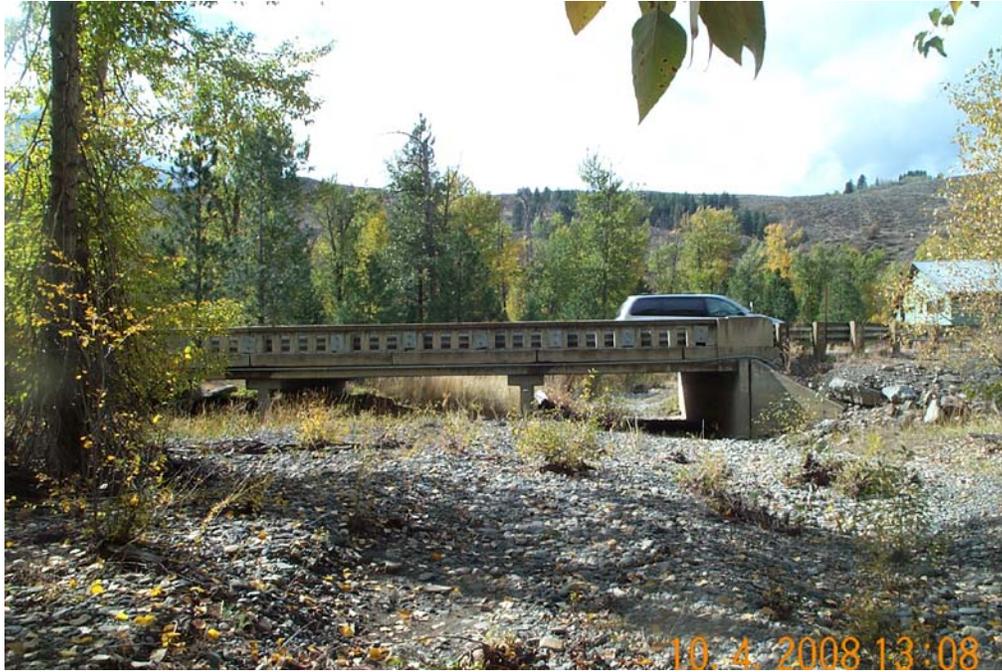
Photograph No. 31. View is to the southwest looking downstream at the highway bridge crossing an overflow channel near RM 42.6. Middle Methow Reach Assessment – Methow Subbasin, Washington – Bureau of Reclamation Photograph by E. Lyon, October 4, 2008.

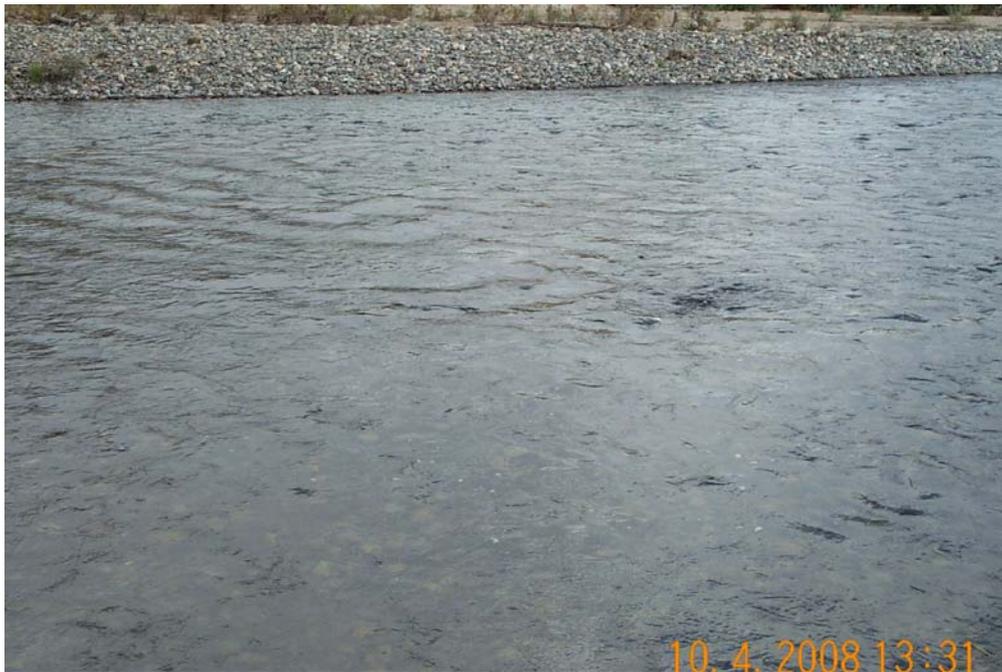
Photograph No. 32. View is to the east looking at turbulence caused by spawning summer Chinook salmon near RM 43.0. Middle Methow Reach Assessment – Methow Subbasin, Washington – Bureau of Reclamation Photograph by E. Lyon, October 4, 2008.

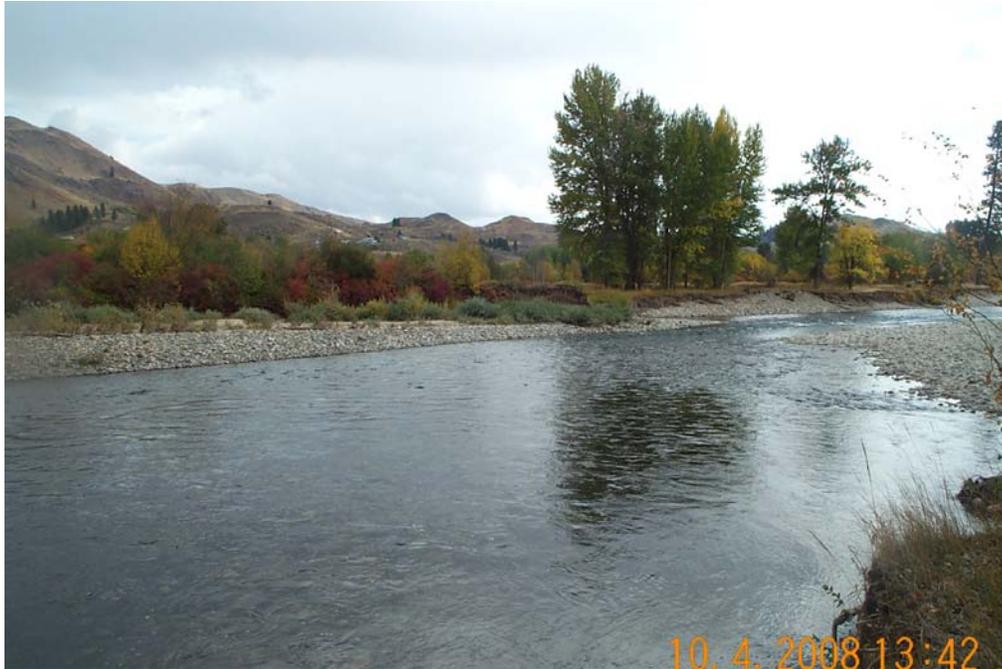
Photograph No. 33. View is to the southeast looking downstream at a run-riffle-rapid sequence near RM 43.0. Numerous summer Chinook salmon were observed spawning in the run-riffle channel units as noted in Photograph No. 32. Middle Methow Reach Assessment – Methow Subbasin, Washington – Bureau of Reclamation Photograph by E. Lyon, October 4, 2008.

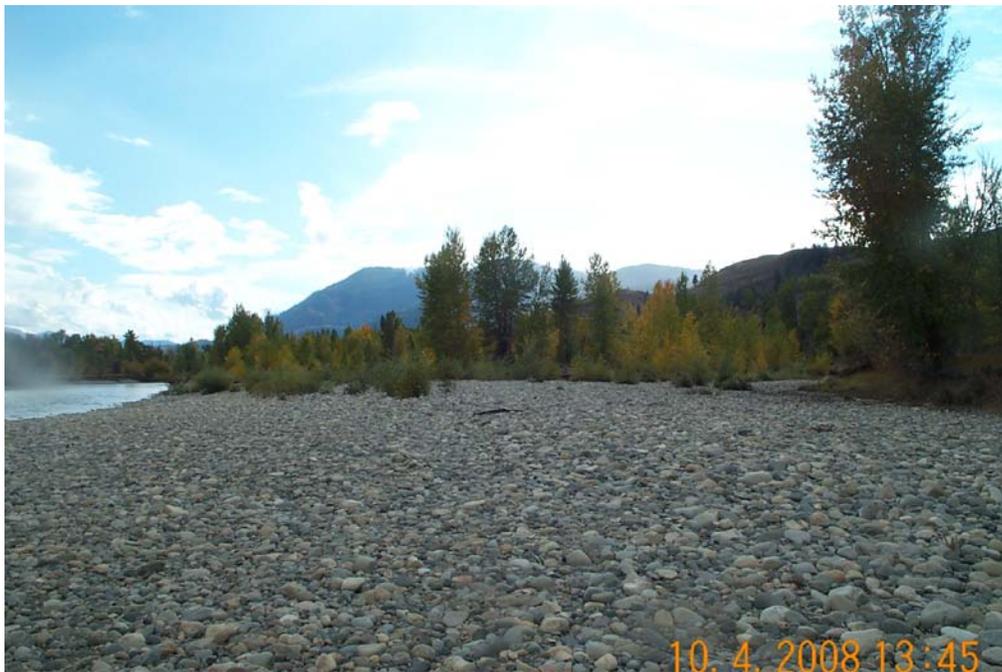
Photograph No. 34. View is to the south looking downstream at the head of a side channel forming along river right near RM 42.9. Middle Methow Reach Assessment – Methow Subbasin, Washington – Bureau of Reclamation Photograph by E. Lyon, October 4, 2008.

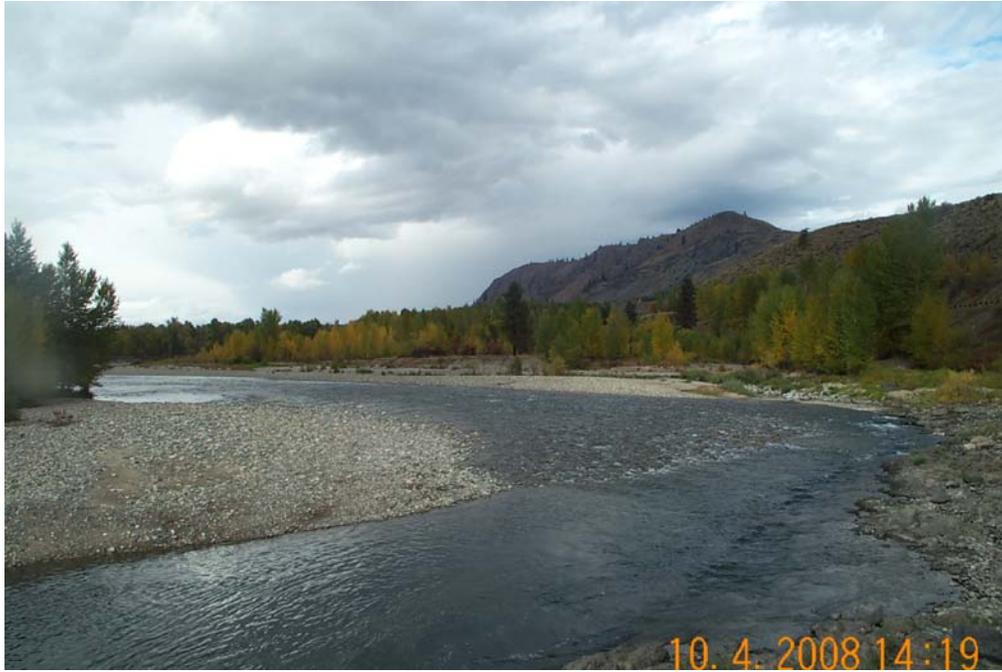
Photograph No. 37. View is to the north looking upstream at a riffle-rapid-pool sequence as the river flows against a bedrock outcrop along river left near RM 41.2. Middle Methow Reach Assessment – Methow Subbasin, Washington – Bureau of Reclamation Photograph by E. Lyon, October 4, 2008.

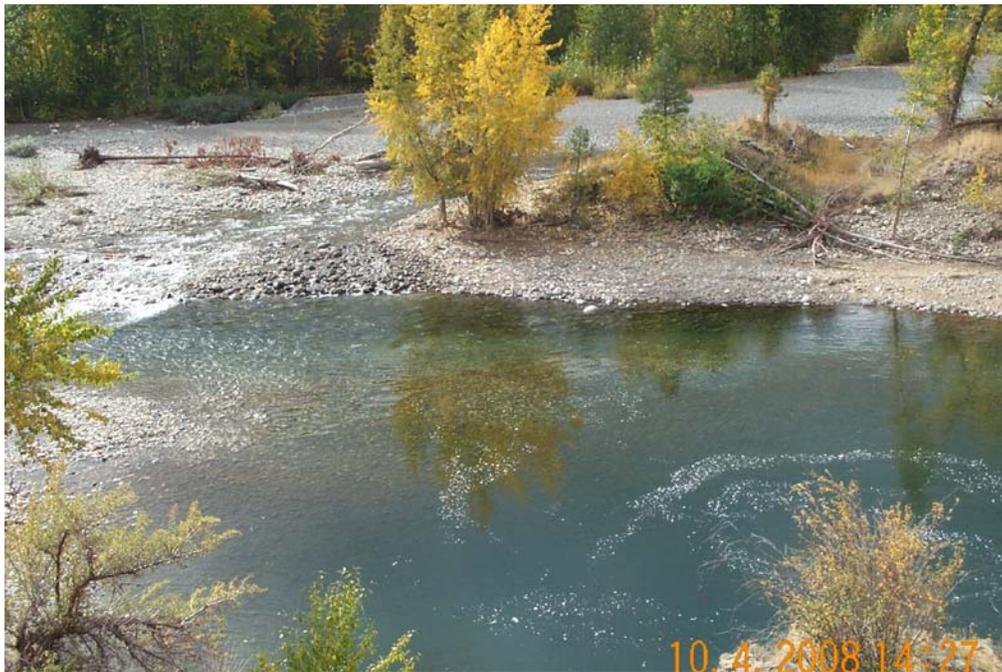
Photograph No. 38. View is to the west looking at a large pool formed by lateral scour against a bedrock outcrop near RM 41.2 just upstream of the confluence with the Twisp River. Also note the large redd and spawning summer Chinook salmon in the “clean gravels” in the pool tailout. Middle Methow Reach Assessment – Methow Subbasin, Washington – Bureau of Reclamation Photograph by E. Lyon, October 4, 2008.

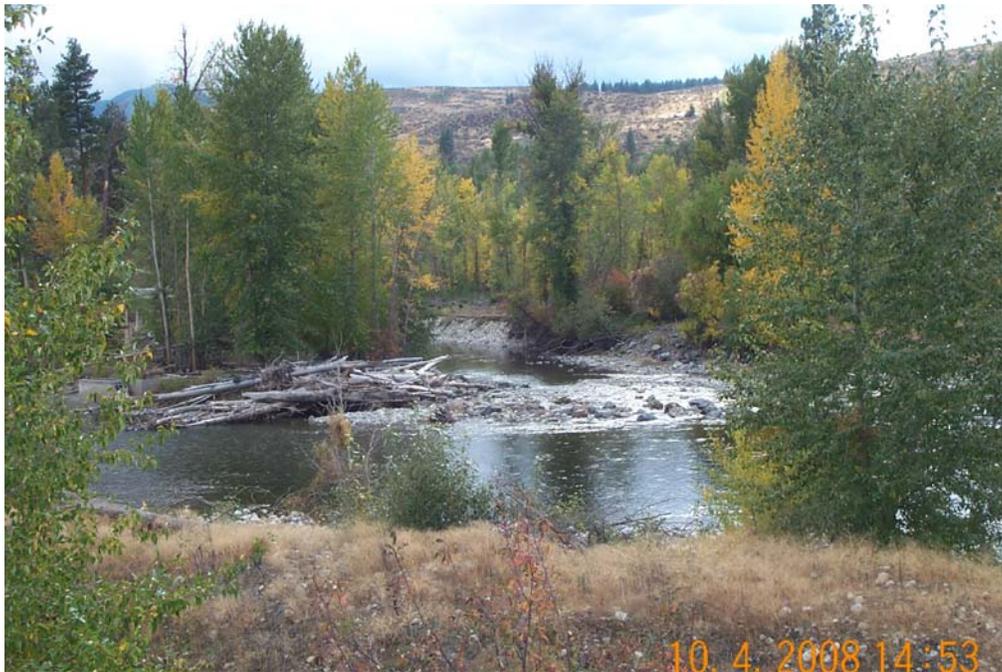
Photograph No. 40. View is to the southwest looking across at the head of a perennial side channel along river right just upstream of Methow Valley Irrigation District east diversion near RM 46.0. Middle Methow Reach Assessment – Methow Subbasin, Washington – Bureau of Reclamation Photograph by E. Lyon, October 4, 2008.
