APPENDICES

Reach-based Ecosystem Indicators (REI) Version 1.1

MIDDLE METHOW RIVER (M2 Reach) HABITAT ASSESSMENT OVERVIEW
River Mile 40.3 to River Mile 52.4

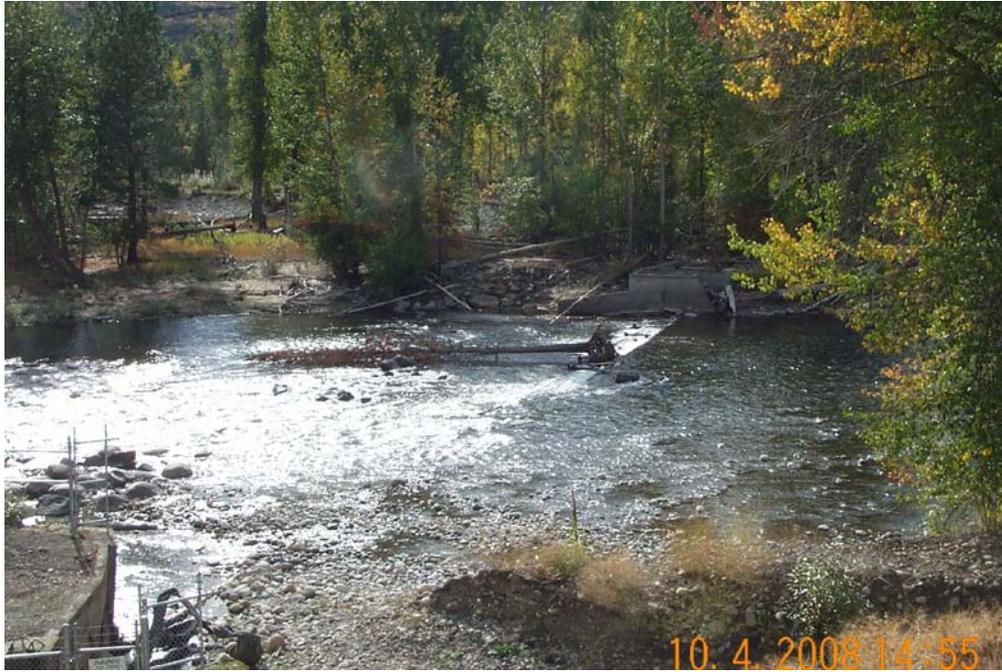
Photograph No. 41. View is to the west looking across at the Methow Valley Irrigation District's east canal diversion dam that was mechanically lowered in 2007 near RM 46.0. Middle Methow Reach Assessment – Methow Subbasin, Washington – Bureau of Reclamation Photograph by E. Lyon, October 4, 2008.

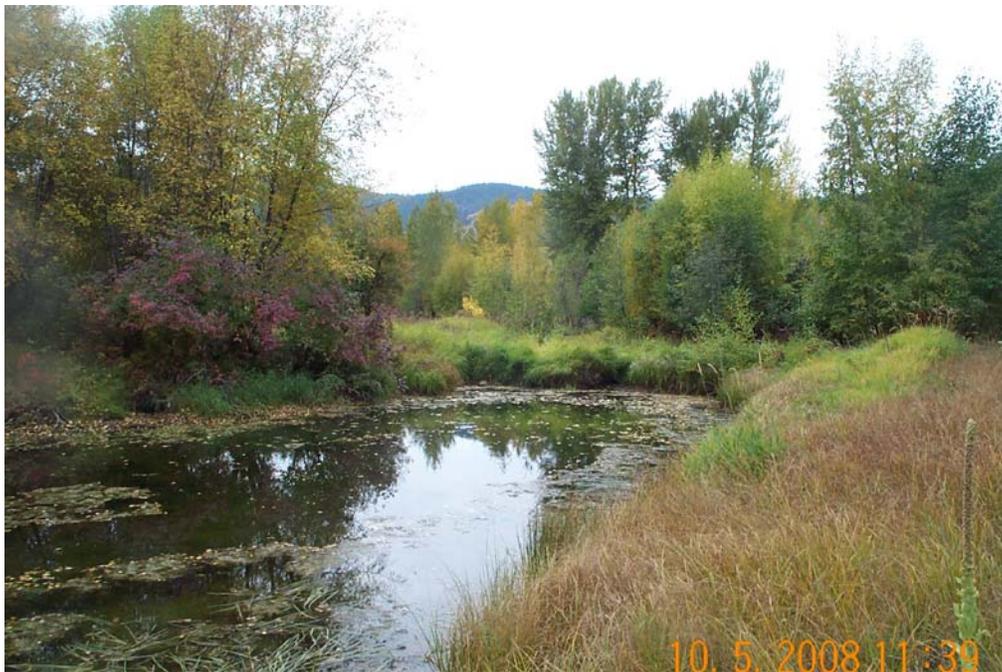
Photograph No. 42. View is to the south looking downstream along Anderson side channel at a historic beaver dam or embankment near RM 41.5. Middle Methow Reach Assessment – Methow Subbasin, Washington – Bureau of Reclamation Photograph by E. Lyon, October 5, 2008.

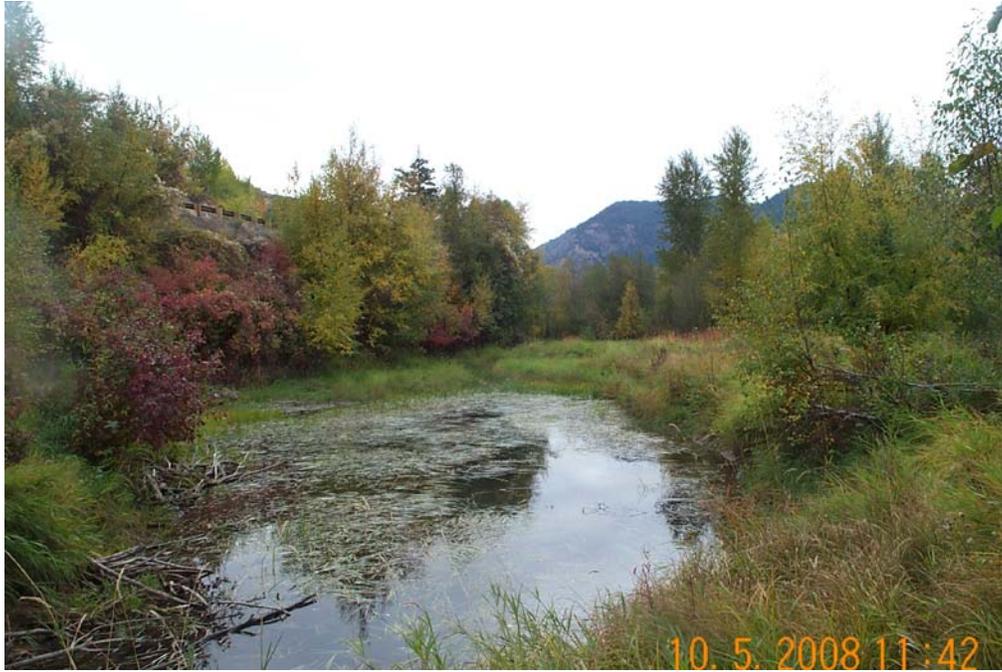
Photograph No. 43. View is to the south looking downstream along the Anderson side channel near RM 41.5. Middle Methow Reach Assessment – Methow Subbasin, Washington – Bureau of Reclamation Photograph by E. Lyon, October 5, 2008.

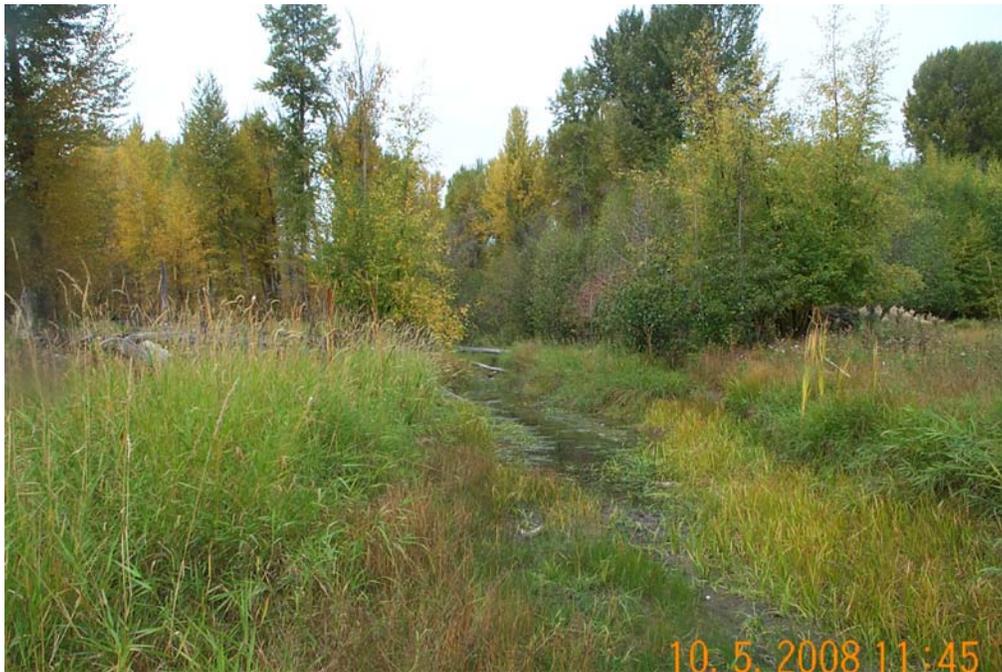
Photograph No. 44. View is to the northwest looking upstream at an overflow channel along river left near RM 41.5. Middle Methow Reach Assessment – Methow Subbasin, Washington – Bureau of Reclamation Photograph by E. Lyon, October 5, 2008.

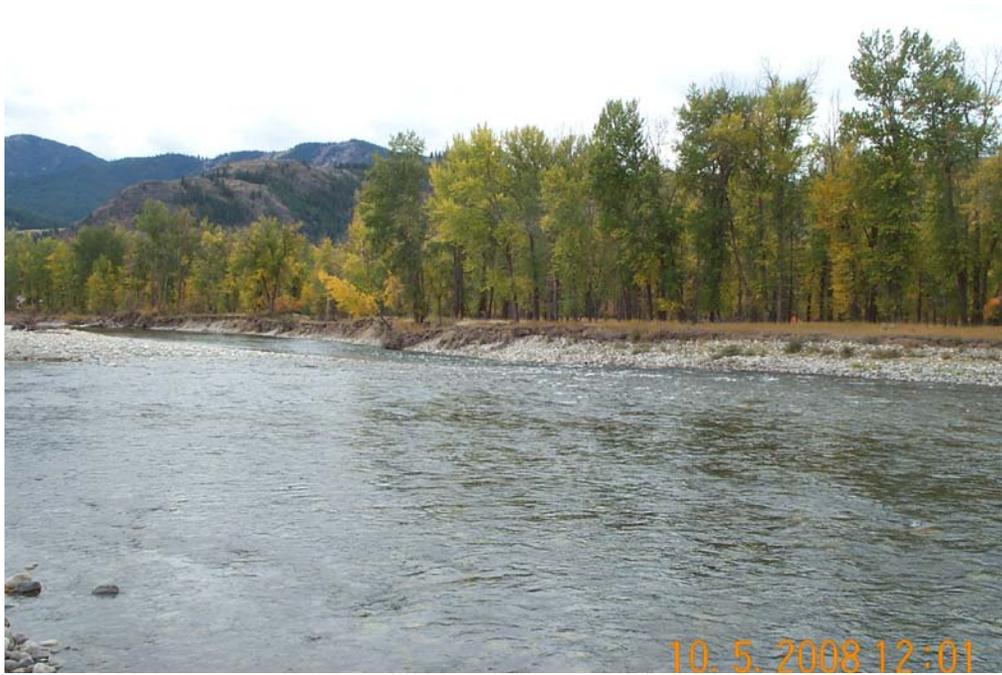
Photograph No. 45. View is to the southwest looking downstream at a riffle-rapid-run sequence near RM 41.8. Middle Methow Reach Assessment – Methow Subbasin, Washington – Bureau of Reclamation Photograph by E. Lyon, October 5, 2008.

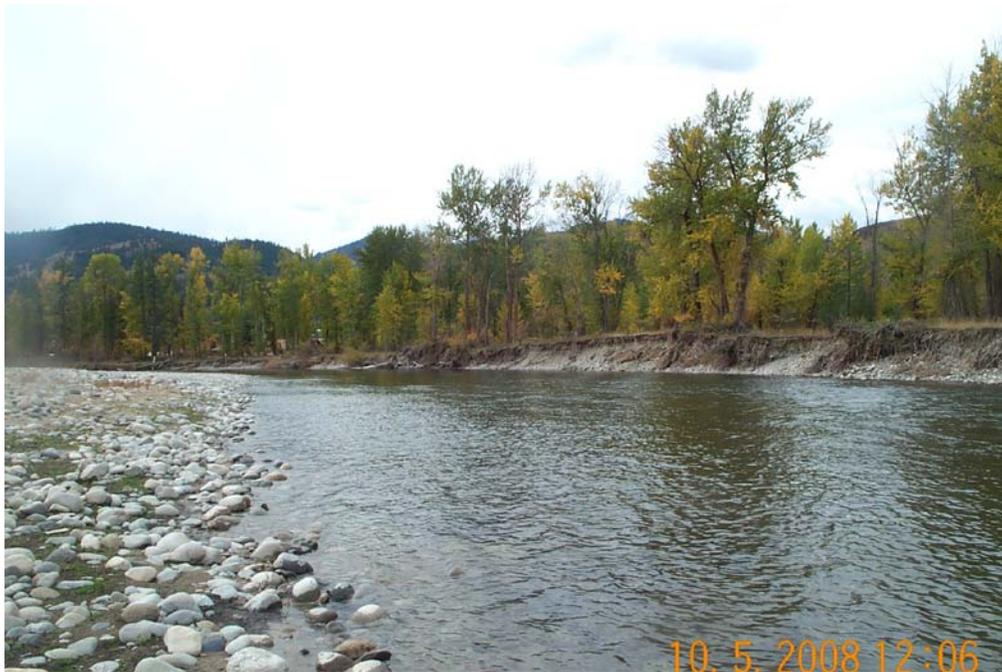
Photograph No. 46. View is to the southwest looking downstream at a run near RM 41.6. Note the bank erosion along river right. Middle Methow Reach Assessment – Methow Subbasin, Washington – Bureau of Reclamation Photograph by E. Lyon, October 5, 2008.

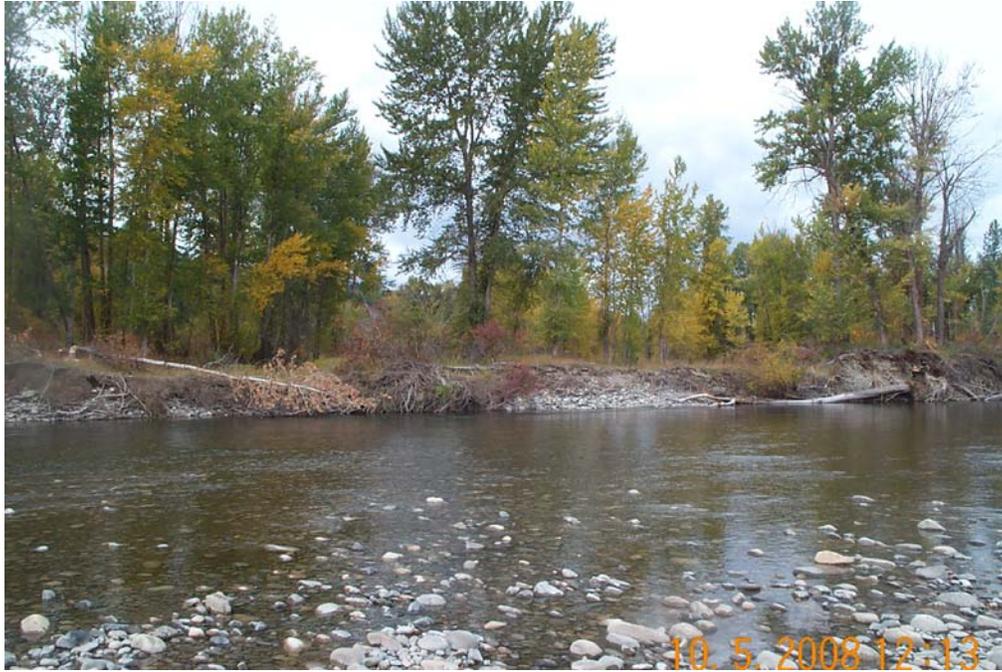
Photograph No. 47. View is to the northwest looking across at the head of a side channel (left of center in photograph) that is elevated about 0.5 m above the channel; and the mouth of an unnamed side channel (right of center in photograph) that is elevated about 1 m above the channel along river right near RM 41.5. Middle Methow Reach Assessment – Methow Subbasin, Washington – Bureau of Reclamation Photograph by E. Lyon, October 5, 2008.

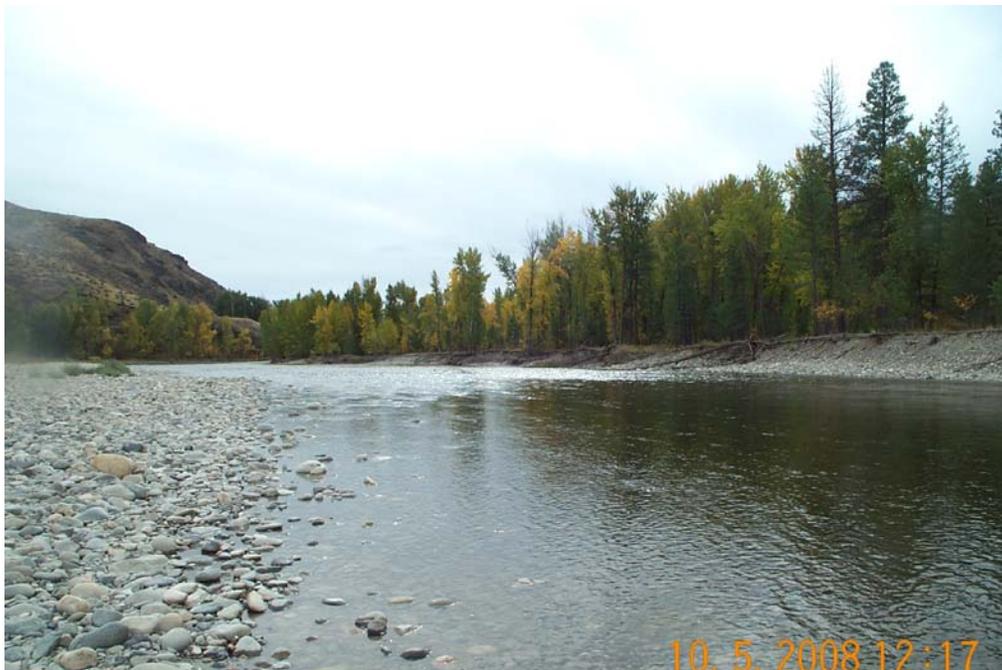
Photograph No. 48. View is to the south looking downstream at a run-riffle sequence near RM 41.5. Middle Methow Reach Assessment – Methow Subbasin, Washington – Bureau of Reclamation Photograph by E. Lyon, October 5, 2008.

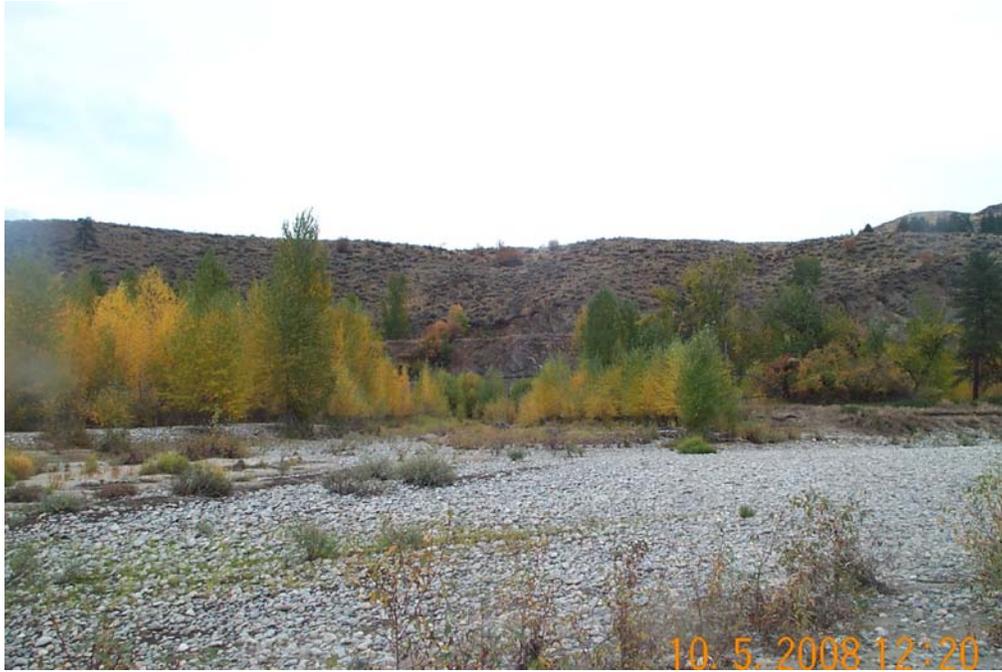
Photograph No. 49. View is to the east looking downstream at a side channel developing along river left near RM 41.4. During high flows this side channel connects the outlet of the Anderson side channel to the mainstem. Middle Methow Reach Assessment – Methow Subbasin, Washington – Bureau of Reclamation Photograph by E. Lyon, October 5, 2008.

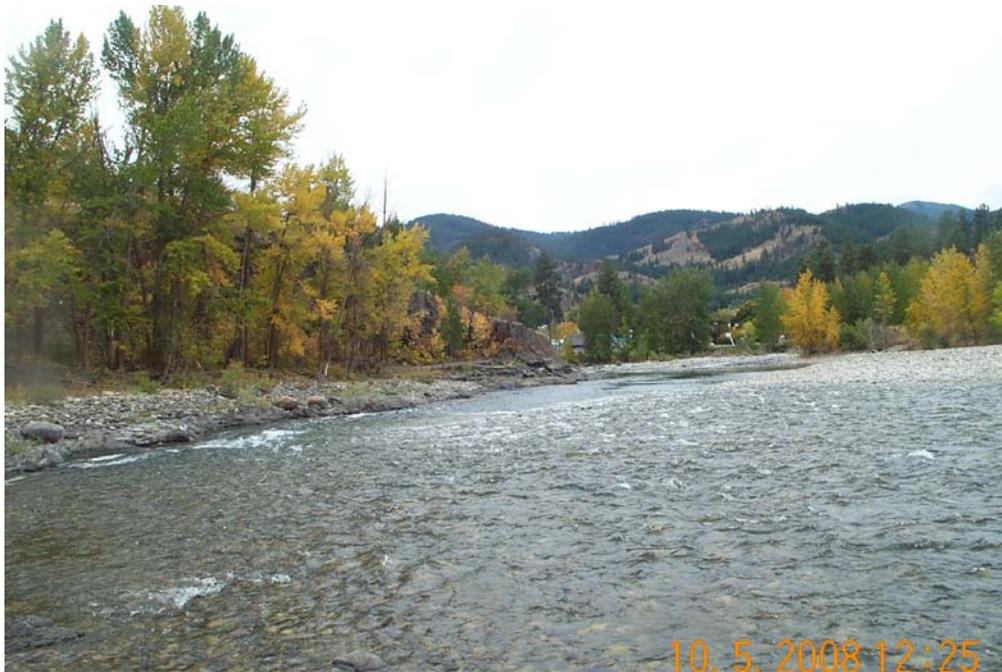
Photograph No. 50. View is to the south looking downstream at a riffle and large lateral scour pool formed by bedrock near RM 41.3. Middle Methow Reach Assessment – Methow Subbasin, Washington – Bureau of Reclamation Photograph by E. Lyon, October 5, 2008.

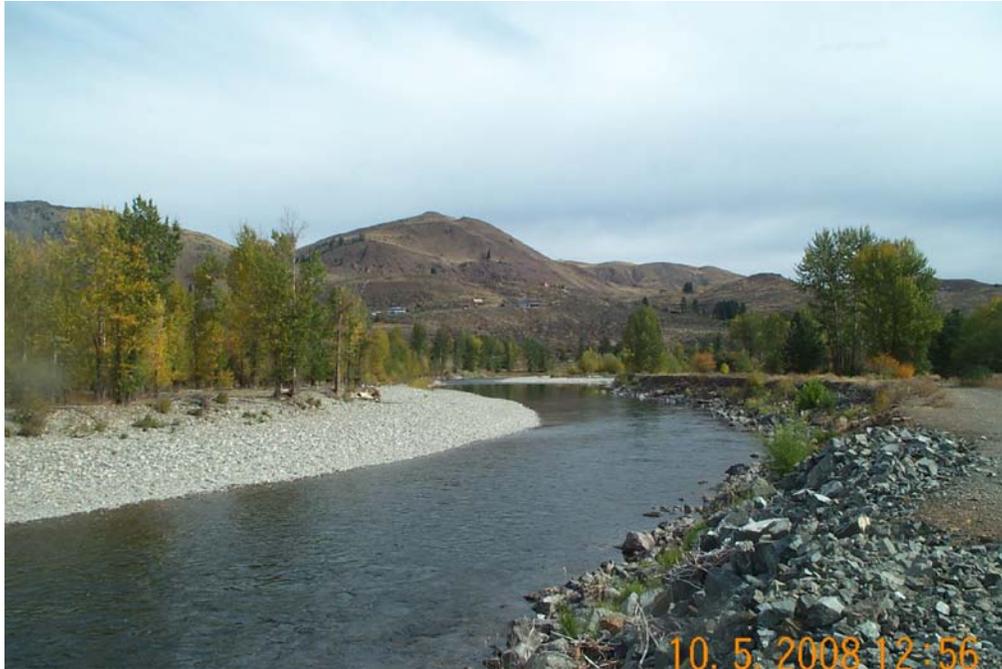
Photograph No. 51. View is to the east looking downstream at a run developed along levee placed on river right near RM 42.5. Note the downstream end of the riprap is failing. Middle Methow Reach Assessment – Methow Subbasin, Washington – Bureau of Reclamation Photograph by E. Lyon, October 5, 2008.

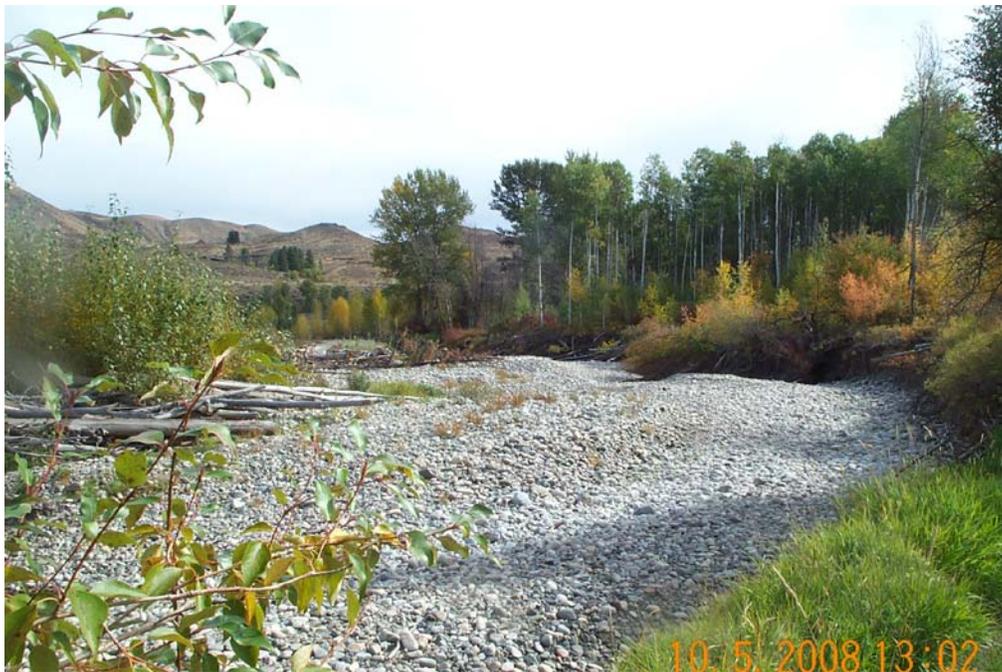
Photograph No. 52. View is to the southeast looking downstream at the head of Pederson side channel on river right near RM 42.3. Middle Methow Reach Assessment – Methow Subbasin, Washington – Bureau of Reclamation Photograph by E. Lyon, October 5, 2008.

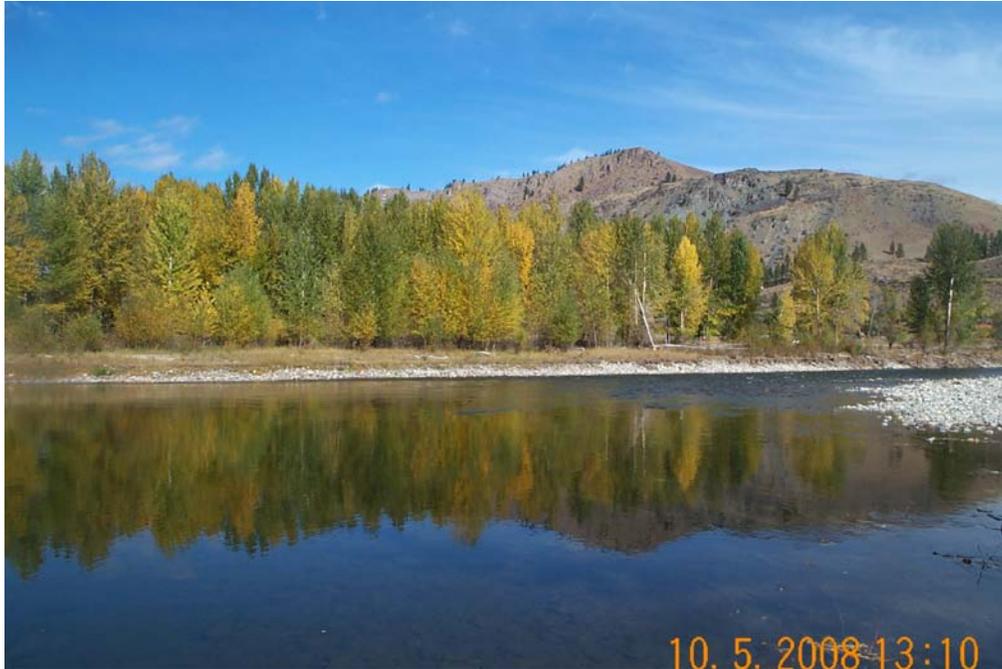
Photograph No. 53. View is to the west looking downstream at a large mid-channel scour pool downstream of the riprap in Photograph No. 51 near RM 42.3. Note summer Chinook salmon were observed spawning at the head of the riffle downstream of the pool. Middle Methow Reach Assessment – Methow Subbasin, Washington – Bureau of Reclamation Photograph by E. Lyon, October 5, 2008.

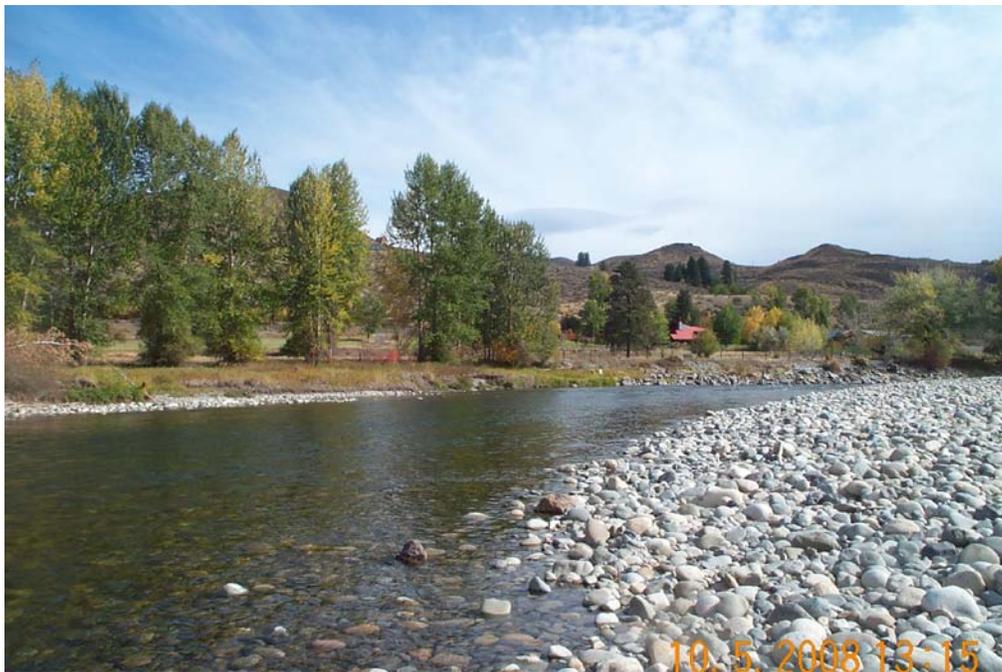
Photograph No. 54. View is to the southeast looking downstream at a run-riffle-rapid sequence near RM 42.2. Note riprap placed along river left where the rapid has developed. Middle Methow Reach Assessment – Methow Subbasin, Washington – Bureau of Reclamation Photograph by E. Lyon, October 5, 2008.

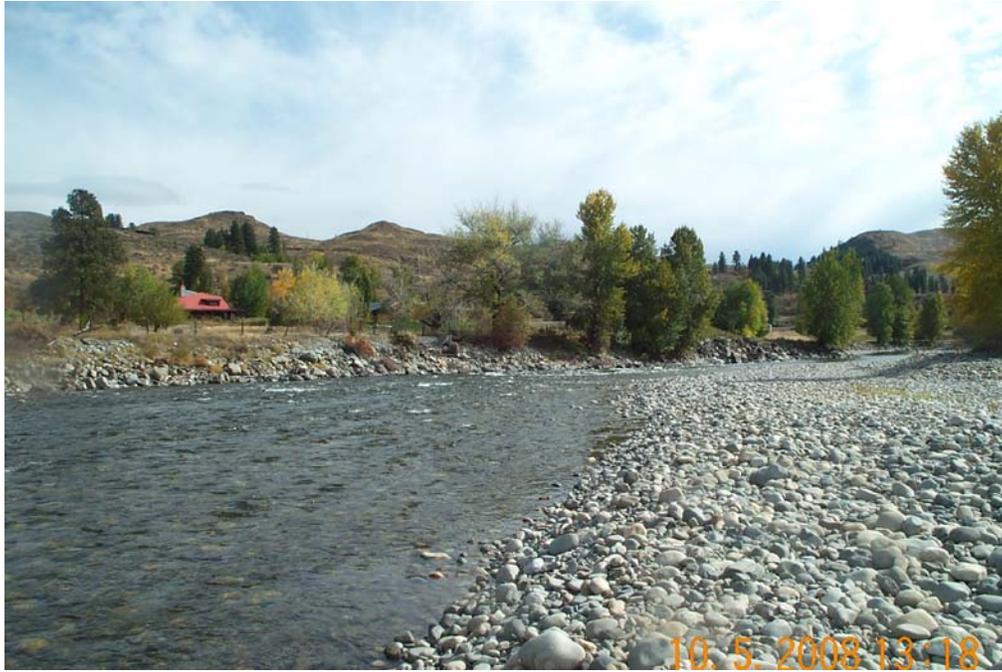
Photograph No. 55. View is to the southeast looking downstream at a riffle-rapid sequence near RM 42.1. Note riprap placed along river left appears to have captured the thalweg where the rapid has developed. Middle Methow Reach Assessment – Methow Subbasin, Washington – Bureau of Reclamation Photograph by E. Lyon, October 5, 2008.

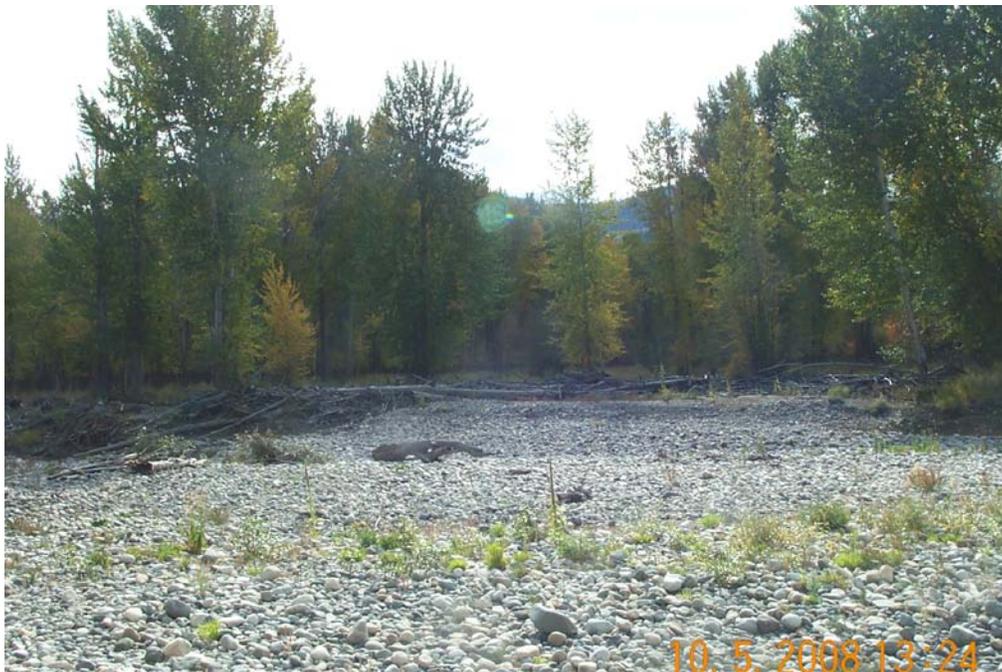
Photograph No. 56. View is to the south looking across the Pederson side channel and downstream at the head of a developing unnamed side channel near RM 42.0. Note cattle accessing the river along river left. Middle Methow Reach Assessment – Methow Subbasin, Washington – Bureau of Reclamation Photograph by E. Lyon, October 5, 2008.

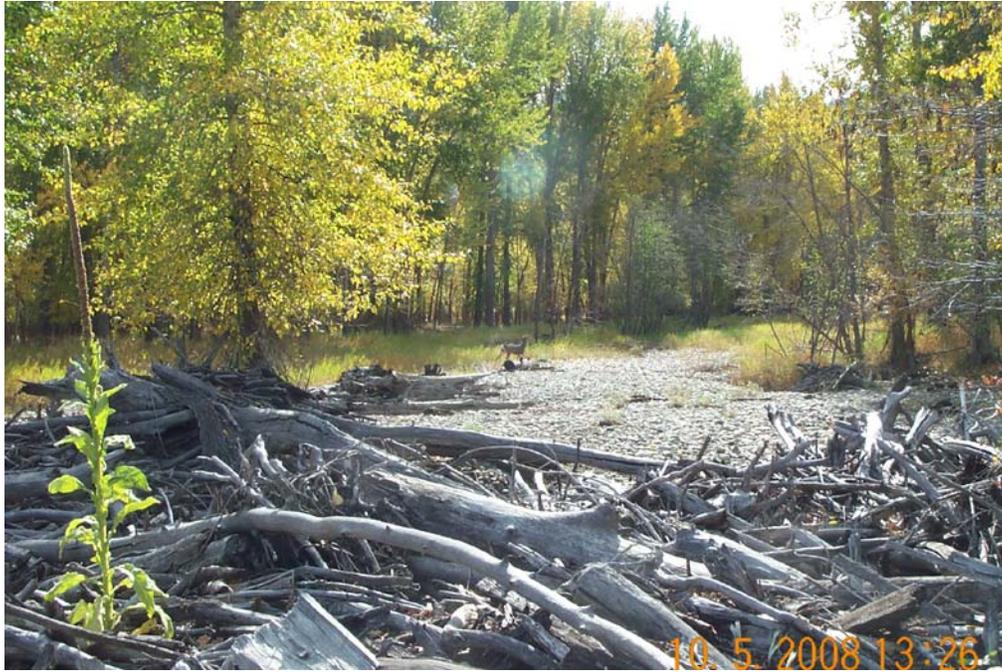
Photograph No. 57. View is to the southwest looking downstream along the developing side channel in Photograph No. 56 near RM 42.0. Middle Methow Reach Assessment – Methow Subbasin, Washington – Bureau of Reclamation Photograph by E. Lyon, October 5, 2008.

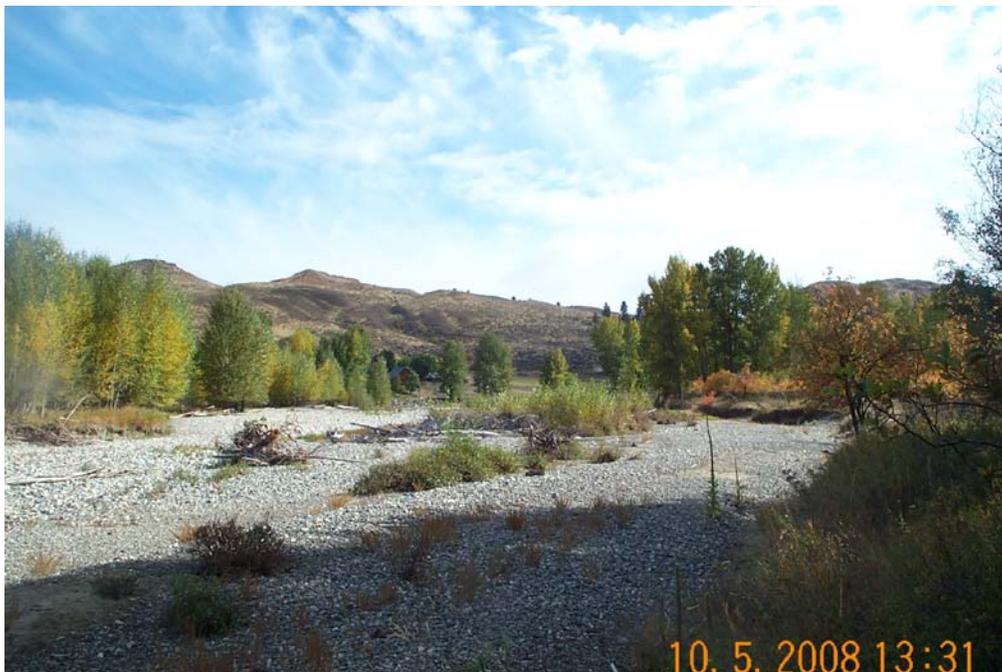
Photograph No. 58. View is to the southeast looking downstream along the Pederson side channel near RM 42.1. Middle Methow Reach Assessment – Methow Subbasin, Washington – Bureau of Reclamation Photograph by E. Lyon, October 5, 2008.

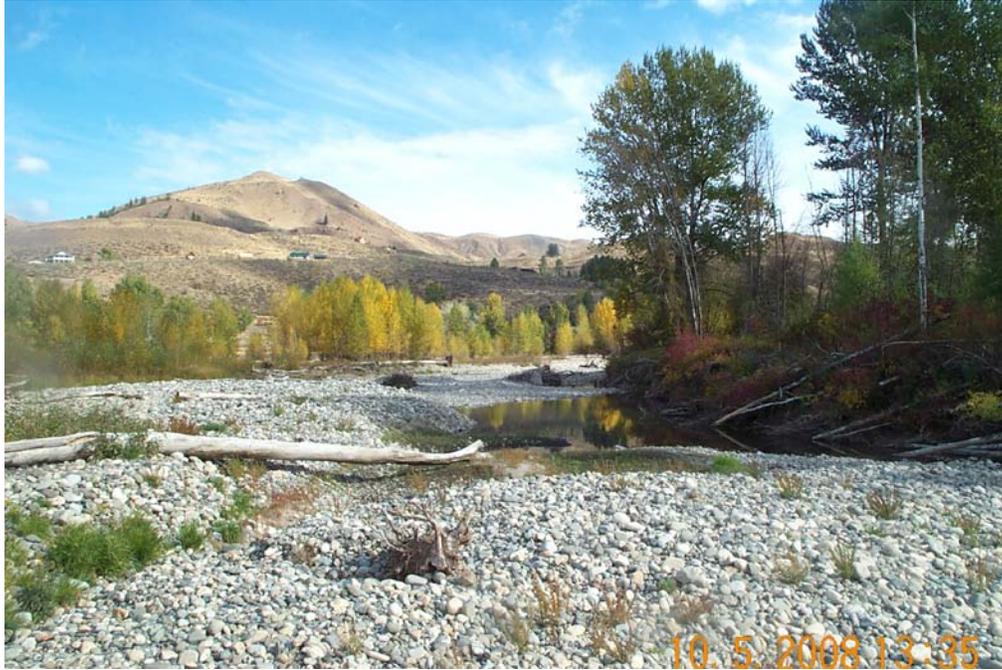
Photograph No. 59. View is to the east looking downstream at a lateral scour pool formed by large wood along the Pederson side channel near RM 42.3. Middle Methow Reach Assessment – Methow Subbasin, Washington – Bureau of Reclamation Photograph by E. Lyon, October 5, 2008.

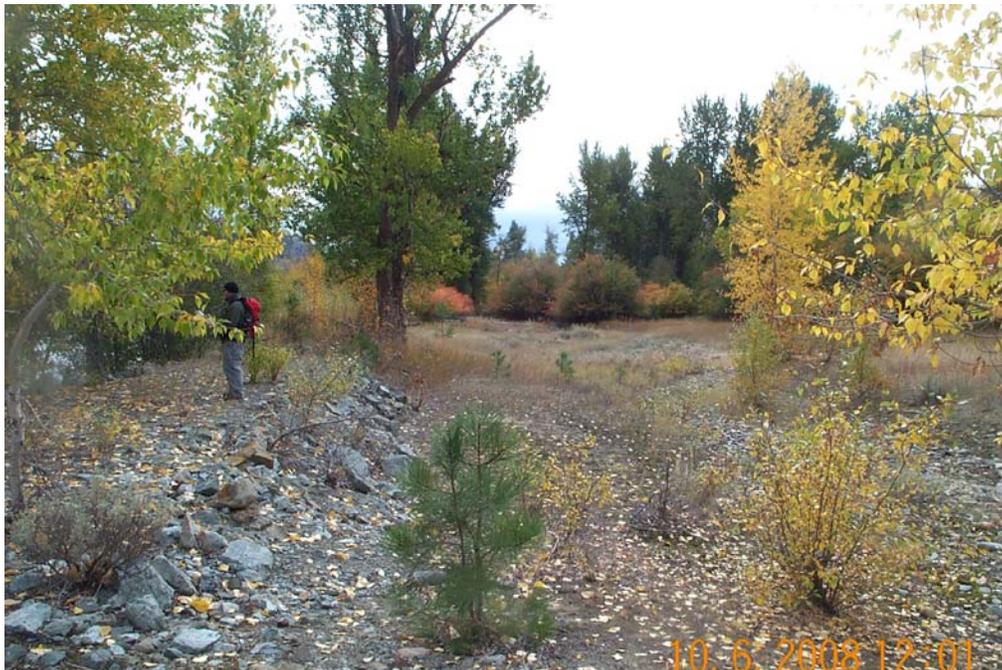
Photograph No. 60. View is to the southeast looking downstream along the backside of a levee along river right near RM 46.1. Middle Methow Reach Assessment – Methow Subbasin, Washington – Bureau of Reclamation Photograph by E. Lyon, October 6, 2008.

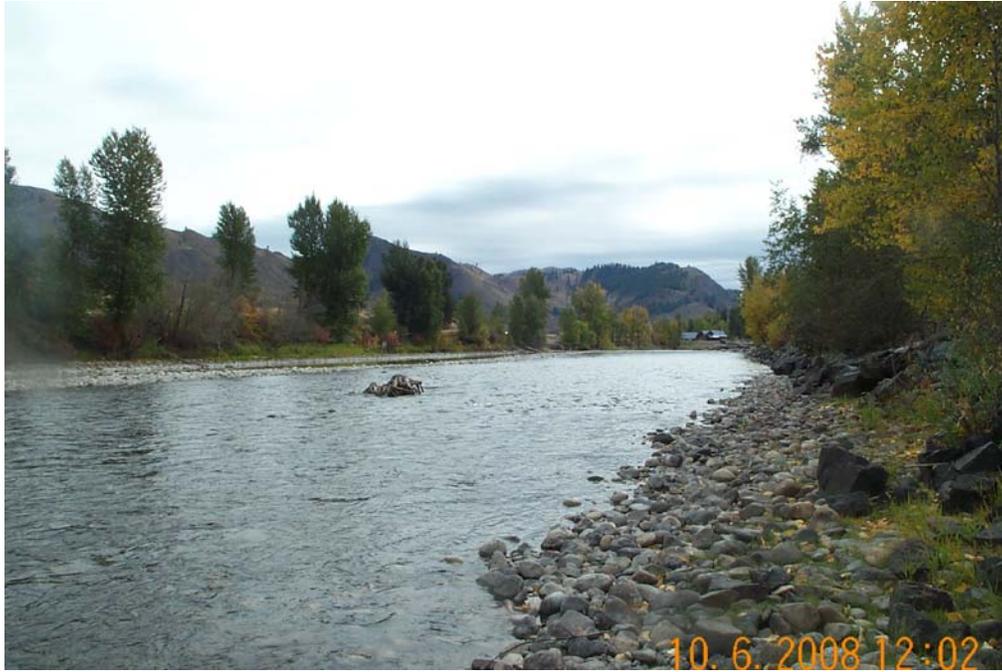
Photograph No. 61. View is to the southeast looking downstream along a levee placed along river right upstream of Methow Valley Irrigation District East Canal diversion dam near RM 46.1. Middle Methow Reach Assessment – Methow Subbasin, Washington – Bureau of Reclamation Photograph by E. Lyon, October 6, 2008.

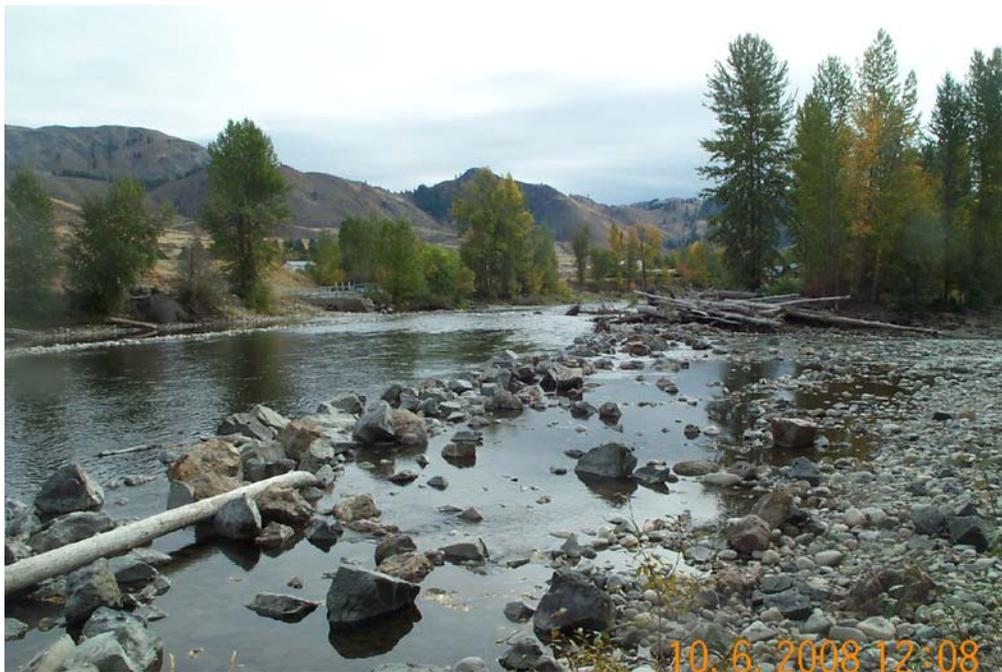
Photograph No. 62. View is to the east looking across the head of McNae side channel with riprap placed across the channel to keep more water in the main channel near RM 46.0. Note the Methow Valley Irrigation District East Canal diversion dam in background. Middle Methow Reach Assessment – Methow Subbasin, Washington – Bureau of Reclamation Photograph by E. Lyon, October 6, 2008.

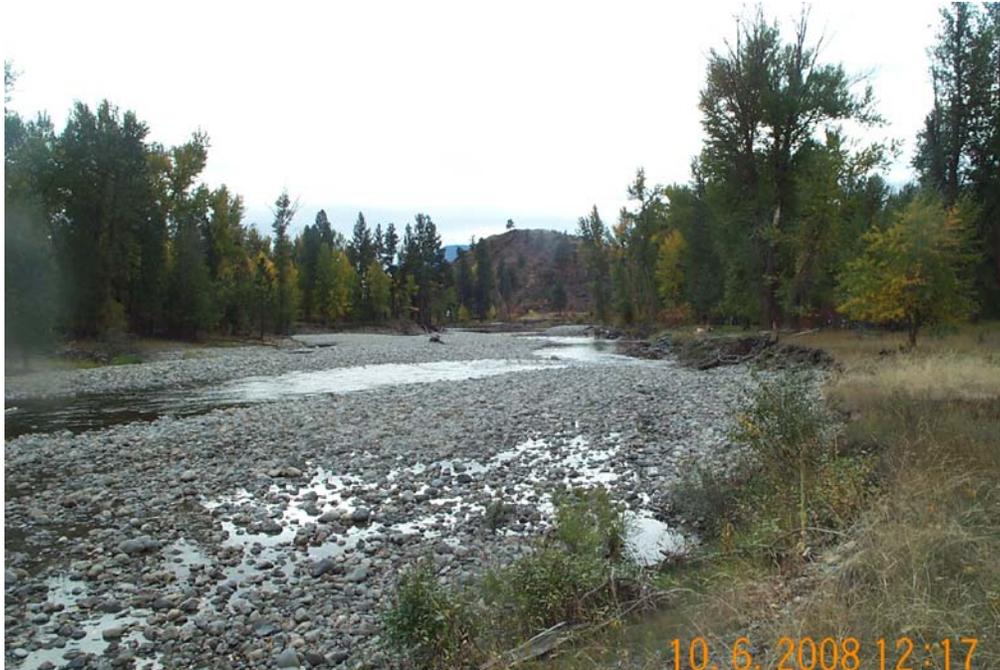
Photograph No. 63. View is to the south looking downstream along McNae side channel at a run-riffle-run sequence and the head of a side channel developing on river left near RM 45.9. Middle Methow Reach Assessment – Methow Subbasin, Washington – Bureau of Reclamation Photograph by E. Lyon, October 6, 2008.

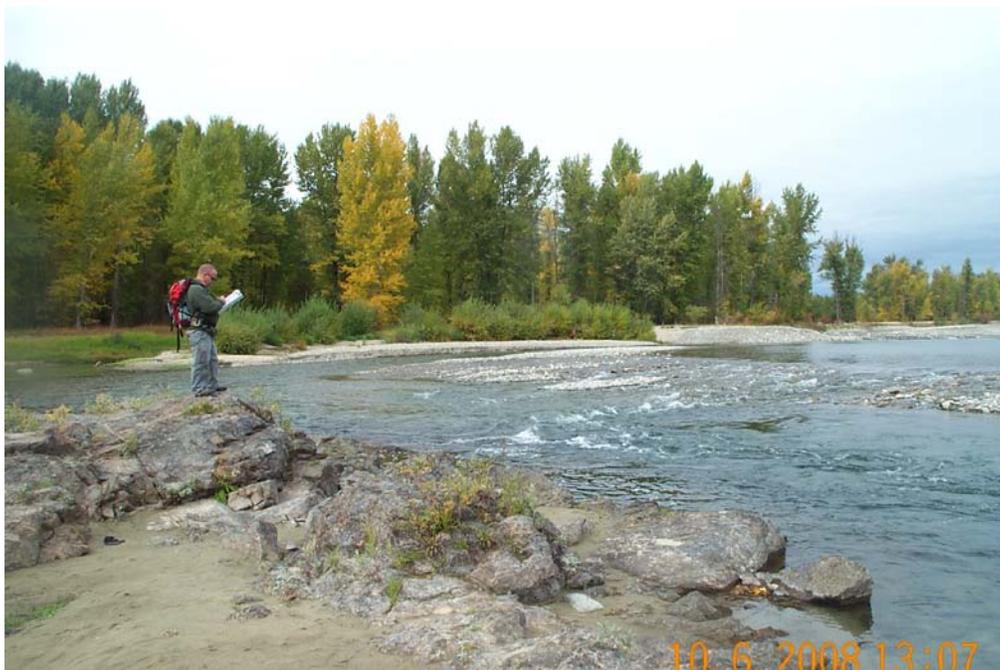
Photograph No. 64. View is to the northwest looking upstream from a bedrock outcrop at a riffle-rapid-pool sequence along river right near RM 45.5. Middle Methow Reach Assessment – Methow Subbasin, Washington – Bureau of Reclamation Photograph by E. Lyon, October 6, 2008.

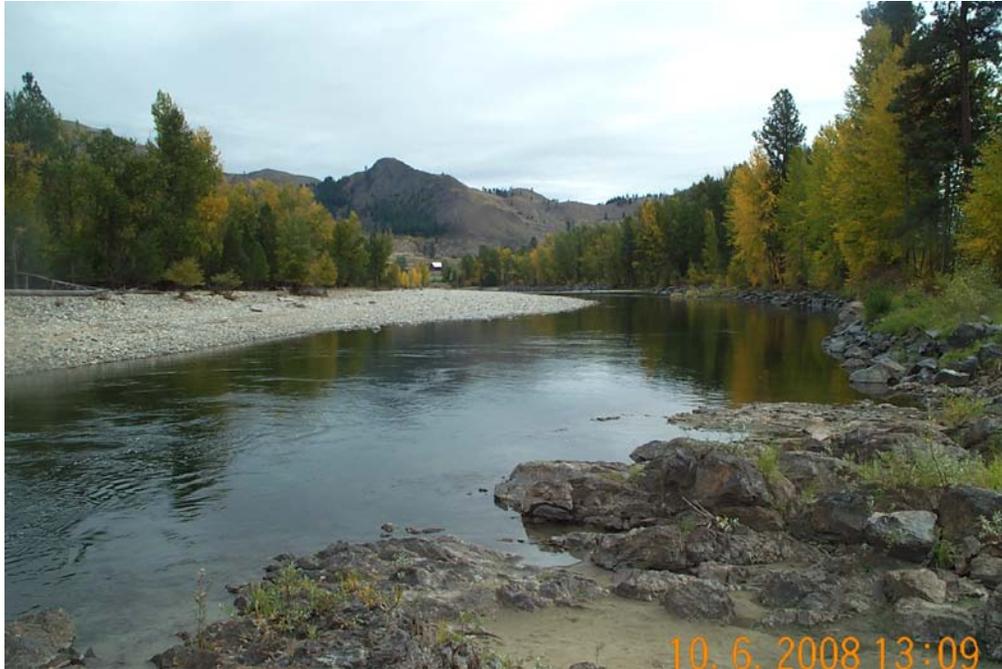
Photograph No. 65. View is to the southeast looking downstream from a bedrock outcrop at a lateral scour pool and riprap placed along river right near RM 45.5. Middle Methow Reach Assessment – Methow Subbasin, Washington – Bureau of Reclamation Photograph by E. Lyon, October 6, 2008.

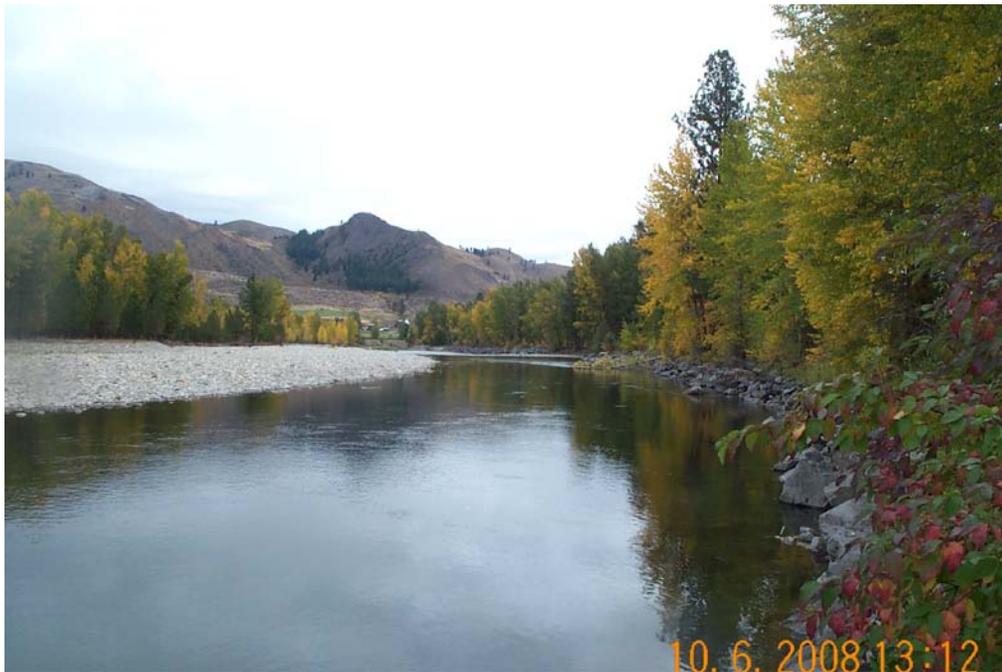
Photograph No. 66. View is to the southeast looking downstream at a pool-run sequence developed along riprap placed on river right near RM 45.5. Middle Methow Reach Assessment – Methow Subbasin, Washington – Bureau of Reclamation Photograph by E. Lyon, October 6, 2008.

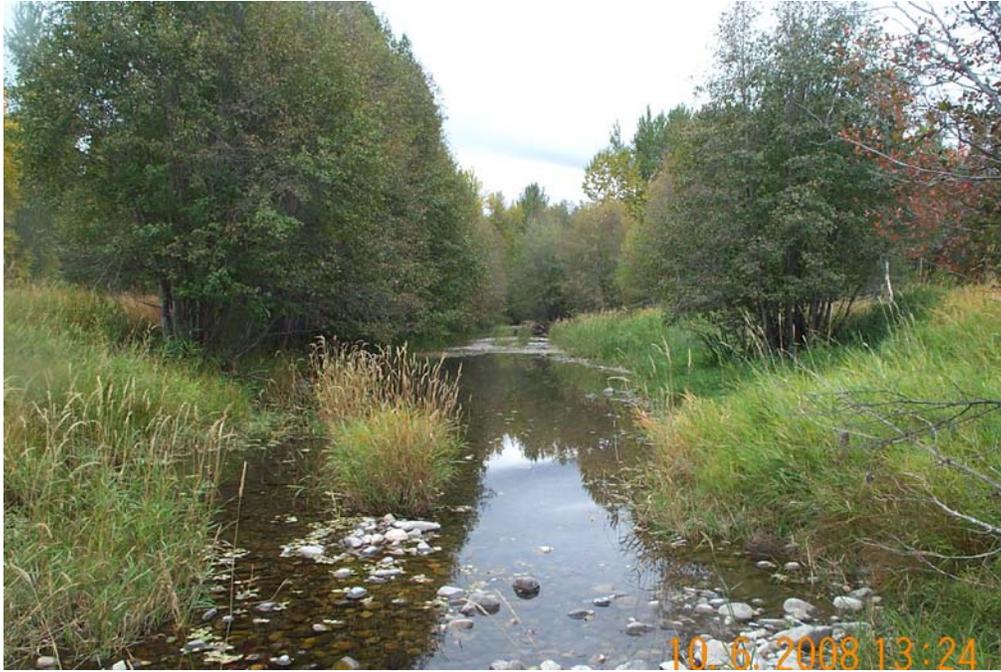
Photograph No. 67. View is to the south looking downstream along Habermahle side channel at where groundwater maintains the flow in the lower section near RM 44.7. Middle Methow Reach Assessment – Methow Subbasin, Washington – Bureau of Reclamation Photograph by E. Lyon, October 6, 2008.

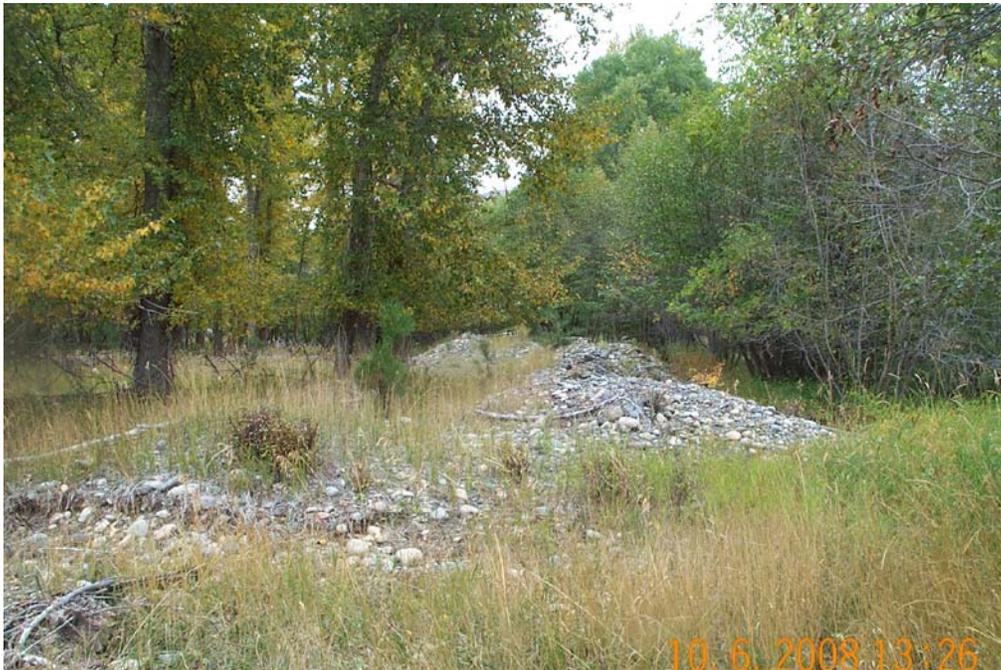
Photograph No. 68. View is to the southeast looking at spoil piles probably excavated from the Habermahle side channel and placed as a training levee near RM 44.7. Middle Methow Reach Assessment – Methow Subbasin, Washington – Bureau of Reclamation Photograph by E. Lyon, October 6, 2008.

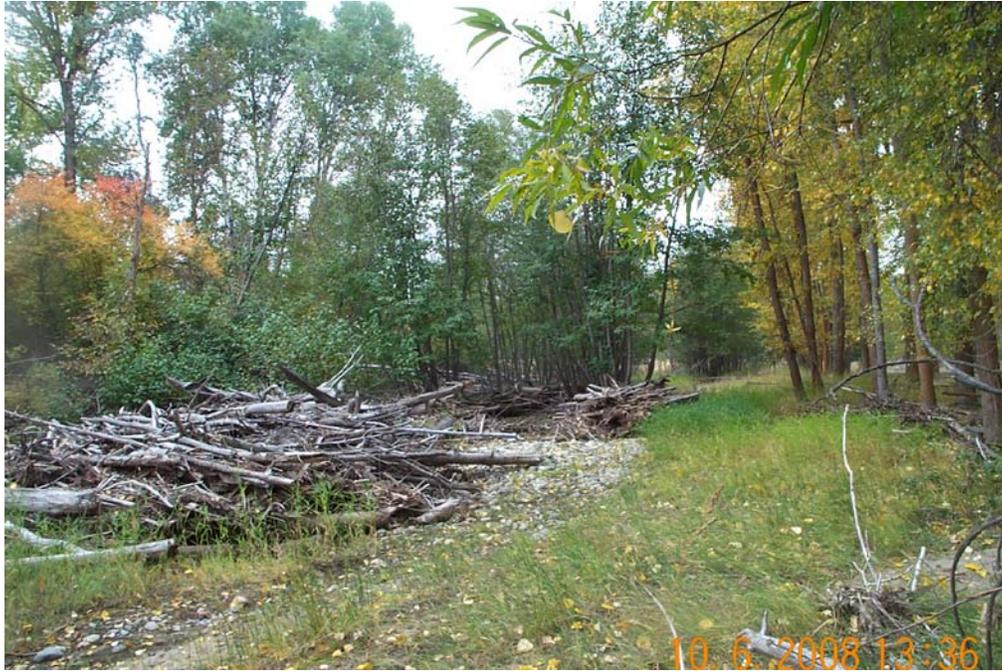
Photograph No. 69. View is to the south along the Habermahle side channel looking downstream at large wood complexes near RM 44.8. Middle Methow Reach Assessment – Methow Subbasin, Washington – Bureau of Reclamation Photograph by E. Lyon, October 6, 2008.

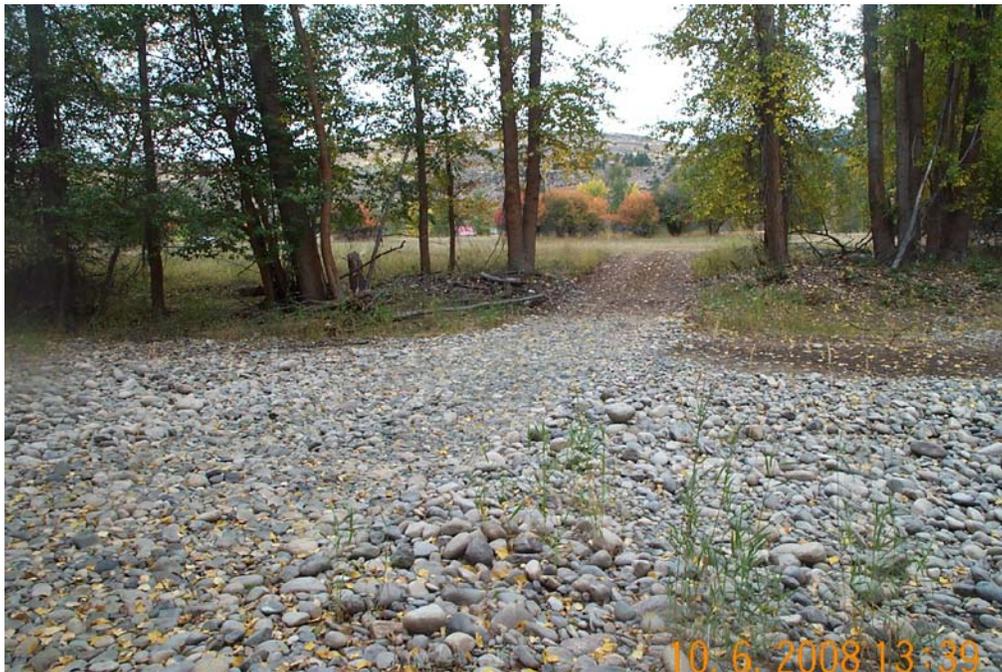
Photograph No. 70. View is to the west looking at a ford crossing the Habermahle side channel near RM 44.9. Middle Methow Reach Assessment – Methow Subbasin, Washington – Bureau of Reclamation Photograph by E. Lyon, October 6, 2008.
