APPENDICES

Reach-based Ecosystem Indicators (REI) Version 1.1

MIDDLE METHOW RIVER (M2 Reach) HABITAT ASSESSMENT OVERVIEW
River Mile 40.3 to River Mile 52.4

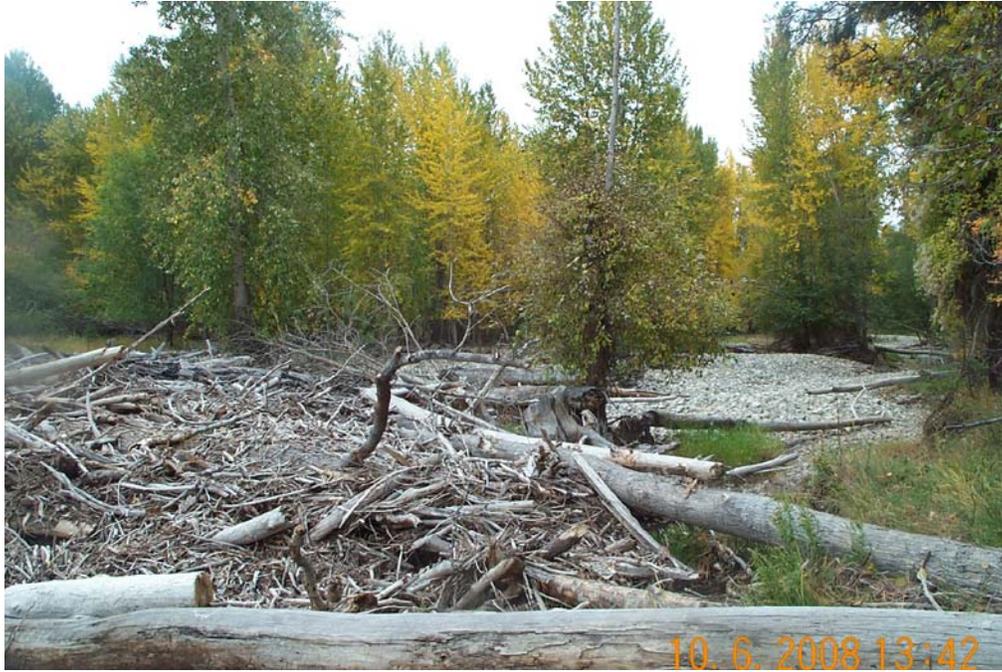
Photograph No. 71. View is to the southeast looking downstream at a large wood complex at the head of the Habermahle side channel near RM 45.1. Middle Methow Reach Assessment – Methow Subbasin, Washington – Bureau of Reclamation Photograph by E. Lyon, October 6, 2008.

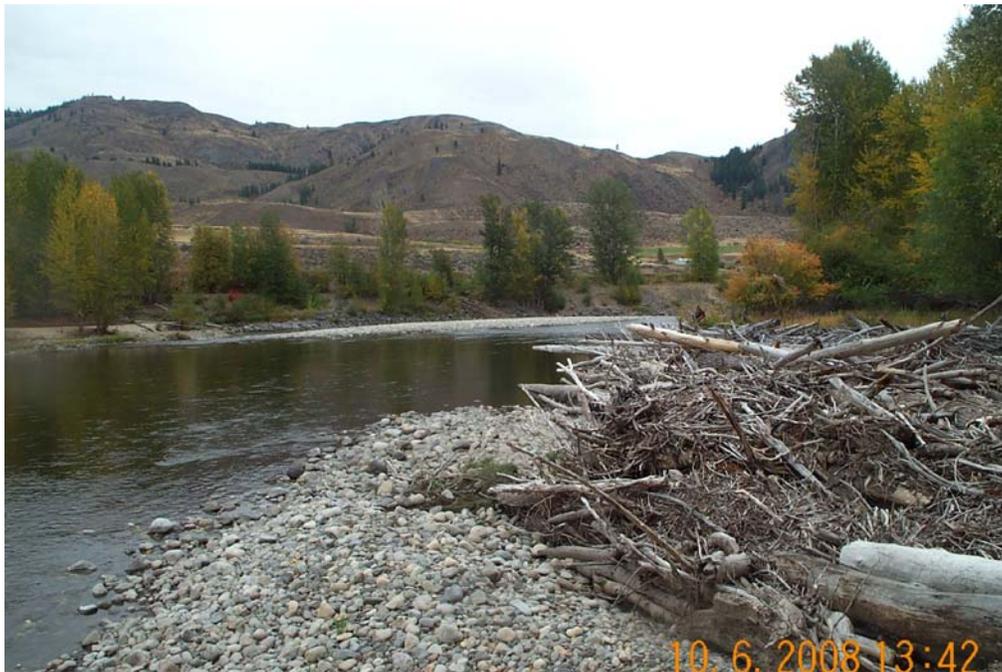
Photograph No. 72. View is to the east looking downstream from the head of the Habermahle side channel near RM 45.1. Middle Methow Reach Assessment – Methow Subbasin, Washington – Bureau of Reclamation Photograph by E. Lyon, October 6, 2008.

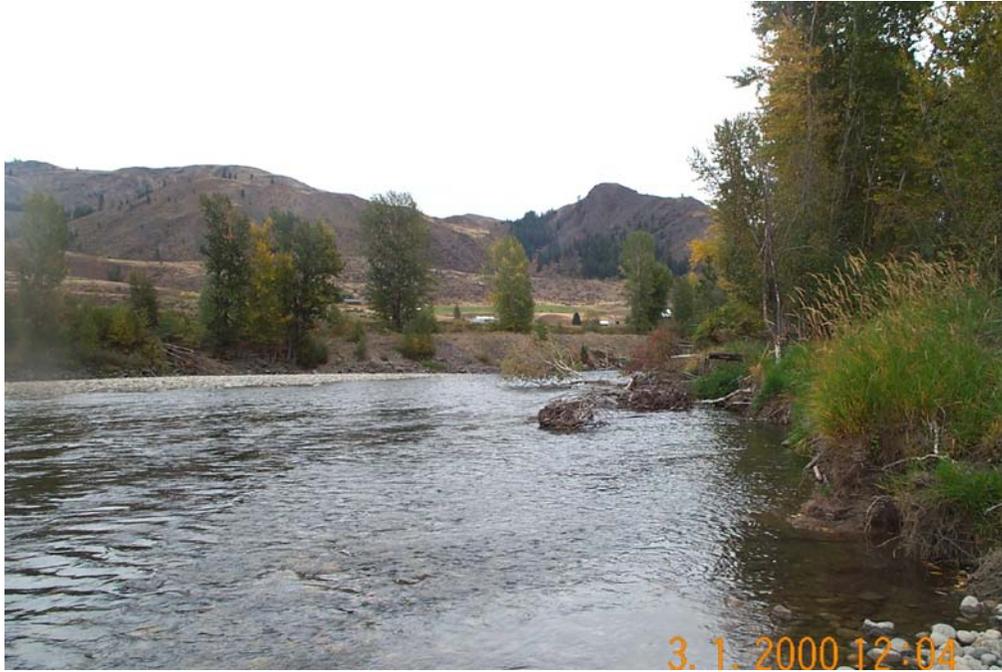
Photograph No. 75. View is to the southeast looking downstream along river right at bank erosion near RM 45.1. Middle Methow Reach Assessment – Methow Subbasin, Washington – Bureau of Reclamation Photograph by E. Lyon, October 6, 2008.

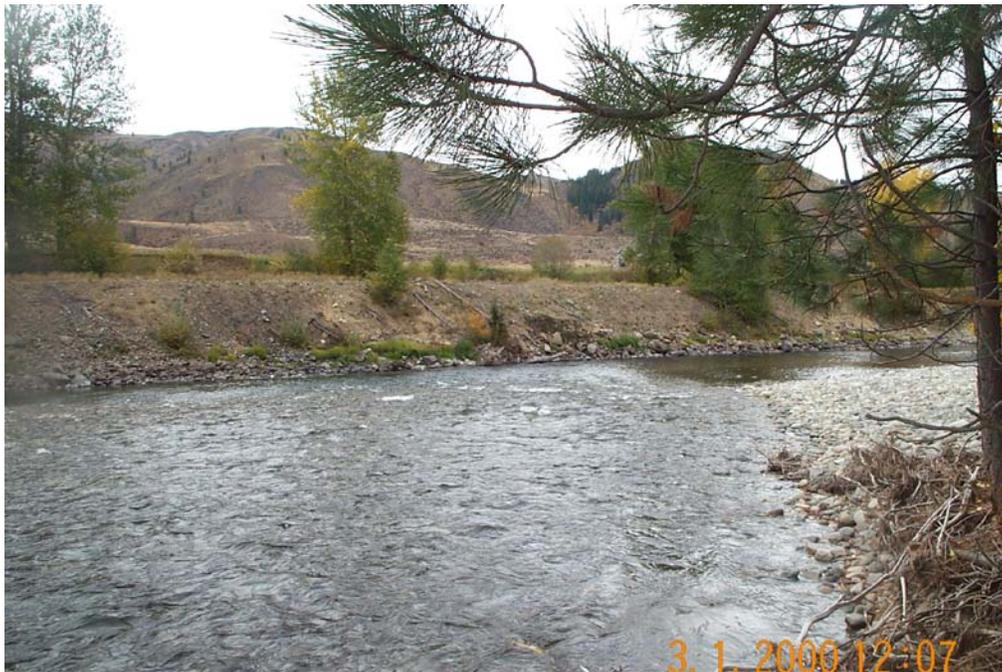
Photograph No. 76. View is to the southeast looking downstream at a riffle-rapid-pool sequence near RM 45.0. Middle Methow Reach Assessment – Methow Subbasin, Washington – Bureau of Reclamation Photograph by E. Lyon, October 6, 2008.

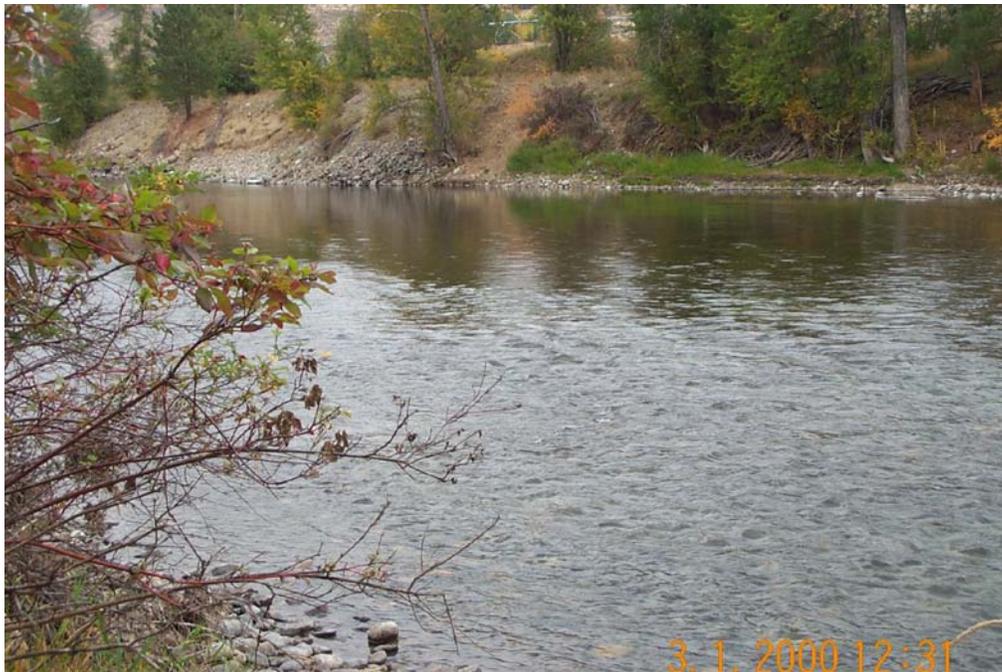
Photograph No. 78. View is to the northeast looking across a riffle where summer Chinook salmon were observed spawning near RM 44.8. Middle Methow Reach Assessment – Methow Subbasin, Washington – Bureau of Reclamation Photograph by E. Lyon, October 6, 2008.

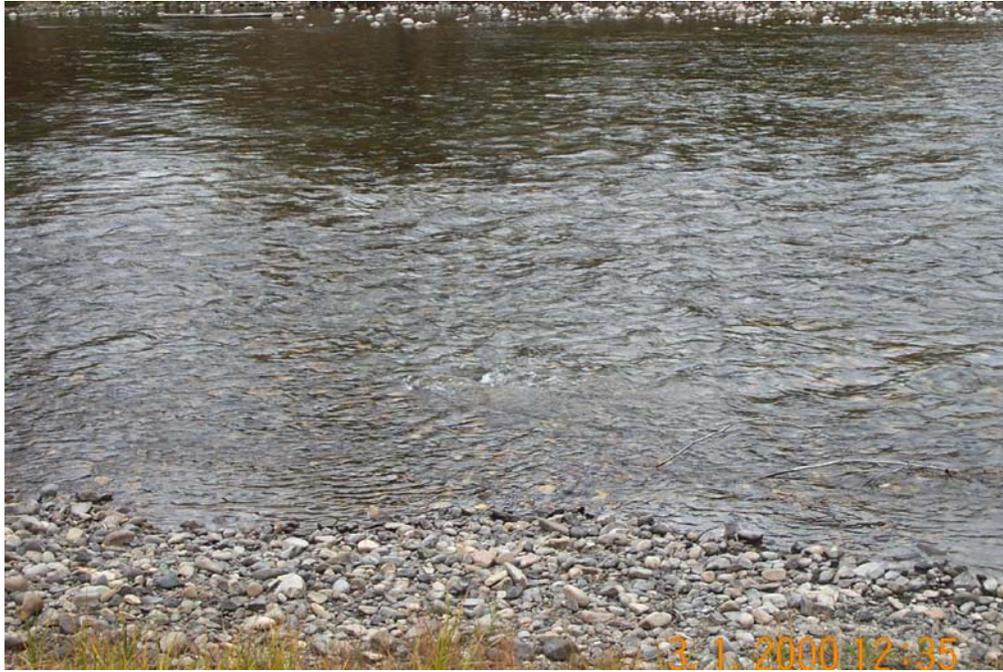
Photograph No. 79. View is to the west looking at a spawning summer Chinook salmon (center of photograph) near RM 44.8. Middle Methow Reach Assessment – Methow Subbasin, Washington – Bureau of Reclamation Photograph by E. Lyon, October 6, 2008.

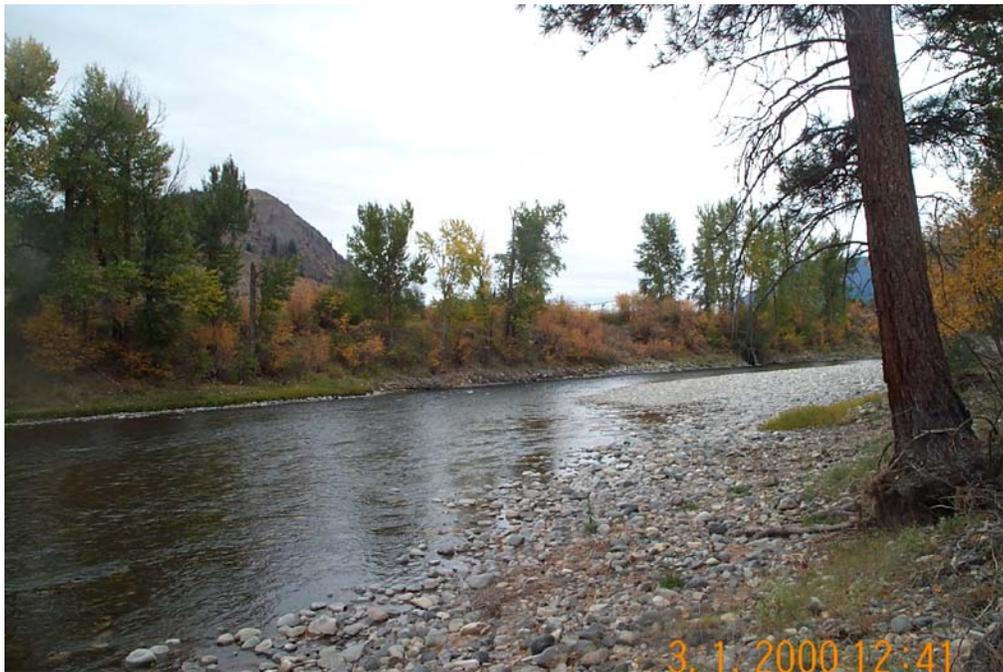
Photograph No. 80. View is to the south looking downstream at a run-riffle sequence near RM 44.7. Middle Methow Reach Assessment – Methow Subbasin, Washington – Bureau of Reclamation Photograph by E. Lyon, October 6, 2008.

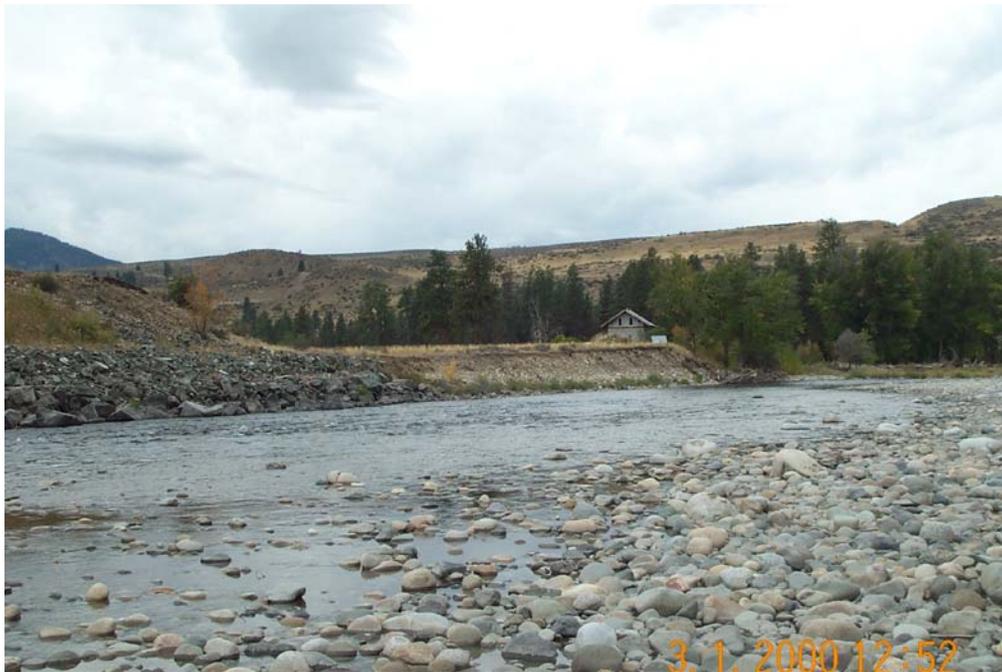
Photograph No. 82. View is to the southwest looking downstream at bank erosion downstream of riprap placed along river left and a house that may be threatened if bank erosion continues near RM 44.5. Middle Methow Reach Assessment – Methow Subbasin, Washington – Bureau of Reclamation
Photograph by E. Lyon, October 6, 2008.

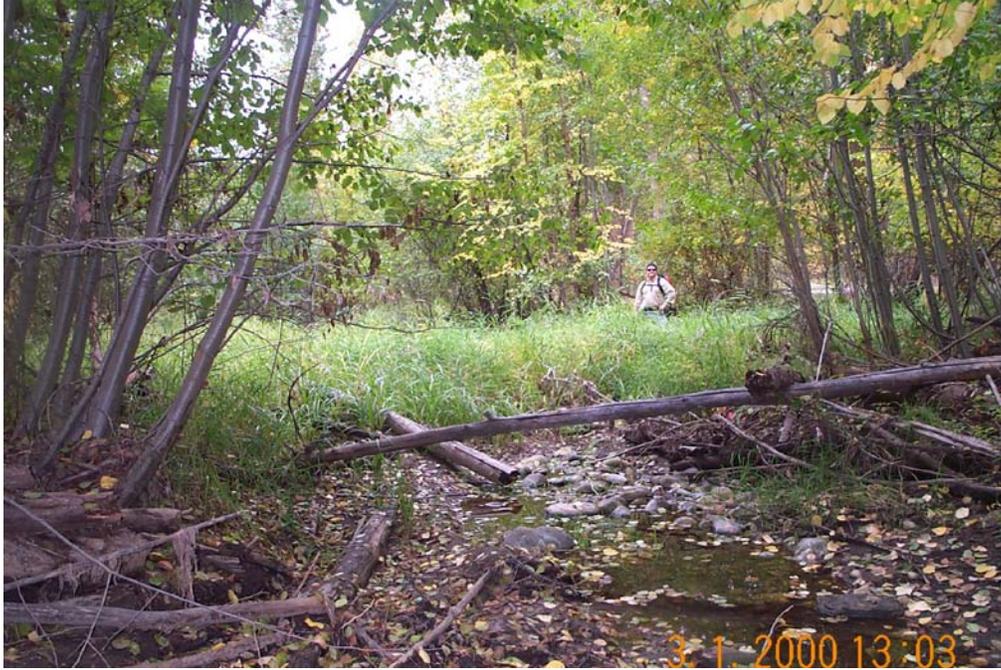
Photograph No. 85. View is to the southwest looking downstream along an overflow channel adjacent to the Habermahle side channel that has a road embankment crossing the channel near RM 44.3. Middle Methow Reach Assessment – Methow Subbasin, Washington – Bureau of Reclamation
Photograph by E. Lyon, October 6, 2008.

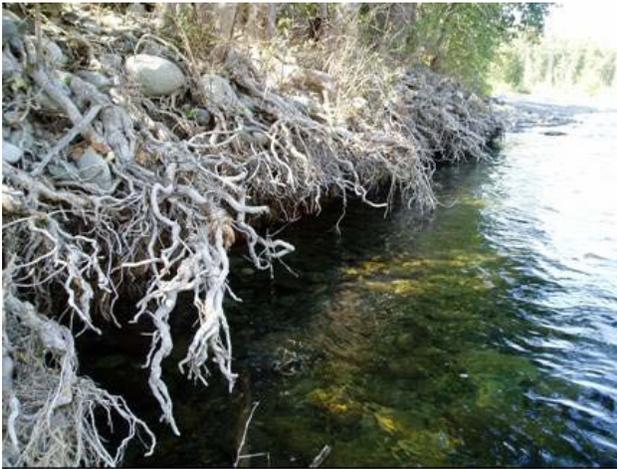
Rearing habitat along right bank at top of reach

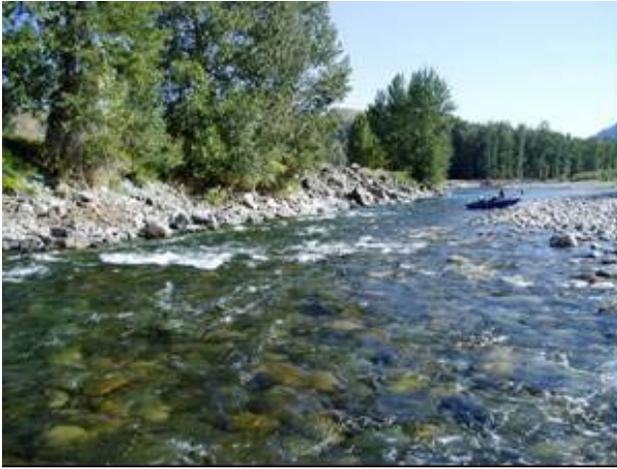
Rip Rap and Narrow Channel at RM 42

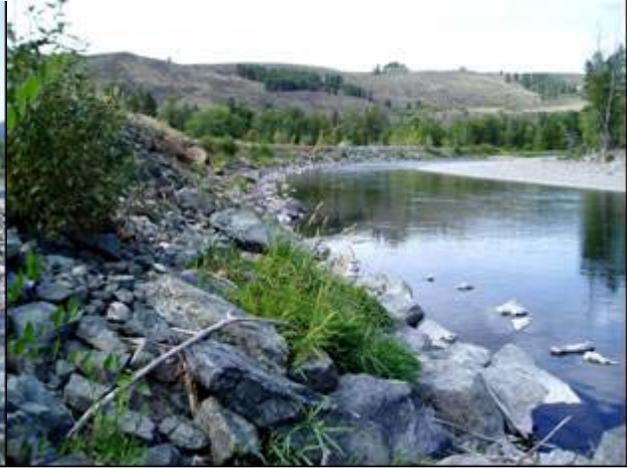
Dike on Right Bank at RM 42.3

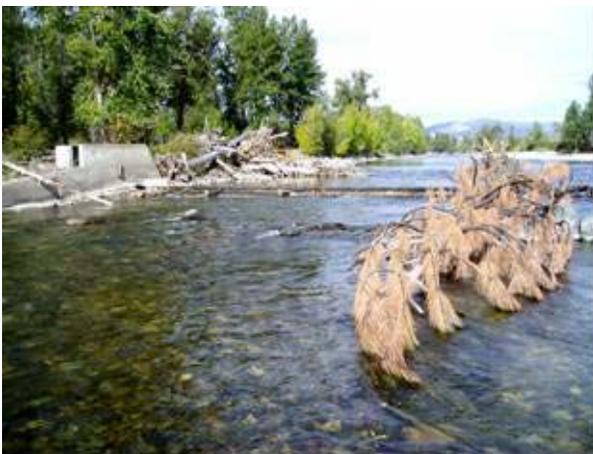
Remains of MVID Diversion at RM 46

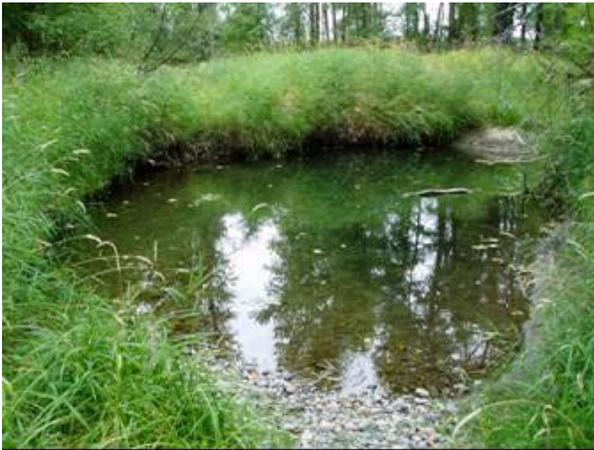
Deep Pool in side channel at RM 47.7 (no flow in the side channel on the day of the survey)

¹The lower 100' of the side channel was flowing. The remaining length of side channel (1,050') was dry, with 4 pools that are possibly stranding fish. The largest of the pools was about 75' long and 30' wide, with a depth of about 5.5'. No fish were observed in the pools at the time of the survey. Only one piece of wood > 35' long with a diameter of at least 12" was observed in the dry segment of the side channel.

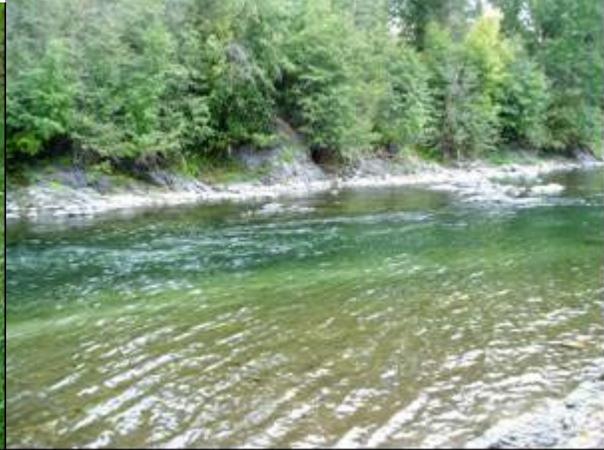
Bedrock on banks and in channel at RM 48

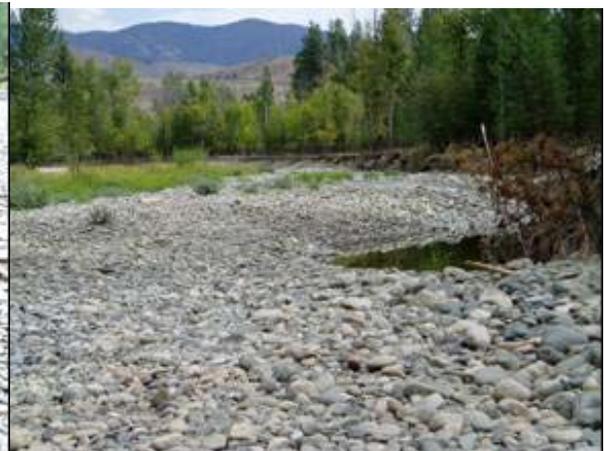
Eroding Bank in Dry Side Channel at RM 48.6

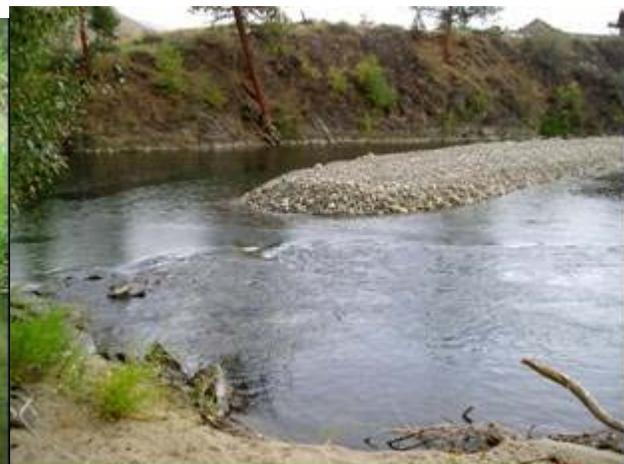
The Barkley Irrigation Diversion – note push up dam used to direct river flow towards head gate

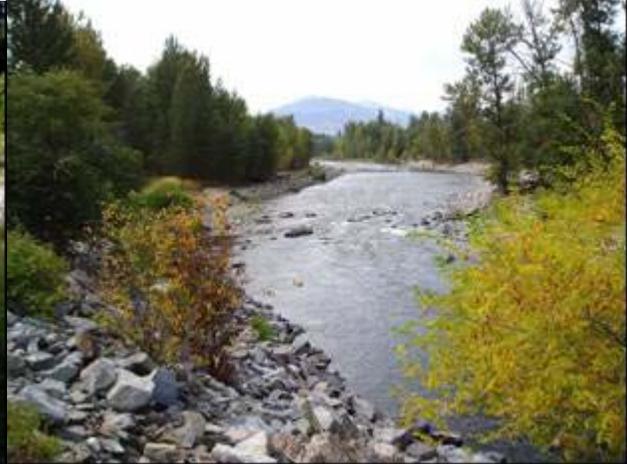
Dike at RM 51.8 at National Fish Hatchery

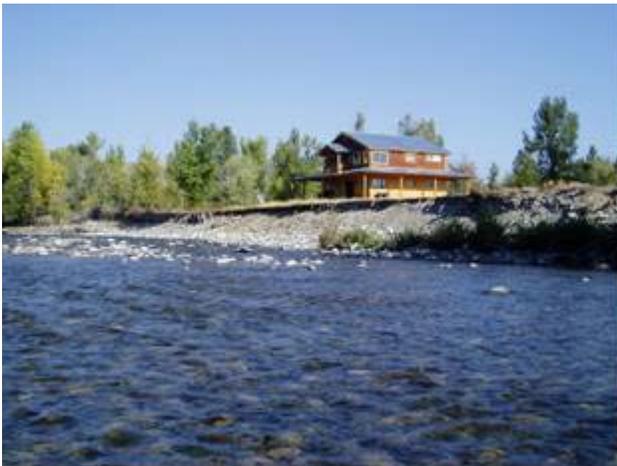
House in floodplain and eroding bank at RM 52.4

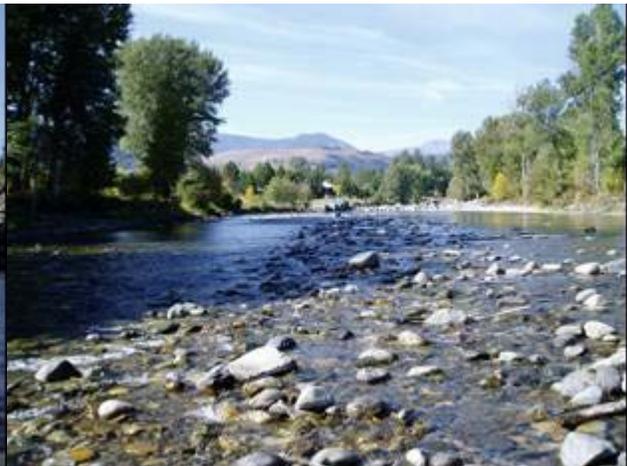
**Channel downcutting on river right side just
Below the Foghorn Diversion**

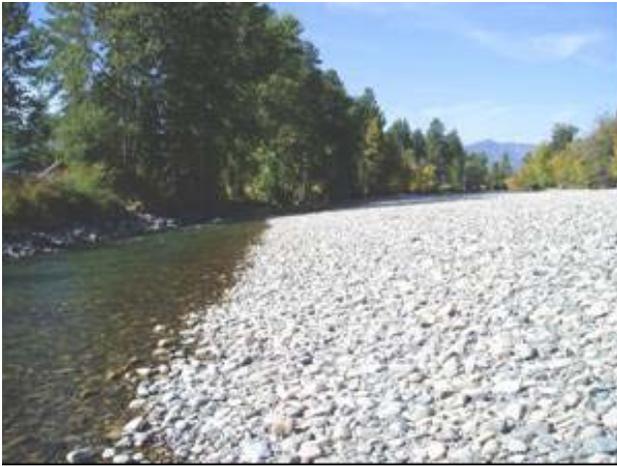
Huge cobble bar and narrow river above Diversion

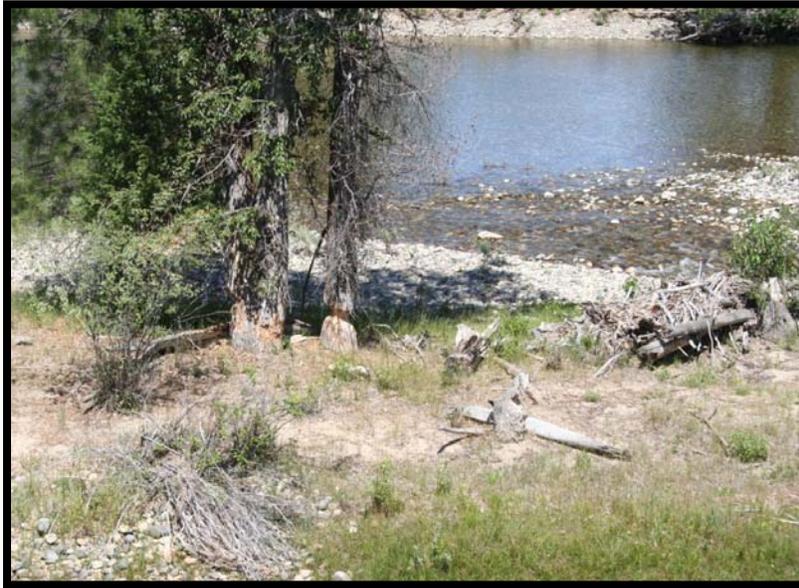
- **RM 47.00 to 46.80.** A large gravel bar island is partially forested with black cottonwood. Cottonwood sprouts are heavily browsed by deer, and severed stumps indicate that beaver have felled many of the large cottonwoods on the island (Fig 1). Ponderosa pine is recruiting and in the absence of a flood disturbance, will likely succeed cottonwood on this island. The gravel bar extends down river and is regenerating with willow shrubs.

Figure 1: Evidence of beaver activity on a gravel bar island at RM 47.00. Cottonwood regeneration in foreground has been browsed by deer.

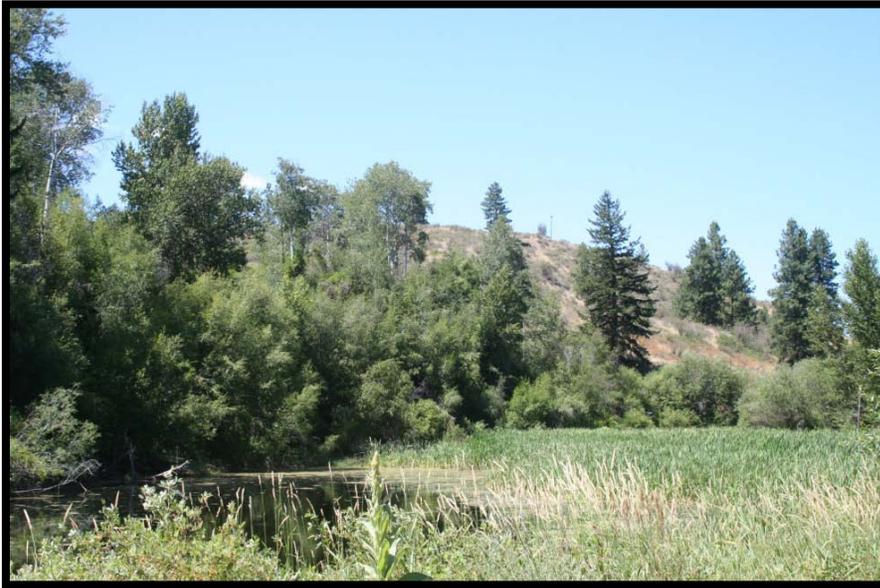
- **RM 45.70 to 45.50.** On river right, a beaver pond (Plumber wetlands, SC 45.60 R) extends from the bend in the river (Fig 2). Gallery forests of mature black cottonwood line either side of the Old Twisp Highway, which bisects the beaver pond and riparian forest. The forest here is dense, shady and has a mixture small and large diameter black cottonwood trees with full, live crowns. Riparian vegetation surrounding the beaver pond is dominated by willow and other deciduous shrub species.

Figure 2: Beaver pond at RM 45.55 (Plumber wetlands, SC 45.60 R).

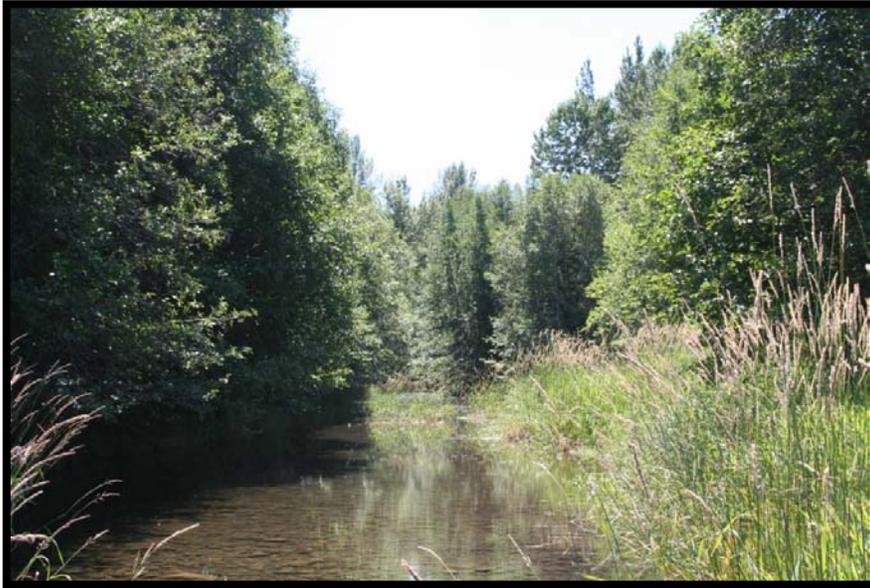
- The Habermehl side channel (Fig 3) begins upriver within a forest of small-diameter cottonwoods with codominant ponderosa pine. The entrance contains a large log jam but is presumably permeable to high water. Where the channel runs through an agricultural field, vegetation grades to narrow band of thin-leaved alder. This vegetation type extends into the mixed deciduous forest at the southern end of the channel.

Figure 3: Habermehl side channel, lined by reed canary grass and thin-leaf alder.

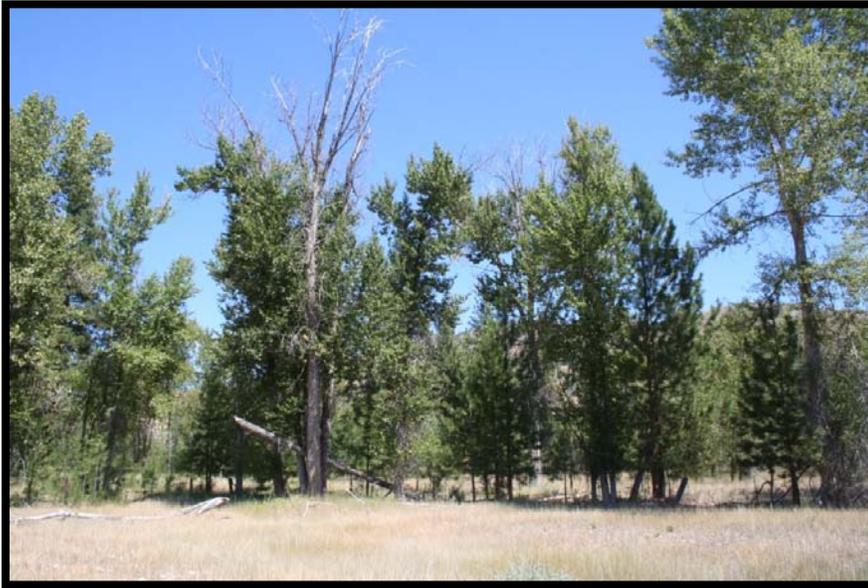
Figure 4: Ponderosa pine regeneration under black cottonwood in an old agricultural field, WDFW land. Note crown dieback on a few cottonwood trees.

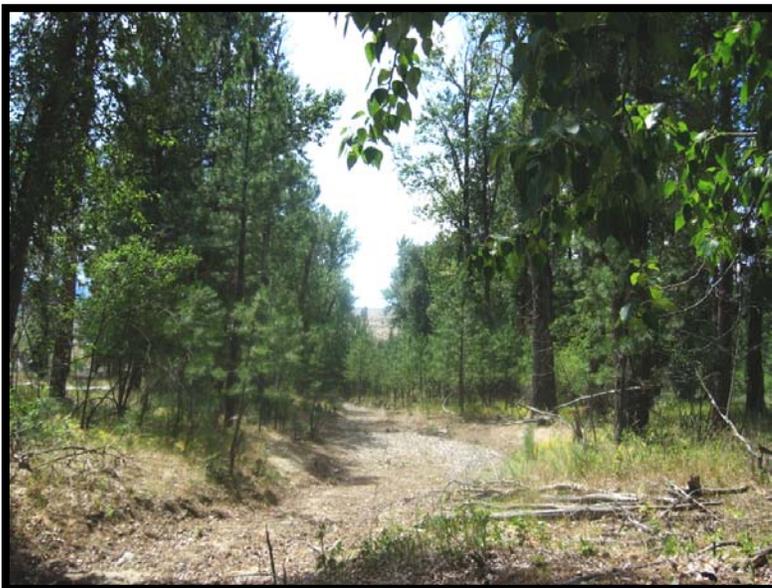
Figure 5: One of the small side channels, located along the eastern margin of subreach MM-0Z-16b. Note the dense ponderosa pine regeneration in the understory.

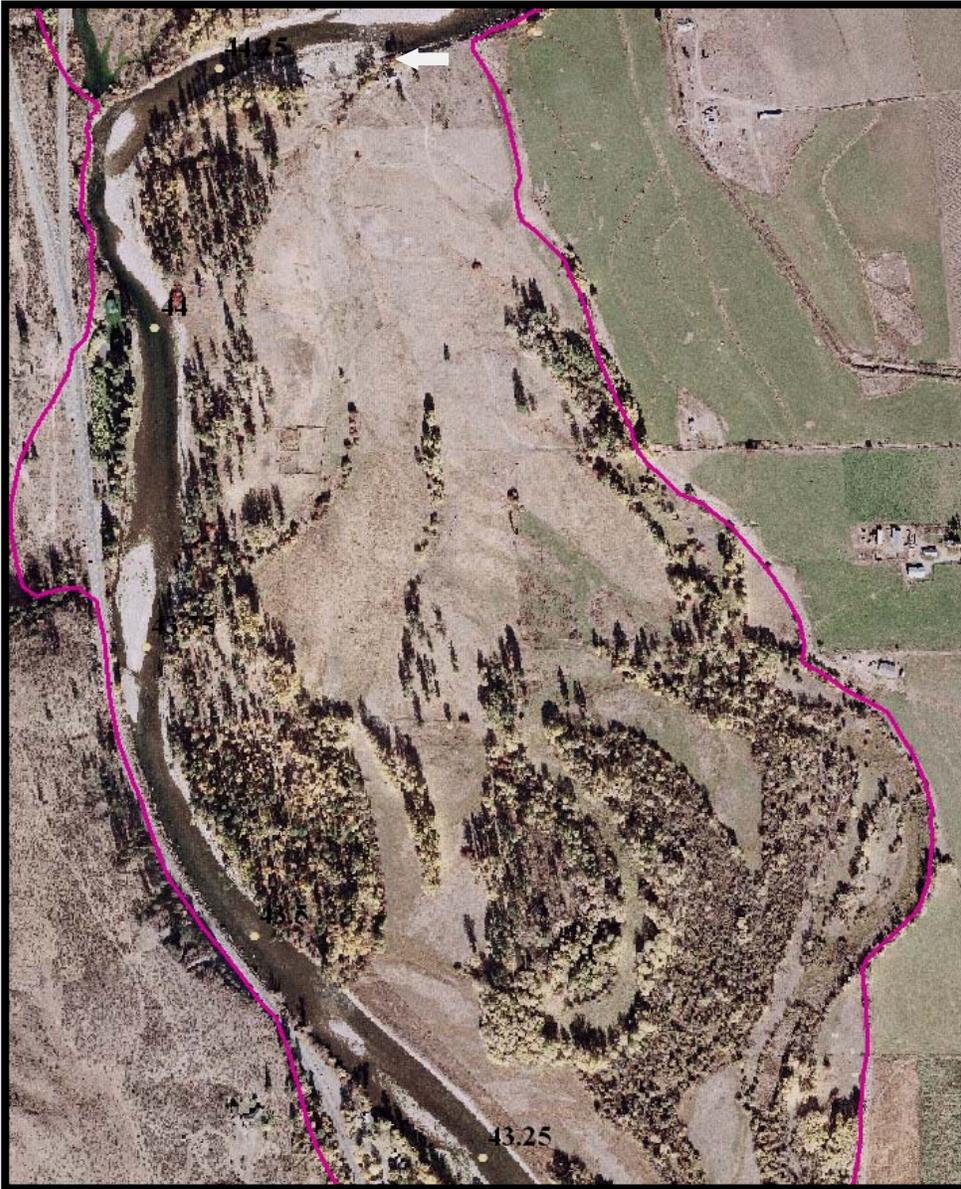
Figure 6: Broad floodplain south of small levee at RM 44.3. The levee, marked by the white arrow at the top center of the image, prevents floodwaters from entering the active floodplain surface.

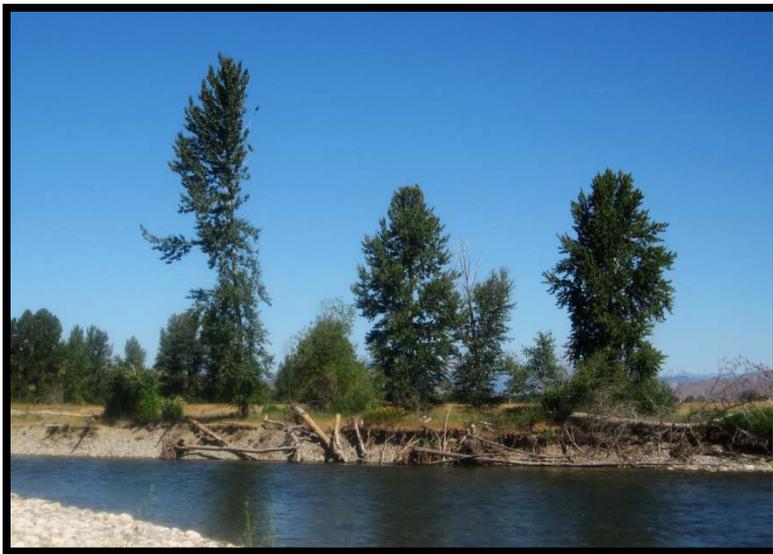
- On river left, a wide band of small-diameter cottonwood saplings and trees is nearest to the main channel and merges upslope with an older forest dominated by black cottonwood. Numerous cottonwood trees have been felled by beavers along the river bank (Fig 7).

Figure 7: Recently felled black cottonwood trees from beaver activity at RM 42.25.

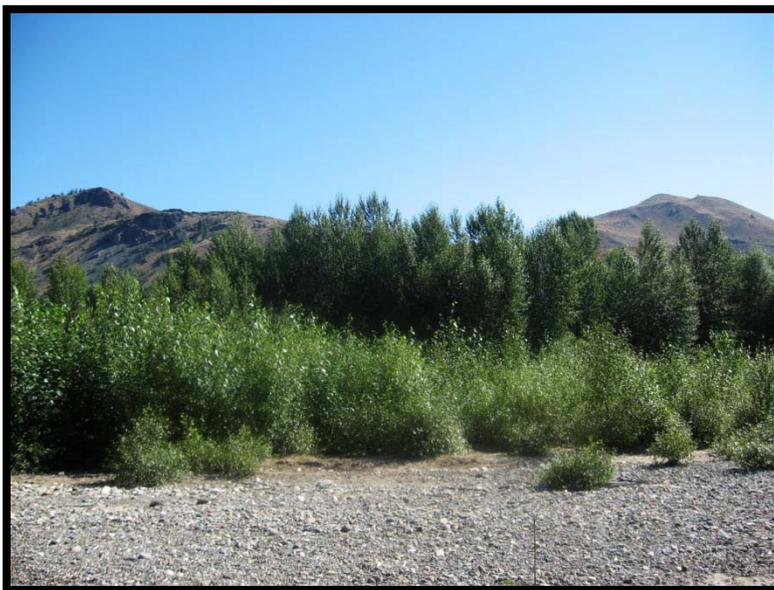
Figure 8: Dense black cottonwood recruitment on a gravel bar island along the Pederson side channel about RM 42.1 on river right.

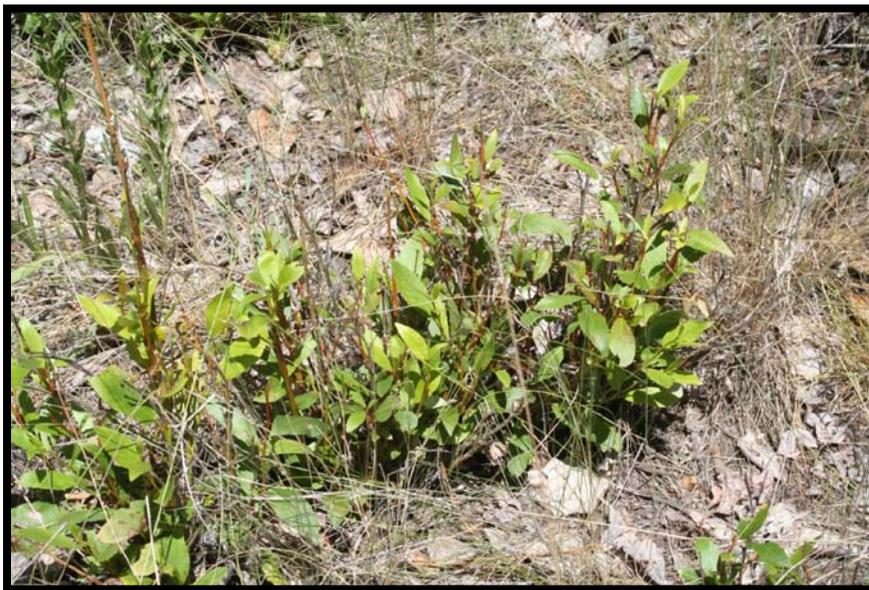
Figure 9. Browsed cottonwood sprouts. Deer browsing appears to be most common on cottonwood sprouts in old agricultural fields and is less of a factor in gravel bar islands with dense cottonwood regeneration.
