Middle Methow Reach Assessment Methow River

Okanogan County, Washington

U.S. Department of the Interior
Bureau of Reclamation
Pacific Northwest Region
Pacific Northwest Regional Office, Boise, Idaho

August 2010

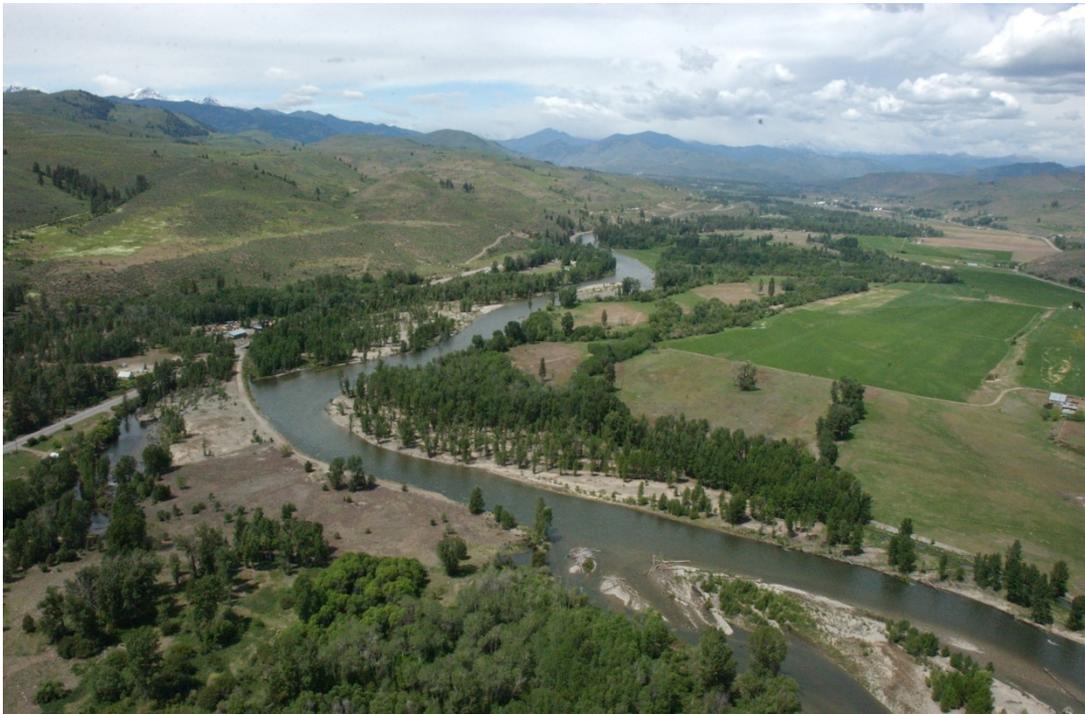
Cover Photo: View is to the northwest looking upstream at a levee (Sugar Dike) placed on river right along the Methow River near Twisp, Washington. Subreach MM-IZ-7 – Methow Subbasin, Washington – Bureau of Reclamation.

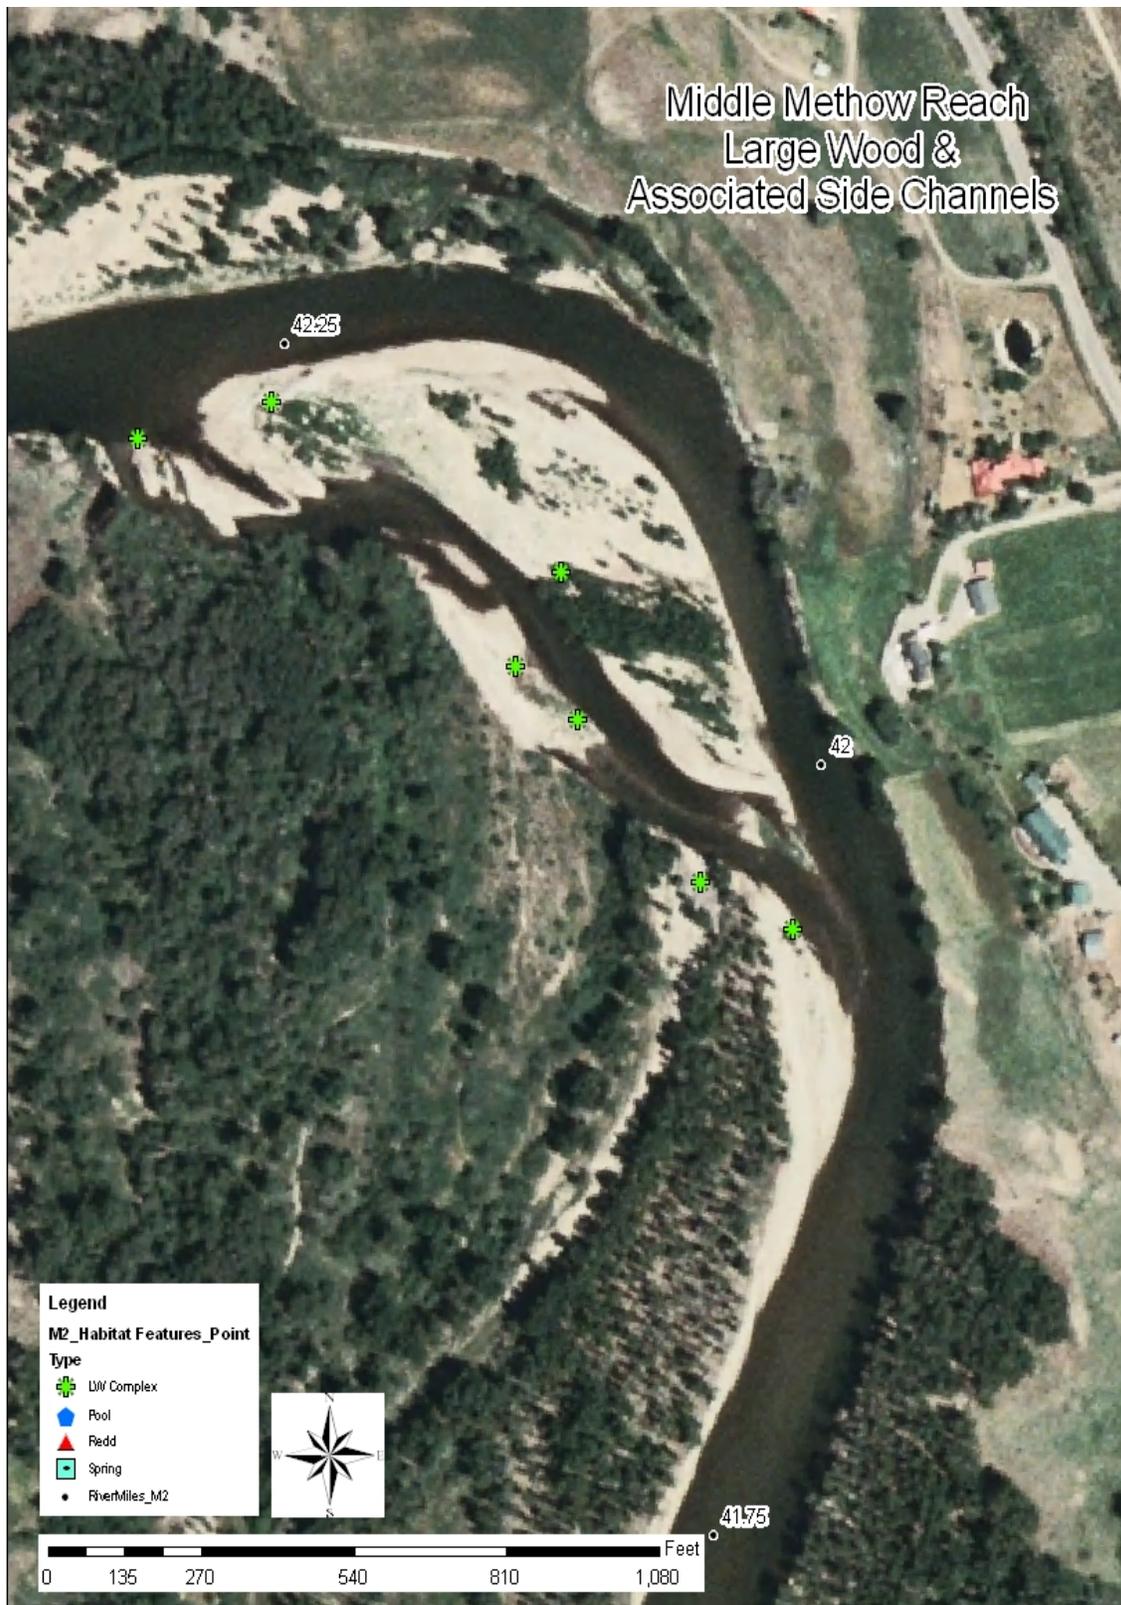
Figure 6. Example of large wood complexes that contribute to the creation and development of side channels (map scale 1:2,800).

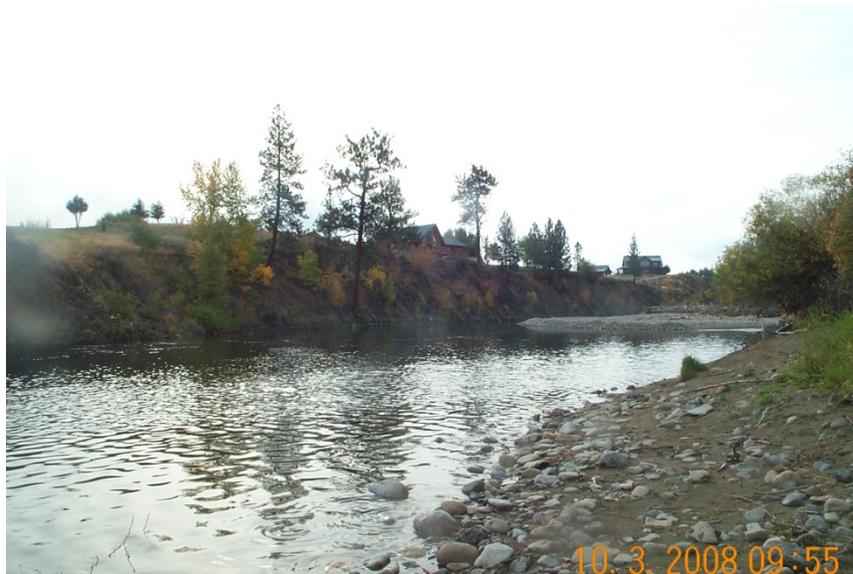
Figure 19. View is to the southeast looking downstream at a large pool created by the Barkley diversion dam near RM 49.5. Methow Subbasin, Washington – Bureau of Reclamation photograph by E. Lyon, October 3, 2008.

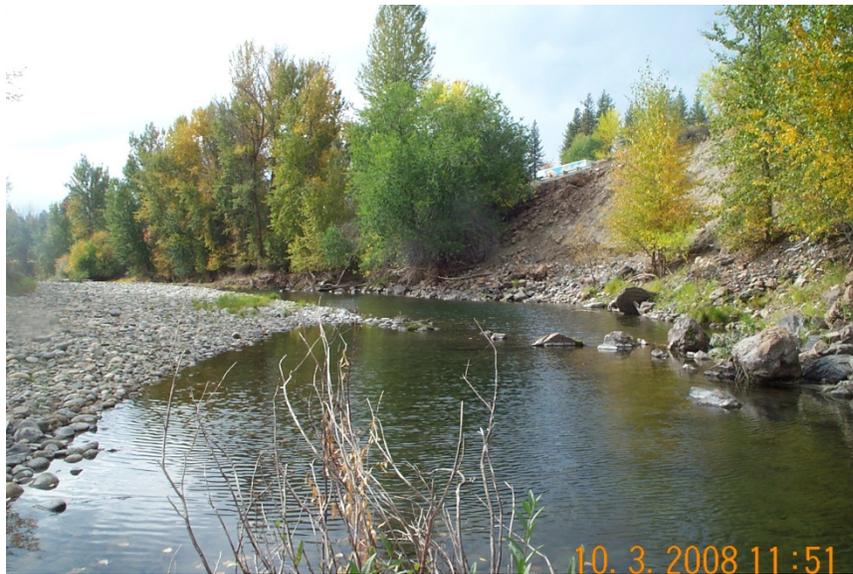
Figure 25. View is to the southwest looking downstream at a lateral scour pool forced by riprap along the Bird side channel near RM 48.7. Methow Subbasin, Washington – Bureau of Reclamation photograph by E. Lyon, October 3, 2008.

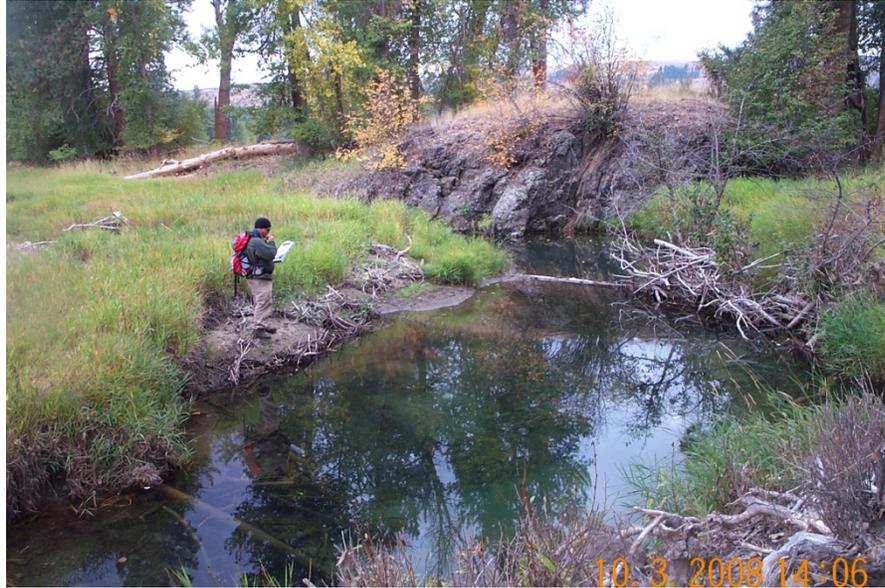
Figure 26. View is to the south looking downstream at a lateral scour pool forced by bedrock along River Rock Reach (3R) side channel along river right near RM 47.6. Methow Subbasin, Washington - Bureau of Reclamation photograph by E. Lyon, October 3, 2008.

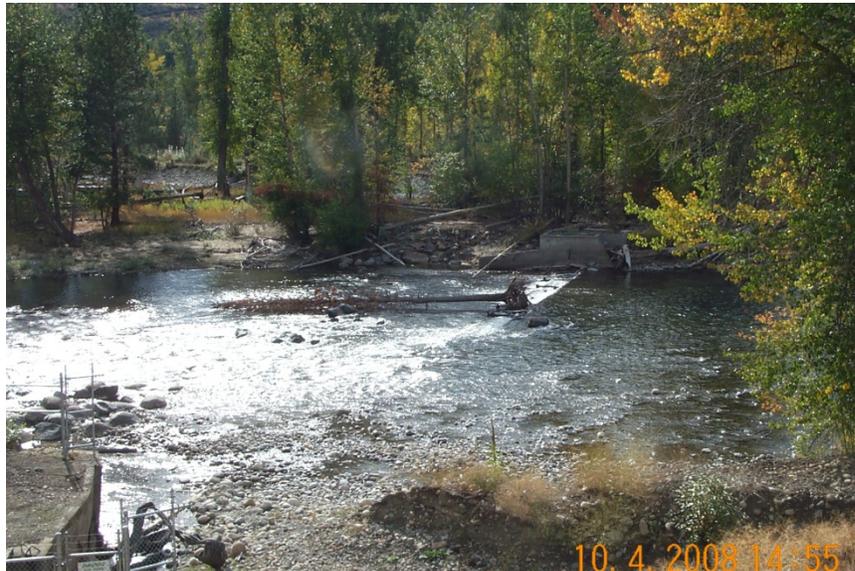
Figure 37. View is to the west looking across at the Methow Valley Irrigation District's east canal diversion dam that was mostly removed in 2008 near RM 46.0. Methow Subbasin, Washington – Bureau of Reclamation photograph by E. Lyon, October 4, 2008.

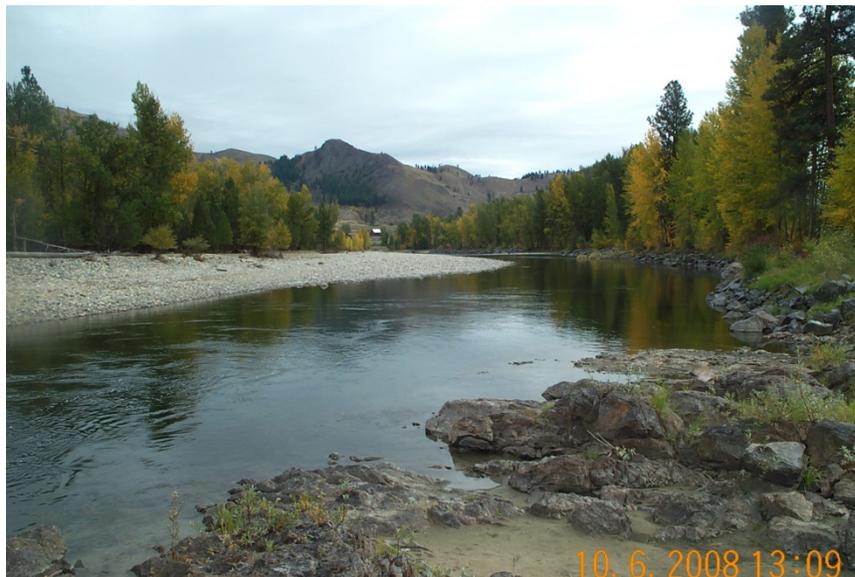
Figure 43. View is to the southeast looking downstream from a bedrock outcrop at a lateral scour pool and riprap placed along river right near RM 45.5. Methow Subbasin, Washington – Bureau of Reclamation photograph by E. Lyon, October 6, 2008.

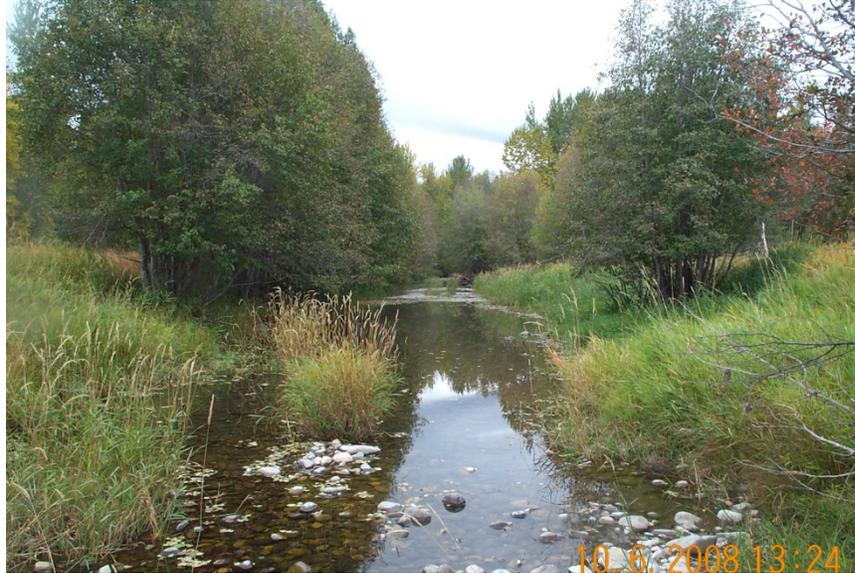
Figure 44. View is to the south looking downstream along Habermehl side channel (SC_45.10_R) where groundwater maintains the flow in the lower section near RM 44.7. Methow Subbasin, Washington - Bureau of Reclamation photograph by E. Lyon, October 6, 2008.

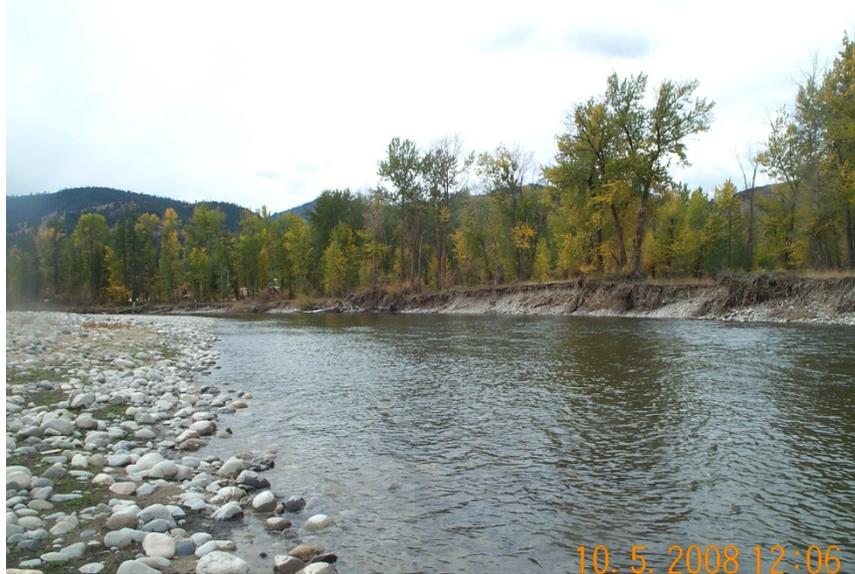
Figure 56 . View is to the southwest looking downstream at a run near RM 41.6. Note the bank erosion along river right. Methow Subbasin, Washington – Bureau of Reclamation photograph by E. Lyon, October 5, 2008.

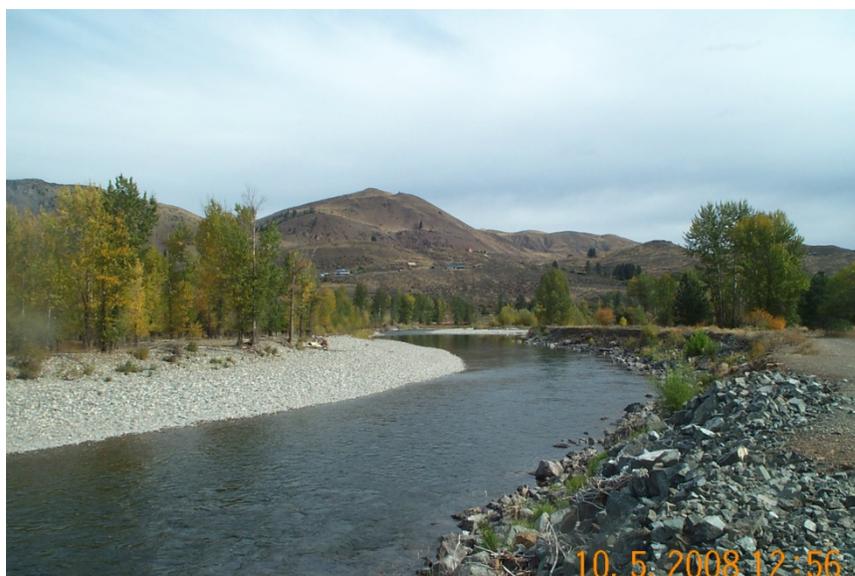
Figure 57. View is to the east looking downstream at a run developed along levee placed on river right near RM 42.5. Note the downstream end of the riprap is failing. Methow Subbasin, Washington – Bureau of Reclamation photograph by E. Lyon, October 5, 2008.

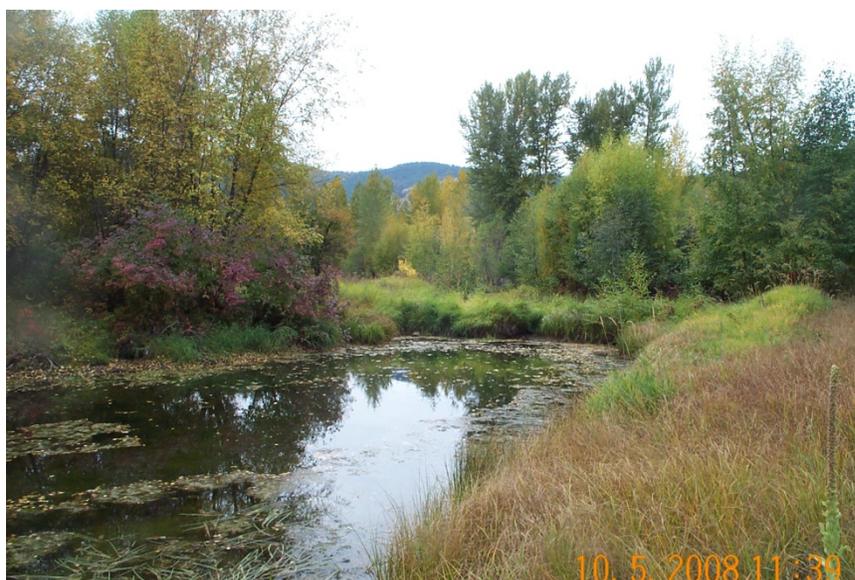
Figure 58. View is to the south looking downstream along Anderson side channel at a historic beaver dam or embankment near RM 41.5 on river left. Methow Subbasin, Washington – Bureau of Reclamation photograph by E. Lyon, October 5, 2008.
