Bonanza Area Reach Assessment
Yankee Fork of the Salmon River,
Upper Salmon Subbasin

Custer County, Idaho

September 2012

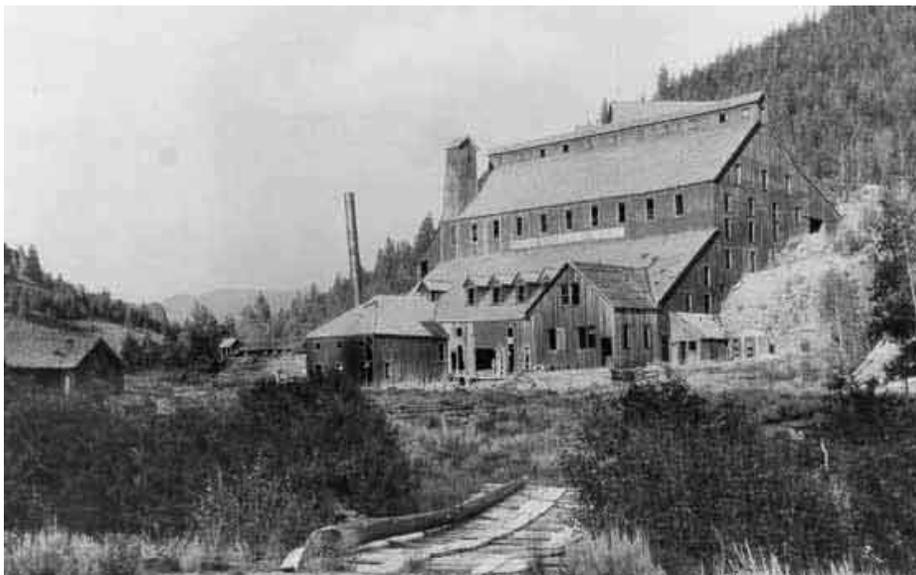
Figure 6. General Custer Mill 1937 located along the Yankee Fork upstream of Custer (http://www.fs.fed.us/r4/sc/yankeefork/generalcustermill_1.shtml).

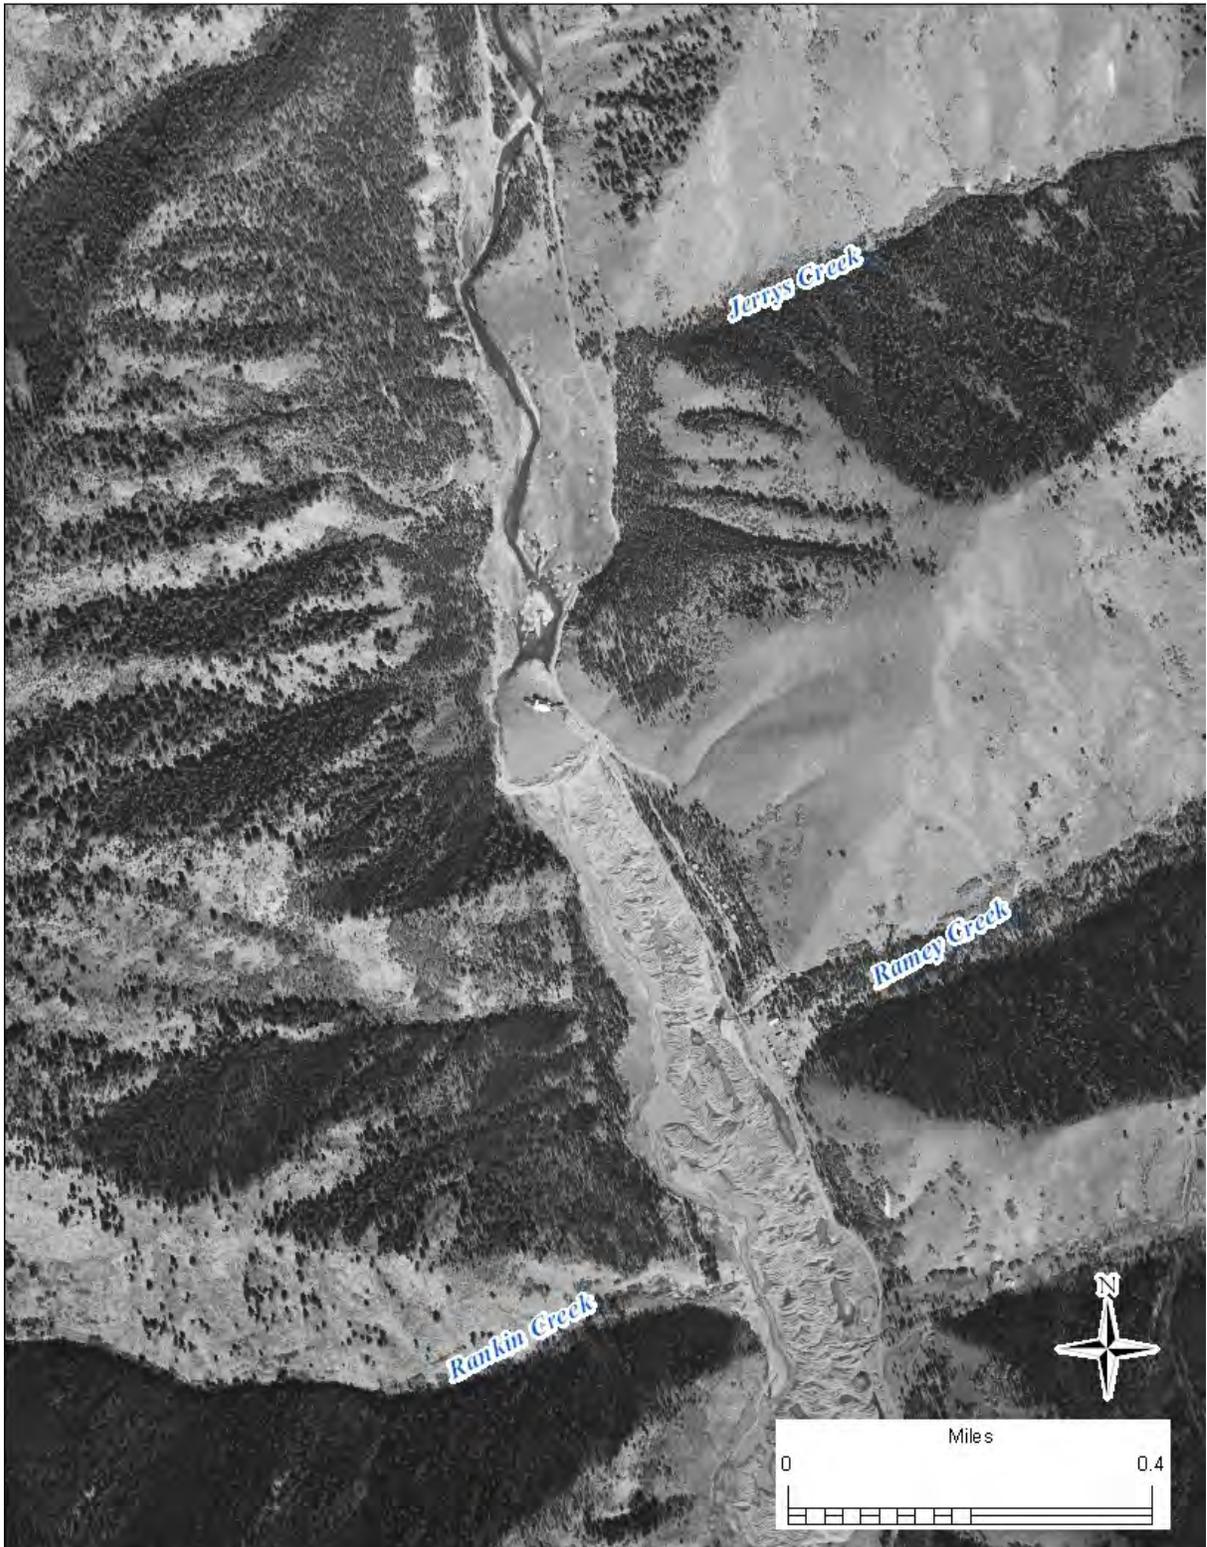
Figure 7. Yankee Fork Gold Dredge working between Rankin Creek and Jerrys Creek in 1945.

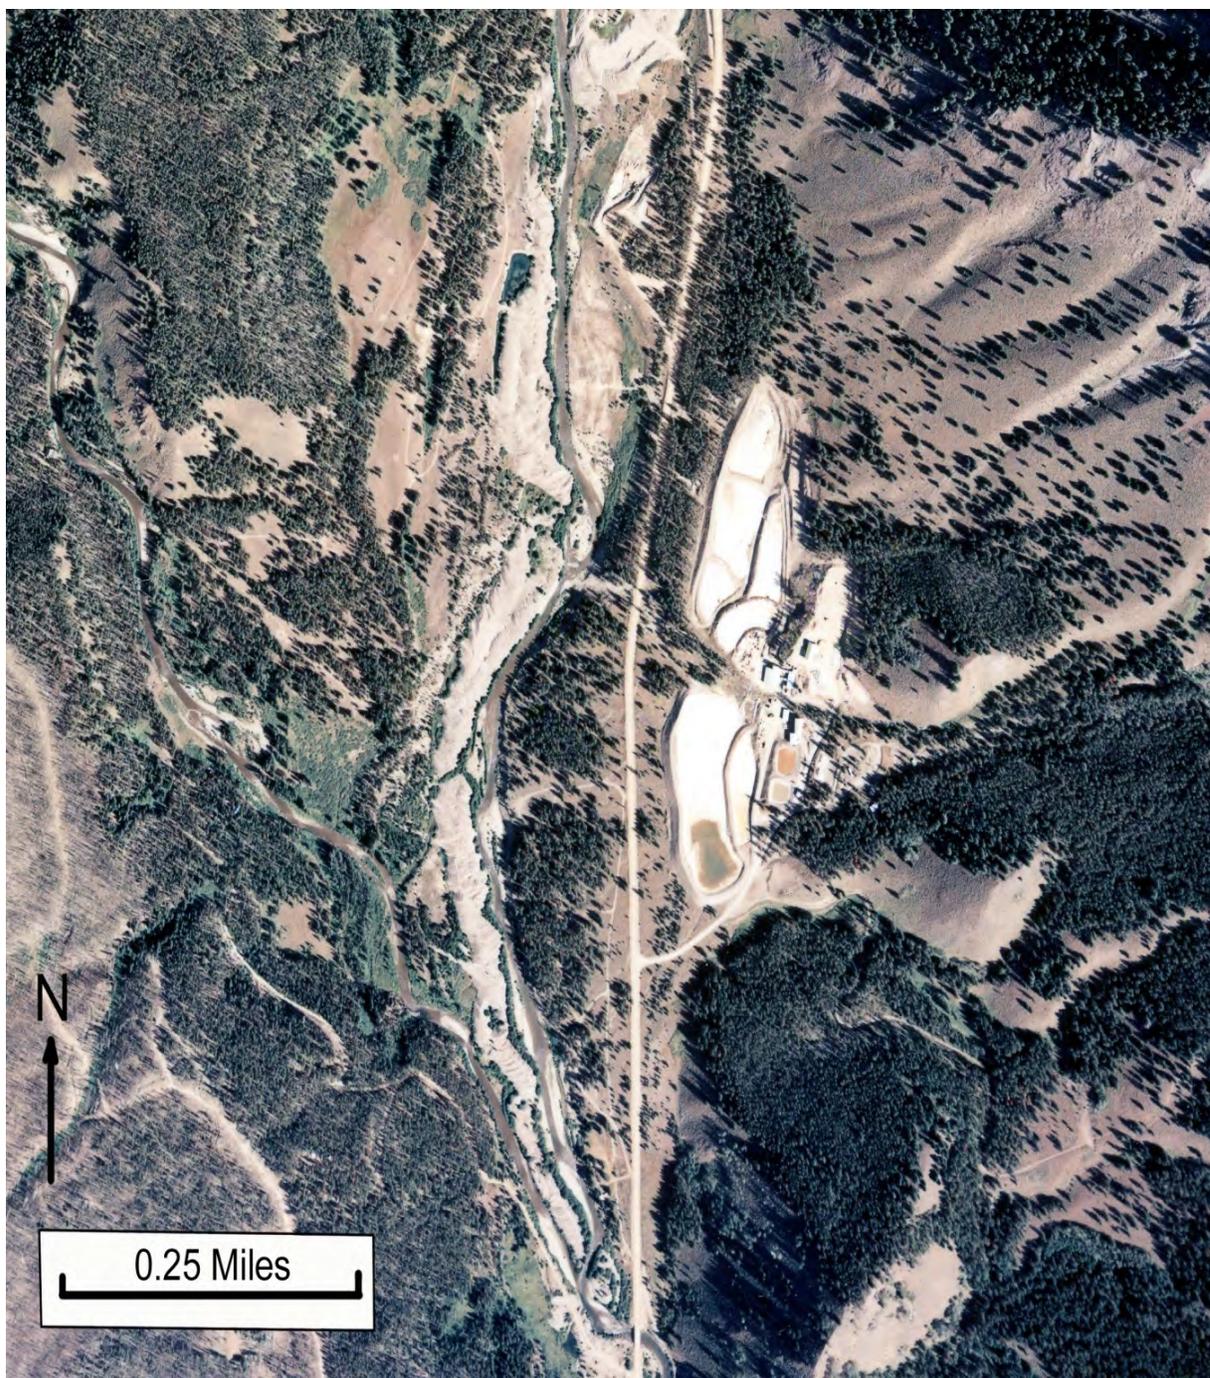
Figure 8. U.S. Antimony Corporation's vat leach cyanide mill at Preachers Cove in 1991.

1980 – 2004	<p>U.S. Antimony Corporation's subsidiary Yankee Fork Silver and Gold Company began processing dump material from Charles Dickens mine and mines on Estes Mountain using a vat leach cyanide mill at Preachers Cove in 1980 (Figure 8). There were some environmental problems at the mill site associated with soil and groundwater contamination from cyanide spills and heavy metals leaching from the tailing ponds. Supposedly by the end of 1993, over 90 percent of the chemicals had been neutralized (Mitchell 1997).</p> <p>In 1995, the U.S. Forest Service (USFS) discovered a cyanide leak at the processing facility. Approximately 20,000 gallons of cyanide solution from the tailing ponds leached into the ground about 650 feet from the Yankee Fork (High Country News 1995). No documented fish kill was associated with this release.</p> <p>U.S. Antimony completed the physical reclamation of the Preachers Cove mill in 2004.</p>

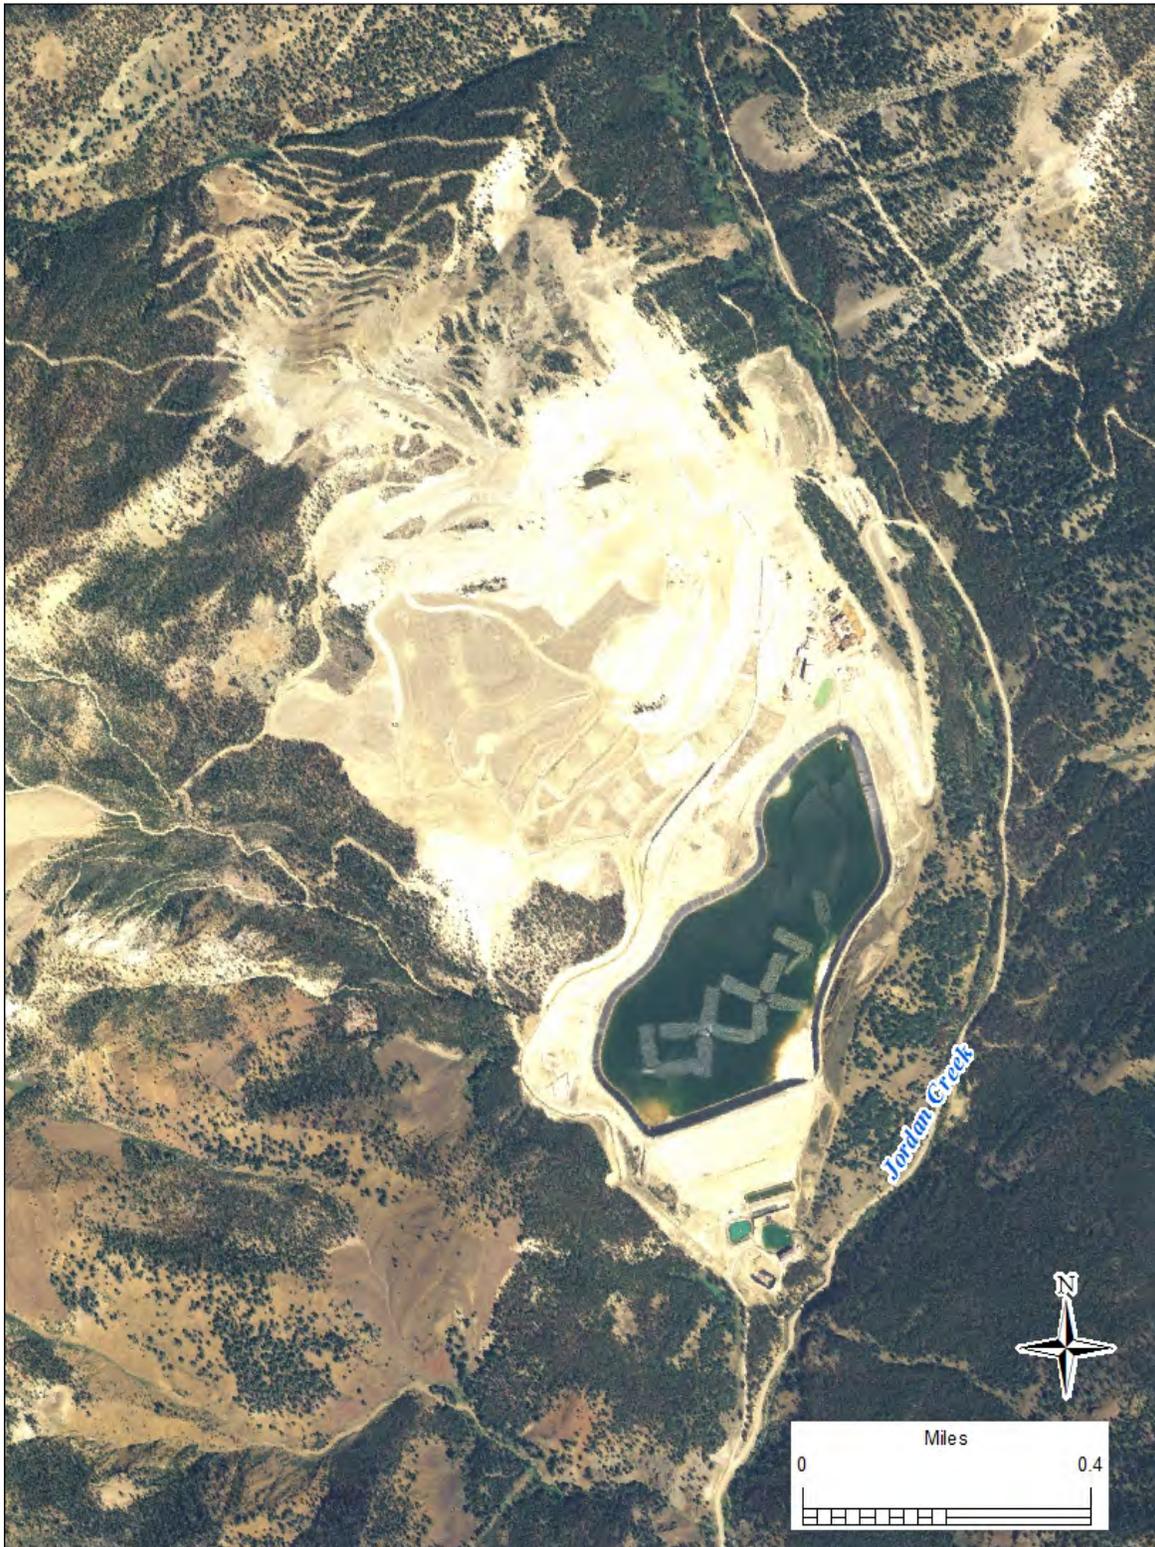
Figure 9. Grouse Creek Mine that was operated by Hecla Mining along Jordan Creek in 2009.

Year or Period	Significant Historical Event
1993 - 2012	<p>The following is a summary of the Grouse Creek Mine based on the <i>Removal Action Memorandum, Grouse Creek Mine Tailings Impoundment Closure</i>, initiated by the USFS in 1998. Construction of the Grouse Creek Mine in the Jordan Creek drainage by Hecla Mining Company (Hecla) began in 1993 and actual mining operations were from 1994 to 1997. The mine was a 536-acre open-pit mine and gold recovery used a carbon-in-pulp cyanide vat leach process which included a 105-acre tailings impoundment (Figure 9). In 1997, Hecla suspended mining operations due to unfavorable economic conditions. Beginning in 1997, water monitoring sites detected weak acid dissociable cyanide off-site, instream and downstream of the mine. In 1999, a USFS Technical Team concluded that cyanide was from the tailings impoundment. In October 2000, Hecla entered into an Administrative Order on Consent, under the Comprehensive Environmental Response Compensation and Liability Act, for a Time-Critical Removal Action with the USFS and the Environmental Protection Agency. In 2003, under an Action Memorandum, Hecla was allowed to discharge treated and untreated tailings impoundment water to the Yankee Fork via a pipe to Outfall 003 located downstream of the Yankee Fork/Jordan Creek confluence. No impacts to aquatic life in Jordan Creek were noted in the <i>Removal Action Memorandum</i>.</p> <p>Presently, Hecla has reclaimed about 80 percent and the final reclamation of the site with completion of the tailings impoundment closure is planned to be completed in 2012 (http://www.hecla-mining.com/resposibility/resposibility_stewardship_reclamation.php).</p>

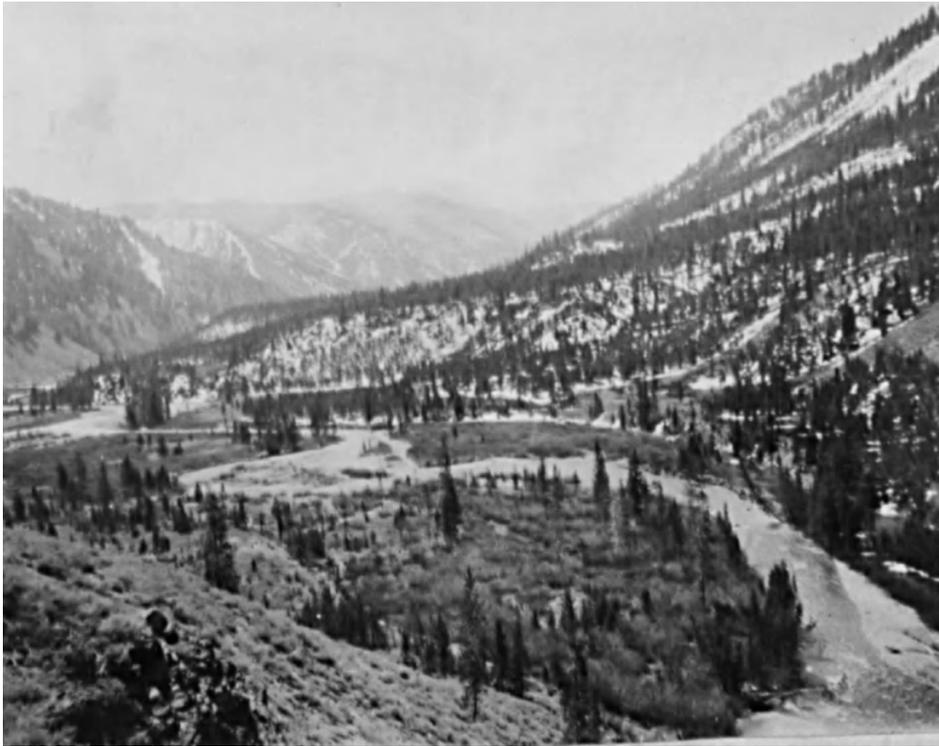
Figure 13. View downstream along the West Fork from about Sawmill Creek toward the confluence with the Yankee Fork (Smith 1911). Photograph taken by Maven Sawyer, winter of 1910.

The oldest historic photograph found during this assessment was from 1911 (Figure 13). In the photograph taken downstream of Sawmill Creek looking toward the Yankee Fork confluence, timber harvests had removed almost all of the large trees (a sawmill was located in Sawmill Creek) and hydraulic mining had already introduced sediment pulses to the system (Sawmill Creek had been diverted for hydraulic mining purposes).

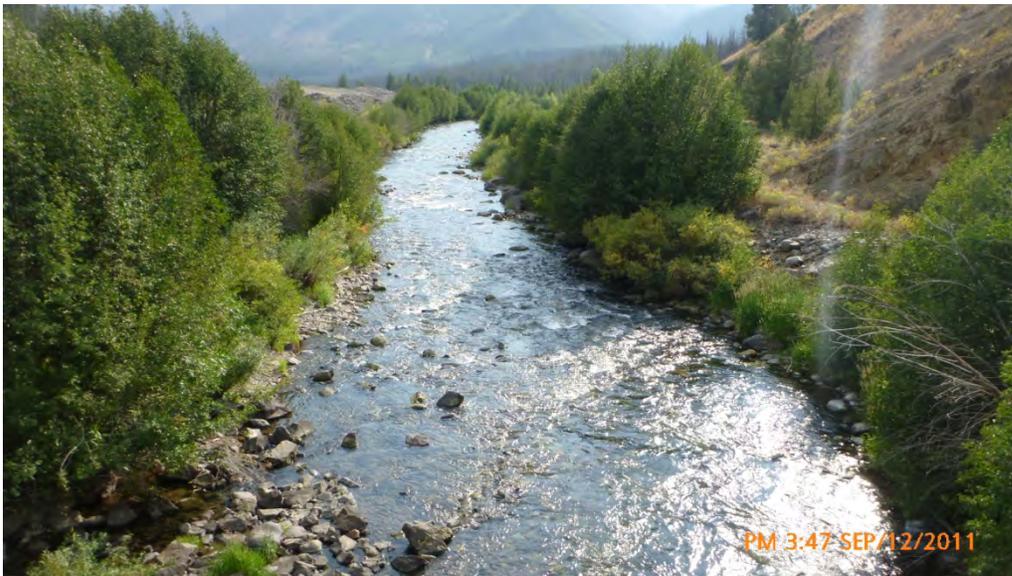
Figure 15. Yankee Fork plane-bed channel as viewed from the Bonanza Bridge.

Channel type is plane-bed with an average unvegetated channel width of about 48 feet within an average valley width of 122 feet (Figure 15). Channel confinement has increased due to the mine tailings that constrain lateral channel migration and limit floodplain development by about 28 percent from Jordan Creek to Preachers Cove, and about 54 percent from Preachers Cove to the Yankee Fork/West Fork confluence. Increased channel confinement and loss of floodplains changes the geometry of the channel/floodplain cross-sectional area. At high flows, the increased confinement results in deeper water and higher velocities in the more confined channel. The increased depths and velocities result in increased shear stress, and sediment mobilization and transport. The outcome is a wider, more uniform plane-bed channel that is often armored with only the larger sediment sizes due to the increased sediment transport. The armor layer inhibits pool development when flows are not sufficient to mobilize the armoring particles, or in the absence of channel-spanning structures or significant channel constrictions (Montgomery and Buffington 1997; Bisson, Buffington, and Montgomery 2006).

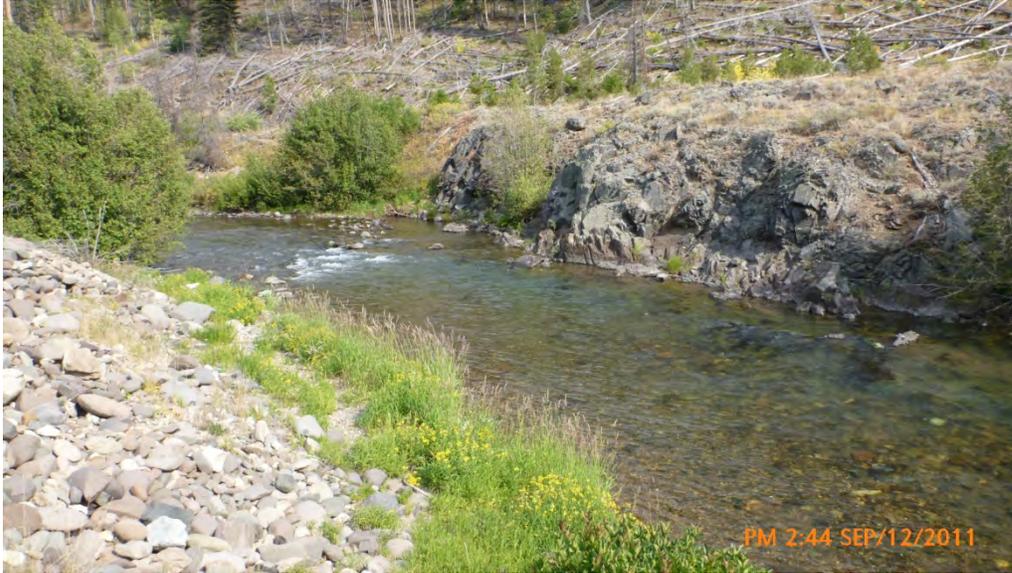
Figure 16. Yankee Fork lateral scour pool forced by bedrock outcrop. Yankee Fork of the Salmon River, Yankee Fork Subbasin, Idaho – Bureau of Reclamation Photograph by P. Drury, September 12, 2011.

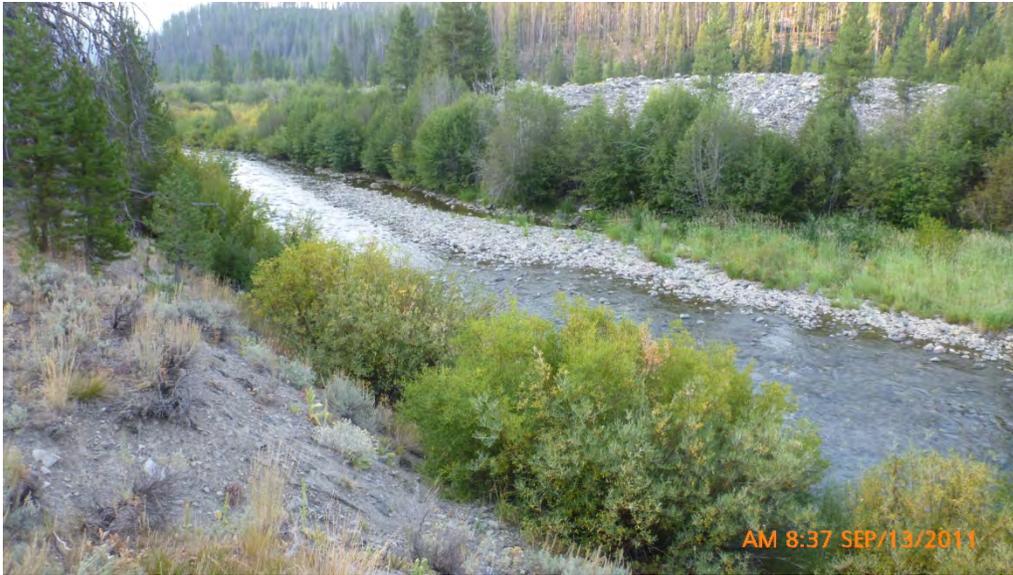
Figure 17. Yankee Fork floodplain-type side channel on far side of vegetated bar. Yankee Fork of the Salmon River, Yankee Fork Subbasin, Idaho – Bureau of Reclamation
Photograph by P. Drury, September 13, 2011.

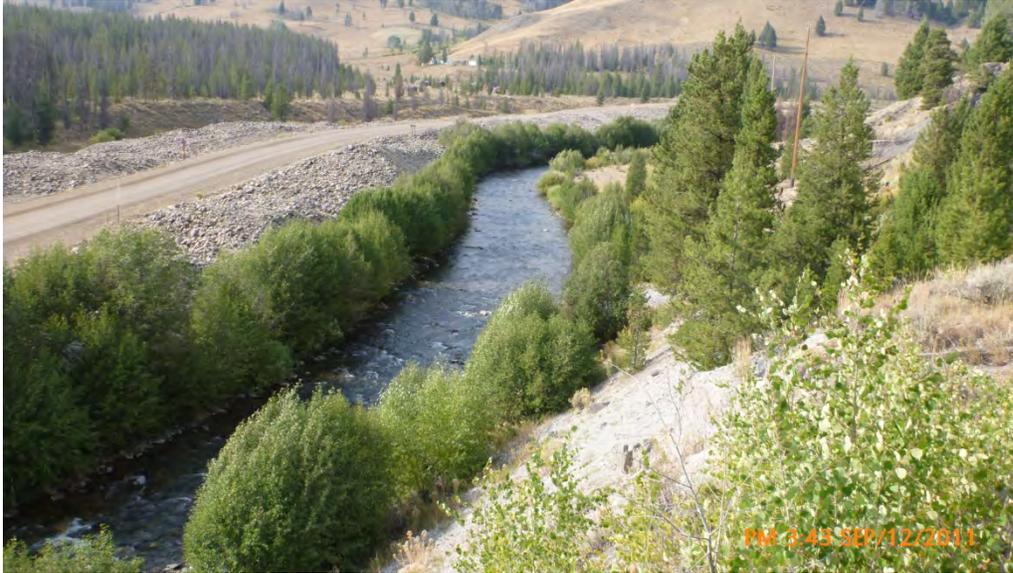
Figure 18. Yankee Fork riparian corridor along mine tailings and valley wall.
Yankee Fork of the Salmon River, Yankee Fork Subbasin, Idaho – Bureau of Reclamation
Photograph by P. Drury, September 12, 2011.

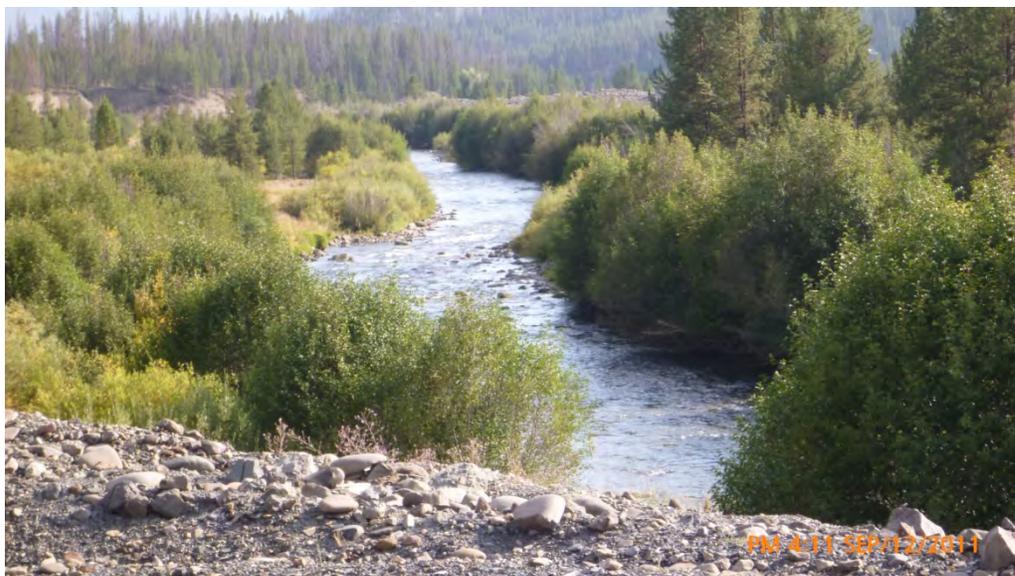
Figure 19. Yankee Fork riparian vegetation along connected floodplains.

Active (connected) floodplain areas are generally vegetated with a mosaic of grassland/forbs, shrub/seedlings, and sapling poles. Alders, willows, grasses, and forbs were dominant in the lower areas where floods frequently disturbed the surface and the soil is wetter from seepage through the mine tailings (Figure 19). Grasses with dispersed lodgepole pines were dominant in the higher areas where floods less frequently disturb the surface and the soils tend to be drier. Most of the mine tailings adjacent to the stream are unvegetated and the vegetation along the channel shades less than 20 percent of the stream (USFS 2010).

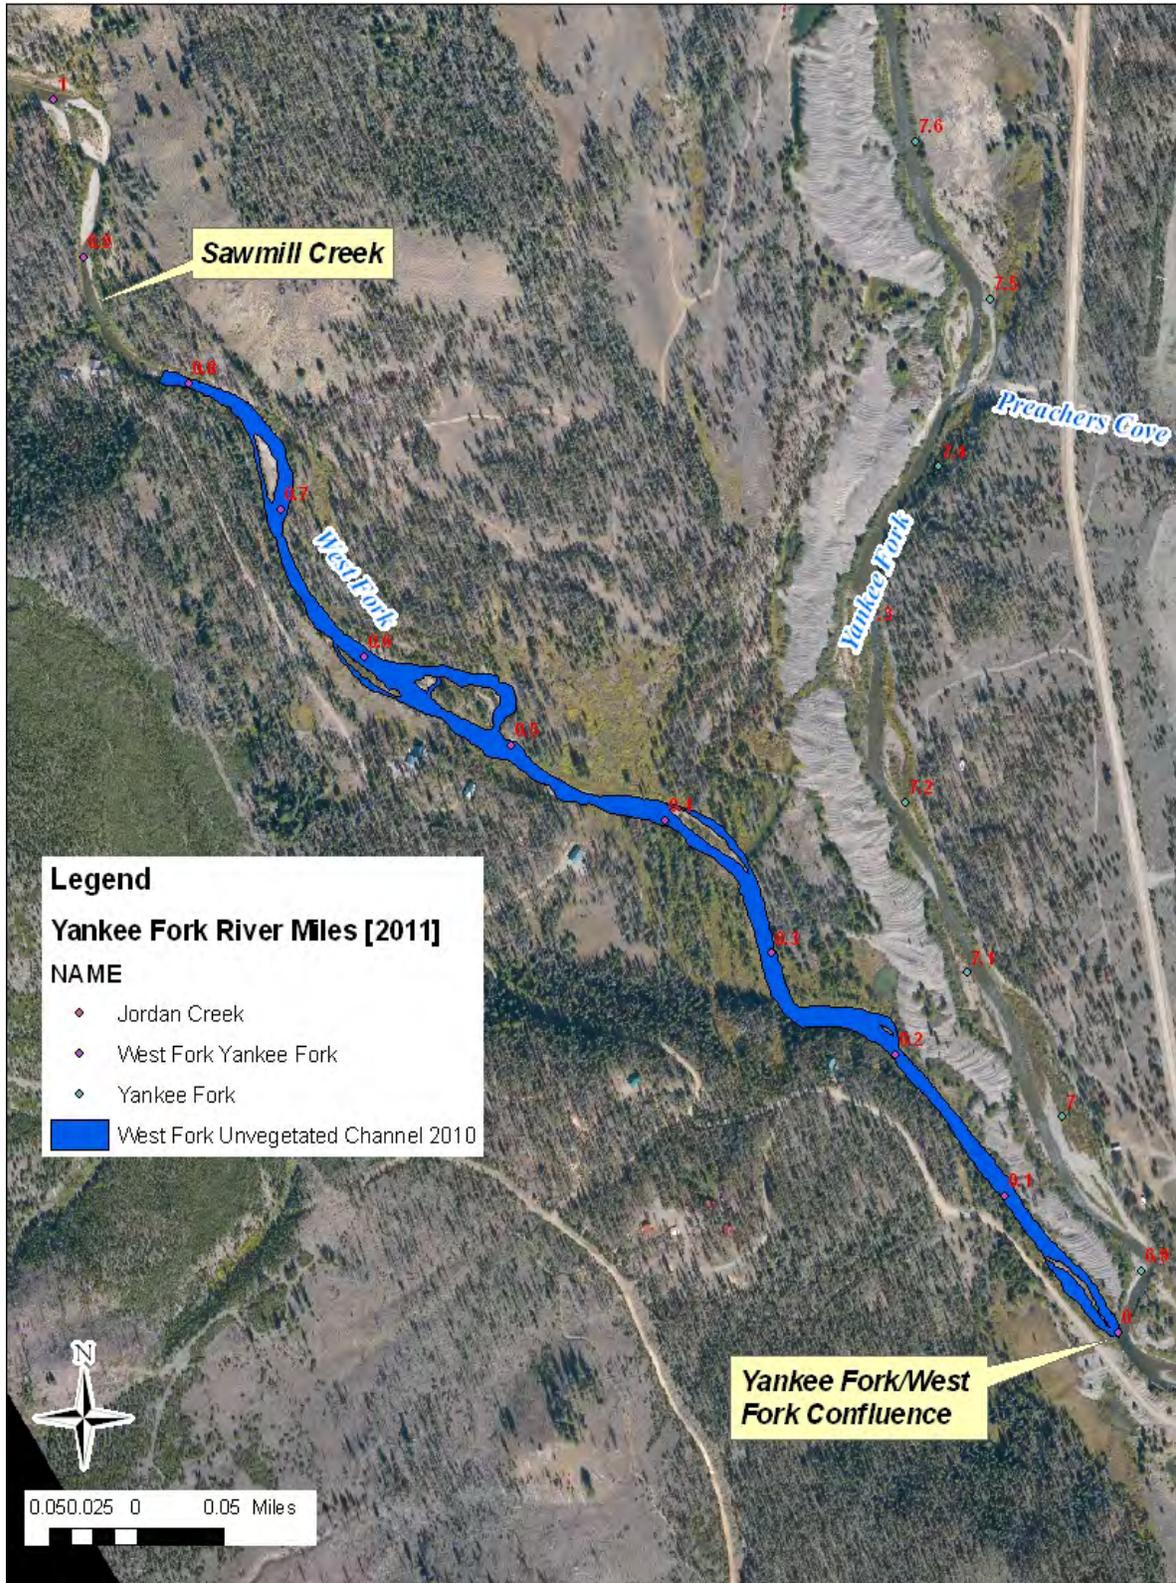
Figure 21. Map of the West Fork (2010) in the assessment area.

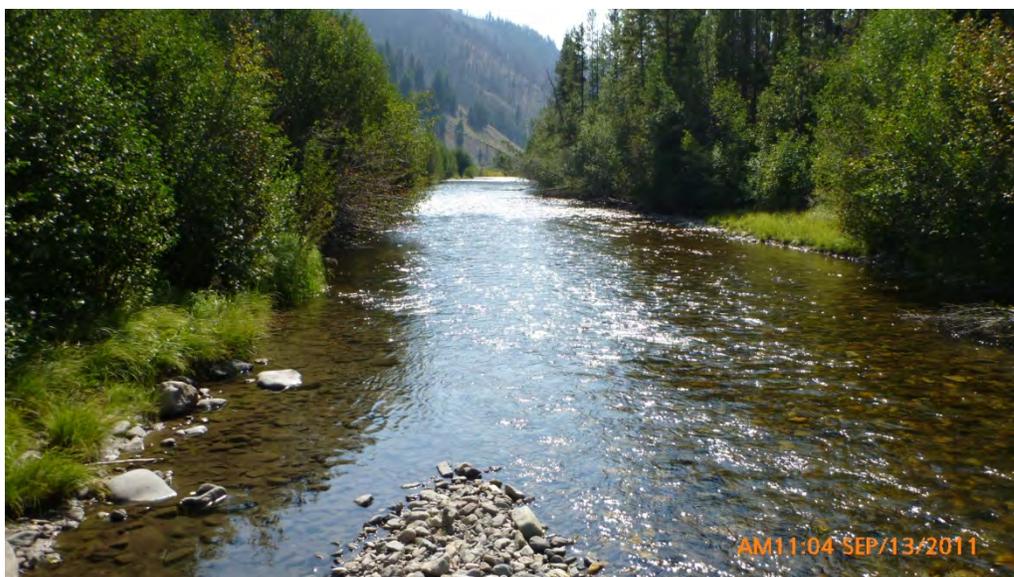
Figure 22. Looking downstream along the West Fork where it becomes confined near RM 0.2. West Fork of the Yankee Fork of the Salmon River, Yankee Fork Subbasin, Idaho – Bureau of Reclamation Photograph by P. Drury, September 13, 2011.

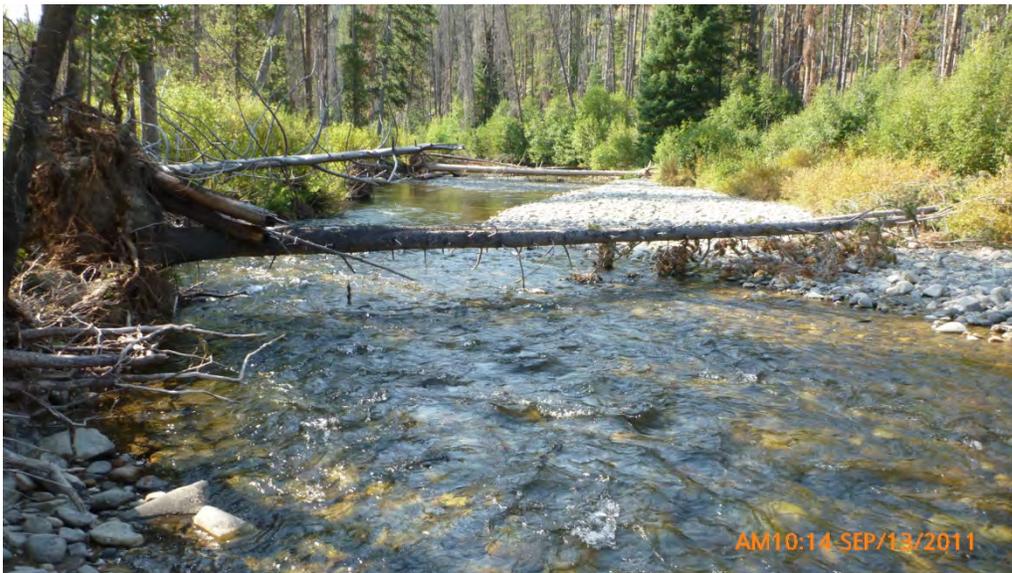
Figure 23. West Fork pool-riffle bedforms influenced by wood and vegetated banks. West Fork of the Yankee Fork of the Salmon River, Yankee Fork Subbasin, Idaho – Bureau of Reclamation Photograph by P. Drury, September 13, 2011.

In the unconfined channel reach (RM 0.8 to 0.2), the channel is predominantly a plane-bed system with bedform diversity associated with local forcing agents that create flow convergence sufficient to mobilize the streambed. This channel reach is dominated by riffles (77 percent TWA) with runs (14 percent TWA) and pools (9 percent TWA). Pools are typically associated with flow convergence on the outside of bends where transient wood tends to accumulate and contribute to forcing lateral scour (Figure 23). A relatively small section of bank protection (about 200 linear feet of large cobbles and boulders) encroaches on the channel causing flow convergence and scouring a mid-channel pool. Instream wood appears to have a significant role by contributing to flow convergence that is sufficient enough to mobilize the bed load and scour pools.

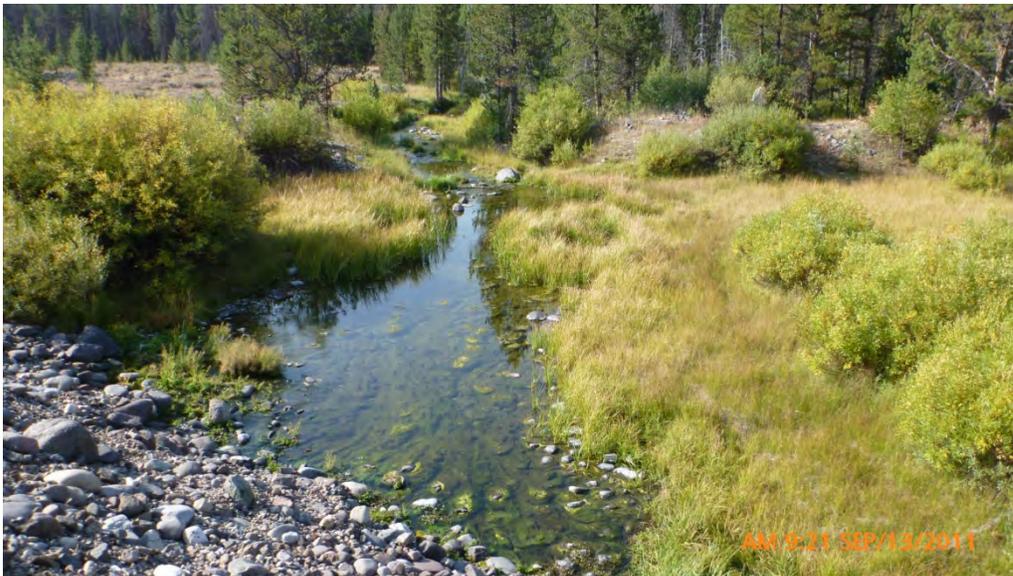
Figure 24. Groundwater channel charged by seepage through the mine tailings. West Fork of the Yankee Fork of the Salmon River, Yankee Fork Subbasin, Idaho – Bureau of Reclamation Photograph by P. Drury, September 13, 2011.

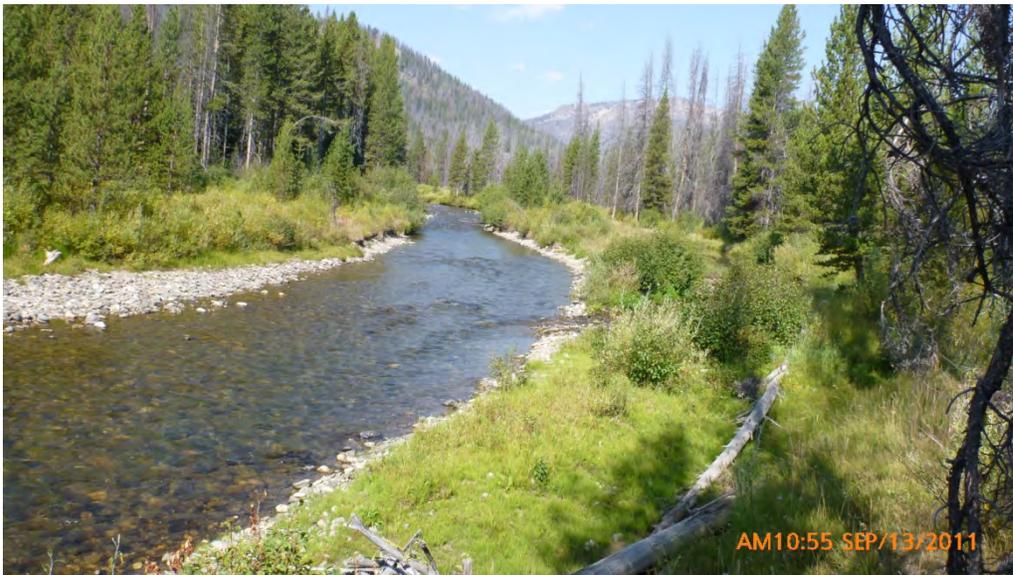
Figure 25. West Fork riparian vegetation along connected floodplains. West Fork of the Yankee Fork of the Salmon River, Yankee Fork Subbasin, Idaho – Bureau of Reclamation Photograph by P. Drury, September 13, 2011.

Active floodplain areas generally have a mosaic of shrub/seedling and small-to-large trees. Alders, willows, grasses, and forbs were dominant in the lower areas where floods frequently disturbed the surface and the soil was wetter from seepage through the mine tailings (Figure 25). Shrubs and seedlings with dispersed lodgepole pines were dominant in the higher areas where floods less frequently disturb the surface and the soils tend to be drier. Much of the mine tailings adjacent to the stream are unvegetated, except for the narrow strip of alders.

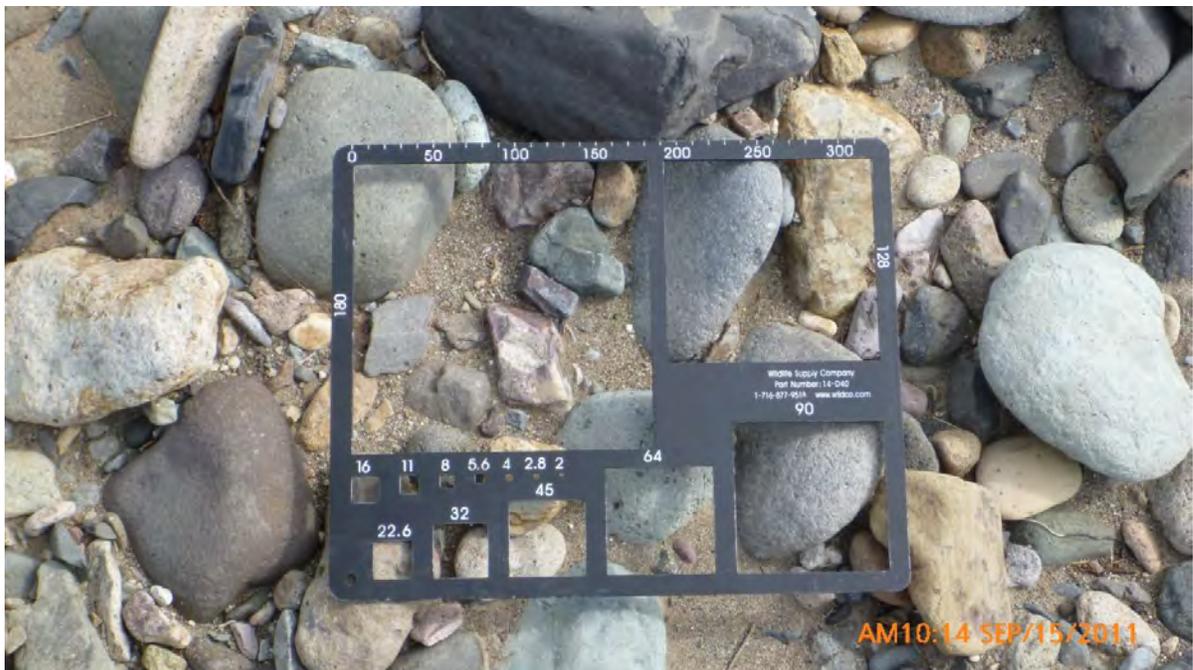
Photograph No. 1. Zoomed in photograph of bar material near Yankee Fork RM 7.00. Yankee Fork of the Salmon River, Yankee Fork Subbasin, Idaho – Bureau of Reclamation Photograph by P. Drury, September 15, 2011.

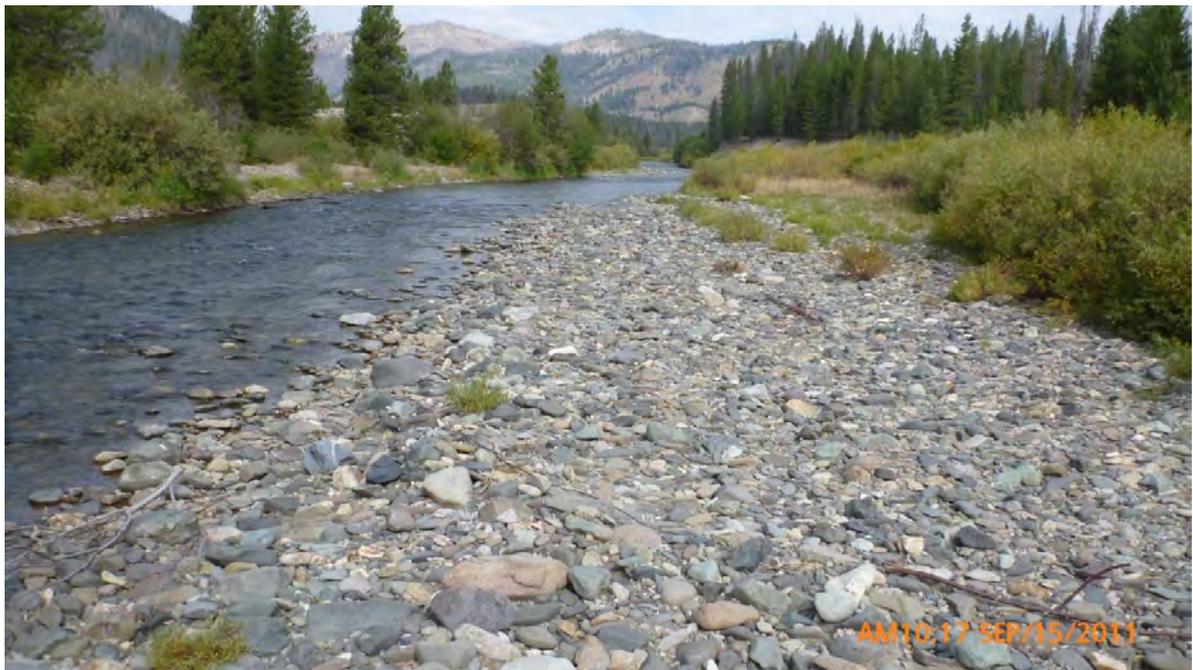
Photograph No. 2. Zoomed out photograph looking upstream at bar near Yankee Fork RM 7.00. Yankee Fork of the Salmon River, Yankee Fork Subbasin, Idaho – Bureau of Reclamation Photograph by P. Drury, September 15, 2011.

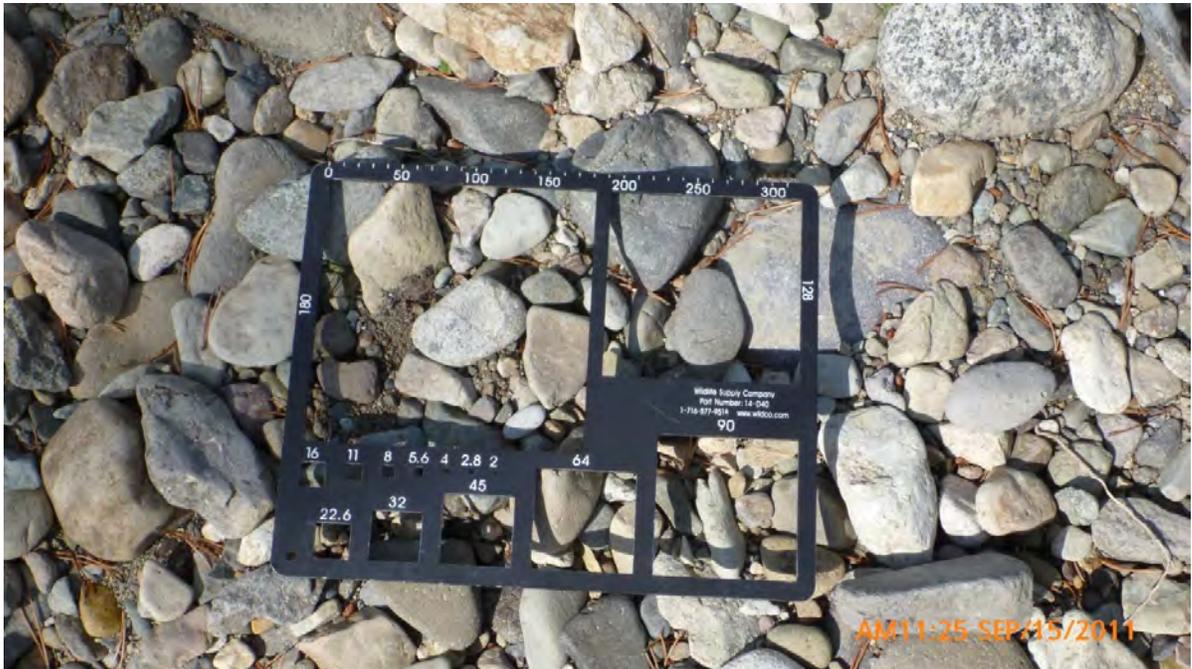
Photograph No. 3. Zoomed in photograph of bar material near West Fork RM 0.70. Yankee Fork of the Salmon River, Yankee Fork Subbasin, Idaho – Bureau of Reclamation Photograph by P. Drury, September 15, 2011.

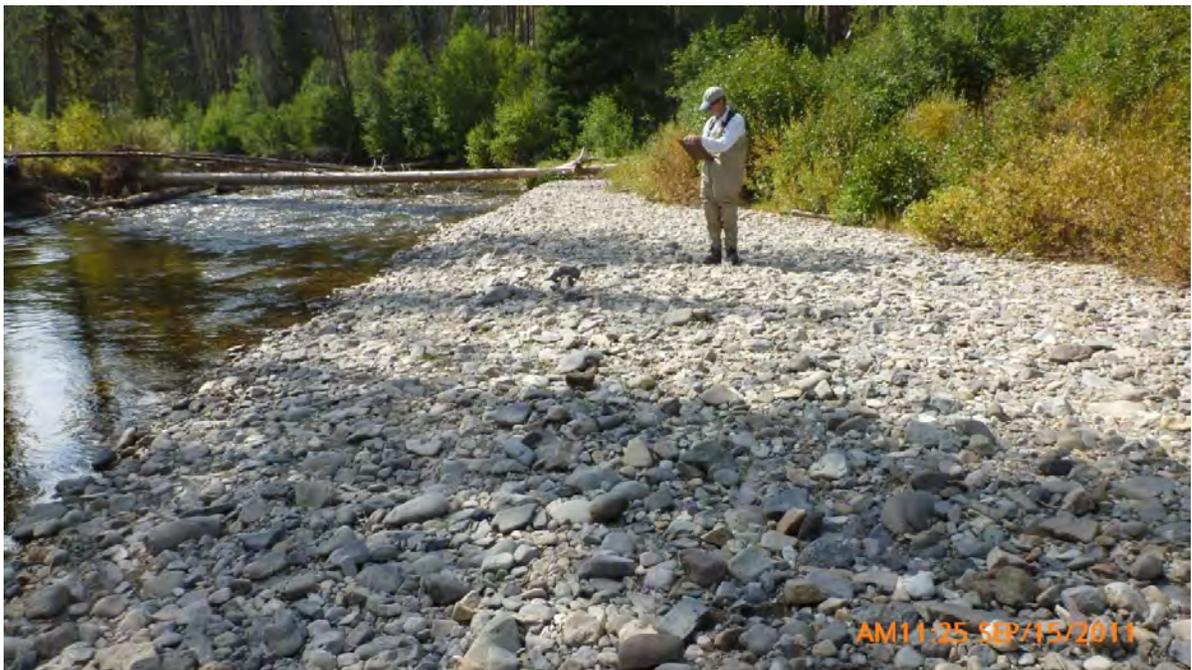
Photograph No. 4. Zoomed out photograph looking downstream at bar near West Fork RM 0.70. Yankee Fork of the Salmon River, Yankee Fork Subbasin, Idaho – Bureau of Reclamation Photograph by P. Drury, September 15, 2011.

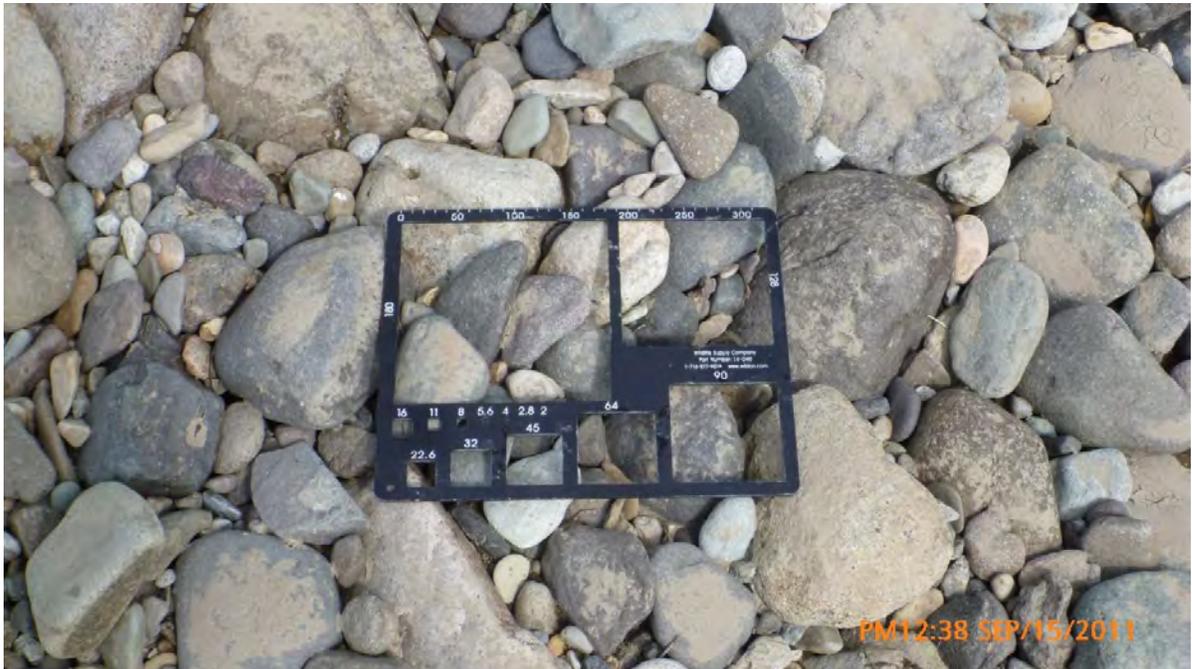
Photograph No. 5. Zoomed in photograph of bar material near Yankee Fork/West Fork confluence at Yankee Fork RM 6.85. Yankee Fork of the Salmon River, Yankee Fork Subbasin, Idaho – Bureau of Reclamation Photograph by P. Drury, September 15, 2011.

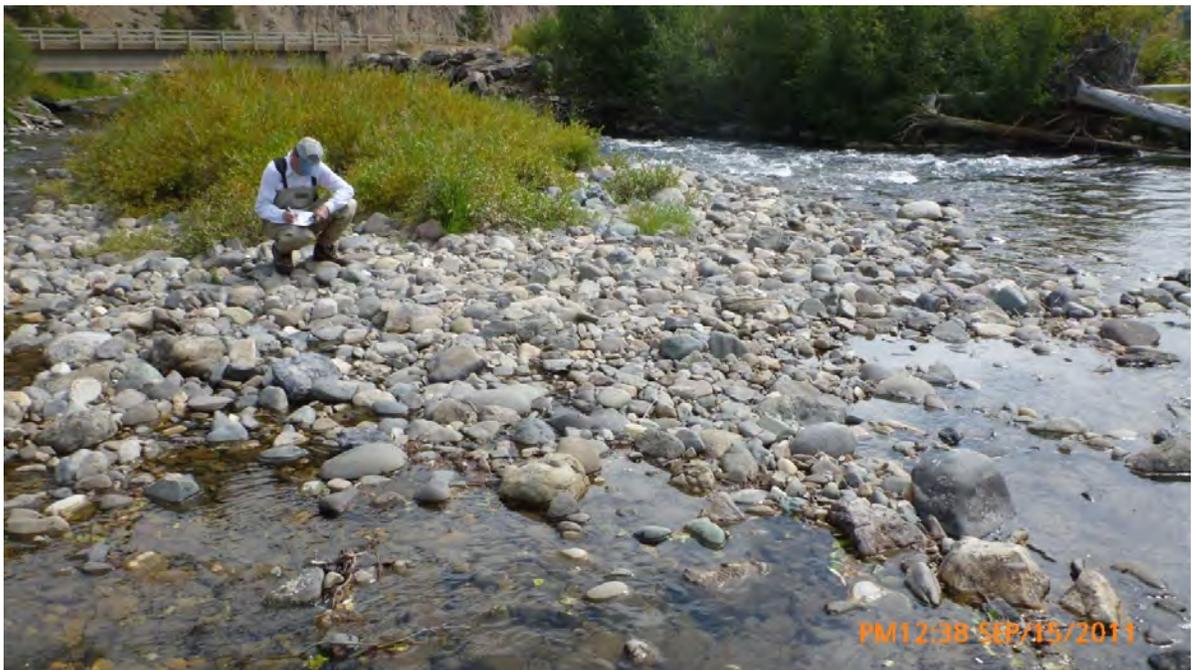
Photograph No. 6. Zoomed out photograph looking downstream at bar near Yankee Fork/West Fork confluence near Yankee Fork RM 6.85. Yankee Fork of the Salmon River, Yankee Fork Subbasin, Idaho – Bureau of Reclamation Photograph by P. Drury, September 15, 2011.

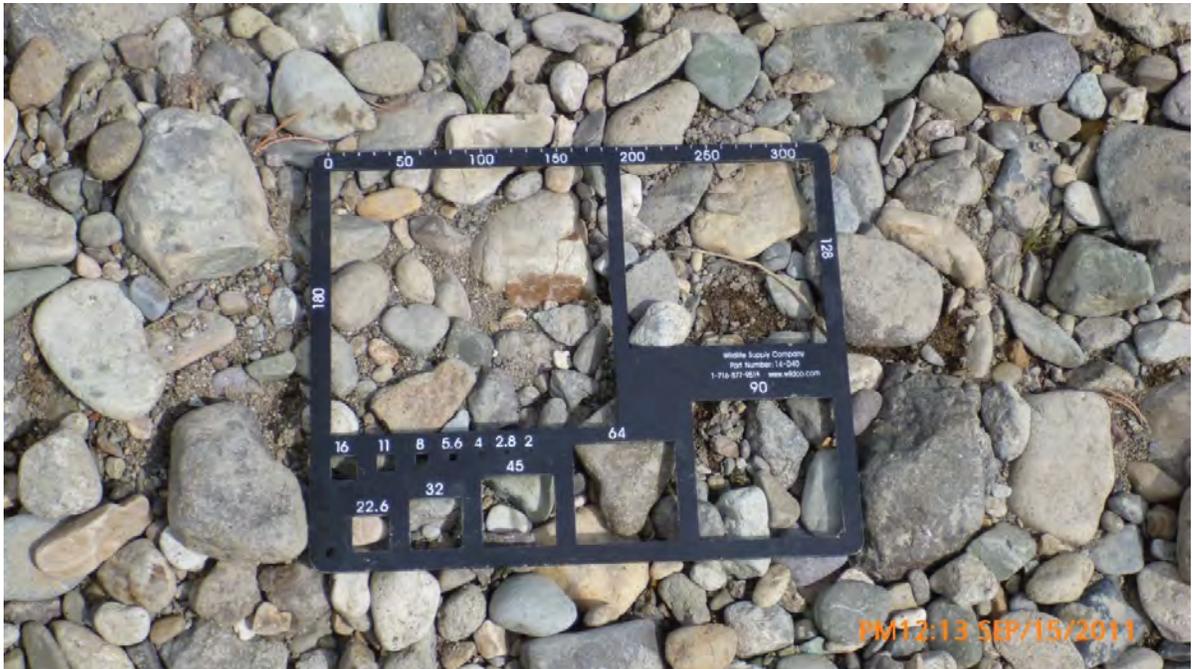
Photograph No. 7. Zoomed in photograph of bar material near West Fork RM 0.10. Yankee Fork of the Salmon River, Yankee Fork Subbasin, Idaho – Bureau of Reclamation Photograph by P. Drury, September 15, 2011.

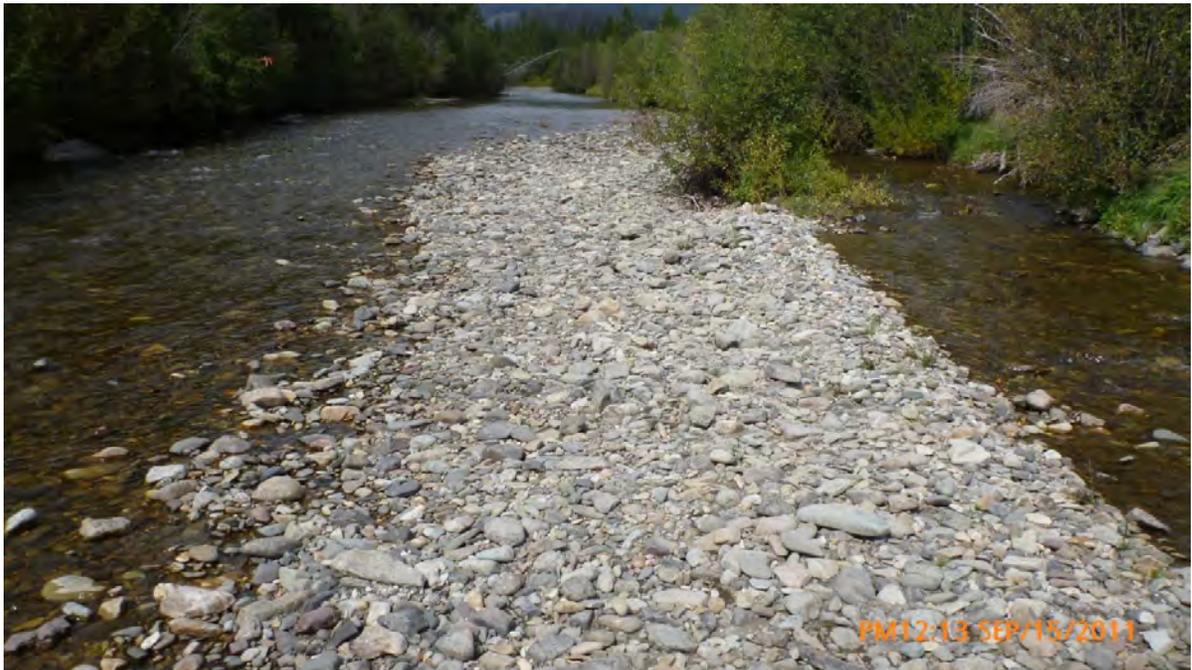
Photograph No. 8. Zoomed out photograph looking upstream at bar near West Fork RM 0.10. Yankee Fork of the Salmon River, Yankee Fork Subbasin, Idaho – Bureau of Reclamation Photograph by P. Drury, September 15, 2011.
