Bonanza Area Reach Assessment
Yankee Fork of the Salmon River,
Upper Salmon Subbasin

Custer County, Idaho

September 2012

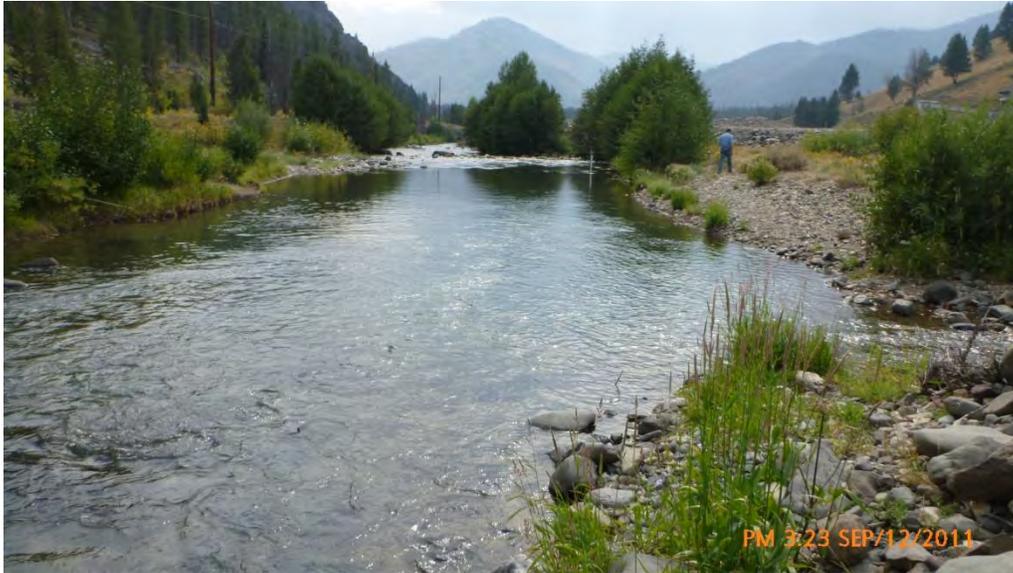
Photograph No. 1. View to the south looking downstream at pool scoured at confluence of Yankee Fork and Jordan Creek. Yankee Fork of the Salmon River, Yankee Fork Subbasin, Idaho – Bureau of Reclamation Photograph by P. Drury, September 12, 2011.

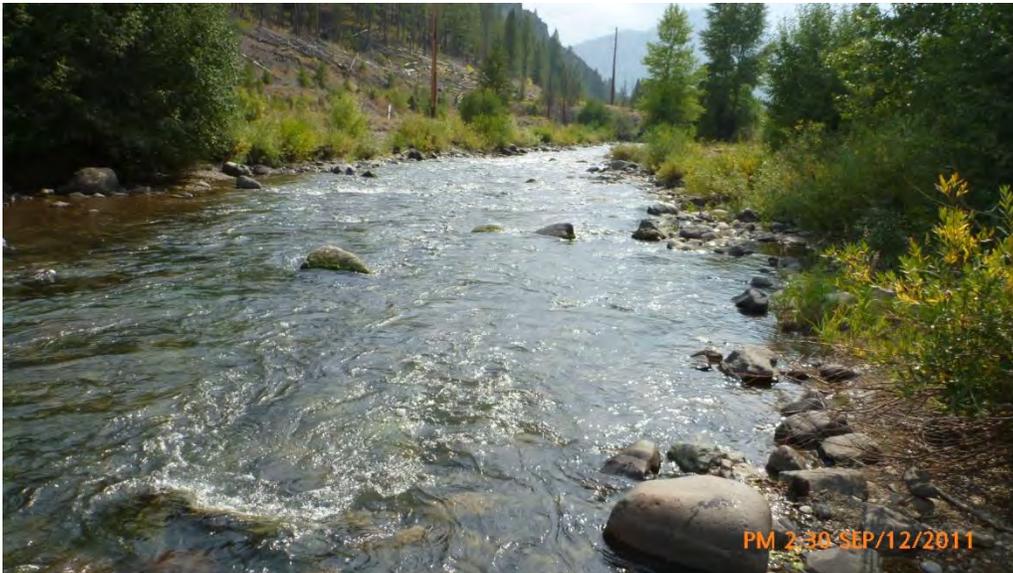
Photograph No. 2. View to the south looking downstream at riffle habitat. The boulders provide hydraulic diversity and provide resting areas for migrating fish. Yankee Fork of the Salmon River, Yankee Fork Subbasin, Idaho – Bureau of Reclamation Photograph by P. Drury, September 12, 2011.

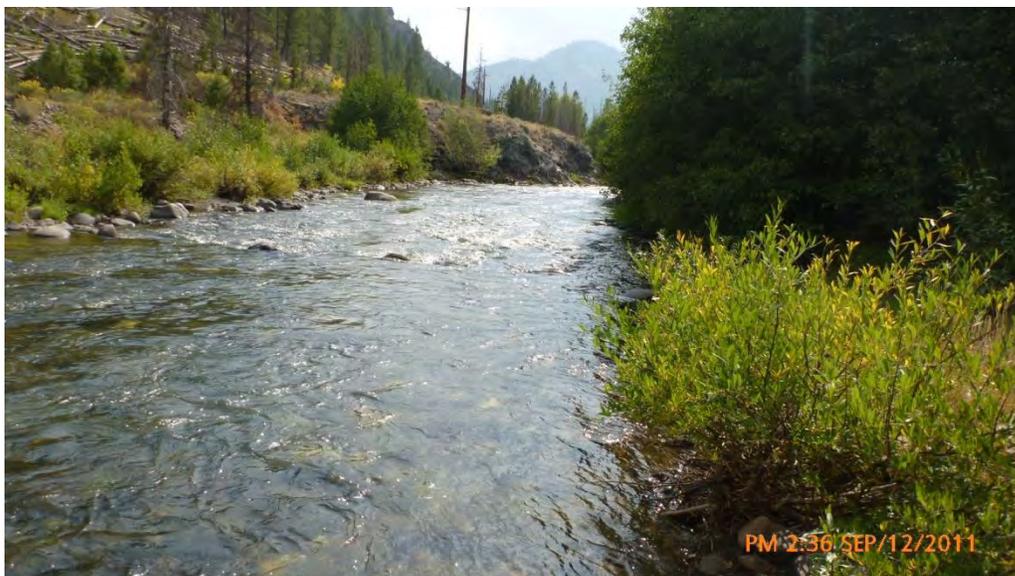
Photograph No. 3. View to the south looking downstream at bedrock outcrop that prevents lateral channel migration and forces lateral scour. Yankee Fork of the Salmon River, Yankee Fork Subbasin, Idaho – Bureau of Reclamation Photograph by P. Drury, September 12, 2011.

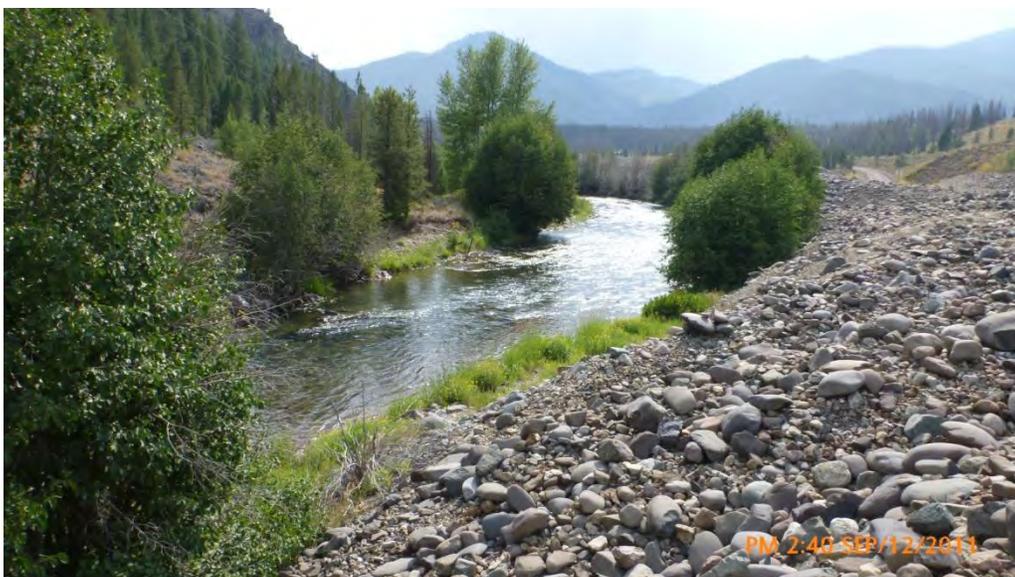
Photograph No. 4. View to the southwest looking downstream at run habitat downstream of bedrock forced lateral scour pool. Yankee Fork of the Salmon River, Yankee Fork Subbasin, Idaho – Bureau of Reclamation Photograph by P. Drury, September 12, 2011.

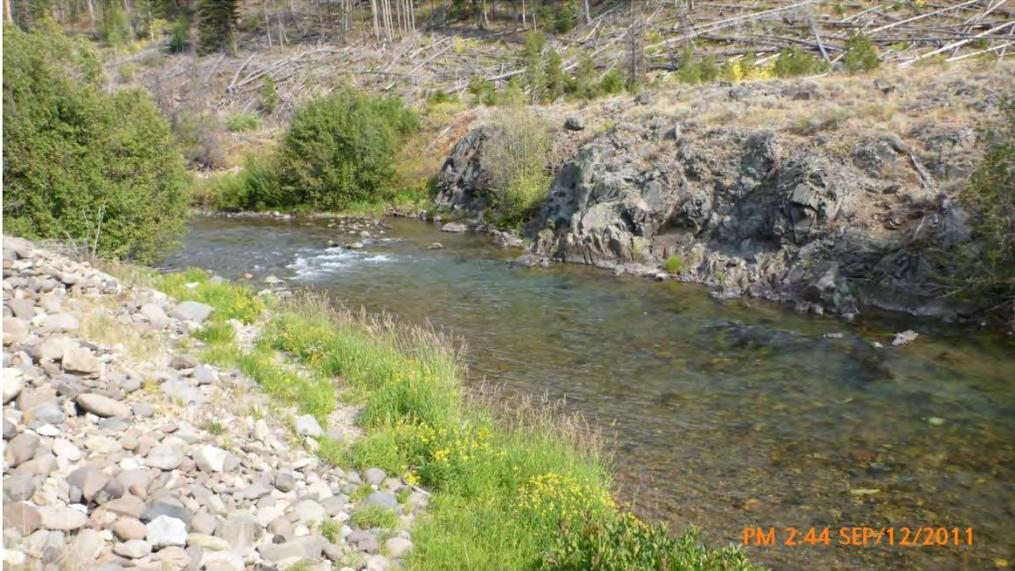
Photograph No. 5. View to the east looking upstream at bedrock outcrop along river left and in the channel. Yankee Fork of the Salmon River, Yankee Fork Subbasin, Idaho – Bureau of Reclamation Photograph by P. Drury, September 12, 2011.

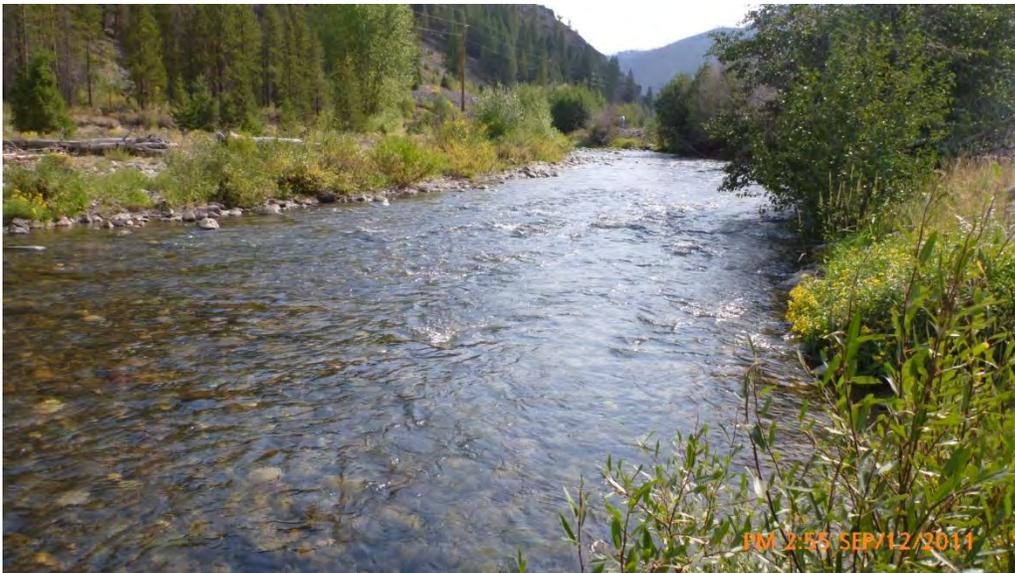
Photograph No. 6. View to the south looking downstream at a gravel/cobble dominated plane-bed channel. In the upper left corner of photograph note the large wood deposited high on a poorly vegetated gravel bar. Yankee Fork of the Salmon River, Yankee Fork Subbasin, Idaho – Bureau of Reclamation Photograph by P. Drury, September 12, 2011.

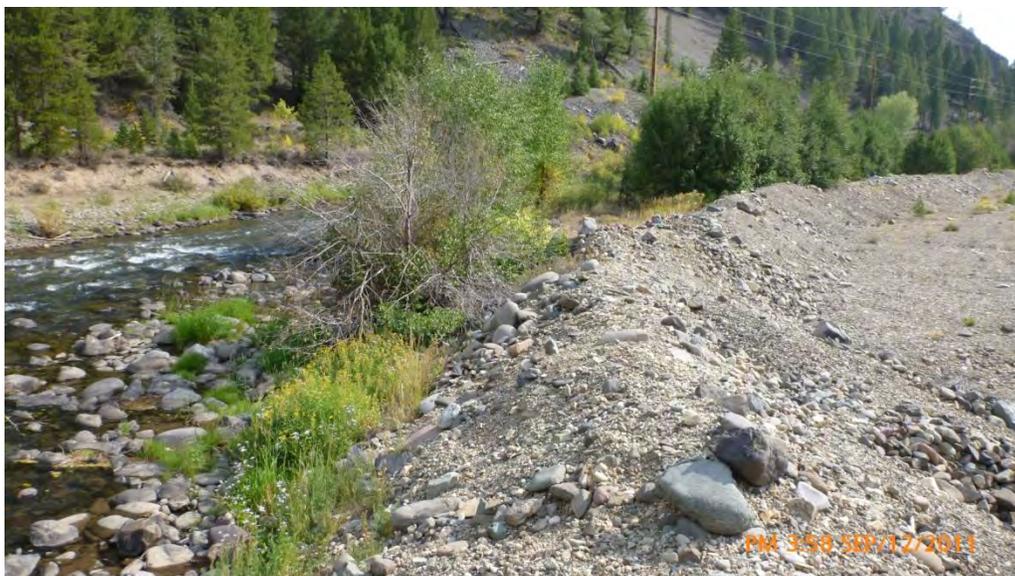
Photograph No. 7. View to the south looking downstream at a levee along river right that has been push-up to protect a gravel processing plant from floods. Yankee Fork of the Salmon River, Yankee Fork Subbasin, Idaho – Bureau of Reclamation Photograph by P. Drury, September 12, 2011.

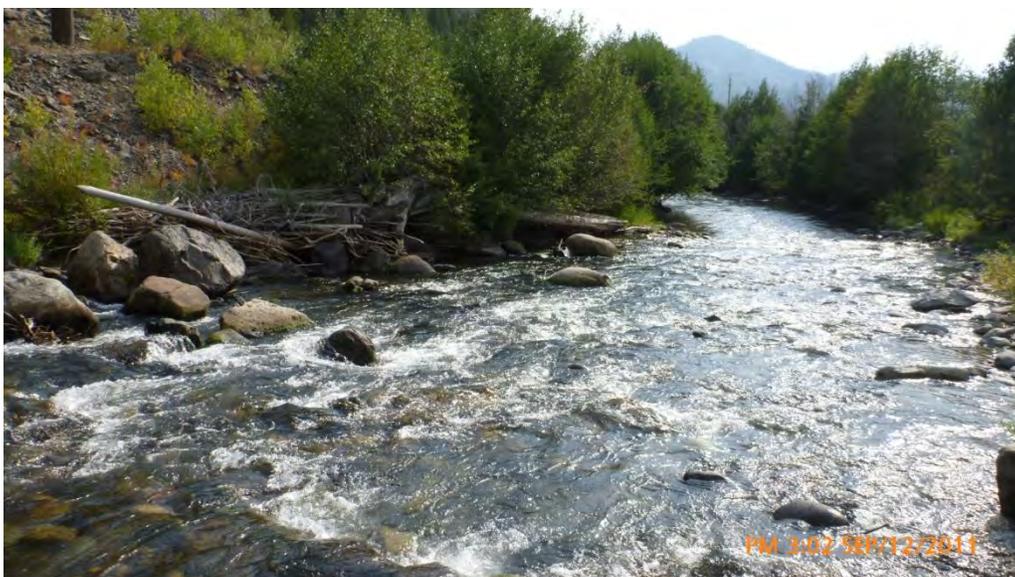
Photograph No. 8. View to the south looking downstream at a concentration of boulders along river left where the stream has been eroding the toe of an alluvial fan deposit. Yankee Fork of the Salmon River, Yankee Fork Subbasin, Idaho – Bureau of Reclamation Photograph by P. Drury, September 12, 2011.

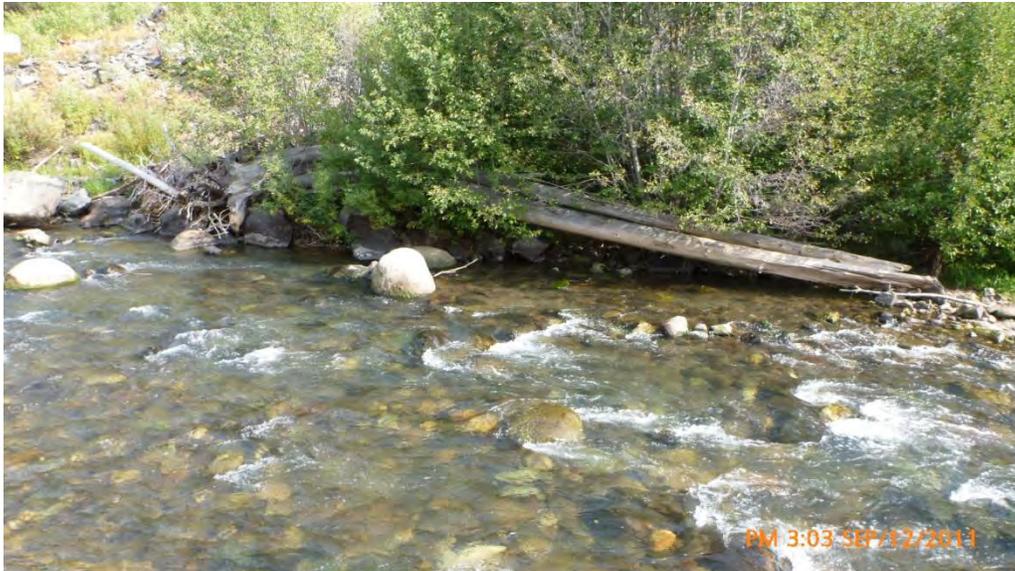
Photograph No. 9. View to the east looking across the channel at wood being recruited through bank erosion. Yankee Fork of the Salmon River, Yankee Fork Subbasin, Idaho – Bureau of Reclamation Photograph by P. Drury, September 12, 2011.

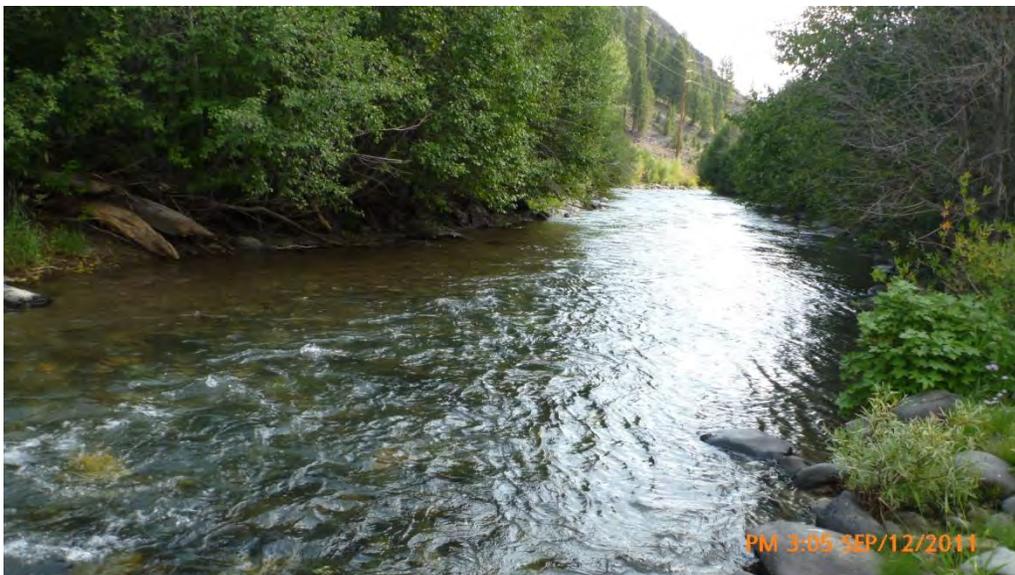
Photograph No. 10. View to the south looking downstream at a lateral scour pool along river right. Note the riparian corridor that provides bank stability, channel boundary roughness and canopy cover. Yankee Fork of the Salmon River, Yankee Fork Subbasin, Idaho – Bureau of Reclamation Photograph by P. Drury, September 12, 2011.

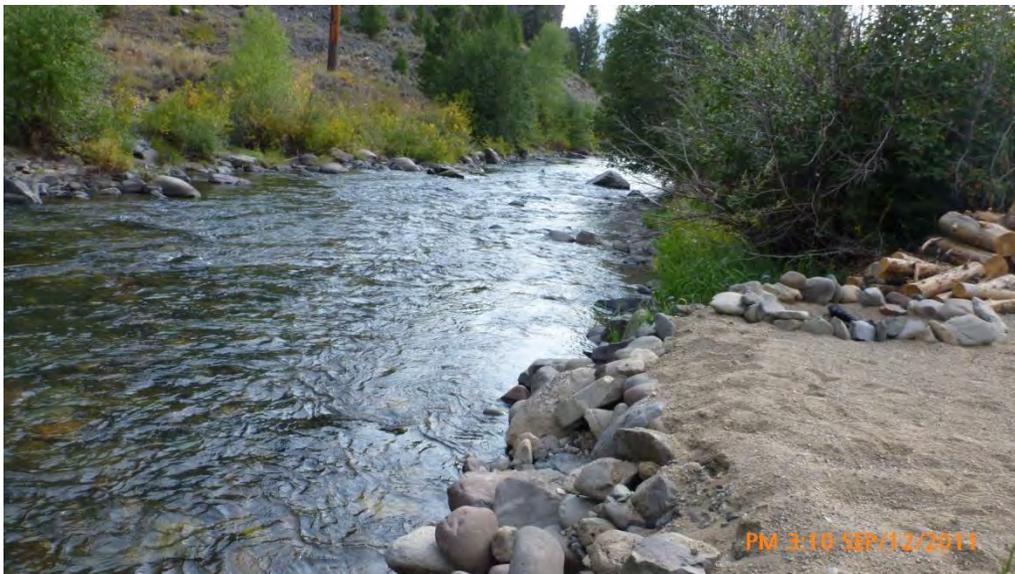
Photograph No. 11. View to the south looking downstream at a concentration of boulders derived from a colluvial deposit along river left. Yankee Fork of the Salmon River, Yankee Fork Subbasin, Idaho – Bureau of Reclamation Photograph by P. Drury, September 12, 2011.

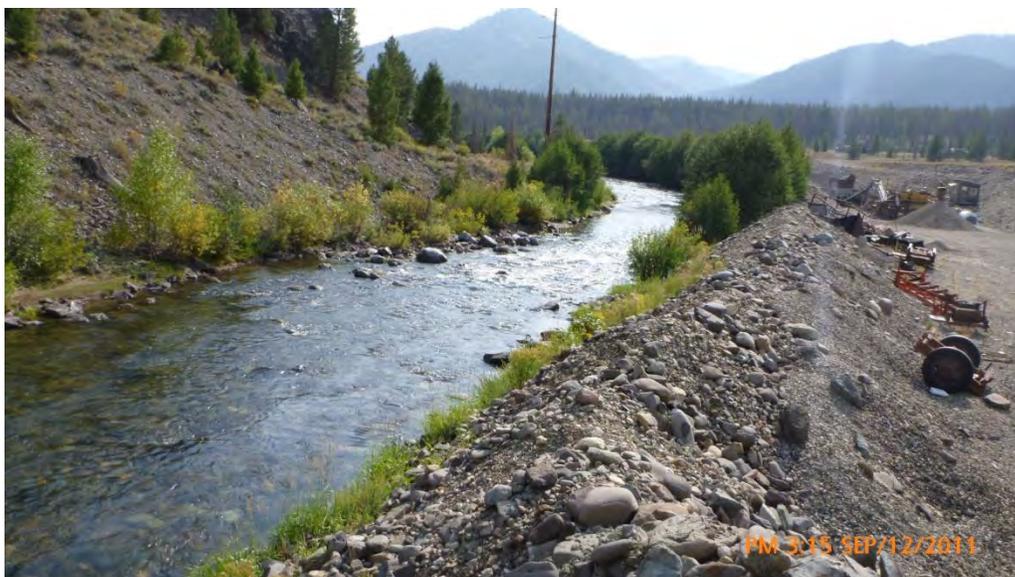
Photograph No. 12. View to the southwest looking downstream along a levee that has been pushed-up to protect a gravel processing operation along river right. Yankee Fork of the Salmon River, Yankee Fork Subbasin, Idaho – Bureau of Reclamation Photograph by P. Drury, September 12, 2011.

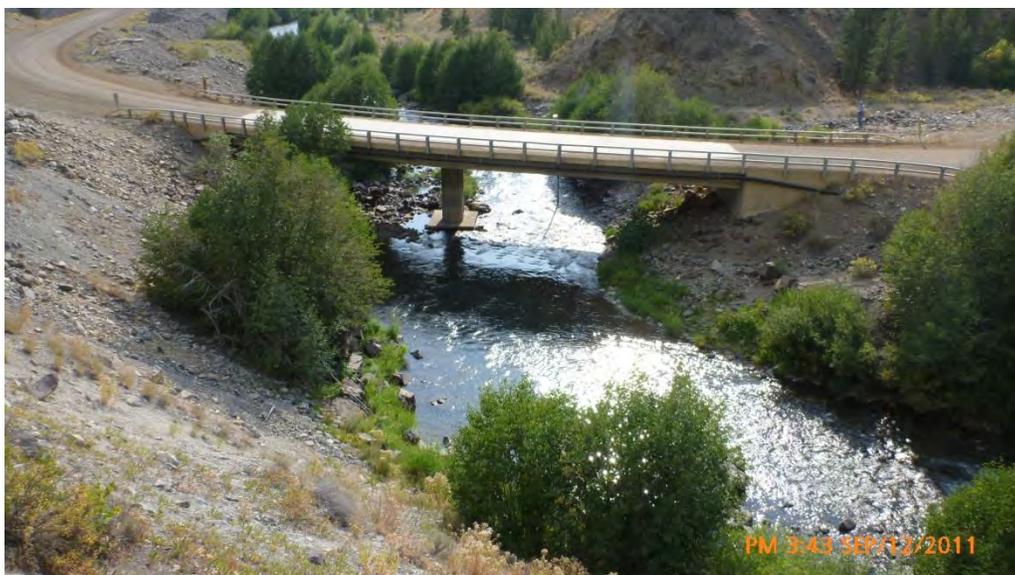
Photograph No. 14. View to the southwest looking downstream at a Custer Motorway bridge (Bonanza Bridge) crossing the Yankee Fork where the channel was constructed through dredge tailings in an area where the channel was naturally constricted by bedrock and colluvial deposits. Yankee Fork of the Salmon River, Yankee Fork Subbasin, Idaho – Bureau of Reclamation Photograph by P. Drury, September 12, 2011.

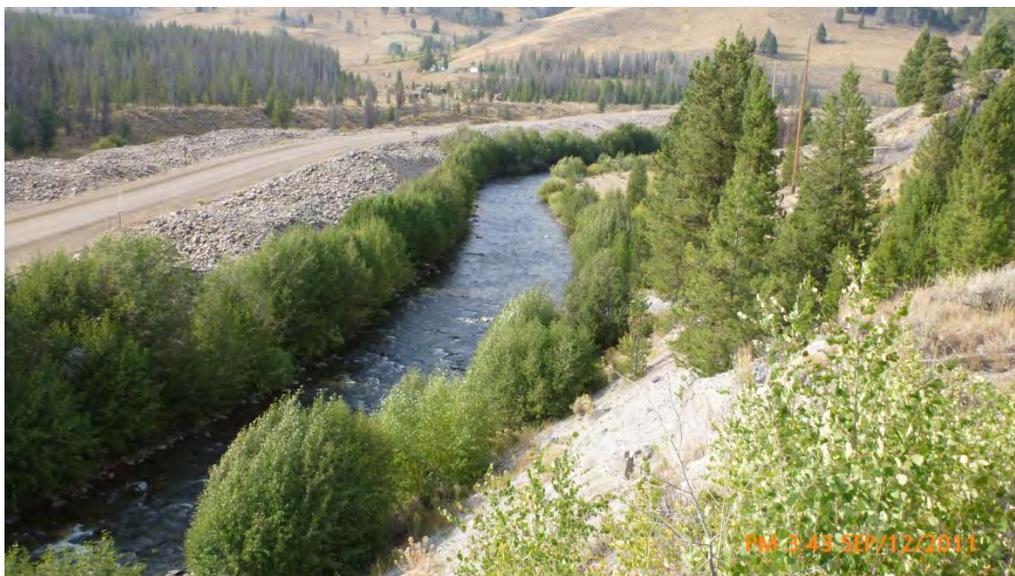
Photograph No. 15. View to the north looking upstream at a plane-bed channel that is confined between dredge tailings (river right) and colluvial deposits (river left). Yankee Fork of the Salmon River, Yankee Fork Subbasin, Idaho – Bureau of Reclamation Photograph by P. Drury, September 12, 2011.

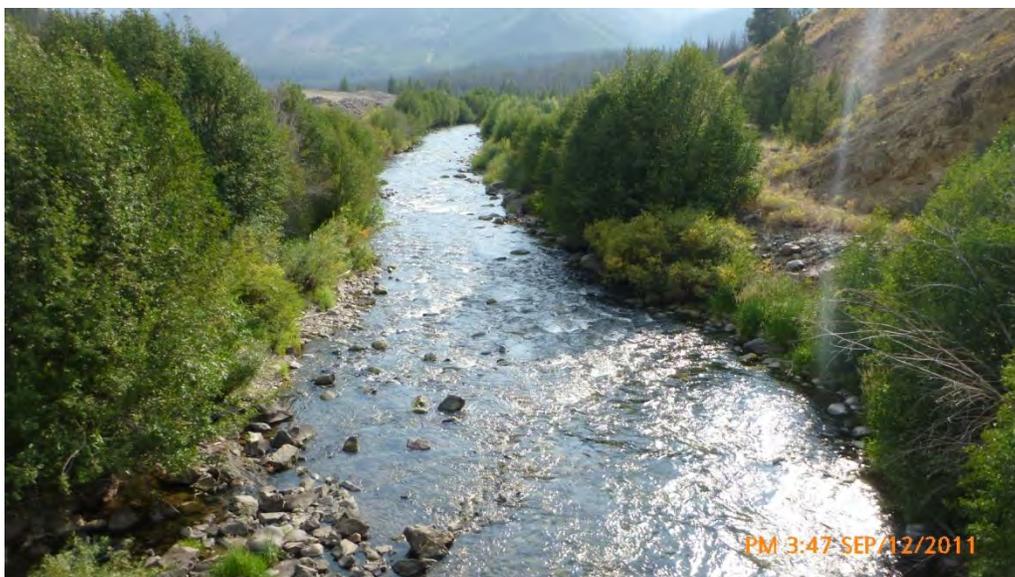
Photograph No. 16. View to the south-southwest looking downstream from the Bonanza Bridge at a plane-bed channel that is constrained by a bedrock outcrop along river right and dredge tailings along river left. Yankee Fork of the Salmon River, Yankee Fork Subbasin, Idaho – Bureau of Reclamation Photograph by P. Drury, September 12, 2011.

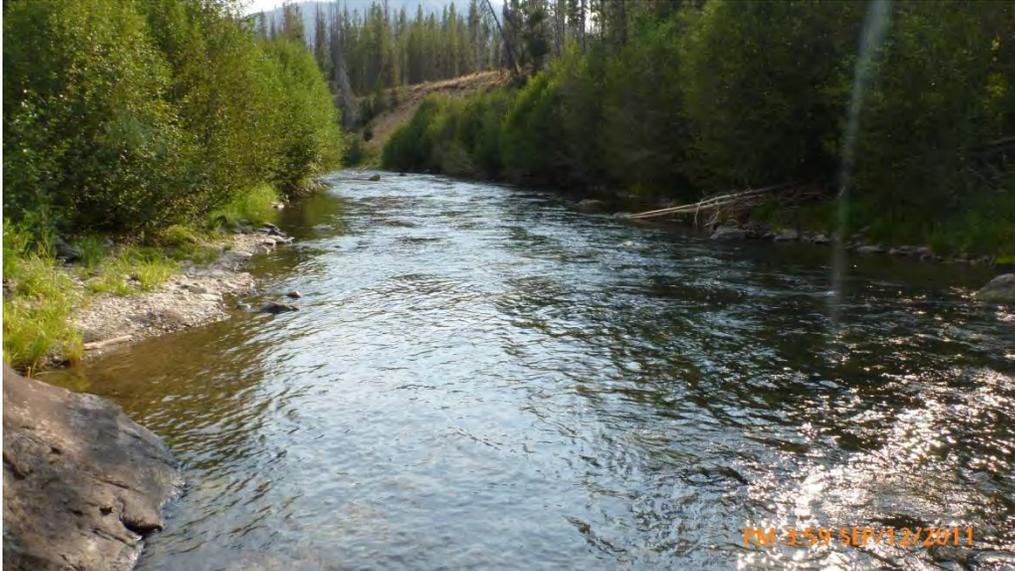
Photograph No. 17. View to the south-southwest looking downstream at bedrock that provides channel grade control. Yankee Fork of the Salmon River, Yankee Fork Subbasin, Idaho – Bureau of Reclamation Photograph by P. Drury, September 12, 2011.

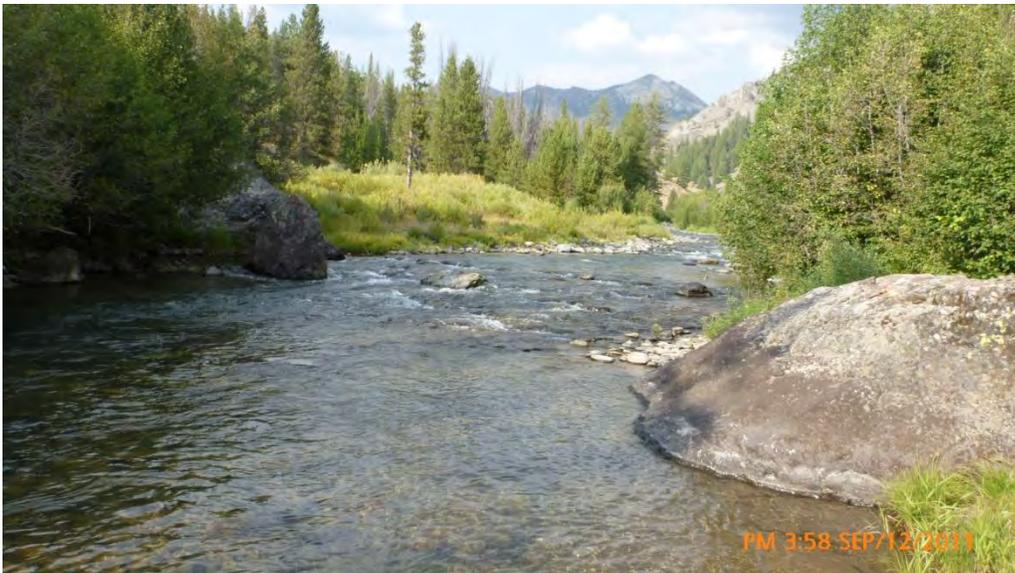
Photograph No. 18. View to the north looking upstream at bedrock that provides channel grade control. Yankee Fork of the Salmon River, Yankee Fork Subbasin, Idaho – Bureau of Reclamation Photograph by P. Drury, September 12, 2011.

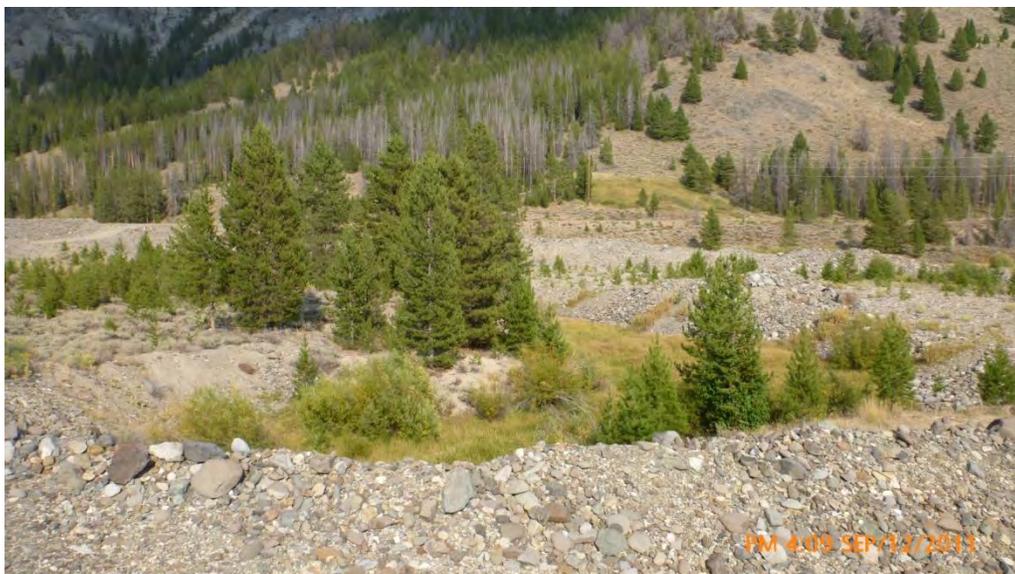
Photograph No. 19. View to the east looking at a “low spot” between dredge tailings. Yankee Fork of the Salmon River, Yankee Fork Subbasin, Idaho – Bureau of Reclamation Photograph by P. Drury, September 12, 2011.

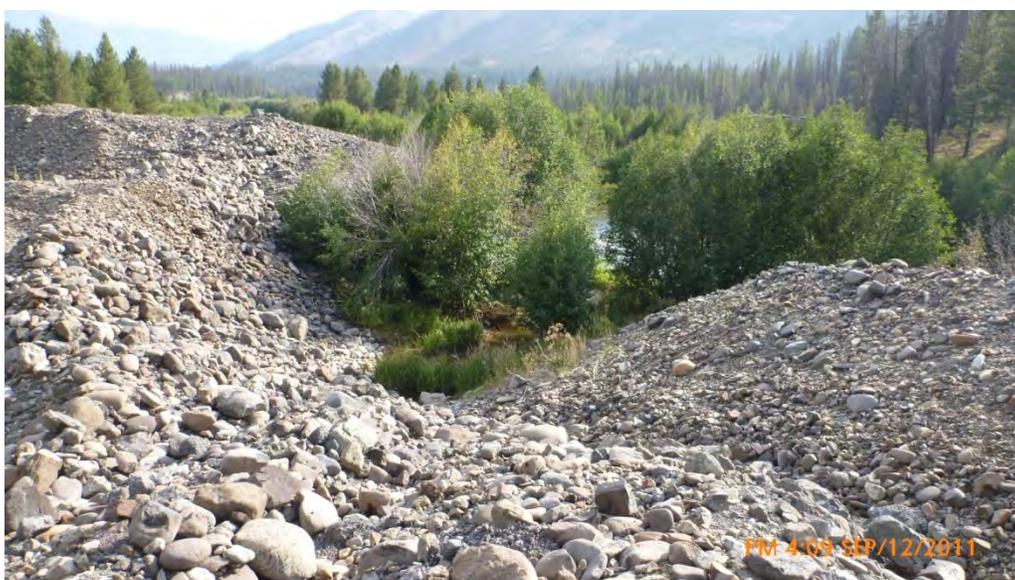
Photograph No. 20. View to the south looking downstream at a seepage area that flows into the Yankee Fork. Yankee Fork of the Salmon River, Yankee Fork Subbasin, Idaho – Bureau of Reclamation Photograph by P. Drury, September 12, 2011.

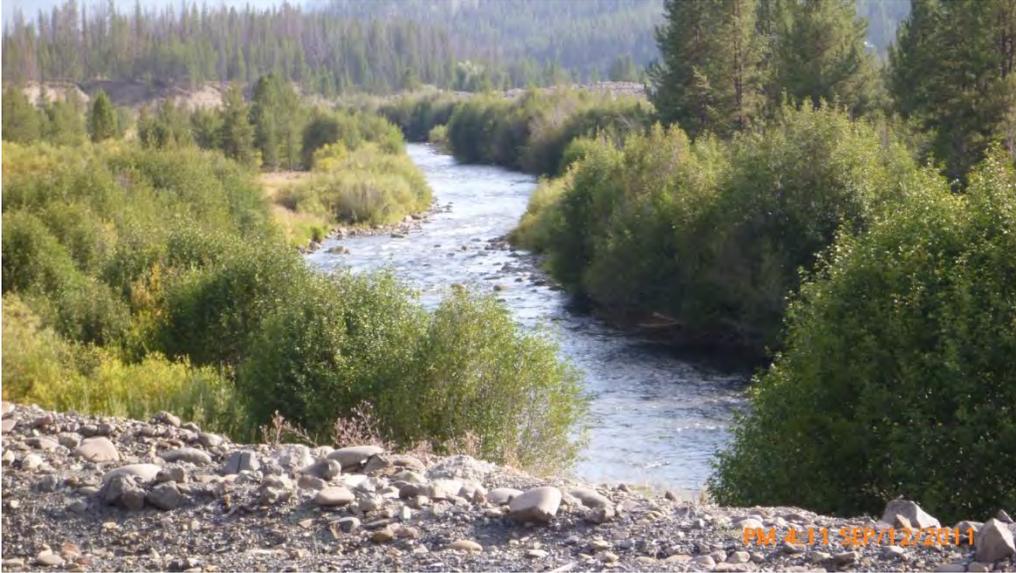
Photograph No. 21. View to the south looking downstream at the active floodplain and riparian corridor. Yankee Fork of the Salmon River, Yankee Fork Subbasin, Idaho – Bureau of Reclamation Photograph by P. Drury, September 12, 2011.

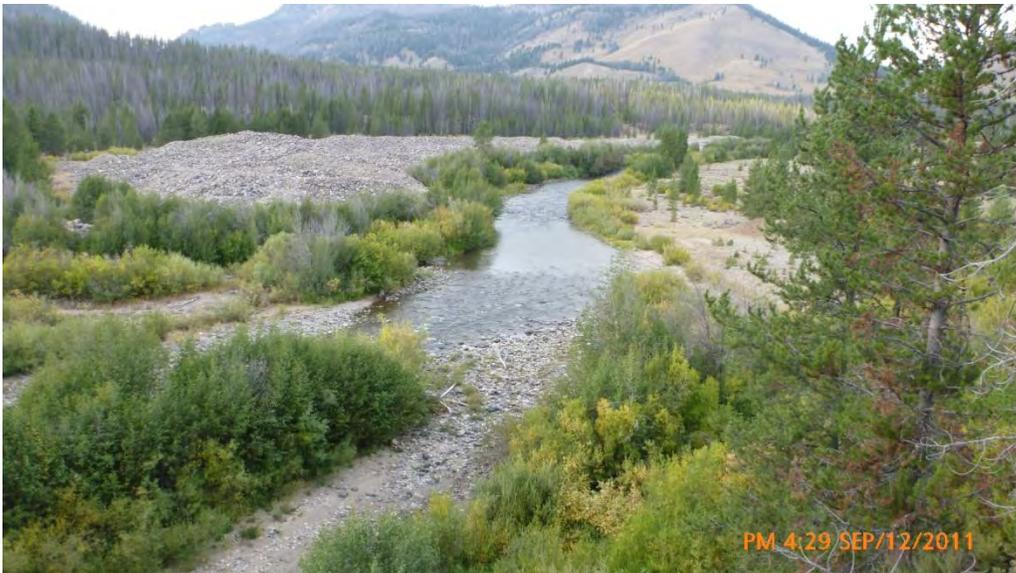
Photograph No. 22. View to the northwest looking upstream at the active floodplain and side channel. Yankee Fork of the Salmon River, Yankee Fork Subbasin, Idaho – Bureau of Reclamation Photograph by P. Drury, September 12, 2011.

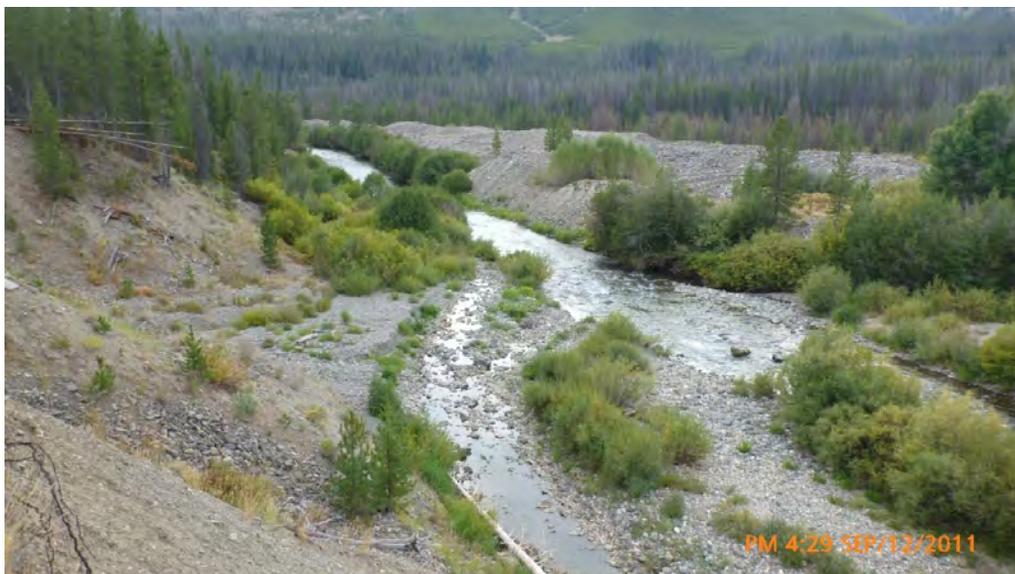
Photograph No. 23. View to the southwest looking downstream along a side channel where Preachers Cove enters the Yankee Fork. Yankee Fork of the Salmon River, Yankee Fork Subbasin, Idaho – Bureau of Reclamation Photograph by P. Drury, September 12, 2011.

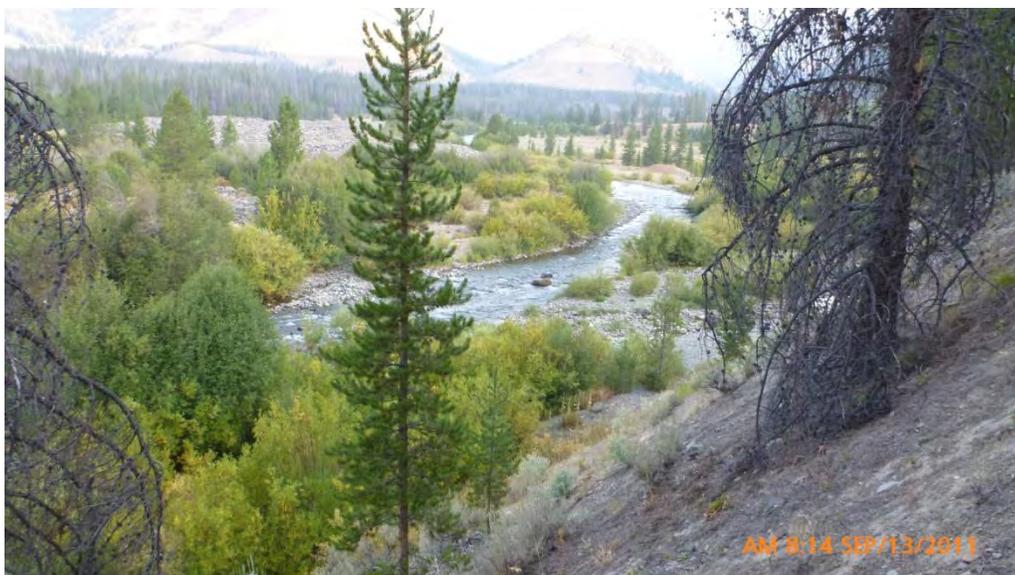
Photograph No. 24. View to the north looking at the active floodplain and side channel near Preachers Cove. Yankee Fork of the Salmon River, Yankee Fork Subbasin, Idaho – Bureau of Reclamation Photograph by P. Drury, September 13, 2011.

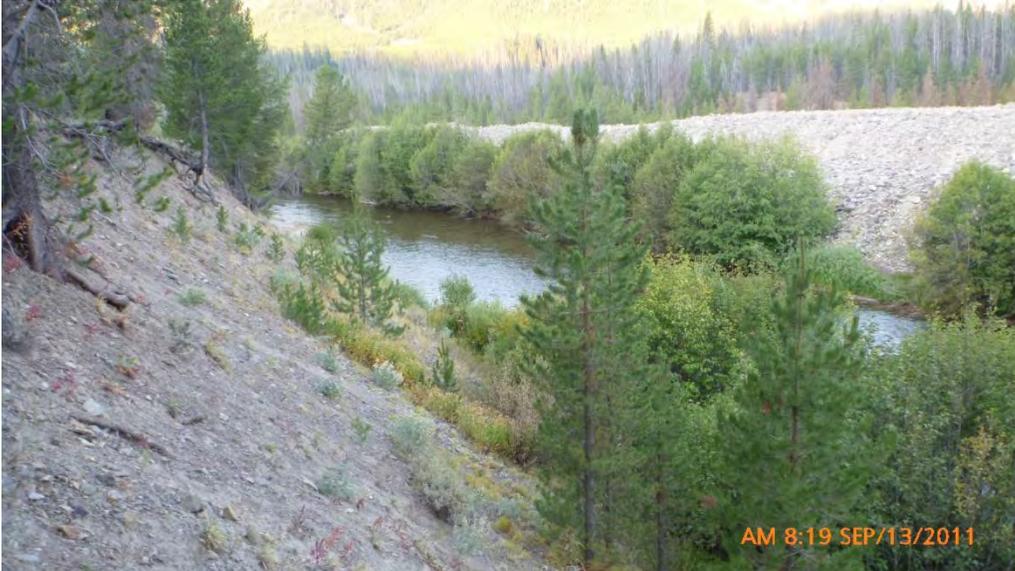
Photograph No. 25. View to the southwest looking downstream where the Preachers Cove alluvial fan and dredge tailings confine the channel. Yankee Fork of the Salmon River, Yankee Fork Subbasin, Idaho – Bureau of Reclamation Photograph by P. Drury, September 13, 2011.

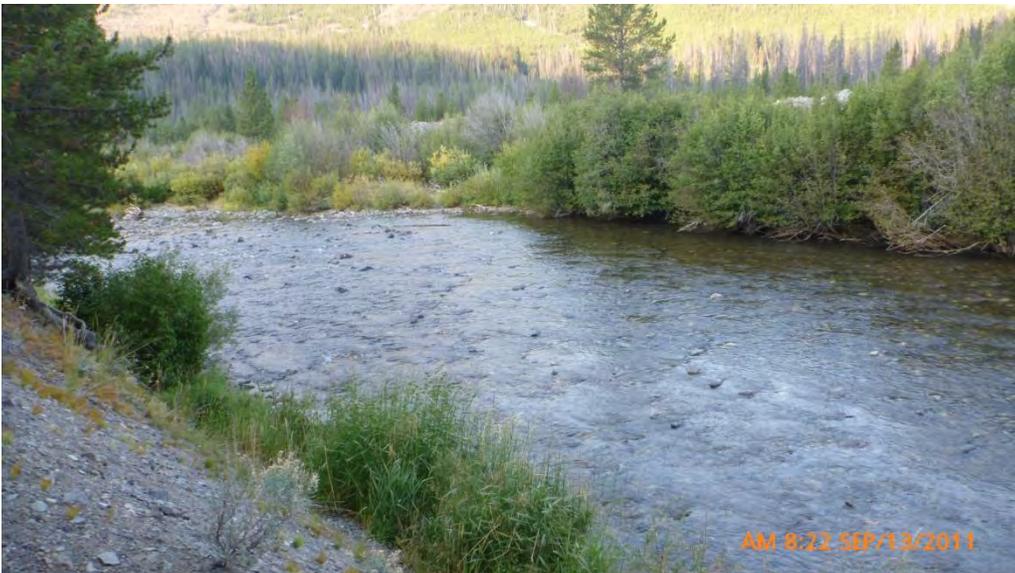
Photograph No. 26. View to the south-southwest looking downstream at the active floodplain along river right. Yankee Fork of the Salmon River, Yankee Fork Subbasin, Idaho – Bureau of Reclamation Photograph by P. Drury, September 13, 2011.

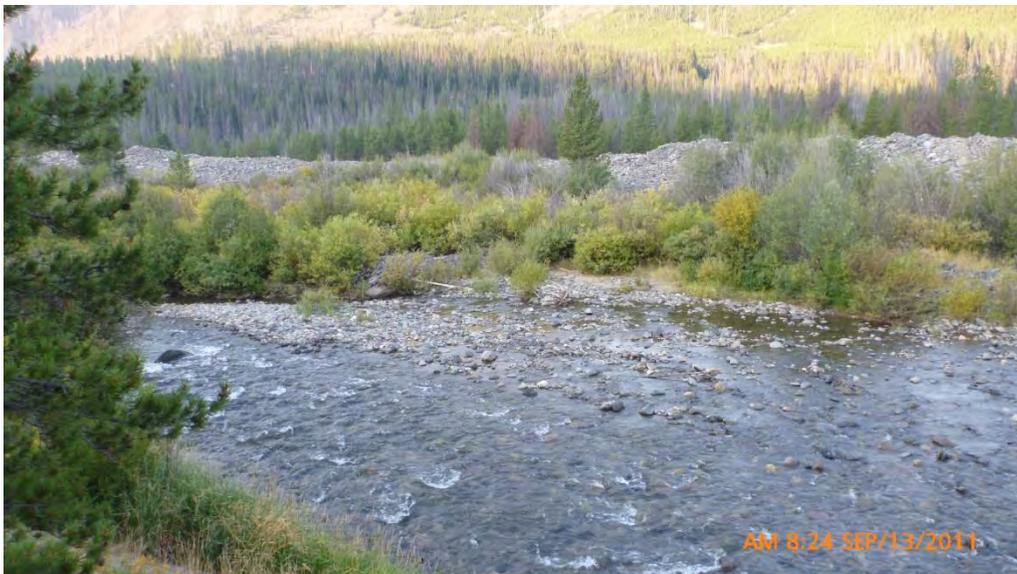
Photograph No. 27. View to the southwest looking across the channel at the active floodplain.
Yankee Fork of the Salmon River, Yankee Fork Subbasin, Idaho – Bureau of Reclamation Photograph by P. Drury, September 13, 2011.

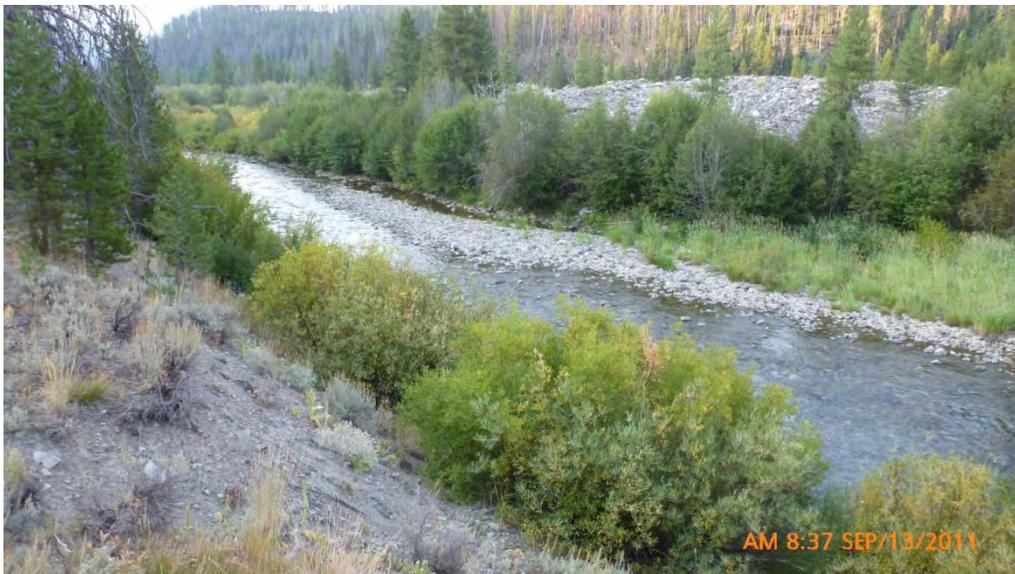
Photograph No. 31. View to the south looking downstream at outlet of side channel along river right. Yankee Fork of the Salmon River, Yankee Fork Subbasin, Idaho – Bureau of Reclamation Photograph by P. Drury, September 13, 2011.

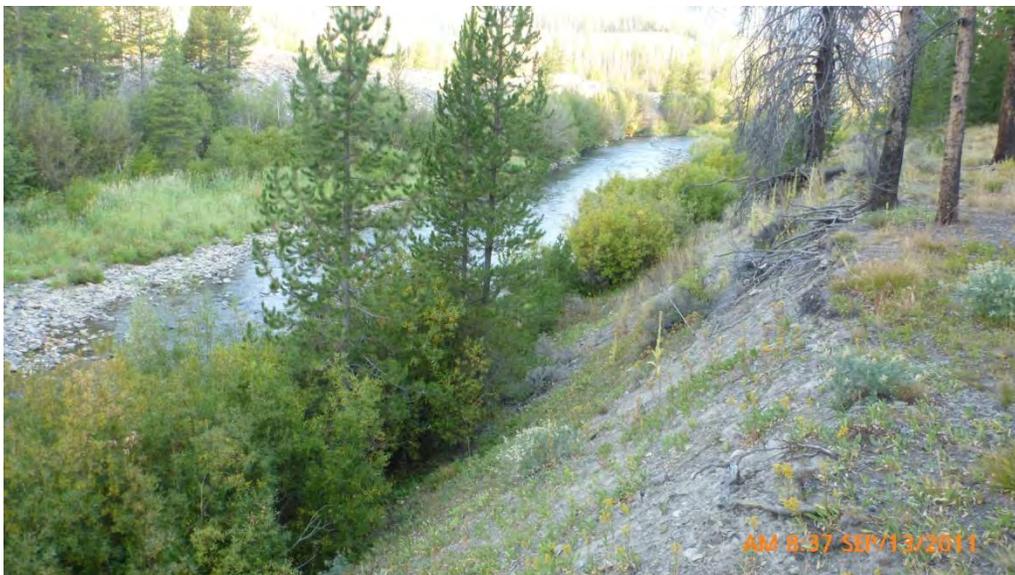
Photograph No. 32. View to the northwest looking upstream at active floodplain and riparian corridor. Yankee Fork of the Salmon River, Yankee Fork Subbasin, Idaho – Bureau of Reclamation Photograph by P. Drury, September 13, 2011.

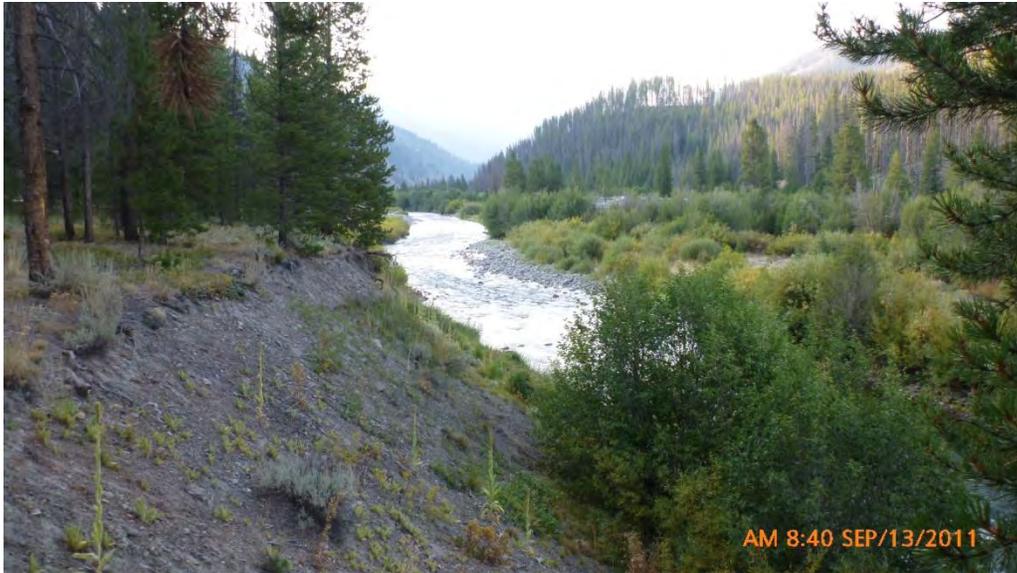
Photograph No. 33. View to the south looking downstream at active floodplain and riparian corridor. Yankee Fork of the Salmon River, Yankee Fork Subbasin, Idaho – Bureau of Reclamation Photograph by P. Drury, September 13, 2011.

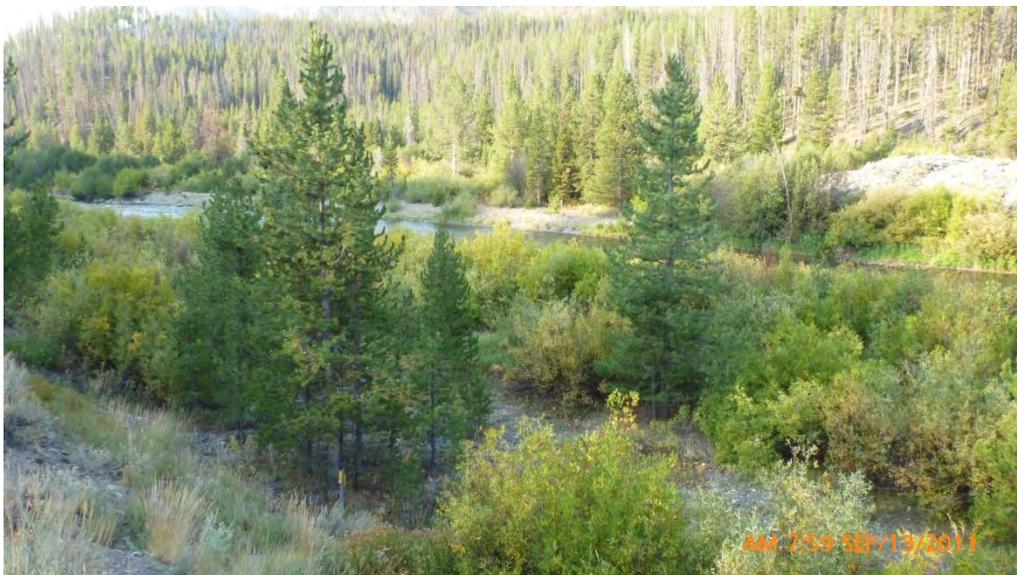
Photograph No. 36. View to the south looking downstream at side channel along river left and riparian corridor. Yankee Fork of the Salmon River, Yankee Fork Subbasin, Idaho – Bureau of Reclamation Photograph by P. Drury, September 13, 2011.

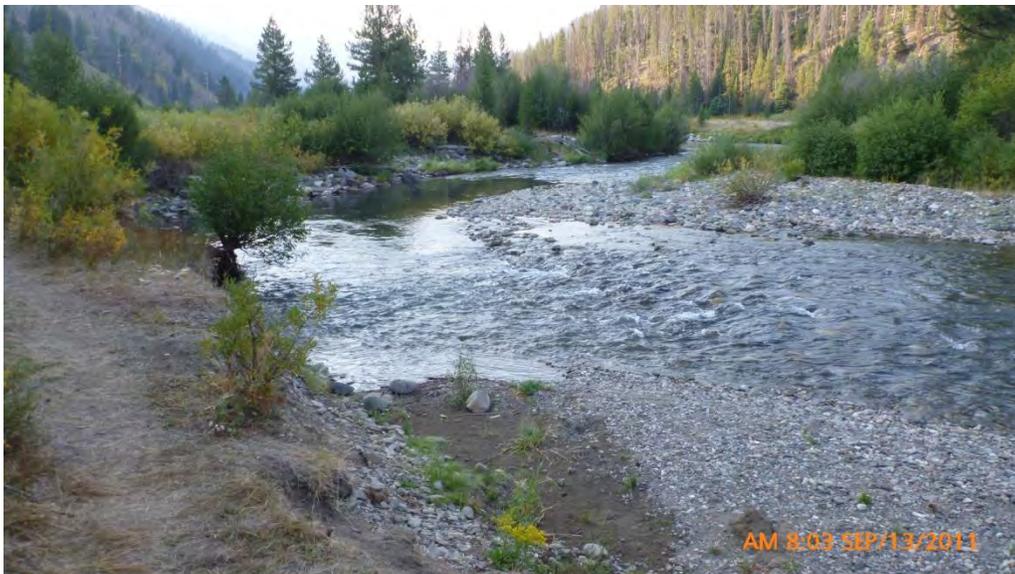
Photograph No. 37. View to the south-southeast looking downstream at lateral scour pool that is forced by boulders and cohesive clays along river left. Yankee Fork of the Salmon River, Yankee Fork Subbasin, Idaho – Bureau of Reclamation Photograph by P. Drury, September 13, 2011.

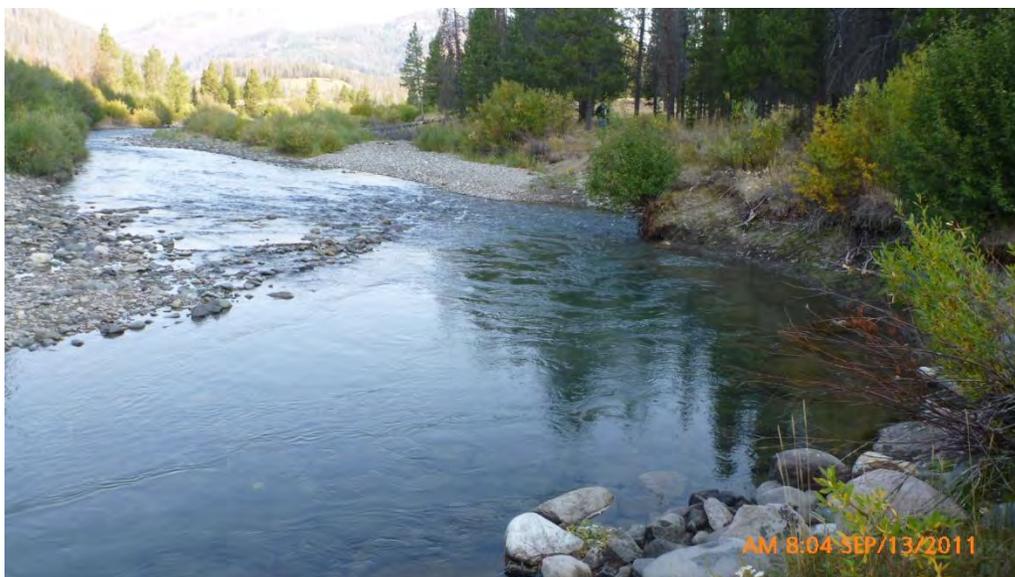
Photograph No. 38. View to the northwest looking upstream at lateral scour pool in the forefront and side channel outlet in upper center. Yankee Fork of the Salmon River, Yankee Fork Subbasin, Idaho – Bureau of Reclamation Photograph by P. Drury, September 13, 2011.

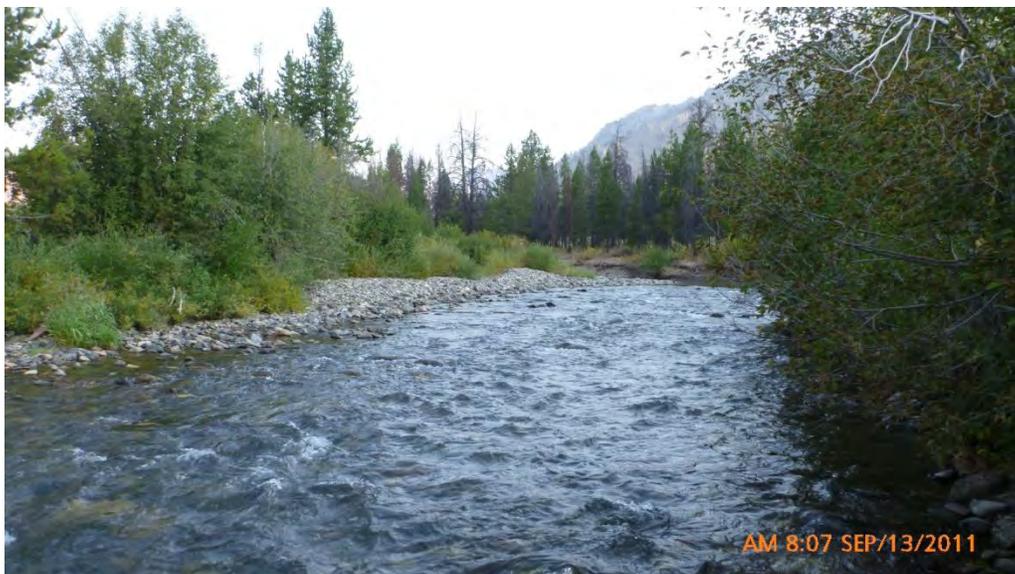
Photograph No. 39. View to the northeast looking upstream at a cobble/boulder dominated riffle, active floodplain along river right, and bank erosion along river left in the distance. Yankee Fork of the Salmon River, Yankee Fork Subbasin, Idaho – Bureau of Reclamation Photograph by P. Drury, September 13, 2011.

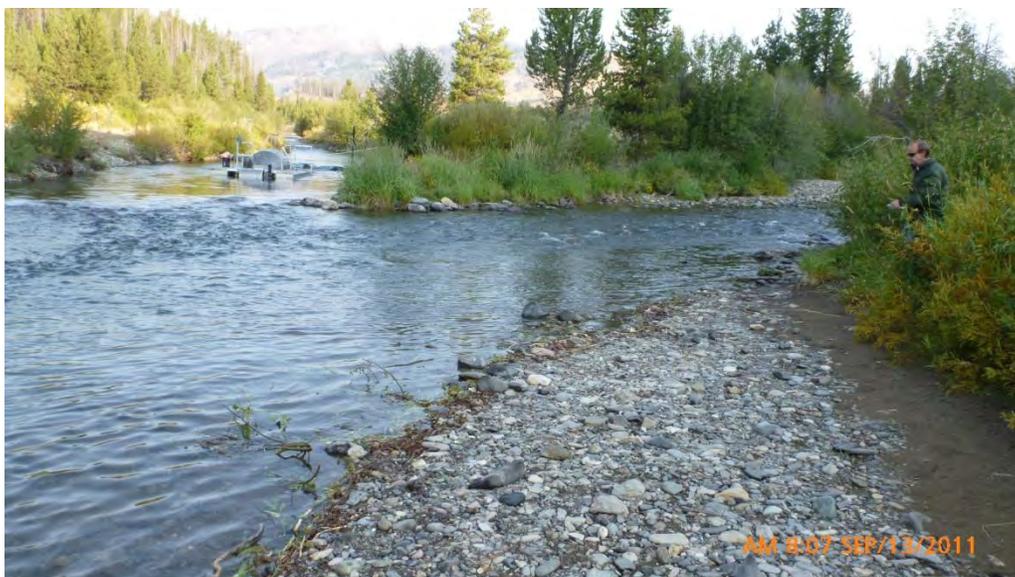
Photograph No. 40. View to the northwest looking upstream at the Yankee Fork/West Fork confluence. Note the screw-trap in upper left on the West Fork. Yankee Fork of the Salmon River, Yankee Fork Subbasin, Idaho – Bureau of Reclamation Photograph by P. Drury, September 13, 2011.

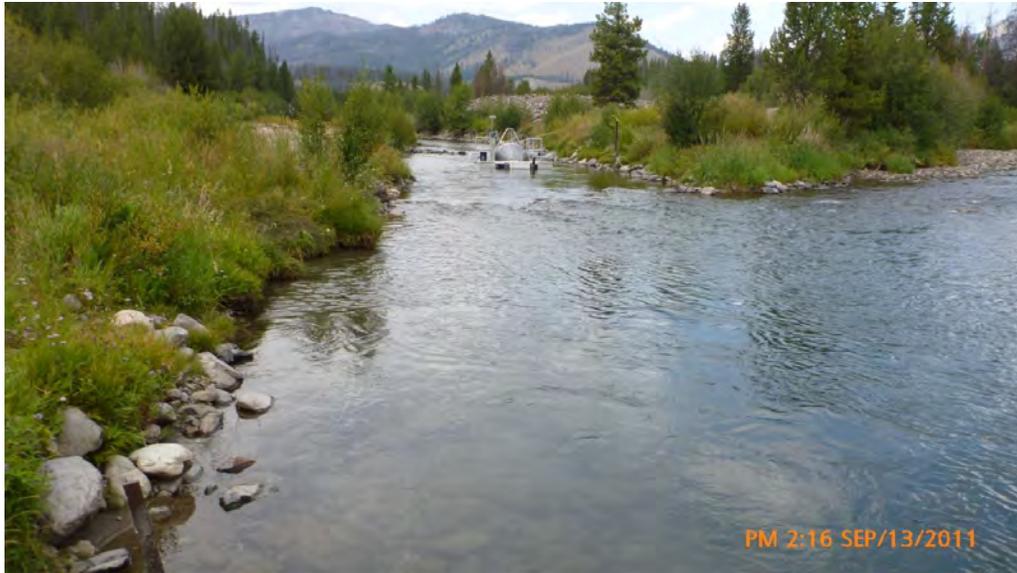
Photograph No. 41. View to the northwest looking at a scour pool created by flow convergence between the Yankee Fork and West Fork. Note screw-trap on the West Fork. Yankee Fork of the Salmon River, Yankee Fork Subbasin, Idaho – Bureau of Reclamation Photograph by P. Drury, September 13, 2011.
