Bonanza Area Reach Assessment
Yankee Fork of the Salmon River,
Upper Salmon Subbasin

Custer County, Idaho

September 2012

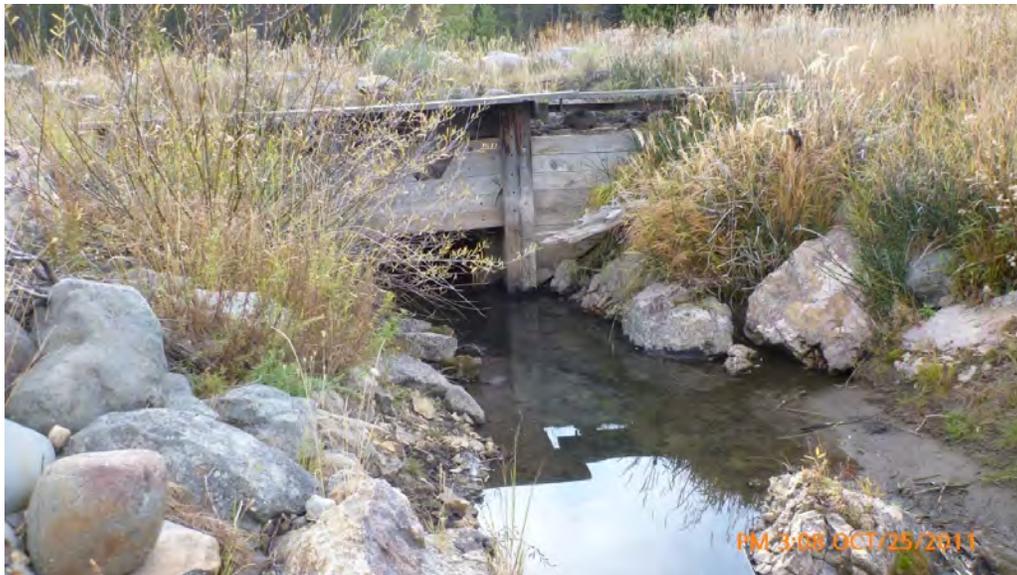
Photograph No. 42. View to the southwest looking downstream at the inlet of pond series three. Yankee Fork of the Salmon River, Yankee Fork Subbasin, Idaho – Bureau of Reclamation Photograph by P. Drury, October 25, 2011.

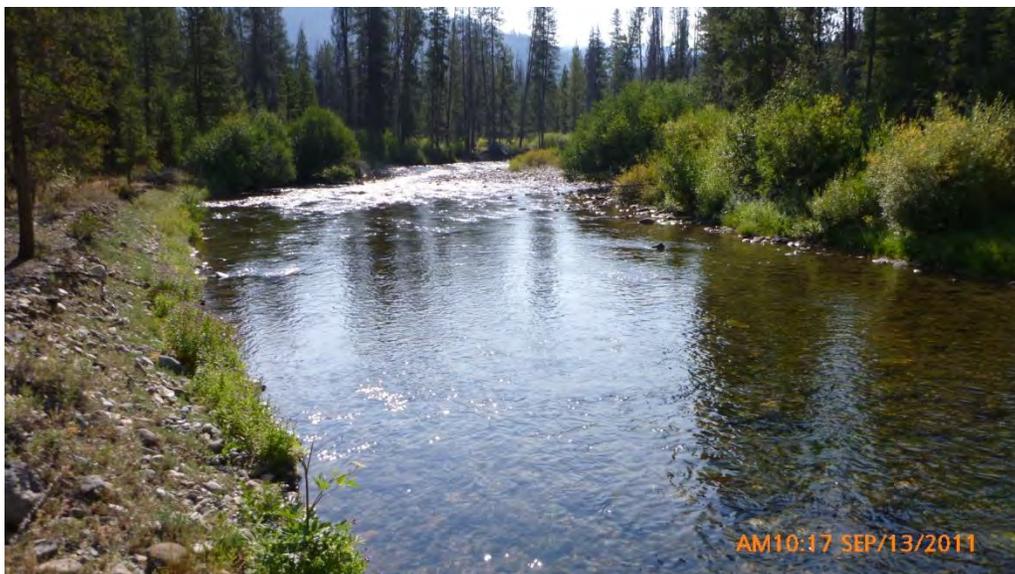
Photograph No. 43. View to the southeast looking downstream along the West Fork where channel confinement transitions from moderately confined to unconfined. West Fork of the Yankee Fork of the Salmon River, Yankee Fork Subbasin, Idaho – Bureau of Reclamation Photograph by P. Drury, September 13, 2011.

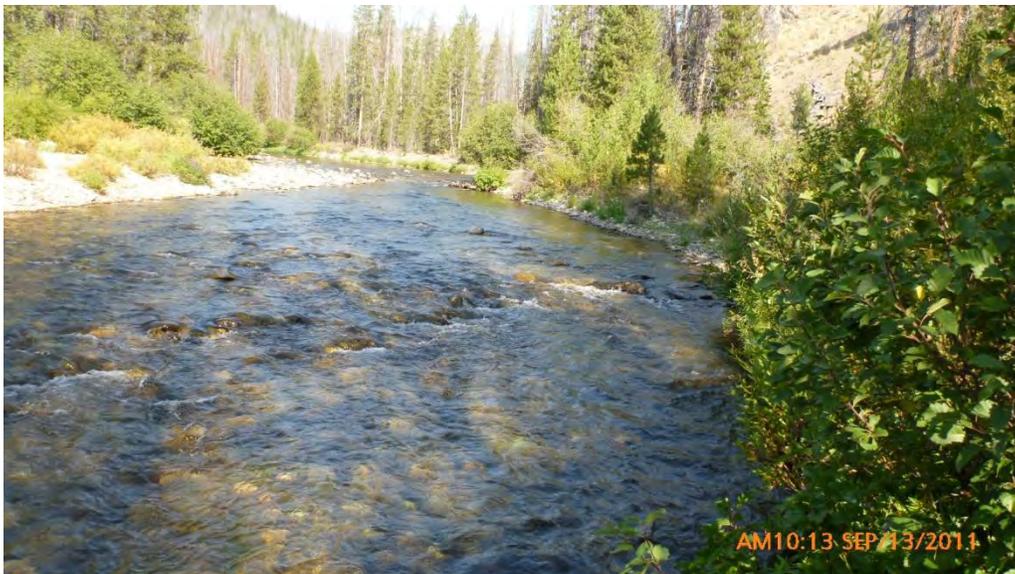
Photograph No. 45. View to the northwest looking upstream at a lateral scour pool along river left (center) and riffle tail-out (foreground). West Fork of the Yankee Fork of the Salmon River, Yankee Fork Subbasin, Idaho – Bureau of Reclamation Photograph by P. Drury, September 13, 2011.

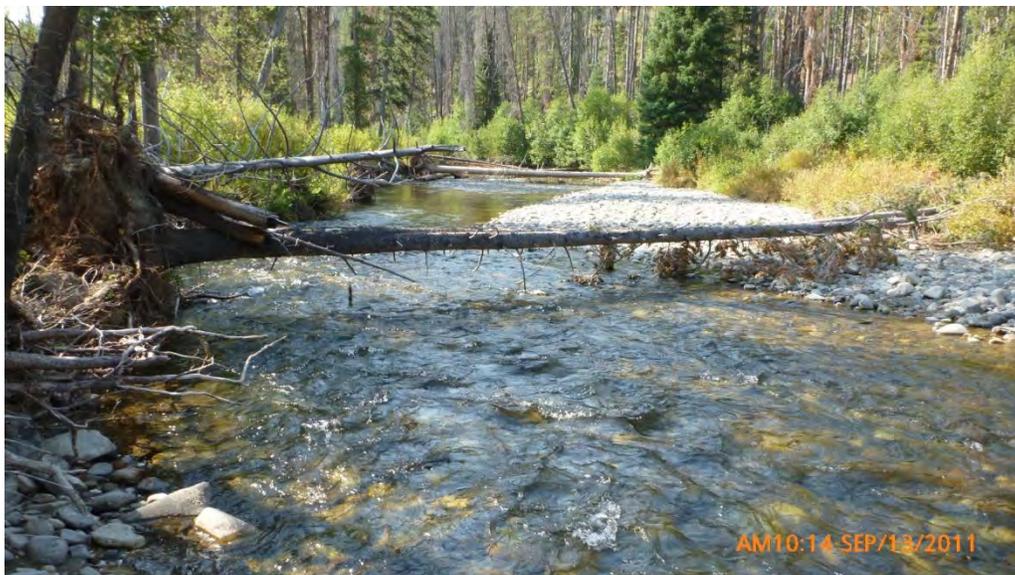
Photograph No. 46. View to the south looking downstream at wood being recruited by lateral channel migration along river left. Note lateral scour pool downstream of point bar (left of center). West Fork of the Yankee Fork of the Salmon River, Yankee Fork Subbasin, Idaho – Bureau of Reclamation Photograph by P. Drury, September 13, 2011.

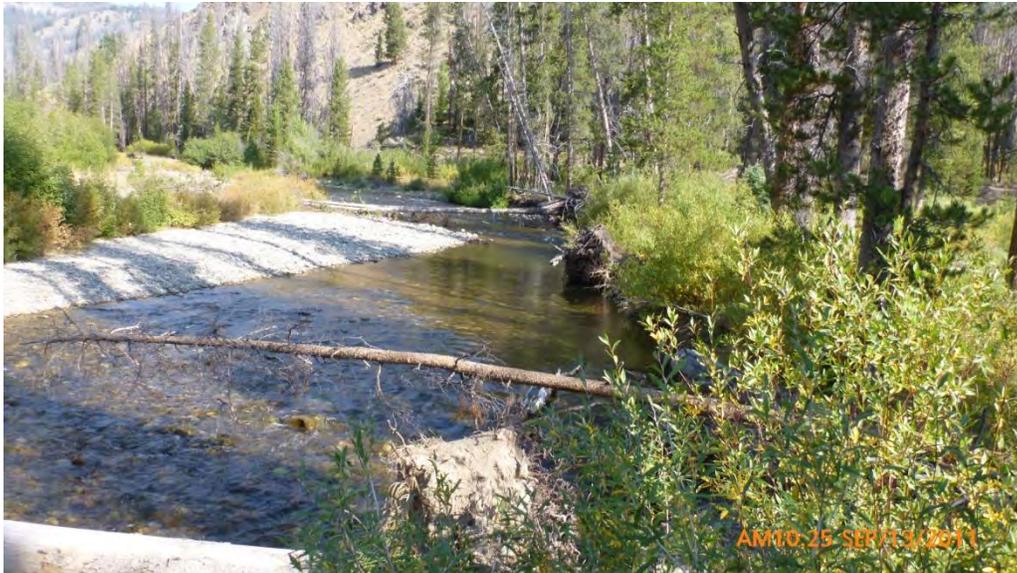
Photograph No. 47. View to the north looking upstream at lateral scour pool along river right that is forced by wood and riparian vegetation along the outside meander. West Fork of the Yankee Fork of the Salmon River, Yankee Fork Subbasin, Idaho – Bureau of Reclamation Photograph by P. Drury, September 13, 2011.

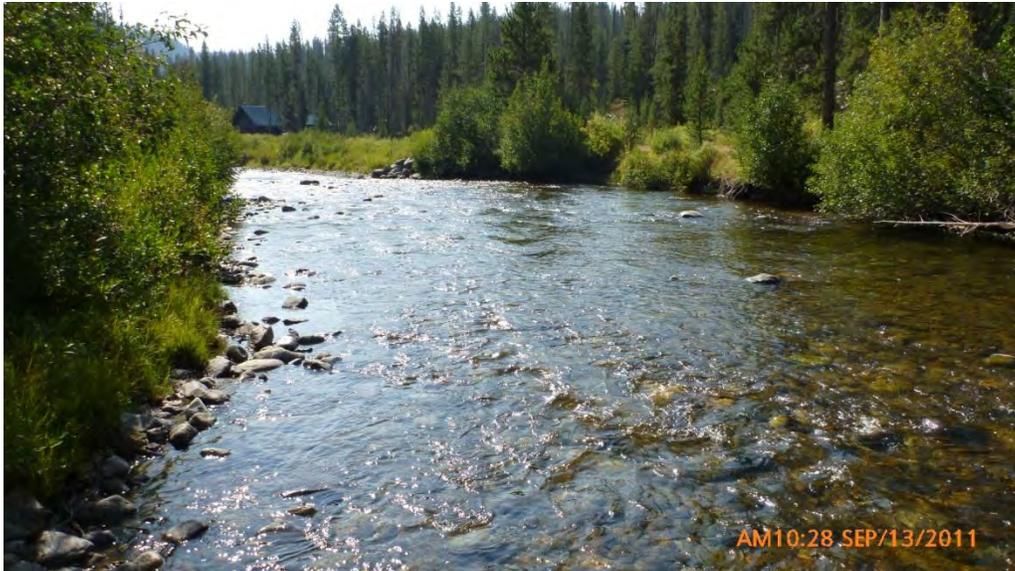
Photograph No. 49. View to the southeast looking downstream at a rock revetment (left of center) that was placed at the head of a side channel. An overflow channel has developed just left of the revetment. West Fork of the Yankee Fork of the Salmon River, Yankee Fork Subbasin, Idaho – Bureau of Reclamation Photograph by P. Drury, September 13, 2011.

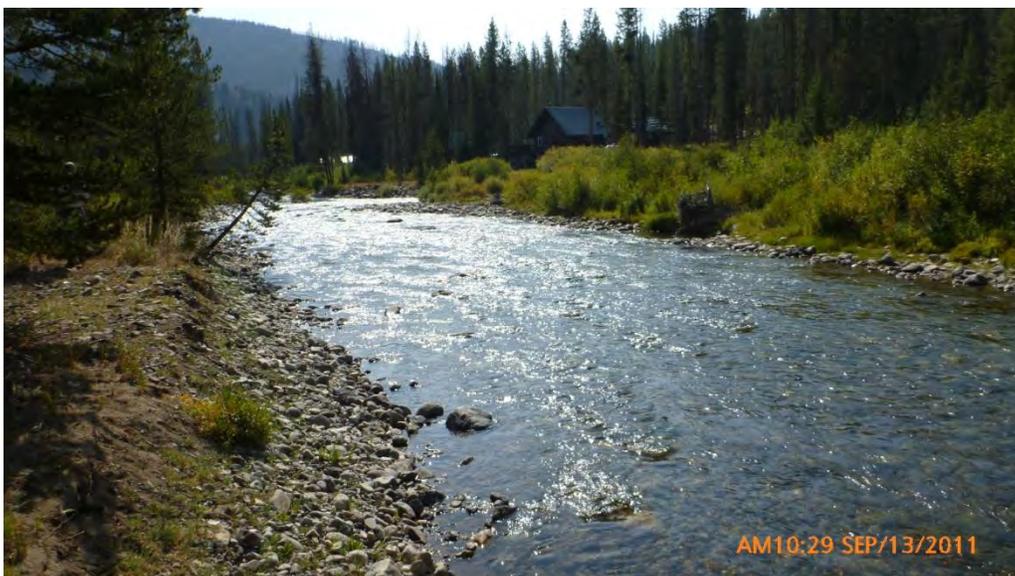
Photograph No. 50. View to the southeast looking downstream at a cobble dominated riffle and vegetated bar along river right. West Fork of the Yankee Fork of the Salmon River, Yankee Fork Subbasin, Idaho – Bureau of Reclamation Photograph by P. Drury, September 13, 2011.

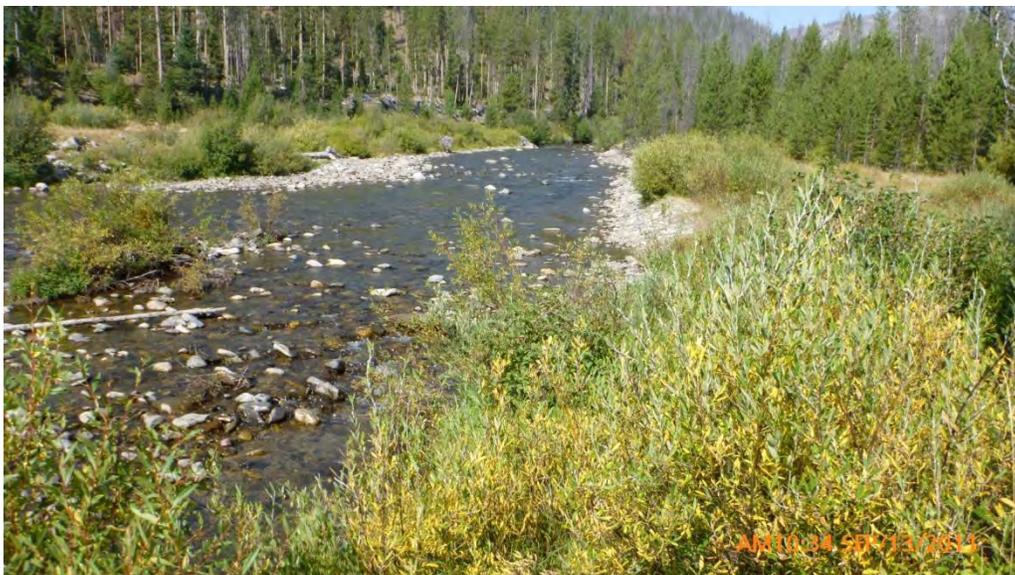
Photograph No. 52. View to the west-northwest looking upstream from the head of a flow split channel along river left. West Fork of the Yankee Fork of the Salmon River, Yankee Fork Subbasin, Idaho – Bureau of Reclamation Photograph by P. Drury, September 13, 2011.

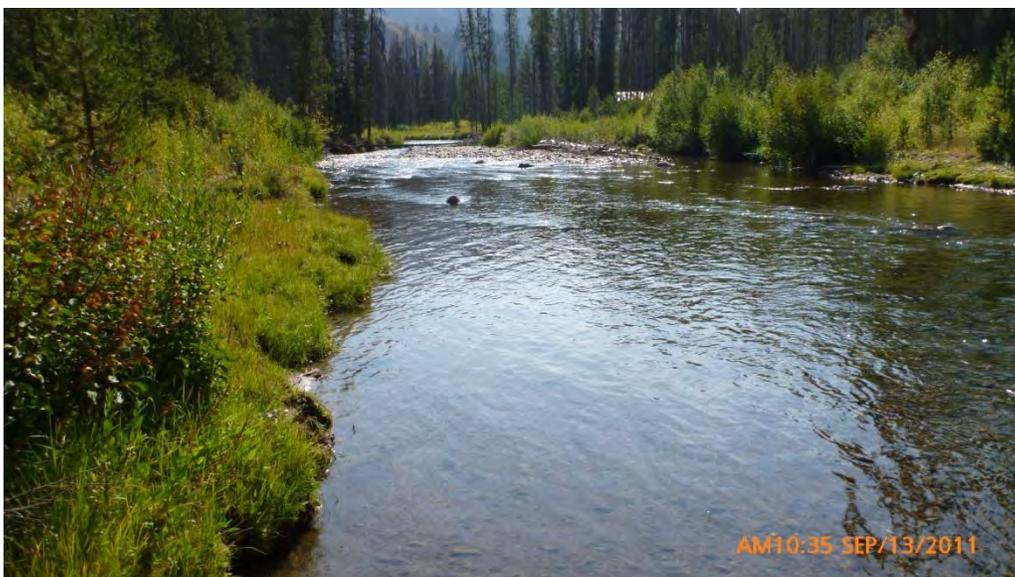
Photograph No. 54. View to the southeast looking downstream at a mid-channel scour pool. West Fork of the Yankee Fork of the Salmon River, Yankee Fork Subbasin, Idaho – Bureau of Reclamation Photograph by P. Drury, September 13, 2011.

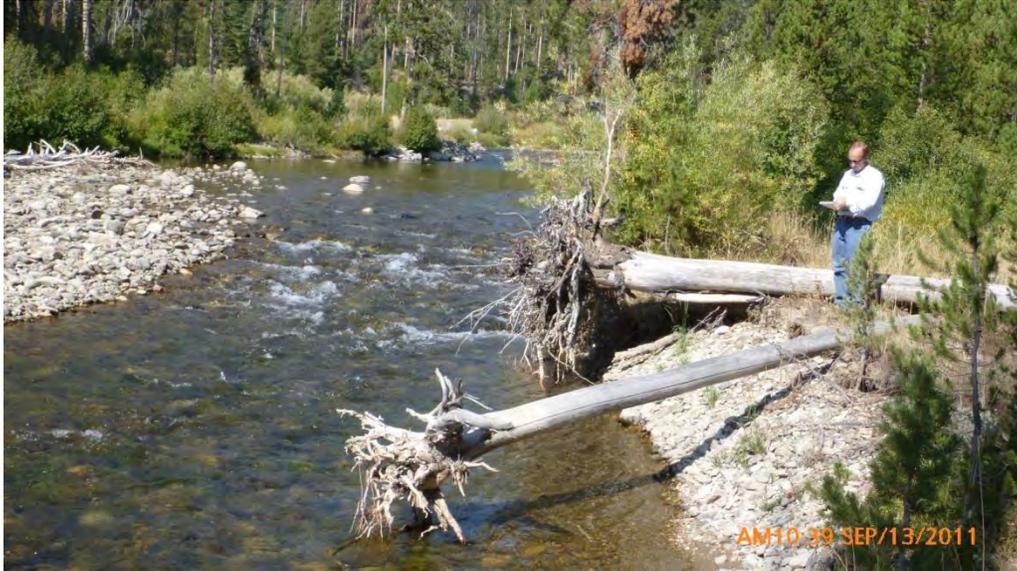
Photograph No. 57. View to the west looking upstream at the low-flow channel flowing around unvegetated bar. West Fork of the Yankee Fork of the Salmon River, Yankee Fork Subbasin, Idaho – Bureau of Reclamation
Photograph by P. Drury, September 13, 2011.

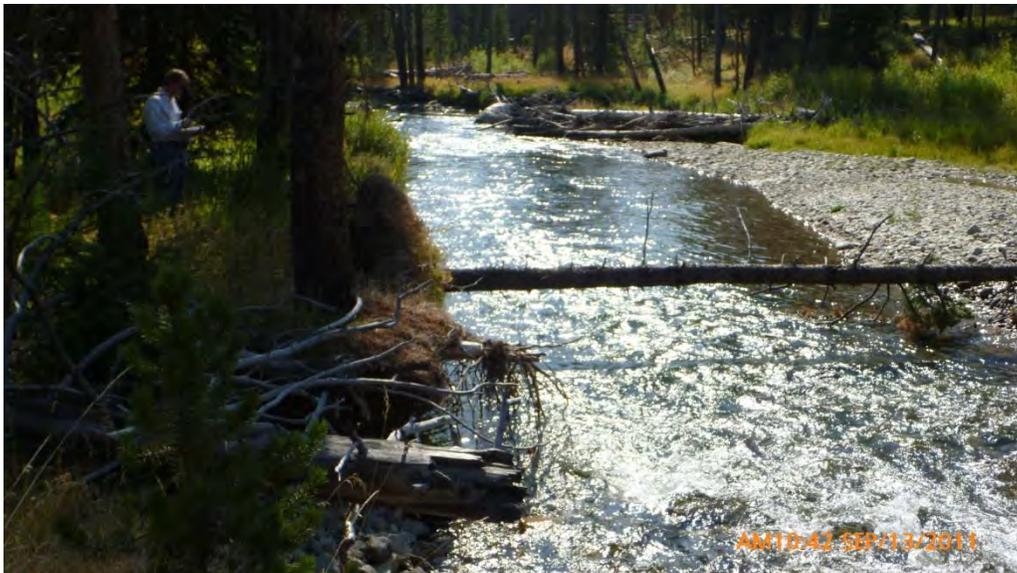
Photograph No. 58. View to the southeast looking downstream at wood recruited by the channel through lateral channel migration. West Fork of the Yankee Fork of the Salmon River, Yankee Fork Subbasin, Idaho – Bureau of Reclamation
Photograph by P. Drury, September 13, 2011.

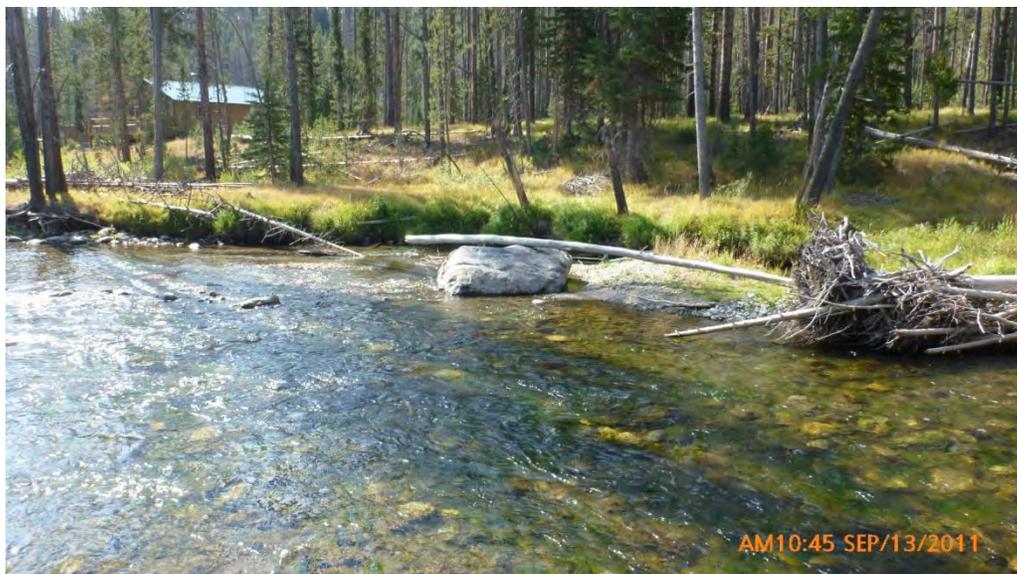
Photograph No. 59. View to the southwest looking across the channel at a side channel outlet along river right. West Fork of the Yankee Fork of the Salmon River, Yankee Fork Subbasin, Idaho – Bureau of Reclamation Photograph by P. Drury, September 13, 2011.

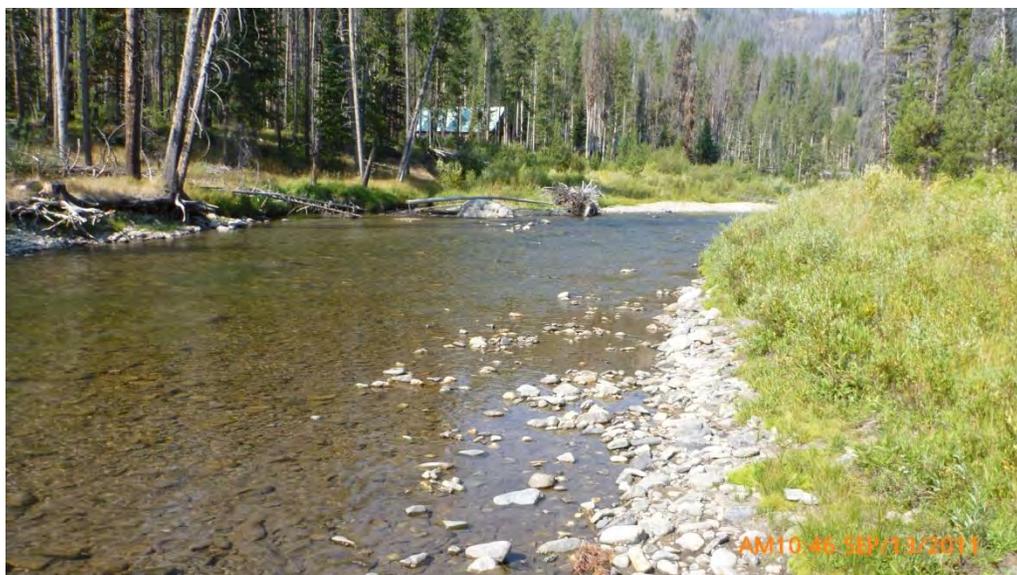
Photograph No. 60. View to the west looking upstream at side channel outlet and bank erosion undermining trees along river right. West Fork of the Yankee Fork of the Salmon River, Yankee Fork Subbasin, Idaho – Bureau of Reclamation Photograph by P. Drury, September 13, 2011.

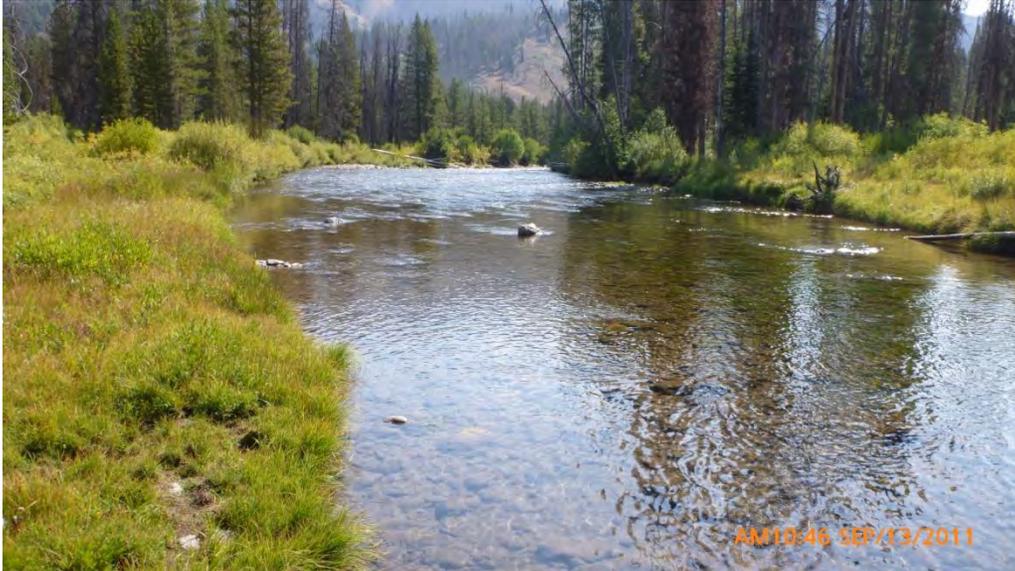
Photograph No. 61. View to east looking downstream at run/riffle sequence and active floodplain on river left. West Fork of the Yankee Fork of the Salmon River, Yankee Fork Subbasin, Idaho – Bureau of Reclamation
Photograph by P. Drury, September 13, 2011.

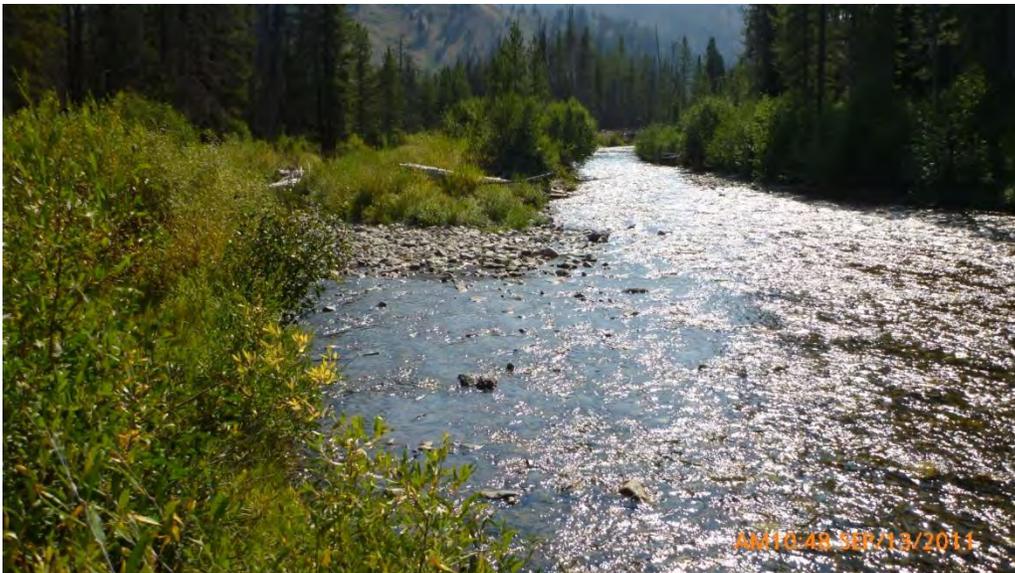
Photograph No. 62. View to the southeast looking downstream at the head of a side channel along river left and vegetated bar that splits the flows. West Fork of the Yankee Fork of the Salmon River, Yankee Fork Subbasin, Idaho – Bureau of Reclamation
Photograph by P. Drury, September 13, 2011.

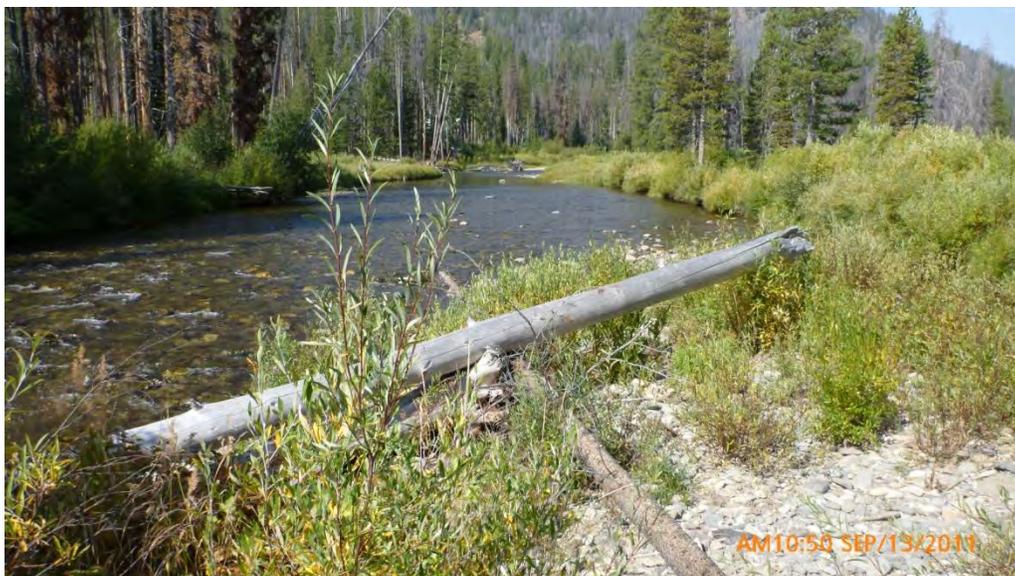
Photograph No. 63. View to the west looking upstream from a vegetated bar that splits flows and the active floodplain upstream. West Fork of the Yankee Fork of the Salmon River, Yankee Fork Subbasin, Idaho – Bureau of Reclamation Photograph by P. Drury, September 13, 2011.

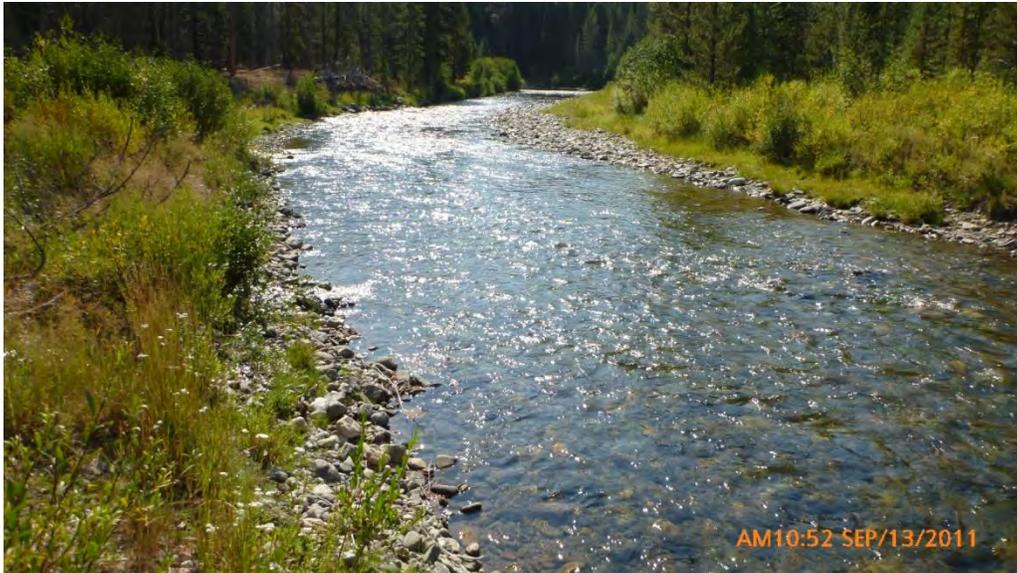
Photograph No. 65. View to the south-southeast looking downstream from vegetated bar at riffle habitat and active floodplain. West Fork of the Yankee Fork of the Salmon River, Yankee Fork Subbasin, Idaho – Bureau of Reclamation Photograph by P. Drury, September 13, 2011.

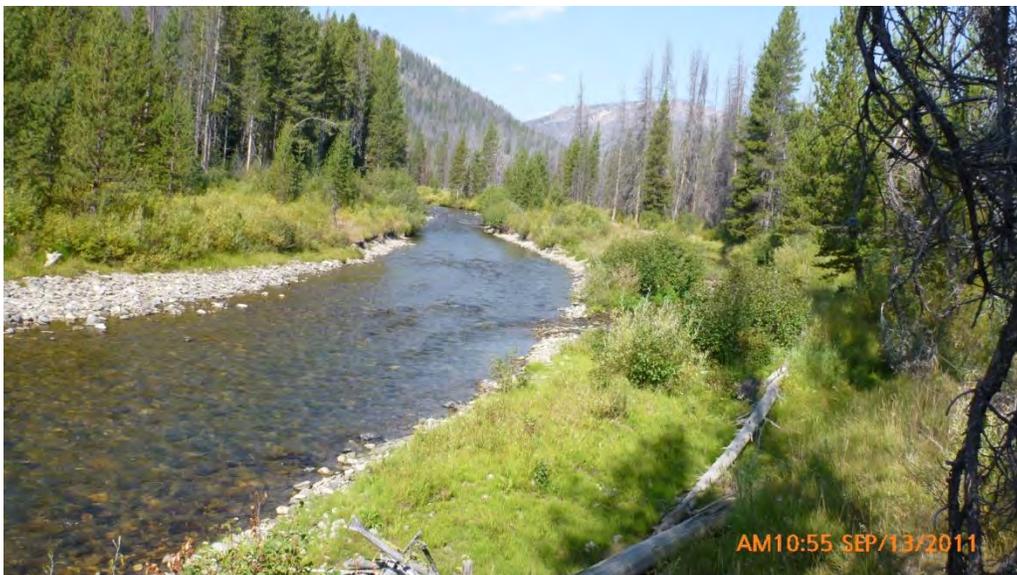
Photograph No. 66. View to the northwest looking upstream at side channel outlet along river left that is also charged by a seep through the dredge tailings and pond. West Fork of the Yankee Fork of the Salmon River, Yankee Fork Subbasin, Idaho – Bureau of Reclamation Photograph by P. Drury, September 13, 2011.

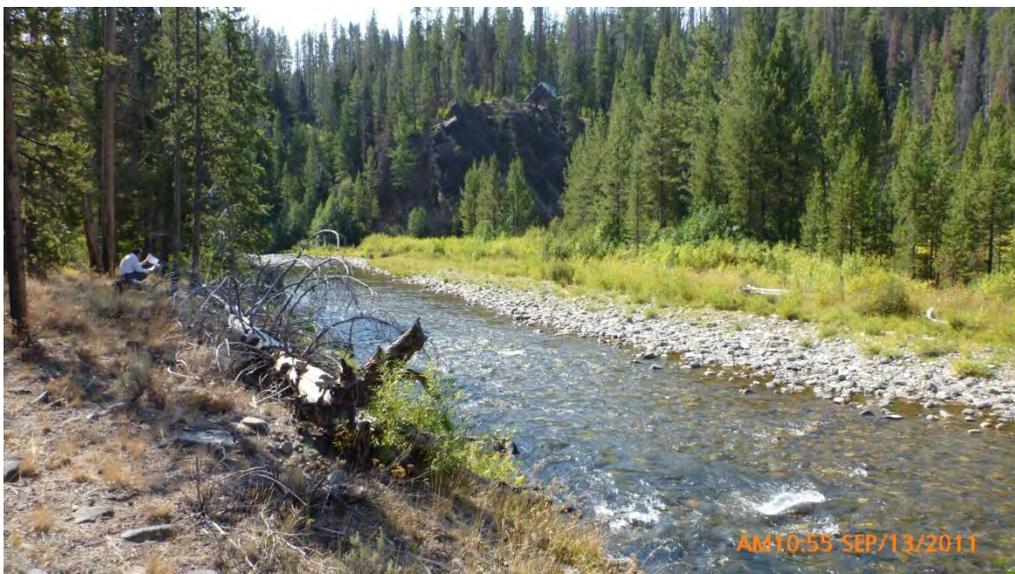
Photograph No. 67. View to the south looking downstream from a remnant of the Preachers Cove alluvial fan at riffle habitat and active floodplain on river right. West Fork of the Yankee Fork of the Salmon River, Yankee Fork Subbasin, Idaho – Bureau of Reclamation Photograph by P. Drury, September 13, 2011.

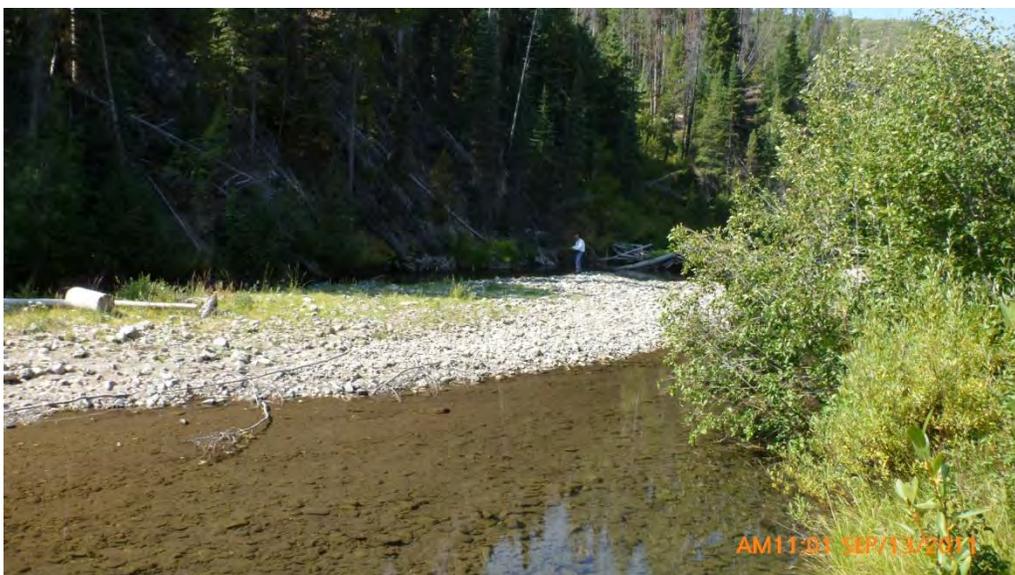
Photograph No. 68. View to the west looking upstream at a bedrock outcrop that restricts lateral channel migration. West Fork of the Yankee Fork of the Salmon River, Yankee Fork Subbasin, Idaho – Bureau of Reclamation Photograph by P. Drury, September 13, 2011.

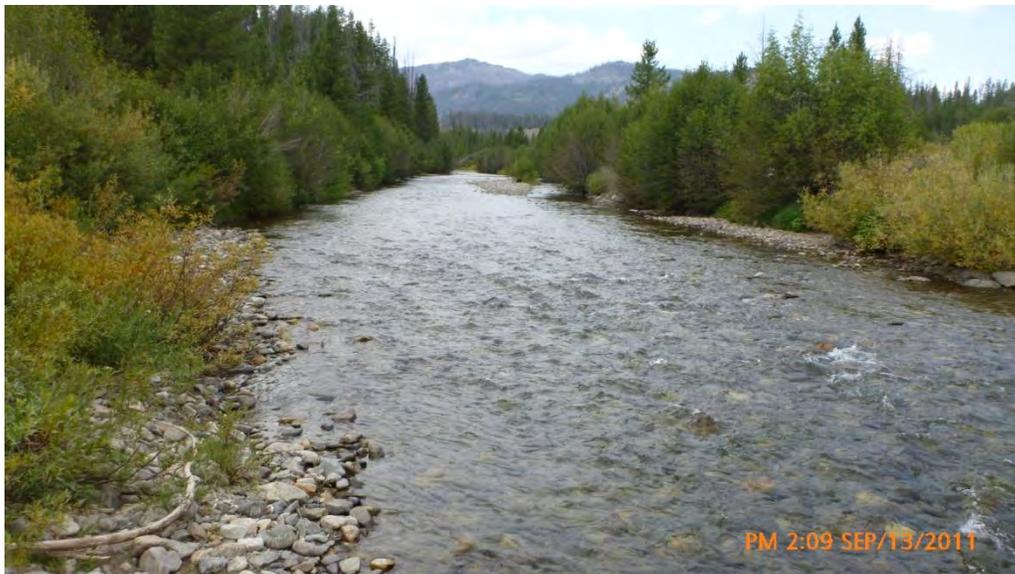
Photograph No. 73. View to the northwest looking upstream at the straight, confined section of lower West Fork. West Fork of the Yankee Fork of the Salmon River, Yankee Fork Subbasin, Idaho – Bureau of Reclamation
Photograph by P. Drury, September 13, 2011.

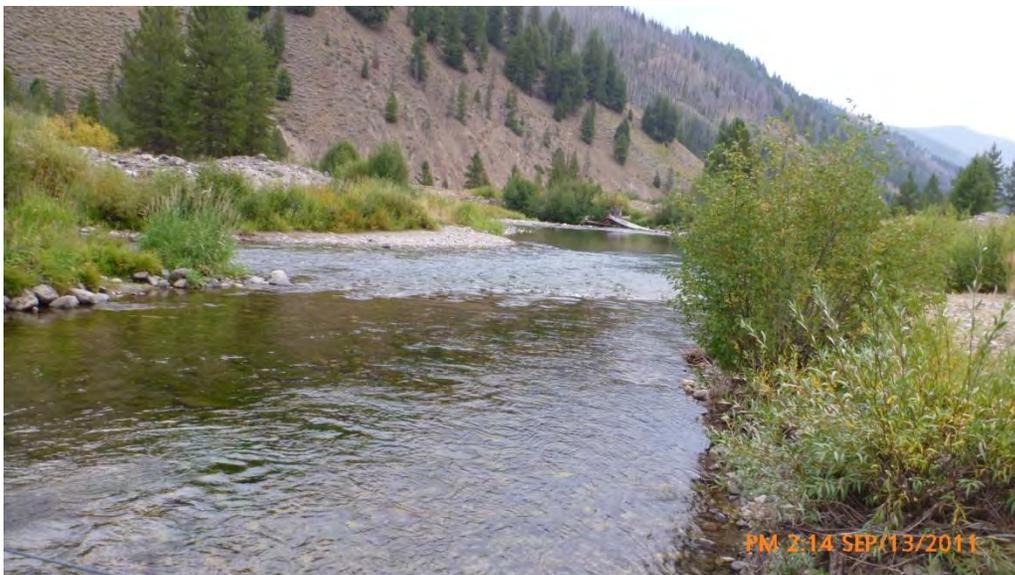
Photograph No. 75. View to the north looking at a narrow exaction through the dredge tailings. West Fork of the Yankee Fork of the Salmon River, Yankee Fork Subbasin, Idaho – Bureau of Reclamation Photograph by P. Drury, September 13, 2011.

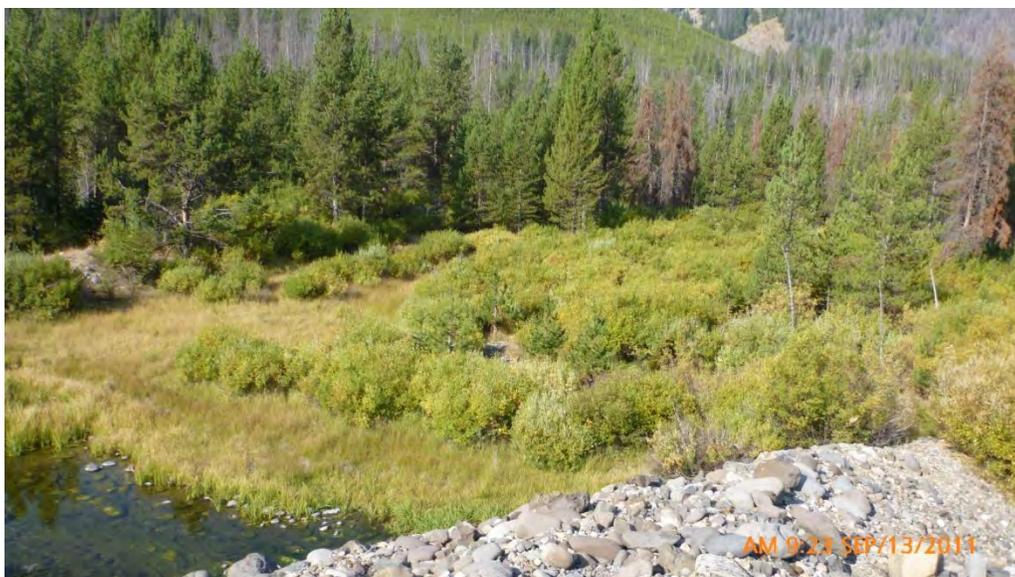
Photograph No. 76. View to the west looking at vegetation along the 1945 Yankee Fork channel alignment. West Fork of the Yankee Fork of the Salmon River, Yankee Fork Subbasin, Idaho – Bureau of Reclamation Photograph by P. Drury, September 13, 2011.

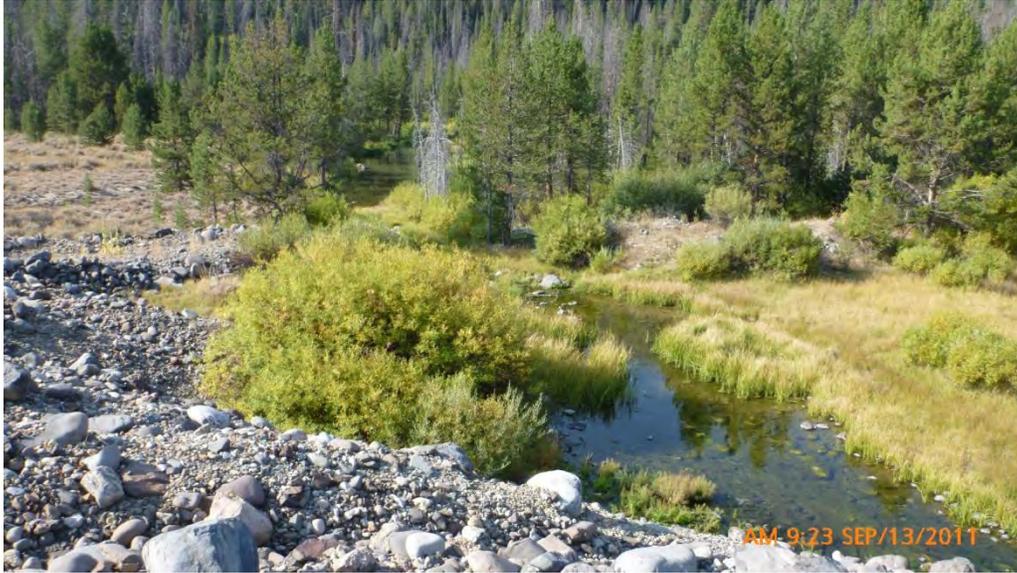
Photograph No. 77. View to the southwest looking along the edge of the dredge tailings where the 1945 Yankee Fork channel probably flowed. Note the road embankment that bisects part of the historic floodplain (right of center). West Fork of the Yankee Fork of the Salmon River, Yankee Fork Subbasin, Idaho – Bureau of Reclamation Photograph by P. Drury, September 13, 2011.

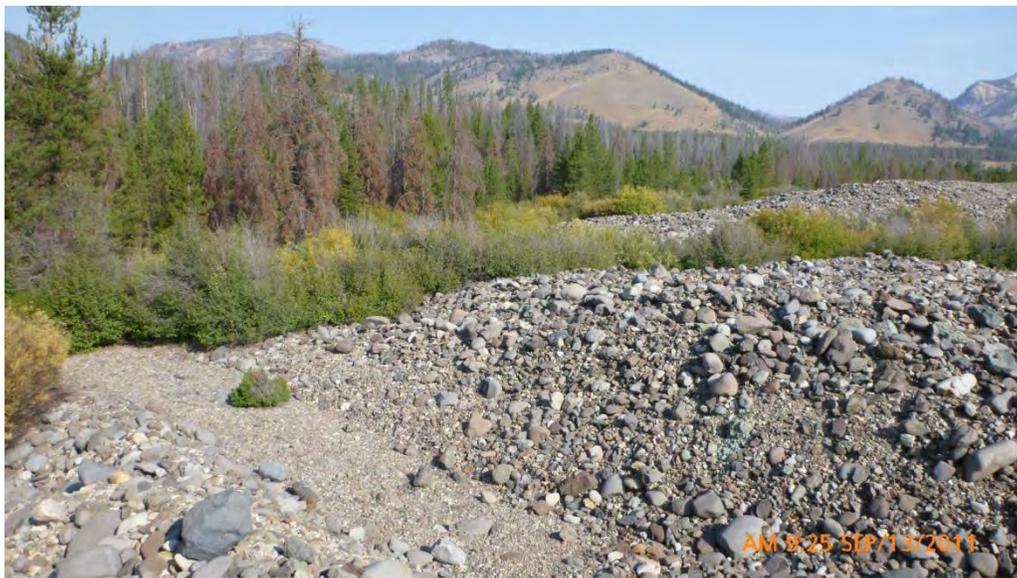
Photograph No. 78. View to the northwest looking at the historic (pre-dredging) Yankee Fork floodplain. West Fork of the Yankee Fork of the Salmon River, Yankee Fork Subbasin, Idaho – Bureau of Reclamation Photograph by P. Drury, September 13, 2011.

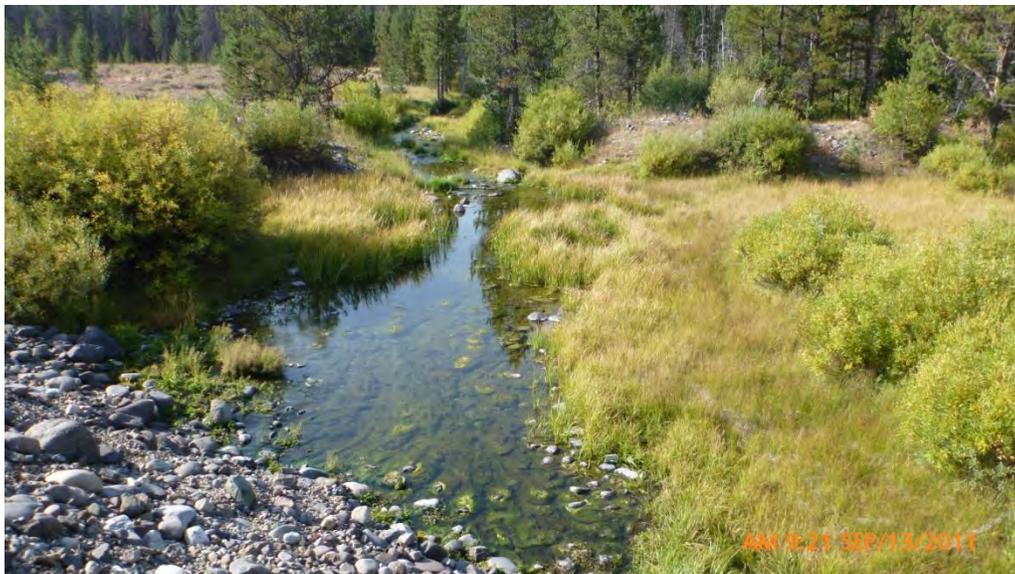
Photograph No. 79. View to the south-southwest looking downstream along a seep from the dredge tailings that flows into the West Fork. West Fork of the Yankee Fork of the Salmon River, Yankee Fork Subbasin, Idaho – Bureau of Reclamation Photograph by P. Drury, September 13, 2011.

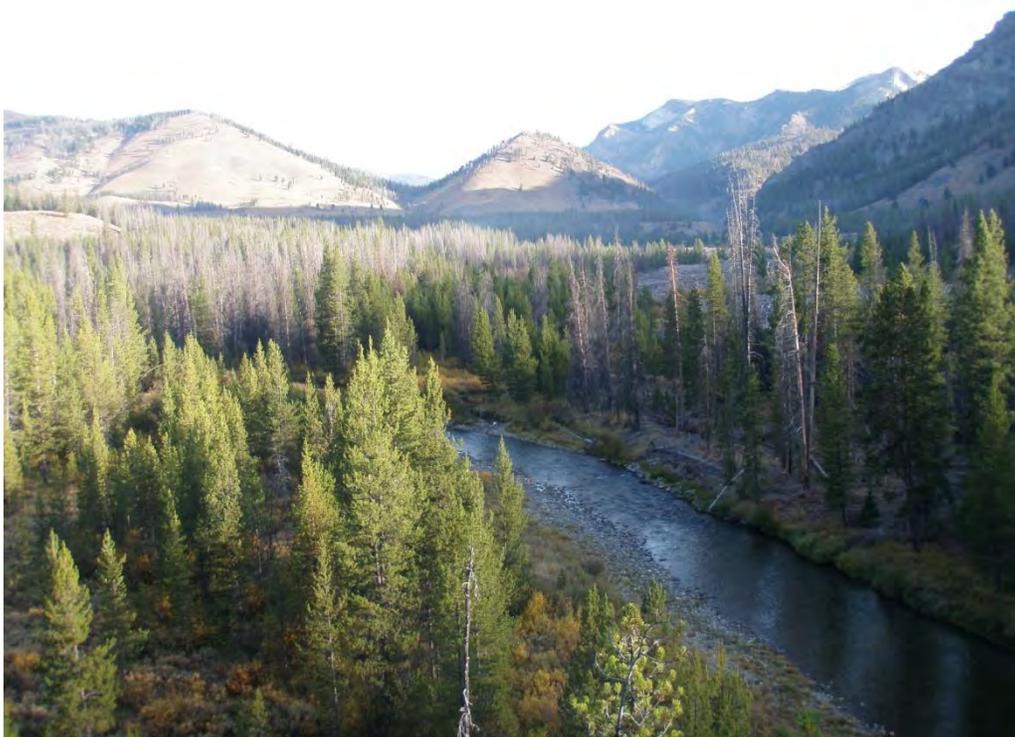
Photograph No. 80. View to the north looking upstream from a bedrock outcrop that overlooks where the historic (pre-dredging) West Fork/Yankee Fork confluence was located. Note the green, young evergreens and riparian vegetation near the center and foreground in the photograph. West Fork of the Yankee Fork of the Salmon River, Yankee Fork Subbasin, Idaho – Bureau of Reclamation Photograph by E. Lyon, September 30, 2011.
