Pole Flat Area Baseline Condition Assessment
Yankee Fork of the Salmon River,
Upper Salmon Subbasin

Custer County, Idaho

U.S. Department of the Interior
Bureau of Reclamation
Pacific Northwest Region
Pacific Northwest Regional Office, Boise, Idaho

October 2012

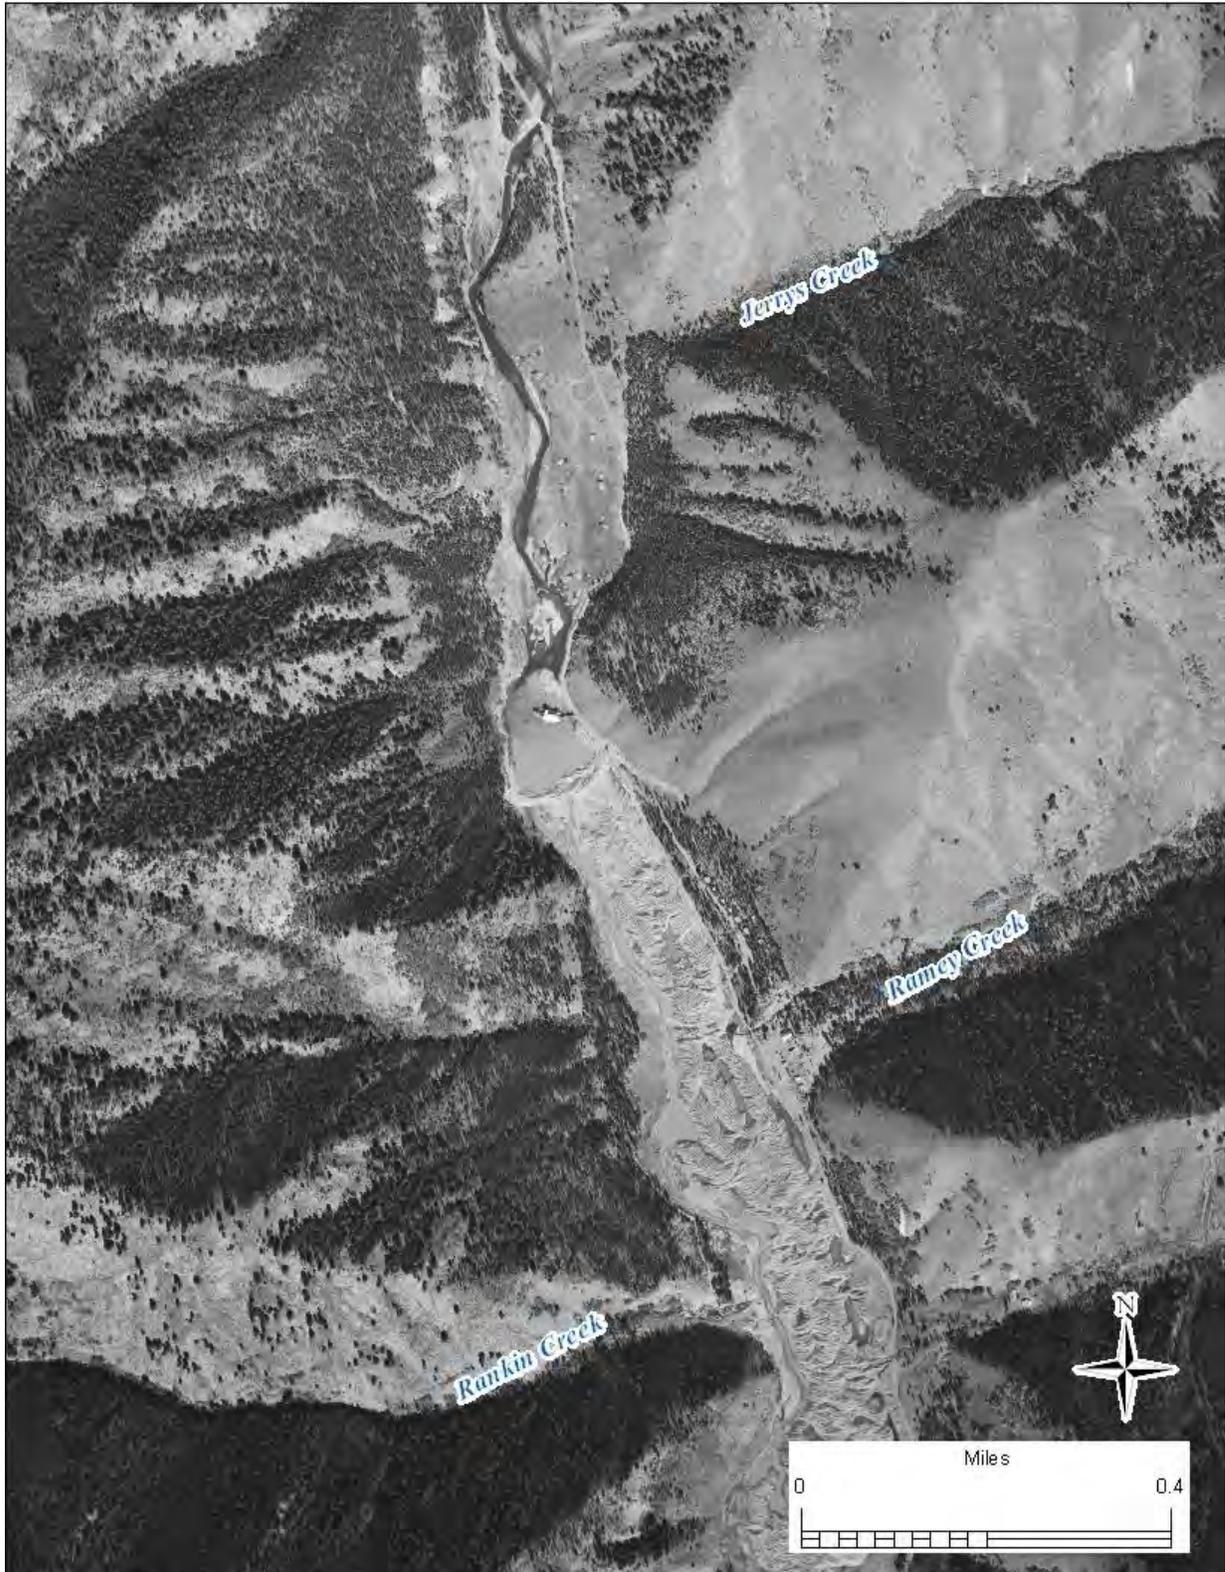
Figure 6. Yankee Fork Gold Dredge working between Jerrys Creek and Rankin Creek in 1945.

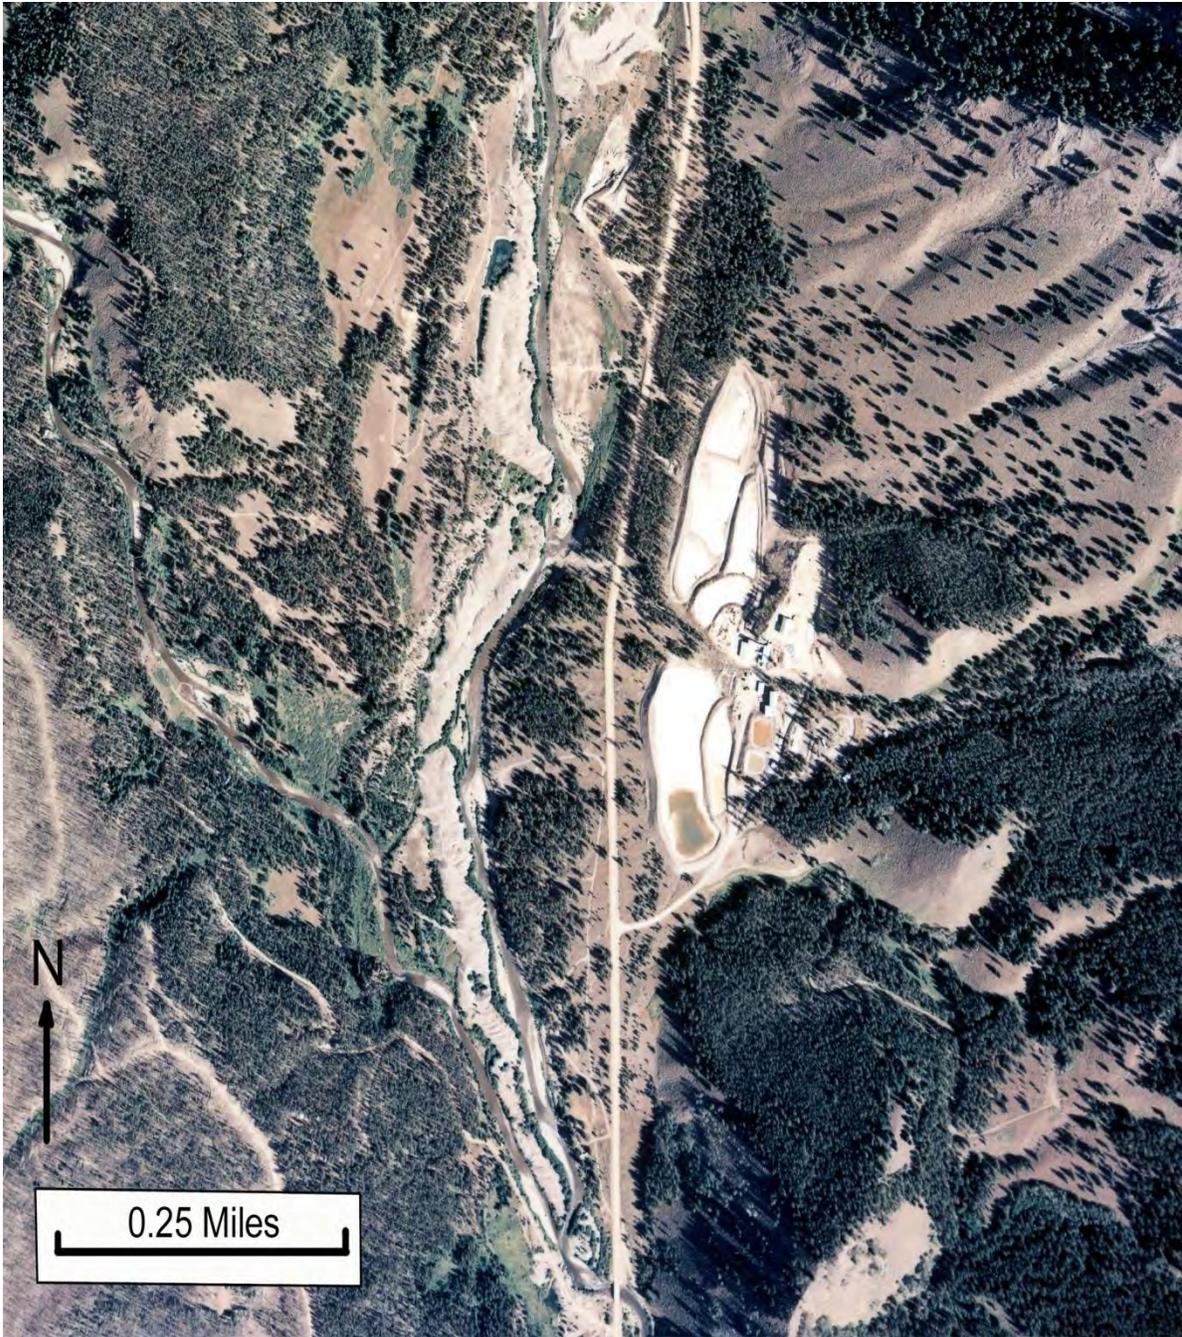
Figure 7. U.S. Antimony Corporation's vat leach cyanide mill at Preachers Cove in 1991.

1980 - 2004	<p>U.S. Antimony Corporation's subsidiary Yankee Fork Silver and Gold Company began processing dump material from Charles Dickens mine and mines on Estes Mountain using a vat leach cyanide mill at Preachers Cove in 1980 (Figure 7). There were some environmental problems at the mill site associated with soil and groundwater contamination from cyanide spills and heavy metals leaching from tailing ponds. Presumably, by the end of 1993, over 90 percent of the chemicals had been neutralized (Mitchell 1997).</p> <p>In 1995, the U.S. Forest Service (USFS) discovered a cyanide leak at the processing facility. Approximately 20,000 gallons of cyanide solution from the tailing ponds leached into the ground about 650 feet from the Yankee Fork (High Country News, August 21, 1995). No documented fish kill was associated with this release.</p>

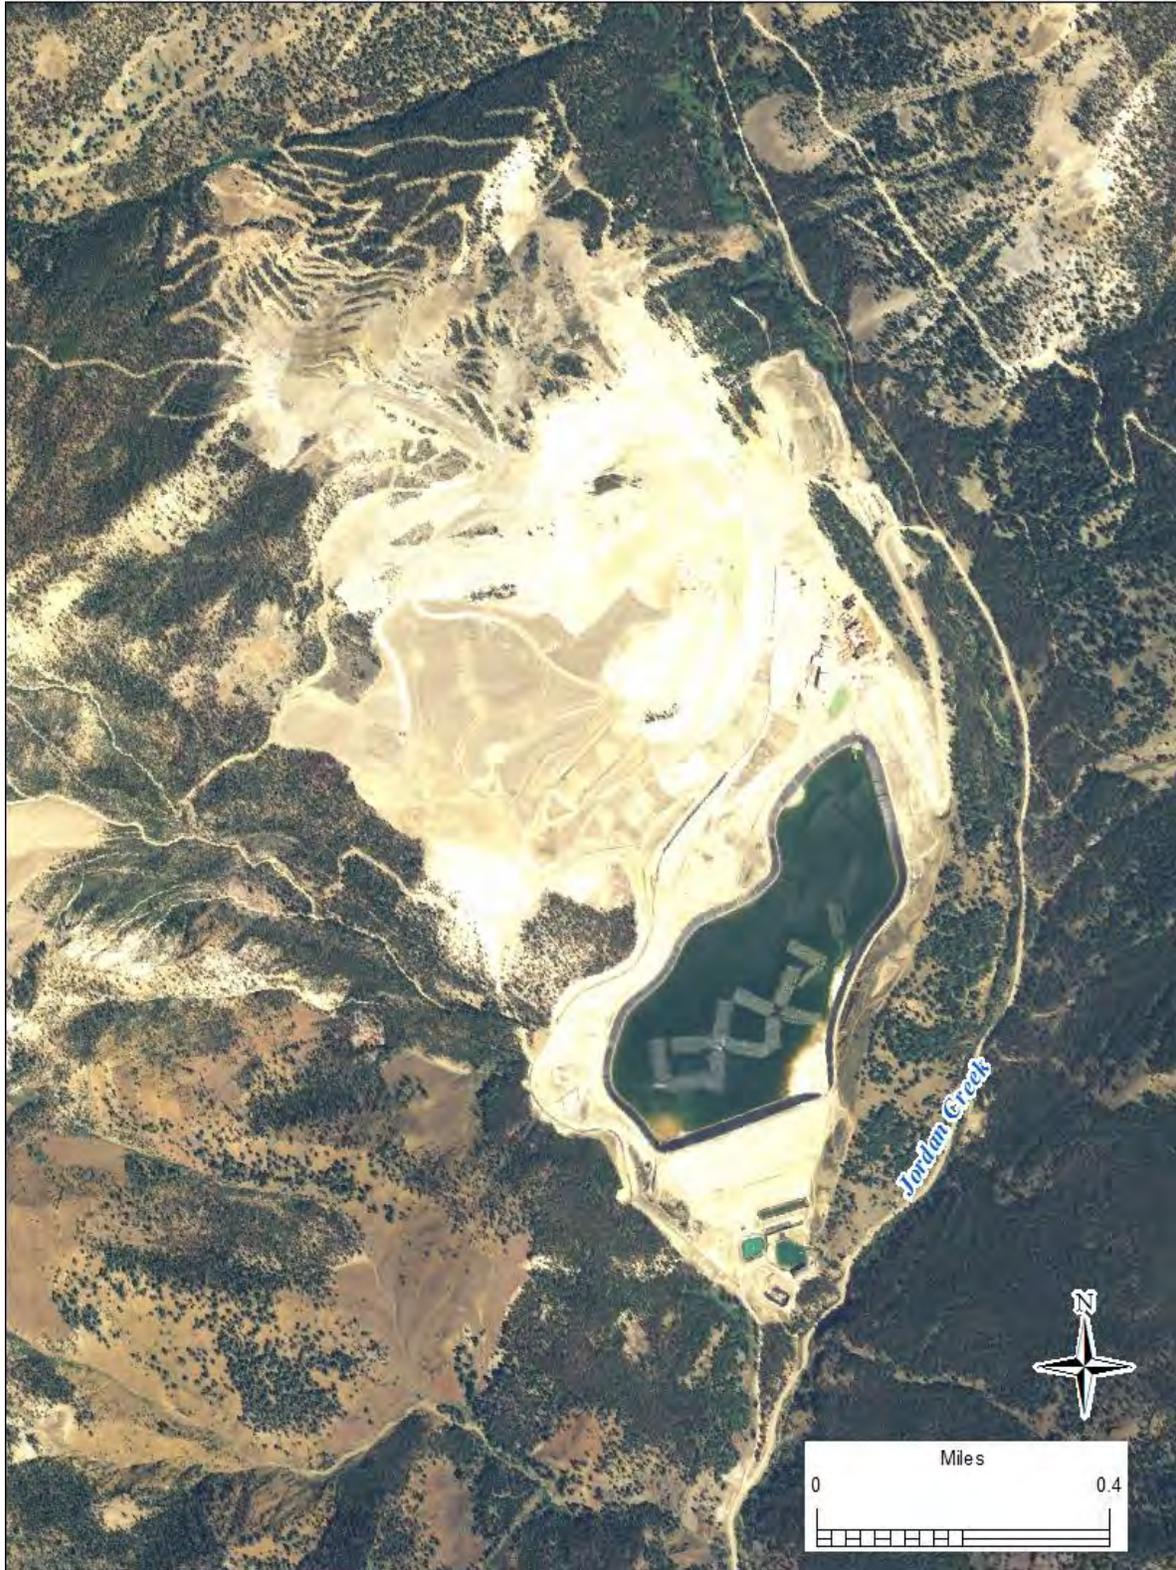
Figure 8. Grouse Creek Mine that was operated by Hecla Mining along Jordan Creek in 2009.

Year or Period	Significant Historical Event
1993 - 2012	<p>The following is a summary of activities associated with the Grouse Creek Mine based on the <i>Removal Action Memorandum, Grouse Creek Mine Tailings Impoundment Closure</i>, initiated by the USFS in 1998. Construction of the Grouse Creek Mine in the Jordan Creek drainage by Hecla Mining Company (Hecla) began in 1993, and actual mining operations were from 1994 to 1997. The mine was a 536 acre open-pit mine and gold recovery used a carbon-in-pulp cyanide vat leach process which included a 105 acre tailings impoundment (Figure 8). In 1997, Hecla suspended mining operations due to unfavorable economic conditions. Beginning in 1997, water monitoring sites detected weak acid dissociable (WAD) cyanide off-site, instream and downstream of the mine. In 1999, a USFS Technical Team concluded that cyanide was from the tailings impoundment. In October of 2000, Hecla entered into an Administrative Order on Consent (AOC), under the Comprehensive Environmental Response Compensation and Liability Act (CERCLA), for a Time-Critical Removal Action with the USFS and the Environmental Protection Agency (EPA). In 2003, Hecla under an Action Memorandum was allowed to discharge treated and untreated tailings impoundment water to the Yankee Fork via a pipe to Outfall 003 (Lat. 44° 23' 01": Long. 114° 43' 22"; downstream of the Yankee Fork/Jordan Creek confluence). No impacts to aquatic life in Jordan Creek were noted in the <i>Removal Action Memorandum</i>.</p> <p>Presently, Hecla has reclaimed about 80 percent and the final reclamation of the site with completion of the tailings impoundment closure is planned to be completed in 2012 (http://www.hecla-mining.com/resposibility/resposibility_stewardship_reclamation.php).</p>

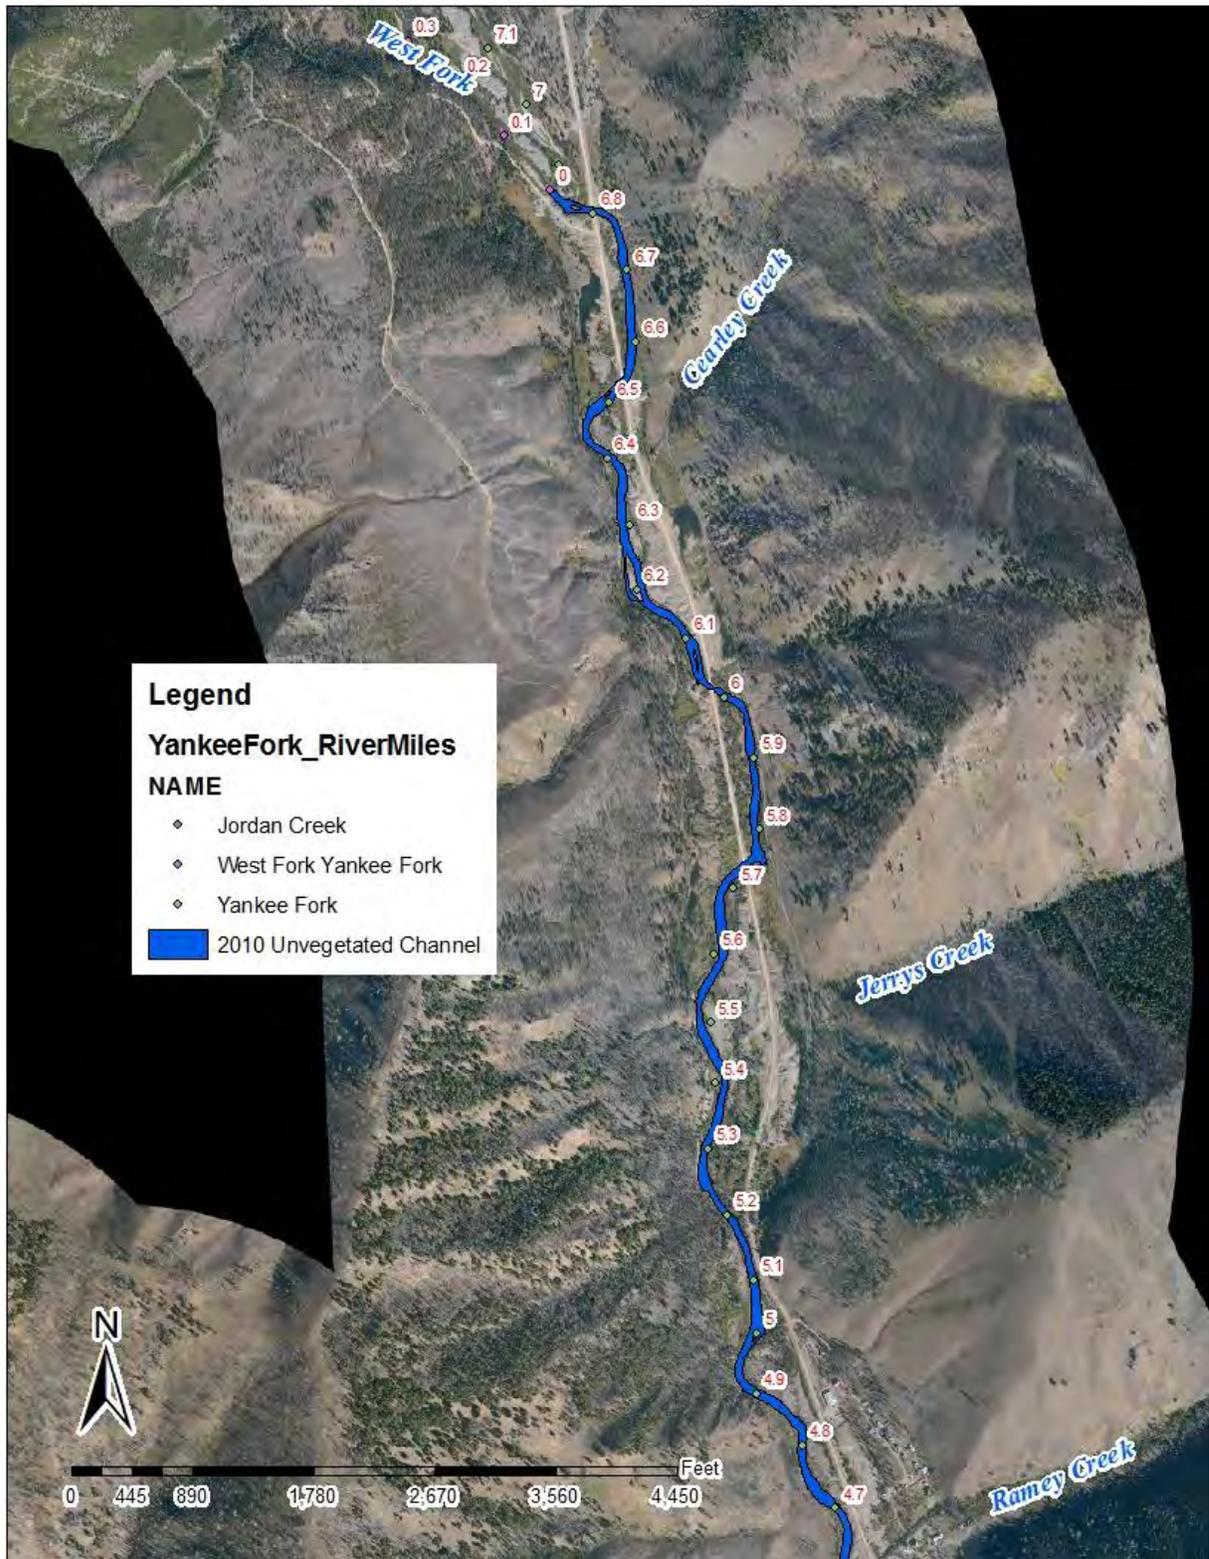
Figure 10. Yankee Fork 2010 unvegetated channel between RM 6.8 and 4.7.

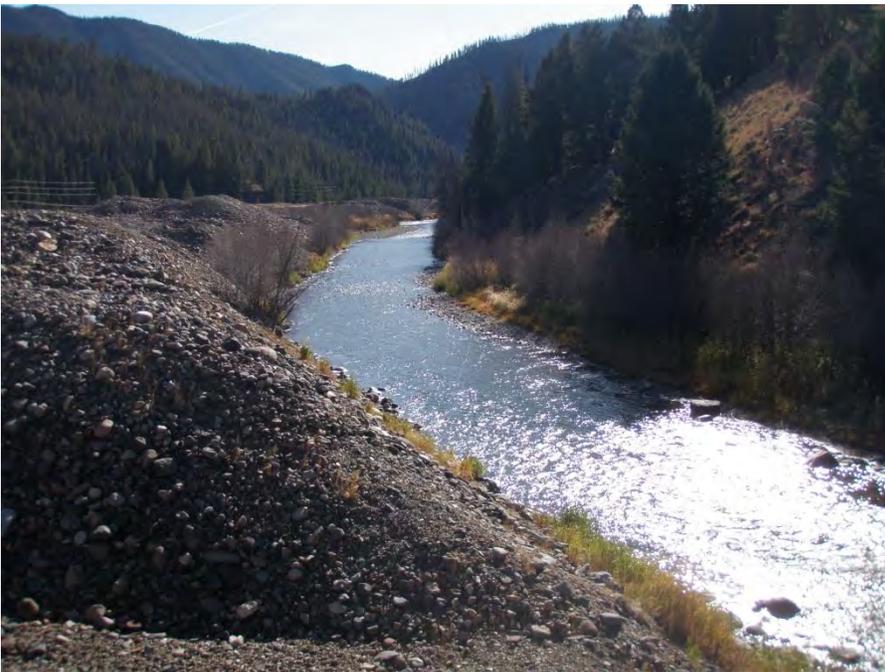
Figure 12. View to the south looking downstream along a confined channel segment constrained by mine tailings, colluvial deposits, and bedrock along the Yankee Fork. Yankee Fork of the Salmon River, Yankee Fork Subbasin, Idaho – Bureau of Reclamation Photograph by E. Lyon, October 26, 2011.

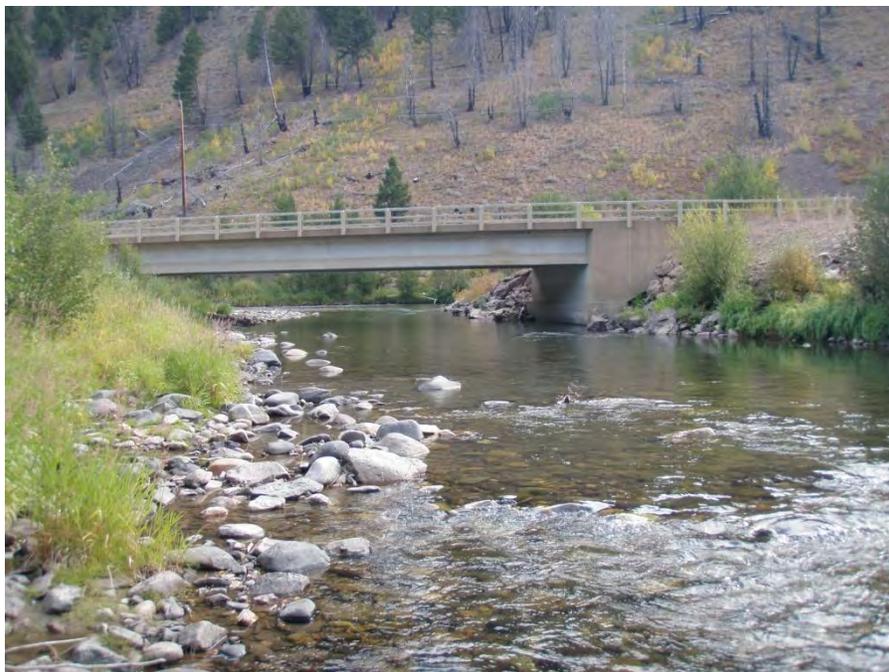
Figure 13. View to the northeast looking upstream at mid channel pool forced by flow constriction at a Custer Motorway Bridge. Yankee Fork of the Salmon River, Yankee Fork Subbasin, Idaho – Bureau of Reclamation Photograph by E. Lyon, September 15, 2011.

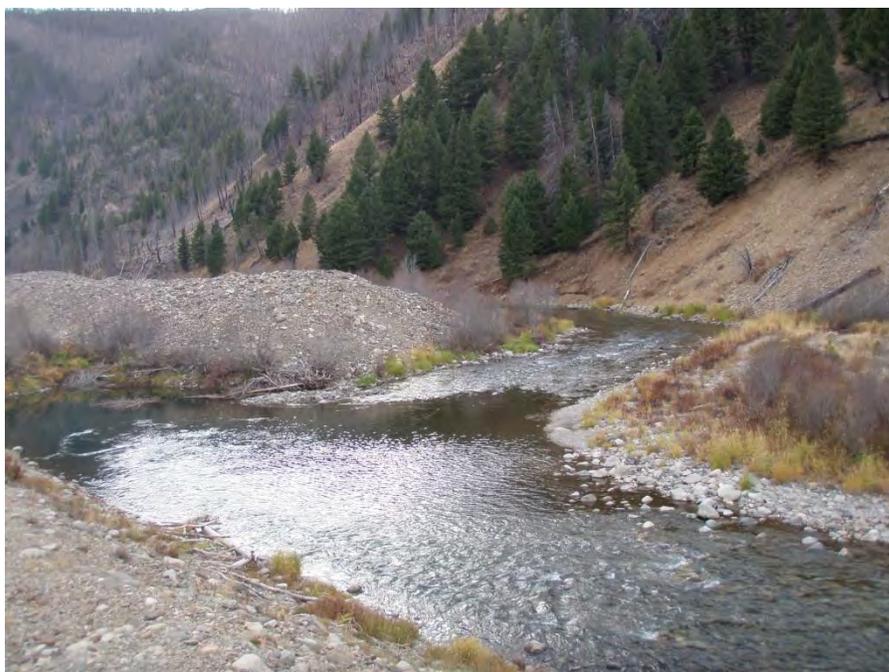
Figure 14. View to the south looking downstream at mid channel pool most likely created during dredging operations and then maintained by flow convergence. Yankee Fork of the Salmon River, Yankee Fork Subbasin, Idaho – Bureau of Reclamation Photograph by E. Lyon, October 26, 2011.

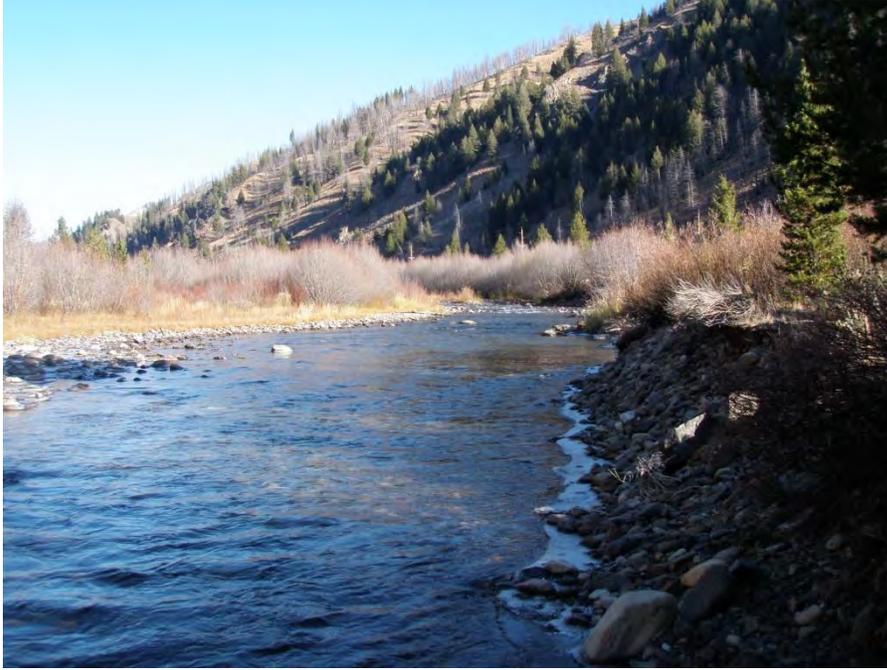
Figure 15. Yankee Fork channel actively eroding mine tailings along river left.

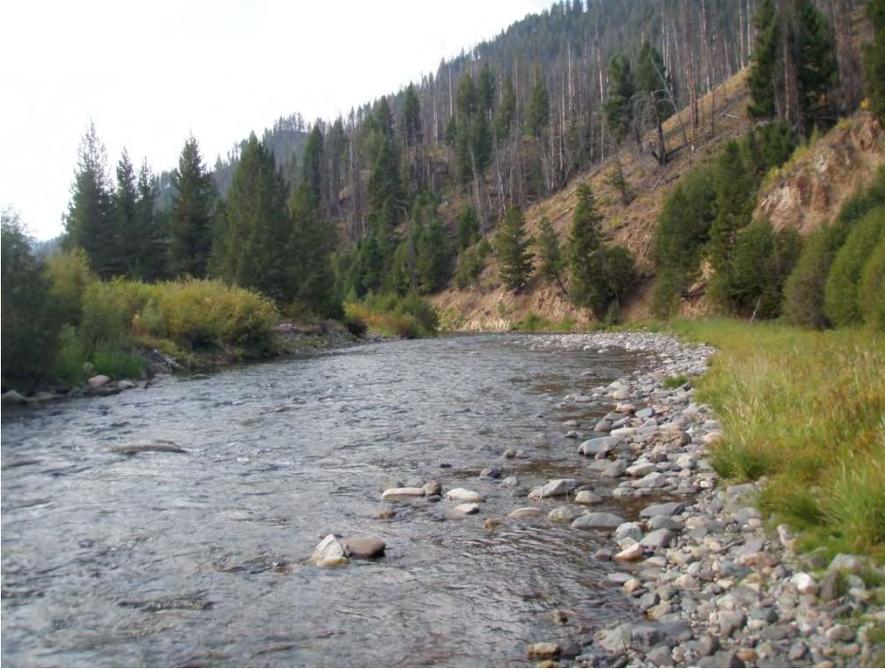
Figure 16. Yankee Fork riparian vegetation showing varying vegetation successional stages associated with floodplain elevations and disturbance histories. Yankee Fork of the Salmon River, Yankee Fork Subbasin, Idaho – Bureau of Reclamation Photograph by E. Lyon, September 15, 2011.

Active (connected) floodplain areas are generally comprised of smaller patches (less than a half acre) that either have no vegetation, or vegetation consisting of grassland/forbs, shrub/seedlings, and/or sapling poles, depending on the degree of disturbance (i.e. ground disturbing flows or mining activities). Alders, willows, grasses, and forbs were dominant in the lower areas of the active floodplain (Figure 16) and along the pond series (Figure 17) where floods commonly disturb the surface and the soils tend to be wetter. Grasses with dispersed lodgepole pines were dominant in the higher areas where floods less frequently disturb the surface and the soils tend to be drier. Most of the mine tailings adjacent to the stream are unvegetated, and the vegetation along the channel shades less than 35 percent of the stream (USFS 2010).

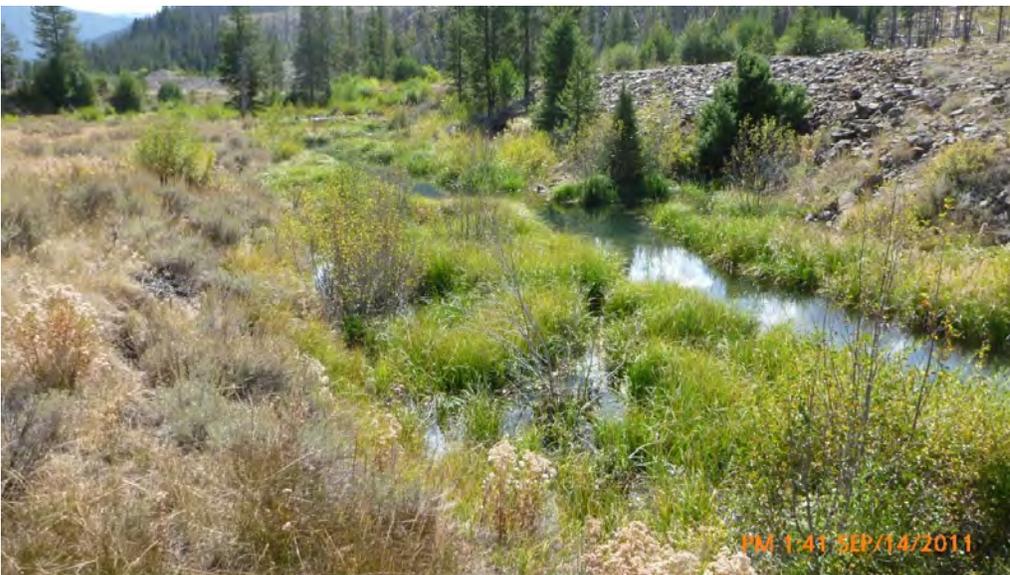
Figure 17. Pond Series Three (PS3) riparian vegetation showing the varying vegetation composition associated with elevations and soil moisture content. Yankee Fork of the Salmon River, Yankee Fork Subbasin, Idaho – Bureau of Reclamation Photograph by P. Drury, September 14, 2011.

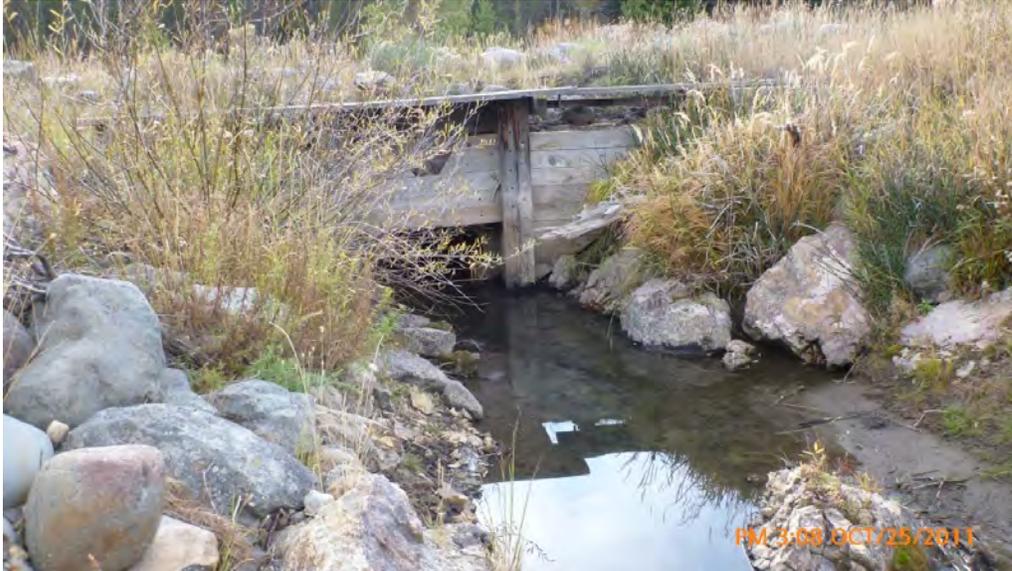
Figure 19. View to the southwest looking downstream at a culvert placed through a dirt road embankment that provides a high-water connection between the Yankee Fork and Pond Series Four. Yankee Fork of the Salmon River, Yankee Fork Subbasin, Idaho – Bureau of Reclamation Photograph by P. Drury, October 25, 2011.

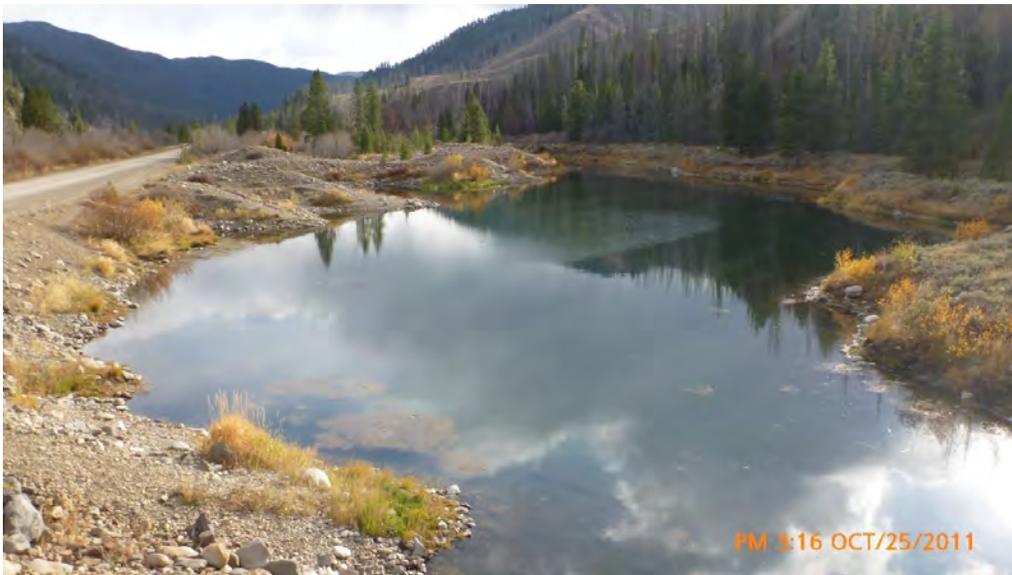
Figure 20. View to the south looking downstream at Pond 2 bordered by mine tailings (left) and undisturbed ground (right) along Pond Series Four. Yankee Fork of the Salmon River, Yankee Fork Subbasin, Idaho – Bureau of Reclamation Photograph by P. Drury, October 25, 2011.

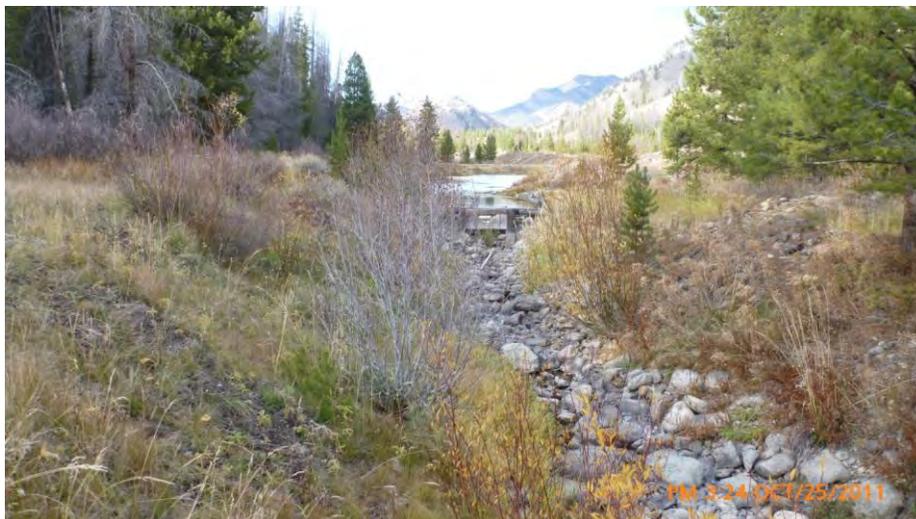
Figure 21. View to the north looking upstream at connecting channel and check structure along Pond Series Four. Yankee Fork of the Salmon River, Yankee Fork Subbasin, Idaho – Bureau of Reclamation Photograph by P. Drury, October 25, 2011.

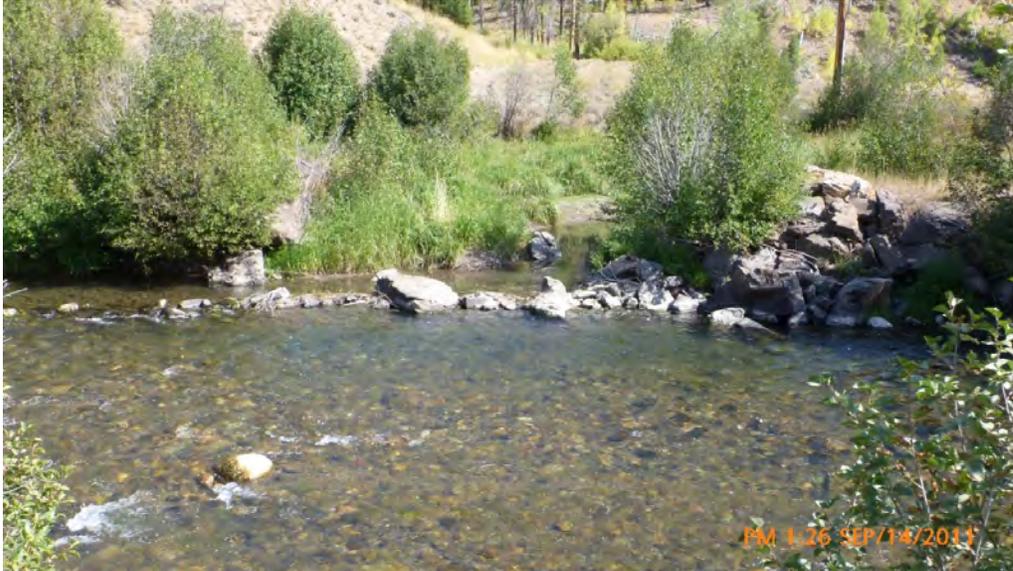
Figure 23. View to the southeast looking across the Yankee Fork at breach through the riprap berm and placement of boulders to divert flows from the Yankee Fork into Pond Series Three. Yankee Fork of the Salmon River, Yankee Fork Subbasin, Idaho – Bureau of Reclamation Photograph by P. Drury, September 14, 2011.

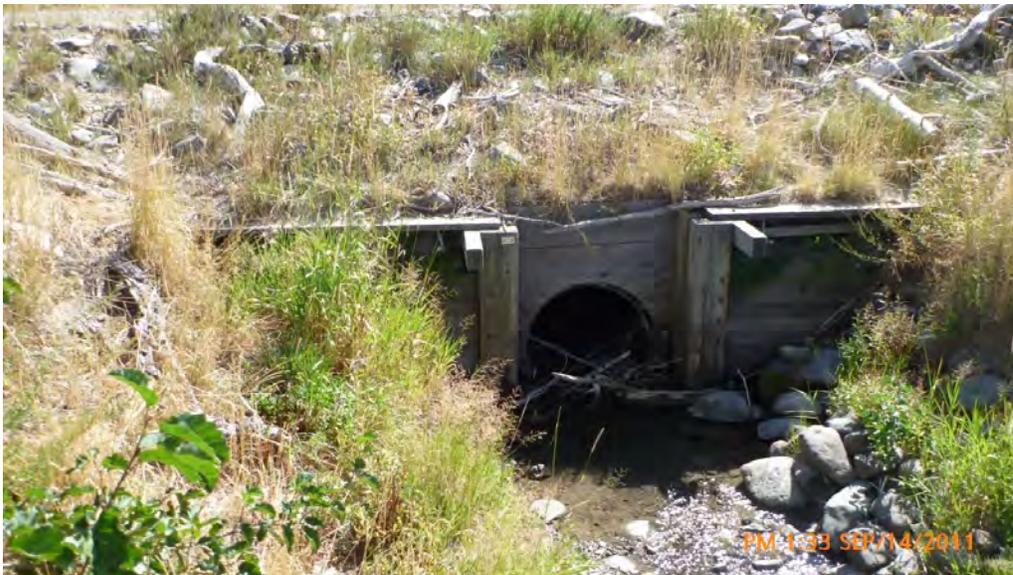
Figure 24. View to the south looking downstream at culvert placed through an existing road to help regulate flows into Pond Series Three. Yankee Fork of the Salmon River, Yankee Fork Subbasin, Idaho – Bureau of Reclamation Photograph by P. Drury, September 14, 2011.

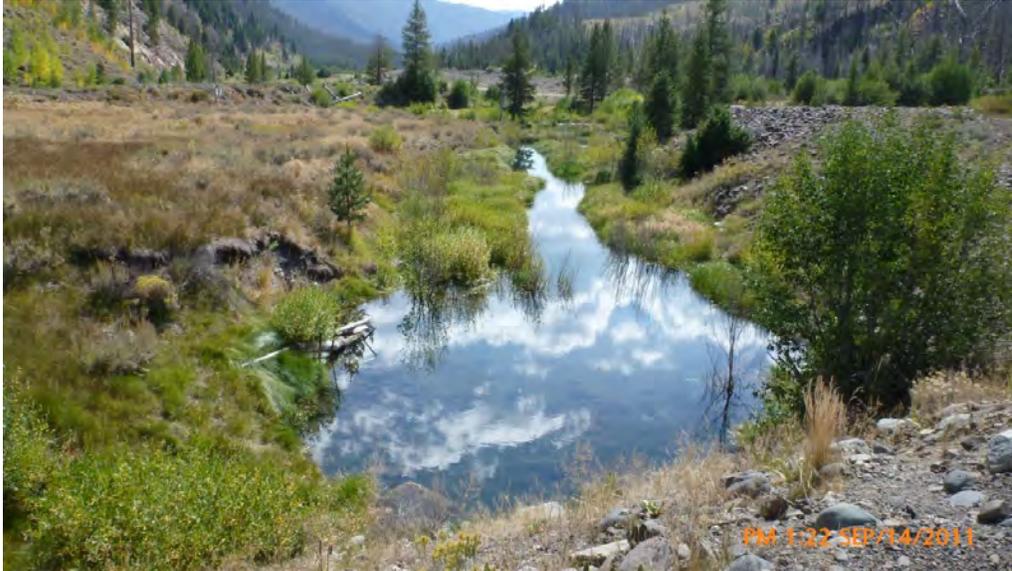
Figure 25. View to the south looking downstream from dirt road embankment at constructed channel along Pond Series Three. Yankee Fork of the Salmon River, Yankee Fork Subbasin, Idaho – Bureau of Reclamation Photograph by P. Drury, September 14, 2011.

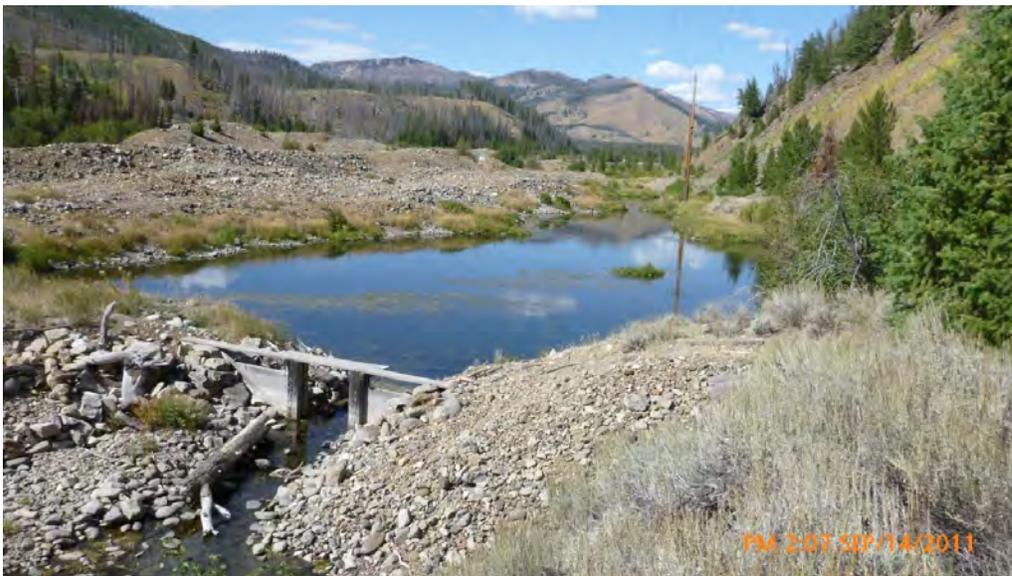
Figure 26. View to the north looking upstream at check structure placed between embankment constrictions at the outlet of Pond 1. Yankee Fork of the Salmon River, Yankee Fork Subbasin, Idaho – Bureau of Reclamation Photograph by P. Drury, September 14, 2011.

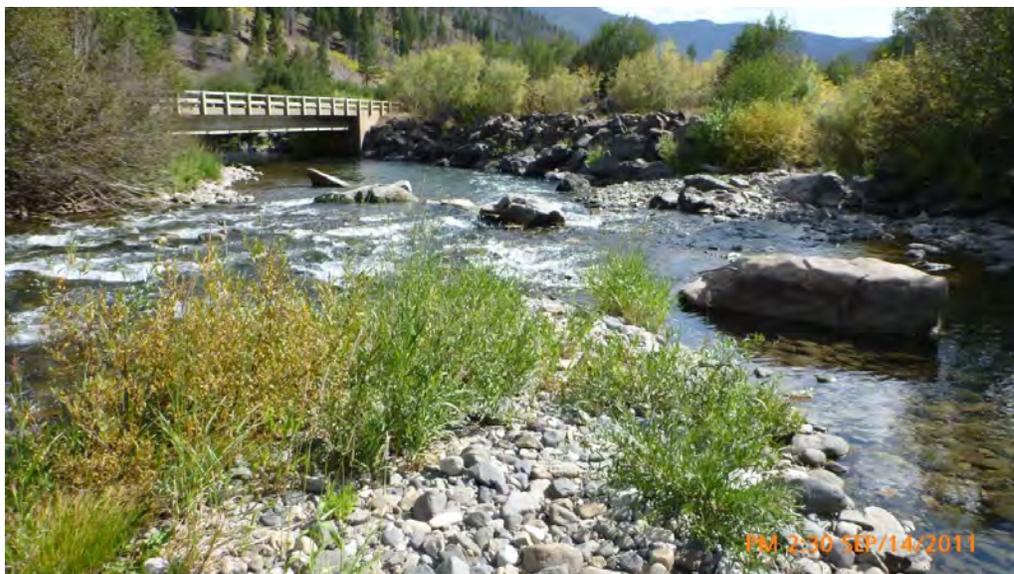
Figure 28. View to the southeast looking downstream along the Yankee Fork at the inlet to Pond Series Two. Yankee Fork of the Salmon River, Yankee Fork Subbasin, Idaho – Bureau of Reclamation Photograph by P. Drury, September 14, 2011.

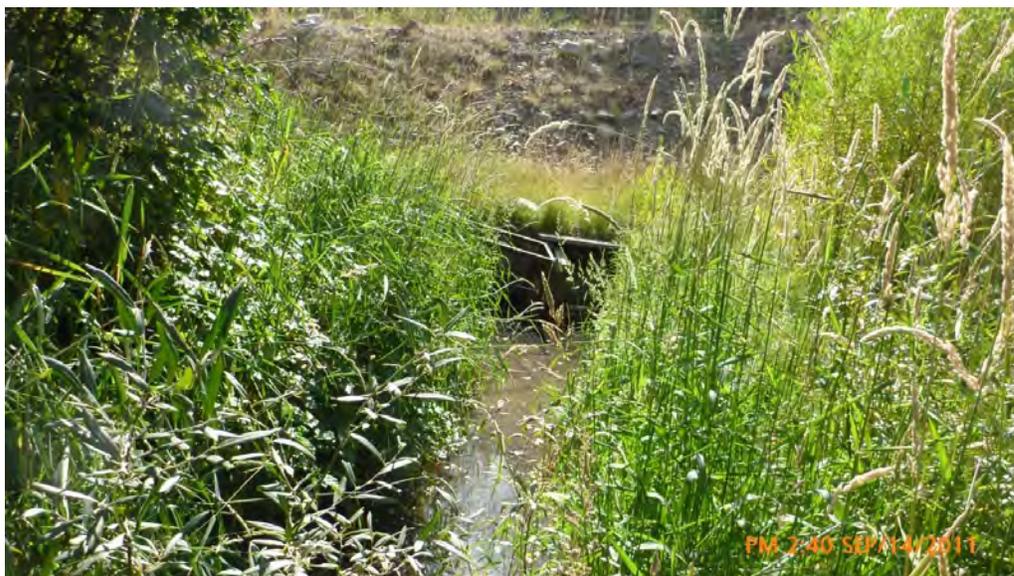
Figure 29. View to the southwest looking downstream at culvert placed through road embankment that controls flow into Pond Series Two. Yankee Fork of the Salmon River, Yankee Fork Subbasin, Idaho – Bureau of Reclamation Photograph by P. Drury, September 14, 2011.

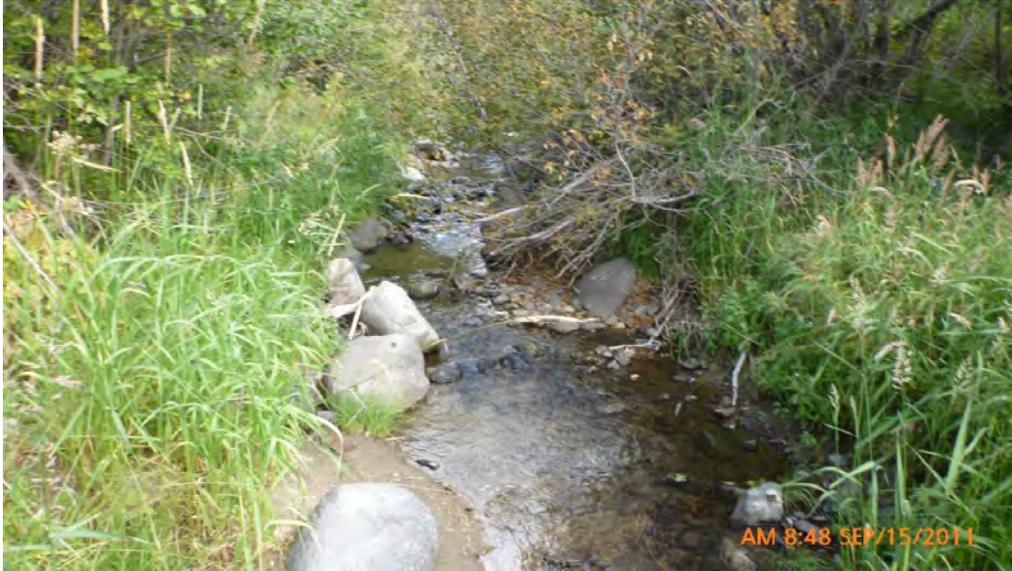
Figure 30. View to the southeast looking downstream along constructed channel with boulder placements along Pond Series Two. Yankee Fork of the Salmon River, Yankee Fork Subbasin, Idaho – Bureau of Reclamation Photograph by P. Drury, September 15, 2011.

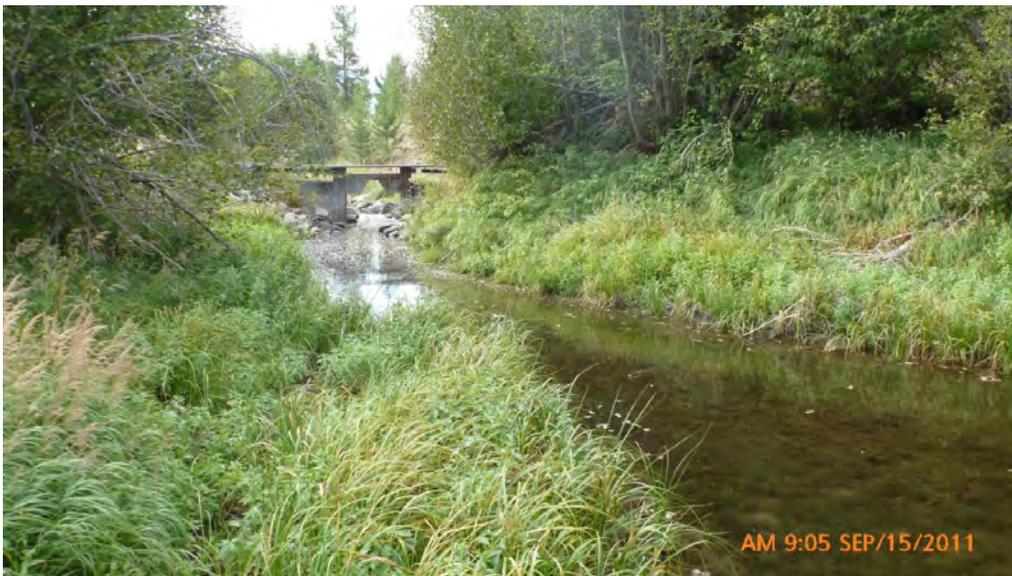
Figure 31. View to the south looking downstream at check structure along Pond Series Two. Yankee Fork of the Salmon River, Yankee Fork Subbasin, Idaho – Bureau of Reclamation Photograph by P. Drury, September 15, 2011.

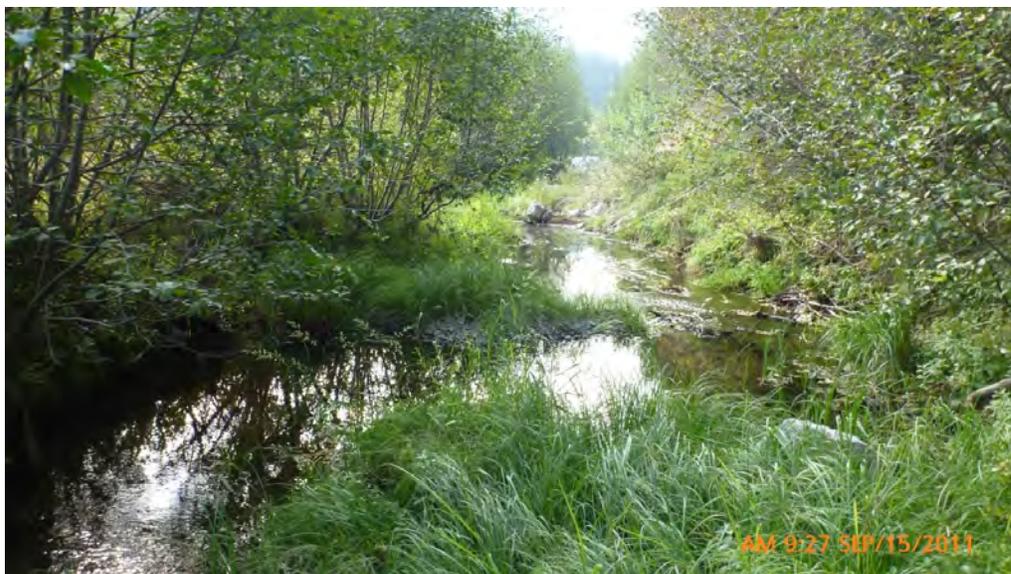
Figure 32. View to the south looking downstream near outlet where there were signs of beaver activity along Pond Series Two. Yankee Fork of the Salmon River, Yankee Fork Subbasin, Idaho – Bureau of Reclamation Photograph by P. Drury, September 15, 2011.

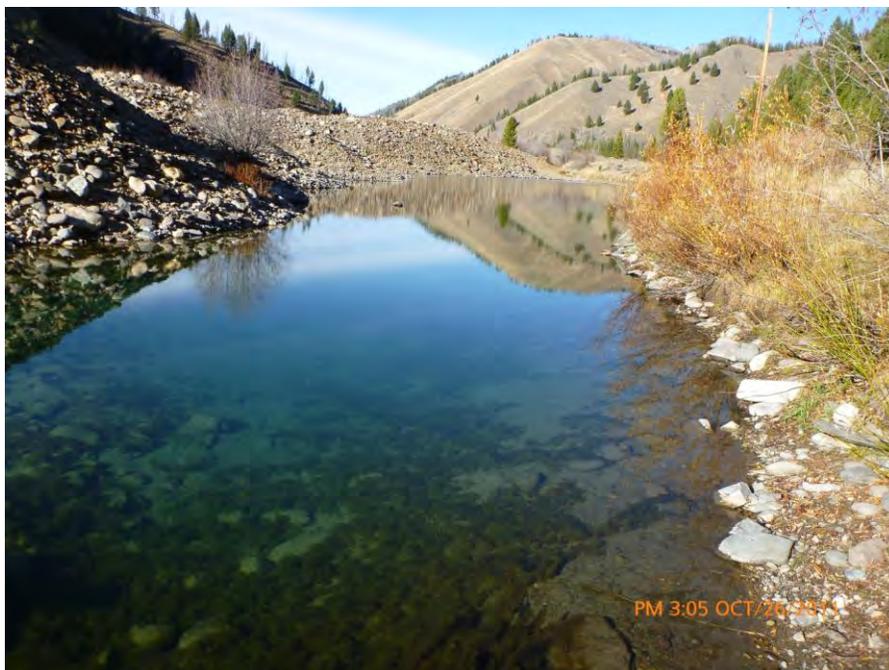
Figure 34. View to the north looking upstream at Pond 4, the largest pond, that is maintained as a put-and-take rainbow trout fishery along Pond Series One. Yankee Fork of the Salmon River, Yankee Fork Subbasin, Idaho – Bureau of Reclamation Photograph by P. Drury, October 26, 2011.

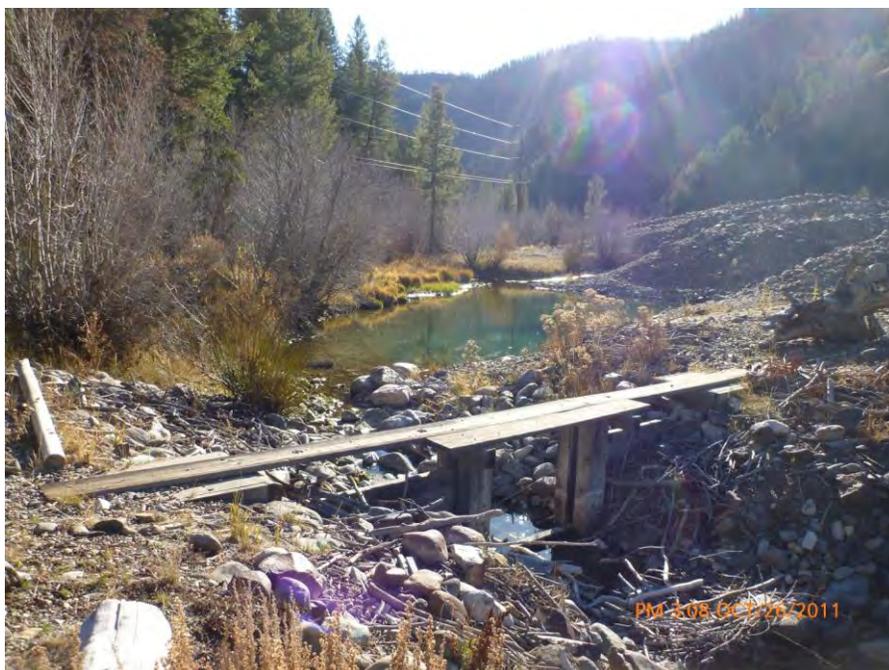
Figure 35. View to the southwest looking downstream at check structure in a constructed channel along Pond Series One. Yankee Fork of the Salmon River, Yankee Fork Subbasin, Idaho – Bureau of Reclamation Photograph by P. Drury, October 26, 2011.

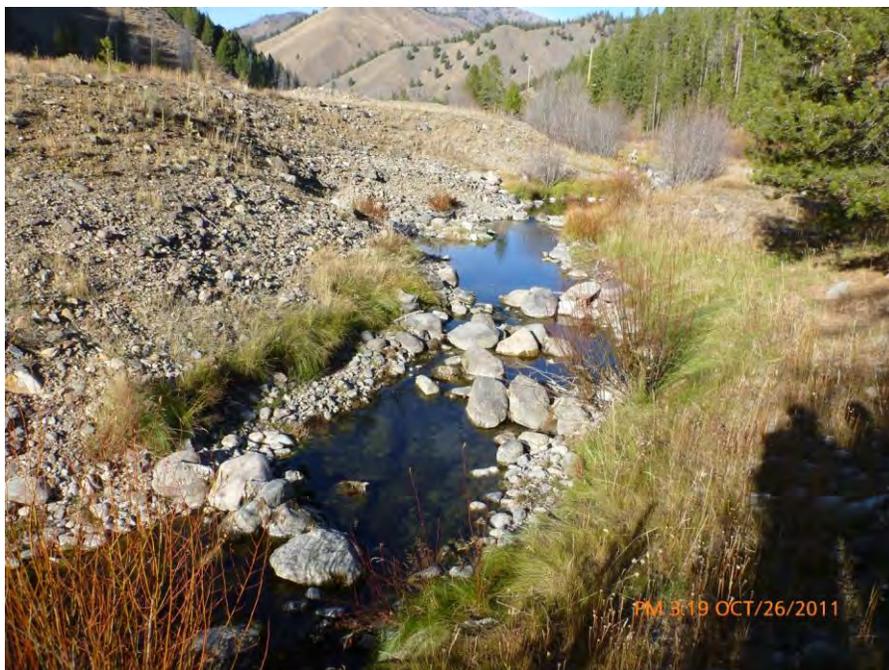
Figure 36. View to the northeast looking upstream at boulder placement along Pond Series One. Yankee Fork of the Salmon River, Yankee Fork Subbasin, Idaho – Bureau of Reclamation Photograph by P. Drury, October 26, 2011.

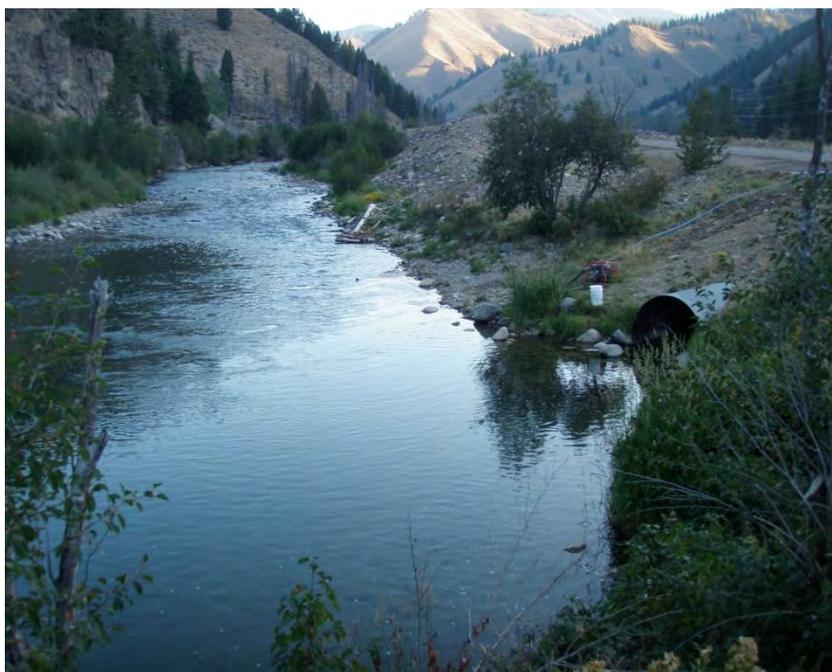
Figure 37. View to the northeast looking upstream at outlet to the Yankee Fork from Pond Series One. Yankee Fork of the Salmon River, Yankee Fork Subbasin, Idaho – Bureau of Reclamation Photograph by E. Lyon, September 1, 2011.
