Pole Flat Area Baseline Condition Assessment
Yankee Fork of the Salmon River,
Upper Salmon Subbasin

Custer County, Idaho

U.S. Department of the Interior
Bureau of Reclamation
Pacific Northwest Region
Pacific Northwest Regional Office, Boise, Idaho

October 2012

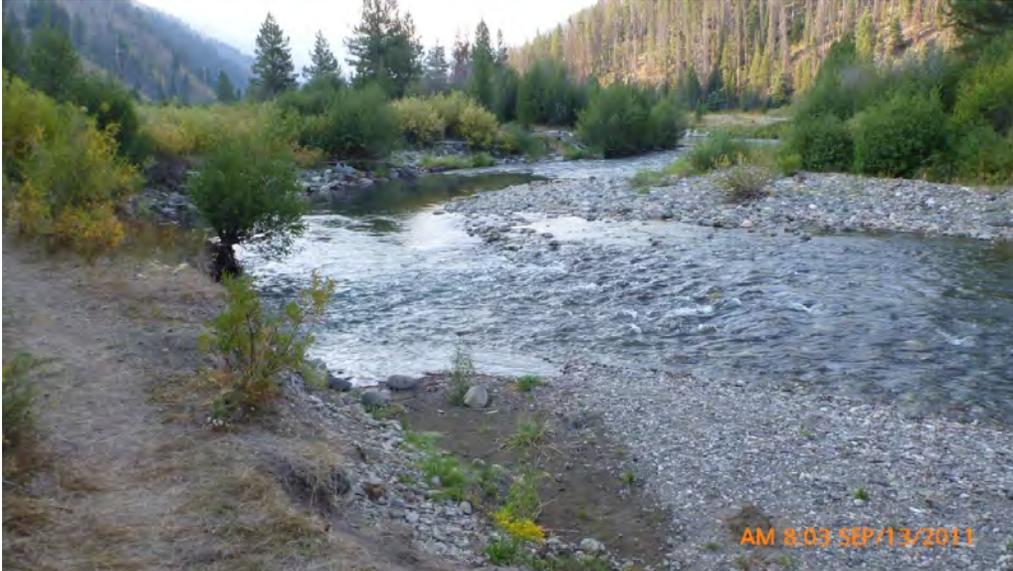
Photograph No. 3. View to the south looking downstream at a lateral scour pool forced by boulders along the Yankee Fork. Yankee Fork of the Salmon River, Yankee Fork Subbasin, Idaho – Bureau of Reclamation Photograph by P. Drury, September 13, 2011.

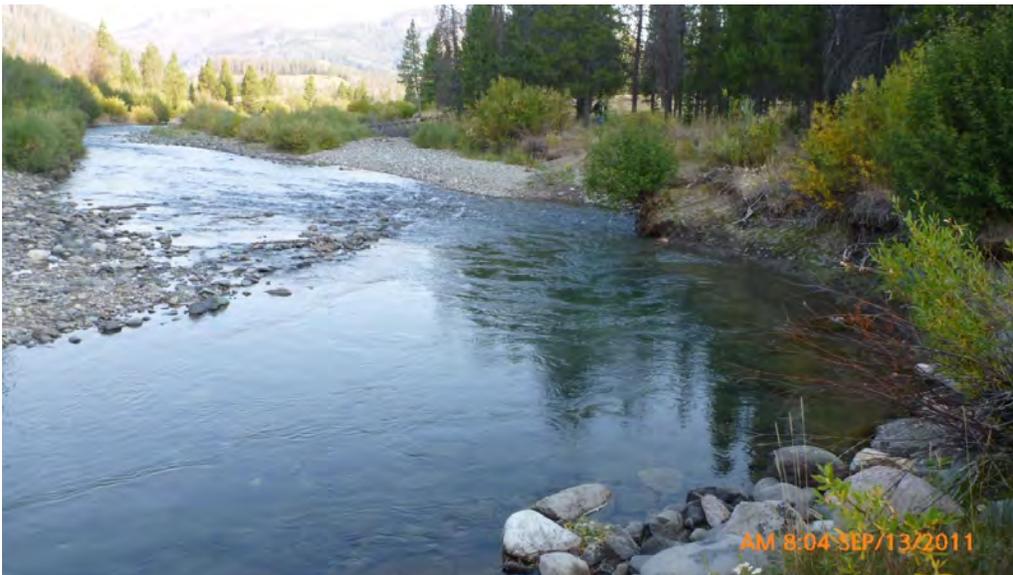
Photograph No. 4. View to the north looking upstream at a lateral scour pool along the Yankee Fork. Yankee Fork of the Salmon River, Yankee Fork Subbasin, Idaho – Bureau of Reclamation Photograph by P. Drury, September 13, 2011.

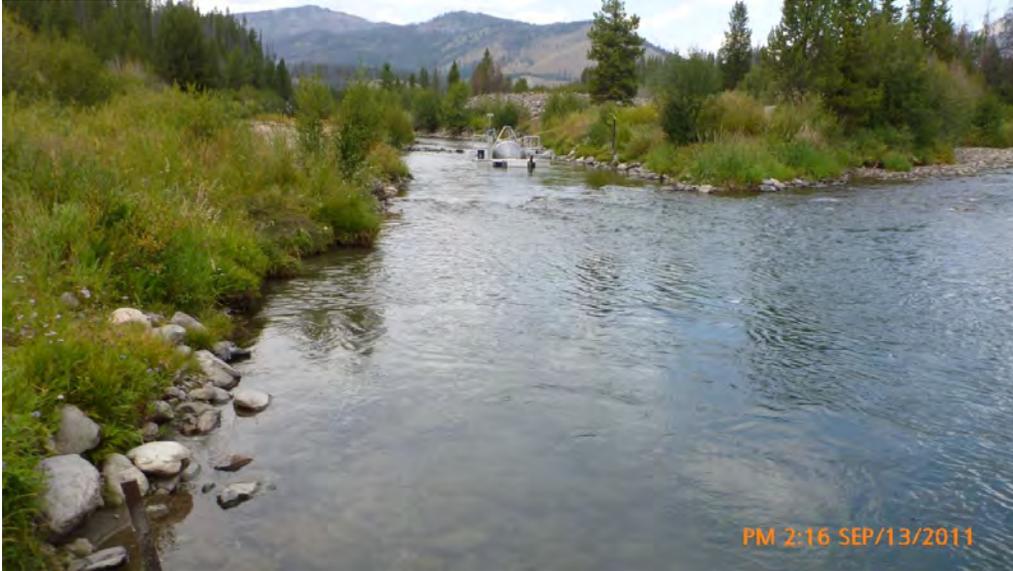
Photograph No. 7. View to the north looking upstream at middle channel scour pool forced by flow convergence at the West Fork/Yankee Fork confluence. Yankee Fork of the Salmon River, Yankee Fork Subbasin, Idaho – Bureau of Reclamation Photograph by P. Drury, September 13, 2011.

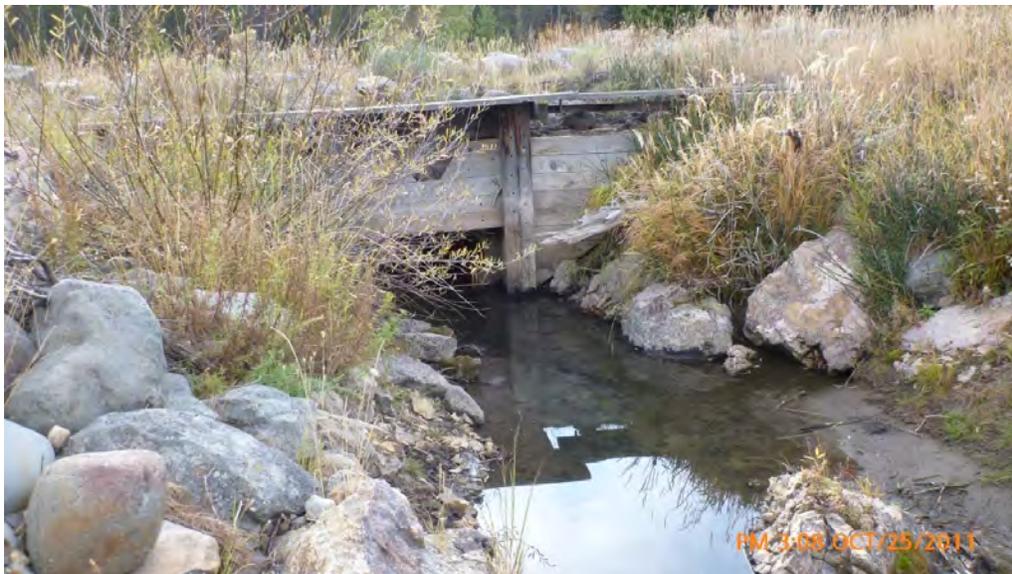
Photograph No. 9. View to the southwest looking downstream at a culvert at the entrance of Pond Series Four. Yankee Fork of the Salmon River, Yankee Fork Subbasin, Idaho – Bureau of Reclamation Photograph by P. Drury, October 25, 2011.

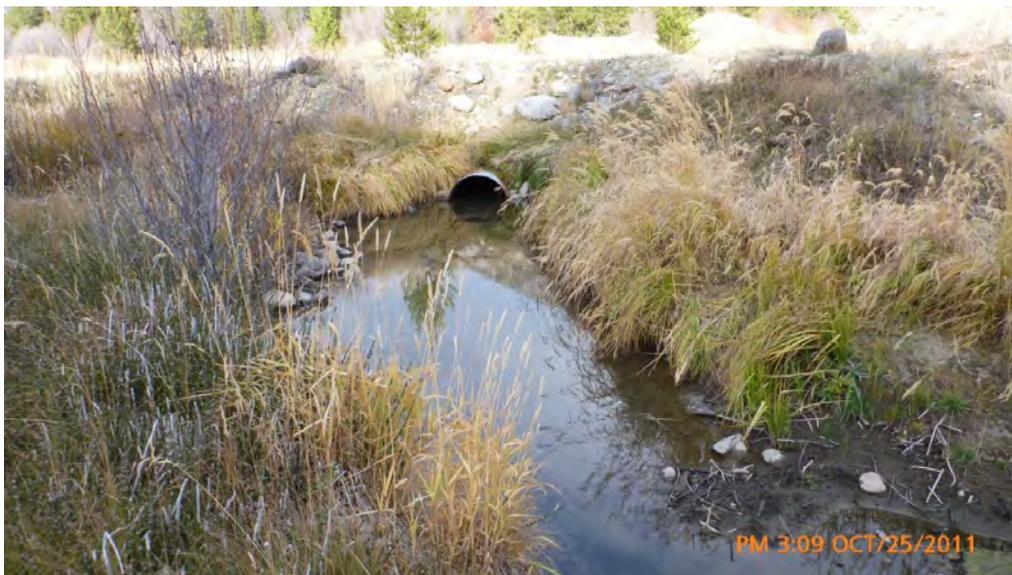
Photograph No. 10. View to the northeast looking upstream at the culvert at the entrance of Pond Series Four. Yankee Fork of the Salmon River, Yankee Fork Subbasin, Idaho – Bureau of Reclamation Photograph by P. Drury, October 25, 2011.

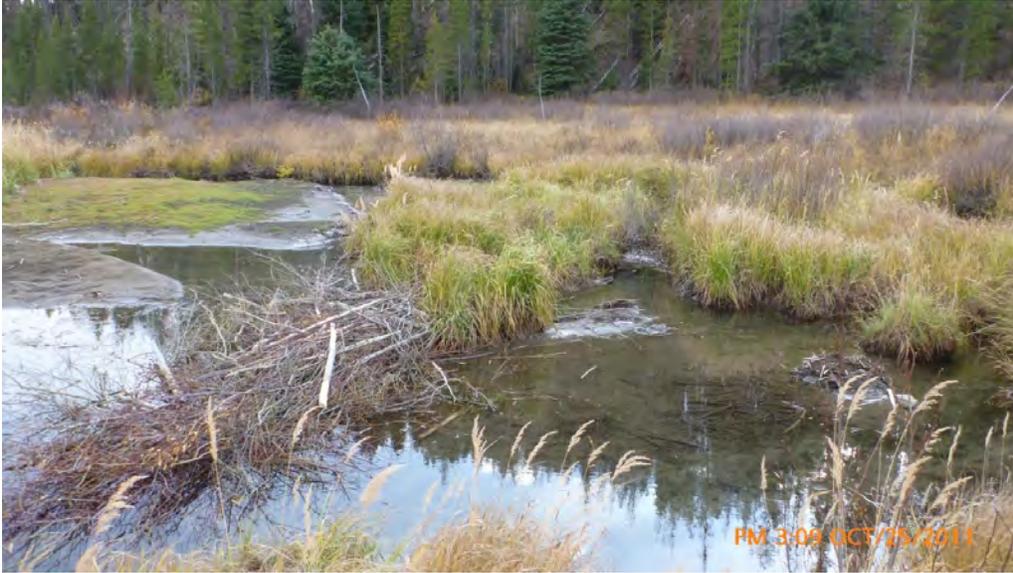
Photograph No. 11. View to the south looking downstream at beaver activity and sedimentation along Pond Series Four. Yankee Fork of the Salmon River, Yankee Fork Subbasin, Idaho – Bureau of Reclamation
Photograph by P. Drury, October 25, 2011.

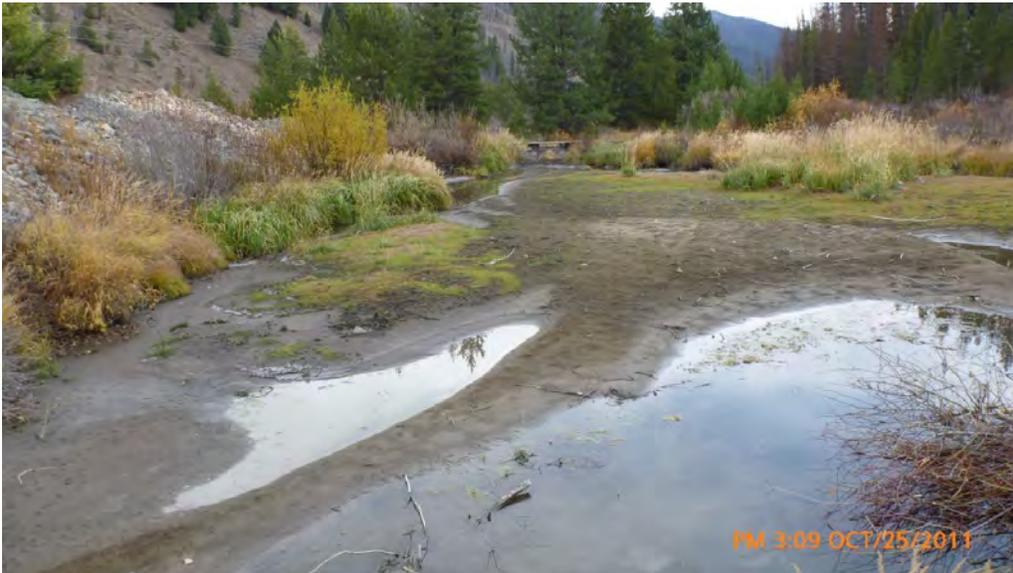
Photograph No. 12. View to the south looking downstream at sedimentation along Pond Series Four. Yankee Fork of the Salmon River, Yankee Fork Subbasin, Idaho – Bureau of Reclamation
Photograph by P. Drury, October 25, 2011.

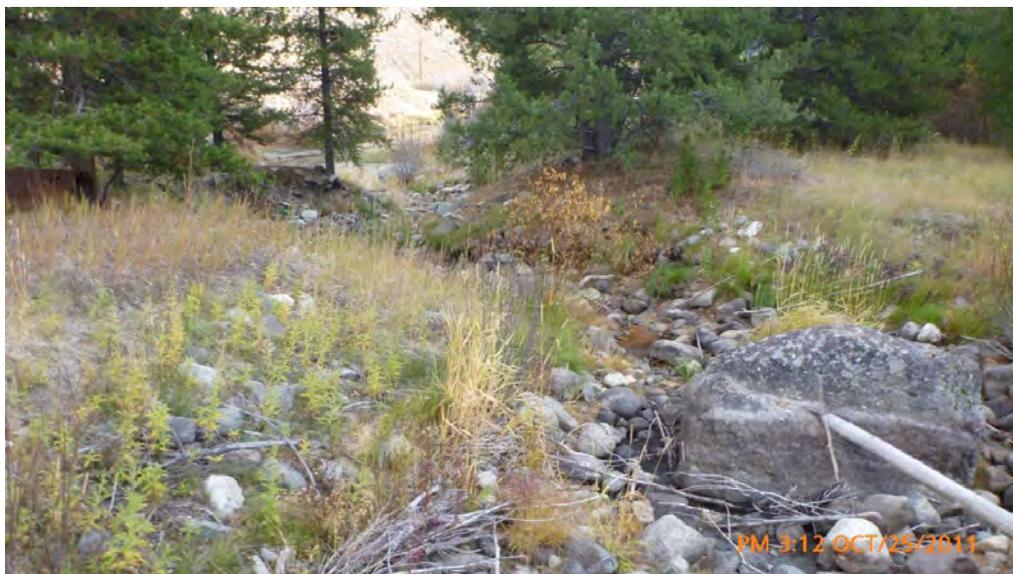
Photograph No. 13. View to the southeast looking downstream at channel that connects two of the ponds along Pond Series Four. Yankee Fork of the Salmon River, Yankee Fork Subbasin, Idaho – Bureau of Reclamation Photograph by P. Drury, October 25, 2011.

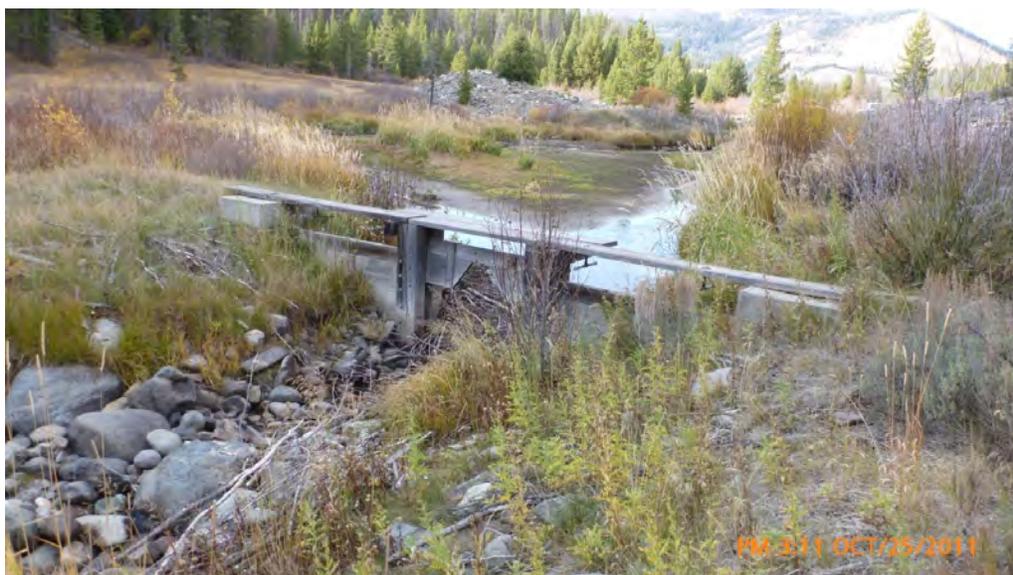
Photograph No. 14. View to the northwest looking upstream at check structure along Pond Series Four. Yankee Fork of the Salmon River, Yankee Fork Subbasin, Idaho – Bureau of Reclamation Photograph by P. Drury, October 25, 2011.

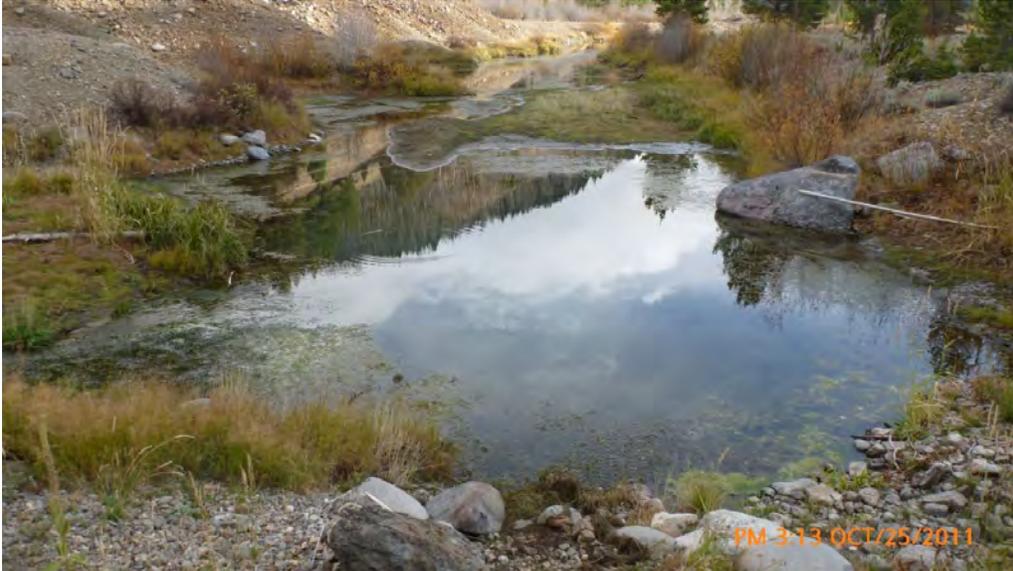
Photograph No. 15. View to the southeast looking downstream at head of a pond where groundwater daylights along the mine tailings (left) along Pond Series Four. Yankee Fork of the Salmon River, Yankee Fork Subbasin, Idaho – Bureau of Reclamation Photograph by P. Drury, October 25, 2011.

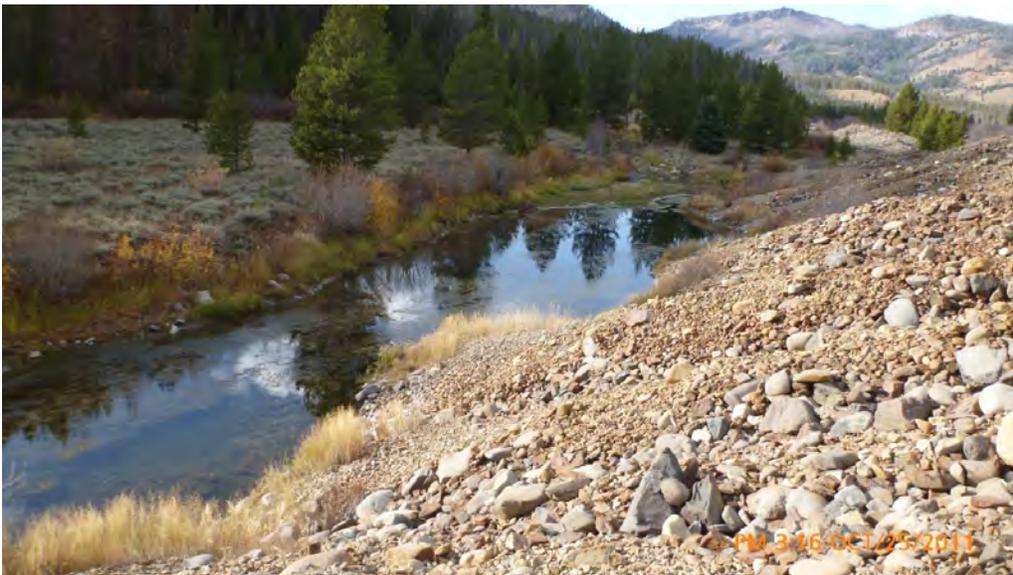
Photograph No. 16. View to the northwest looking upstream at pond bordered by mine tailings (right) and undisturbed ground (left) along Pond Series Four. Yankee Fork of the Salmon River, Yankee Fork Subbasin, Idaho – Bureau of Reclamation Photograph by P. Drury, October 25, 2011.

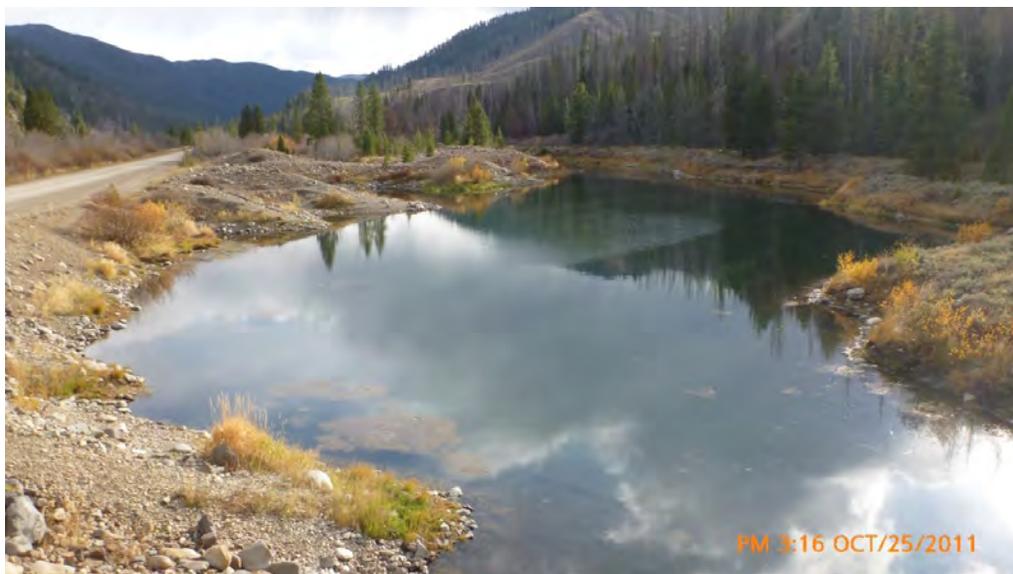
Photograph No. 17. View to the south looking downstream at pond bordered by mine tailings (left) and undisturbed ground (right) along Pond Series Four. Yankee Fork of the Salmon River, Yankee Fork Subbasin, Idaho – Bureau of Reclamation Photograph by P. Drury, October 25, 2011.

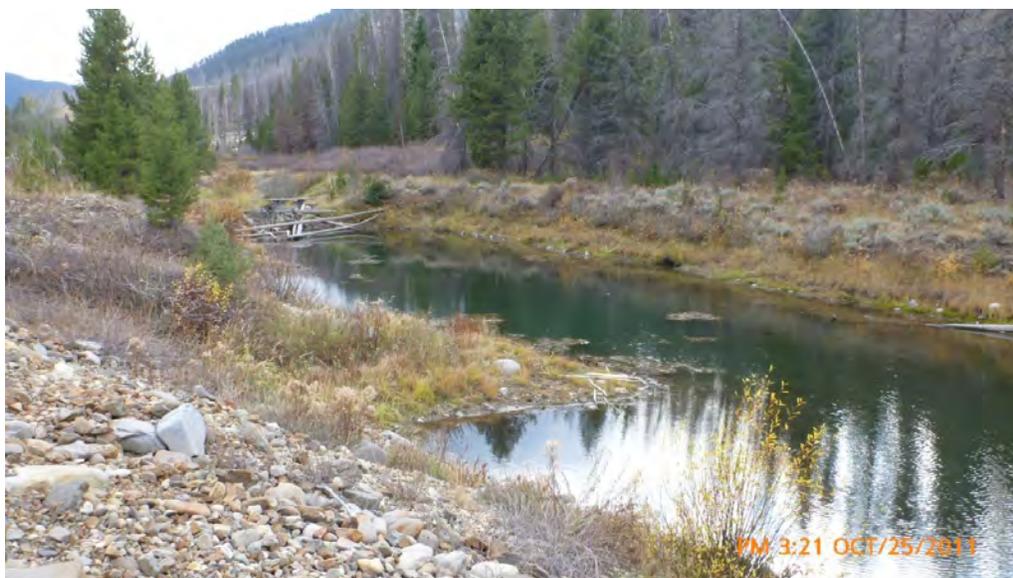
Photograph No. 18. View to the south looking downstream at wood accumulation at check structure near the mouth of the pond along Pond Series Four. Yankee Fork of the Salmon River, Yankee Fork Subbasin, Idaho – Bureau of Reclamation Photograph by P. Drury, October 25, 2011.

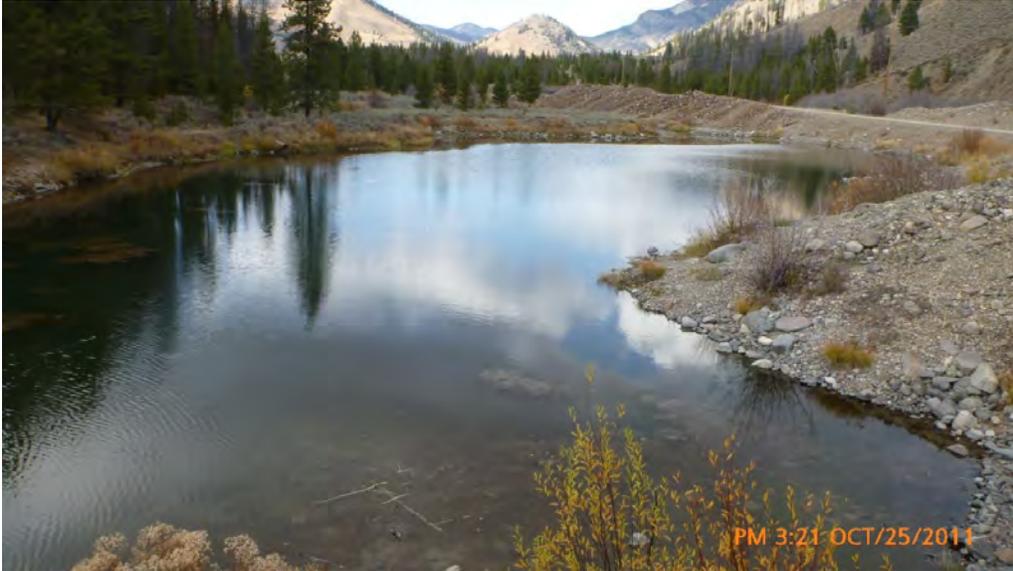
Photograph No. 19. View to the north looking upstream at pond bordered by mine tailings (right) and undisturbed ground (left) along Pond Series Four. Yankee Fork of the Salmon River, Yankee Fork Subbasin, Idaho – Bureau of Reclamation Photograph by P. Drury, October 25, 2011.

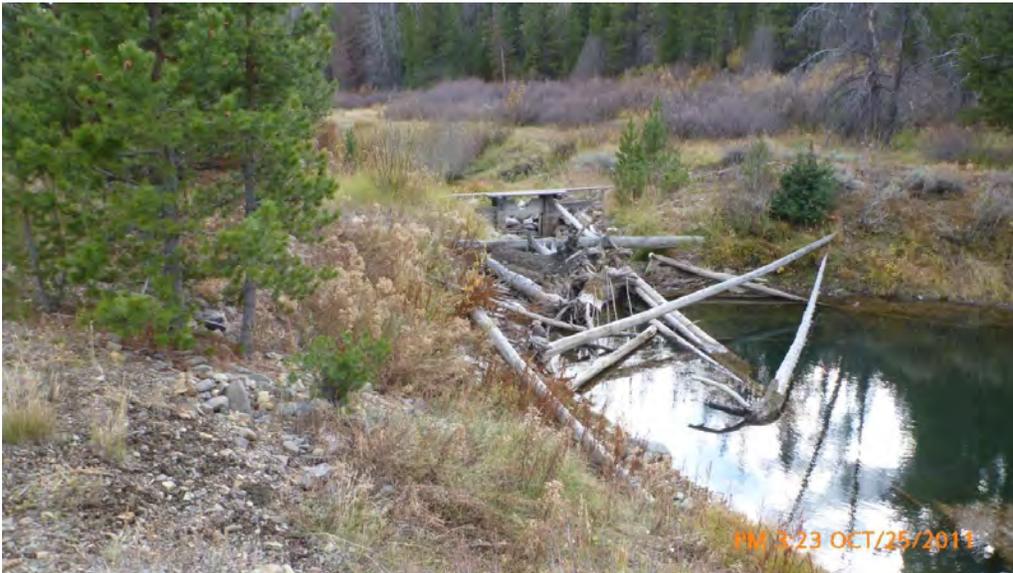
Photograph No. 20. View to the south looking downstream at wood accumulation at check structure near the mouth of a pond along Pond Series Four. Yankee Fork of the Salmon River, Yankee Fork Subbasin, Idaho – Bureau of Reclamation Photograph by P. Drury, October 25, 2011.

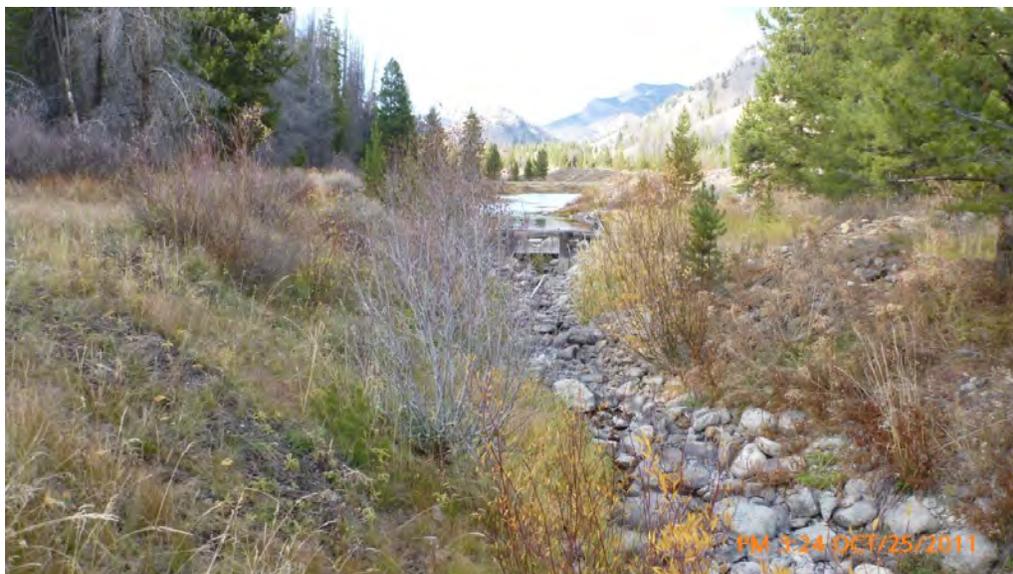
Photograph No. 21. View to the north looking upstream at check structure along Pond Series Four. Yankee Fork of the Salmon River, Yankee Fork Subbasin, Idaho – Bureau of Reclamation Photograph by P. Drury, October 25, 2011.

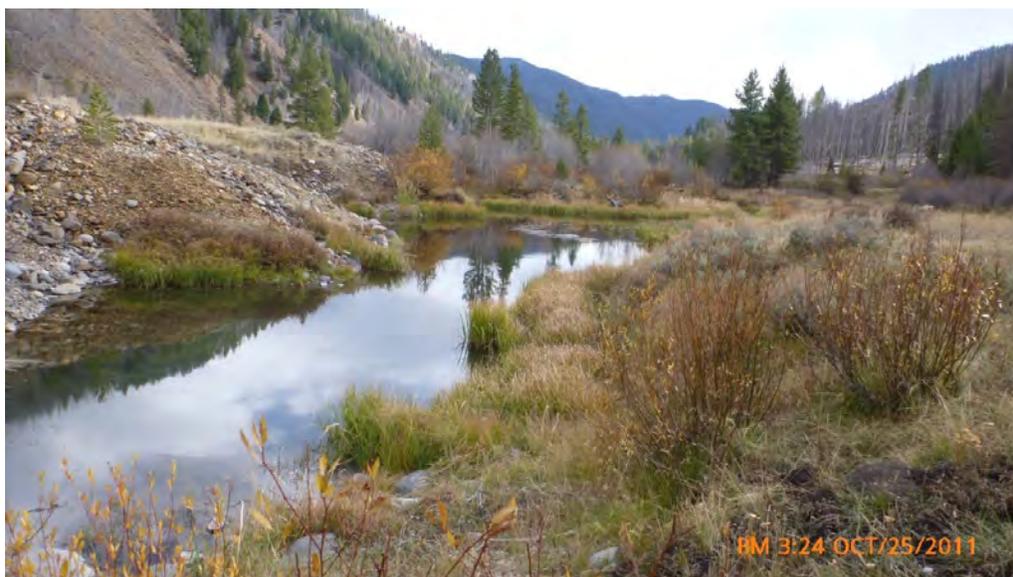
Photograph No. 22. View to the south looking downstream at pond bordered by mine tailings (left) and undisturbed ground (right) along Pond Series Four. Yankee Fork of the Salmon River, Yankee Fork Subbasin, Idaho – Bureau of Reclamation Photograph by P. Drury, October 25, 2011.

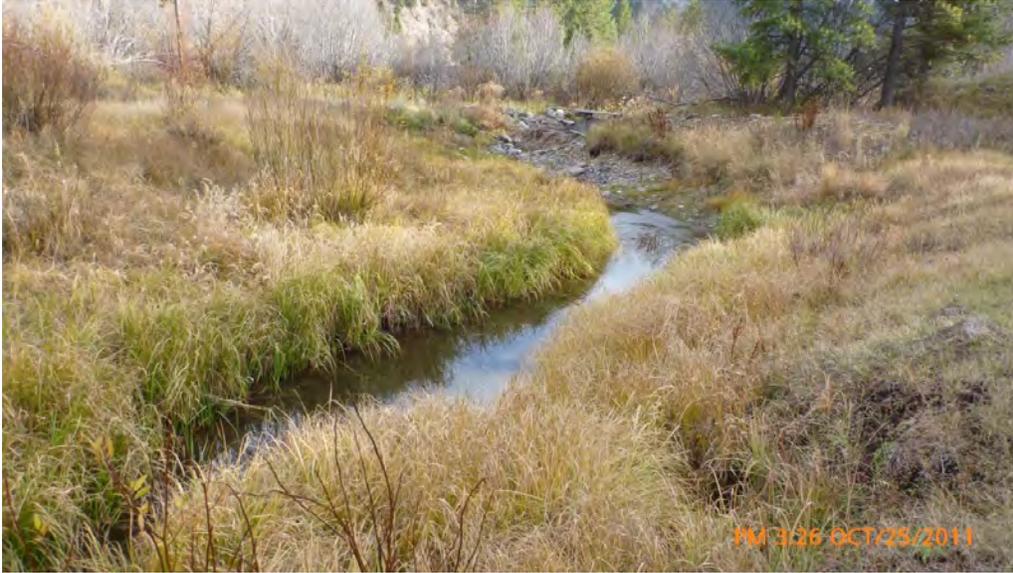
Photograph No. 23. View to the south looking downstream along outlet of Pond Series Four. Yankee Fork of the Salmon River, Yankee Fork Subbasin, Idaho – Bureau of Reclamation Photograph by P. Drury, October 25, 2011.

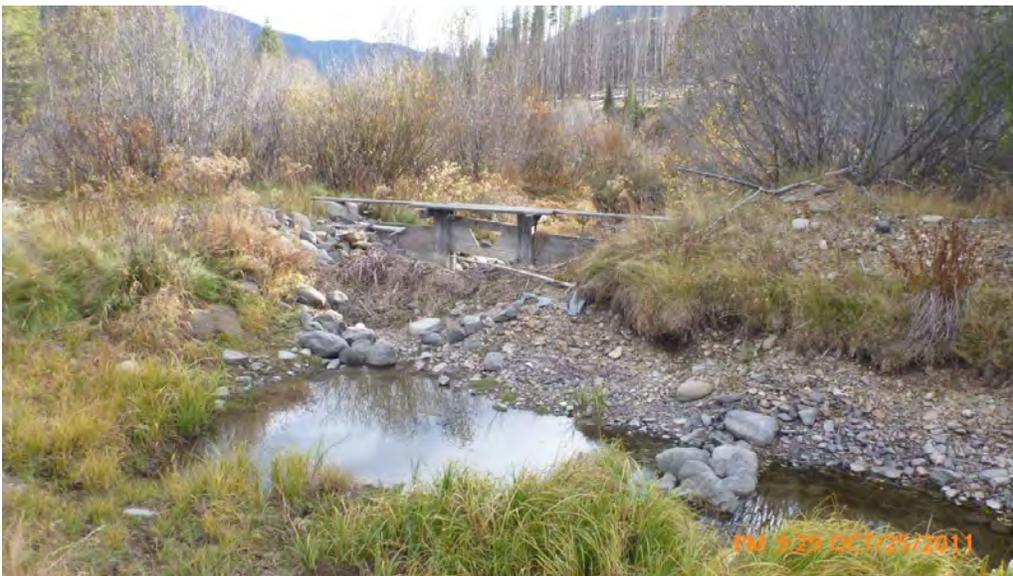
Photograph No. 24. View to the southwest looking downstream at check structure along outlet of Pond Series Four. Yankee Fork of the Salmon River, Yankee Fork Subbasin, Idaho – Bureau of Reclamation Photograph by P. Drury, October 25, 2011.

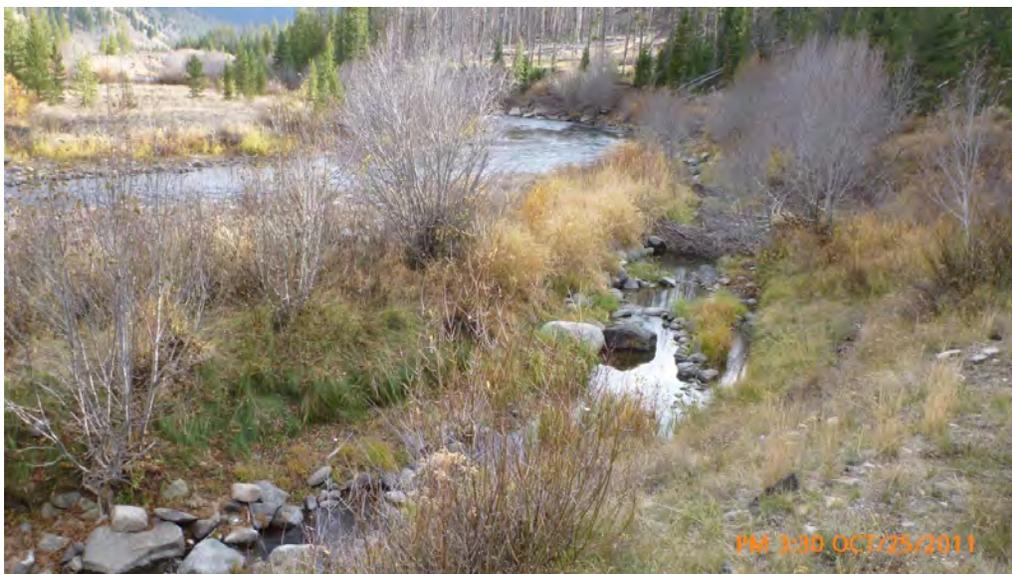
Photograph No. 25. View to the south looking downstream along outlet of Pond Series Four.
Yankee Fork of the Salmon River, Yankee Fork Subbasin, Idaho – Bureau of Reclamation Photograph by P. Drury, October 25, 2011.

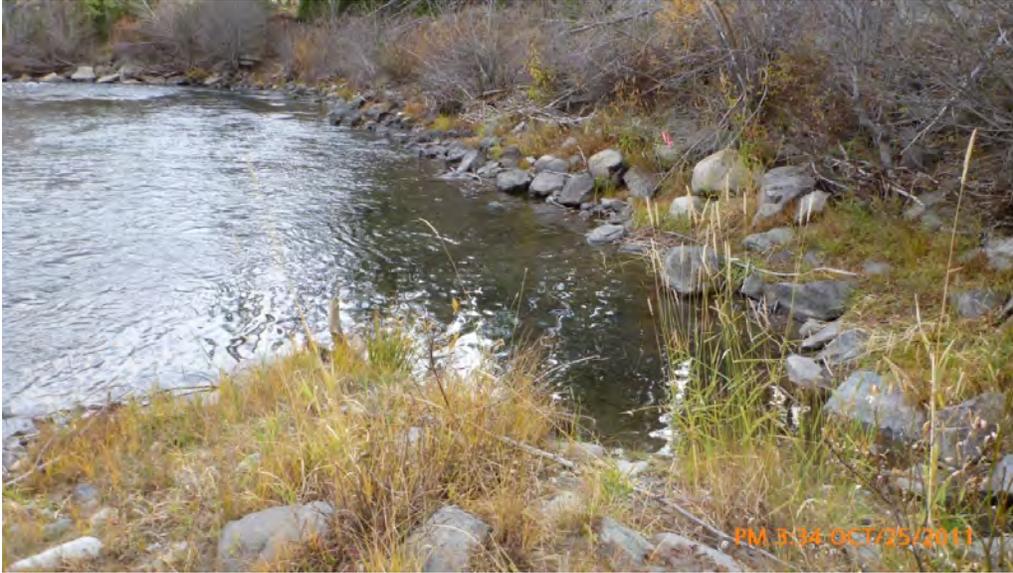
Photograph No. 27. View to the south looking at where the outlet enters the Yankee Fork along Pond Series Four. Yankee Fork of the Salmon River, Yankee Fork Subbasin, Idaho – Bureau of Reclamation Photograph by P. Drury, October 25, 2011.

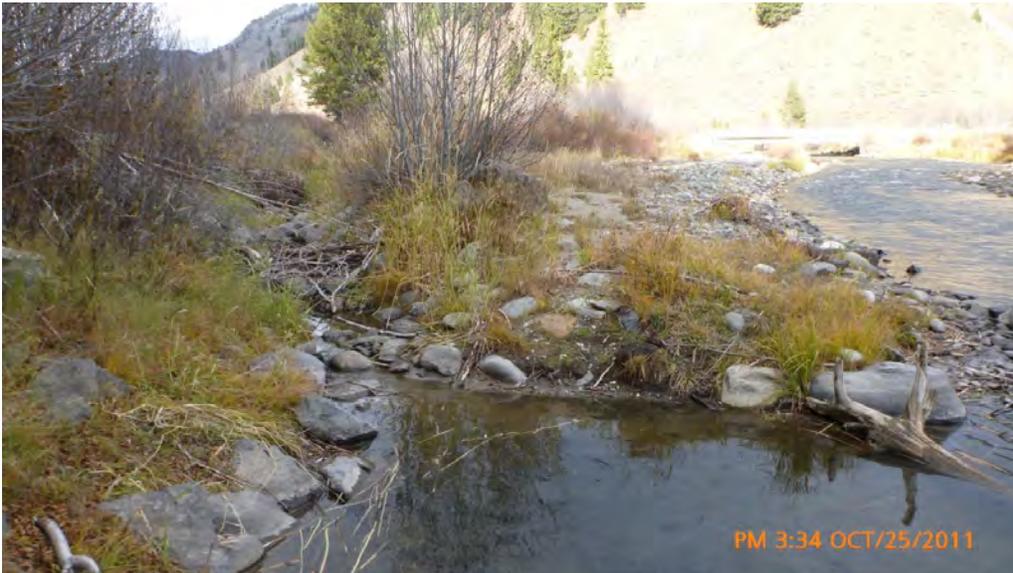
Photograph No. 28. View to the north looking upstream at outlet of Pond Series Four. Yankee Fork of the Salmon River, Yankee Fork Subbasin, Idaho – Bureau of Reclamation Photograph by P. Drury, October 25, 2011.

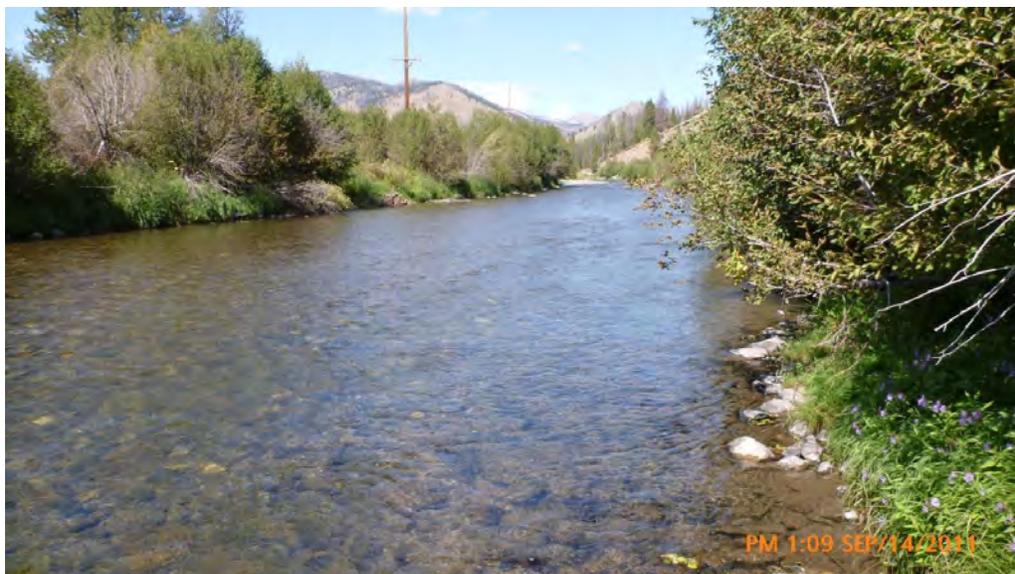
Photograph No. 29. View to the north looking upstream at the plane-bed channel along the Yankee Fork. Yankee Fork of the Salmon River, Yankee Fork Subbasin, Idaho – Bureau of Reclamation Photograph by P. Drury, September 14, 2011.

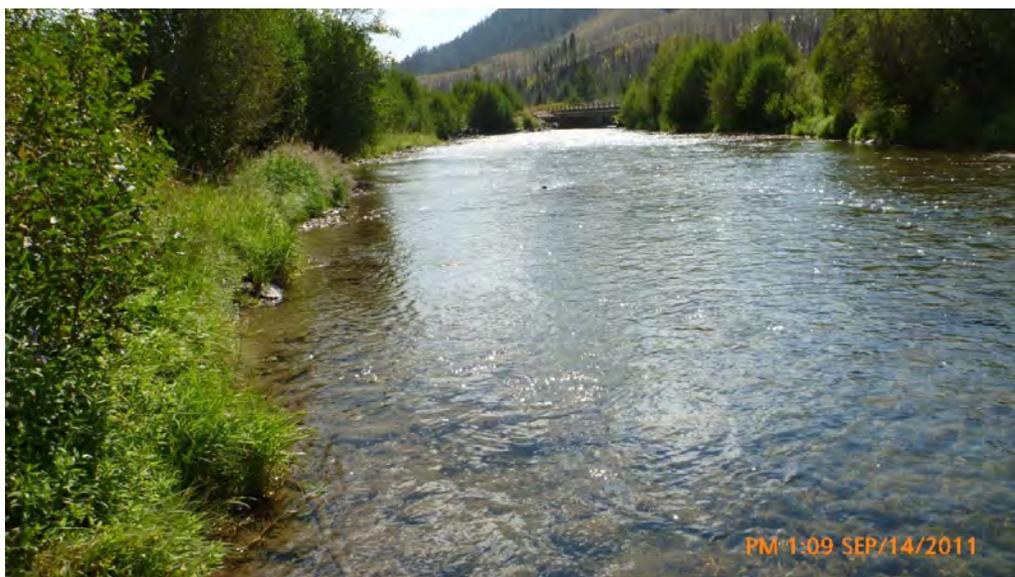
Photograph No. 30. View to the south looking downstream at the plane-bed channel along the Yankee Fork. Yankee Fork of the Salmon River, Yankee Fork Subbasin, Idaho – Bureau of Reclamation Photograph by P. Drury, September 14, 2011.

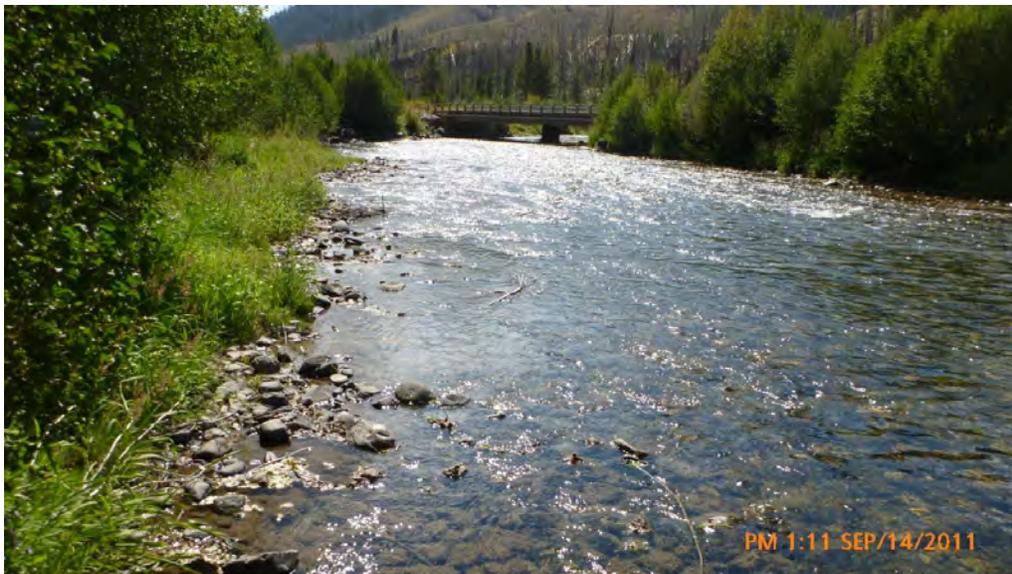
Photograph No. 31. View to the southwest looking downstream at Custer Motorway bridge crossing along the Yankee Fork. Yankee Fork of the Salmon River, Yankee Fork Subbasin, Idaho – Bureau of Reclamation Photograph by P. Drury, September 14, 2011.

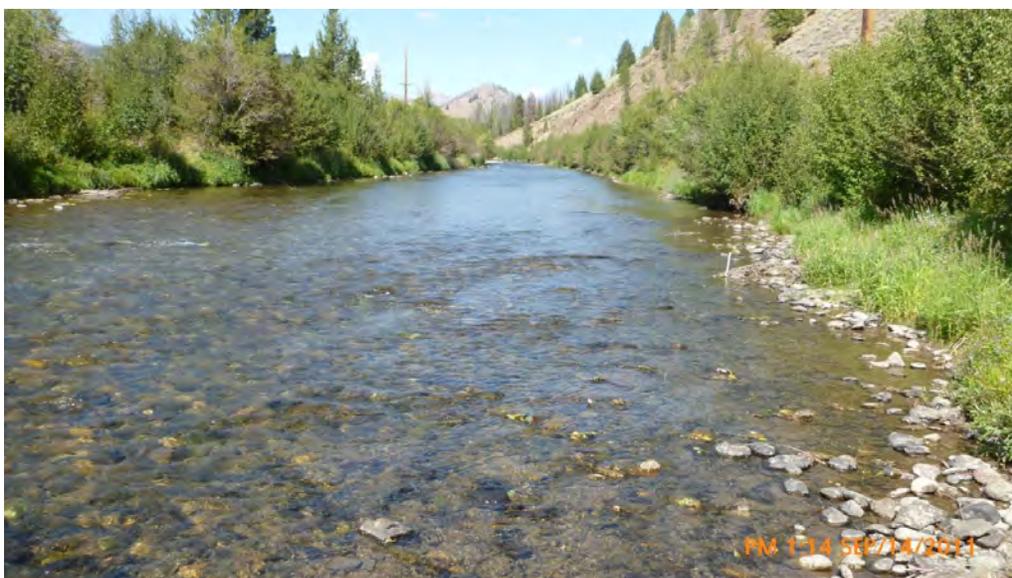
Photograph No. 32. View to the north looking upstream at the plane-bed channel along the Yankee Fork. Yankee Fork of the Salmon River, Yankee Fork Subbasin, Idaho – Bureau of Reclamation Photograph by P. Drury, September 14, 2011.

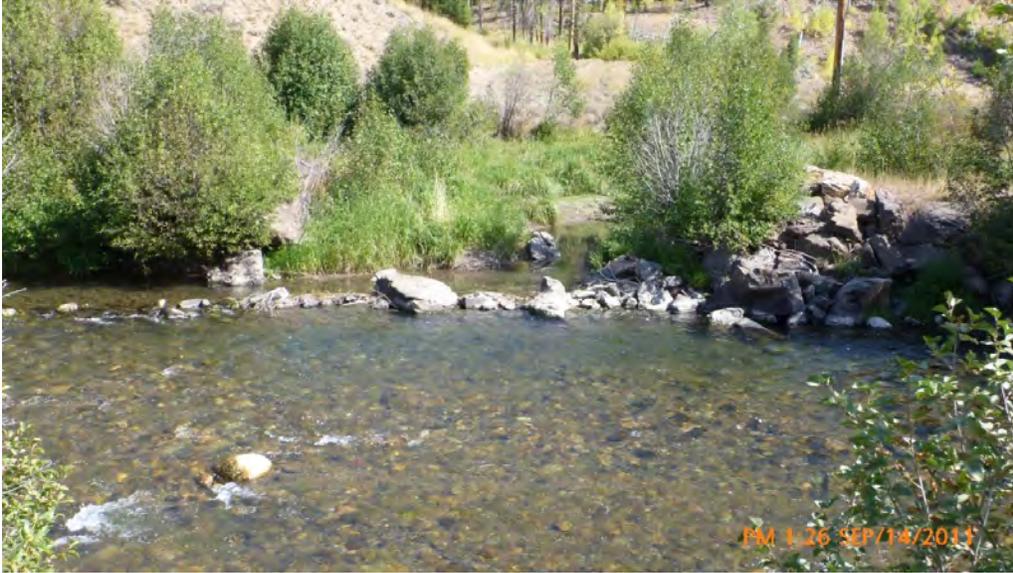
Photograph No. 35. View to the southeast looking across the Yankee Fork at the inlet to Pond Series Three. Yankee Fork of the Salmon River, Yankee Fork Subbasin, Idaho – Bureau of Reclamation Photograph by P. Drury, September 14, 2011.

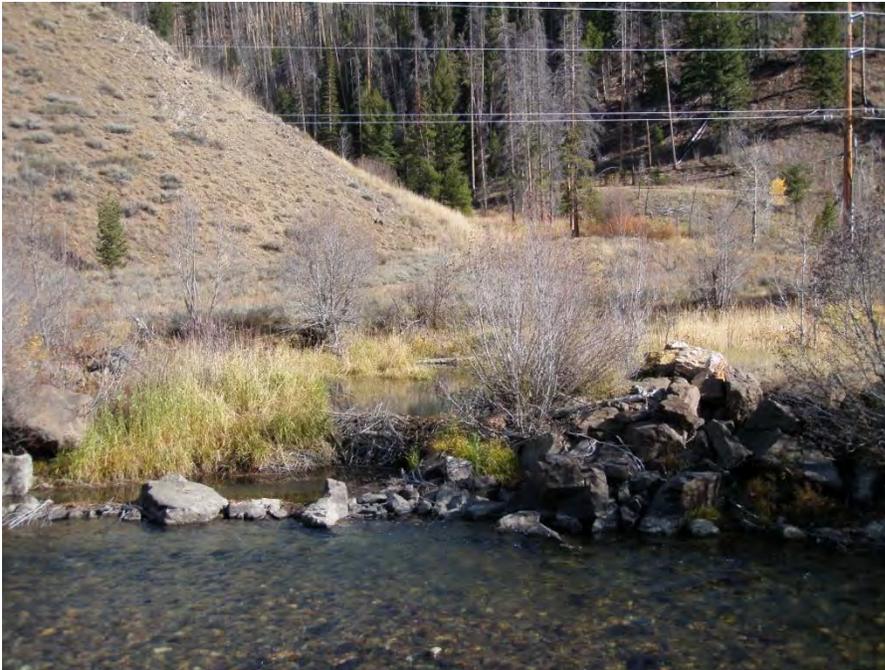
Photograph No. 36. View to the east looking across the Yankee Fork at beaver dam at the inlet to Pond Series Three. Yankee Fork of the Salmon River, Yankee Fork Subbasin, Idaho – Bureau of Reclamation Photograph by E. Lyon, October 25, 2011.

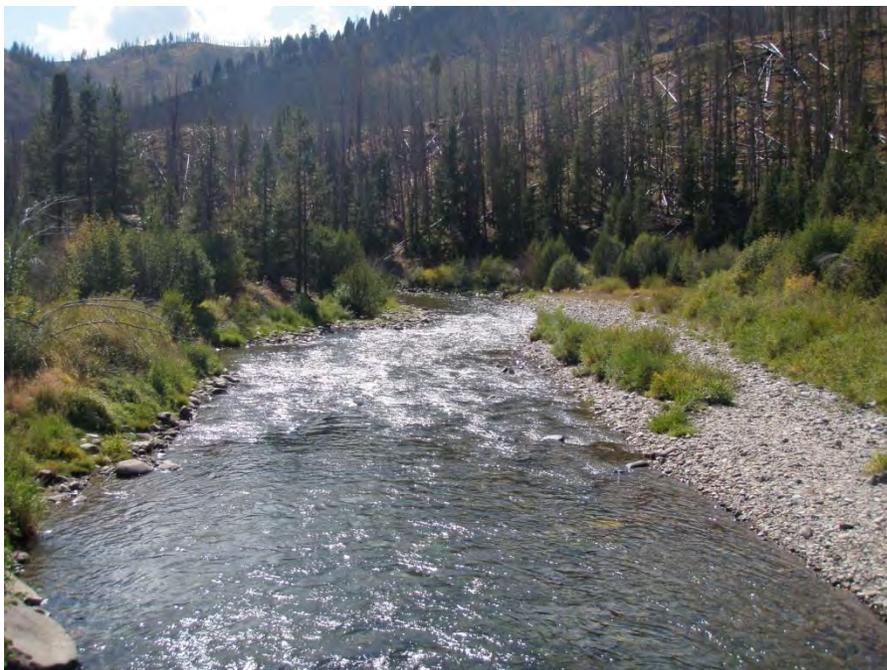
Photograph No. 37. View to the southwest looking downstream from Custer Motorway bridge along the Yankee Fork. Yankee Fork of the Salmon River, Yankee Fork Subbasin, Idaho – Bureau of Reclamation Photograph by E. Lyon, September 12, 2011.

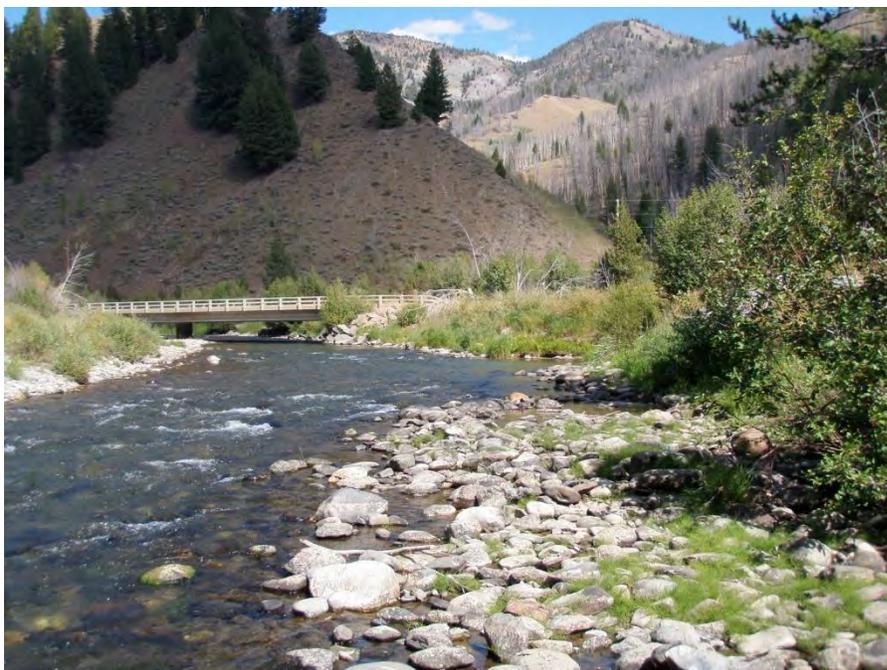
Photograph No. 38. View to the northeast looking upstream at Custer Motorway bridge along the Yankee Fork. Yankee Fork of the Salmon River, Yankee Fork Subbasin, Idaho – Bureau of Reclamation Photograph by E. Lyon, September 12, 2011.

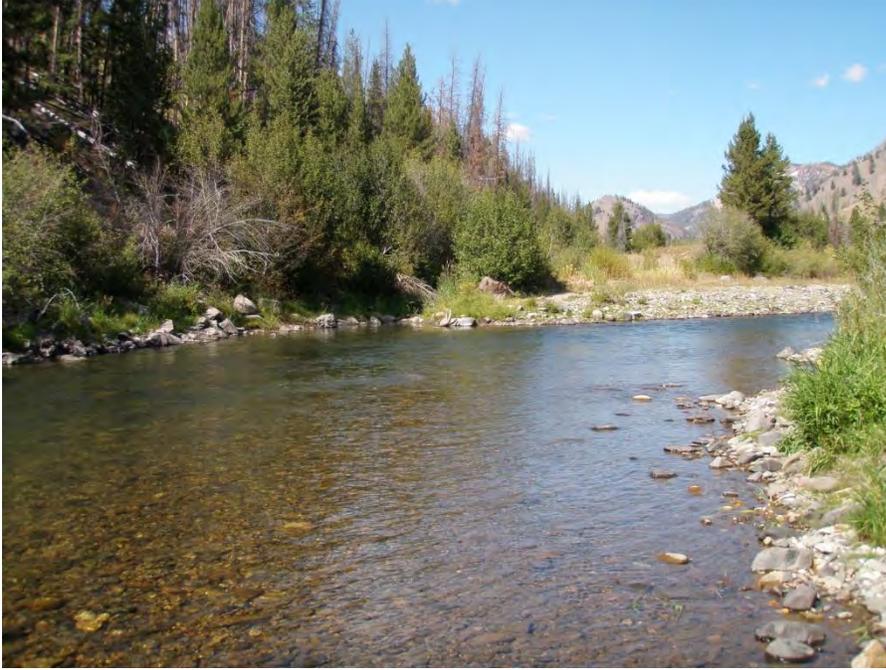
Photograph No. 39. View to the north looking upstream along the Yankee Fork at Pond Series Four outlet. Yankee Fork of the Salmon River, Yankee Fork Subbasin, Idaho – Bureau of Reclamation Photograph by E. Lyon, September 12, 2011.

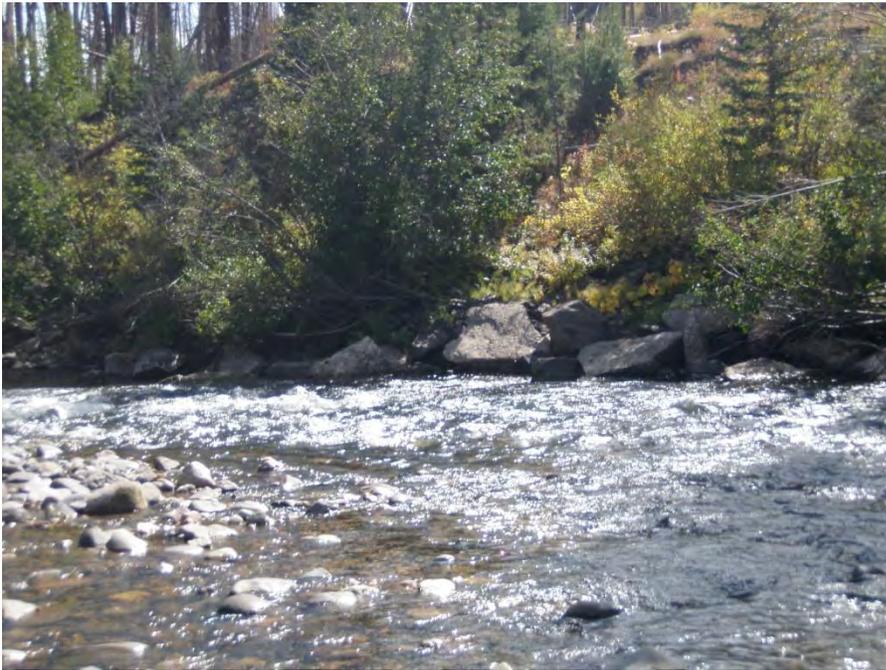
Photograph No. 40. View to the west looking across the Yankee Fork at riprap placed along historic roadway. Yankee Fork of the Salmon River, Yankee Fork Subbasin, Idaho – Bureau of Reclamation Photograph by E. Lyon, September 12, 2011.

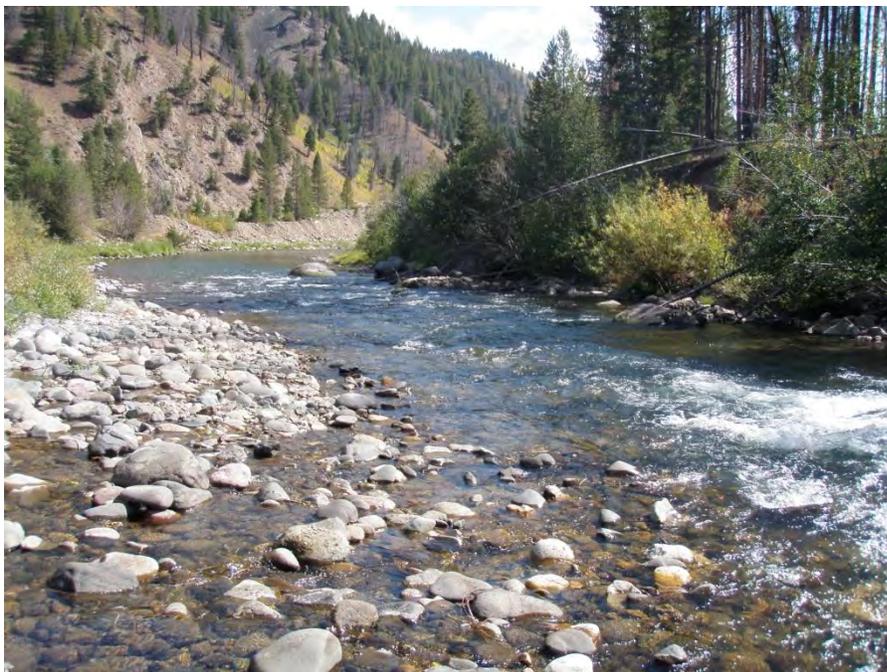
Photograph No. 41. View to the southeast looking downstream at actively eroding bank (mine tailings) on the outside meander along the Yankee Fork. Yankee Fork of the Salmon River, Yankee Fork Subbasin, Idaho – Bureau of Reclamation Photograph by E. Lyon, September 12, 2011.

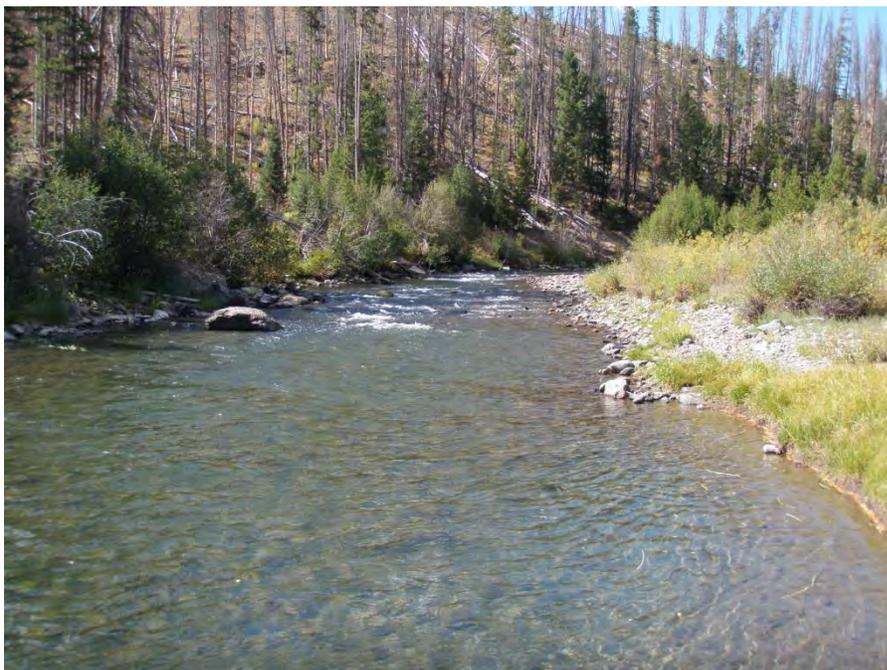
Photograph No. 42. View to the northwest looking upstream along the Yankee Fork. Yankee Fork of the Salmon River, Yankee Fork Subbasin, Idaho – Bureau of Reclamation Photograph by E. Lyon, September 12, 2011.

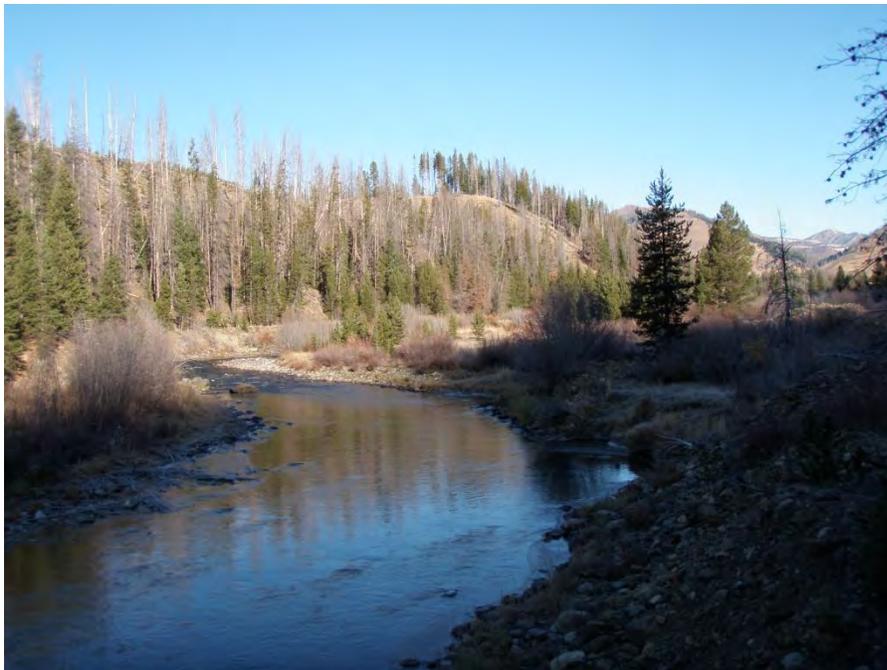
Photograph No. 43. View to the northwest looking upstream from eroding bank (mine tailings) along the Yankee Fork. Yankee Fork of the Salmon River, Yankee Fork Subbasin, Idaho – Bureau of Reclamation Photograph by E. Lyon, October 25, 2011.
