Pole Flat Area Baseline Condition Assessment
Yankee Fork of the Salmon River,
Upper Salmon Subbasin

Custer County, Idaho

U.S. Department of the Interior
Bureau of Reclamation
Pacific Northwest Region
Pacific Northwest Regional Office, Boise, Idaho

October 2012

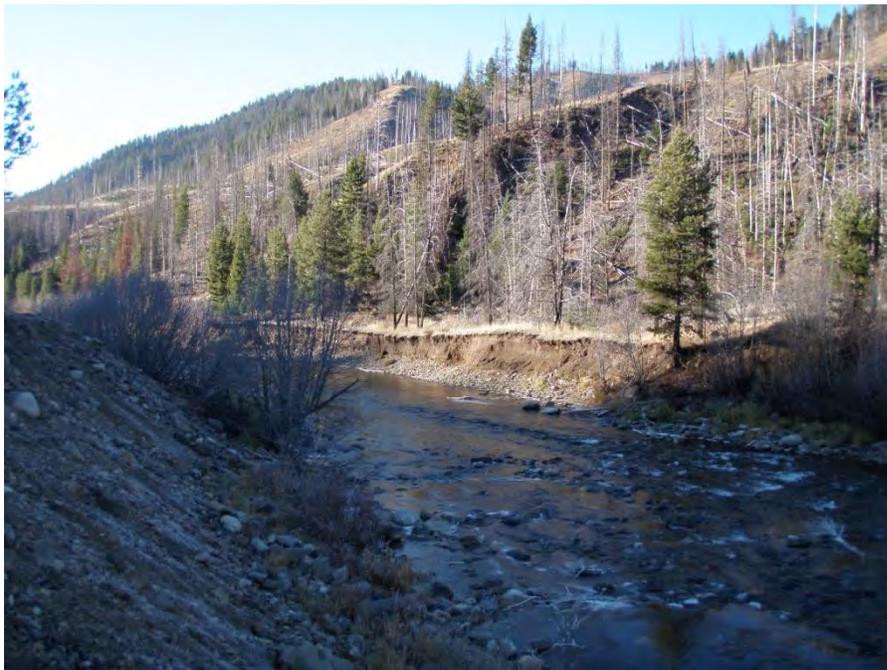
Photograph No. 44. View to the southwest looking downstream from eroding bank (mine tailings) at eroding bank (alluvial fan) on river right along the Yankee Fork. Yankee Fork of the Salmon River, Yankee Fork Subbasin, Idaho – Bureau of Reclamation Photograph by E. Lyon, October 25, 2011.

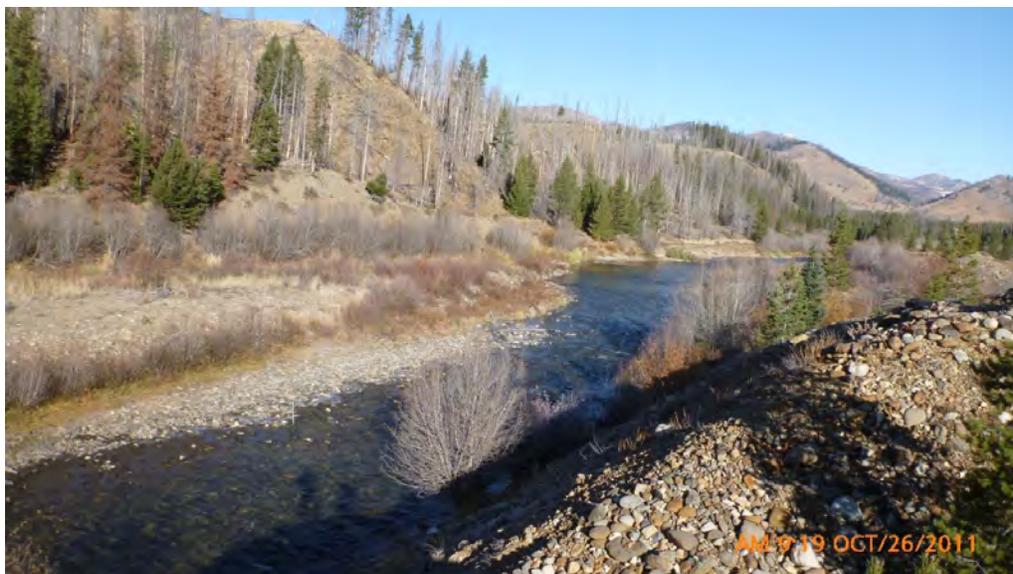
Photograph No. 45. View to the northwest looking upstream from eroding bank (mine tailings) at vegetated bar with floodplain type side channel along the Yankee Fork. Yankee Fork of the Salmon River, Yankee Fork Subbasin, Idaho – Bureau of Reclamation Photograph by P. Drury, October 26, 2011.

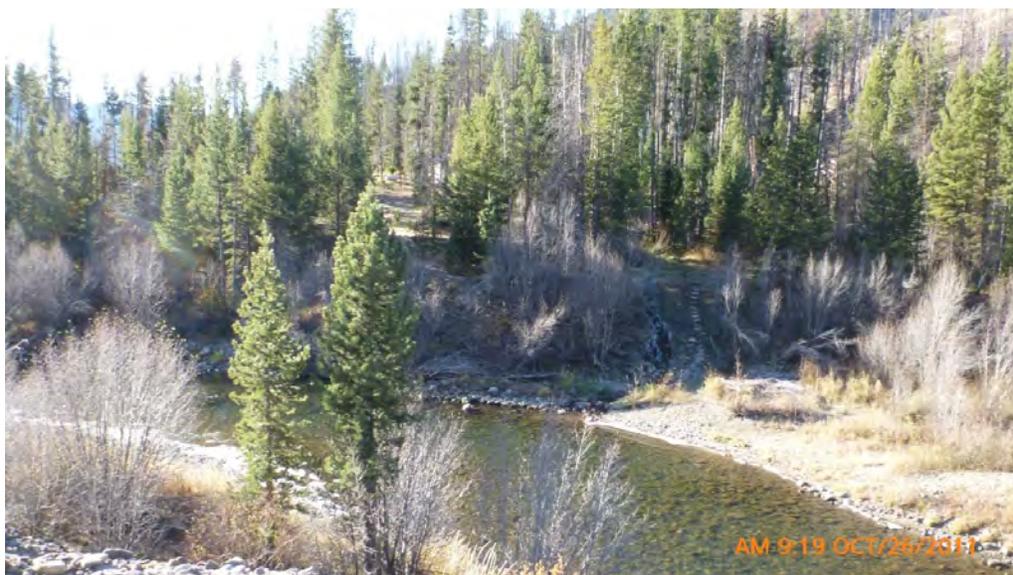
Photograph No. 46. View to the south looking downstream at outlet of floodplain type side channel along the Yankee Fork. Yankee Fork of the Salmon River, Yankee Fork Subbasin, Idaho – Bureau of Reclamation Photograph by P. Drury, October 26, 2011.

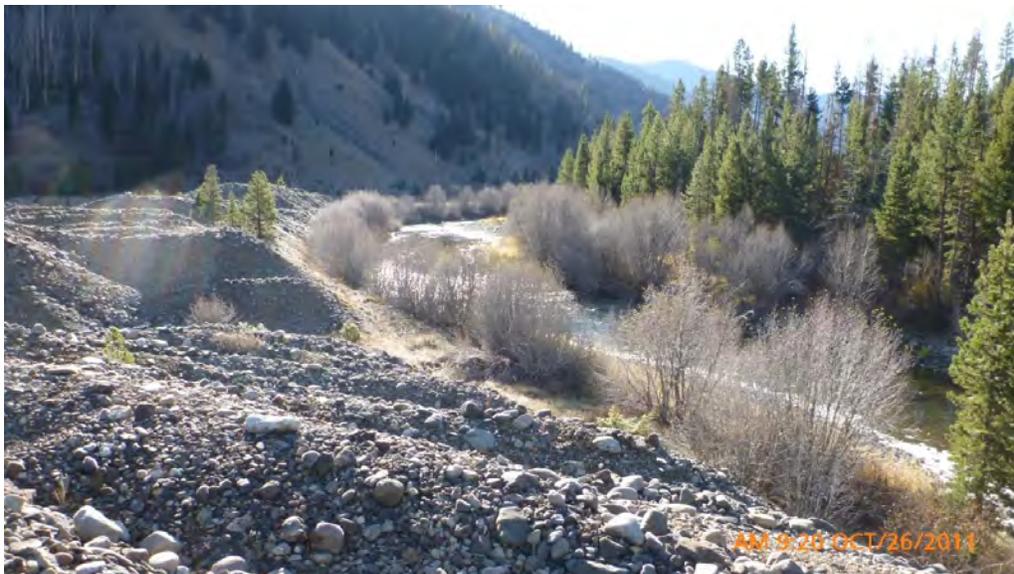
Photograph No. 47. View to the southeast looking downstream from mine tailings along the Yankee Fork. Yankee Fork of the Salmon River, Yankee Fork Subbasin, Idaho – Bureau of Reclamation Photograph by P. Drury, October 26, 2011.

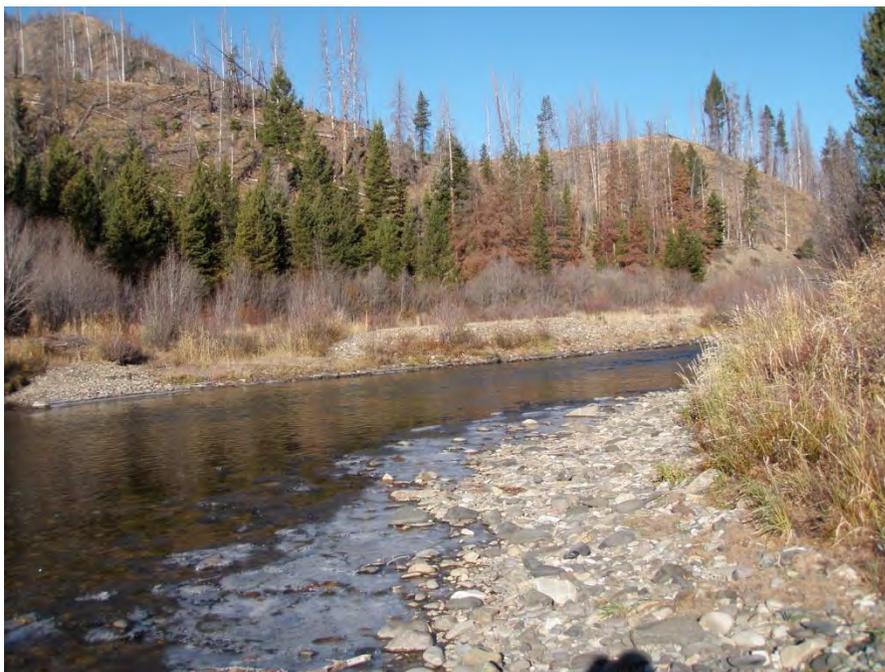
Photograph No. 48. View to the northwest looking upstream at vegetated bar with floodplain type side channel along the Yankee Fork. Yankee Fork of the Salmon River, Yankee Fork Subbasin, Idaho – Bureau of Reclamation Photograph by E. Lyon, October 25, 2011.

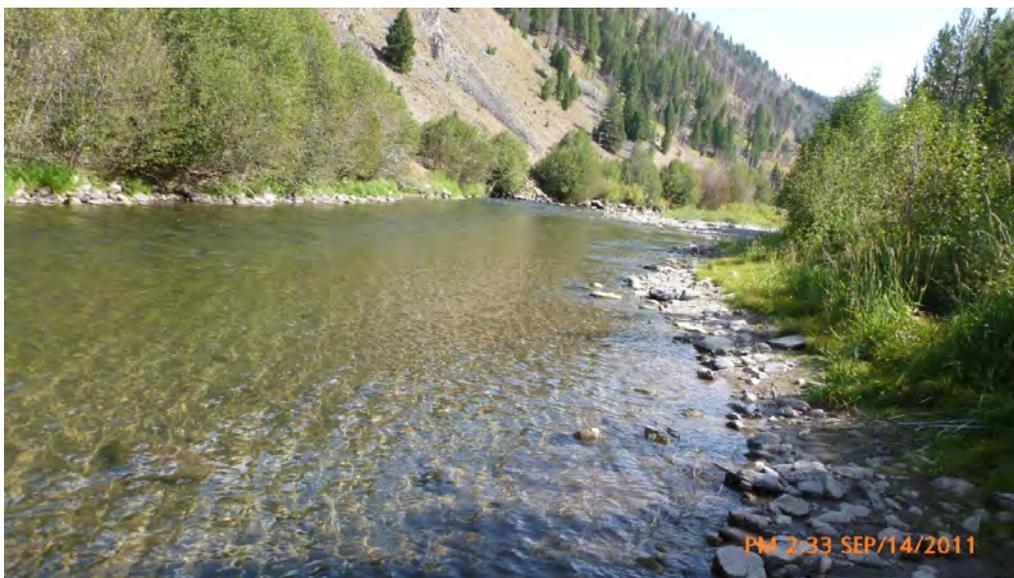
Photograph No. 50. View to the southeast looking downstream at run along the Yankee Fork. Yankee Fork of the Salmon River, Yankee Fork Subbasin, Idaho – Bureau of Reclamation Photograph by P. Drury, September 14, 2011.

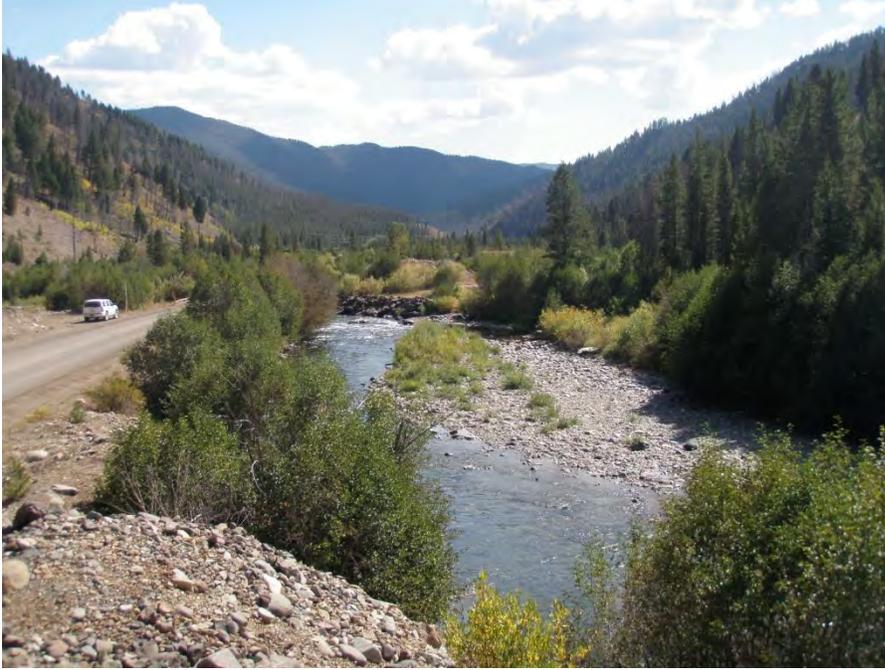
Photograph No. 51. View to the south looking downstream at split-flow type side channel and riprap in the distance at the head of Pond Series Two along the Yankee Fork. Yankee Fork of the Salmon River, Yankee Fork Subbasin, Idaho – Bureau of Reclamation Photograph by E. Lyon, September 12, 2011.

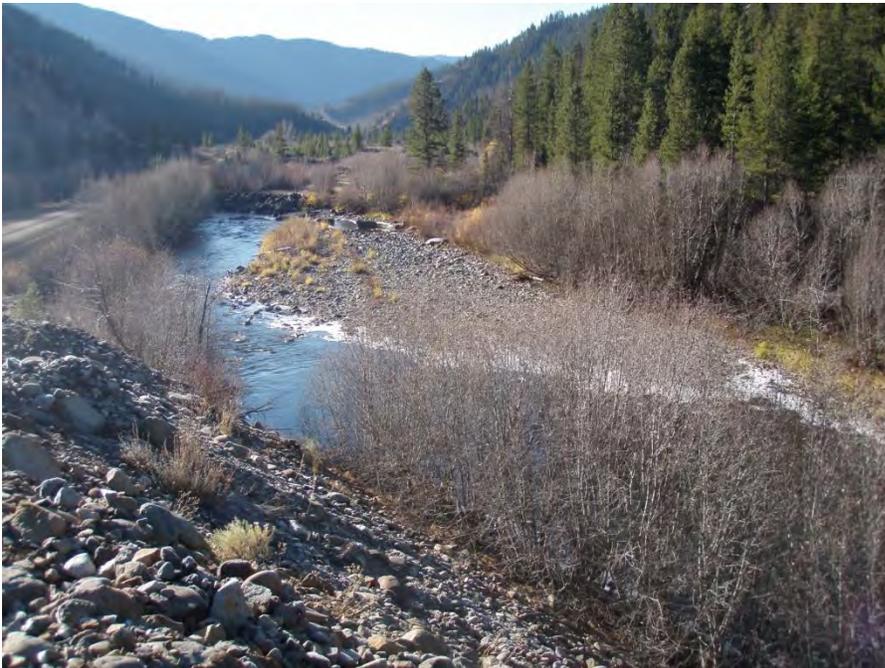
Photograph No. 52. View to the south looking downstream at split-flow type side channel and riprap in the distance at the head of Pond Series Two along the Yankee Fork. Yankee Fork of the Salmon River, Yankee Fork Subbasin, Idaho – Bureau of Reclamation Photograph by E. Lyon, October 25, 2011.

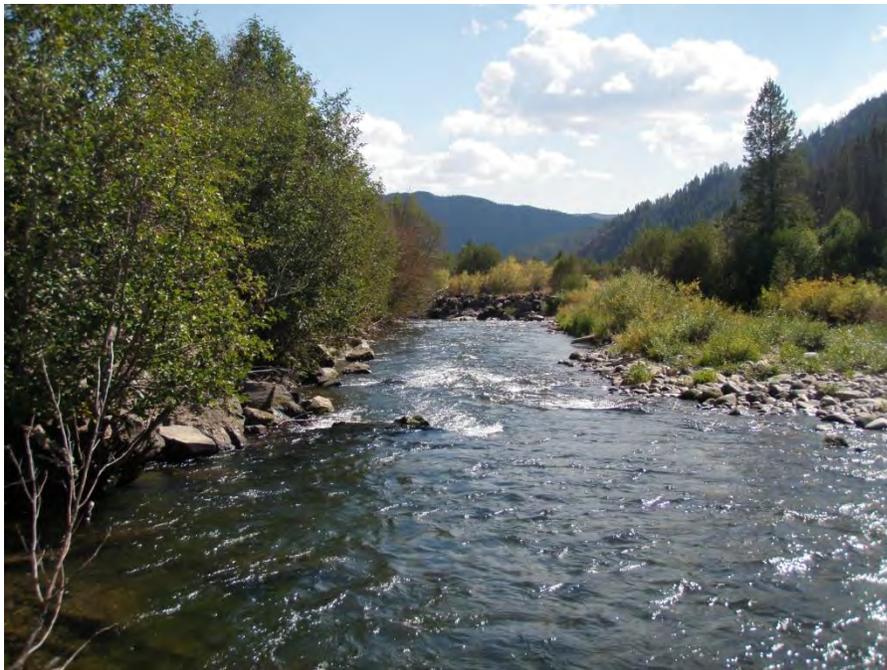
Photograph No. 53. View to the south looking downstream at riprap along river left and in the distance on river right at the head of Pond Series Two along the Yankee Fork. Yankee Fork of the Salmon River, Yankee Fork Subbasin, Idaho – Bureau of Reclamation Photograph by E. Lyon, September 12, 2011.

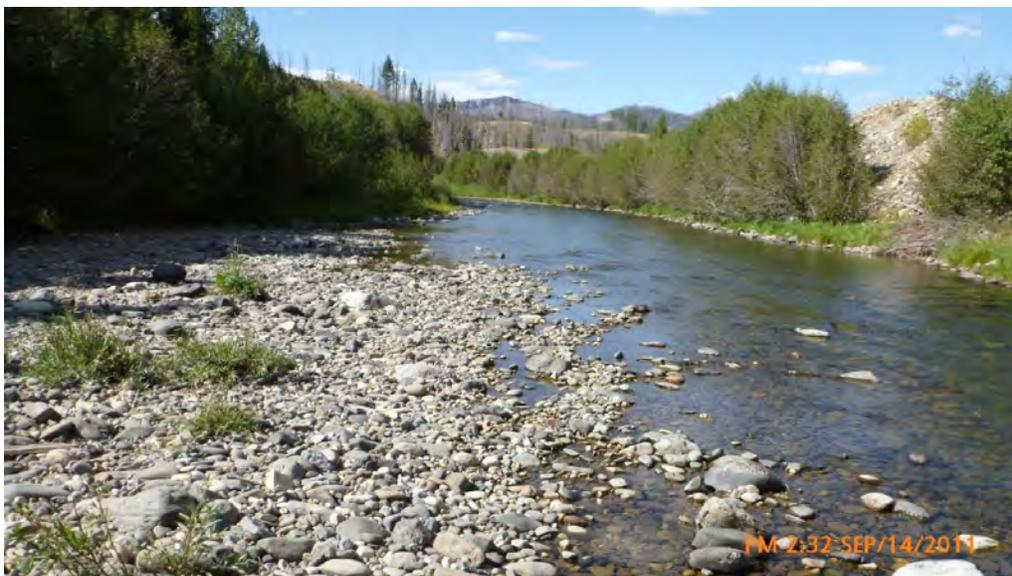
Photograph No. 54. View to the northwest looking upstream from middle channel bar along the Yankee Fork. Yankee Fork of the Salmon River, Yankee Fork Subbasin, Idaho – Bureau of Reclamation Photograph by P. Drury, September 14, 2011.

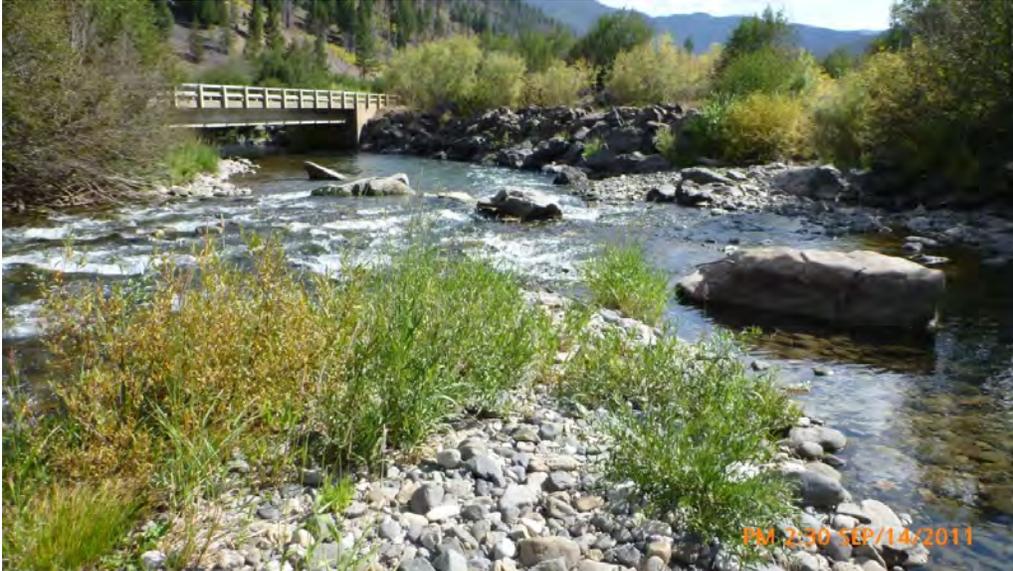
Photograph No. 55. View to the southeast looking downstream from middle channel bar at large boulders (5 feet plus) placed in the channel near the head of Pond Series Two along the Yankee Fork. Yankee Fork of the Salmon River, Yankee Fork Subbasin, Idaho – Bureau of Reclamation Photograph by P. Drury, September 14, 2011.

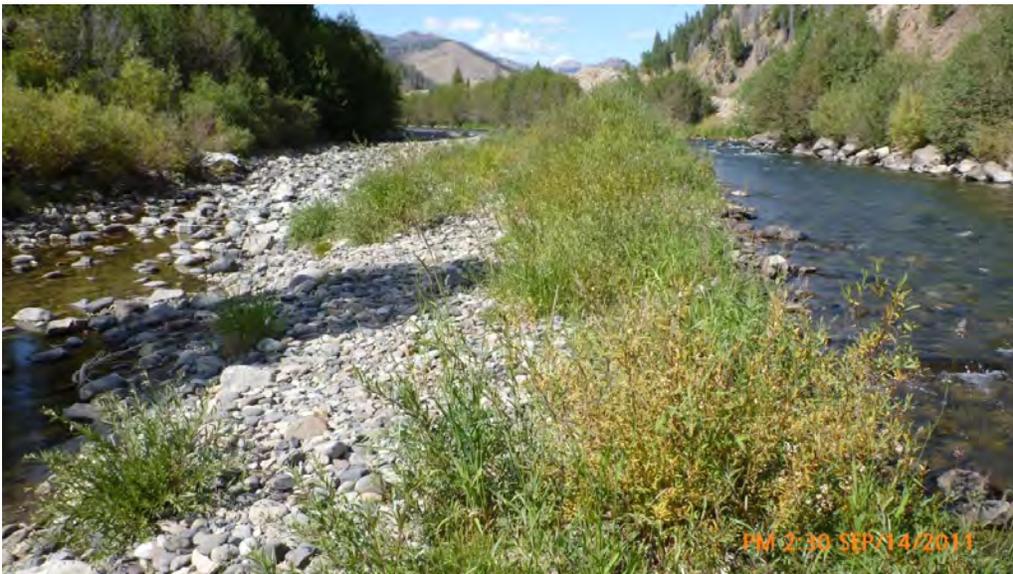
Photograph No. 56. View to the north looking upstream on middle channel bar along the Yankee Fork. Yankee Fork of the Salmon River, Yankee Fork Subbasin, Idaho – Bureau of Reclamation Photograph by P. Drury, September 14, 2011.

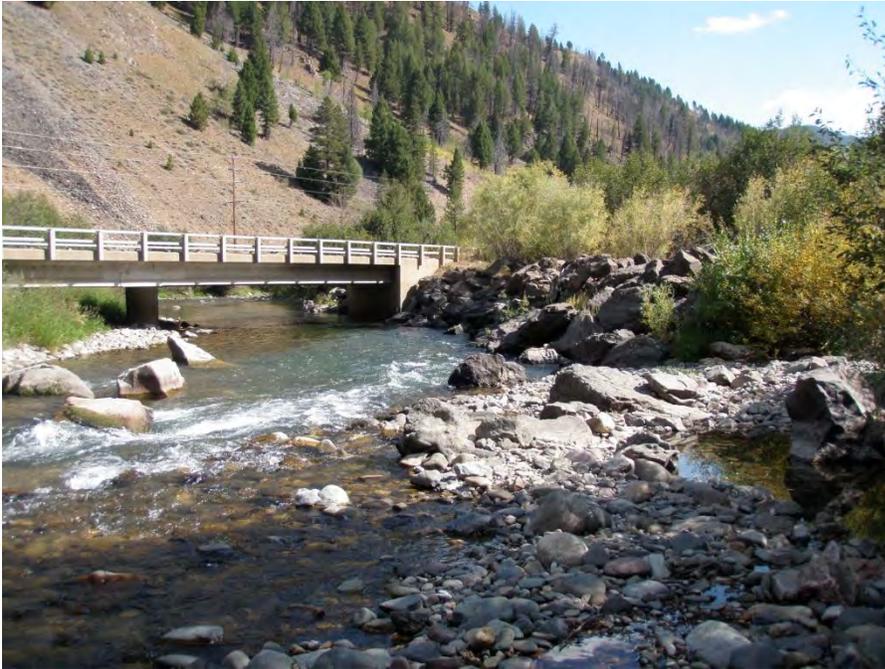
Photograph No. 57. View to the southeast looking downstream at Pond Series Two inlet and riprap along river right along the Yankee Fork. Yankee Fork of the Salmon River, Yankee Fork Subbasin, Idaho – Bureau of Reclamation Photograph by E. Lyon, September 12, 2011.

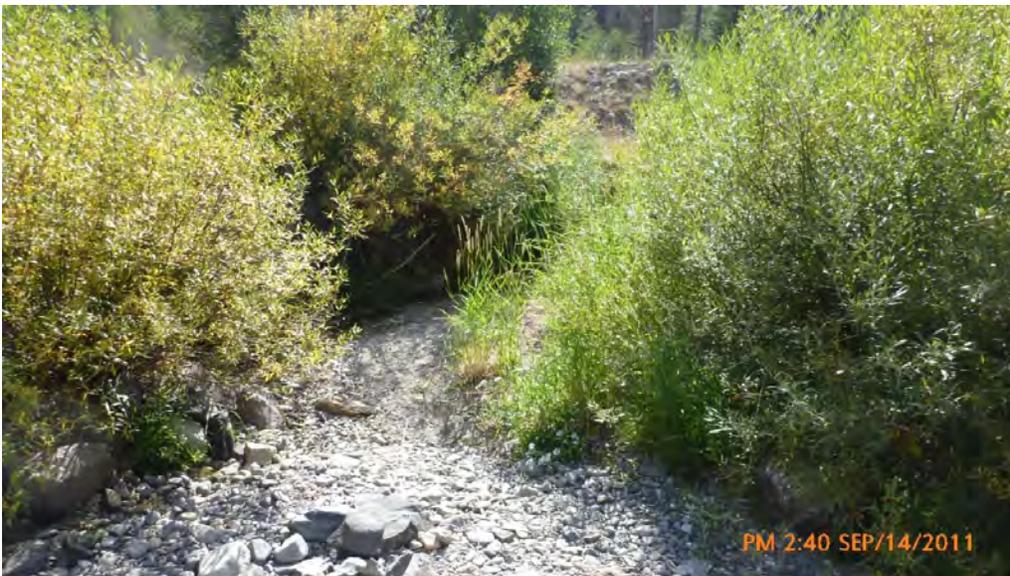
Photograph No. 58. View to the southwest looking downstream at the inlet to Pond Series Two along the Yankee Fork. Yankee Fork of the Salmon River, Yankee Fork Subbasin, Idaho – Bureau of Reclamation Photograph by P. Drury, September 14, 2011.

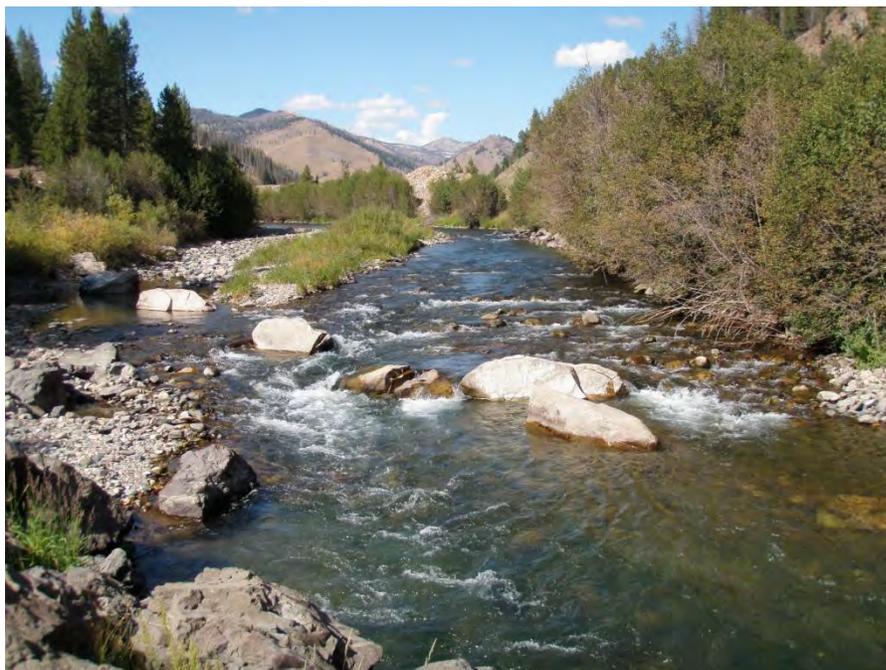
Photograph No. 60. View to the north looking upstream at middle channel bar from riprap placed near the inlet to Pond Series Two along the Yankee Fork. Yankee Fork of the Salmon River, Yankee Fork Subbasin, Idaho – Bureau of Reclamation Photograph by E. Lyon, September 12, 2011.

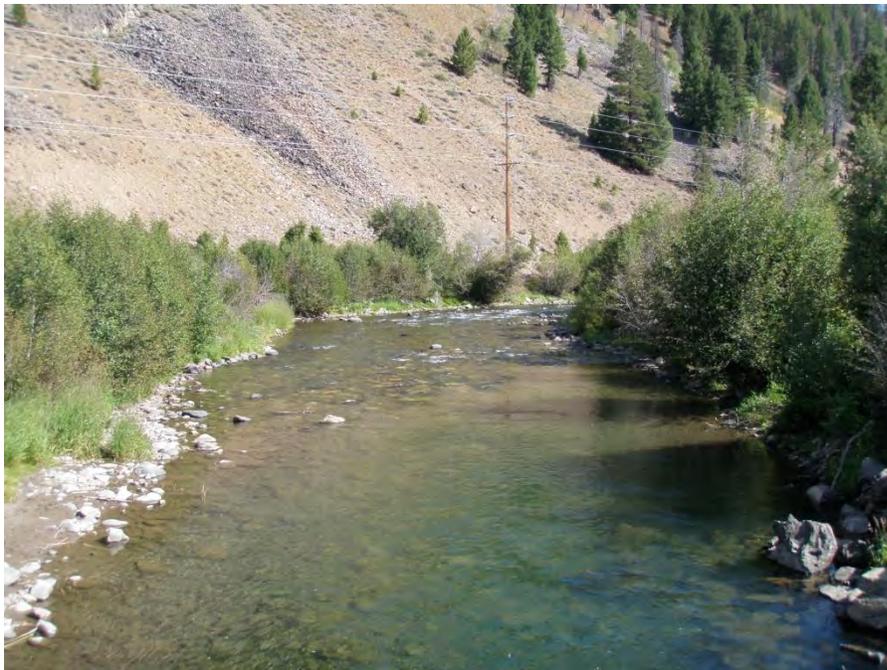
Photograph No. 61. View to the southeast looking downstream from Custer Motorway bridge at lateral scour pool forced by riprap along the Yankee Fork. Yankee Fork of the Salmon River, Yankee Fork Subbasin, Idaho – Bureau of Reclamation Photograph by E. Lyon, September 12, 2011.

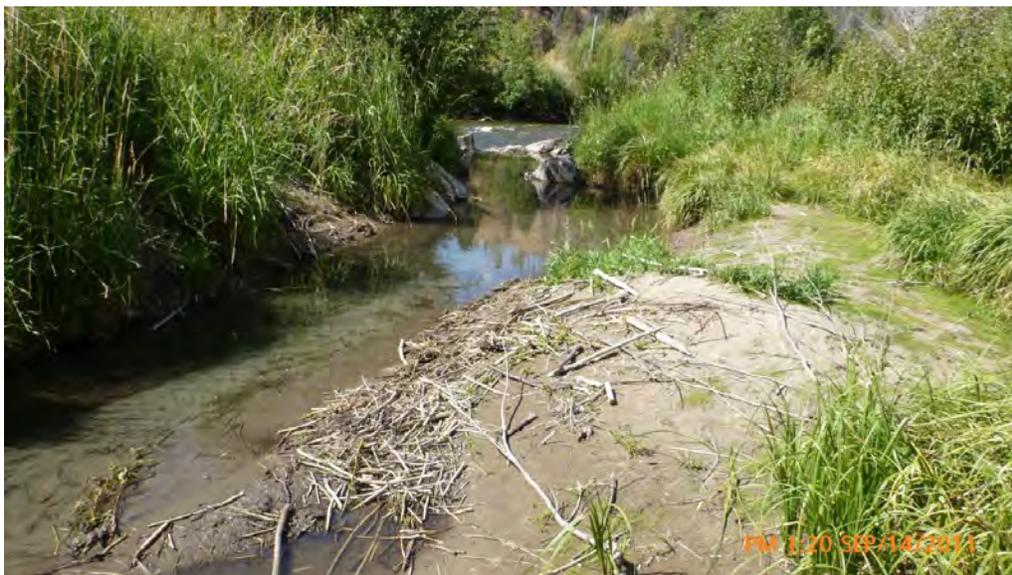
Photograph No. 62. View to the northwest looking upstream at inlet to Pond Series Three. Yankee Fork of the Salmon River, Yankee Fork Subbasin, Idaho – Bureau of Reclamation Photograph by P. Drury, September 14, 2011.

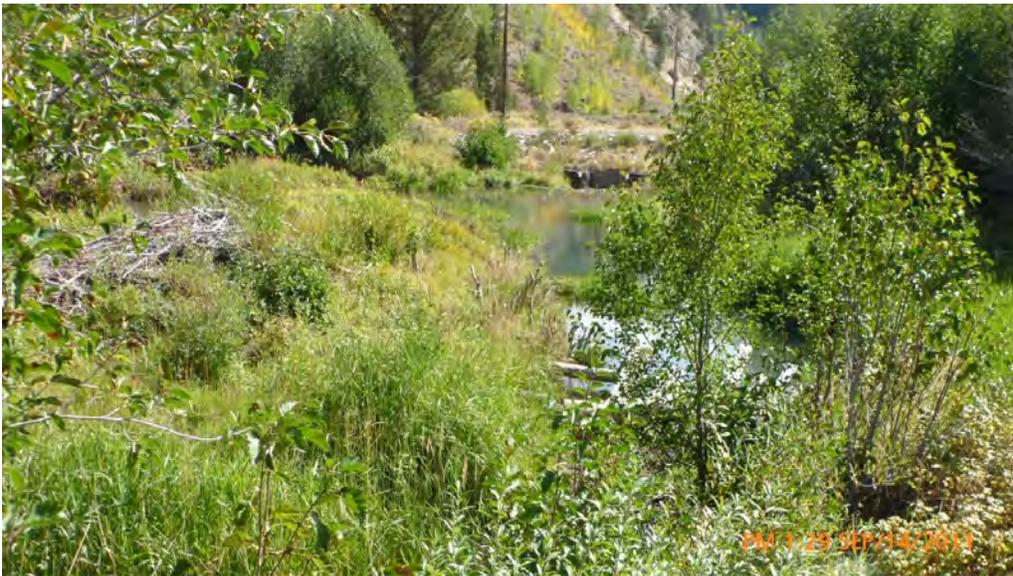
Photograph No. 63. View to the northwest looking upstream at inlet to Pond Series Three. Yankee Fork of the Salmon River, Yankee Fork Subbasin, Idaho – Bureau of Reclamation Photograph by P. Drury, September 14, 2011.

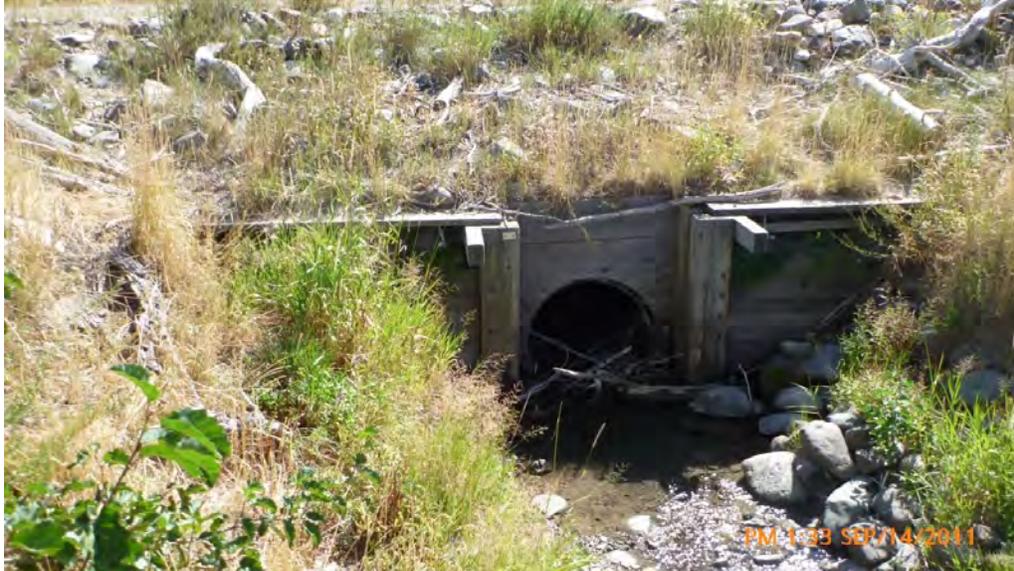
Photograph No. 64. View to the southeast looking downstream at side inlet to Pond Series Three. Yankee Fork of the Salmon River, Yankee Fork Subbasin, Idaho – Bureau of Reclamation Photograph by P. Drury, September 14, 2011.

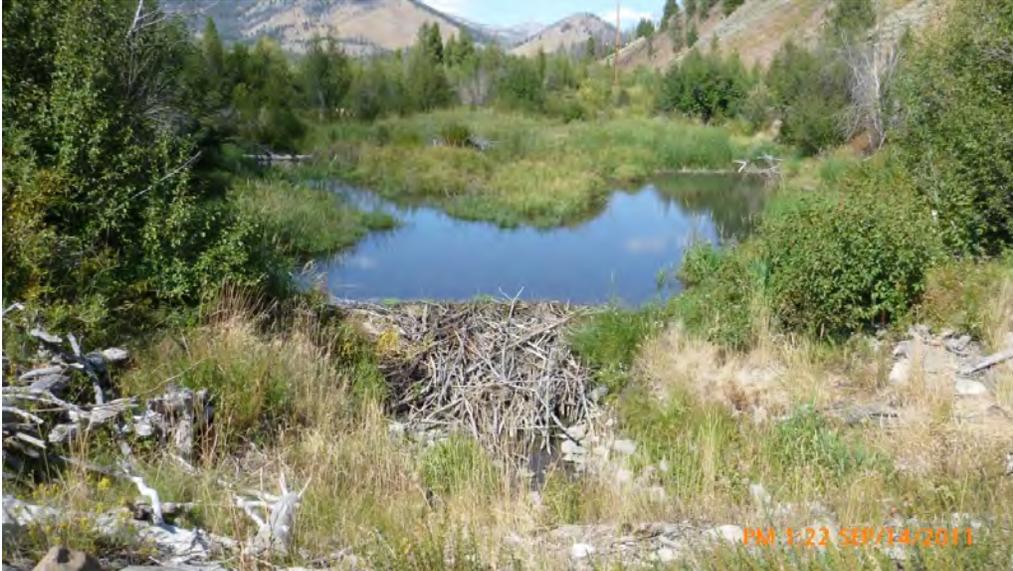
Photograph No. 66. View to the south looking downstream from road embankment along Pond Series Three. Yankee Fork of the Salmon River, Yankee Fork Subbasin, Idaho – Bureau of Reclamation Photograph by P. Drury, September 14, 2011.

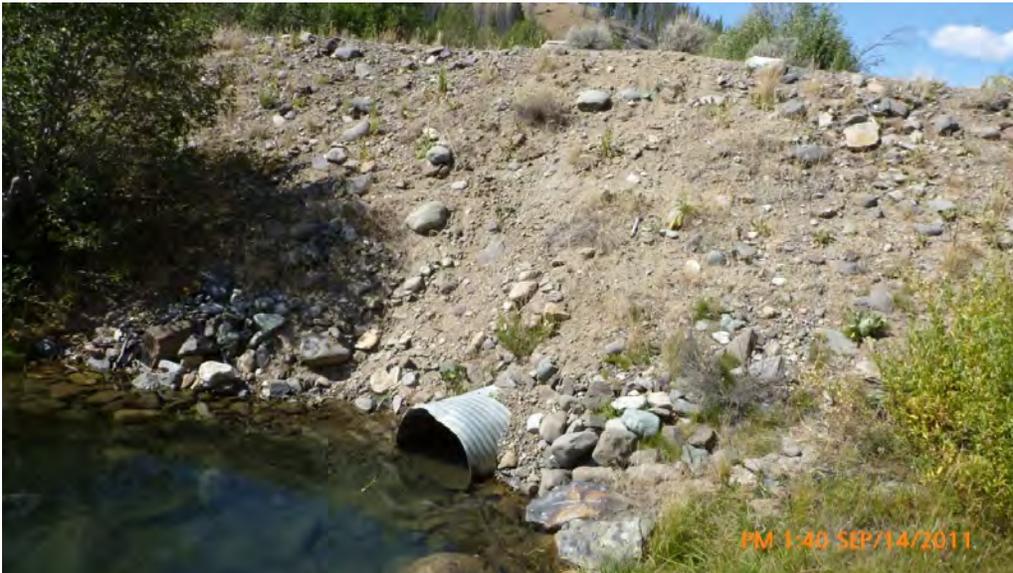
Photograph No. 67. View to the north looking upstream from road embankment at beaver dam along Pond Series Three. Yankee Fork of the Salmon River, Yankee Fork Subbasin, Idaho – Bureau of Reclamation
Photograph by P. Drury, September 14, 2011.

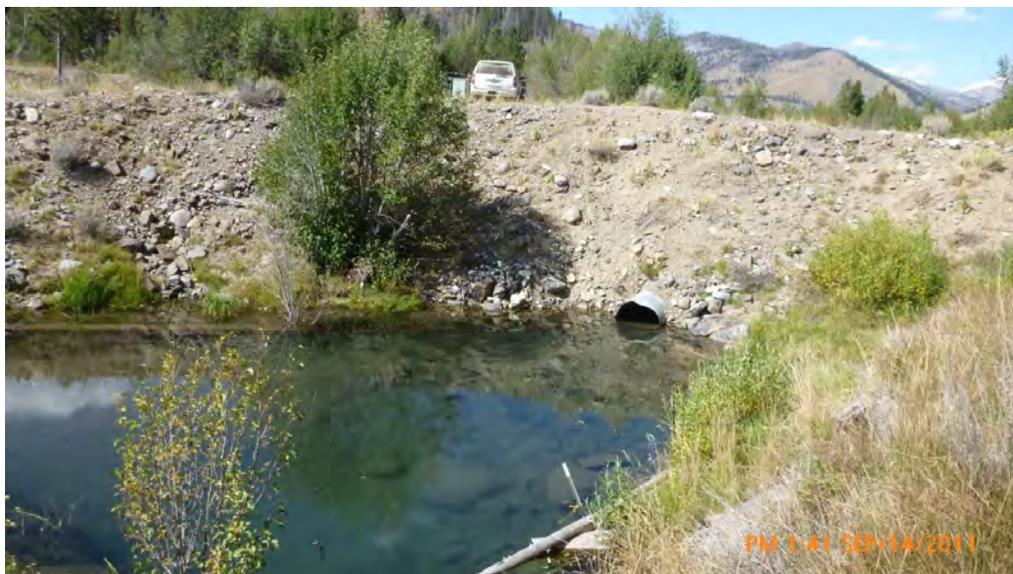
Photograph No. 68. View to the north looking upstream at culvert through road embankment along Pond Series Three. Yankee Fork of the Salmon River, Yankee Fork Subbasin, Idaho – Bureau of Reclamation
Photograph by P. Drury, September 14, 2011.

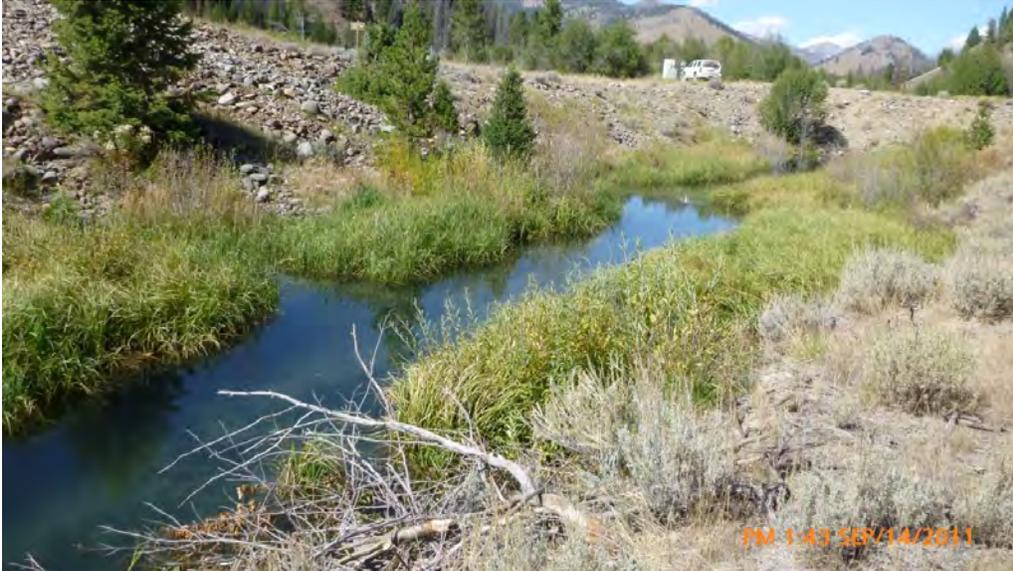
Photograph No. 70. View to the south looking downstream along Pond Series Three. Yankee Fork of the Salmon River, Yankee Fork Subbasin, Idaho – Bureau of Reclamation Photograph by P. Drury, September 14, 2011.

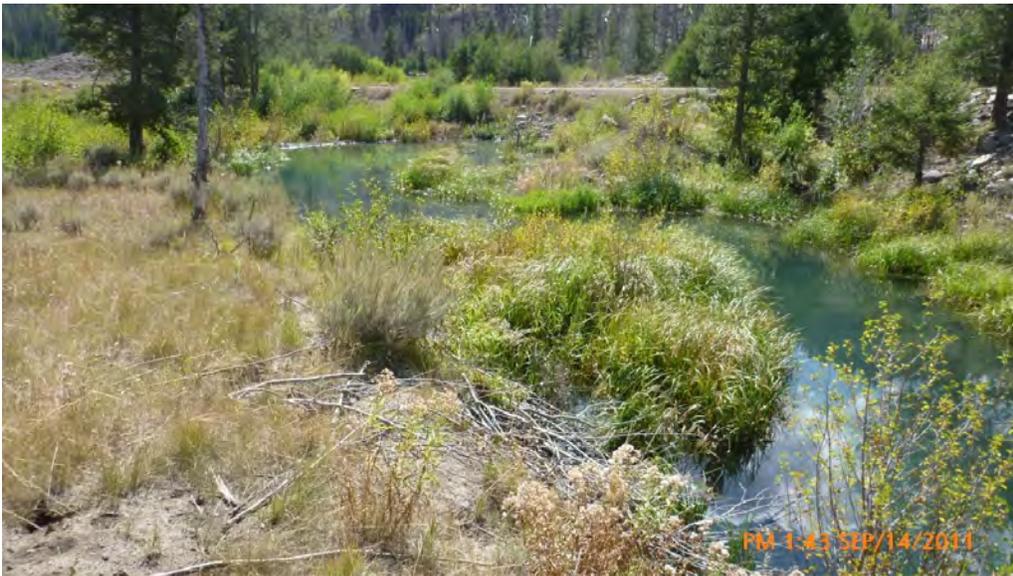
Photograph No. 71. View to the north looking upstream along Pond Series Three. Yankee Fork of the Salmon River, Yankee Fork Subbasin, Idaho – Bureau of Reclamation Photograph by P. Drury, September 14, 2011.

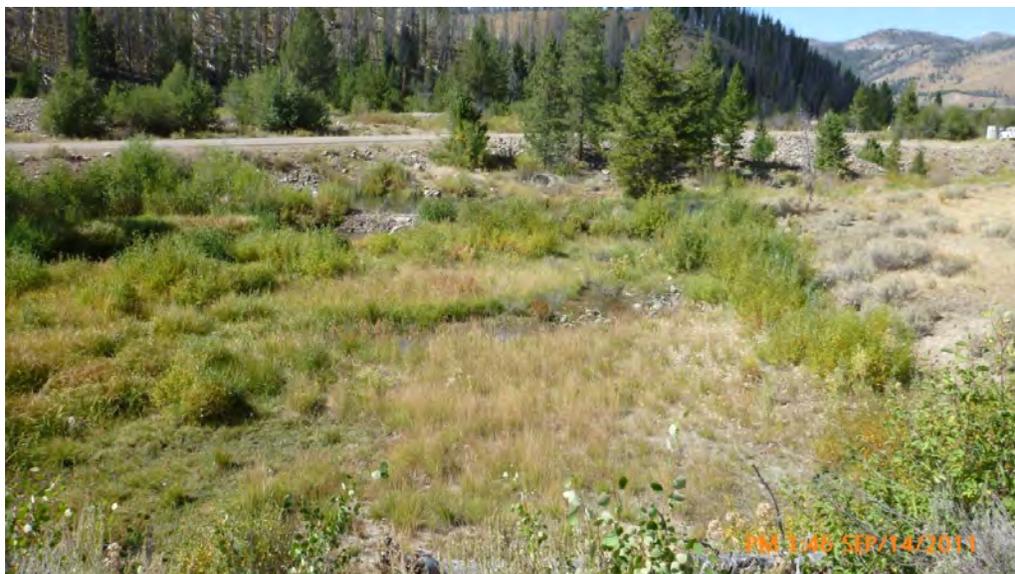
Photograph No. 72. View to the southwest looking downstream along Pond Series Three. Yankee Fork of the Salmon River, Yankee Fork Subbasin, Idaho – Bureau of Reclamation Photograph by P. Drury, September 14, 2011.

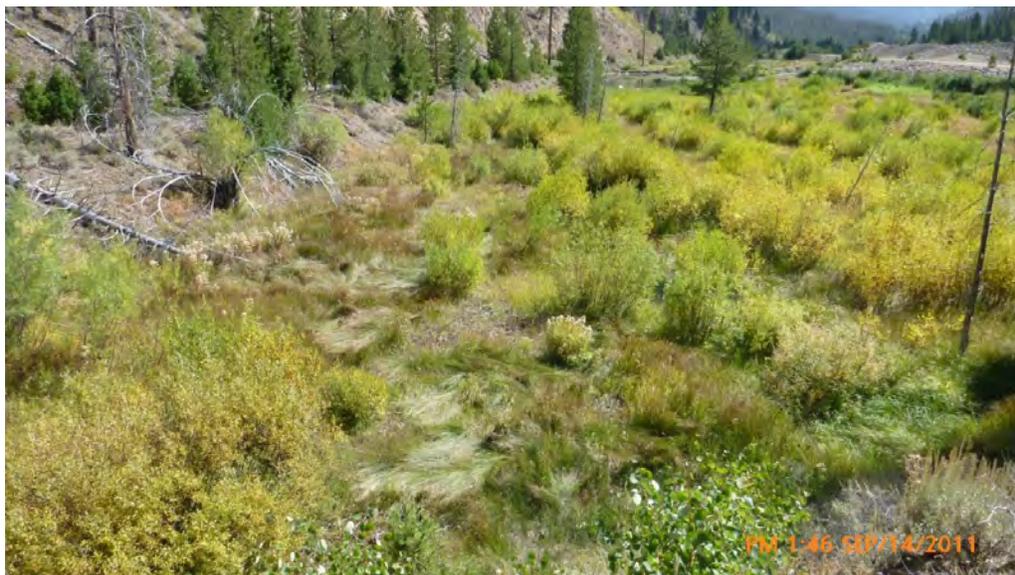
Photograph No. 73. View to the northwest looking upstream from road embankment along Pond Series Three. Yankee Fork of the Salmon River, Yankee Fork Subbasin, Idaho – Bureau of Reclamation Photograph by P. Drury, September 14, 2011.

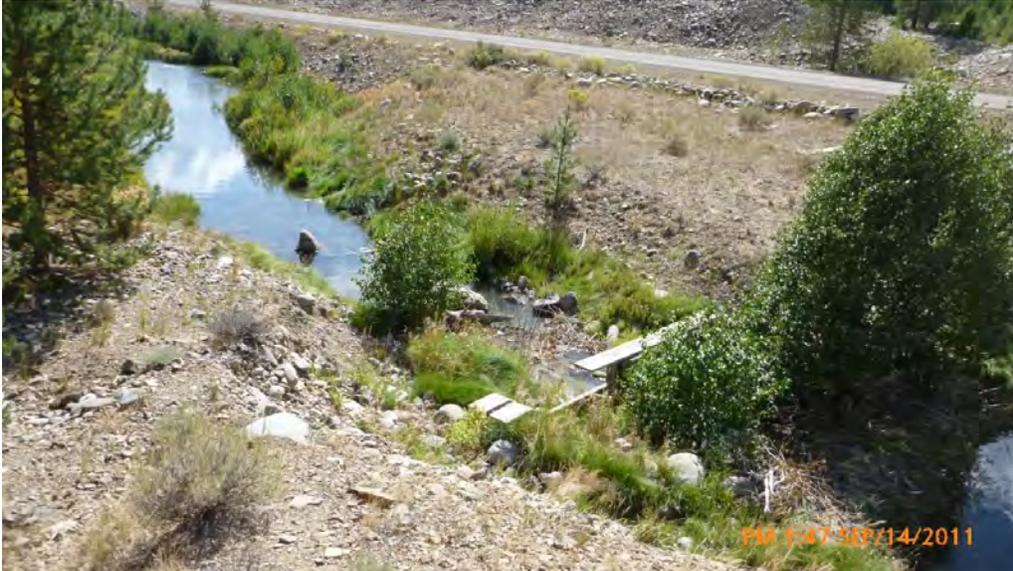
Photograph No. 74. View to the south looking downstream from road embankment along Pond Series Three. Yankee Fork of the Salmon River, Yankee Fork Subbasin, Idaho – Bureau of Reclamation Photograph by P. Drury, September 14, 2011.

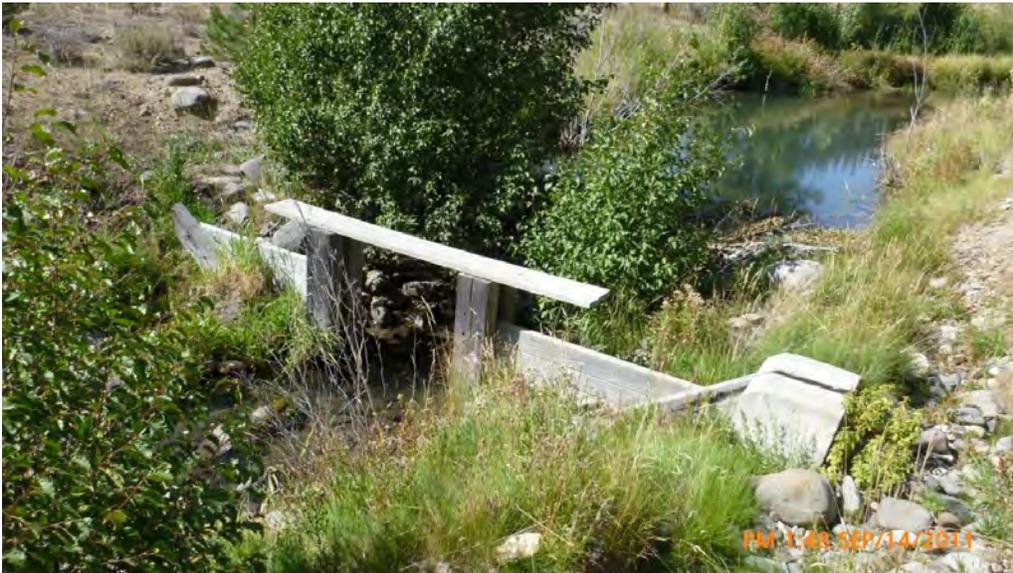
Photograph No. 75. View to the southwest looking at check structure placed between cut in road embankment along Pond Series Three. Yankee Fork of the Salmon River, Yankee Fork Subbasin, Idaho – Bureau of Reclamation Photograph by P. Drury, September 14, 2011.

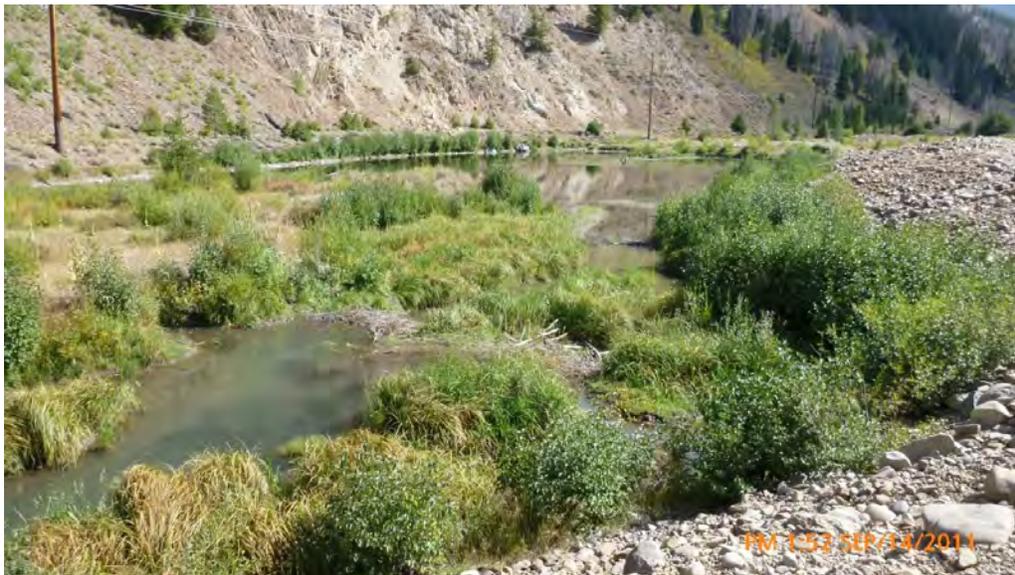
Photograph No. 77. View to the southeast looking downstream at beaver dam along Pond Series Three. Yankee Fork of the Salmon River, Yankee Fork Subbasin, Idaho – Bureau of Reclamation Photograph by P. Drury, September 14, 2011.

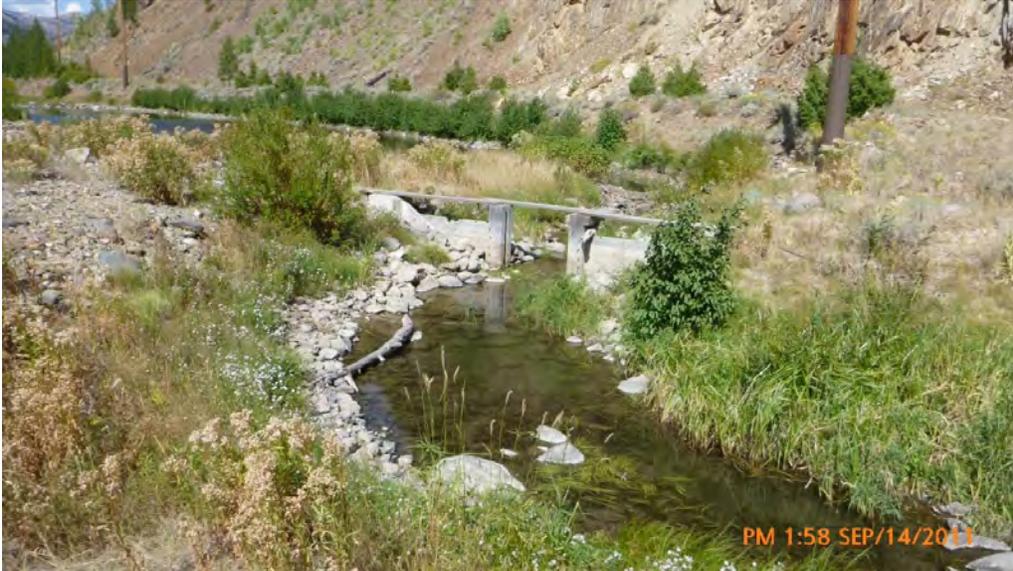
Photograph No. 78. View to the south looking downstream at beaver dam along Pond Series Three. Yankee Fork of the Salmon River, Yankee Fork Subbasin, Idaho – Bureau of Reclamation Photograph by P. Drury, September 14, 2011.

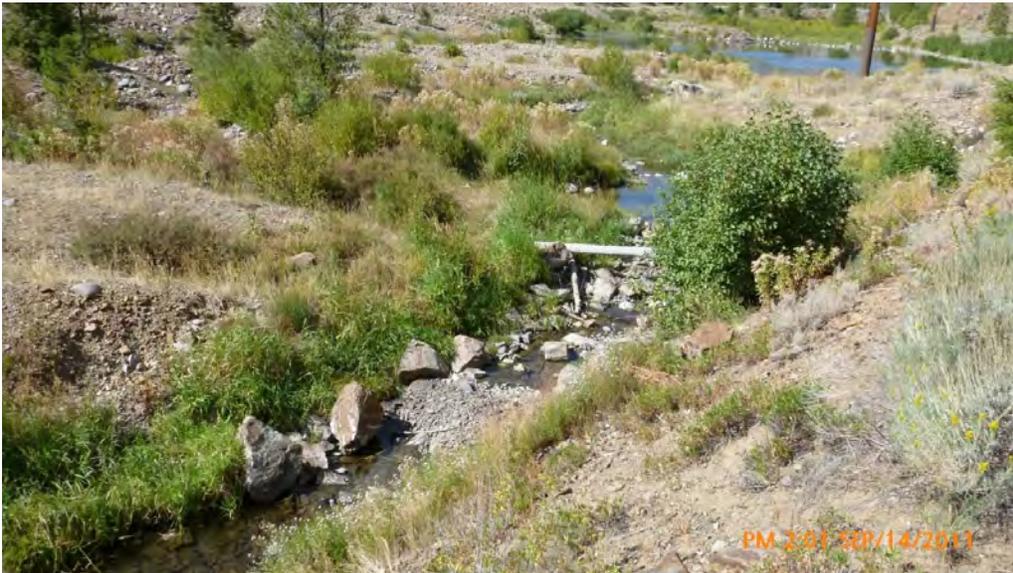
Photograph No. 79. View to the northeast looking upstream at check structure along Pond Series Three. Yankee Fork of the Salmon River, Yankee Fork Subbasin, Idaho – Bureau of Reclamation Photograph by P. Drury, September 14, 2011.

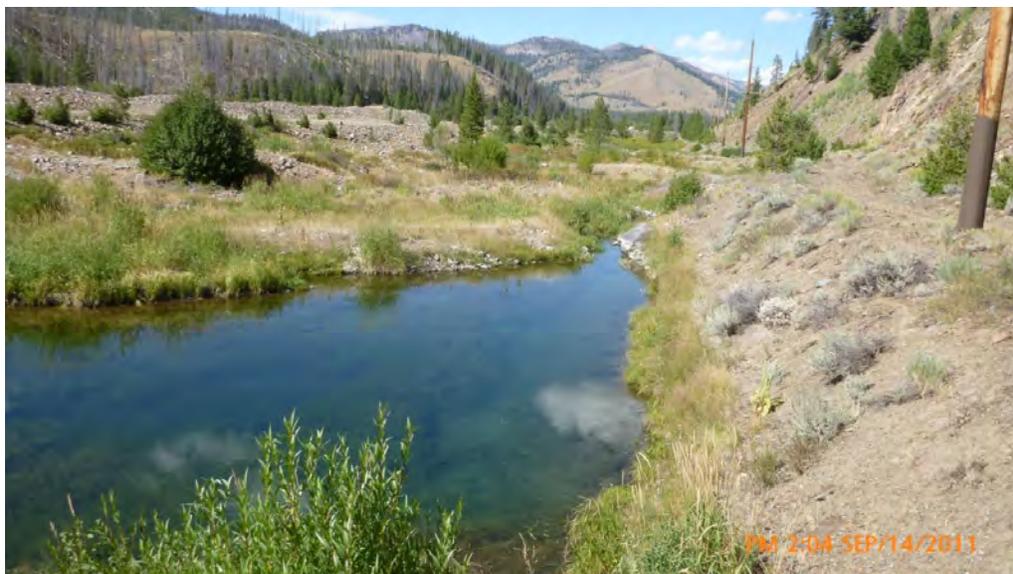
Photograph No. 80. View to the north looking upstream along Pond Series Three. Yankee Fork of the Salmon River, Yankee Fork Subbasin, Idaho – Bureau of Reclamation Photograph by P. Drury, September 14, 2011.

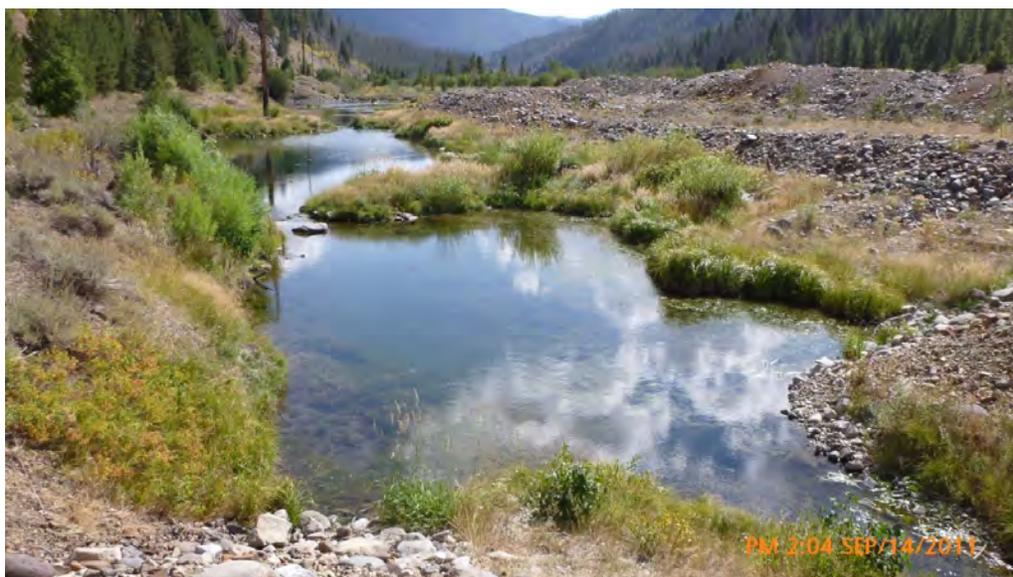
Photograph No. 81. View to the north looking upstream from road embankment constriction along Pond Series Three. Yankee Fork of the Salmon River, Yankee Fork Subbasin, Idaho – Bureau of Reclamation Photograph by P. Drury, September 14, 2011.

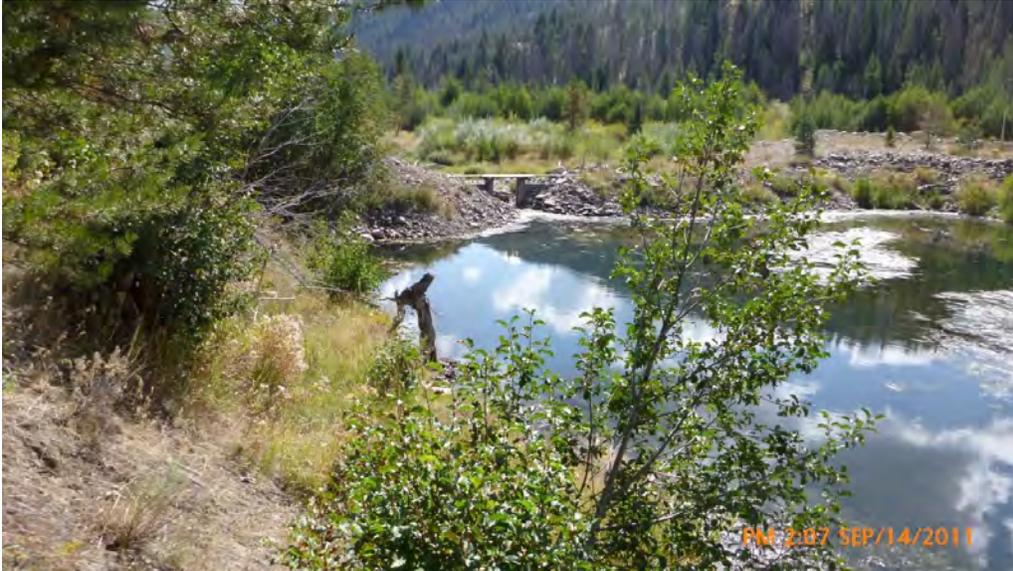
Photograph No. 82. View to the south looking downstream from road embankment constriction along Pond Series Three. Yankee Fork of the Salmon River, Yankee Fork Subbasin, Idaho – Bureau of Reclamation Photograph by P. Drury, September 14, 2011.

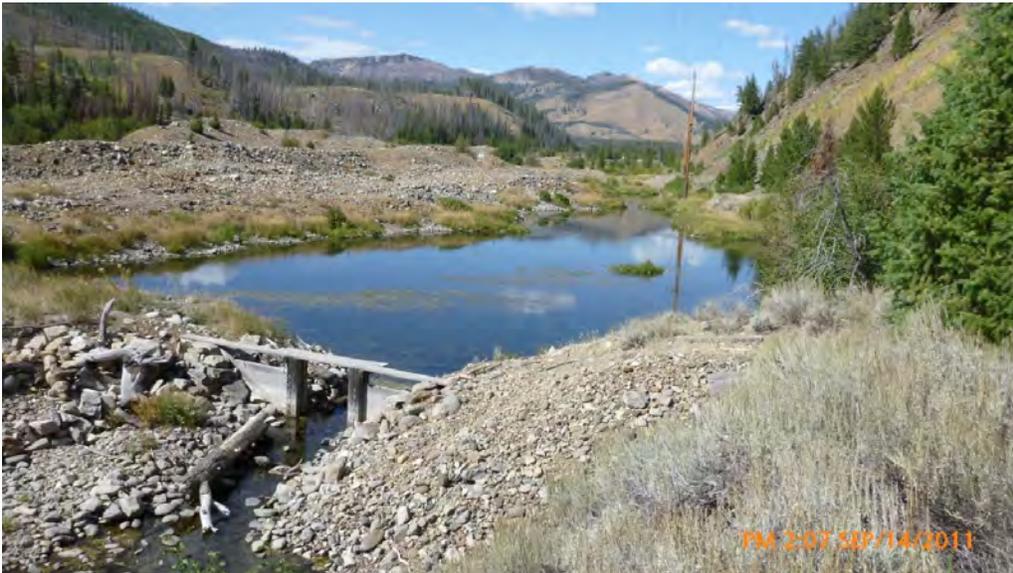
Photograph No. 83. View to the south looking downstream at check structure placed between embankment constrictions along Pond Series Three. Yankee Fork of the Salmon River, Yankee Fork Subbasin, Idaho – Bureau of Reclamation Photograph by P. Drury, September 14, 2011.
