Pole Flat Area Baseline Condition Assessment
Yankee Fork of the Salmon River,
Upper Salmon Subbasin

Custer County, Idaho

U.S. Department of the Interior
Bureau of Reclamation
Pacific Northwest Region
Pacific Northwest Regional Office, Boise, Idaho

October 2012

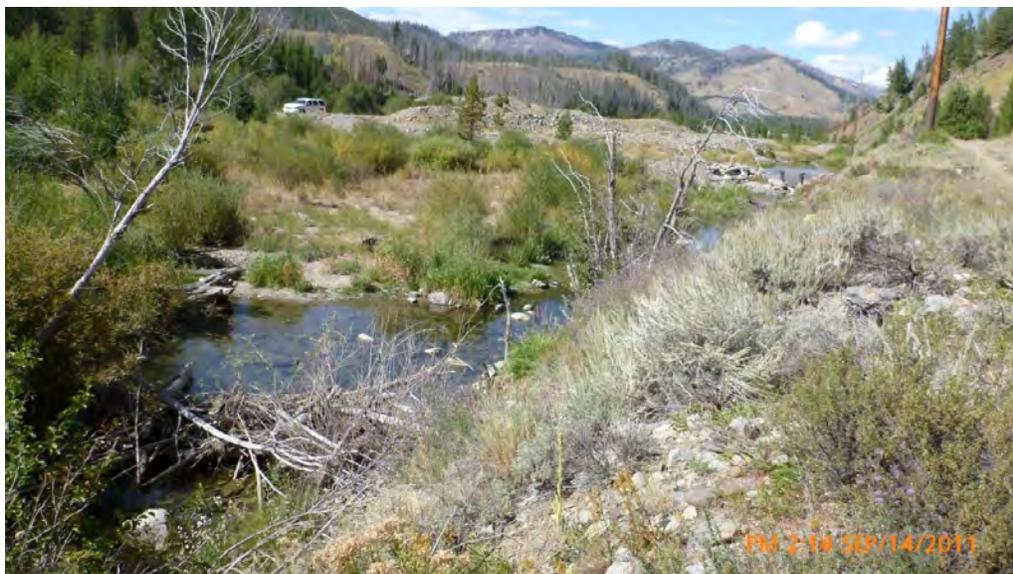
Photograph No. 84. View to the north looking upstream at check structure placed between embankment constrictions along Pond Series Three. Yankee Fork of the Salmon River, Yankee Fork Subbasin, Idaho – Bureau of Reclamation Photograph by P. Drury, September 14, 2011.

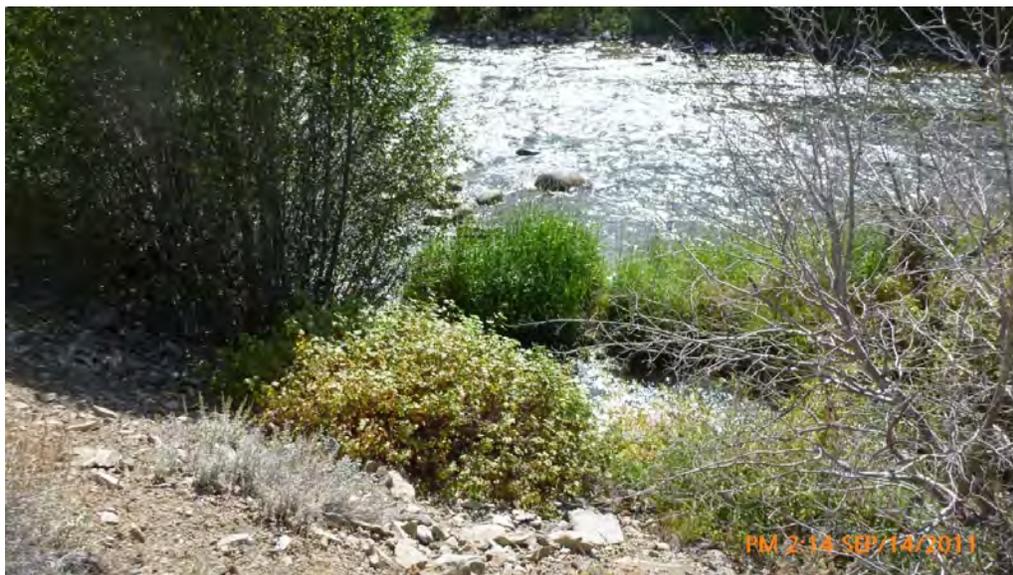
Photograph No. 85. View to the northwest looking upstream at beaver dam near the outlet along Pond Series Three. Yankee Fork of the Salmon River, Yankee Fork Subbasin, Idaho – Bureau of Reclamation Photograph by P. Drury, September 14, 2011.

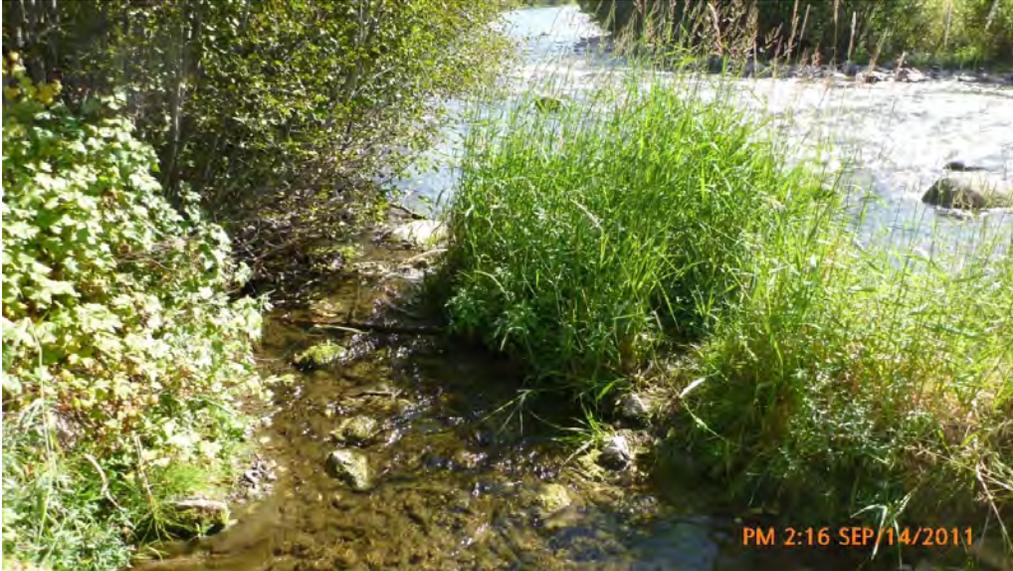
Photograph No. 86. View to the southwest looking downstream at outlet to Yankee Fork along Pond Series Three. Yankee Fork of the Salmon River, Yankee Fork Subbasin, Idaho – Bureau of Reclamation Photograph by P. Drury, September 14, 2011.

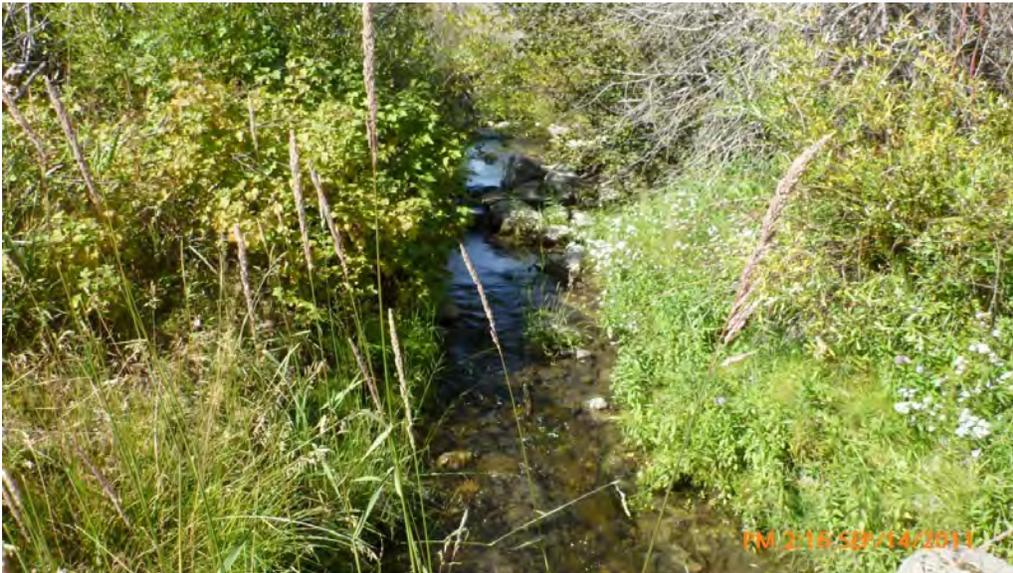
Photograph No. 87. View to the south looking downstream at outlet to Yankee Fork along Pond Series Three. Yankee Fork of the Salmon River, Yankee Fork Subbasin, Idaho – Bureau of Reclamation Photograph by P. Drury, September 14, 2011.

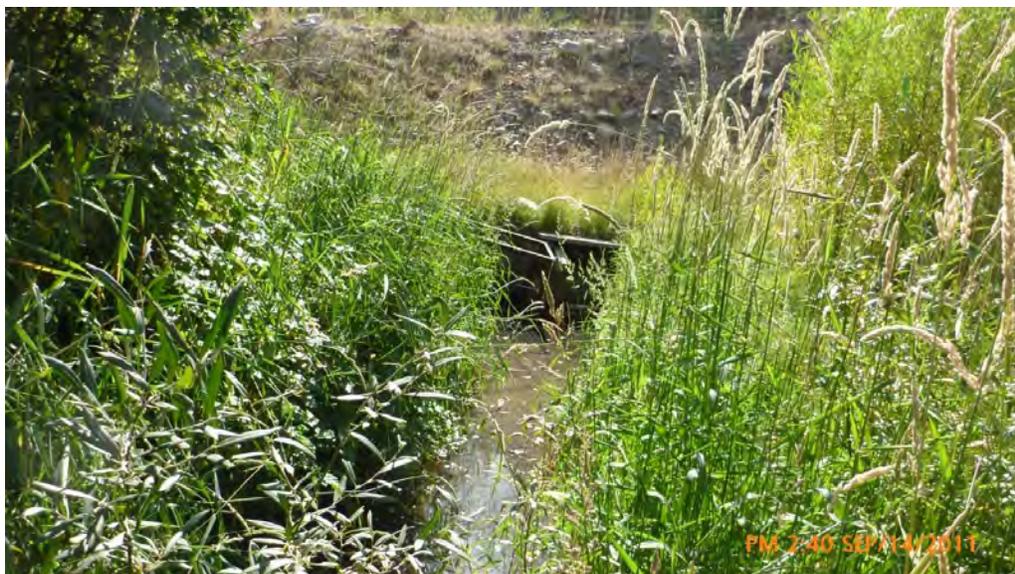
Photograph No. 88. View to the north looking upstream from outlet to Yankee Fork along Pond Series Three. Yankee Fork of the Salmon River, Yankee Fork Subbasin, Idaho – Bureau of Reclamation Photograph by P. Drury, September 14, 2011.

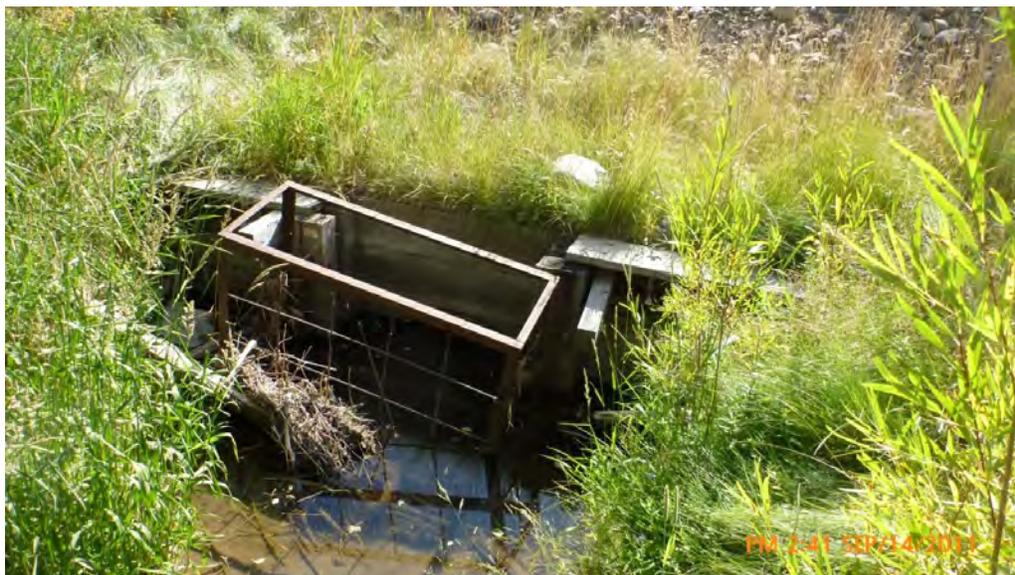
Photograph No. 89. View to the southwest looking downstream at culvert placed through road embankment near inlet along Pond Series Two. Yankee Fork of the Salmon River, Yankee Fork Subbasin, Idaho – Bureau of Reclamation Photograph by P. Drury, September 14, 2011.

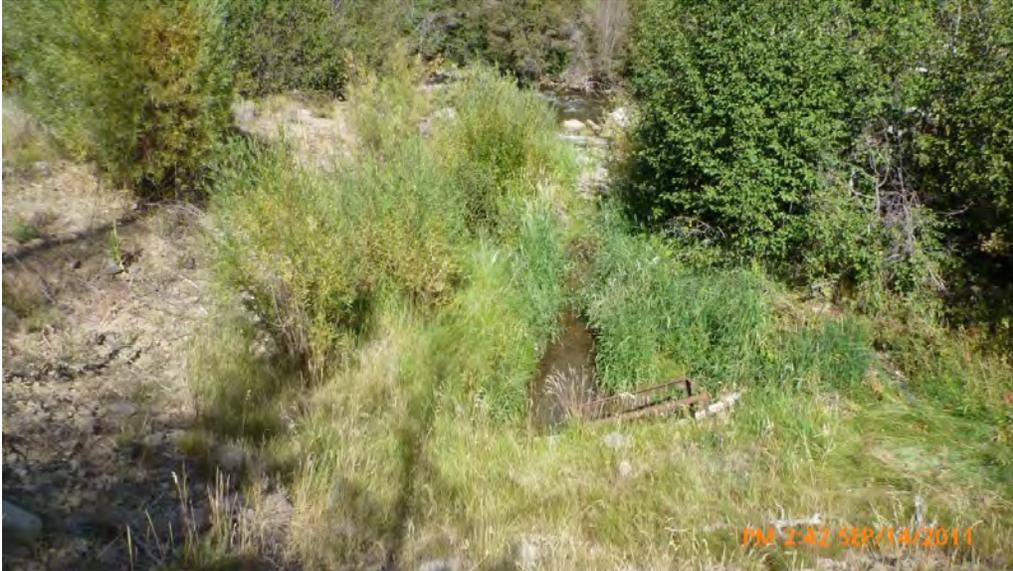
Photograph No. 90. View to the southwest looking downstream at culvert near the inlet along Pond Series Two. Yankee Fork of the Salmon River, Yankee Fork Subbasin, Idaho – Bureau of Reclamation Photograph by P. Drury, September 14, 2011.

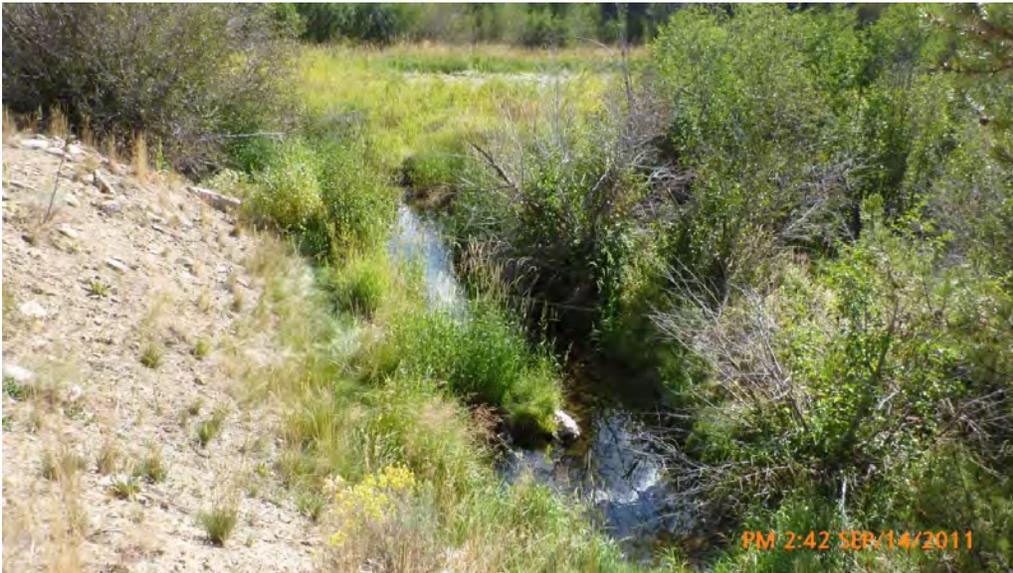
Photograph No. 91. View to the northeast looking upstream from road embankment at inlet along Pond Series Two. Yankee Fork of the Salmon River, Yankee Fork Subbasin, Idaho – Bureau of Reclamation Photograph by P. Drury, September 14, 2011.

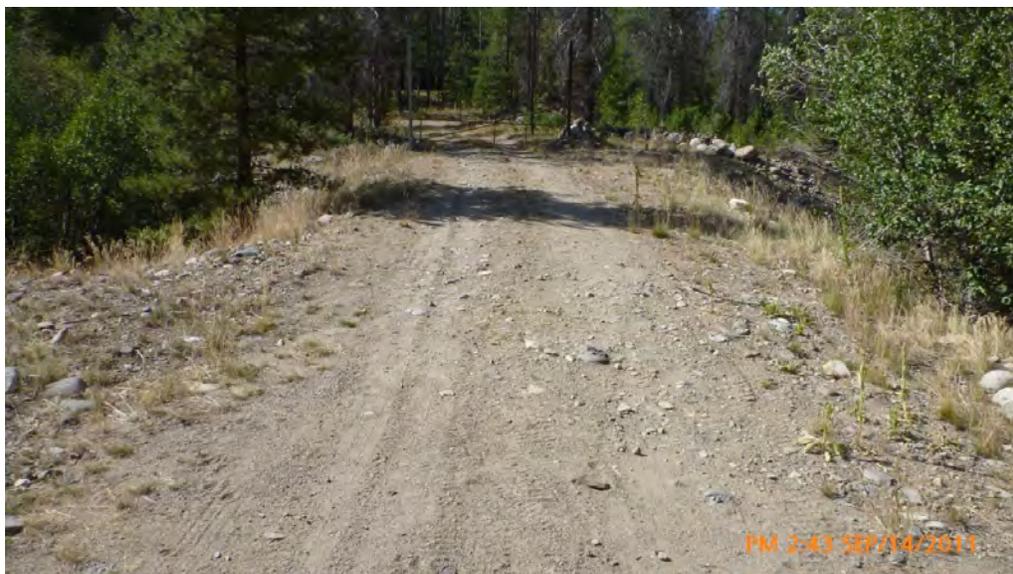
Photograph No. 92. View to the south looking downstream from road embankment along Pond Series Two. Yankee Fork of the Salmon River, Yankee Fork Subbasin, Idaho – Bureau of Reclamation Photograph by P. Drury, September 14, 2011.

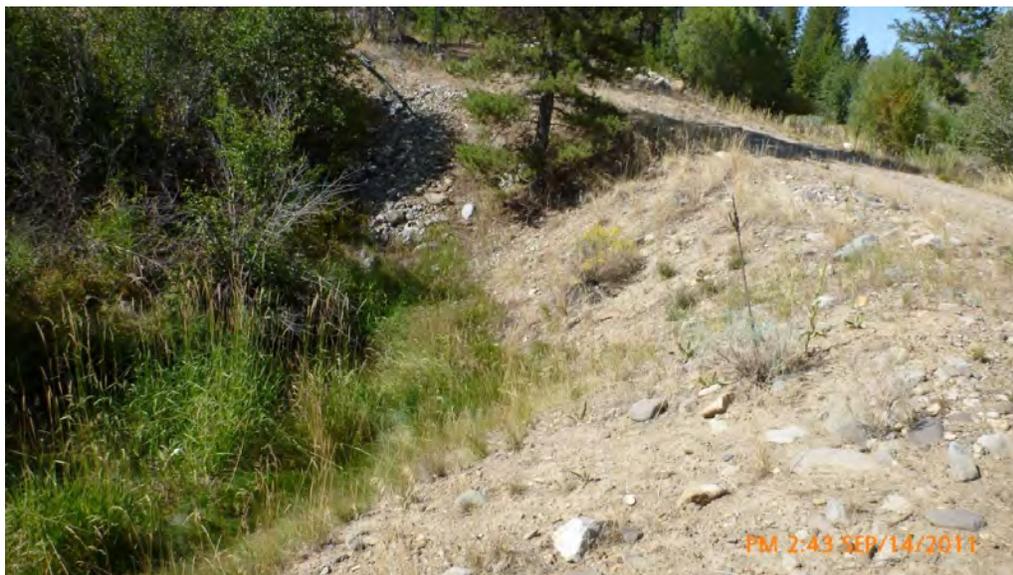
Photograph No. 93. View to the west looking along road embankment with culvert along Pond Series Two. Yankee Fork of the Salmon River, Yankee Fork Subbasin, Idaho – Bureau of Reclamation Photograph by P. Drury, September 14, 2011.

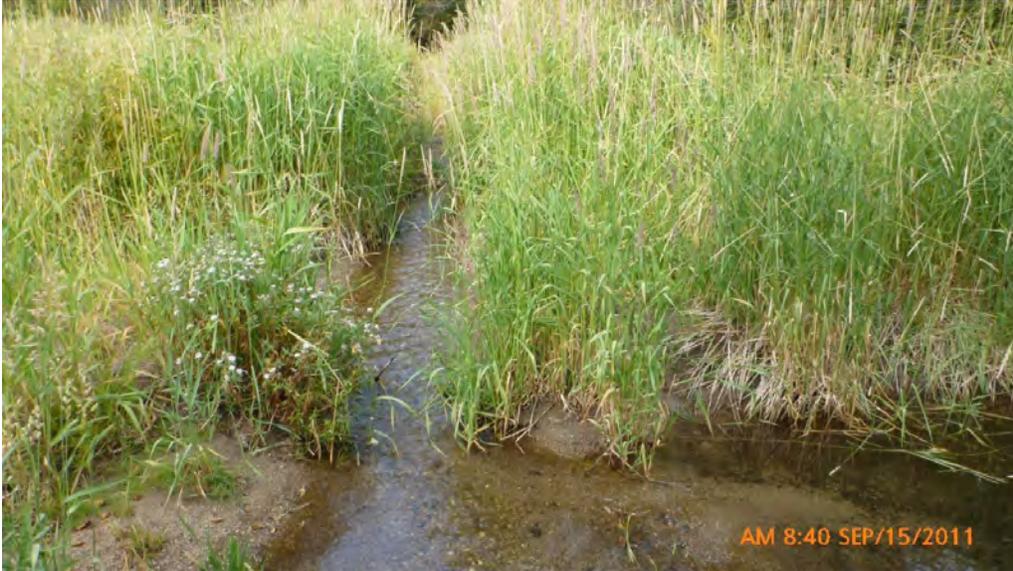
Photograph No. 94. View to the northwest looking at the road embankment with culvert along Pond Series Two. Yankee Fork of the Salmon River, Yankee Fork Subbasin, Idaho – Bureau of Reclamation Photograph by P. Drury, September 14, 2011.

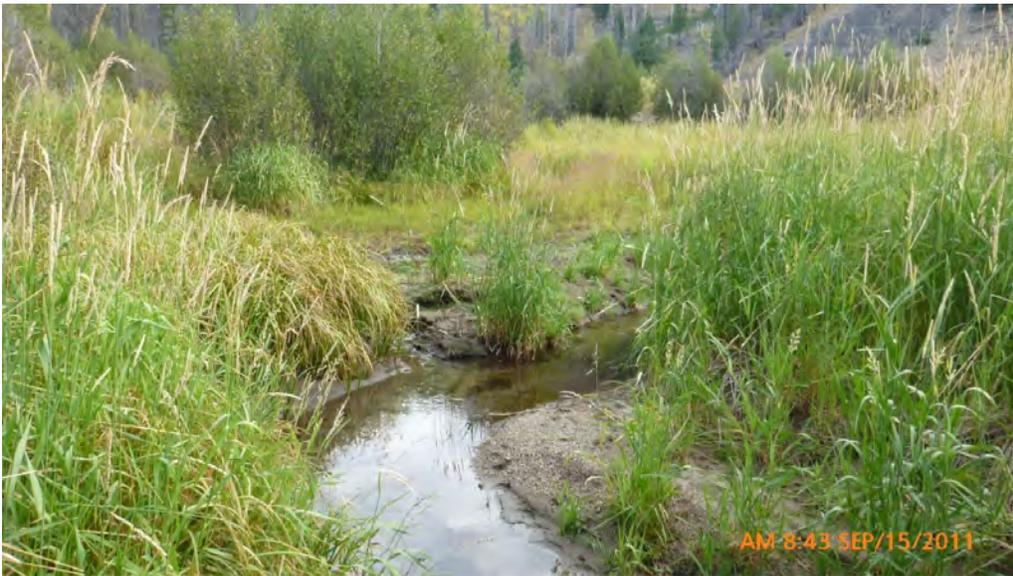
Photograph No. 95. View to the southeast looking downstream along Pond Series Two. Yankee Fork of the Salmon River, Yankee Fork Subbasin, Idaho – Bureau of Reclamation Photograph by P. Drury, September 15, 2011.

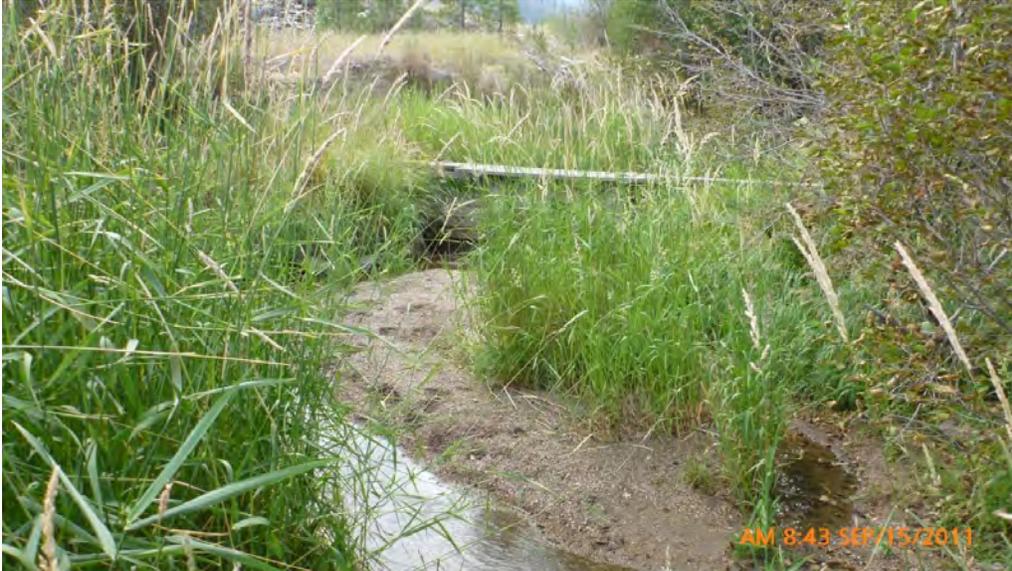
Photograph No. 96. View to the south looking downstream along Pond Series Two. Yankee Fork of the Salmon River, Yankee Fork Subbasin, Idaho – Bureau of Reclamation Photograph by P. Drury, September 15, 2011.

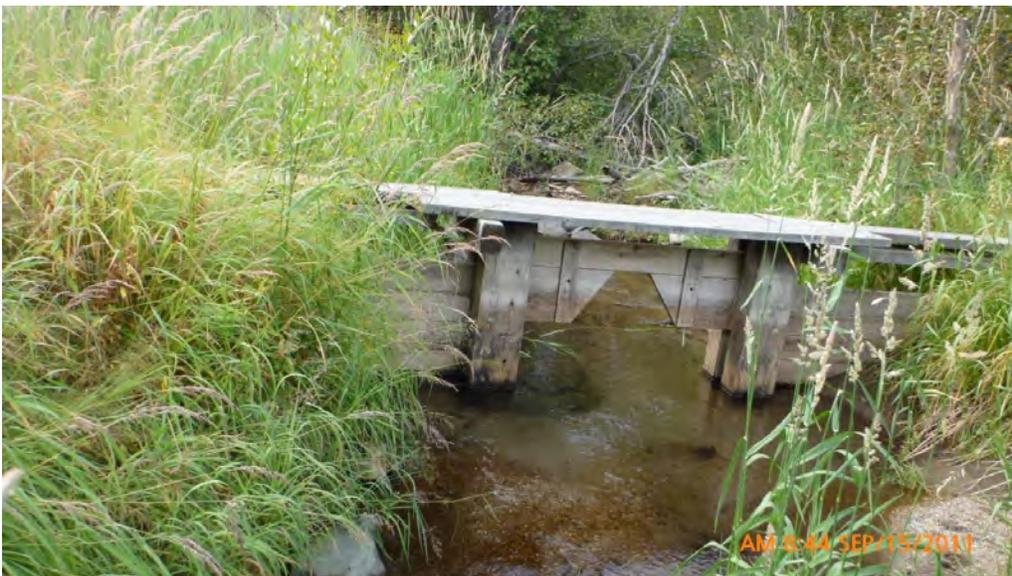
Photograph No. 97. View to the south looking downstream along Pond Series Two. Yankee Fork of the Salmon River, Yankee Fork Subbasin, Idaho – Bureau of Reclamation Photograph by P. Drury, September 15, 2011.

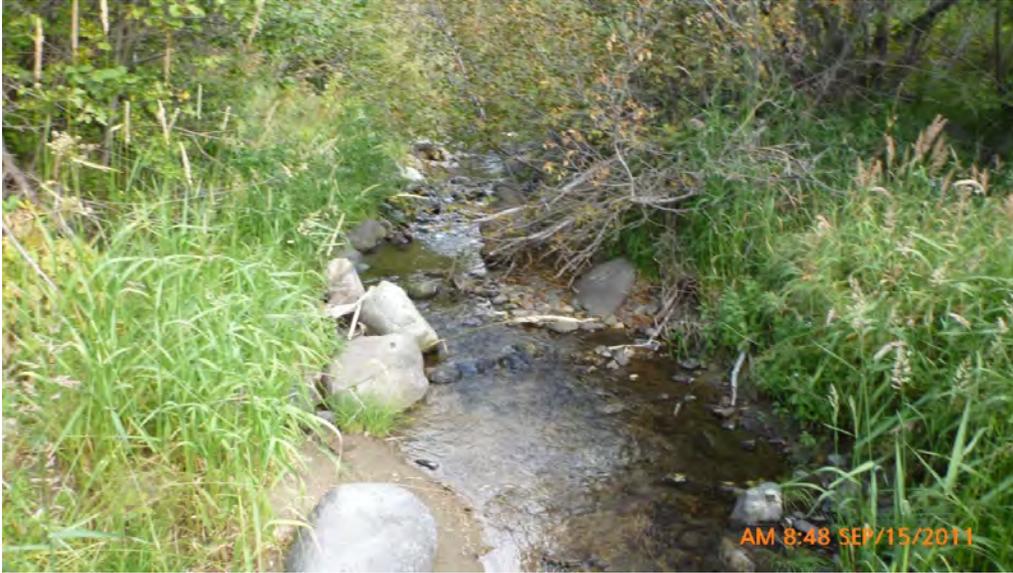
Photograph No. 98. View to the south looking downstream at check structure along Pond Series Two. Yankee Fork of the Salmon River, Yankee Fork Subbasin, Idaho – Bureau of Reclamation Photograph by P. Drury, September 15, 2011.

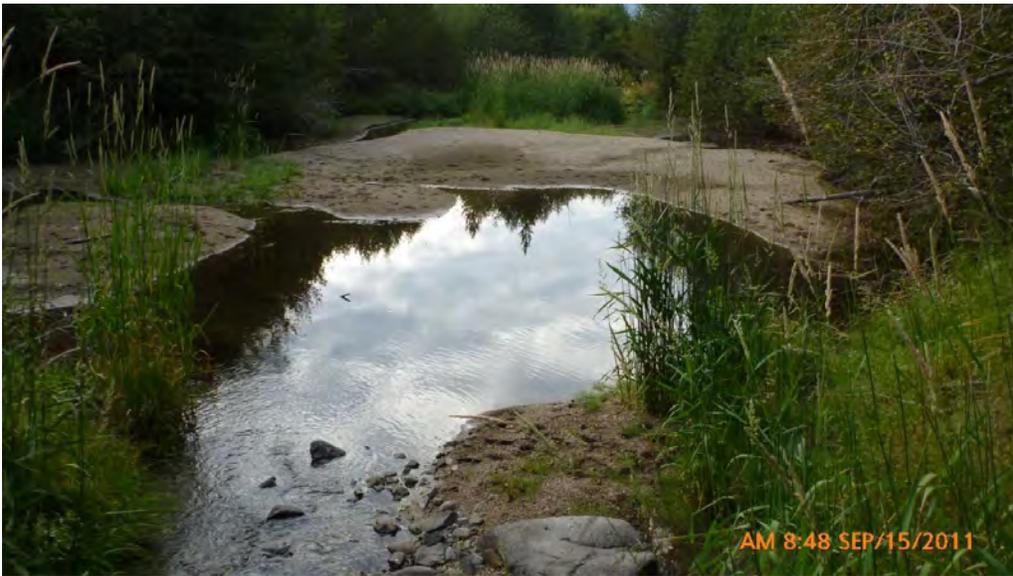
Photograph No. 99. View to the southeast looking downstream along Pond Series Two. Yankee Fork of the Salmon River, Yankee Fork Subbasin, Idaho – Bureau of Reclamation Photograph by P. Drury, September 15, 2011.

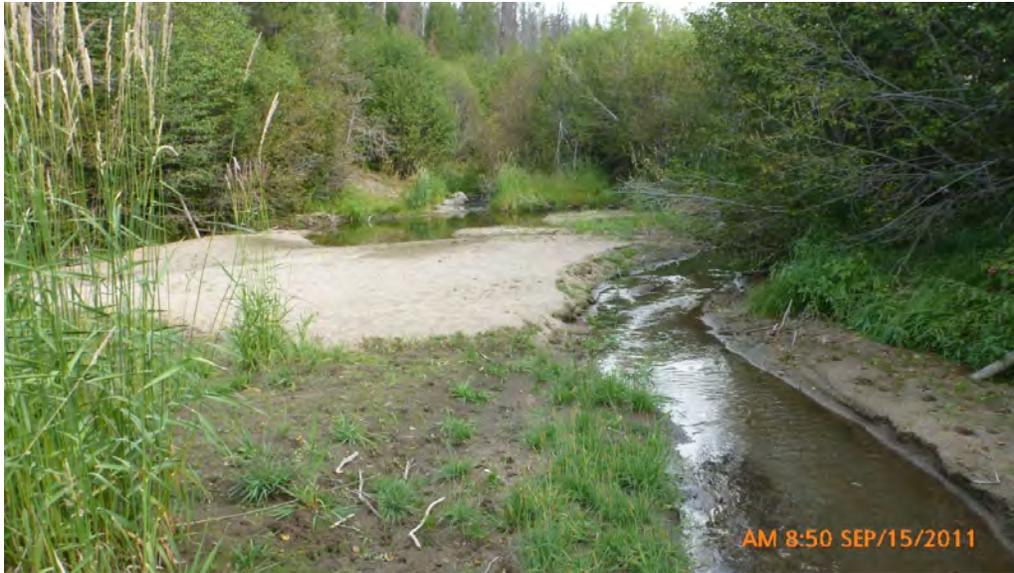
Photograph No. 100. View to the southeast looking downstream along Pond Series Two. Yankee Fork of the Salmon River, Yankee Fork Subbasin, Idaho – Bureau of Reclamation Photograph by P. Drury, September 15, 2011.

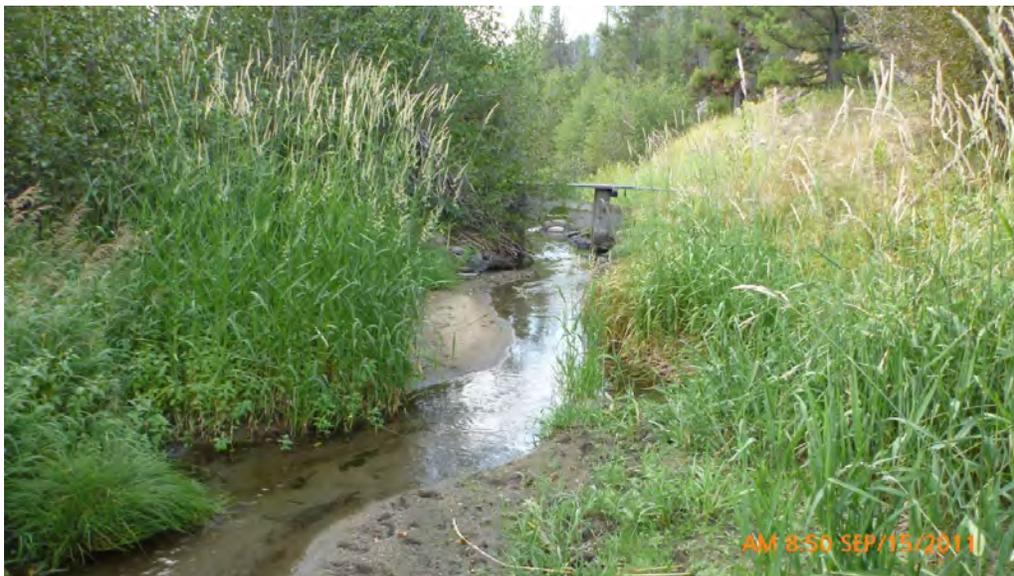
Photograph No. 101. View to the south looking downstream along Pond Series Two. Yankee Fork of the Salmon River, Yankee Fork Subbasin, Idaho – Bureau of Reclamation Photograph by P. Drury, September 15, 2011.

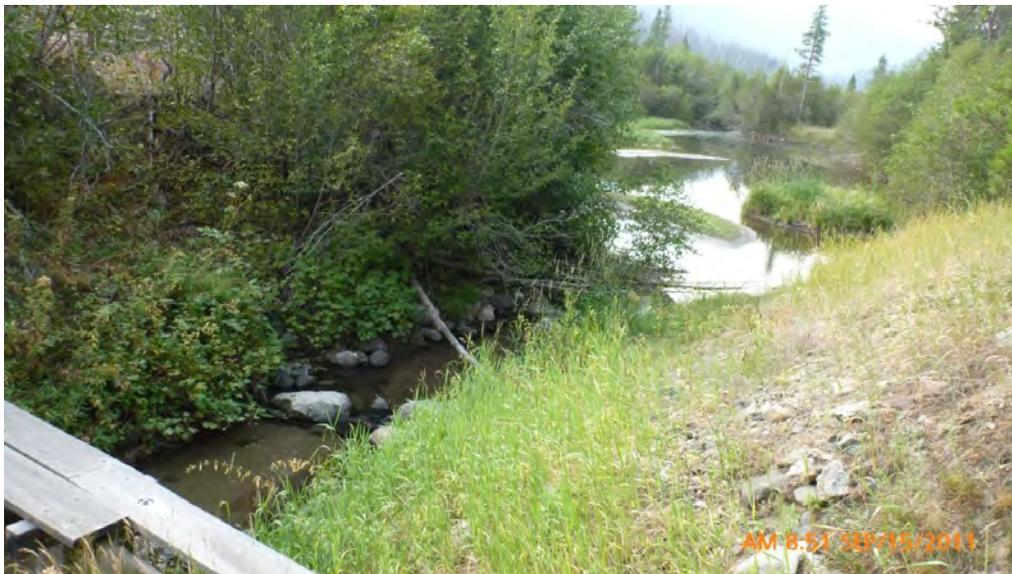
Photograph No. 102. View to the south looking downstream at check structure along Pond Series Two. Yankee Fork of the Salmon River, Yankee Fork Subbasin, Idaho – Bureau of Reclamation Photograph by P. Drury, September 15, 2011.

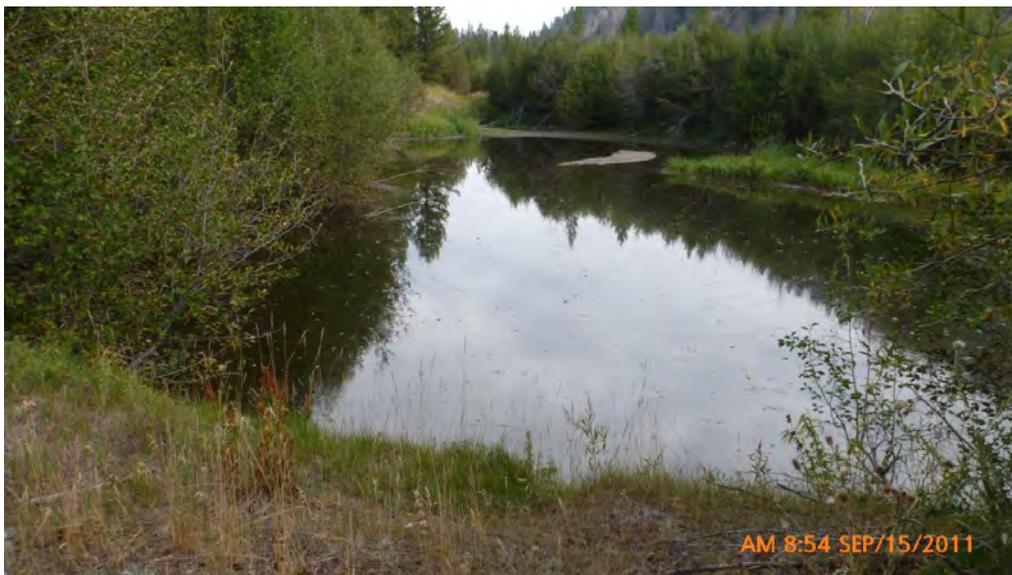
Photograph No. 103. View to the south looking downstream from check structure along Pond Series Two. Yankee Fork of the Salmon River, Yankee Fork Subbasin, Idaho – Bureau of Reclamation Photograph by P. Drury, September 15, 2011.

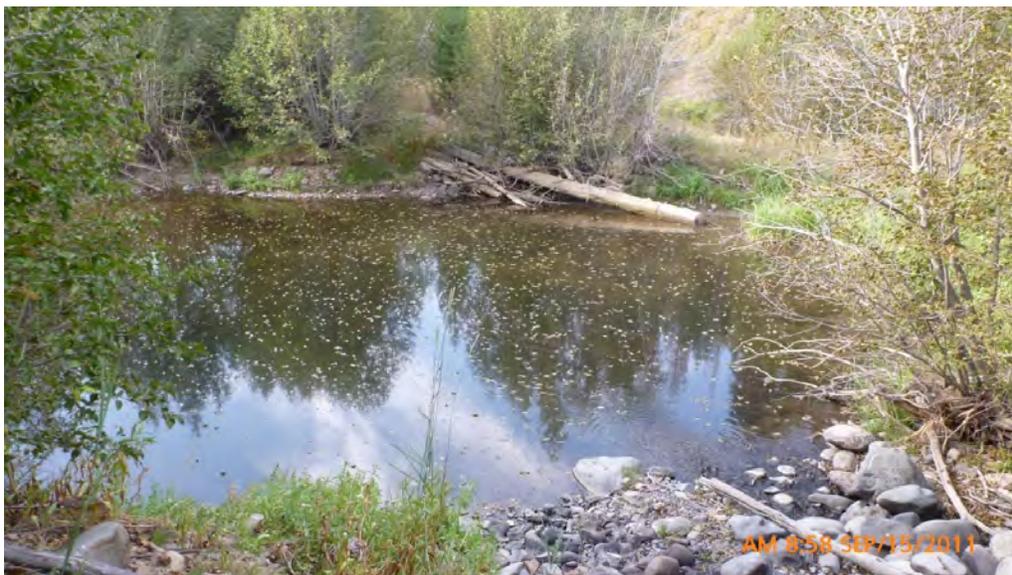
Photograph No. 105. View to the northwest looking upstream at check structure along Pond Series Two. Yankee Fork of the Salmon River, Yankee Fork Subbasin, Idaho – Bureau of Reclamation Photograph by P. Drury, September 15, 2011.

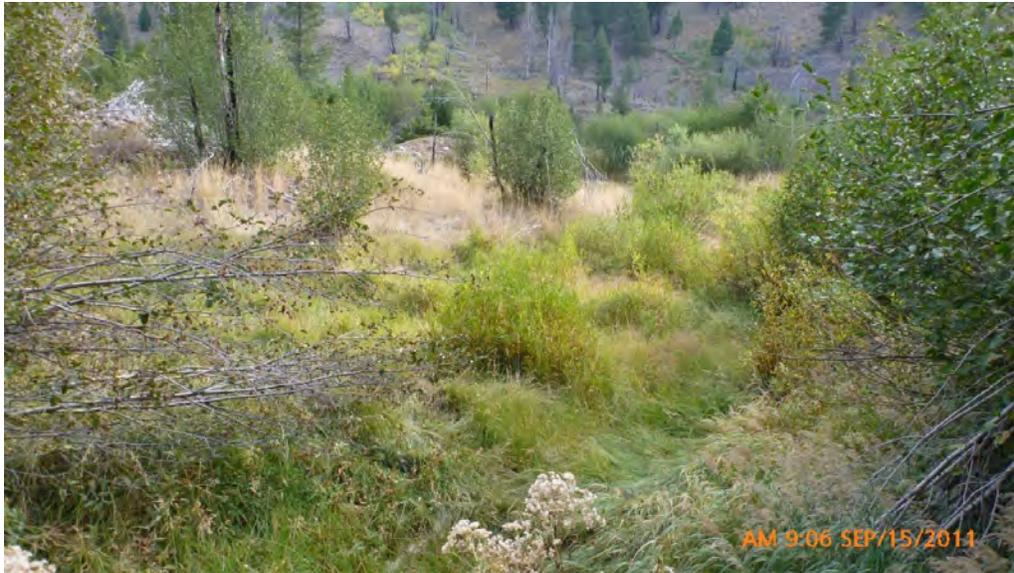
Photograph No. 108. View to the south looking downstream at check structure along Pond Series Two. Yankee Fork of the Salmon River, Yankee Fork Subbasin, Idaho – Bureau of Reclamation Photograph by P. Drury, September 15, 2011.

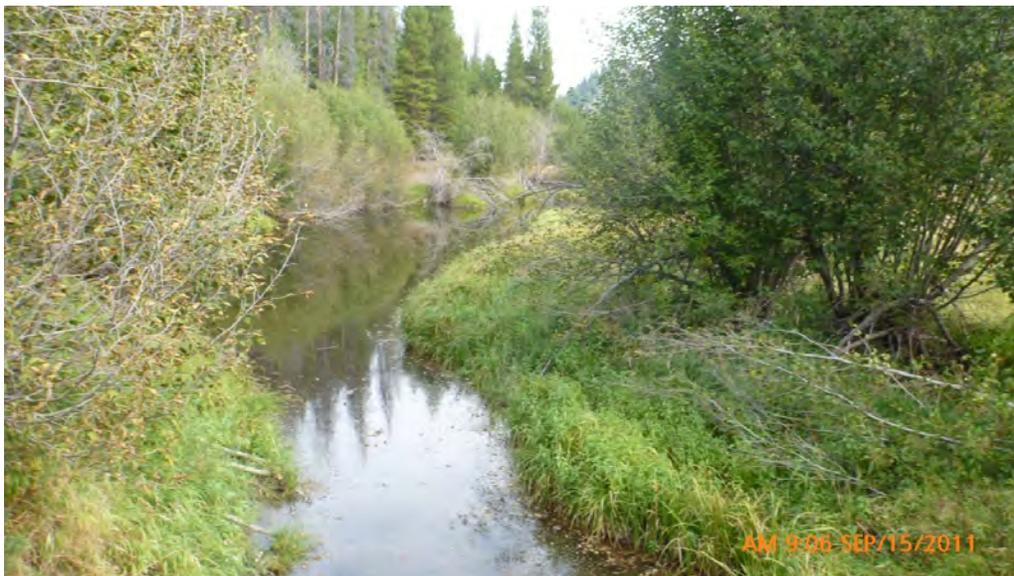
Photograph No. 109. View to the east looking across seepage area along Pond Series Two. Yankee Fork of the Salmon River, Yankee Fork Subbasin, Idaho – Bureau of Reclamation Photograph by P. Drury, September 15, 2011.

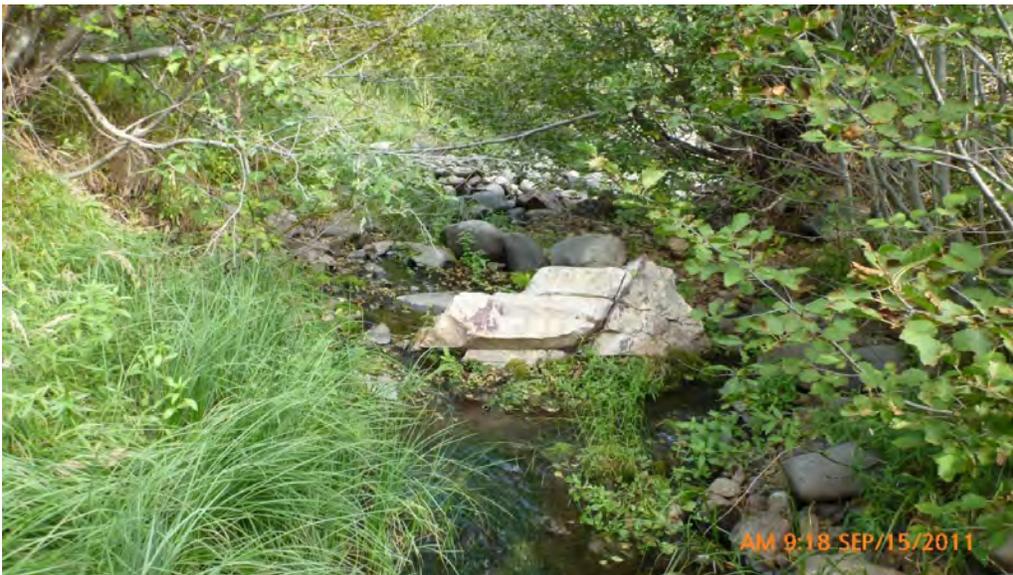
Photograph No. 119. View to the southwest looking downstream at check structure along Pond Series Two. Yankee Fork of the Salmon River, Yankee Fork Subbasin, Idaho – Bureau of Reclamation Photograph by P. Drury, September 15, 2011.

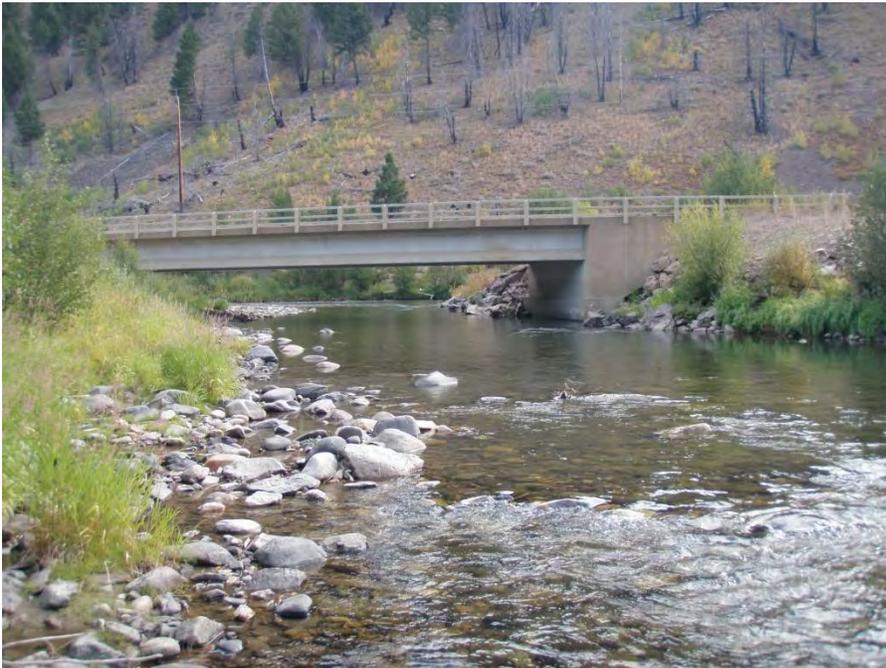
Photograph No. 133. View to the west looking downstream at Custer Motorway bridge crossing along the Yankee Fork. Yankee Fork of the Salmon River, Yankee Fork Subbasin, Idaho – Bureau of Reclamation
Photograph by E. Lyon, September 15, 2011.

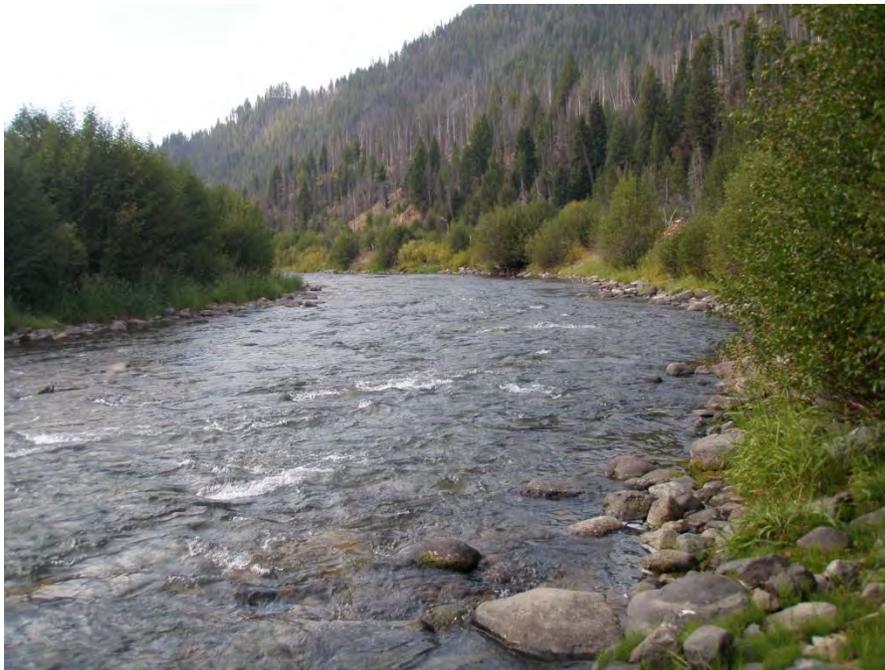
Photograph No. 134. View to the northeast looking upstream at Custer Motorway bridge along the Yankee Fork. Yankee Fork of the Salmon River, Yankee Fork Subbasin, Idaho – Bureau of Reclamation
Photograph by E. Lyon, September 15, 2011.

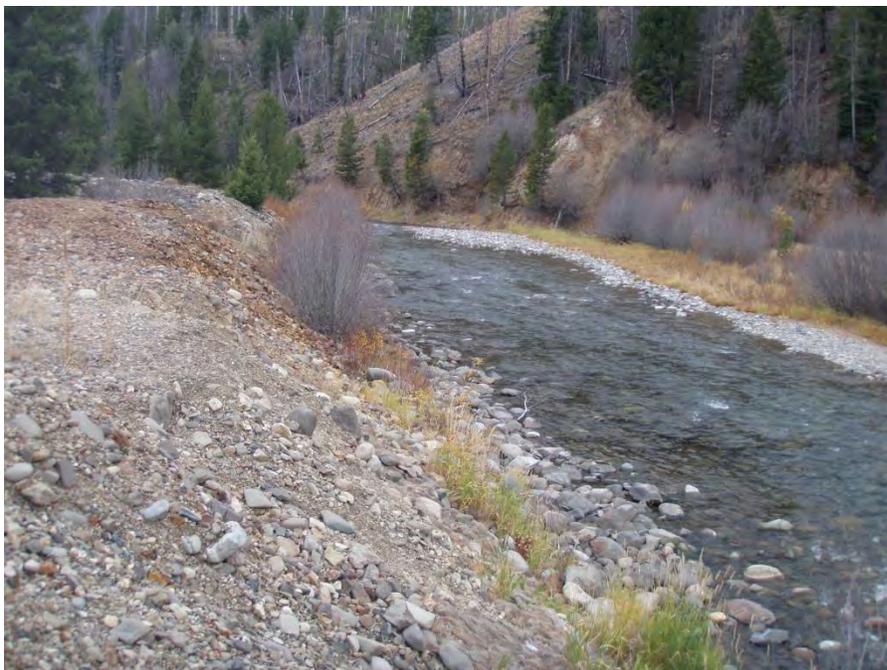
Photograph No. 136. View to the south looking downstream at eroding left bank (mine tailings) along the Yankee Fork. Yankee Fork of the Salmon River, Yankee Fork Subbasin, Idaho – Bureau of Reclamation Photograph by E. Lyon, September 15, 2011.

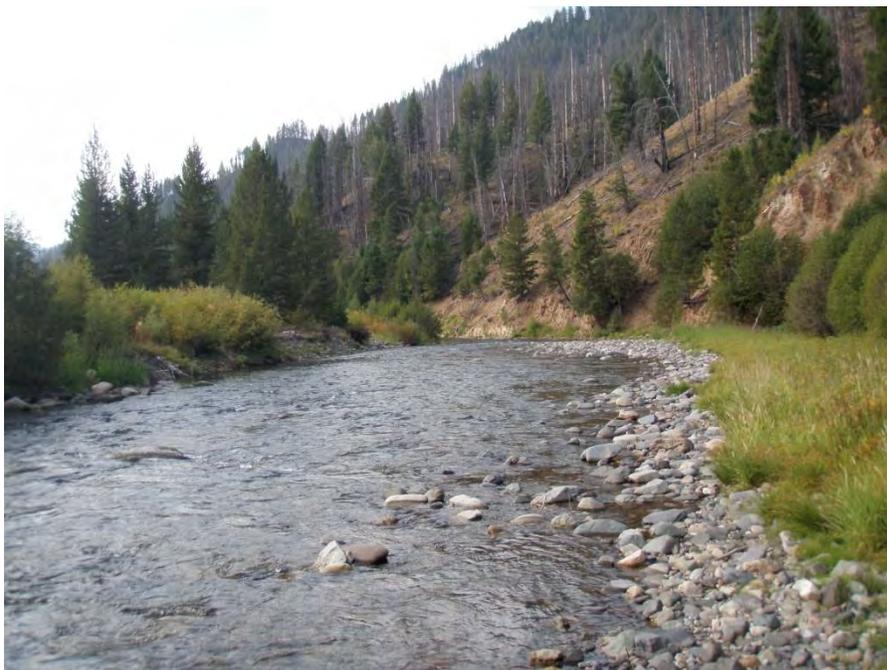
Photograph No. 137. View to the southwest looking downstream along eroding left bank (mine tailings) toward bedrock restriction along the Yankee Fork. Yankee Fork of the Salmon River, Yankee Fork Subbasin, Idaho – Bureau of Reclamation Photograph by E. Lyon, October 26, 2011.

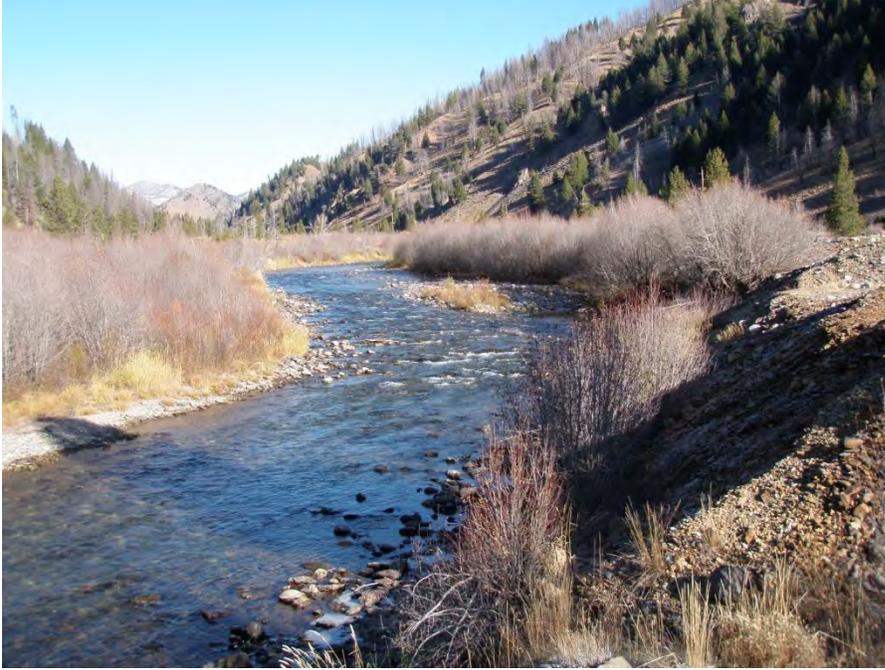
Photograph No. 138. View to the southwest looking downstream toward bedrock restriction along the Yankee Fork. Yankee Fork of the Salmon River, Yankee Fork Subbasin, Idaho – Bureau of Reclamation Photograph by E. Lyon, September 15, 2011.

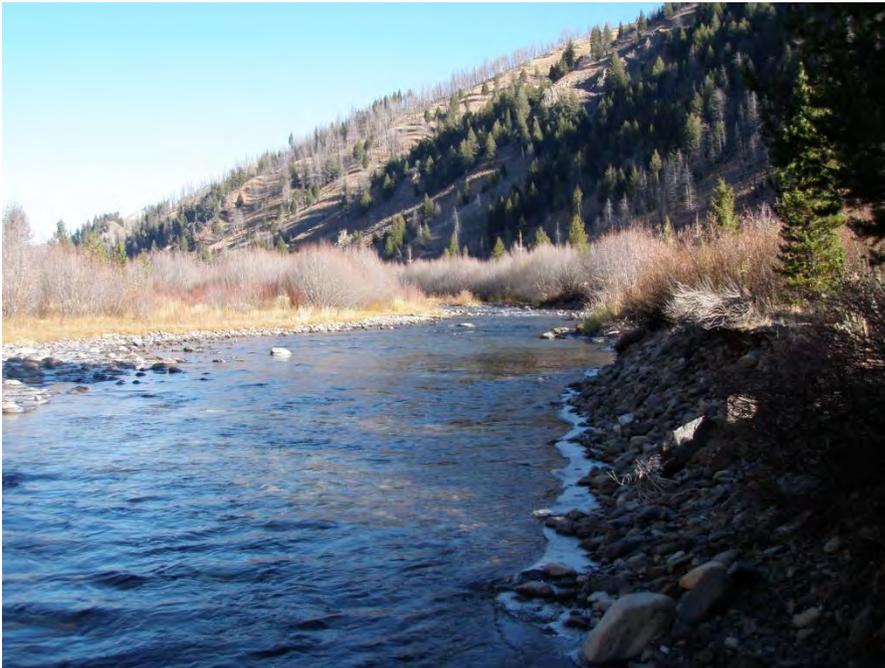
Photograph No. 139. View to the northeast looking upstream along eroding toward bedrock restriction along the Yankee Fork. Yankee Fork of the Salmon River, Yankee Fork Subbasin, Idaho – Bureau of Reclamation Photograph by E. Lyon, October 26, 2011.

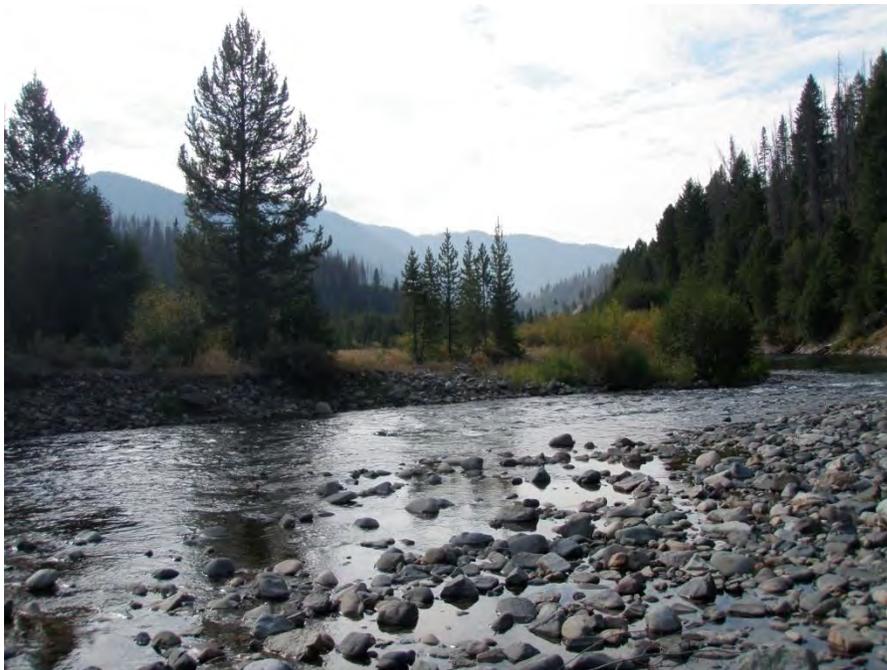
Photograph No. 140. View to the northeast looking upstream at eroding bank along the Yankee Fork. Yankee Fork of the Salmon River, Yankee Fork Subbasin, Idaho – Bureau of Reclamation Photograph by E. Lyon, October 26, 2011.

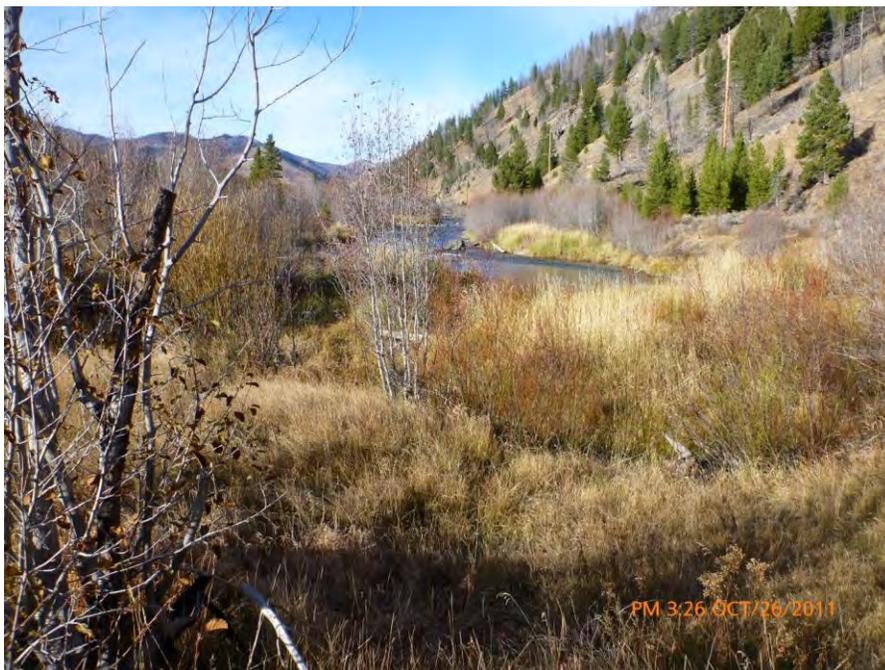
Photograph No. 143. View to the south looking downstream from outlet of Pond Series Two at bedrock restriction along river right along the Yankee Fork. Yankee Fork of the Salmon River, Yankee Fork Subbasin, Idaho – Bureau of Reclamation Photograph by E. Lyon, October 26, 2011.

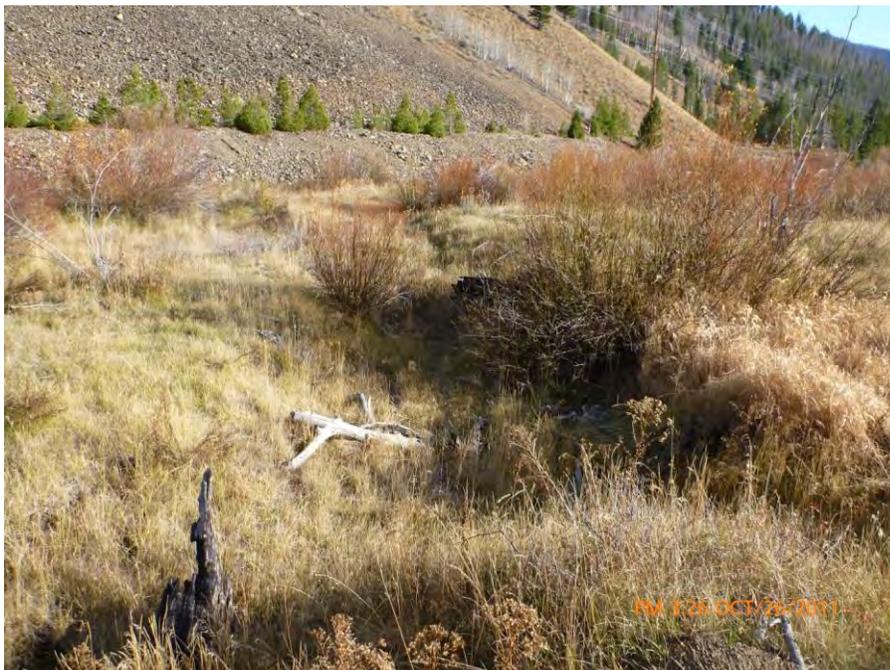
Photograph No. 146. View to the southeast looking upstream at channel along Jerrys Creek flowing toward the Yankee Fork. Yankee Fork of the Salmon River, Yankee Fork Subbasin, Idaho – Bureau of Reclamation
Photograph by P. Drury, October 26, 2011.

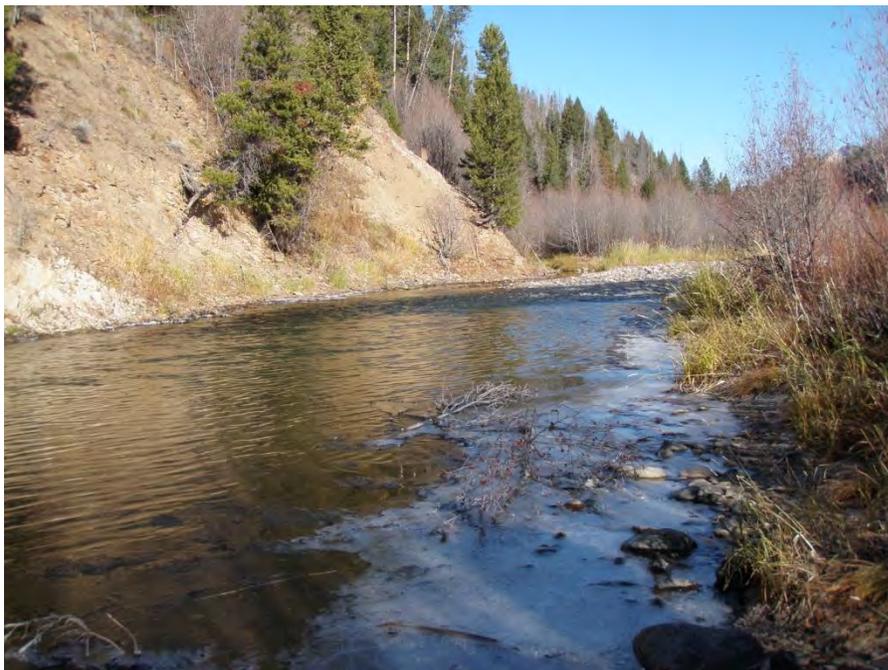
Photograph No. 152. View to the north looking upstream at lateral scour pool forced by bedrock on river right along the Yankee Fork and outlet of Pond Series Two. Yankee Fork of the Salmon River, Yankee Fork Subbasin, Idaho – Bureau of Reclamation
Photograph by E. Lyon, October 26, 2011.

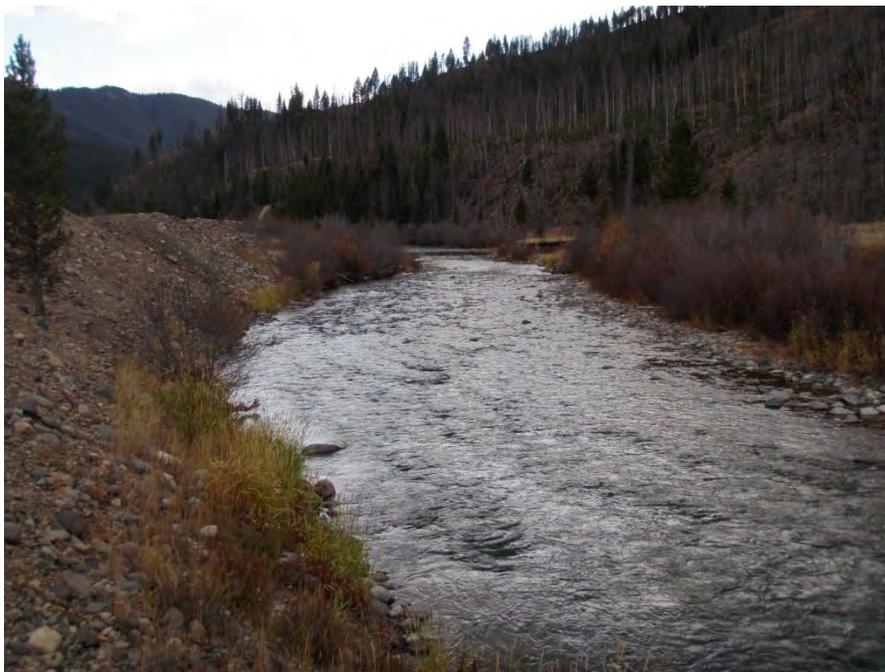
Photograph No. 154. View to the south looking downstream at eroding banks along the Yankee Fork. Yankee Fork of the Salmon River, Yankee Fork Subbasin, Idaho – Bureau of Reclamation Photograph by E. Lyon, October 26, 2011.
