Pole Flat Area Baseline Condition Assessment
Yankee Fork of the Salmon River,
Upper Salmon Subbasin

Custer County, Idaho

U.S. Department of the Interior
Bureau of Reclamation
Pacific Northwest Region
Pacific Northwest Regional Office, Boise, Idaho

October 2012

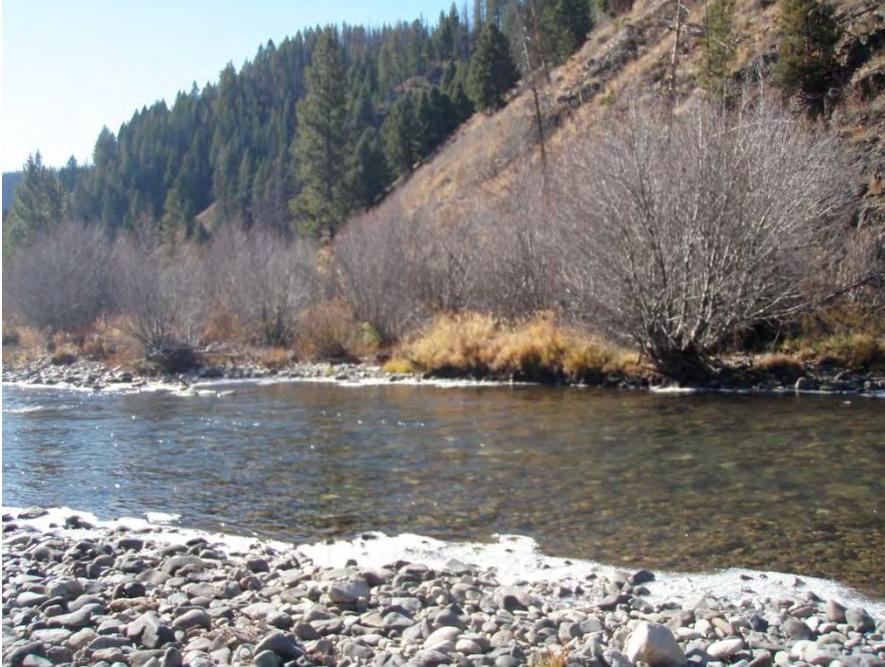
Photograph No. 158. View to the south looking downstream at lateral scour pool along river left that is forced by a mine tailings mound along the Yankee Fork. Yankee Fork of the Salmon River, Yankee Fork Subbasin, Idaho – Bureau of Reclamation Photograph by E. Lyon, October 26, 2011.

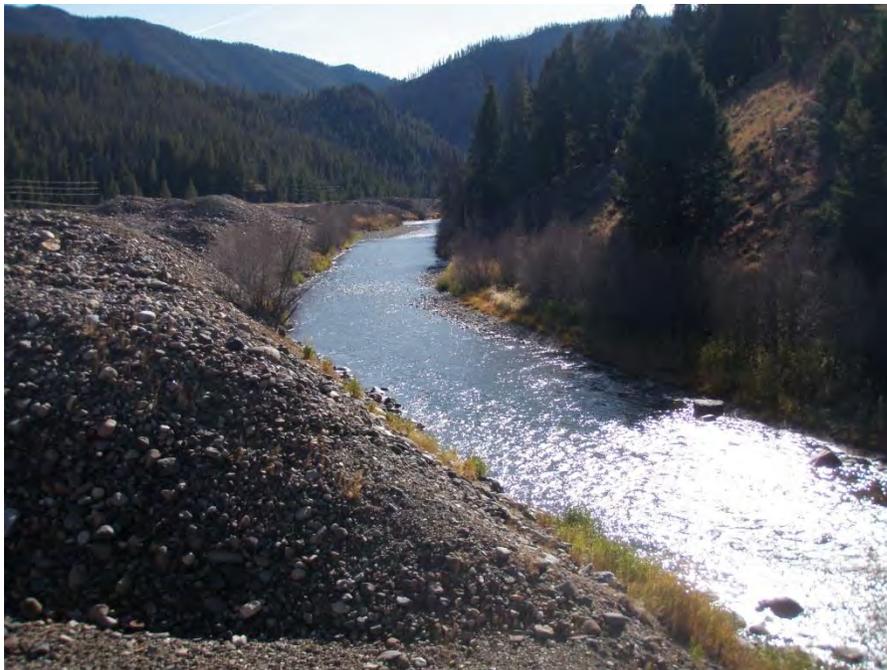
Photograph No. 162. View to the south looking downstream at lateral scour pool forced by mine tailings mound along the Yankee Fork. Yankee Fork of the Salmon River, Yankee Fork Subbasin, Idaho – Bureau of Reclamation Photograph by E. Lyon, October 26, 2011.

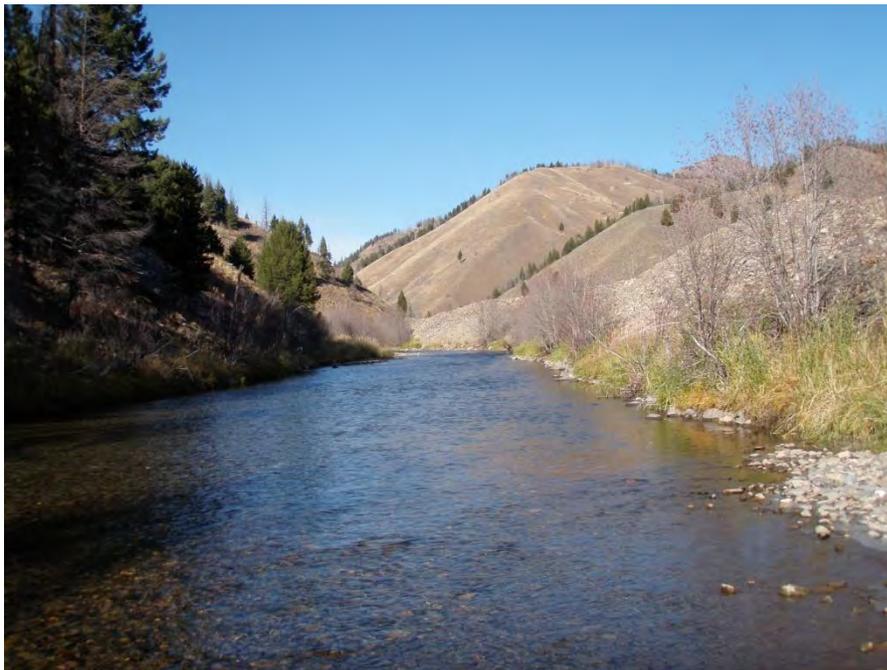
Photograph No. 163. View to the south looking downstream along a confined channel segment constrained by mine tailings, colluvial deposits and bedrock along the Yankee Fork. Yankee Fork of the Salmon River, Yankee Fork Subbasin, Idaho – Bureau of Reclamation Photograph by E. Lyon, October 26, 2011.

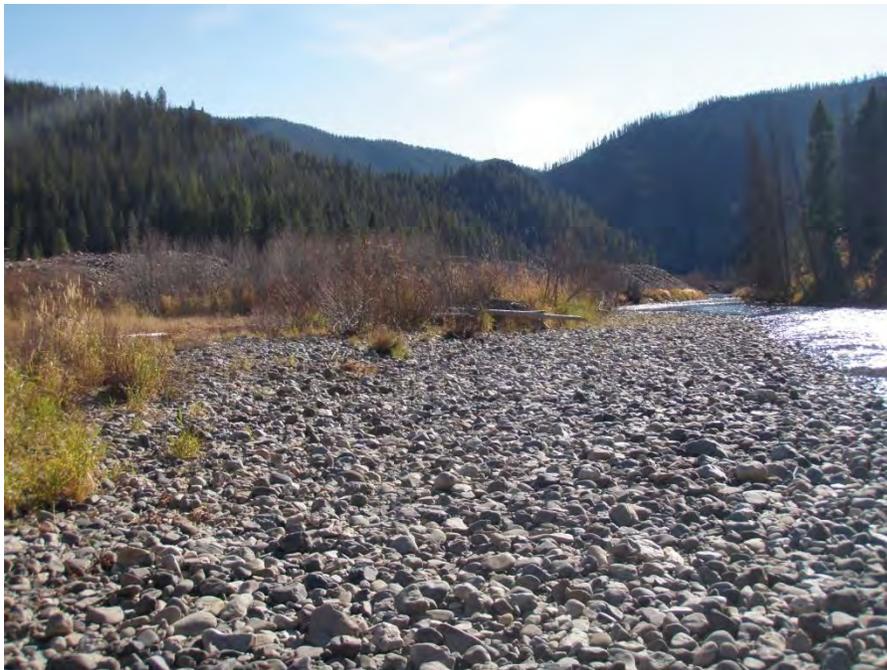
Photograph No. 164. View to the north looking upstream at confined, plane-bed channel along the Yankee Fork. Yankee Fork of the Salmon River, Yankee Fork Subbasin, Idaho – Bureau of Reclamation Photograph by E. Lyon, October 26, 2011.

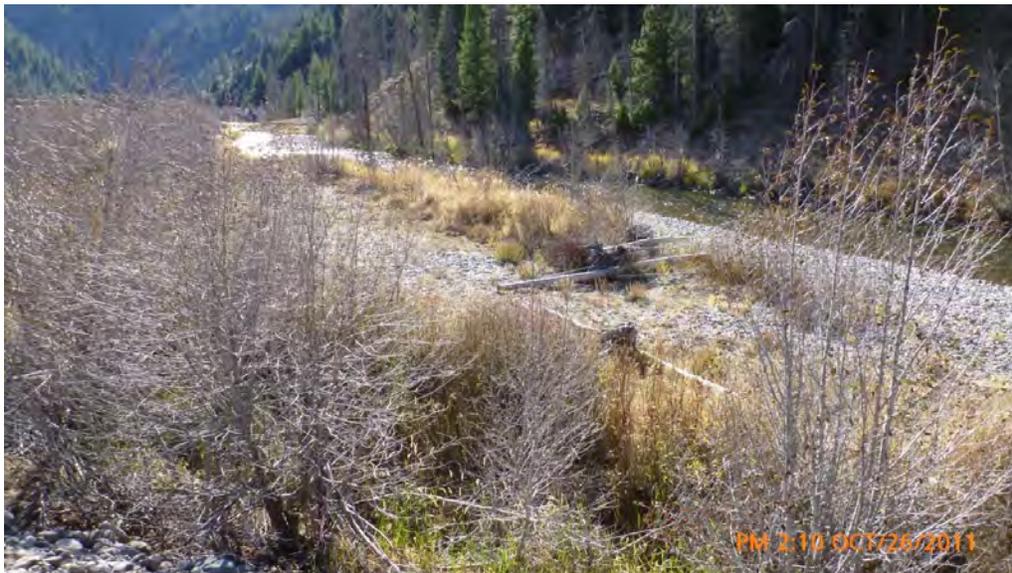
Photograph No. 165. View to the south looking downstream at floodplain patch on river left where a split-flow type channel activates during channel forming flows along the Yankee Fork. Yankee Fork of the Salmon River, Yankee Fork Subbasin, Idaho – Bureau of Reclamation Photograph by E. Lyon, October 26, 2011.

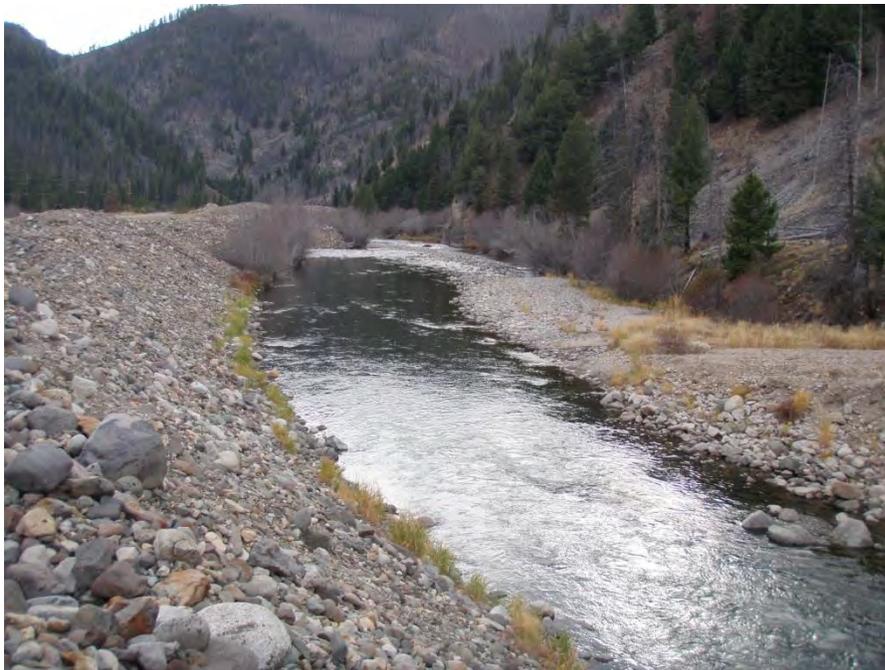
Photograph No. 167. View to the south looking downstream at eroding banks caused by debris flows from an unnamed tributary near RM 3.7 forcing the channel to adjust laterally toward the left bank along the Yankee Fork. Yankee Fork of the Salmon River, Yankee Fork Subbasin, Idaho – Bureau of Reclamation Photograph by E. Lyon, October 26, 2011.

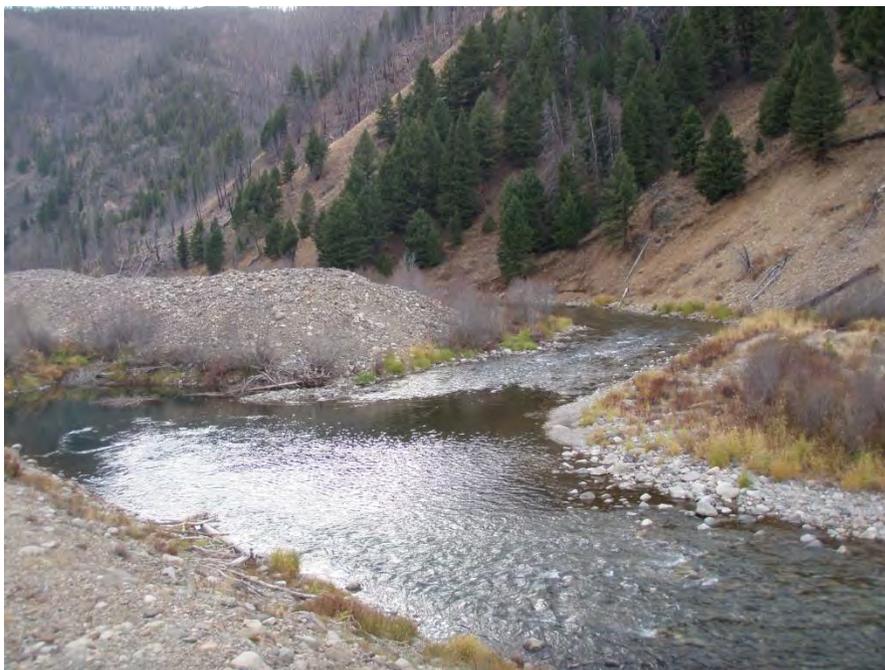
Photograph No. 168. View to the south looking downstream at middle channel pool caused by mine tailing mounds that forces the river to flow around the mounds along the Yankee Fork. Yankee Fork of the Salmon River, Yankee Fork Subbasin, Idaho – Bureau of Reclamation Photograph by E. Lyon, October 26, 2011.

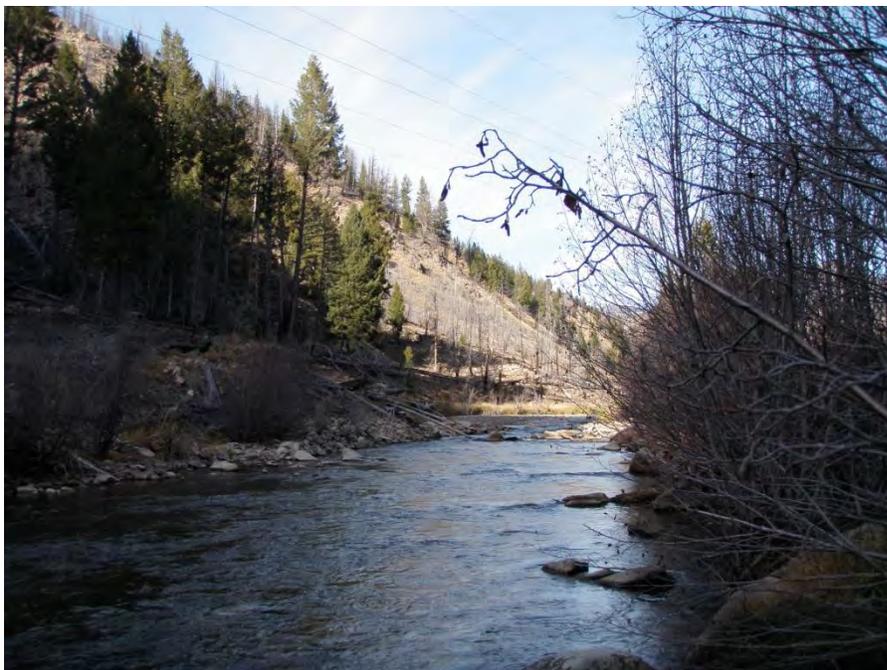
Photograph No. 169. View to the north looking upstream where the channel becomes naturally confined by bedrock and colluvial deposits near RM 3 along the Yankee Fork. Yankee Fork of the Salmon River, Yankee Fork Subbasin, Idaho – Bureau of Reclamation Photograph by E. Lyon, October 26, 2011.

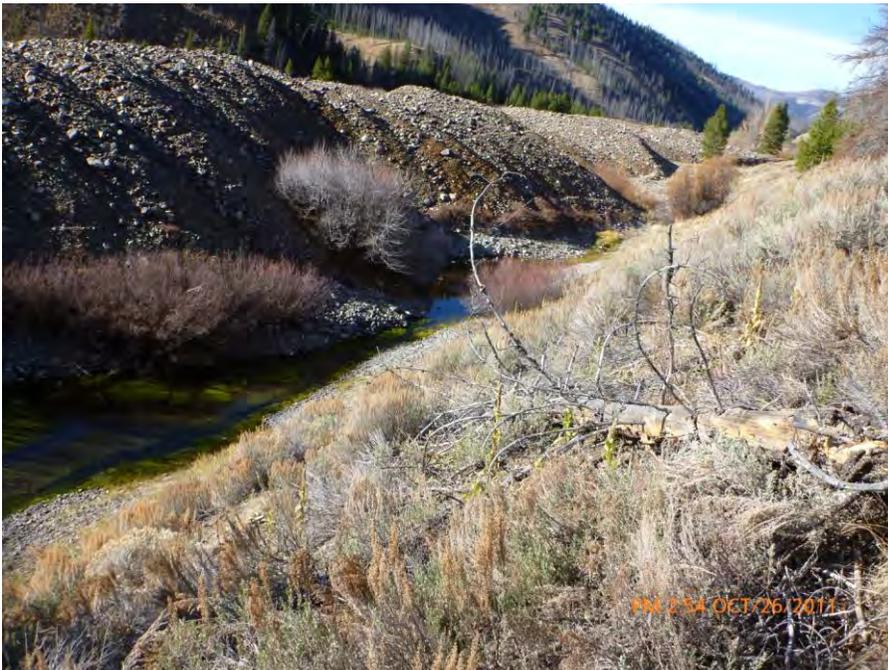
Photograph No. 171. View to the south where Silver Creek could potentially be diverted into Pond Series One. Yankee Fork of the Salmon River, Yankee Fork Subbasin, Idaho – Bureau of Reclamation Photograph by P. Drury, October 26, 2011.

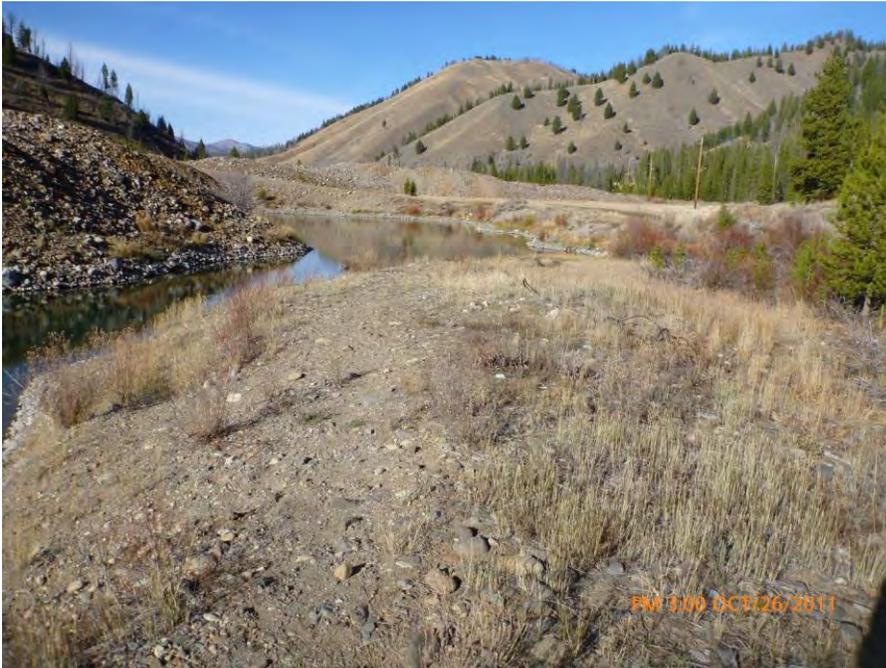
Photograph No. 175. View to the south looking across a meadow where a constructed channel is being considered to connect the upper ponds and Silver Creek along Pond Series One. Yankee Fork of the Salmon River, Yankee Fork Subbasin, Idaho – Bureau of Reclamation Photograph by P. Drury, October 26, 2011.

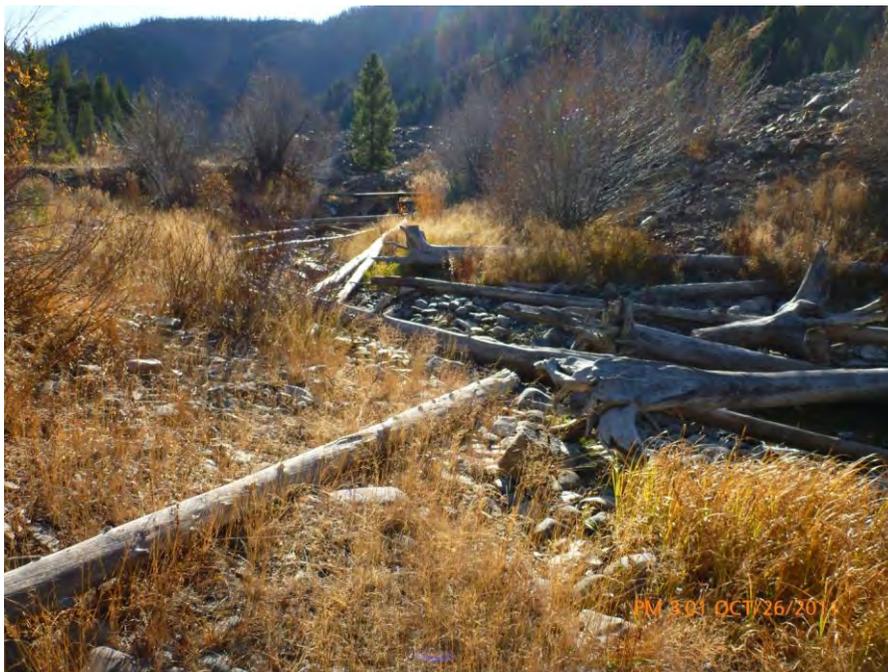
Photograph No. 178. View to the south looking downstream accumulated (or placed) wood along Pond Series One. Yankee Fork of the Salmon River, Yankee Fork Subbasin, Idaho – Bureau of Reclamation Photograph by P. Drury, October 26, 2011.

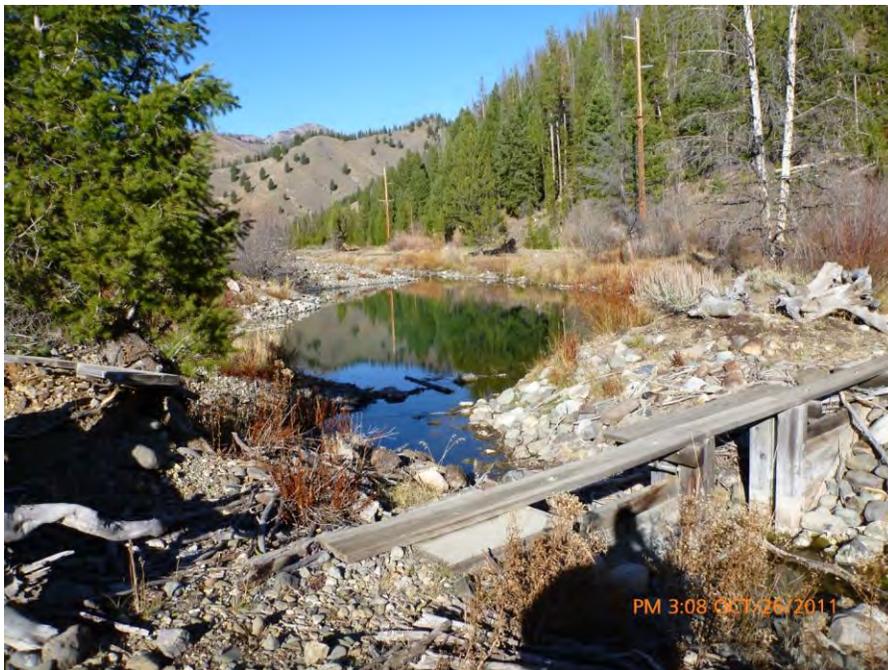
Photograph No. 185. View to the northeast looking upstream at check structure along Pond Series One. Yankee Fork of the Salmon River, Yankee Fork Subbasin, Idaho – Bureau of Reclamation Photograph by P. Drury, October 26, 2011.
