Yankee Fork Tributary Assessment Upper Salmon Subbasin

Custer County, Idaho

U.S. Department of the Interior
Bureau of Reclamation
Pacific Northwest Region
Pacific Northwest Regional Office, Boise, Idaho

January 2012

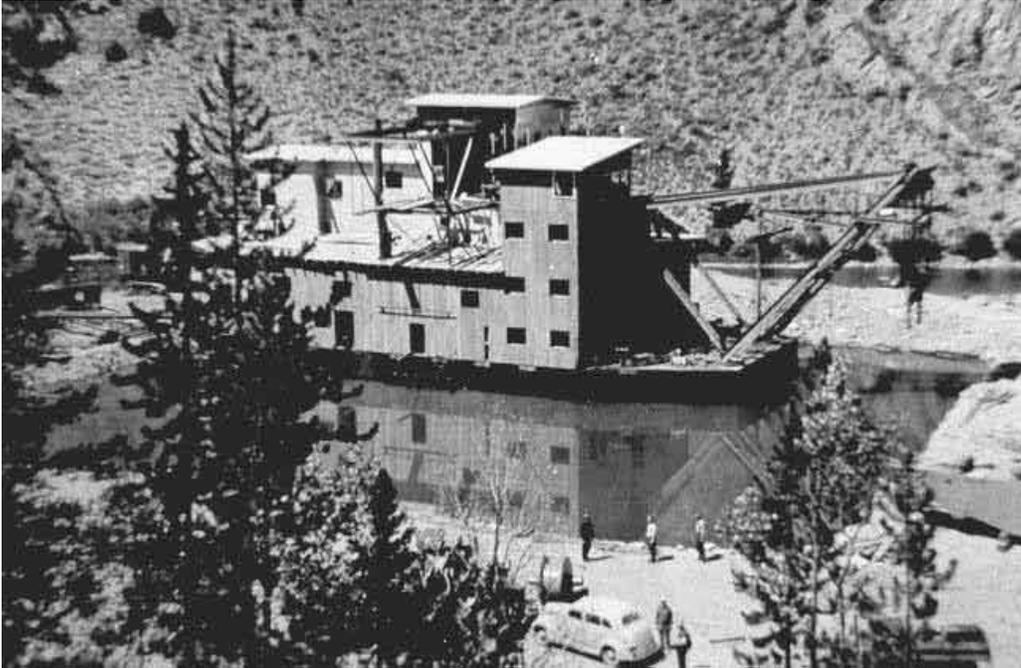
Figure 6. Yankee Fork Gold Dredge
(<http://www.fs.fed.us/r4/sc/yankeefork/pointsofinterest.shtml#dredge>).

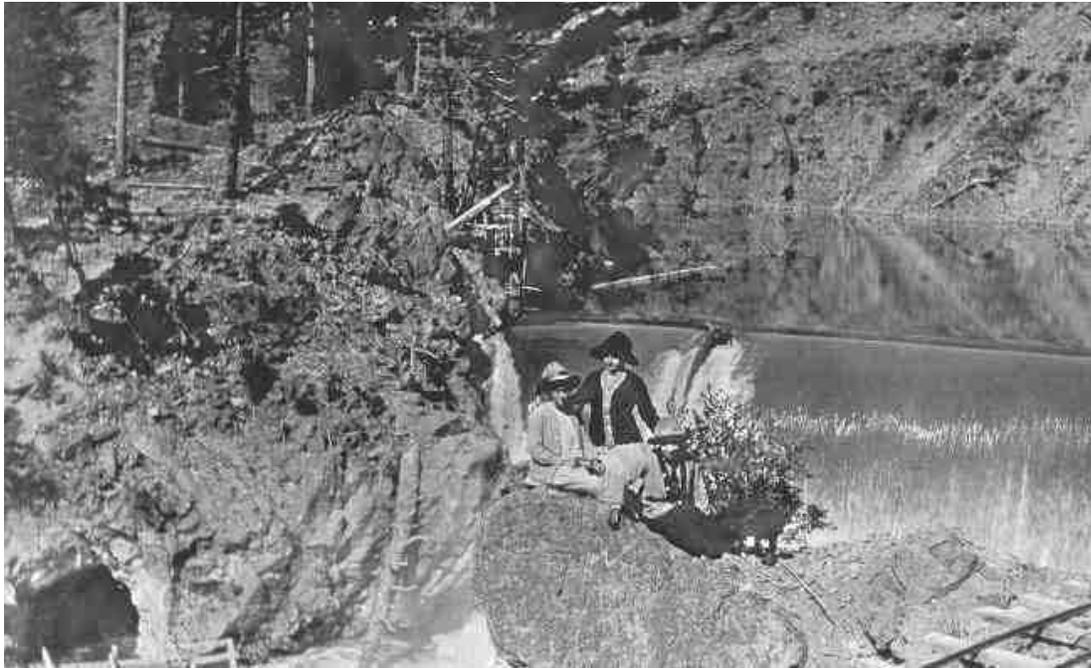
Figure 7. Sunbeam Dam on the Salmon River
(http://www.fs.fed.us/r4/sc/yankeefork/sunbeam_1.shtml).

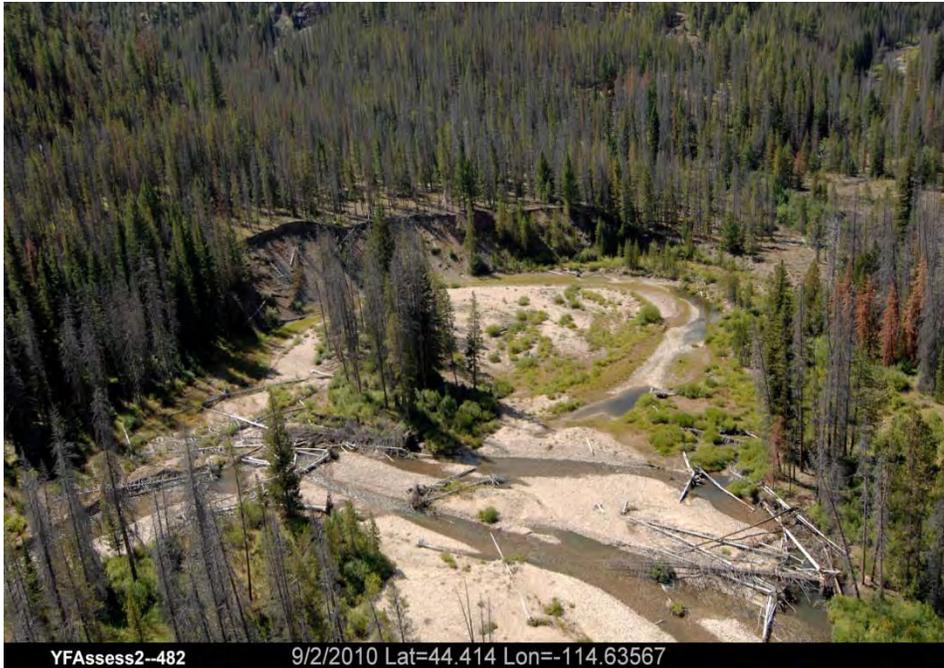
Figure 23. View to the southwest near RM 14.9 showing forced alluvial channel variability. *Wood complexes influence variability in channel processes and habitat complexity. Lake and glacial outwash deposits (eroded high bank in the background) are common in this geomorphic reach and provide sediment inputs of predominantly gravel to fines.* Bureau of Reclamation photograph by Dave Walsh, September 2, 2010.

Other anthropogenic disturbances that have affected channel/floodplain processes include road embankments along the Custer Motorway adjacent to the channel, the Fivemile Creek Bridge crossing near RM 13.9, and dispersed campsites. Road embankments have encroached on the river in some locations and placement of bank protection along sections of the embankments affect lateral channel migration and bed scour along hard-points in localized areas. The Fivemile Creek Bridge causes artificial channel confinement, disconnects localized floodplain areas, and appears to create a backwater condition upstream of the bridge by imparting hydraulic controls at the 2-year and above recurrence floods. Campsites adjacent to the river impact riparian vegetation needed for bank stability and channel boundary roughness, and may provide additional fine sediment inputs to the river. However, at the reach-scale these anthropogenic disturbances affect a relatively small percentage of the geomorphic reach and modifications (or rehabilitation actions) would not significantly benefit fish production or abundance.

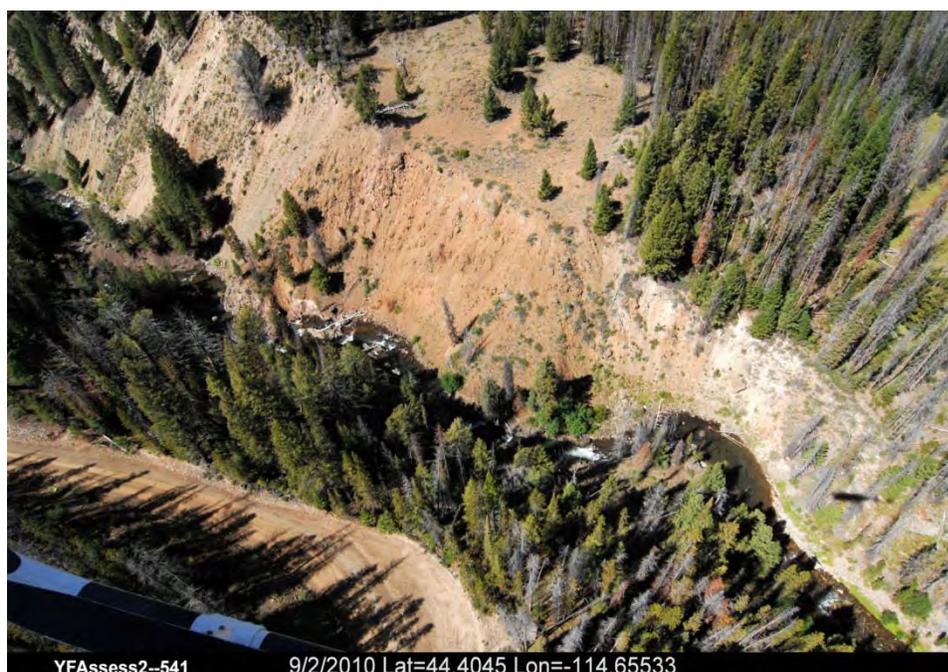
Figure 25. View to the west near RM 13.2 showing bedrock channel. *The channel is in essentially a bedrock canyon and has developed predominantly a step-pool bedform.* Bureau of Reclamation photograph by Dave Walsh, September 2, 2010.

There are no anthropogenic disturbances within the canyon (Figure 25), but there are some disturbances below the canyon related to road embankments along the Custer Motorway adjacent to the channel, and the Custer Bridge crossing near RM 12. The Custer Motorway was constructed, for the most part, along the valley walls in this reach, but does encroach on the channel near RM 11.7. Modeling results suggest that the Custer Bridge creates backwater conditions by imparting hydraulic controls during the 10-year and higher recurrence flood event. However, the overall impacts to reach-scale channel processes from these anthropogenic features are negligible.

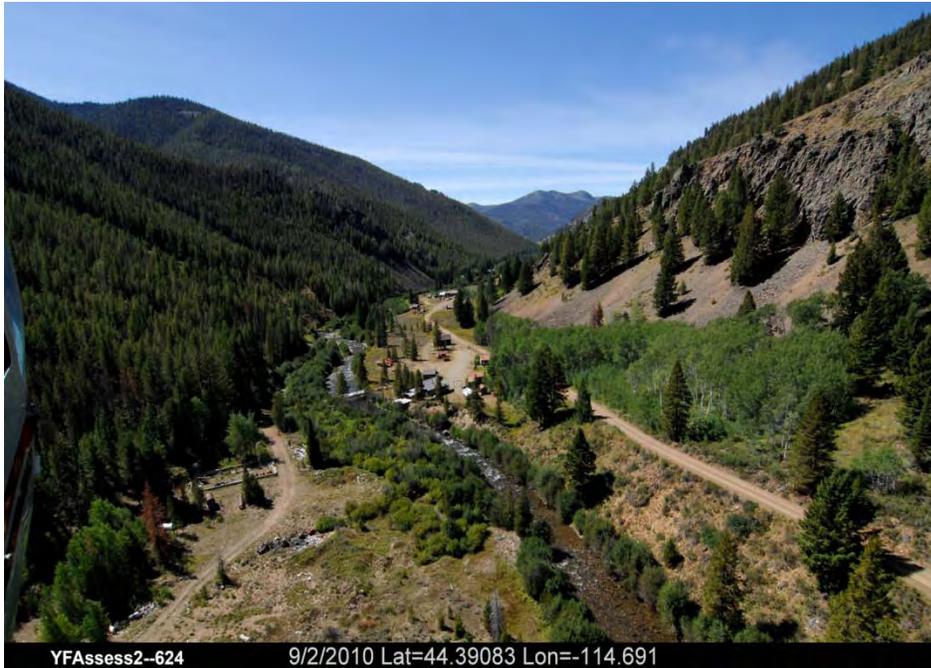
Figure 27. View to the southwest near RM 11.1 showing floodplain clearing associated with development. Mining activities have been occurring along river left (left foreground in photo); the residential development is protected from overbank flow by a levee along river right (center of photo); and General's Bridge that provides access to the mining site constrains the channel.
Bureau of Reclamation photograph by Dave Walsh, September 2, 2010.

Other anthropogenic disturbances that have affected channel/floodplain processes include General's Bridge near RM 10.9 that confines the channel and exerts hydraulic control at the 10-year and above recurrence floods; a levee placed near RM 10.3 to protect a mining operation disconnects channel/floodplain interactions; and a deflection berm that protects a mining operation placed near RM 10 that restricts lateral channel migration and confines the channel (Figure 27). The overall impact of these anthropogenic features on channel processes and floodplain connectivity at the reach-scale is minimal, and rehabilitation of these areas probably would not significantly increase fish production in this reach.

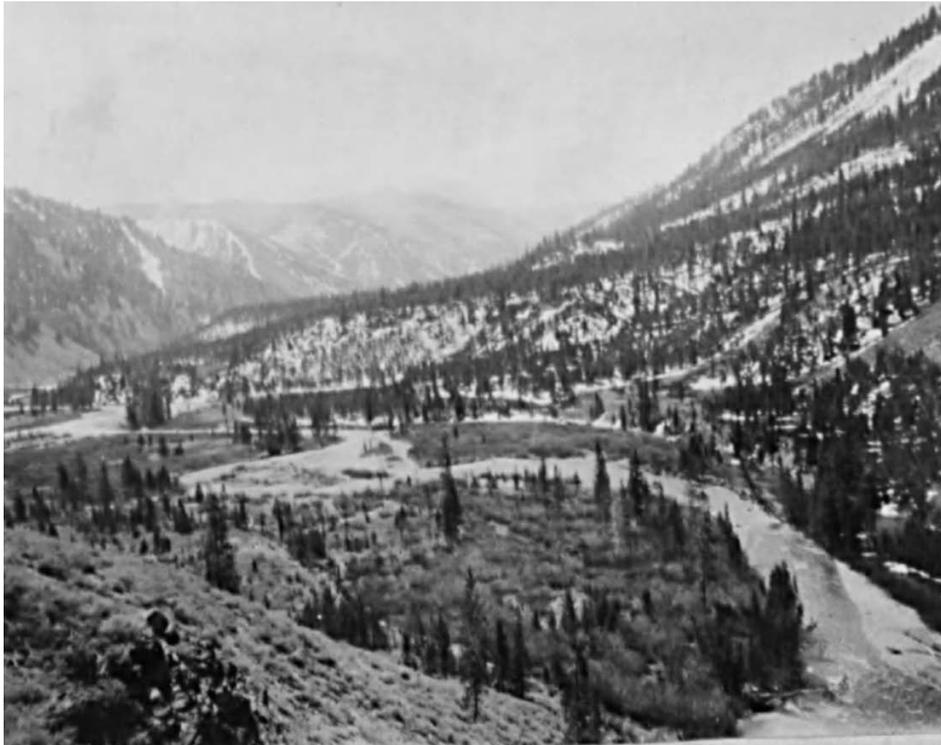
Figure 31. View is to the north looking upstream from near RM 6.8 toward the Yankee Fork and West Fork confluence (Smith 1911). Photograph taken by Maven Sawyer, winter of 1910.

Historically (pre-dredging), the valley bottom constraints were from higher surfaces (comprised predominantly of glacial outwash), alluvial fans, and bedrock. From about RM 7.5 to 6.9, the channel was unconfined and the river had developed a broad floodplain and channel/floodplain interactions were connected (Figure 31). The river had a straight-to-meandering channel pattern that indicates a low-to-moderate rate of lateral channel migration was occurring. Channel type was a free-formed alluvial channel with some vegetated islands and wood complexes creating flow convergence and divergence. The floodplain contained riparian shrub and upland tree species that contributed to the development of channel morphology and habitat structure.

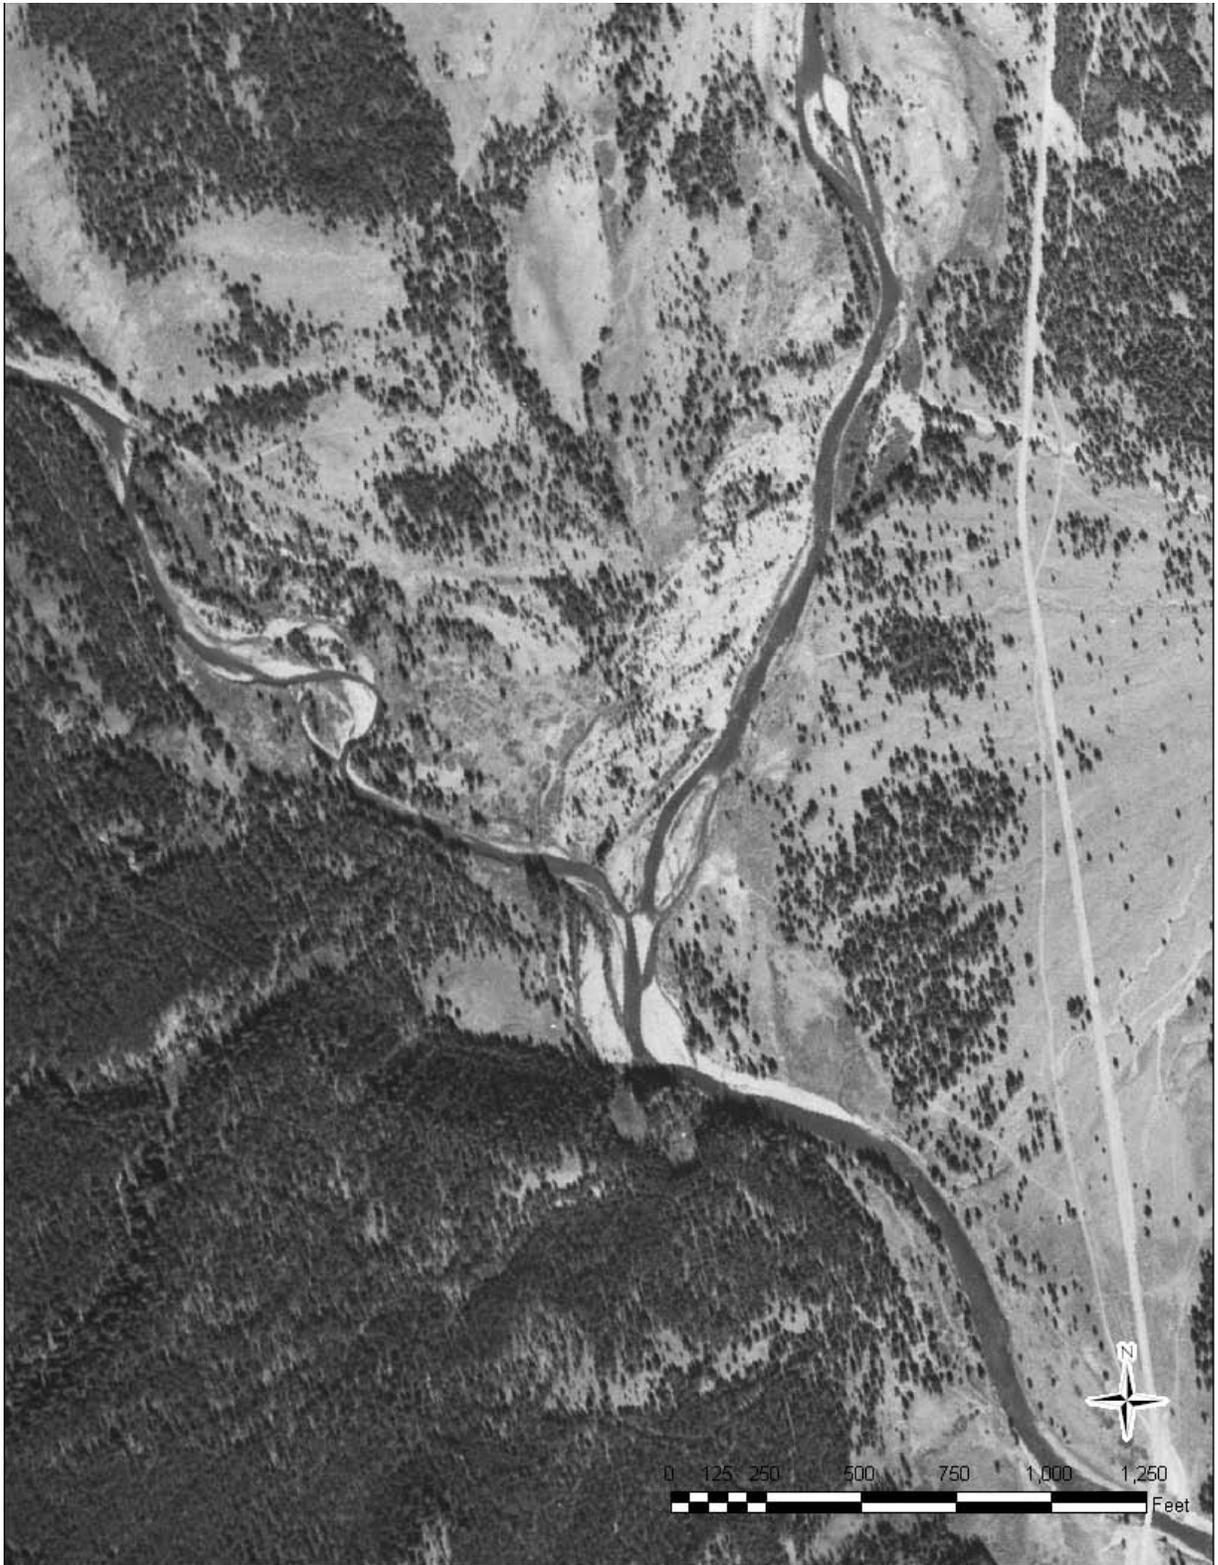
Figure 32. 1945 aerial photograph of West Fork and Yankee Fork confluence.

In the 1945 aerial photographs, the channel flowed along the right valley wall between RM 9.1 and 8.4 and a new channel was constructed through the dredge tailings along the left valley wall by the 1966 aerial photographs. Between about RM 8.3 and 7.5, the channel has essentially remained in the same location based on the 1945 to 2010 aerial photographic record; however, in order for the dredge to have operated in this location, the channel had to be at least temporarily impounded or otherwise manipulated to support the floating dredge. From RM 7.3 to 6.8, the channel was rerouted away from the West Fork confluence and disconnected from floodplain areas by dredge tailings sometime between 1945 and 1952 (Figure 32 and Figure 33).

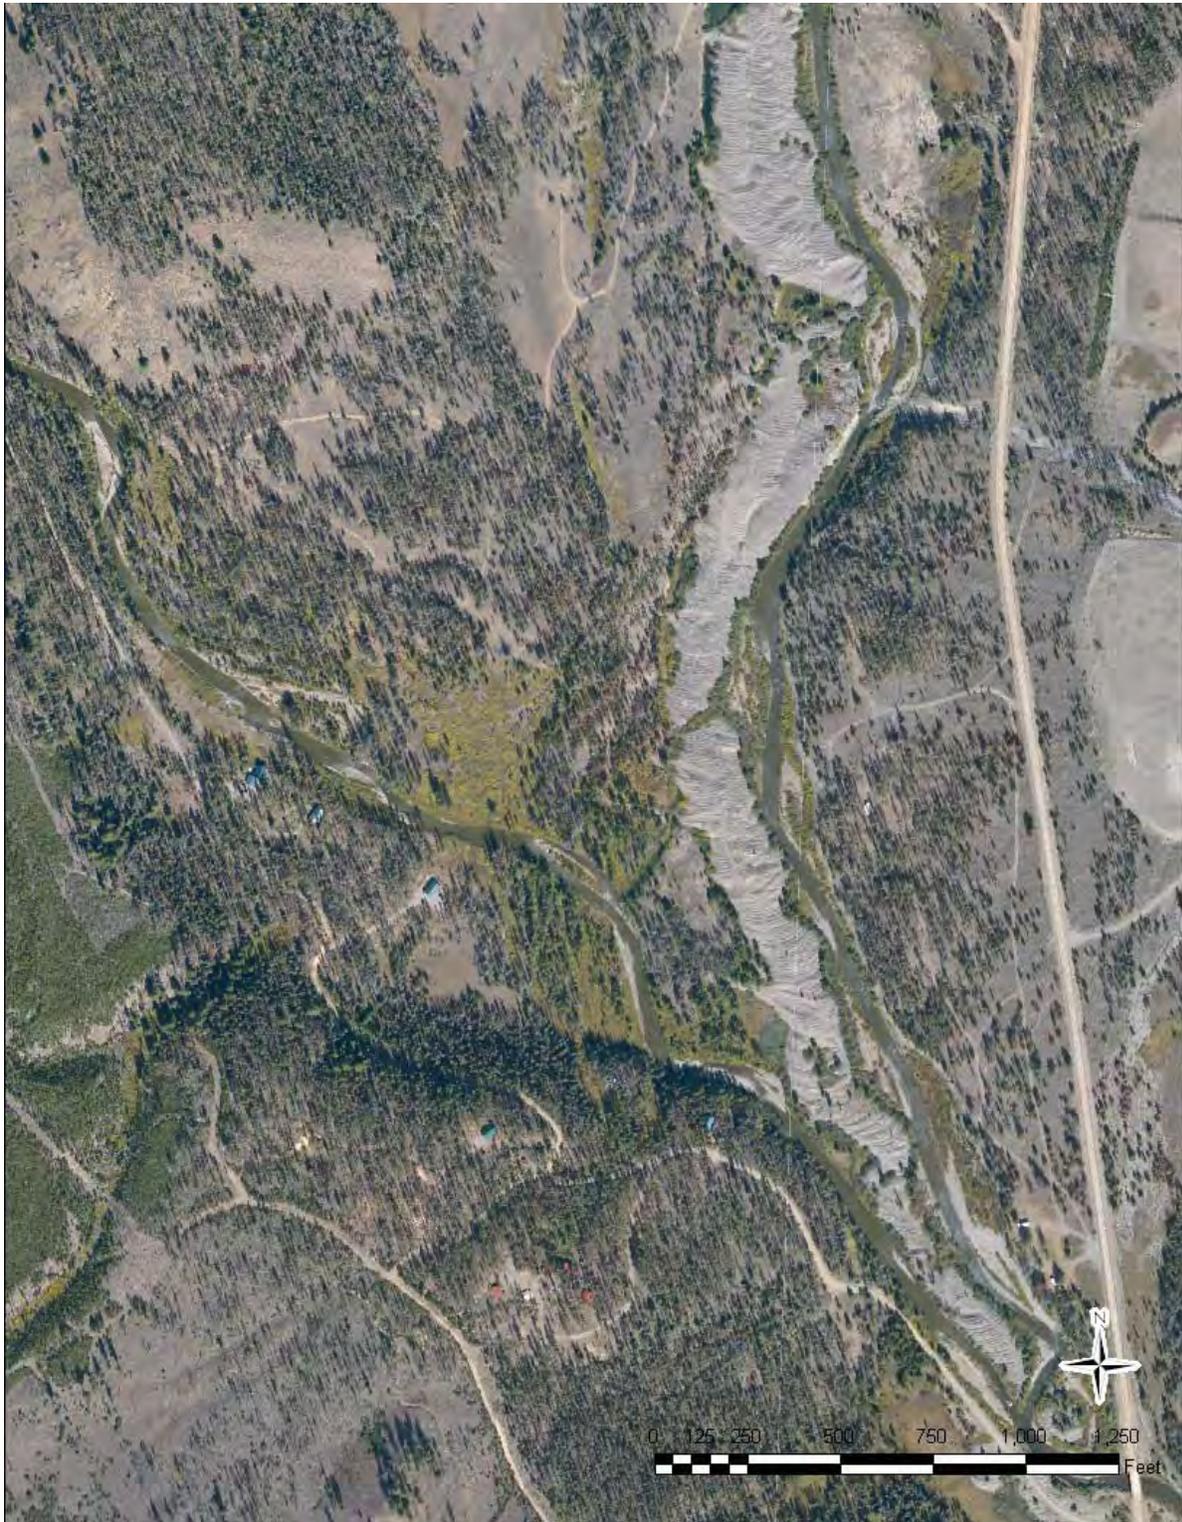
Figure 33. 2010 aerial photograph of West Fork and Yankee Fork confluence.

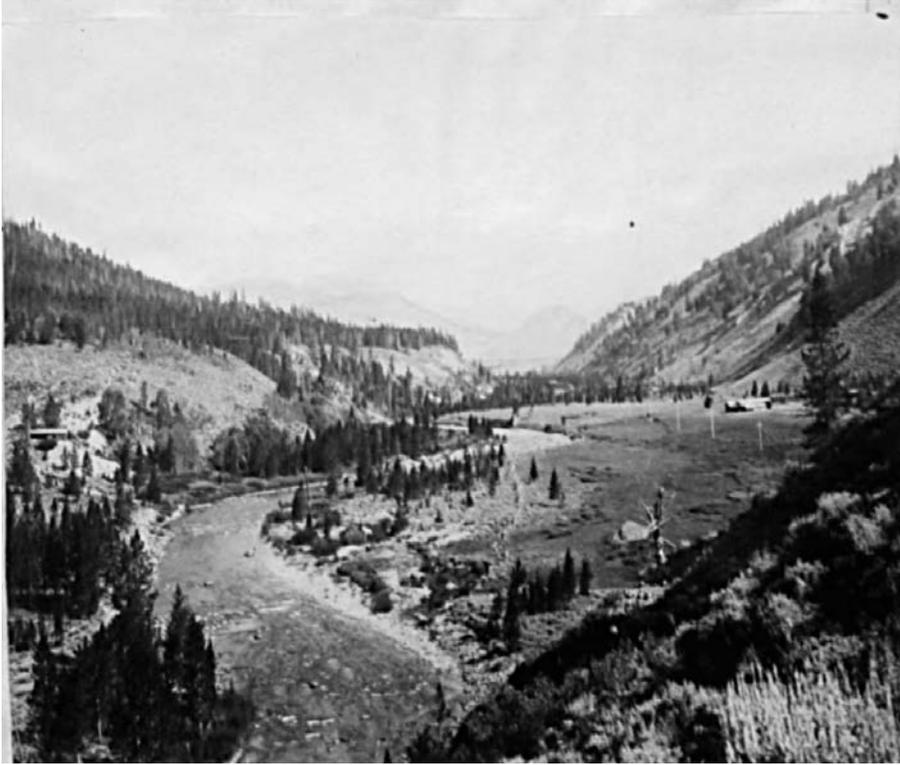
Figure 35. View is to the north looking upstream from glacial terrace near RM 5.2 at Jerrys Creek alluvial fan (Smith 1911).

Historically (pre-dredging), the channel was moderately confined based on valley bottom constraints from glacial terraces and outwash, alluvial fans, and bedrock (Figure 35). The river had a relatively straight channel pattern that indicates a low rate of lateral channel migration was occurring. Channel type was a plane-bed (USDC 1934), free-formed alluvial channel with a cobble-dominated substrate. There were small-to-moderate sized patches of floodplain accessible to the river during high flows, but these floodplain areas were not extensive (Figure 36), and qualitatively appear similar to their present (2010) extent (Figure 37). In addition, three perennial tributaries were connected to the Yankee Fork that included Cearley Creek, Jerrys Creek, and Silver Creek.

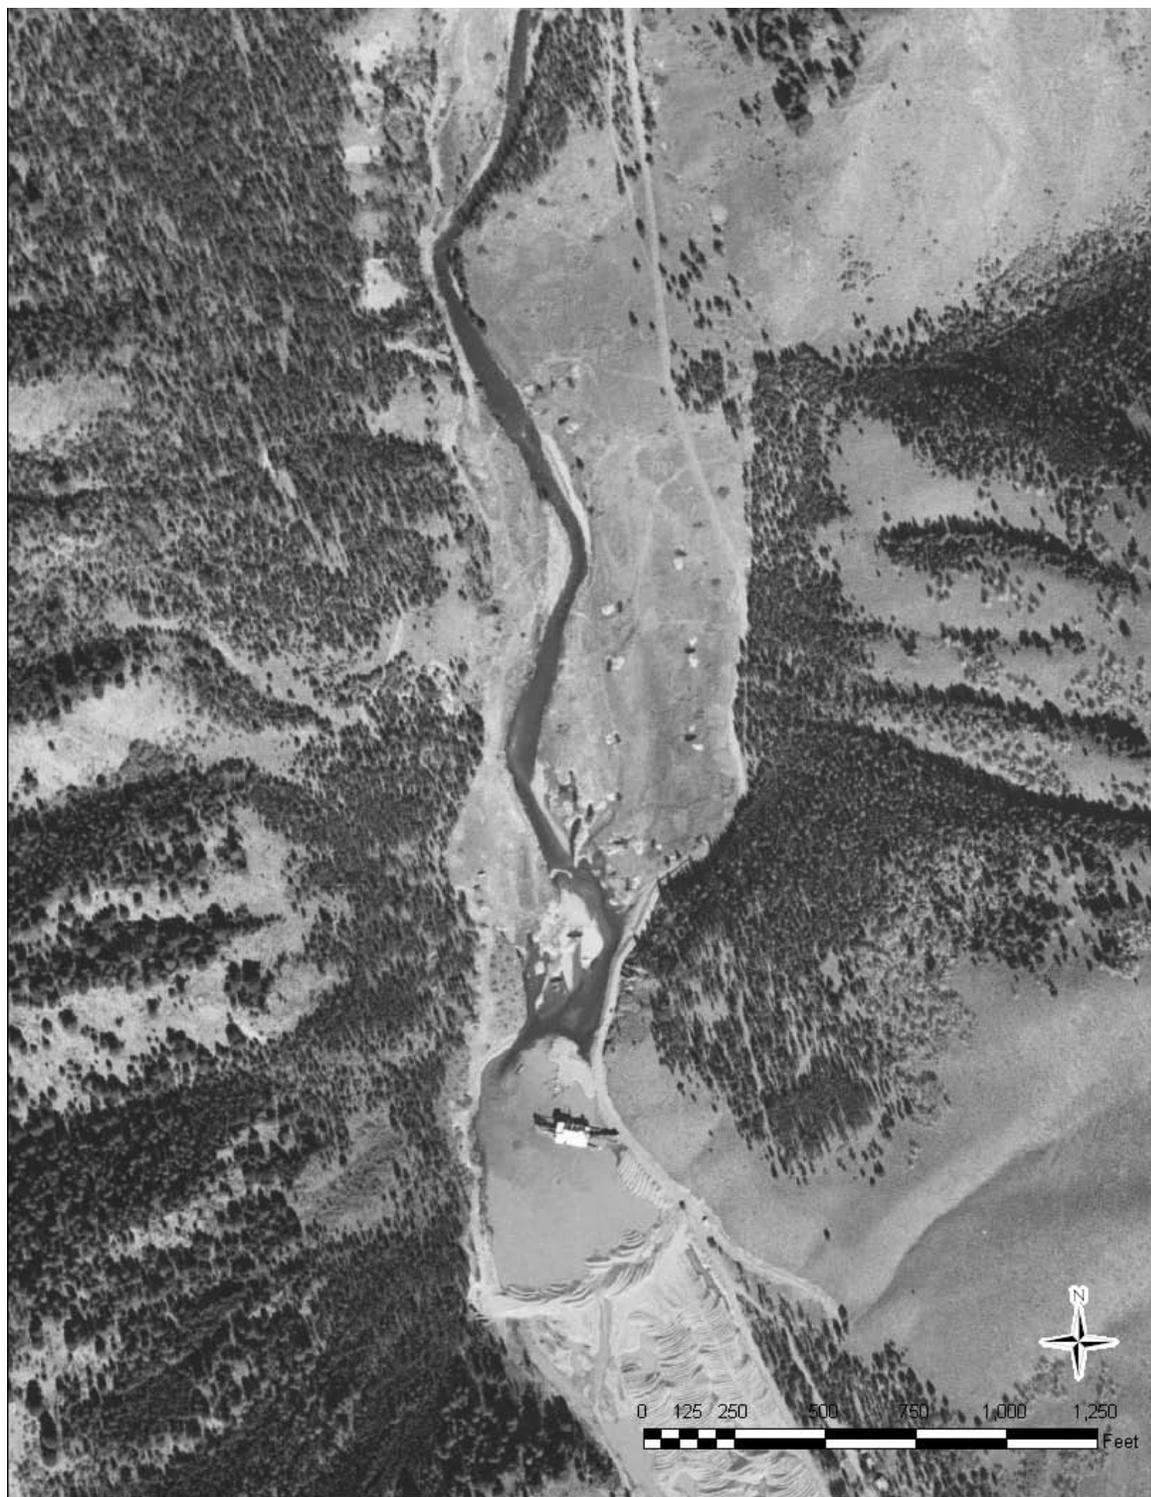
Figure 36. 1945 aerial photograph of Yankee Fork near Jerrys Creek. *Note the floating dredge in the lower center of the photograph and the dredge tailings deposited across the valley floor.*

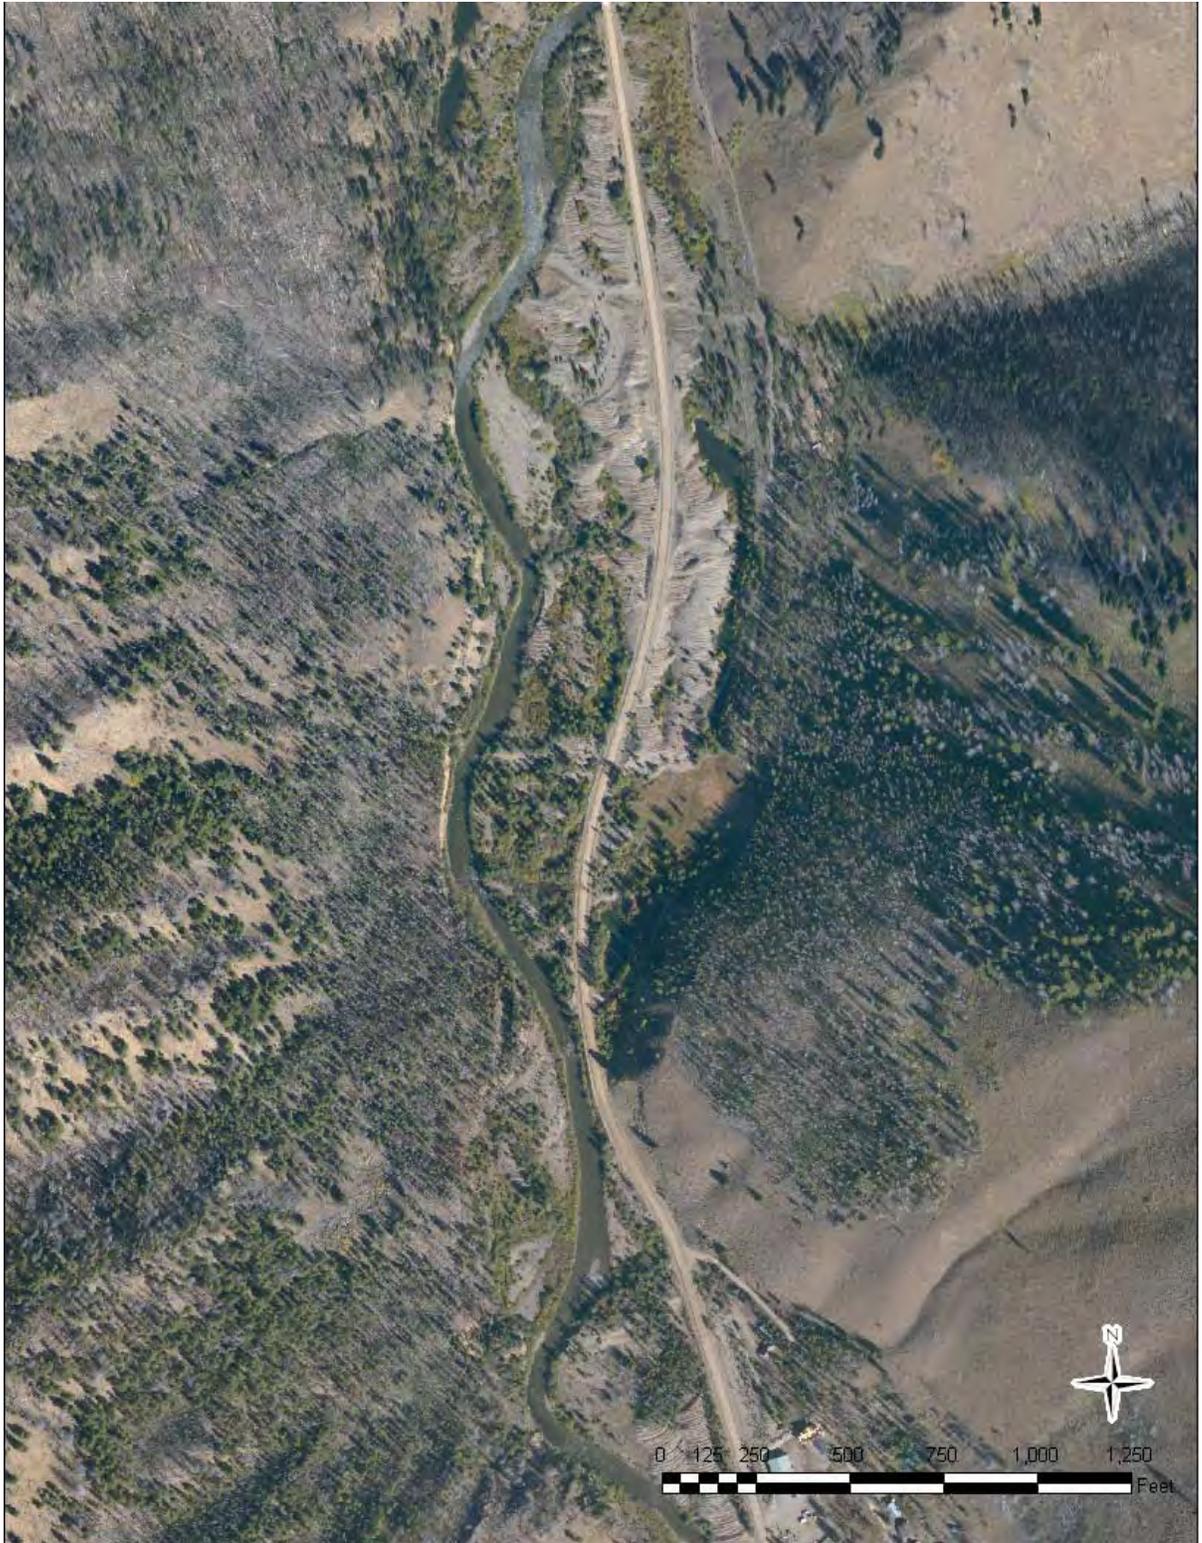
Figure 37. 2010 aerial photograph of Yankee Fork near Jerrys Creek.

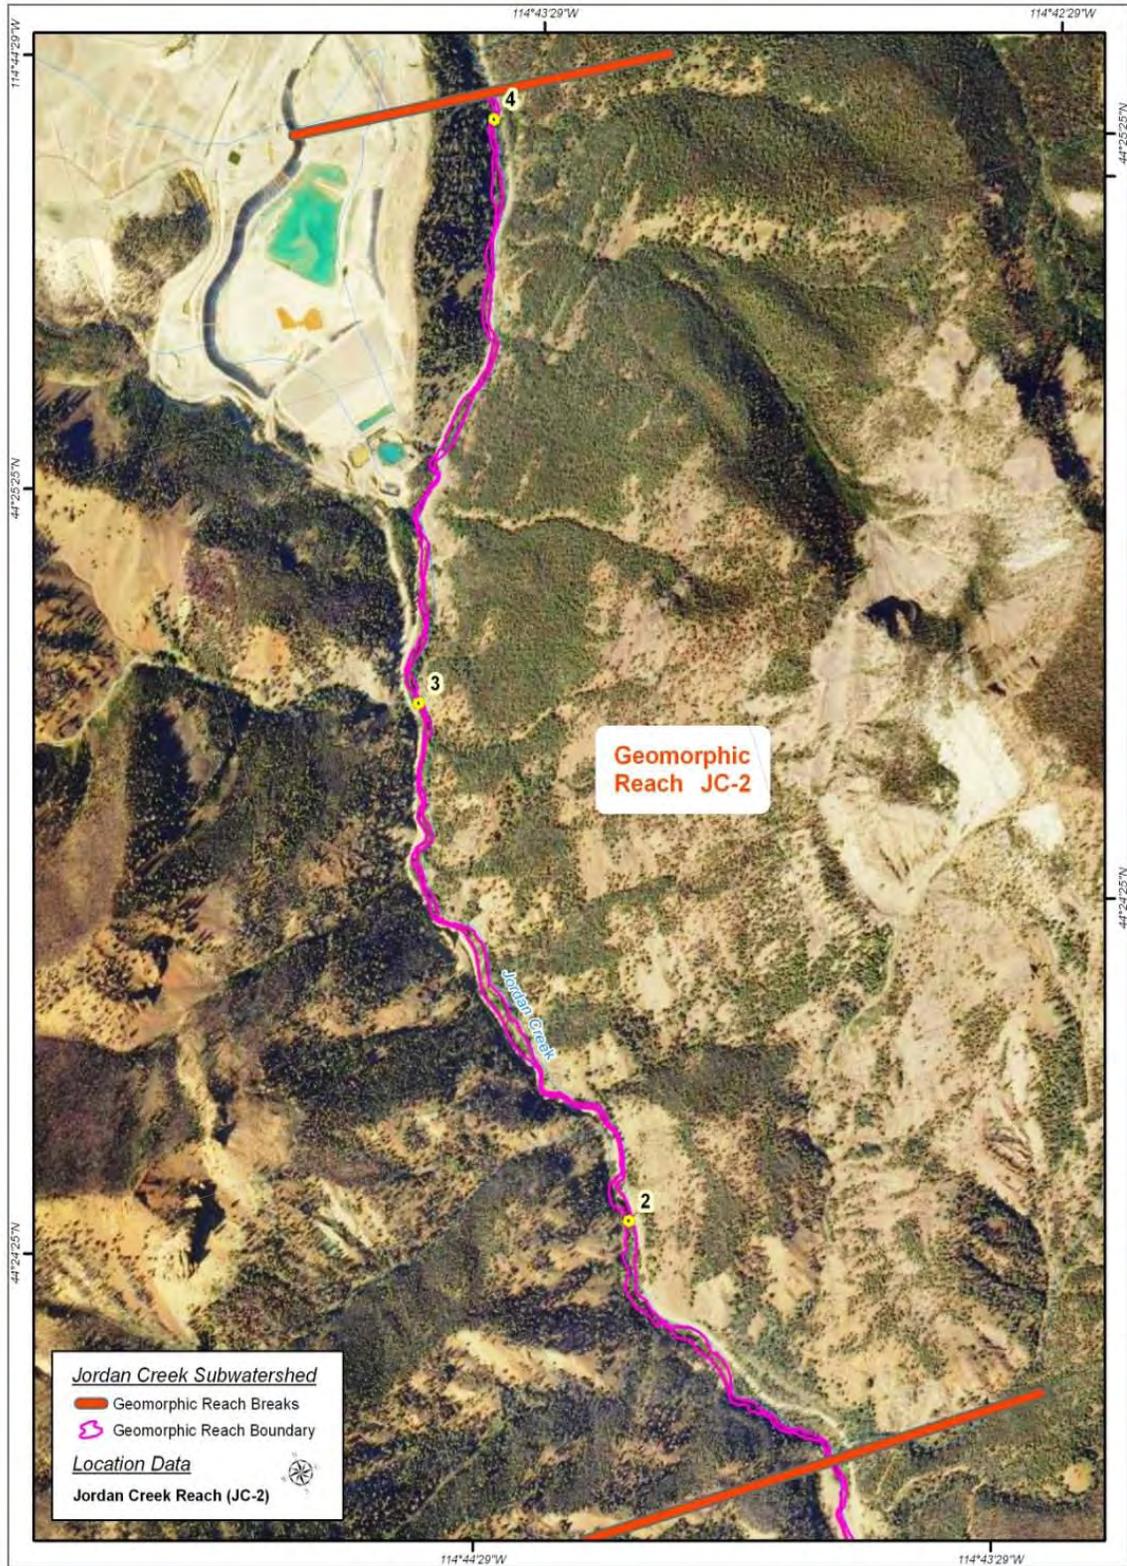
Figure 41. Jordan Creek Geomorphic Reach JC-2 in the Jordan Creek subwatershed.

Geomorphic Reach JC-2 (Figure 41) is located between RM 4.0 and 1.4 in a moderately-confined valley segment that is constrained by bedrock with colluvial, glacial, alluvial fan, and landslide deposits that further constrain the channel. The channel type is predominantly a bedrock channel with alternating plane-bed and pool-riffle bedforms and has a straight channel pattern. Channel slope is about 2.9 percent with a cobble-dominated substrate with boulders and bedrock being very common.
