# **More Fish Use Reconnected Side Channel near Elbow Coulee**

## **Methow River, Washington**

**Bureau of Reclamation**

May 2013

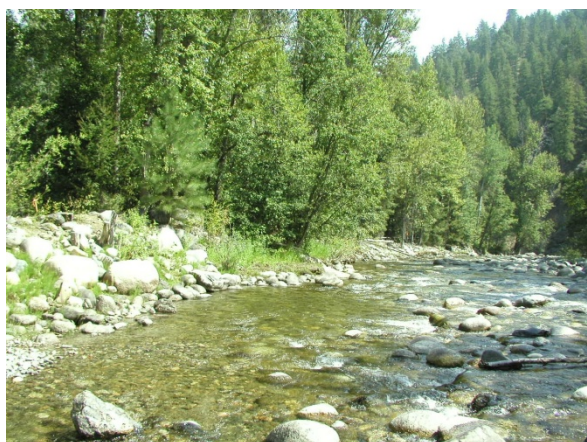
1)

Photo 1. Levee at river left along Twisp River conceals the side channel with extensive floodplain rearing habitat. Photograph was taken in summer 2008 looking east.

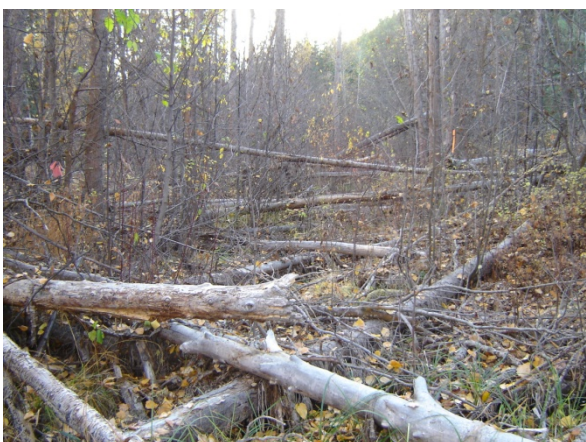
2)

Photo 2. Disconnected side channel showing numerous downed trees and woody vegetation. Photograph was taken in 2006 looking down-gradient viewing northeast.

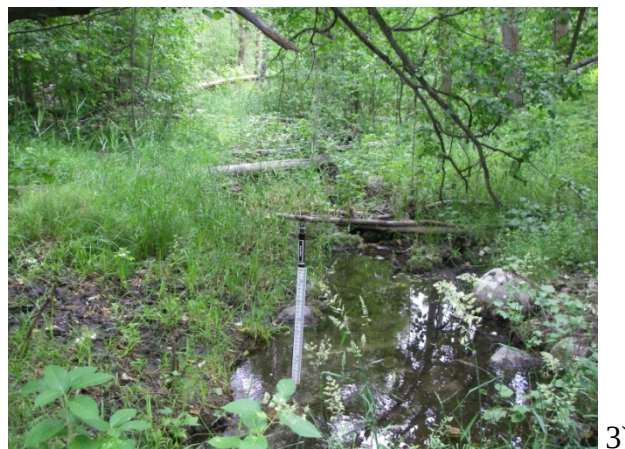
3)

Photo 3. Before the project, this previously groundwater fed side channel had a terminal connection to the Twisp River. A levee was breached at the upstream end of the Elbow Coulee side channel along the left bank of the Twisp River in Fall 2008. A monitoring program was soon initiated in the side channel, which received its first flows from the Twisp River in 2009 during the spring freshet. The photograph was taken in summer 2008 looking northeast down gradient.

The perennial nature of groundwater inputs provide at least 700 linear feet of rearing habitat for fish including spring Chinook salmon and steelhead, along the entire length of the baseflow wetted channel (Crandall, 2009) (Photo 3). The perennial groundwater provides year-round downstream connectivity to the Twisp River and monitoring results indicate juvenile fish are using the side channel for rearing.

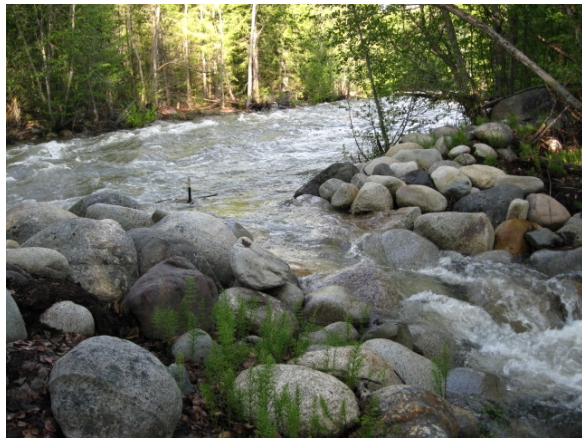
4)

Photo 4. View looking west and upstream of the side channel confluence with the Twisp River and the reconstructed inlet of the side channel. The view shows side channel activation during high water May 2010.

Twisp River flows greater than approximately 580 cfs are sufficient to crest the rock sill in the breach and fish would have uninhibited passage into the upstream end of the side channel (Crandall, 2009) (Photos 4 – 5). Once in the side channel, fish would have the ability to move downstream within the side channel and also back into the Twisp River at the terminus of the side channel. Thus, flows in excess of 600 cfs are sufficient to allow passage for all life stages of fish. Due to the extended length of activation this last year, fine sediment and smaller particles were flushed out of the breach and it is expected to activate at a lower discharge (Crandall, 2011, unpublished communication). This will be confirmed in 2012 during the winter/spring flows. This adjustment is a natural outcome of a system allowed to freely adjust and settle out.

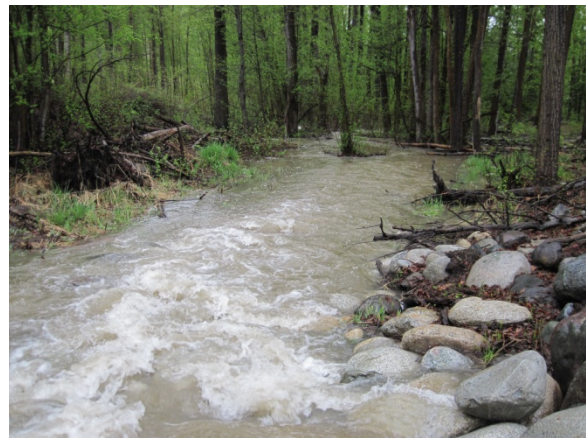
5)

Photo 5. The same event as Photo 4, downstream view of the activated side channel looking northeast during high water spring 2010.

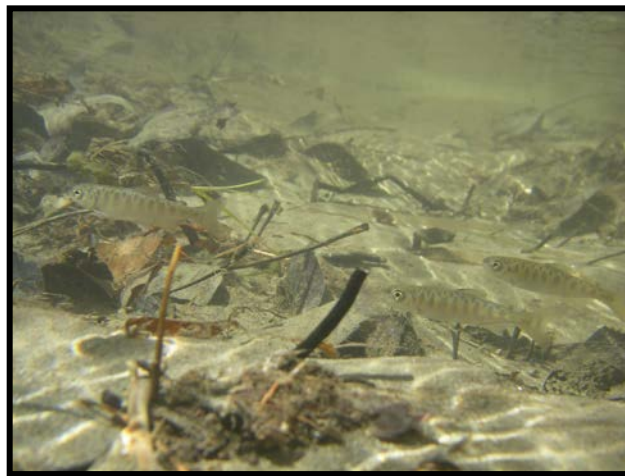
6)

Photo 6. Endangered spring Chinook salmon, *Oncorhynchus tshawytscha*, in the Elbow Coulee side channel during the first post-construction spring channel activation event, June 2009.

In late 2008, 42 fish representing three species were captured and identified during an electrofishing survey (Figure 2). Fish were captured along the entire length of the wetted channel and were most commonly observed in the deeper portions of the channel in pools (Crandall, 2009) (Photo 6). A subsequent electrofishing survey in late 2011 recorded an almost three-fold increase from 2008 in fish abundance and a greater diversity of fish species present in the side channel.

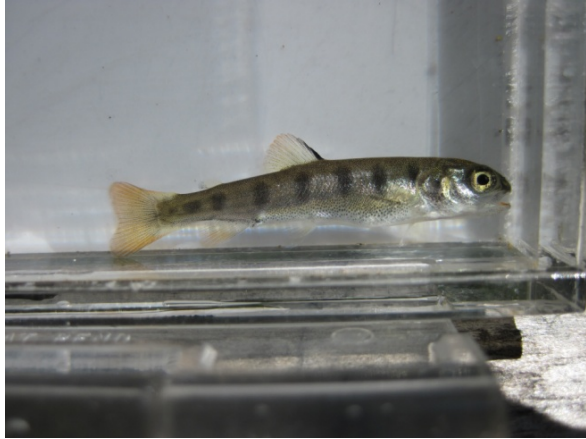
7)

Photo 7. A rearing wild young-of-the-year rainbow/steelhead trout collected from the side channel during May 2010.

While rearing-sized fish were observed in the side channel prior to reconnection, the presence of young-of-the-year fish, including ESA listed salmonids, in the uppermost pool in the side channel is strong evidence that these fish gained access to the side channel through the newly constructed breach (Photos 7 – 8). Although it is plausible that 40 mm salmonids could have gained access to and entered the side channel from the bottom, the presence of larval sculpin (less than 20mm) that lack the swimming ability to move upstream through the side channel, is evidence that fish are entering the side channel through the newly created breach. Thus, it was concluded that fish gained access to the side channel during the first activation event post-emergence and resided in the channel (Crandall, 2009). Based on observations, the period of fish residency is estimated at several weeks to months and possibly longer for fish that select to remain in the groundwater influenced portion of the channel. Future monitoring will focus on determining whether undesired stranding is occurring and whether the channel may begin to prematurely fill in with fine sediment and detritus.

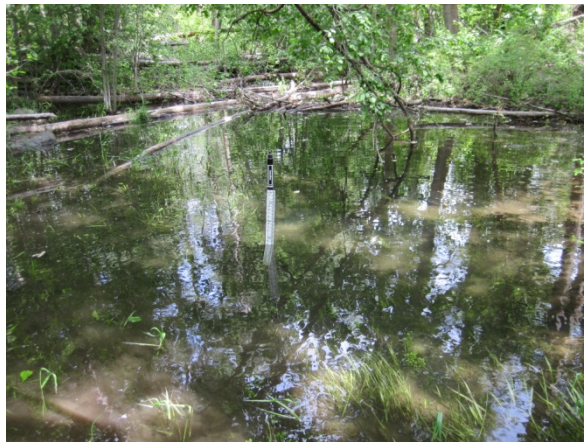
9)

Photo 9. Pond habitat in July 2011 on the activated side channel created by a beaver dam construction just downstream of the flow monitoring site established in early 2009. Note that photo location is identical to Photo 3.

In 2011, beaver constructed two dams just downstream of the flow monitoring site in the side channel (Photos 9 – 10). While the ponds that resulted from this activity disrupted the continuous flow monitoring instrumentation by flooding the area, listed fish species were observed using the ponds almost immediately (Molesworth, USBR, pers. comm.). This change in habitat type has increased habitat complexity within the channel through increased pool habitat, wetted width and large woody debris.

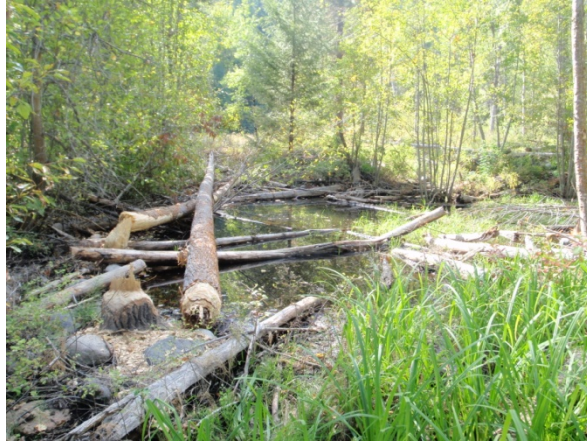
Photo 10. Beaver dams built in 2010 resulted in two ponds within the side channel that were subsequently inhabited and used for rearing by listed fish species.
