Riparian Habitat Management Plan

Upper Lemhi River, Leadore, ID

January 6, 2016

Prepared for Lemhi Regional Land Trust
Project Name Leadore Land Partners Conservation Easement,
 Upper Lemhi River, Leadore, ID
Project Number E51509700
Project Manager Rob Richardson
Date January 6, 2016

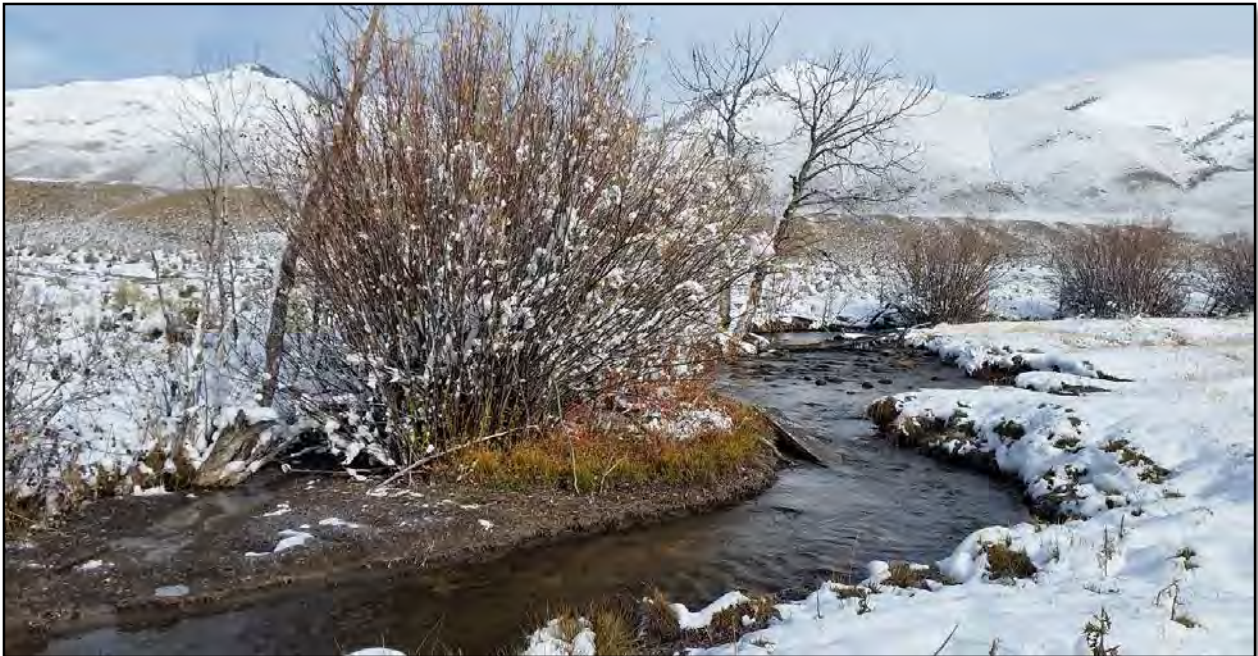
Figure 3-1 Representative photo of Canyon Creek

Within the Isom Upper Pivot Field. Photo is taken looking upstream illustrating three floodplain surfaces – low surface with willow, moderate surface with sparse cottonwood and/or grass, and high surface with sage and rabbit brush.

Within Isom Upper Pivot Field (Figure 3-1)

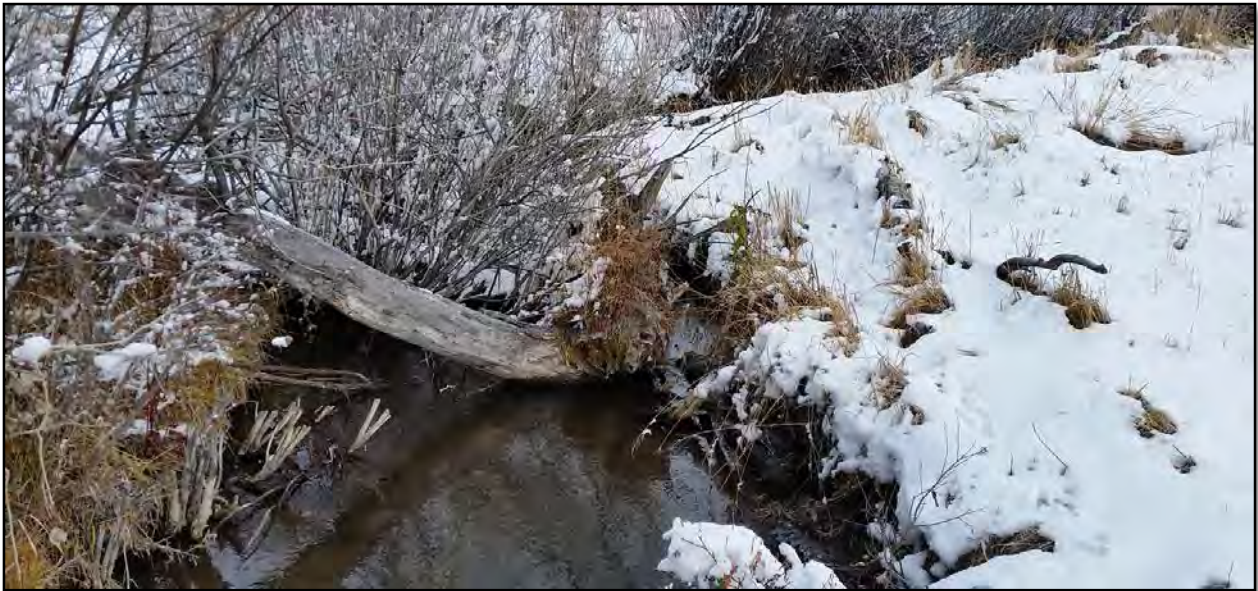
Figure 3-2 Forced pool formed as a result of scour

Associated with an obstruction (large woody cottonwood debris seen in the photo) and backwater from willow growth obstructing the channel (located behind the photographer, not seen in the photo). Photo taken looking upstream.

- > Forced riffle-pool (Figure 3-2)
 - > Pools are typically a result of backwater conditions upstream of channel obstructions (large woody debris or live willow encroachment; occasional gravel/cobble riffles)

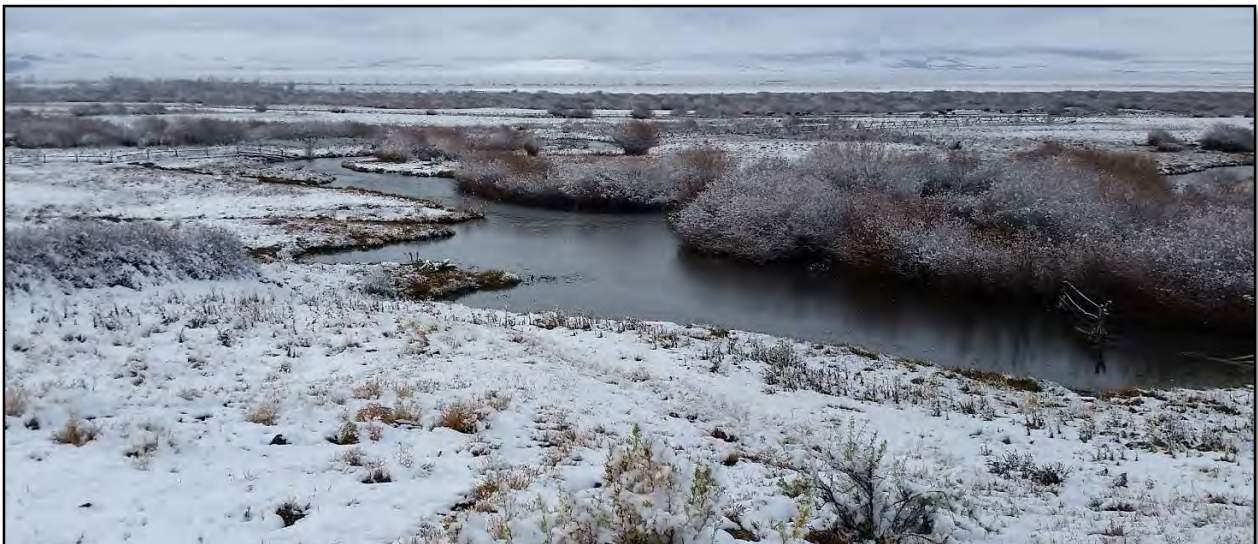
Figure 3-5 **Photos of the Lemhi River at Faye illustrating representative conditions where grazing has not been excluded**

The channel has a high width-to-depth ratio and willow Riparian vegetation is sparse, typically located on the inside of meander bends.

- With grazing (Figure 3-5)
 - > Little to no new willow growth or expansion even in low-lying areas
 - > Heavy browse and observable damage on existing willow plants

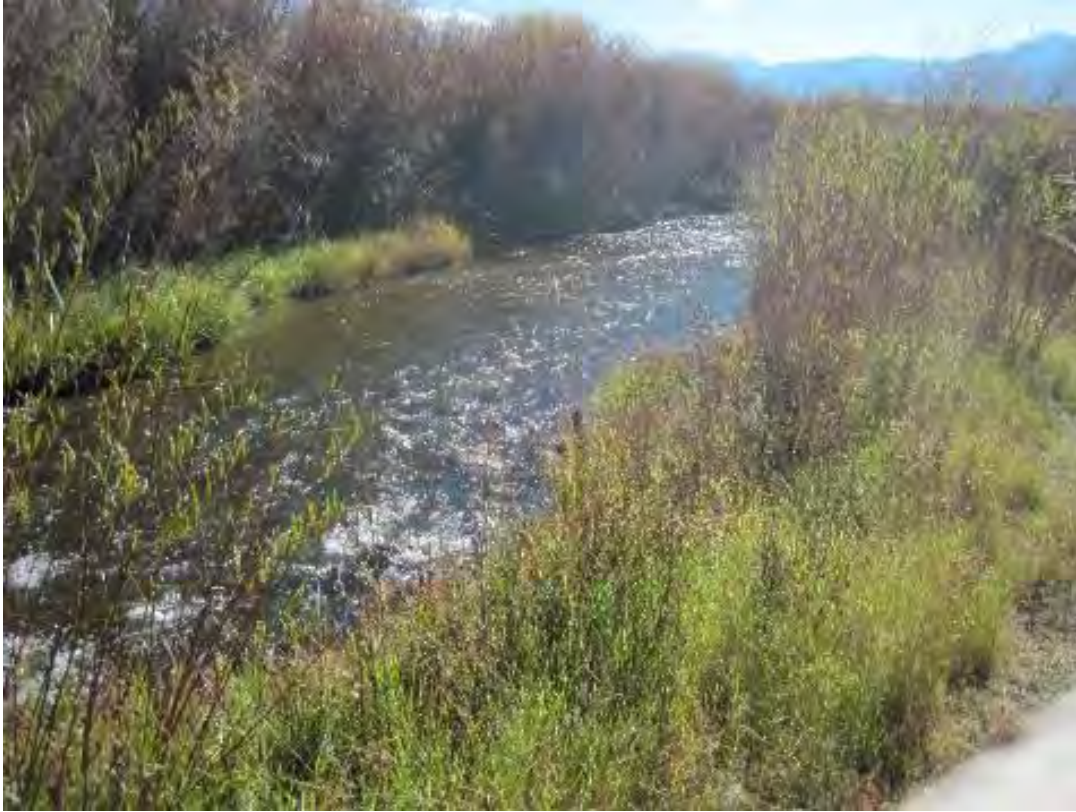
Figure 3-6 **Photo of the Lemhi River near the downstream end of the project site illustrating representative conditions where grazing has been largely excluded**

Dense willow Riparian growth dominates the low floodplain areas, while higher banks are more sparsely vegetated with willow

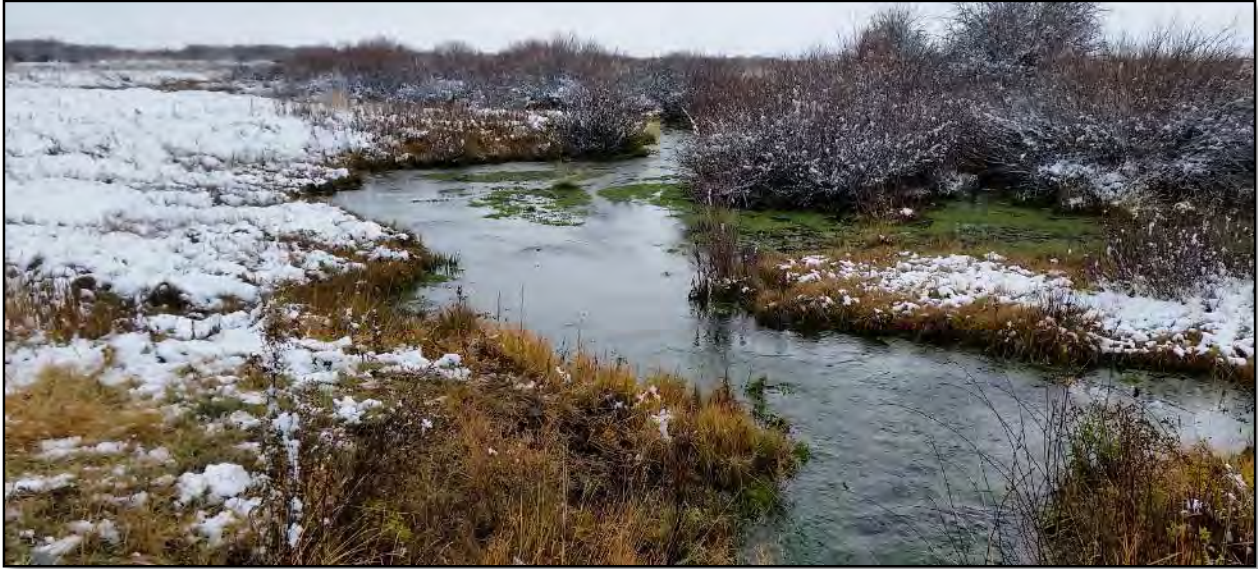
Figure 3-7 **Representative photo illustrating the headwaters area of Big Springs Creek**

Photo is taken looking upstream along the southern branch of the channel. Note the sparse willow Riparian vegetation on high banks (left half of photo) and the high width-to-depth ratio of the channel.

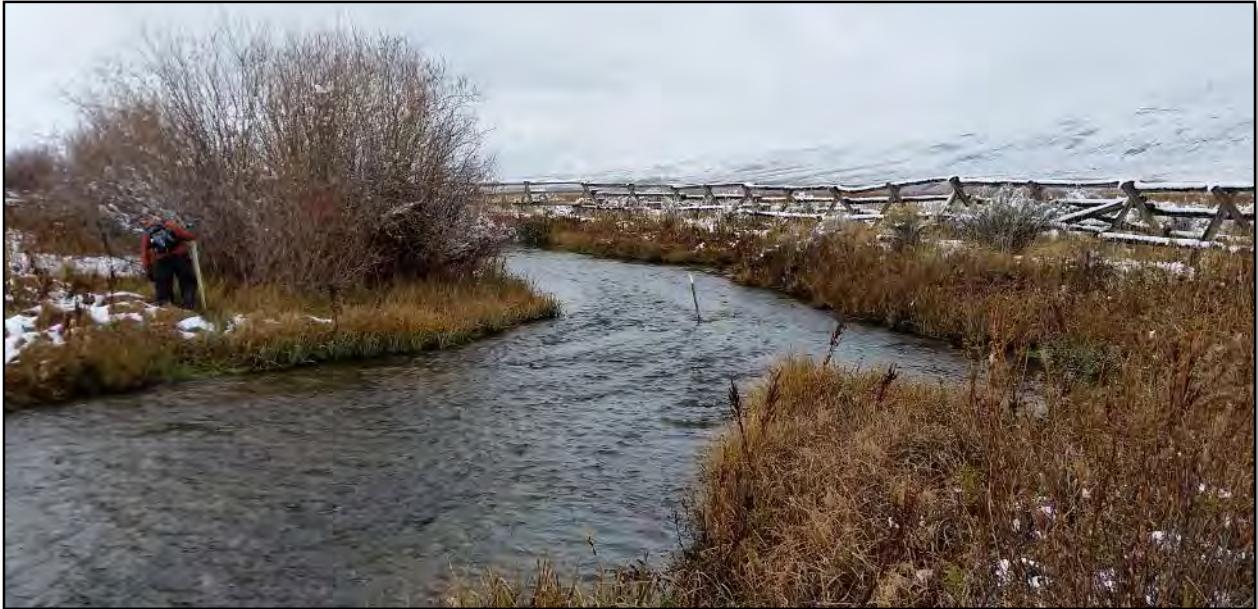
Figure 3-8 Representative photo of Big Springs Creek looking upstream within the exclusion area between the Neibaur pasture (22) and Unknown pasture (31).

The photo illustrates willow riparian vegetation on the low floodplain surface along the inside of the bend, and the lack of willow riparian vegetation on the relatively high surface located along the outside of the bend.

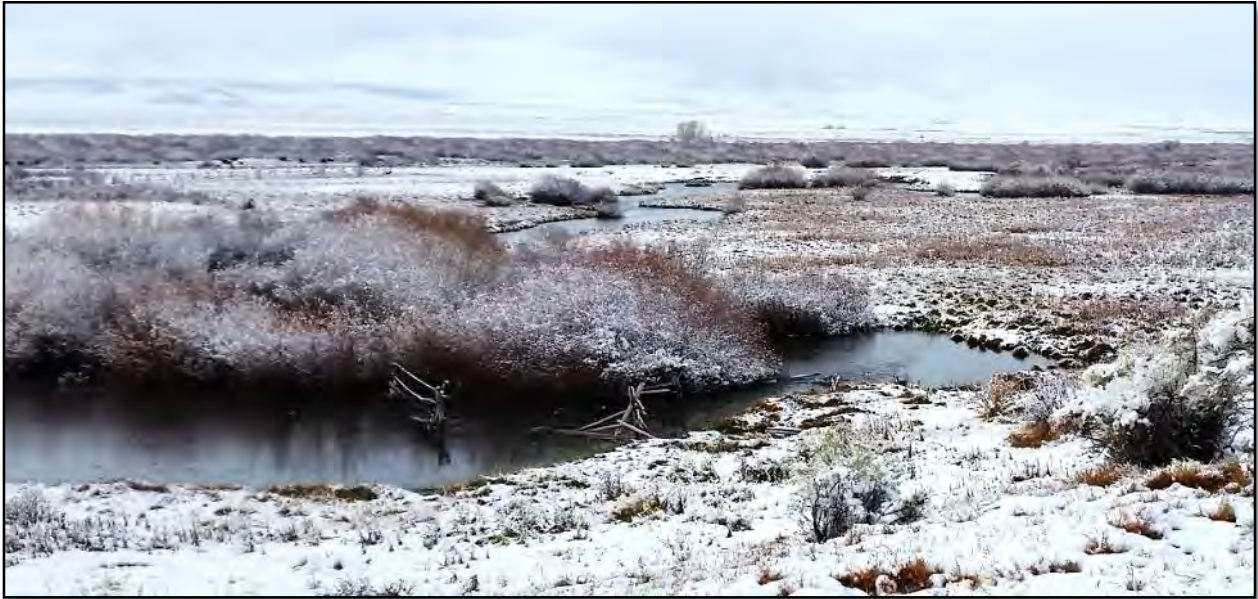
Figure 3-9 Representative photo of the Lemhi River within Billy's Pasture (24).

Photo is looking downstream and illustrates the lack of Riparian willow vegetation associated with historically heavy grazing. Areas of dense willow Riparian vegetation occur where grazing is limited, such as on islands (left side of photo) and along the inside of some bends.

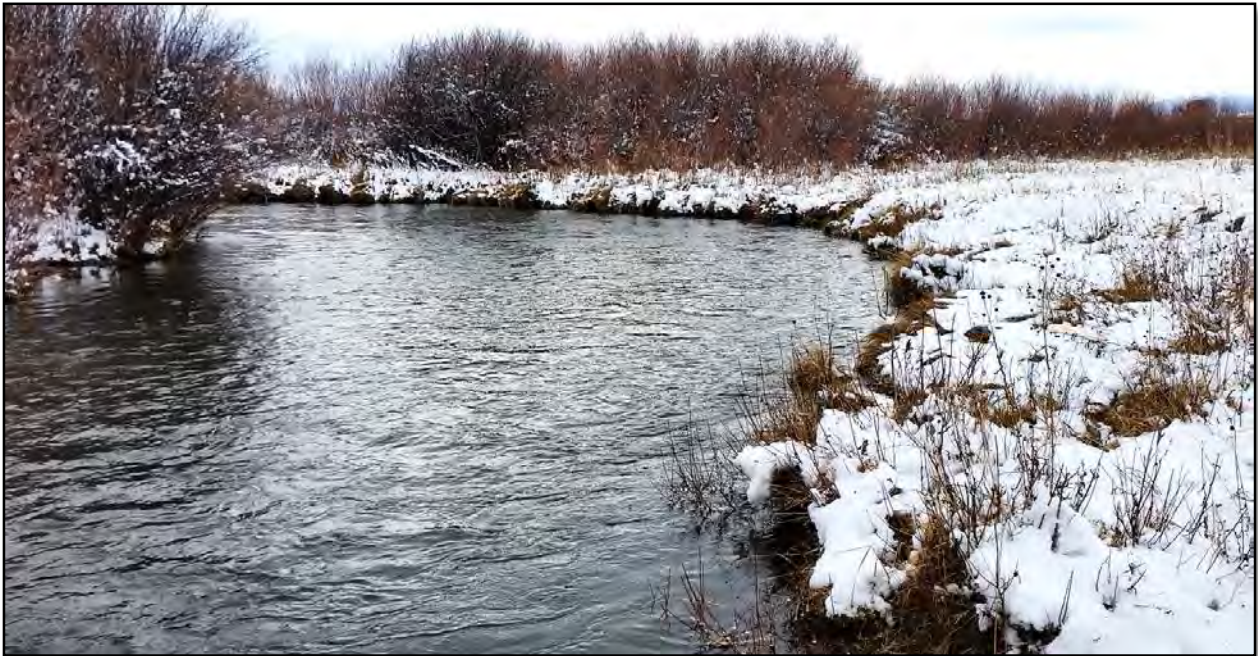
Figure 3-10 Representative photo of the Lemhi River in the middle of the project reach within the Neibaur Middle Pasture (21).

Photo illustrates generally dense willow Riparian vegetation in low areas, and sparse willow Riparian vegetation in high areas and/or along the apex of bends.

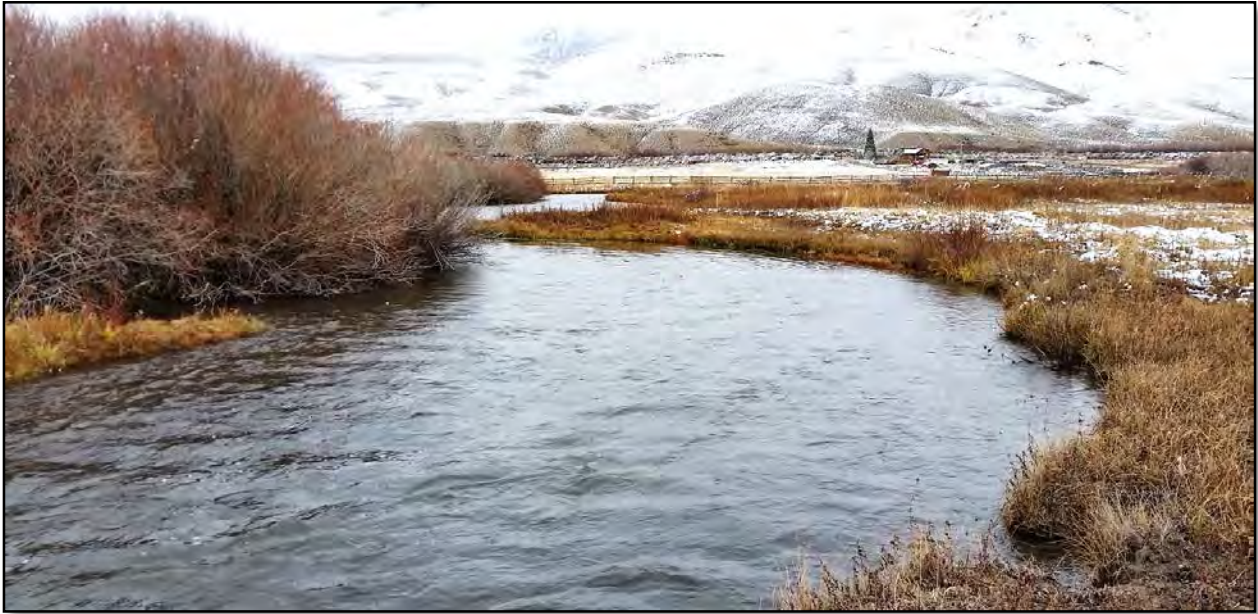
Figure 3-11 **Representative photo of the Lemhi River immediately upstream of the confluence with Big Springs Creek**

The majority of the floodplain in this area is lacking willow Riparian vegetation with the exception of areas isolated from grazing (left side of image – along the inside of a bend).

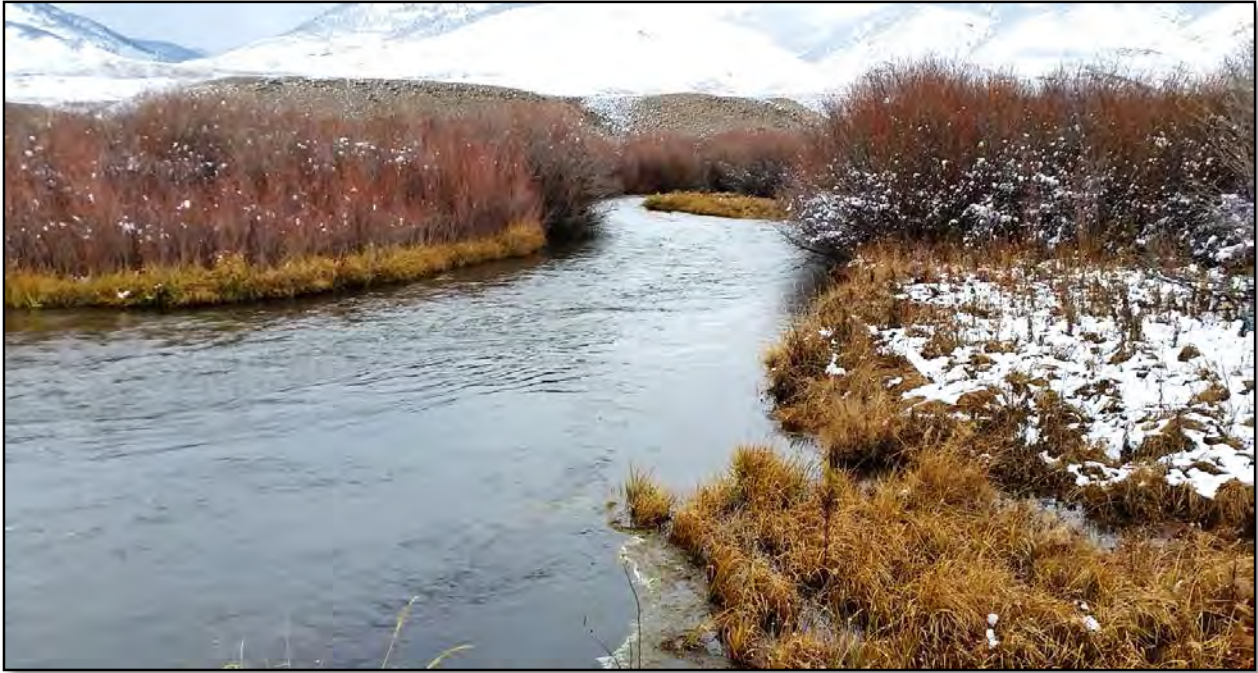
Figure 3-12 **Representative photo of the Lemhi River near the downstream end of the project area – within the exclusion area**

Adjacent the Bull pasture (1) and Feed Lot pasture (6). The majority of low-lying floodplain areas are densely populated with mature or emerging willow Riparian vegetation. Willow Riparian vegetation is sparse or lacking on relatively high floodplain surfaces and/or the outsides of several meander bends.

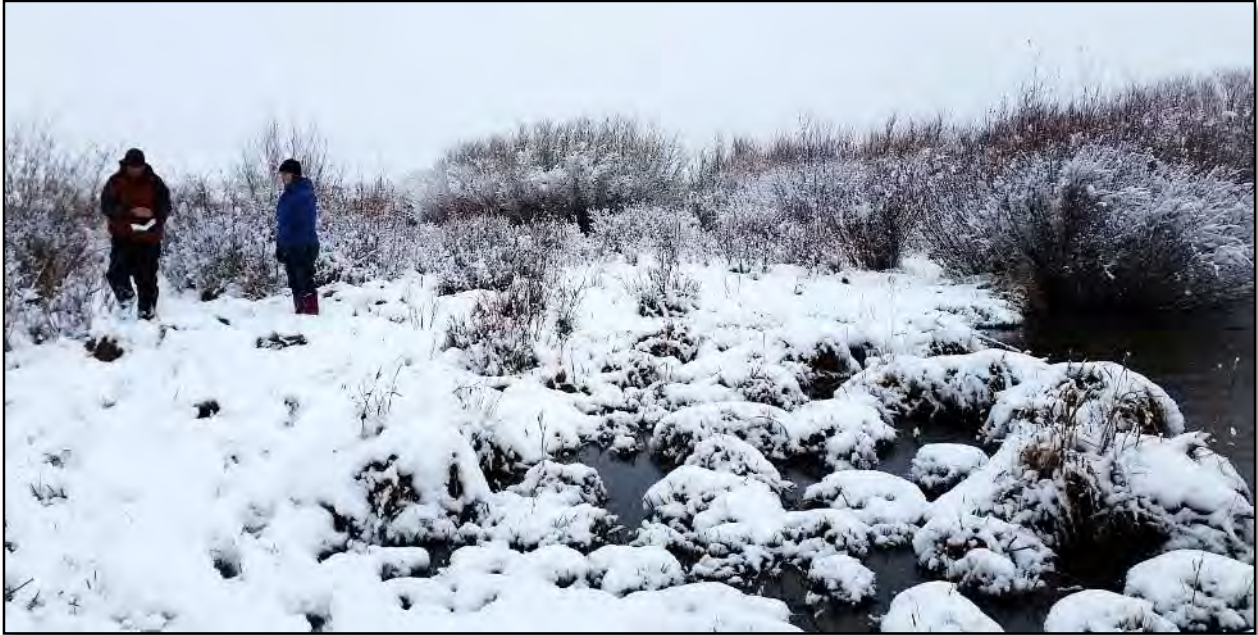
Figure 3-13 Representative photo of Texas Creek

(Right side of photo) and adjacent floodplain (left side of photo) illustrating extensive natural willow regeneration in existing low-lying areas of the floodplain.

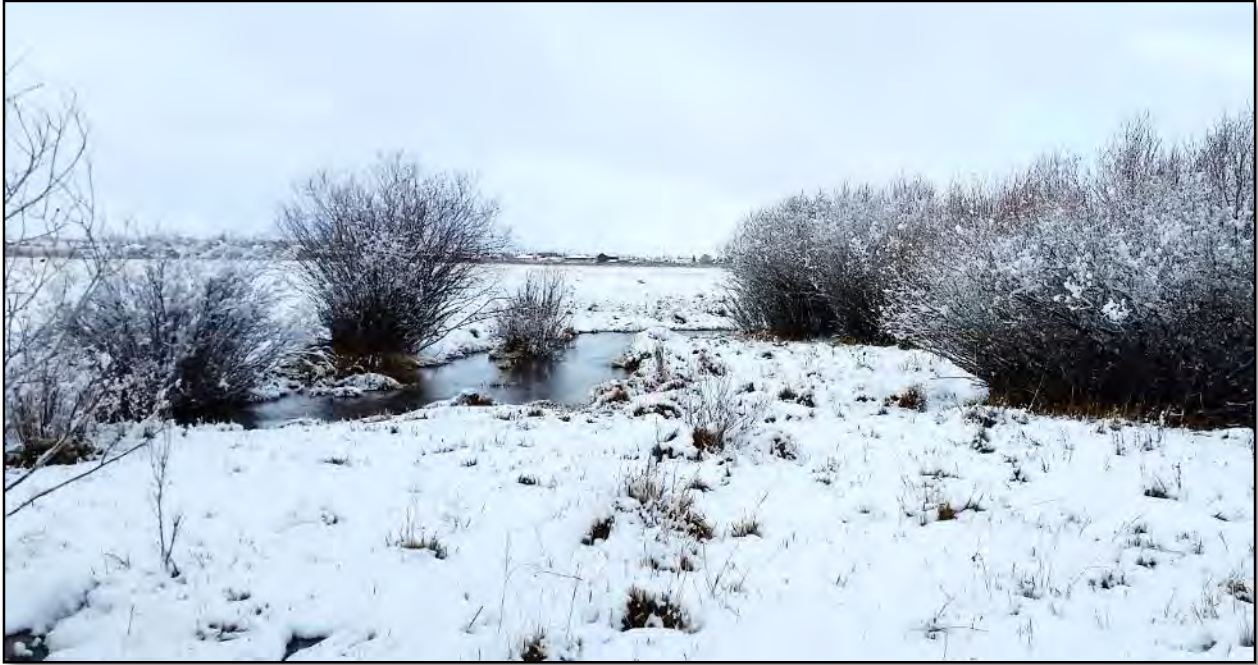
Isom Hawley/Eighteen Mile Field (35) – Figure 3-14

Figure 3-14 Representative photo of Eighteen Mile Creek

Illustrating dense willow Riparian vegetation in some areas with sparse willow Riparian vegetation in others.

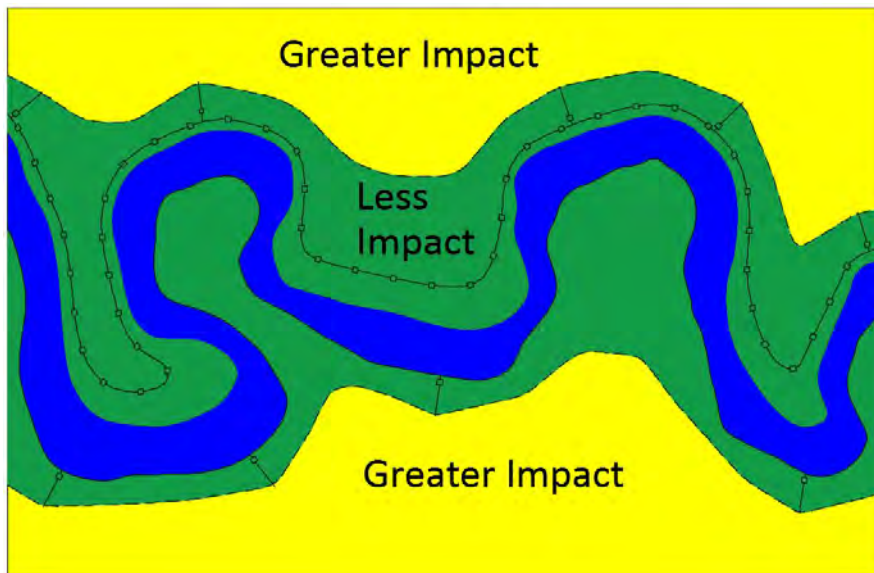
Figure 5-1 Conceptual drawing of fence barbs used to force cattle concentrations away from the apex of meander bends creating a disturbance buffer without reducing pasture area.

This treatment can be used with or without existing exclusion fence.

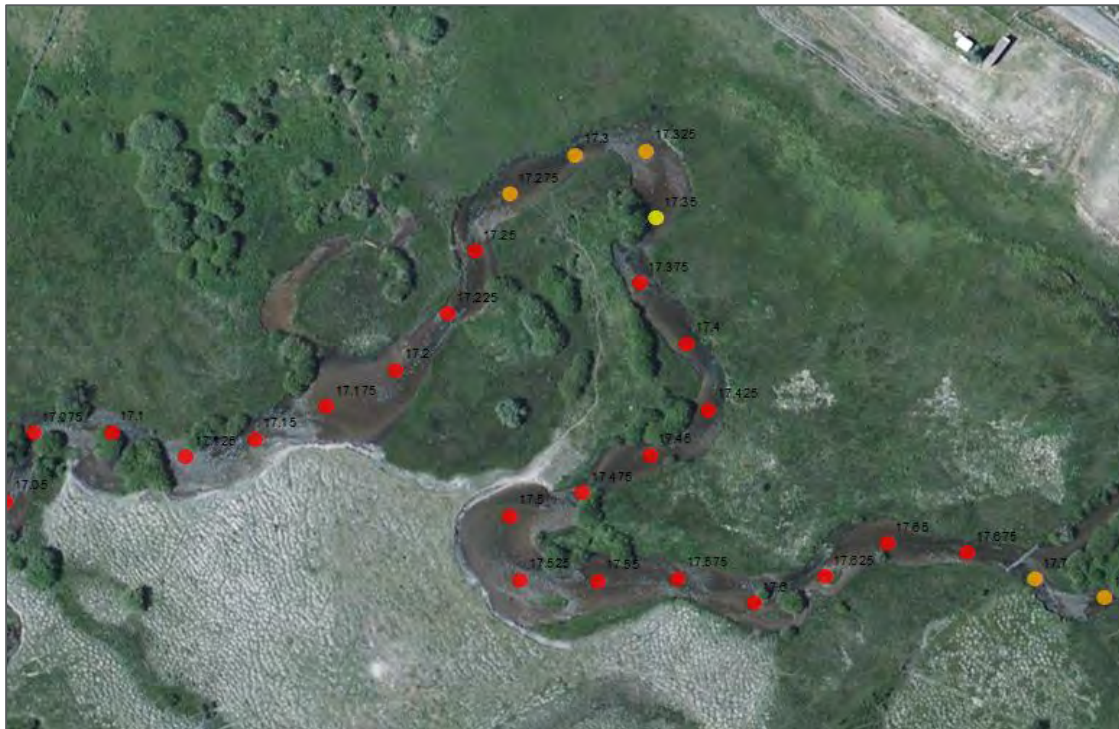
Figure 3 – An example screenshot showing the stream centerline nodes attributed with average current condition effective shade values at 10% intervals, with red being below 10% effective shade.

Additionally, latitude/longitude, stream gradient, and the effective shade averages for each stream centerline node can also be viewed on the results spreadsheets and shapefiles. In addition to modeling the current conditions, future scenarios were also modeled. This model extrapolated future vegetation heights of 6 meters within a consistent riparian buffer width along each river. These widths were 25 feet on the Lemhi River, 15 feet on Big Springs Creek, Texas Creek, and Eighteenmile Creek, and 10 feet on Canyon Creek. The current condition effective shade can then be subtracted from the future condition on each stream centerline node to derive a delta (change).

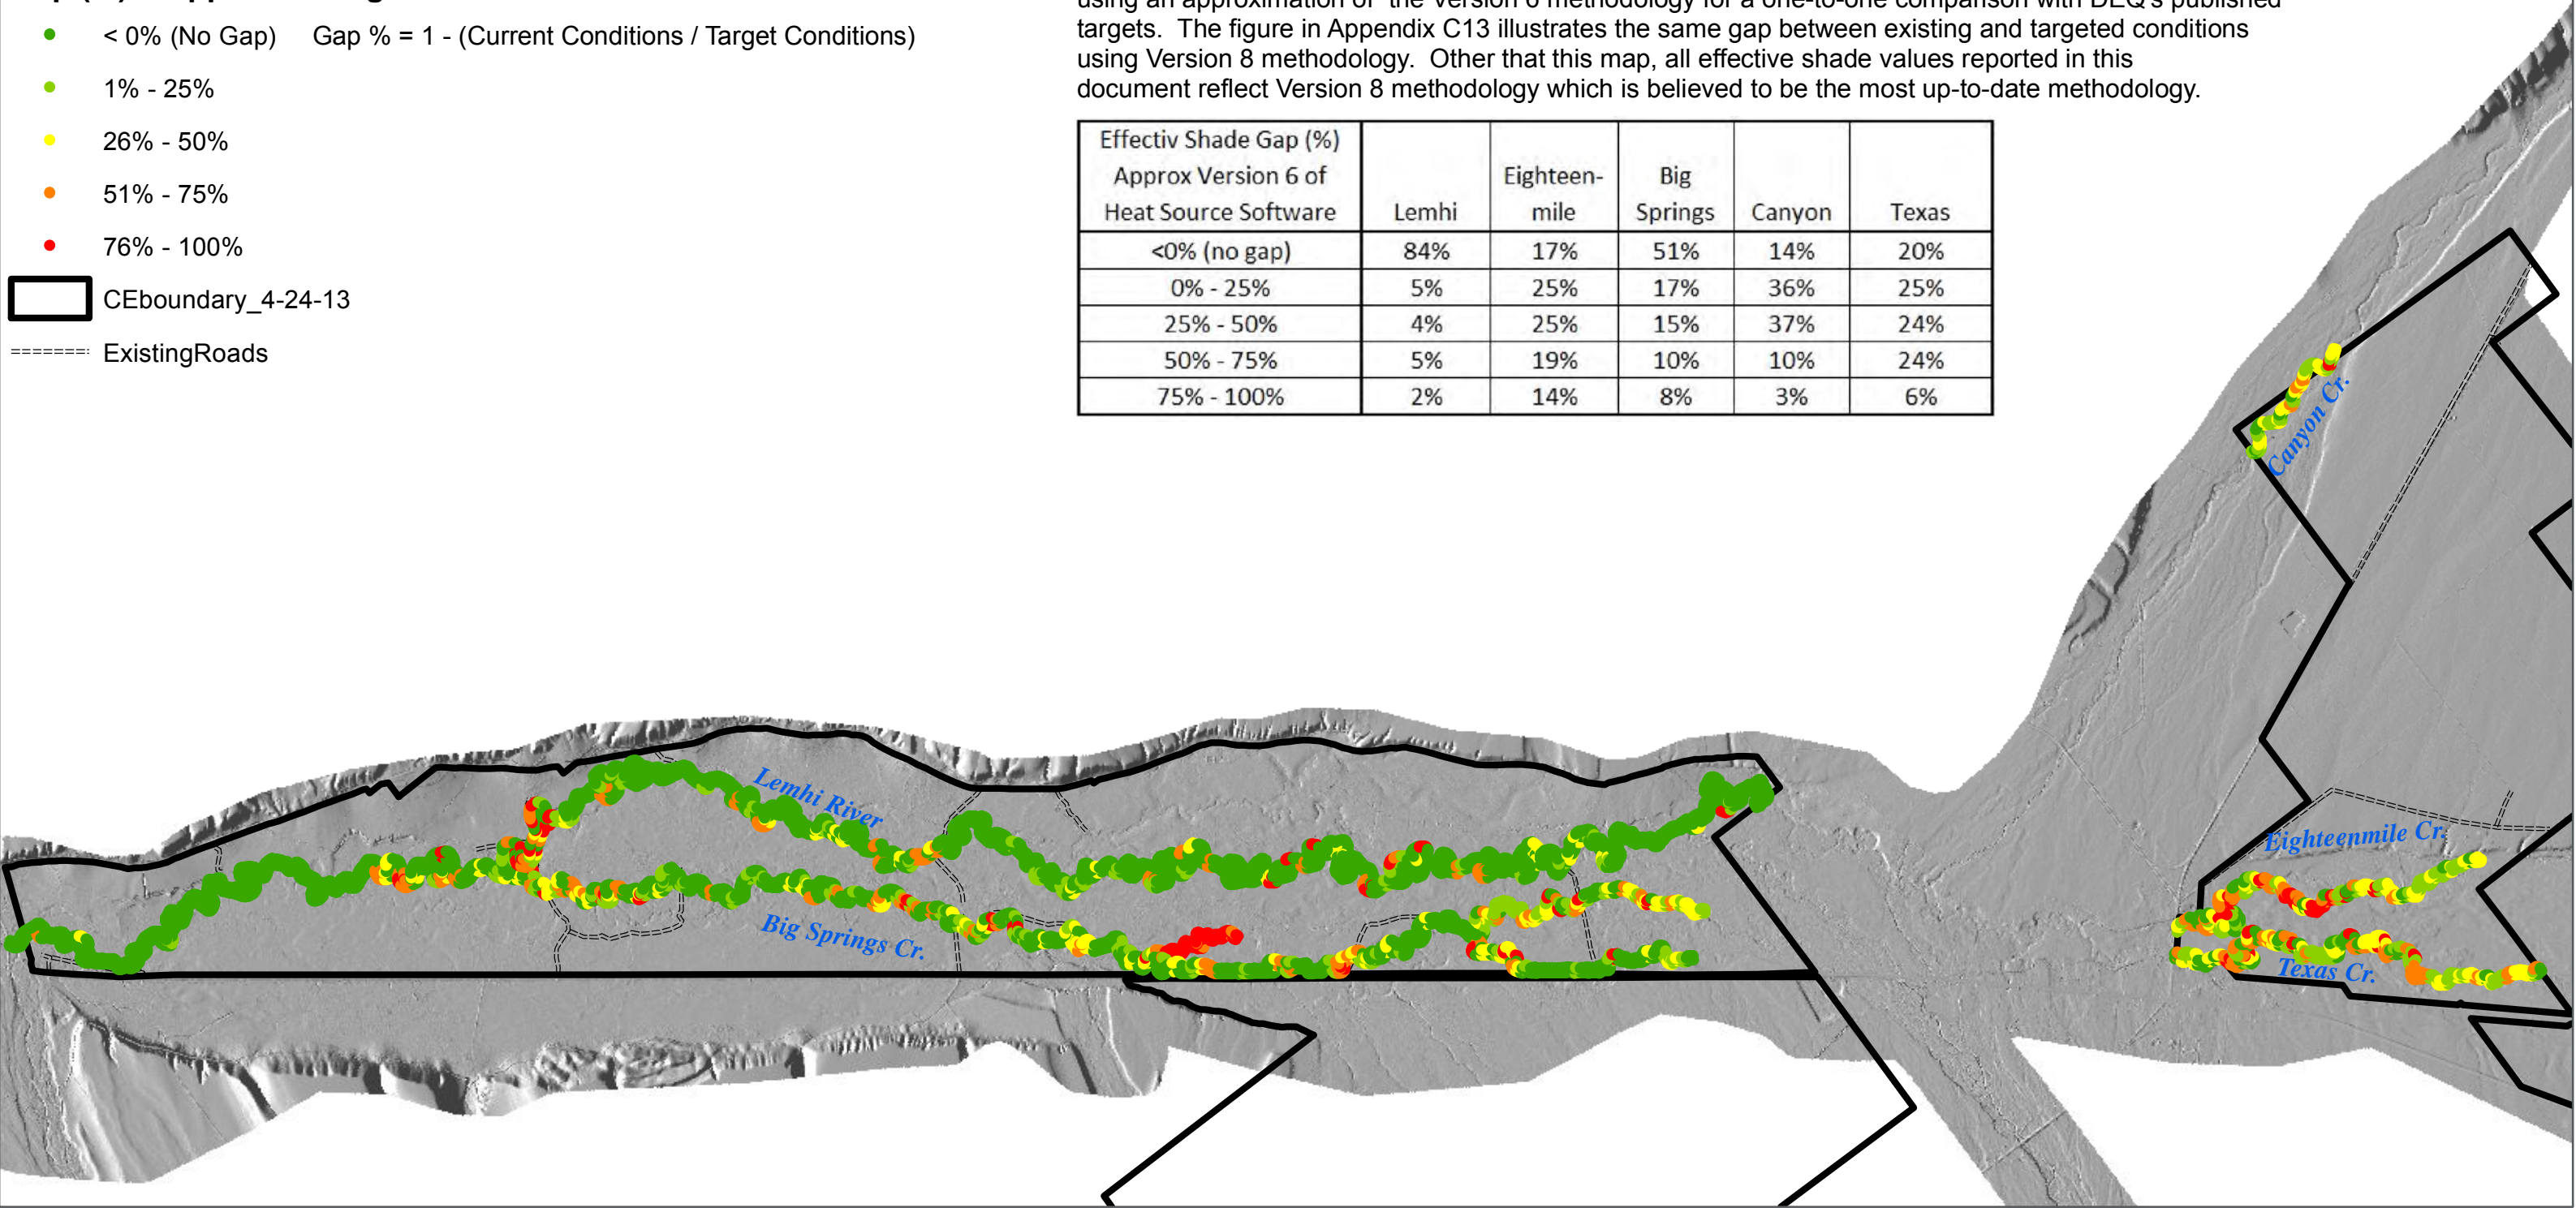
Effective shade has been calculated using software called Heat Source. There is a discrepancy in results between Version 6 of Heat Source (used by DEQ to develop effective shade targets) and Version 8 of Heat Source (used in this document to assess current effective shade values). This figure illustrates the gap between the existing conditions and the targeted conditions as measured using an approximation of the Version 6 methodology for a one-to-one comparison with DEQ's published targets. The figure in Appendix C13 illustrates the same gap between existing and targeted conditions using Version 8 methodology. Other than this map, all effective shade values reported in this document reflect Version 8 methodology which is believed to be the most up-to-date methodology.

Effectiv Shade Gap (%) Approx Version 6 of Heat Source Software	Lemhi	Eighteen- mile	Big Springs	Canyon	Texas
<0% (no gap)	84%	17%	51%	14%	20%
0% - 25%	5%	25%	17%	36%	25%
25% - 50%	4%	25%	15%	37%	24%
50% - 75%	5%	19%	10%	10%	24%
75% - 100%	2%	14%	8%	3%	6%
