## **Technical Memorandum**

### **Alternative A—Crab Creek**

## **Potholes Reservoir Supplemental Feed Route Draft Environmental Assessment**

**Columbia Basin Project  
Grant County, Washington**

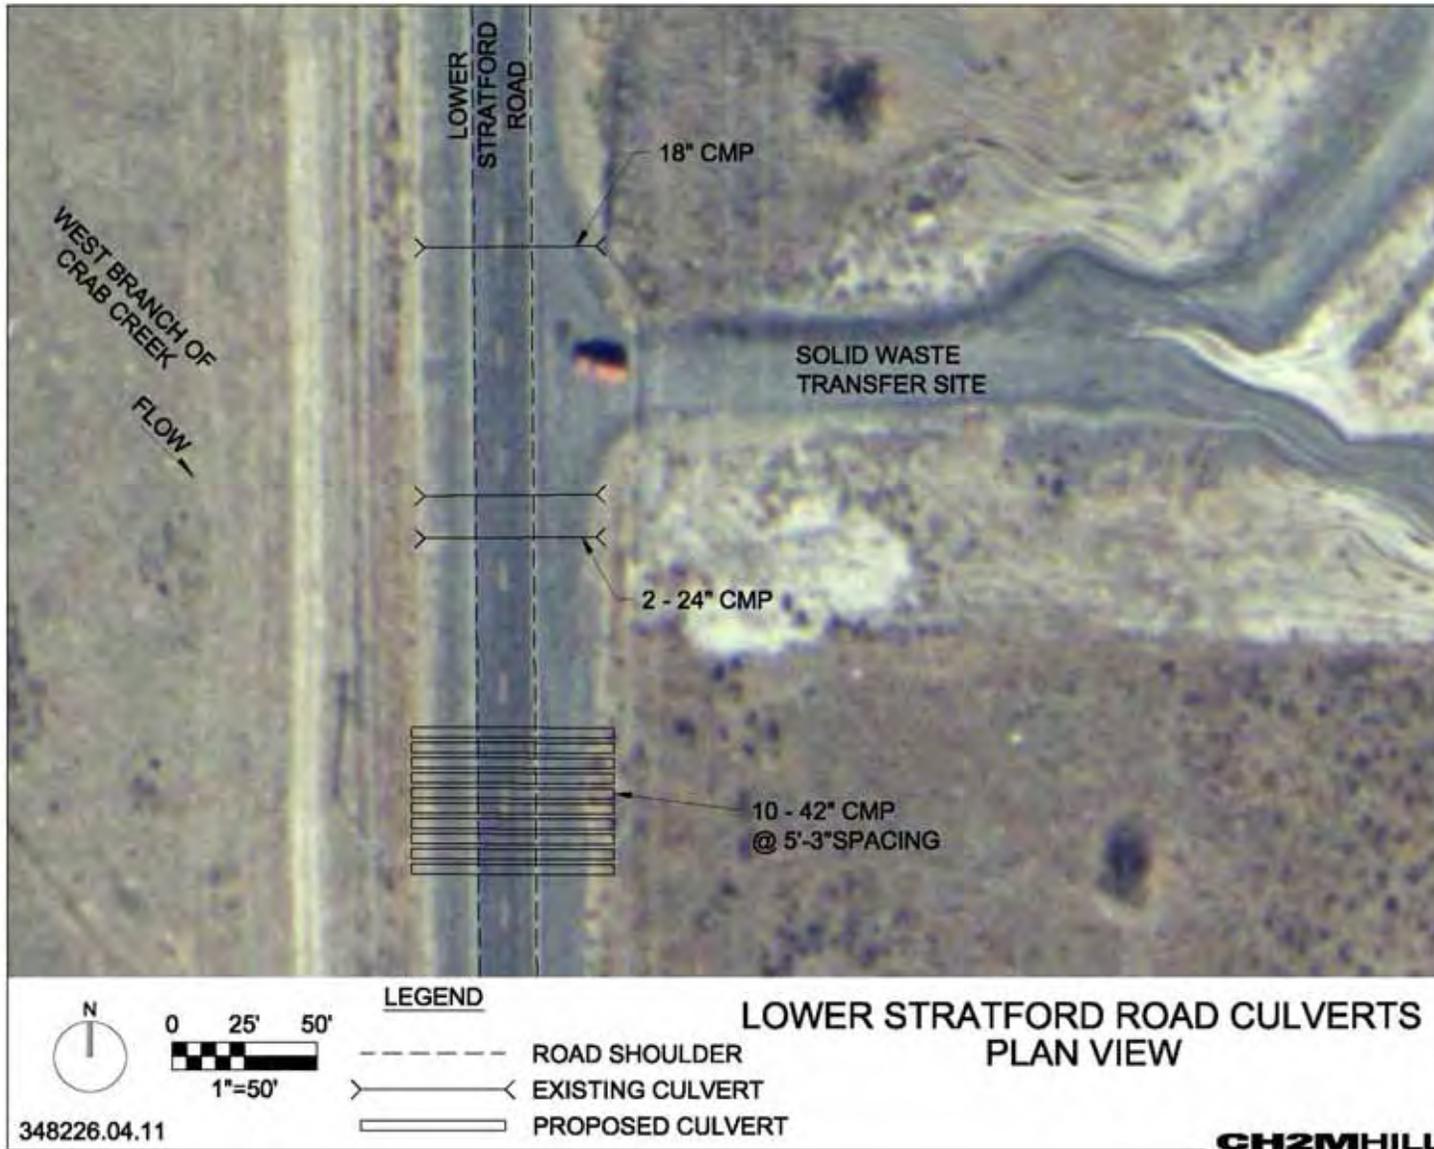
FIGURE 20  
Lower Stratford Road Culverts Plan View

Hydraulic analysis shows that ten (10) 36-inch CMPs will meet the design criteria. The proposed location of these culverts is to the south of the existing culvert, which places the proposed culverts more in-line with the main channel according to the field survey data. A limited amount of site grading would be needed adjacent to the roadway.

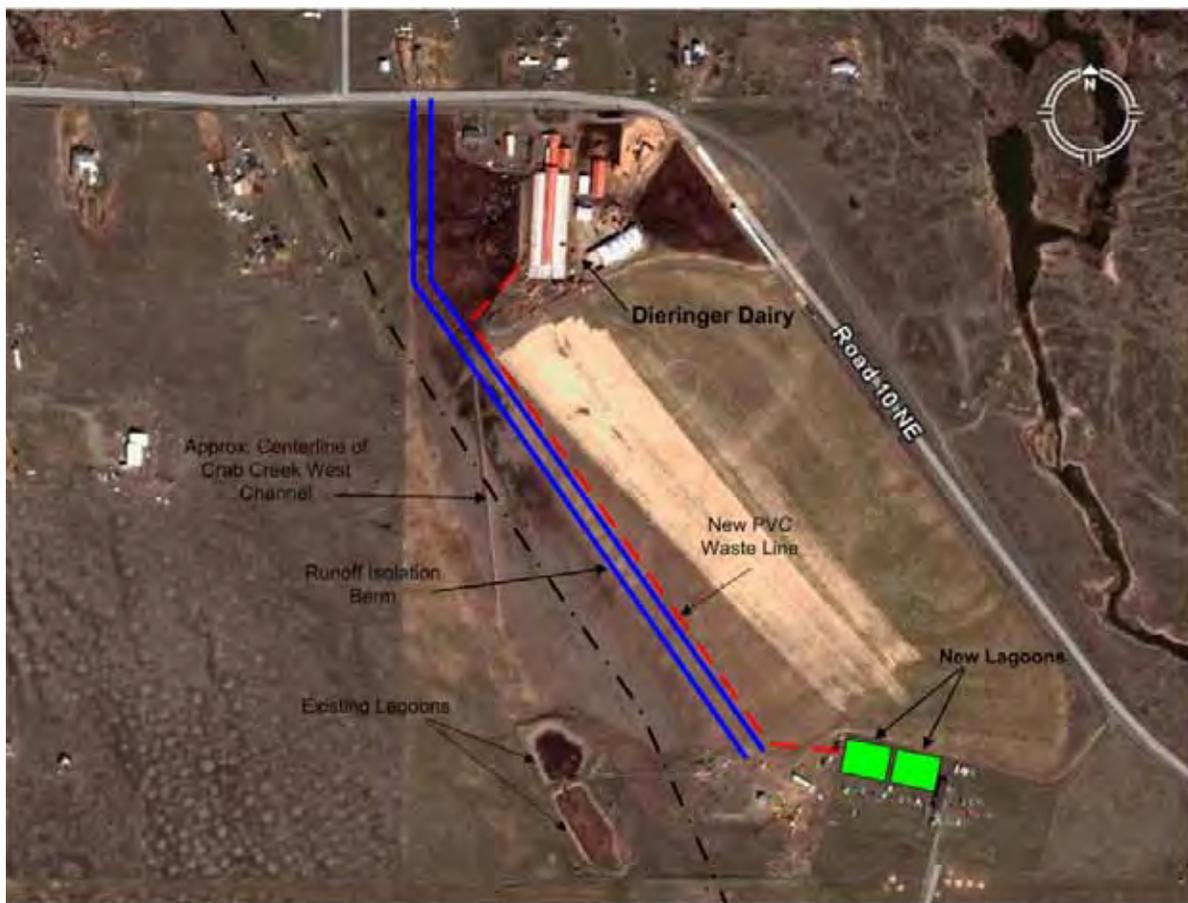
FIGURE 21  
Dieringer Dairy Site Map

The location of the proposed improvements is shown on Figure 21.
