Preliminary Results from the Lower Yakima River Survival Study, 2021

Tobias Kock¹, Scott Evans¹, Michael Porter², Pat Monk³,
Adam Pope¹, and Russell Perry¹

September 9, 2021

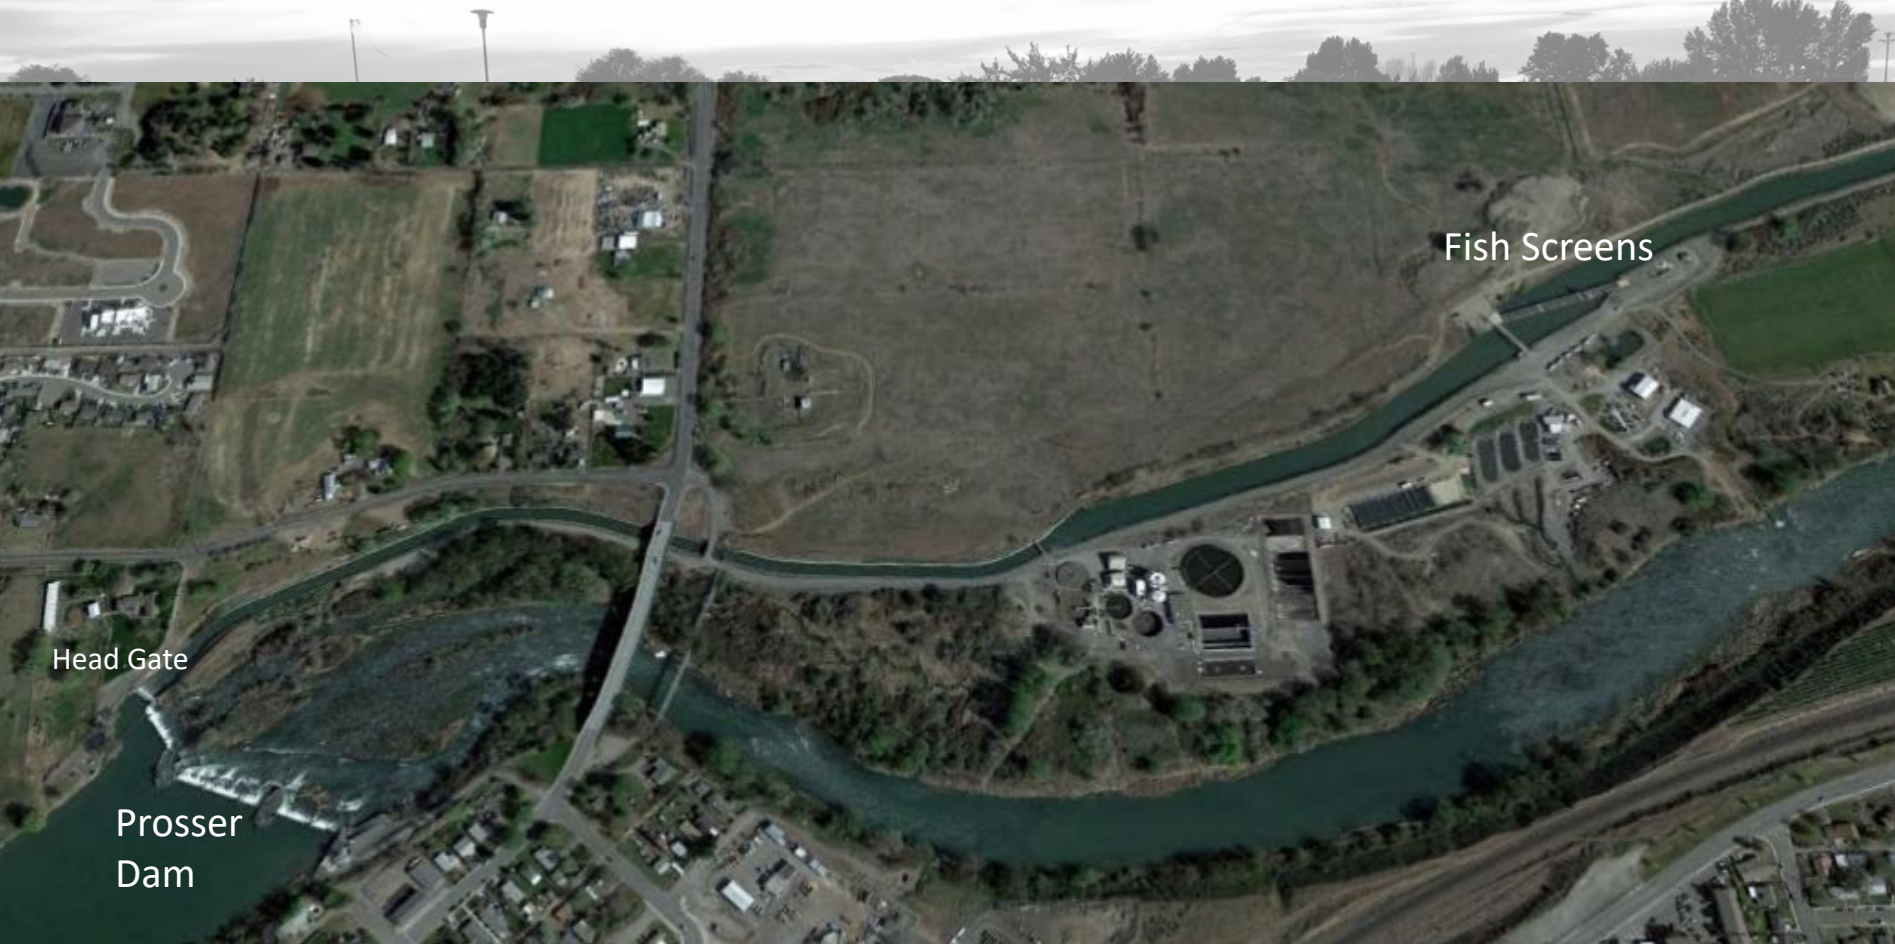
Prosser Dam and Chandler Canal Fish Screens

Percent of fish using the canal
Yearling Chinook salmon = 21.6%

Survival through Canal = 0.76
Survival over the Dam = 0.98

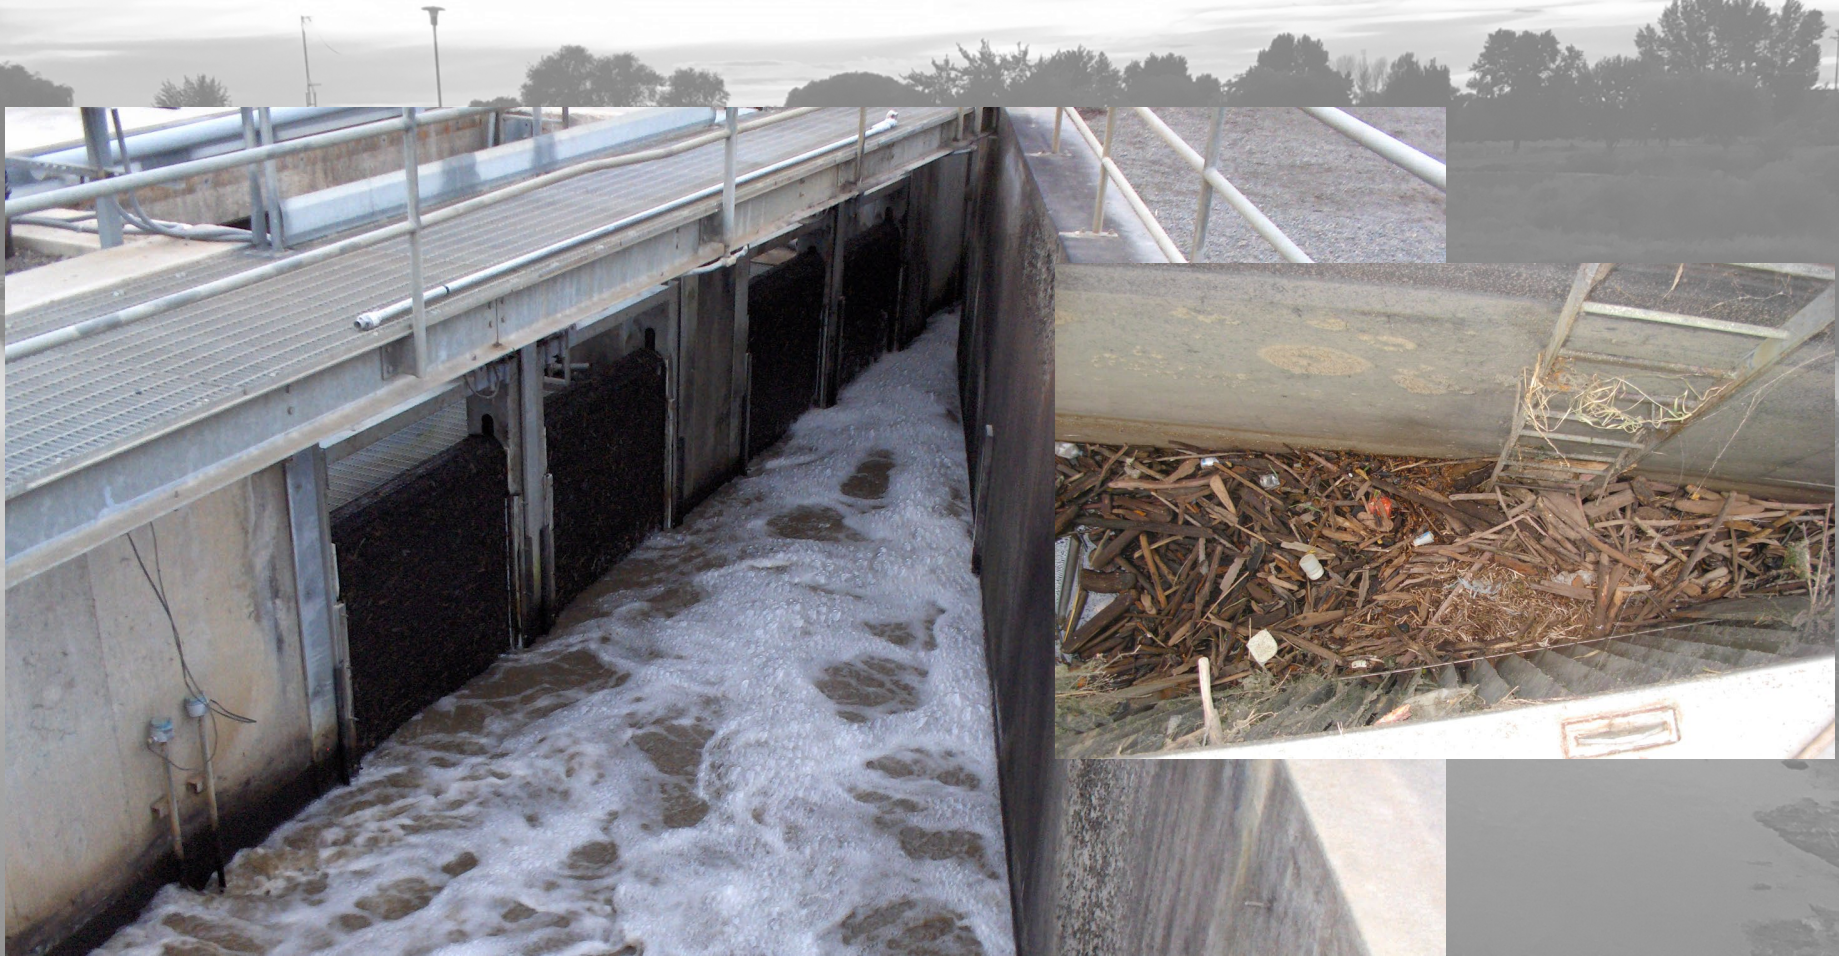
Use of booms and netting for
Fish guidance, Baker Lake WA
