Clear Creek Dam Fish Passage Assessment

First Annual Progress Report

**U.S. Fish and Wildlife Service
Mid-Columbia Fishery Resource Office
Yakima Sub-Office**

**U.S. Bureau of Reclamation
Columbia-Cascades Area Office**

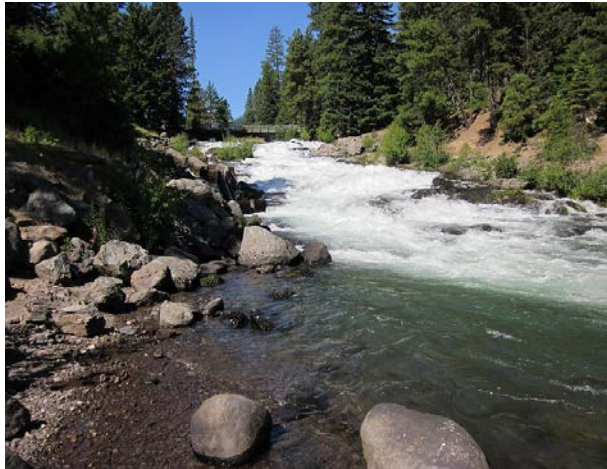
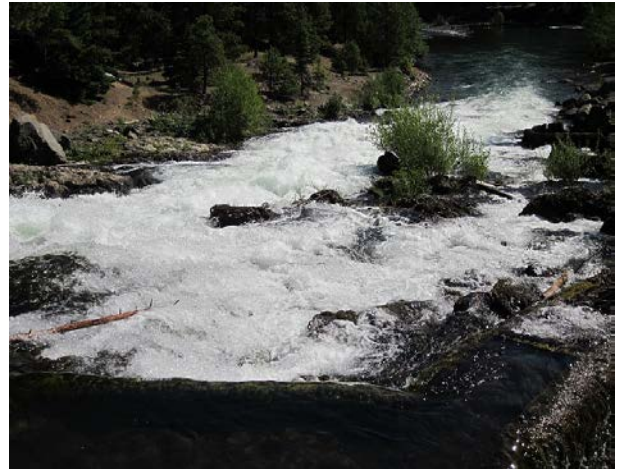
Lower spillway channel at Clear Lake elevation of 3012.8 feet

Without the benefit of serviceable ladders passage up the spillway channel for migrating fish is difficult at best. This channel, blasted out of bedrock, is approximately 140 meters long with two high gradient segments. The lower segment is approximately 70 meters long with an average gradient of 20-25 percent (all gradients are estimates); the upper segment is shorter (40 meters) but steeper with an average gradient of about 35 percent. In between these two segments is a low gradient section (< 5%) approximately 30 meters long which extends from the exit of the denil ladder to just below the entrance to the first pool of the upper ladder. The extent to which it is possible for bull trout to swim up the lower section of the spillway channel is unknown. Hydraulic conditions vary drastically depending on the volume of discharge coming down the spillway, consequently so does one's judgment as to whether fish could successfully swim up the channel. It is strongly suspected that fish cannot ascend the channel at high flows. In July, 2011 two bull trout were observed repeatedly trying without success. Photographs of hydraulic conditions in the spillway channel over a range of flows are presented in Appendix A.

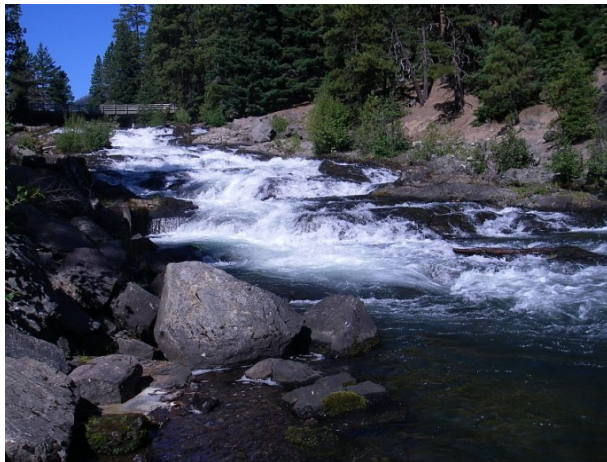
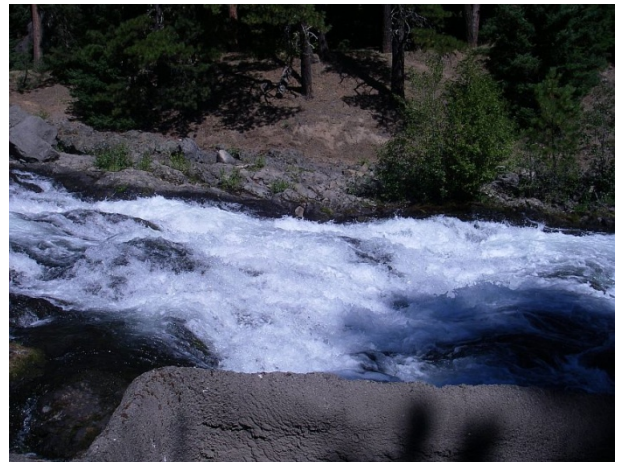
Lower spillway channel at Clear Lake elevation of 3011.6 feet

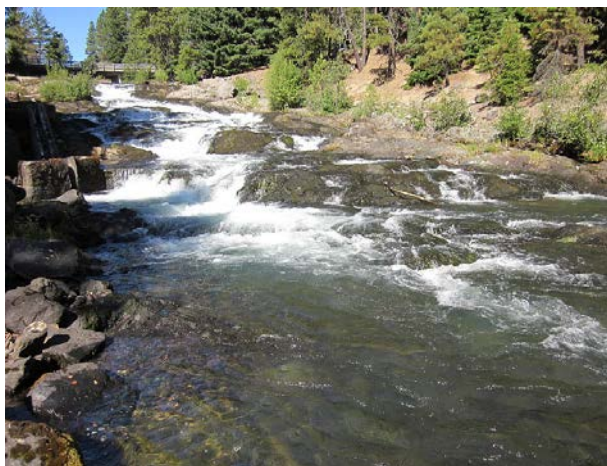
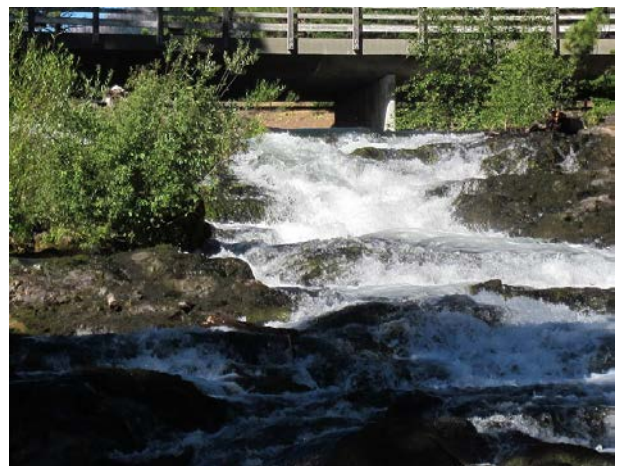
Lower spillway channel at Clear Lake elevation of 3011.4 feet

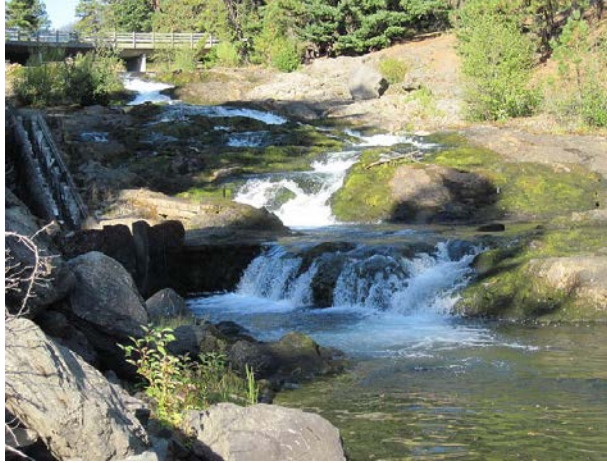
Lower spillway channel at Clear Lake elevation of 3011.0 feet

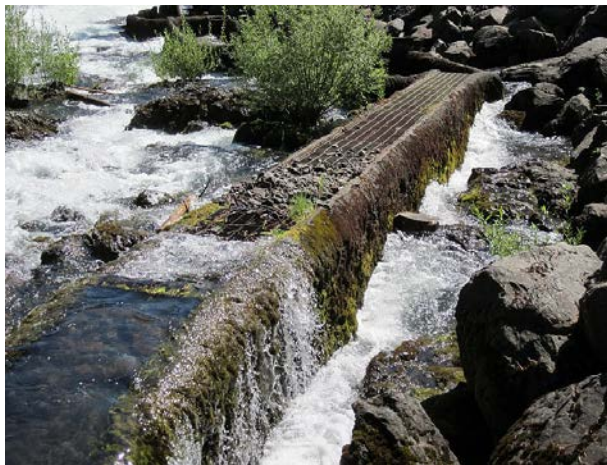
Upstream terminus of the Denil ladder completely clogged with bed load

Clear Creek and Tieton dams were constructed without fish passage facilities. Consequently, upon their completion anadromous salmonids were excluded from habitat upstream and resident fish populations above the dams were isolated. While Tieton Dam remains impassable, two fish ladders were constructed in the bedrock spillway channel of Clear Creek Dam in 1992. The lower "ladder" is actually a series of four denil ladders interspaced with resting pools located on the right bank of the spillway. The slopes of the four ladder sections range from 12.5 to 45 percent. The upper ladder is a pool-and-weir design constructed on the left side of the spillway channel. It contains 11 weirs with a two-foot hydraulic drop from weir to weir. The pool-and-weir ladder appears to be functional but this is not the case with the denil ladder. It is considered too steep and does not meet accepted criteria (USBR 2004) so it may have never passed fish with much success. It most certainly does not at present as it has not been maintained in years, is completely clogged with gravel, and is otherwise in disrepair. Photographs of both ladders are presented in Appendix A.

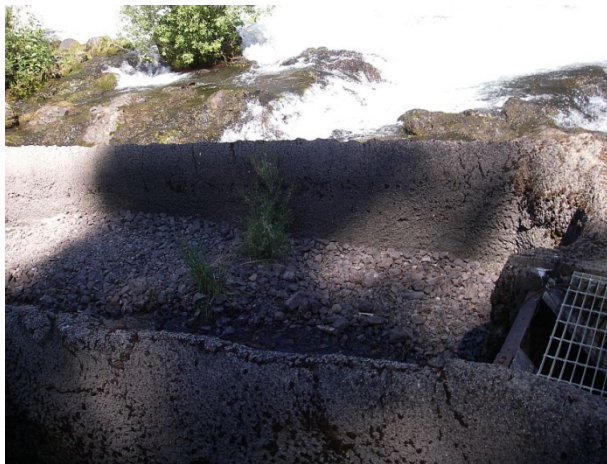
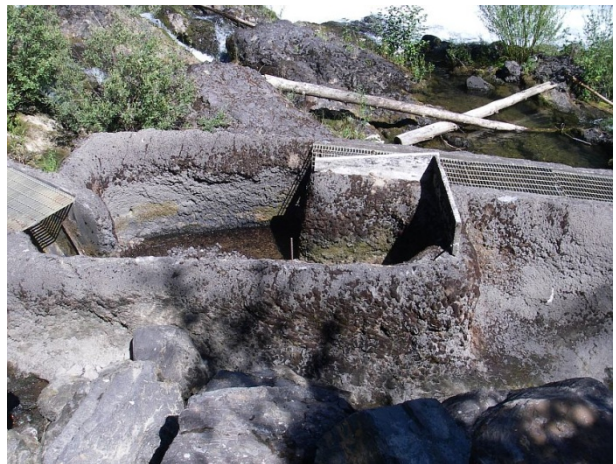
Totally dewatered downstream sections of the Denil ladder

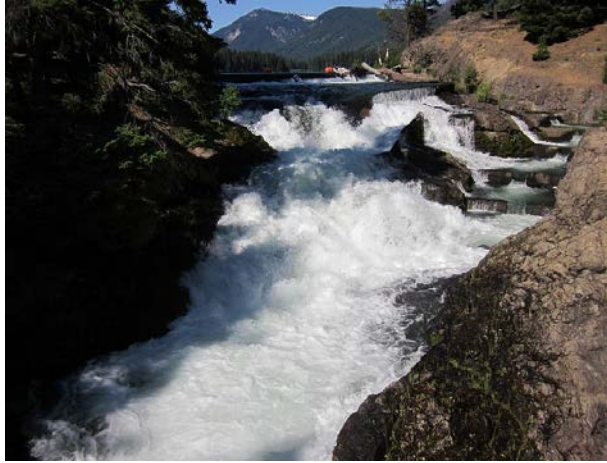
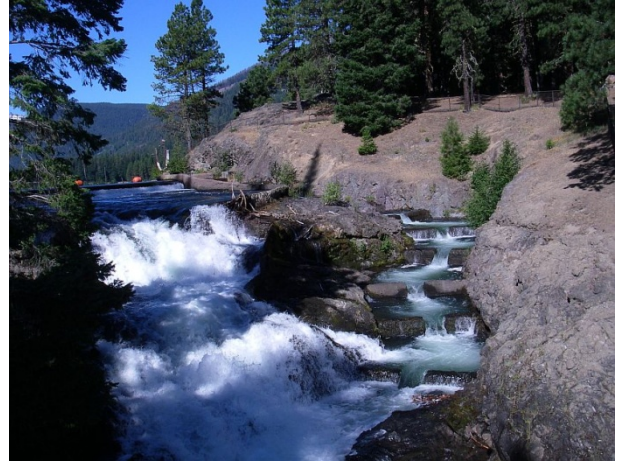
Upper spillway channel at lake elevation 3012.2 feet (left) and 3011.6 feet (right)

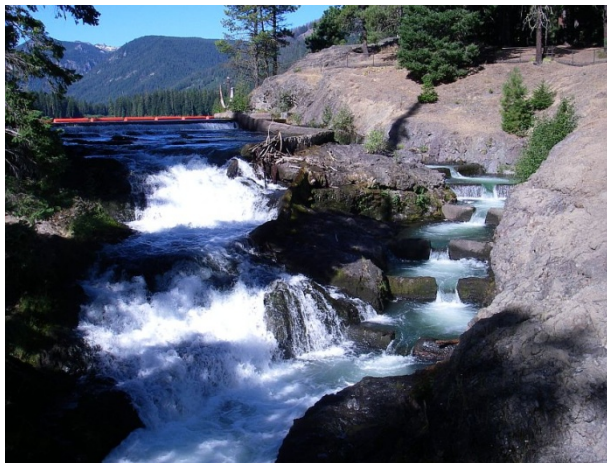
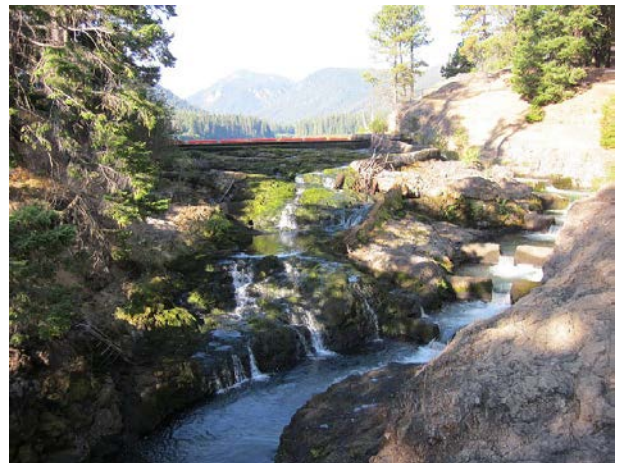
Upper spillway channel at lake elevation 3011.4 feet (left) and 3011.0 feet (right)

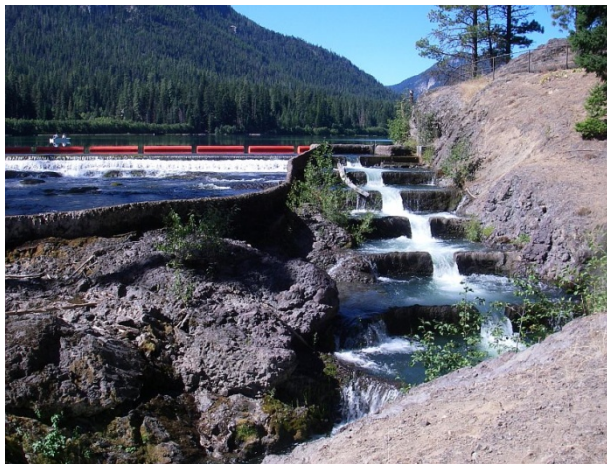
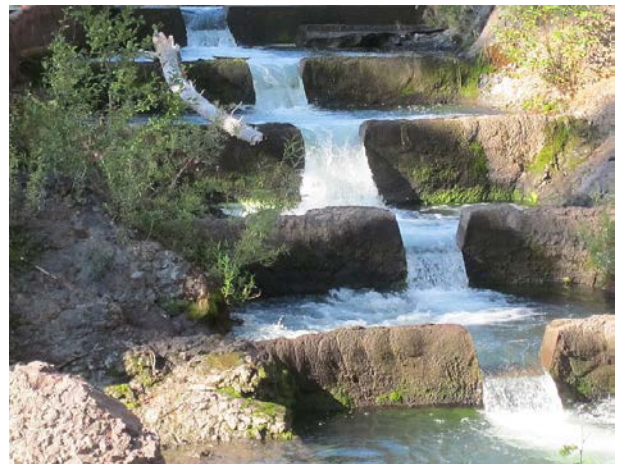
Pool-and-weir fish ladder in upper spillway channel

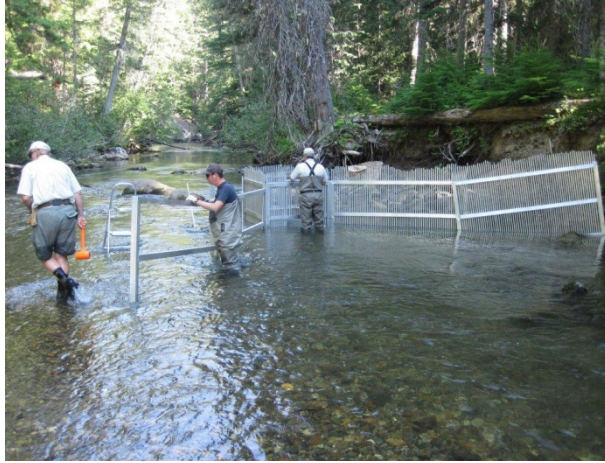
Weir and trap installation on the North Fork Tieton River (September 17, 2012)

Three eight-foot weir panels were coupled together and extended from the left bank downstream at about a 40 degree angle where they connected with the capture box; two panels were used on the right bank angled somewhat less. The capture box was situated in the thalweg of the channel, a location where the stream bed was relatively flat. With the braces, numerous sandbags strategically placed, and all pickets driven into the stream bed to the extent possible, the weir and the trap box were impressively solid. To prevent potential avian predation a tarp was draped over the top of the box and secured, burlap was wired to the top of the funnel opening to prevent captured fish from jumping out, and half-inch wide zip ties were affixed to the back of the vertical opening to dissuade captured fish from swimming back out. Photographs of the trap under construction and completed are presented in Appendix B.

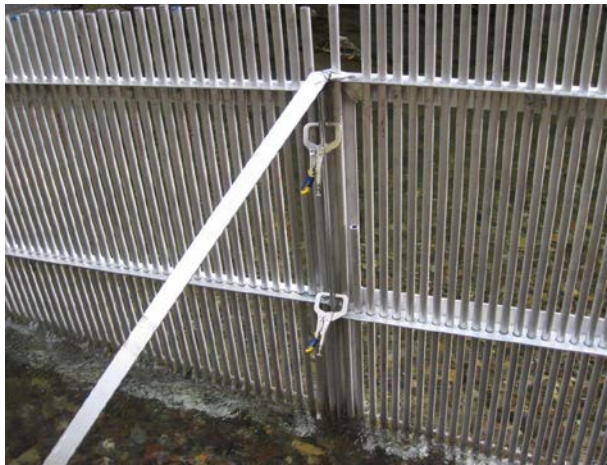
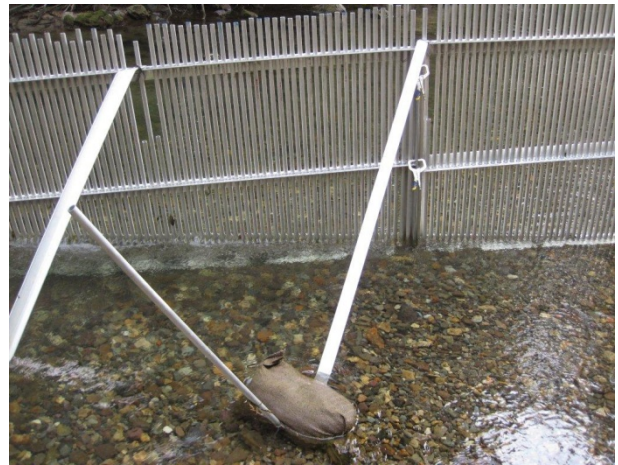
Weir and trap installation on the North Fork Tieton River (September 17, 2012)

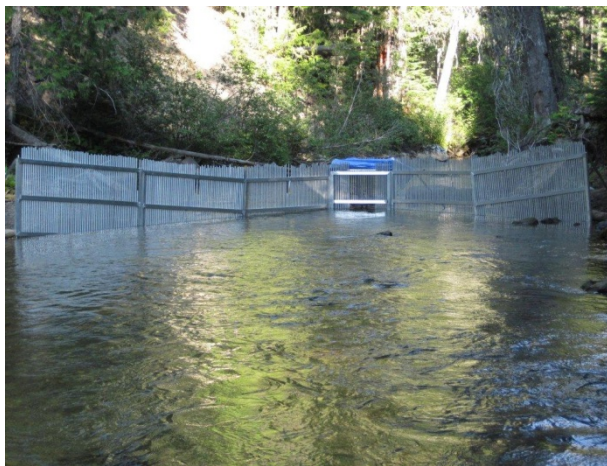
Completed picket-weir and box trap

The trap was constructed by WDFW's Region 3 screen shop. The component parts of the picket-weirs and the capture box were made out of aluminum which was both durable and lightweight. The weir panel frames were eight-feet long by four-feet tall; approximately seventy spiked pickets (60" x 0.75") slipped through holes drilled in each frame and were pounded into the stream bed (spacing between pickets was about 0.6"). Adjacent panels were coupled together and all panels were braced from downstream. The dimensions of the capture box were 4 x 4 x 4 feet. It was assembled from four panels, used the same type of pickets as the weirs, and had a funnel opening. There was no aluminum top or bottom to the capture box.

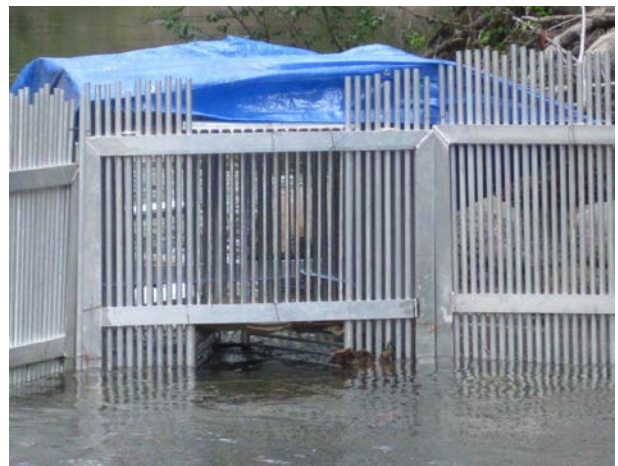
The capture box

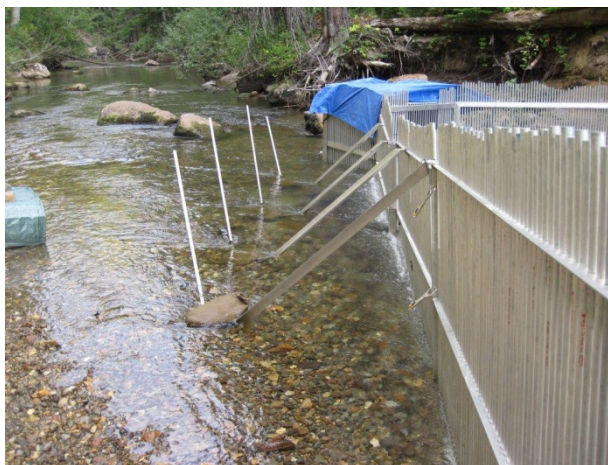
Downstream side of trap

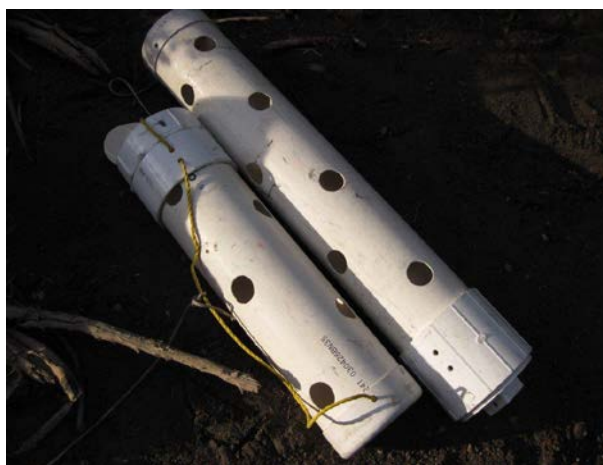
PVC recovery tubes

After completing the tag implantation an Oregon RFID® portable reader was used to scan the tag number and fish were placed in 6-inch diameter PVC flow-thru recovery tubes. These were secured in the channel where a light current existed with the head of the fish oriented upstream. They were held and monitored until able to swim away freely. Photographs related to the tagging operation are presented in Appendix B.

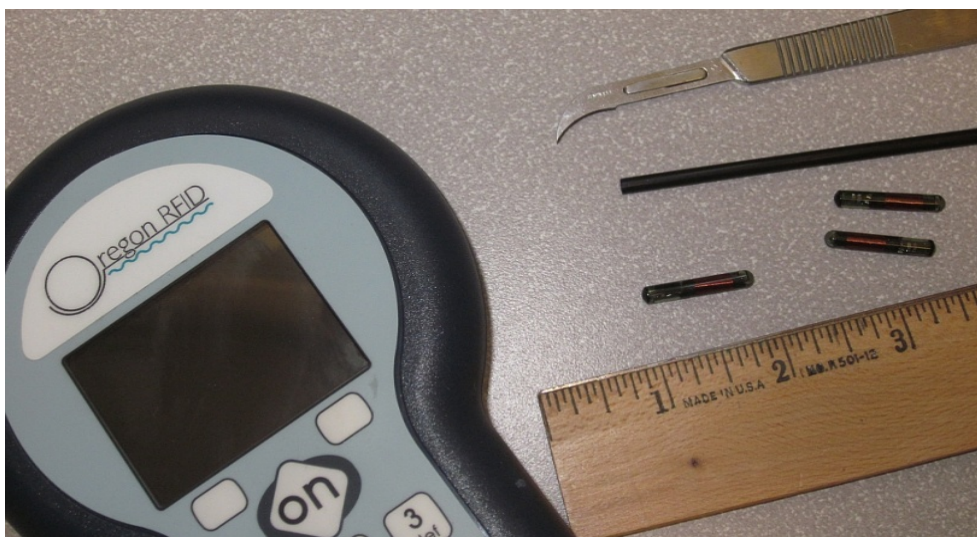
HDX PIT tags, scalpel, insertion straw and Oregon RFID® portable tag reader

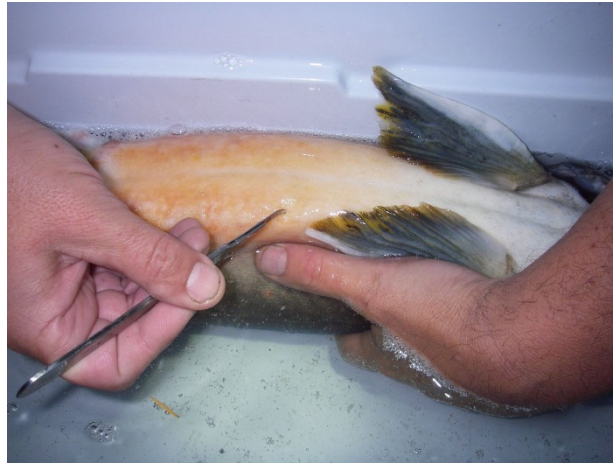
Making the incision to insert the HDX PIT tag

The fish were measured, sexed, and a small tissue sample was taken from the anal fin which was preserved in 70% isopropyl alcohol for genetic analysis. A scalpel was used to make a one-half inch vertical incision just posterior and ventral to the pectoral musculature near the end of the pectoral fin. This incision penetrated only the epidermal layer under which a half-duplex PIT (HDX PIT) tag was horizontally inserted. We used 23 mm x 3.65 mm tags (manufactured by Texas Instruments, Inc.) operating on the 134.2 kHz radio frequency identification standard for animal tagging. The tag was gently pushed in between muscle and skin towards the tail of the fish until barely visible, at which point a cocktail straw was used to implant it about one inch further. This surgical procedure was fairly simple and did not require any sutures.

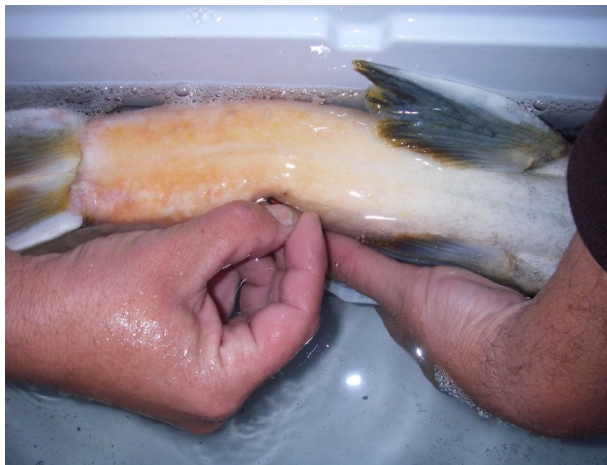
Inserting the HDX PIT tag

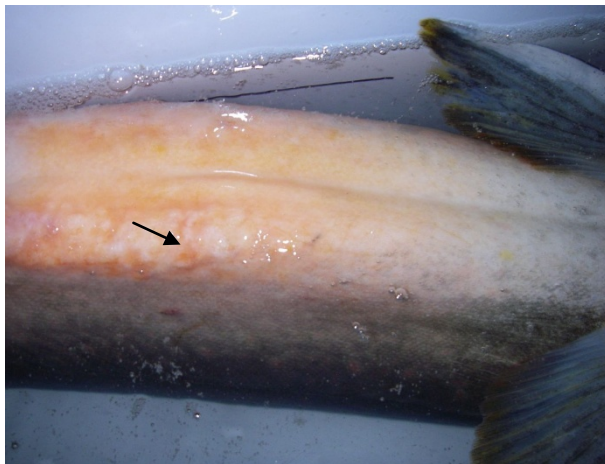
Finished. Arrow points to inserted PIT tag

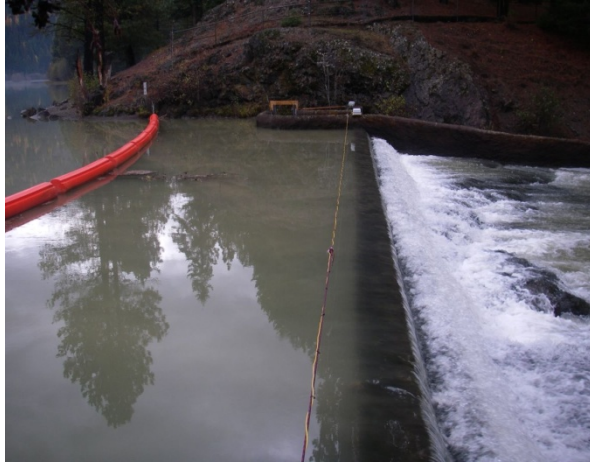
Antenna spanning the spillway weir

A HDX PIT tag interrogation site was constructed at the top of the spillway of Clear Creek Dam during early September, 2012 and was functioning prior to trapping and tagging adult bull trout. HDX PIT tag readers and data loggers, manufactured by Texas Instruments, were procured from Oregon RFID®. A large, single loop antenna was constructed spanning the entire width of the spillway weir, approximately 27 m (85 ft) in length. The antenna was constructed out of 1/0 gage welding cable for the bottom of the loop and 8 gage THHN wire for the top. The top loop was affixed to 1.5 cm climbing rope which was stretched tight. The antenna operated on 18 volt DC current supplied by rechargeable deep-cycle batteries and was installed in a swim-through configuration (Zydlewski et al. 2006) to detect fish migrating over the weir. The detection range of the spillway antenna was approximately 0.3 m (1 ft) upstream and downstream throughout the entire loop.

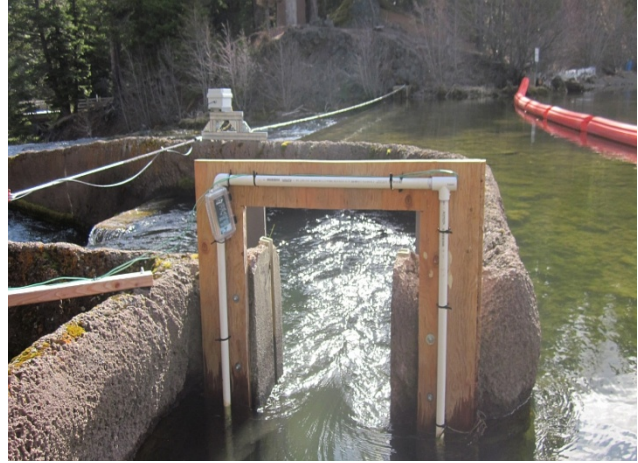
Antenna at exit of pool-and-weir fish ladder

A second antenna was installed in a swim-through configuration on the upstream exit of the pool-and-weir fish ladder. This antenna was approximately 1 m x 1.5 m (3 ft x 5 ft) in size, constructed from 3 wraps of 12 gage THHN wire housed in a PVC pipe frame and mounted to the wall of the fish ladder. Operating on a 12 volt DC current, also supplied by rechargeable deep-cycle batteries, the detection range of the ladder antenna was approximately 1.0 m (3 ft) upstream and downstream of the antenna. Antennae performance was evaluated periodically during the study using test tags and by using timer tags set to send a tag code every 31 minutes. Data was downloaded manually with a laptop computer and subsequently stored on Reclamation's Upper-Columbia Area Office network. Photographs of the spillway and ladder antennae are provided in Appendix C.

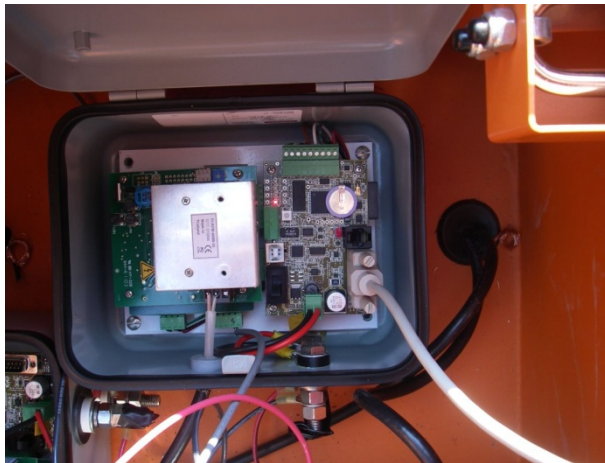
HDX PIT tag reader in job box

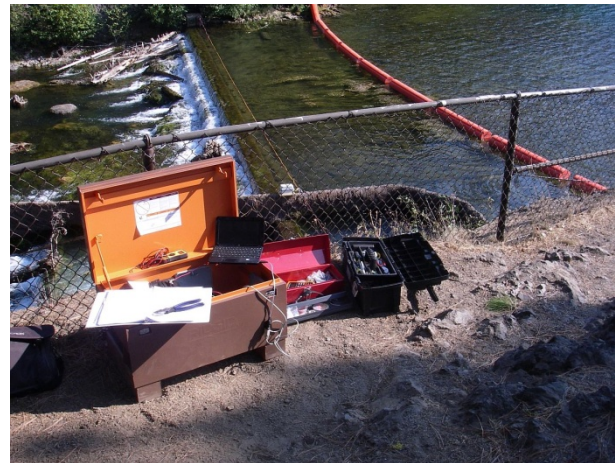
Steel job box holding batteries and tag readers

drawdown between batteries was somewhat erratic. This was due in part to a few that were defective. These were quickly identified and replaced but still the rate at which the power supply would deplete was hard to predict. The power system required consistent attention and short-term outages were not uncommon. Batteries were generally exchanged at least weekly with numerous exchanges occurring even more frequently.

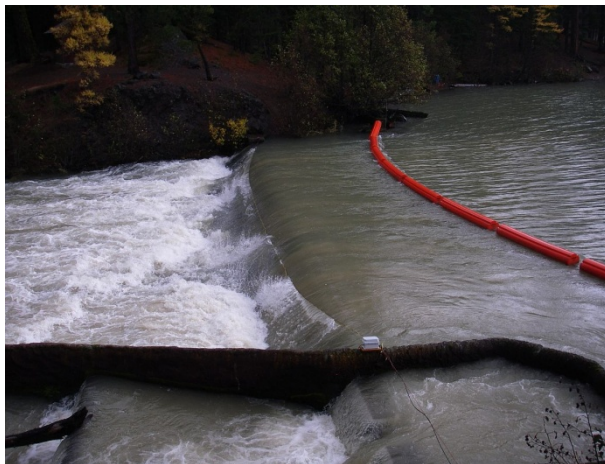
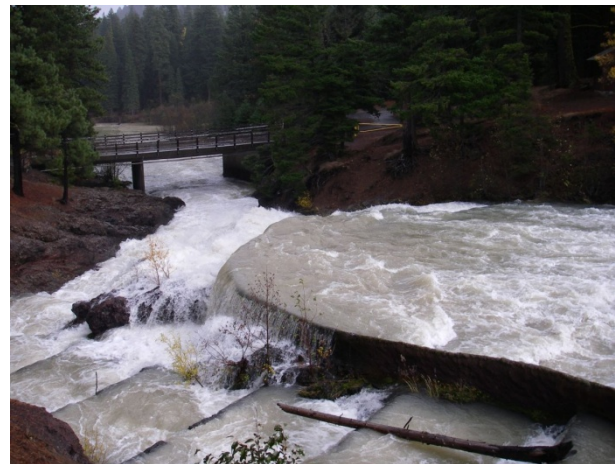
October high flow event which submerged and stretched the spillway antenna (photo on left)

Another factor which caused power interruptions affecting detection capability was significant short-term variation in hydrologic conditions. Because of its small size Clear Lake is subject to rapid increases in lake elevation, and thus spillway flow, during storm events. With the top loop of the spillway antenna stretched a bit less than two feet above the spillway weir, the antenna is vulnerable to submersion under these circumstances. Two such events occurred in October, 2012. One occurred mid-month and resulted in breakage of the antenna and the other (two weeks later) submerged it and stretched the rope to which it was attached. Both resulted in the loss of detection capability for over two days before repairs could be made. The ladder antenna was not affected in either case.
