Proposed Rehabilitation for the Schaake Reach of the Yakima River, Washington

Yakima River Basin Water Enhancement Project

March 2007

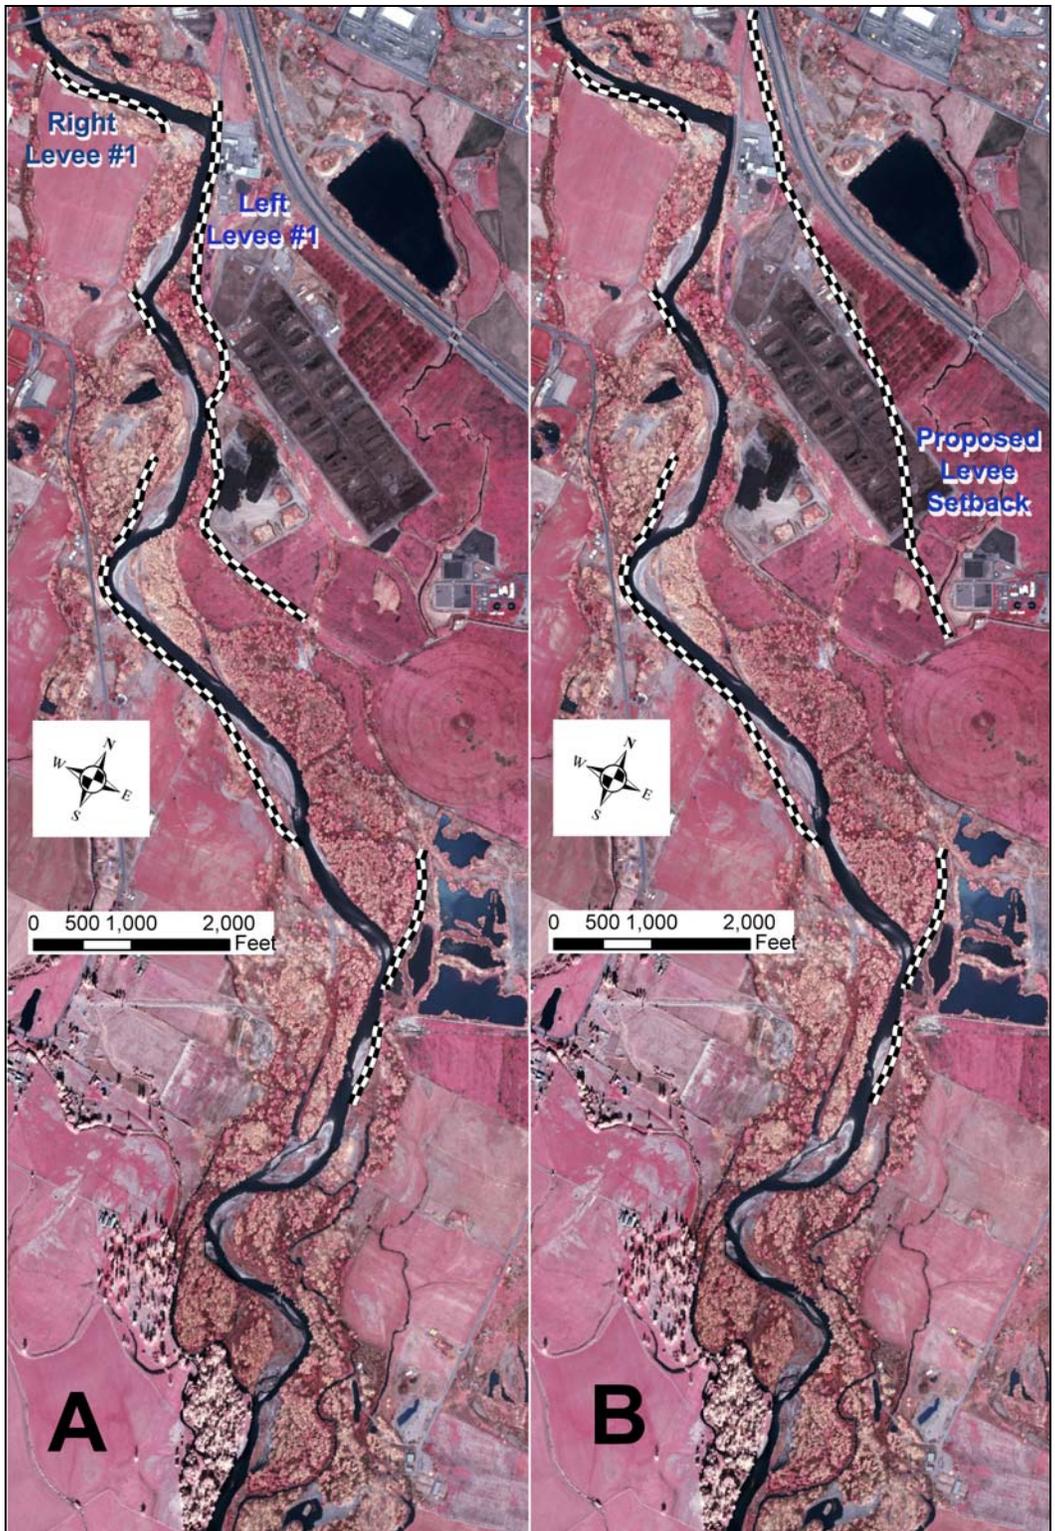
Figure 1: False color IR aerial photograph of the study site showing the existing levee configuration (A) and the proposed levee alignment (B). Flow direction is top to bottom of the figure.

The Schaake reach of the Yakima River (Figure 1) has a series of levees on both sides of the river, five within the study reach. The presence of these levees has confined the river and prevented regular interaction between the river and the floodplain. This has caused some incision of the river channel and a coarsening of the bed material in this reach (Hilldale and Klinger, 2003). The disconnection of the floodplain from the river has significantly decreased the ability of the river to build and maintain side channel habitat critical to the existence of salmonid fish species in the Yakima River Basin (Ring and Watson, 1999, Stanford et al., 2002). Side channel habitat is beneficial to fish attempting to escape high velocities during flood events and provides rearing habitat throughout the year for juvenile fish. These side channels may also provide spawning habitat. Food is typically more abundant in side channels due to increased vegetative cover and reduced flow velocities.

The current report details the modeling results for moving left levee #1 from its existing location (Figure 1 A) to the setback location (Figure 1 B) while maintaining the existing alignment of right levee #1 and all other levees. The primary difference regarding levee scenarios from the 2004 report is that right levee #1 and all other right bank levees remain intact. This report also details modeling results of newly proposed side channel locations (Figure 2) that differ from the previous report (Hilldale, 2004).

After all flows were modeled with the existing topography and levee configuration, proposed modifications were incorporated into the modeling surface. Left levee #1 was removed in such a way that existing ground elevations on both sides of the levee were used to determine the new ground elevation where the levee had existed in the original modeling surface. This anticipates the physical levee removal will occur in a similar fashion. The existing and proposed alignments are shown in Figure 1 and Figure 2.

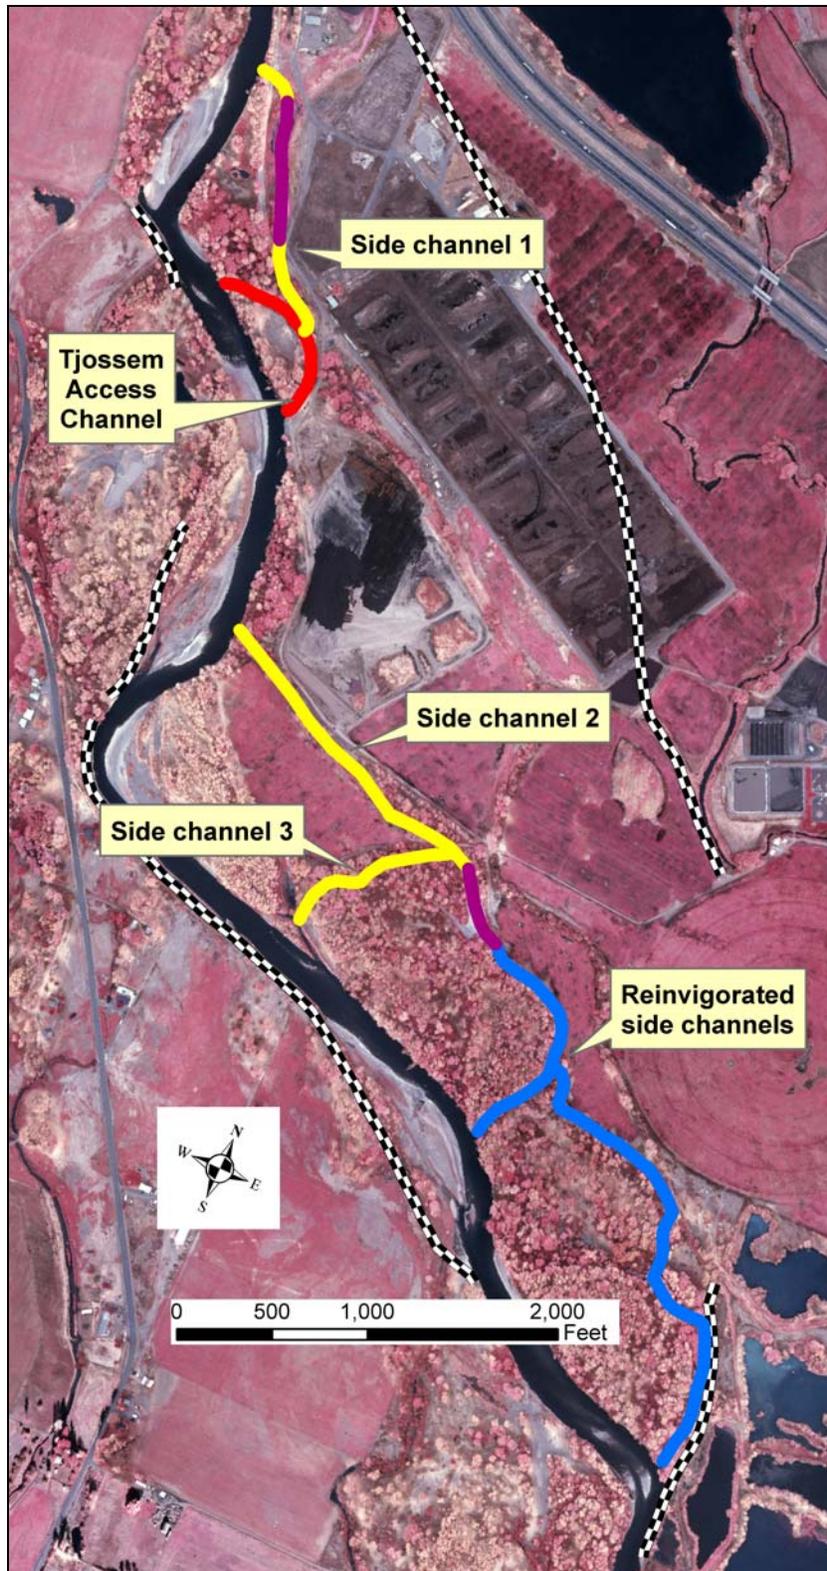
Figure 2: False color IR aerial photograph showing the proposed side channels. Yellow indicates newly wetted side channels, purple indicates existing ponds connected to side channels and blue indicates reinvigorated side channels. Flow direction is from top to bottom of the figure.

Side channel #1 is approximately 1,485 feet in length (Figure 2). The inlet and outlet invert elevations of side channel #1 were set at an elevation equal to one foot beneath the water surface elevation for a main channel discharge of 1,000 ft³/s. This channel flows into and out of an existing pond on the property. This pond has a long and narrow configuration and is approximately 2 to 3 feet deep (Philip Small, pers. comm.). The intent behind such a configuration is to add complexity in the channel while reducing the excavation cost and level of disturbance to the site. Side channel #1 also flows into an existing slough that is situated between the current levee and the Tjossem access ditch. Existing vegetation along side channel #1 precludes the need for planting of the riparian areas in this channel. Constructing side channels in the currently proposed locations is favorable with respect to phosphorous levels (Small, 2006).

Side channel #2 is approximately 1,650 feet in length (Figure 2). The invert elevation for side channel #2 was based on the elevation of the existing dry ditch through which side channel #2 flows. This location currently supports mature cottonwood and willow of varying age. There will be no need to vegetate the banks of this side channel to provide stability and shade. The channel is currently dry throughout its length with the exception of approximately 350 feet at the downstream end, which is fed by groundwater. Phosphorous levels in this area are very low (Small, 2006).

Side channel #3 is approximately 945 feet long and connects side channel #2 to the main channel (Figure 2). This channel has a lower slope than the other side channels, which may present the possibility of aggradation. This poses two potential problems; 1) the channel could become ineffective at lower discharges in side channel #2 due to excessive aggradation, and 2) if fine sediment accumulates in this channel, the growth of macrophytes could be promoted, starving the water of oxygen during no/low flow periods. Although the soil in the vicinity of side channel #3 was not tested, it is not expected that this area has elevated levels of phosphorous. The area is forested and was not subjected to activities related to the stockyard or direct spraying of vegetable production waste.

Downstream of side channel #2 is an existing pond of unknown depth (Figure 2). It is proposed that this pond be connected to side channel #2 in such a way that flow from side channel #2 can be connected to existing side channels that currently experience little or no surface water interaction, depending on the main channel discharge. These channels combine to form a total of approximately 3,800 linear feet. Currently, these channels are primarily fed by groundwater. These side channels are expected to increase the overall habitat potential with additional surface water flow.

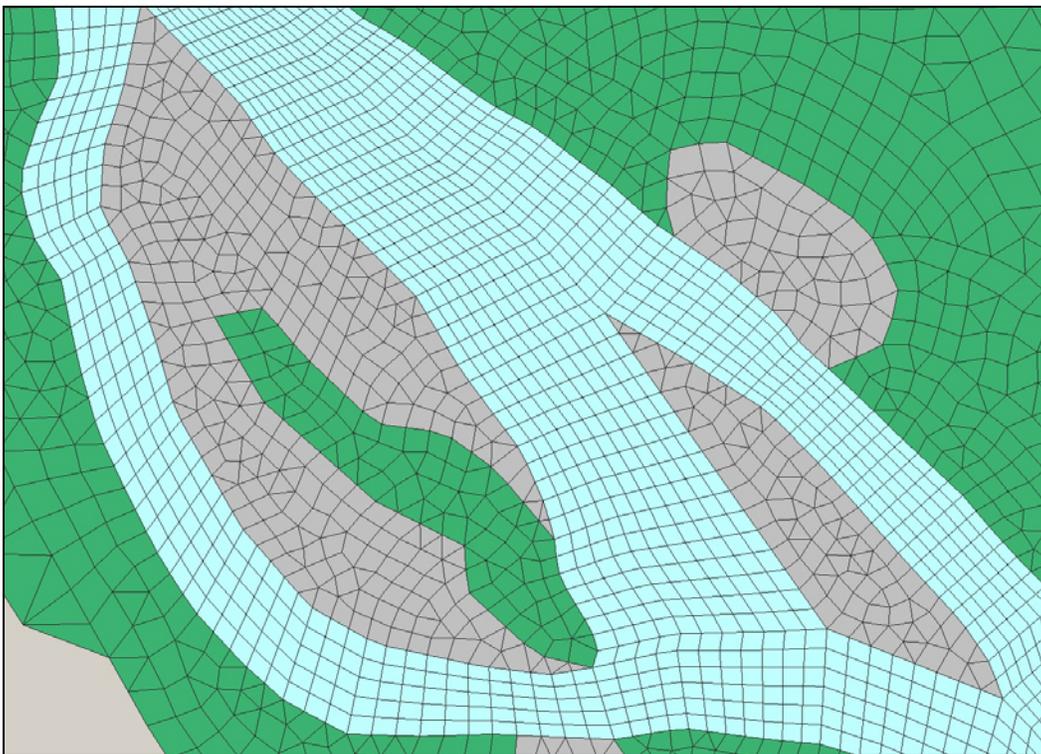
Figure 3: Example of structured and unstructured mesh. Colors represent different roughness values. Note the structured quadrilateral elements representing the channel and a combination of quadrilateral and trilateral unstructured elements representing the floodplain. Also note the finer resolution within and near the channel and coarser resolution toward the edges of the mesh.

Typical dimensions for mesh cells representing the main channel are 6 ft. X 10 ft. with the long dimension coincident with the longitudinal direction. Mesh cells representing the floodplain begin at this cell size and increase with increasing distance from the channel. Mesh cells in the side channels are often smaller than the main channel in order to force multiple cells across a narrow channel width.

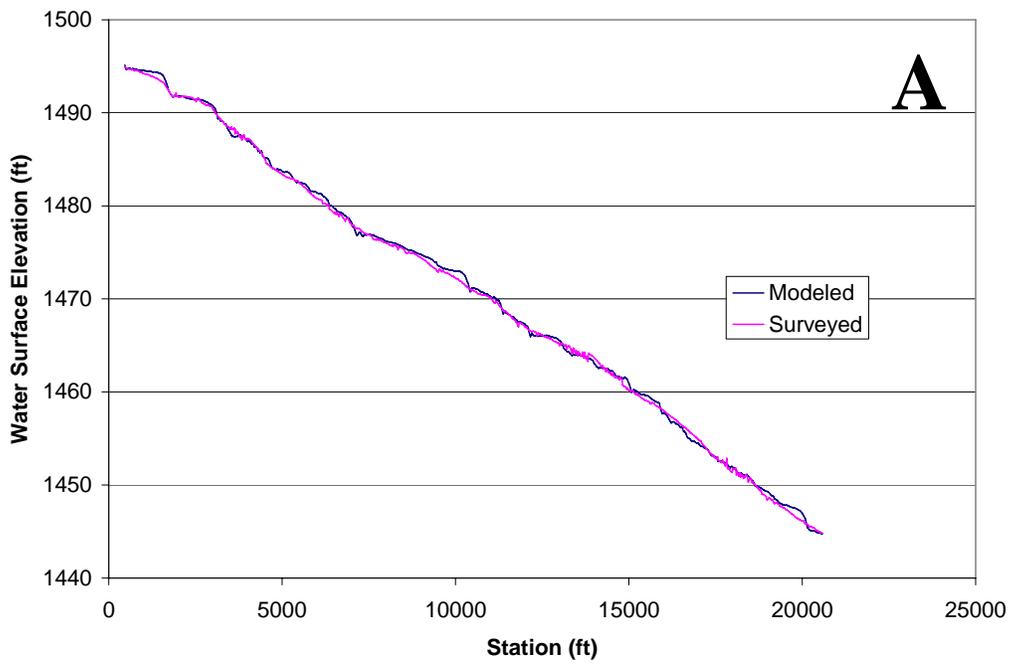
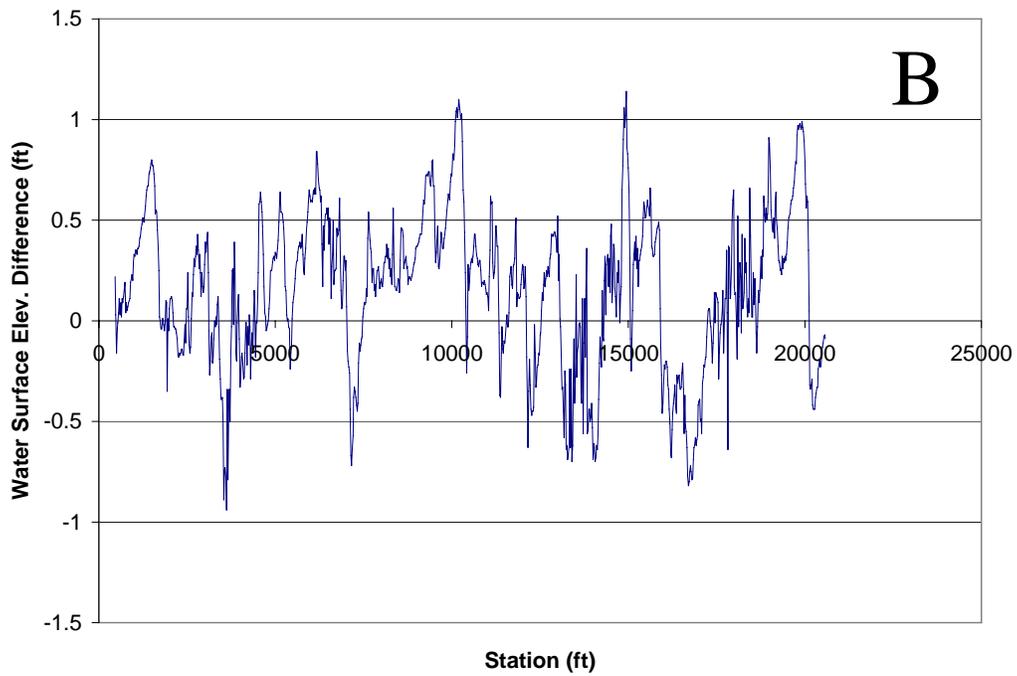
Figure 4: Comparison of the modeled and surveyed water surface elevations (A), and difference between modeled and surveyed water surface elevations (B). The surveyed value was subtracted from the modeled value.

The model was run for a range of discharges (Table 1). This model was verified using water surface elevations obtained during the bathymetric survey, for which the discharge of the Yakima River was 3,150 ft³/s, as measured at the Ellensburg Gage (ELNW) located approximately 2.7 miles upstream of the property. The comparison of the surveyed and modeled water surface elevations are shown in Figure 4. At the upstream end of the reach potential errors may exist in the survey due to extended loss of satellite and radio reception as the raft passed under the Umptanum Road Bridge. After passing under the bridge the equipment would take a few minutes to reacquire an accurate position. Because the raft was moving during this reacquisition the GPS survey was less accurate for some distance downstream of the bridge. The error in this portion of the reach prompted the replacement of the raft-surveyed bathymetric data with aerial surveyed bathymetric data using water penetrating LiDAR (Hilldale and Raff, 2007). The other locations where disagreement exists between modeled and surveyed water surface elevations in Figure 4 B are locations where there was a brief loss of GPS acquisition due to riparian vegetation interfering with satellite reception. These errors exist for short distances and do not represent significant concern regarding the model results.

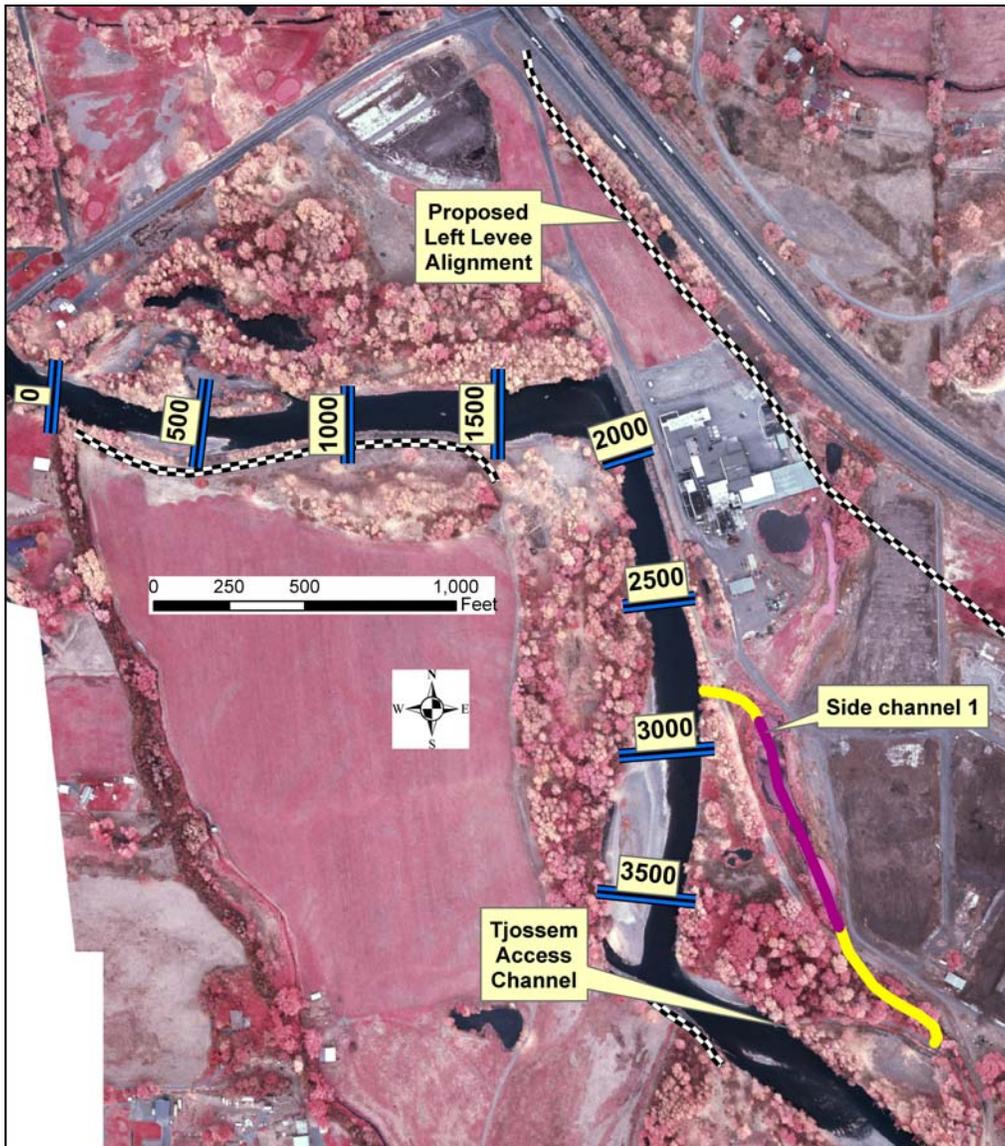
Figure 5: False color IR aerial photograph showing the area of greatest concern with the removal of left levee #1 at the 90 degree bend. Stationing is used to reference specific locations along this reach in Figures 6.

The area of greatest concern with respect to the removal of left levee #1 is the 90 degree bend in the river near the north end of the Schaake property (Figure 5). This is also the reach of greatest change in hydraulic conditions with respect to the removal of left levee #1. In addition to plan-view results, it is instructive to show changes in depth and velocity in graphical form. For this reason, Figure 5 shows stationing along the reach, which only has significance for location reference. Station zero begins at the upstream end of the model.

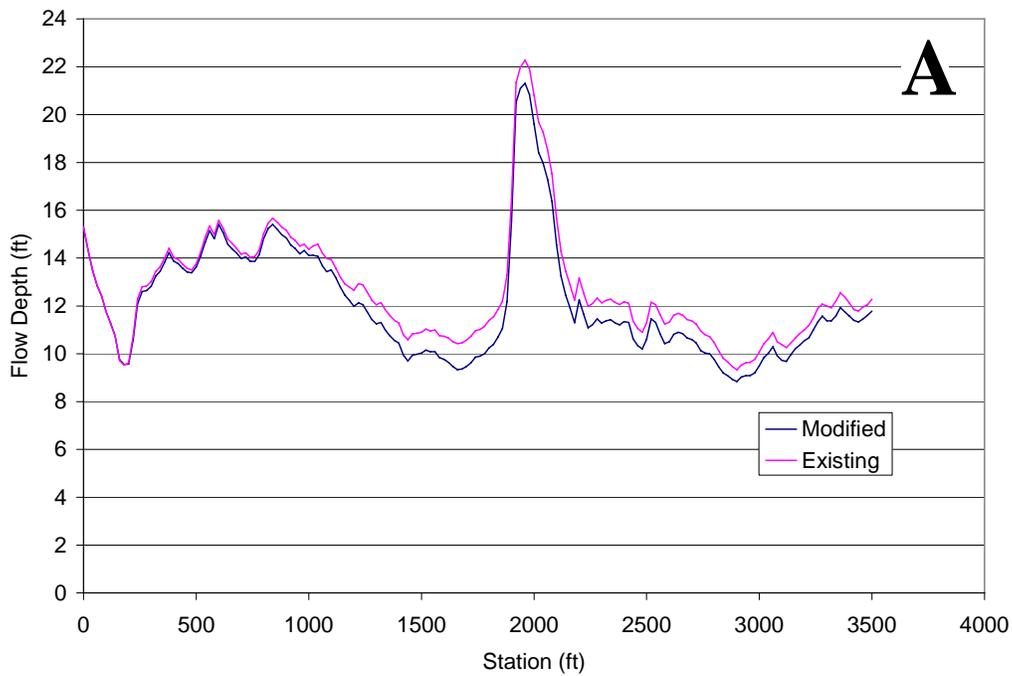
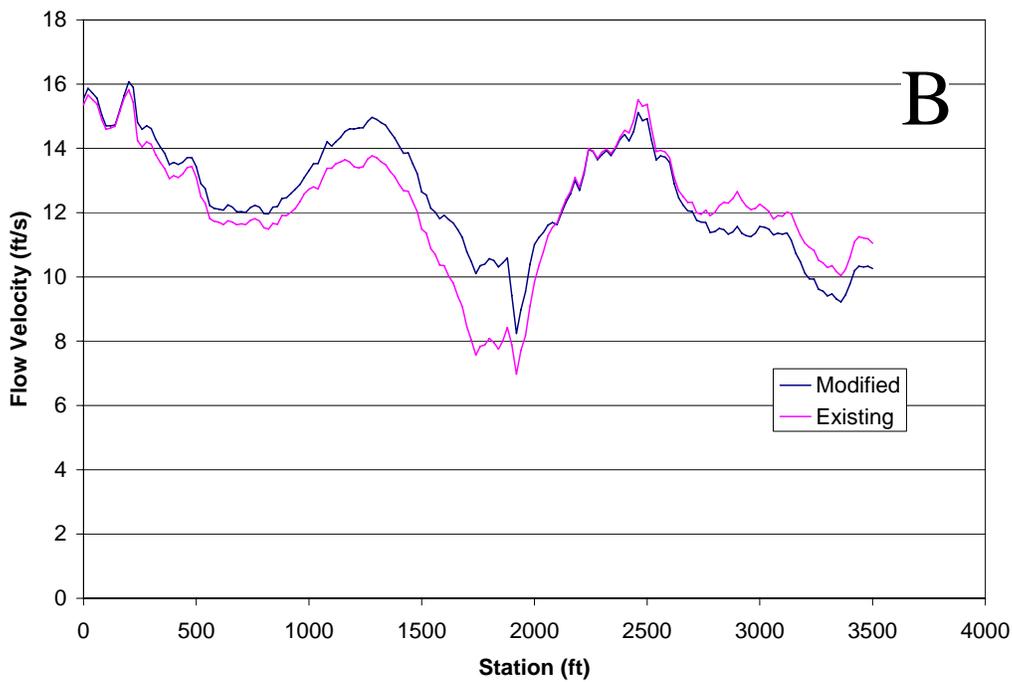
Figure 6: Charts showing the modeled change in centerline flow depth (A) and change in centerline velocity (B) in the vicinity of the 90 degree bend at a discharge of 25,000 ft³/s following the removal of left levee #1.

The centerline flow depth and velocity for the 25,000 ft³/s discharge along this reach is graphed in Figure 6 A and B. It can be seen that the flow depth decreases following the setback of left levee #1, however the main channel velocity increases. The velocity increase is contrary to previous findings when left levee #1 was set back and right levee #1 was removed (Hilldale, 2004). This increase in velocity is likely due to the lack of flow attenuation on the right floodplain with right levee #1 in place. Modeling results are shown in plan-view in Appendix A.

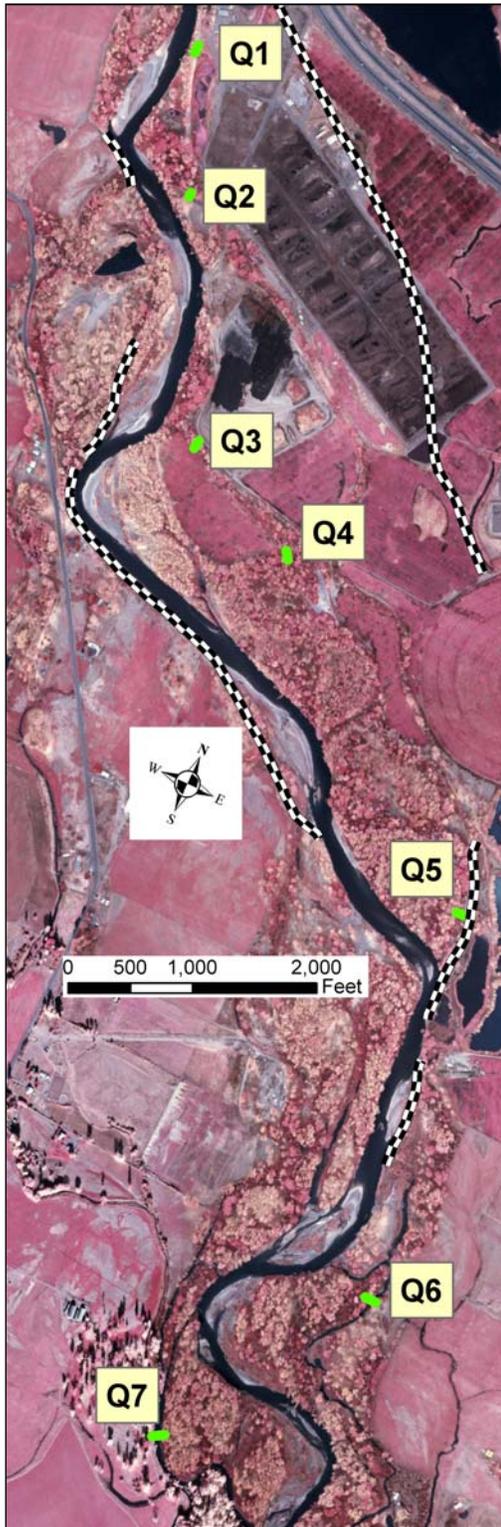
Figure 7: False color IR aerial photograph showing the location of monitoring lines for discharge. Flow is from top to bottom of the figure.

Discharge through each of the side channels was monitored at specific locations in the model (monitoring lines shown in Figure 7). Not all of the monitoring lines indicate flow for all modeling scenarios.

Table 2 lists which side channel is monitored with each monitoring line. Monitoring lines 6 and 7 (Q6 and Q7) are used as a reference under the existing scenario but were not monitored during the modified scenario because discharge in these two side channels will not change under the modified scenario. There was no survey performed in these side channels and as such, the channel bottom was approximated. It was assumed that the channel bottom was 2 feet below the lowest contour line provided by the terrestrial LiDAR. This is a reasonable assumption based on observation made during site visits to some of these side channels. The downstream portion of the side channels indicated as reinvigorated (in the vicinity of Q5) were cut 2 feet below the lowest contour. The upstream portion of this channel was surveyed. Depth and velocity maps of the side channels are contained in Appendix B for a main channel discharge of 4,000 ft³/s.

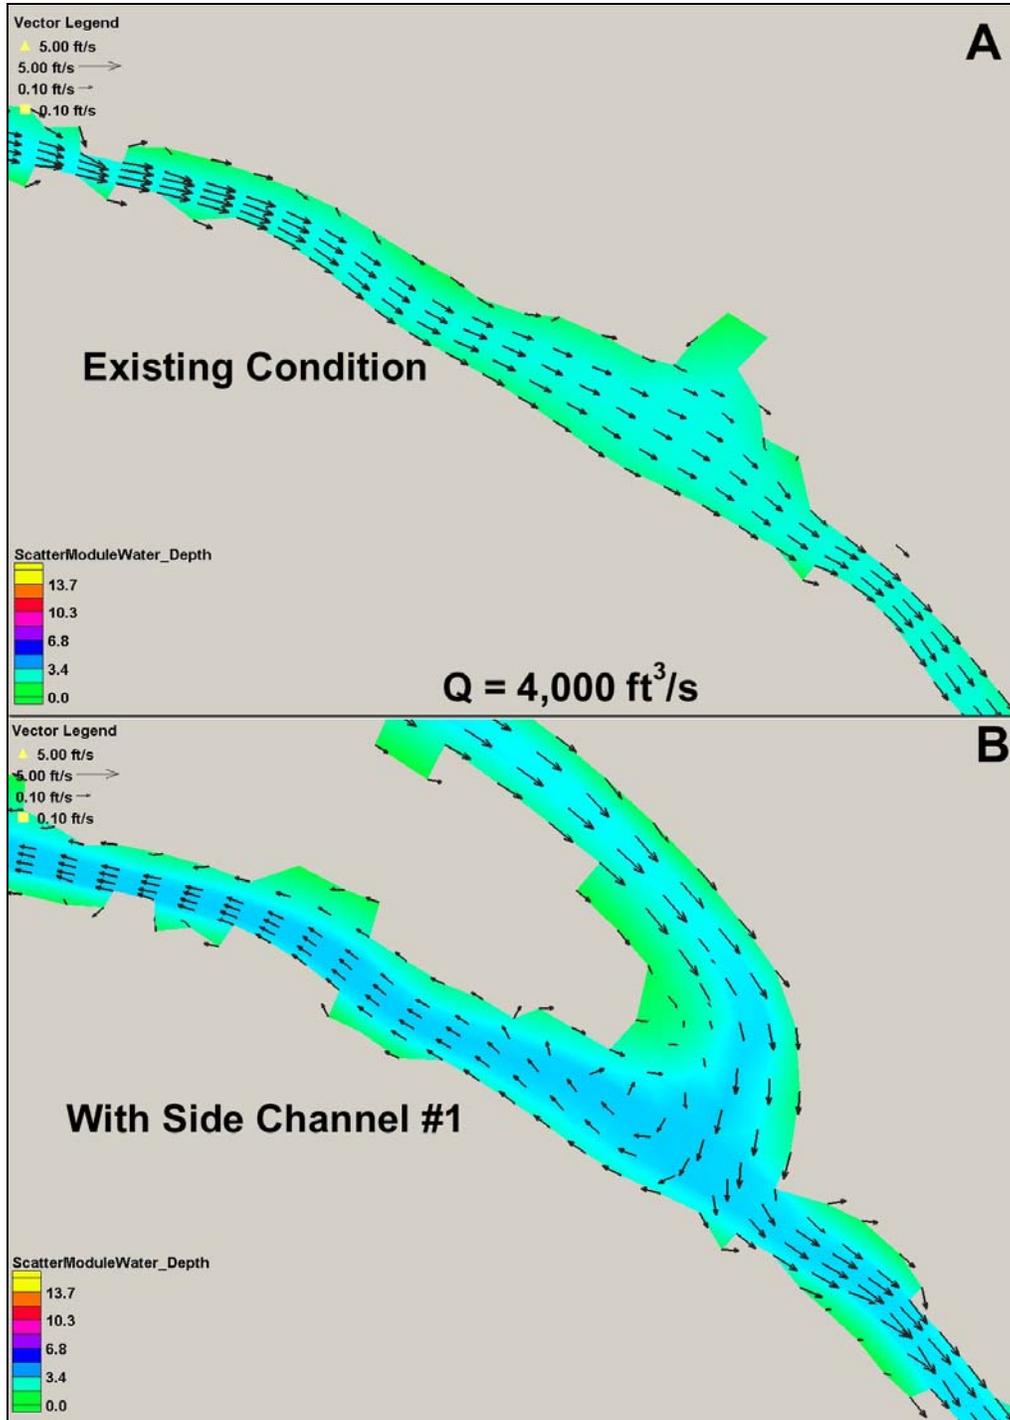
Figure 8: Velocity vectors and depth color ramp for the Tjossem access ditch where proposed side channel #1 enters the ditch. (A) Existing condition, (B) with proposed side channel #1.

When the main channel discharge is greater than 2,000 ft³/s, discharge of side channel #1 into the Tjossem access channel causes a change in flow direction in the upstream portion of the Tjossem access channel. Figure 8 shows this

occurrence with a main channel discharge of 4,000 ft³/s. This result is consistent with the previous report (Hilldale, 2004). The change in flow direction at this location is not expected to have any impact on habitat or water delivery to Tjossem Ditch. Discharges through proposed side channel #1 are sufficient to provide the 8 ft³/s required for the water right to Tjossem Ditch during the summer irrigation season (see Table 2).

The change in flow direction in the upstream portion of the Tjossem access channel changes the shear stress values from existing conditions (Figure 8). At 4,000 ft³/s shear stresses range from 0.18 to 15 Pa under existing conditions and 0.10 to 2 Pa with side channel #1 present. The difference in shear stresses at 1,000 ft³/s is less, with 0.03 to 1.8 Pa under existing conditions and 0.06 to 0.70 Pa with side channel #1 present. The entrance to the channel experiences the lowest shear stress in the portion of the channel where the flow direction changes. The portion of the access channel where flow direction is changed will likely experience a decrease in particle size and may aggrade. Over time this aggradation may create a condition whereby the surface connection is lost at common summer discharges. However, the Yakima River in this reach has relatively low suspended sediment concentrations, which indicates that any aggradation in the access channel will be slow and more likely dependant on conditions related to the falling limb of a flood hydrograph. Should this portion of the access channel aggrade such that a surface connection is lost, discharge through the proposed side channel #1 will be able to accommodate the required water right to Tjossem Ditch. Although the existing system has been operable for many years with respect to providing sufficient discharge to Tjossem Ditch, there is no guarantee that morphological changes will not occur as to render the access channel useless, with or without the proposed changes being implemented. Maintenance at the entrance of the Tjossem access channel has been necessary in the past (Jeff Graham, per. Comm.).

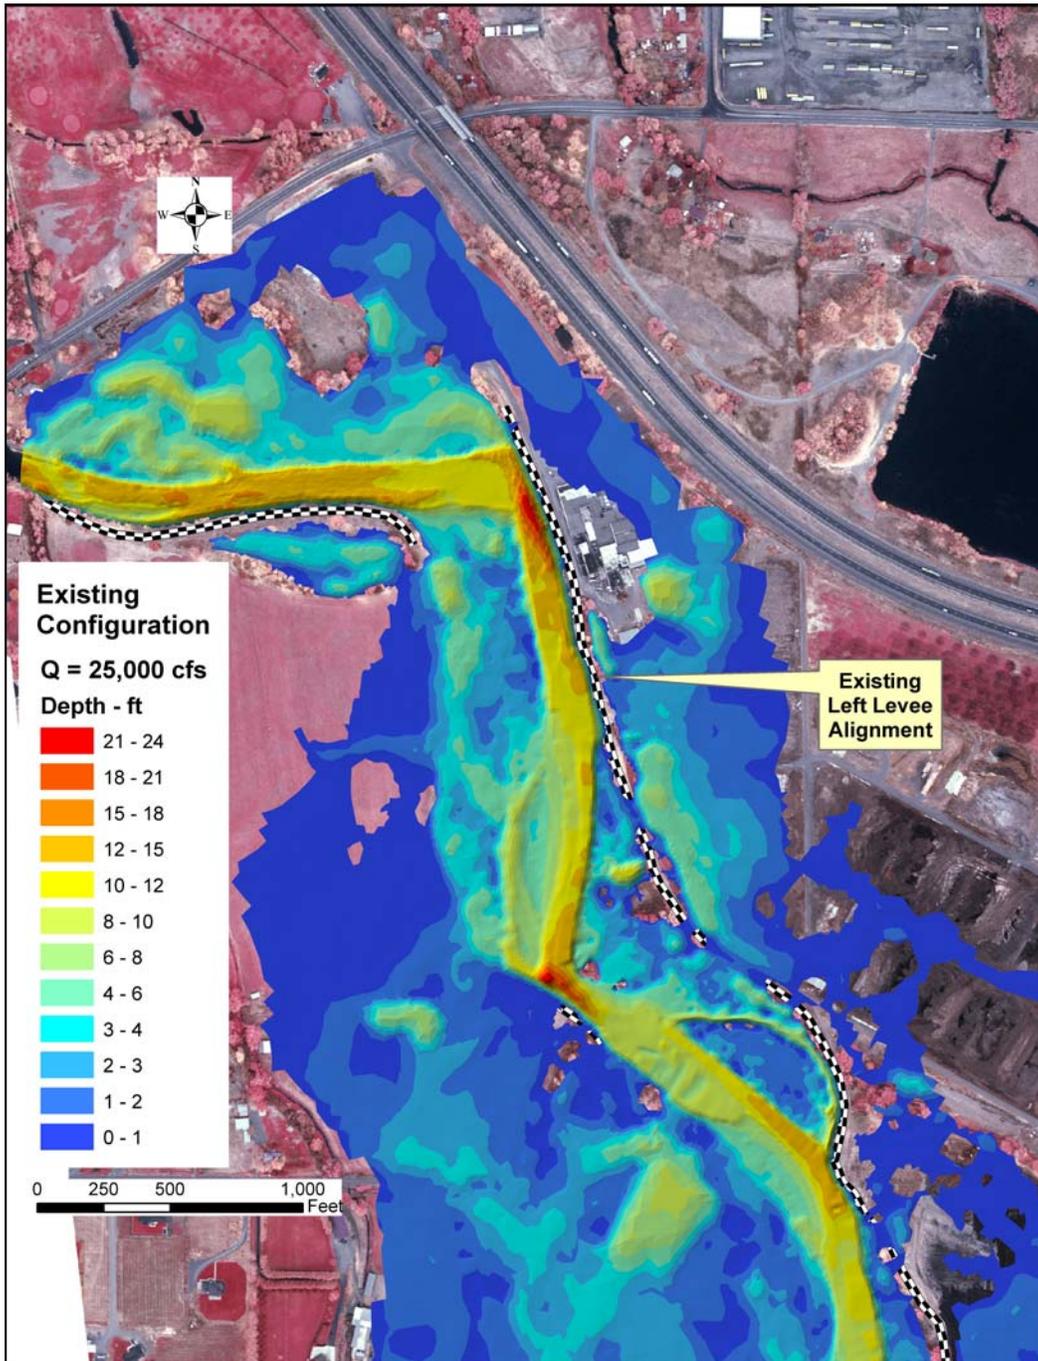
Figure 9: Modeling results showing modeled flow depth at 25,000 ft³/s under existing conditions. Flow direction is toward the bottom of the figure.

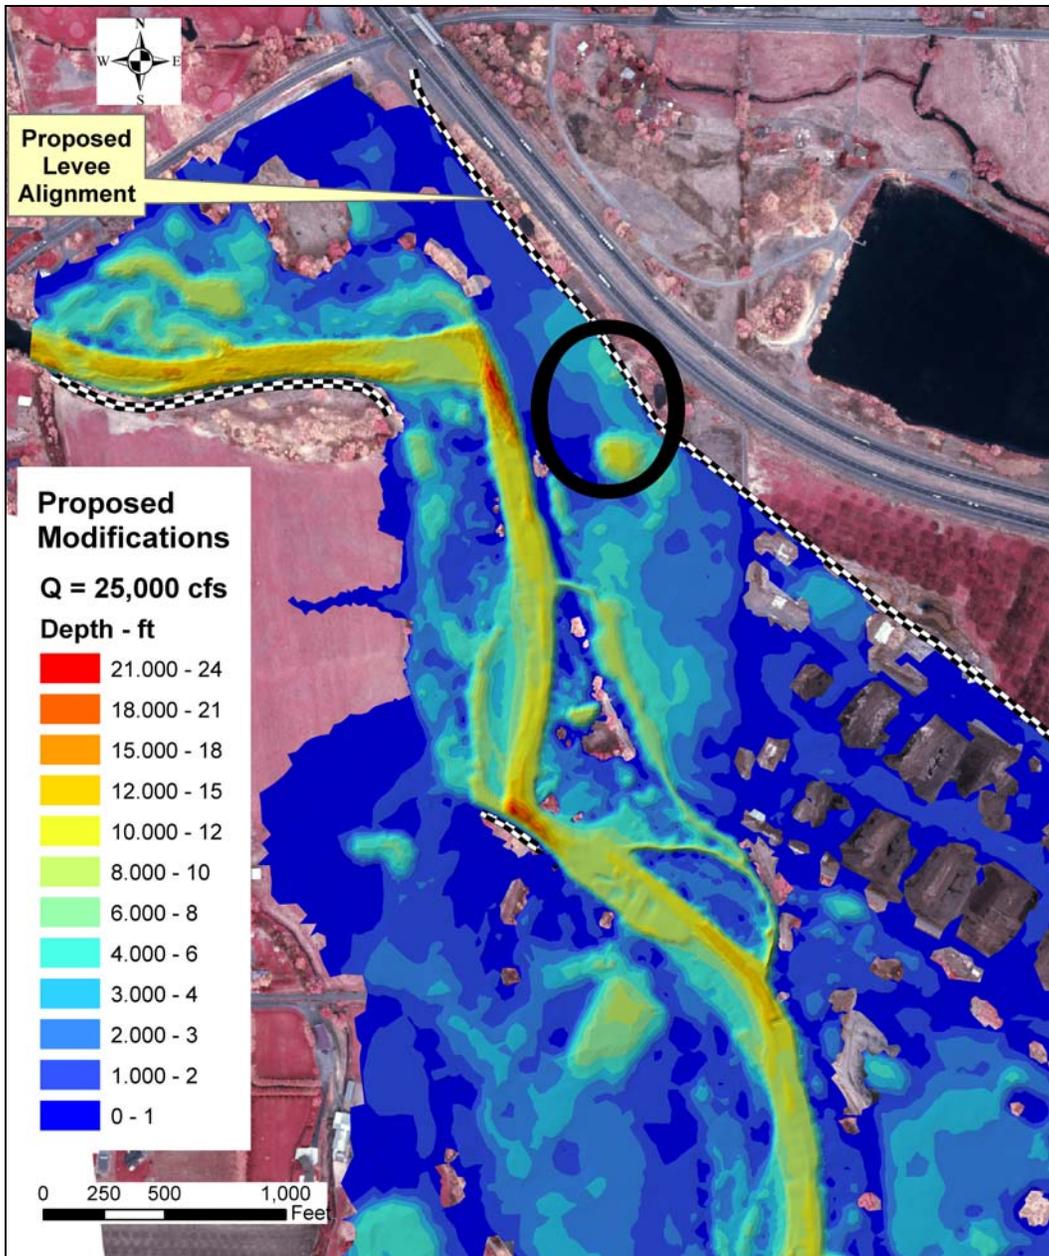
Figure 10: Modeling results showing modeled flow depth at 25,000 ft^3/s under the proposed conditions. Circle indicates area of greatest depth, which has changed following regrading of the site. Flow direction is toward the bottom of the figure.

After left levee #1 is setback, migration of the river east toward the interstate must be anticipated. Although that is not to say that the river will rapidly migrate completely to the proposed levee. Early maps (ca. 1913) indicate that the main channel at the 90-degree bend has moved approximately 350 feet eastward (Hilldale and Klinger, 2004) to its current location. Current levee removal plans are to remove the levee and riprap above the existing ground elevation on the floodplain side of the levee. Leaving the riprap below the new bank elevation should slow the migration of the river eastward. It is possible that overtopping flows may scour behind the remaining riprap that is level with the new bank elevation, possibly creating a scour hole in this location. As this process progresses over a few flood cycles, a split channel configuration may form, which is what existed in 1966 aerial photography, albeit further west (Hilldale and Klinger, 2003). Widening of the channel decreases energy and therefore the potential to migrate all the way to the proposed levee location. This is only considered to be a probable scenario and no guarantee that the river will not migrate to the proposed levee location over time. Modeled depth for the proposed scenario is shown in Figure 10.

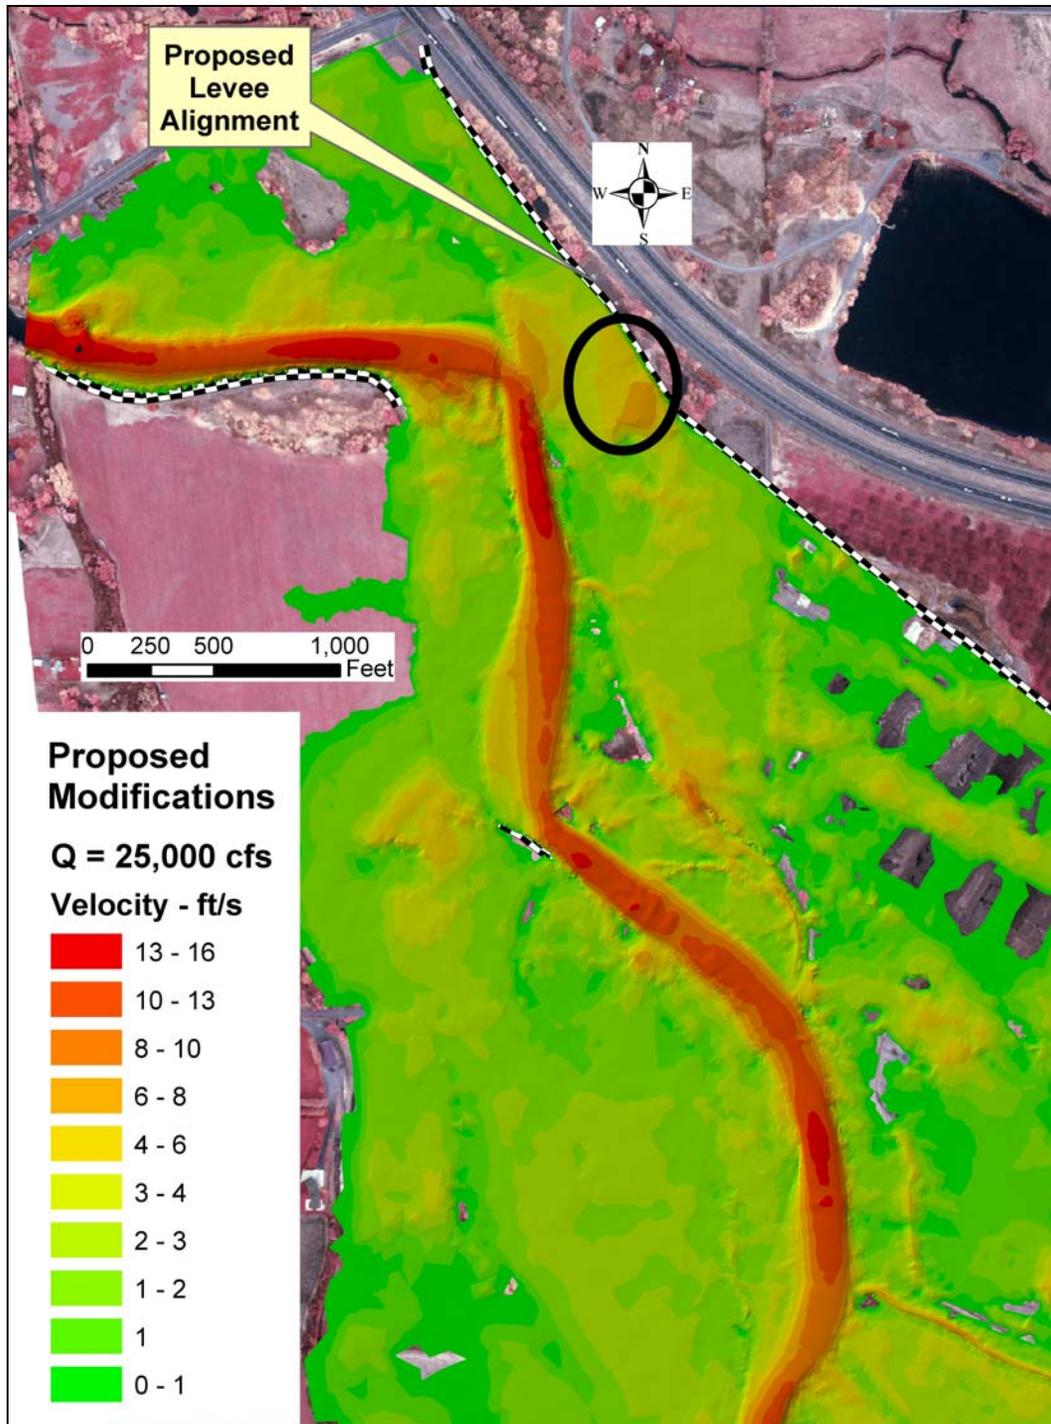
Figure 11: Modeling results showing modeled velocity at 25,000 ft³/s under proposed conditions. The circled area with high velocity has been changed since regrading of the site. Flow direction is top to bottom of the figure.

Results showing modeled velocity (Figure 11) indicate generally low velocities (approximately 1 ft/s or less) along the proposed levee during a 25,000 ft³/s discharge. The area of highest velocity along the levee, indicated with a black circle on Figure 11, has been changed by regrading after the removal of the structures on the site. This suggests that the velocity in this area will be similar to velocities along the rest of the levee.

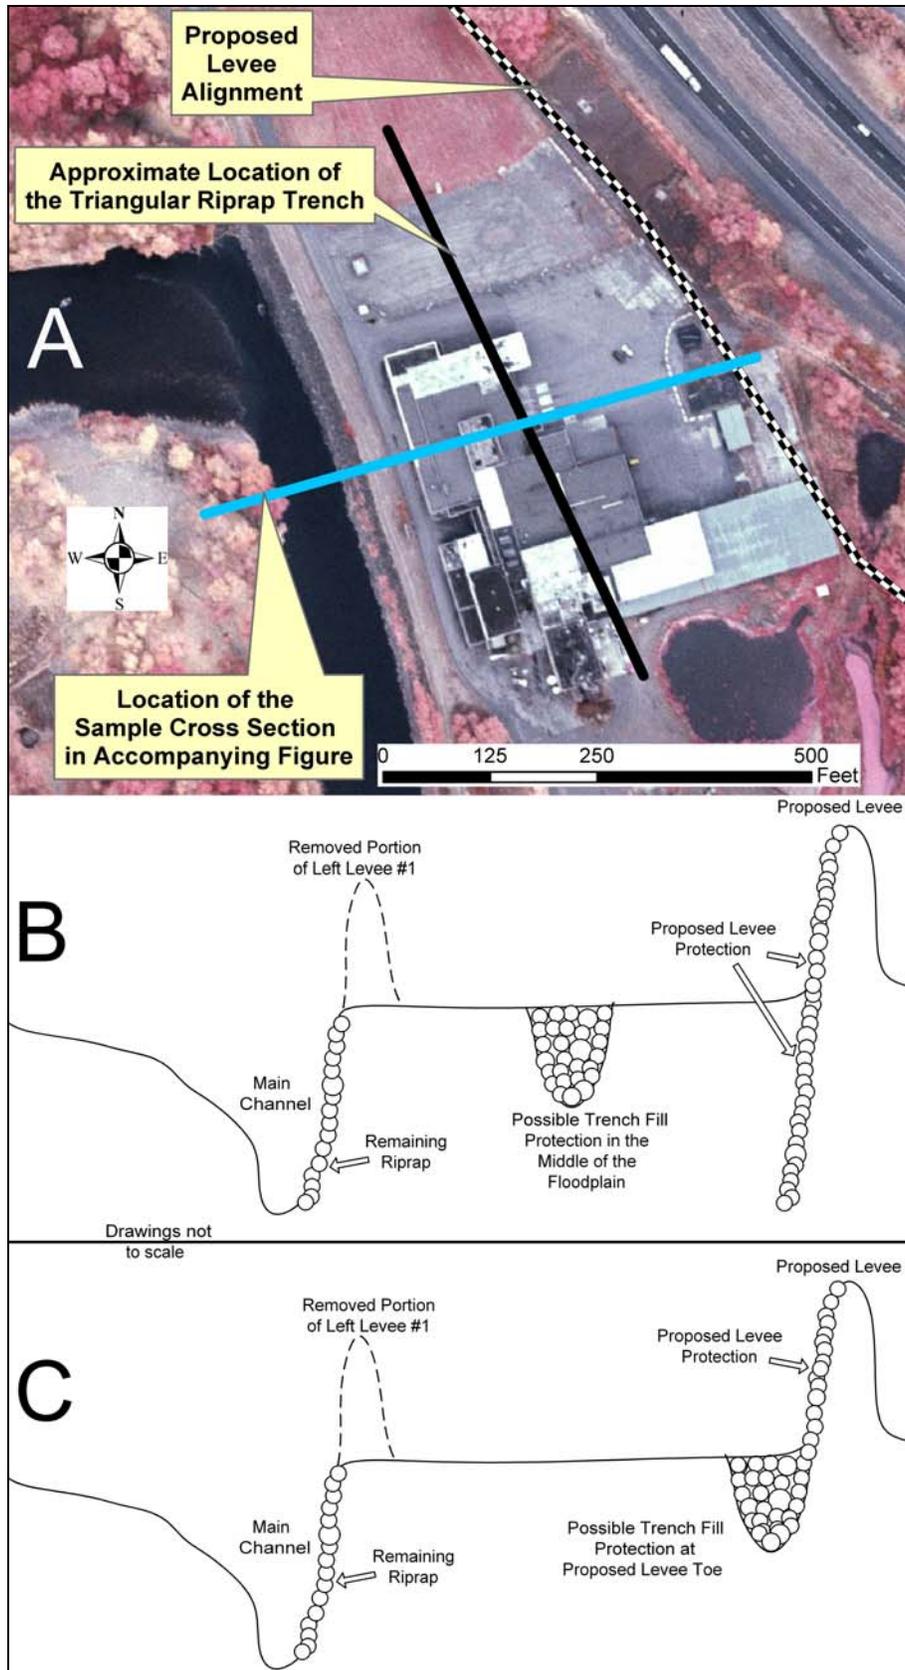
Figure 12: Diagrams of possible bank protection schemes and location.

It is advisable that the proposed levee and perhaps the floodplain be protected against erosion and channel migration. There are several possibilities for this type of protection, some of which are shown in Figure 12. At a minimum the levee surface should be reinforced for approximately 3,000 feet, beginning at the north end. Other possibilities include burying riprap at the toe of the levee to an elevation similar to the current main channel thalweg elevation (Figure 12 B).

A potential remedy for preventing channel migration all the way to the proposed levee is to bury riprap in the floodplain (trenched rock) between the current location of left levee #1 and the proposed location of the setback levee (Figure 12). The proposed trench location shown in Figure 12 A and B suggests placing the trench approximately half way between the main channel and the proposed levee. The length of the trench is 700 feet (Figure 12 A). If a trench is placed in the floodplain, the north end should begin at such a location that potential migration will not flank the trench to the north. Another possible solution for reinforcing the toe of the proposed levee is to place trenched rock at the toe of the levee (Figure 12 C). The trenched rock is expected to launch the accumulated riprap along the face of the eroding bank should the river migrate to the trench. An advantage of the trenched rock is that it is not seen until such a time that the river begins to erode the material from the buried rock. More detail regarding trenched rock can be found in river restoration manuals (e.g. Design of Riprap Revetment, FHWA, 1989 and Sacramento River Conservation Area Forum Handbook, 2003). Consideration needs to be given that the river channel may not migrate completely to the trench or the levee and that these measures can be considered an added level of protection against complete migration to the proposed levee toe. The level of protection required for this levee has yet to be determined.

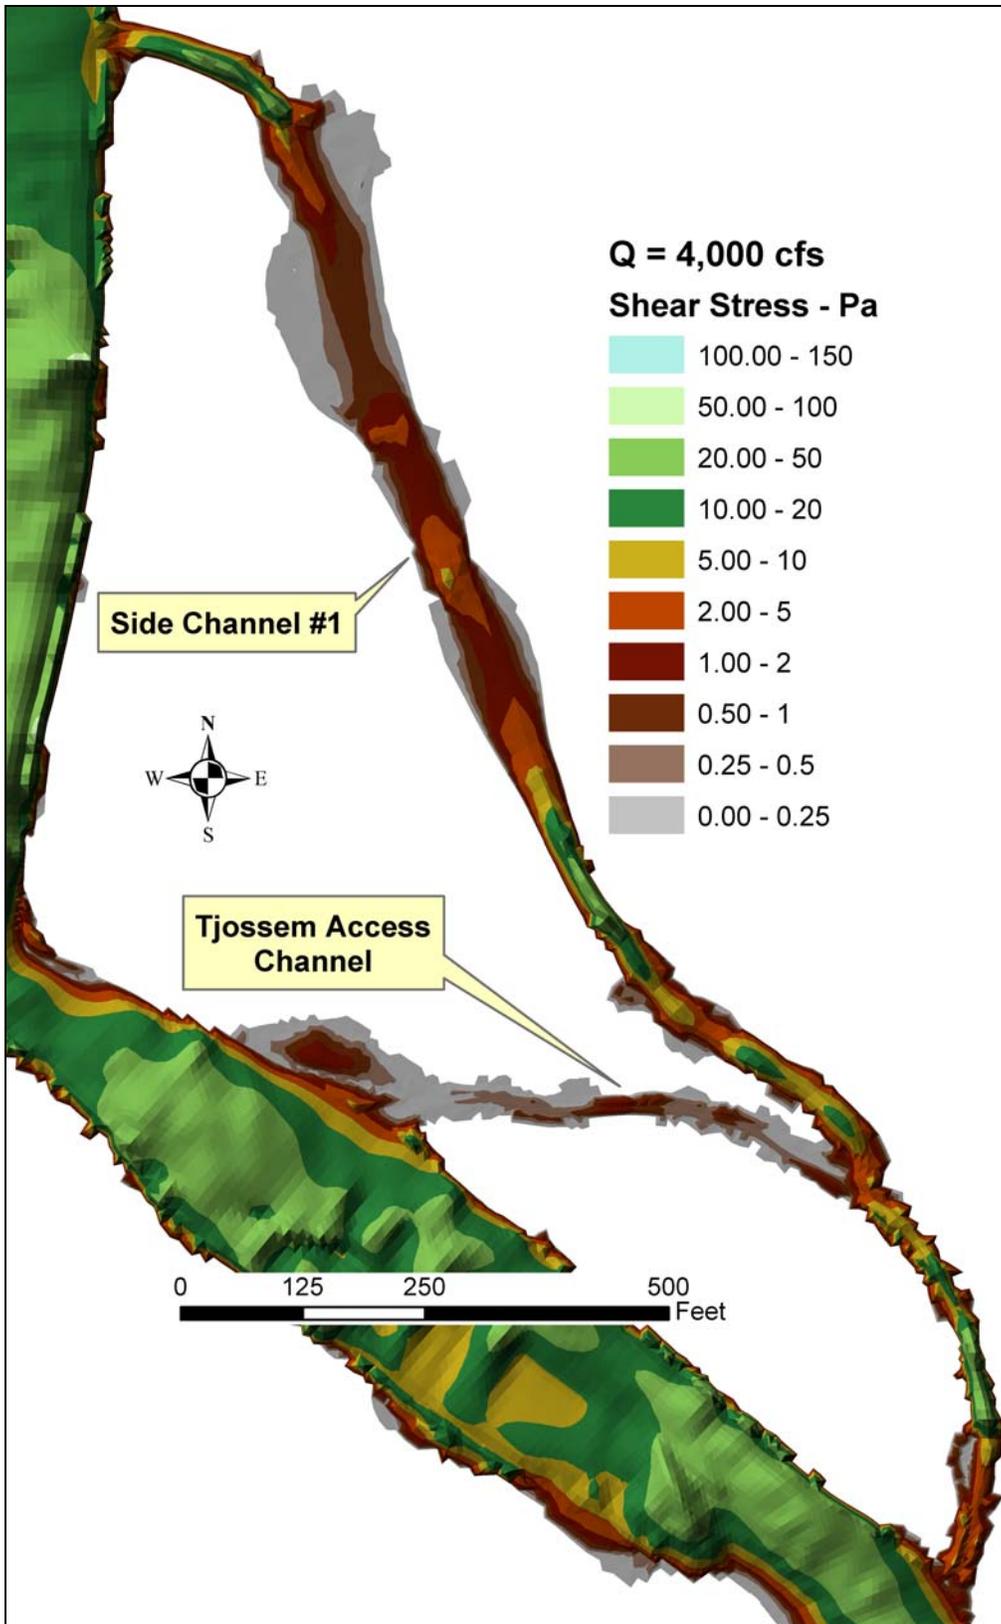
Figure 13: Model results showing predicted shear stress in side channel #1 and the Tjossem access channel. Flow is from top to bottom of the figure.

which occurs on an annual basis, conclusions can be made regarding the minimum particle size in the side channels. The modeled values of shear stress in the side channels obtained from GSTAR-W are shown in Figures 13 – 15. Details regarding the computation can be found in Lai (2006). All figures are shown with a main channel discharge of 4,000 ft³/s. Along much of the length of the side channels, shear stresses are greater than 0.5 Pa. The primary exceptions to this are the ponds in side channel #1 (Figure 13) and in the reinvigorated side channel (Figure 15).
