Proposed Rehabilitation for the Schaake Reach of the Yakima River, Washington

Yakima River Basin Water Enhancement Project

March 2007

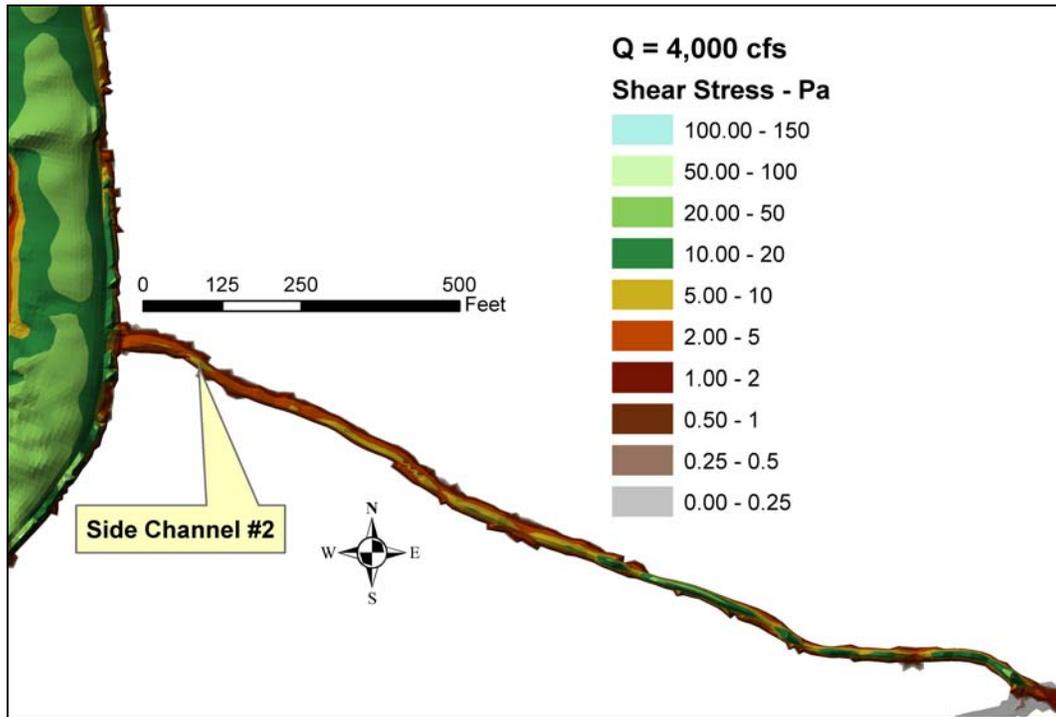
Figure 14: Model results showing predicted shear stress values for side channel #2. Flow in the side channel is from right to left of the figure.

which occurs on an annual basis, conclusions can be made regarding the minimum particle size in the side channels. The modeled values of shear stress in the side channels obtained from GSTAR-W are shown in Figures 13 – 15. Details regarding the computation can be found in Lai (2006). All figures are shown with a main channel discharge of 4,000 ft³/s. Along much of the length of the side channels, shear stresses are greater than 0.5 Pa. The primary exceptions to this are the ponds in side channel #1 (Figure 13) and in the reinvigorated side channel (Figure 15).

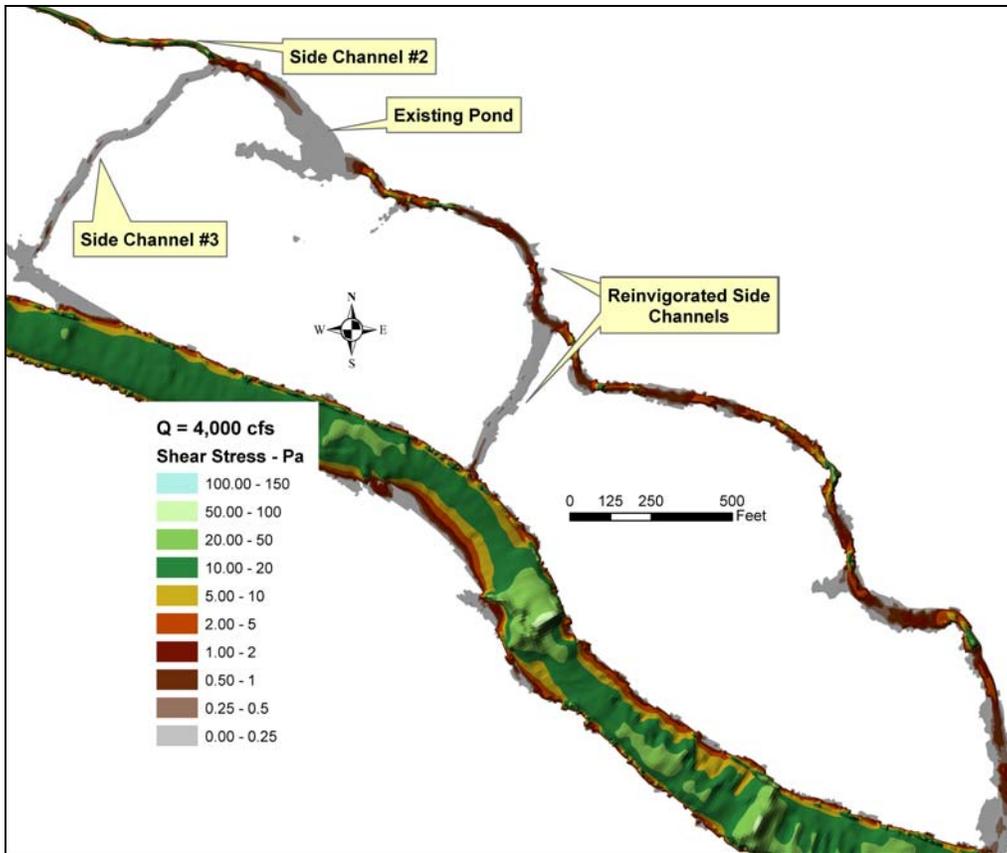
Figure 15: Model results showing predicted values of shear stress for the reinvigorated side channels. Flow is from upper left to lower right of the figure.

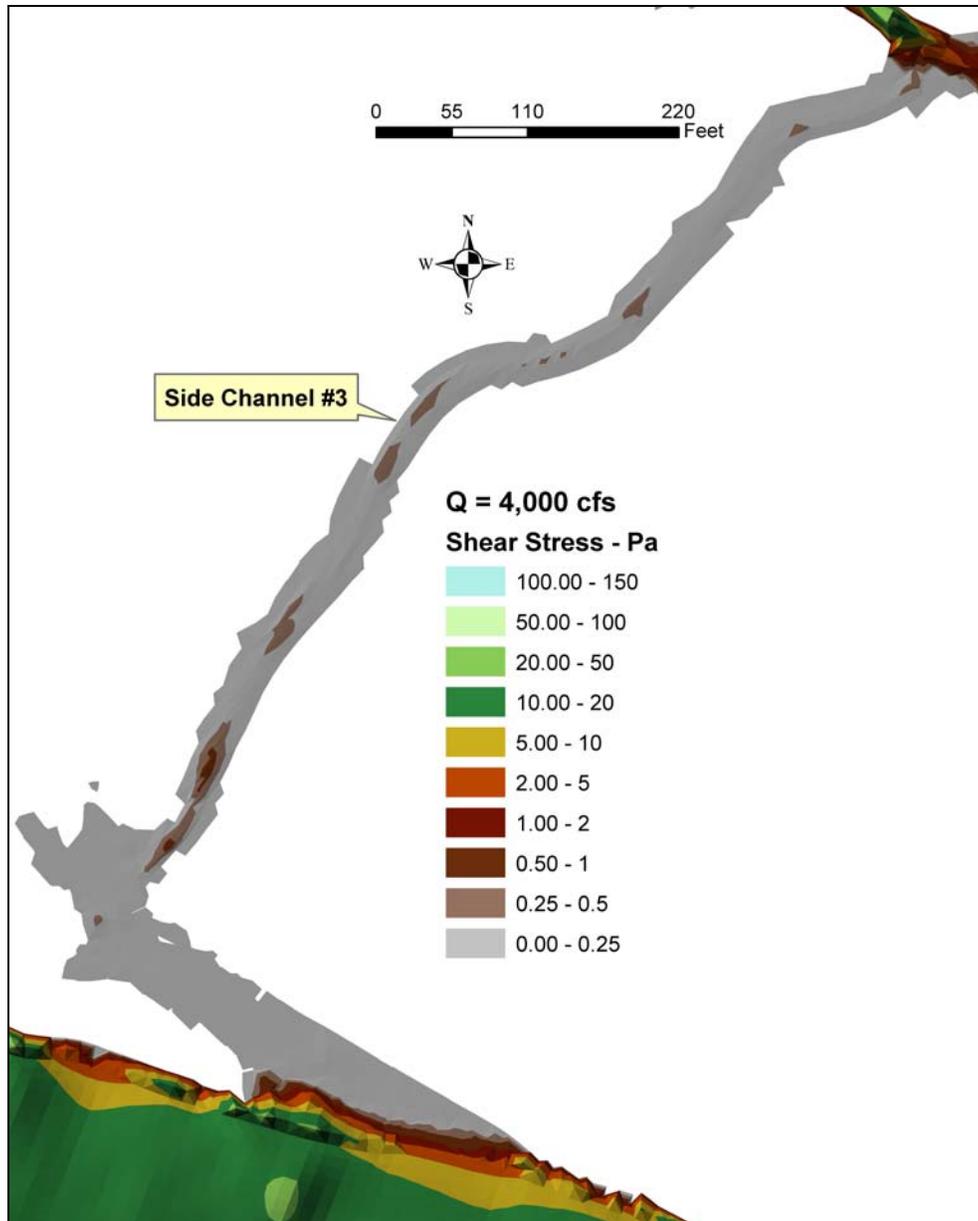
Figure 16: Model results showing predicted shear stress values for side channel #3. Flow is from upper right to lower left of the figure.

Modeling results indicate very low levels of shear stress in side channel #3 along its length (Figure 16), indicating the potential for aggradation of fine sediment. This may not meet the goals of creating side channels that require little or no maintenance and provide appropriate habitat for salmonid species. This side channel is proposed to be constructed through portions of what is thought to be a remnant channel. The model results indicate that there is likely not enough slope to maintain the desired channel type. It should be noted that one of the existing side channels has a similar condition (Figure 16), yet maintains a bed primarily consisting of coarse sand and fine to medium gravel. This is likely a result of the Yakima River carrying low suspended sediment concentrations, meaning that a source for fine sediment must be available for it to deposit.

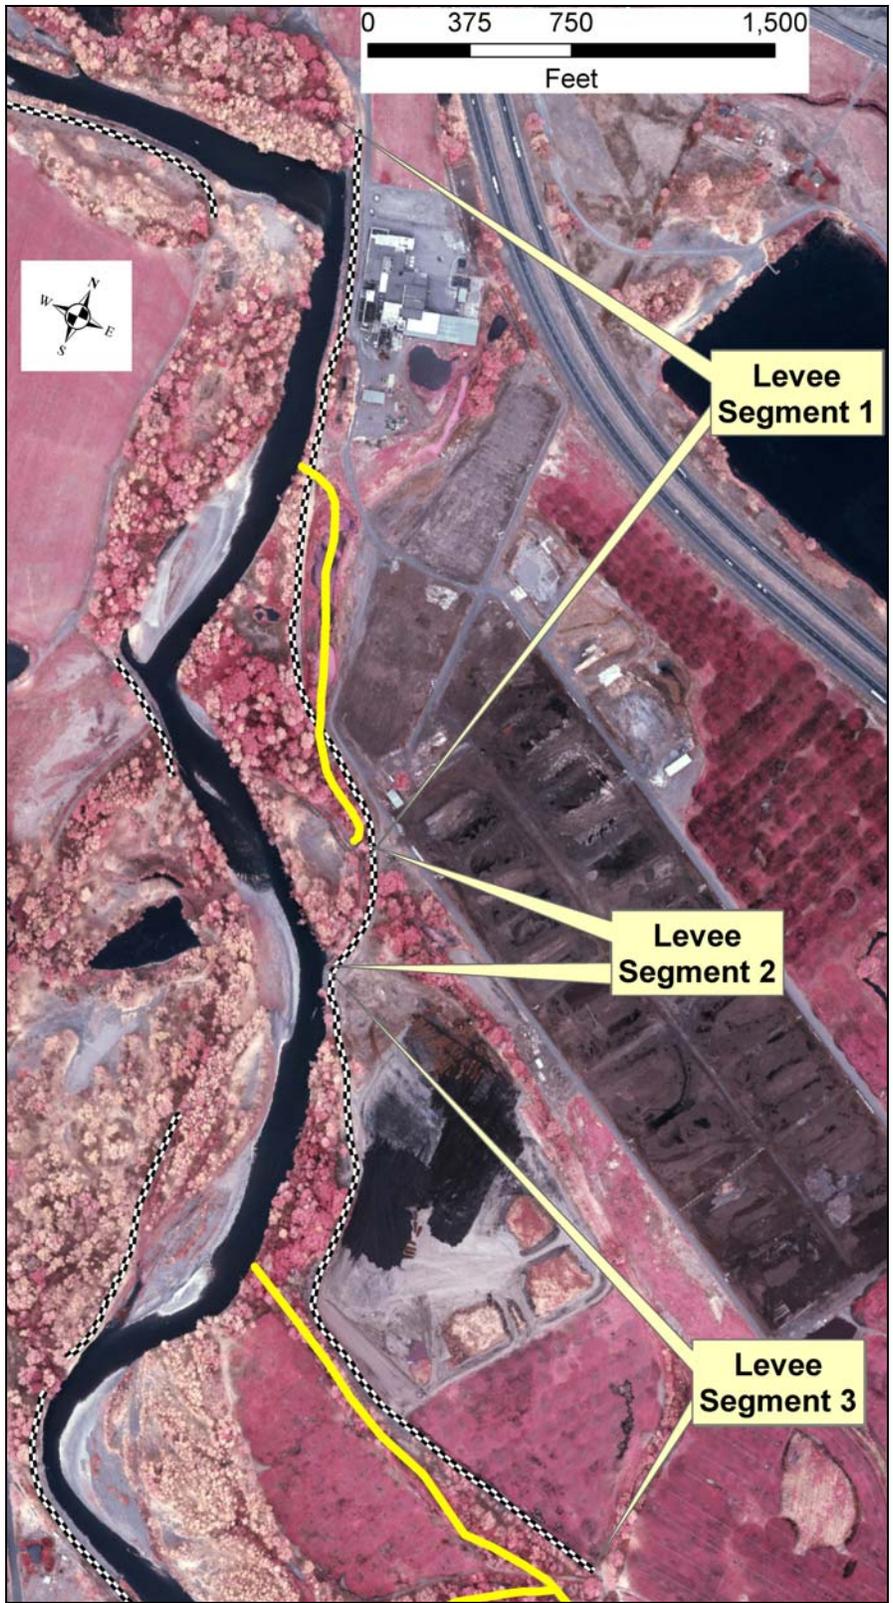
Figure 17: False color IR aerial photograph of the study reach showing three segments of the existing left levee#1.

It is possible to remove less than the entire length of the existing left levee #1 and still fulfill the goal of habitat improvement. Figure 17 shows the existing levee configuration broken into three segments. It is recommended that all of segment 1 be removed. All of segment 2 should remain to stabilize the bank at the head of Tjossem Ditch. It is recommended that a minimum of 50% of segment 3 be removed, with no continuous length of remaining levee being longer than the length of removed levee.
