**Schaake Property Habitat
Improvement Designs,
Yakima River Basin Water
Enhancement Project**

Executive Summary to Phase 1 Report

Prepared for
Bureau of Reclamation

June 2011

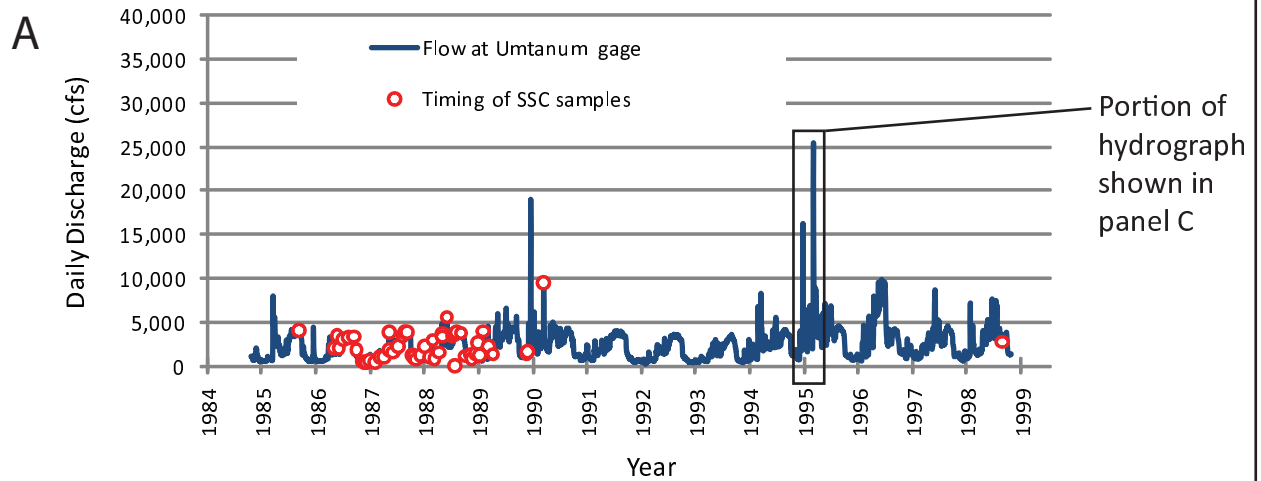
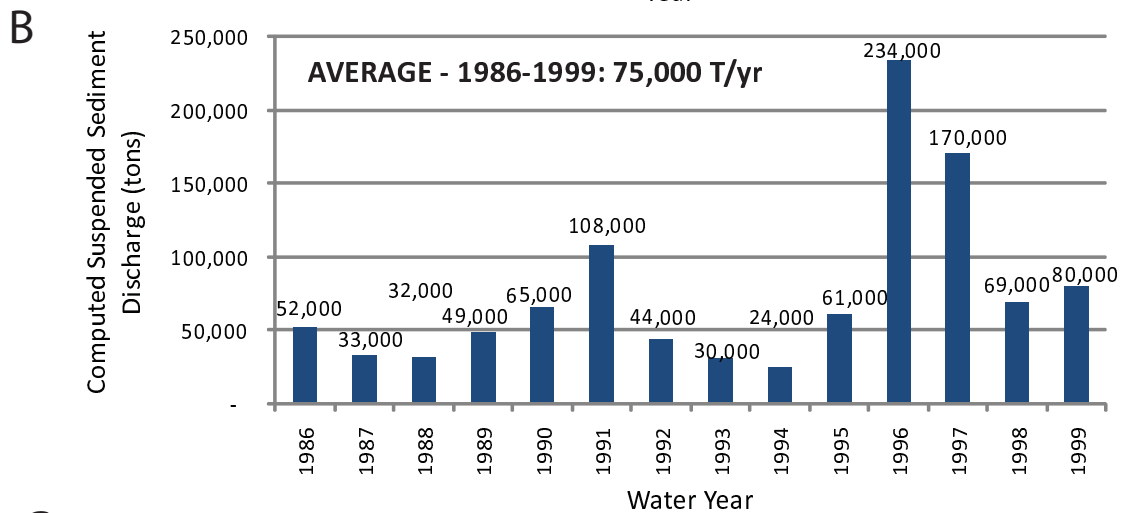
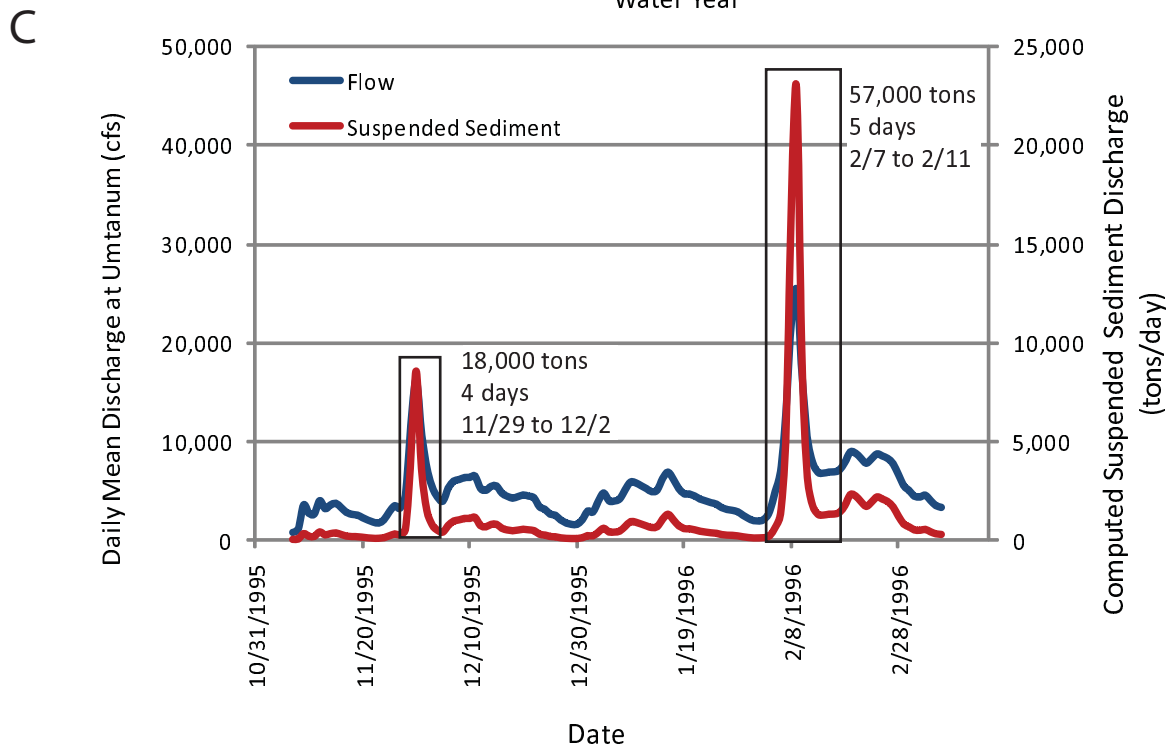
EXHIBIT ES8.

Water Discharge and Computed Suspended Sediment Transport Rates on the Yakima River (1986 to 1999). (A) Hydrograph for period that includes suspended sediment samples. (B) Computed annual suspended sediment discharge using rating curve in Exhibit 12. (C) Detail of flows and computed suspended sediment flux during two flood events in WY 1996 that contributed to the high computed suspended sediment discharge in that year.

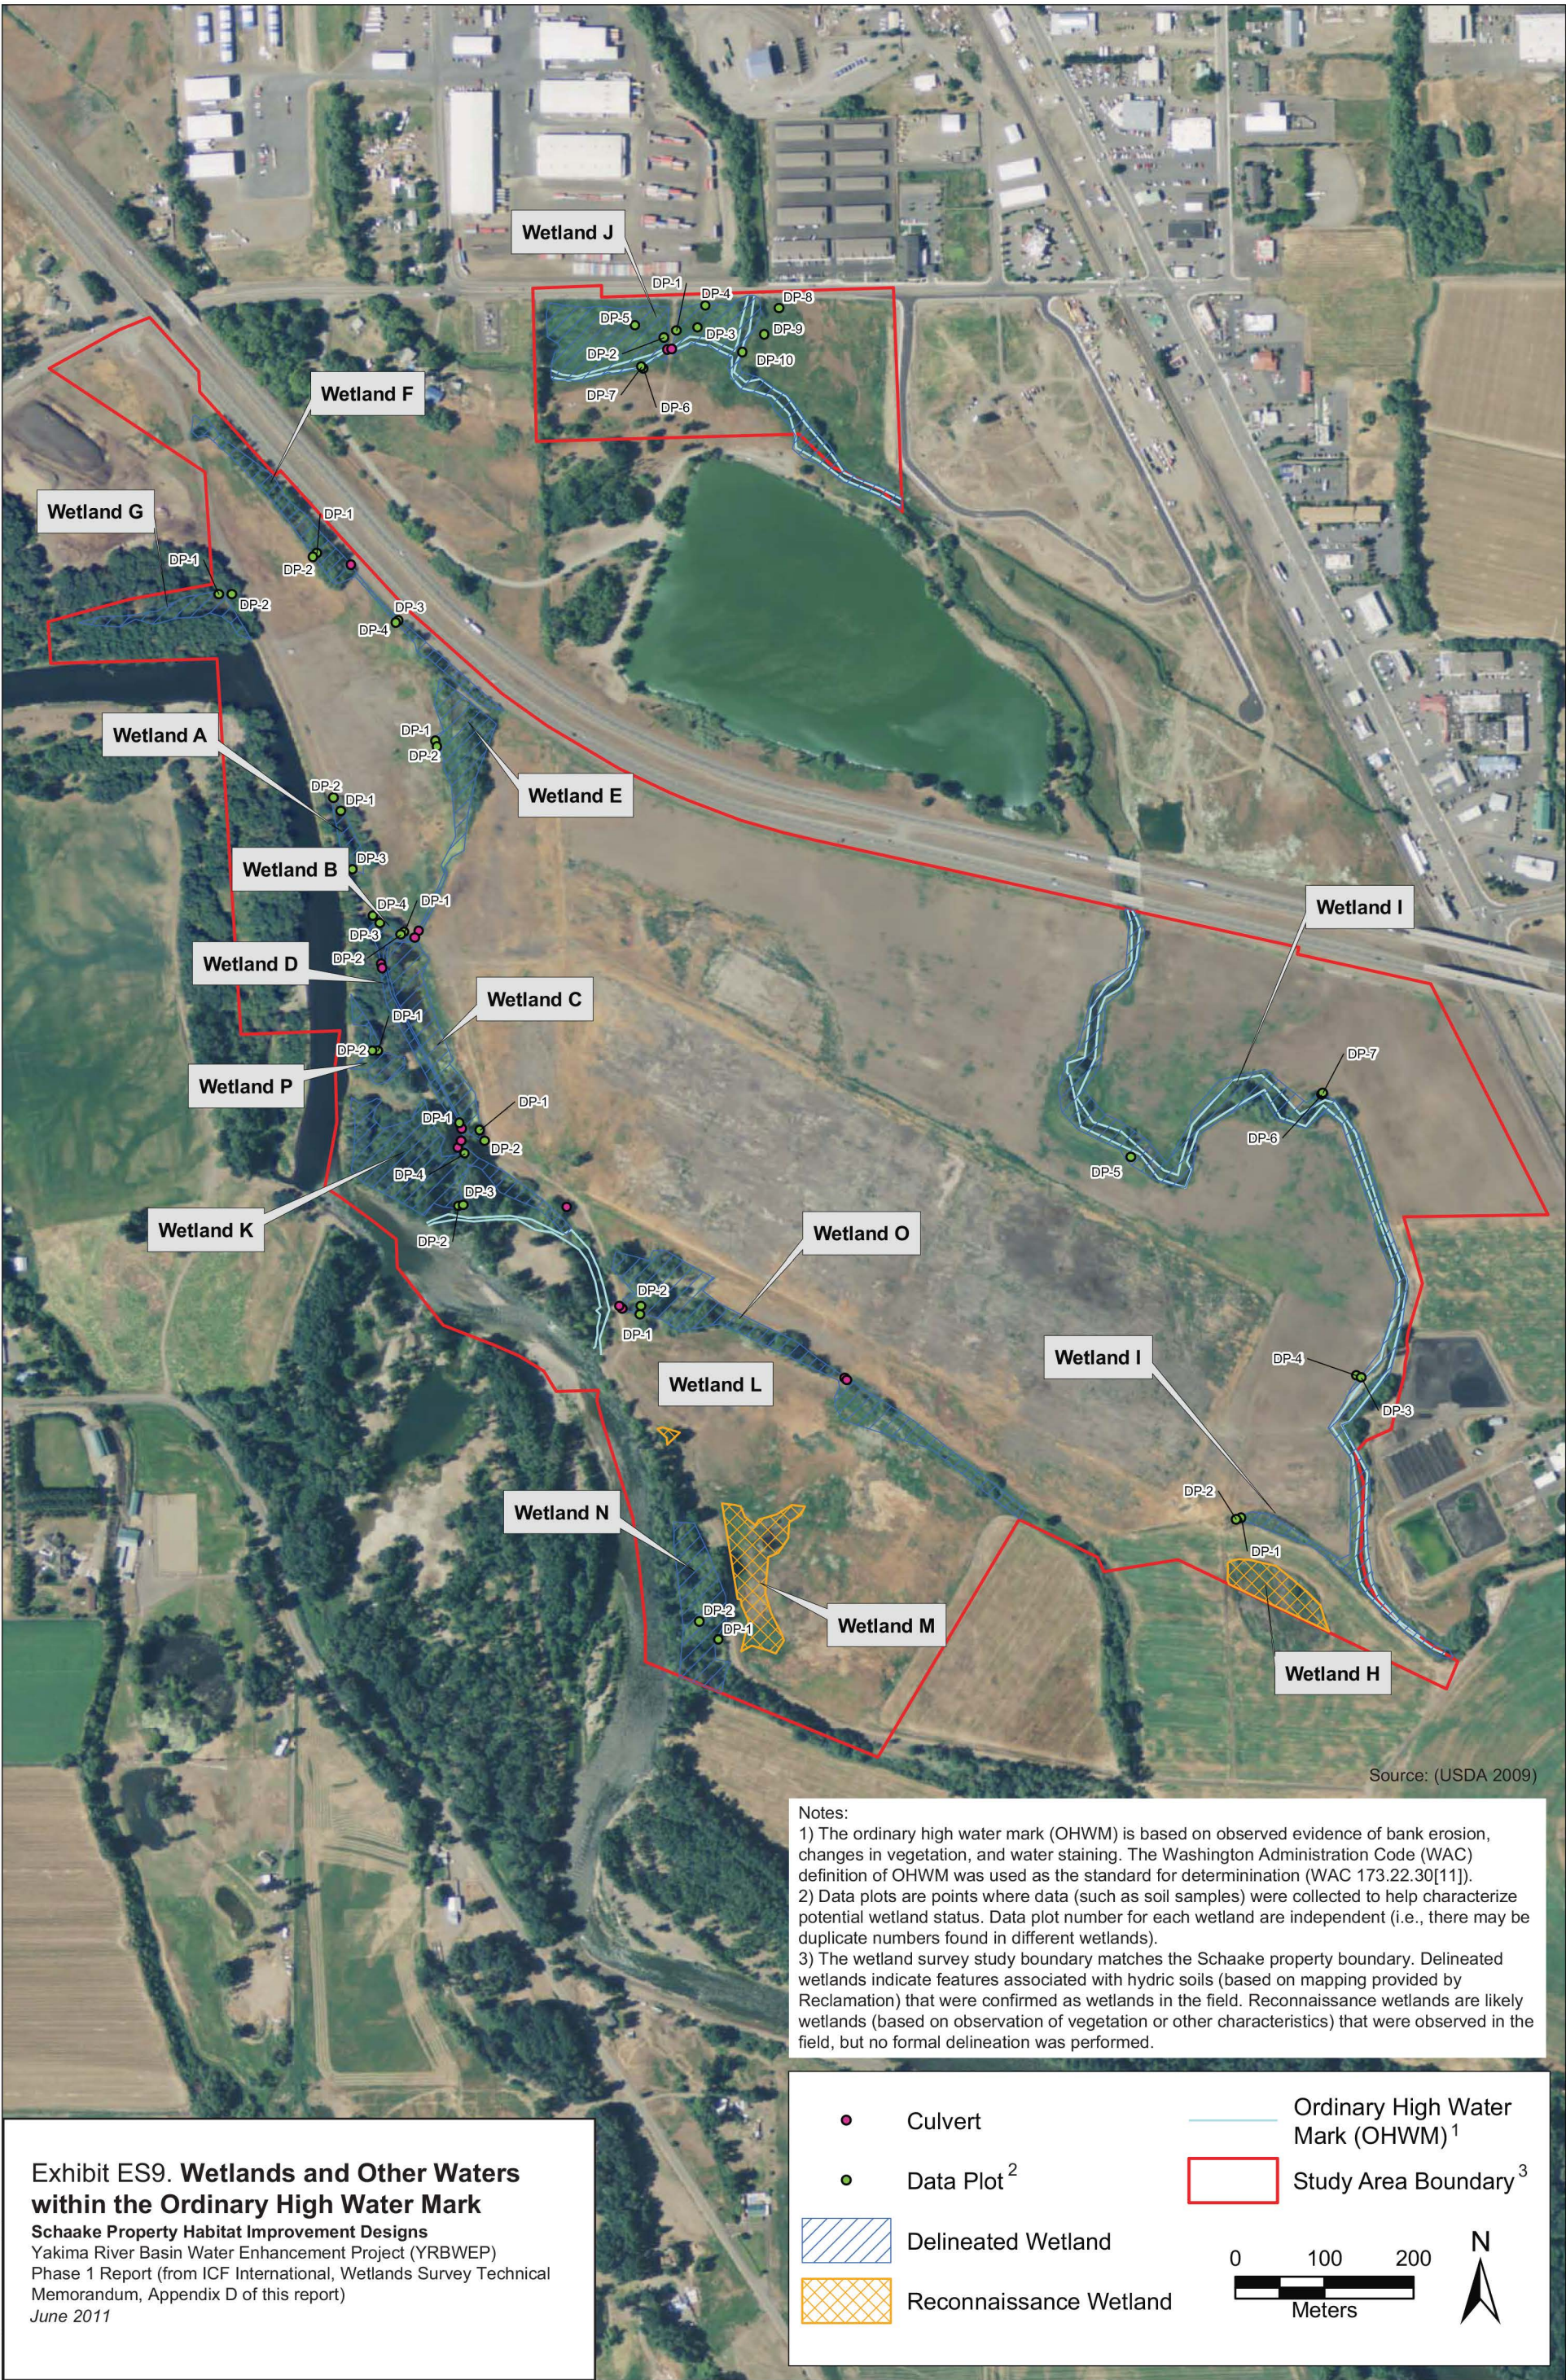
Notes:
1) The ordinary high water mark (OHWM) is based on observed evidence of bank erosion, changes in vegetation, and water staining. The Washington Administration Code (WAC) definition of OHWM was used as the standard for determination (WAC 173.22.30[11]).

2) Data plots are points where data (such as soil samples) were collected to help characterize potential wetland status. Data plot number for each wetland are independent (i.e., there may be duplicate numbers found in different wetlands).

3) The wetland survey study boundary matches the Schaake property boundary. Delineated wetlands indicate features associated with hydric soils (based on mapping provided by Reclamation) that were confirmed as wetlands in the field. Reconnaissance wetlands are likely wetlands (based on observation of vegetation or other characteristics) that were observed in the field, but no formal delineation was performed.

During fall 2010, our project team further characterized existing conditions on the Schaaake property. The preliminary wetland delineation identified the ordinary high water mark (OHWM) of regulated streams, and potential wetlands were estimated to cover approximately 22 of the 285 acres. Thirteen wetlands were identified within the OHWM

(Exhibit ES9), and three were identified outside the OHWM boundary (additional wetlands outside the OHWM may also be present). Despite the low flow in the Yakima River and Wilson Creek at the time of the geotechnical investigation, the groundwater table on the left bank floodplain was relatively high, ranging from 0.2 to 5.8 feet below ground surface (bgs).
