**Soil and Site Study  
For  
Bureau of Reclamation**

**Former Schaake Property  
1180 Umptanum Road  
Ellensburg, WA**

Land Profile Inc.  
P.O. Box 2175  
Spokane WA 99210  
509-844-2944

Presented September 29, 2004

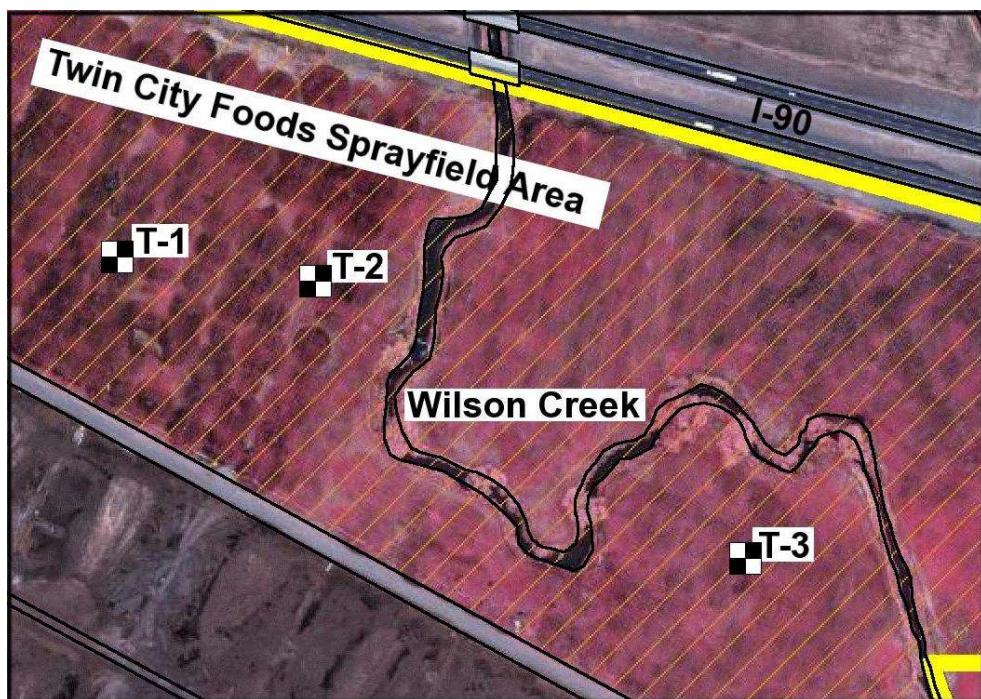
Figure 2 Sample Site Locations for T-1, T-2 and T-3

Samples were taken from the deepest portions of the pit first ahead of rising water levels and caving gravels. Pits were left open long enough to allow water in pit to equalize with the water table, typically about half an hour.

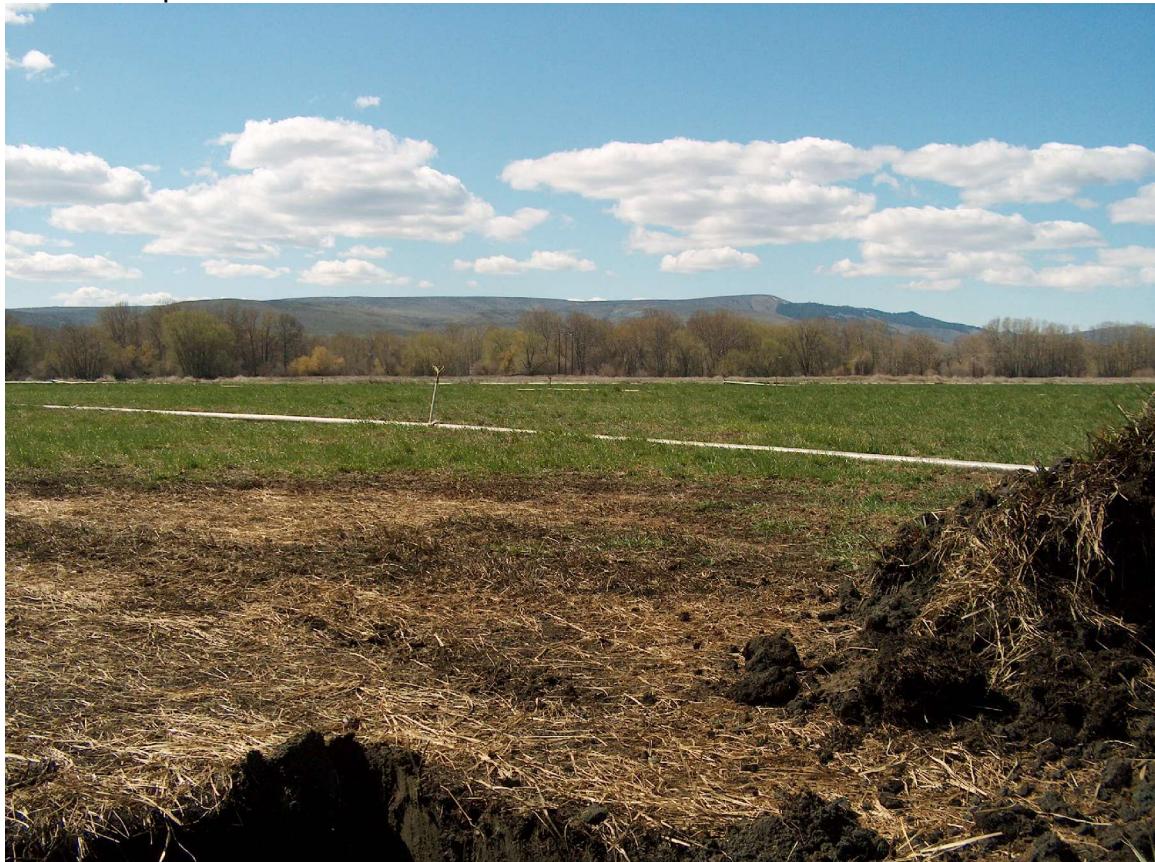
The grass hay crop had died at T1, apparently due to prolonged anaerobic conditions at the soil surface. The likely cause of these conditions is excess wastewater, as discussed on page 11. Gley,<sup>3</sup> an anaerobic soil condition, was observed at the surface and confirmed with dipyril solution.<sup>4</sup> Gravel and water table were present below 36".

Figure 3 Site T-1 Note absence of growing crop.

Anaerobic soil conditions were observed (April, 2004) at site T-1. This site was chosen because it was representative of a pattern of poor growth observed on aerial photos and confirmed to be in swale bottoms throughout the sprayfield. The patterned area, while distinctive, accounted for between 1% and 2% of the sprayfield portion of the study area at the time of the visit.

Anaerobic conditions observed at T-1 were due to wastewater application of oxygen demanding constituents in excess of sprayfield treatment capacity. The anaerobic conditions observed appeared to have persisted from the previous fall despite limited irrigation in the immediately preceding months. This persistence is an indication that anaerobic wastewater ponded on the surface for a significant period of time.

To prevent anaerobic conditions, solids should be screened to the point that nozzle pressure can be maintained within manufacturer's performance specifications, with a discharge radius no less than sprinkler spacing down the laterals. Pressure loss down the lateral should be less than 20%.

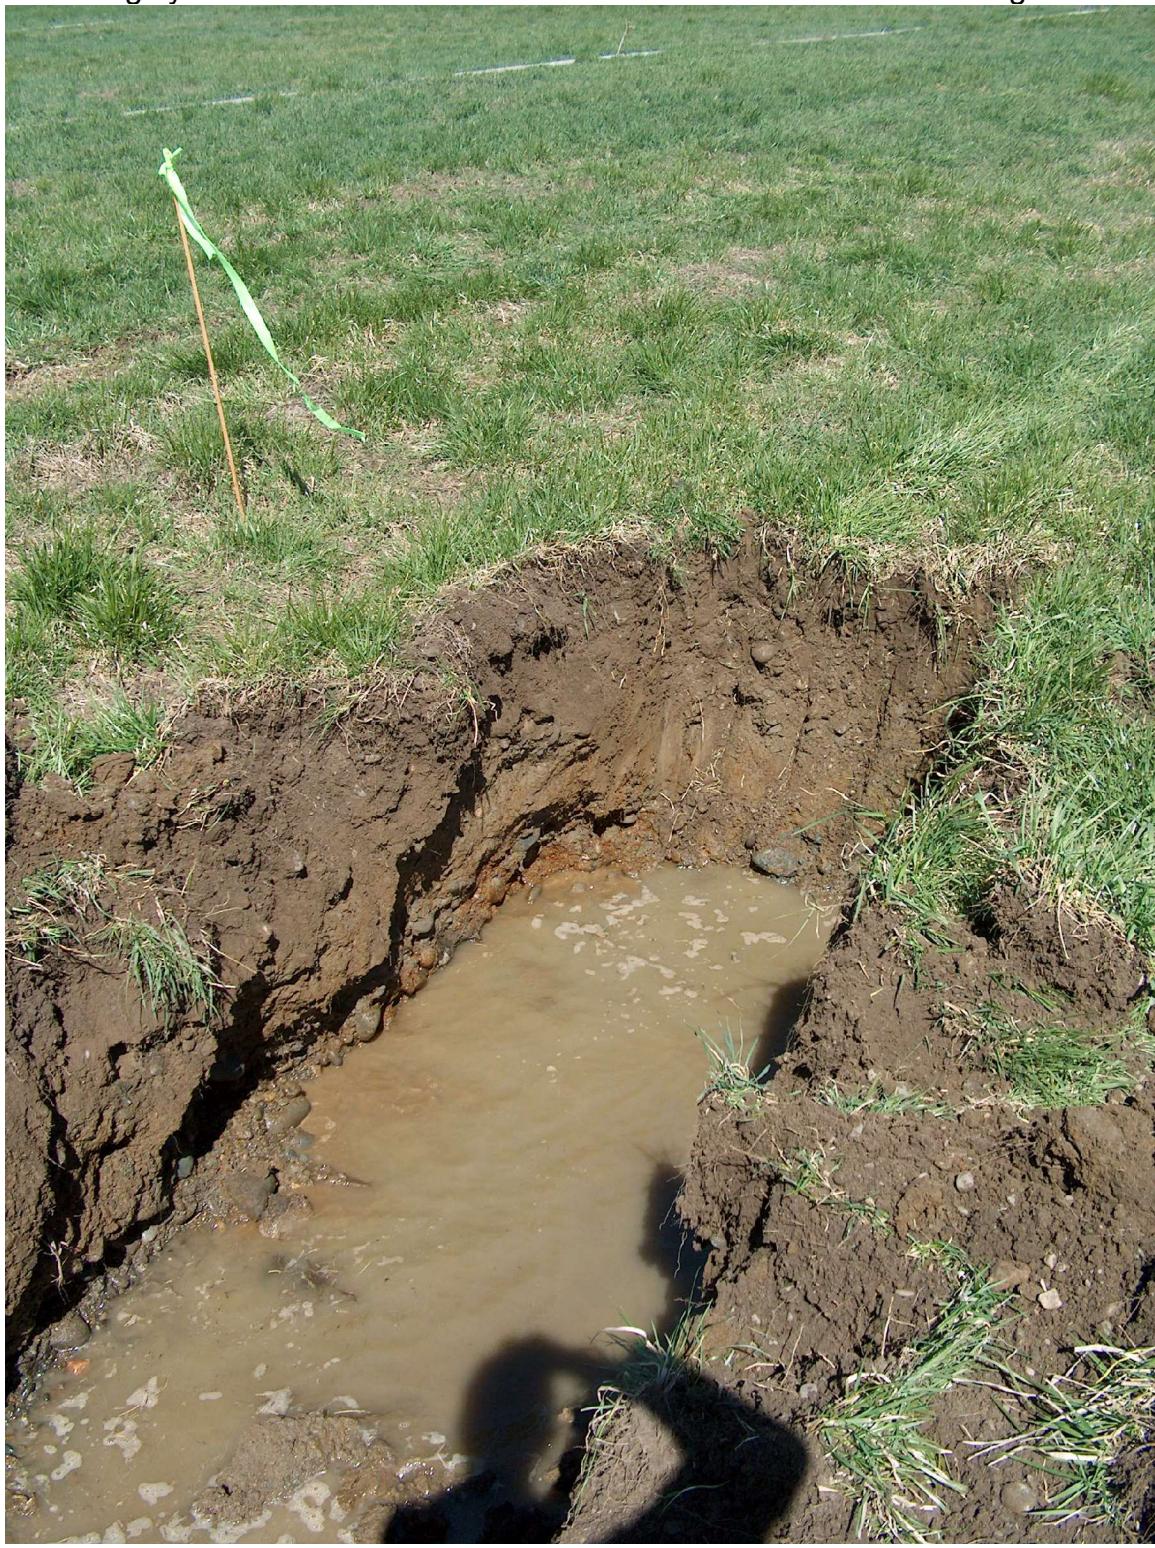
Figure 4 Sample Site T-2

Sites T2 and T3 were 18 and 44 inches, respectively, to water table with 14 to 36 inches of fine sandy loam over gravel.

T-3 had gley colors below the water table Photos of T2 and T3 to the right.

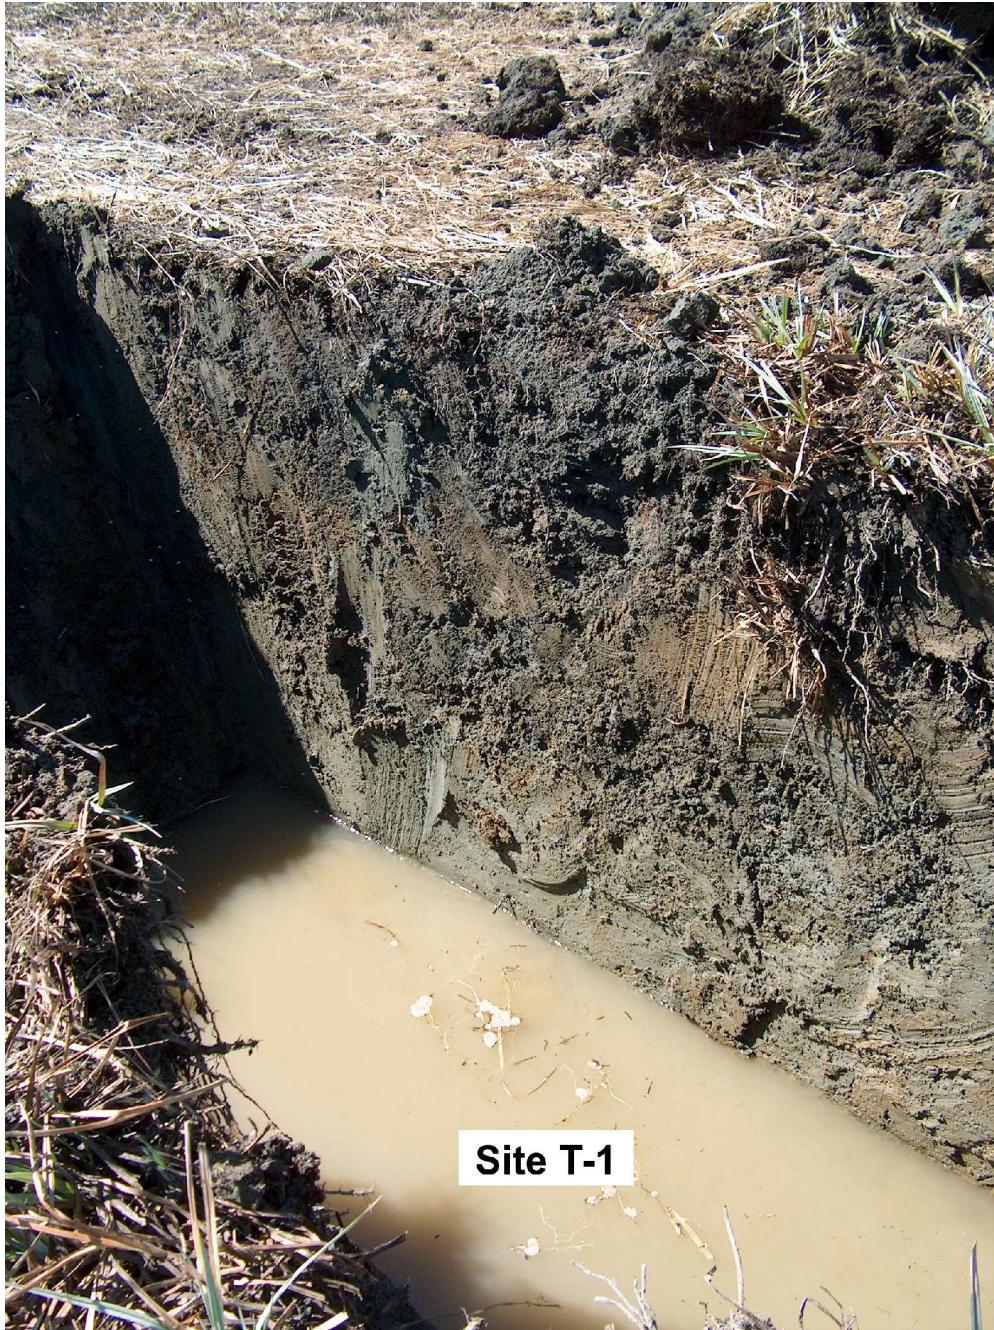
Figure 5 Site T-1. Note gley soil conditions

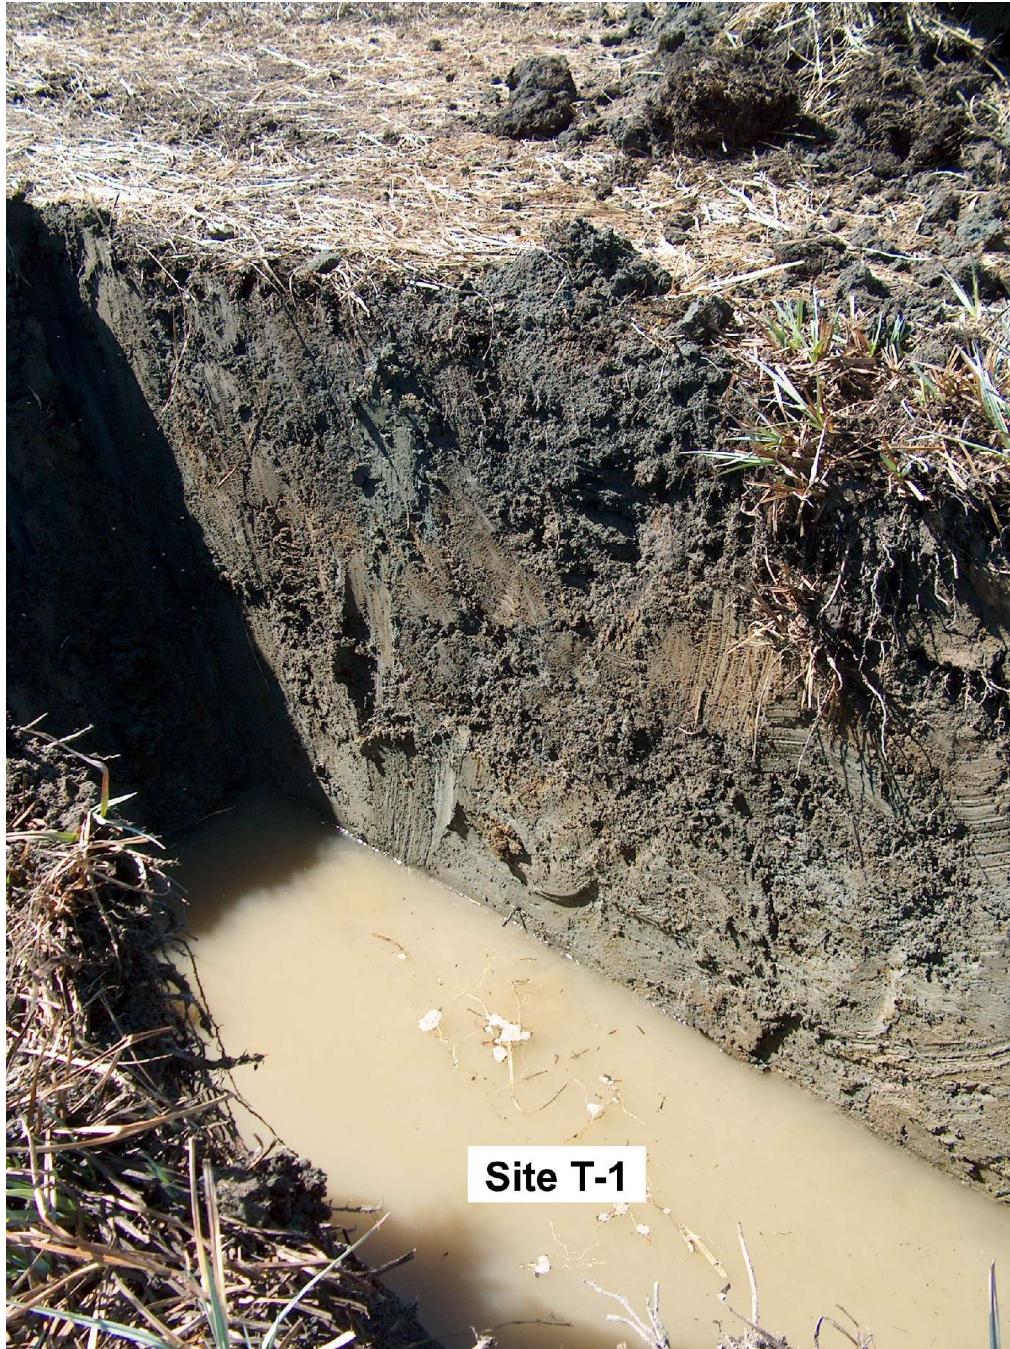
Figure 6 Site T-1. Note gley soil conditions

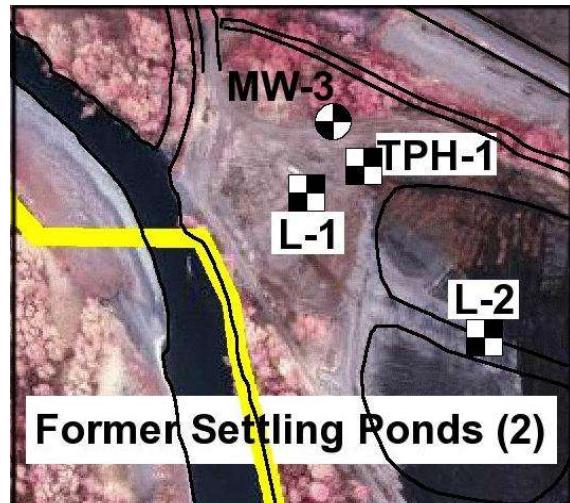
Figure 7 Sample Location TPH-1

Candidate petroleum contaminated soil at the north end of the main lagoon area was sampled on March 24<sup>th</sup>, 2004 in an area where an oily-appearing material was observed. Affected area was about 150 square feet. The substance of concern was up to 0.2 inches thick of a brown to gray translucent highly viscous substance. No point of origin or pattern of spill, run and fill was observed. The material of concern had no detectable

odor.

The lab result indicates a level of petroleum contamination below cleanup standards. On discussion with the lab, this is likely a false positive. Note the X2 Flag for the results (see Figure 8 Original Results): the material did not fit the expected characteristics of petroleum.

With the lab confirming the field observation that the material did not appear to be consistent with petroleum hydrocarbons, it is reasonable to conclude that petroleum hydrocarbons are not present or, if petroleum hydrocarbons are present, they are below a level of concern. No further action is warranted.

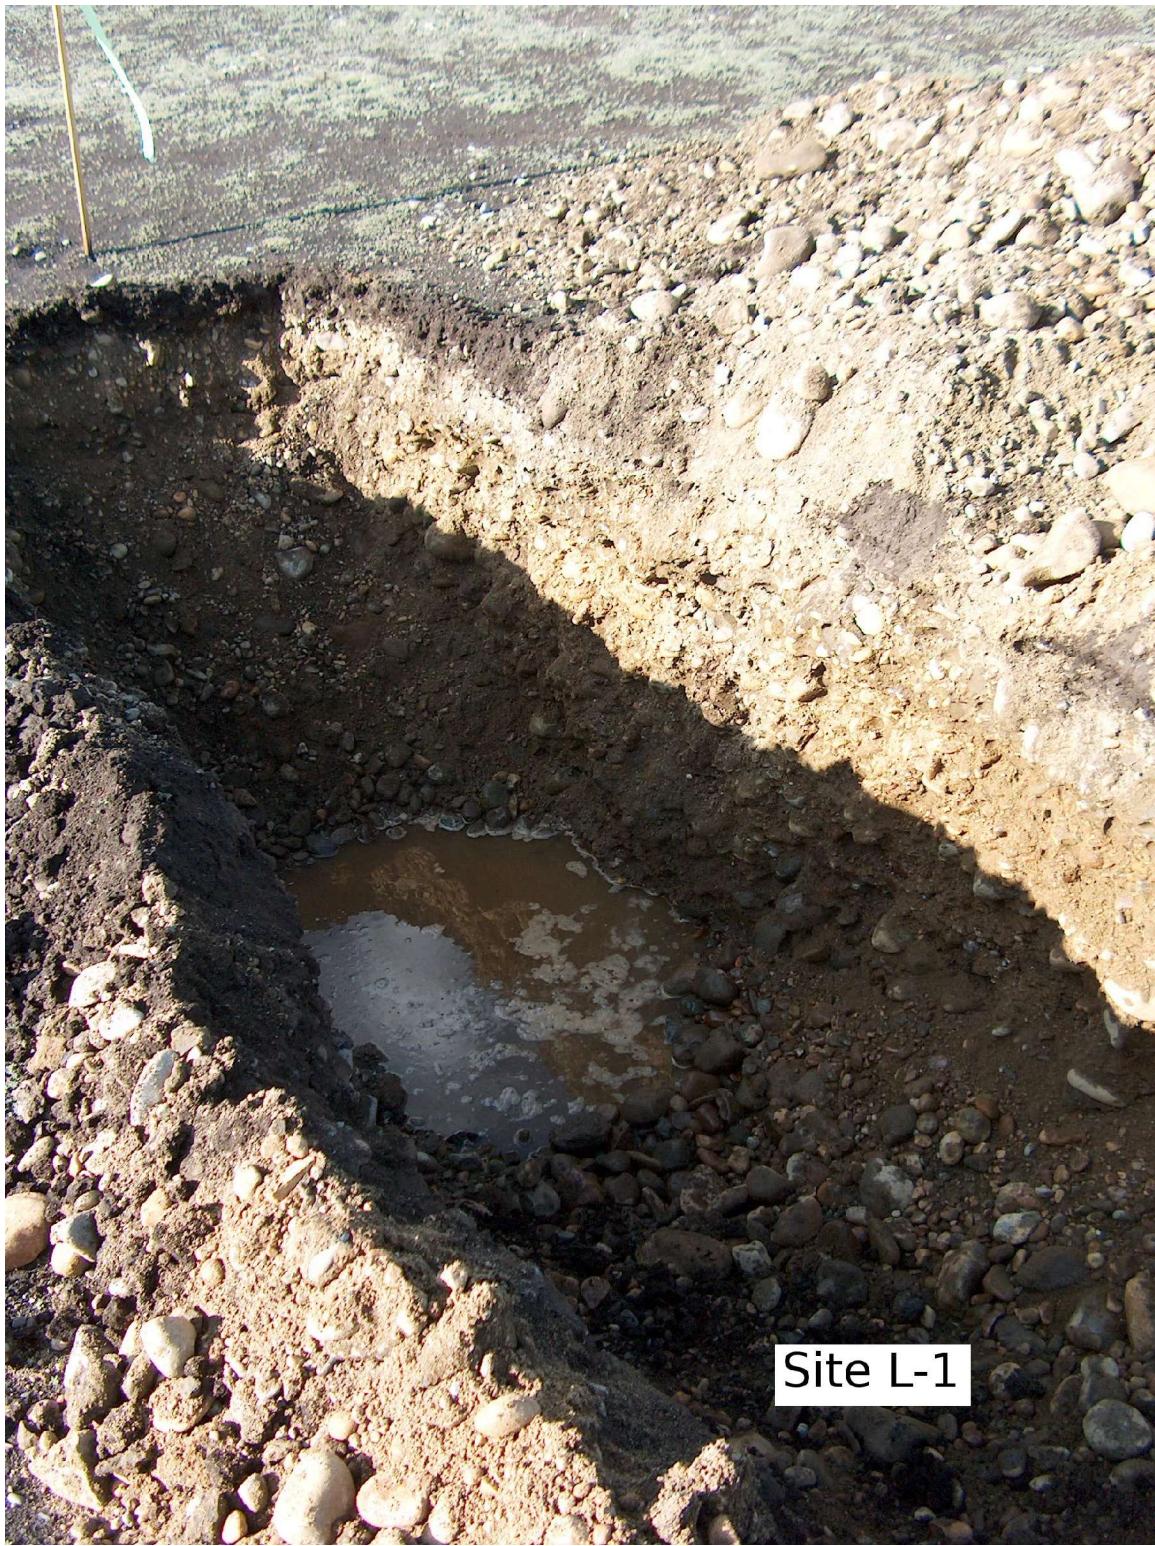
Figure 10 Site L-1

Apparent water table was 28 to 48 inches below the surface. The typical profile was a foot of manure and manure enriched gravel over extremely gravelly sand. Gravel content was 60 to 95% by volume through most of the profile, . No gleying was apparent.

Identify areas adjacent to proposed channels where residual surface foot material with greater than 60 ppm should also be removed and replaced with less enriched soil to avoid risk of sediment transport.

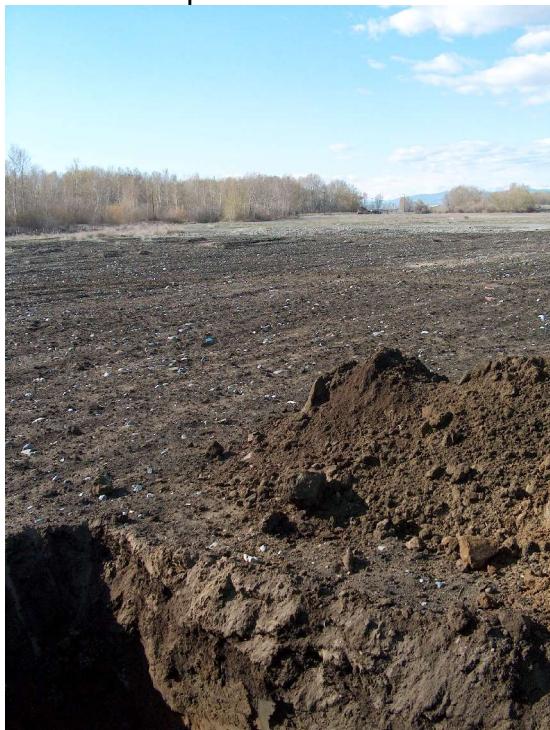
Figure 14 Site L-1 surface

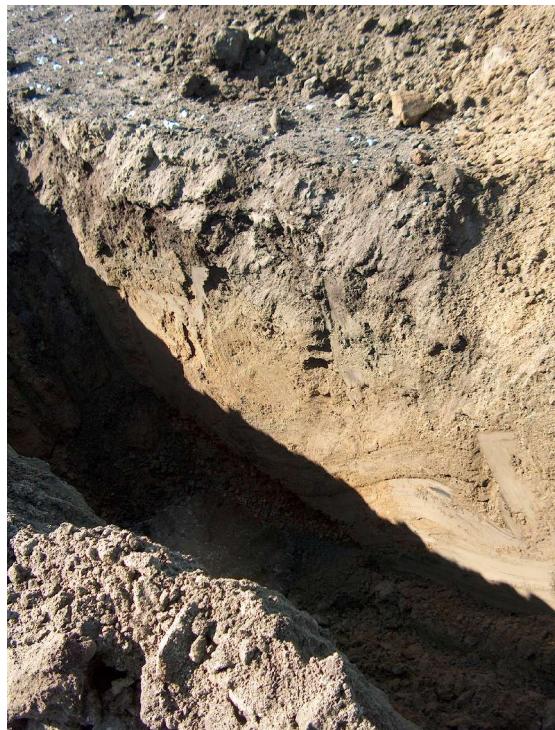
Figure 15 Site L-1 profile

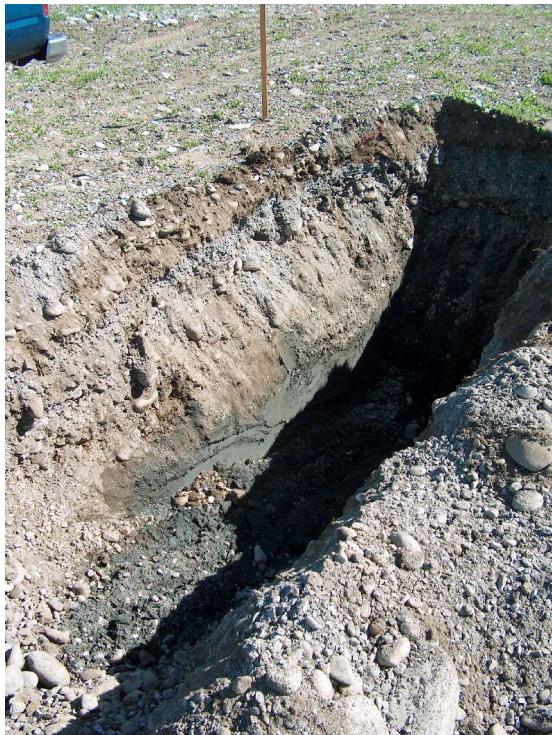
Site S3 was located on a former feed pad site,. The profile was gravelly to the surface and 36 inches to groundwater. Soil was highly compacted in the second foot and gleyed below that.

Figure 16 Site S-3 Former Feed Storage Area

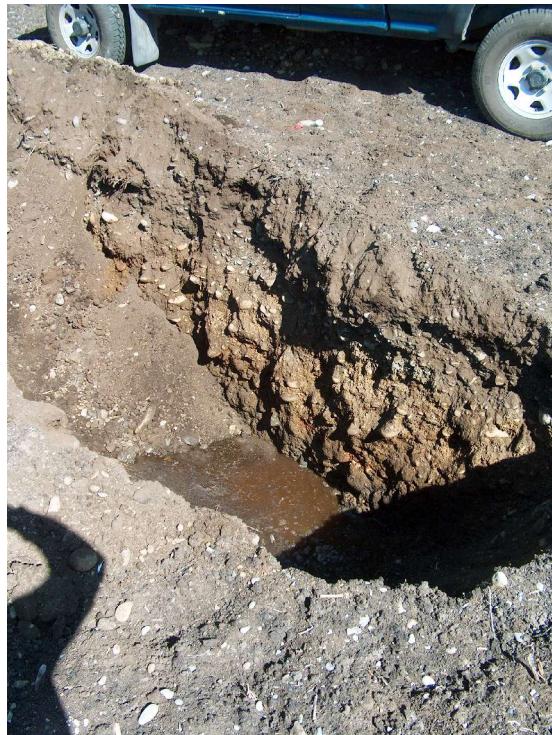
Sites S-4 and S-5 were located at the east end of the pens. Depth to water table was 42 and 44 inches respectively. Both had a surface foot of manure but had different profiles. S-4 had very gravelly sand (60 to 95% gravel) below the manure layer and no gley colors. S5 had gleyed sandy loam to 36 inches over mottled, ungleyed gravel.

Figure 17 Site S-4 Southeast Corner of Pens

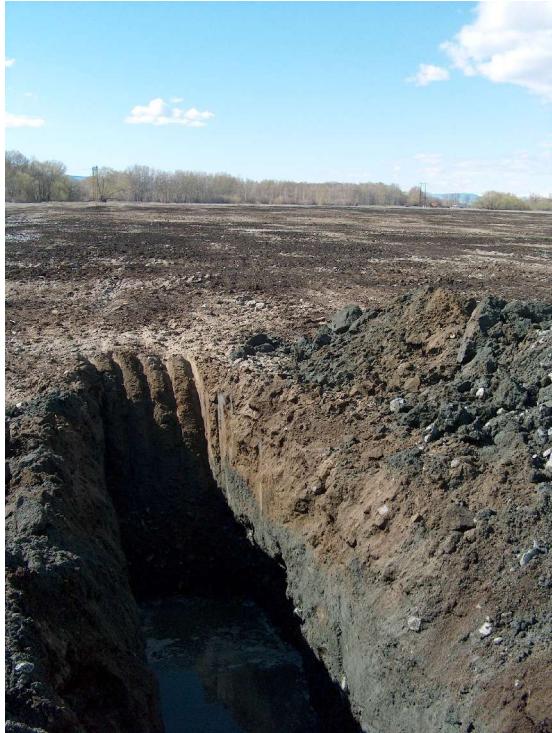
Figure 18 Site S-6

Sites S-6 and S-7 were located in the middle of the pen complex, south of the feed storage area. Water table was at 60 and 55 inches, respectively. Both had a surface foot of manure enriched soil. Below the surface enriched layer, S-6 had very fine sand with gley below 24 inches. This was underlain at 60 inches by gleyed gravelly fine sand. S-7 had no gley, with sand to 27 inches and gravel to 60 inches.

In the areas of S-1, S-2, S-5, S-6 and S-7, soils have low gravel surfaces and are similar enough to those in the Twin City Foods sprayfield area to consider an irrigated field crop. A legume is recommended to avoid problems with tetany, as discussed on page 13.

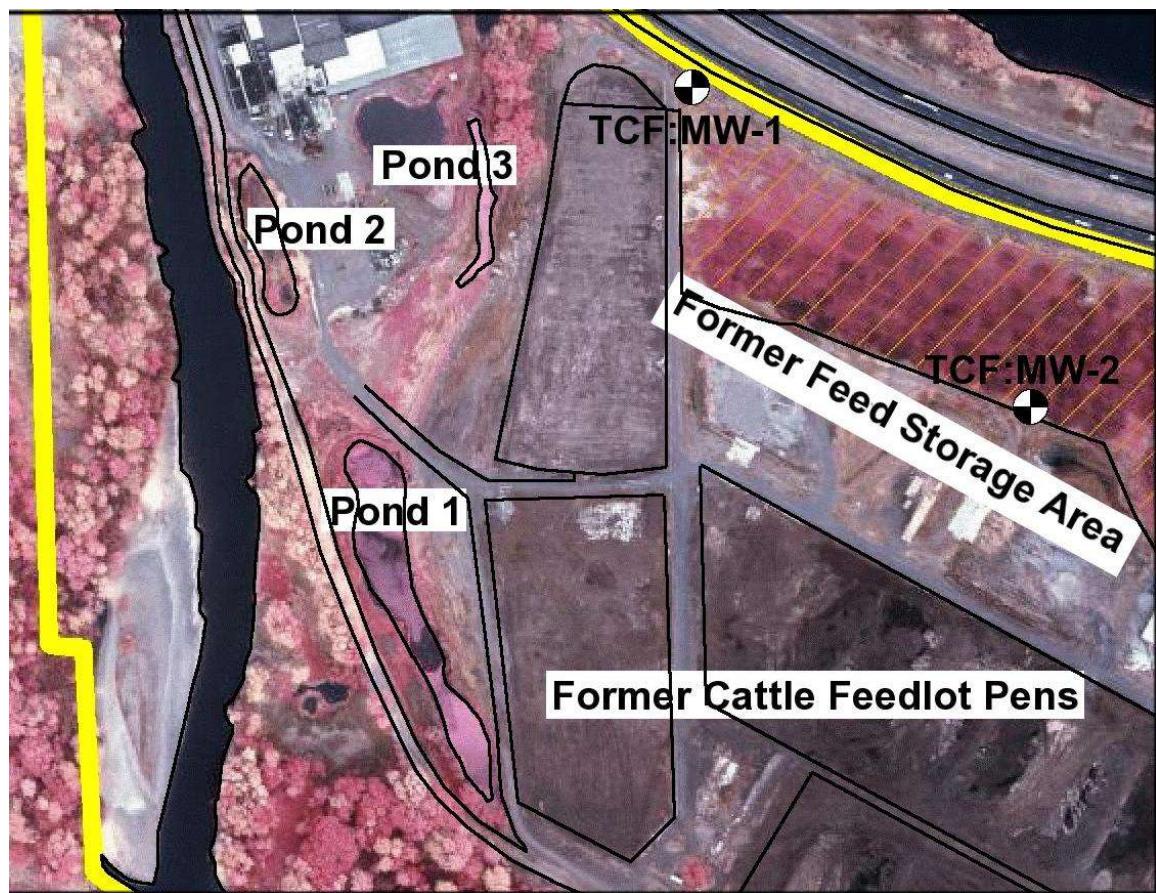
Figure 20 Pond Sample Sites

Sampling was conducted on May 24<sup>th</sup>, 2004, with subsequent analysis by Anatek Labs, Inc., Spokane, WA. Ponds 1 and 3 were sampled from an inflated raft. Pond 2 was too shallow for the raft so was sampled using waders. Sediment samples were extracted from Pond 1 and 2 using an open face soil probe. Due to greater depth, Pond 3 was sampled using a “sludge king” sampler, consisting of a Plexiglas tube and a one way valve.

Pond 3 had small blocks of a whitish industrial waste product floating in it. This material was sampled as was the pond water itself

On May 24th , three shallow pond bottoms were sampled. Ponds 1 and 2 were adjacent to the Yakima River levee. Pond 2, was in the most natural state, with a relatively intact forested riparian border, abundant and diverse aquatic invertebrate population. Depth was up to 3 feet. sediment was 6 to 12 inches over gravel Several newts or salamanders were observed in Pond 2.
