Knowledge Stream

Research and Development Office

*Materials Research: Preserving the
Longevity of Reclamation Structures*

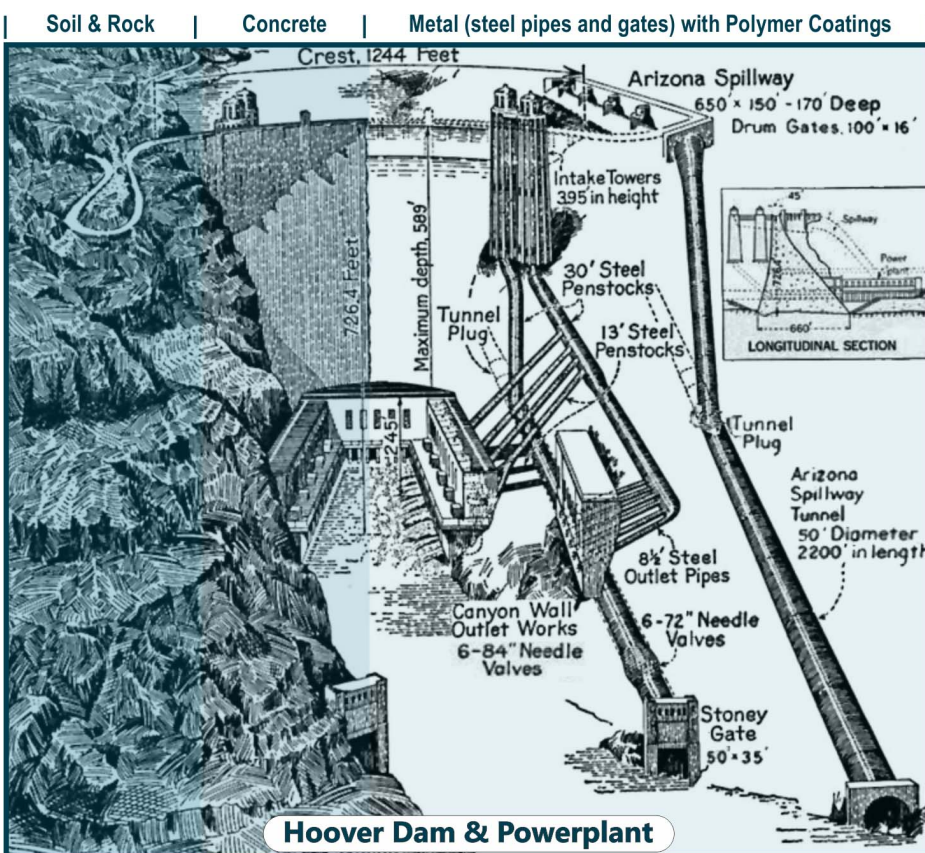
Diagram of a powerplant showing general locations of soil and rock, concrete, metals, and polymers. The left side of the image shows the facility exterior, and the right illustrates the interior components and equipment.

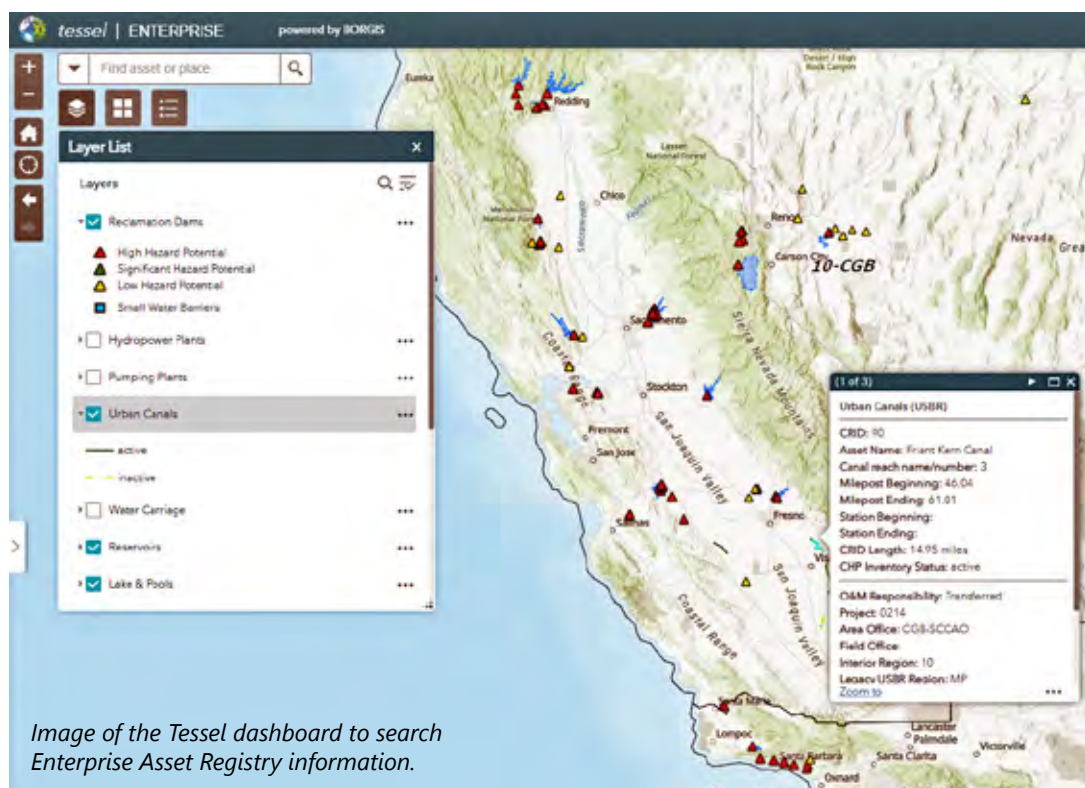
Image of the Tessel dashboard to search Enterprise Asset Registry information.

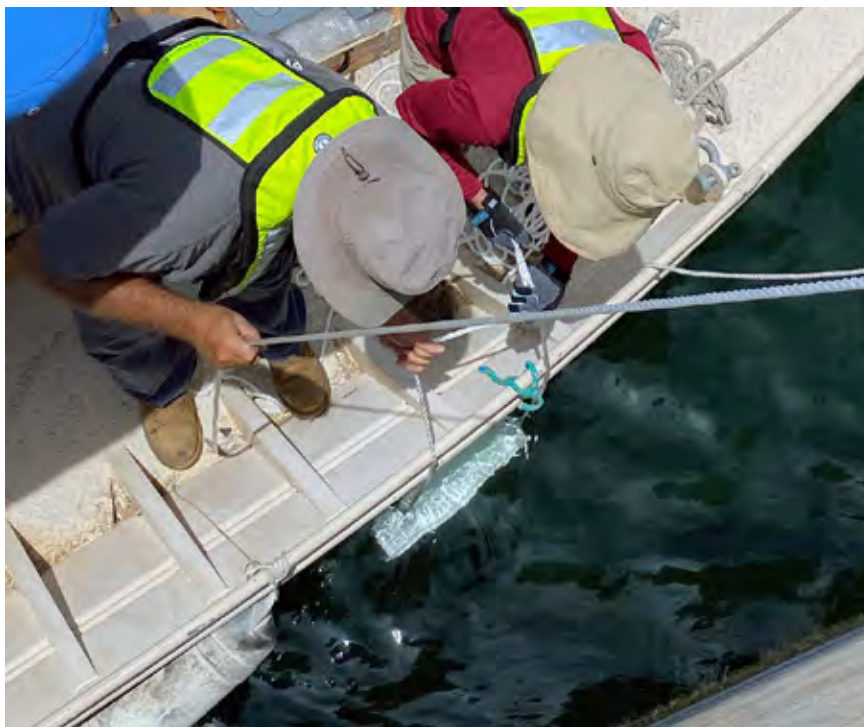
Reclamation staff lowering Rust Busters prototypes for testing at Parker Dam, California.

Rust Busters field testing began in July 2021 with installation of four field-ready prototypes at Parker Dam, California, in the Lake Havasu reservoir. These prototypes will remain in the field to test their corrosion resistance and will be evaluated on their performance. Reclamation's Materials and Corrosion Laboratory Group tested the five solutions for corrosion protection performance in the lab and awarded the Best Laboratory Performer in December 2021 to a novel robotic spray application technology for coal tar enamel.

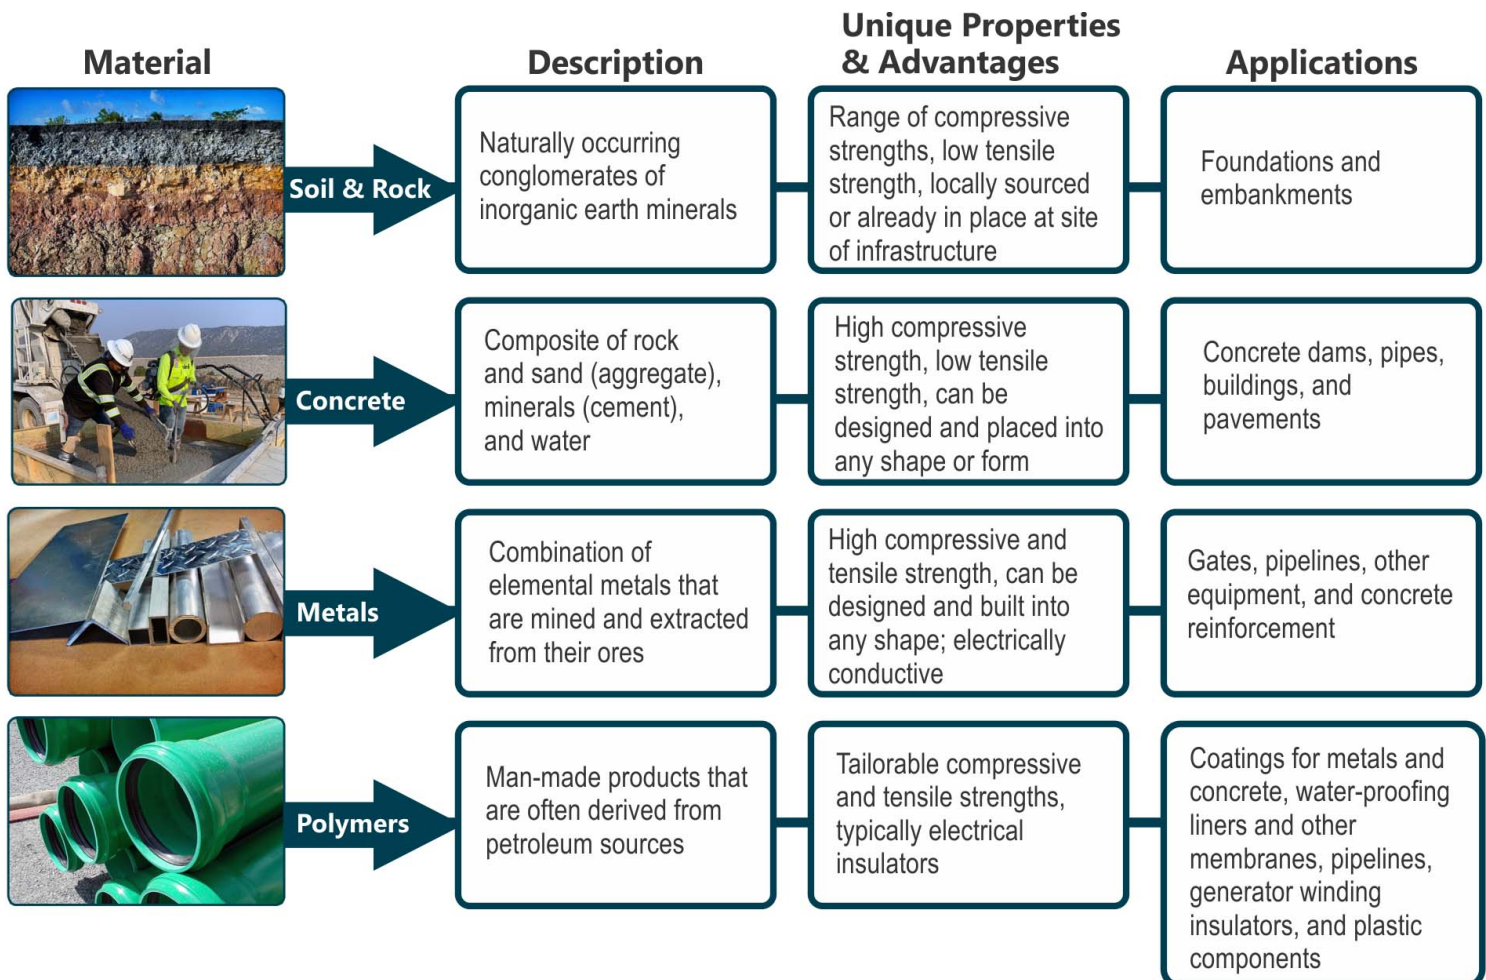
The four material types used in Reclamation construction with description, properties, and applications.

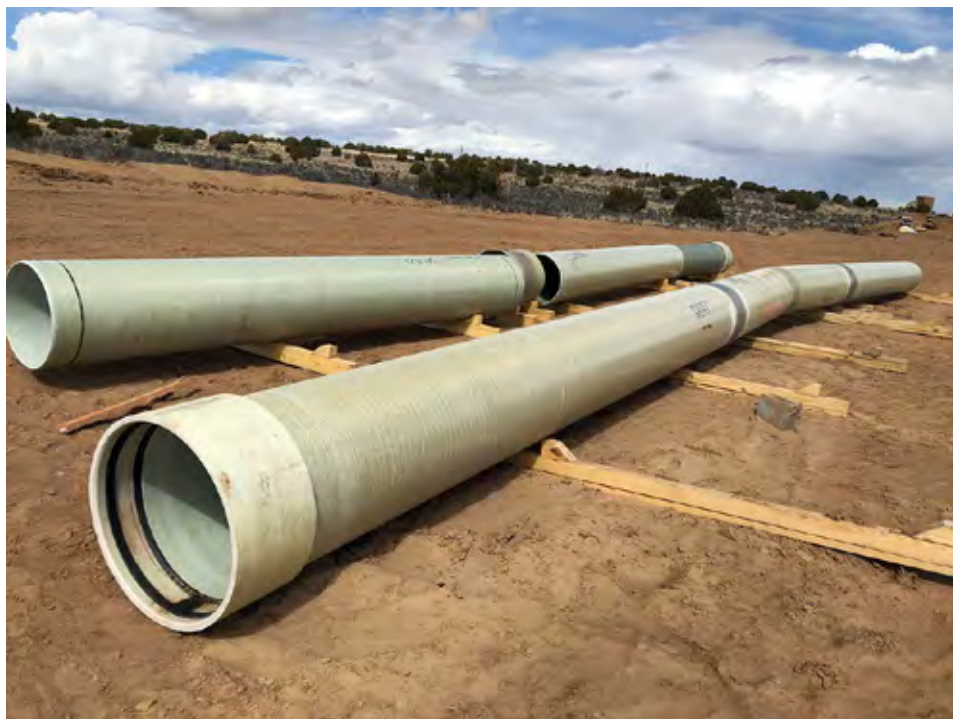
Fiberglass reinforced polymer (FRP) composite pipe at field installation site.

Polymer pipe can reduce life cycle costs, when compared to steel, by reducing the expenses associated with corrosion control. Depending on the operating pressures, volumes, etc., a plastic pipe such as high-density polyethylene (HDPE) may be selected. A fiber-reinforced polymer (FRP) “composite” pipe such as fiberglass may be used for higher pressures. FRP materials are also sometimes used to repair damaged surfaces of steel or concrete structures in the field. Reclamation is funding a prize competition to identify new inspection methods for FRP composite infrastructure—see earlier article in this issue, [“Prize Competitions Improving Reclamation Materials.”](#)

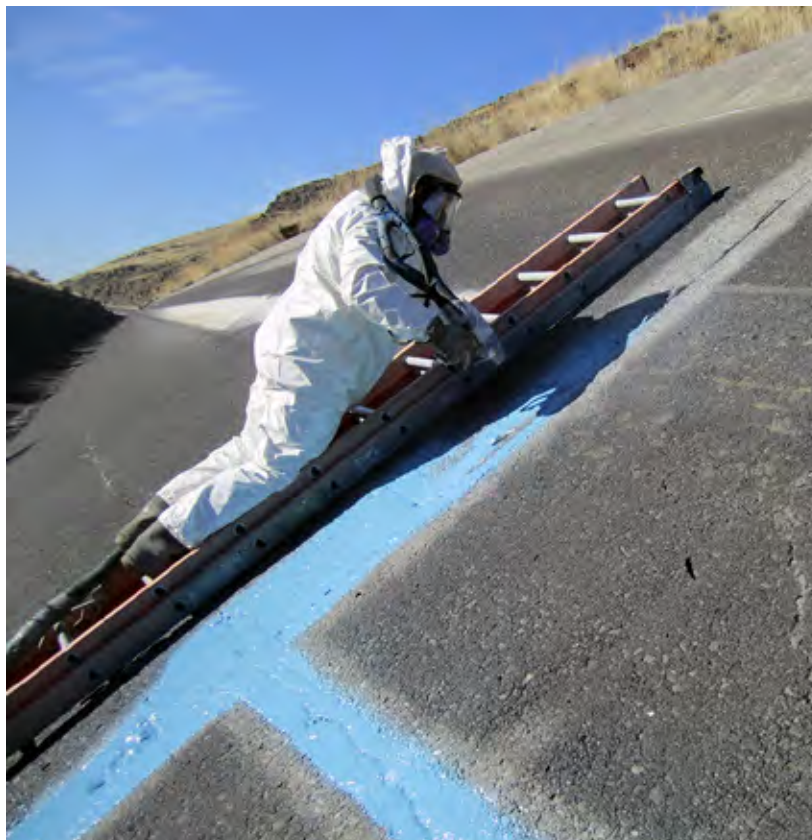
Elastomeric polymer coating being applied as a crack sealant for concrete panels to reduce canal leakage.

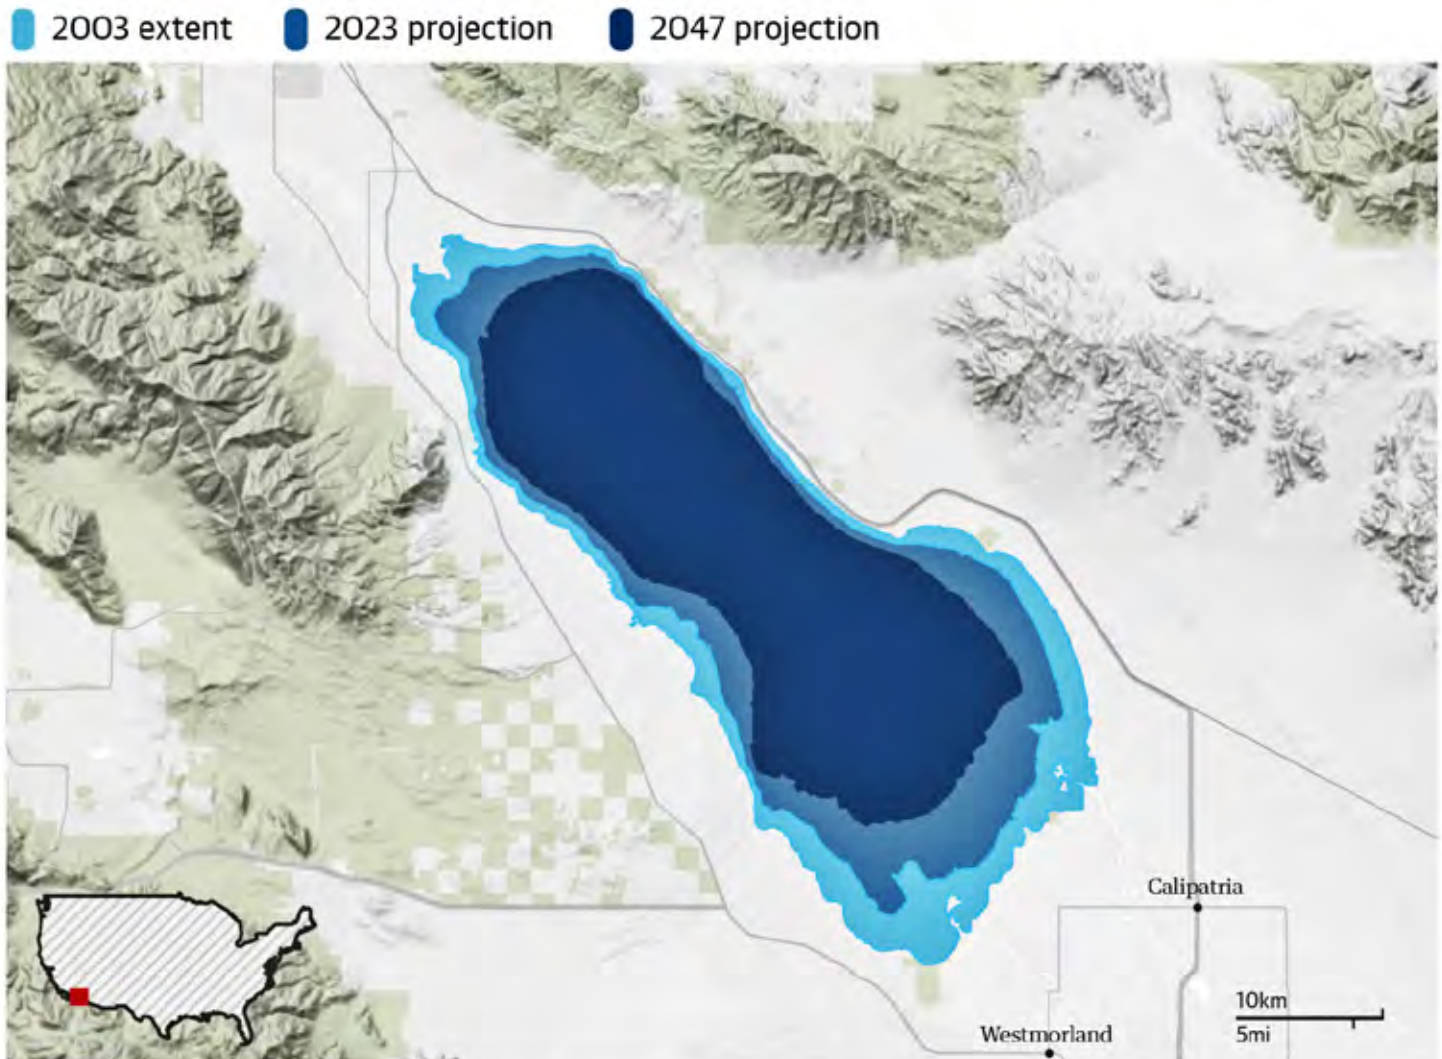
Salton Sea Shorelines, 2003 – 2047 (projected). (Image retrieved from ca.audubon.org)

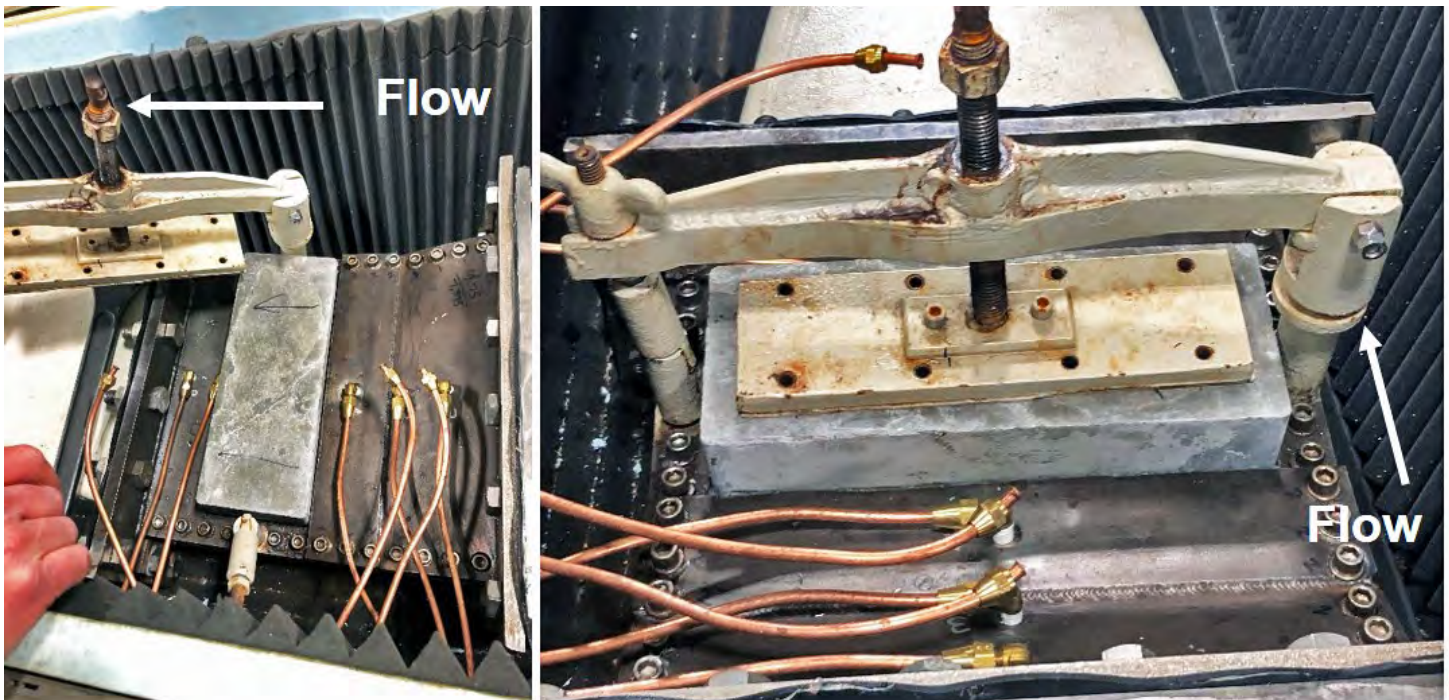
Concrete test sample installed in the cavitation venturi facility in Reclamation's Hydraulics Laboratory.

The main objective of this study is to develop a reliable correlation between concrete properties and local hydraulic conditions. This enables design engineers to choose the most cost-effective concrete design for the application. Reclamation began collaborating in 2018 with materials and hydraulics laboratories at FURNAS of the Brazilian Government and their partner, Federal University of Rio Grande do Sul, to study flow-induced damage to concrete surfaces. The approach to this study includes an analysis of historical field data and laboratory testing of concrete cavitation damage.

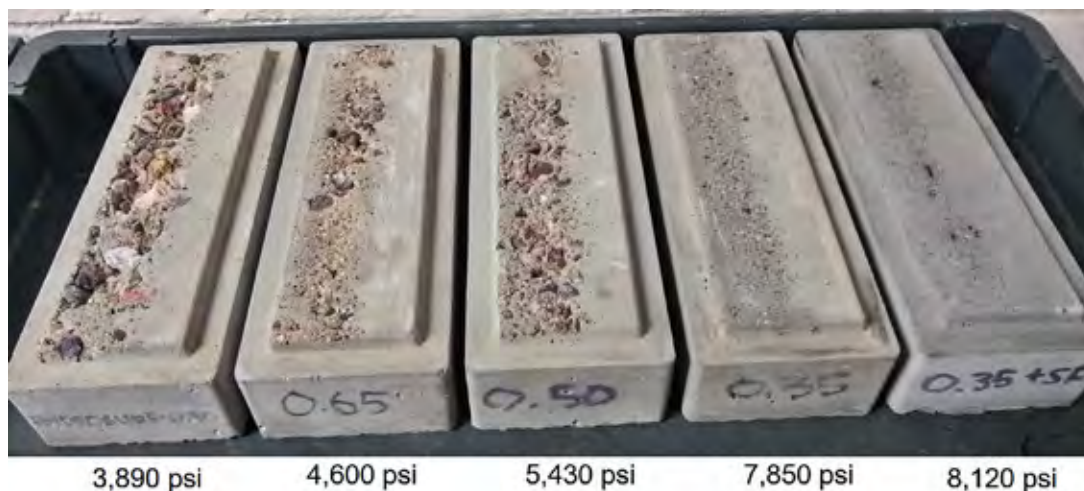
Comparison of current concrete damage results to a similar study in 1953 (Peterka, 1953). The current study extends results to concrete strengths above 8,000 psi and air content levels down to 0.25%.

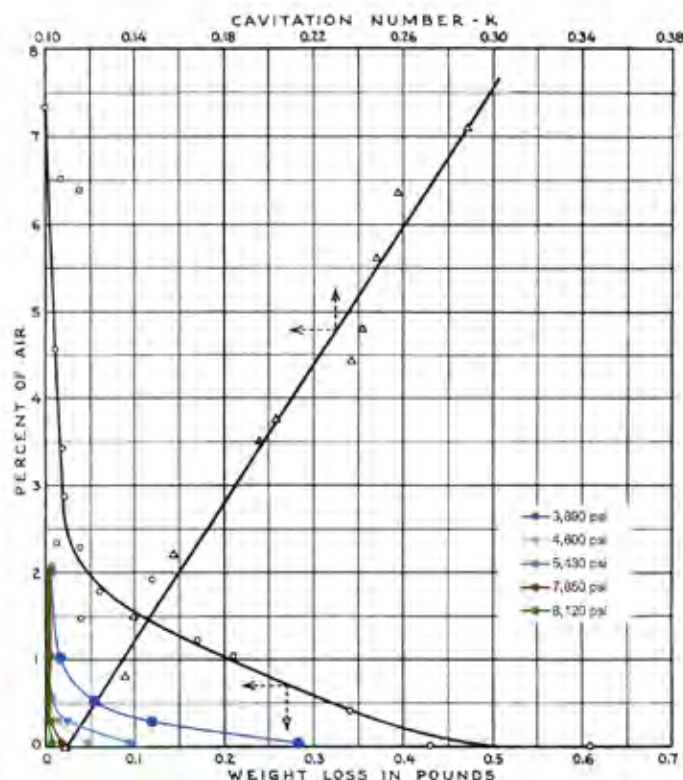
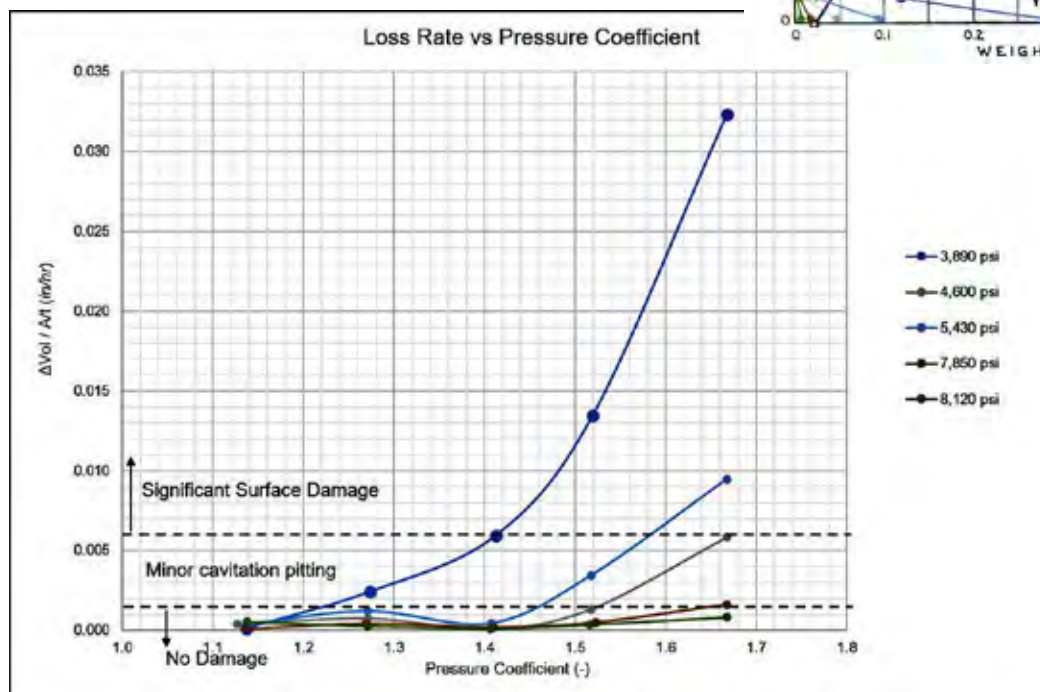
Resulting correlation of concrete loss rate (extent of damage) to a pressure coefficient which indicates the level of hydraulic intensity at the surface.

Results provide a method to estimate the extent of concrete surface damage in the field based on concrete strength and a pressure coefficient describing localized hydraulics. These results are limited to a single operating condition with intense cavitation (typical cavitation index of 0.06) that may not yet be applicable to other conditions. Additional test results and conclusions are expected from the Brazilian hydraulics laboratory in late 2022.

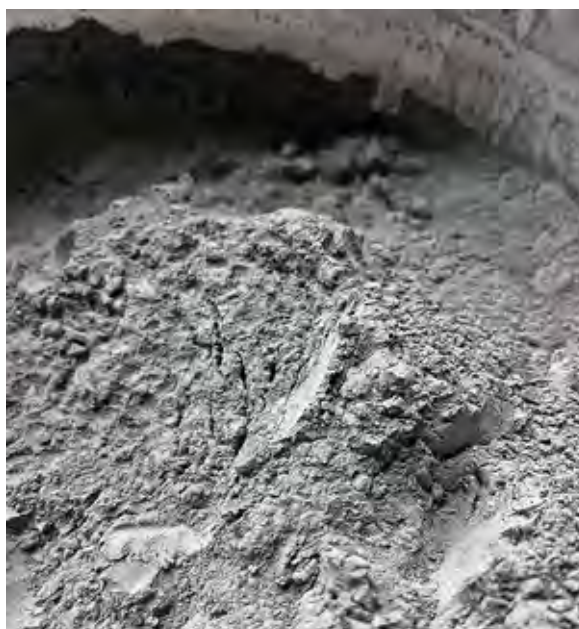
A sample of harvested fly ash from Brunner Island Power Plant.

Research demonstrated that it can be recovered and processed to meet the ASTM C618 specification. In the end, it performs the same as “new” fly ash. Like fly ash direct from the powerplant, the harvested fly ash also has variability. These new commercially available sources can help ease strain on the market when coal plants go offline or are decommissioned in the future.

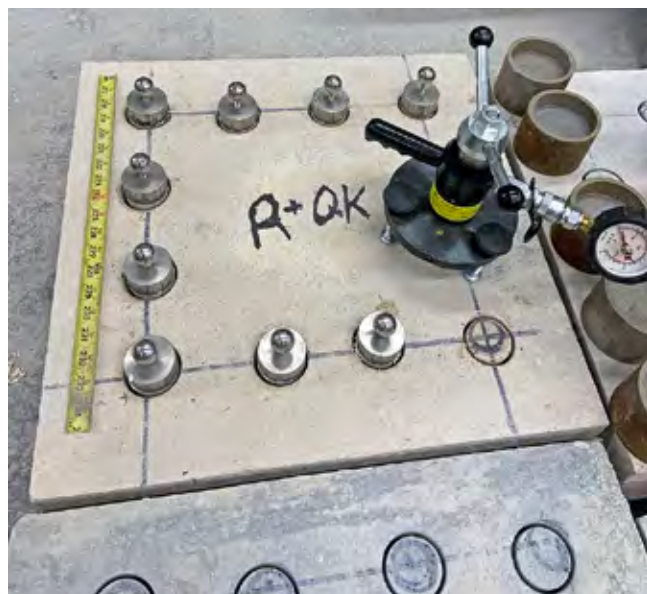
Several bond testing samples prepared for testing.

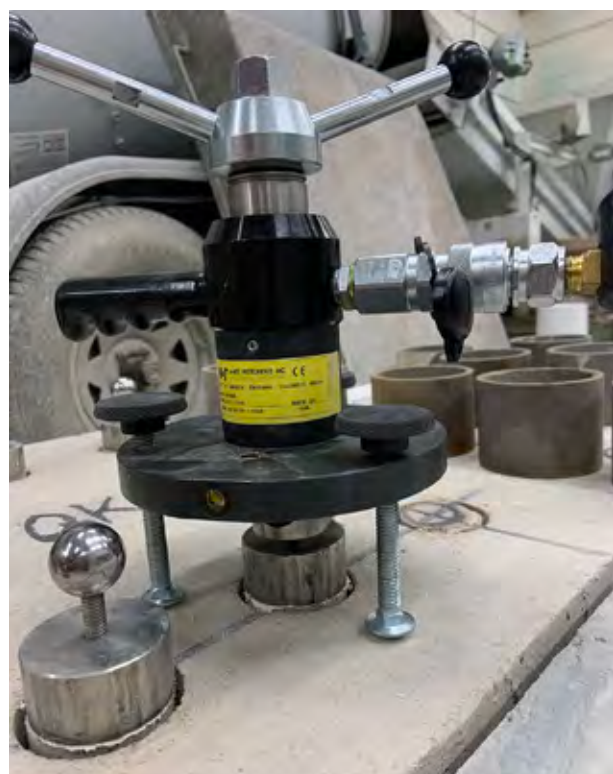
Bond testing device used to perform bond testing on concrete overlay.

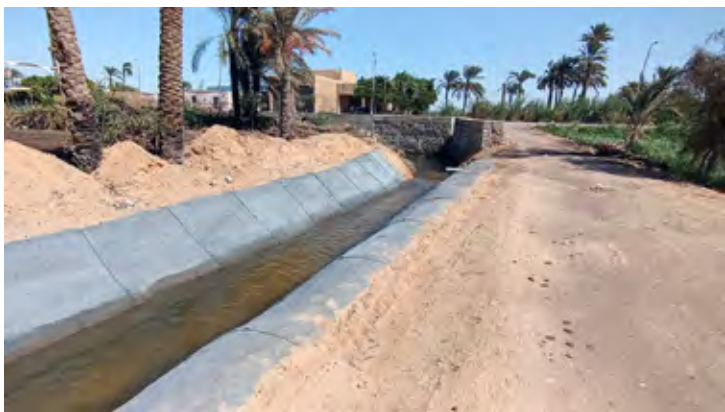
*Example of a completed lining project using a GCCM.
(picture courtesy of Concrete Canvas)*

Geosynthetic Cementitious Composite Mats (GCCMs) are a cement impregnated geosynthetic composite material used in numerous applications. Two applications of interest to Reclamation are lining an unlined canal for seepage reduction and repairing corroded corrugated metal pipe (CMP). The ease of installation for this concrete-based material makes it a desirable solution for reducing seepage of an unlined canal because it can be installed in small canals using a small crew without having to involve a contractor or heavy equipment. The material is supplied in rolls that can be cut into the desired strip lengths with a box cutter. Once fastened into place, it is sprayed with water to hydrate the cement inside the geosynthetic. The hydration process will create a hardened surface that will protect the canal from seepage losses.

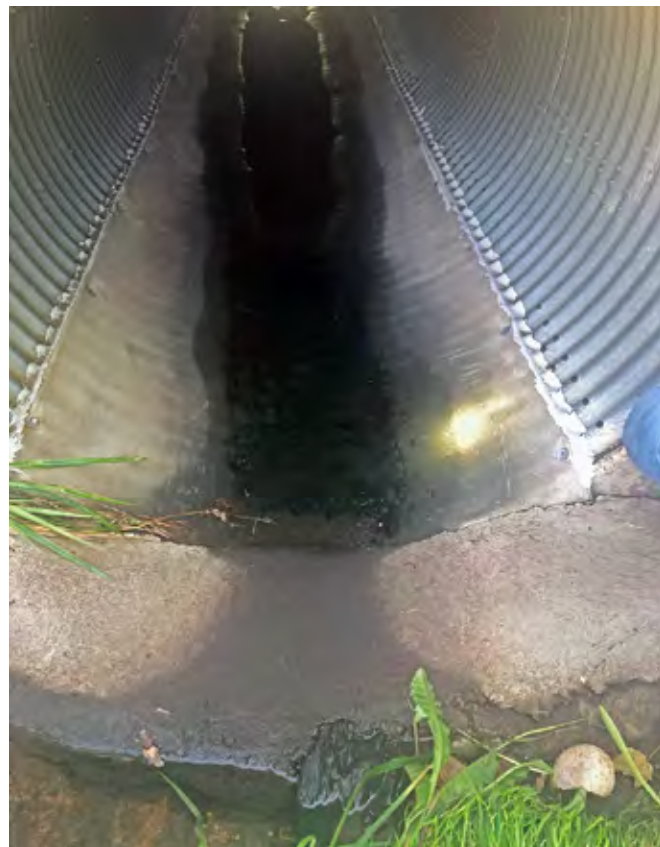
GCCM used for repair of a corrugated metal pipe in Jefferson County, Colorado.

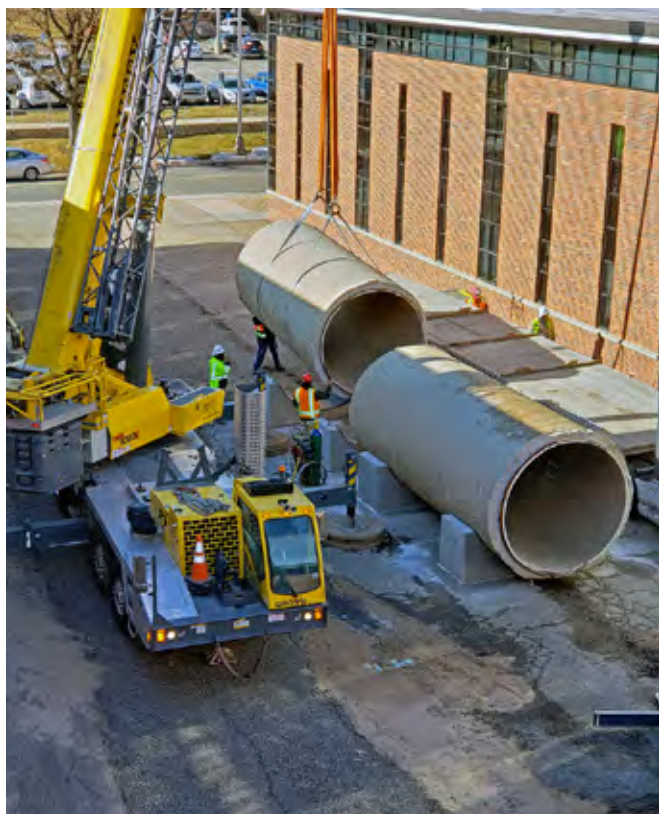
PCCP sections being installed at the Denver Federal Center.

sections of PCCP and comparing the results to inspection findings. In addition, they are repurposing excavated pipe sections as an educational tool for training Reclamation staff. For example, two sections of PCCP were installed outside the laboratories at the Denver Federal Center. These sections of PCCP were provided by Tarrant Regional Water District after discovering a large amount of damage during inspection and then removing them from service. Walkways were installed around the outside of the pipe to give students access to different areas of the pipes for a hands-on demonstration of different inspection techniques. The pipe sections will next be undergoing a forensic analysis to compare the results against the initial inspection findings. For the educational portion of this study, a curriculum will be developed that includes classroom materials, hands-on tasks, and the use of inspection tools. Support for this activity was provided by Reclamation's Asset Management Division.

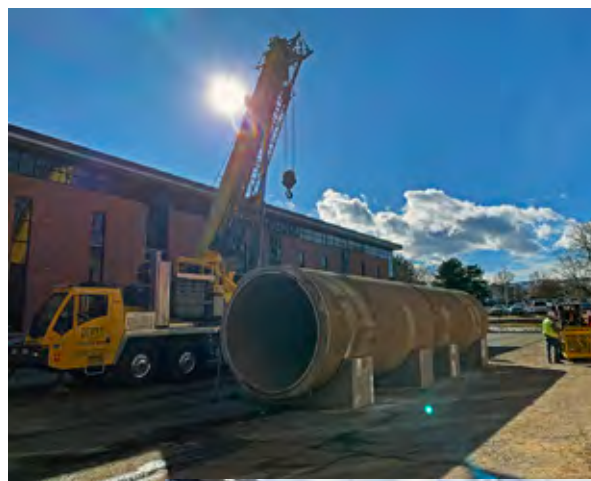
PCCP sections after installation.

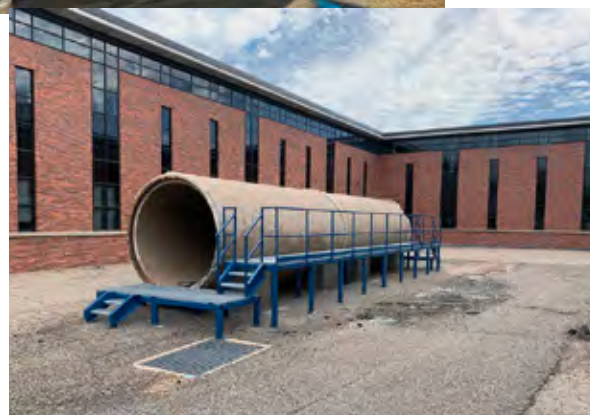
PCCP demonstration setup with walkways.

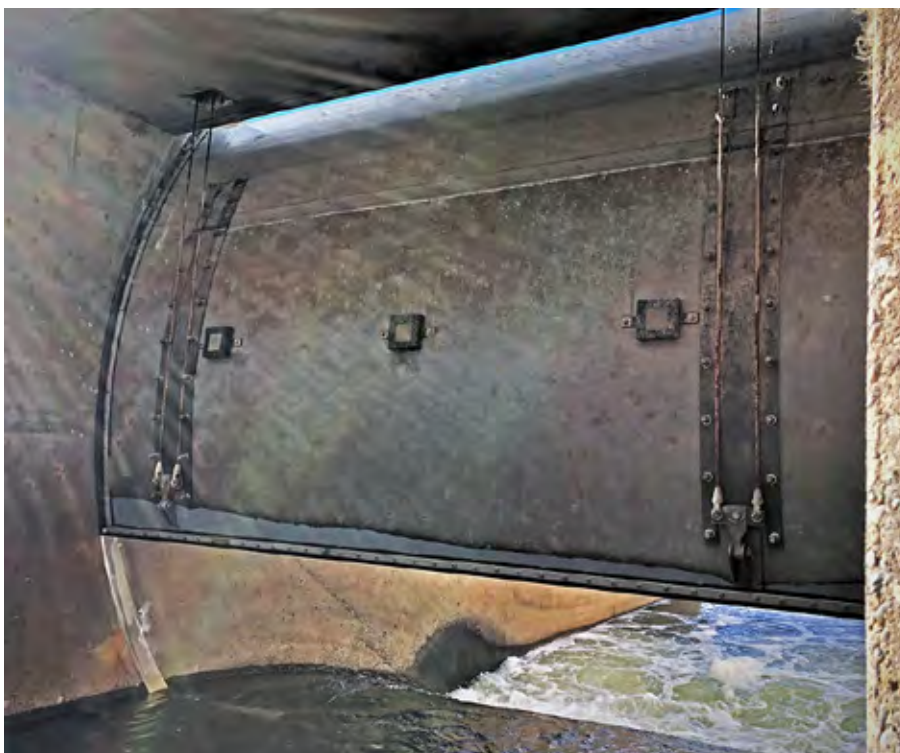
Traditional wire ropes hoisting radial gate.

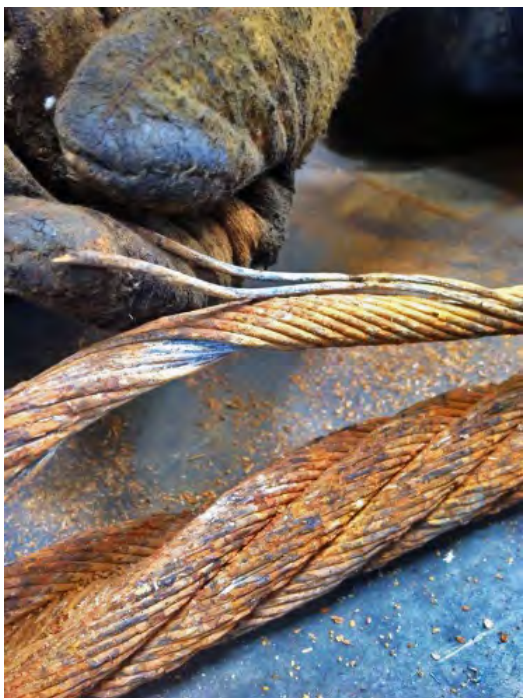
Close-up of traditional wire rope containing broken strands.

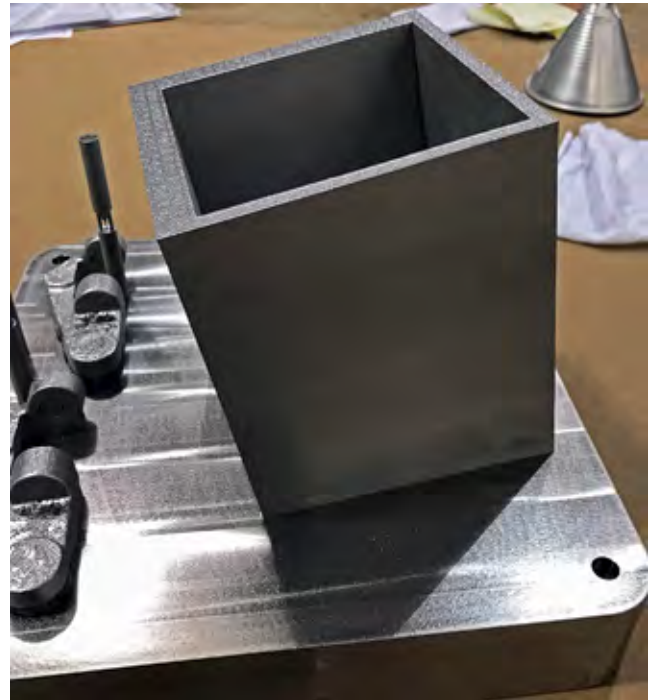
A cube 3D-printed from stainless steel using a powder bed fusion AM process. Note that the angle of the cube relative to the build plate was selected to minimize warping from thermal stresses.

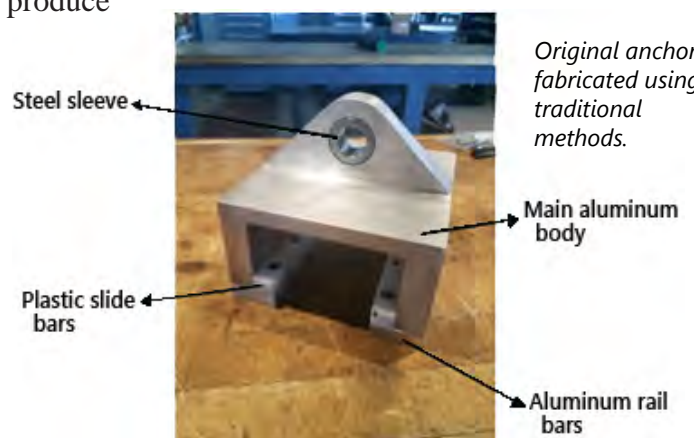
Original anchor fabricated using traditional methods.

In partnership with Oak Ridge National Laboratory, Reclamation is looking at three case studies—an anchor block, a governor part, and a slinger ring—to see if these parts can be made faster or cheaper with AM. Researchers are also looking to take advantage of the complex shapes that can be produced with AM to improve the end product, such as by reducing the weight or the number of parts in a component (middle and bottom image). The goal of this project is to better understand the limitations and best-use case scenarios of AM to allow Reclamation to take advantage of this evolving technology.

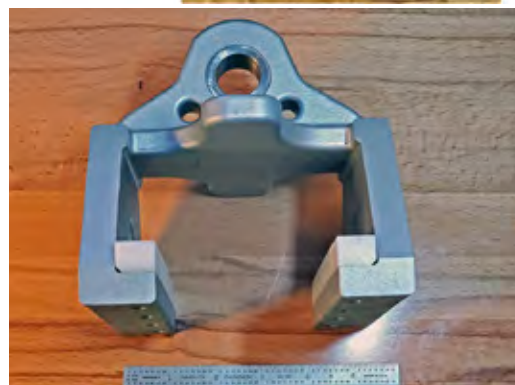
Anchor 3D-printed from aluminum using a powder bed fusion AM process. The additively manufactured anchor was redesigned to reduce material while maintaining the necessary strength.

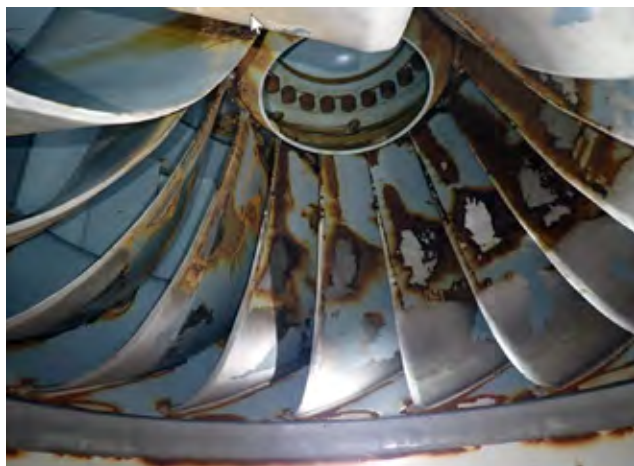
Turbine runner damage from cavitation.

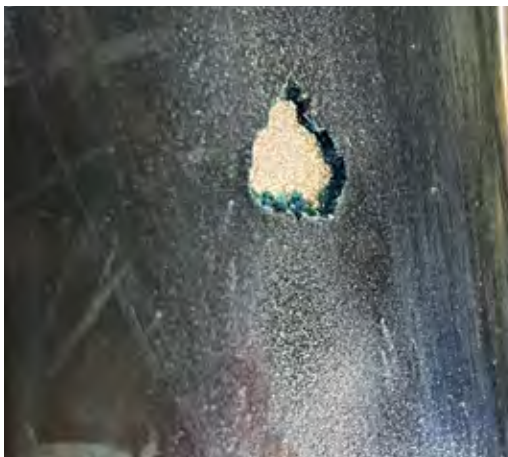
Elastomeric coated sample result after cavitation testing at 3.5 gallons/min for 32 hours (40 hours before damage to base metal is the pass/fail criteria).

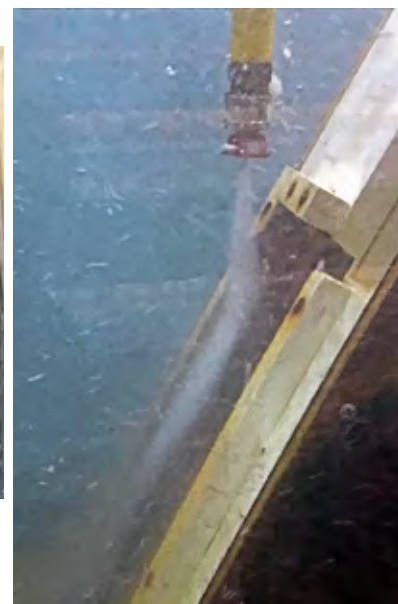
Cavitation submerged water jet test set-up.

Phase I of this research established a cavitation/erosion testing methodology to test different material

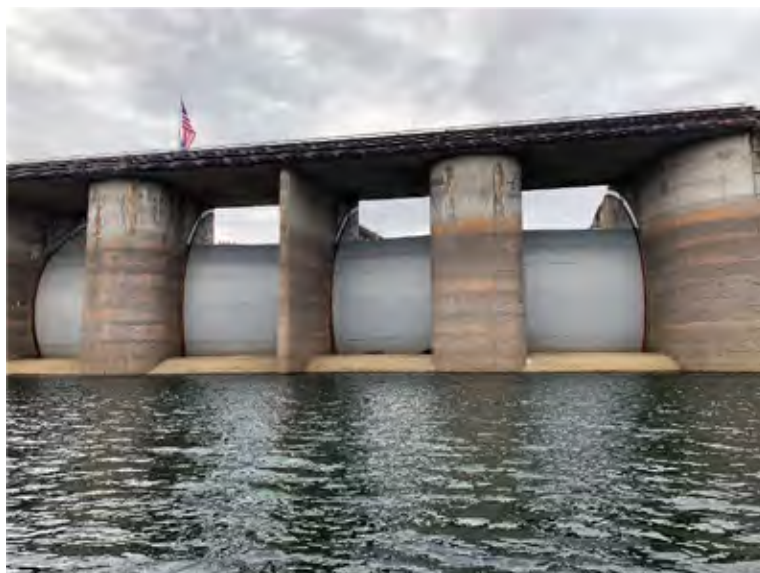
Radial gates at Fontana Dam that are coated with a polysiloxane coating system.

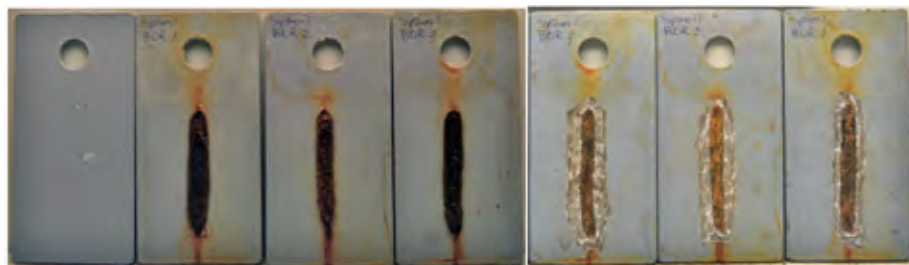
Vinyl test panels after cyclic testing showing corrosion damage at the scribe (left) before and (right) after removing loose coating.

manufacturers had similar performance to vinyl coatings in immersion testing, barrier properties, and all accelerated weathering and cyclic testing. However, some of the mechanical properties such as impact, erosion, and abrasion resistance had much poorer performance than vinyl. The research showed that some epoxy polysiloxane coatings may be suitable for use in immersion and fluctuating immersion service if the service environment does not have moderate erosion, high impact forces from debris, or abrasion forces from mechanical equipment; vinyl is still recommended in these service environments.

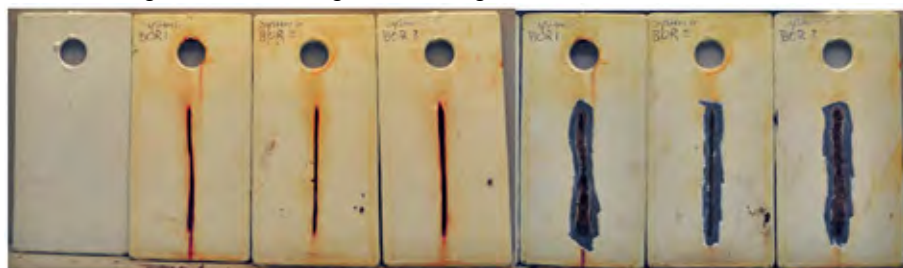
Polysiloxane test panels after cyclic testing showing corrosion damage at the scribe (left) before and (right) after removing loose coating.

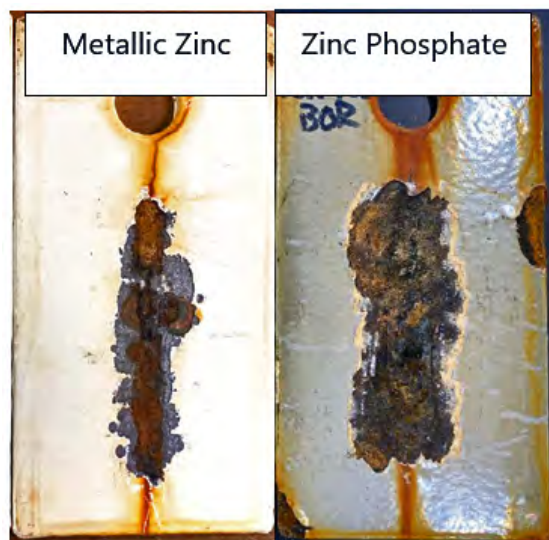
Compared to the coating system with the zinc phosphate additive, the metallic zinc additive had significantly less corrosion undercutting after the same evaluation period.

A previous Reclamation study found that three different additives are most common in inhibitor coating systems: metallic zinc, zinc phosphate, and organic additives. The current work tested commercially available and experimental coatings that contain those rust-preventing additives. Researchers used accelerated weathering and other tests to evaluate coating performance. One coating system with a metallic zinc additive performed similar to the vinyl system that had the properties researchers were trying to match. In addition, the metallic zinc inhibitor system can be applied in two layers, compared to the vinyl system, which is five or more layers. Testing for a longer period is needed to confirm the results, but this study showed that some newer coating systems perform as well as long-lasting, older ones.

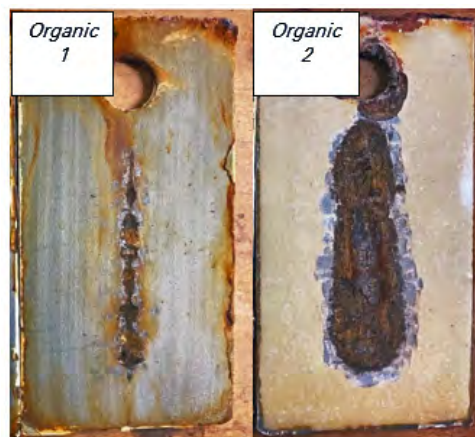
Coating systems with the organic inhibitor additives had different amounts of corrosion undercutting.

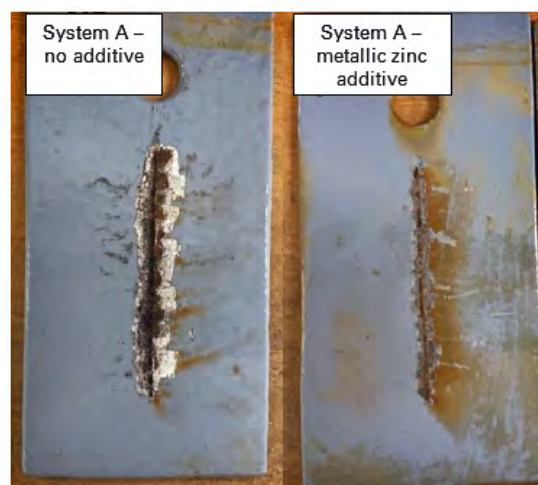
The metallic zinc additive prevented corrosion undercutting compared to the same coating system without the additive.

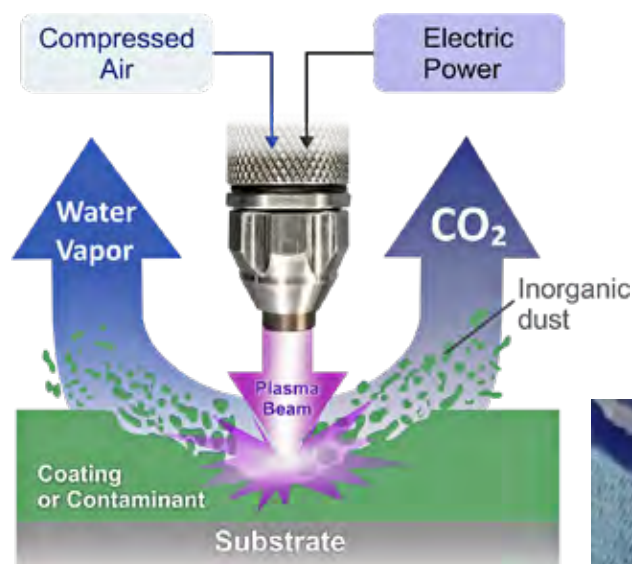
Process of coating removal using atmospheric plasma (credit: APS).

[Atmospheric Plasma Solution, Inc.](#) (APS) developed a coatings removal technology that applies plasma at atmospheric pressures. This is sometimes referred to as “cold plasma” because it can operate in the open air without the need of any special chambers and containment.

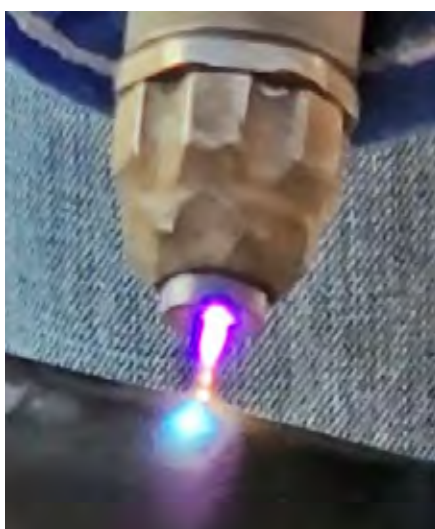
Close up view of plasma with “shock diamonds” on a small panel coated with coal tar enamel.

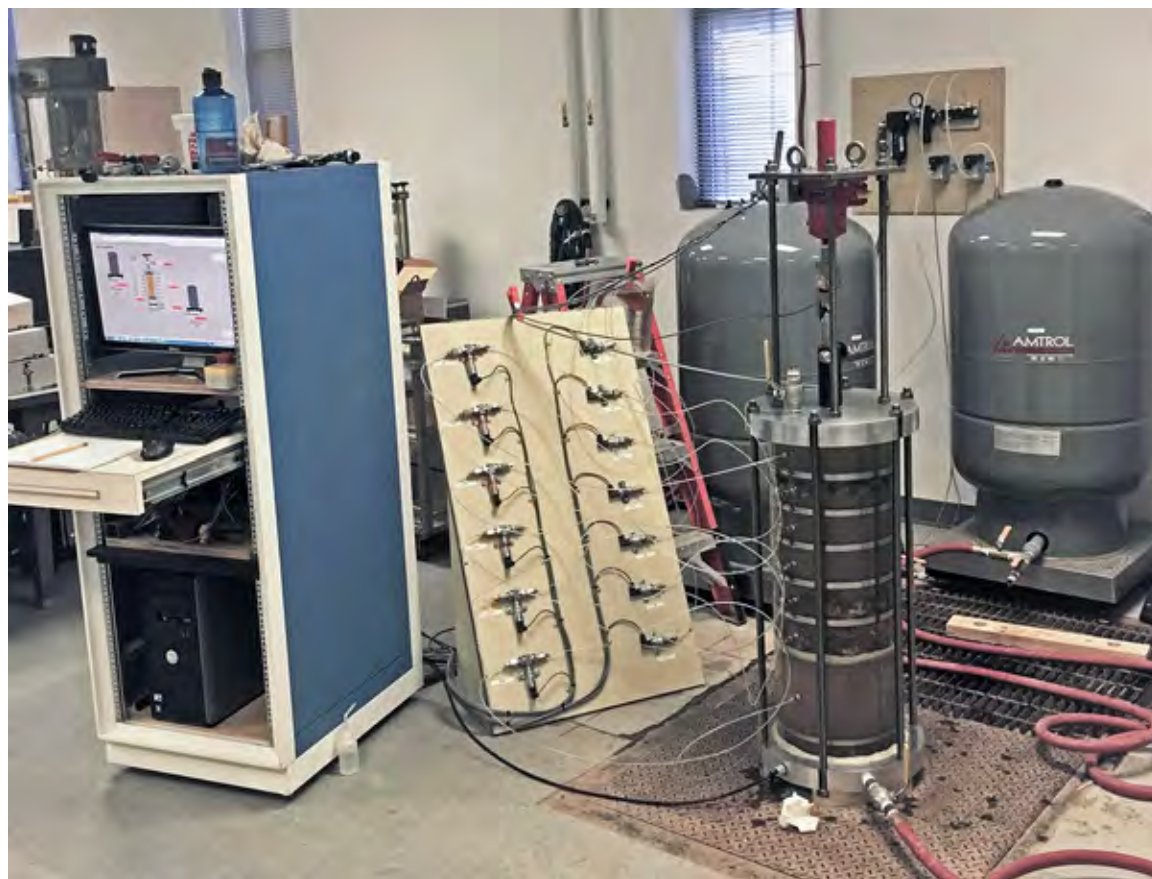
Testing apparatus (rigid cell permeameter) with loaded soil specimen, pore pressure transducer, water tanks, and the LabVIEW program used to run the test.

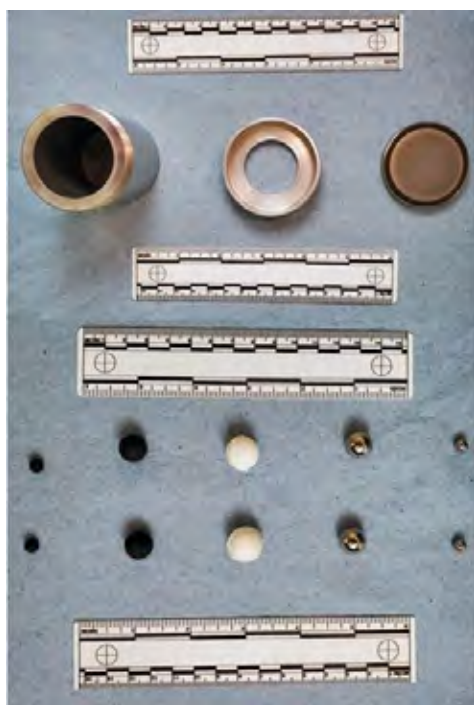
Sample processing cannister (top) and ball bearings of various size and material (bottom).

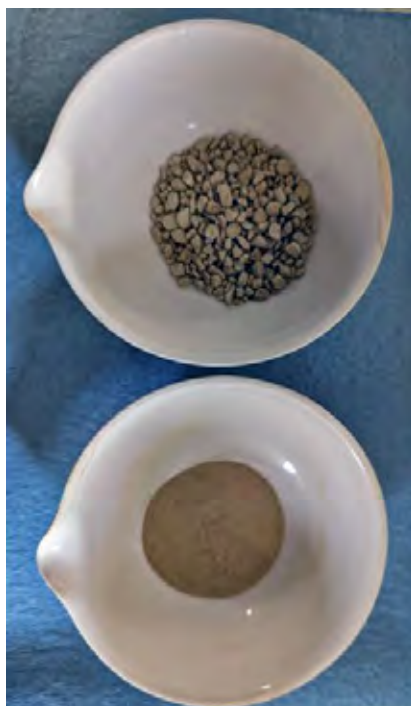
Unprocessed rock and soil (top) vs. ball milled rock (bottom).

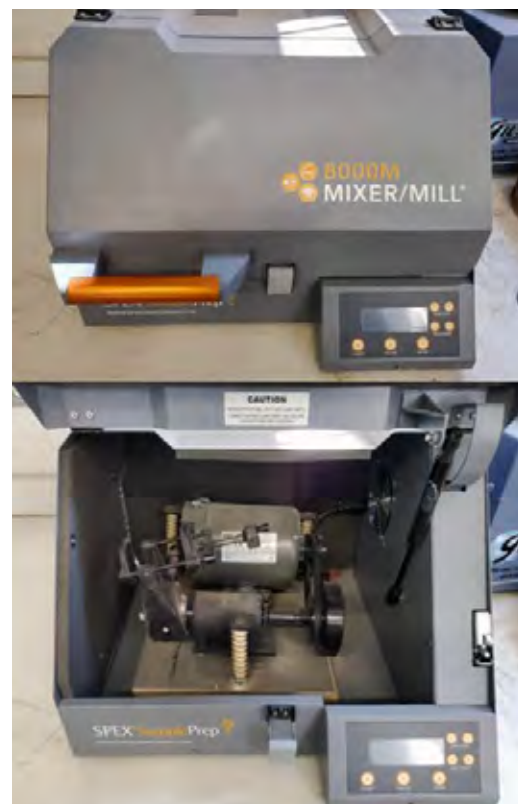
Ball mill device being used in this research.
