Knowledge Stream

Research and Development Office

*Materials Research: Preserving the
Longevity of Reclamation Structures*

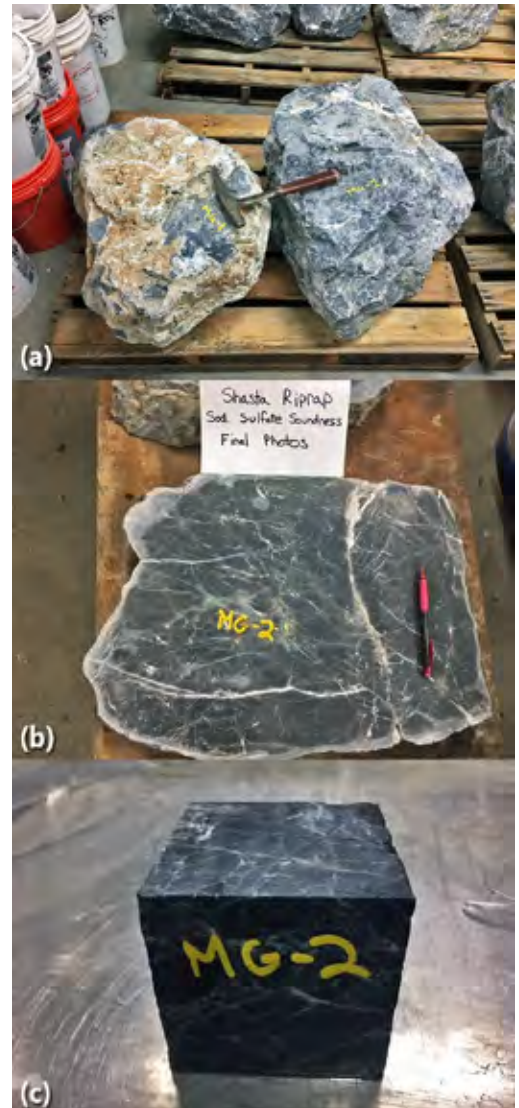
(a) Riprap block (b) 2-1/2-inch-thick freeze-thaw slab specimen used for new testing methods, and (c) 2-7/8-inch cubic freeze-thaw specimen used for traditional testing methods.

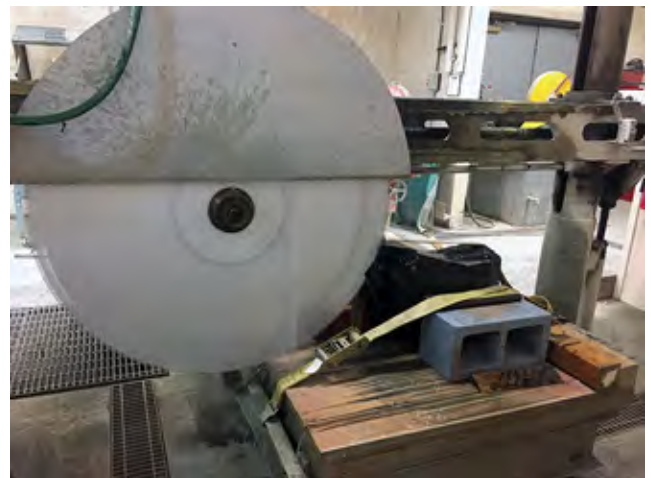
Equipment used to prepare riprap test specimens; 42-inch diameter diamond wet saw.
