Research Update

Summer 2016
Bulletin 2016-14

Foul-Release Scaleup: A Real World Trial of Mussel Resistant Coatings

Foul-release coatings applied on a new 10'x10' trashrack panel were put to the ultimate test at Parker Dam

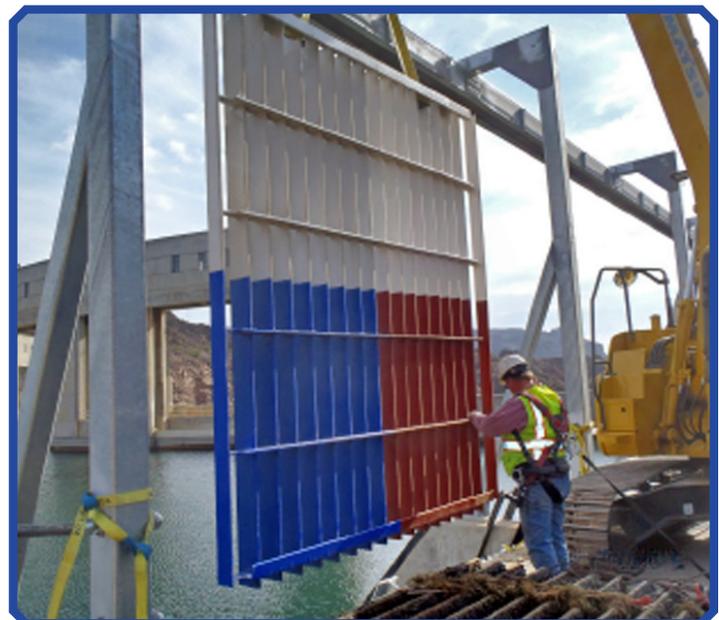
Installing the trash rack panel with four test coatings.

This Reclamation Science and Technology Program research project scaled up testing efforts to evaluate how coatings perform in actual service conditions. In 2012, a full-sized trashrack panel was fabricated and coated with four candidate commercially available foul-release coating systems:

- International Intersleek 970
- Fuji Sher-Release
- PPG Sigmaglide 890
- Seacoat Seaspeed V5

The panel was installed in Parker Dam's trashrack structure, which contains an automated cleaning system, whose periodic operations result in mechanical wear on the trashrack panels.

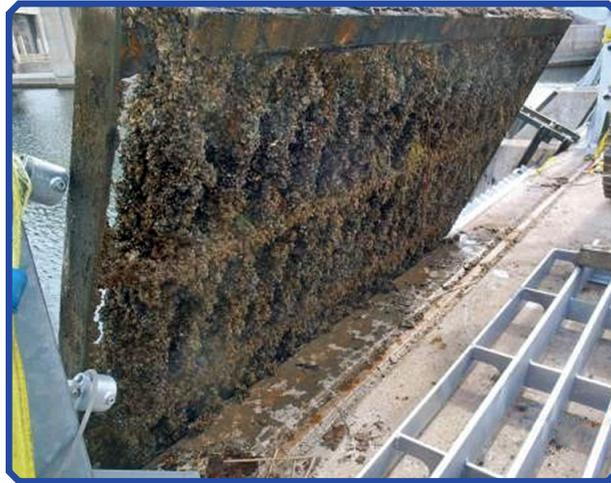
Existing trashrack heavily fouled with zebra and quagga mussels.

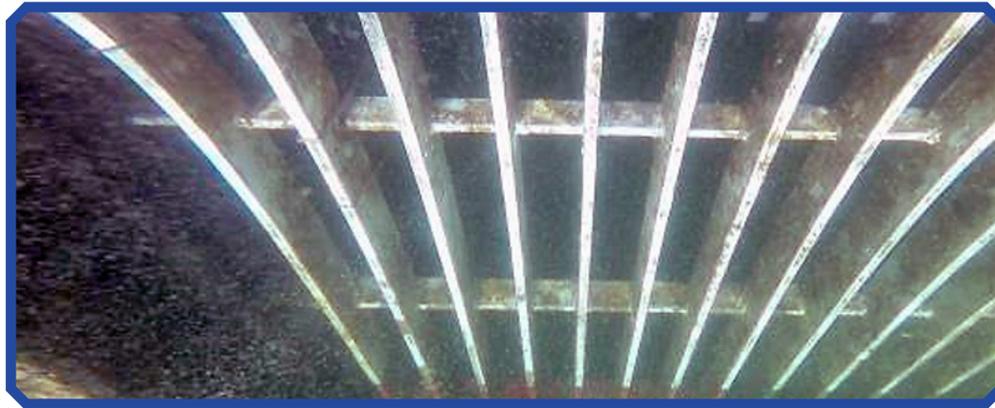
International Intersleek 970 after 18 months exposure.

It was expected that there would be some localized abrasion damage due to contact from the automated trash rake, which runs approximately every 7 days. As expected, damage occurred on the front facing surfaces of the trashrack where the trash rake guides scraped the surface. The front surfaces of the original trashrack panels, coated with a coal tar enamel, and the new galvanized steel racks were also damaged to bare steel due to the mechanical damage from the trash rake guides. Surprisingly, after 18 months of exposure, the silicone foul-release coatings (International Intersleek 970, Fuji Sher-Release, and PPG Sigmaglidle 890) had less damage than the hard epoxy siloxane hybrid (Seacoat Seaspeed V5). The inner surfaces of the trashrack panel bars still appeared to be in good condition.

No mussels appear to be attaching to the silicone foul-release coatings. However, a few mussels were found colonizing on the epoxy siloxane hybrid coating (Seacoat Seaspeed V5). The silicone foul-release coatings experienced wear patterns similar to the original coating. Thus, these coatings appear to be a promising solution for controlling mussels on Reclamation's infrastructure.
