S&T Program Project ID 7738-02
Bulletin 2017-06

UAS Data Collection and Photogrammetry From Elephant Butte Dam

Using unmanned aerial systems data to build a photogrammetric three-dimensional dam model

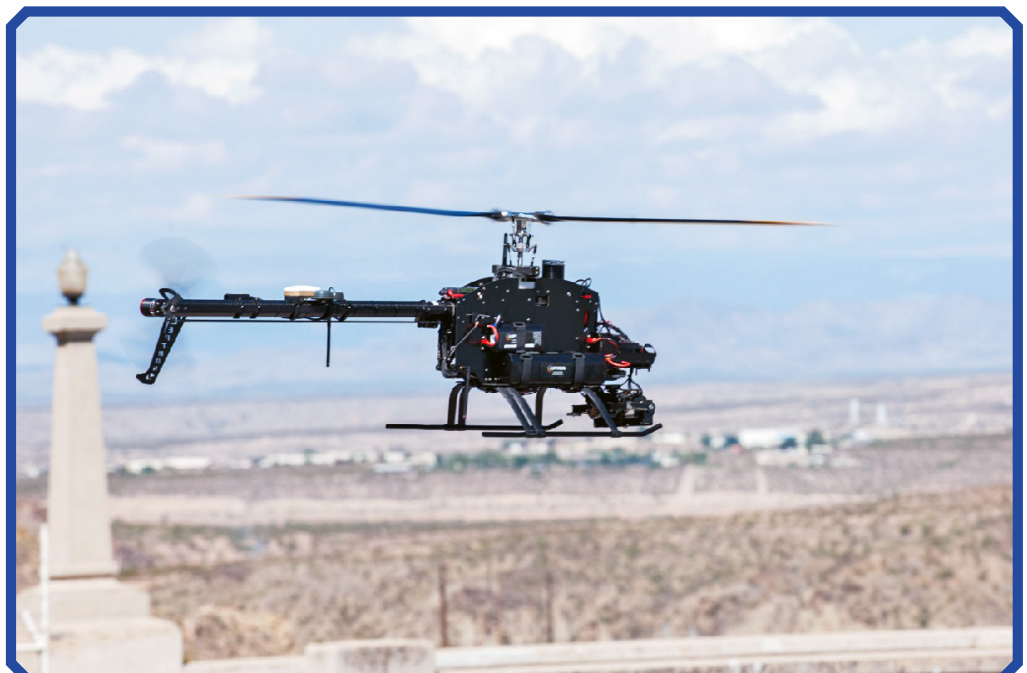
Lepton Avenger E Model UAS at Elephant Butte Dam, New Mexico. Note sensor gimbal at the front of the airframe.

UAS data collection was performed in several autonomous flights over a 2-day period in June 2016. The imagery collected was used to build a 3D model that was processed overnight. Both optical and infrared data were collected. The optical data were used to provide a photorealistic high-resolution texture over the model and the infrared data were used to help identify subsurface defects.

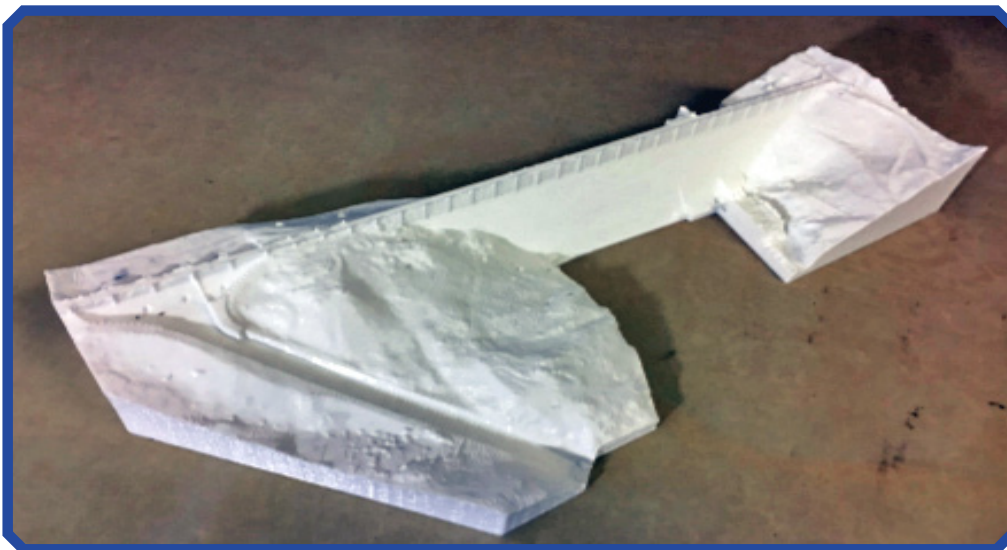
A 3D print of the photogrammetric model of Elephant Butte Dam, New Mexico.

Photogrammetry as a condition assessment tool is a relatively new idea at Reclamation. The process of photogrammetry involves stitching a series of images together to create a digital three-dimensional (3D) model. The 3D model is overlaid with a photorealistic texture with the same resolution as the original images. Thus, the model can be inspected in lieu of an actual inspection. By inspecting digital models, the inspector is not encumbered by weather, safety, gravity, or other physical limitations. This reduces the time to perform the inspection and makes the inspection safer.
