## Western Water and Power Solution Bulletin

Bulletin No. 28  
September 2011

### Improved Clamshell Gate Design

*New simplified design reduces leakage and improves discharge flow characteristics*

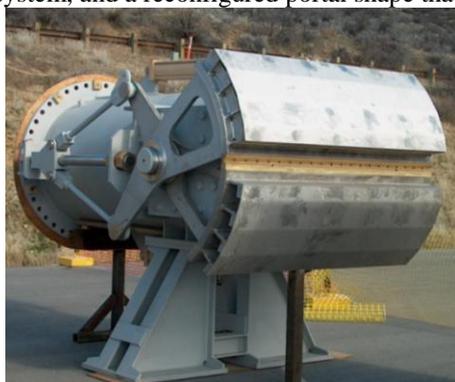
48-inch clamshell gate pre-installation.

Engineers in Reclamation's Technical Service Center, Mechanical Equipment Group, have developed and patented an improved clamshell gate design. The new design includes a simplified and more efficient control mechanism, a more sophisticated sealing system, and a reconfigured portal shape that provides for better discharge characteristics.

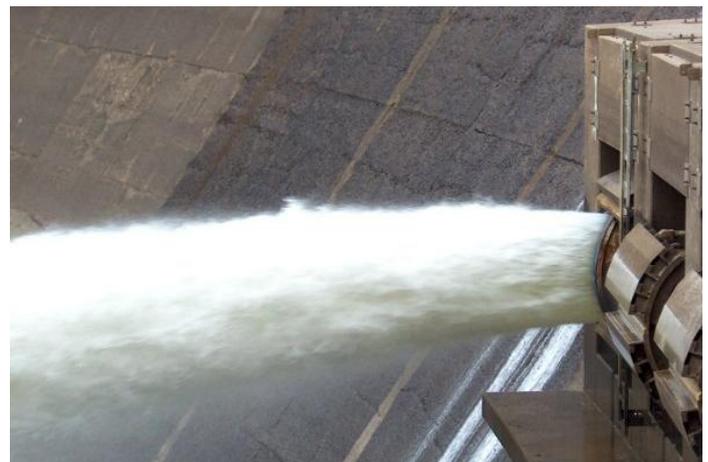
48-inch clamshell gates installed at Arrowrock Dam.

Clamshell gates have been installed at Reclamation's Grassy Lake Dam (1991), Salt River Siphon Replacement—Evacuation Structure (1995), Syar Tunnel (1996), and Arrowrock Dam (2004).
