Novel Online Surrogates to Monitor Reverse Osmosis Performance in Reuse Applications

**Desalination and Water Purification Program
Report No. 243**

U.S. Department of the Interior
Bureau of Reclamation
Technical Service Center
Denver, Colorado

May 2022

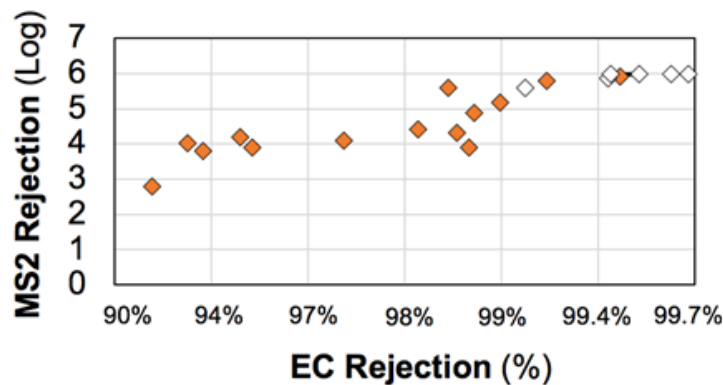
Figure 3. Correlation between EC rejection and MS2 (adapted from Antony et al., 2016; unfilled markers represent removal limited by detection in permeate sample)

The function of the O-rings is to seal the connection that keeps the feed and permeate streams separate. When an O-ring is compromised, feed water may pass into the permeate stream without passing through the membrane, causing unintentional contamination of the permeate. In contrast, chlorine damage affects the outer polyamide layer of RO membranes, revealing the polysulfone support layer, similar to an ultrafiltration (UF) membrane structure in pore size which is still an effective barrier for virus sized or larger particles (Antony et al. 2016). Indeed, Antony et al. (2016) reported that MS2 rejection by RO was constantly greater than 4 logs even at a decreased EC rejection of 93 percent (Figure 3).

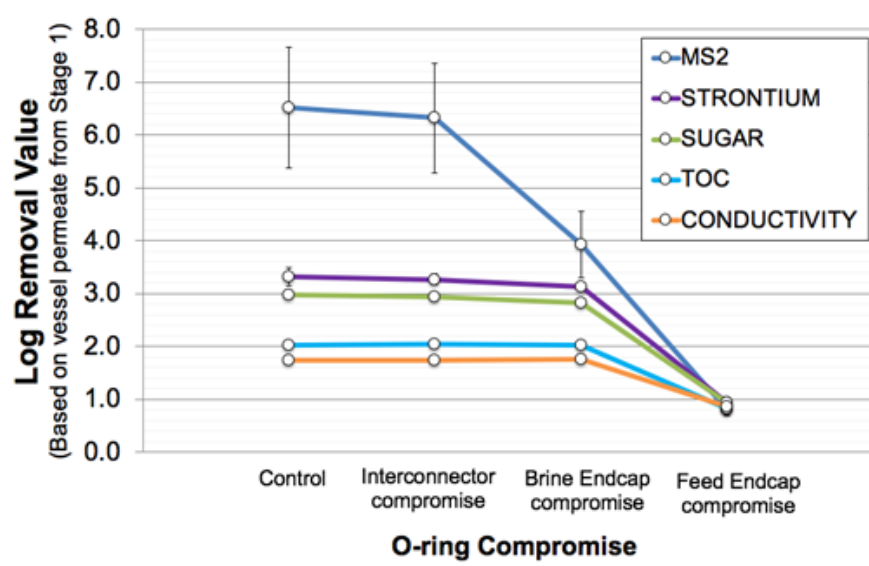
Figure 4. Response of surrogates to O-ring compromises (adapted from Trussell et al., 2017; error bars represent standard deviation of average removal from three events)

from different locations (i.e., endcaps and interconnector). Removing O-rings from the feed-side endcap was found to be the most impactful on both surrogate and MS2 rejection. This is likely due to the feed flow being highest at the feed end of an RO vessel. Removing O-rings from other locations did not inflict as much of a compromise to the surrogates as could be expected but did show decreased MS2 rejection beyond what any of the tested surrogates could measure. It is understood that this was because the surrogates were not sufficiently sensitive to capture the decrease in MS2 rejection for those specific compromises. In terms of surrogate performance, the inability to detect the MS2 decrease is considered acceptable since 1) the surrogate remained conservative to MS2 for the conditions tested, and 2) the credit sought for any of the surrogates would be several orders of magnitude lower than the observed decreases in MS2 rejection.

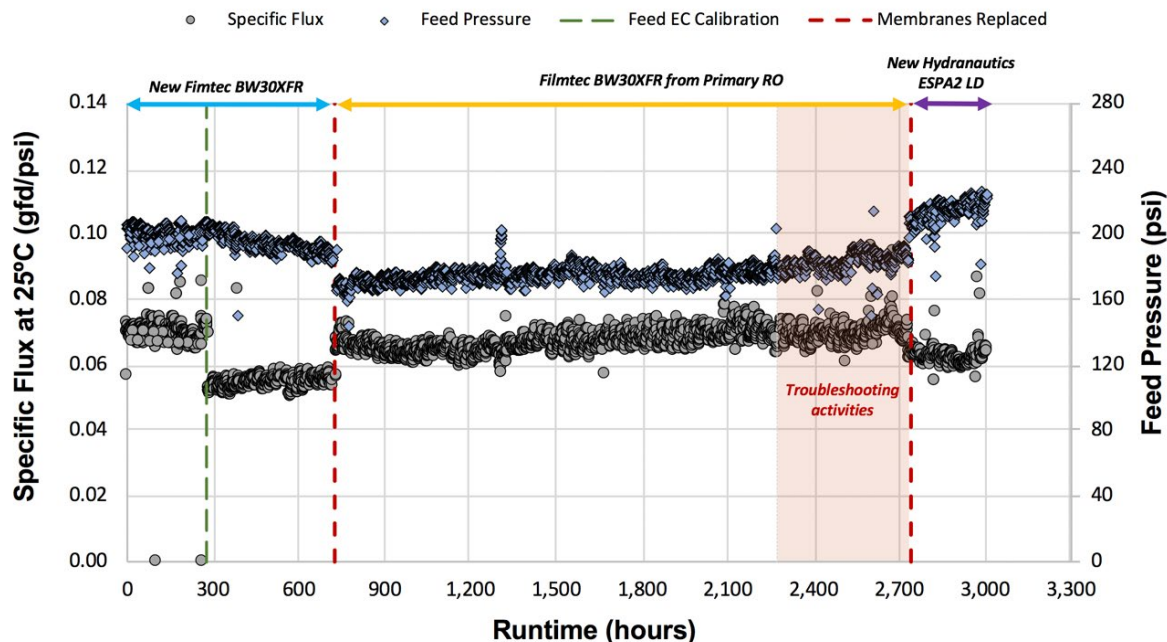
Figure 21. CCRO operational performance during testing

CCRO feed pressure was around 200 psi at the start of data logging. Specific flux at 25°C was approximately 0.07 gfd/psi at the start of data logging, yet a calibration of the feed EC probe on 07/26/2019 (282 runtime hours) shifted specific flux to approximately 0.05 gfd/psi since feed EC is used to calculate specific flux. Per Figure 21, a general increase in specific flux and decrease feed pressure was observed starting from approximately 300 runtime hours until membranes were replaced on 08/18/2019 (717 runtime hours) due to an unforeseen integrity issue. The integrity issue was captured as sharp rise in permeate EC as measured in the CCRO permeate tank, as shown in Figure 22. In an effort to recommence testing under normal conditions, the CCRO membranes were replaced with tail elements taken from primary RO on 07/31/2019. No other components (e.g., seals, connections, spacer element) were replaced at the time and integrity was restored. Once membranes were replaced, permeate conductivity was restored to approximately 120 μ S/cm. In addition, specific flux at 25°C slightly increased to 0.06 gfd/psi.

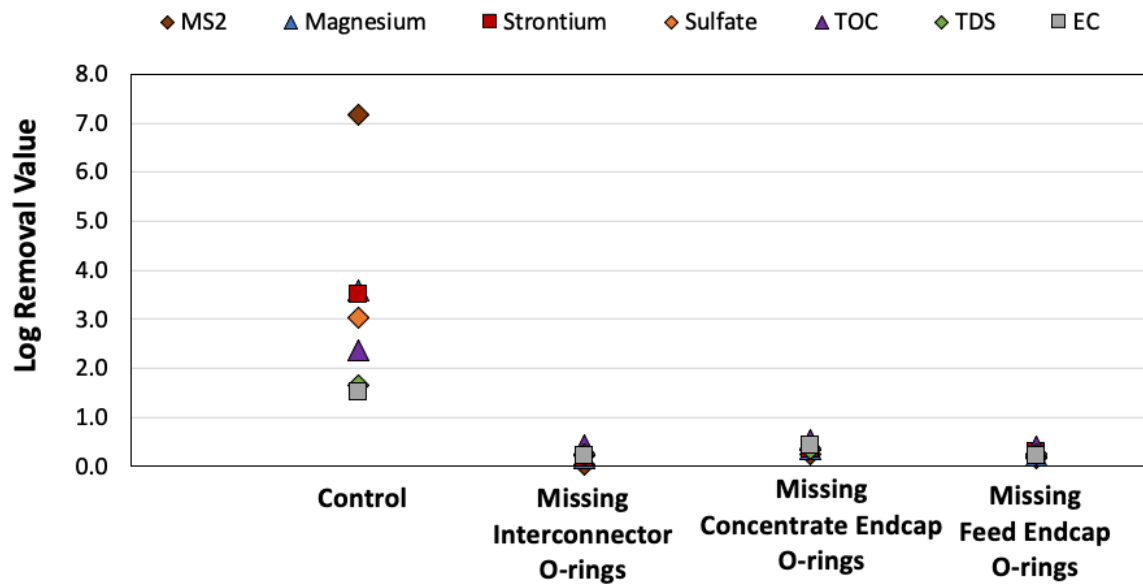
Figure 27. Rejection of surrogates and MS2 during CCRO compromise testing

1. CCRO integrity is highly sensitive to the removal of O-rings from the locations tested (interconnectors and endcaps).
2. All surrogates accurately tracked the reduction of MS2 rejection when the O-rings were removed, showing their ability to indicate when membrane integrity has been compromised.

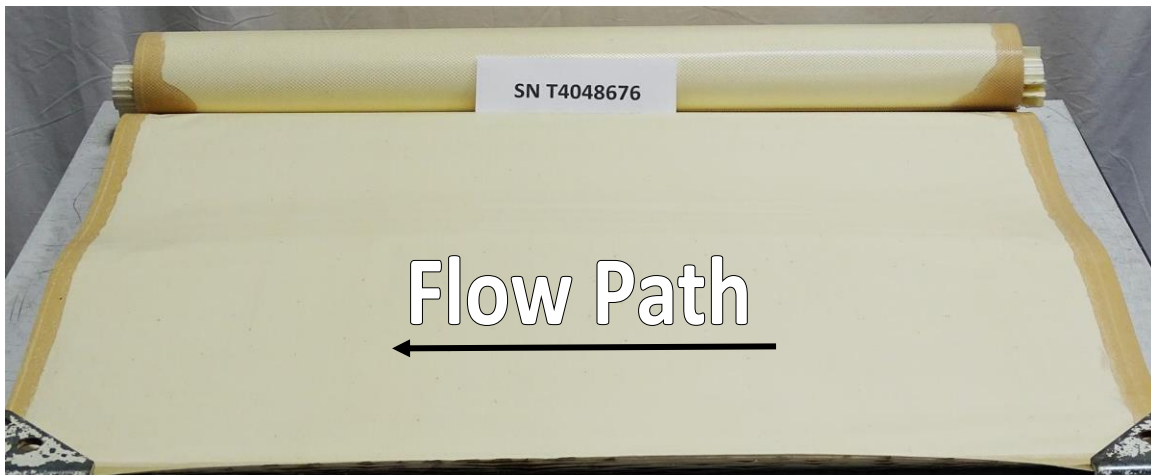
Tan-colored foulant was noted in primarily the feed spacer contact points. Additionally, random spots were observed across the membrane on all membrane leaves.

Exposed membrane surface of SN T4048676

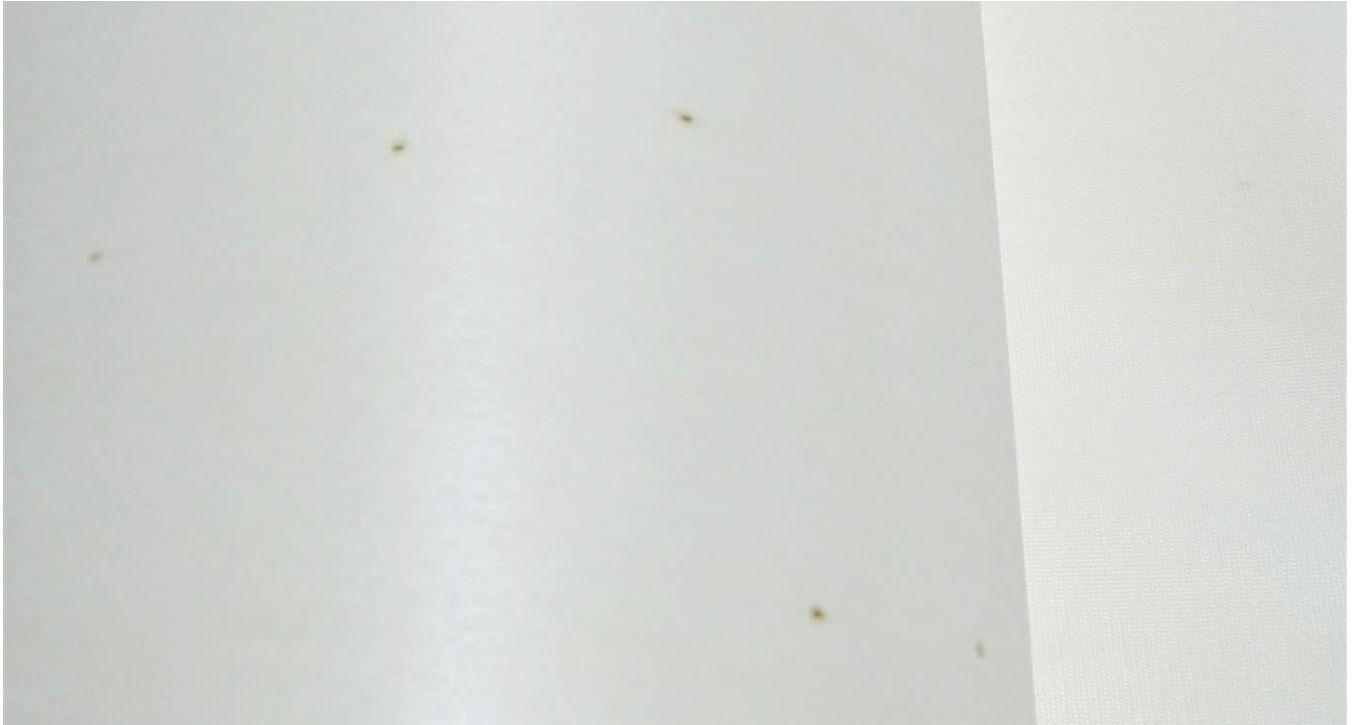
Tan-colored spots were observed on the membrane backing and permeate carriers.

Membrane backing of SN T4048676
