Desalination and Water Purification Research
and Development Program Report No. 135

Pilot Testing of Zero-Discharge Seawater Desalination – Application to Selenium Removal from Irrigation Drainage

April 2008

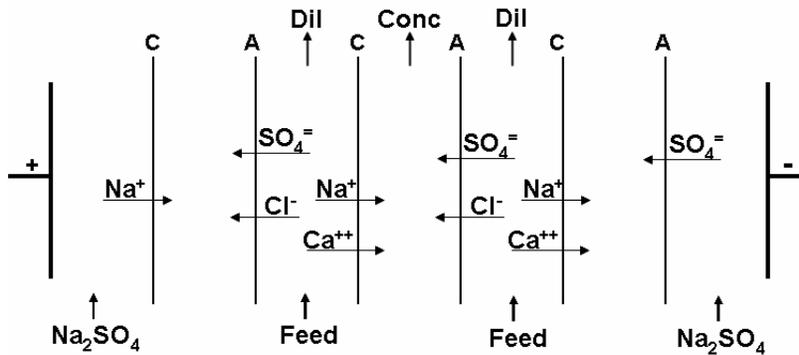
Figure 1. Conventional electro dialysis with ordinary membranes concentrates CaSO_4 .

The concept that was investigated in this study is called zero-discharge desalination. ZDD is similar to a ZLD system, but ZDD differs from other ZLD processes in that the ZDD process allows separation of the salts into salable products. The ZDD concept as practiced in this project utilizes the energy-saving feature of a special electro dialysis (ED) technique to remove the CaSO_4 from the concentrate stream of reverse osmosis and recovers it as a solid, potentially salable byproduct of the desalination process. Figure 1 illustrates what would happen if one would attempt to concentrate the divalent salts by conventional ED with ordinary ion-exchange membranes. The SO_4^- ions would migrate through the anion-exchange membrane designated by A, and Ca^{++} ions would migrate through the cation-exchange membrane designated by C. Substantial buildup in the concentrations of these divalent ions would result in precipitation of CaSO_4 in the concentrating stream of the ED process, and such precipitation would cause deterioration in the performance of the ED process.

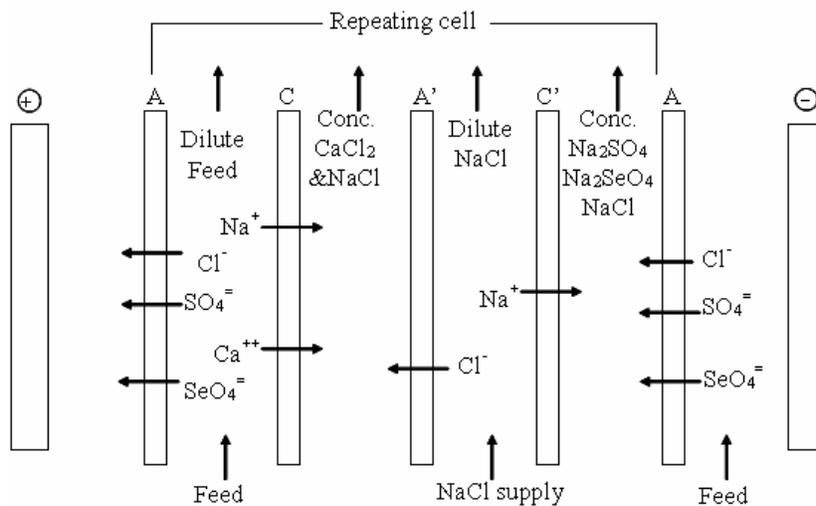
Figure 2. Membrane arrangement and transport of ions in electro dialysis metathesis.

Precipitation of sparingly soluble CaSO_4 is avoided in the ZDD process by the application of a variant of ED called electro dialysis metathesis (EDM). In EDM, the ions of CaSO_4 in the RO reject stream are separated to make two separate streams of highly soluble salts sodium sulfate (Na_2SO_4) and calcium chloride (CaCl_2). The EDM technique utilizes four ion-exchange membranes in a repeating unit cell of the ED stack. Such an arrangement can be used to change partner ions of two salts. In this example, the two salts, CaSO_4 and sodium chloride (NaCl) in two separate diluate streams change partners to form Na_2SO_4 and CaCl_2 in two separate concentrate streams. The EDM technique is illustrated in figure 2. The designations A and C are used for the ion-exchange membrane bounding the diluate stream containing CaSO_4 , and the designations A' and C' are used for the ion-exchange membrane bounding the diluate stream containing NaCl . A repeating unit cell has the sequence A, C, A' C' when the anode is to the left, as illustrated in figure 2. The solution containing CaSO_4 , in this example RO concentrate solution, flows between the A and C membranes. When an electric potential is applied to the electrodes, portions of all of the anions migrate through the A membrane, and portions of all of the cations migrate through the C membrane. A solution comprising monovalent salt (called the NaCl supply in figure 2) flows between the A' and C' membranes. When an electric potential is applied to the electrodes, Cl^- anions migrate through the A' membrane, and Na^+ cations migrate through the C' membrane. Thus, the solution flowing between the C' and A membranes becomes concentrated with Na_2SO_4 , and the solution flowing between the C and A' membranes becomes concentrated with CaCl_2 . Since the Na_2SO_4 and CaCl_2 salts are substantially soluble in water, these salts can be concentrated appreciably by recirculating the solutions through their respective ED compartments as shown in figure 2.

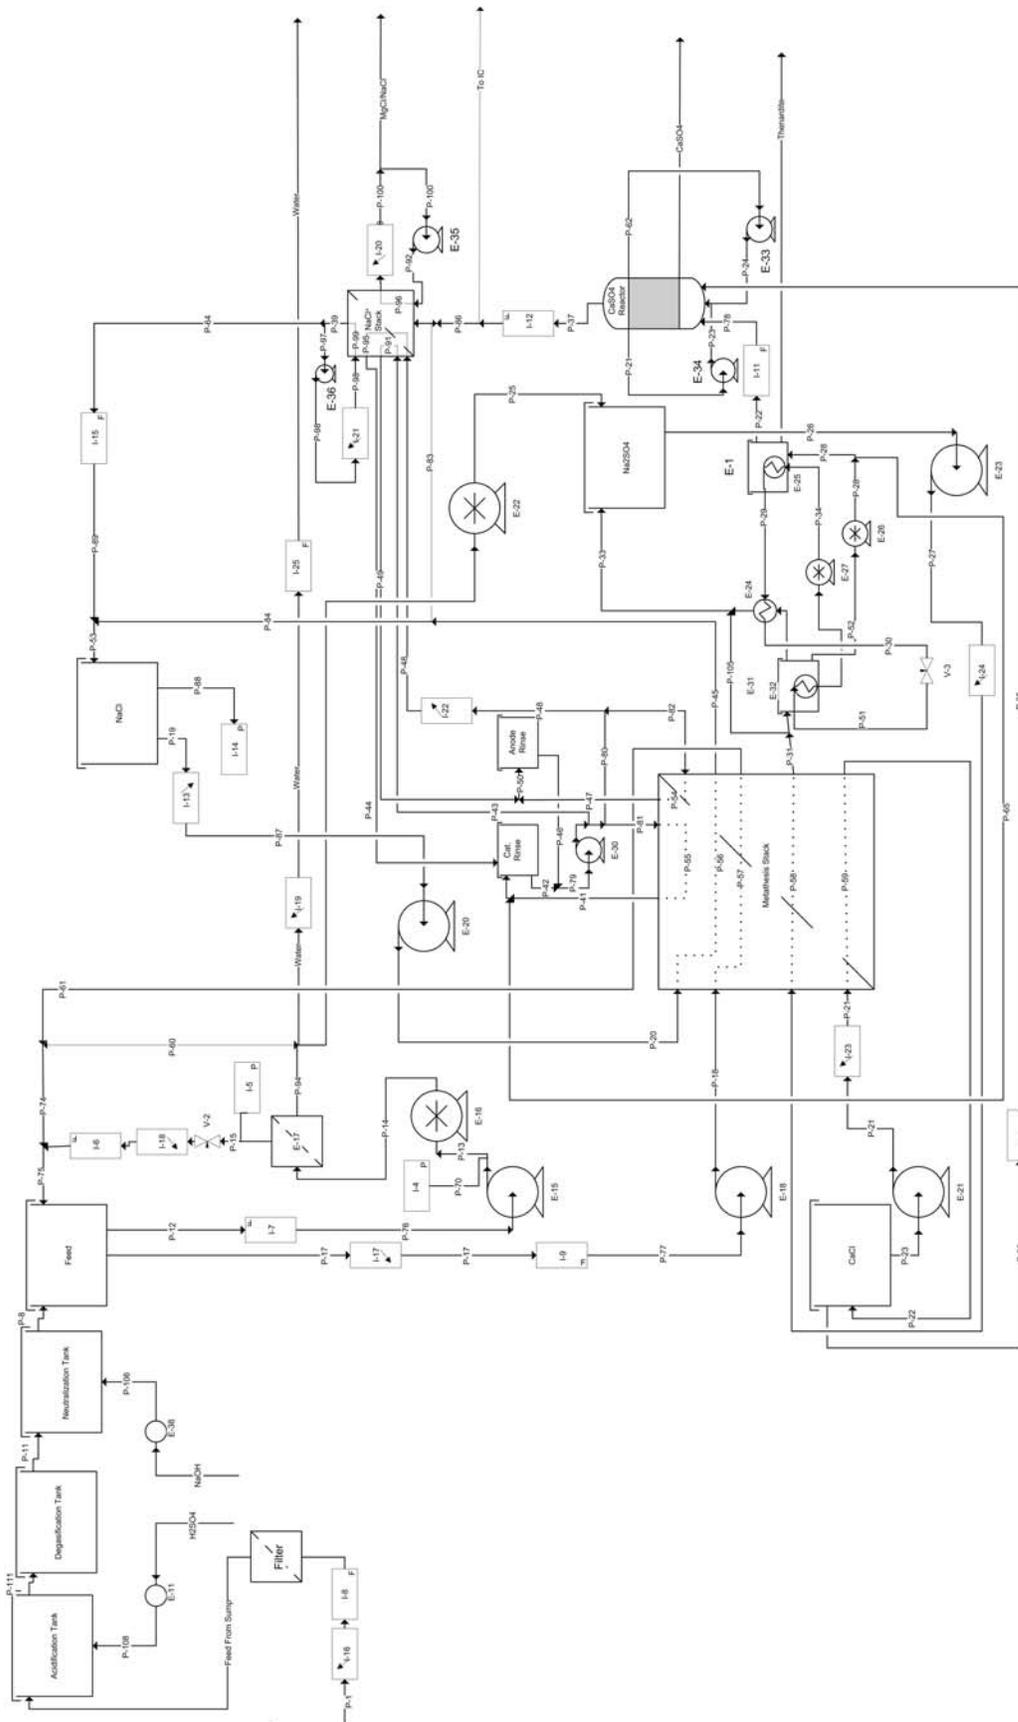
Figure 4. Flow diagram of pilot plant for Panoche.

A schematic of the skid is shown in figure 4. The EDM stack was purchased from Ameridia, Inc. Each membrane had an exposed area of 500 square centimeters (cm^2) (Matsunaga 2003). The membrane arrangement was like that shown in figure 2. All membranes were of the Neosepta trademark of Tokuyama Corp. The membranes in the 20 repeating units were A = AMX, C = CMX, A' = ACS and C' = CMS. The cation-exchange membrane next to the anode was CMB, and the anion-exchange membrane next to the anode was AHA.

The ED stack designated in figure 4 as the “NaCl Stack” was purchased from Electrolytica, Inc. The end plates of the purchased stack were modified to provide two entry ports for each gasket spacer. Steel-rule dies were purchased, and gaskets, spacers, and membranes were cut in a hydraulic press. The membranes used in the 20 repeating cell pairs of the NaCl stack were ACS and CMS. CMB membranes were used next to the anode and the cathode.

The flow diagram in figure 4 shows how the process works. The pretreatment section of the pilot plant utilizes gravity flow between the tanks in the pretreatment portion, which eliminates the need to actively control the level in the tanks with valves and float switches. The feed water flows through a cartridge filter before it enters the system. Sulfuric acid is added to the filtered water in a stirred tank to maintain a pH of 4. Acidification converts carbonate or bicarbonate into dissolved carbon dioxide. The water then flows into a second tank that is packed with high surface area packing (Vexar netting) to disengage the carbon dioxide (CO_2) from the water. Sodium hydroxide is then added to the solution in a stirred tank to bring the pH back to neutral.

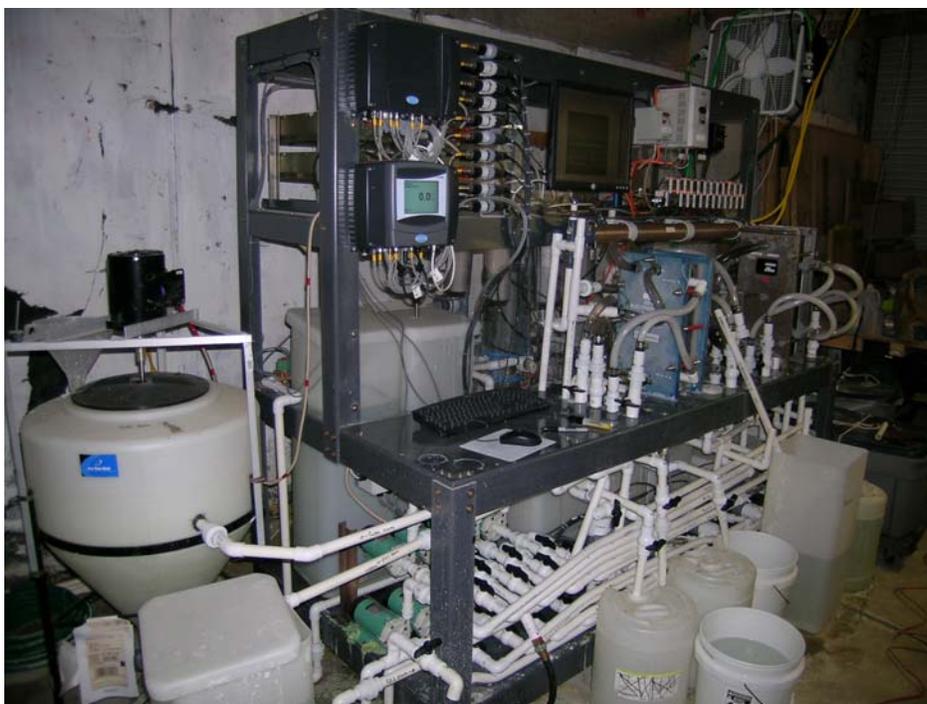
Figure 5. ZDD pilot skid installed at Panoche farm.

After assembly and shakedown testing at the University of South Carolina, the skid was rolled onto an automobile-transport trailer, and a plywood box was constructed around it for protection. A motor home was used to pull the trailer from South Carolina to California. A photograph of the installed pilot skid is shown in figure 5.

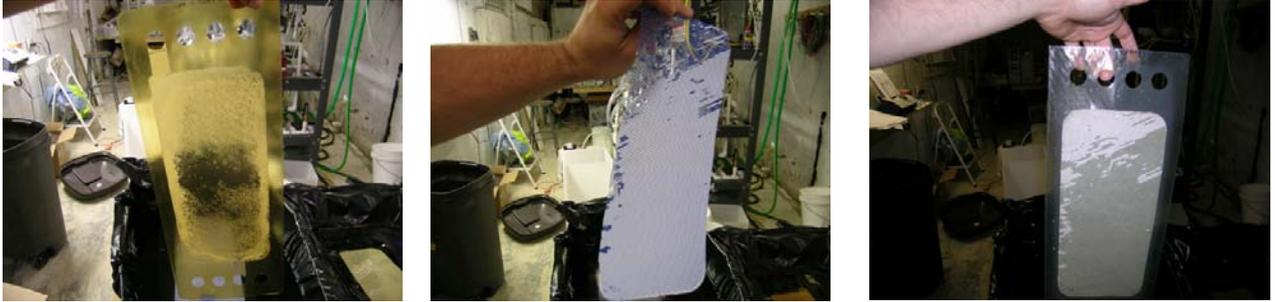
Figure 6. Photographs from left to right of the CMX membrane above the CaCl_2 compartment, the spacer in the CaCl_2 compartment, and the ACS membrane below the CaCl_2 compartment

In Run 1, which was started on June 26, 2006, at 12:00 p.m., NaCl for the EDM salt supply was prepared by dissolving water softener salt obtained from Lowes with deionized water produced using an under-the-sink RO unit and a mixed-bed ion exchange column. The electrode rinse solution was prepared by dissolving sodium sulfate obtained from UNIVAR with deionized water as noted above. The EDM CaCl₂ and the EDM Na₂SO₄ tanks were partially filled with deionized water prepared as noted above. The EDM feed was irrigation drainage water from Panoche Drainage District sump DP 25 that was stored in a large, black tank. Only the EDM stack was operated at the beginning of Run 1 until the conductivity of the feed solution had dropped significantly. This was done to prevent the formation of CaSO₄ on the RO membrane. The RO system was started after the conductivity of the EDM RO feed tank had dropped to about 10 millisiemens per centimeter (mS/cm). The RO feed pressure was adjusted regularly to maintain the conductivity of the EDM RO feed tank at approximately 15 mS/cm. The concentrated solutions in the CaCl₂ and Na₂SO₄ tanks were withdrawn and mixed in the agitated, conical precipitation tank to produce CaSO₄ precipitate. A slurry of the precipitate was withdrawn from the conical tank and allowed to settle in a 5-gallon bucket, and the supernatant was decanted from the bucket and stored for processing in the ED2 stack. After 3.5 days of operation, it was noticed that flow had stopped in the EDM CaCl₂ solution compartments. The system was shut down, and the EDM stack was disassembled. Examination revealed that the CaCl₂ compartments were full of a white solid, shown in figure 6. Also it was noticed that the solids were adhered very firmly to the ACS membrane. There was no obvious reason why the solids had formed. The

compartment that shares the ACS membrane is the EDM NaCl compartment of which the NaCl solution was prepared with water-softener salt, which would appear to eliminate the NaCl supply as the source of the problem. It was also noted that while the solids did not dissolve in RO permeate water or in dilute sulfuric acid (H_2SO_4), they did dissolve in the presence of hydrochloric acid (HCl). The solids were removed from the stack components by rinsing the membranes and spacers with dilute HCl solution, and the stack was reassembled and put back into service.

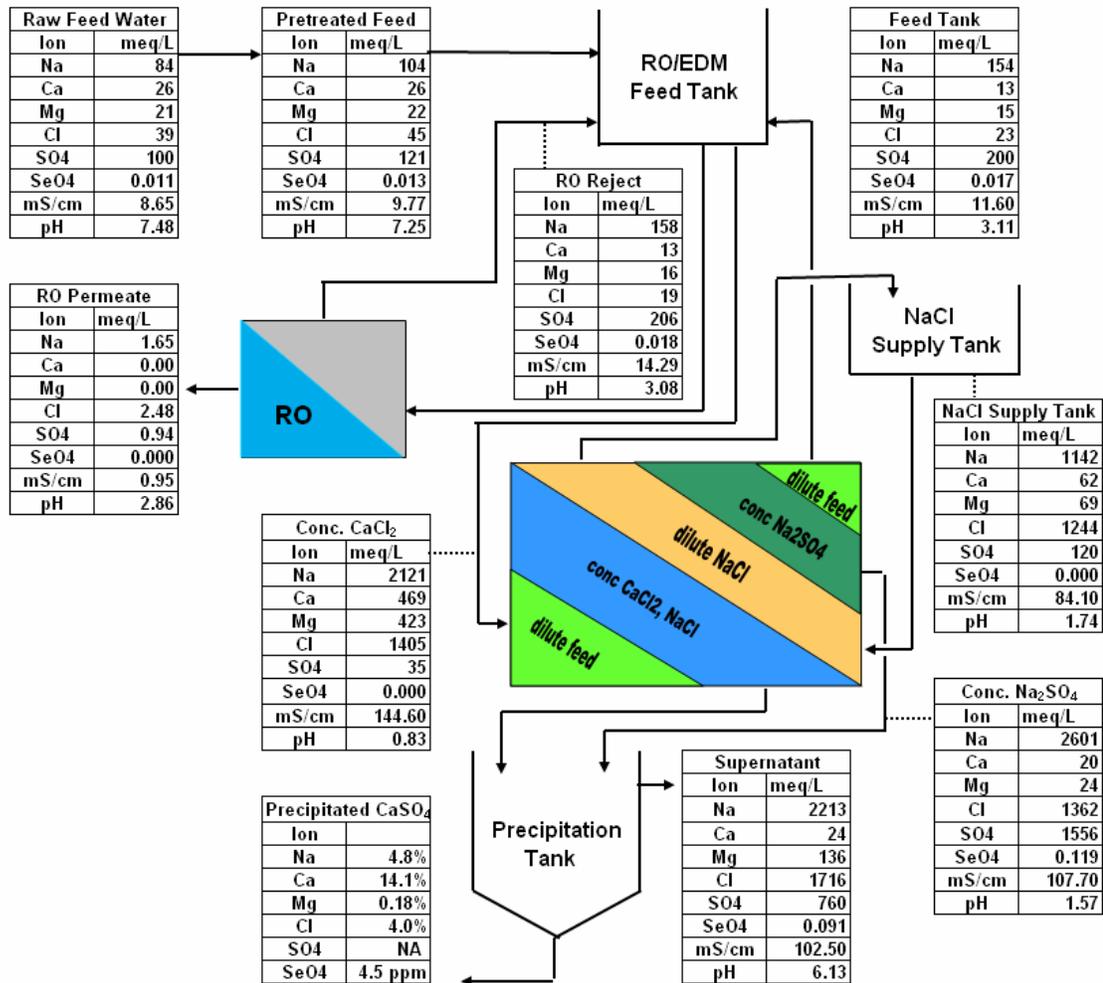
Figure 7. Composition of process streams in Run 5.

The analytical data are presented in figure 7. Since selenium is a major concern, it will be discussed first. The RO treatment reduced the SeO_4 to undetectable levels (less than 50 parts per billion) in the permeate. Consequently, the SeO_4 level was elevated in the RO concentrate and in the feed tank. The SeO_4 was undetectable in the concentrated CaCl_2 stream. That is not surprising, because anions should only enter that stream from the NaCl supply stream through a univalent-anion-selective membrane (ACS). In contrast, there was abundant SeO_4 in the concentrated Na_2SO_4 stream, because the SeO_4^- ions are similar to SO_4^- ions in their ionic transport properties. The SeO_4 was also abundant in the supernatant with a reported value of 3.6 ppm. The SeO_4 content of the precipitate was 4.5 ppm and Mg was 1,800 ppm, not much higher than that in the supernatant. Evidently, there was little, if any, co-precipitation of SeO_4 or Mg in the formation of the solid CaSO_4 byproduct. This is good news, because it indicates that disposal or utilization of the byproduct will not be hampered by selenium contamination or soluble MgSO_4 .

Data in figure 7 indicate that the concentration of sulfate in the supernatant of the precipitation tank was substantially higher than the concentration of calcium. This situation occurred because the irrigation drainage had more sulfate than calcium, and none of the concentrated Na_2SO_4 solution was diverted from entering the precipitation tank. It was also observed that the product of concentration of calcium and sulfate ions was higher than that predicted on the basis of reported solubility product for CaSO_4 . The reason for the unexpected solubility is that the presence of NaCl increases the solubility of CaSO_4 (Cameron and Seidell 1901). At the concentrations in the supernatant, the solubility is increased by a factor of 3.

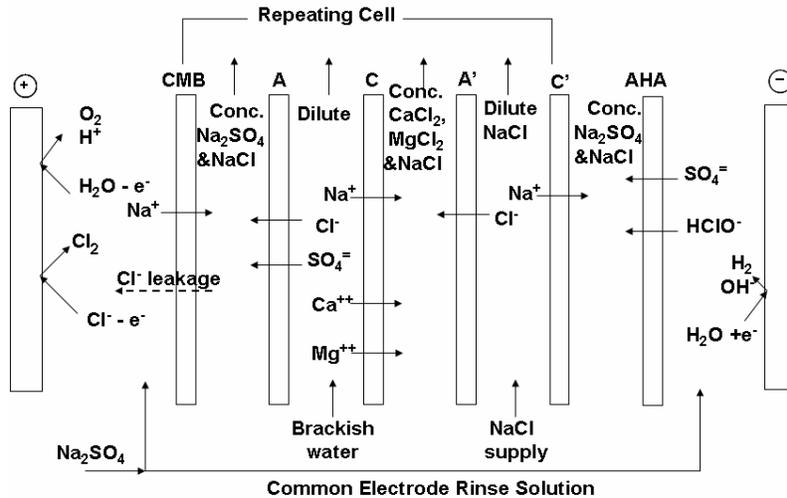
Figure 8. Mechanism for chloride entry into electrode rinse and oxidative damage to the AHA membrane.

Figure 8 illustrates what can happen when there is substantial chloride in the solution compartment next to the anode compartment. Although the CMB membrane is selective for the transport of cations (Na^+ ions in this case), that selectivity is not absolute. According to the principles of Donnan exclusion, the selectivity decreases as concentration increases. Thus, there is a mechanism for chloride ions to enter the anode compartment. Chloride ions in the anode compartment can lose an electron at the anode and become oxidized to elemental chlorine, which readily dissolves in the electrode rinse solution. When that common rinse solution enters the cathode compartment, the chlorine reacts with hydroxyl ions generated at the cathode and becomes hypochlorite anions, which readily migrate into and through the AHA membrane. AHA membrane is the only commercial anion exchange membrane that is supposedly resistant to oxidation, but its oxidative resistance in this environment appears to be insufficient.
