Desalination & Water Purification Research
and Development Program Report No. 186

Evaluation of a Small Rural Community Zero Liquid Discharge Desalination System

March 2016

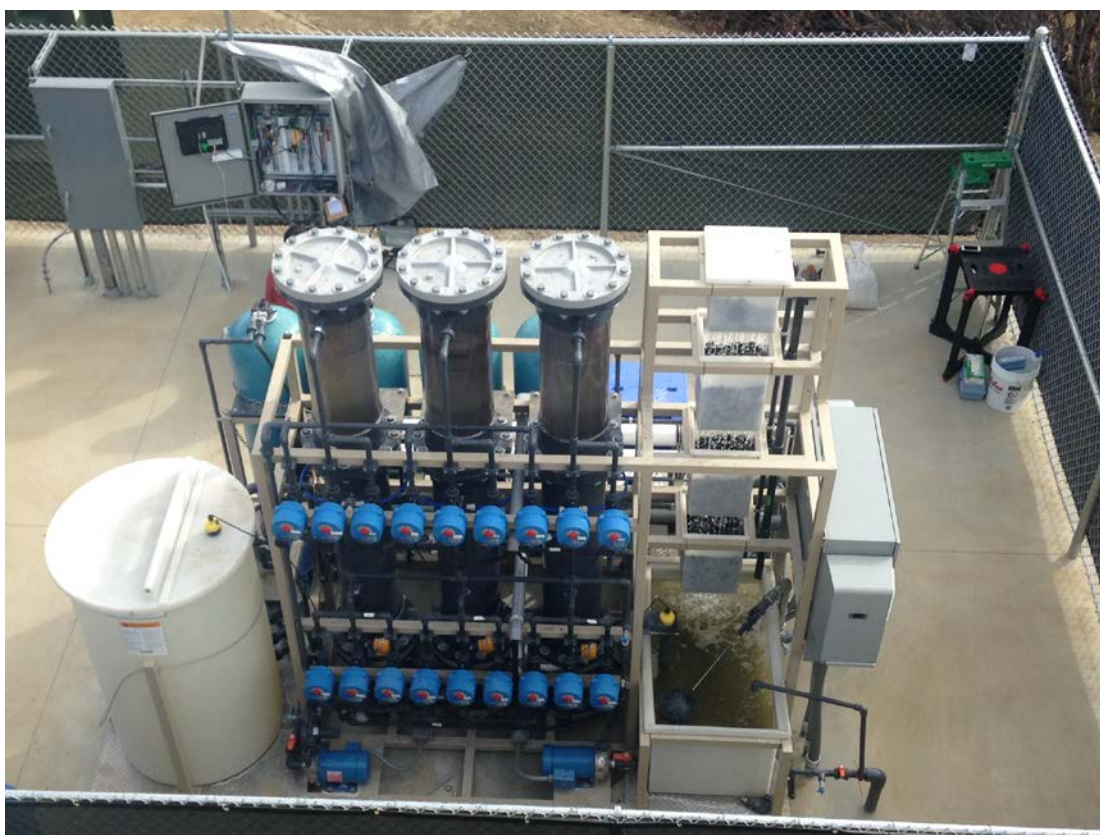
The initial delays were caused by lack of power and water to the RO skid. The contractor successfully procured electricity and water in March 2015, which allowed for this study begin. The operational system is shown in Figure 3.

Figure 3.—RO Skid.

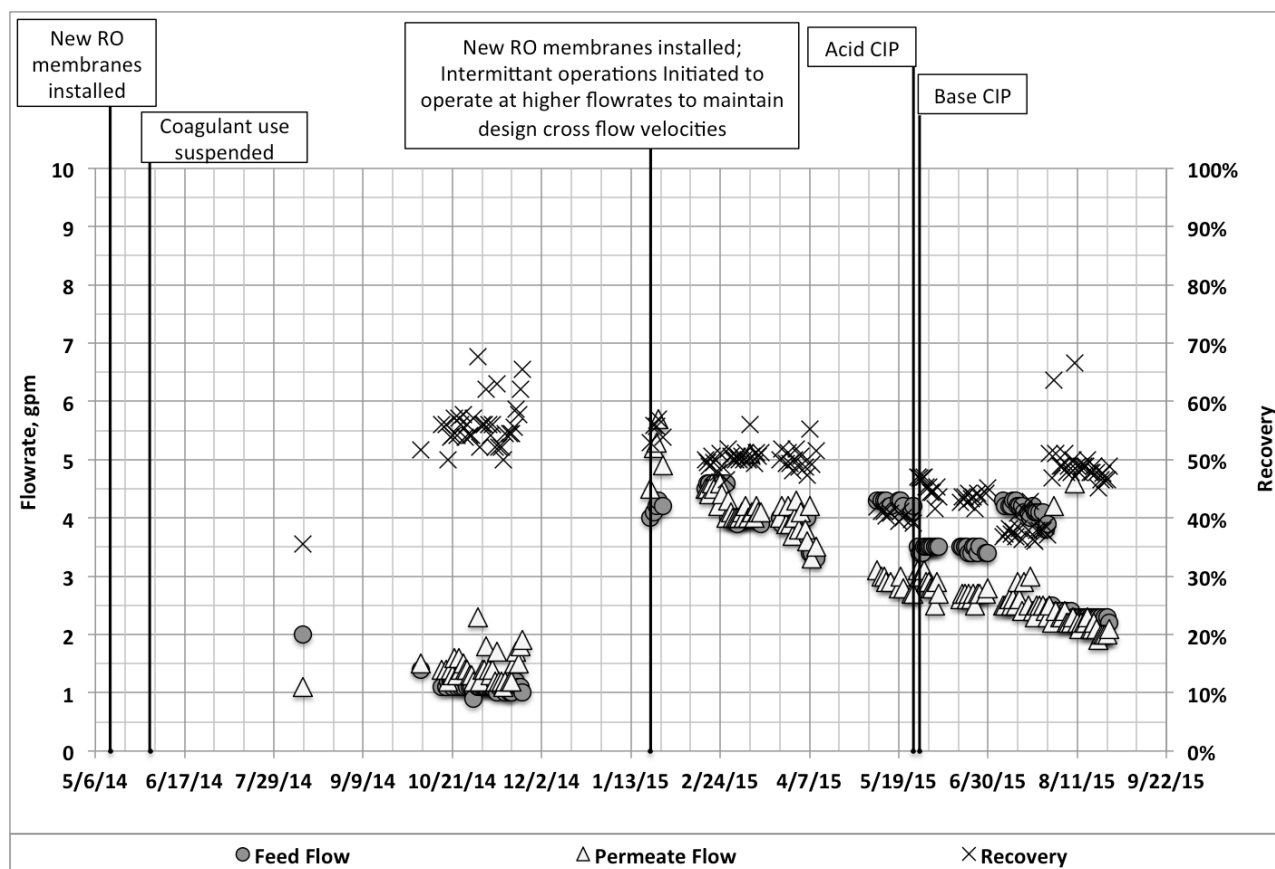
The RO component was closely monitored and the performance is shown in Figure 5, Figure 6, and Figure 7.

Figure 5.—RO Performance (Flowrates and Recovery)

During the study period, RO performance trending was difficult due to scattered operational settings. The primary cause of variable operations was diminishing raw water well capacity. The flow supplied to the RO skid had gradually decreased to compensate for the well's limited output. The well was originally producing 10 gpm and gradually decreased to 3 gpm. This has significant implications, as the RO system was designed for a minimum feed flowrate of 6 gpm and a minimum reject flow of 3 gpm. With lower production rate, the RO system does not achieve sufficient cross-flow velocity to carry away membrane foulants to prevent premature membrane fouling. At the end of 2014, it was decided that the RO would be operated intermittently to preserve its design production rate, which is important for RO membrane lifespan. This was achieved by using liquid level high and low setpoints in the tray aerator as measured by an ultrasonic liquid level sensor and transmitter.

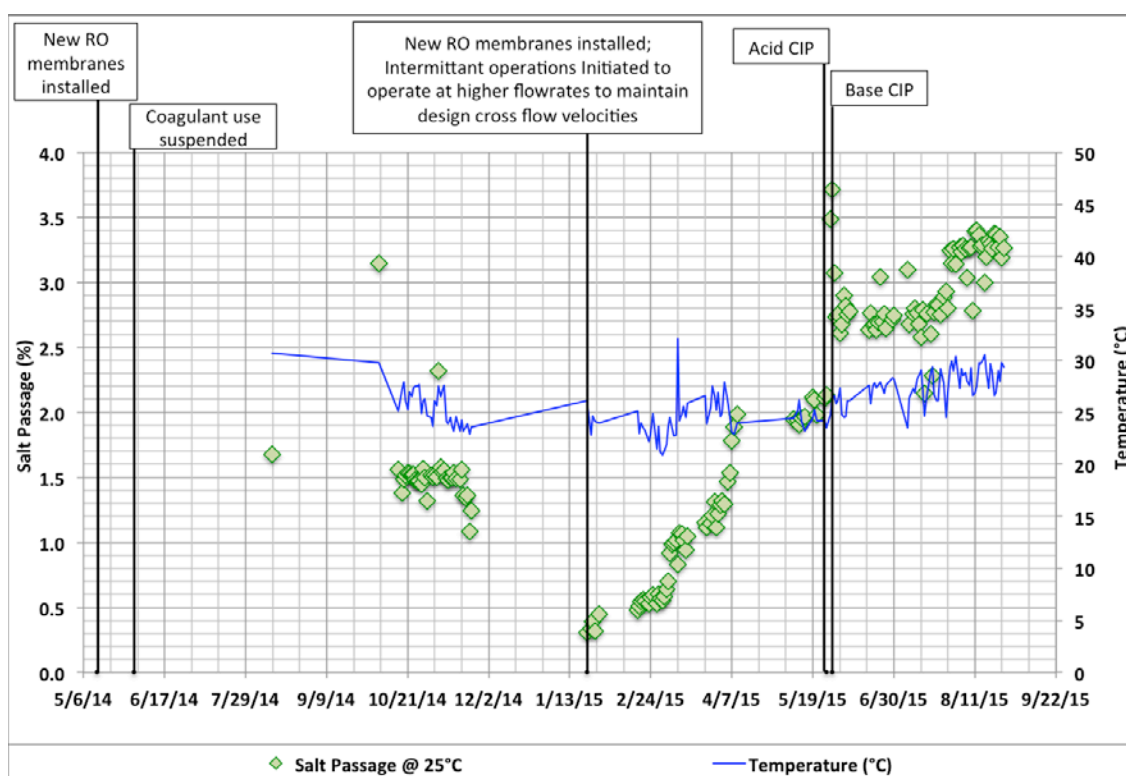
Figure 6.—RO Performance (Salt Passage)

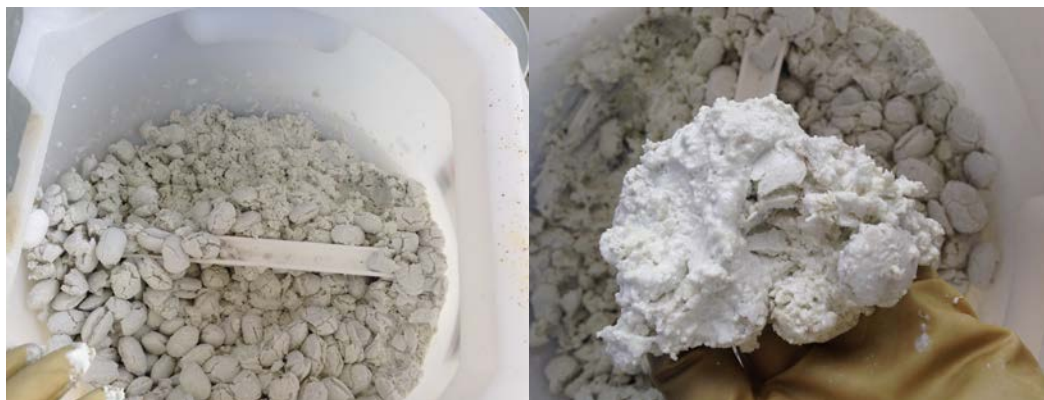
During the course of this study, it was learned that if chlorine tablets are not used at a certain rate, they disintegrate with time and make their way through the grate, resulting in a slurry in the reservoir, shown in Figure 8.

Figure 8.—Tablet chlorinator and chlorine tablet consistency.

The tablet receptacle requires occasional cleaning and appears to work best when loaded with only a single layer of tablets, rather than filling the basket completely, presumably so there is less weight on top of the wet tablets to squeeze them through the grate. The problem may in part be that the tablets remained in the chlorinator for months, since they are not being used as quickly as originally anticipated because the greensand no longer necessitates regeneration (which accounted for most of the chlorine demand). Although the chlorinator may be converted to serve simply as a household bleach receptacle, the operator has opted to continue using the tablet chlorinator and periodically cleans the system to prevent buildup of tablet slurry and to maintain lower product water turbidities.

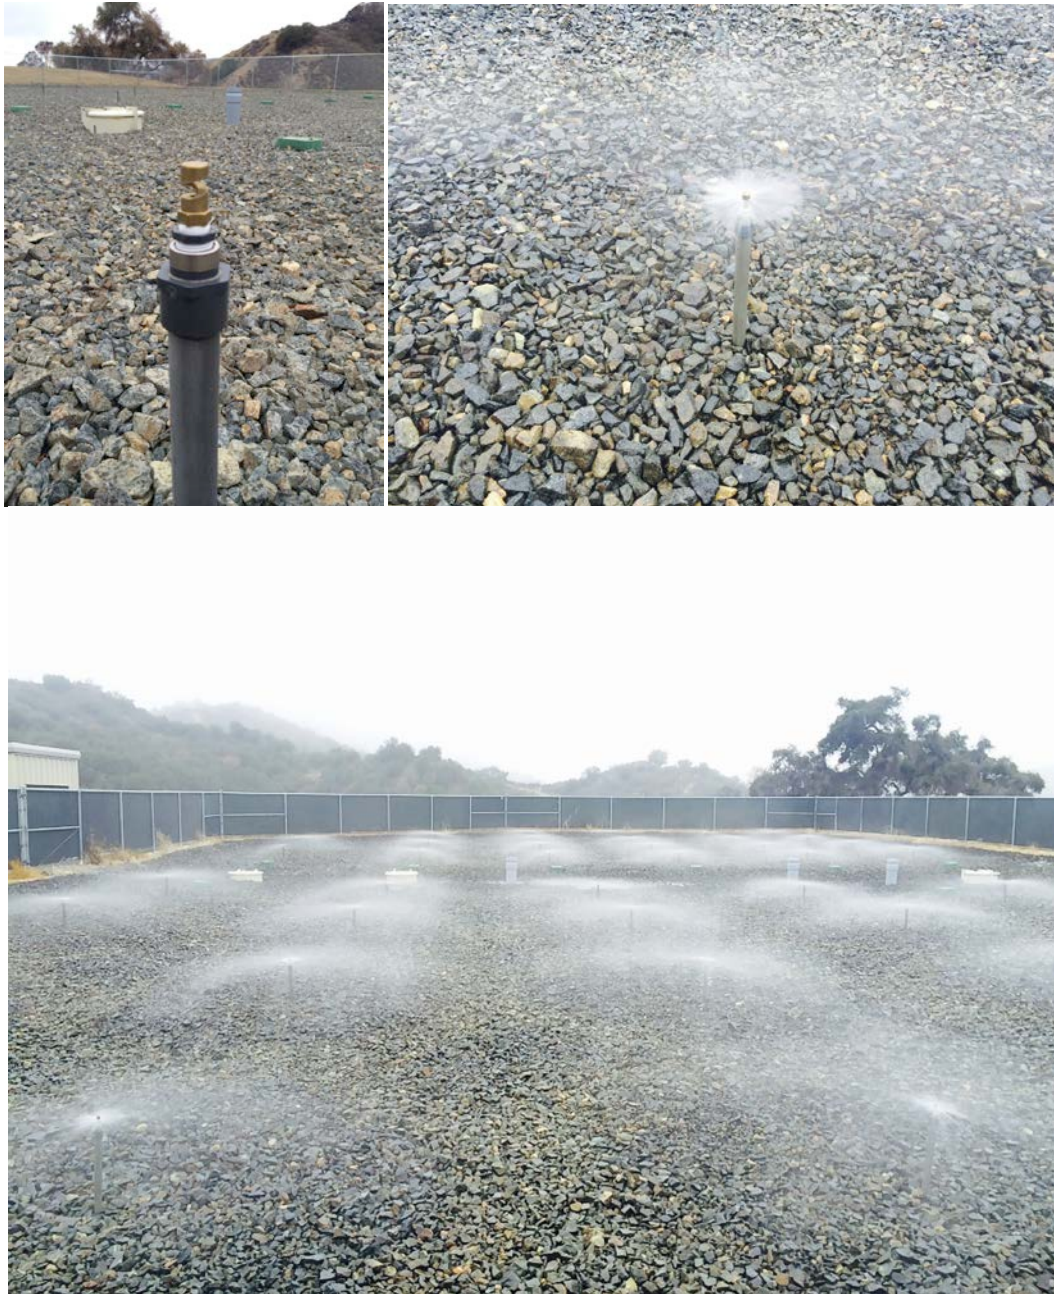
Brine beds have been operational since April 2014. Photos of the brine beds and the nozzles from the high rate solar evaporator are shown in Figure 9 and RO brine data are shown Table 10.

Figure 9.—High rate solar evaporator bed and nozzle

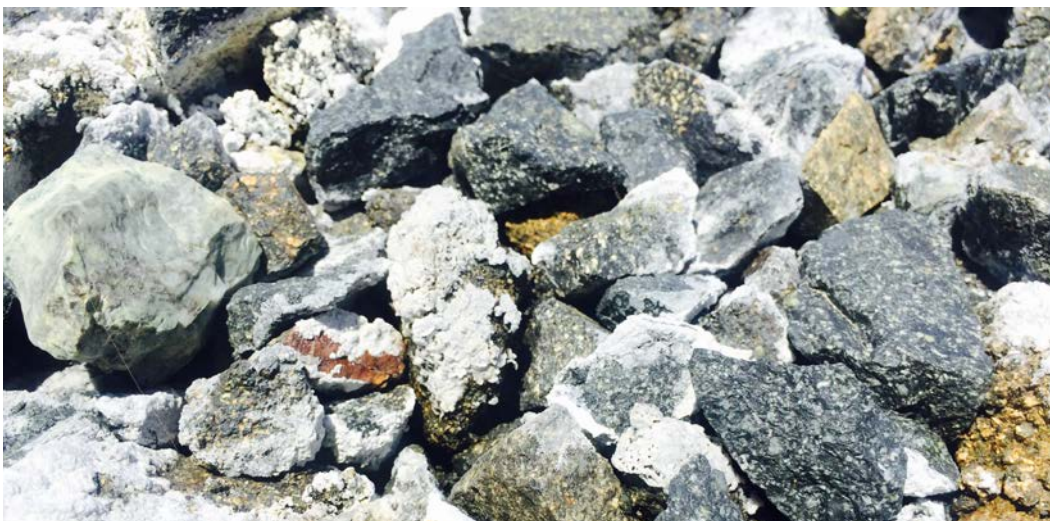
Figure 15 is an image of the solids left on the brine bed rocks over approximately two years of operation. There is also evidence of solids accumulating along the fence line, shown in Figure 16.

Figure 15.—Solids on brine bed rocks.

Laboratory analysis reveal that 70% of the mass by weight deposited was thenardite [Na_2SO_4] and the remaining 30% burkeite [$\text{Na}_6(\text{CO}_3)(\text{SO}_4)_2$]. This is supported by the water quality results as they show the brine having high alkalinity (1,548 mg/L as CaCO_3) and substantial sodium and sulfate content. The list of compounds that would result in solids is summarized in Table 11 in the order of highest to lowest concentration. Sulfate and sodium are by far present at significantly higher concentrations than the other compounds with solids formation potential (e.g. manganese and calcium).

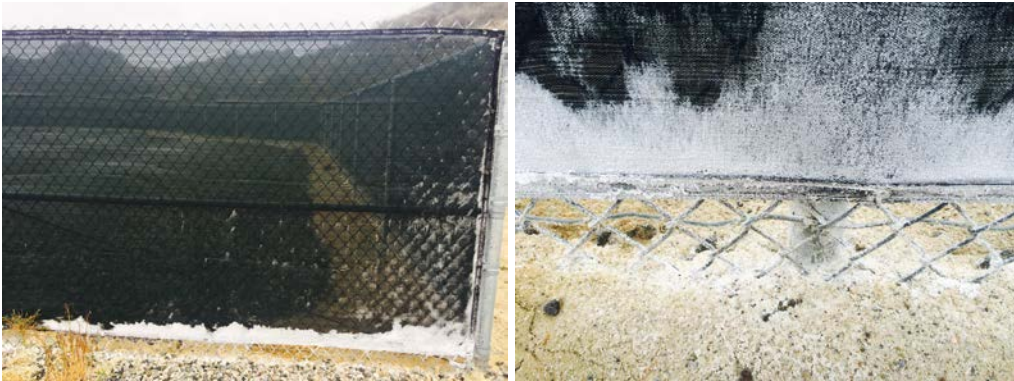
Figure 16.—Accumulation of solids along fence line.
