## Coating Evaluation by Electrochemical Impedance Spectroscopy (EIS)

Research and Development Office  
Science and Technology Program  
Final Report ST-2016-7673-1

December 2015

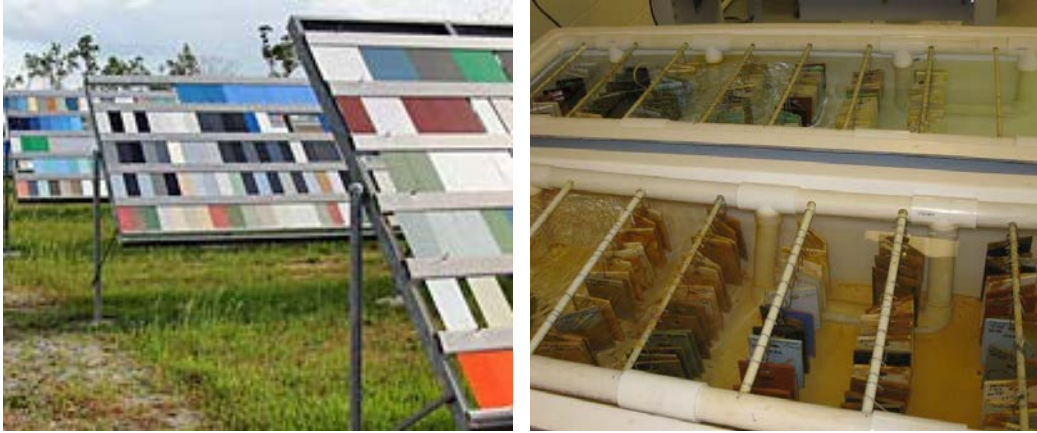
**Figure 1. Example weather methods: (left) USACE Paint Technology Center atmospheric test rack and (right) Reclamation immersion tanks.**

The primary application of EIS testing in a coatings laboratory is for the periodic evaluation of protective coatings on steel substrates during natural or accelerated weathering. Here natural weathering could be an outdoor atmospheric test rack such as those used at the U.S. Army Corps of Engineers (USACE) Paint Technology Center in Champaign, IL (Figure 1). Standard accelerated weathering procedures include ASTM G85 [15], ASTM D4587 [16], and ASTM D870 [17]. MERL's coating laboratory uses all of these techniques. Accelerated weathering techniques, as the name suggests, greatly decrease the amount of time to cause failure of the protective coating under evaluation. The assumption required to use accelerated weathering methods appropriately is that the coating degradation mechanism is consistent with that experienced during its anticipated service.

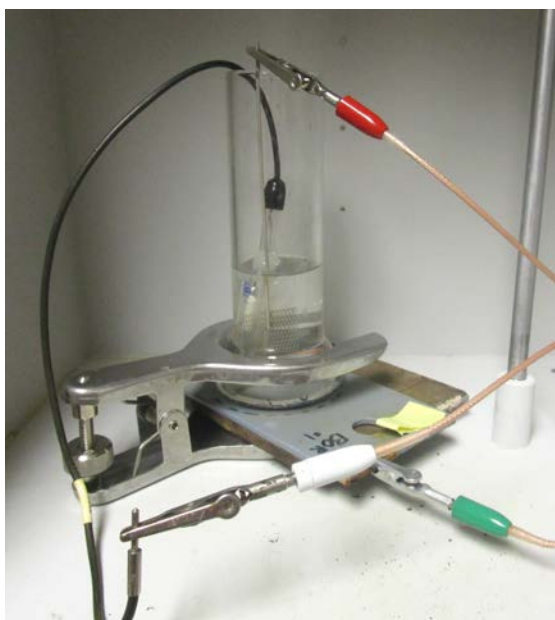
**Figure 2. EIS testing three-electrode cell set-up; the colored leads are the working (green), reference (white), and counter (red) electrodes.**

A Gamry Instruments (Warminster, PA) FAS2 Femtostat, with dedicated EIS300 software, served as the potentiostat for EIS testing. The test parameters for all measurements were 10 mV sinusoidal perturbation at the open circuit potential, a frequency range of  $10^5$  to  $10^{-2}$  Hertz (Hz), and ten data points per decade. The EIS test cell was consistent with a three-electrode set-up, as demonstrated in Figure 2. Here, a saturated calomel electrode (SCE), platinum mesh electrode, and the steel substrate were connected to the instrument as the reference, counter, and working electrode, respectively. The EIS testing surface area, as defined by the test cell, is 20 centimeters square ( $\text{cm}^2$ ). No corrections were made to the raw data for surface area.

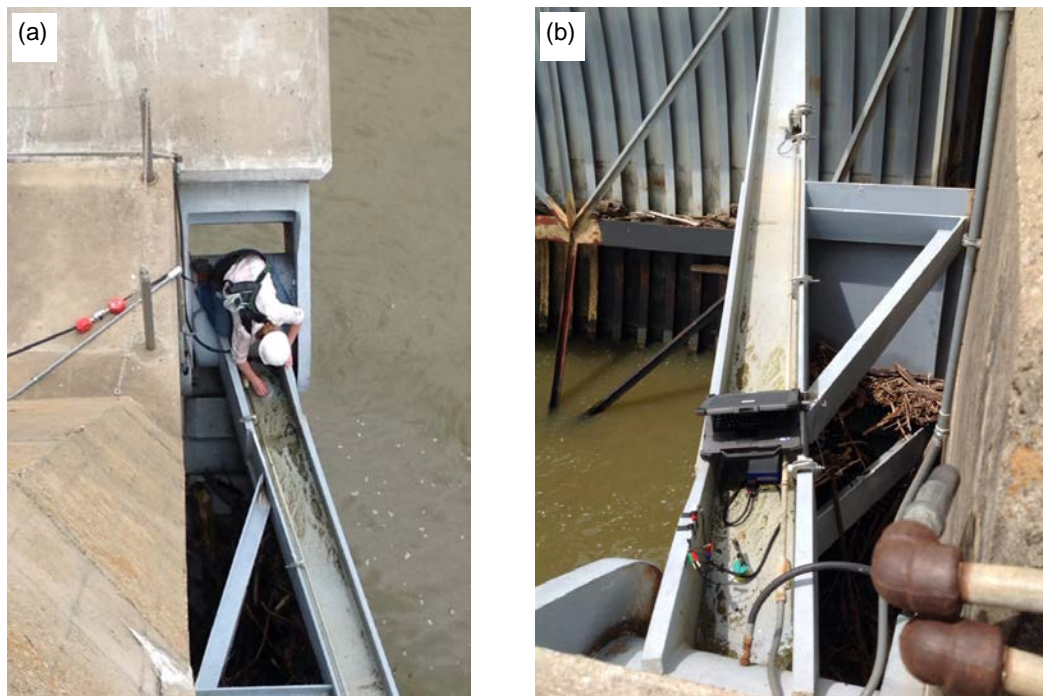
**Figure 8. EIS field demonstration at US Army Corps of Engineers' Ozark-Jeta Taylor Lock and Dam (a) test cell set-up and (b) test in progress.**

Initial EIS field testing began mid-2014. USACE's Ozark-Jeta Taylor Lock and Dam in Arkansas provided the first opportunity to demonstrate the portable EIS test. Figure 8 provides photos for a successful test on a tainter gate arm. The results appear in much greater detail in the prepared conference proceedings, Ref [41]. The paper was presented at the Society for Protective Coatings annual conference, SSPC 2015, and is a joint production of Reclamation and USACE. A key feature is recommendations for identifying ideal EIS test cell locations.

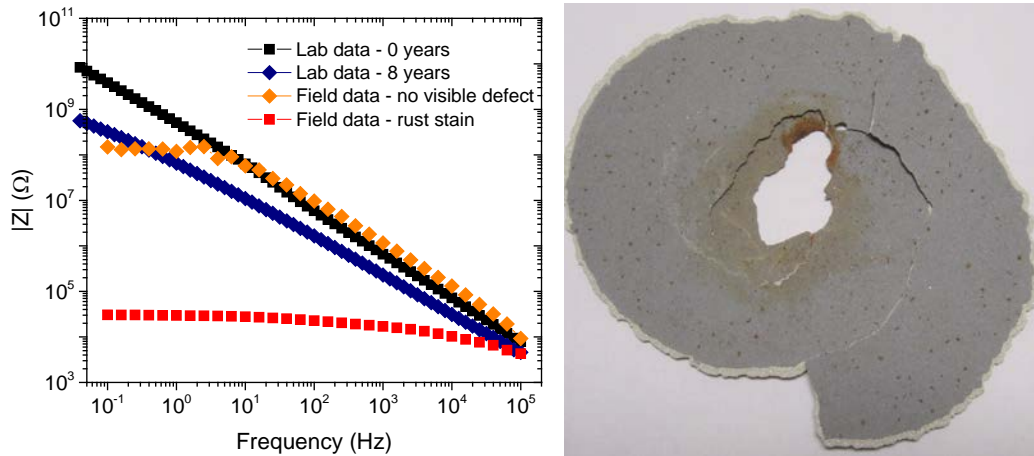
**Figure 9. Comparison of EIS data for laboratory reference and field structure (left) and destructive evaluation revealed corrosion spots on the underside of the coating (right)**

A thorough investigation of the recoating work ensued, including standard qualitative inspection techniques and EIS field testing. In this case, EIS laboratory data existed for the coating product applied to these gates. The coating's batch applied to the gates received additional laboratory investigation, including EIS testing. The EIS test data appears in Figure 9 for each of these.

The evaluation concluded that the coating applied to the penstock gates was not providing effective corrosion protection. In this case, the coating batch provided a low frequency  $|Z|$  value near  $10^8 \Omega$  and instead of the anticipated  $10^{10} \Omega$  for a newly applied coating. The EIS data suggests the coating film had inherent defects at the time of application and product cure. Also, note that the end test data frequency was  $10^{-1}$  Hz compared to  $10^{-2}$  Hz in lab testing. This reduced the field test time to five minutes. However, the disparity in the test data remains apparent. A sample of the coating was removed using a putty knife (Figure 9, right). This destructive test revealed corrosion spots on the underside of the coating. This confirms the non-destructive results obtained by EIS testing.

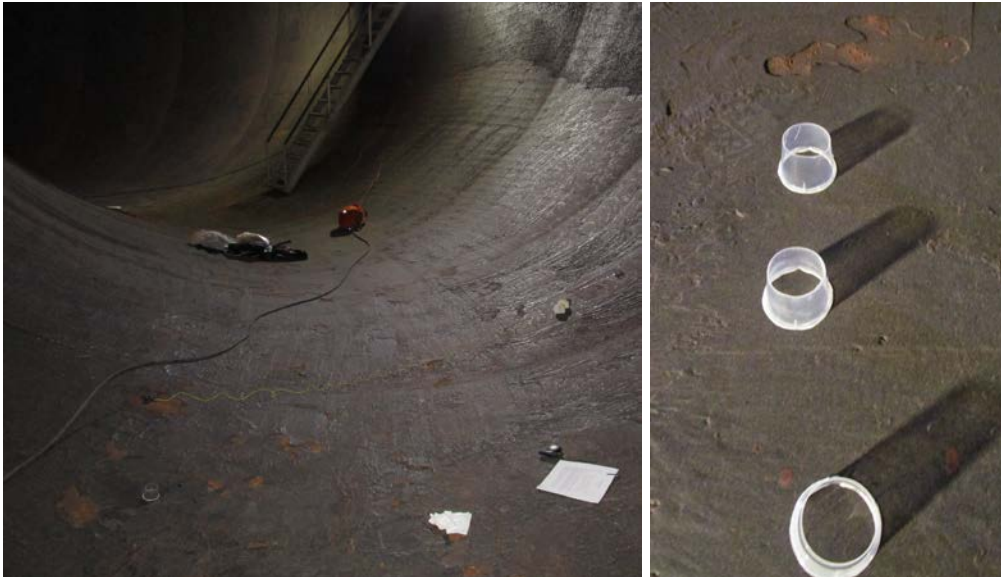
**Figure 10. EIS field demonstration at Grand Coulee Dam, Cells 1 and 2 located near the scroll case mandoor (left) and triplicate Cells 3, 4, and 5 (right).**

The first investigation of a penstock lining occurred at Grand Coulee Dam, Washington. The interior penstock coatings provide corrosion protection to this critical component of the hydroelectric facility, and these coatings are very expensive to replace. The goal was to apply EIS field testing to penstock coatings' evaluation in order to maximize the service life of these coatings. Predicting the degradation of these coatings has the potential to greatly improve maintenance planning for facility owners. Figure 10 shows the test set-up for several test cells.

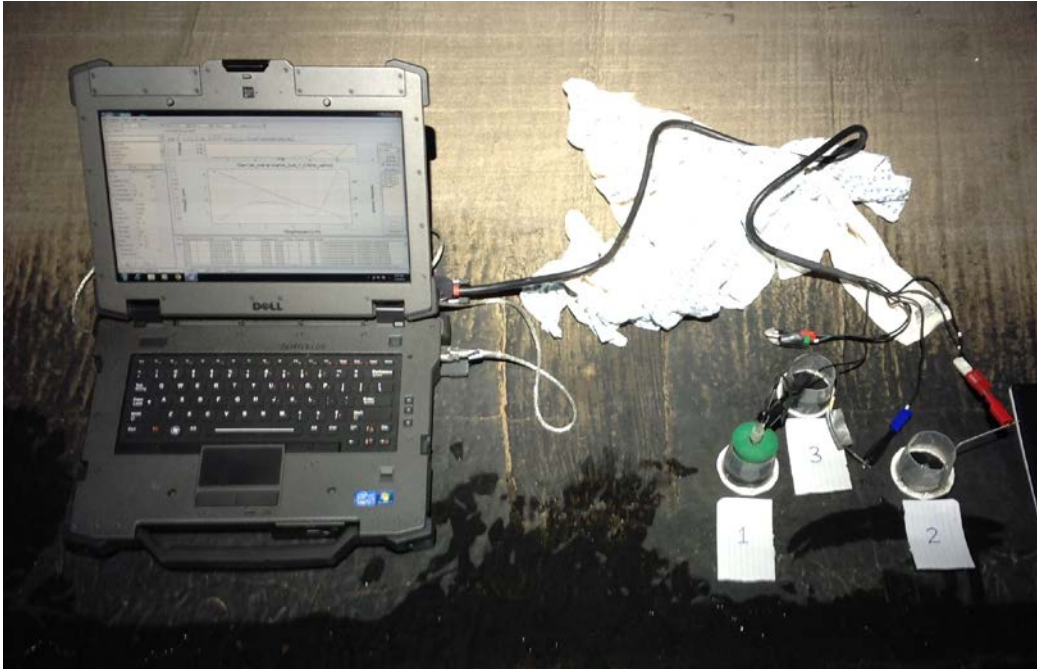
**Figure 13. EIS test set-up for two-electrode experiment. Three test cells shown; Cell 1 is reference cell and Cell 2 is working cell in this example.**

EIS field testing on the interior penstock coating at Glen Canyon Dam in Arizona produced the desired two-electrode method demonstration, yielding excellent results (Figure 13). Additional advancements to the field method reduced the test time per EIS test spectra. Here, the final tested frequency was reduced from  $10^{-2}$  Hz to  $8 \times 10^{-2}$  Hz. This change reduces the total test time to approximately 4 minutes per test spectra. By comparison, the laboratory test method typically exceeds 30 minutes. At this point the recommendation became to proceed with fast EIS tests at several coating sites within the structure and to make one or more measurements with the end frequency at  $10^{-2}$  Hz, as time permitted. The latter provides additional information that could be useful during analysis. This reduced test time also incorporates the change from 10 points per decade to 5 points per decade, a practice since the first outdoor demonstration.

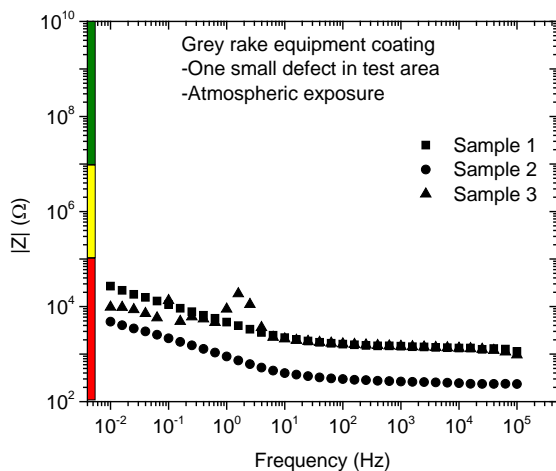
Figure 15. EIS field test results for coating with one visible defect (left); photograph Sample 3 (right)

Figures 14 and 15 provide field EIS data from Little Oso Dam in Colorado for sample areas with and without visible defects, respectively. A photograph is also provided for one sample from each set. The lowest frequencies, less than  $10^{-1}$  Hz, provide a data set that is useful for basic evaluation by Reclamation facilities. These values indicate the coating's total barrier protection, i.e., the resistance to water and ion migration, and represent its ability to prevent corrosion.

The colored strip at the left of each graph provides a stoplight analogy, designating the coating condition by green-yellow-red as good-moderate-poor, respectively. The coating with no visible defects is in moderate condition, measuring  $10^6 \Omega$  of resistance at  $10^{-2}$  Hz. To illustrate a failed coating system, the smallest visible defect in Figure 15 measured poor resistance to corrosion,  $10^4 \Omega$  at  $10^{-2}$  Hz. Over time, the coating impedance decreases in the low frequency region of the plot. Maintenance planning should begin when the coating measurement approaches the red region of the plot. As a caution, the color designations in this stoplight are appropriate for light duty atmospheric exposure only.
