RECLAMATION Managing Water in the West GYdHYa ber 2012 Research and Development Office Bulletin 2012-29 The Knowledge Stream Research Update

Tracking History with LiDAR

Using LiDAR to assess Reclamation's priceless and irreplaceable heritage assets

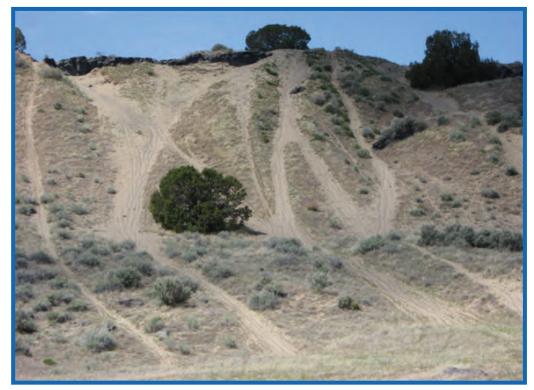
Example of the detrimental effect that off-road vehicles have on an area.

These assets are non-collectable—they must stay in place. However, these sites are now threatened as shifting ground surfaces can cover and uncover the archaeological resources. When sites are uncovered and exposed, they can be vandalized, washed away, or removed. They are exposed to wind and water erosion, off-road vehicle use, and cattle trampling. Understanding both the natural forces and human activities that impact these sites is critical to managing and preserving these invaluable cultural resources.
