As-Built Survey Report at San Felipe Phase 2 Downstream Sites

Research and Development Office
Science and Technology Program
Final Report ST-2016-2645-01

U.S. Department of the Interior
Bureau of Reclamation
Research and Development Office

September 30, 2016

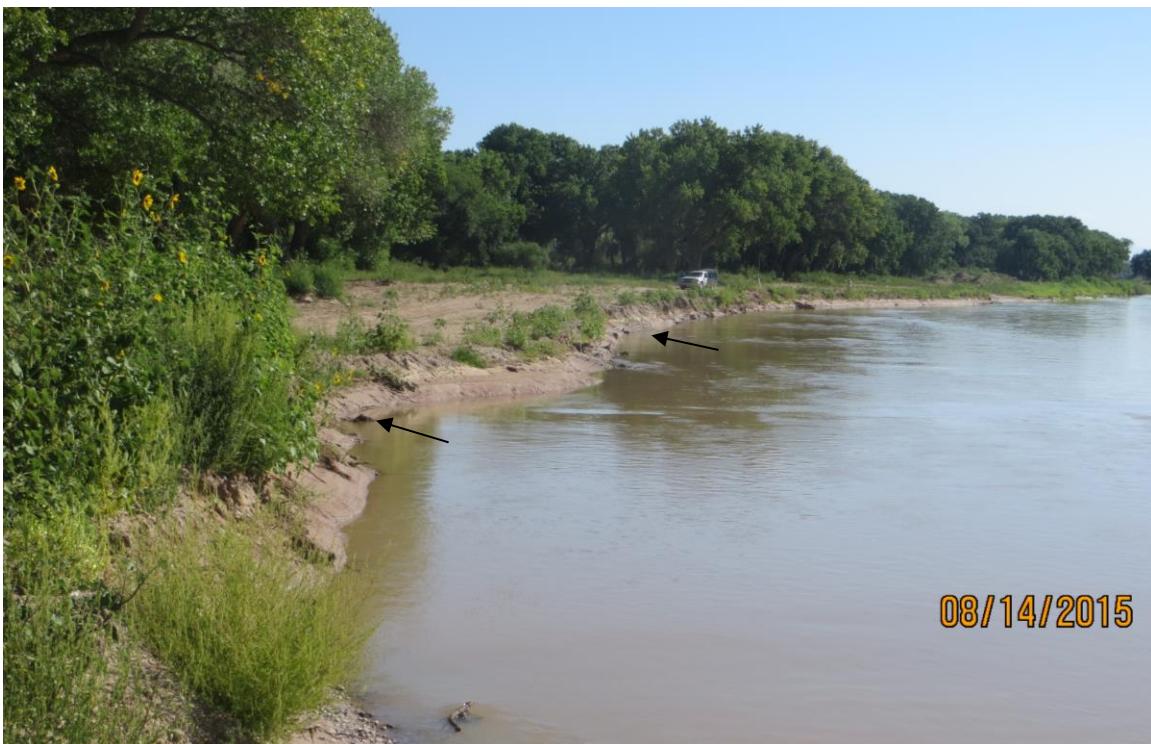
Figure 6: Scalloping of Right Bankline in between Weirs 5-6 and Weirs 7-8 (looking upstream)

areas have also caused some bankline scalloping which is illustrated in Figure 6. The bankline scalloping between weirs W5-W6 marks the transition from continuous bank protection (LFSTP) coupled with directive bank protection (bendway weirs) to only directive bank protection. The keys of the upstream bendway weirs have a length of 100 feet from the bankline into the floodplain. This key length would help to prevent high flows from flanking the upstream weirs if scalloping progresses between these weirs. Also re-vegetation of the right bankline in this project area is scheduled to occur in the coming dormant winter months by the Pueblo, which also will help to stabilize the bankline.

The 2015 as-built data at the upstream bend showed different responses of the upstream bendway weir field. There is no distinct thalweg profile along the weir tips. The length of the LFSTP has helped most of the bankline from being eroded from last spring runoff. However as the bank protection method transitions from a continuous to directive method, scour holes developed near the bankline have caused scalloping between weirs W5 and W6, and between weirs W7 and W8. After the construction crew came back in August 2015, the outer bankline along the upstream bend has been reshaped. It is hoped that coyote willow planting this coming dormant winter season will help to strengthen the rest of the bankline without the continuous bank protection. Monitoring of these scalloping areas is necessary as there is some trend of deposition along the excavated bar on the opposite side of the upstream bend which may narrow down the channel width and increase hydraulic pressure along the scalloping bankline areas.

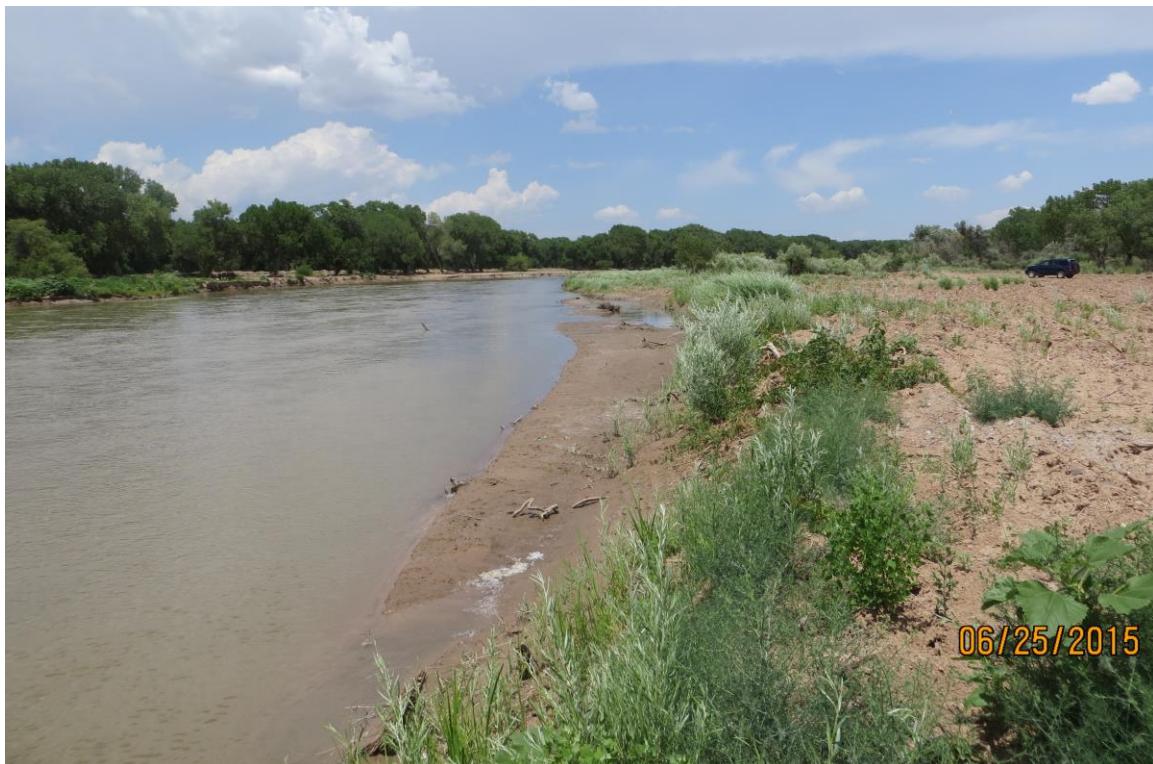
Figure 7: New Deposition along Left Bank Line of Weirs E1-E8 (flow = 1,700 cfs)

The near bank areas from weirs E1-E8 of the downstream weir field have a lot of very recent deposition of very fine materials and with minimal velocities as featured in Figure 7. The majority of the 1,100-cfs water depths in this area are less than 1 foot. Areas above the crests of these first eight weirs and in between weirs have been filled in, which completely cover the riprap. In the near bank

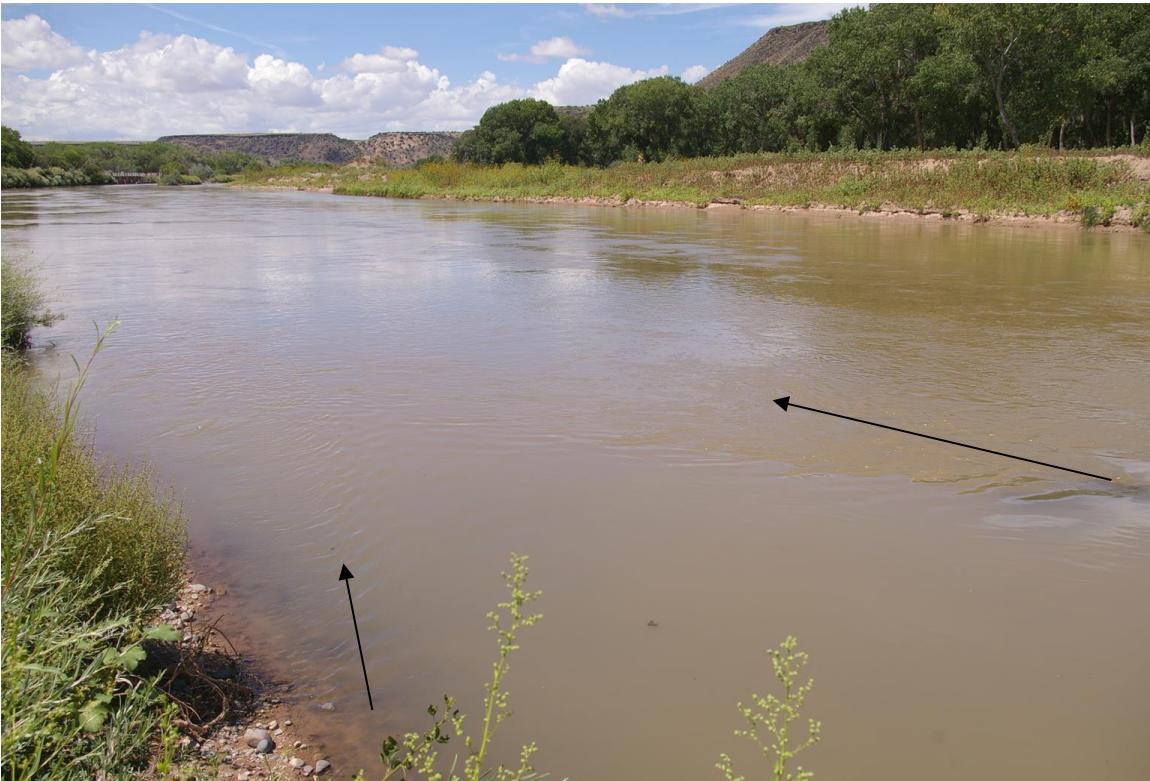
Figure 9: Flow pattern at weir E9 – Photo taken on August 27, 2015 – Flow = 930 cfs

areas from weirs E9-E19, water depths below 2 feet are not caused by deposition, but because of weir crest elevations being constructed higher than the design elevation of 5,084 feet at weirs E9, E16, E17, and E18 as marked by the yellow pins in Figure 8. The depositional pattern in the near bank areas shifts to shallow depths on the weir crests and deep pools in front of and behind these high weirs. Velocities next to the toe of the left bankline increased two to three times in the vicinity of the high crests.

Figure 9 shows streamwise flows accelerating over the visible high crest of weir E9 with a small stream of water shooting from the bankline toe at a velocity of 1.3 ft/s at 1,100 cfs, increasing from 0.7 ft/s in the vicinity of weir E8. The velocity on the high crest of weir E9 was 2.8 ft/s, increasing from 1.7 ft/s on the crest of weir E8. The small stream of flow next to the bankline toe continued to the next downstream weir E10 with a velocity of 2.3 ft/s. A small amount of bankline scalloping between weirs E9-E10 was detected during the as-built data collection trip as the left bankline in this project area had not been re-vegetated before snowmelt runoff and monsoon peaks occurred from May through July 2015. This scalloping trend has been observed for weirs with higher crest elevations (Reclamation 2015). Re-vegetation of the right bankline in this project area is scheduled to occur in the coming dormant winter months by the Pueblo, which also will help to stabilize the bankline.
