Cavitation Detection Technology for Optimizing Hydraulic Turbine Operation and Maintenance

Research and Development Office
Science and Technology Program
(Final Report) ST-2015-2944-01

U.S. Department of the Interior
Bureau of Reclamation
Research and Development Office

March 2018

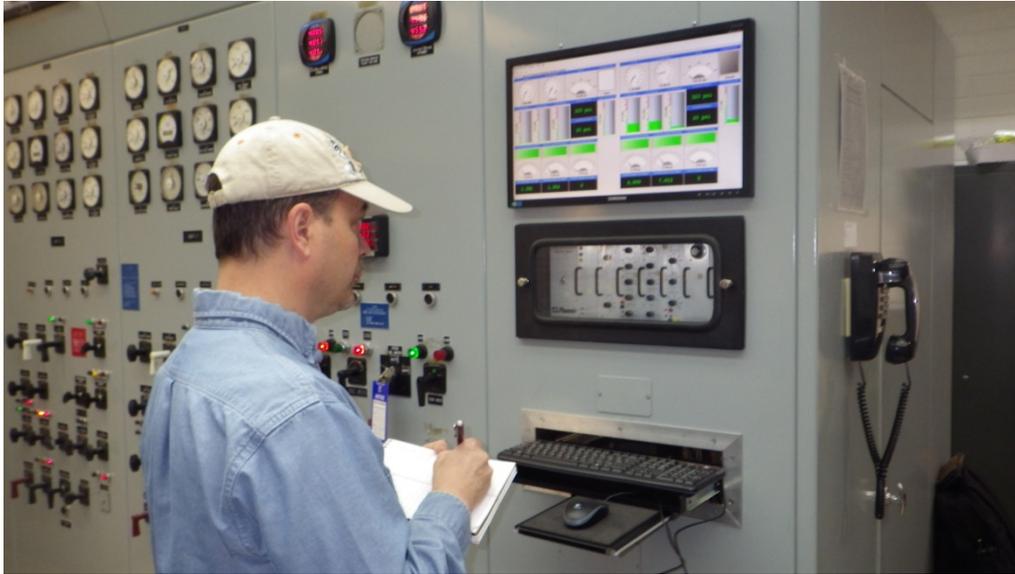
Figure 1. Cavitation display screen from a cavitation monitor at J F Carr powerplant.

Work at J. F. Carr resulted in the successful construction, installation and testing of online cavitation monitors to identify, alarm, and trend cavitation activity over long-term operations. Two cavitation monitors and a machine condition monitor were designed, parts procured and instrumentation fabricated for installation on Units 1 & 2 at J. F. Carr powerplant. Final installation and testing of two cavitation monitors was completed in January 2015. The installation of these monitors allows for better prediction of cavitation behavior over varying unit operations and changing reservoir elevations. The two cavitation monitors transmit data to a single machine condition monitor which stores data and monitors other unit parameters. The cavitation monitors produce an alarm whenever a unit is operating in a high intensity cavitation zone. Alarms are given on the machine condition monitor screen, the unit annunciator board and at Reclamation's Central Valley Operations Control Center.

Cavitation data is also routinely saved to allow for trending and further in-depth analysis. The monitors integrate time and cavitation intensity that occurs while operating within a cavitation zone and this information is saved for trending purposes. Both monitors have been actively collecting data since their installation. Reclamation continues to improve on the hardware and software of these machine condition monitors and the cavitation monitors associated with these units. It is Reclamation's intent to install the cavitation monitors at other facilities where cavitation may be an issue.

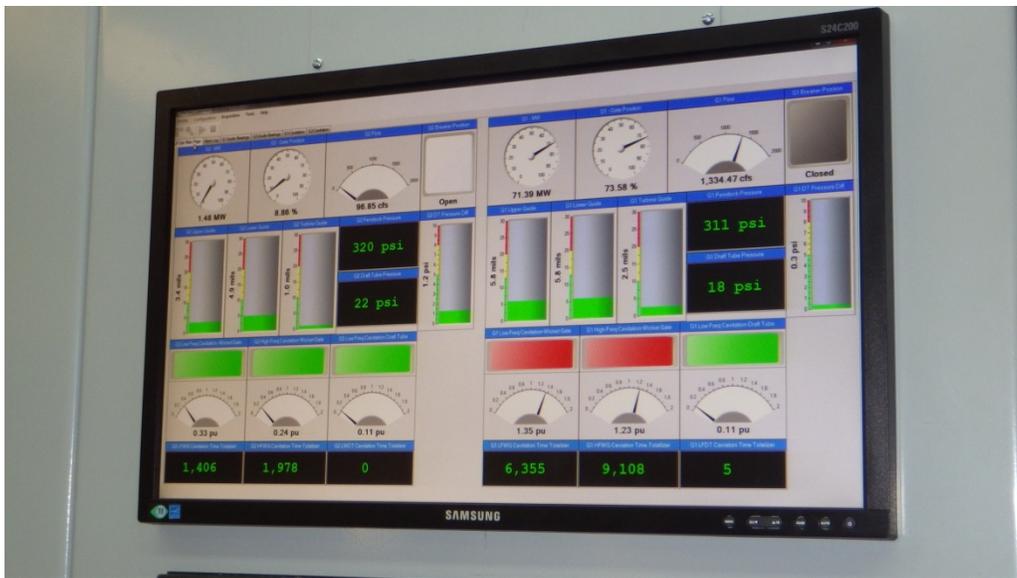
Figure 2. Displayed cavitation data from the cavitation monitor at J F Carr powerplant.

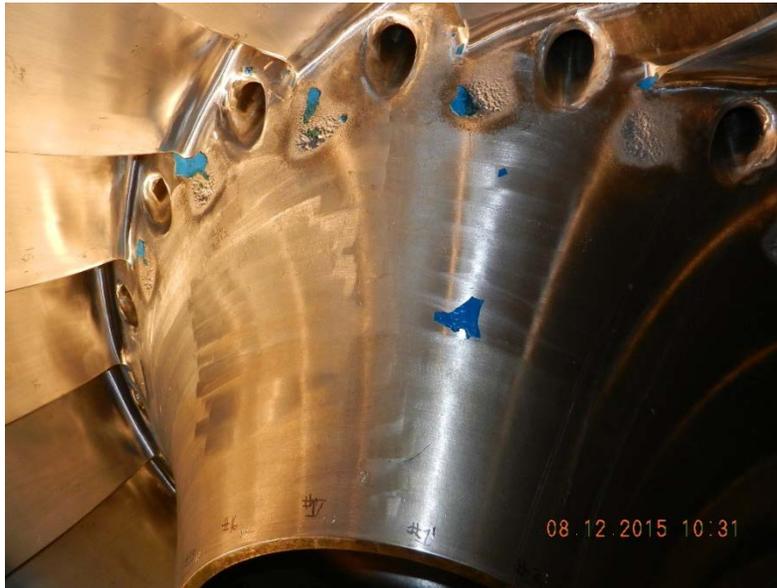
Figure 4. Typical cavitation damage downstream of the turbine runner air vent at Flaming Gorge powerplant.

Cavitation data was taken during two test periods at the Flaming Gorge Powerplant. The first test were conducted in early November, 2015. Each unit was tested as part of a larger efficiency study to accurately measure performance unit and plant performance characteristics. This study, entitled “*Quantification of Optimization Benefits from Detailed Performance Testing of Multiunit Hydropower Facilities*”, was conducted by Reclamation, WolffWare, Ltd and Hydro Performance Process’s Incorporated and partially funded by Reclamation’s S&T program and Department of Energy, Oak Ridge National Laboratory [16]. Proximity sensors were installed on each unit to measure shaft runout. Accelerometers and AE sensors were also mounted on each unit draft tube to measured turbine vibration and acoustic emissions.

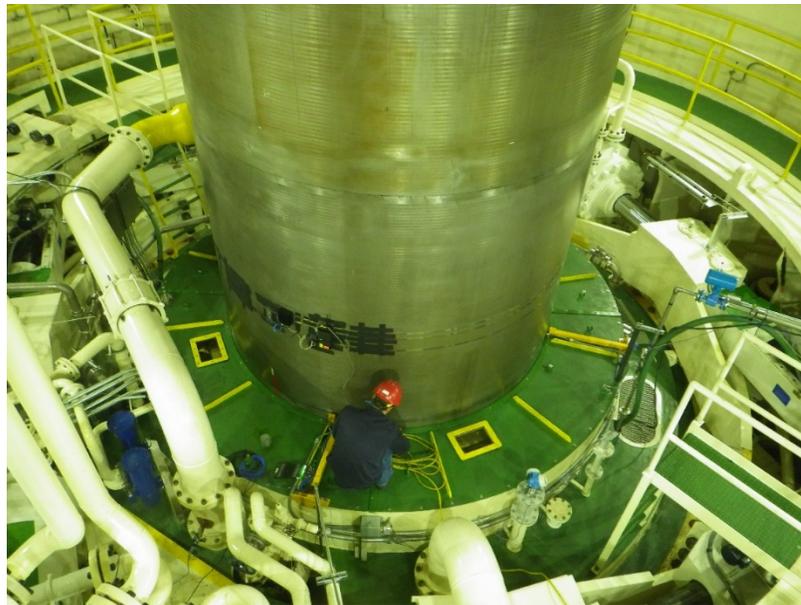
Figure 7. Grand Coulee Unit G24 turbine shaft with attached AE sensor and accelerometer, and wireless data transfer system.

Residual stress measurements are scheduled to be conducted in early 2018. During the 2018 study a data acquisition system is schedule to be installed on hydro generator G24. The Alstom machine condition monitor will monitor and quantify cavitation data supplied from fixed sensors through the water season. The final year of the study, 2019 will analyze this data and produce a final report.
