## **Continuation of Field Research on Advanced Coatings for Mussel Control**

**Research and Development Office  
Science and Technology Program  
(Final Report) ST-2018-7089-01**

**August 2018**

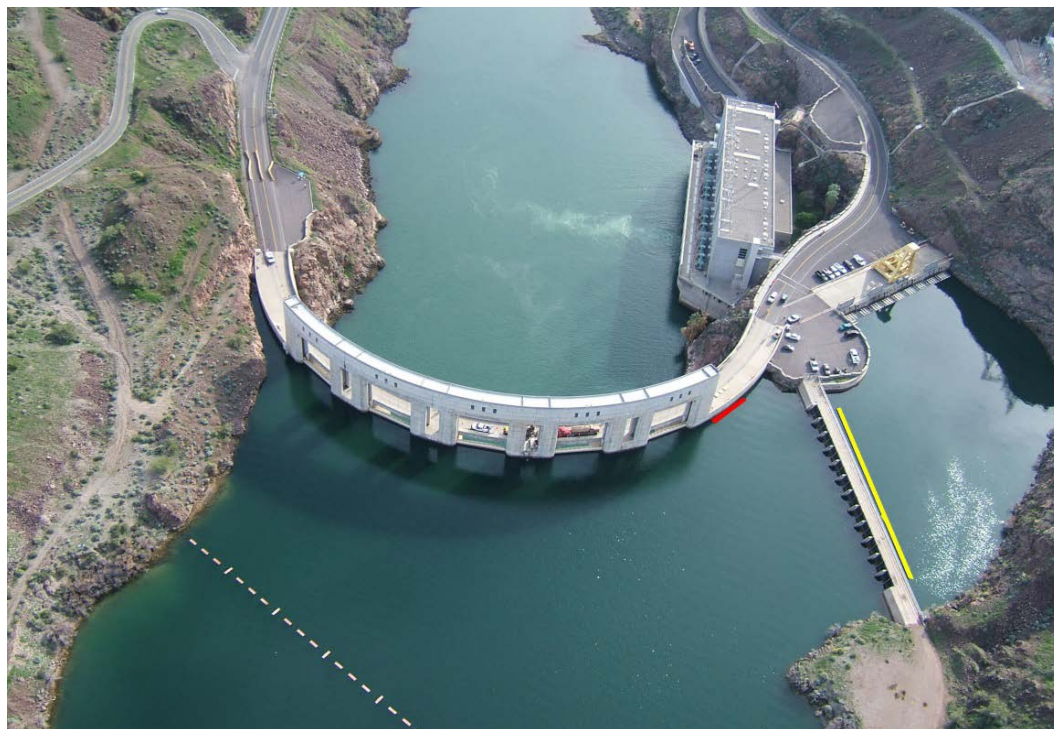
Figure 1. Aerial photo of Parker Dam, CA. The red line indicates the location where the plates were placed, and the yellow line indicates where the grates were placed.

Parker Dam, at Lake Havasu Reservoir on the border between Arizona and California (Figure 1), was selected as the field test site to evaluate materials and coatings in quasi-static (low-flowing) and dynamic (flowing) exposure conditions. Mussels at this location on the lower Colorado River reproduce almost year-round and have more reproductive cycles per year than northern climate infestations.

For each coating system tested, three one-square foot steel plates were used in quasi-static exposure. They were secured by a nylon rope and lowered approximately 50 feet (ft.) into the water near the face of the dam. For the dynamic conditions, one 18-inch (in.) by 24-in. coated floor grate with 1-in. spacing was lowered to a depth of approximately 40 ft. below the water's surface. The samples were hung downstream from the forebay trashrack structure. For velocity measurements and water temperature changes refer to report ST-2015-7095-01.<sup>Error! Bookmark not defined.</sup>

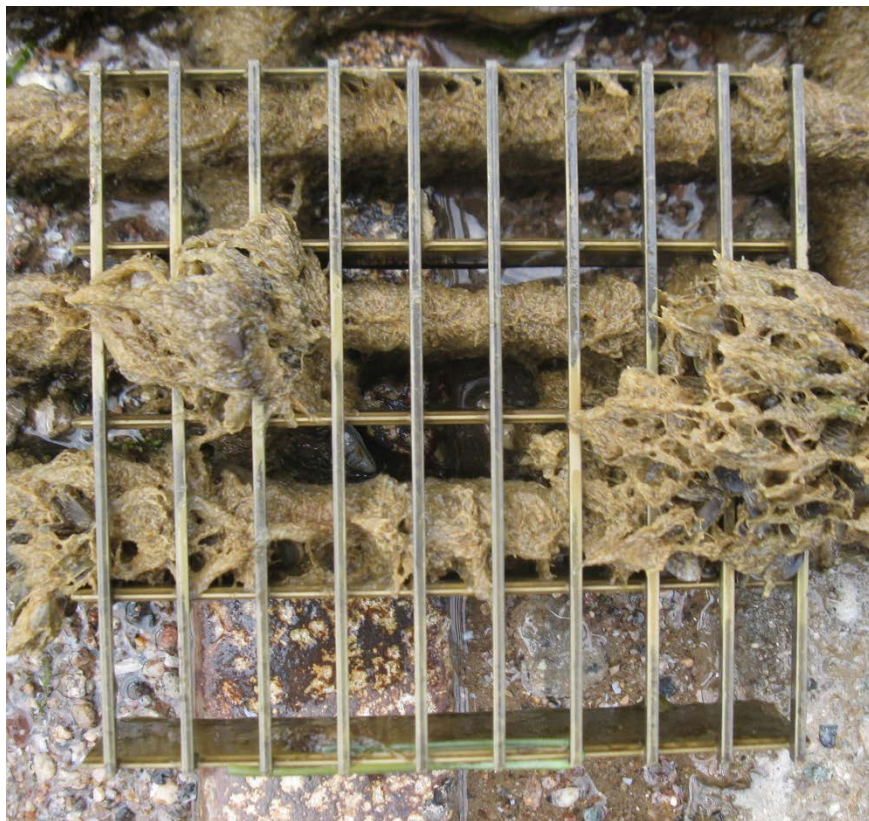
Figure 4. Z-Alloy in dynamic exposure after two years' exposure, photo taken July 2017.

Z-Alloy, a copper alloy, was added to the study in May 2015 and is still being tested. Z-Alloy can be made into intakes and fish screens. No mussels have attached to the test specimens in either quasi-static or dynamic conditions after three years of exposure. Figure 4 shows a Z-Alloy fish screen after two years of exposure.

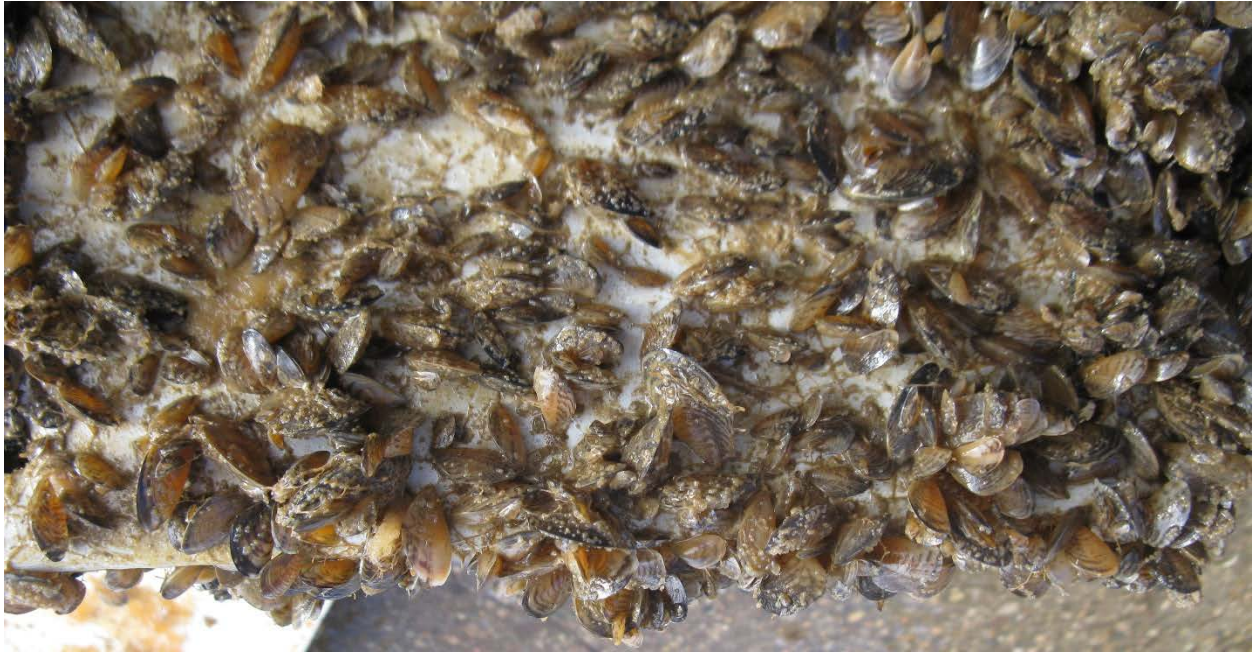
Figure 6. PPG PSX 700 in dynamic conditions, photo taken December 2015.

Sherwin Williams Polysiloxane XLE-80 and PPG PSX 700 systems are designed for atmospheric service and were evaluated since they have graffiti resistance properties. Both systems were removed from testing because they didn't perform well against mussel fouling (Figures 5 and 6). Sharkskin, a micro/nano texturing polymeric film, (said to mimic shark skin) was evaluated. It was removed from testing in April 2018 due to poor performance (Figure 7).

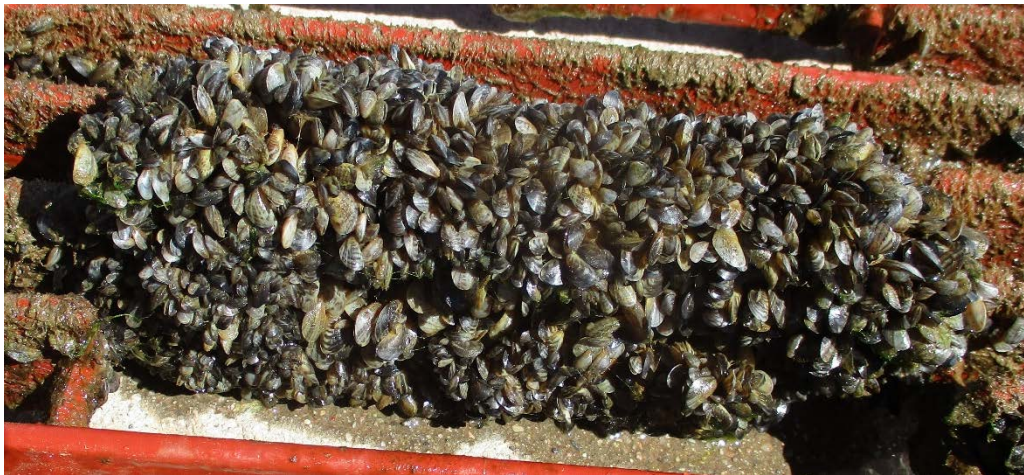
Figure 7. Sharkskin in dynamic exposure after nine months' exposure, photo taken April 2018.

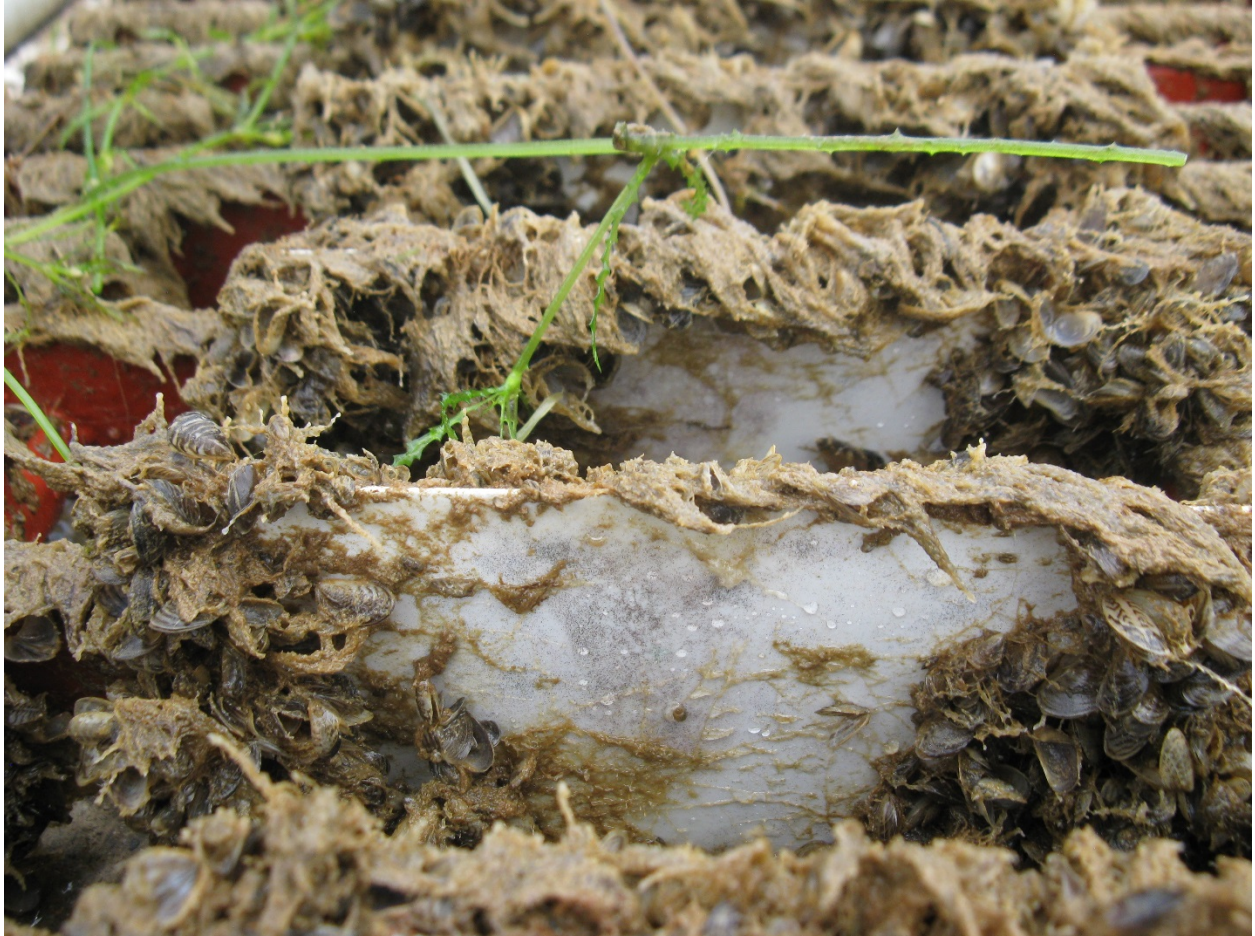
Figure 8. Partner 2012-MTA-9-1003 formulation C4-20% after three years' dynamic water exposure, photo taken July 2017.

Figure 8 shows C4-20% after three years of flowing water exposure. The coating surface remains mussel free while the surrounding area has significant mussel buildup. The panels were secured by zip ties and the mussels fouled the zip ties.

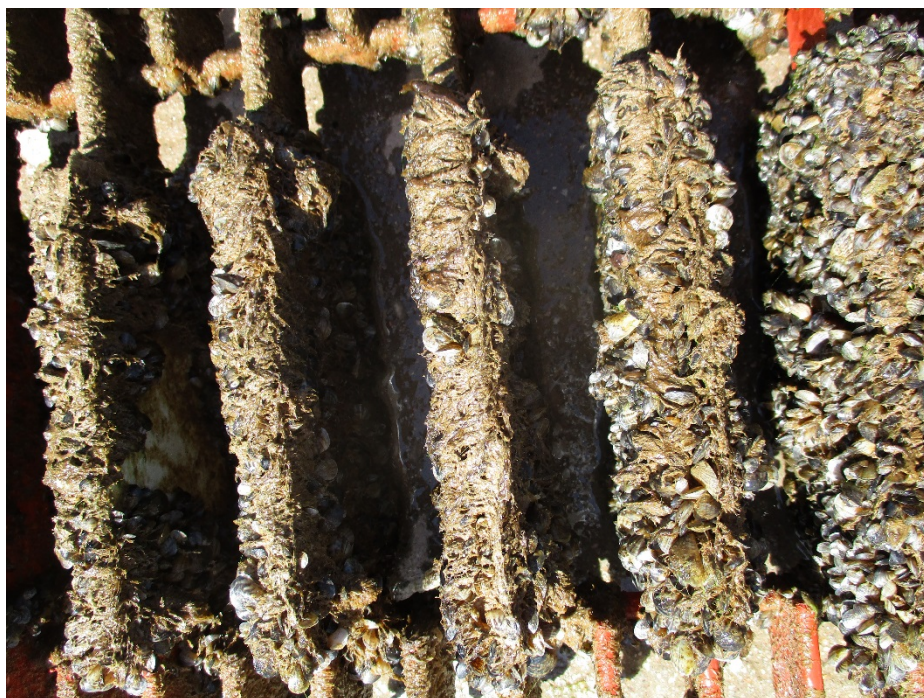
Figure 9. Partner 14-MTA-8-1010 formulations 1, 3, 4, 5, & 6 (left to right) after 3 ½ years in dynamic exposure, photo taken April 2018.

MTA partner 2014-MTA-8-1010 provided ten experimental formulations. Five formulations are performing as well as the commercially available FRC, shown in Table 5. Four other formulations have more fouling buildup than commercially available FRC and are moderately easy to remove. Fouling was difficult to remove from one formulation. Figures 9 and 10 show the latest photos of the specimens coated with these formulations.

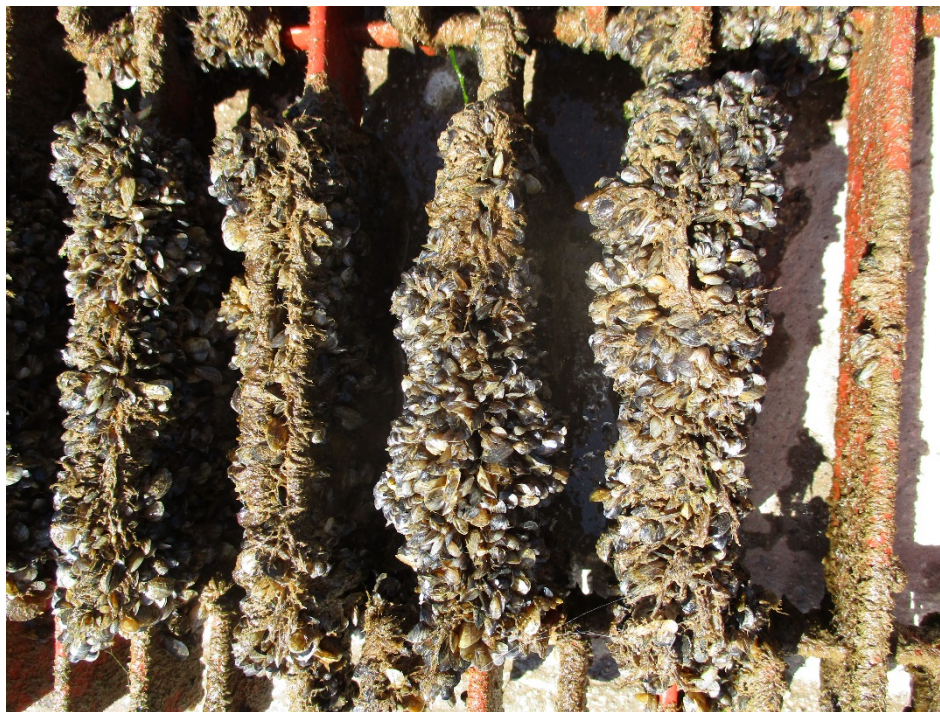
Figure 10. 14-MTA-8-1010, formulations 7, 8, 9, 10 (left to right), after 3 ½ years in dynamic exposure, photo taken April 2018.

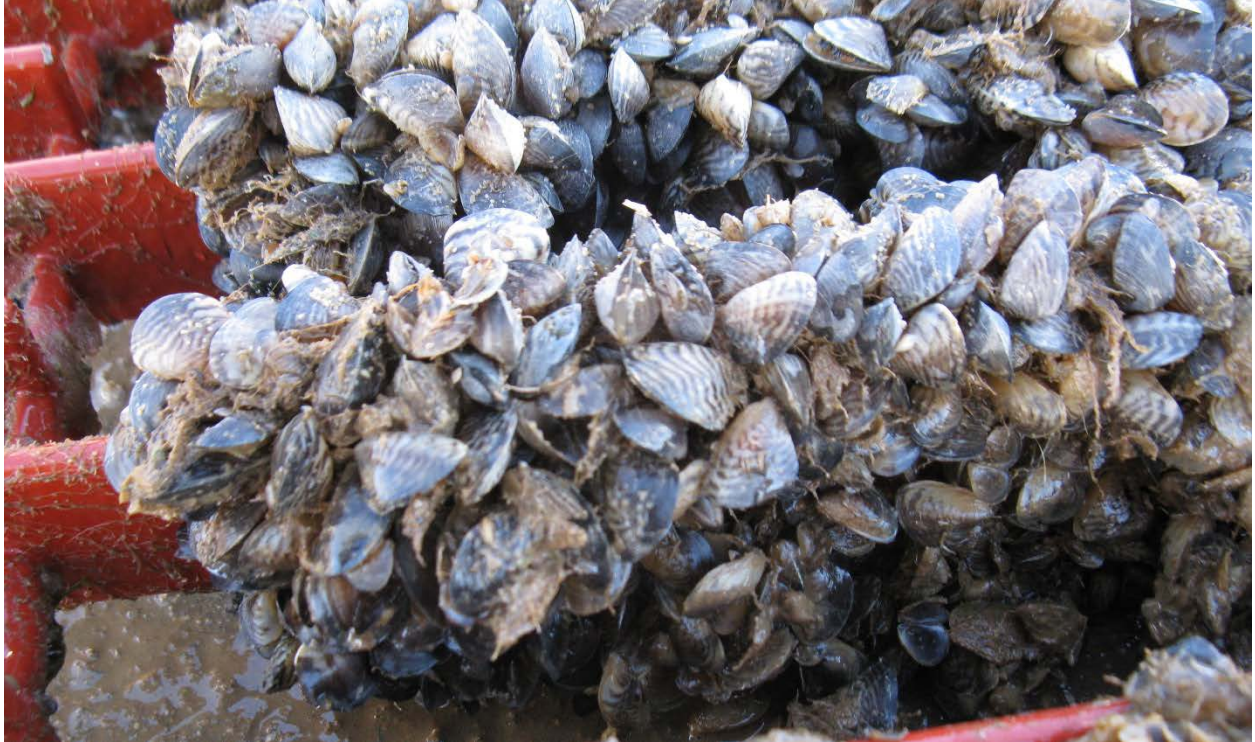
Figure 11. 14-MTA-8-1008 #1 experimental formulation after one year of dynamic exposure, photo taken December 2016.

Figure 11 shows a test specimen coated with the 14-MTA-8-1008 (#1) formulation after one year in dynamic exposure. There is extensive mussel buildup on this coating. Figure 12 is a photo of 15-MTA-8-1012 formulation #1 after one year of dynamic exposure. A few mussels attached to the surface and were very difficult to remove, leaving the byssal threads on the coating surface. Figure 13 is a photo of the 15-MTA-8-1013 #1 experimental formulation after six months of exposure. Mussels attached to the surface and required significant force to remove them resulting in breaking their shells. All three of these MTA partner experimental systems were removed from testing in December 2016.

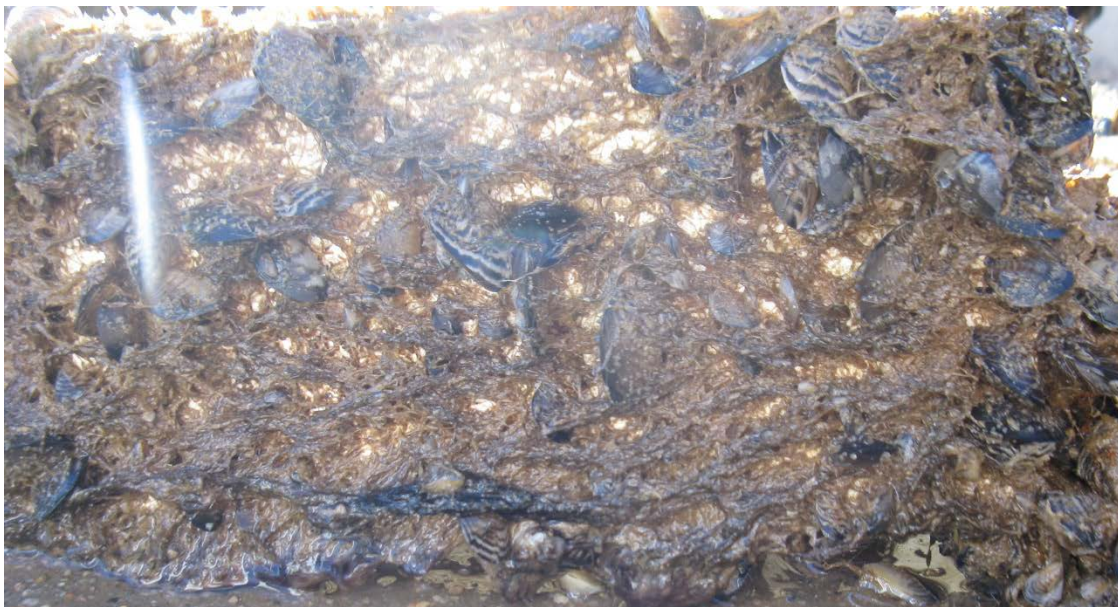
Figure 12. 15-MTA-8-2012 #1 after one year of dynamic exposure, photo taken December 2016.

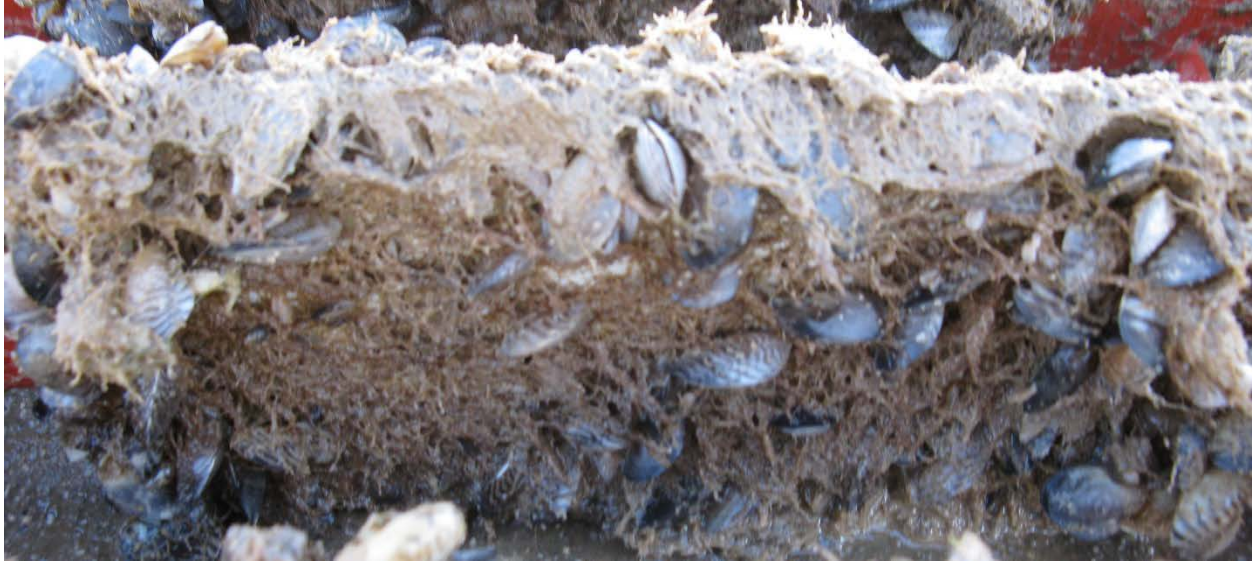
Figure 13. 15-MTA-8-1013 #1 after one year of dynamic exposure, photo taken December 2016.

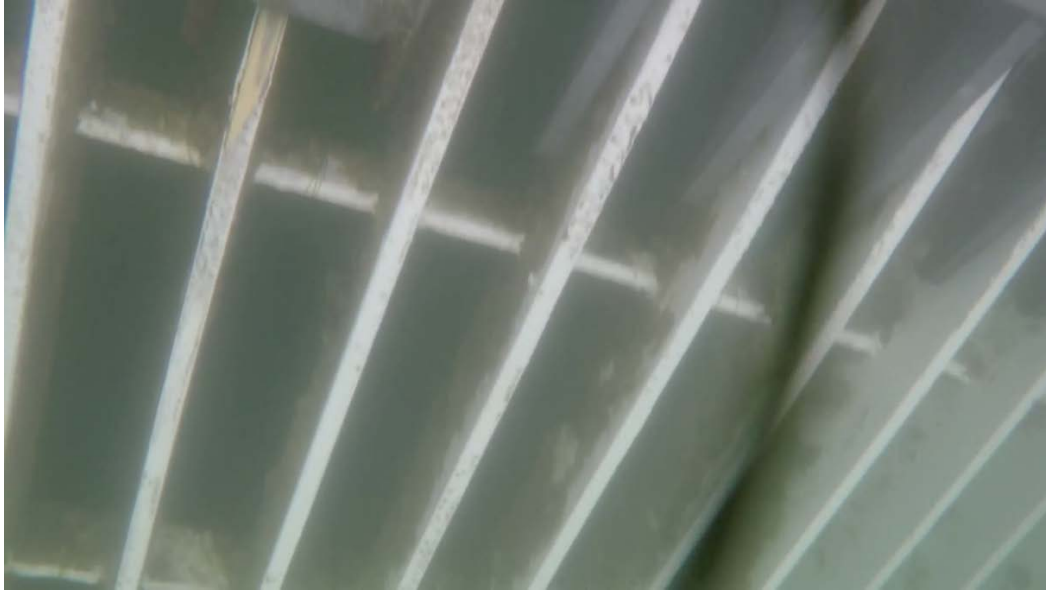
Figure 14. International Paint Intersleek 970 after 3.5 years exposure, photo taken underwater in July of 2017.

The trashrack inspection showed that after three and a half years the three FRC Intersleek 970, Sigmaglide 890, and Sher-Release had minimal fouling (primarily algae) on the surface with damage to the bars where the trashrake glides on the surface. The PPG Sigmaglide 890 and Seacoat Seaspeed V5 had more fouling on the surface due to being in deeper water. The majority of the corrosion was on the leading edge of the bars that contained the hard silicone/epoxy hybrid Seaspeed V5. The weight of the trashrake caused cracking and chipping of the coating. Figures 14-17 show the condition of the trashrack coatings after 3.5 years while in service.

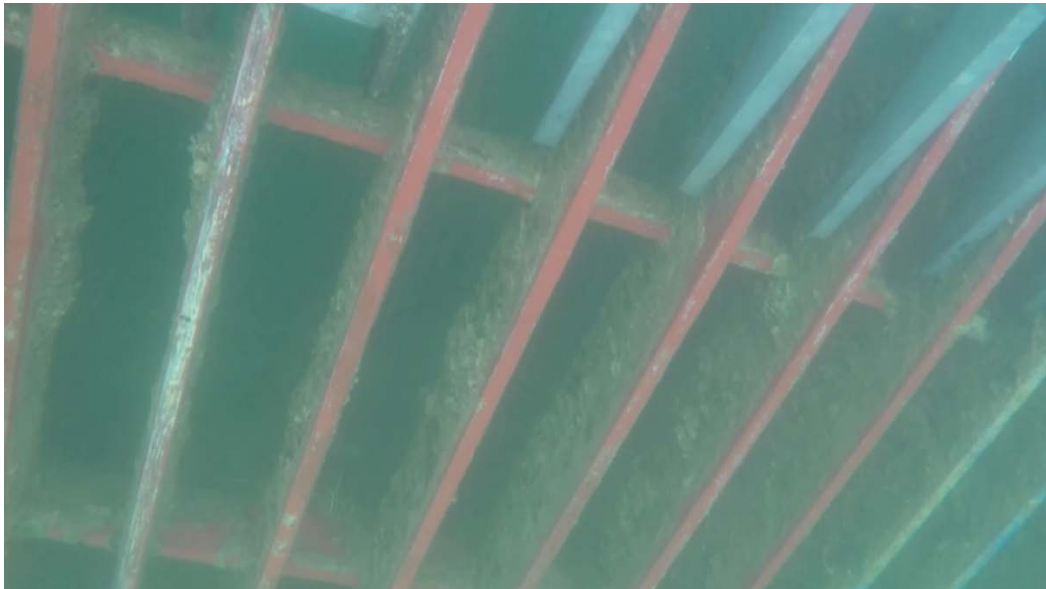
Figure 15. Sigmaglide 890 after 3.5 years exposure, photo taken underwater in July of 2017.

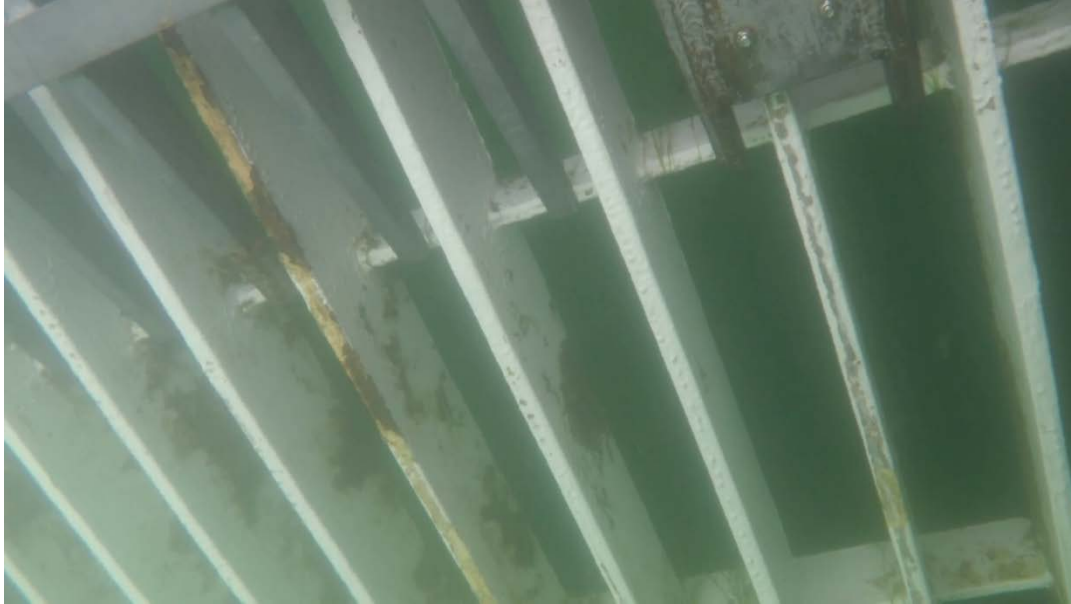
Figure 16. Sherwin Williams Sher-Release after 3.5 years exposure (no longer manufactured), photo taken underwater in July of 2017.

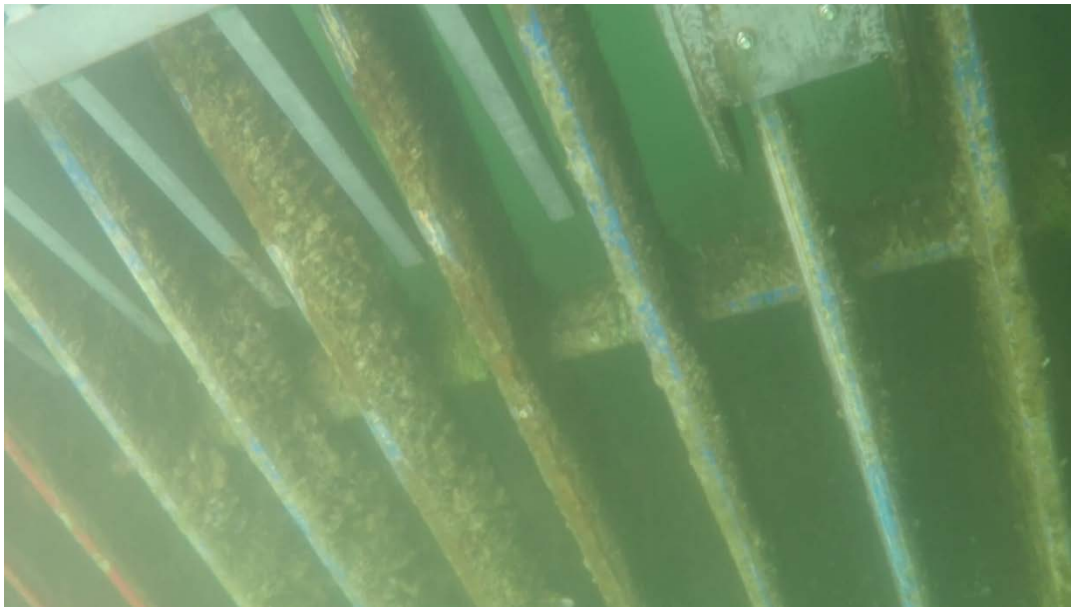
Figure 17. Seacoat Seaspeed V5 after 3.5 years exposure, photo taken underwater in July of 2017.
