Evaluating Corrosion Protection Methods for Riveted and Bolted Connections

Research and Development Office
Science and Technology Program
Final Report ST-2019-1717-01
Technical Memorandum No. 8540-2019-34

September 2019

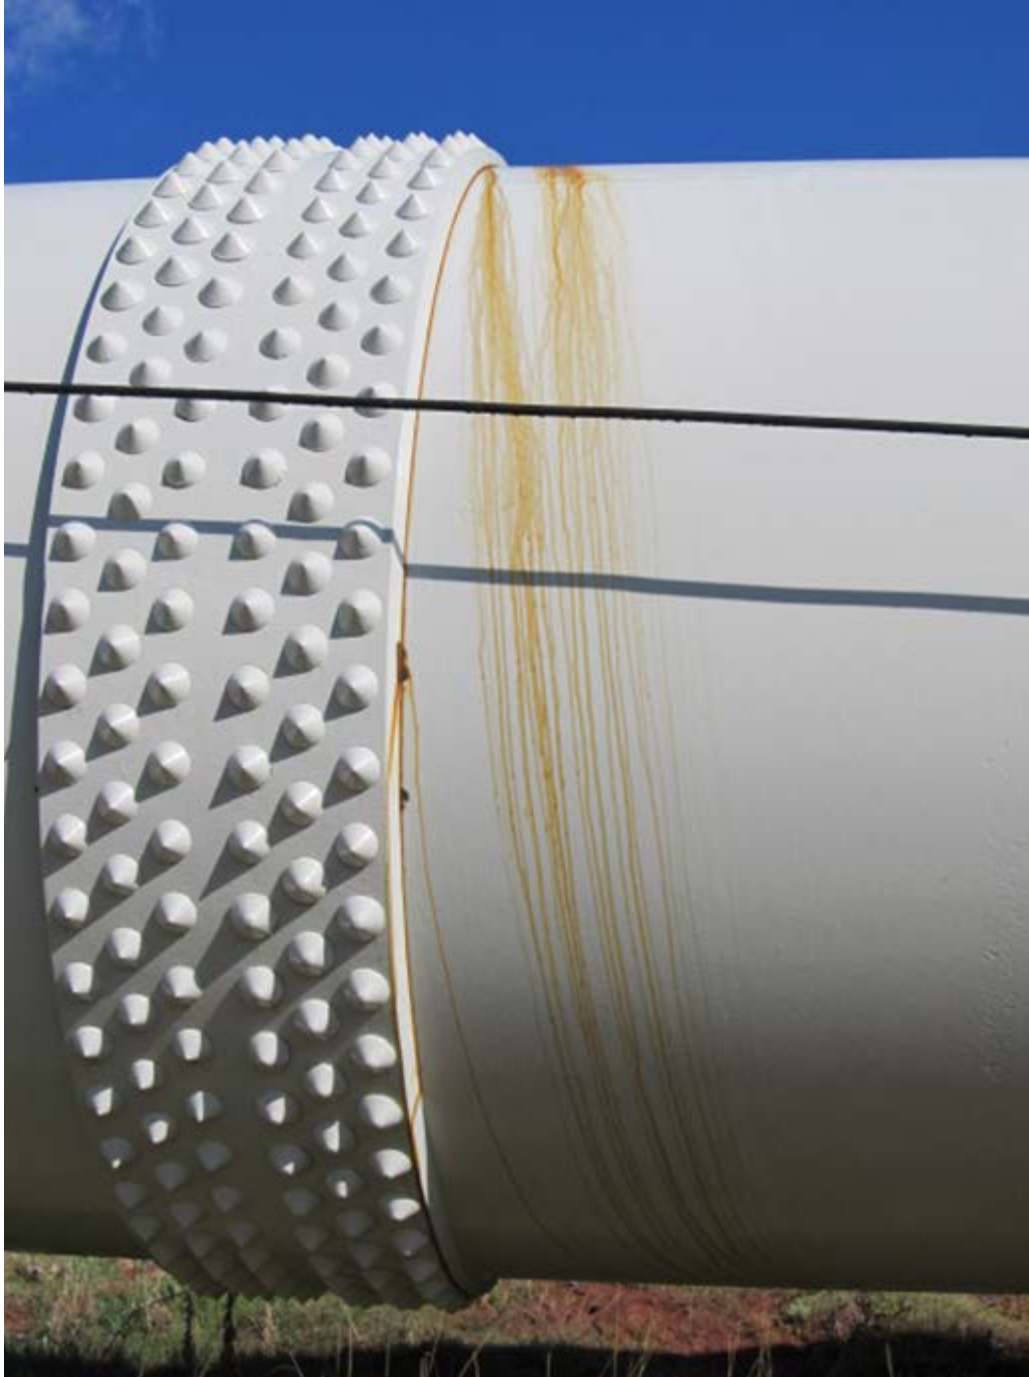
Figure 1. Flatiron penstock riveted connection, coating failure at collar due to vibration

In 2010, the exterior surfaces of the Flatiron Powerplant Penstocks were coated with a zinc rich epoxy/ epoxy intermediate/ polyurethane topcoat 3-coat system. The coating has experienced cracking at the riveted connections and collars. The cracking appears to be occurring due to the vibration of the pipe as water is flowing through the interior. The vibration concentrates at the riveted collars due to the steel thickness in those areas. As a result, the highly crosslinked, brittle coating cracks and chips. Figures 1 and 2 show the condition representative of every riveted connection on these penstocks after 7 years in service.

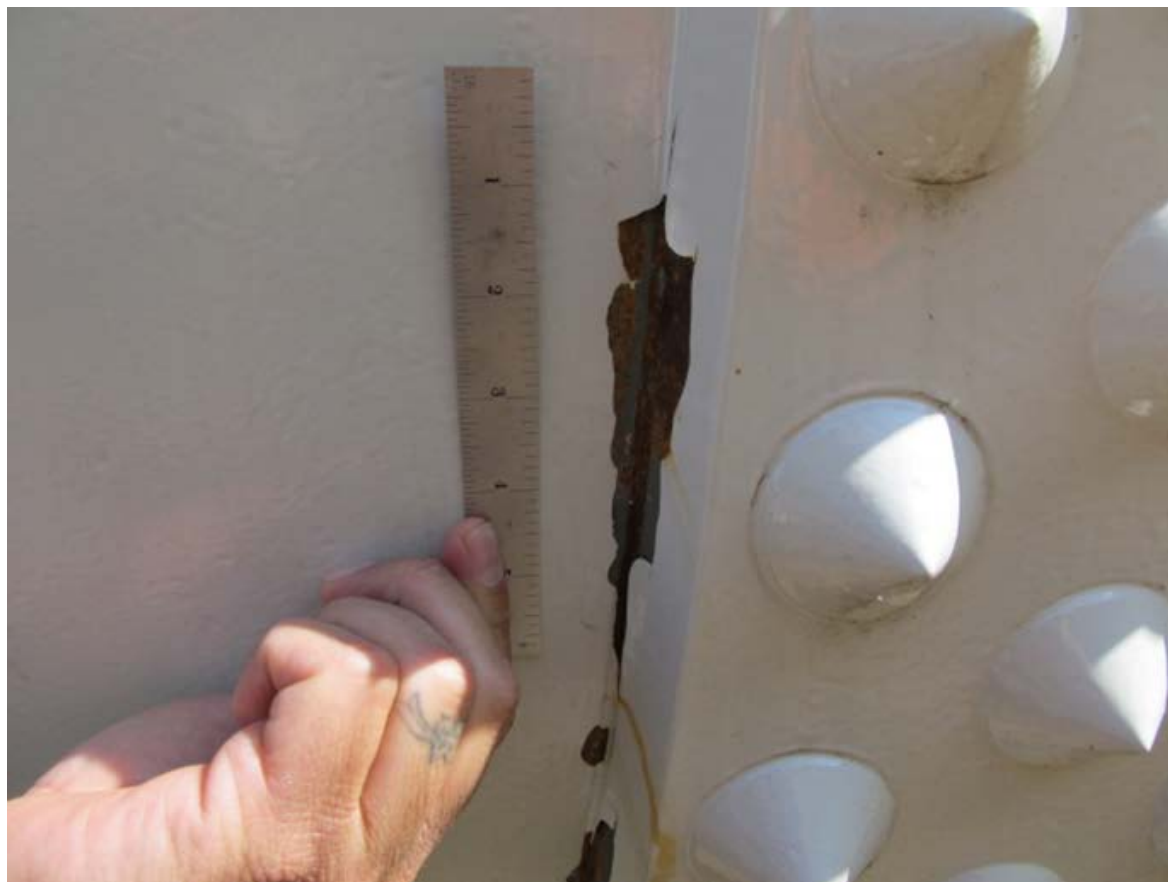
Figure 2. Flatiron penstock riveted connection, closeup of coating failure at collar

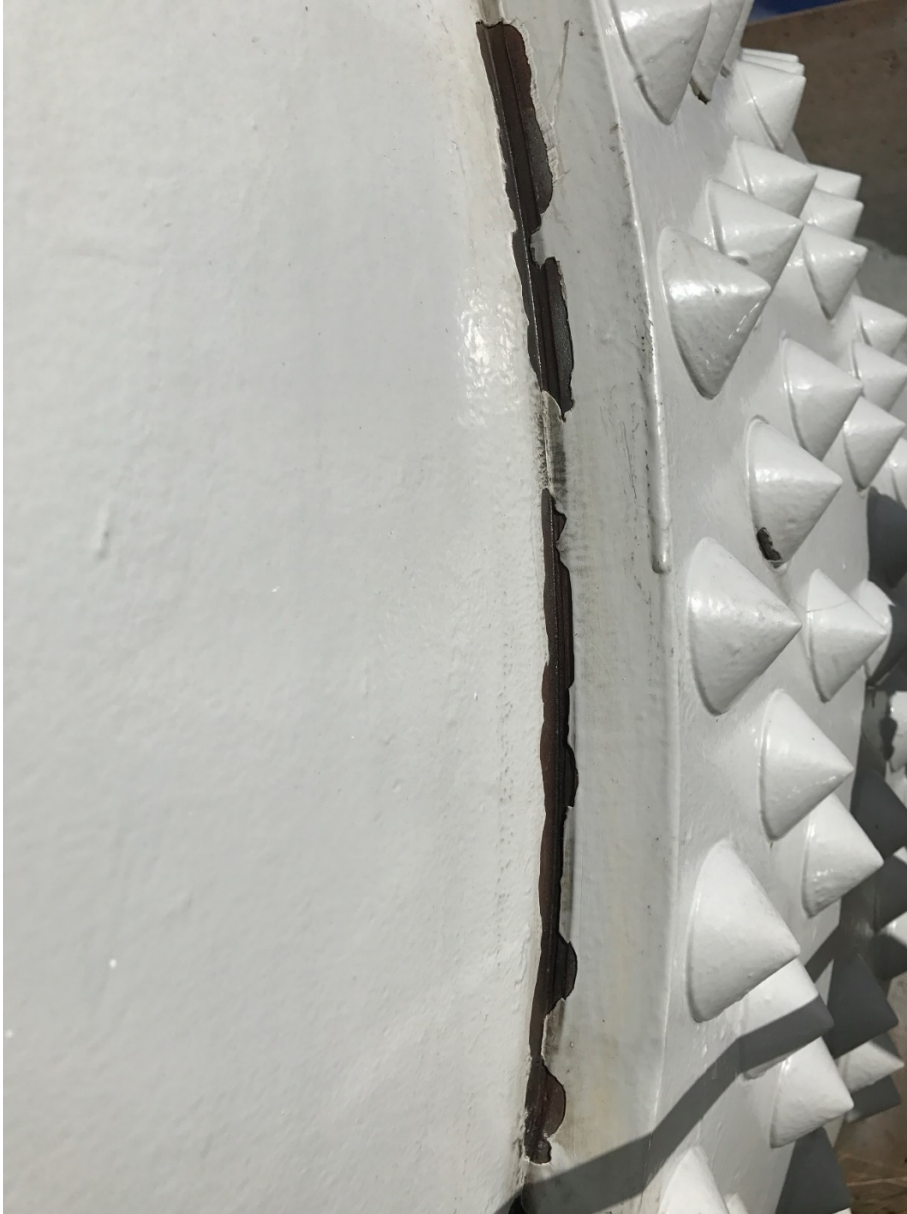
Figure 3. Appearance of steel collar/ pipe interface after surface preparation.

The surface preparation consisted of hand-tool cleaning to remove all loose material, hand sanding, and solvent cleaning to remove dust and loose corrosion products. Figure 3 shows the extent of surface preparation. Power tool cleaning was not performed due to the potential that sparking could set fire to the dry brush on the hillside. Repairing the full circumference of the joint required extensive surface preparation, so spot repairs were conducted instead.

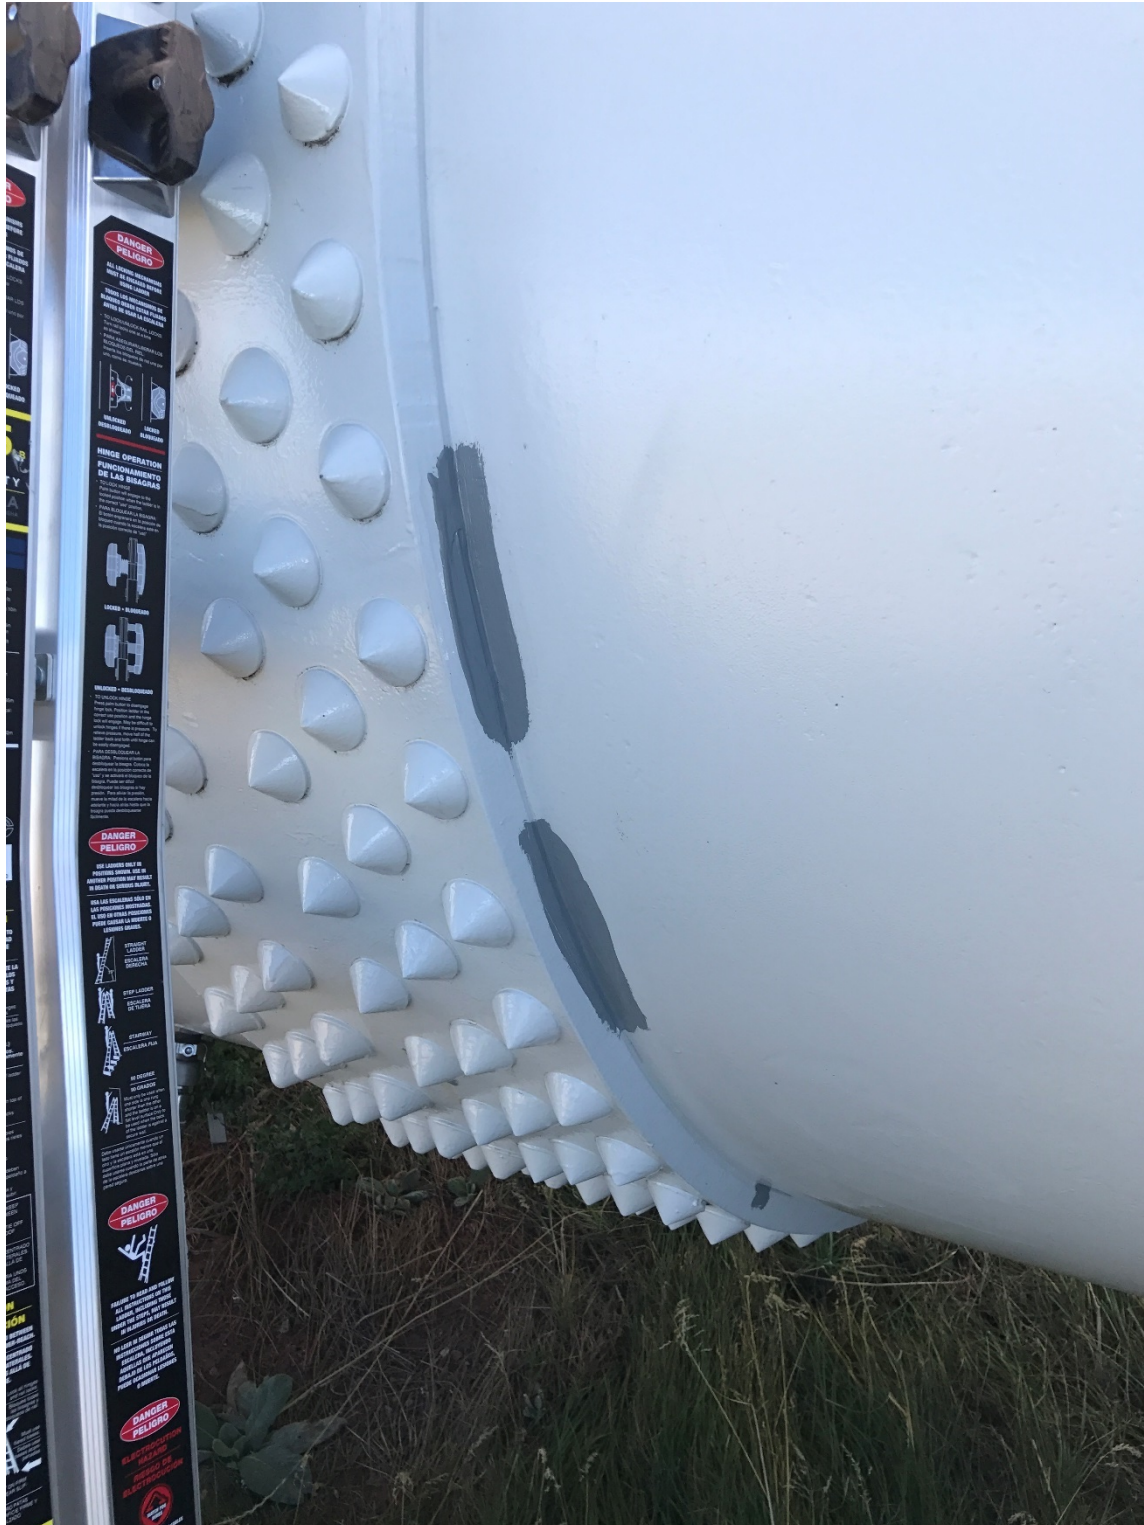
Figure 4. Anodic alkyd spot repairs at the steel collar interface.

The polyurethane caulk was applied at the transition between the concrete anchor block and penstock. The anodic alkyd was applied at the first two sets of rivets upstream from block 14. A typical spot repair is shown in Figure 4. The calcium sulfonate alkyd was applied at the fourth set of rivets upstream from block 14.

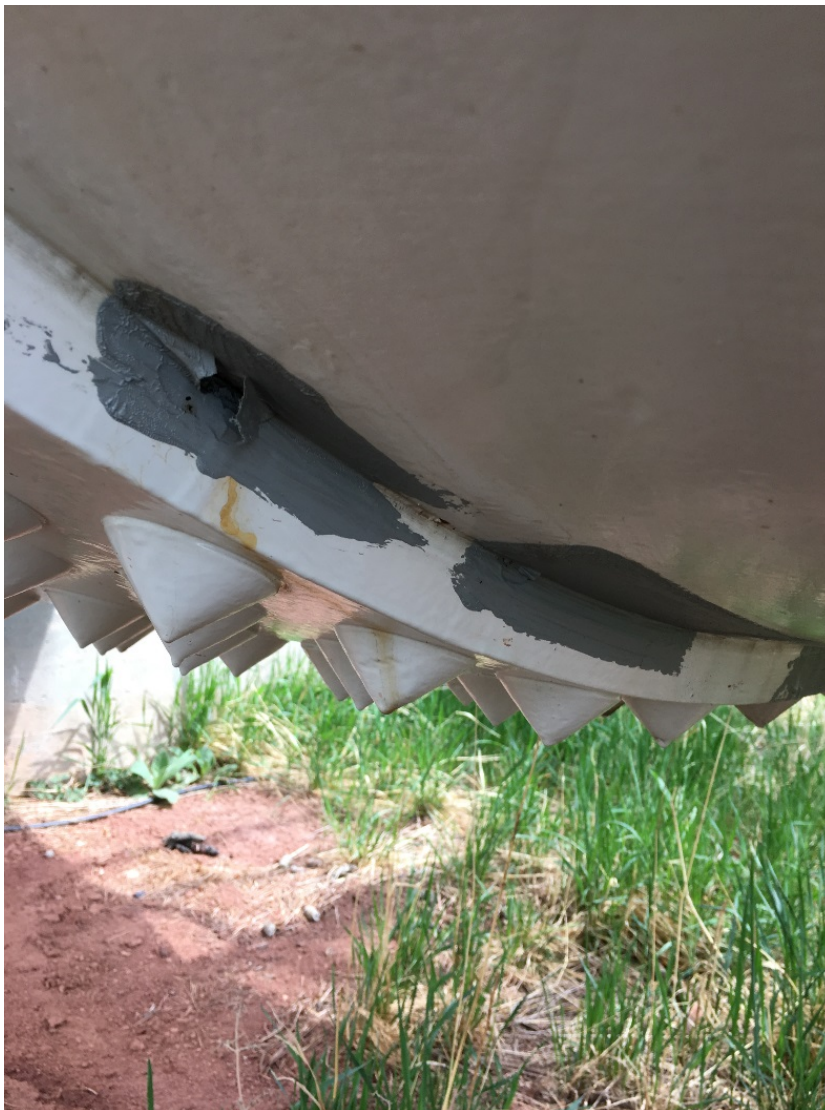
Figure 5. Anodic alkyd spot repairs after 6 months exposure, some areas had cracked coating.

After 6 months of exposure, an inspection of the field trials was conducted. The majority of the spot repairs were found to have failed, and the original coating (a brittle epoxy) under the flexible coating had cracked and flaked as shown in Figures 5, 6, and 7. Areas that were previously undamaged had also cracked and spalled, indicating the vibration problem continued to spread, and the entire joint requires recoating. Spot repairs are not recommended since the damage progression continues around the full circumference. The 3-coat system should have been completely removed or cut through to bare metal for the full circumference of the joint. Figure 8 shows one area that was successful.

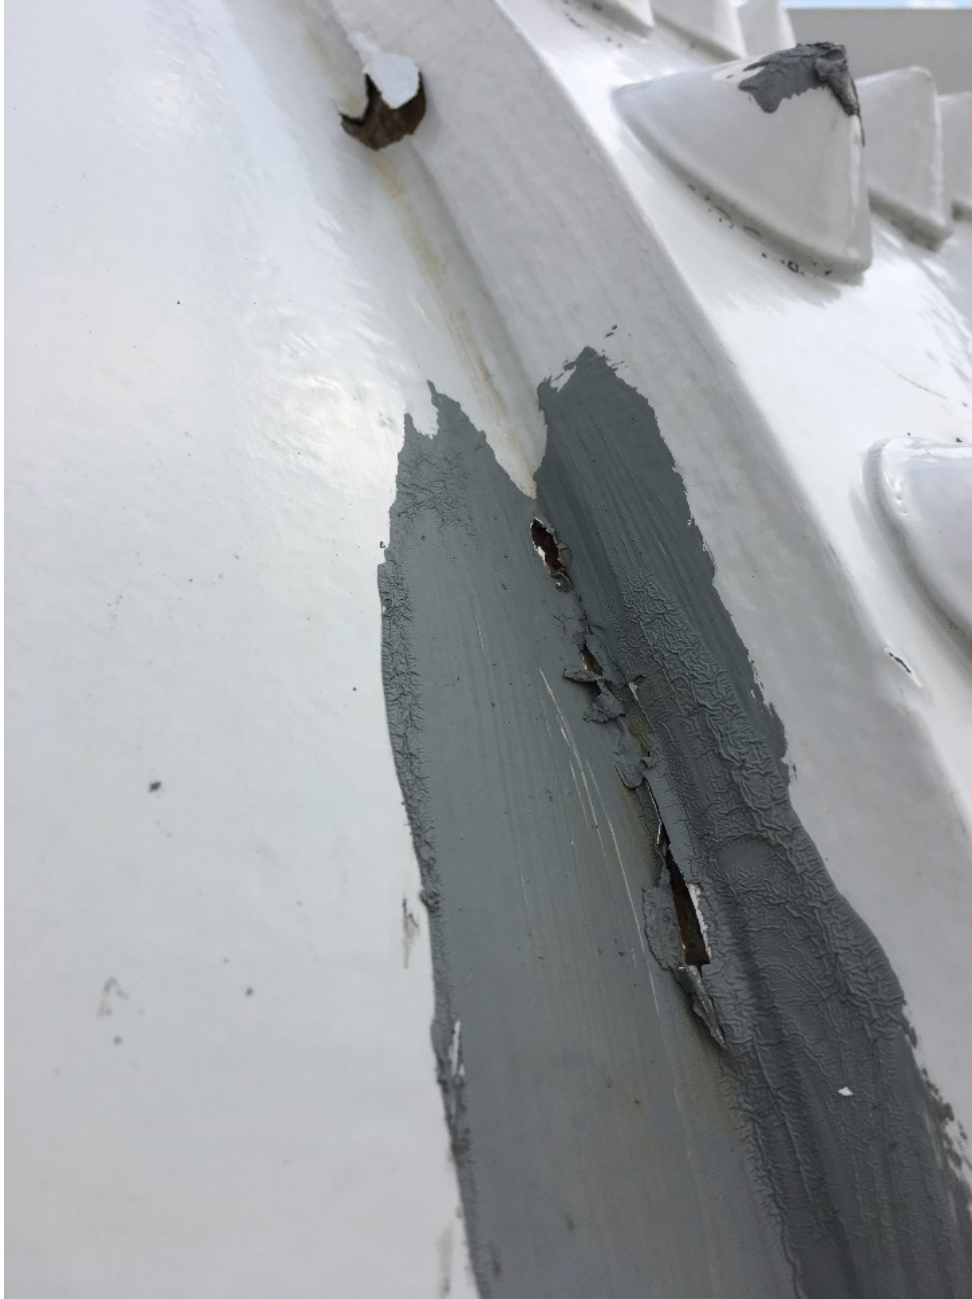
Figure 6. Anodic alkyd spot repair after 6 months the epoxy coating cracked and flaked the spot repair.

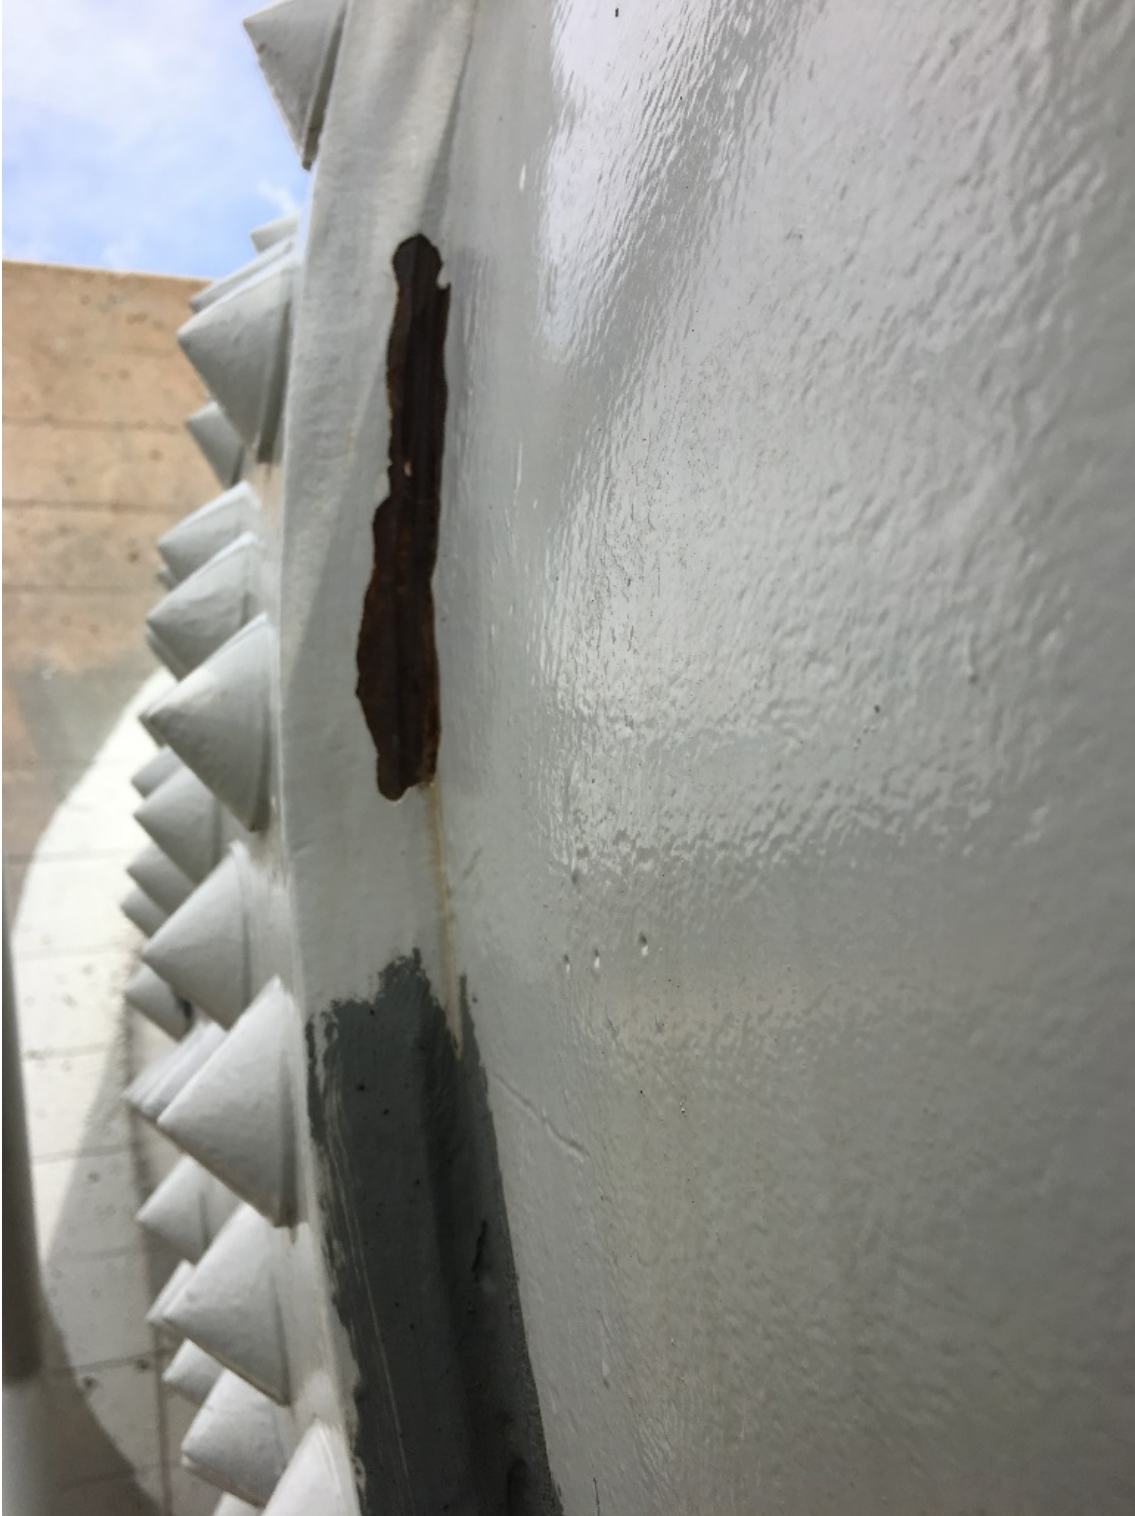
Figure 7. Adjacent to the anodic alkyd spot repair (lower area) another area has cracked and spalled (upper area).

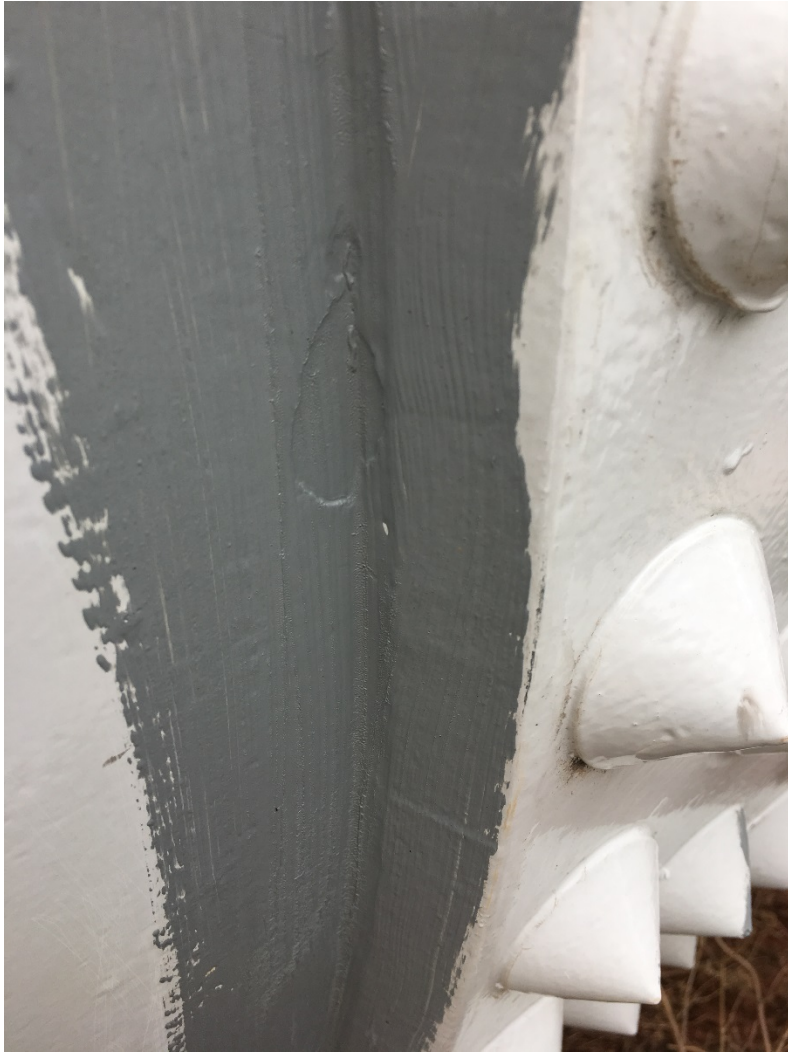
Figure 8. A successful anodic alkyd spot repair after 6 months.

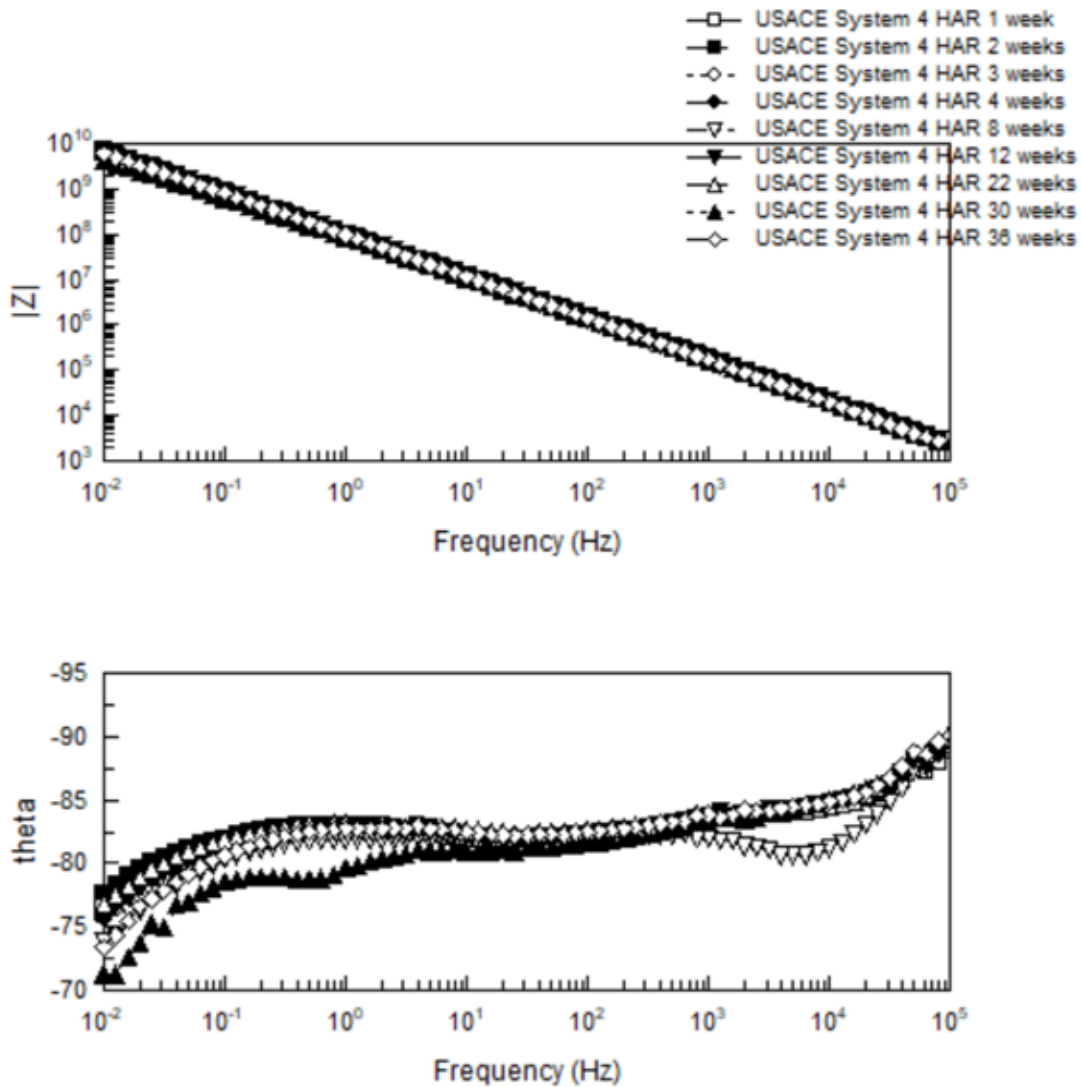
Figure 9. Bode plot of USACE System 4 in HAR water after 7 months. Capacitive behavior, phase angle is above -70 degrees.

The coating benchmark has excellent barrier properties showing capacitive behavior, i.e. the Bode plot curve should have a continuous 45-degree slope without any horizontal bending. The phase angle should remain near -90 degrees at all frequencies. The USACE system 4 and 5-E-Z both exhibits these properties [7] [8]. Figure 9 shows the Bode plot of USACE system 4 in deionized water after 7 months exposure. Notice there is minimal degradation and the 45-degree line is continuous, indicating the coating is capacitive with no corrosion under the coating.

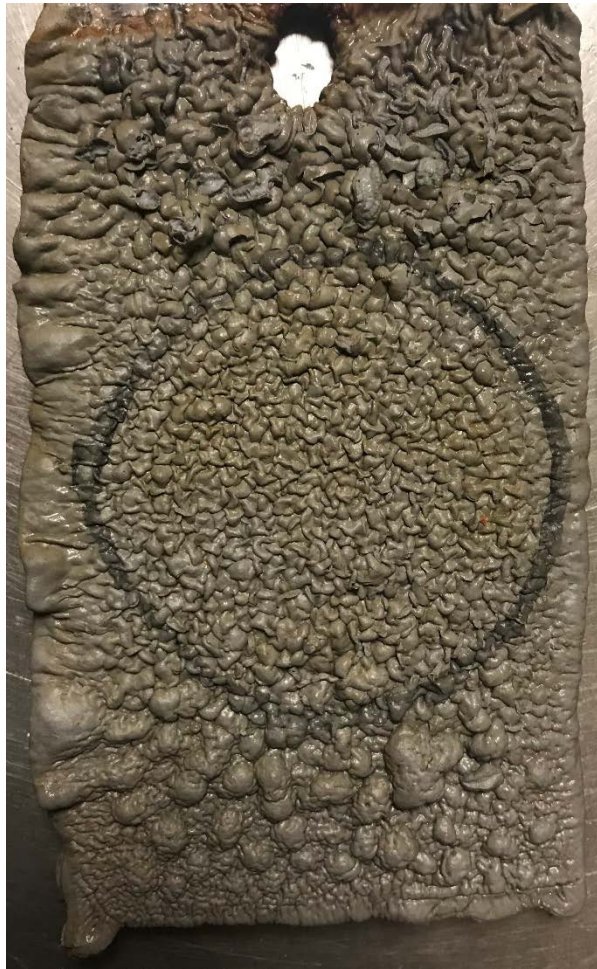
Figure 10. Failure of coating system 5, severely wrinkled in water immersion service.

Flexible coating systems 2, 3, and 5 completely failed by either blistering or wrinkling as seen in Figure 10 [13] [15] [16]. The EIS data showed high permeability of electrolyte through these coating systems [19] [20] [21]. Figure 11 shows the EIS Bode plots of flexible coating 5, (an example of a coating system that failed) with high permeability because of the low impedance magnitude, $|Z|$, value and the phase angle (lower graph) goes to zero degrees [13]. The plots also show resistive behavior with the curve becoming horizontal at high frequencies, indicating the presence of corrosion at the steel-coating interface.

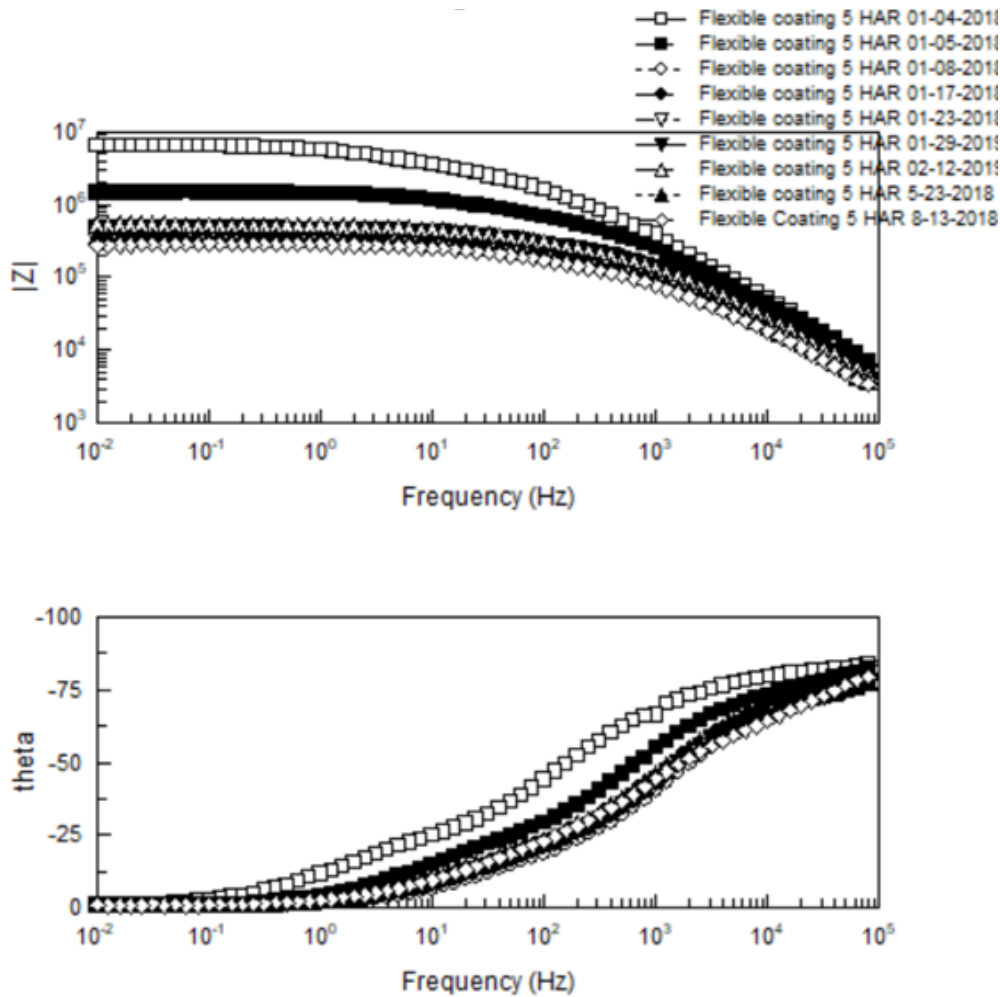
Figure 11. EIS data of flexible coating 5 in HAR immersion. Bode (top) plot, shows resistive behavior and phase angle (bottom) shows high permeability properties as the phase goes to zero.

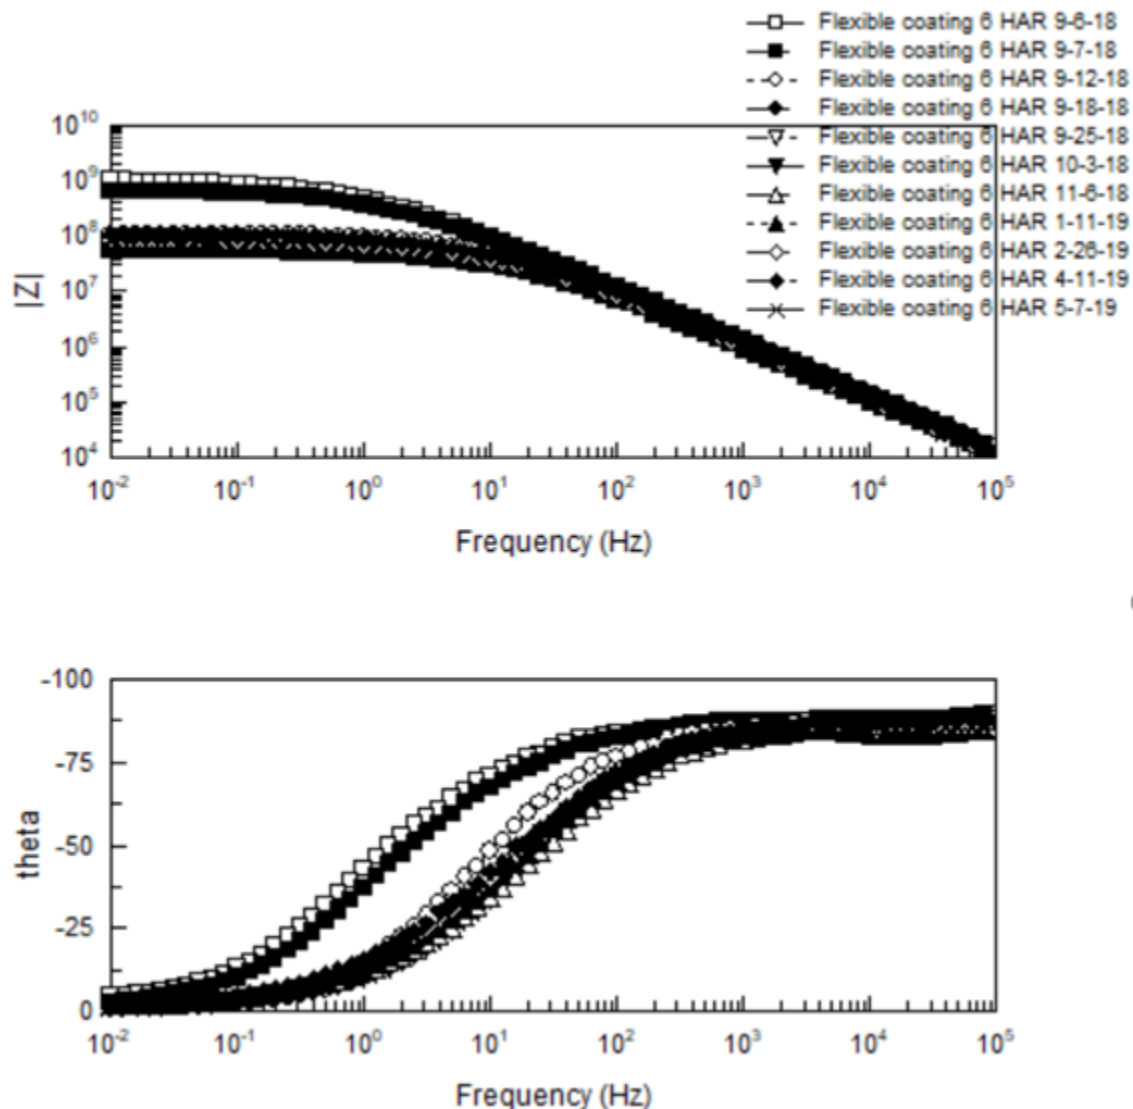
Figure 12. Bode plot of Flexible coating 6 in HAR immersion after 7 months. Capacitive and resistive behavior, but phase angle goes to zero indicating corrosion at interface.

Flexible coating 6 was developed by the Navy to be a rapidly curing product to coat steel pilings during low tide. The polysulfide epoxy has good flexibility. Figure 12 shows the EIS results of the system which was found to have high permeability with a combination of capacitive and resistive behavior indicating there is a small amount of corrosion at the interface [18]. Many coatings have similar EIS plots. Reclamation uses coatings that have the lowest resistive behavior as possible. Flexible coating 6 has higher resistive behavior than desired and should not be used on Reclamation structures for corrosion protection.

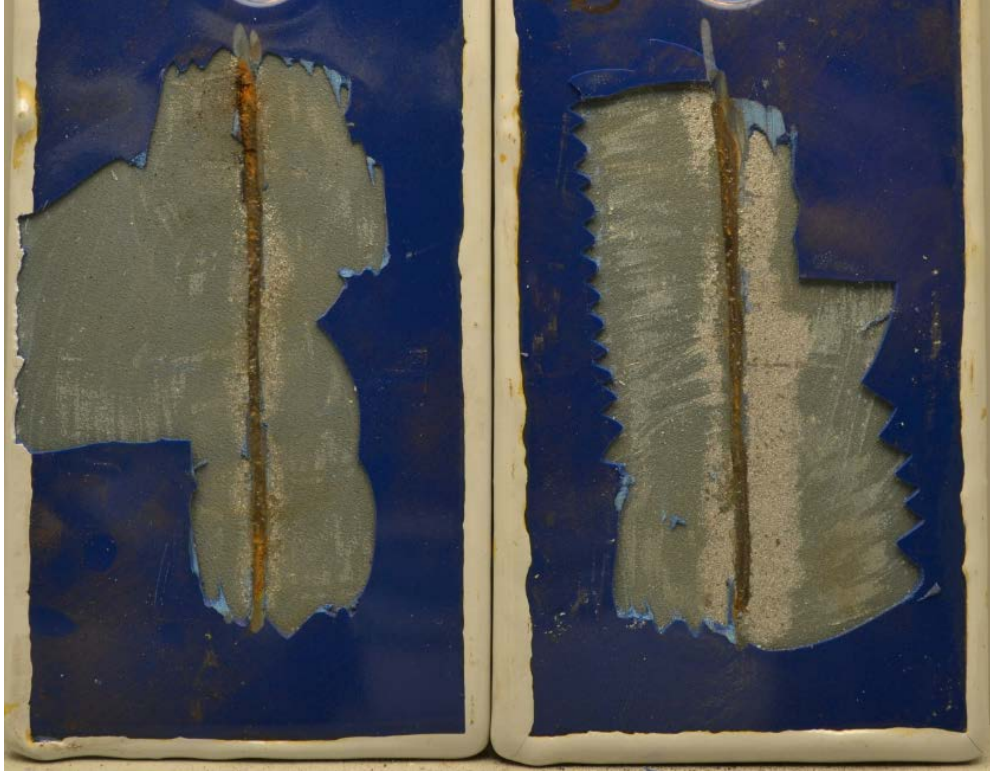
Figure 13. Flexible coating 7 wet adhesion disbondment between the zinc rich primer and the topcoat.

Flexible coating 7 was the only coating in the entire set that provided capacitive properties in EIS [10]. However, the wet adhesion between the topcoat and the zinc rich primer was low and the topcoat could be easily peeled from the primer. This coating system would be highly susceptible to delamination if it were to be used in flowing water applications as seen in Figure 13.

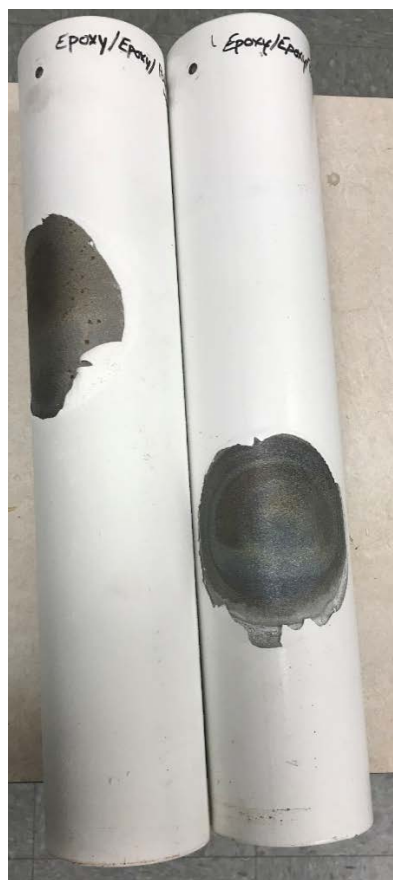
Figure 14. Cathodic disbondment of two coats of epoxy with polyurethane topcoat with and without SHDE.

The cathodic disbondment testing showed that the only systems to be compatible with cathodic protection were Systems 2A and 2B [22]. This study revealed that large blisters formed on surfaces closest to the anodes, not at the intentional defect, for Systems 4A and 4B shown in Figure 14 [22]. Systems 4A and 4B had the same result with large blisters forming on the side closest to the anode [22]. Reclamation has specified this system, two coats of epoxy with a polyurethane topcoat, for the splash zone of gate structures. The polyurethane was used to provide UV protection. This is concerning because many Reclamation structures coated with this system use CP to enhance corrosion protection on riveted construction. There is potential that the CP system may result in blistering of the coating.

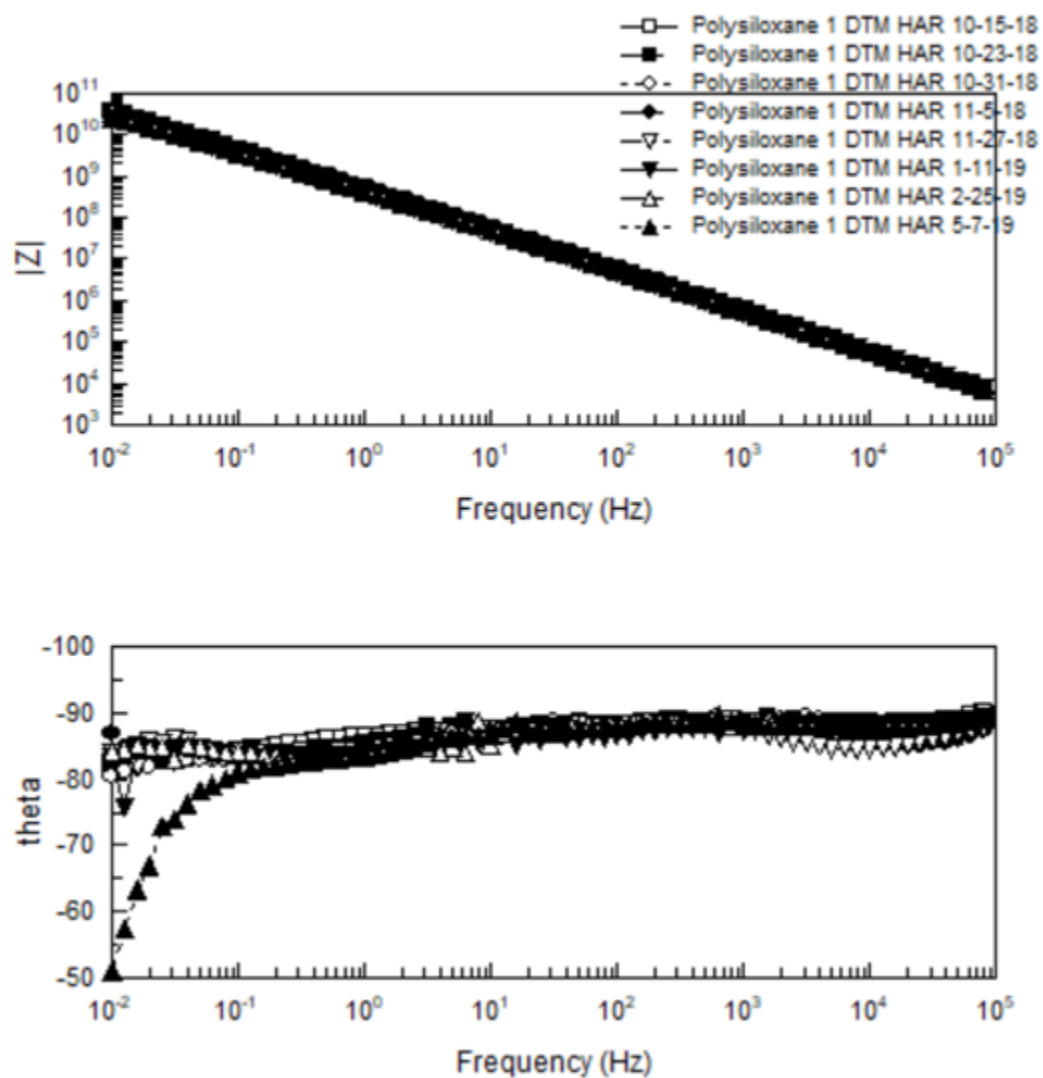
Figure 15. EIS Bode Plot of Polysiloxane 1 DTM after 7 months exposure in HAR immersion

The polysiloxane set provided the most promising results for corrosion protection during laboratory testing. Some of the polysiloxane systems were found to provide excellent barrier properties like the legacy coatings such as coal tar enamel and vinyl resin. The results are compared to USACE vinyl systems 4 and 5-E-Z in Appendix Table 3 for further review [23] [24] [25] [26] [27] [28] [29]. The EIS results showed capacitive behavior for five systems: polysiloxane 1 DTM, polysiloxane 2 DTM, epoxy A/polysiloxane 1, epoxy A/ polysiloxane 4, and epoxy B/ polysiloxane 2 [23] [24] [26] [27] [29]. Figure 15 and Figure 16 show the EIS Bode plots for polysiloxane 1 and polysiloxane 2 respectively; both have capacitive properties with values above 10^{10} at 0.01 Hz. These systems exhibit EIS performance similar to USACE system 4 shown in Figure 9. Since similar results had not previously been observed for epoxy systems alone, polysiloxanes 1 and 2 provide the capacitive properties for the abrasion resistant epoxy primer/ polysiloxane topcoat systems. Polysiloxane 3 DTM and epoxy B/ polysiloxane 3 had a combination of resistive and capacitive behavior [25] [28]. Figure 17 shows the resistive and capacitive behavior of the polysiloxane 3 DTM in the EIS Bode plot. Polysiloxane 4 DTM blistered and micro-cracked within the first few weeks of testing and was withdrawn from testing.

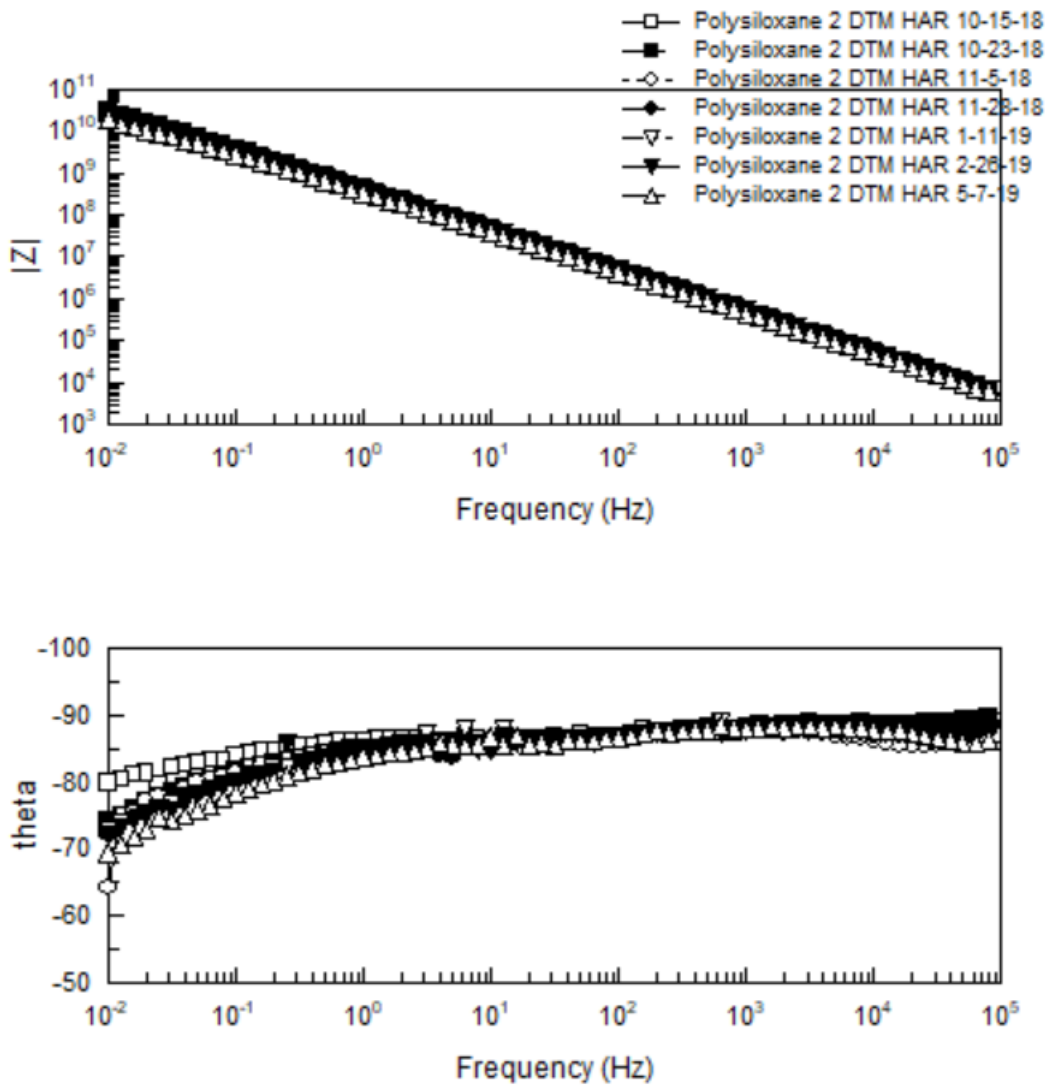
Figure 16. EIS Bode plot of Polysiloxane 2 DTM after 7 months exposure in HAR immersion

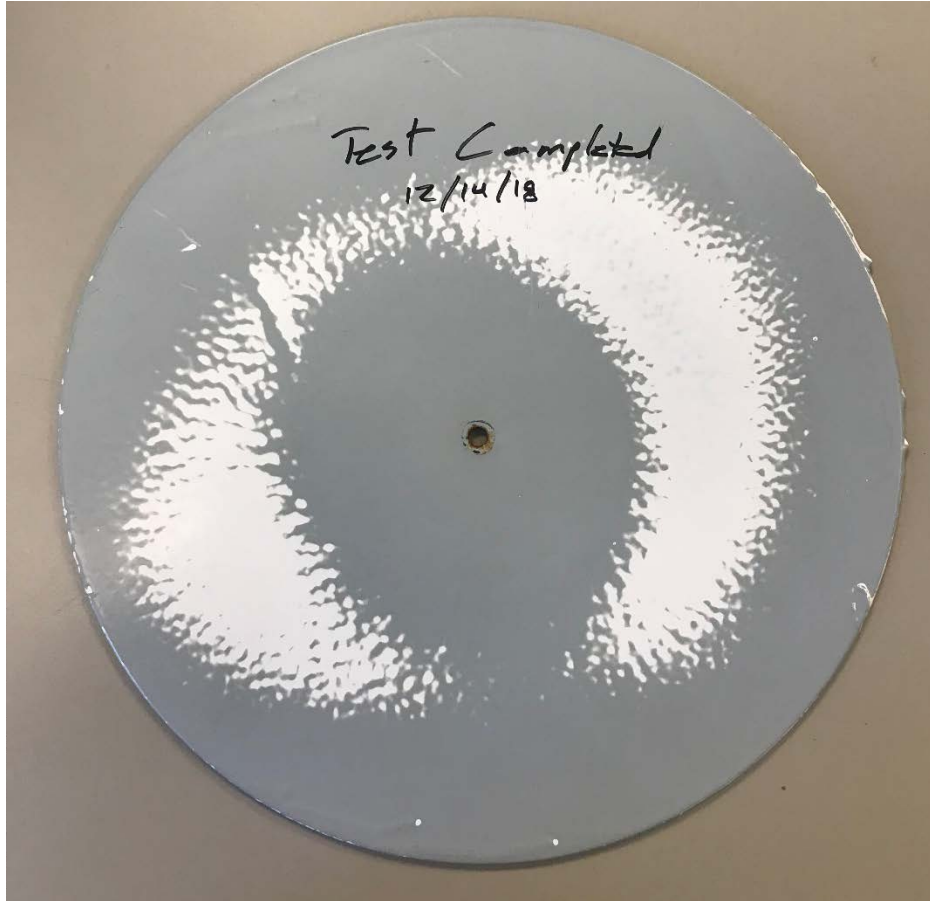
Figure 18. Erosion of Polysiloxane 2 DTM after 96hrs of slurry erosion

The systems that closely match the properties to the USACE vinyl systems 4 and 5-E-Z are polysiloxane 1 DTM, polysiloxane 2 DTM, epoxy A/ polysiloxane 1, and epoxy B/ polysiloxane 2. The USACE vinyl system 5-E-Z has better undercutting resistance because it contains a zinc rich primer, whereas none of the other systems contain zinc. The $|Z|$ for the four polysiloxane systems were slightly higher than the vinyl systems. When subjected to the cathodic disbondment test, the polysiloxane systems prevented disbondment, which was a significant improvement compared to vinyl. Based on the test data, these systems could provide long term corrosion protection with or without CP. One aspect that could reduce the service life is the durability of the coating system. The polysiloxane systems did not have as good of erosion resistance or impact resistance as USACE vinyl system 5-E-Z. Figure 18 shows the erosion pattern of polysiloxane 2 after a 96-hour test the topcoat has eroded through to the intermediate

coat [24]. The longevity of these systems will be highly dependent upon the erosion rate, impact damage from debris, and ability to withstand cracking.
