Optimization of Test Methods for Cathodic Protection Systems on Hydraulic Structures

Research and Development Office
Science and Technology Program
Final Report ST-2019-4108-01
Technical Memorandum No. 8540-2019-08

June 2019

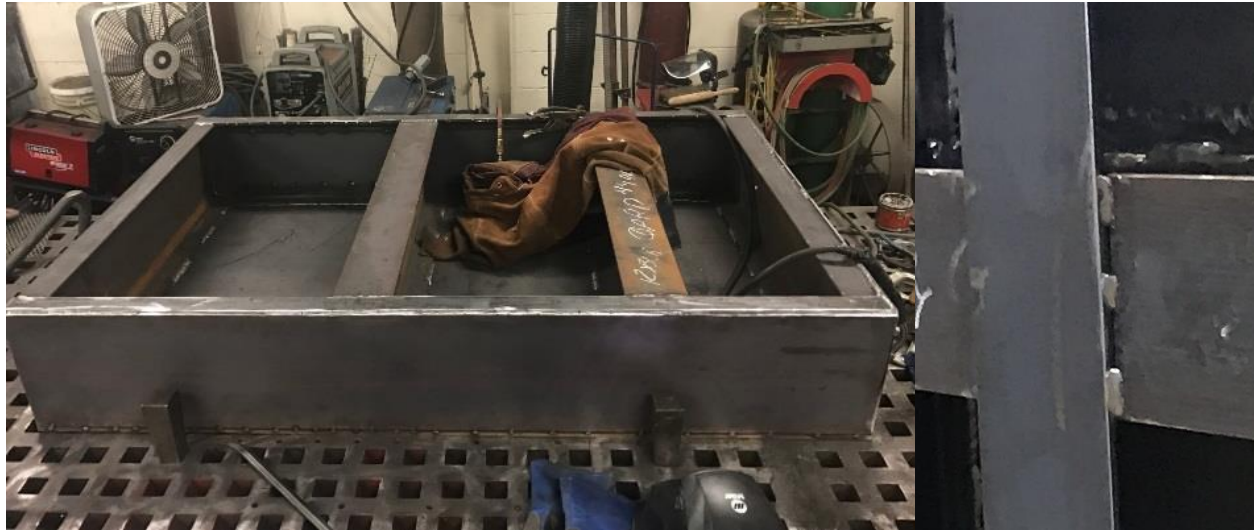
Figure 1. Bulkhead-style mild steel test gate (left) and a close-up of skip welding purposely performed to promote corrosion (right).

To test the effectiveness of the corrosion monitoring systems, researchers fabricated a 4-foot (ft) wide by 6-ft tall bulkhead-style test gate out of mild steel panels (Appendix B). The steel panels were joined using the skip welding technique to intentionally create corrosion-susceptible locations at connections (Figure 1).

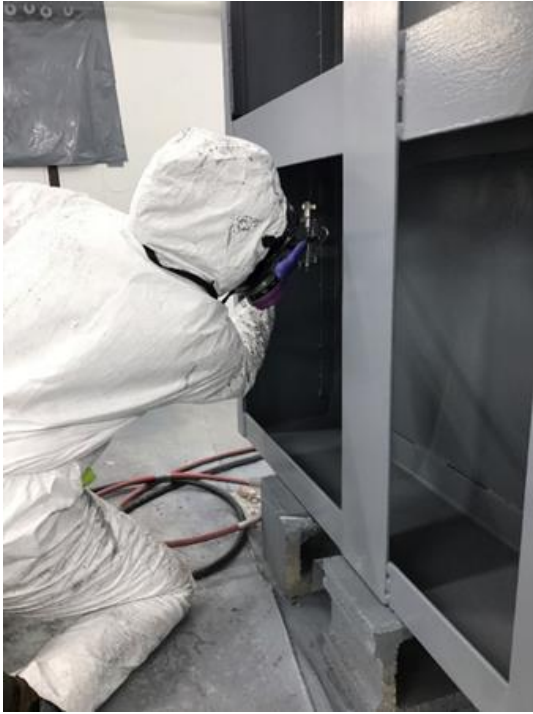
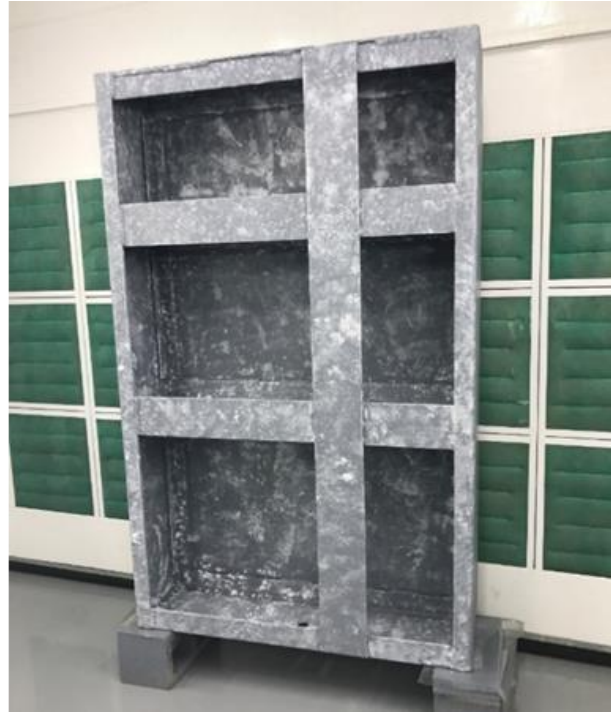
Figure 2. Vinyl coating application (left) and speckled pattern created with white topcoat (right).

The test gate was coated with a zinc-rich vinyl primer and vinyl topcoats (USACE System 5-E-Z) following manufacturer recommendations. On the final coat, a speckle pattern was applied using the white vinyl topcoat to provide a contrasting optical texture for photogrammetry purposes (Figure 2).

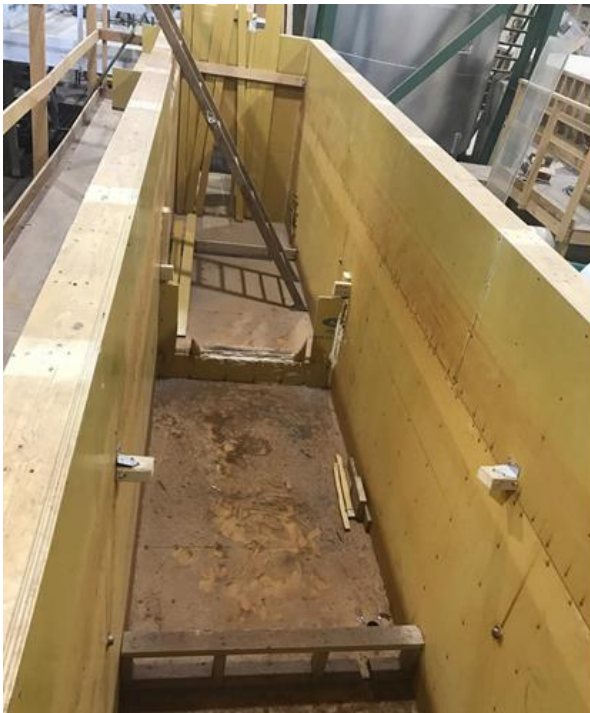
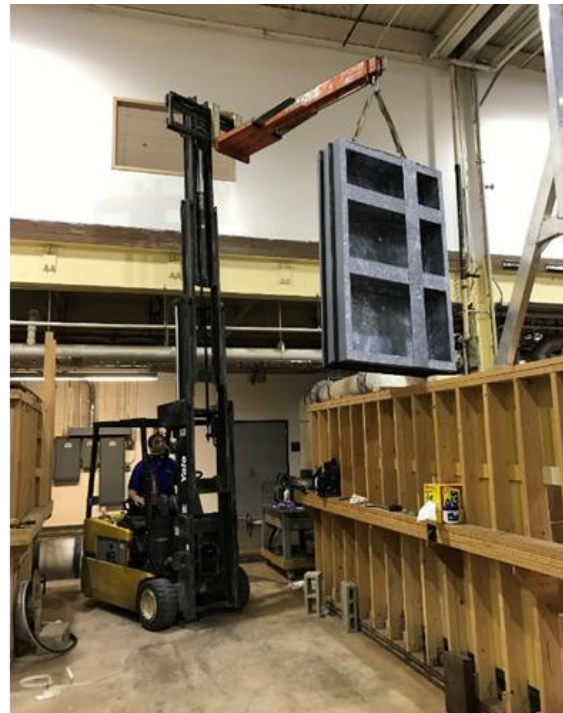
Figure 3. Testing flume during retrofit (left) and installation of test gate (right).

A 4-ft wide by 30-ft long testing flume was outfitted for installation of the test gate by the addition of gate guides, an aluminum support frame, and a plexiglass viewing windows (Figure 3). The flume was sealed for water tightness. After the test gate was set in place, the flume was filled with water, and marks were made on the wall to indicate the minimum and maximum water levels with six inches (in) of allowable fluctuation. The water level was maintained between these marks for the duration of all tests.

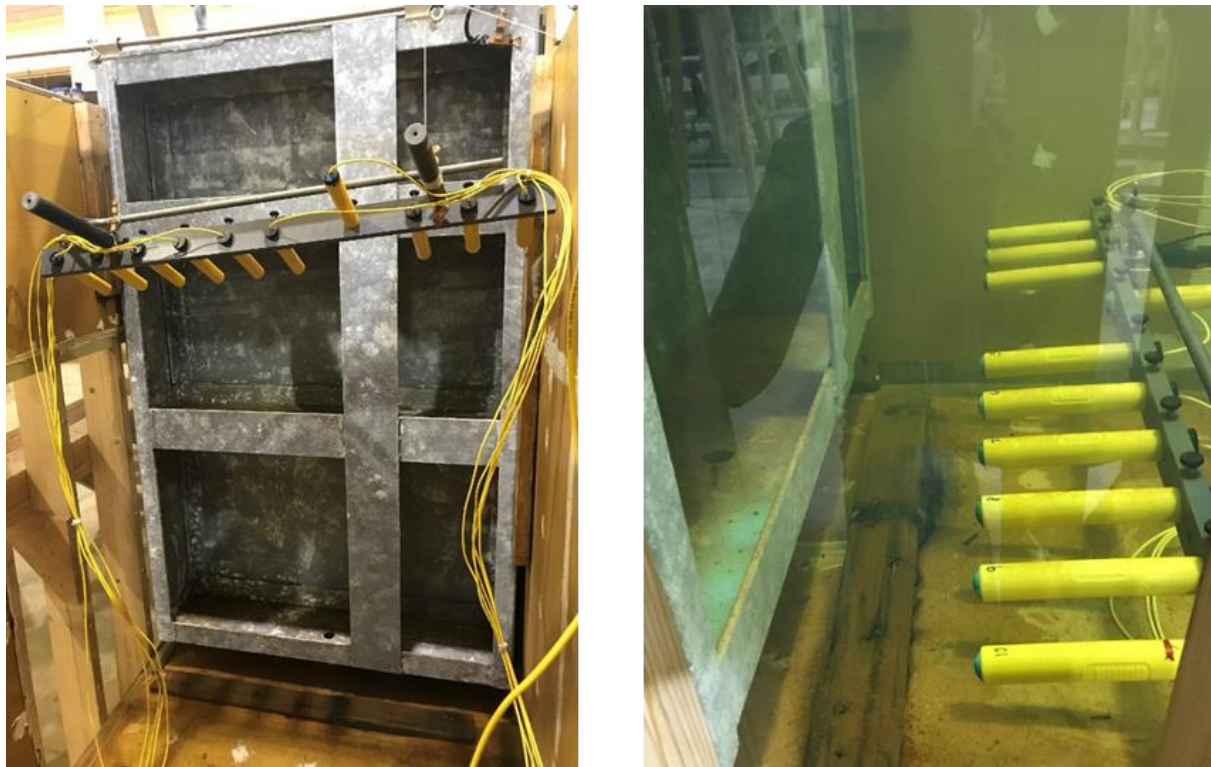
Figure 4. CSE array in dewatered test gate (left) and submerged at the bottom of flume (right).

An ICCP system was installed on the test gate consisting of an 18-in platinum rod anode, power supply, and current interrupter. The evaluation procedure to record potentials on the test gate employed a custom-made array of ten copper-copper sulfate reference electrodes (CSEs) suitable for prolonged immersion service. The design included counterweights opposite the CSEs to keep the array level in the water. The array ensured that each CSE was equidistant from the steel surface it faced. One CSE, #4, was offset for positioning in front of the vertical steel brace of the gate, and all other CSEs were evenly distributed and set further forward for positioning at the interior of the test gate (Figure 4).

The CSE array was suspended from a pulley system which allowed the array to be vertically positioned spanning the entire immersed gate height. A rail system allowed the array to be moved horizontally into the frame of the gate, i.e., the “IN” position. The ten CSEs in the array also spanned the full width of the gate (Figure 4). This combination of vertical and horizontal mobility allowed researchers to record the polarized potential at several different regions of the gate over the duration of each experiment. By moving the reference electrode array closer to and further from the test gate, researchers observed differences between localized and general effects of corrosion on potential measurements.

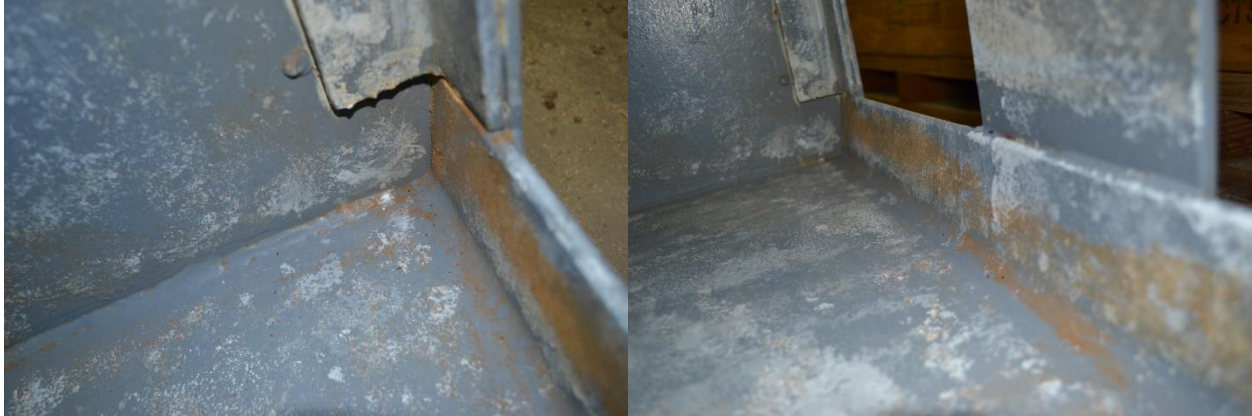
Figure 13. Photos of the front lower right corner of the test gate. Little corrosion can be seen, with most of the discoloration attributed to fouling.

In all heat maps, the lower right corner of the gate tends to have a less negative polarized potential, indicated by the cooler color in this area. These results were compared to visual inspection of that location (Figure 13, Figure 14). The front lower right corner did not appear to have significant corrosion damage, with most of the discoloration in the examination due to fouling product. The back lower right corner, however, had significant rust staining in all the skip welds. It could not be determined that this was the causing factor for the less negative polarized potentials that were measured. The shielding and anode proximity effects discussed above likely have more weight on the observed polarizations in this location.

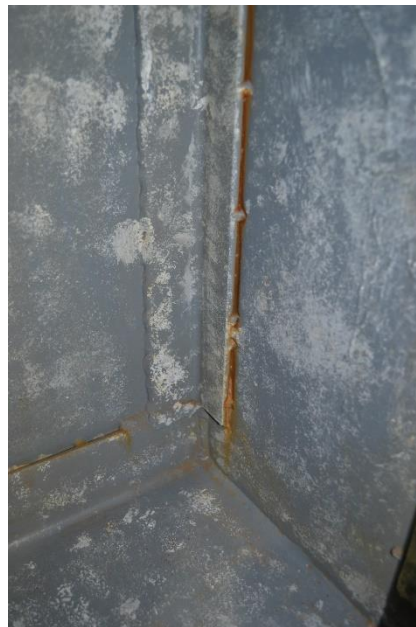
Figure 14. Photo of the back lower right corner of the test gate. Corrosion staining can be seen in the crevices that are present due to skip welding.

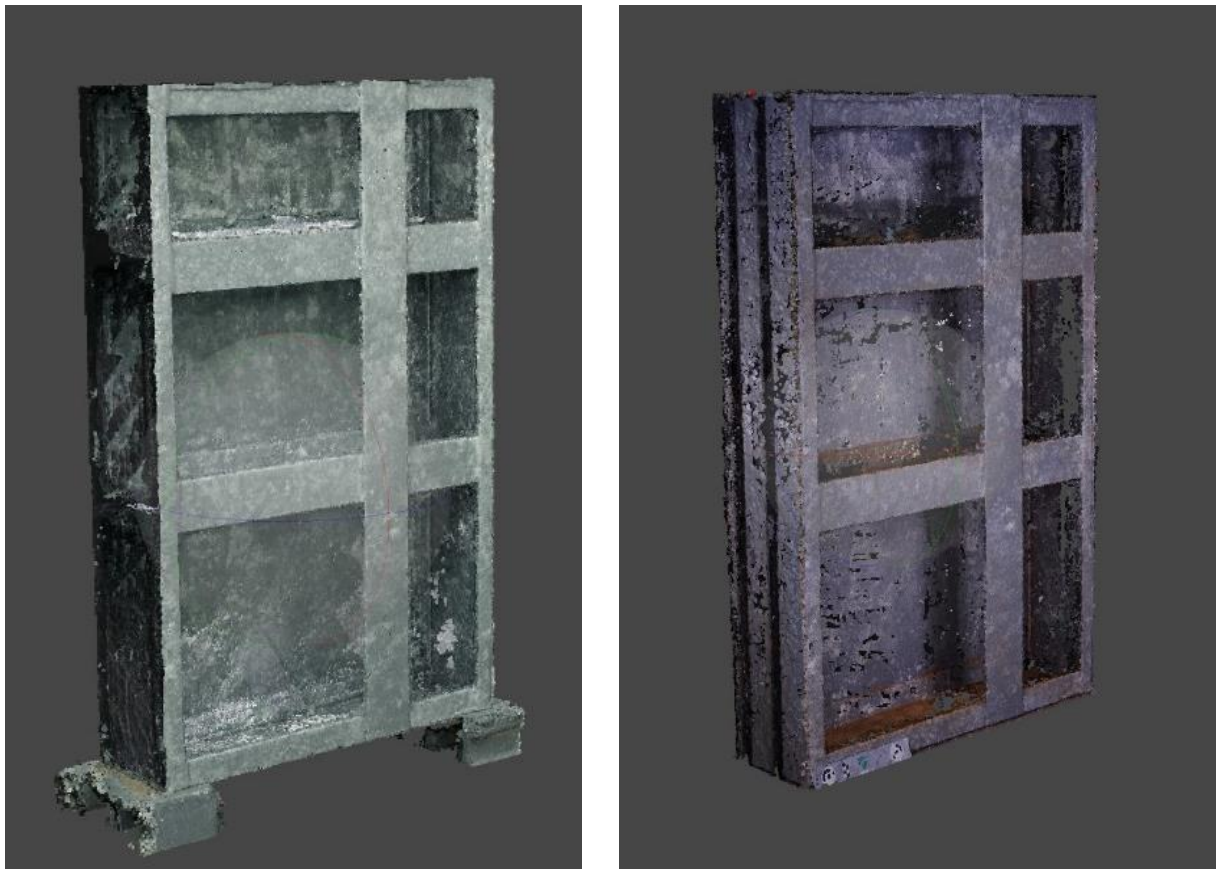
Figure 15. Isometric view of each model: uncoated, coated before immersion, and coated after immersion with corrosion highlighted in brown (from left to right).

After creating 3D geometric models of the test gate, researchers utilized feature extraction to highlight suspected corrosion areas on the post-immersion model (Figure 15). First, a point on the model within an area known to be corrosion product was chosen to provide a color reference. The feature extraction software then searched the model for other similarly-colored areas within a certain RGB value range. These areas are highlighted on the model, as shown in the rightmost image in Figure 15. In practice, however, the corrosion product may be the same color as other

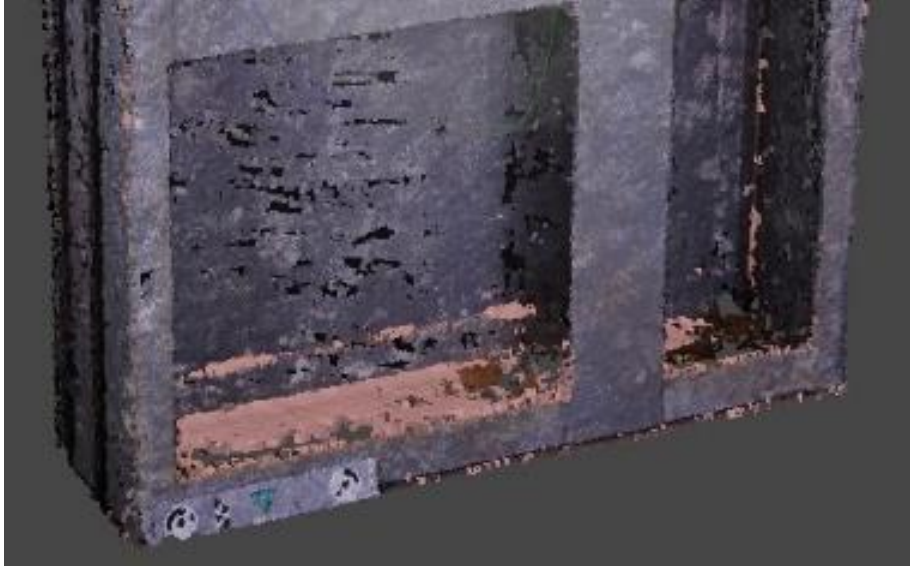
Figure 16: Feature extraction for corrosion in lower compartment of gate with corrosion highlighted as pink; the analysis could not differentiate between rusting staining and fouling.

non-corrosion deposits that form or collect on the surface and may not always be representative of corrosion. In the example shown in Figure 16, there was corrosion detected in the corners and edges of some welds (see right hand side corresponding to skip welds in Figure 14), but the software also identified fouling deposits on the bottoms of the compartments as corrosion. This illustrates the need for a clean surface or optically-distinguishable rust staining when using photogrammetry to identify corrosion. In practice, it may require pressure washing or other methods to clean a gate that has been in immersion service for many years before photogrammetry could be employed.
