Application of Enzyme Induced Carbonate Precipitation (EICP) for Channel Lining and Repair, Low Volume Road Stabilization, Embankment Construction, and Erosion Control

Research and Development Office Science and Technology Program (Final Report) ST-2019-1840-01

Facilities Engineering Group, Yuma Area Office, YAO-2110

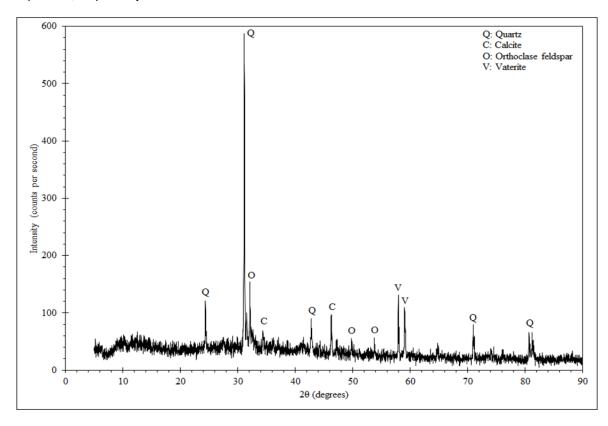
Figure 1. X-ray diffractogram of fine fraction (passing No. 200 sieve) of Sample 5. The X-rays were generated from a cobalt (Co) source ($K\alpha = 1.79026 \text{ Å}$).

EICP bulk stabilization tests were conducted on six samples, designated Sample No. 1, 4, 5, 7, 11, and 12, of sand and silty sand obtained from various locations in the Yuma area. Samples 2, 3, 6, 8, 9, and 10 were not tested for bulk stabilization because of excessive fines content. The sampling locations, fines content, and Atterberg limits of the samples are reported in Table 1. Fines content and Atterberg limit tests were conducted in general accordance with the relevant ASTM standards. Based upon the fines content and Atterberg limits of the samples, Sample No.7 was classified as a clean sand (poorly graded, or SP, based upon visual observation) in the Unified Soil Classification System (USCS). Samples 4, 5, and 11 were dual classified poorly graded silty sand, SP-SM in the USCS. Samples 1 and 12 are silty sands, classified as SM in the USCS. The fines in Samples 4,5, 7, and 11 were non-plastic while the fines in Samples 1 and 12 were classified as low plasticity silt in the USCS. The mineralogy of Samples 5 and 7 was characterized by X-ray diffractometry. The diffractograms, shown in Figures 1 and 2, indicated the presence of quartz, calcite, vaterite, and orthoclase feldspar in the specimens.

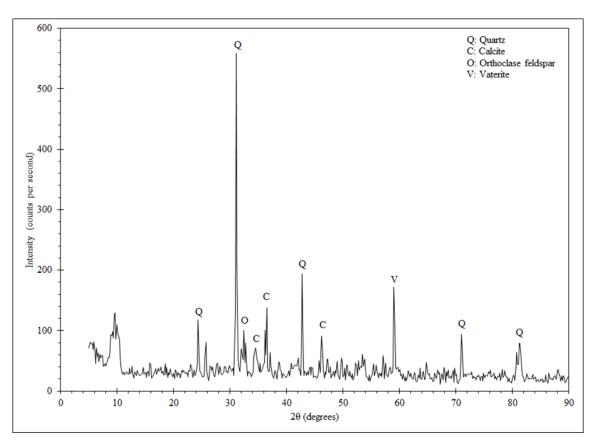
Figure 2. X-ray diffractogram of fine fraction (passing No. 200 sieve) of Sample 7. The X-rays were generated from a cobalt (Co) source ($K\alpha = 1.79026 \text{ Å}$).

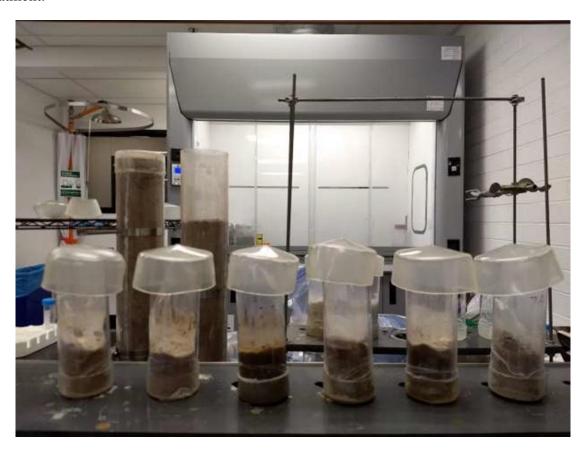
Figure 3. Typical setup of soil columns treated via EICP.

In the EICP bulk stabilization tests, samples were treated in 50 mm (\approx 2-in.) diameter acrylic tubes to form columnar specimens. The bottom of the tube was closed with a plastic cap and sealed with an adhesive. A polypropylene liner was placed inside the acrylic tubes to facilitate the extraction and testing of the treated specimens . Approximately 150 g of soil was added to each acrylic tube to create a specimen of approximately 45 mm in height. Following placement of soil within the tube, the EICP treatment solution was prepared and mechanically mixed with the soil inside the tube. Approximately one pore volume of treatment solution was added during each treatment cycle. The first cycle of treatment was performed by mixing the treatment solution with the soil using a spatula followed by light tamping of the soil-treatment solution mixture.

Figure 3 shows the typical setup of soil columns treated via EICP. Table 2 presents a summary of the EICP testing performed for this study, including the number of treatment cycles, any special treatment conditions, and the percentage of calcium carbonate in the soil before and after treatment.

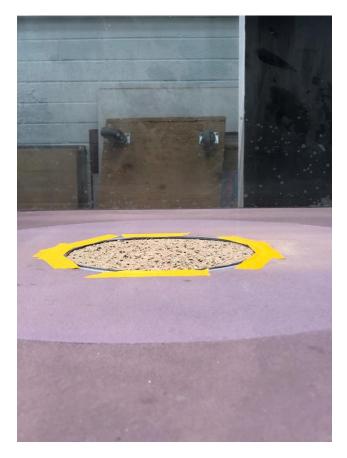
Figure 4. Specimen 2-3 (dry control) set into the floor of the wind tunnel and taped to secure during testing.

After curing, the specimens were wind tunnel tested, penetration tested, the crust thickness was measured, and crust calcium carbonate contents were evaluated. Resistance to wind erosion was evaluated in the ASU NASA Planetary Wind Tunnel. This wind tunnel is designed to produce laminar flow for measurement of the threshold detachment velocity (TDV) of the specimen. TDV is defined as the wind speed at which the soil is continuously detached from the surface and entrained in air. The wind tunnel has a maximum safe operating velocity of 24 m/s (54 mph). Figure 4 shows the placement of the specimen into the wind tunnel with the surface flush with the bed of the wind tunnel and the pan secured with tape.

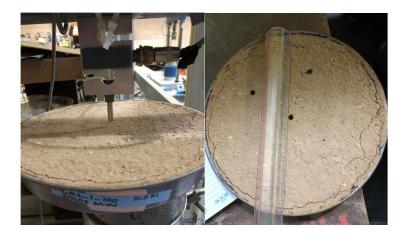
Figure 5. Specimen 2-2 (226 L/m2 EICP treatment solution) undergoing penetration testing (left) with the spacing between tests (Right).

Following the completion of the wind tunnel testing, penetration testing was performed on intact portions of the crust. In the penetration tests, a 0.64 cm (0.25-in)-diameter flat-nose cylindrical probe affixed to an unconfined compression machine loading piston was pushed into the specimen at a constant rate of 0.10 cm/min (0.04 in/min) and the normal force exerted on the crust was recorded. This test was performed at three points spread out over the surface and the reported results are the average of the three trials. Figure 5 shows the penetration testing setup and location of the three penetration tests on one of the specimens. Figure 6 shows the averaged penetration versus depth curves for the six specimens that were tested.

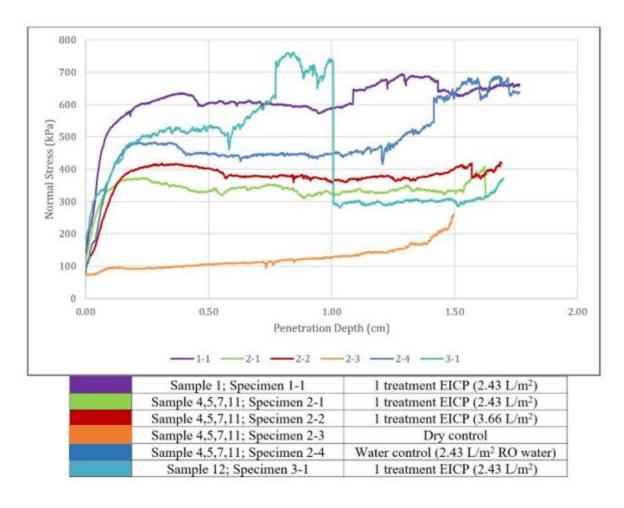
Figure 6. Comparison of EICP treated and untreated specimens crust strength from penetration testing.

The penetration results are summarized in Figure 6. Figure 6 shows the dry untreated specimen has a significantly lower penetration resistance than the other test specimens, consistent with the wind tunnel test results. The penetration resistance for the treated specimens was somewhat variable but, in all cases, significantly greater than that of the dry untreated specimen. The water-treated specimen, specimen 2-4, had a penetrative resistance in the middle of those for the four EICP-treated specimens.

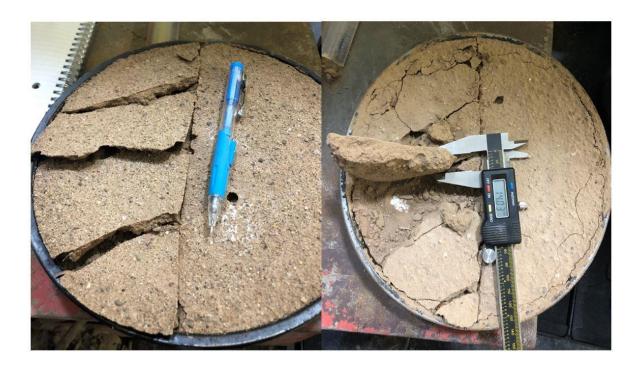
Figure 7. Crust measurements of specimen 2-1 (Left) and 1-1 (Right).

The thickness of the crust of the four EICP-treated specimens and one water-treated specimen were measured using calipers. Sections of the treated specimens were sampled using a spatula to separate the crust from the uncemented layers. Figure 7 shows sections of the crust from an EICP treated specimen.

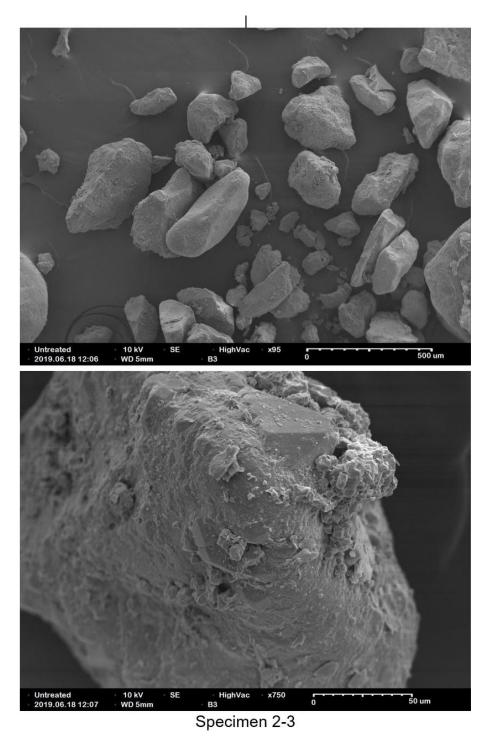
Figure 8. SEM results of untreated soil from specimen 2-3.

SEM results on crust specimens are presented in Figure 8 and 9. Precipitation is noted on and in between sand particles. Though pre-existing precipitation and precipitation related to the native carbonate content of the soil cannot be distinguished from precipitation formed by EICP treatment, these images appear to show a difference in carbonate morphology and carbonate content, with an increase in carbonate crystal precipitation in the treated specimen compared to the untreated specimen. The increase in carbonate precipitation between the two specimens appears, at least visually, to be greater than the measured increase in overall carbonate content, perhaps because the SEM images are more localized in the very top of the crust (the specimen averaged carbonate content over the top 1.5 cm of the crust).

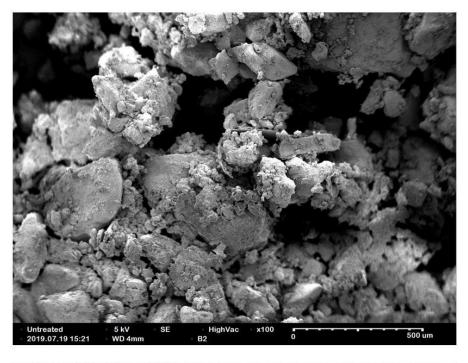
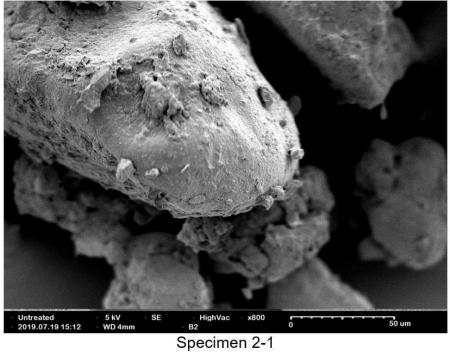
Figure 9. SEM results of treated soil from specimen 2-1.
